STONEMASONRY
MATERIALS
AND SKILLS:
A methodology for
surveys of sandstone
building facades

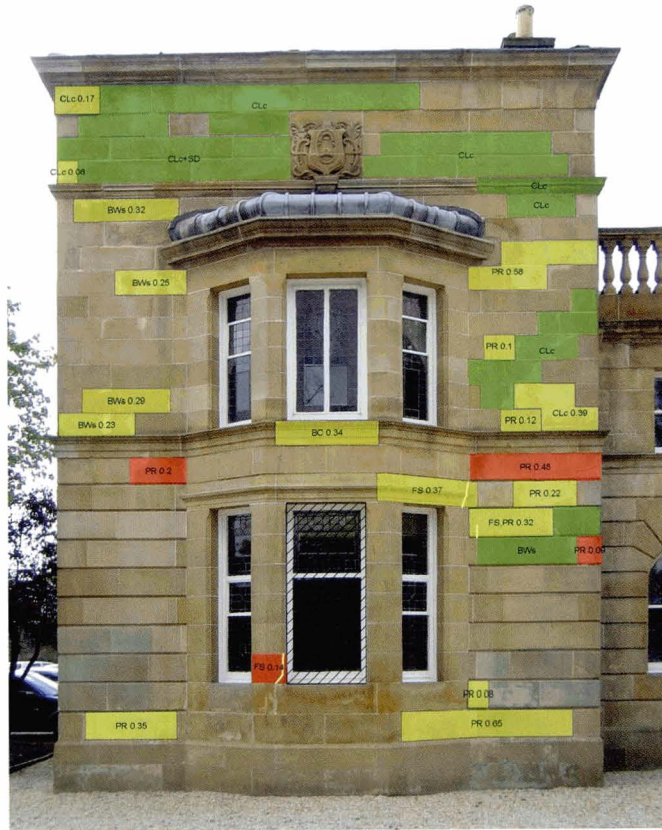
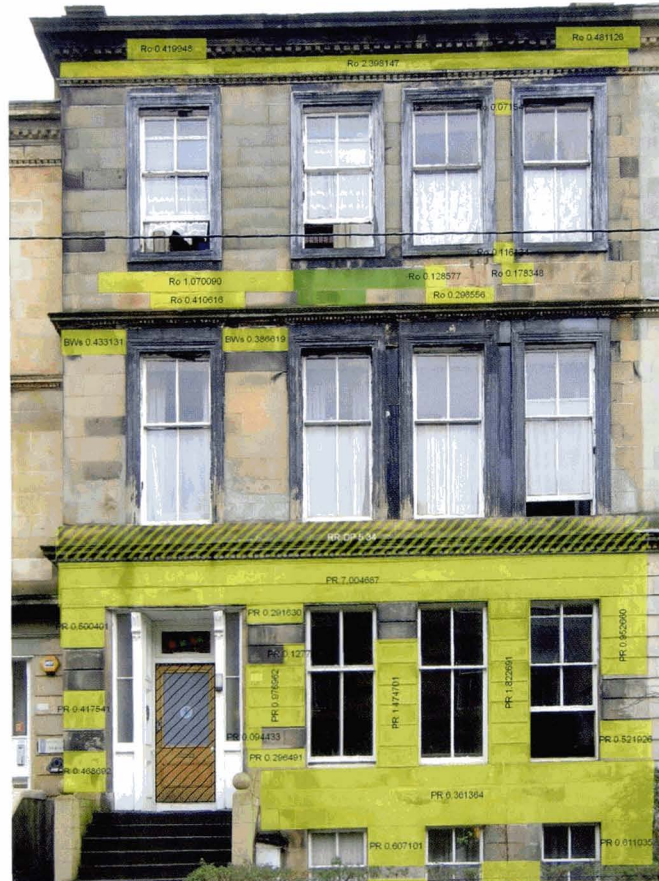
Figure 2. Examples of the results of facade surveys with stone decay identified by a colour coding system (Photos: BGS©NERC)

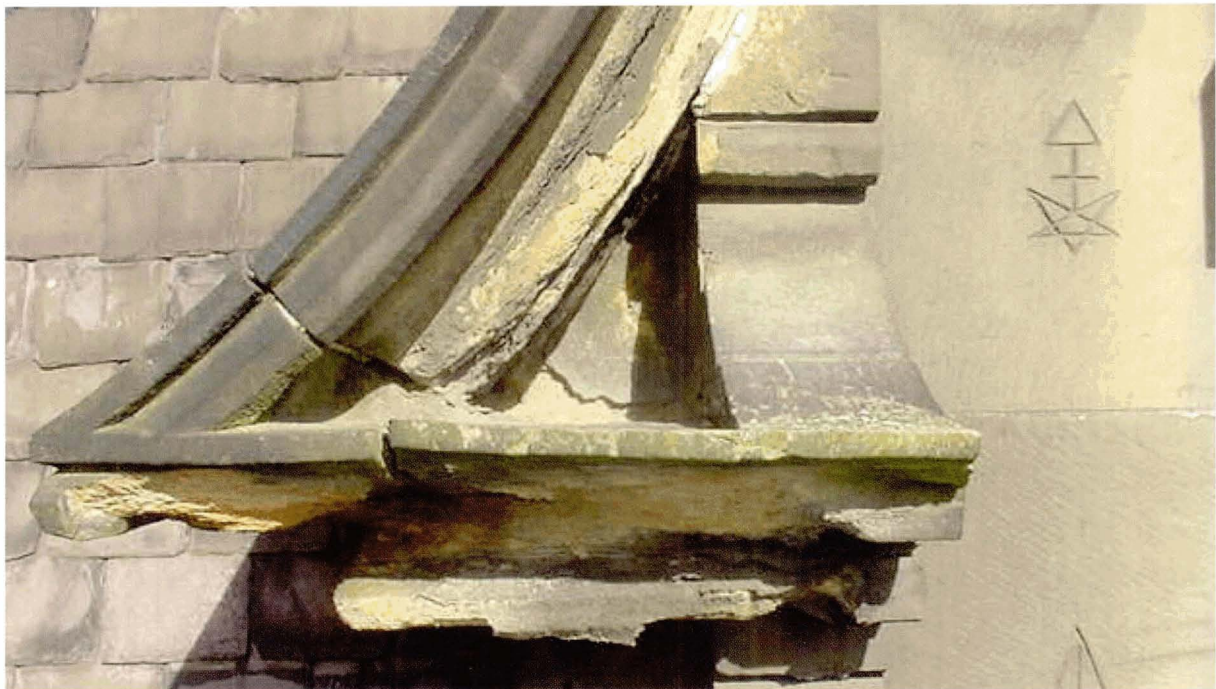
Figure 3. Decayed cornice presenting a risk of falling masonry (Photo: Edinburgh City Council)

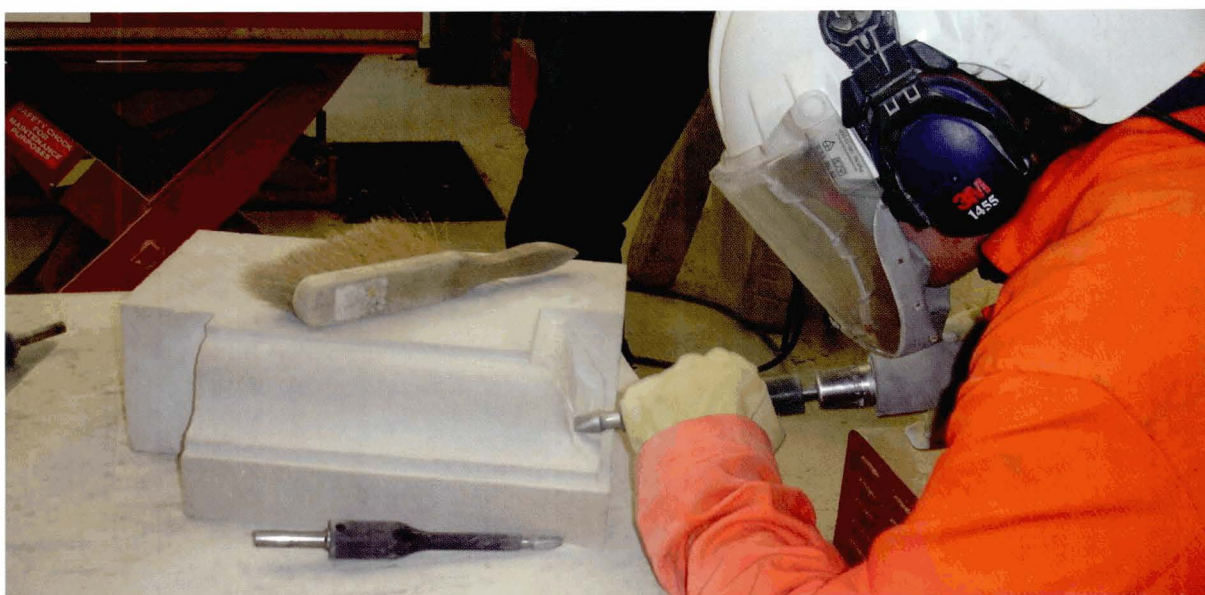
Figure 4. Stone mason apprentice in training (Photo: Historic Scotland)

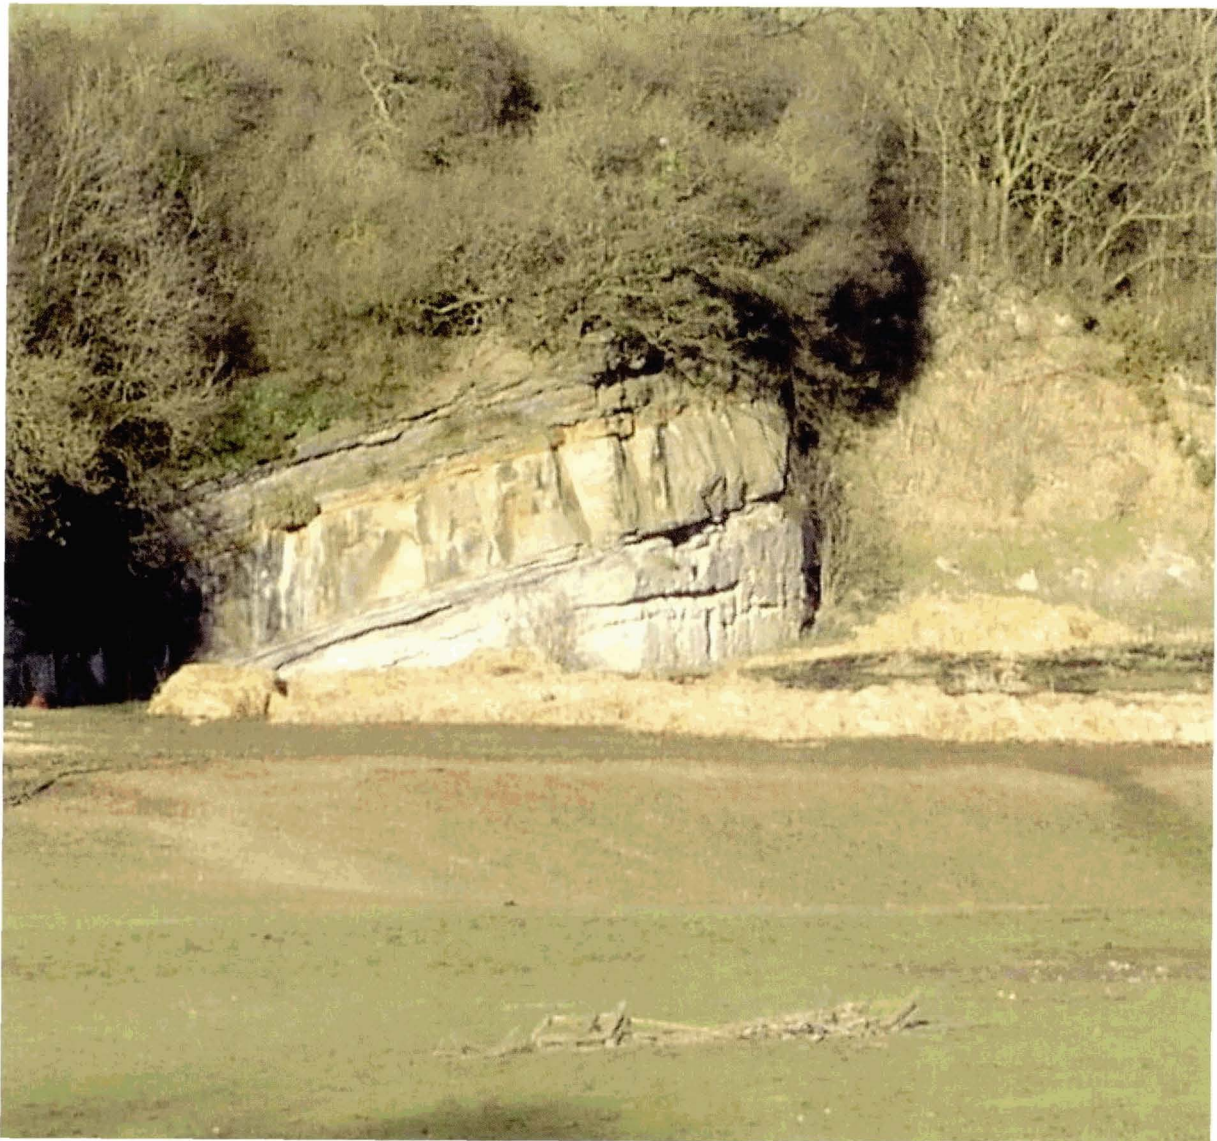
Figure 5. This disused sandstone quarry in Fife, which supplied stone for construction in Edinburgh and the local area prior to closing in 1914 (Photo: E Hyslop, BGS©NERC)

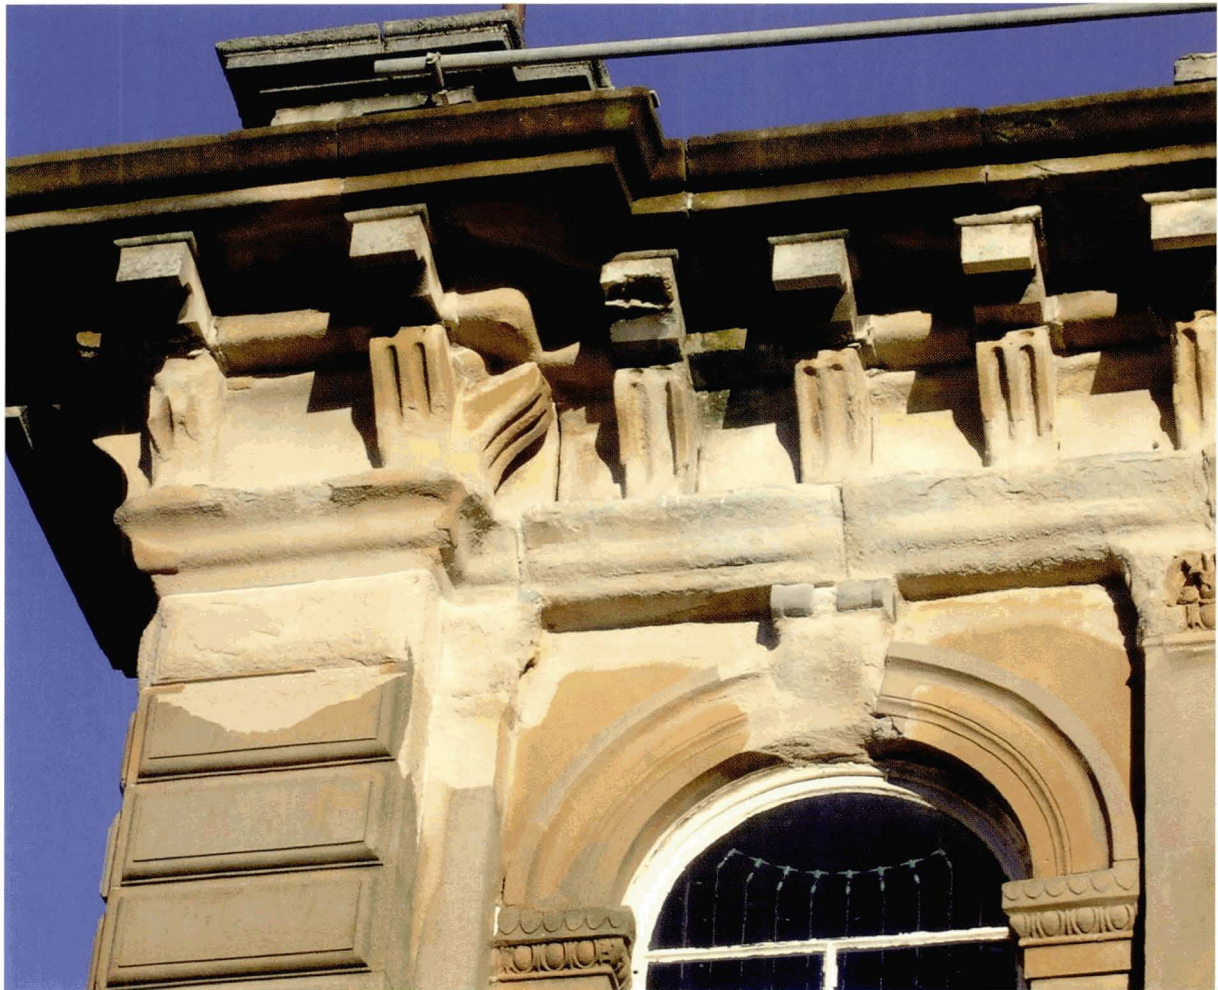
Figure 6. An extreme example of sandstone decay promoted by chemical stone cleaning. Falling masonry is now a risk on this building (Photo: D Urquhart)

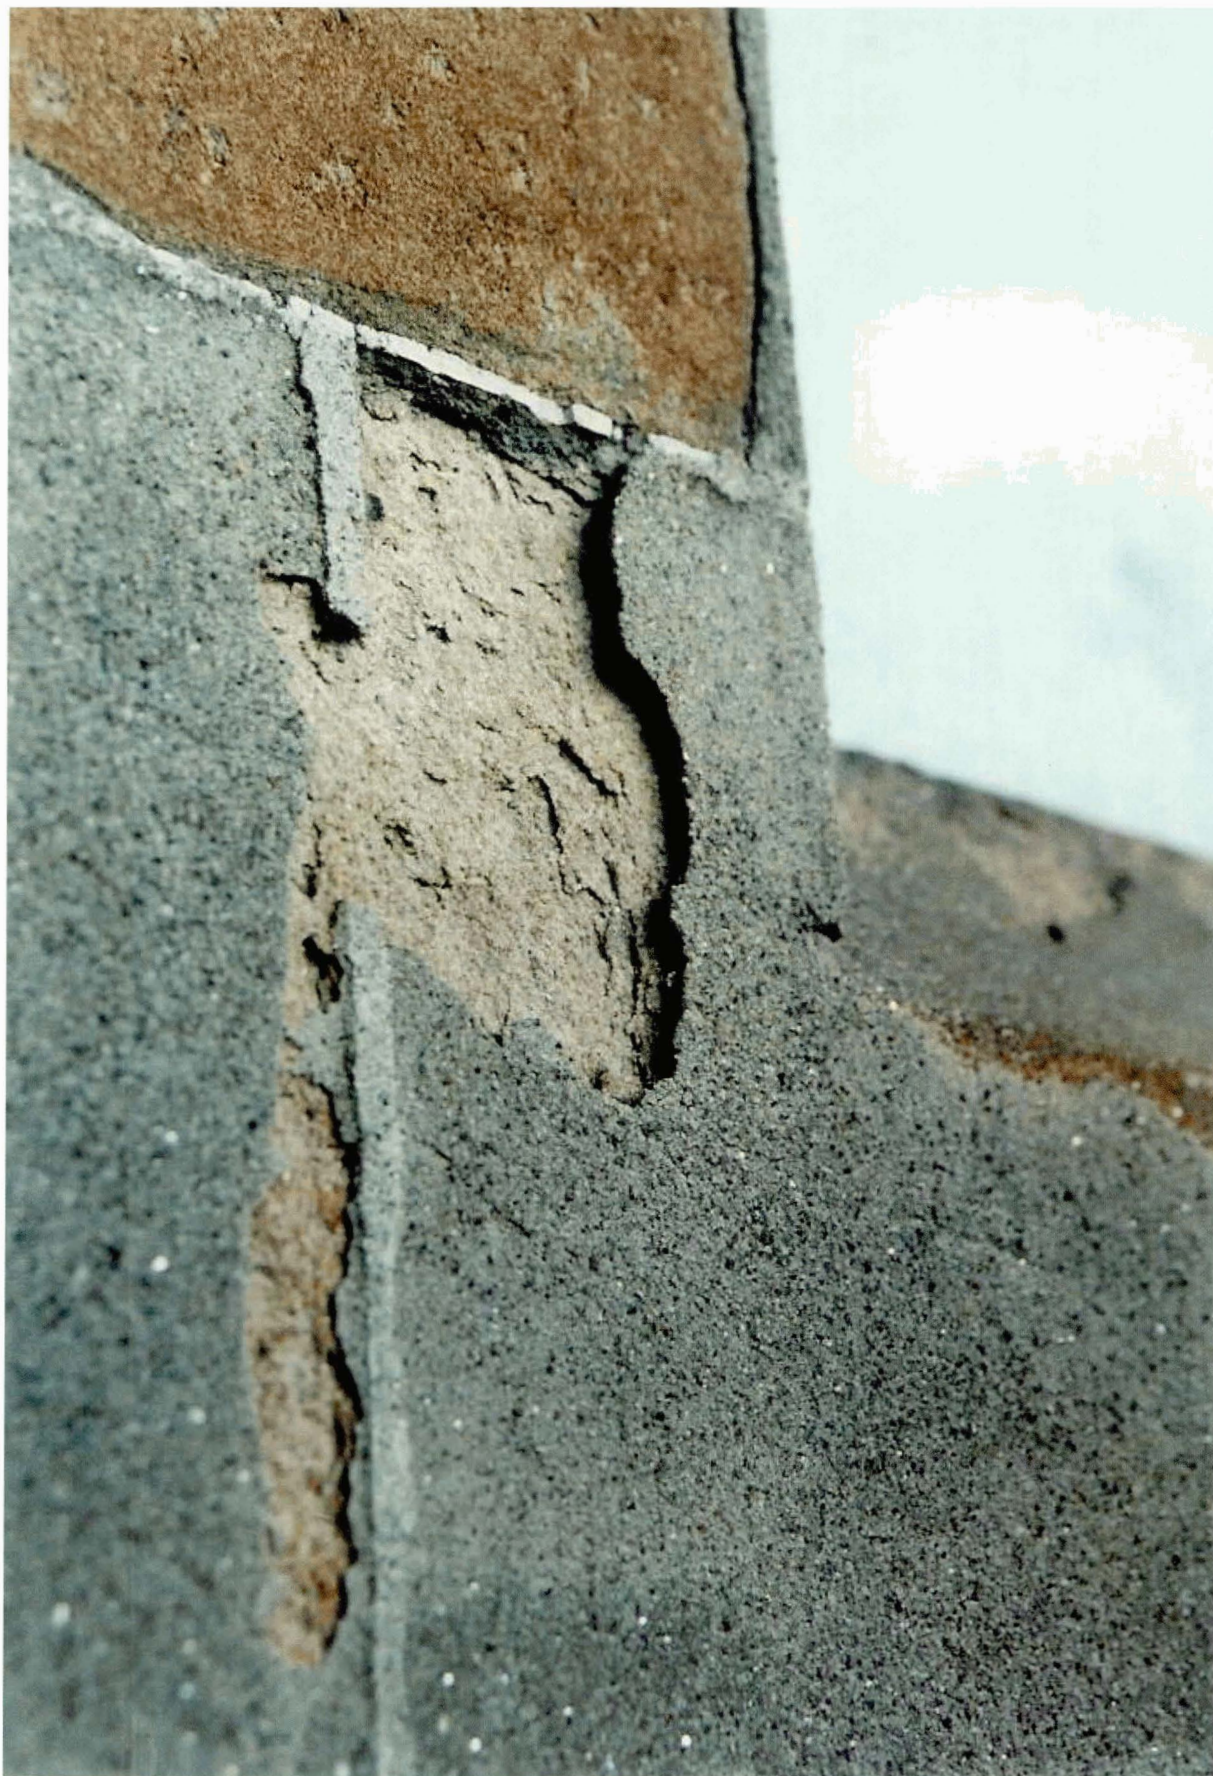
Figure 7. Typical example of plastic repair causing damage to the underlying sandstone (Photo: D Urquhart)

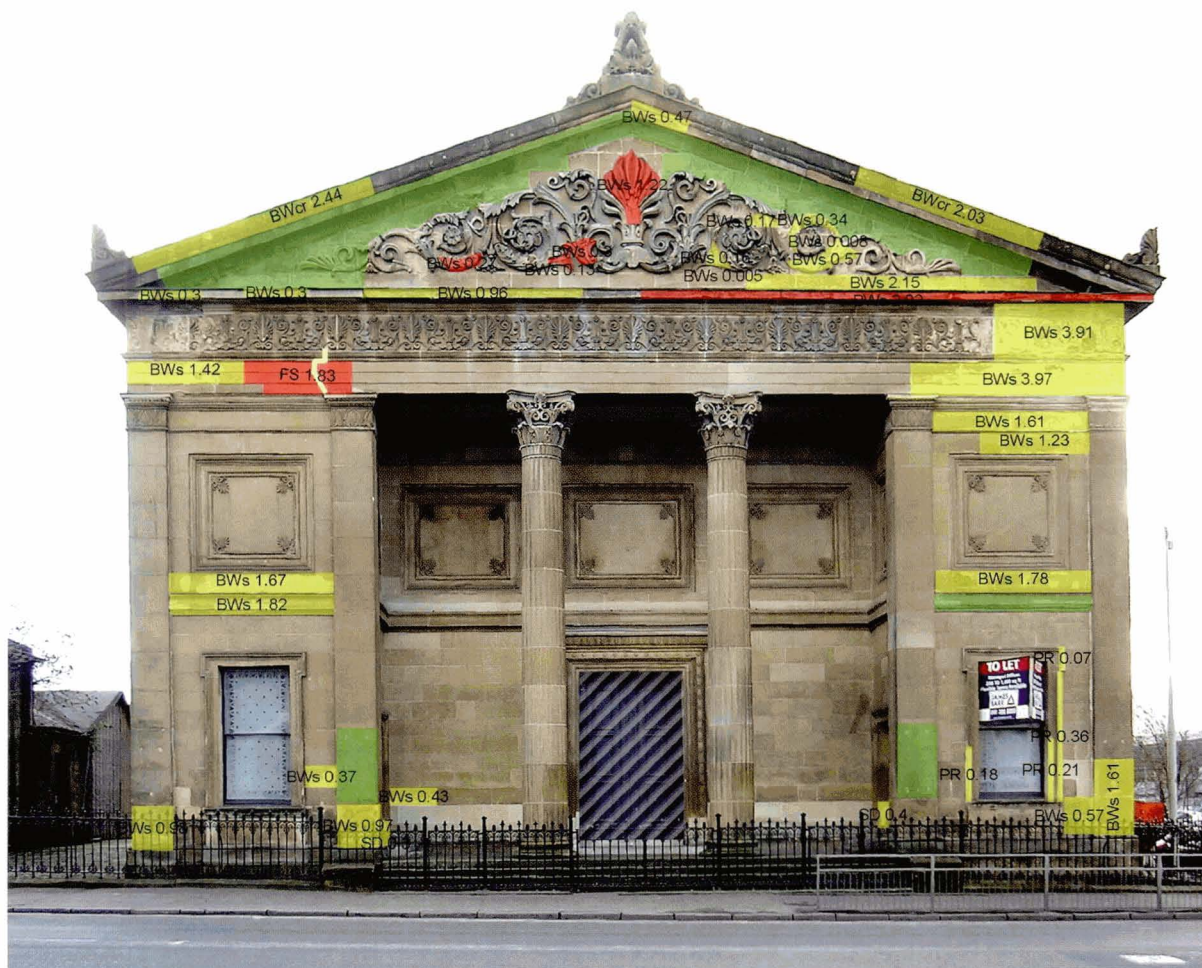
Key to colour coding on marked-up images

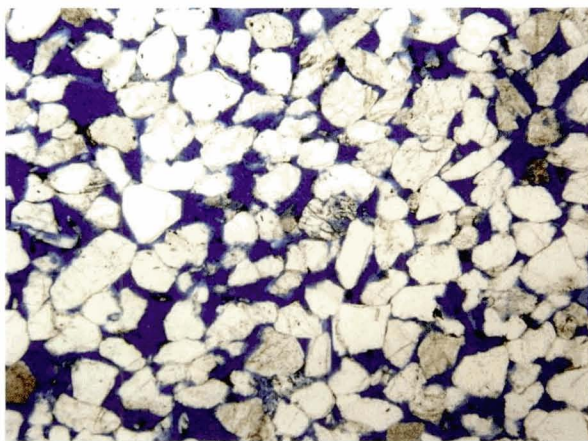
Figure 11. Example of a thin section image of sandstone showing a uniform texture of quartz grains. Scale width represented by the slide is 3 mm. The porosity of the stone is indicated by the blue resin. (Image: British Geological Survey, BGS©NERC, from the Glasgow Report)

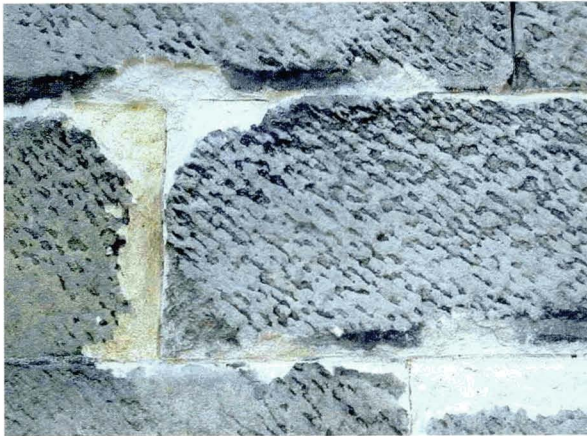
a) Surface crust formed (tooling on surface is still intact) but the loss of sandstone cement from the grains below the surface has led to granular disaggregation in the surface zone for more than 20 mm depth.
Classification: Immediate replacement

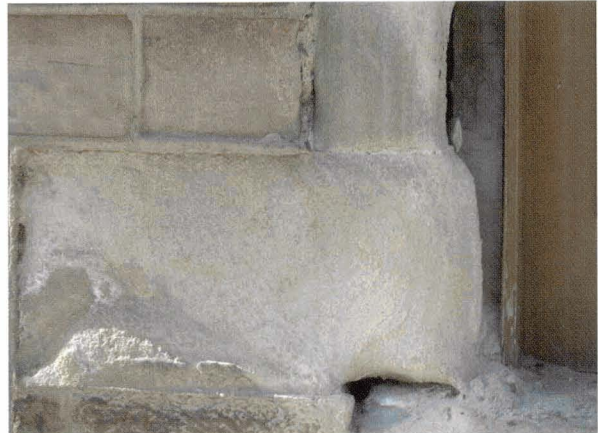
d) Granulation: Serious loss of binding cement in the blonde sandstone. Possibly associated with salt action and hard pointing.
Classification: Immediate replacement

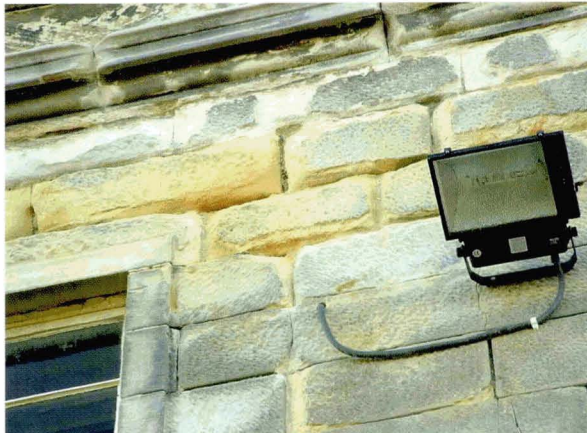
b) Crust plus granulation: Edge erosion: similar action to illustration a) and decay is accelerated by loss of pointing in both the drip moulding, and in the stonework generally, and/or use of hard mortar.
Classification: Immediate replacement

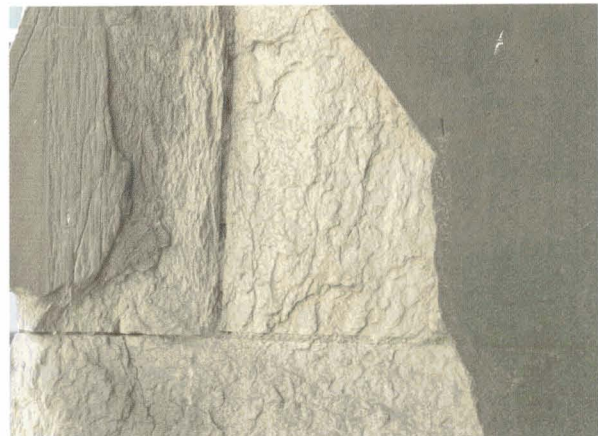
e) Flaking: Pre-existing decay accelerated by a covering of cement mortar plastic repair.
Classification: Immediate replacement

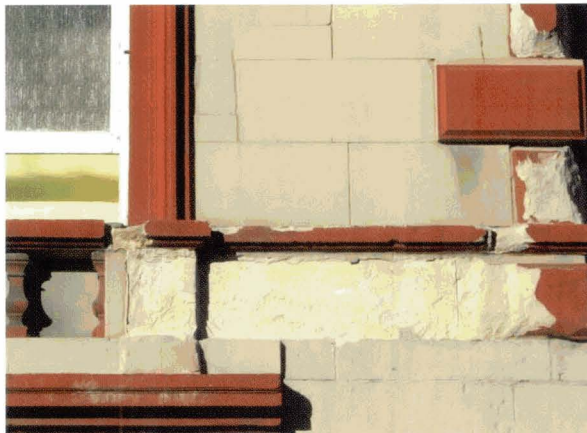
c) Loss of stone surface. Primary cause is difficult to determine but the facade has been cement plastered and painted resulting in entrapped moisture. Maintenance will be required on this facade to remove the cement plaster within the next twenty years.
Classification: Immediate replacement of decayed stone and maintenance of plastered areas within twenty years

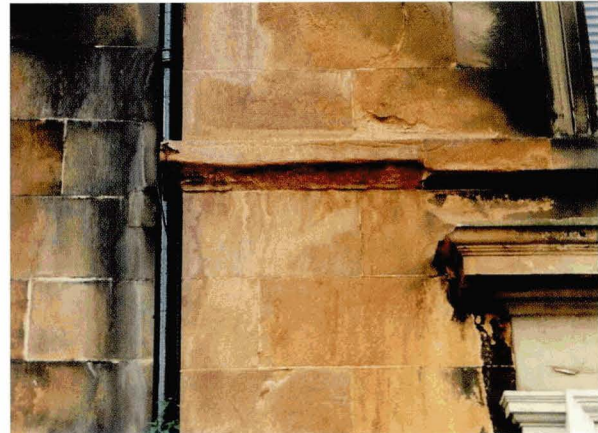
f) Partial loss of stone from drip moulding leading to surface runs of rainwater but some function still retained.
Classification: Replacement within twenty years

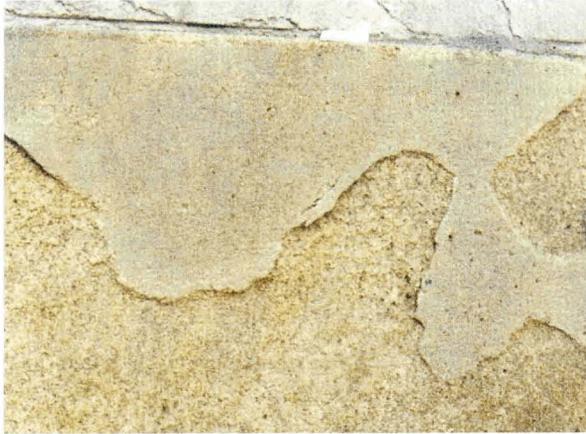
g) Contour scaling on ashlar – large sheets several millimetres in thickness.

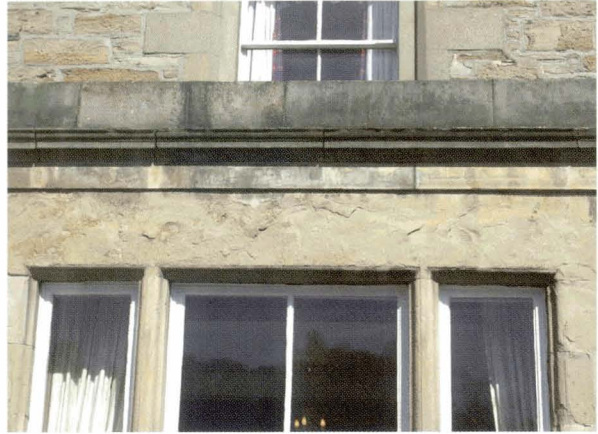
j) Multiple scaling: Surface scaling of lintel. No immediate structural problem.

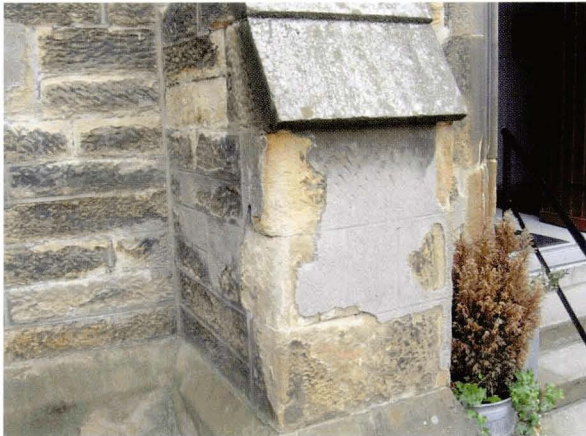
h) Cement mortar patch; in this case the stone decay is minimal behind the patch.

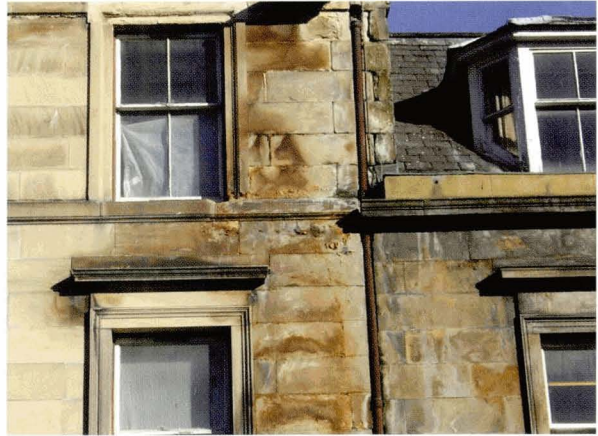
k) Water leaking from parapet gutter has saturated stone causing iron staining.

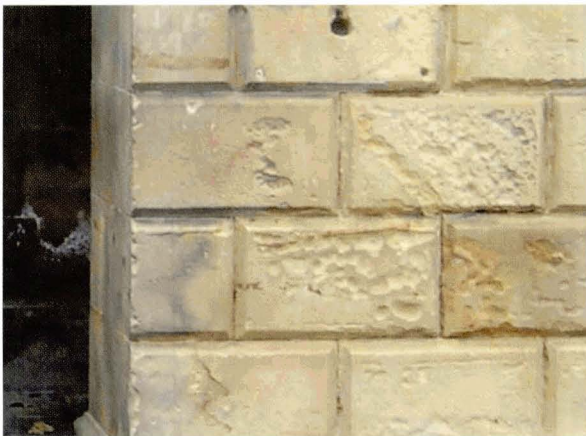
i) Differential decay. Natural weathering of stone on 200 year old facade.

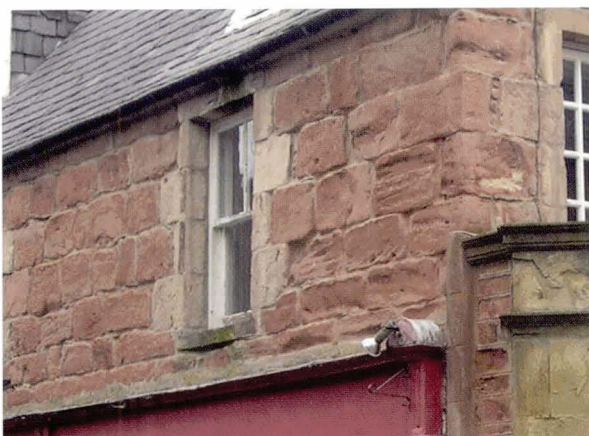
l) Squared rubble (clay-rich sandstone) has suffered long-term granulation, possibly aggravated by salt action due to coastal location. While a lot of surface has been lost the stone remains structurally sound.

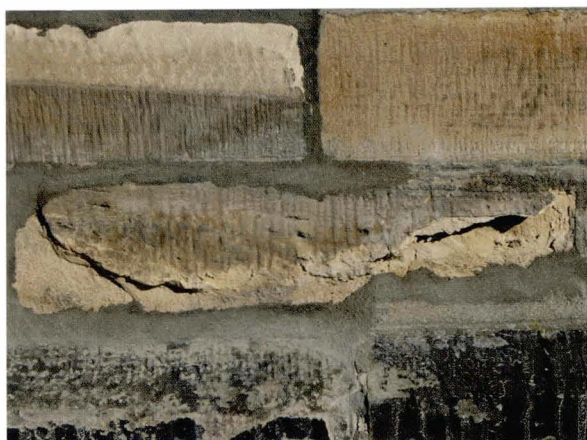
n) Squared rubble. Scaling due to association with hard mortar, allowing water penetration into the wall.

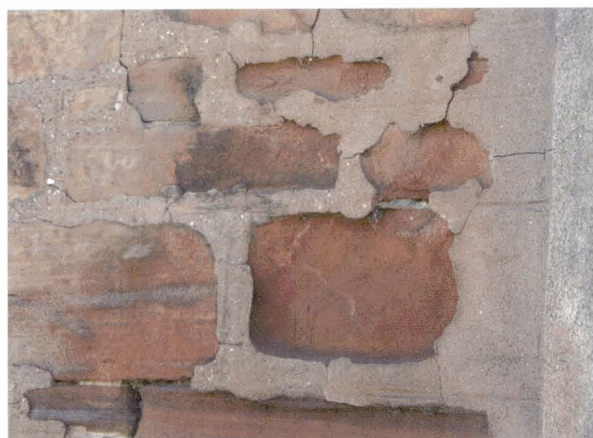
m) Back weathering: Rubble wall - stone erosion due to hard mortar pointing.

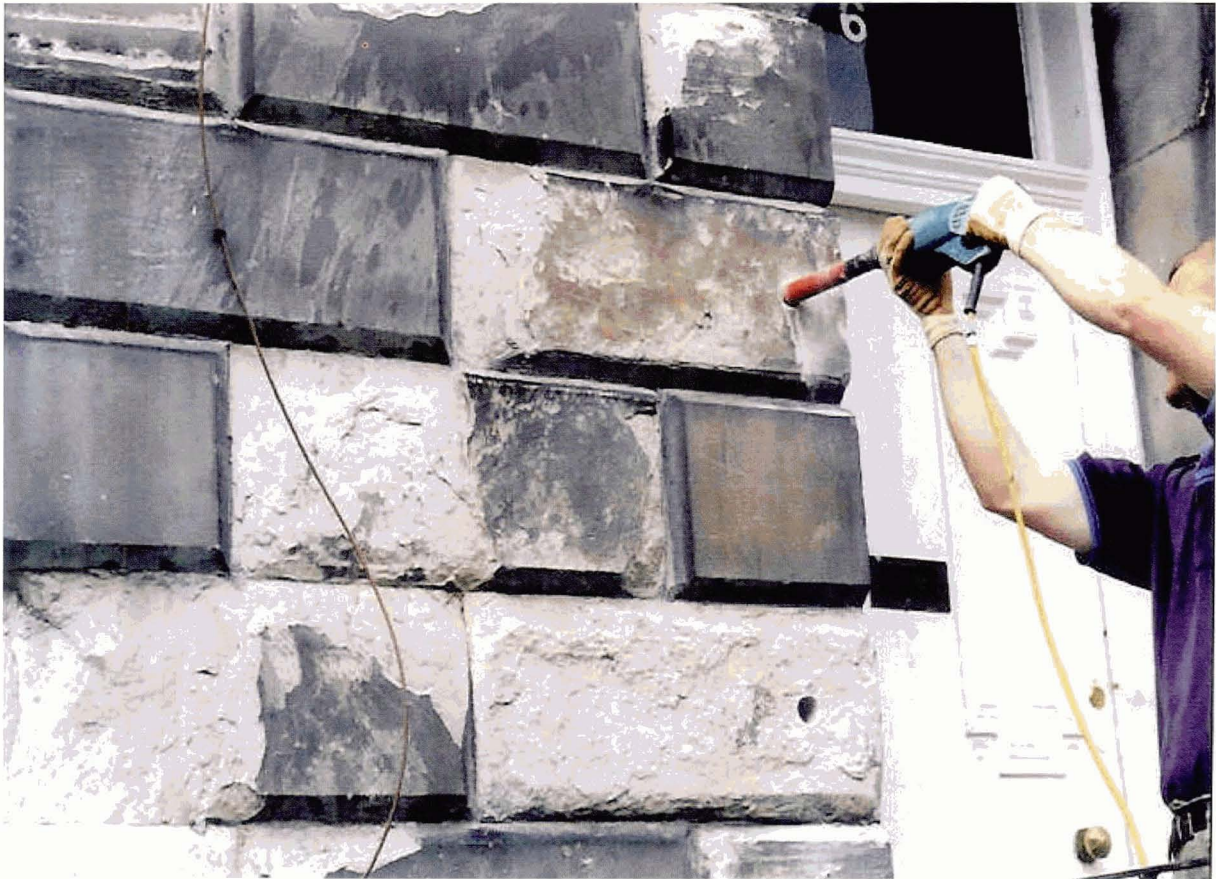
Fig 14 Diamond core drilling to extract small-diameter plug of stone from damaged masonry (Photo: BGS©NERC)

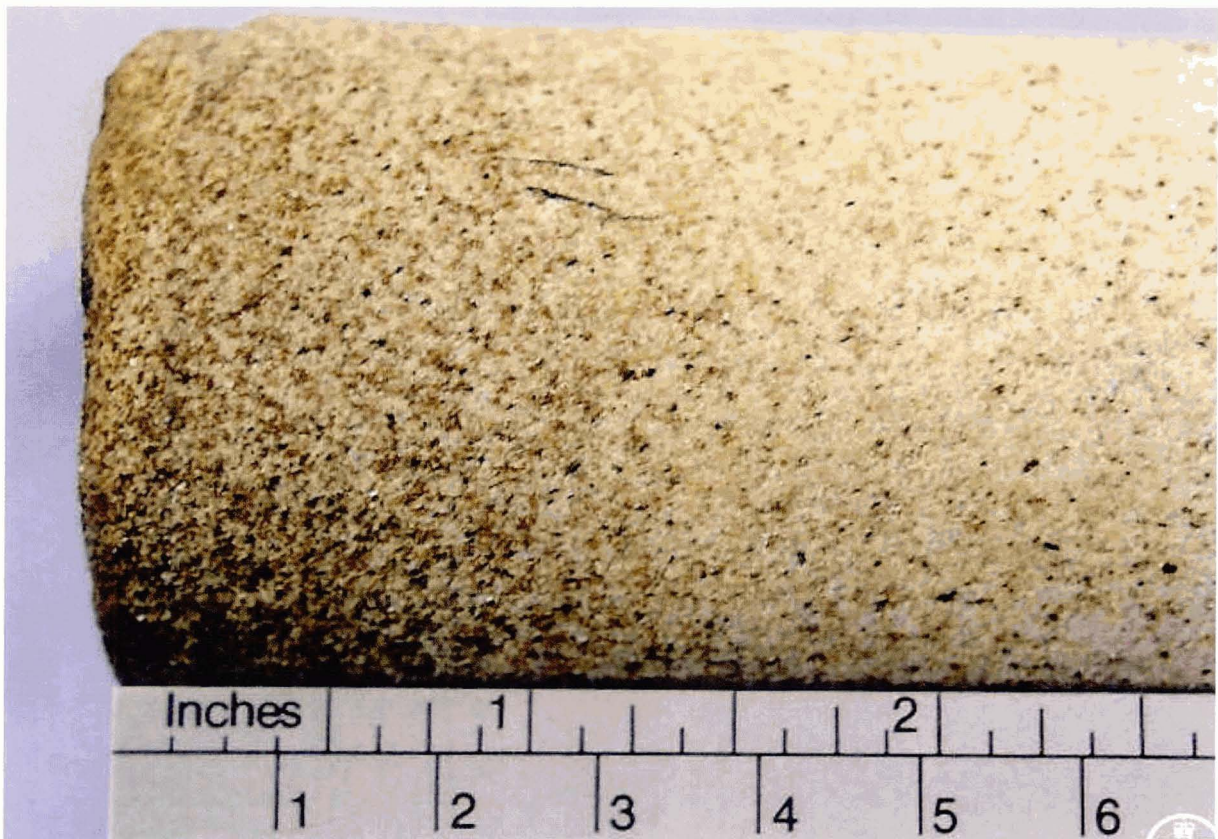
Fig 15 Detail of sandstone core showing decay in the outer few centimeters (Photo: BGS©NERC)
