TECHNICAL PAPER 31

HISTORIC EXTERNAL LIME FINISHES IN SCOTLAND

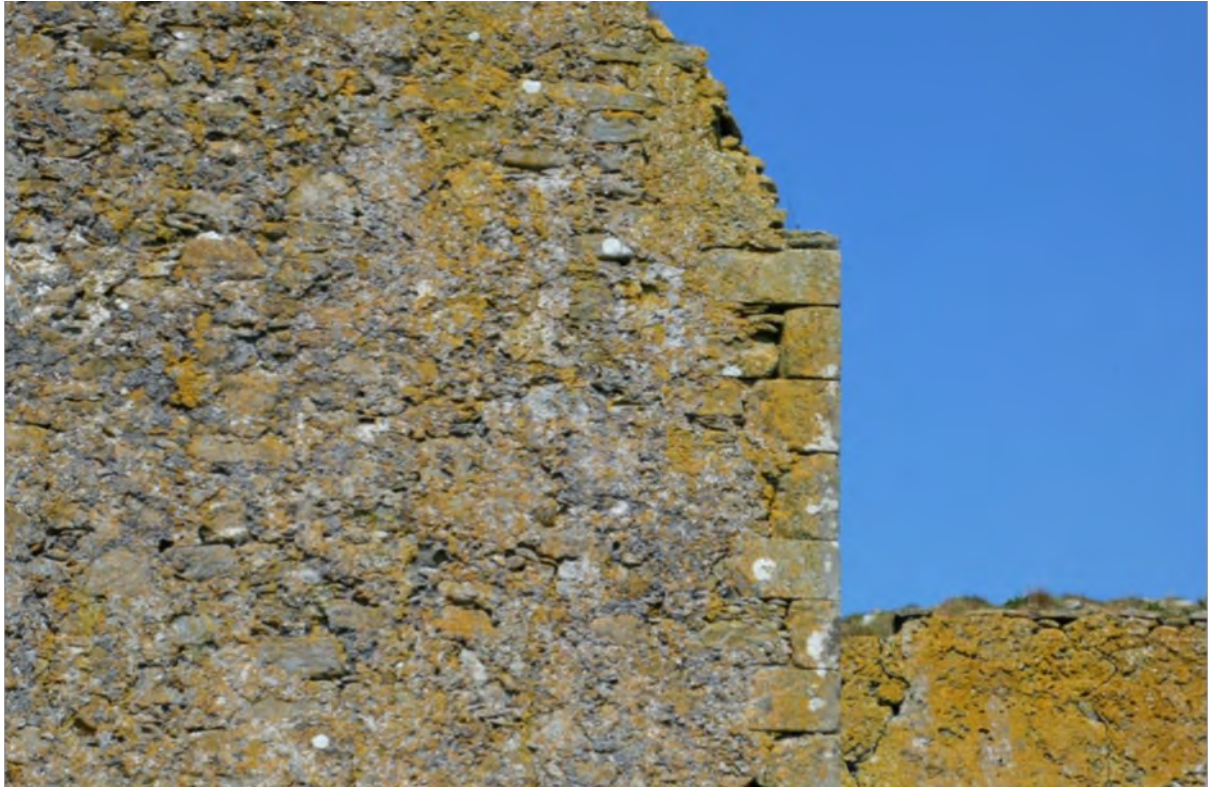
Figure 1. Ormacleit House, South Uist. Decayed harl surviving on the south-west gable.

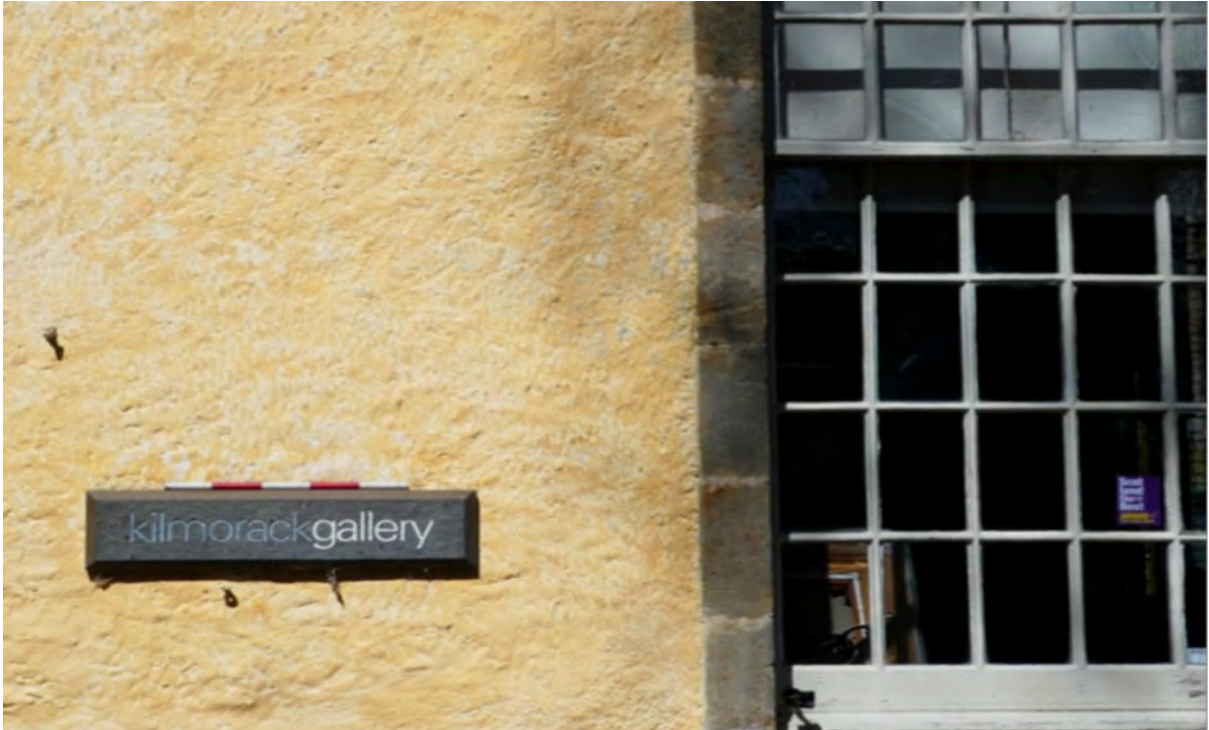
Figure 2. Kilmorack Old Kirk, Beaulieu, Inverness. Fading harl and limewash against the raised margins of the window.

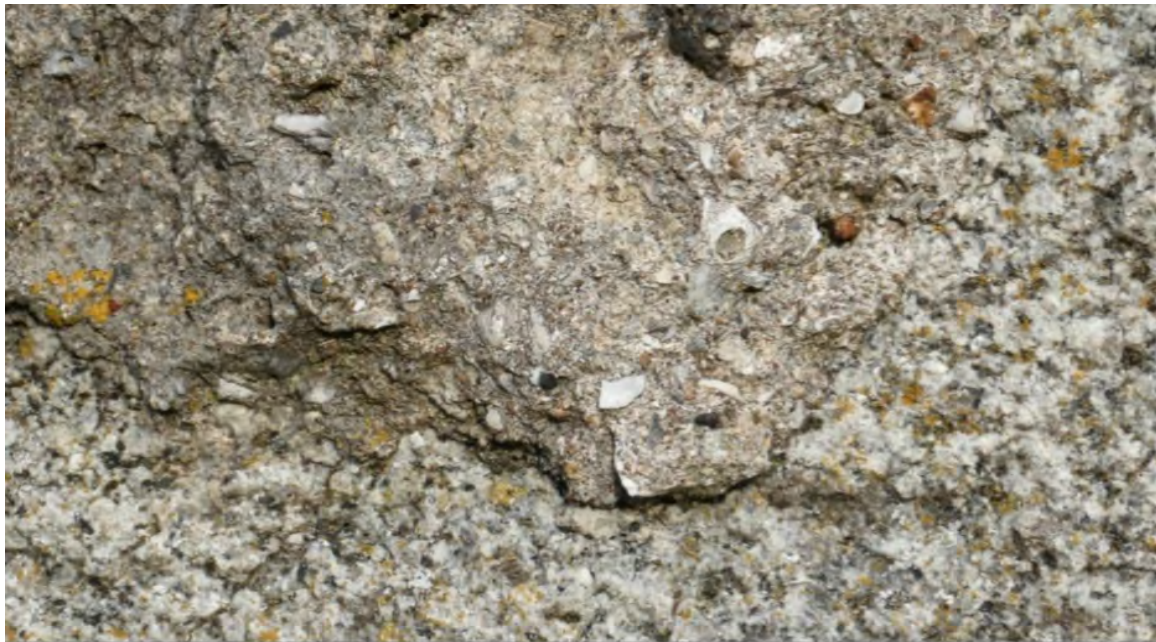
Figure 3. Marine harl fragment from Orchardton Tower, Dumfries and Galloway.

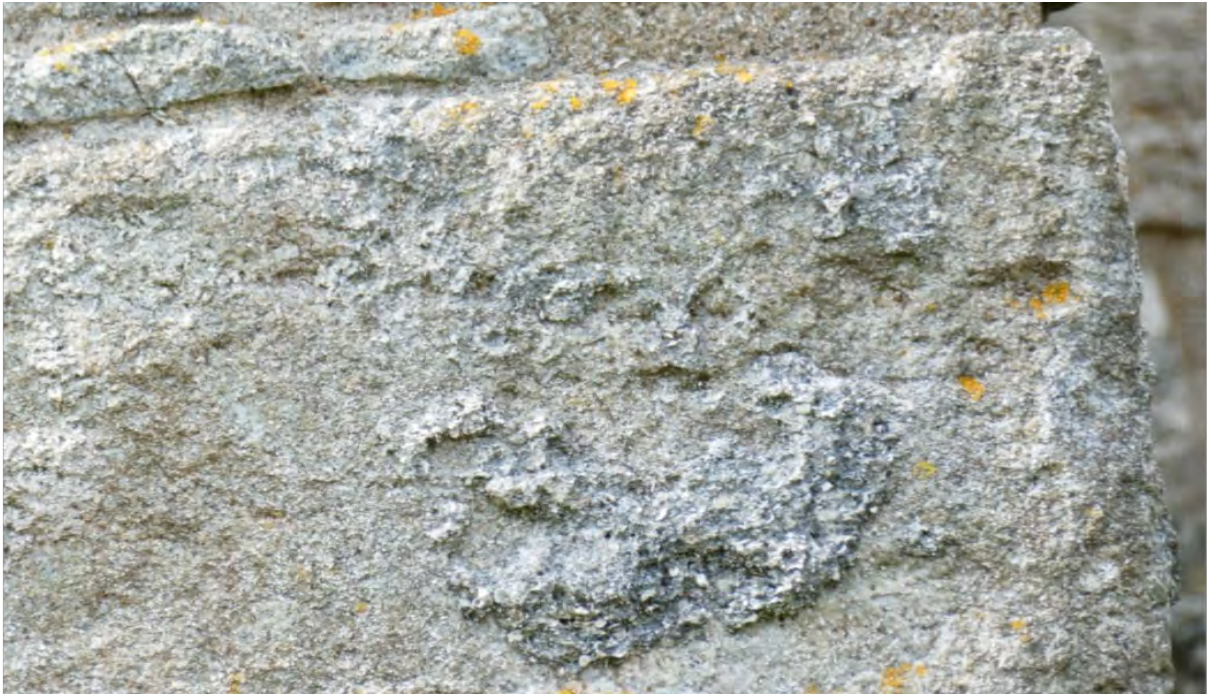
Figure 7. Harl fragment from St Clement's Church, Rodel, Isle of Harris.

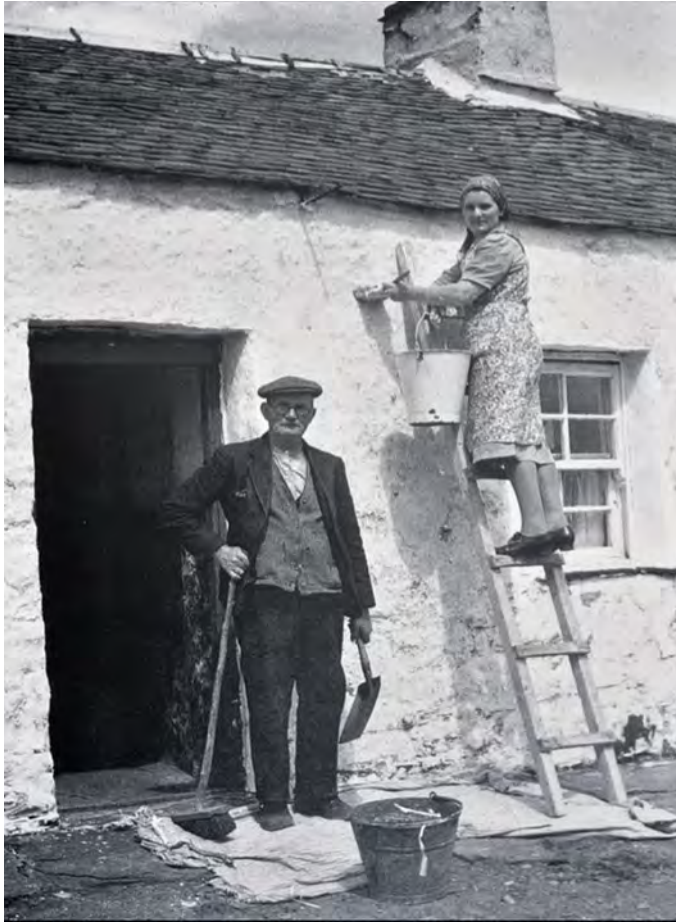
Figure 8. Cullipool, Luing, Argyllshire. This shows seasonal limewashing as part of the annual cycle. From the Alasdair Alpin MacGregor Collection. National Museum of Scotland.

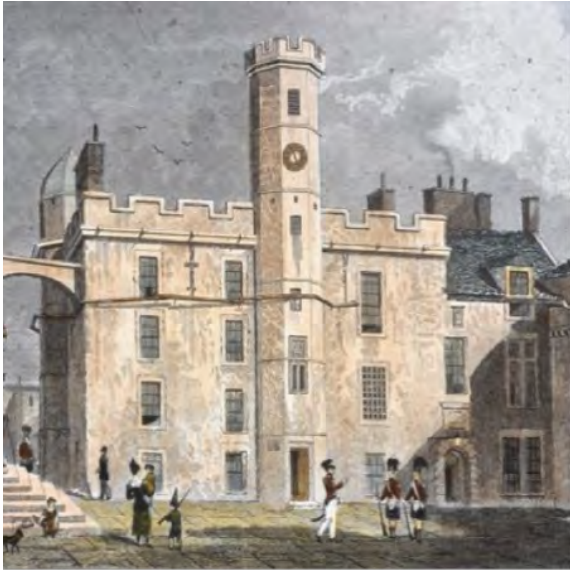
Figure 10. View of the Royal Palace at Edinburgh Castle with harl extant.

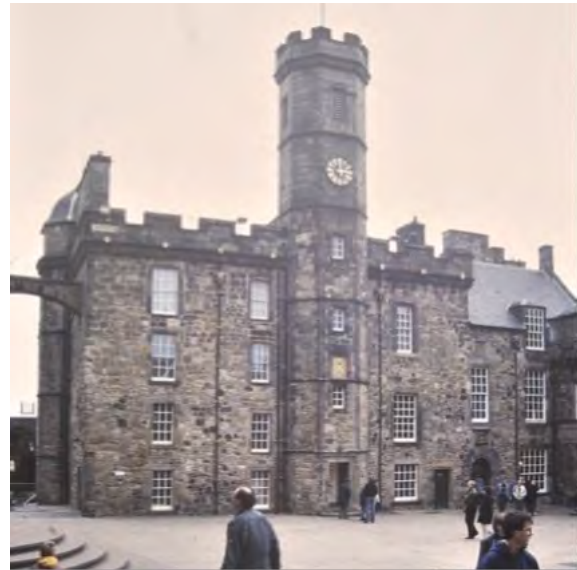
Figure 11. View of the Royal Palace at Edinburgh Castle with harl removed.

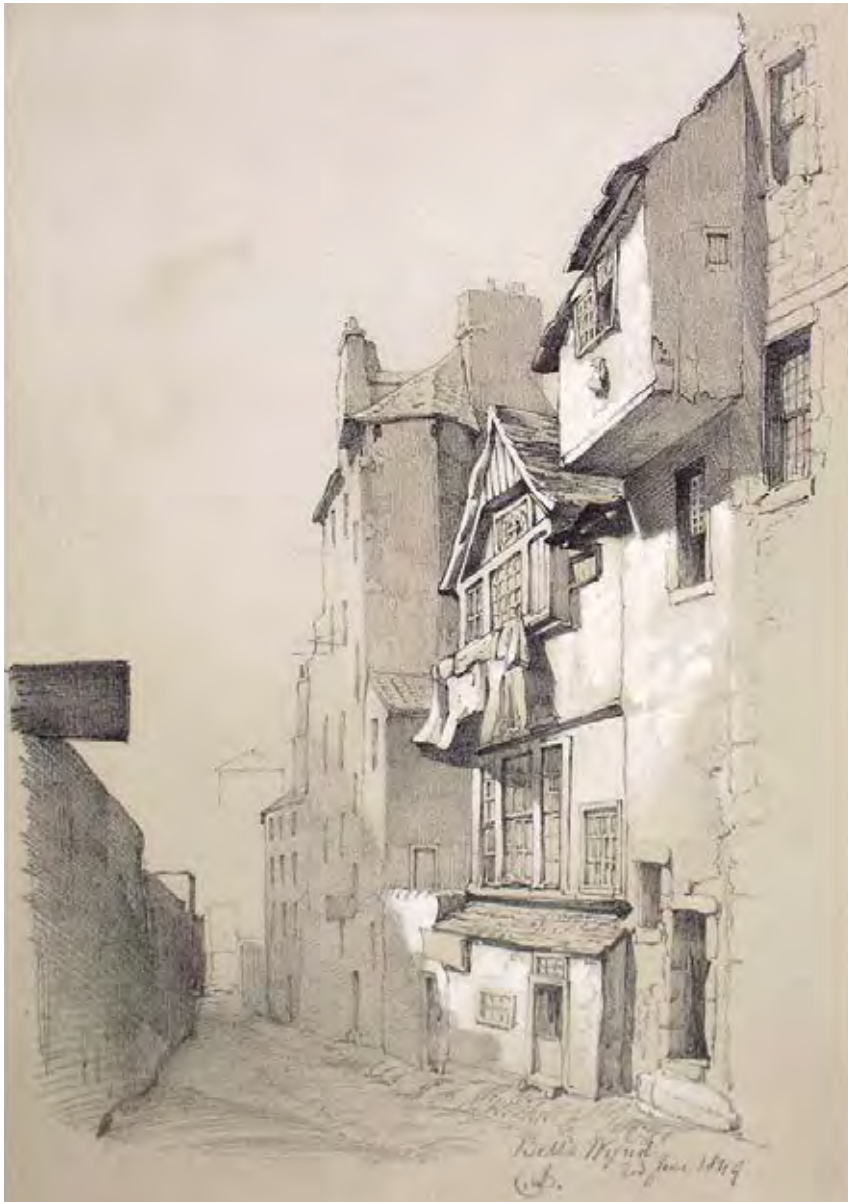
Figure 13. Bell's Wynd, Edinburgh painted in 1849 by James Drummond

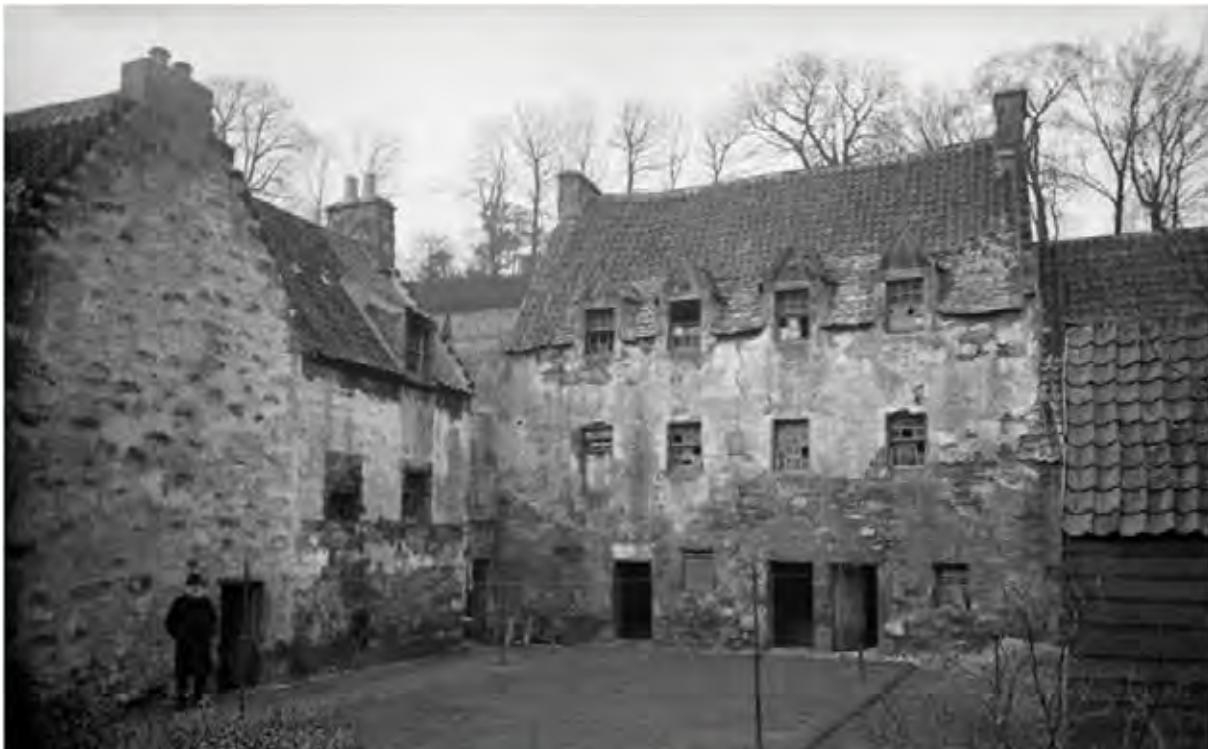
Figure 15. Culross Palace, Fife, by Erskine Beveridge, c.1882-6, Image from Canmore.

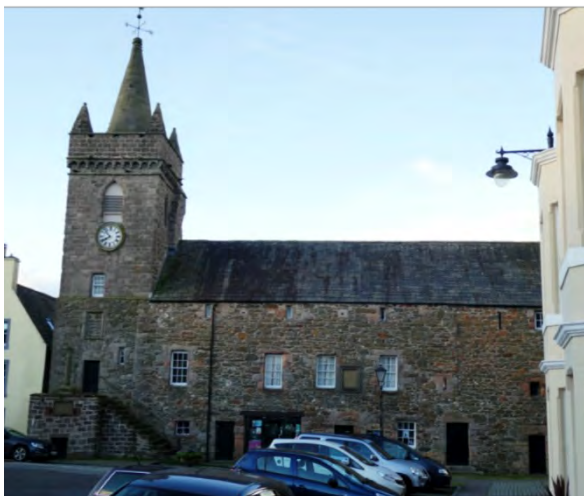
Figure 16. Tollbooth, Kirkcudbright. Seen today without harl.

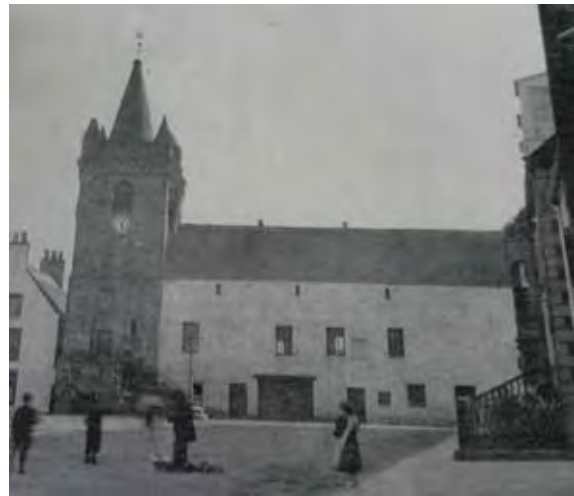
Figure 17. Tollbooth in the 19th century, recorded with harl (photo courtesy of the Stewartry Museum, Kirkcudbright).

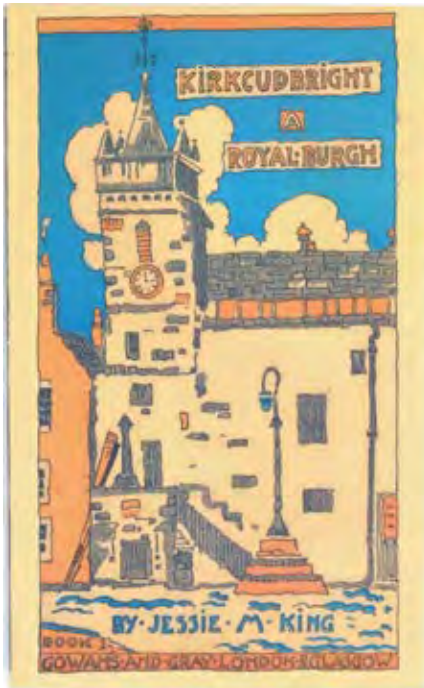
Figure 18. The front cover of *Kirrcudbright, a Royal Burgh* by Jessie King.

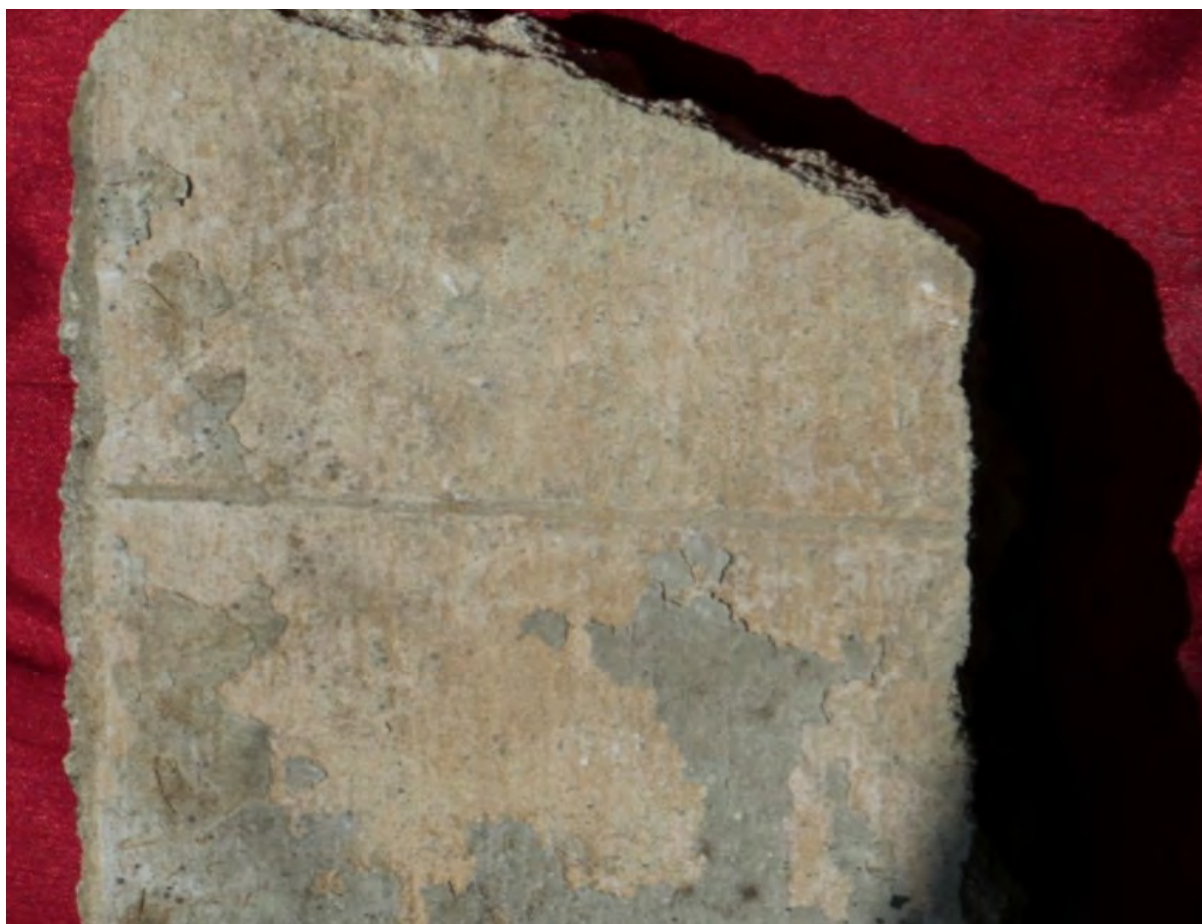
Figure 19. A fragment of a plastered window front door lobby from Douglas Row, Inverness, showing the ‘lining out’ of flat plaster.

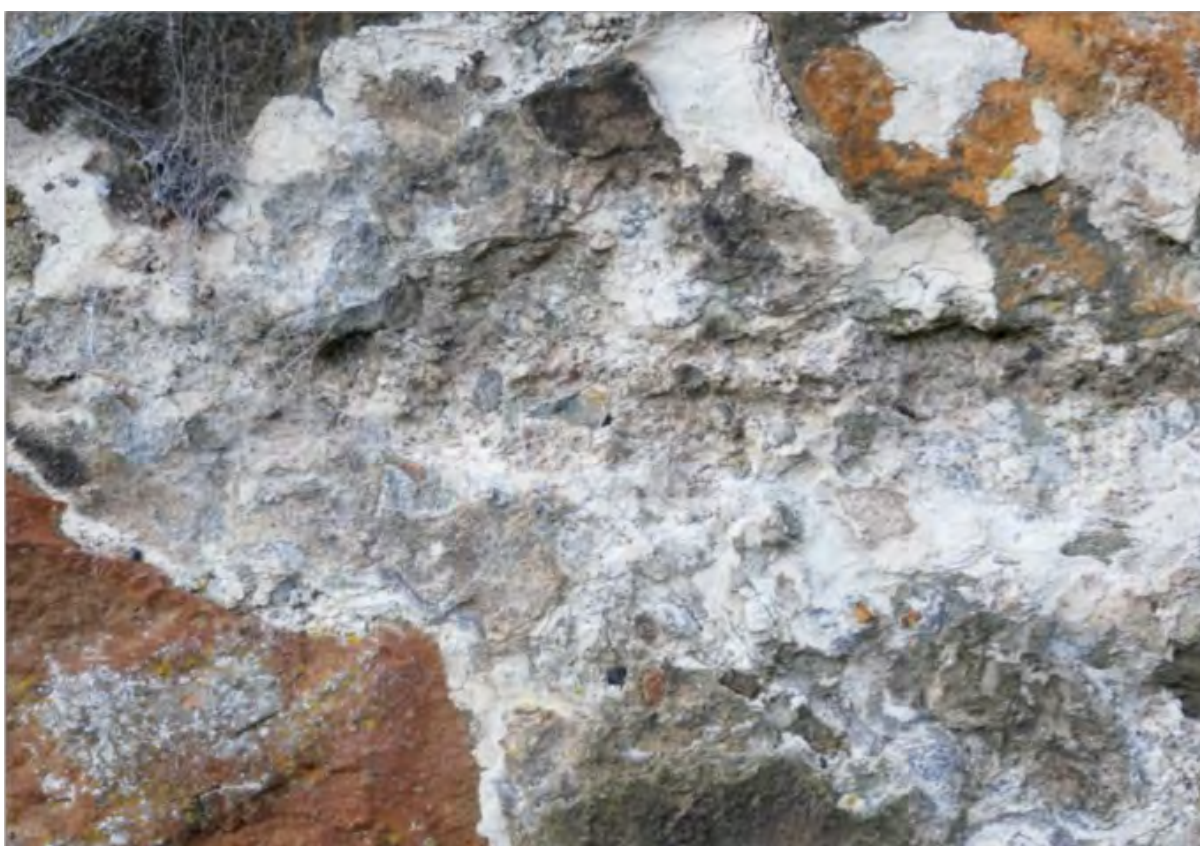
Figure 20. The Kirkcudbright Tollbooth, with harl clinging directly to the stone with many layers of limewash also visible.

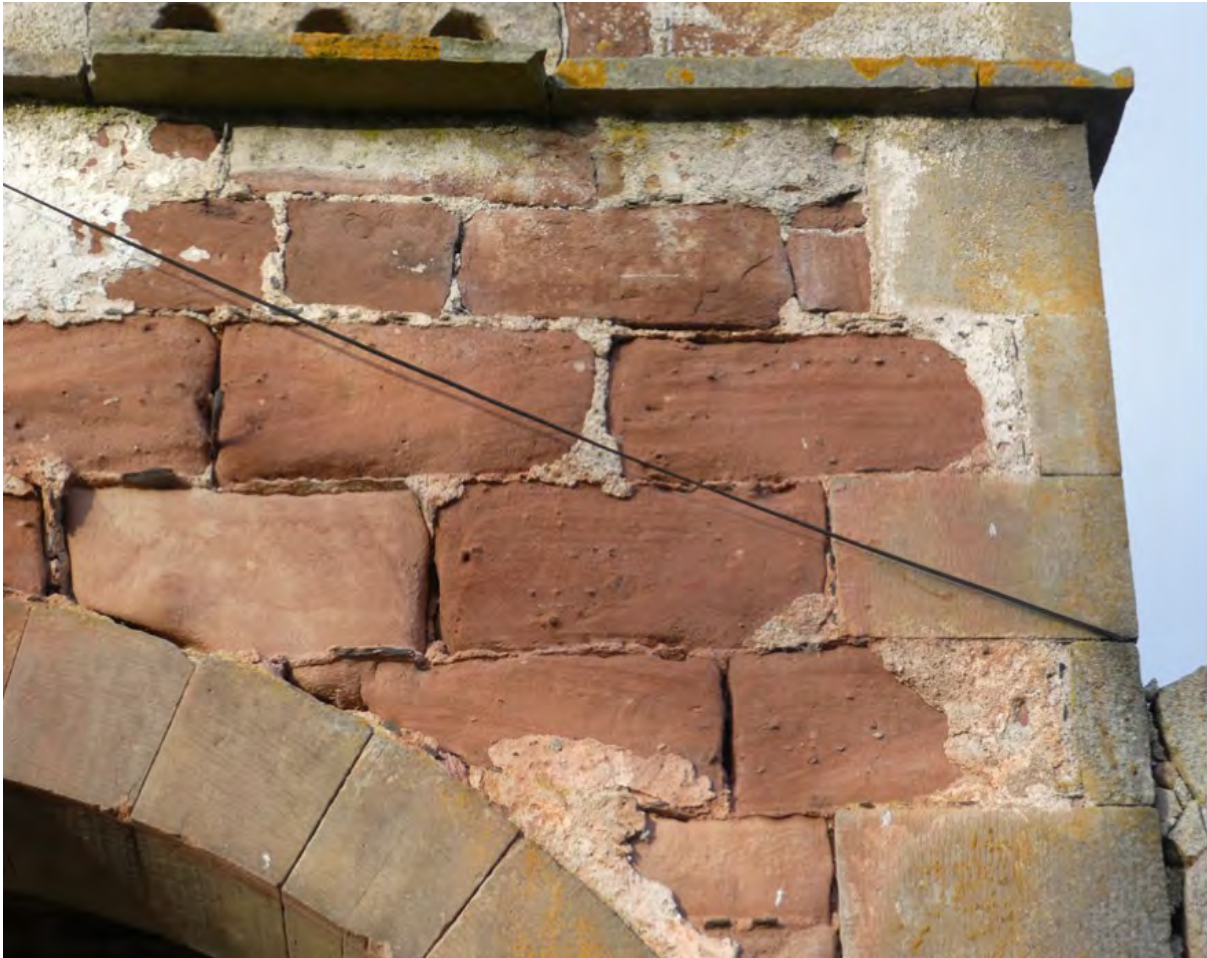
Figure 24. Harl clings to some areas protected by the string course of this mid-18th century steading. In other areas, where there is less protection, the surface of the sandstone has completely eroded away, taking with it any trace of finish.

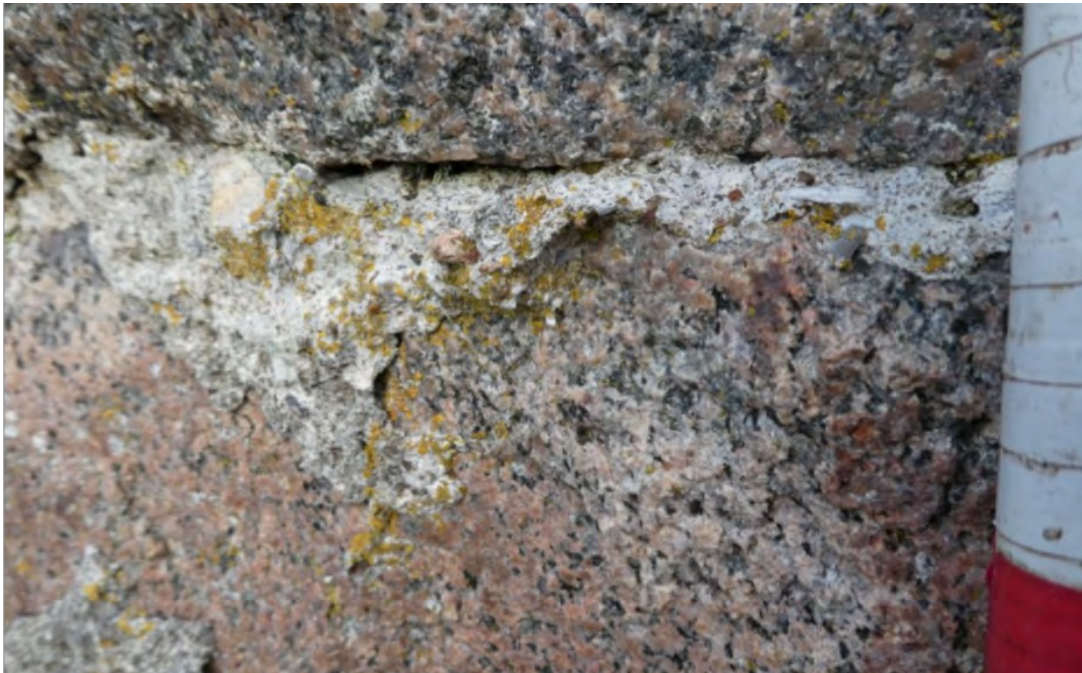
Figure 25. Orchardton Tower, Dumfries and Galloway. The bedding mortar inseparably combined.

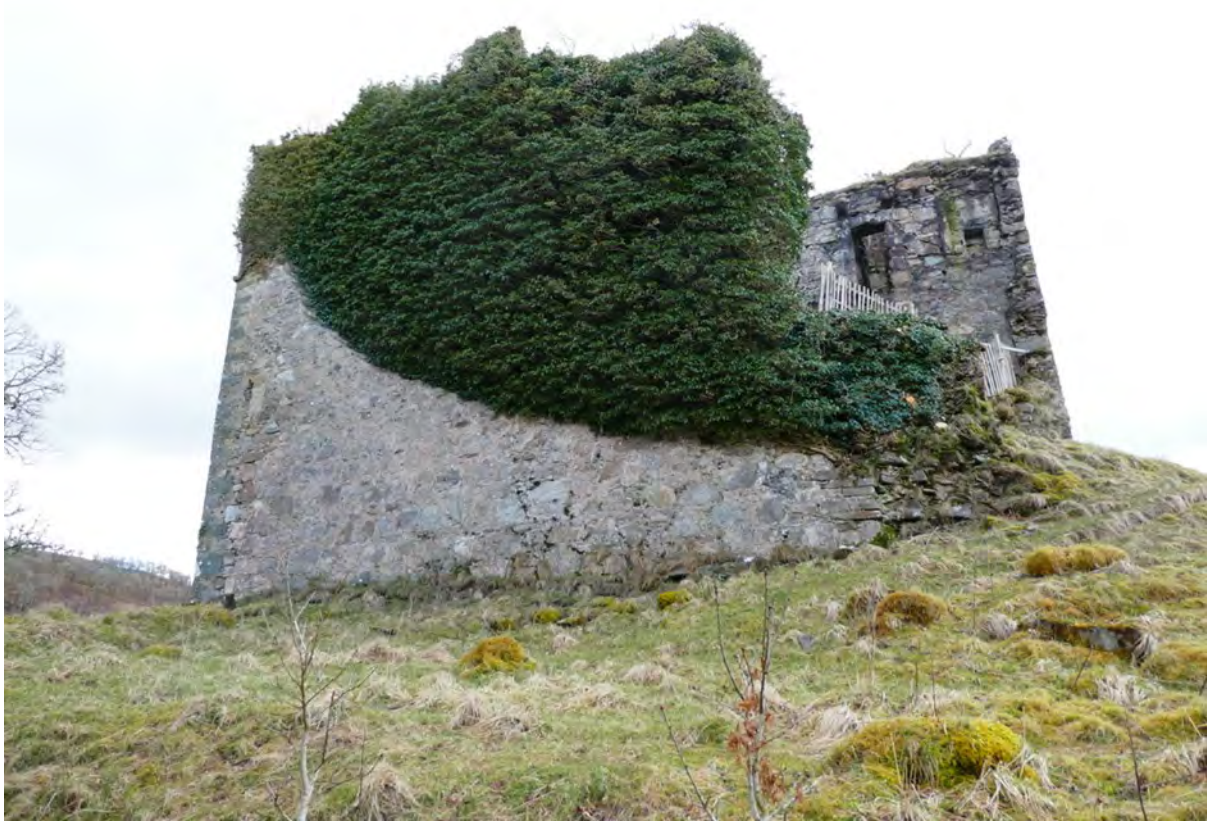
Figure 06.1. Castle Lachlan, west elevation.

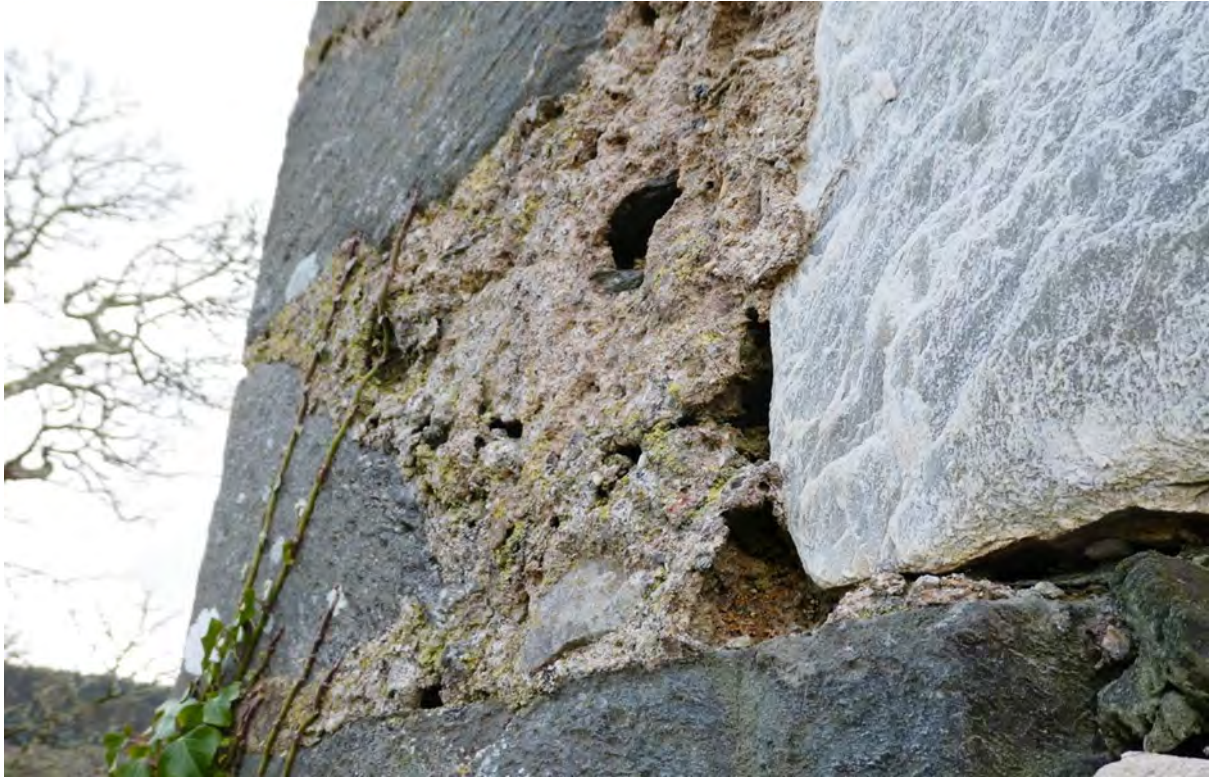
Figure 06.2. Extant integrated harl and bedding mortar visible on the north west corner.

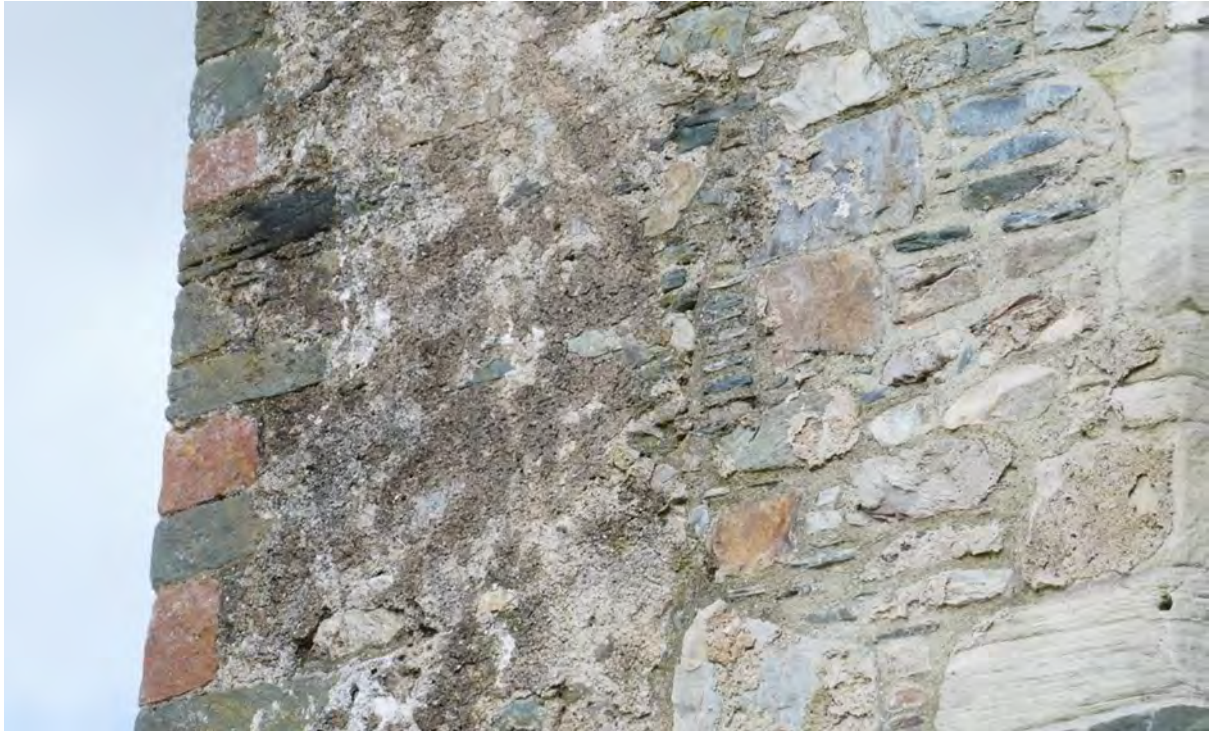
Figure 06.3. Area of surviving harl left, and right on one of the window jamb stones. Some more recent repair work visible centre right.

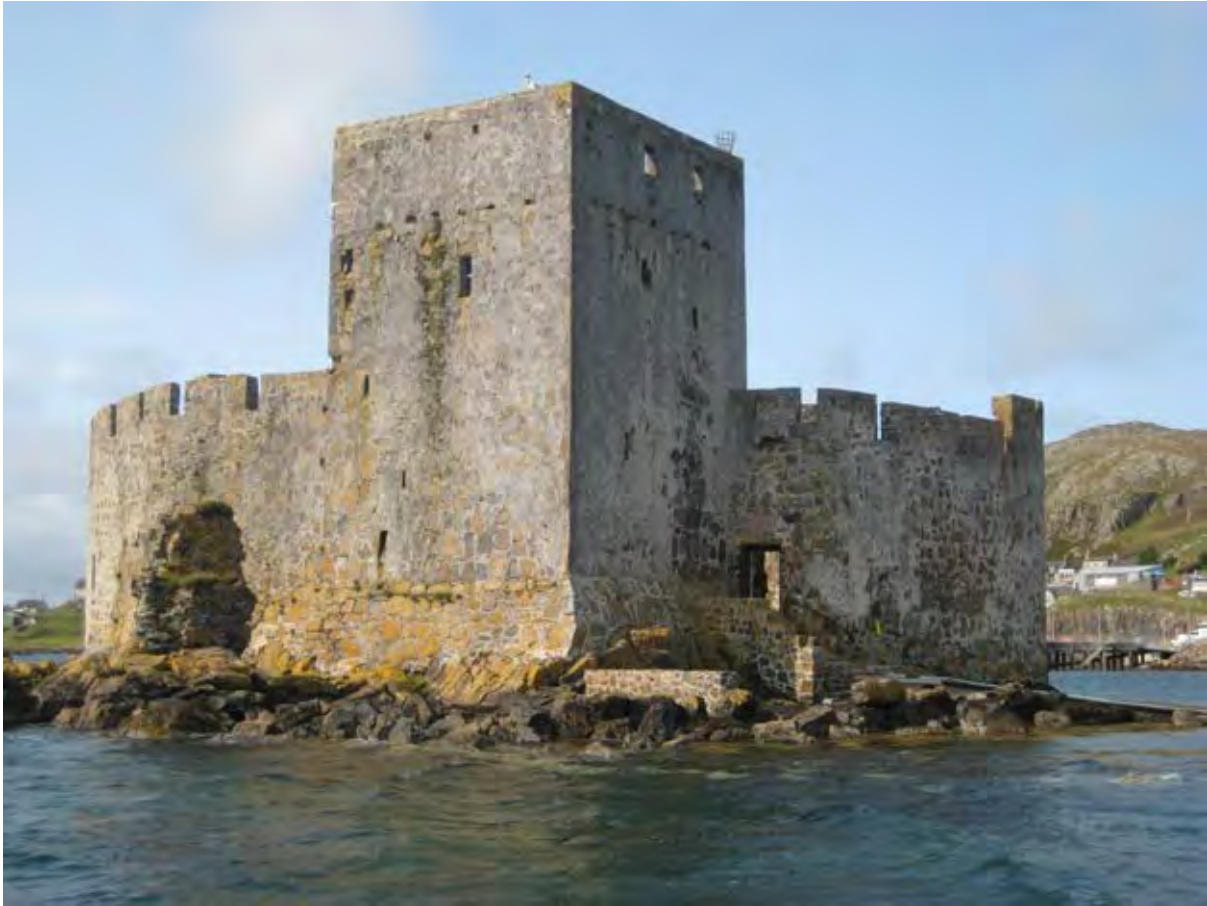
Figure 07.1. Kisimul Castle from the south east. The surviving historic harl is visible on the walls of the tower and the masonry of the curtain wall to the right.

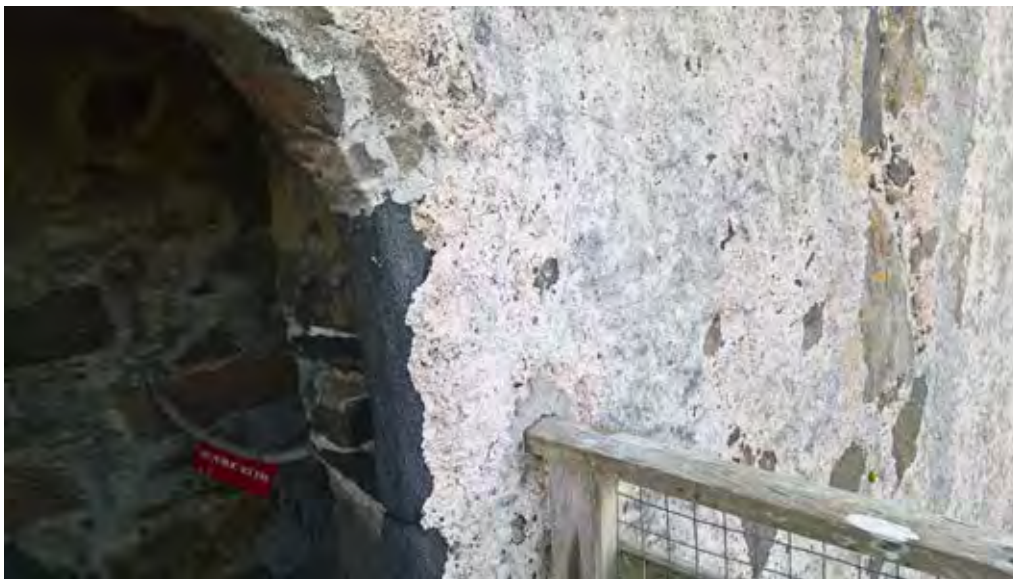
Figure 07.2. The historic harl extending over the dressed stones of the tower doorway. The good condition of the historic harl can also be seen on the rest of the wall.

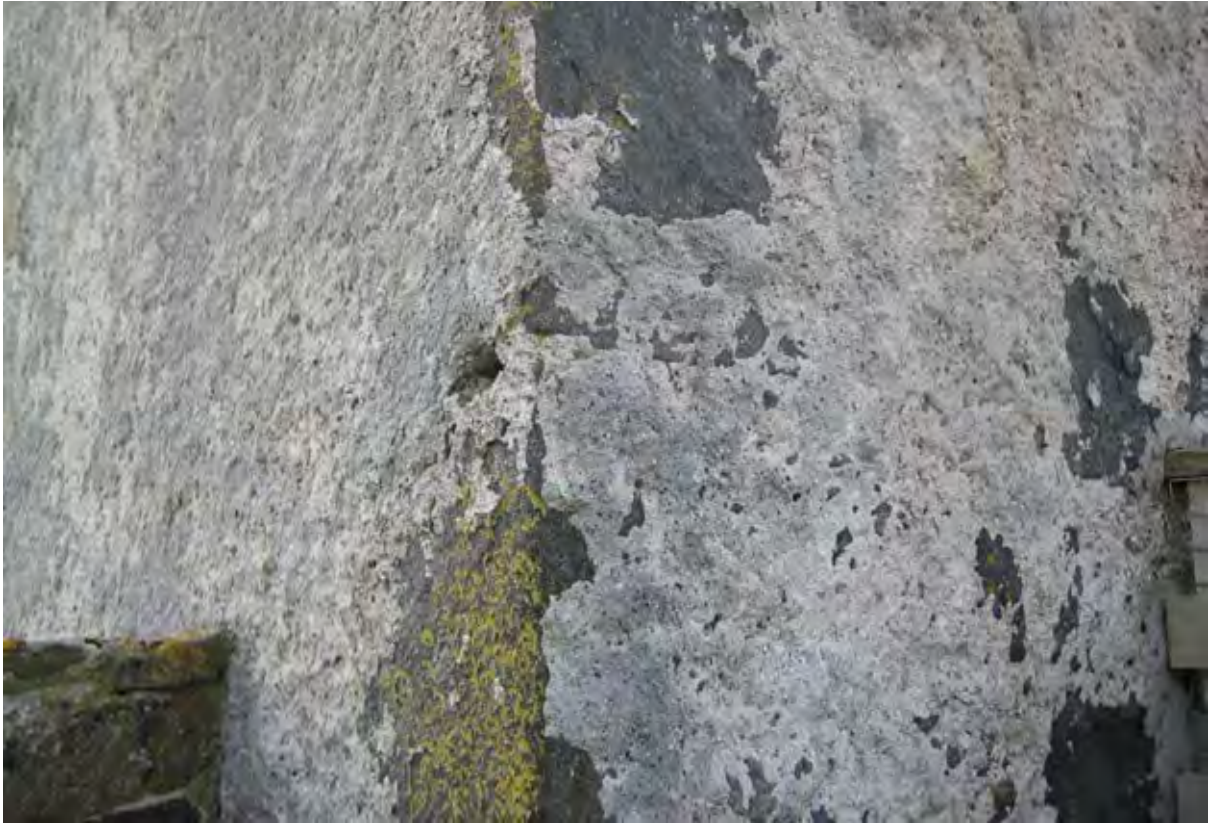
Figure 07.3. The historic harl covering the quoins at the south east corner of the tower.

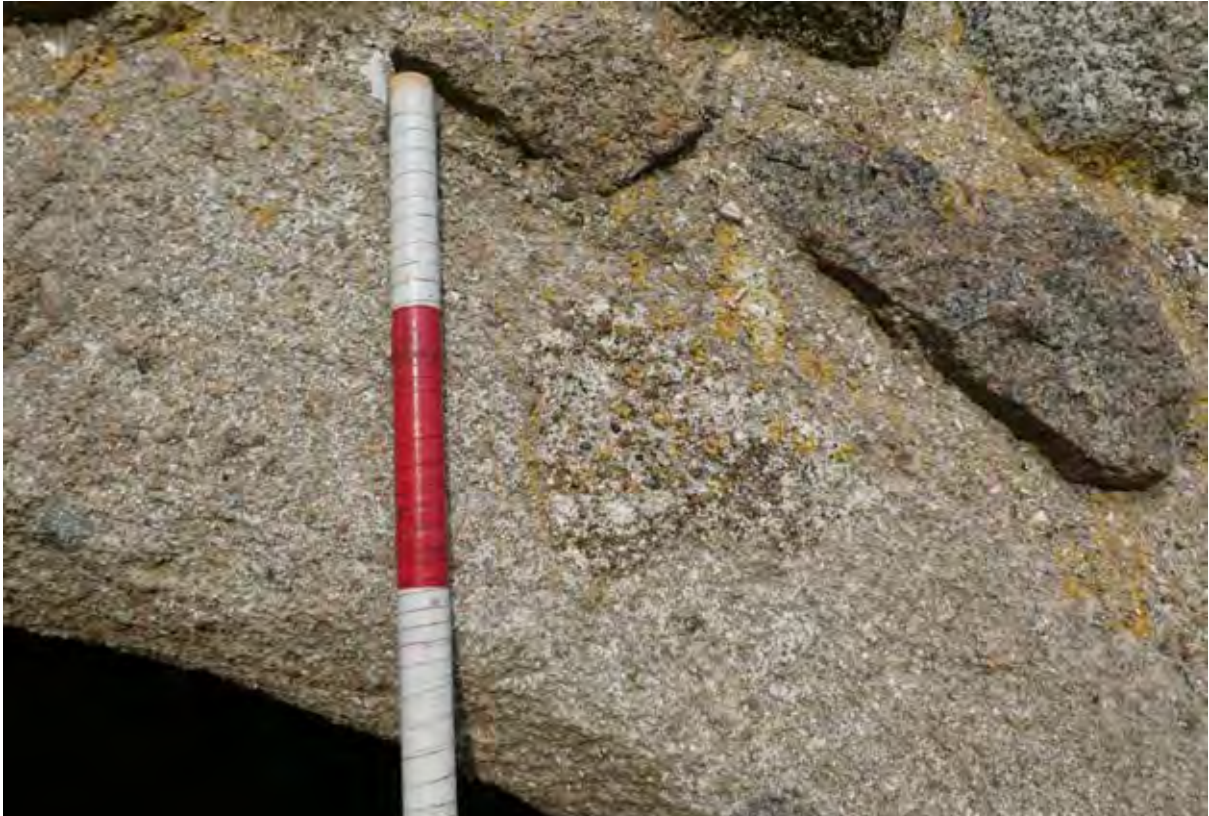
Figure 09.2. Overlay of harl demonstrating a round, gritty mixture.

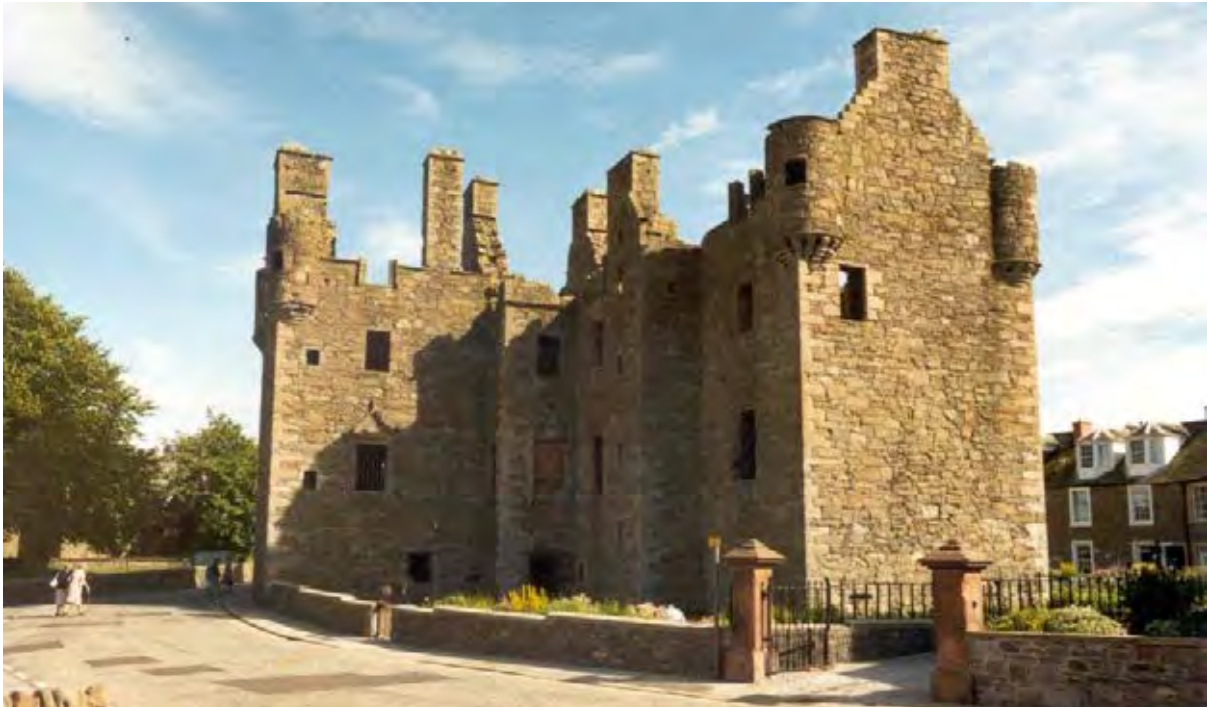
Figure 11.1. View of the castle from the north elevation.

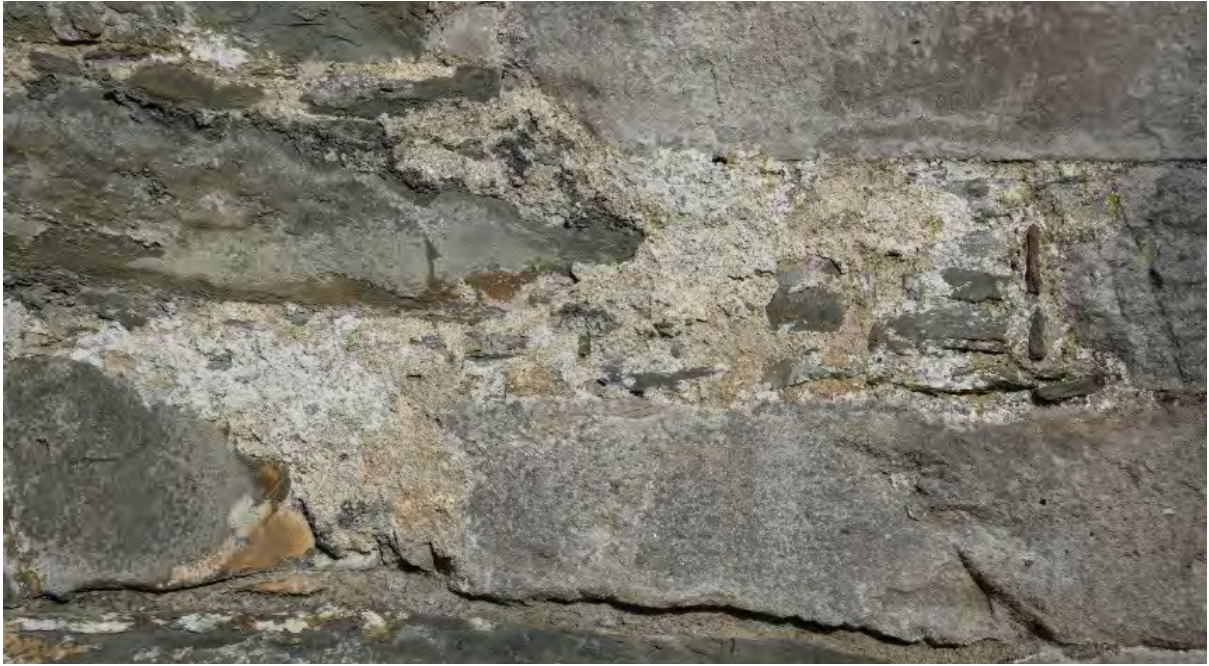
Figure 11.2. Remaining harl on the south west elevation.

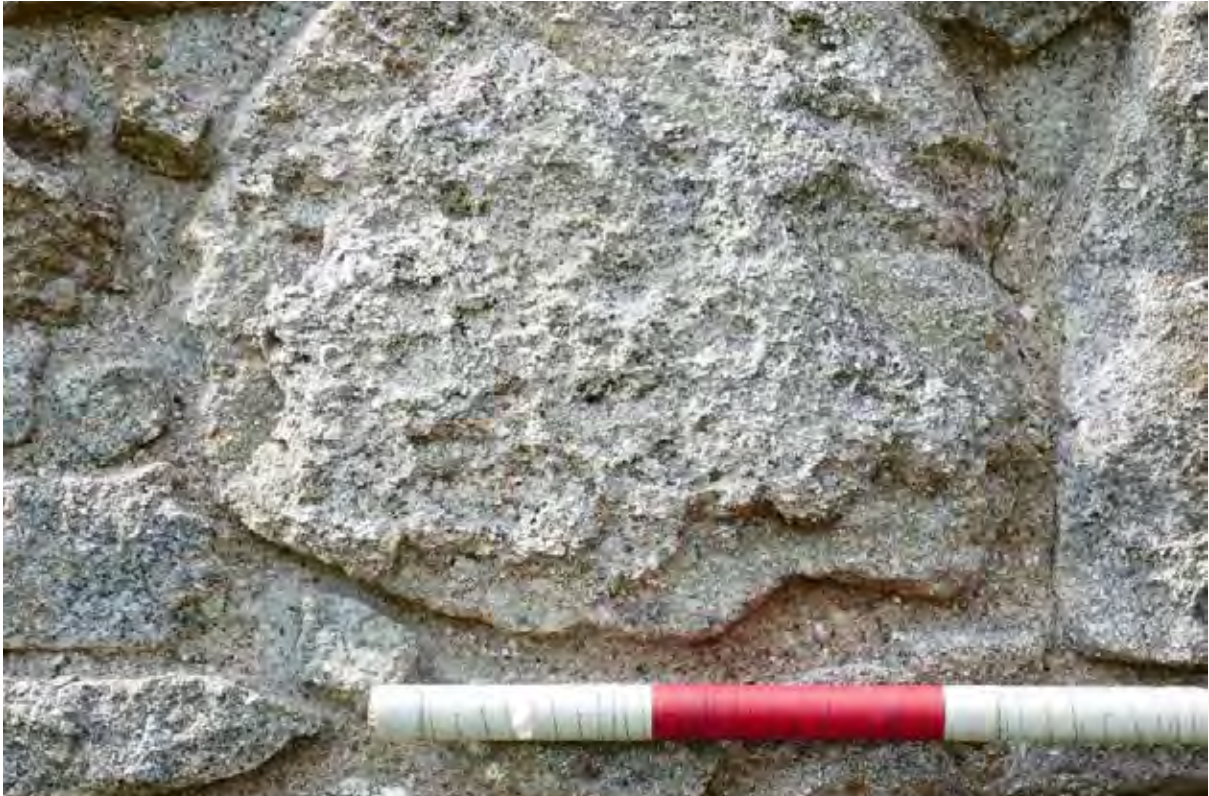
Figure 12.2. Detail of remaining harl, showing its coarse nature and tenacity.

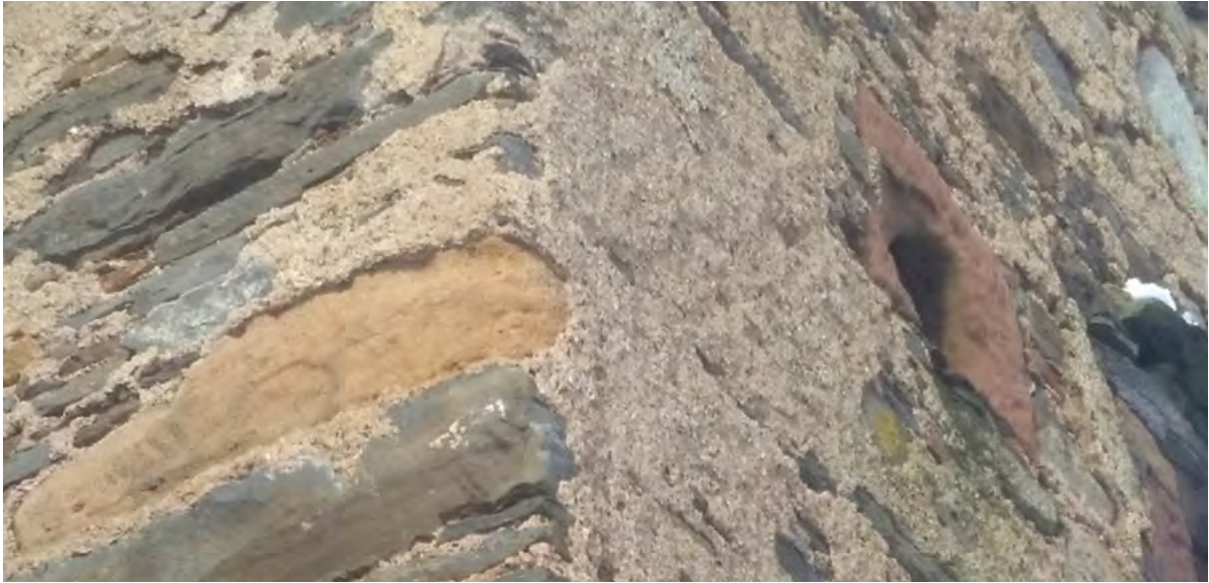
Figure 13.2. Detail of the south east angle of the early tower showing in situ remains of external finish. Note the covering of the quoins with the harl.

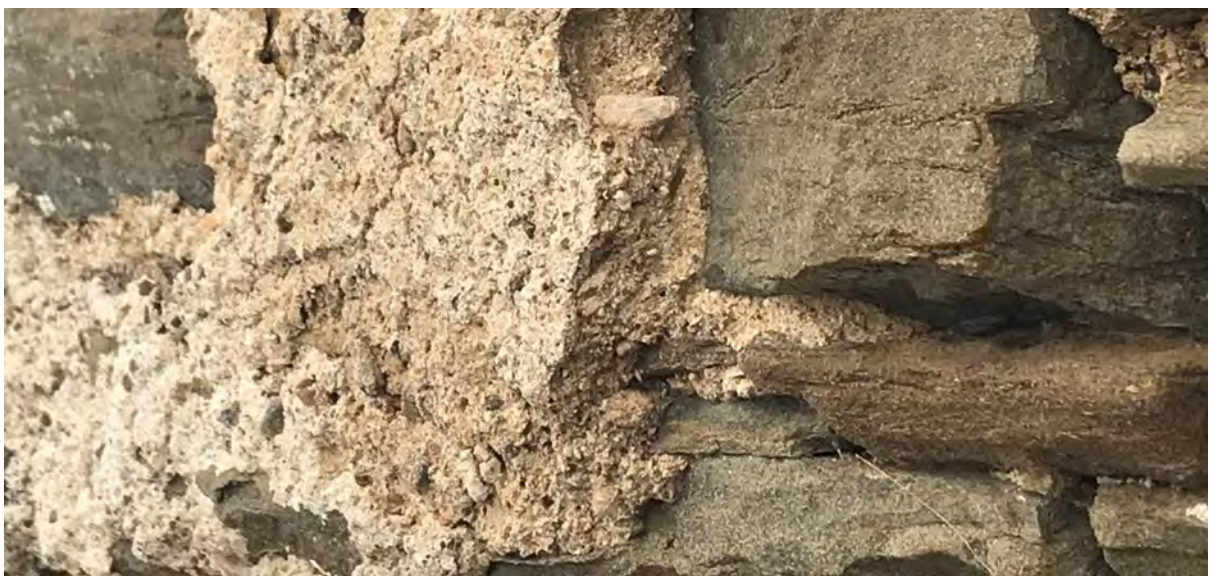
Figure 13.3. Detail from the later stair tower, showing the integrated mortar with overlying secondary thin white harl.
