TECHNICAL PAPER 31

HISTORIC EXTERNAL LIME FINISHES IN SCOTLAND

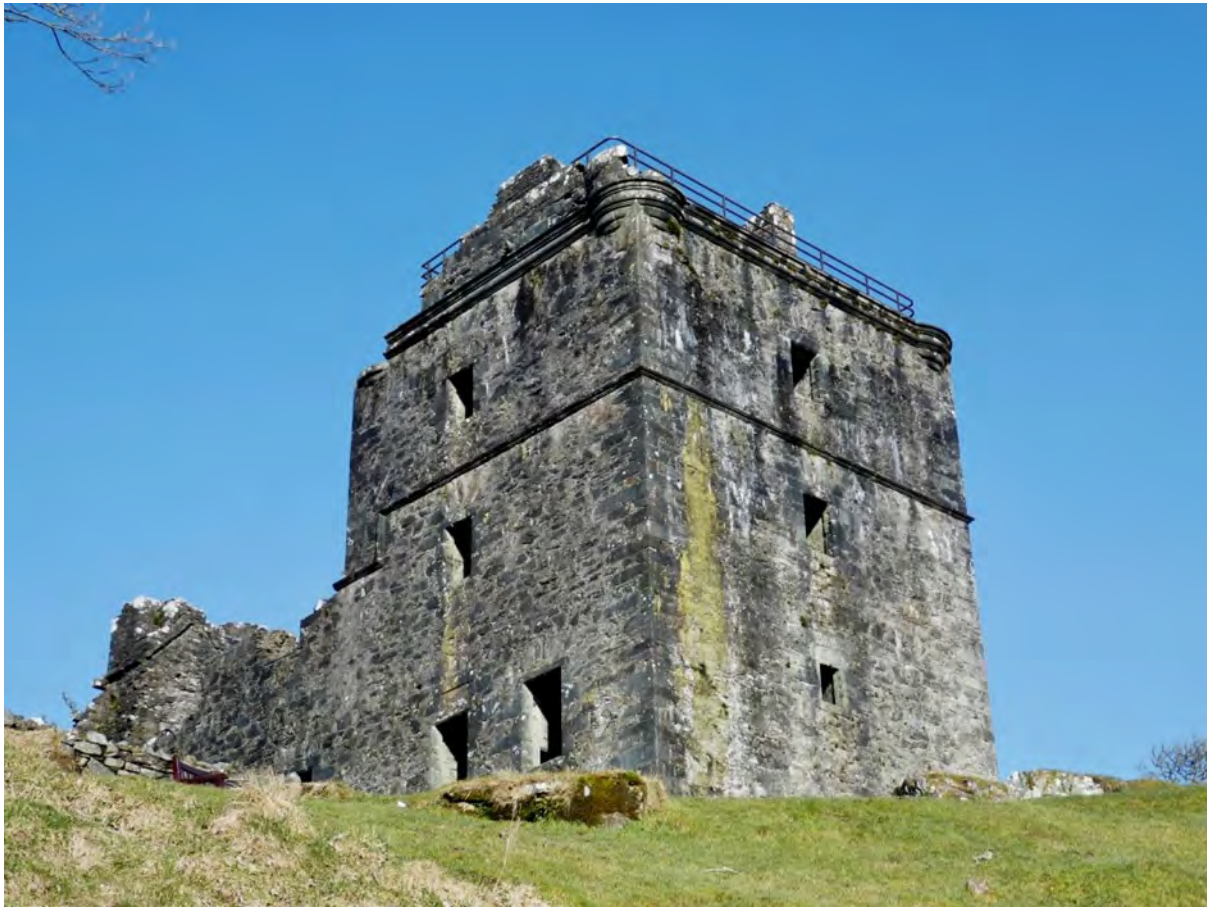
Figure 14.1. General view of Carnasserie Castle.

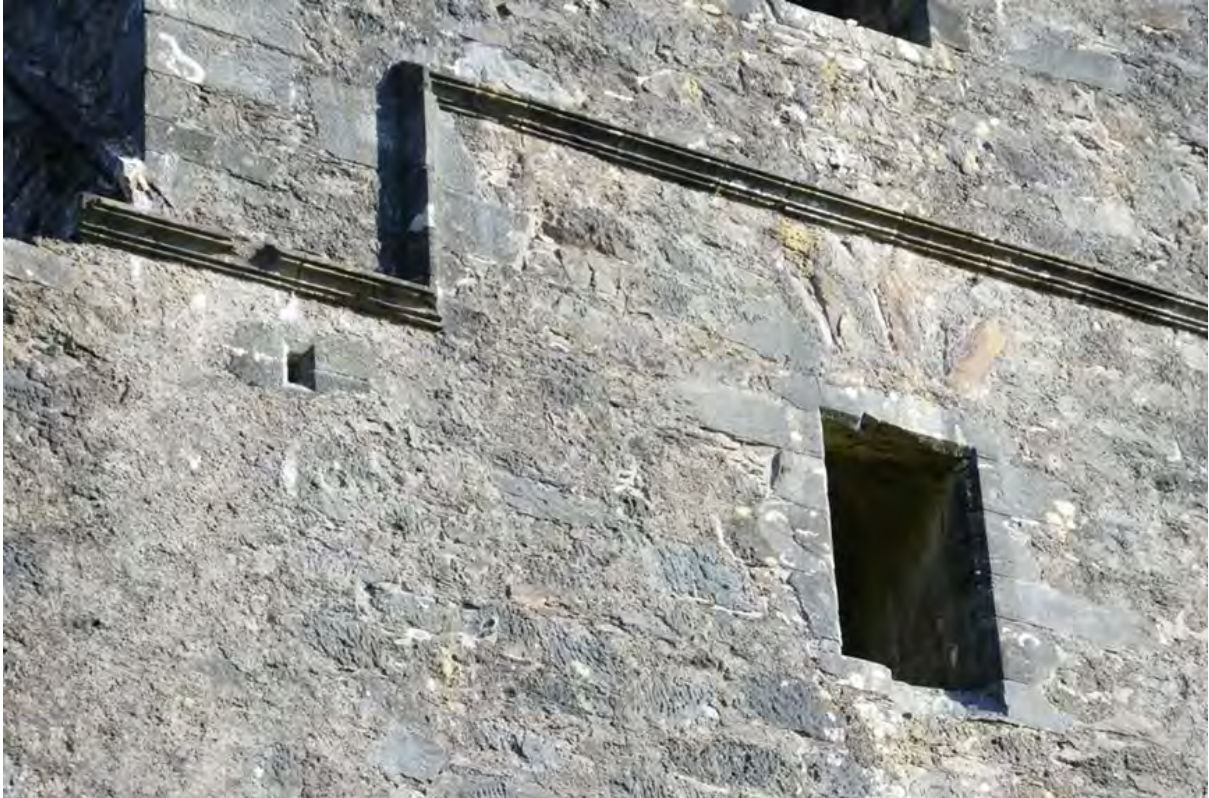
Figure 14.2. Extensive surviving areas of exterior harl finish on the South elevation.

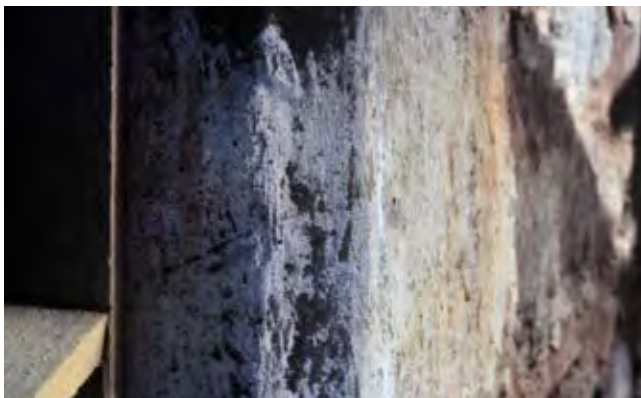
Figure 16.2. Harl returned around the margin into the window frame. Image taken in 1993, prior to re-harling.

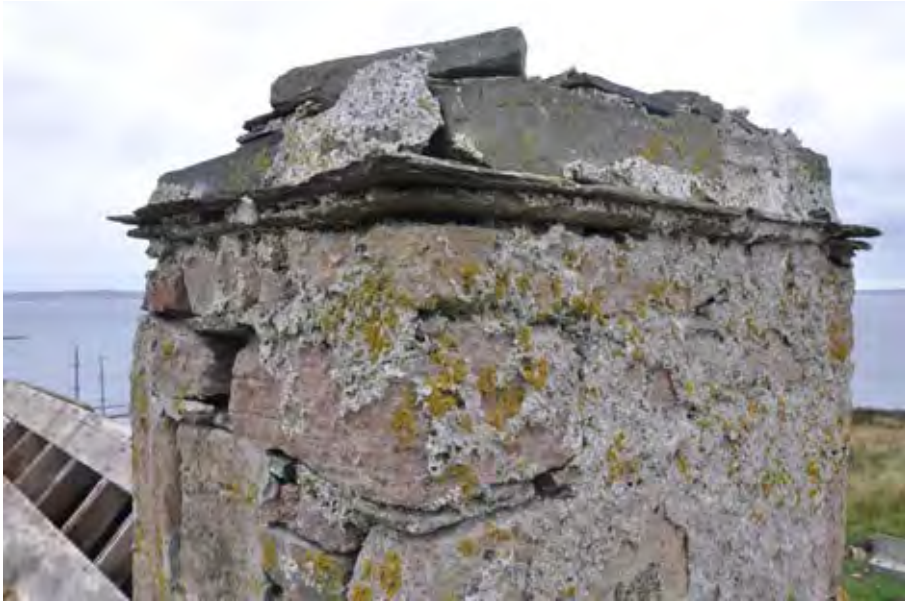
Figure 18.2. Area of harl surviving on a chimney top.

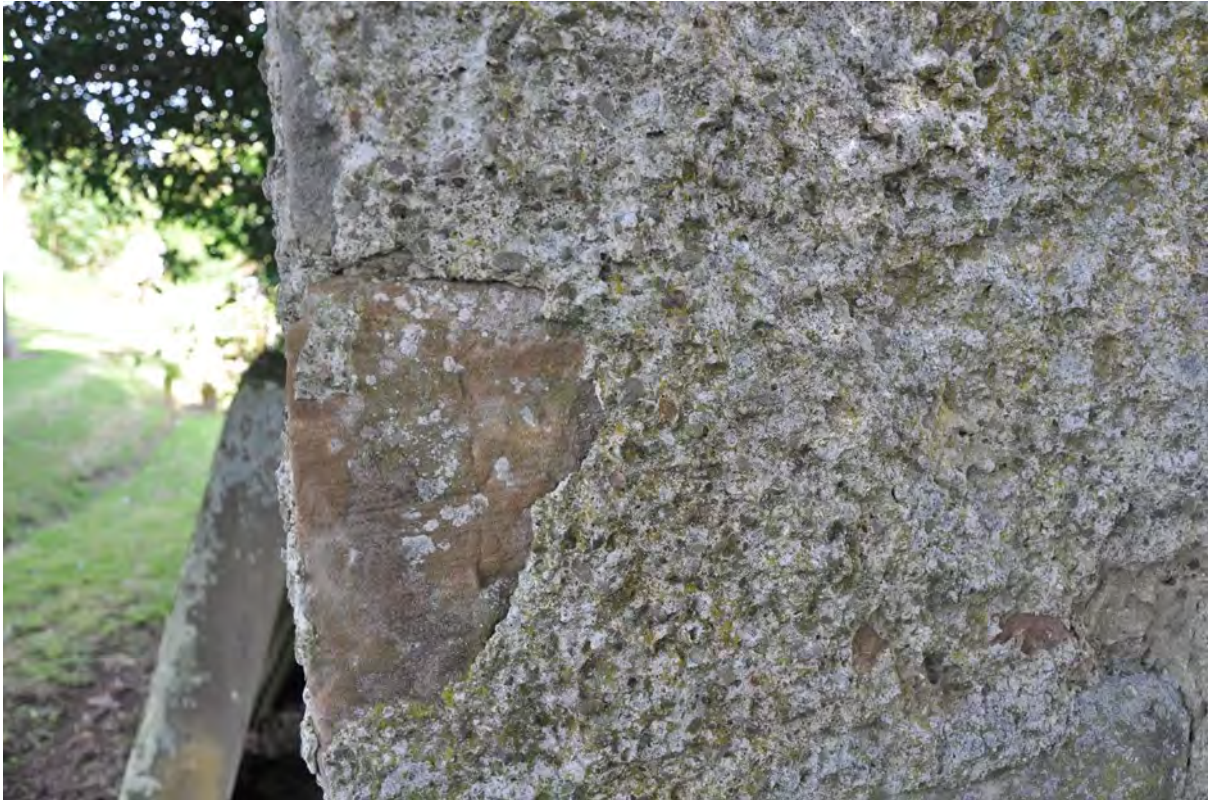
Figure 19.2. A detail of the well preserved lime render on the north corner, showing the quins still largely covered.

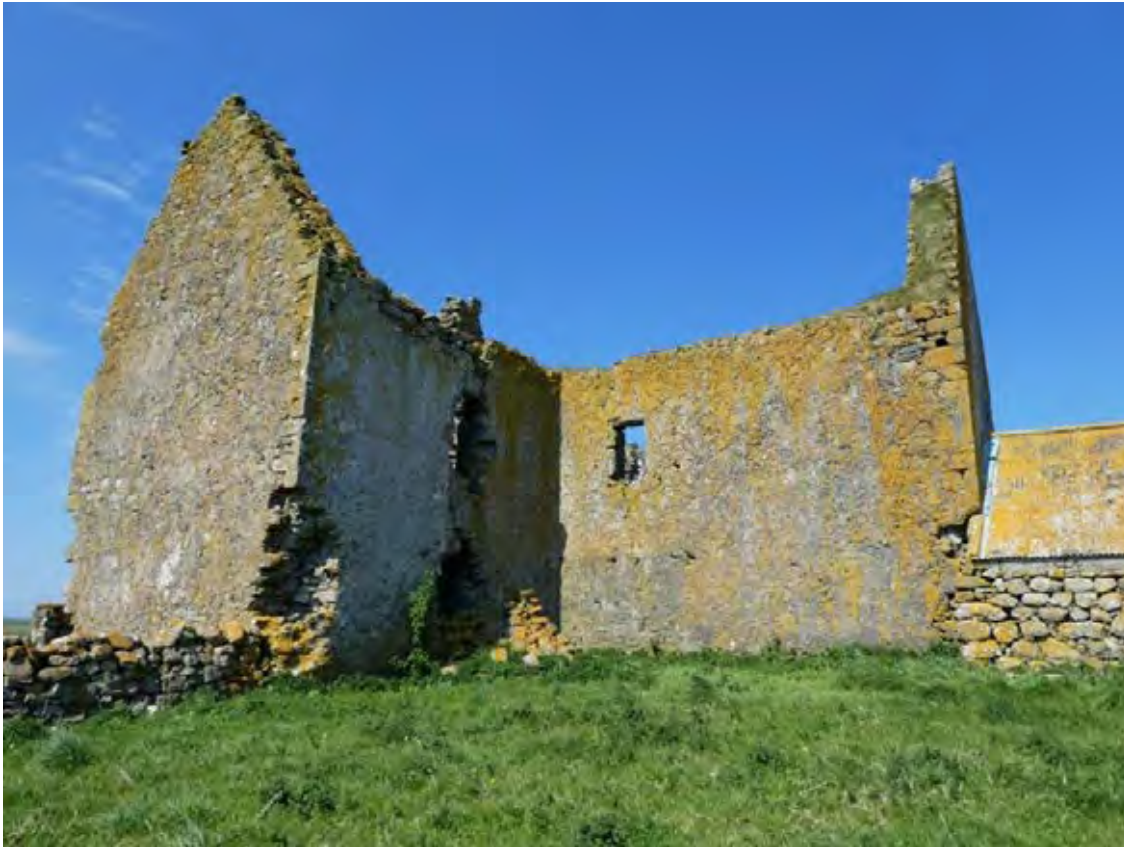
Figure 21.1. View of the ruins, with remnants of harl still visible. Heavy growth of lichens is also evident.

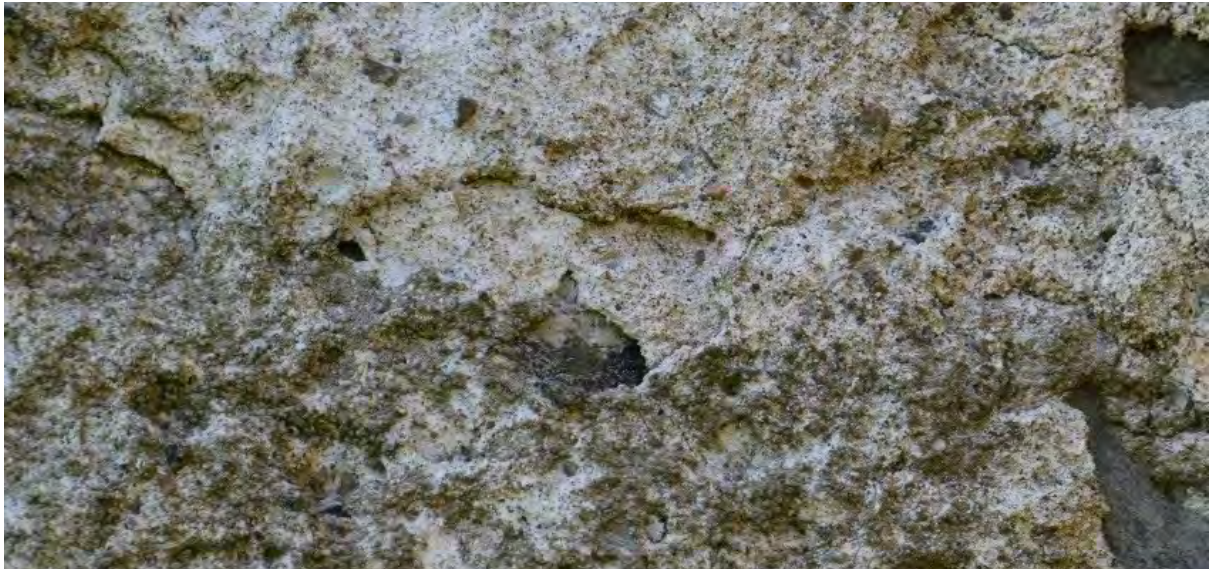
Figure 21.2. Detail of the remaining harl, which is coarse and made with a marine aggregate.

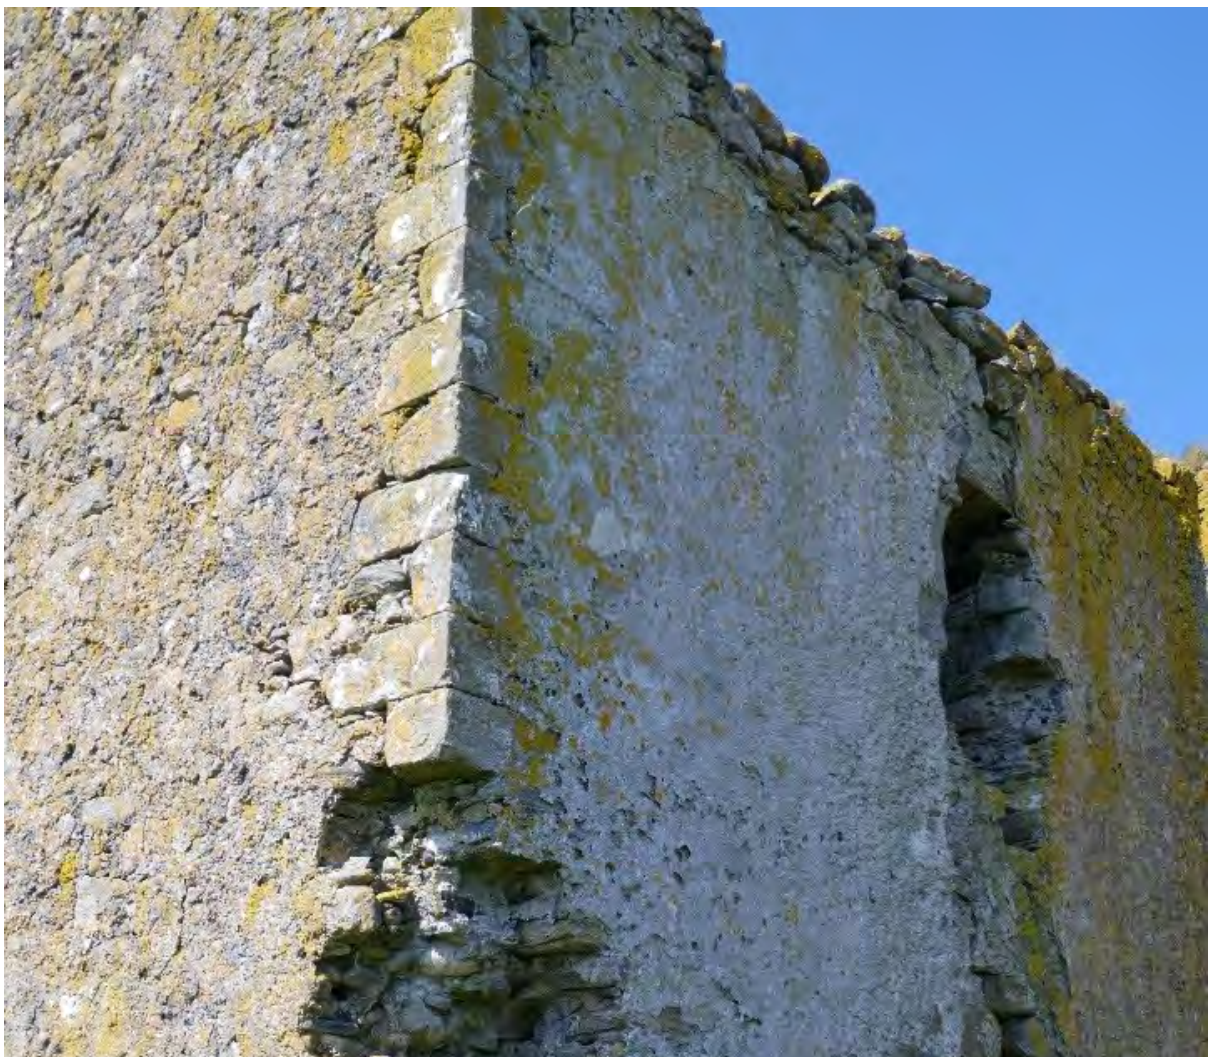
Figure 21.3. Detail of one section of quoining, where the harl is greatly degraded.

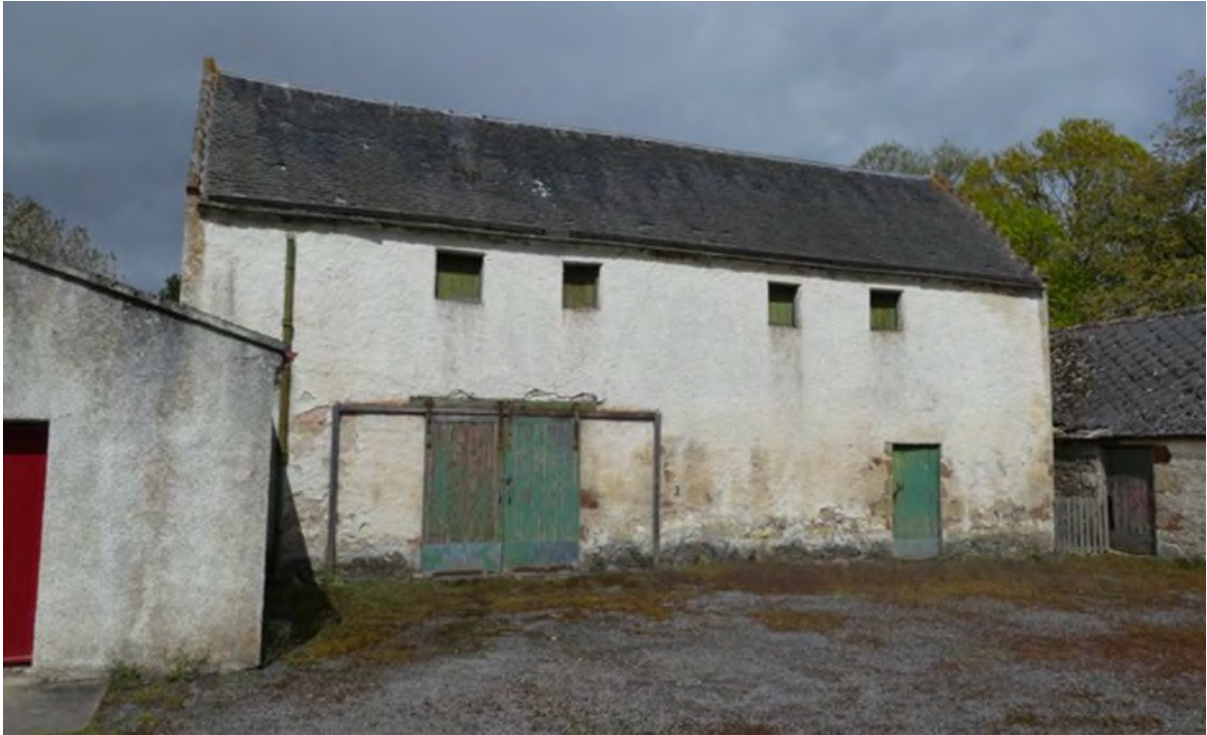
Figure 22.1. Principal elevation of the barn.

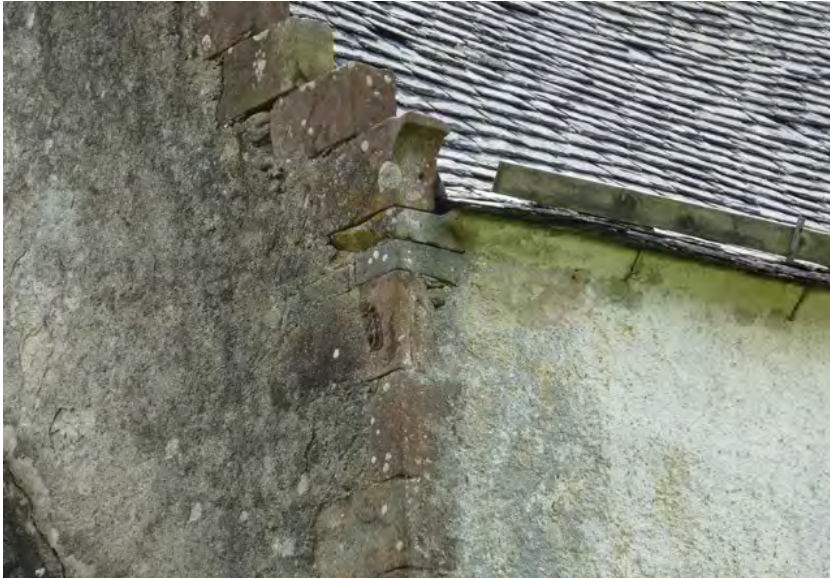
Figure 22.2.
Weathering of harl
apparent where it has
been thinly applied
on the dressed
stonework.

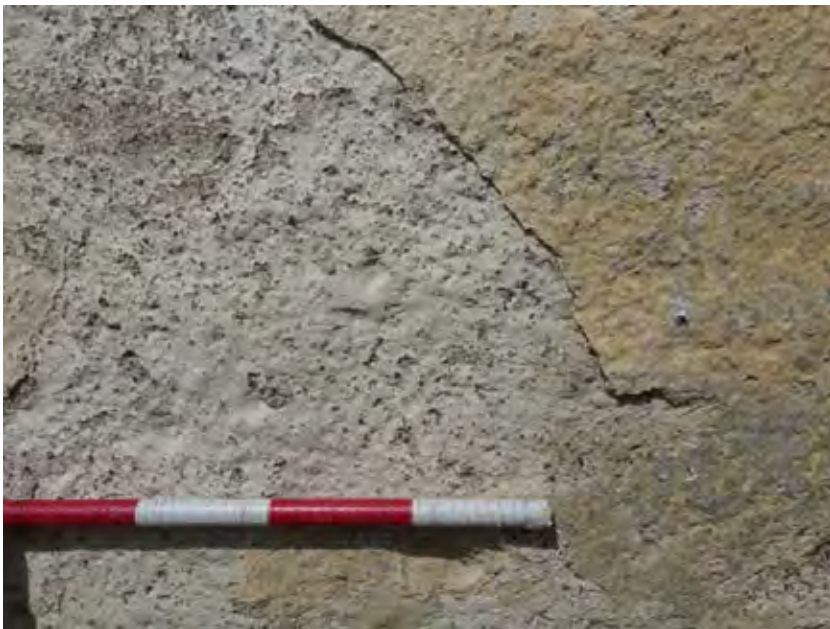
Figure 22.3. The
original thin harl coat
with its pale
limewash finish
overlain by an area
of repair harl, with
yellow limewash.

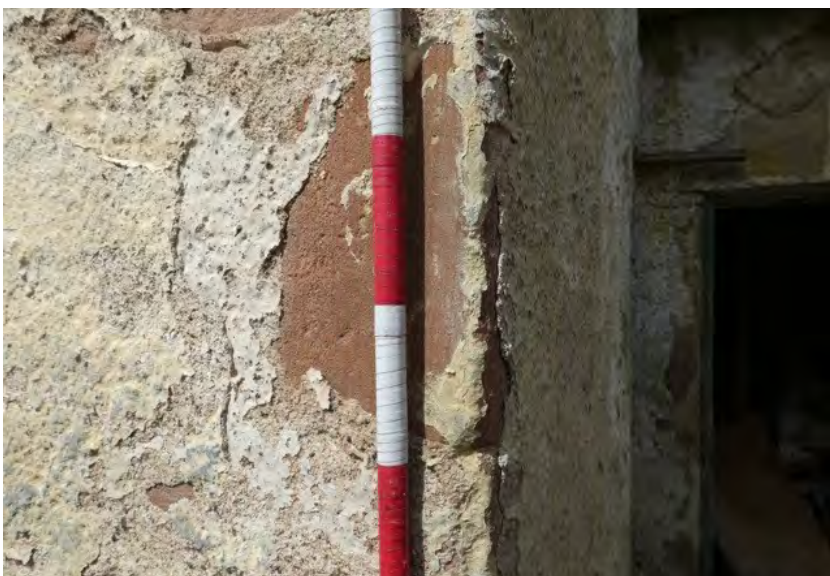
Figure 22.4. Harl
taken over the door
jamb.

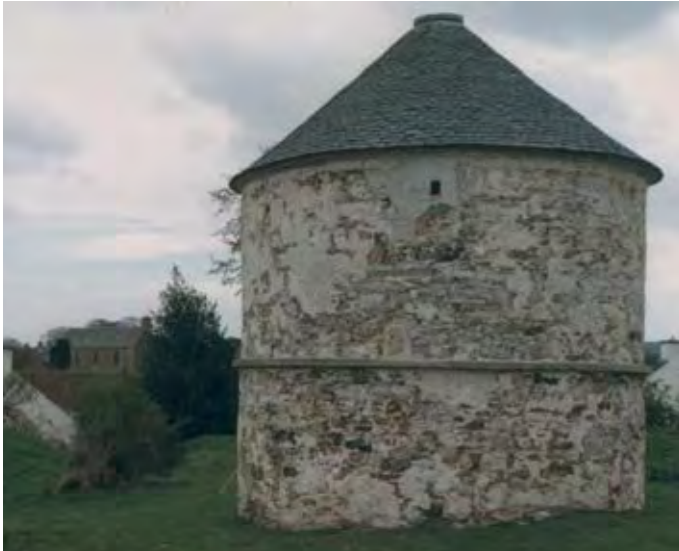
Figure 24.1. The doocot following removal of the cement harl.

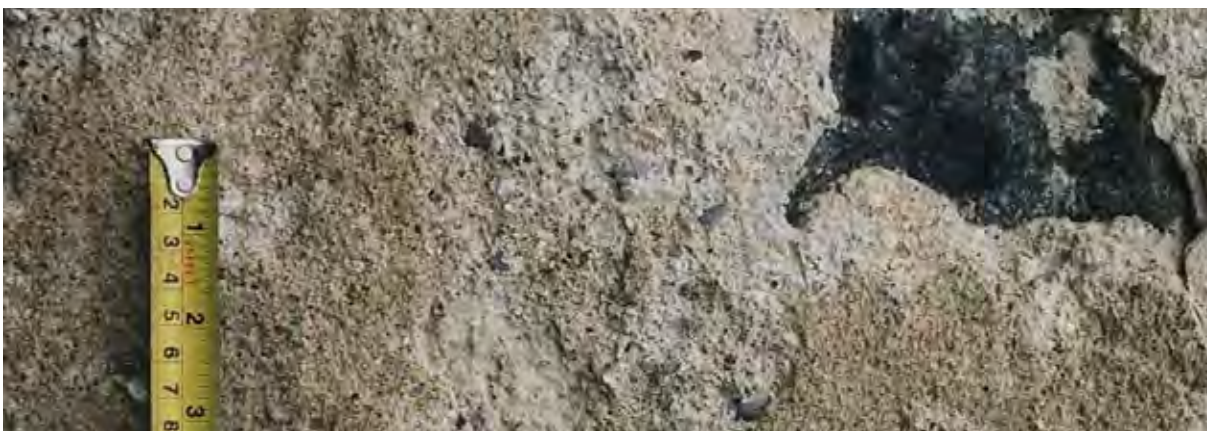
Figure 24.2. Detail of the build-up of external finishes.

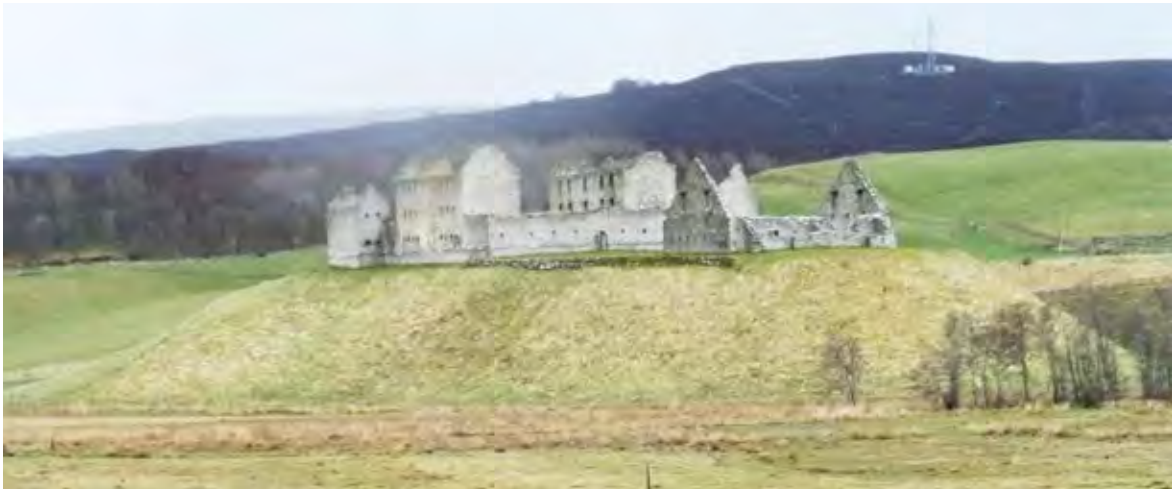
Figure 25.1. Ruthaven Barracks, general view looking south east.

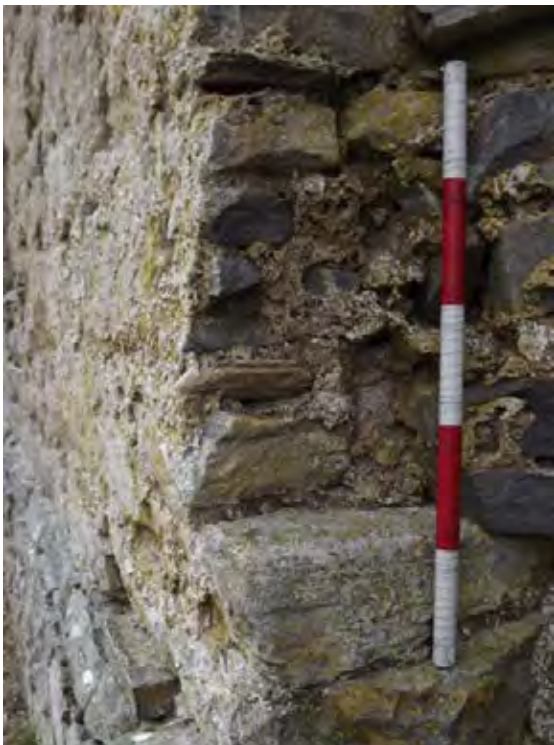
The robust nature and application of the harl is similar to the Bernera Barracks at Glenelg which dates from the same period (Entry 30). This suggests a specific practice common to the early Georgian military engineers.

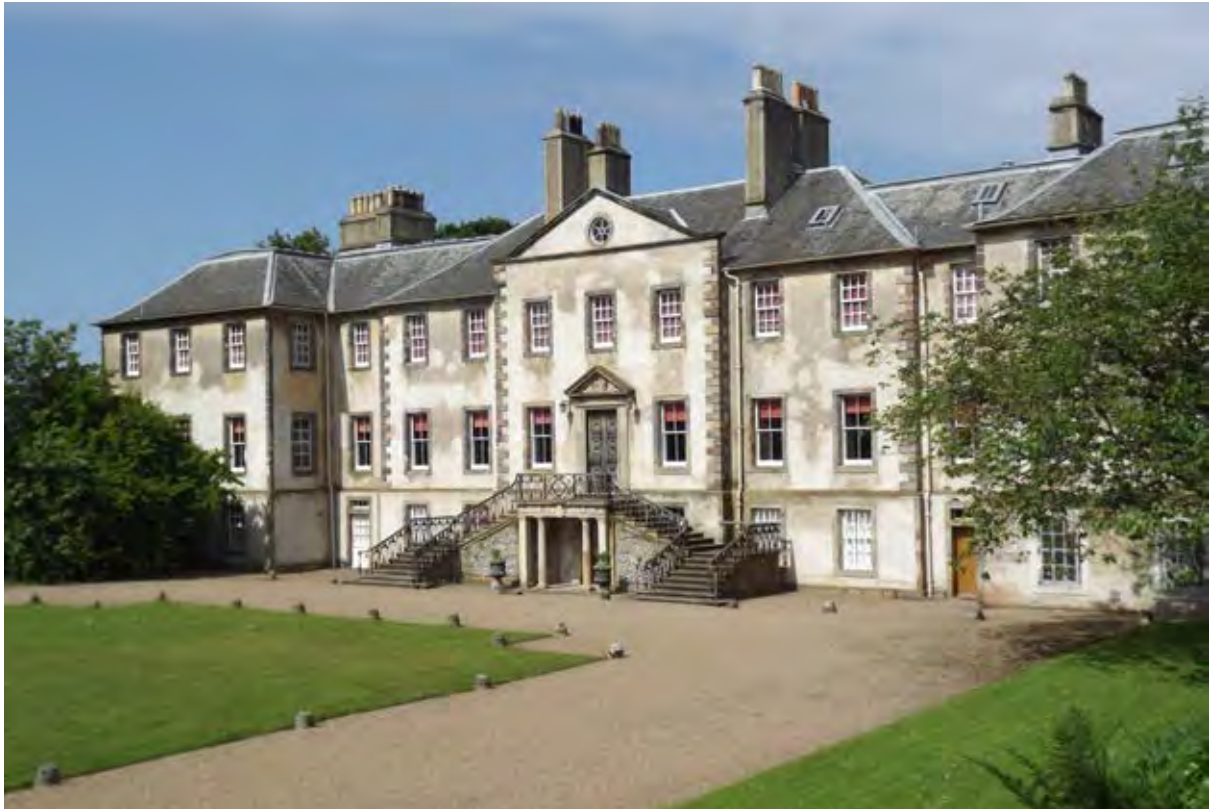
Figure 26.1. Newhailes House, entrance elevation on the west side, following lime-based repairs in the lighter areas in 2001-2002.

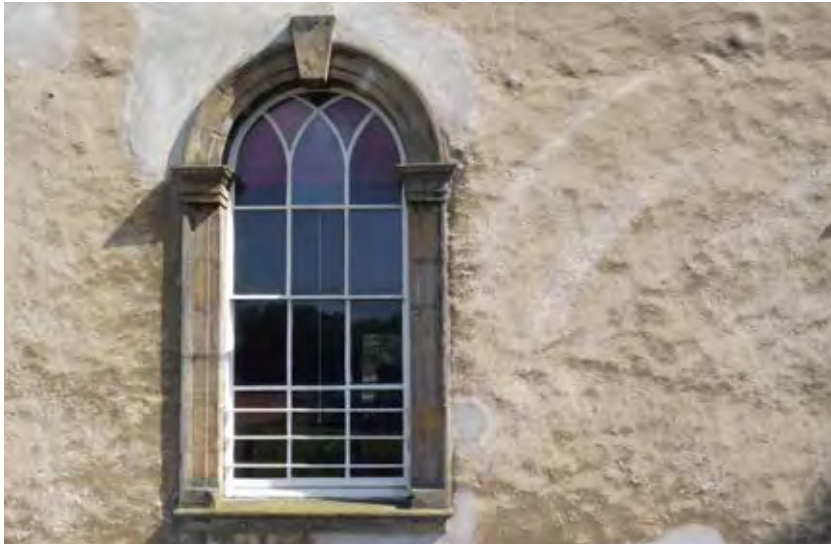
Figure 26.2. Detail of the plain plastered exterior of the north frontage.

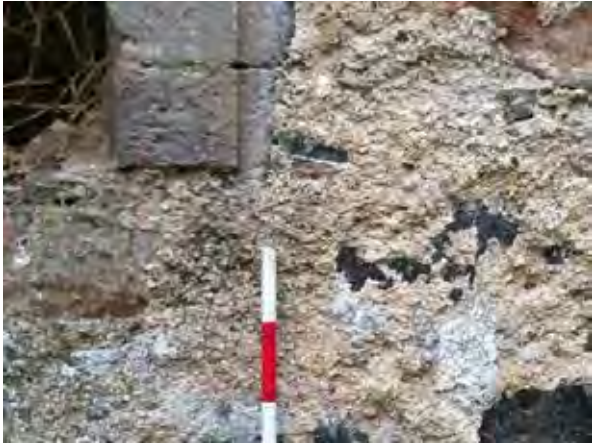
Figure 30.2. The harl is very lime-rich and coarse, with what appears to be quartz included in the aggregate.

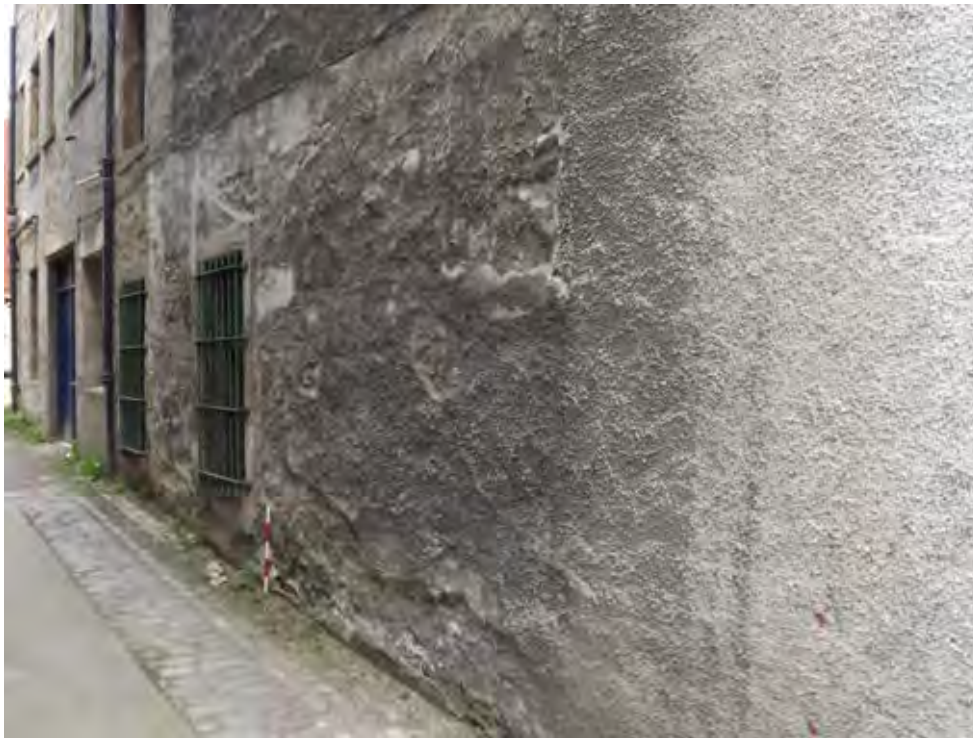
Figure 31.1. Balmerino Close

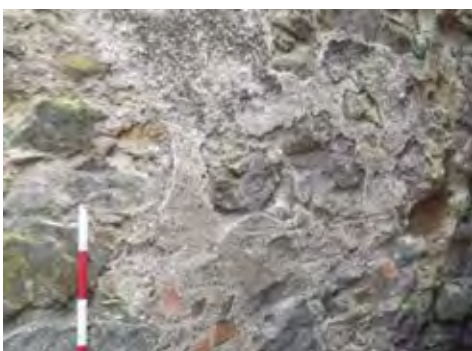
Figure 31.2. Harl application in Balmerino Place.

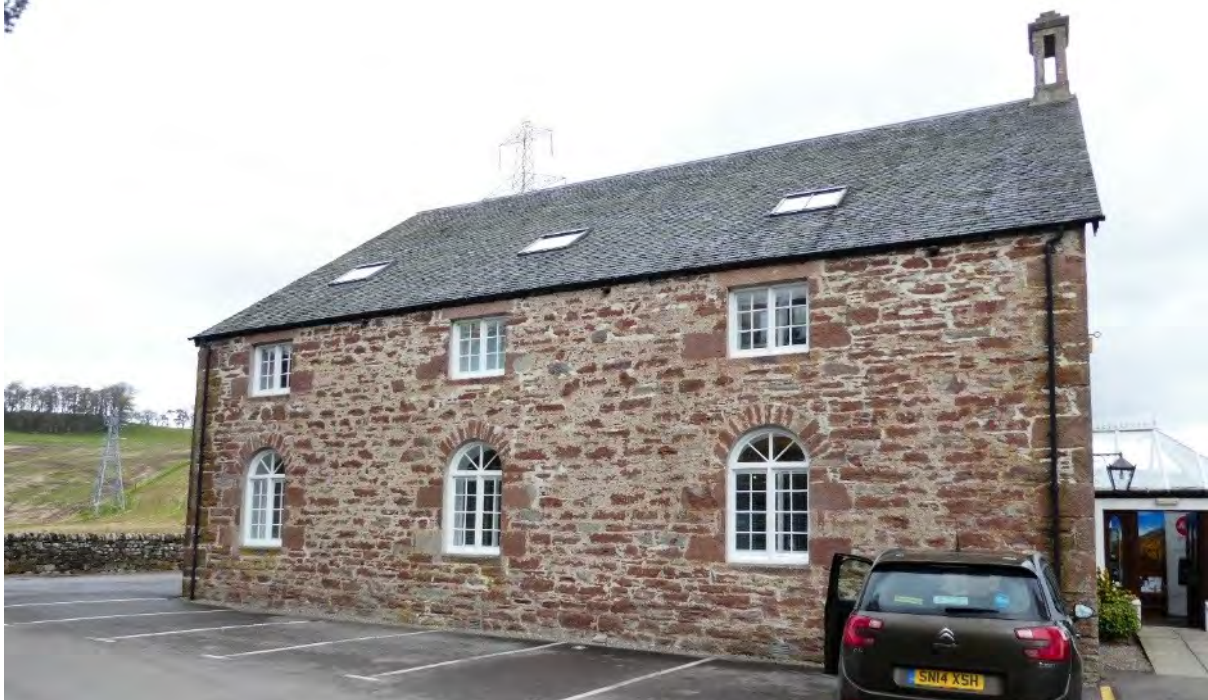
Figure 33.1. Rear elevation of the building.

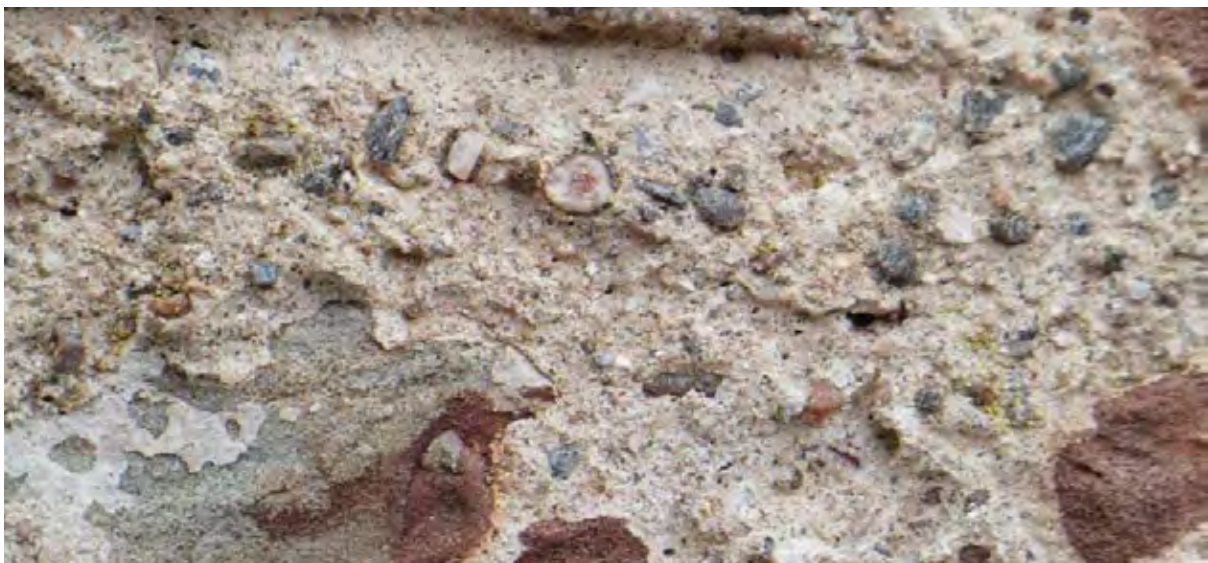
Figure 33.2. Area of remaining mortar, with traces of limewash.

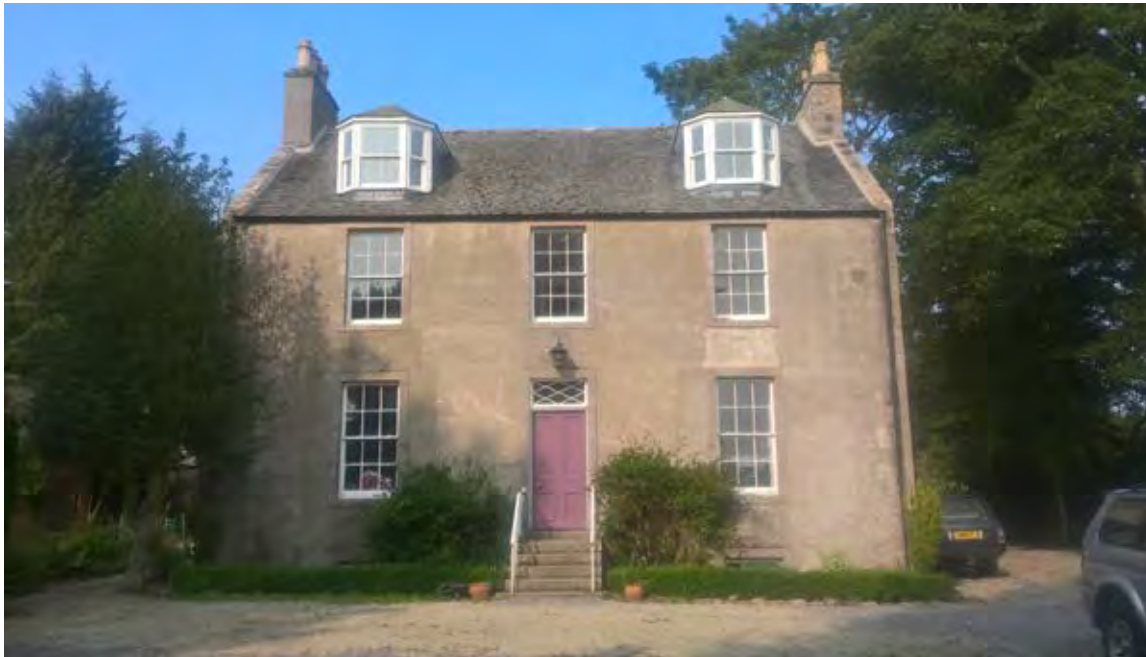
Figure 36.1. The principal elevation of the manse.

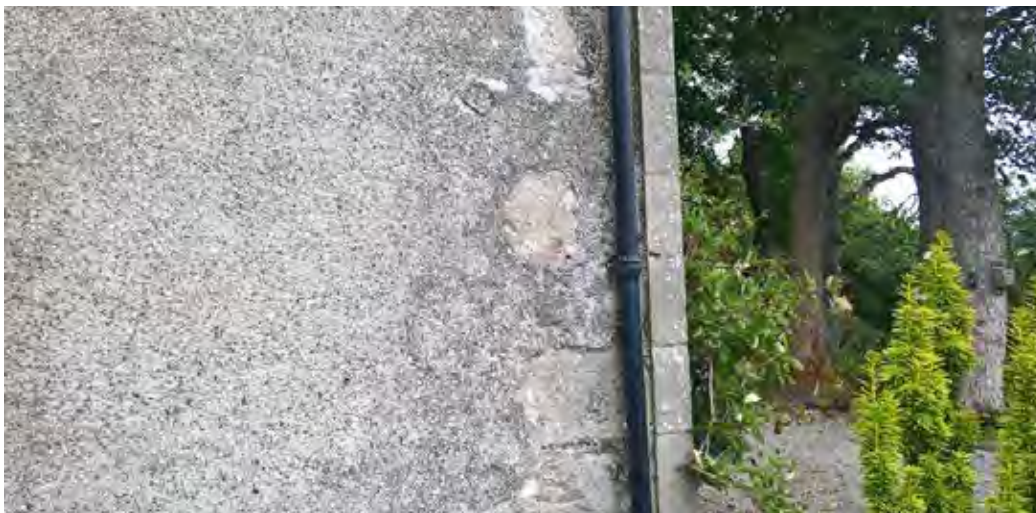
Figure 36.2. The harl covering the quoin on the north east corner, showing some flaking.

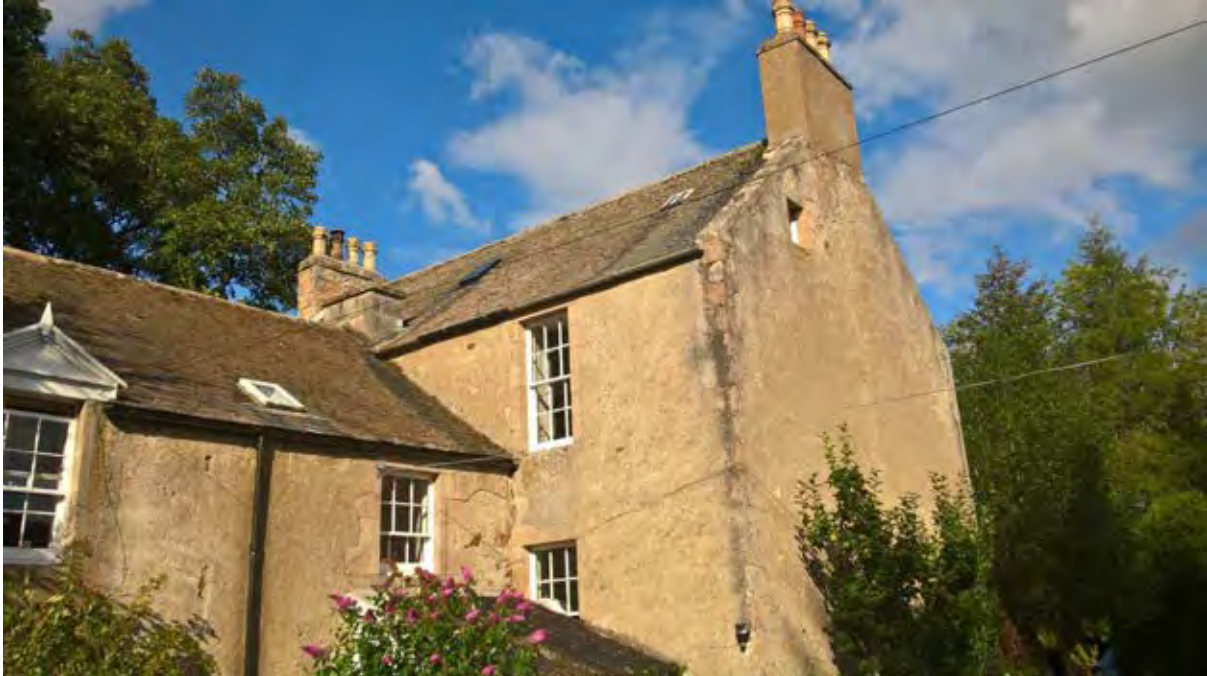
Figure 36.3. The rear elevation of the house. Some decay of the render evident from the run off from the skew cope.

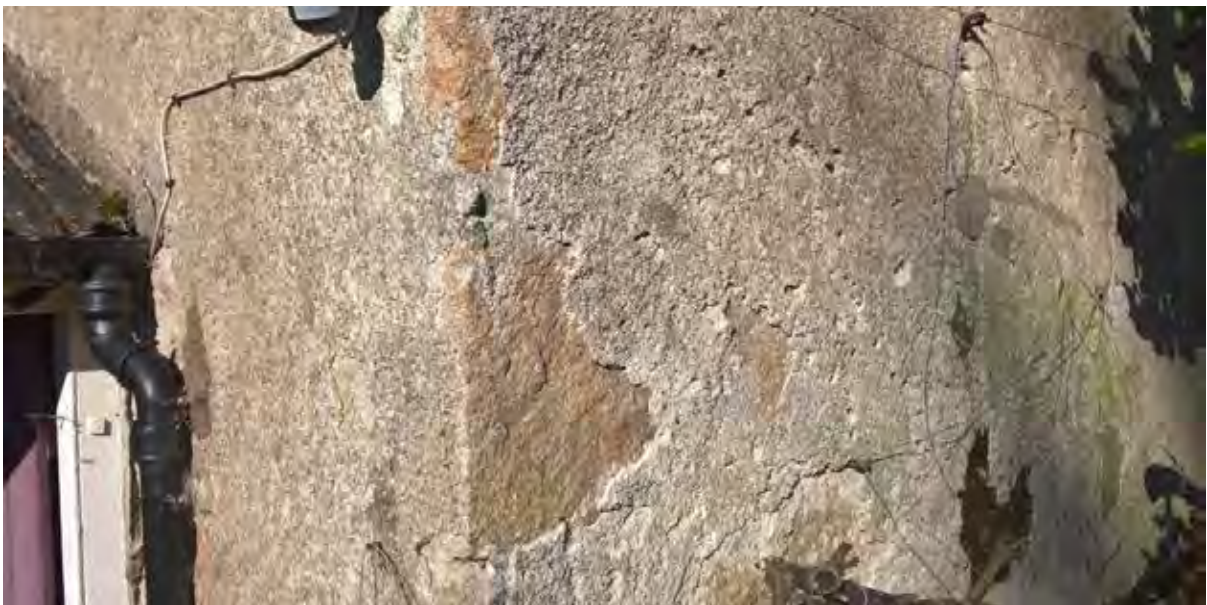
Figure 36.4. The harl is adhering relatively well to the quins, but some spalling.

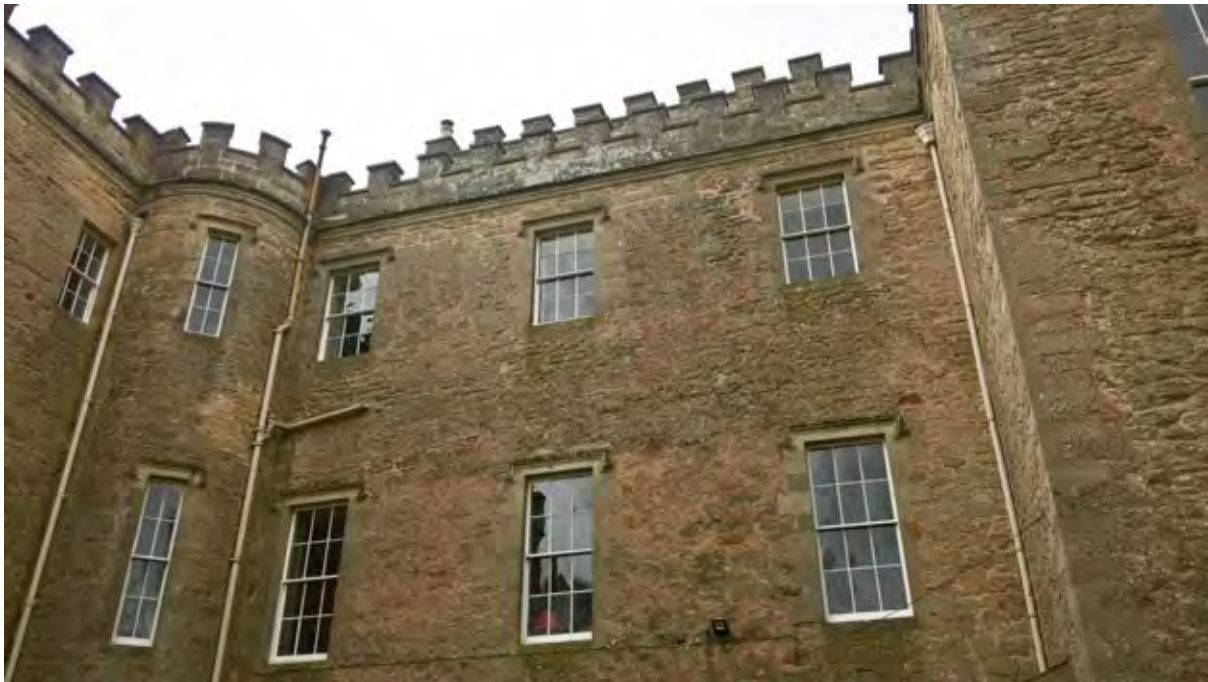
Figure 44.1. The rear or courtyard elevation of the Castle, showing the lime harling.

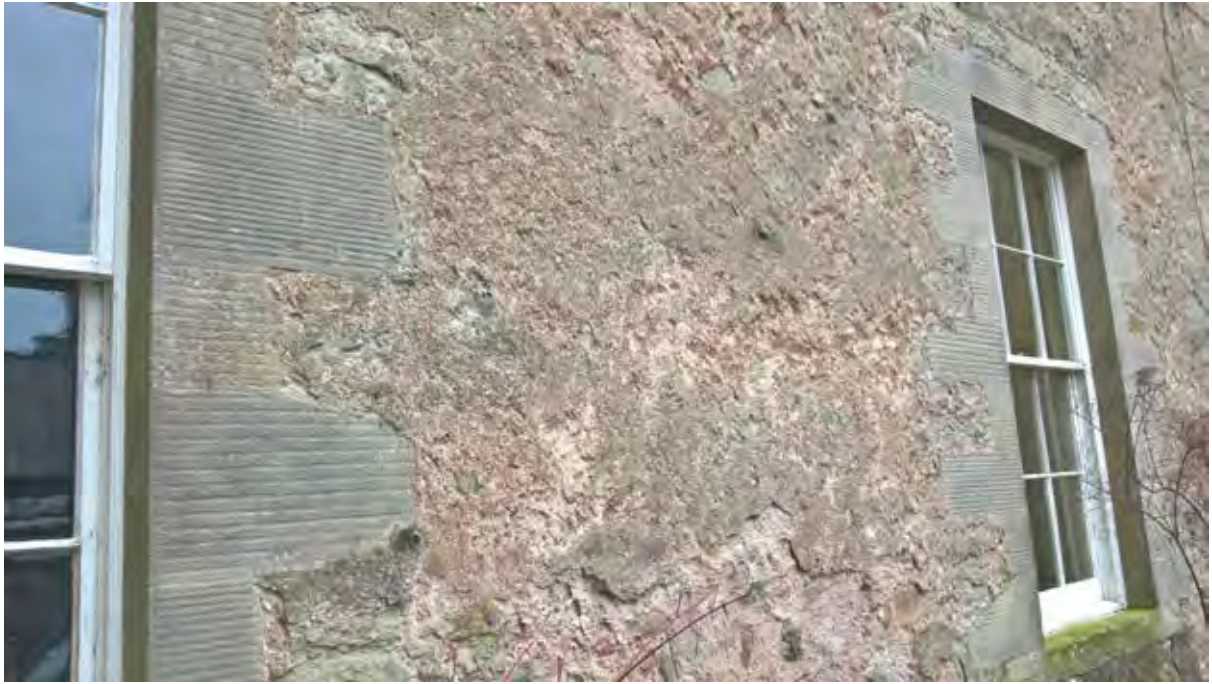
Figure 44.2. The surviving render on the east wall of the courtyard.

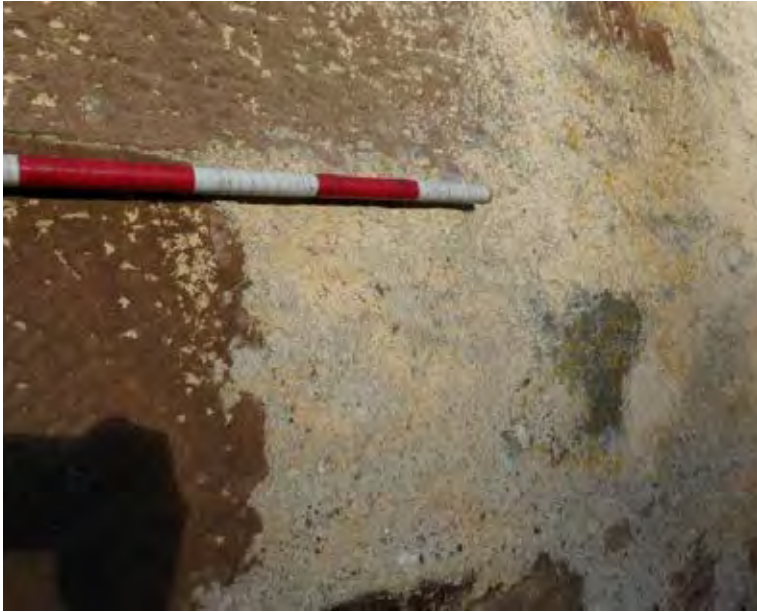
Figure 47.2. Detail of sandstone quoins.

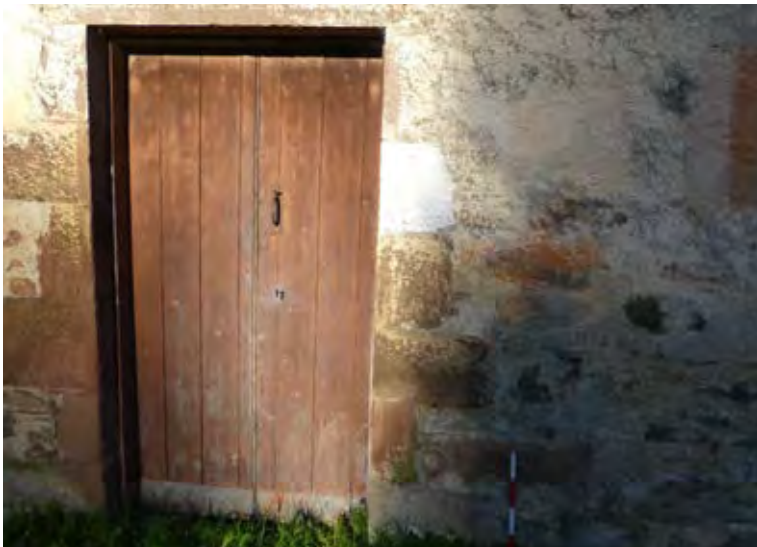
Figure 47.3. Degrading of the harl close to ground level.

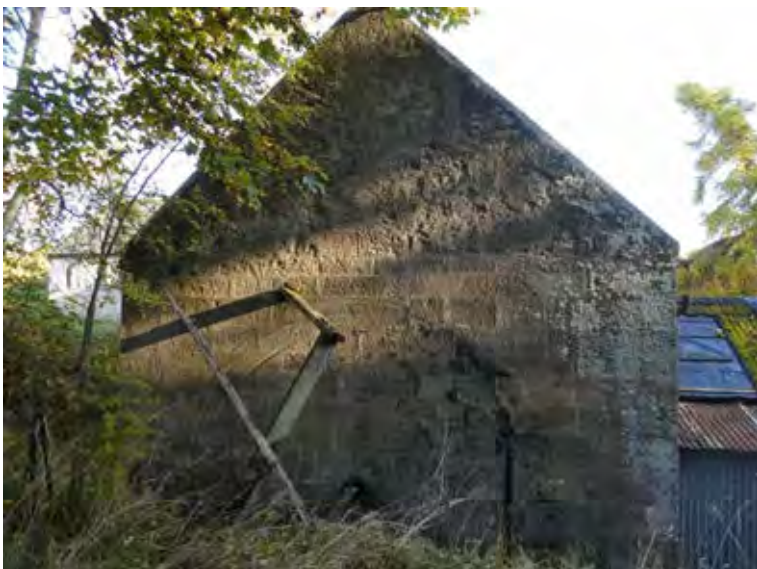
Figure 47.4. The mill gable end, with more dressed masonry blocks laid in lime mortar.

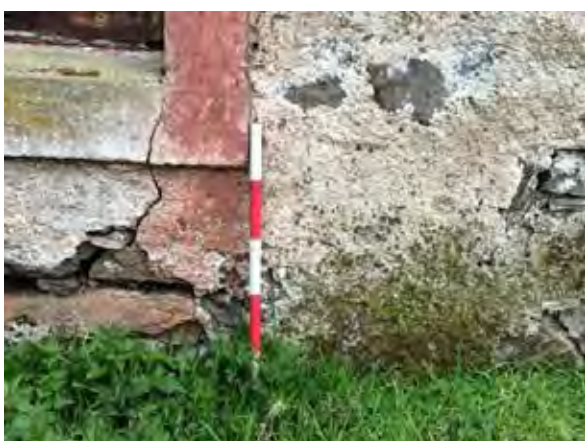
Figure 48.2. The harl exhibits no evidence of complete limewash, but does resemble the neighbouring barrack blocks in terms of texture and robustness.

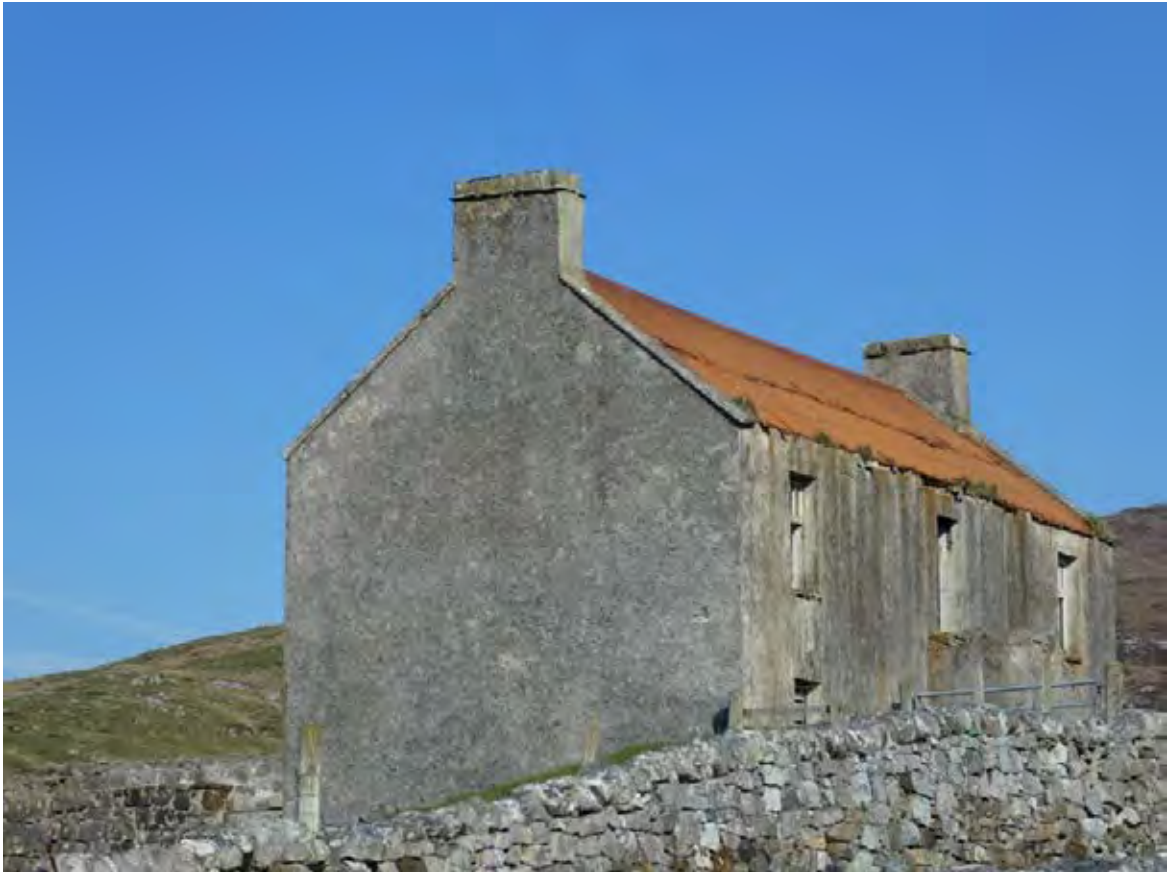
Figure 50.1. General view of the store house.

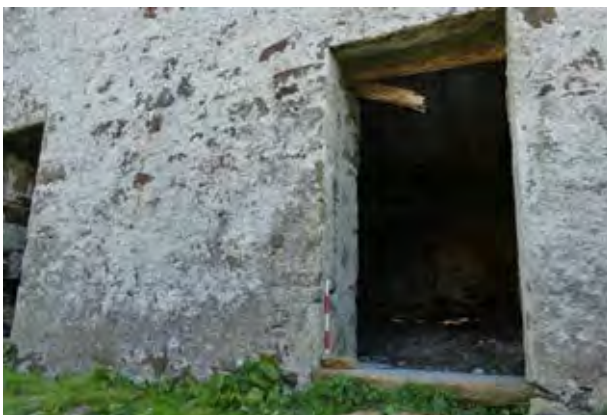
Figure 50.2. Remains of the thin harl.
