TECHNICAL PAPER 31

HISTORIC EXTERNAL LIME FINISHES IN SCOTLAND

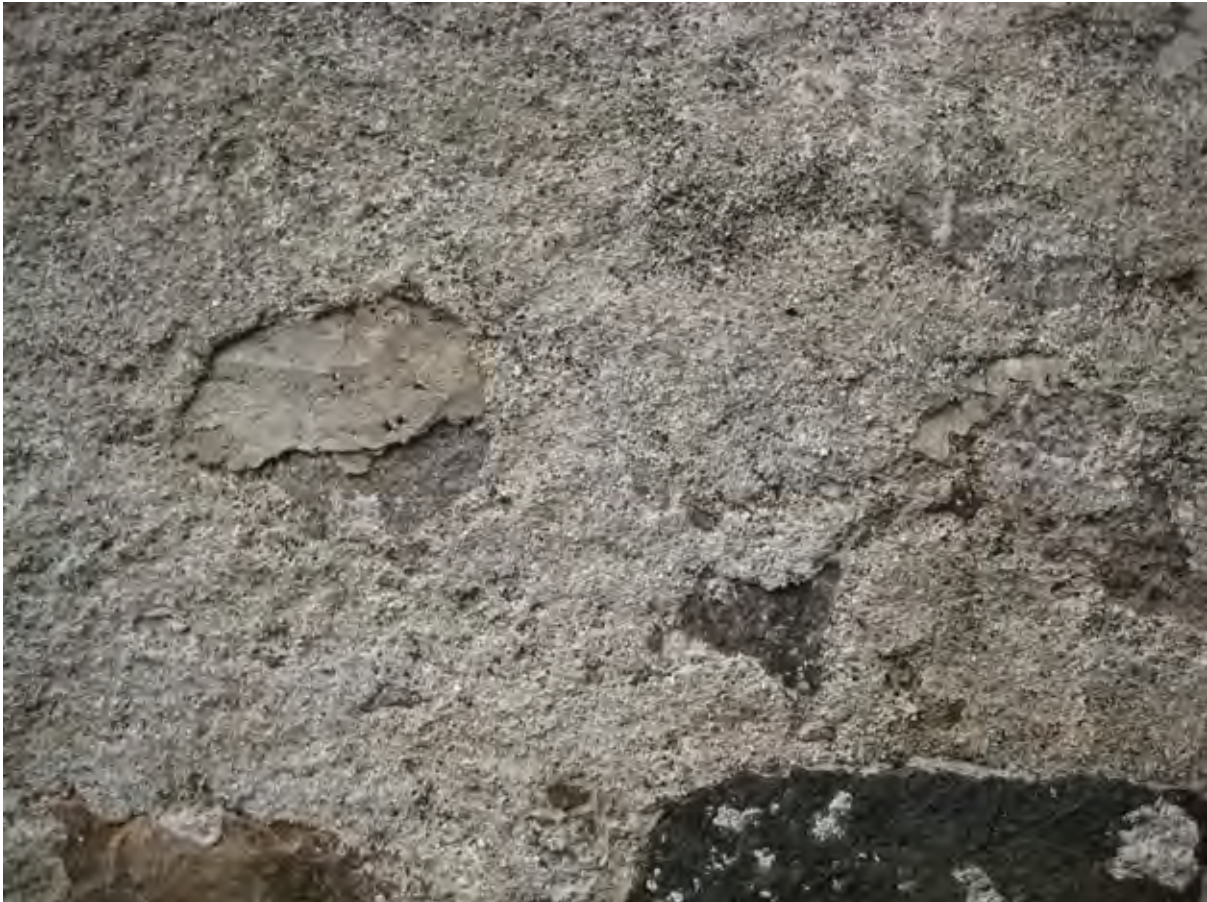
Figure 53.2. The thin traditional render still adhering well.

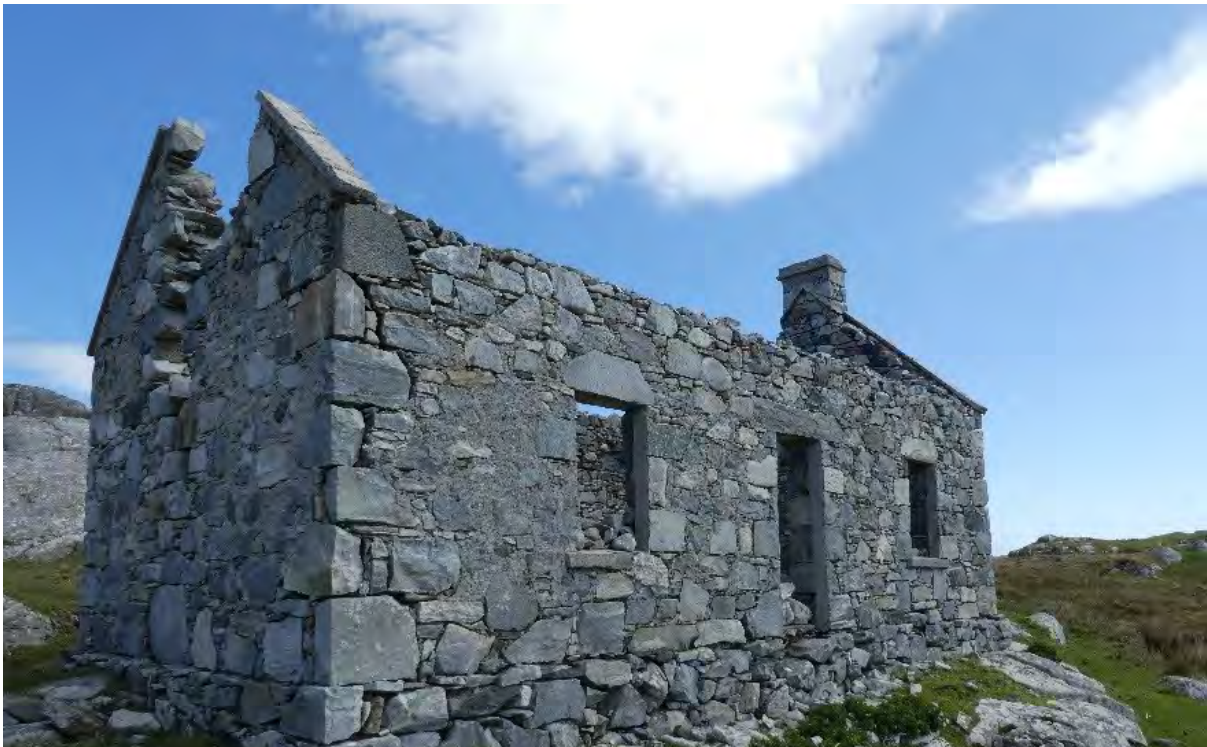
Figure 59.1. The south west elevation of the cottage at Manish.

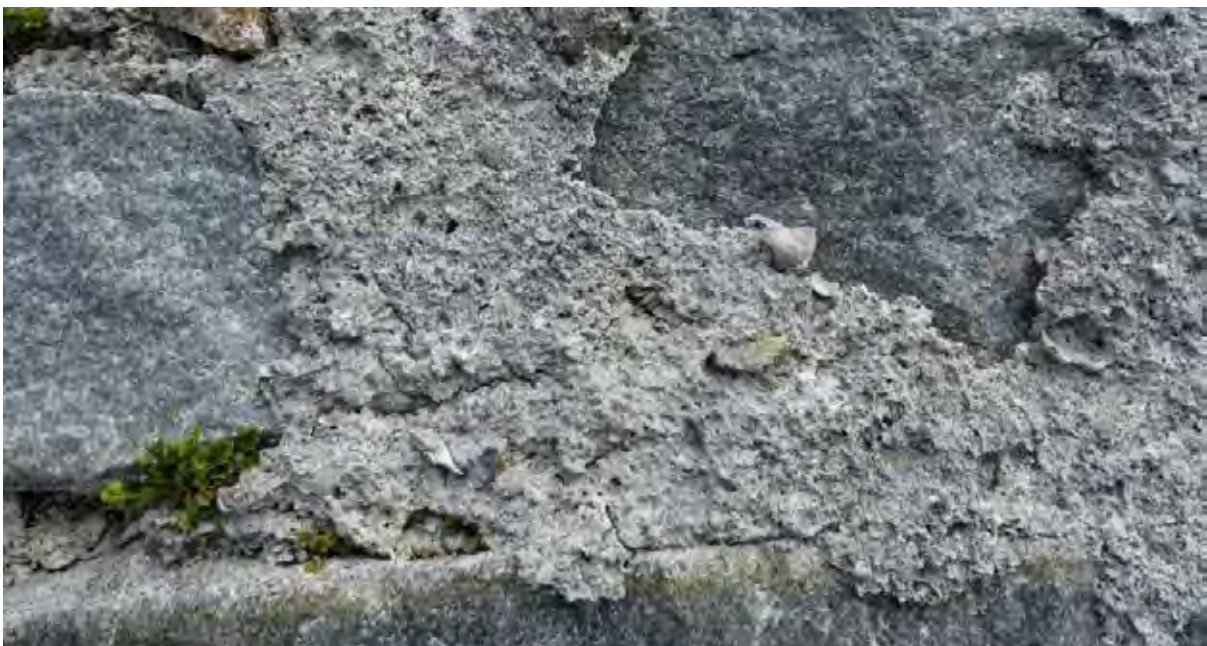
Figure 59.2. Detail of the harl on the south west elevation of the cottage, note the shell fragments.

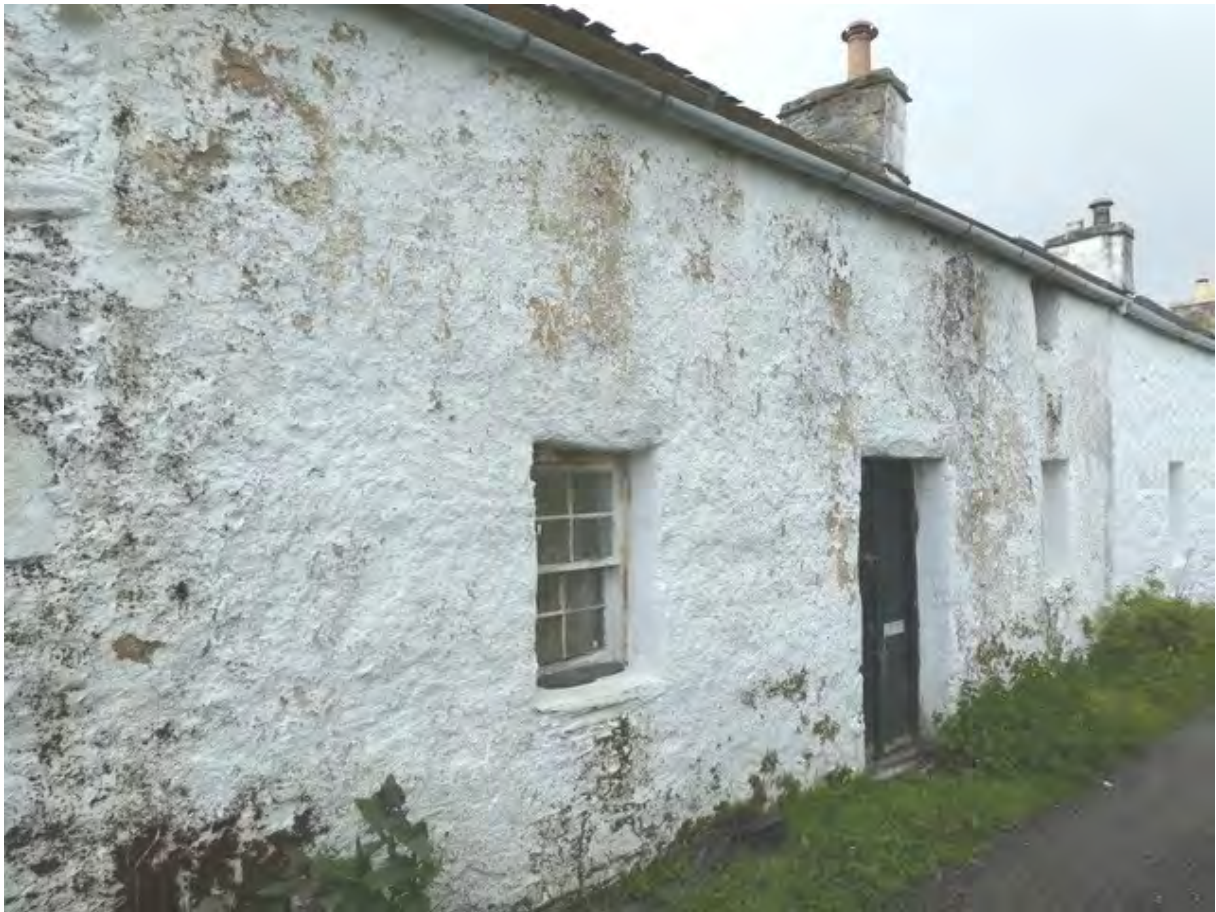
Figure 60.1. The West elevation of the cottage showing the nearly intact lime harl.

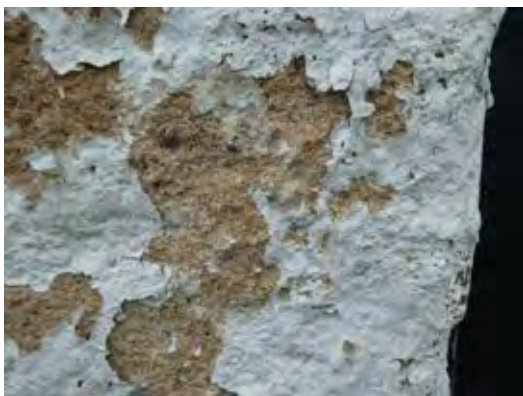
Figure 60.2. Detail of the harl, showing the dark cream colour characteristic of the Lismore lime.

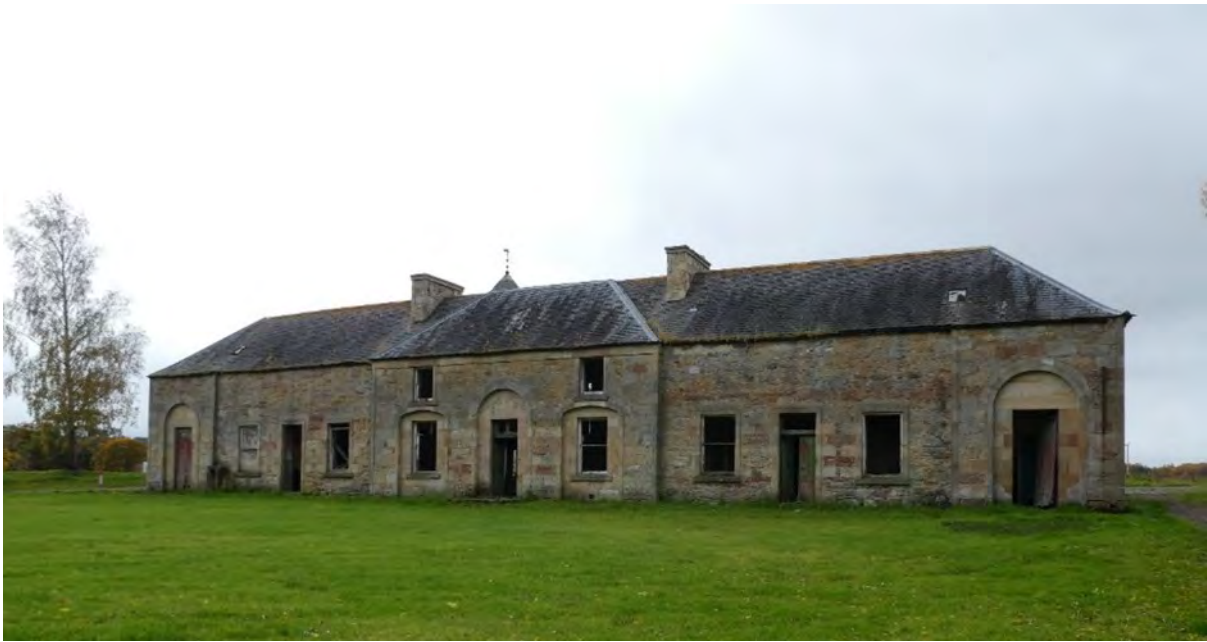
Figure 61.1. Front elevation of the steading.

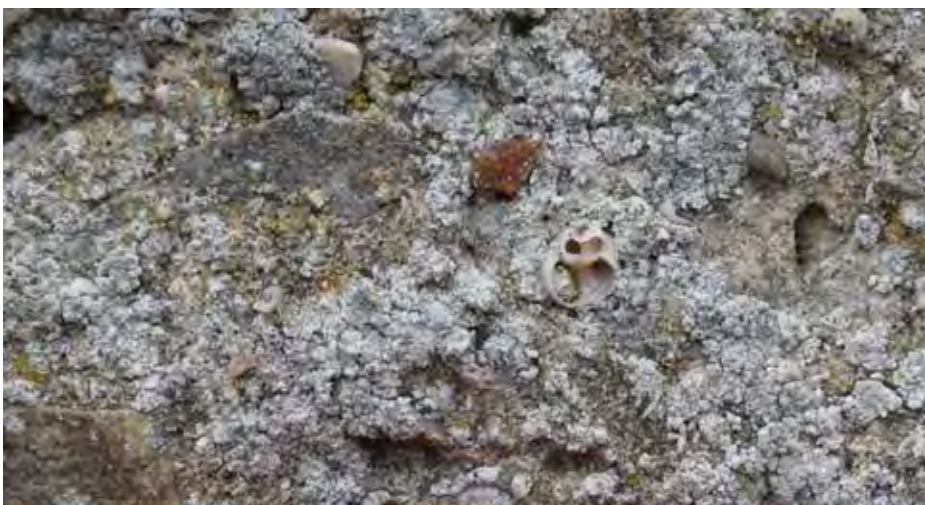
Figure 61.2. Detail of remaining lime harl.

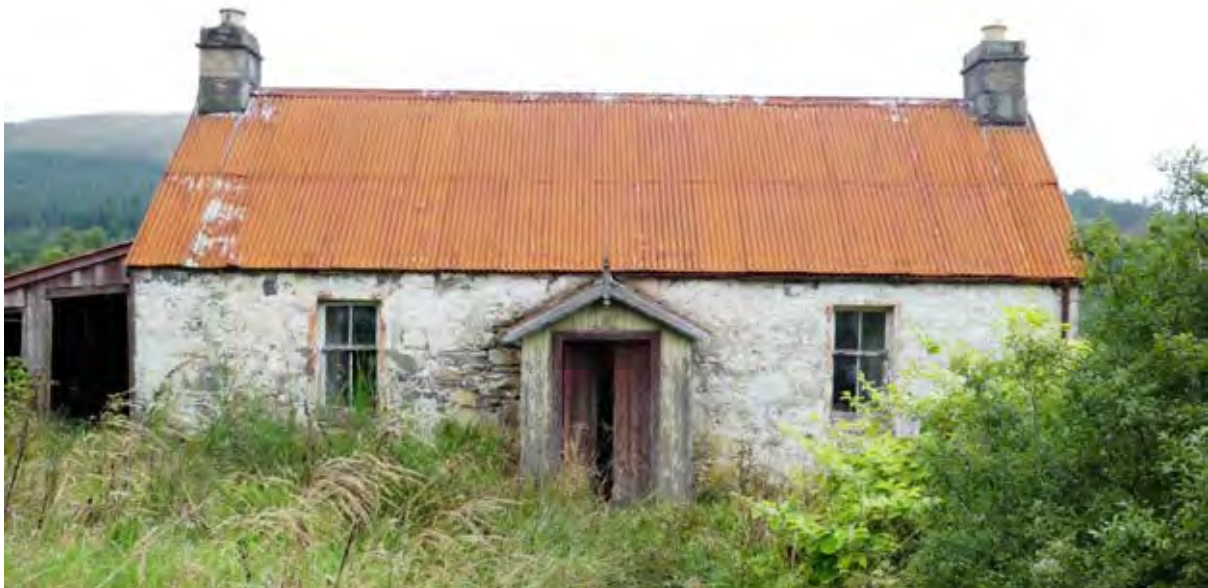
Figure 62.1. Front elevation of the cottage.

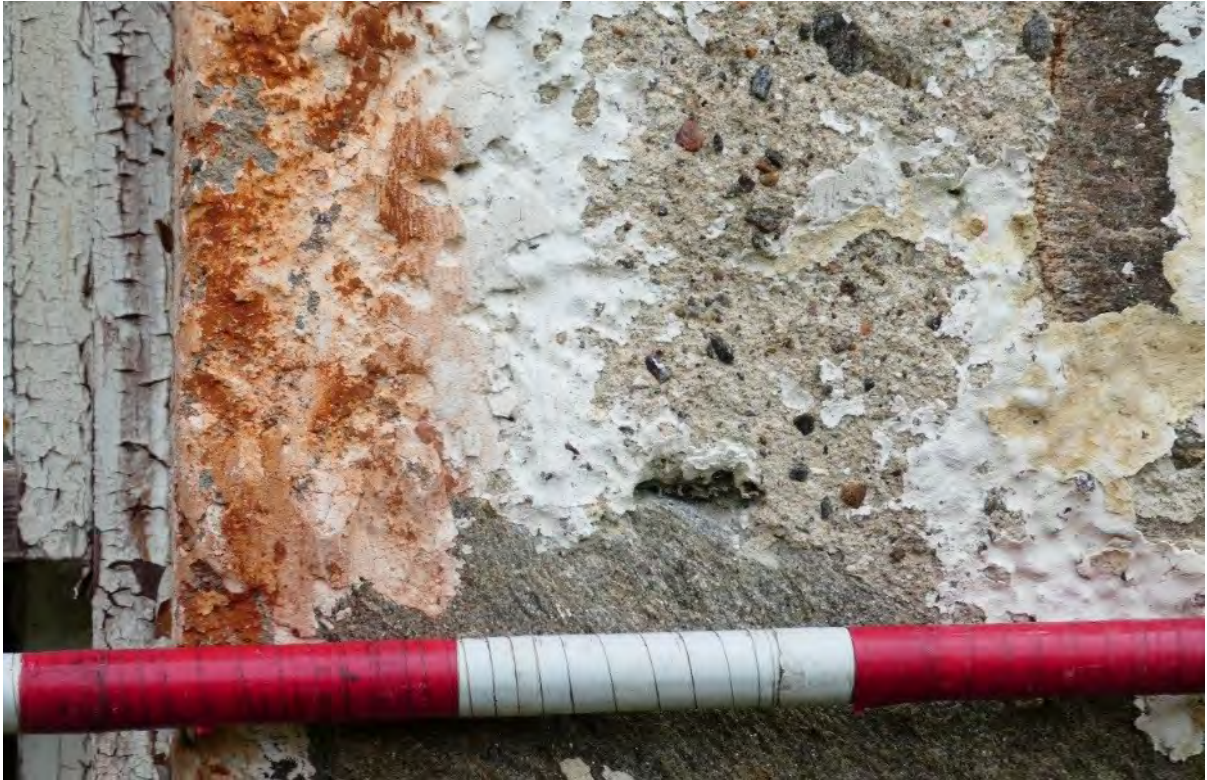
Figure 62.2. Evidence of the different coats of limewash which have been applied to the building.

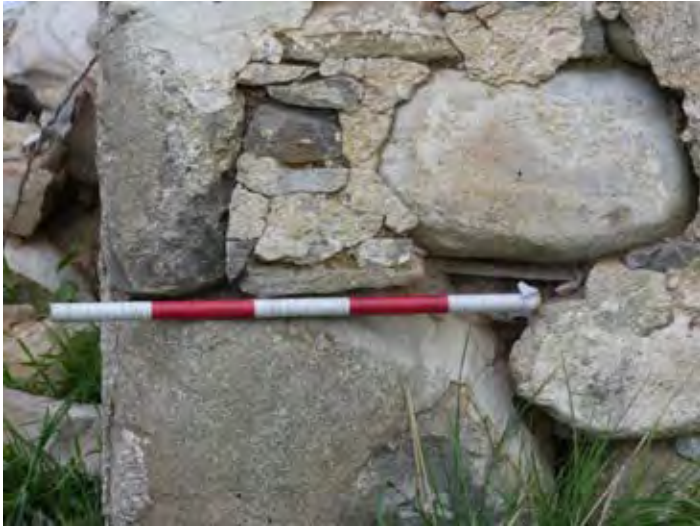
Figure 63.2. Flushing-up over the clay-bonded wall core at the wall face with clay-lime mortar.

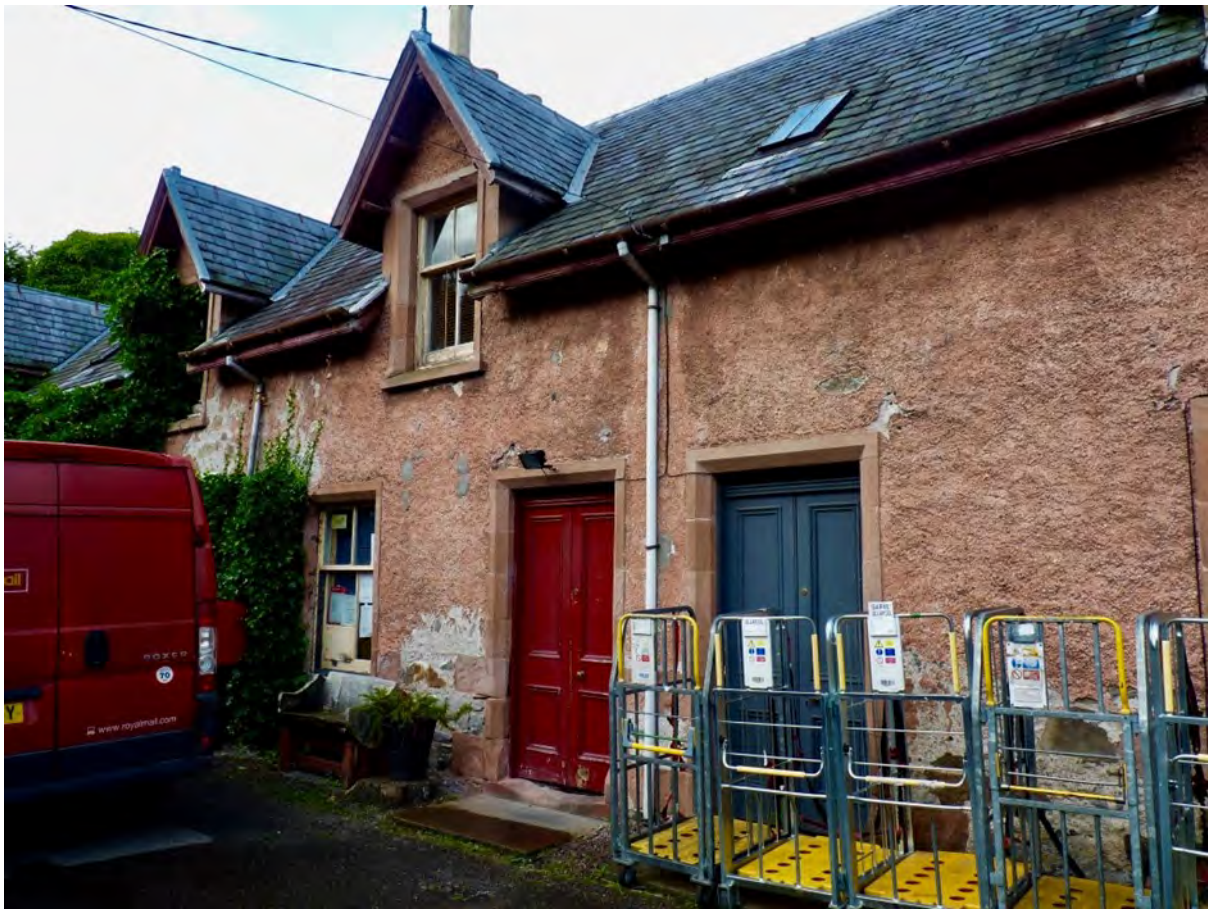
Figure 64.1. General view

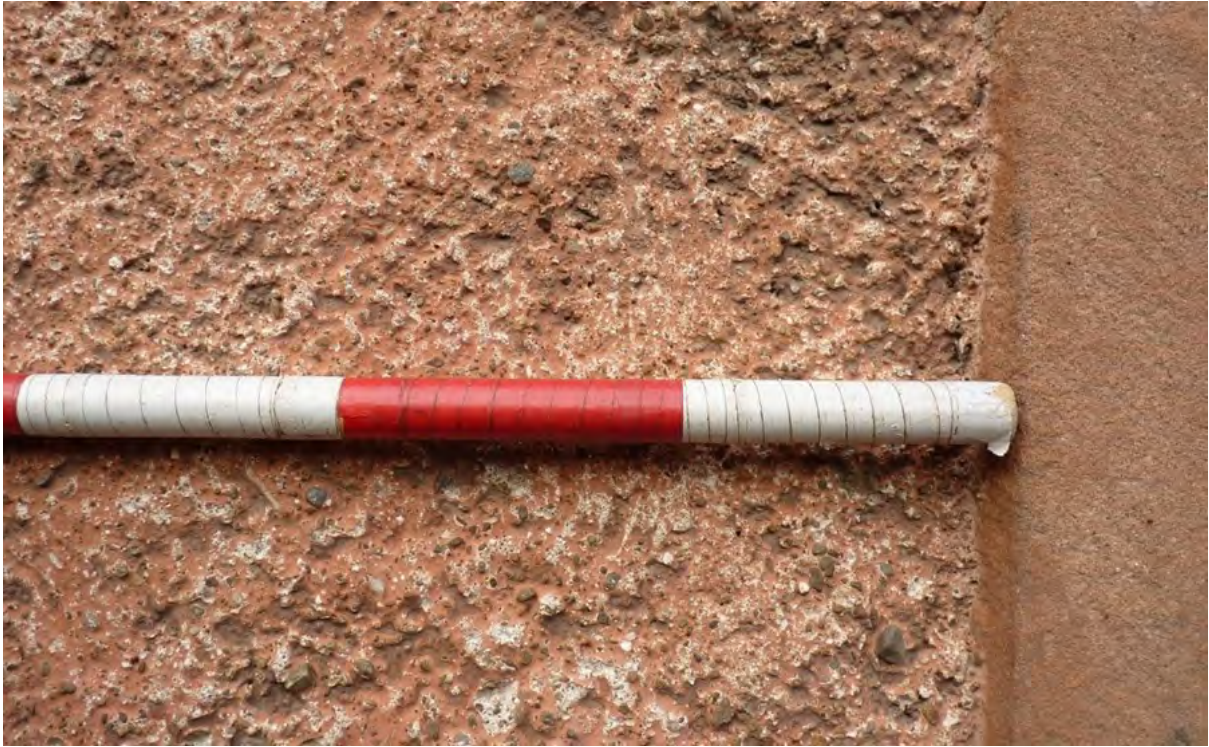
Figure 64.2. Limewashed harl on the principal elevation at the edge of the margin.

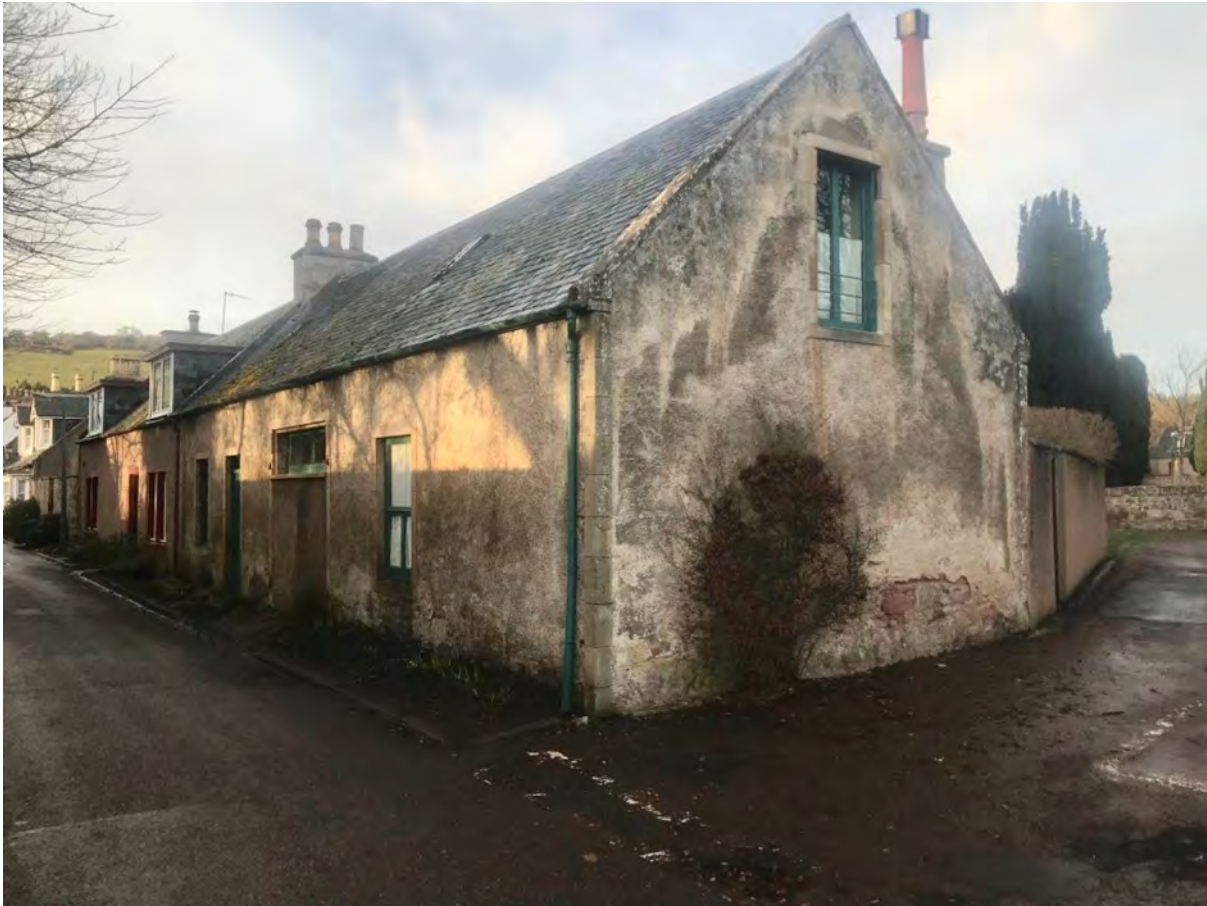
Figure 67.1. General view of the cottage.

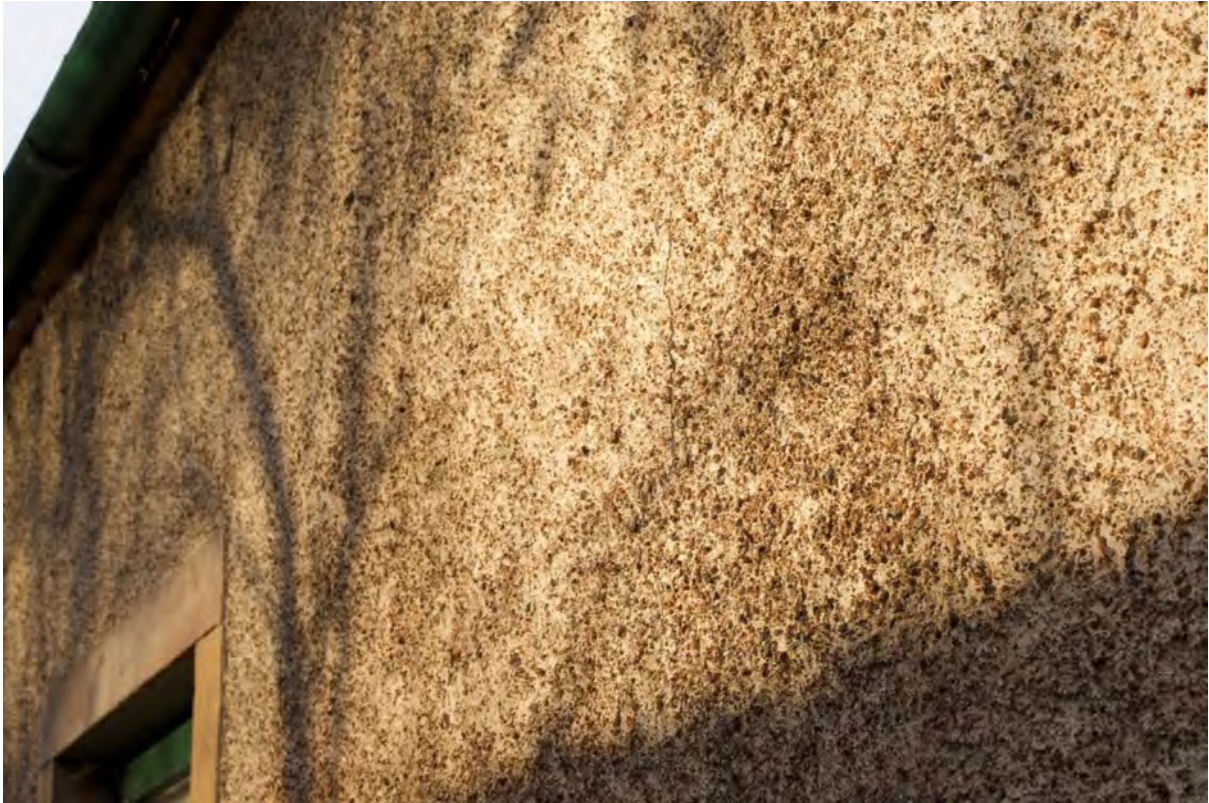
Figure 67.2. The complete lime harl in good condition on the front elevation.

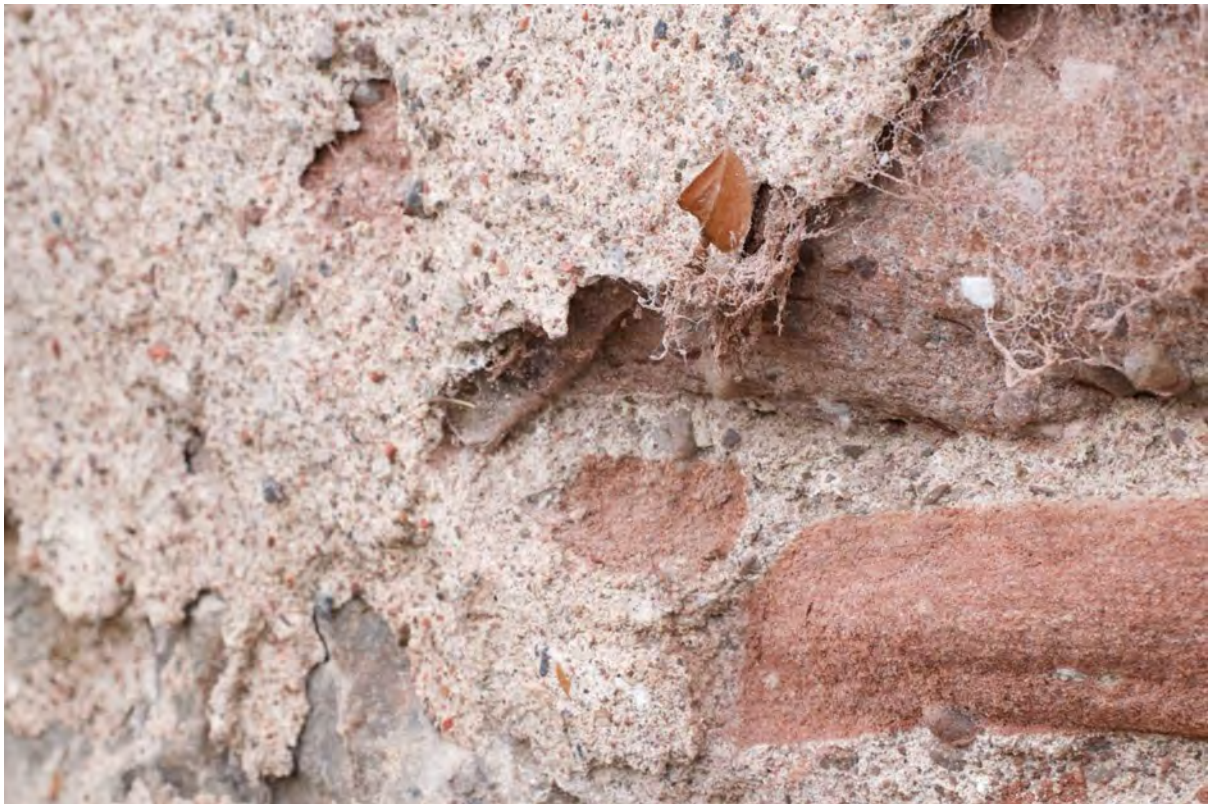
Figure 67.3. Detail of integrated finish seen at a damaged area on the gable; note the bedding mortar and harl are the same mix.

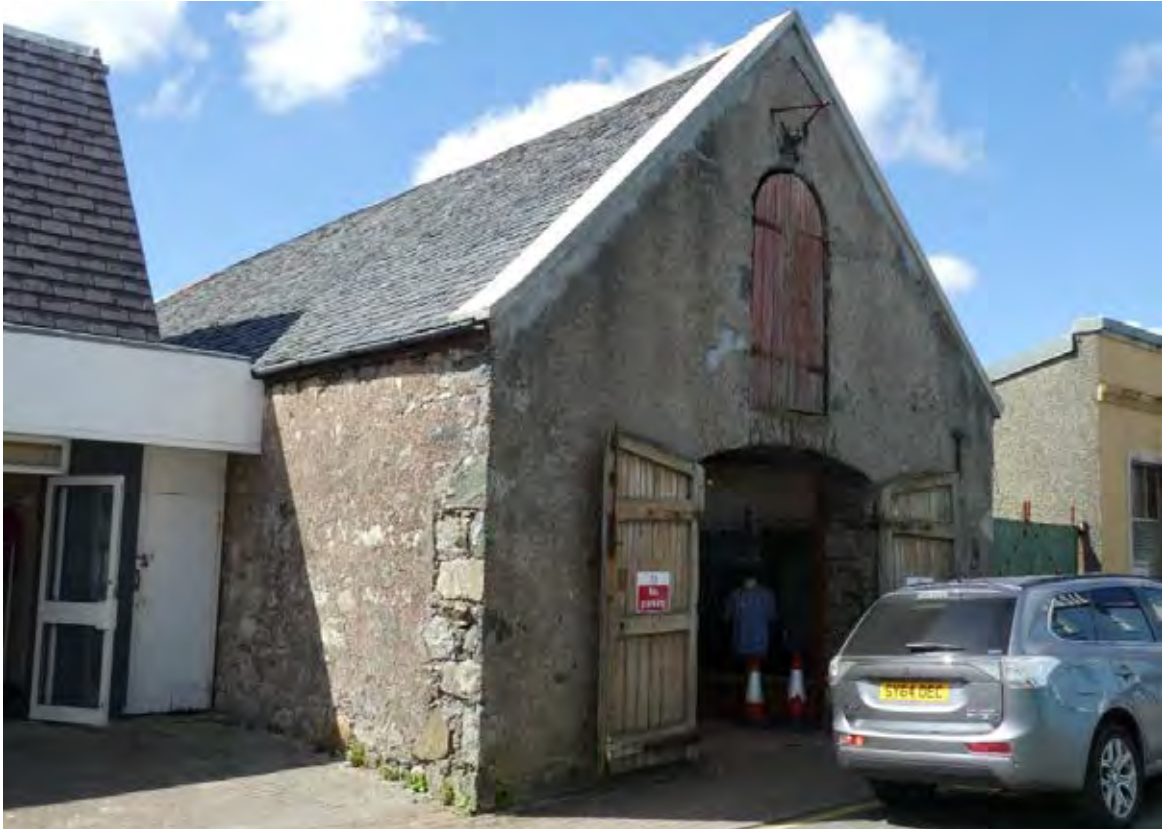
Figure 68.1. View of the warehouse from the main entrance.

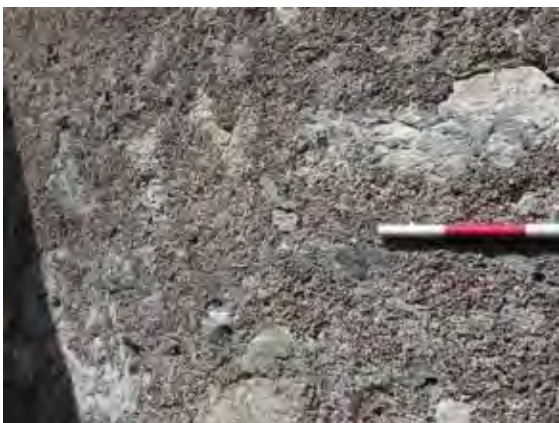
Figure 68.2. Detail of the harl.

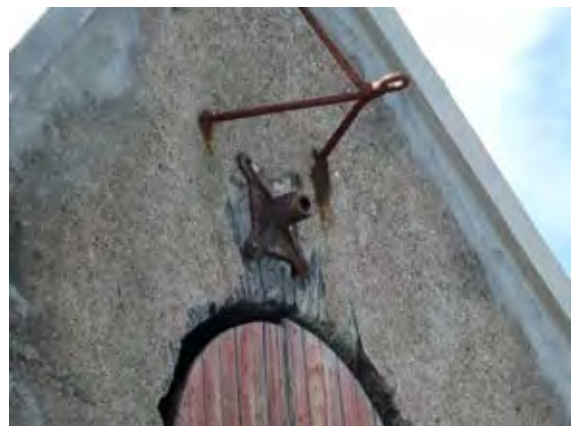
Figure 68.3. Area of harl decay.

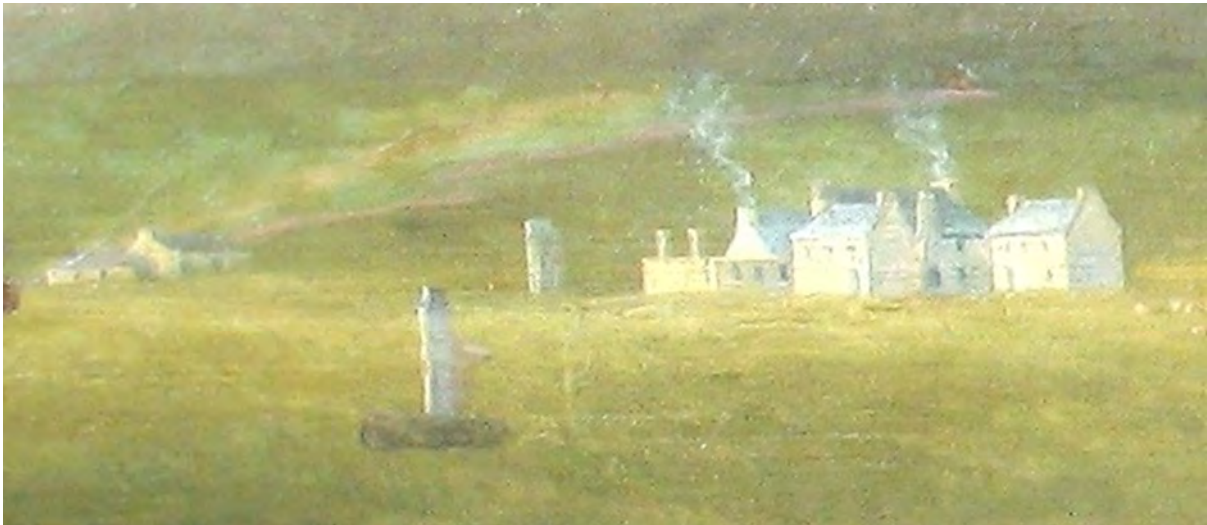
Figure 69.1. Historic view of Seaforth Lodge from 1798.

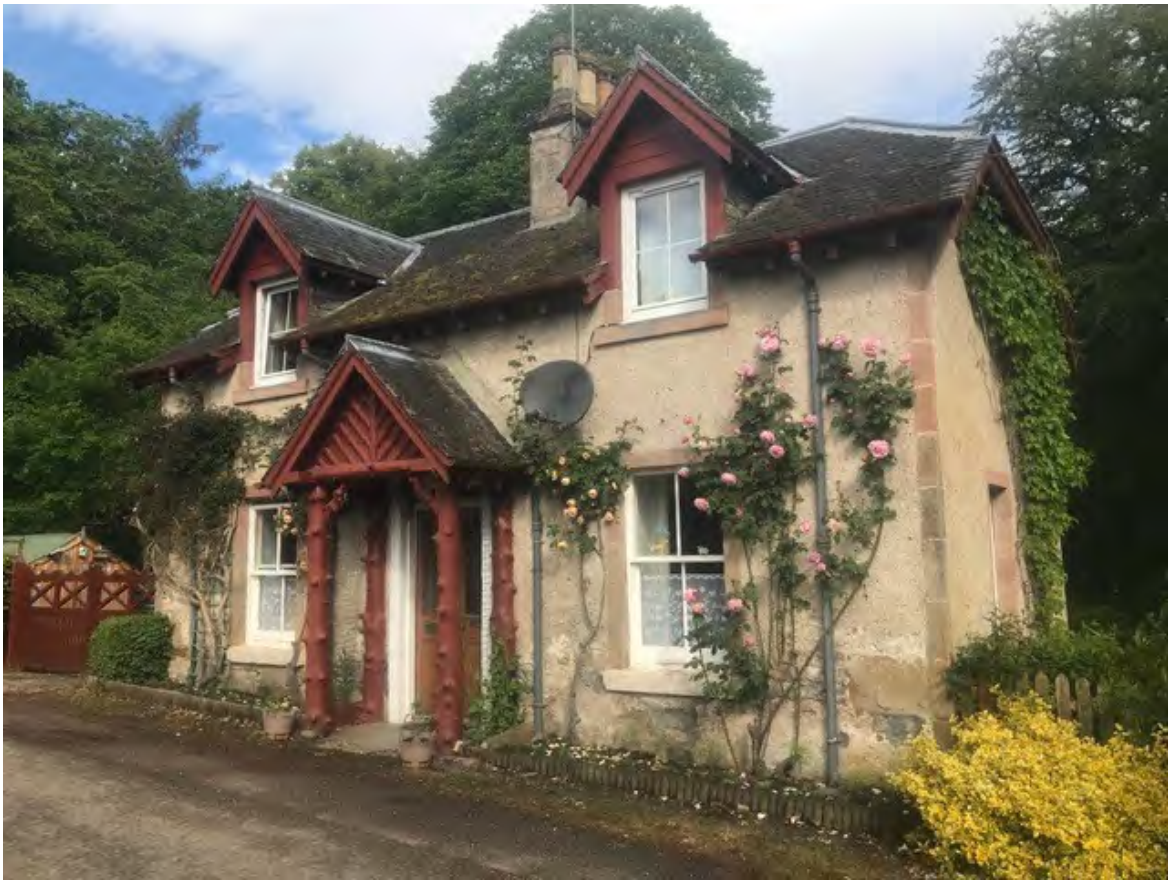
Figure 72.1. General view of the villa.

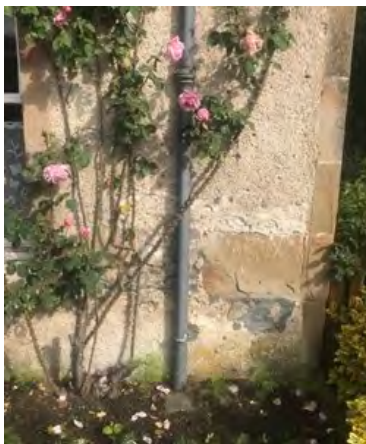
Figure 72.2. Detail of the lower part of the front elevation showing some spalling of the harl due to damp and frost.

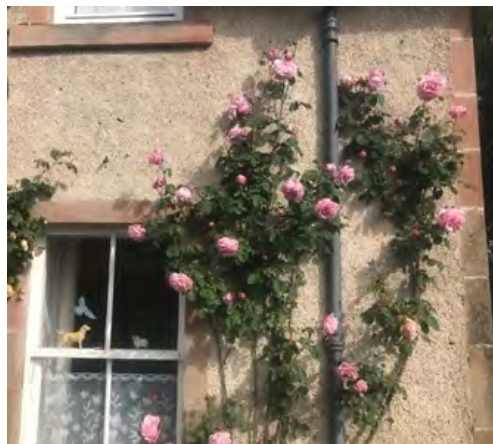
Figure 72.3. Detail of the front elevation showing the neat junction with the window jambs.
