TECHNICAL
ADVICE
NOTE

MAINTENANCE
AND REPAIR
OF CLEANED
STONE BUILDINGS

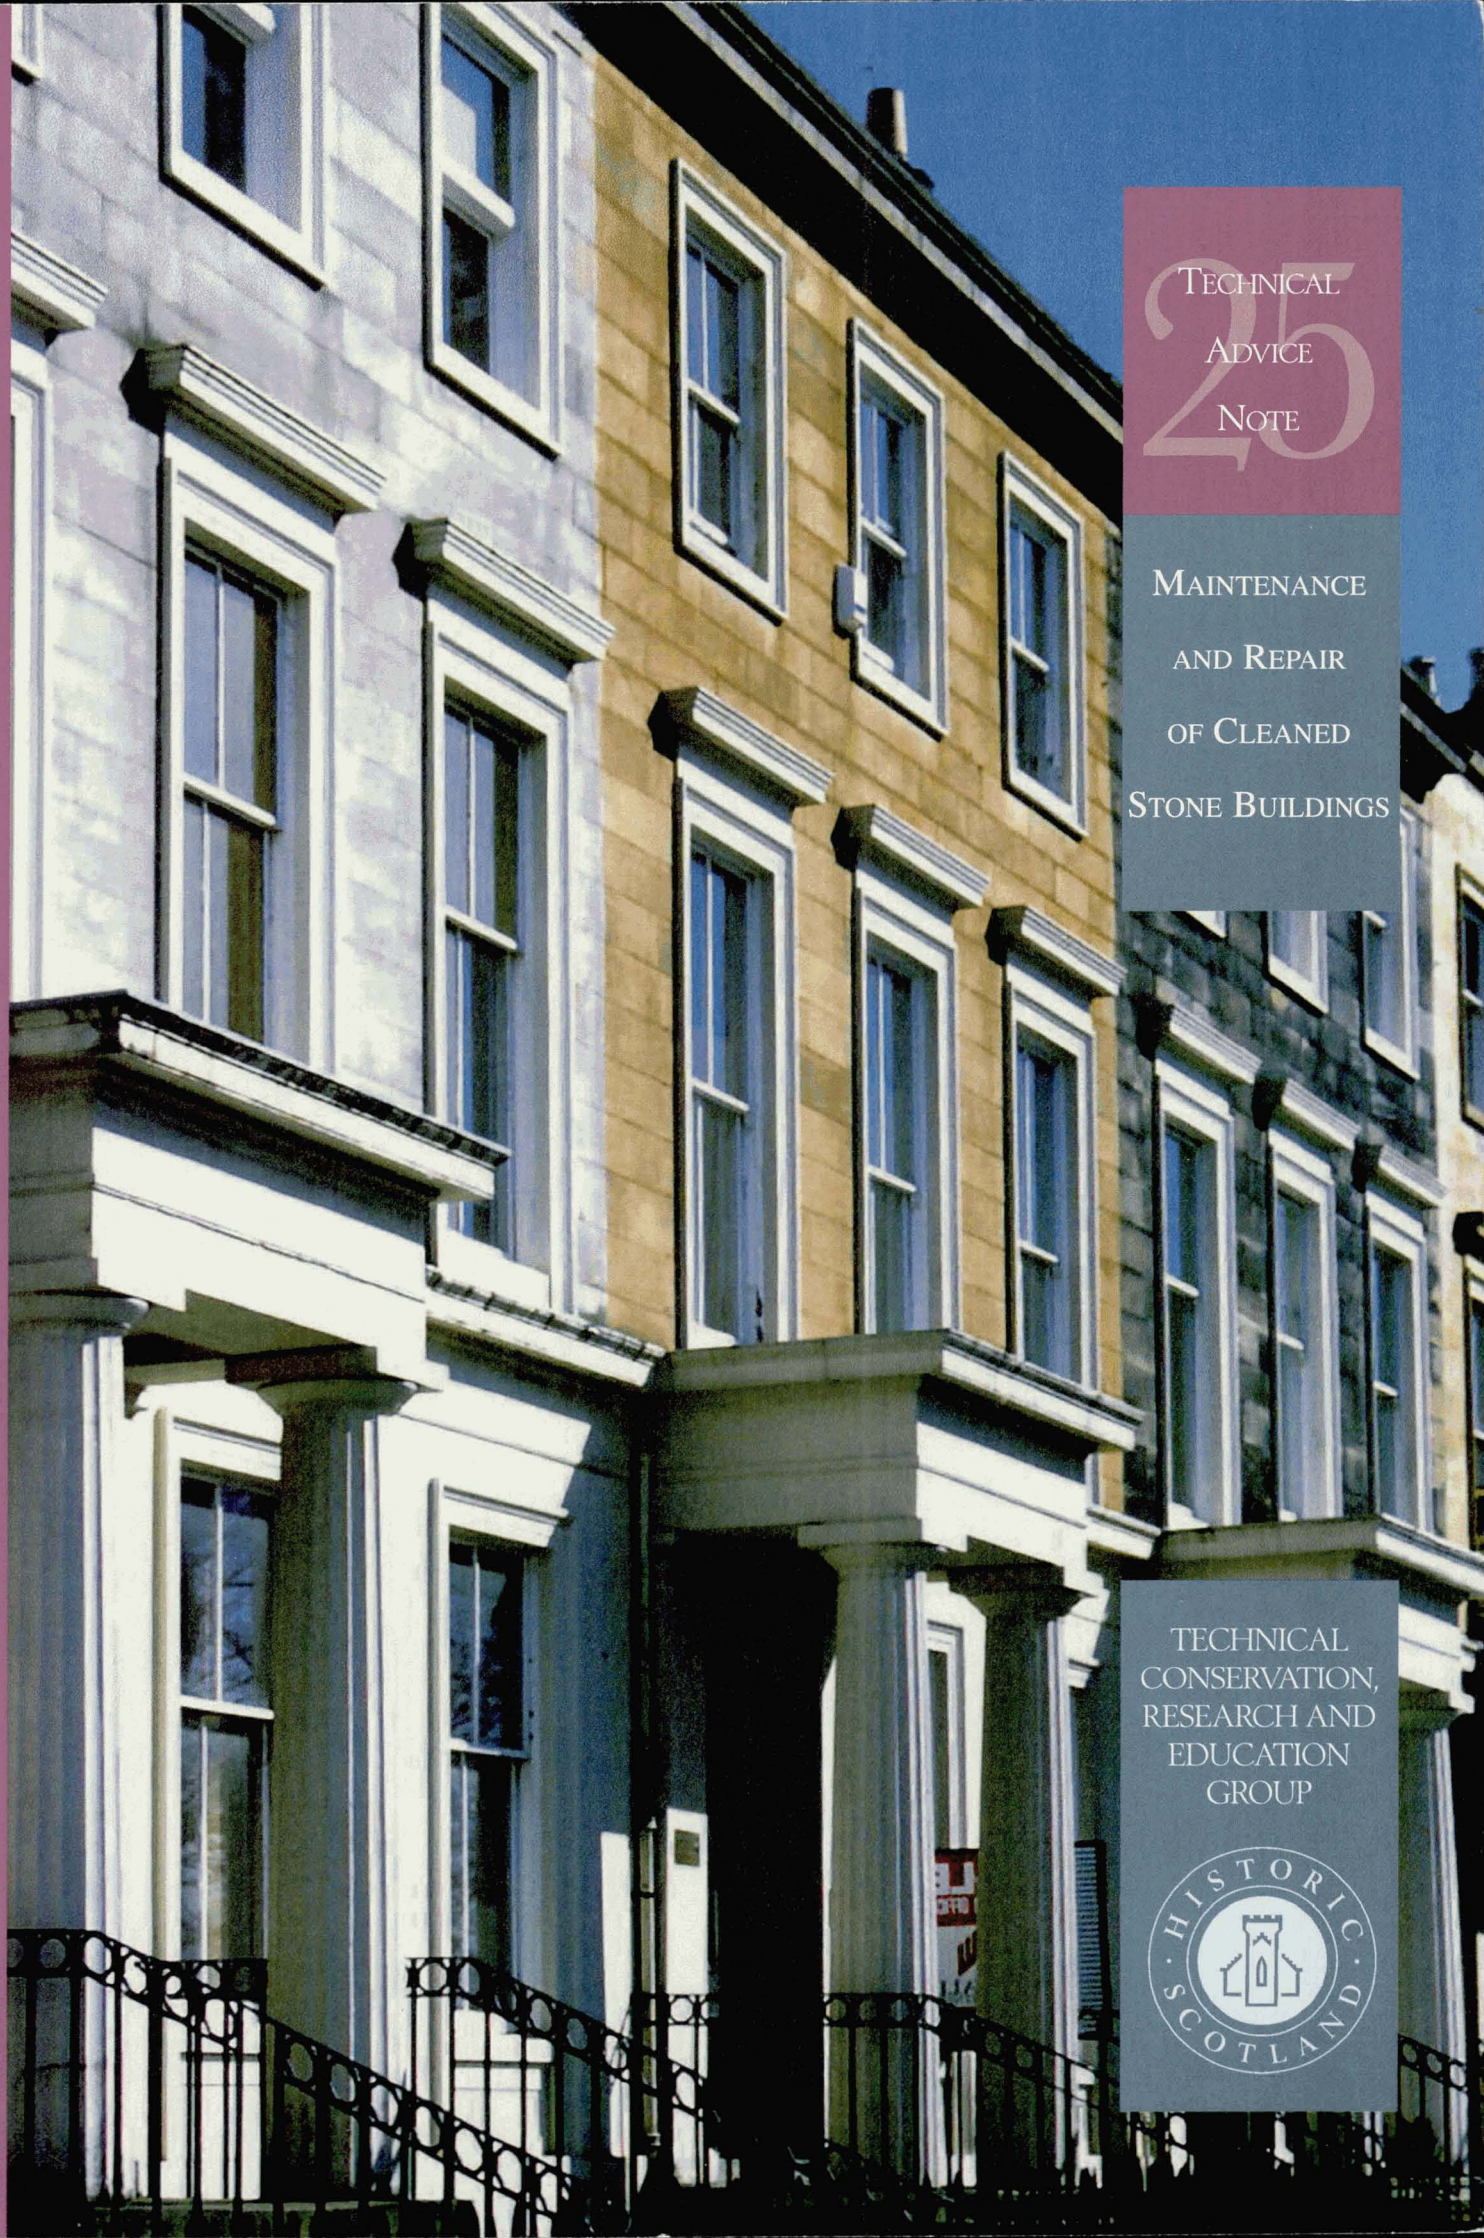
HISTORIC SCOTLAND TECHNICAL ADVICE NOTES

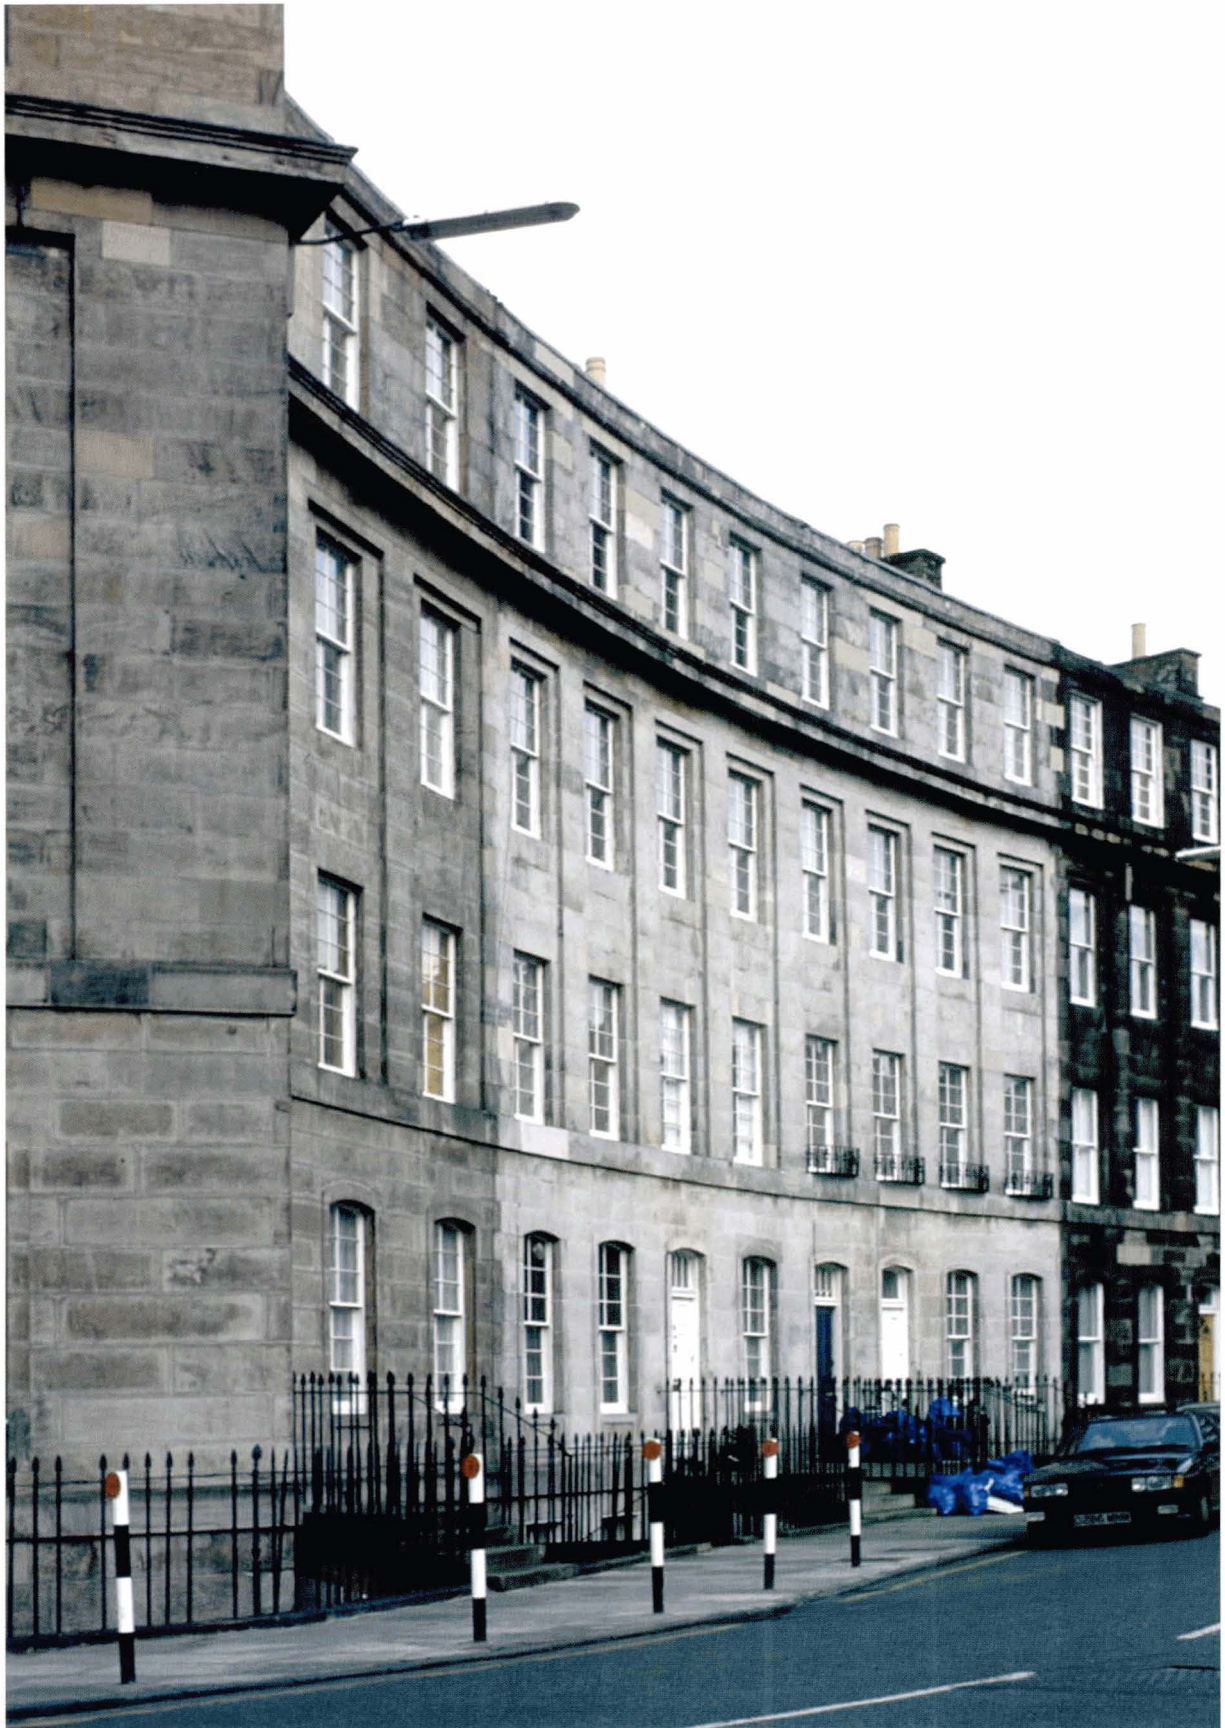
Illus 1. Cleaning at different times using a variety of methods results in a variety of colours and shades on a once unified facade. This is an example from Edinburgh.

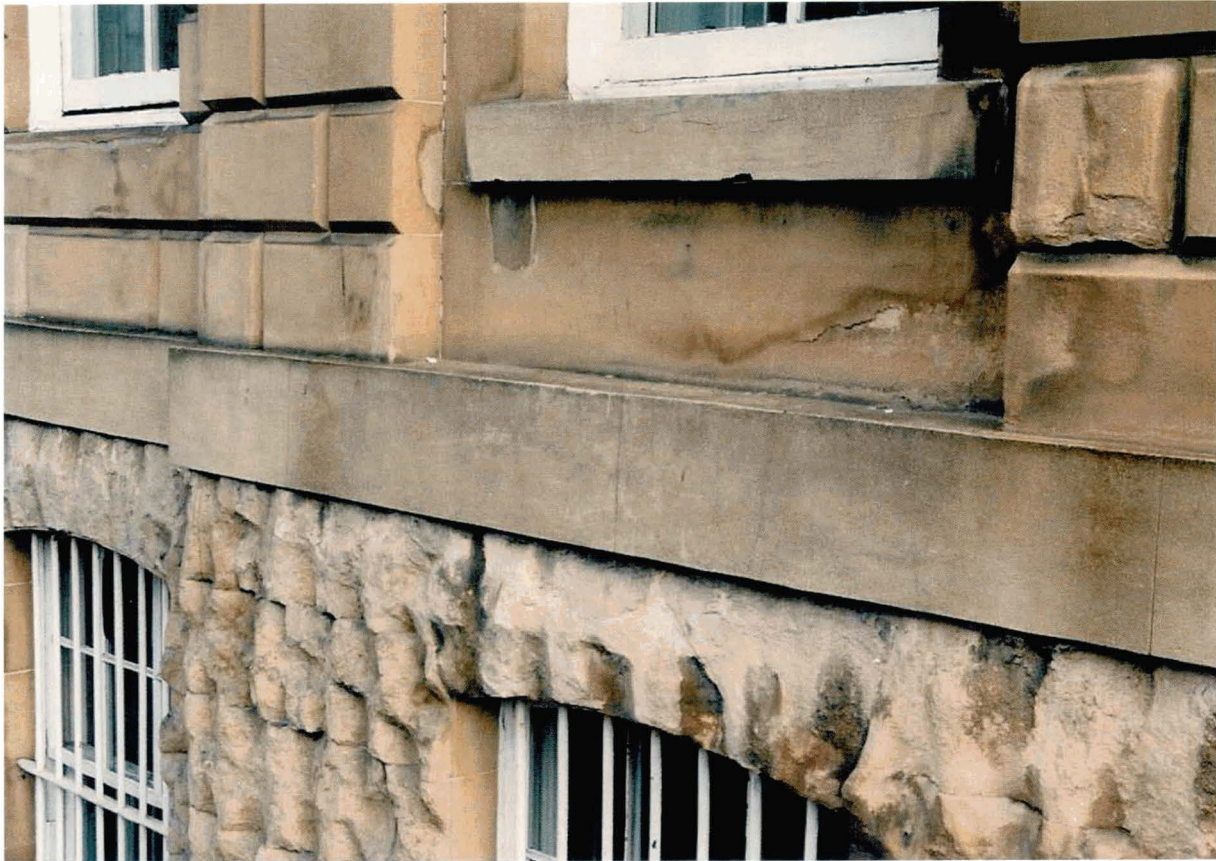
Illus 2. Loss of functional detail post stonecleaning. On this building a decayed string course has caused excessive erosion of the rock-faced sandstone below the string course. An unsatisfactory plastic repair to the string course has subsequently been carried out.

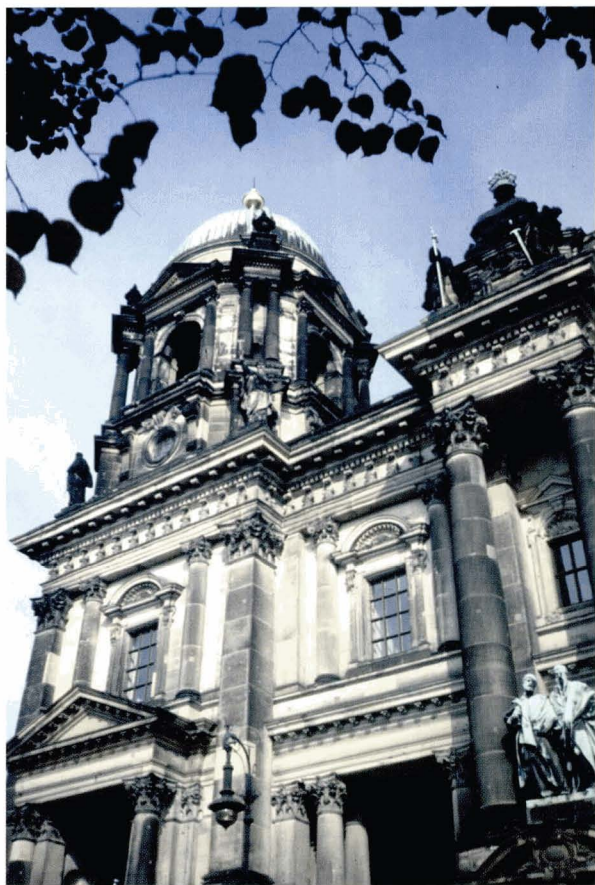
Illus 3. Typical soiling pattern on a sandstone building façade. Soiling is heaviest on areas exposed to rain and run-off.

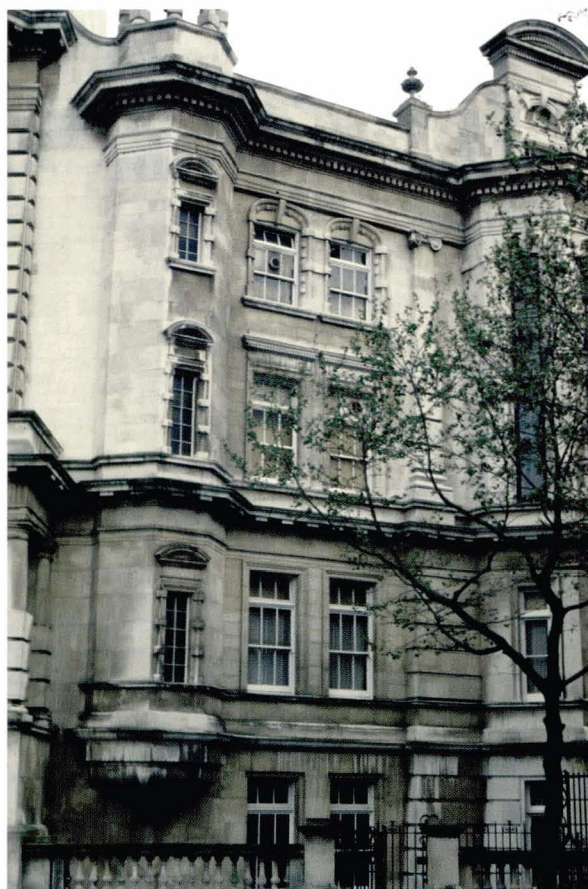
Illus 4. Typical soiling pattern on a limestone building façade. Soiling is heaviest in sheltered areas, unwashed by rainwater or run-off.

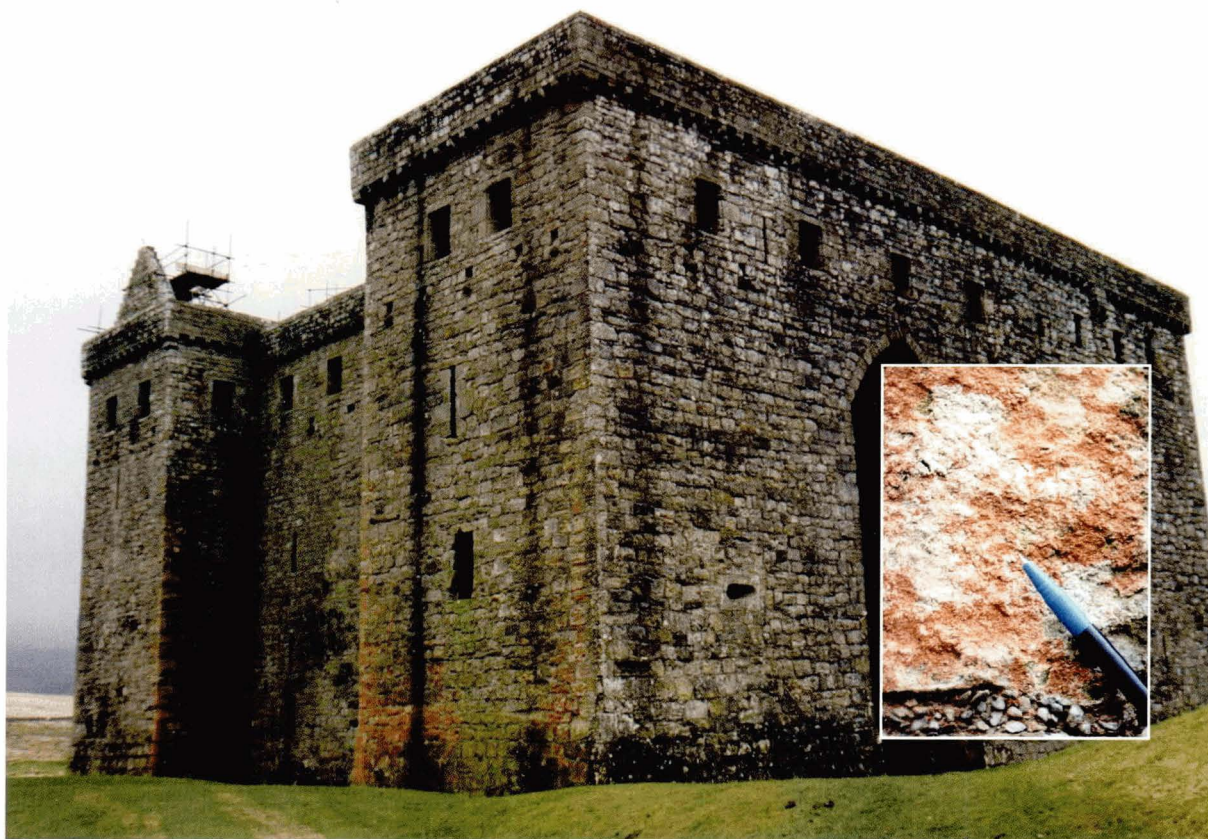
Illus 5. Hermitage Castle, Scottish Borders. The orange colour is not the natural stone colour (which is buff), but is caused by the presence of an orange-coloured algae (*Trentepohlia* sp.).

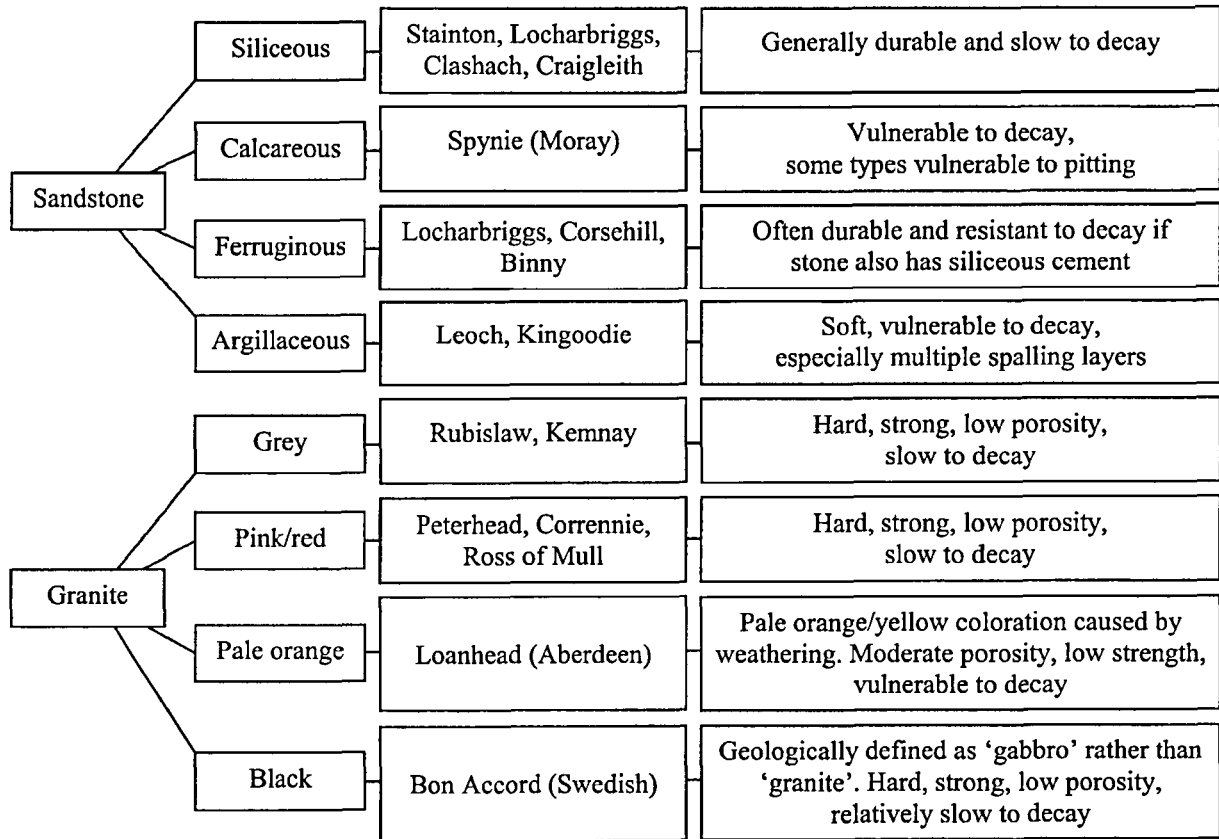
Illus 6. Characteristics of some common sandstone and granite types (NB some stone types or variants may appear in more than one sub-type).

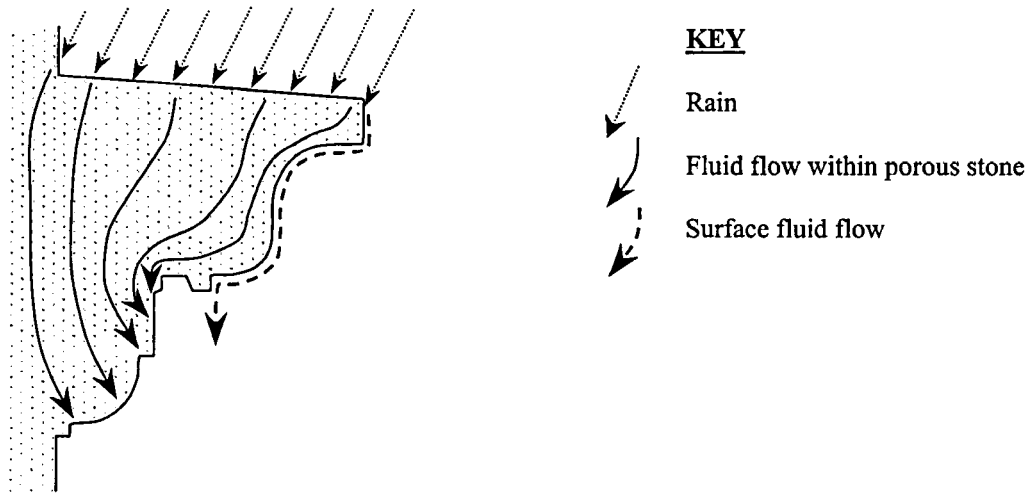
Illus 7a. Exposed detail can concentrate fluids from a large volume of stone into a relatively small zone of evaporation.

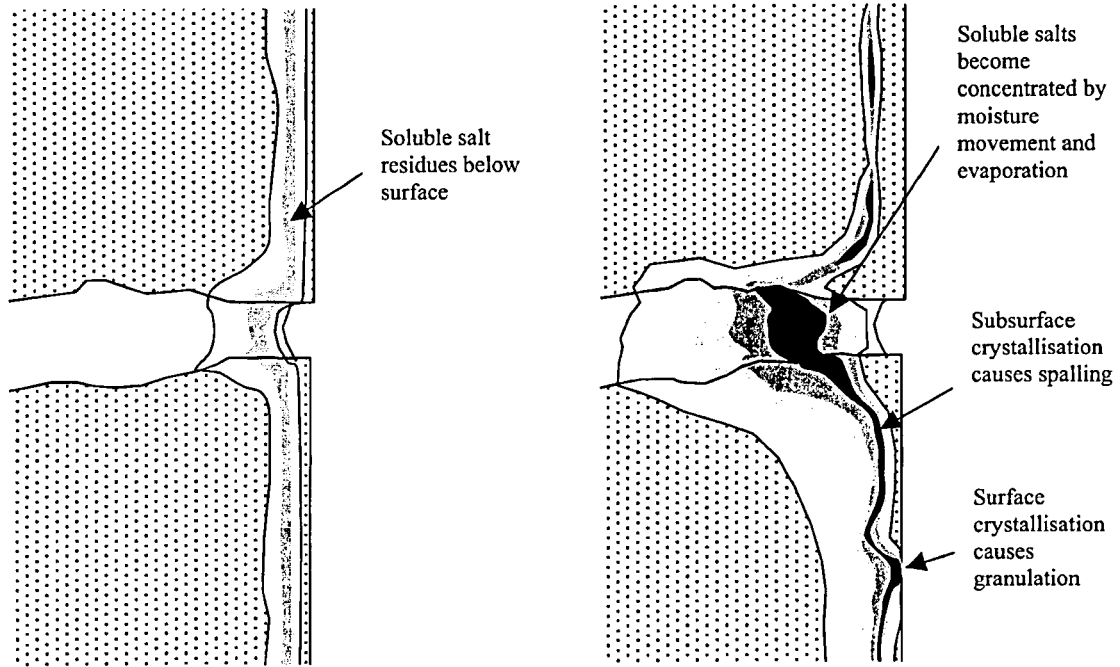
- a) Following chemical cleaning, there will be soluble salt residues below the surface. Substantial concentration can lead to salt decay problems
- c) Wetting and dry cycles concentrate soluble salts in particular areas as salt laden fluids are drawn to areas where evaporation rates are highest

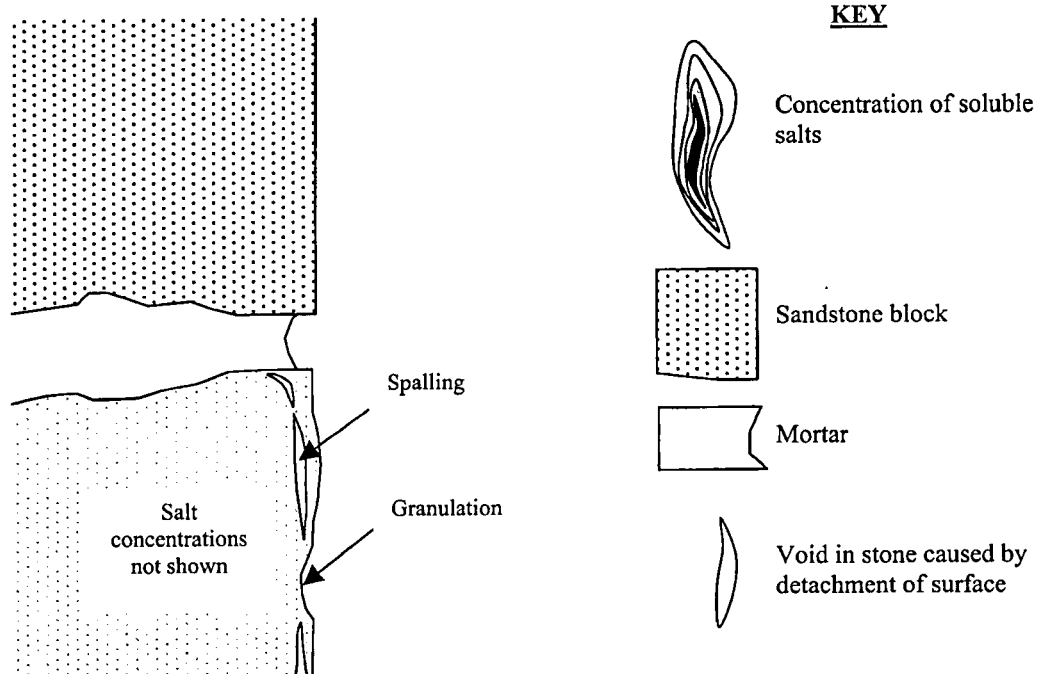
- b) Salt growth and/or size changes of salt crystals on hydration-dehydration cause stone decay - e.g. granulation, spalling, flaking, etc.

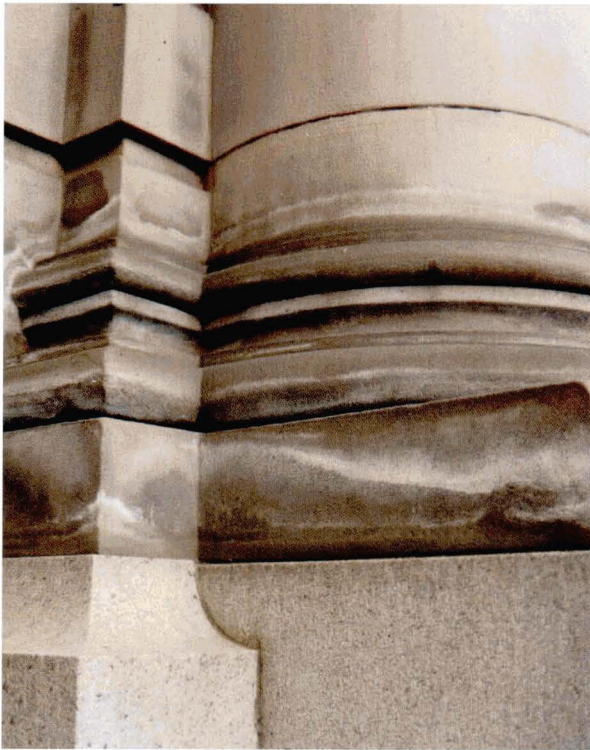
Illus 9. Bottom loading of stones with salt caused by concentration of residues of stone cleaning chemicals. In this case a permeable stone (sandstone) sits above an impermeable stone (granite).

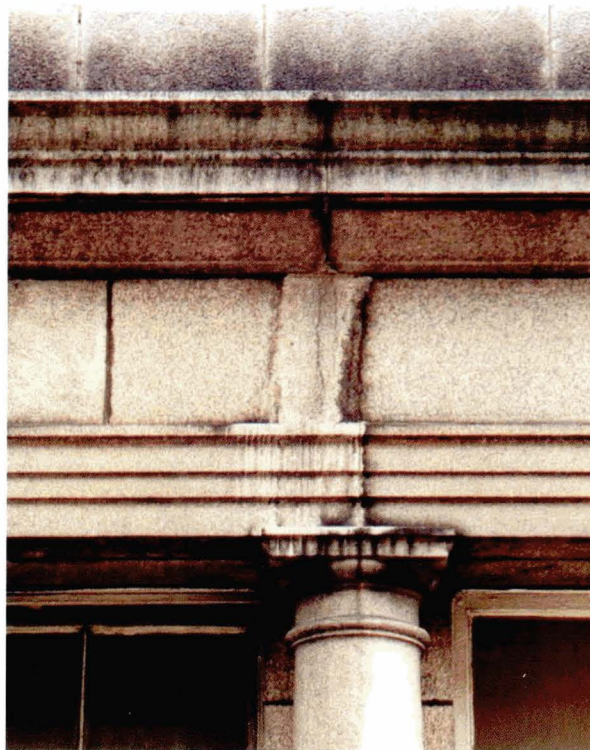
Illus 11. Salt deposition (gypsum) is commonly found at the wetting limits where run-off is channelled through open joints in a string course.

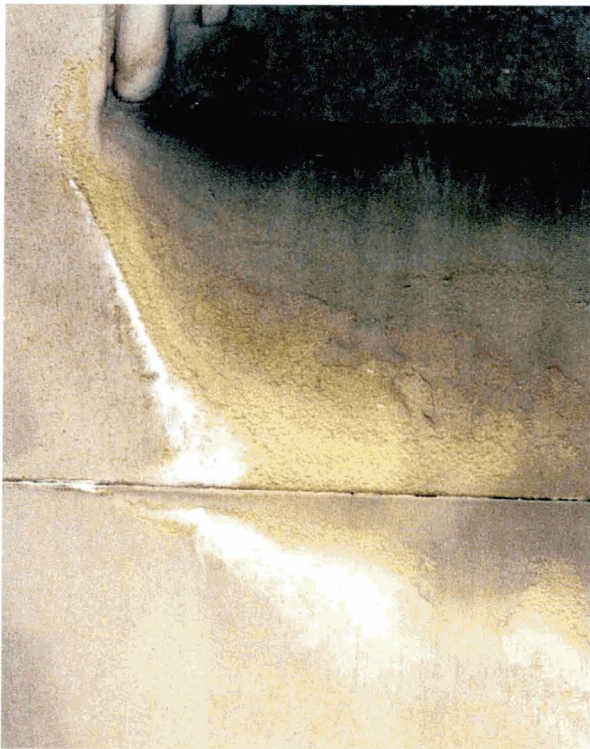
Illus 10. The 'drape' of salt efflorescence below this window is caused by run-off water concentrating salt residues from a large volume of stone within a small zone of evaporation.

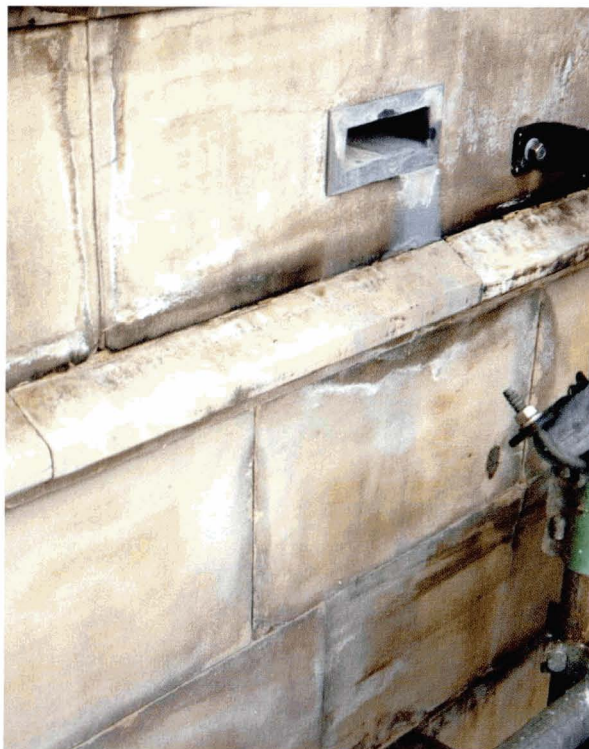
Illus 12. Chemicals were retained in the open joints of this sandstone building following chemical cleaning. This resulted in the formation of salts around the joints in the weeks following cleaning.

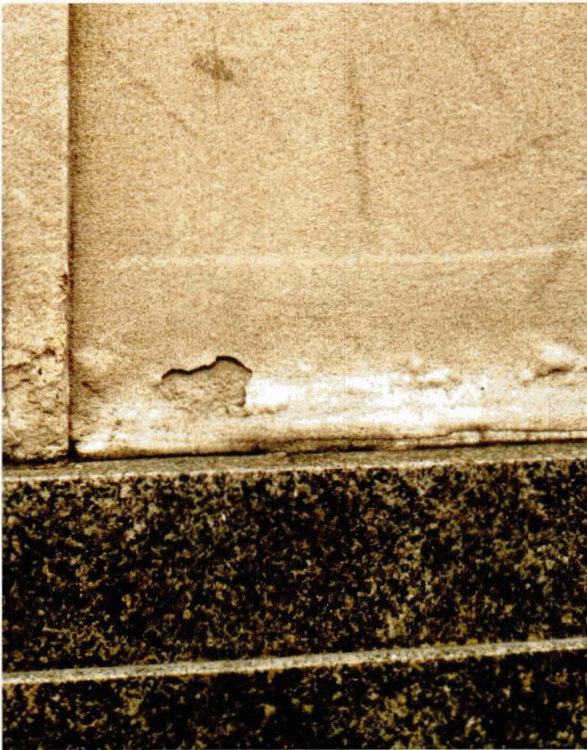
Illus 13. Blistering of this sandstone is caused by moisture trapped against the underlying, impermeable granite.

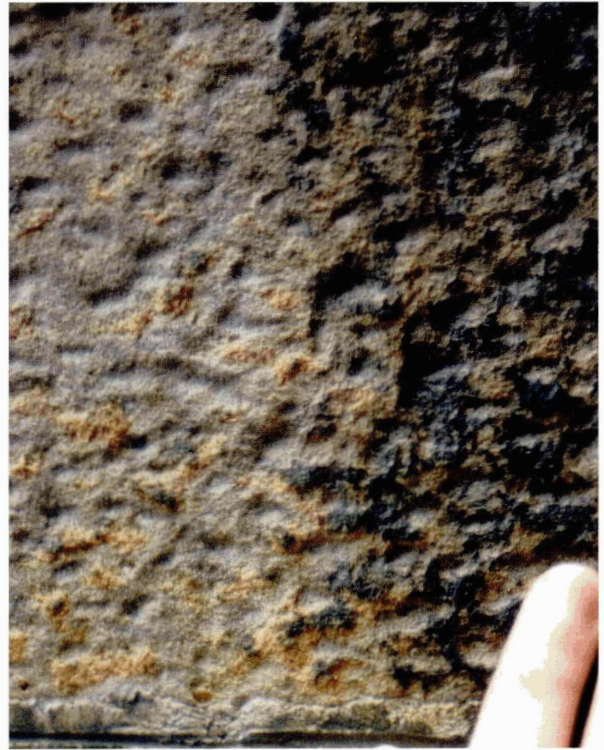
Illus 15. Patina. Patination is a natural colour change caused by surface and near-surface weathering of stone. The left side shows the orange and grey patina, the right side is soiled (black).

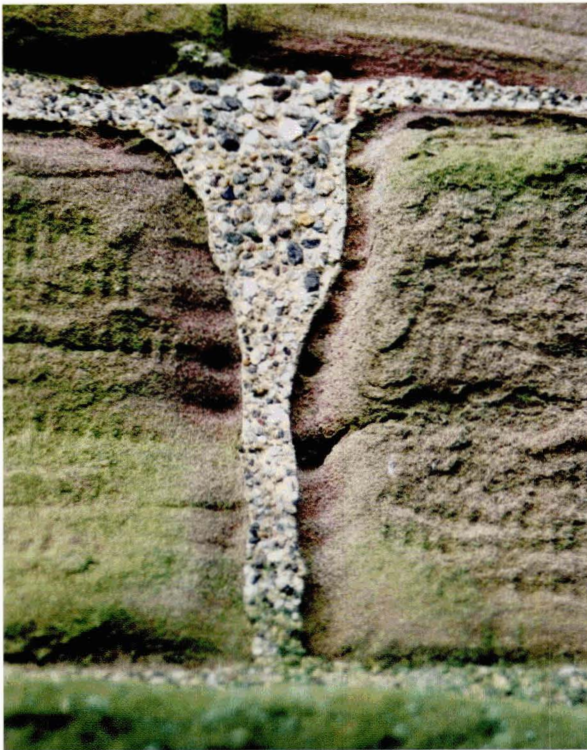
Illus 14. Decay of this sandstone around the joint is caused by the use of a mortar that is too hard and impermeable. Moisture movement is concentrated in the sandstone rather than the mortar.

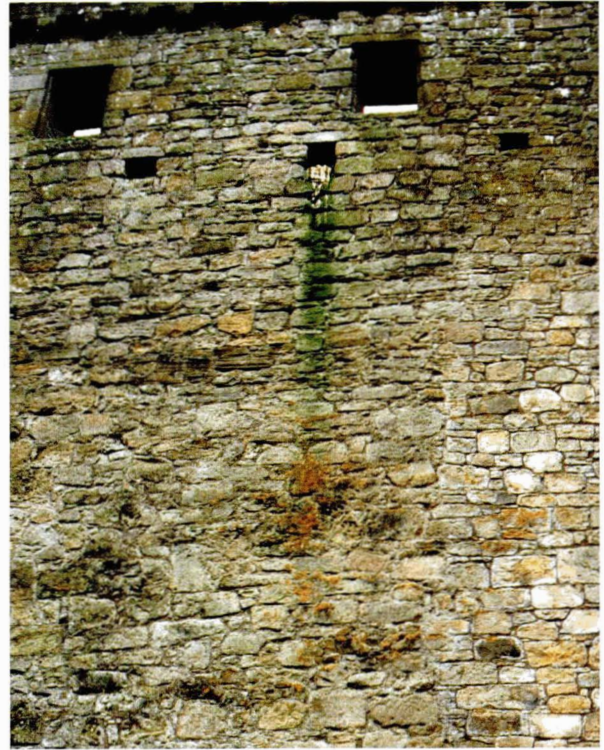
Illus 16. Bird droppings are normally present on and below projecting ledges and other roosting positions. They provide nutrients for algae, lichens and other biological growths as can be seen below the alcove in the centre of the picture.

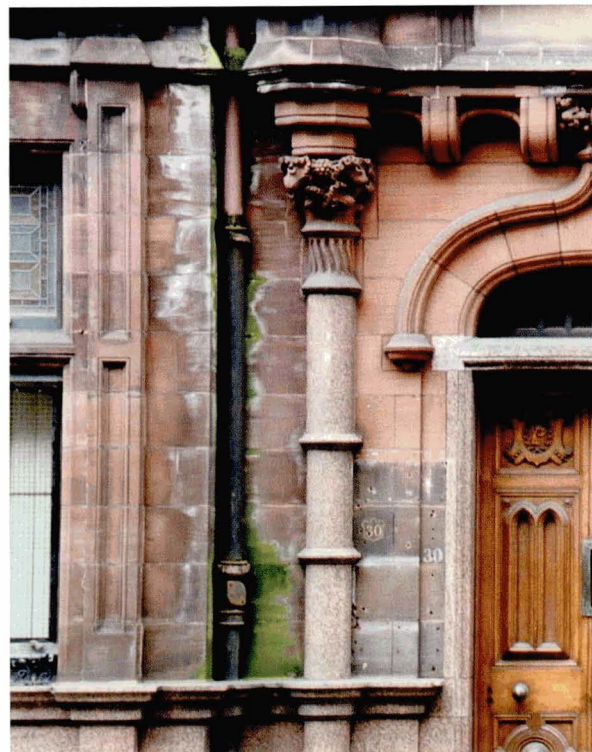
Illus 20. Salt efflorescence. Transient, superficial deposits of soluble salts, usually white or off-white in colour. Most often found at the edges of zones of water run-off or moisture retention. Salt efflorescences are often associated with stone decay.

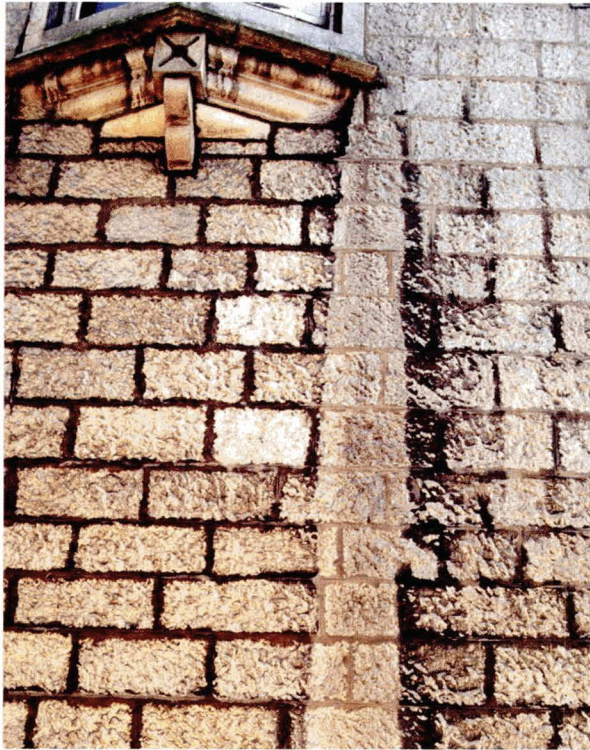
Illus 21. Black gypsum crusts. Thick, black soiling deposits mainly composed of gypsum often occurring in a sheltered area and/or adjacent to pointing. On this granite, gypsum deposits are associated with pointing on a sheltered area wetted by an adjacent run-off zone.

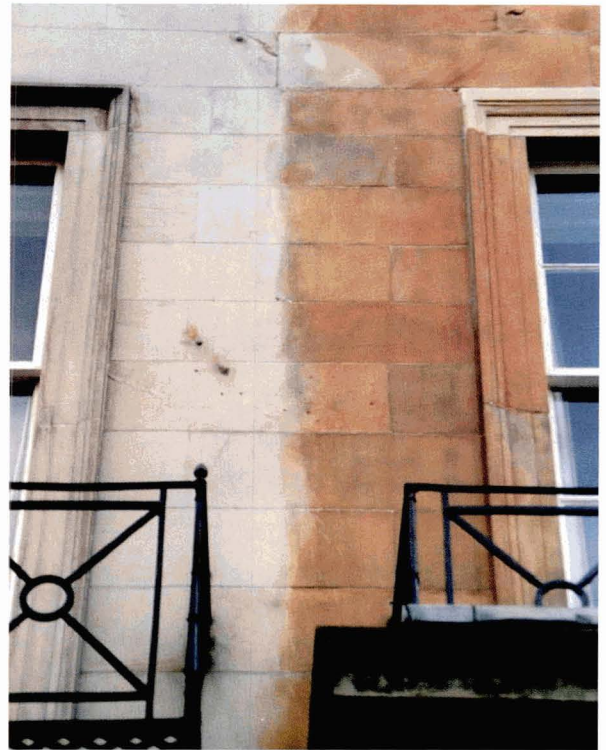
Illus 23. Staining. The façade on the right has been stained as a result of iron mobilisation caused by stone cleaning chemicals. The façade on the left has been bleached as coloured minerals have been dissolved and washed out of the surface.

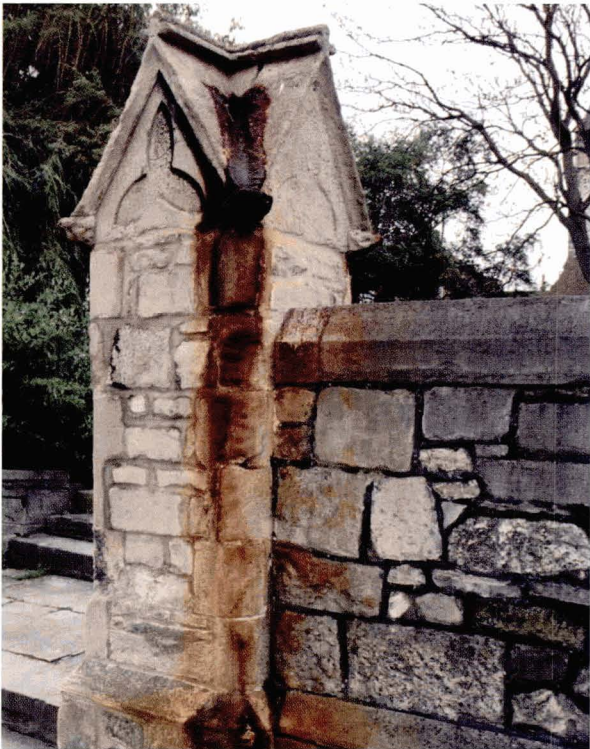
Illus 22. Staining. Black and orange staining on this limestone occurs in the rainwater run-off zone below a decaying iron fixing.

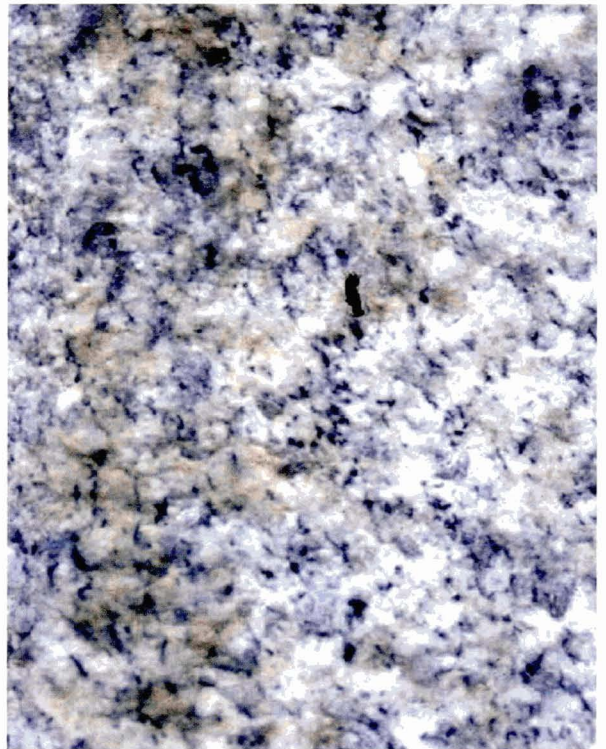
Illus 24. Staining. Iron-staining of this granite has been caused by alkaline cleaning chemicals left in contact with the surface for too long.

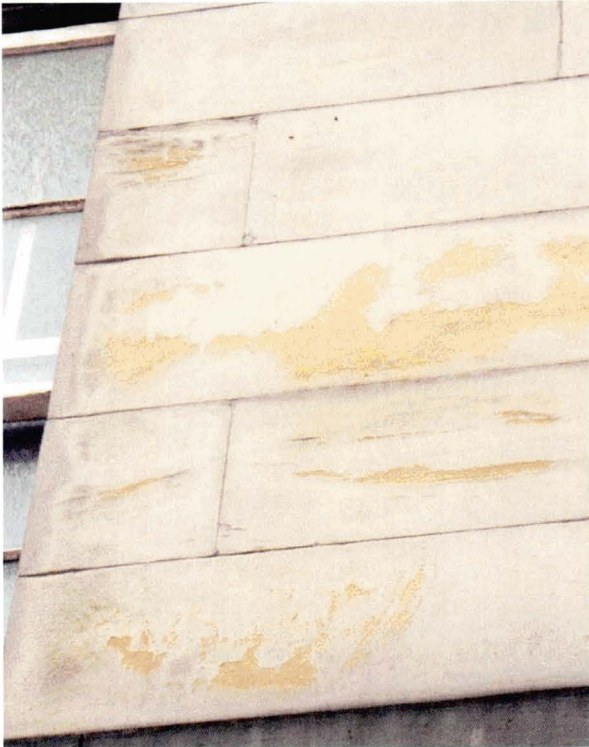
Illus 25. Bleaching. The surface of this sandstone has been bleached by chemical cleaning. Coloured iron-bearing minerals have been dissolved and re-deposited under the surface - now visible due to superficial granulation.

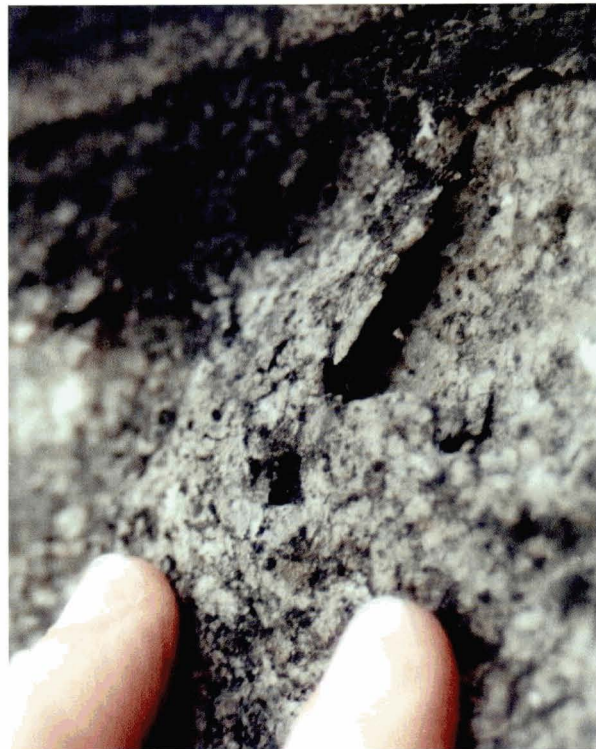
Illus 28. Blistering. Localised blistering of stone caused by expansion of a surface layer. This blistering on granite is caused by growth of gypsum crystals (black crust visible above the blister) which cause expansion and detachment of the surface layer.

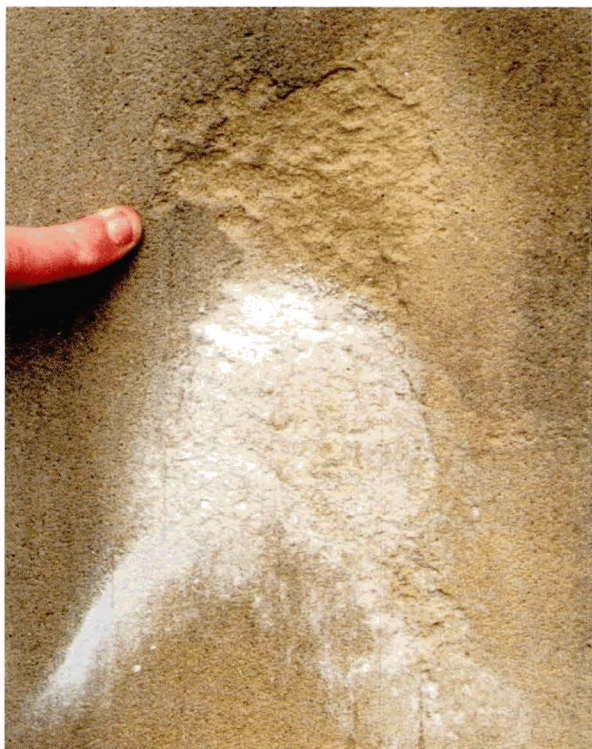
Illus 29. Granular disintegration. Generalised loss of stone surface caused by detachment of individual mineral grains. Granular disintegration of this sandstone surface is caused by sub-surface crystallisation (cryptoflorescence) of salts. Crystallisation on the surface (efflorescence) can be seen below the area of decay.

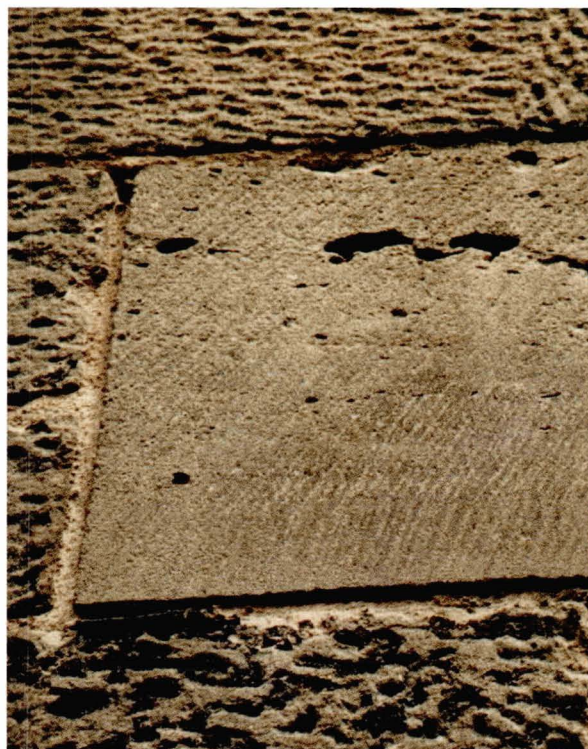
Illus 31. Decay of components. Clearly bounded zones of decay caused by the loss of elements or inclusions, e.g. clay nodules (as seen in this sandstone) or pebbles.

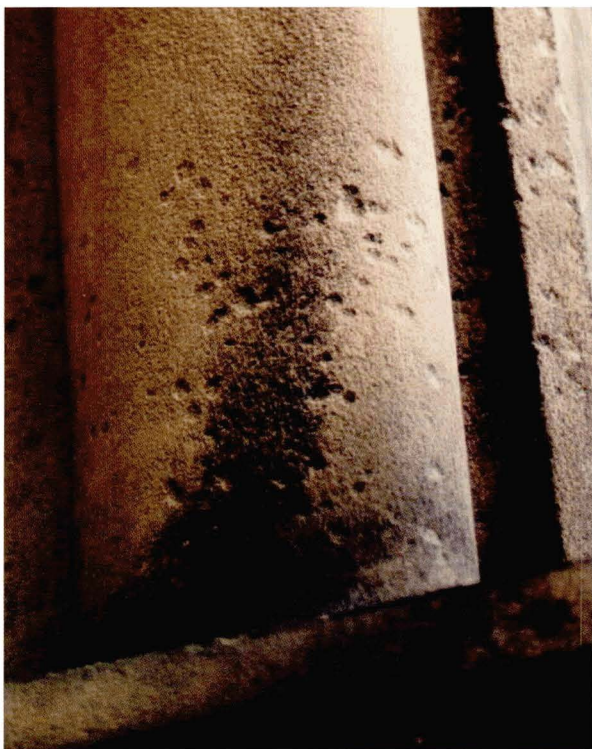
Illus 30. Pitting. Small, irregularly distributed pits on a stone surface. The pitting of this sandstone is caused by dissolution of calcite cemented patches. Being relatively weaker than the rest of the stone, such patches can also be eroded by abrasive or chemical cleaning.

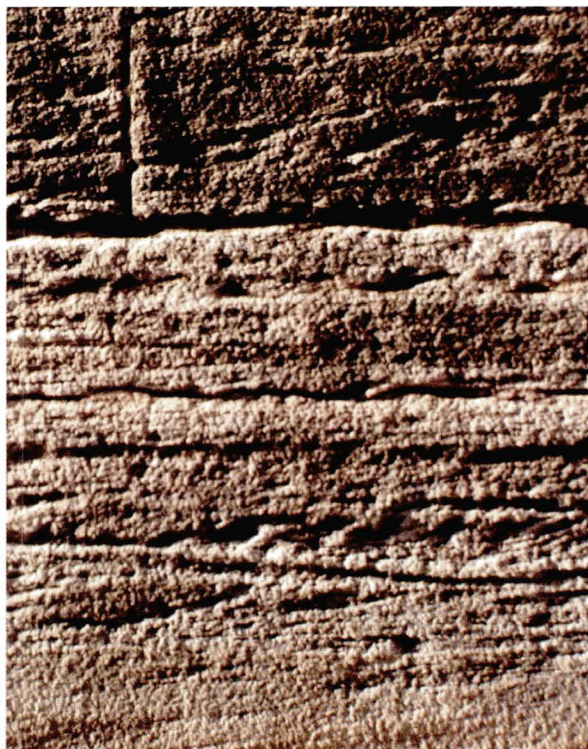
Illus 32. Differential decay. Differential weathering of individual stone components due to naturally occurring variations in their vulnerability to decay. In this sandstone, some layers are weaker and more easily eroded than others.

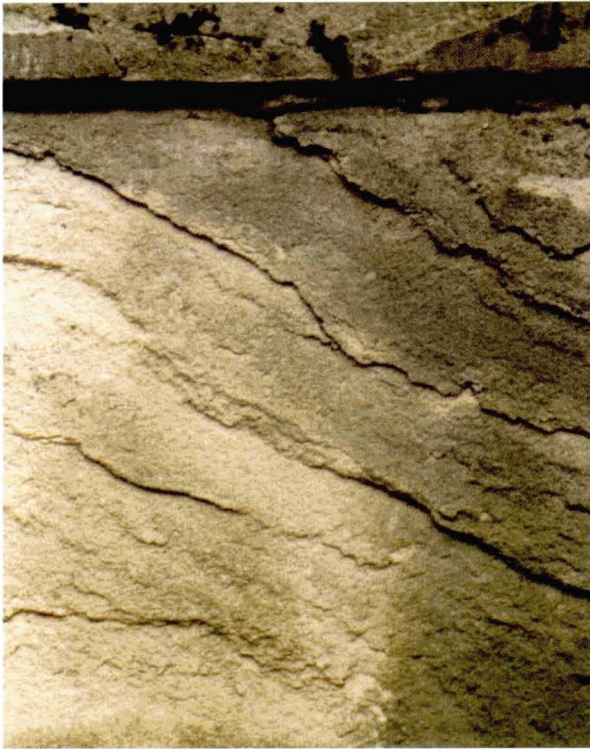
Illus 33. Delamination. Detachment of single or multiple planar sheets parallel to the natural layering or bedding of a stone. This sandstone has been face bedded and layers are now delaminating from the surface.

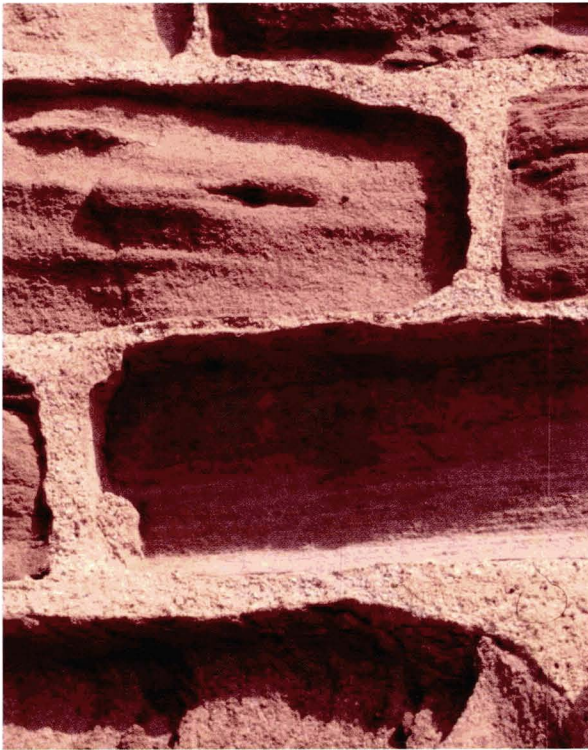
Illus 37. Back weathering. Rapid decay of single stones results in a surface where particular stones are much more deeply recessed than others.

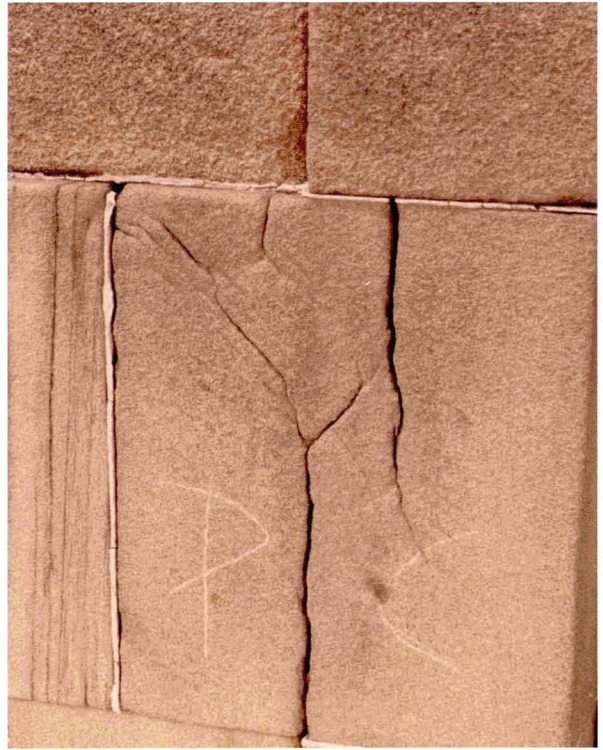
Illus 39. Fissures. Lines of fracture or open cracks. Fissuring of this sandstone occurred because the stone was edge bedded and subject to relatively high stresses adjacent to a window opening.
