TECHNICAL
ADVICE
NOTE

MAINTENANCE
AND REPAIR
OF CLEANED
STONE BUILDINGS

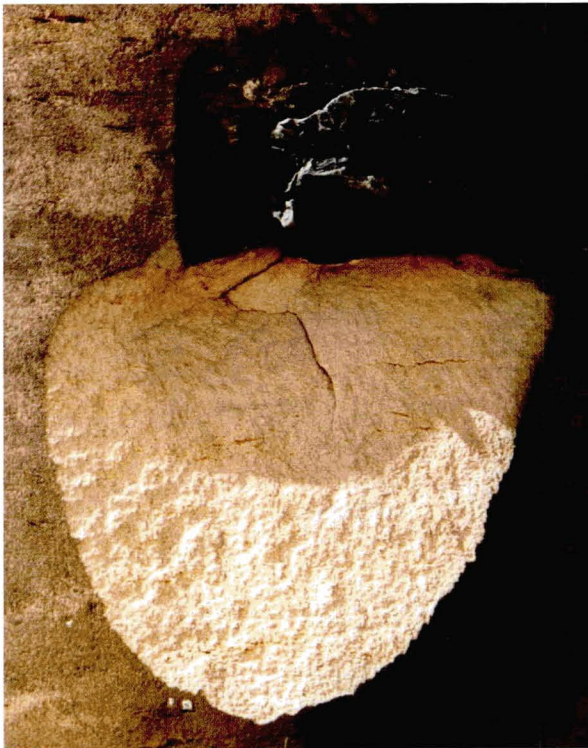
Illus 38. Mechanical damage. Loss of compact stone fragments by fracturing. In this case oxidation and expansion of an iron fixing has caused fracturing and loss of a piece of adjacent sandstone.

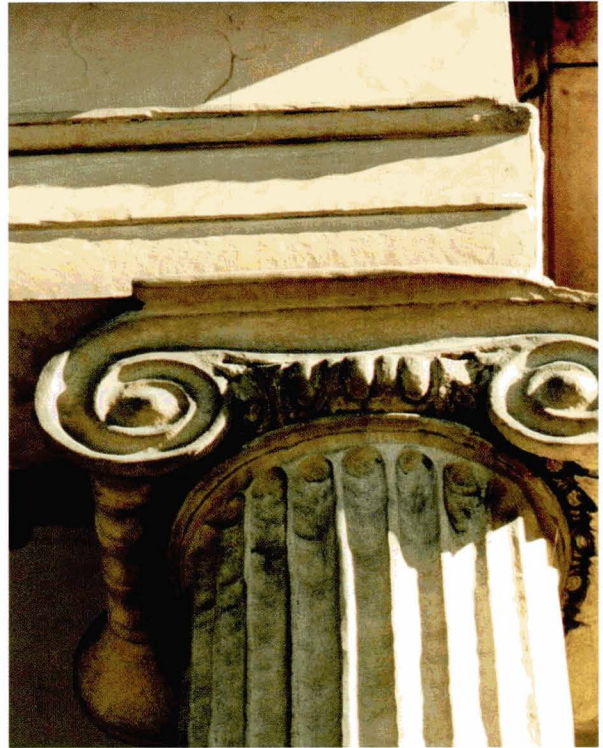
Illus 40. Abrasion damage. General loss of surface or sharpness of detail known to have been caused by stone cleaning. On this sandstone, once smooth surfaces above the capital are visibly roughened. Originally sharp edges on the fluted column have been eroded.

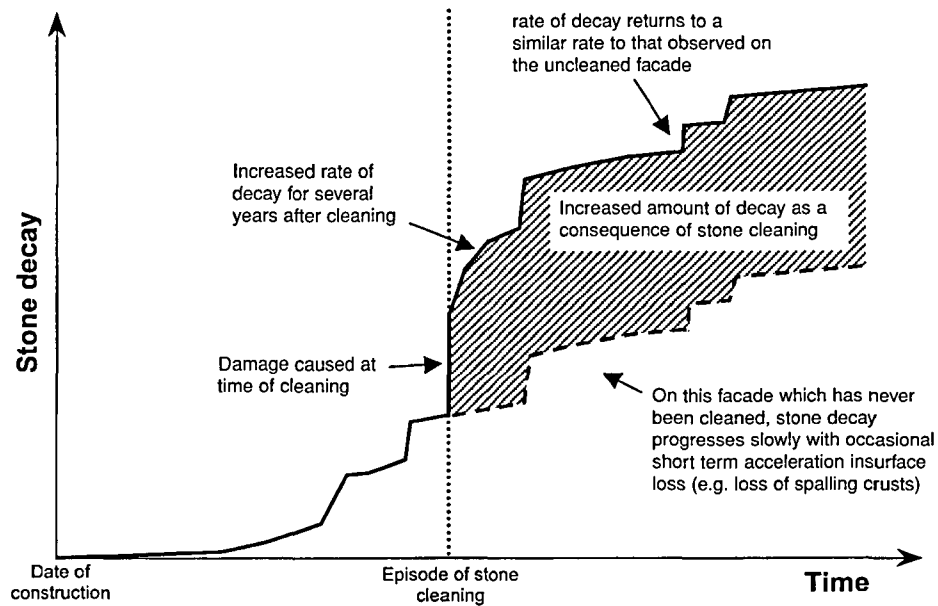
Illus 41. Where stone decay is accelerated for a time following cleaning, this diagram illustrates the absolute amount of decay that might be expected on a cleaned compared to an uncleaned façade.

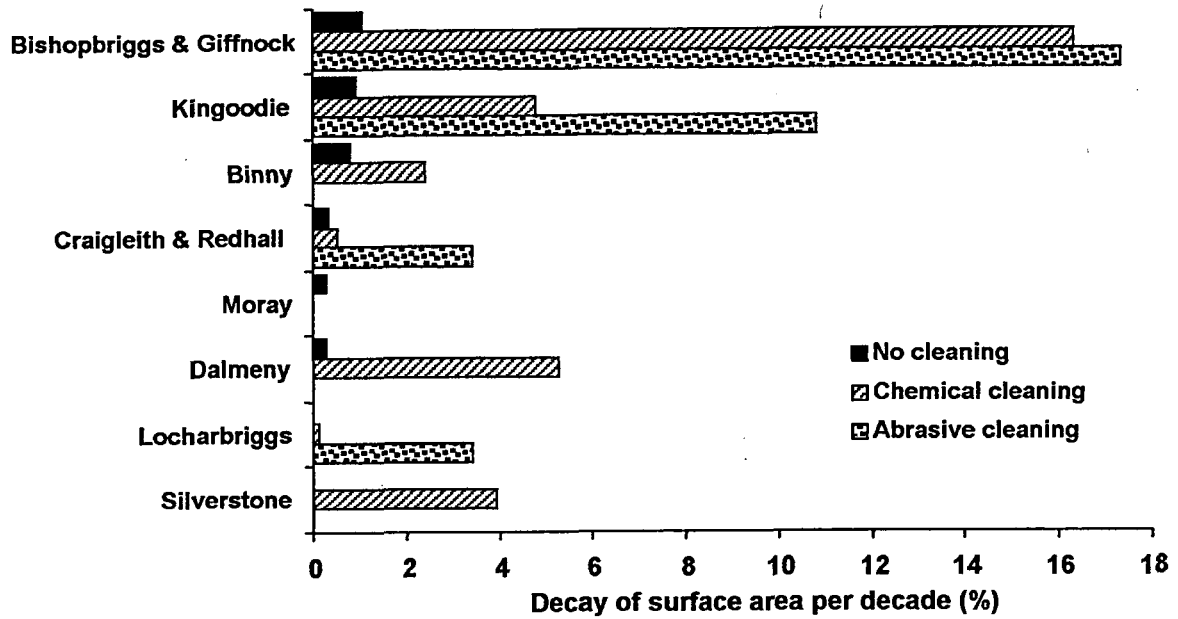
Illus 42. Average rates of decay on sandstone façades in the decade following stone cleaning. Most sandstones decayed more rapidly after cleaning, some Binny and Moray sandstone decayed more slowly for several years following stone cleaning. Rates of decay are affected by stone type, cleaning method and the care taken during cleaning.

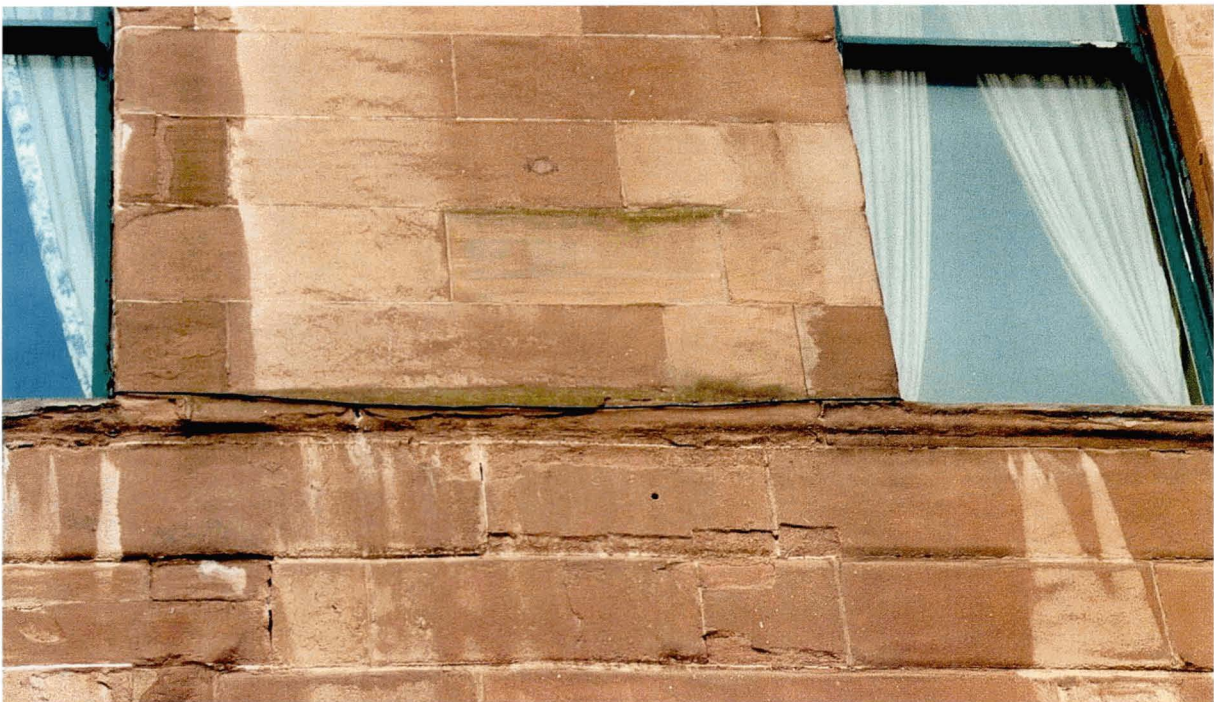
Illus 43. Rapid stone decay on this façade has been caused by a harmful interaction between cleaning and water repellent treatments applied to the stone.

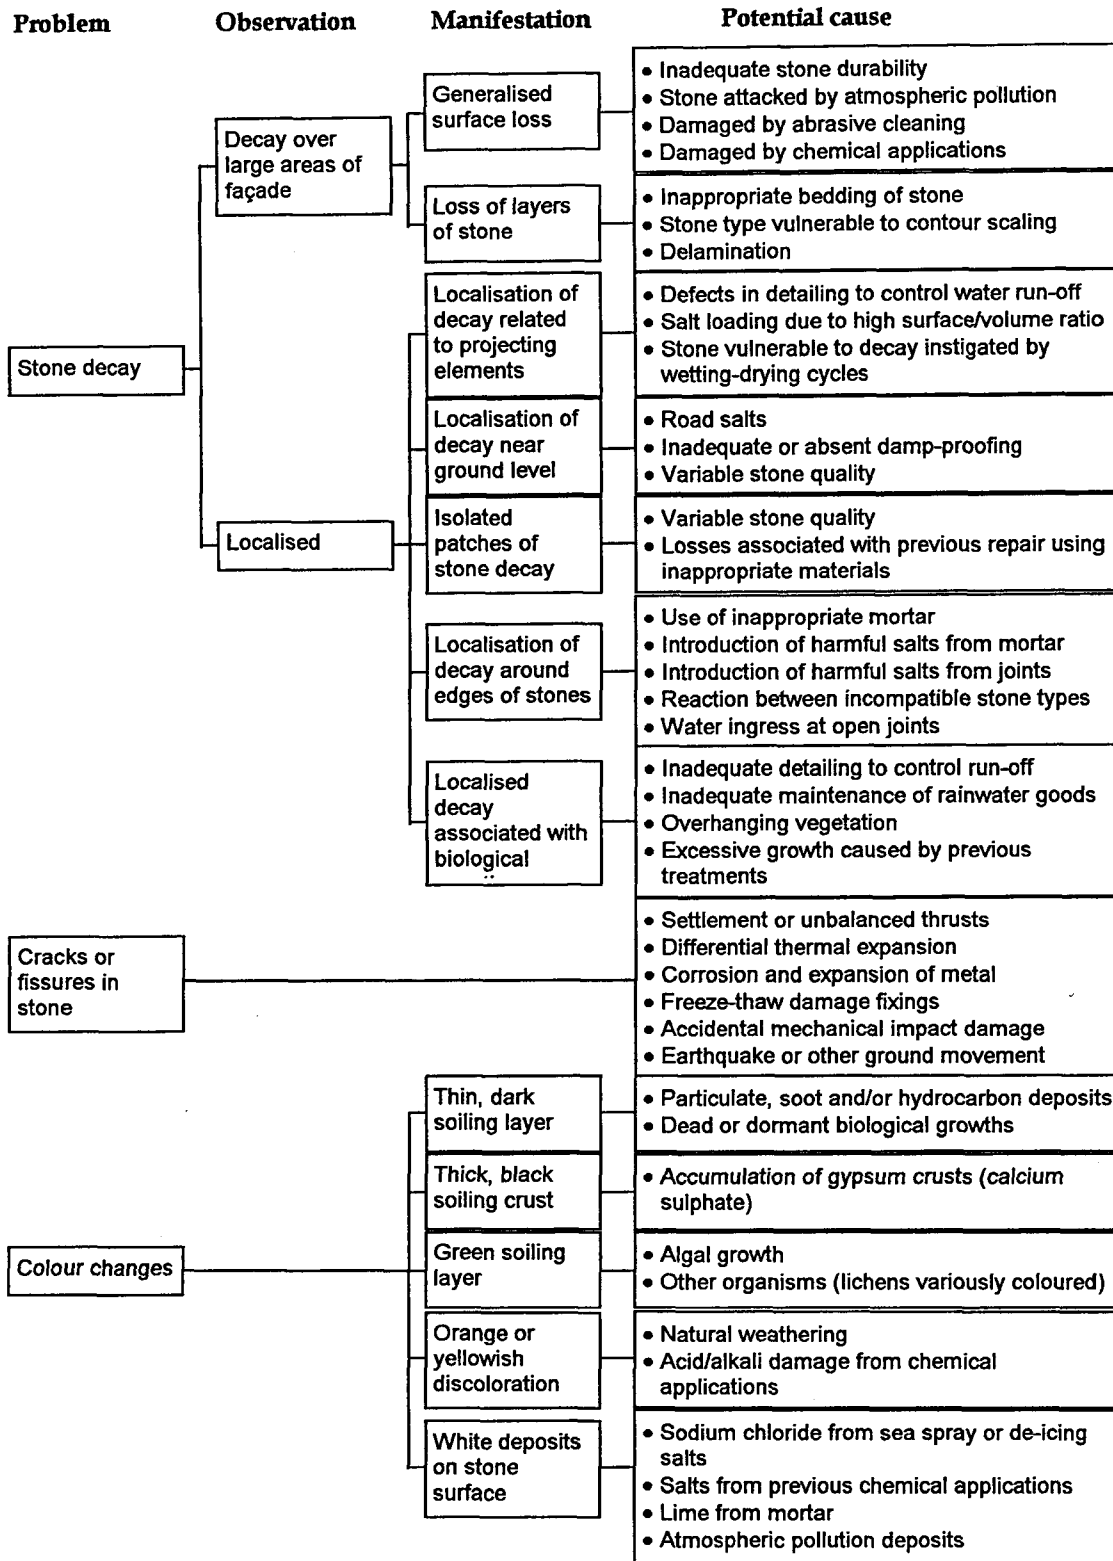
Illus 44 Flow diagram for identification of potential causes of stone deterioration.

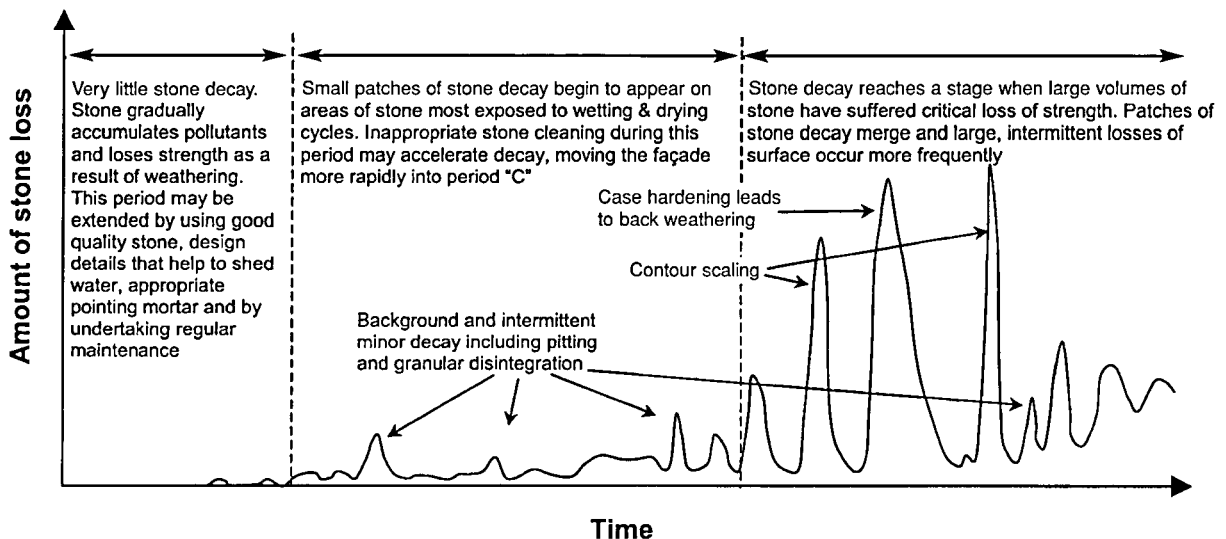
Illus 45. Theoretical progression of stone decay throughout the lifetime of a façade. NB Forms of decay shown are for illustration only and may vary in type and intensity depending on stone type.

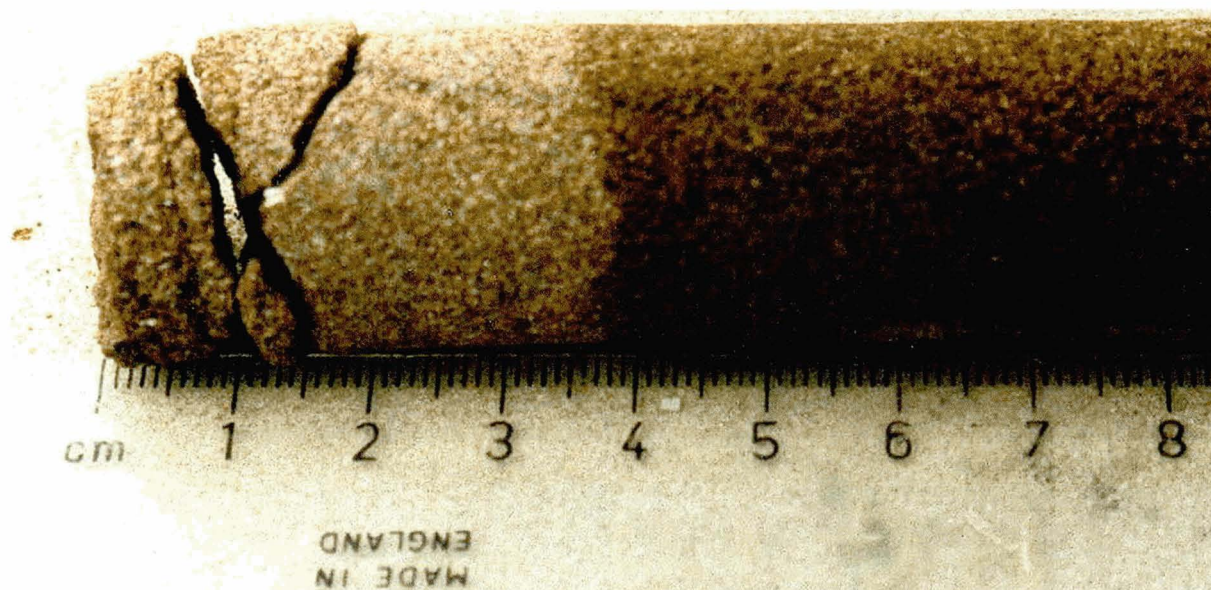
Illus 46. The depth of penetration of water repellent into this sandstone can be determined by wetting the core sample and observing the depth at which the sandstone absorbs water. In this case the water repellent treatment has penetrated to about 36mm depth.

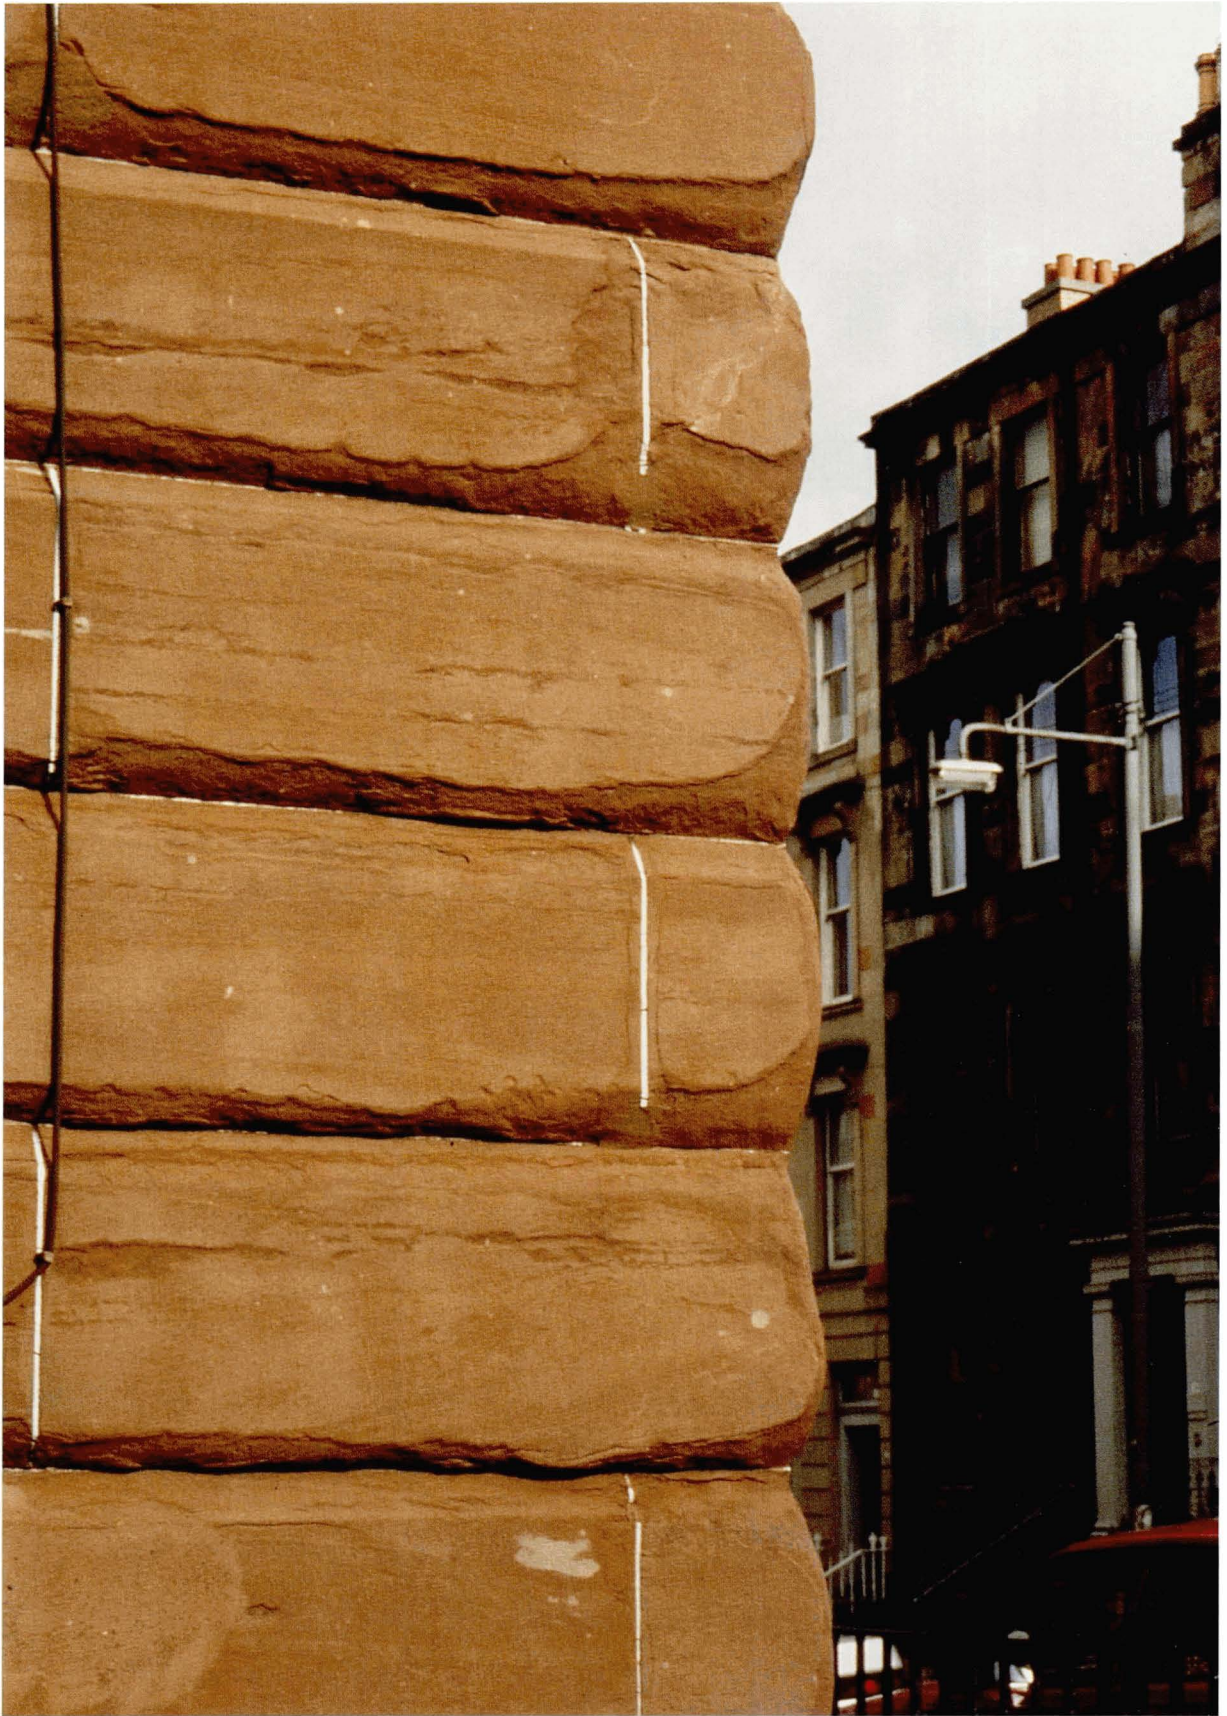
Illus 47. Enhanced widespread decay on this Glasgow tenement resulting from severely abrasive stonecleaning.

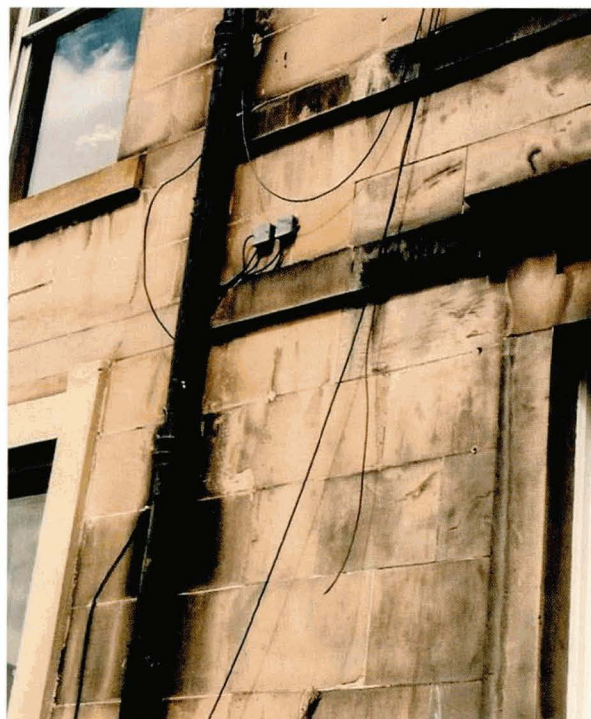
Illus 48. The earlier decay and removal of the string course from the facade, above left hand window, has caused decay to the stone facings around the windows. The facings have been 'repaired' using plastic repair mortar.

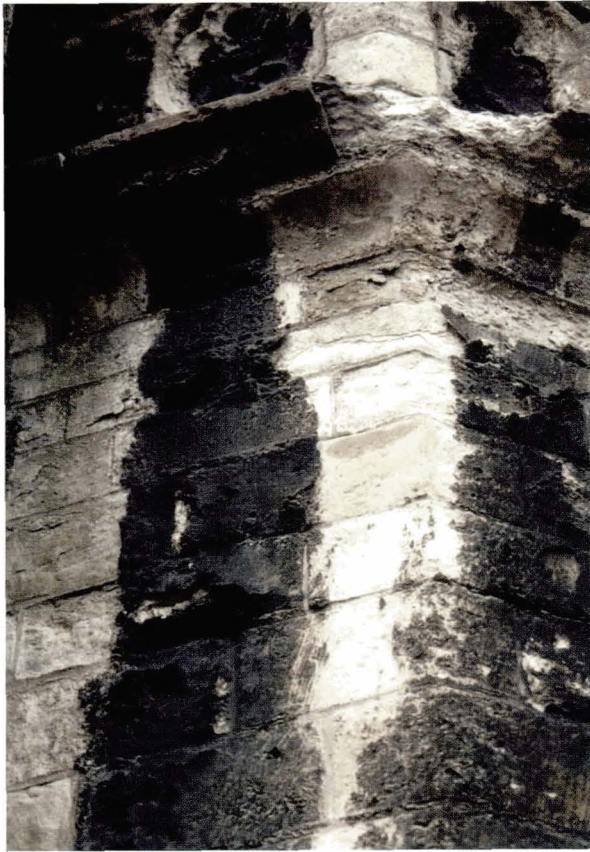
Illus 49. Deterioration of this string course has accelerated decay of underlying limestone due to increased flow of rainwater over the surface.

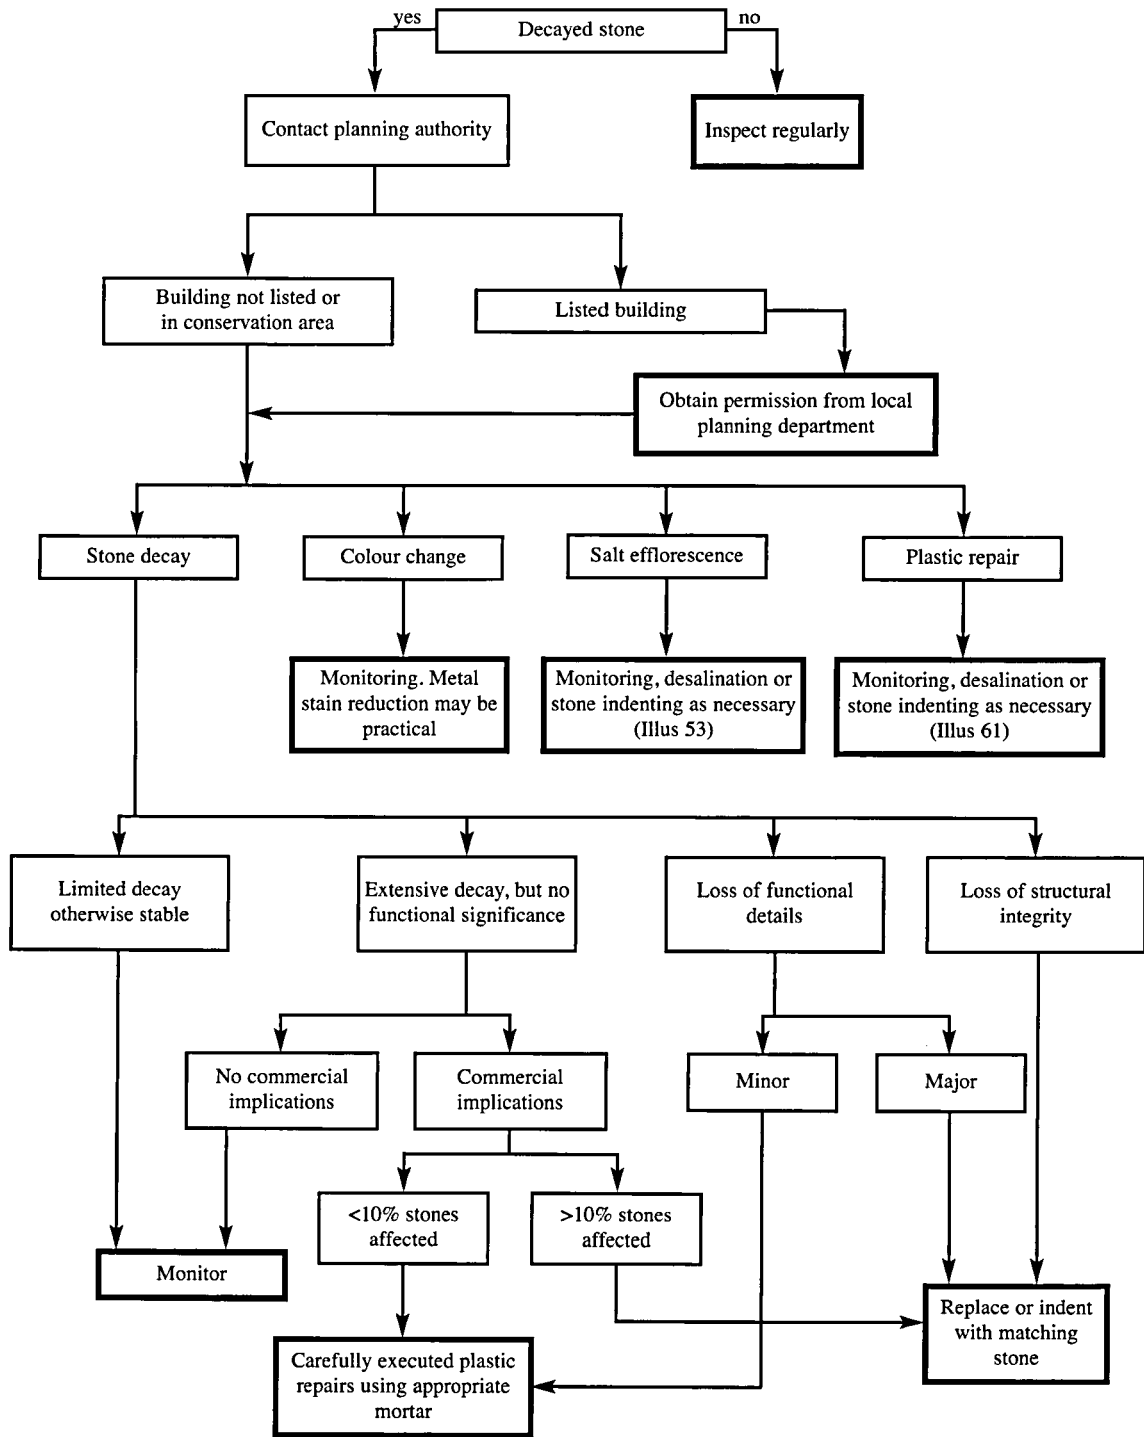
Illus 50. Actions to deal with the consequences of stone cleaning.

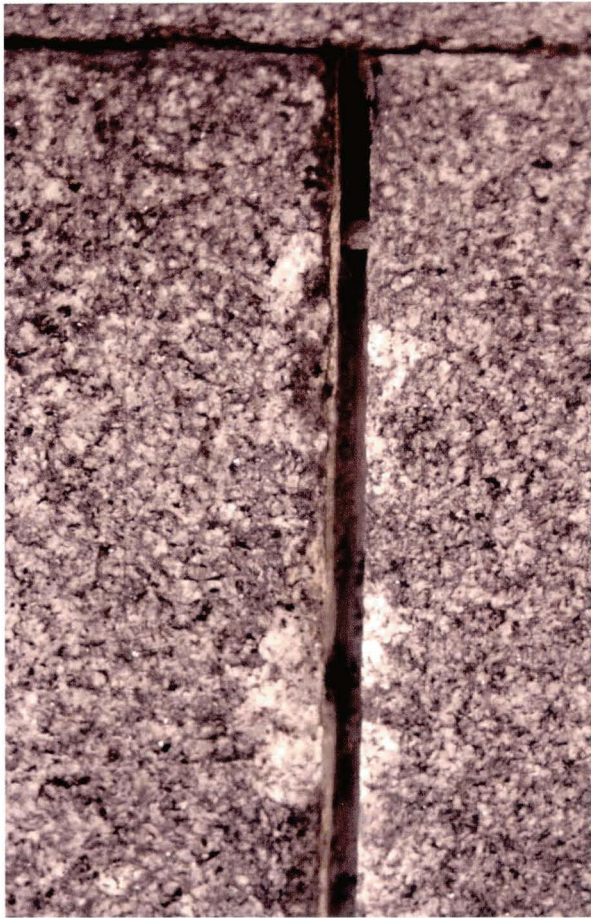
Illus 51. The edges of these granite ashlar blocks have been damaged during raking out of joints prior to repointing.

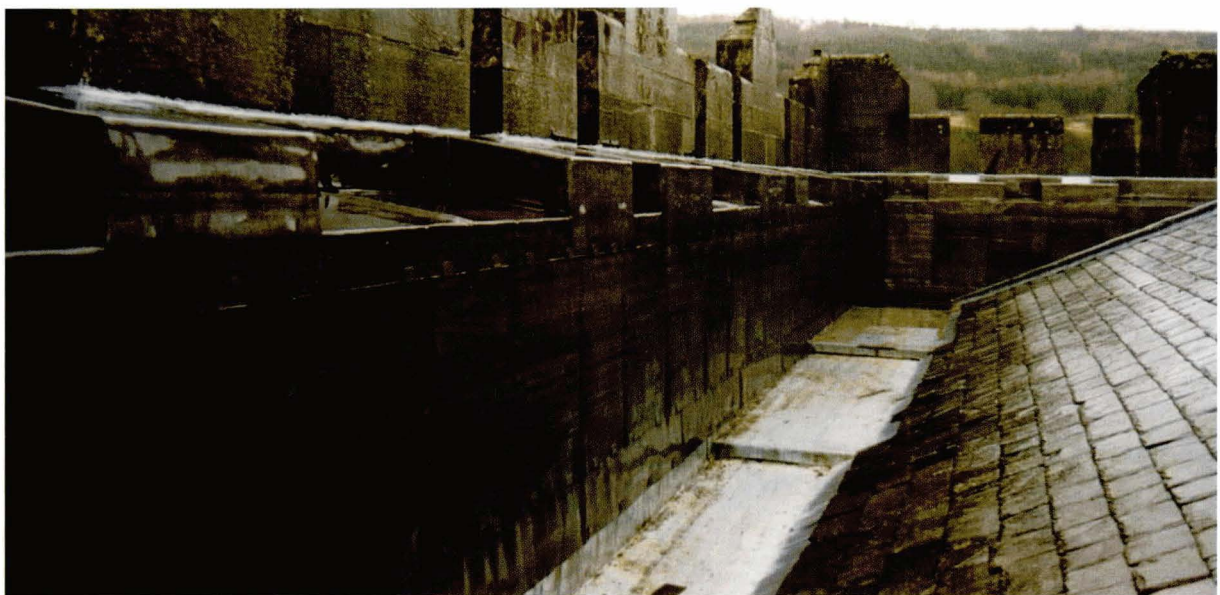
Illus 52. Protective covering. Lead sheeting has been used to prevent water penetration at roof level.

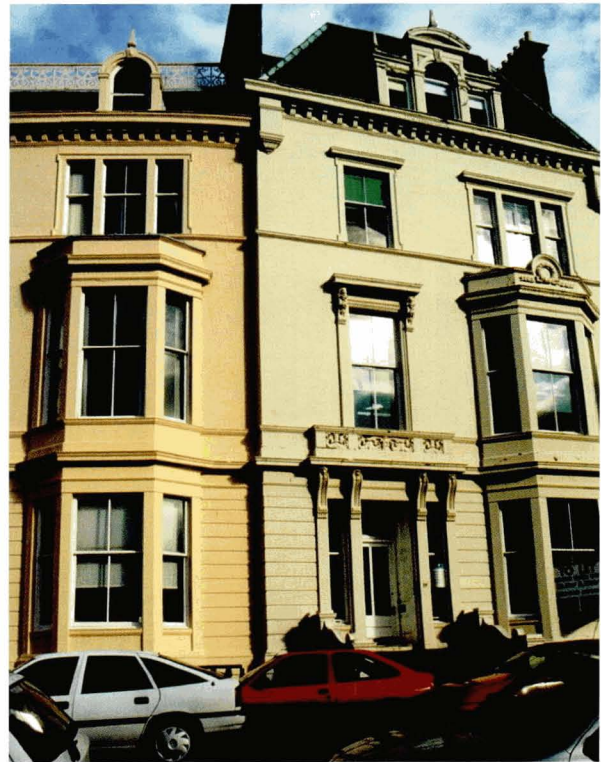
Illus 53. Painted sandstone façade, Park Terrace, Glasgow.

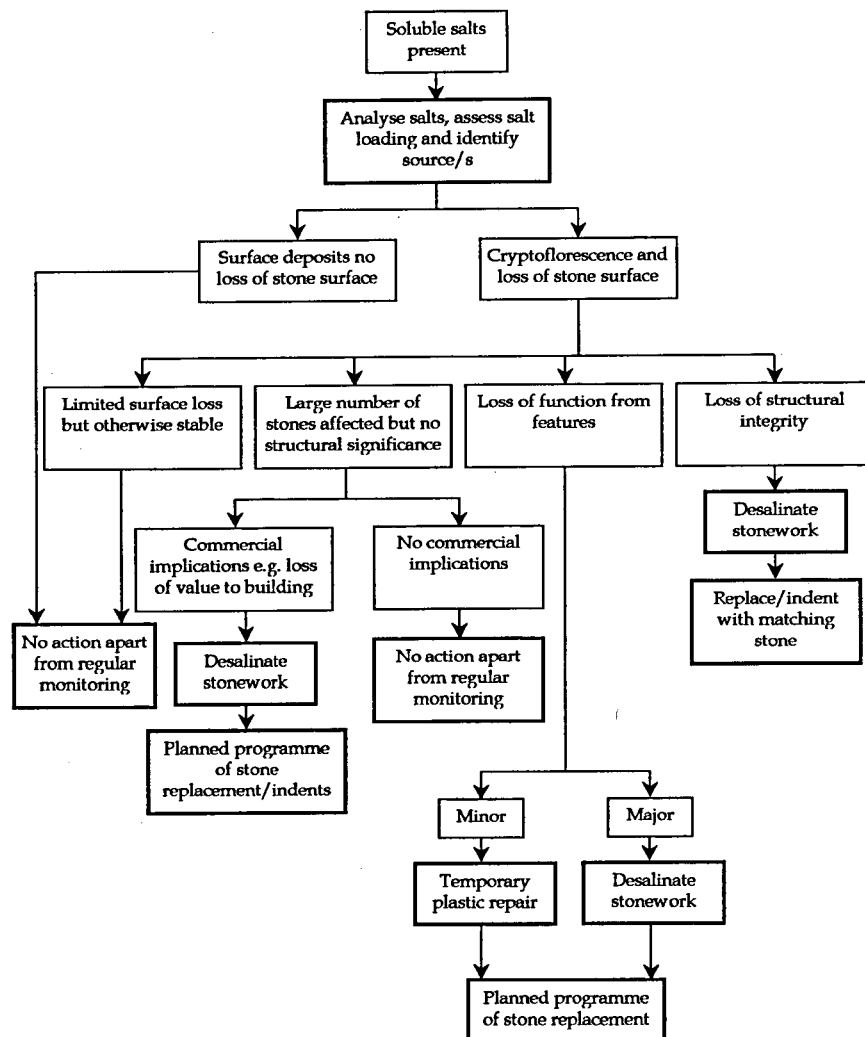
Illus 54. Actions to deal with salts from stone cleaning chemicals.

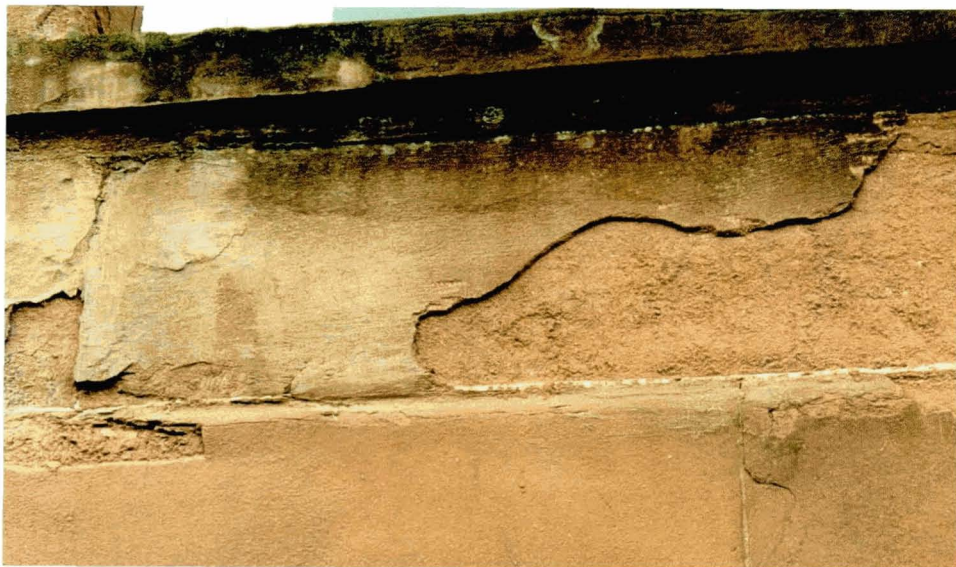
Illus 55. This poorly executed plastic repair on a sandstone facade has failed to bond with the underlying stone.

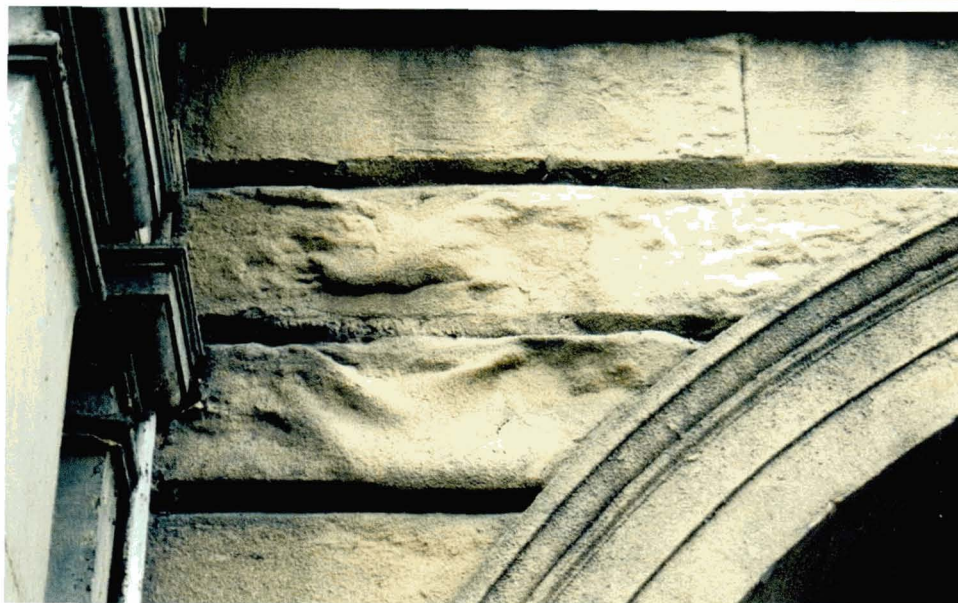
Illus 56. The bond between the thin PVA-based repair coating and the underlying sandstone has failed resulting in slumping and detachment of the repair.

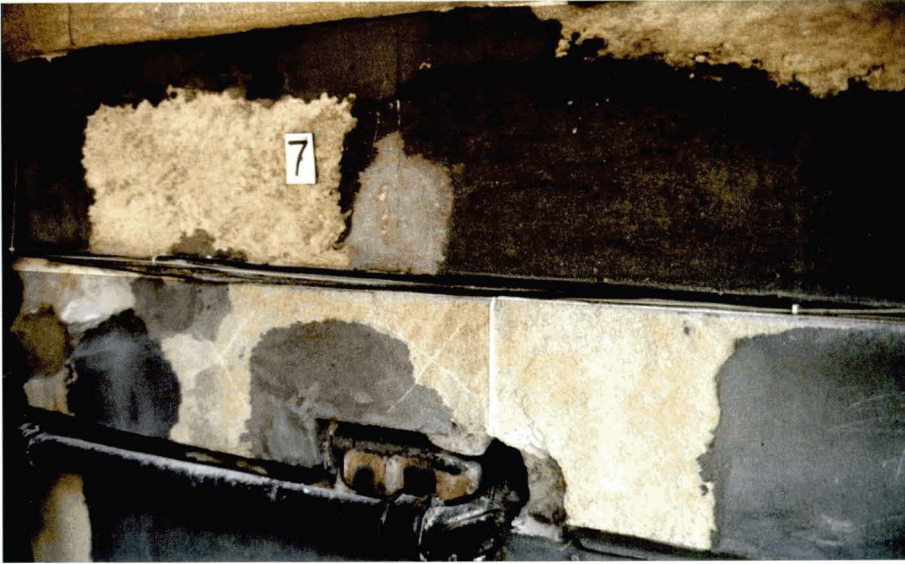
Illus 57. This plastic repair was coloured to match soiled stone. The colour no longer matches when the façade has been cleaned.

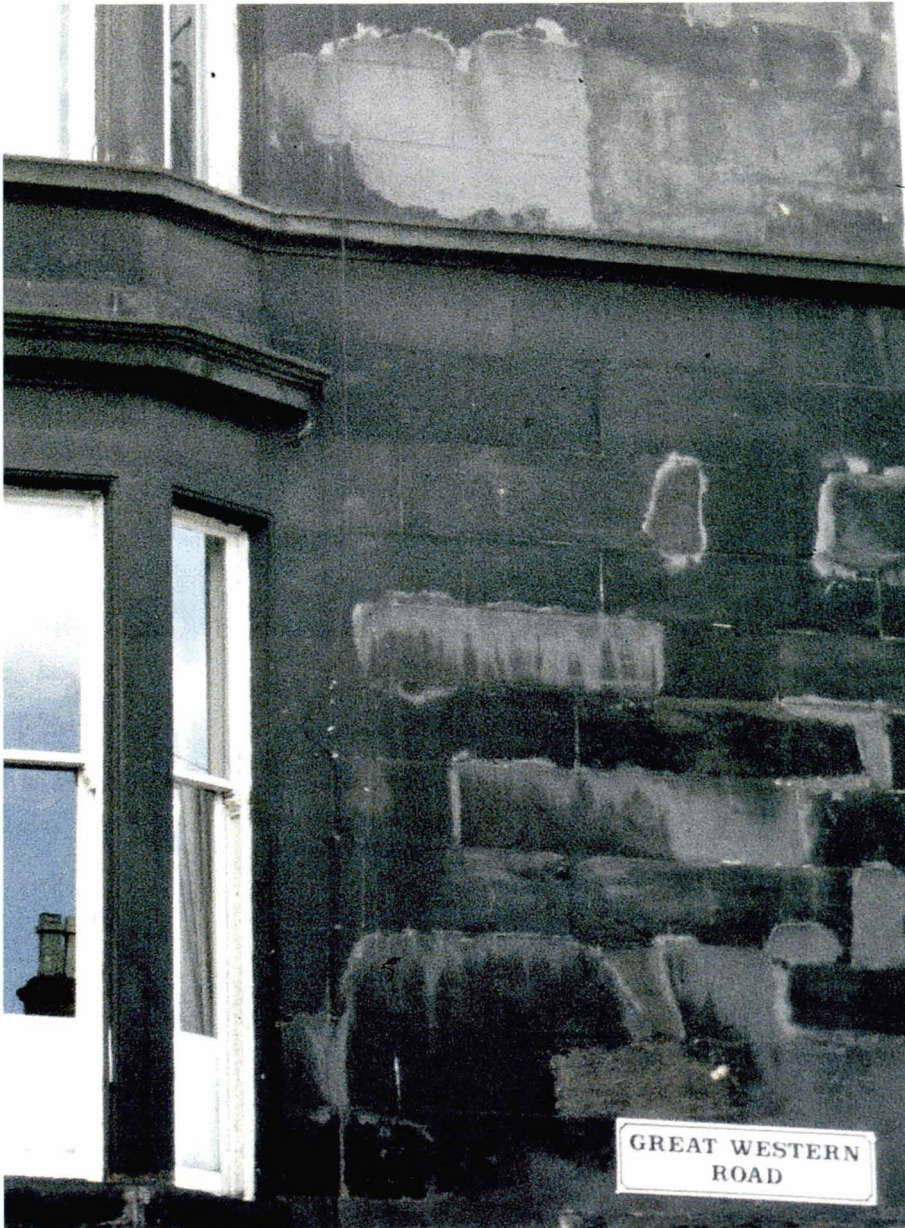
Illus 58. Plastic repair on a non-calcareous sandstone. Note that the rain washed patches of repair are clean in comparison to the surrounding sandstone. This occurs because the calcareous minerals in the repair mortar are slightly soluble in rain water.

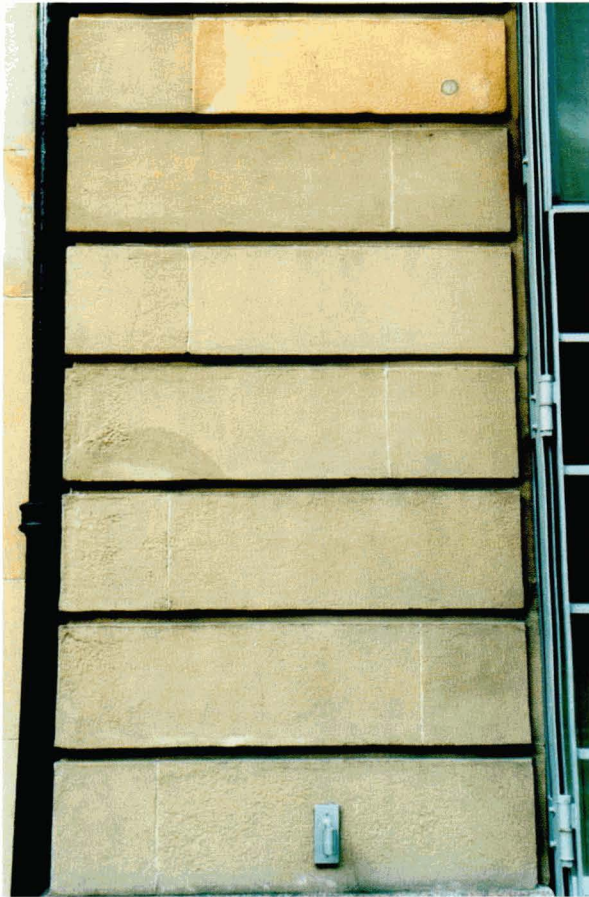
Illus 59. Part of the façade of a city-centre building, Glasgow, showing an extensive area of plastic repair.

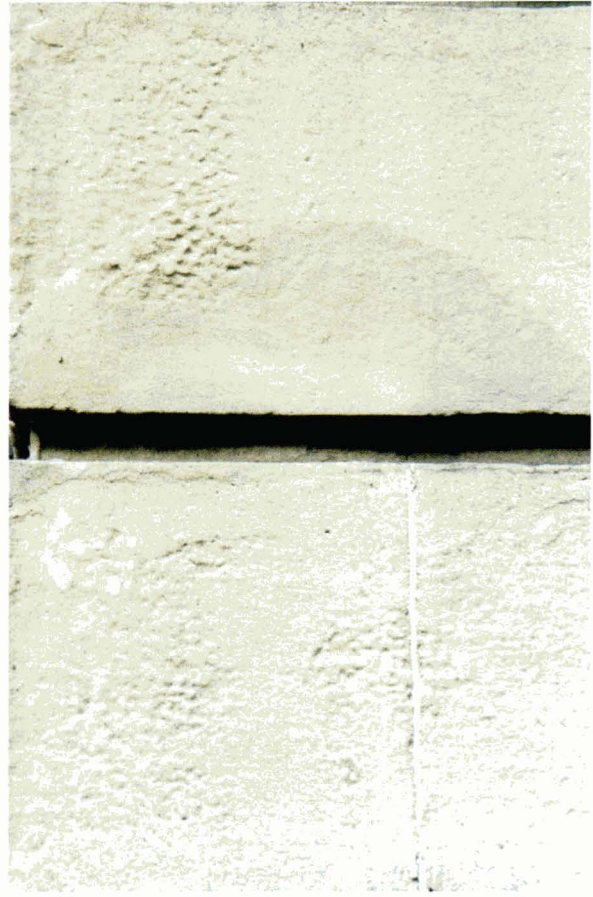
Illus 60. City-centre building, Glasgow. Close-up view of part of the façade in Illus 59 shows the crude nature of the repair after circa fourteen years exposure.

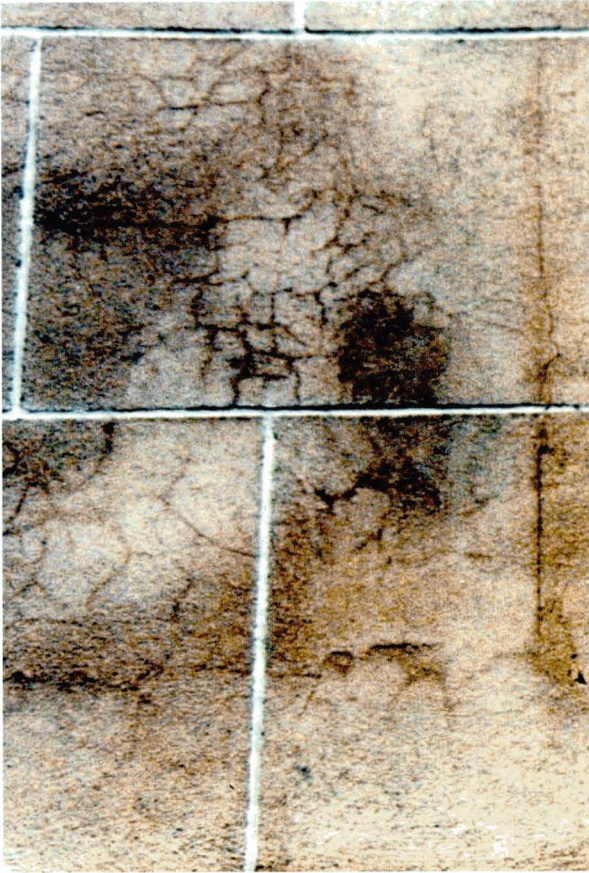
Illus 61. *Crazing of plastic repair. Note the way in which the cracks extend across the artificial 'joints'.*

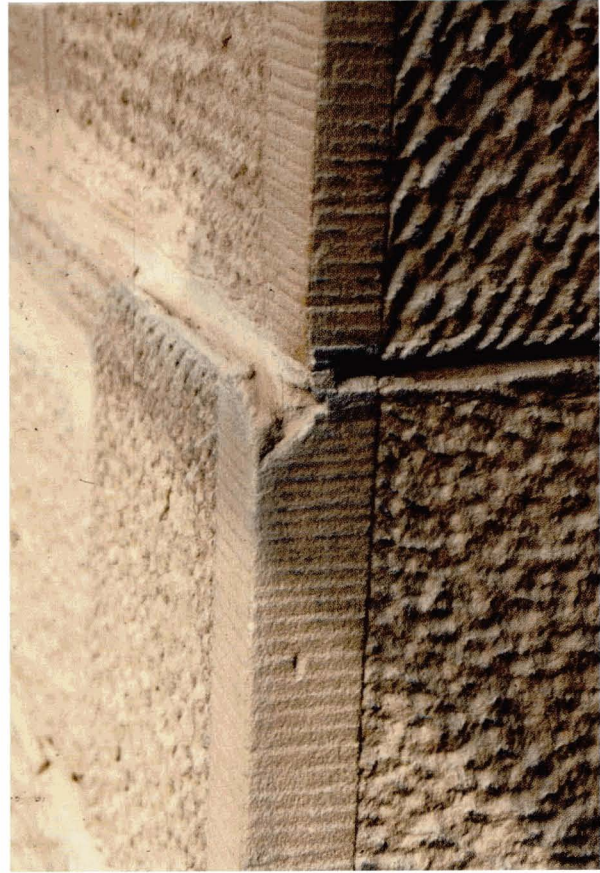
Illus 63. *Redressing stone. The difference in alignment between these two stones was caused by redressing of the upper stone face.*

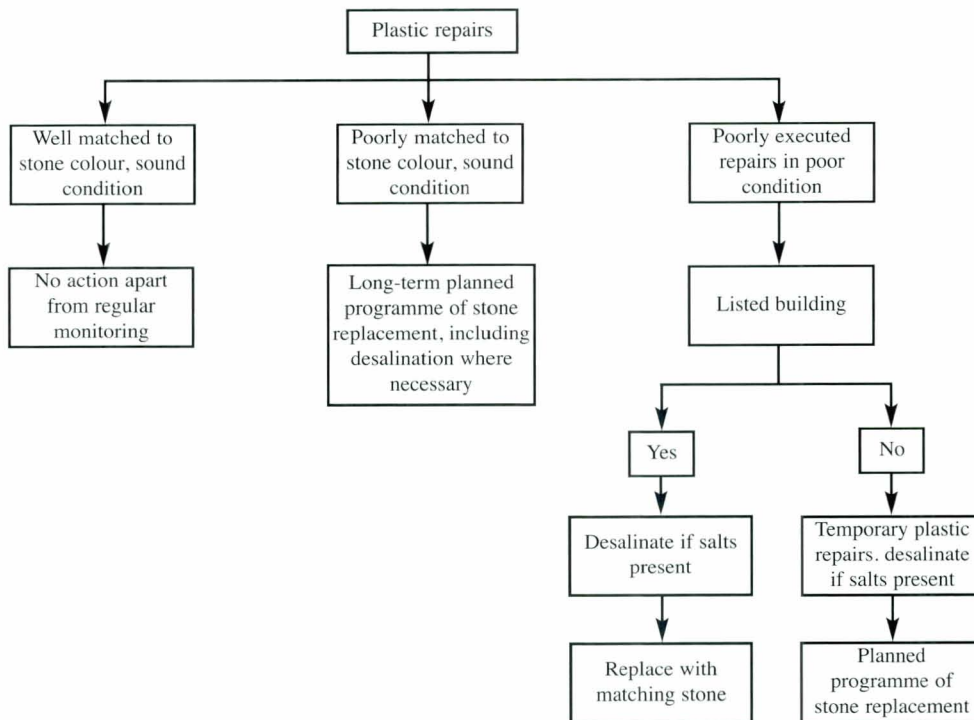
Illus 62. *Dealing with plastic repairs to stonecleaned buildings.*

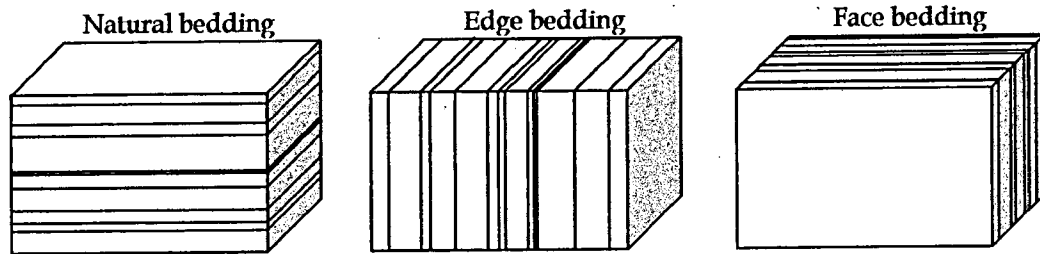
Illus 64. Bedding directions for building stone.

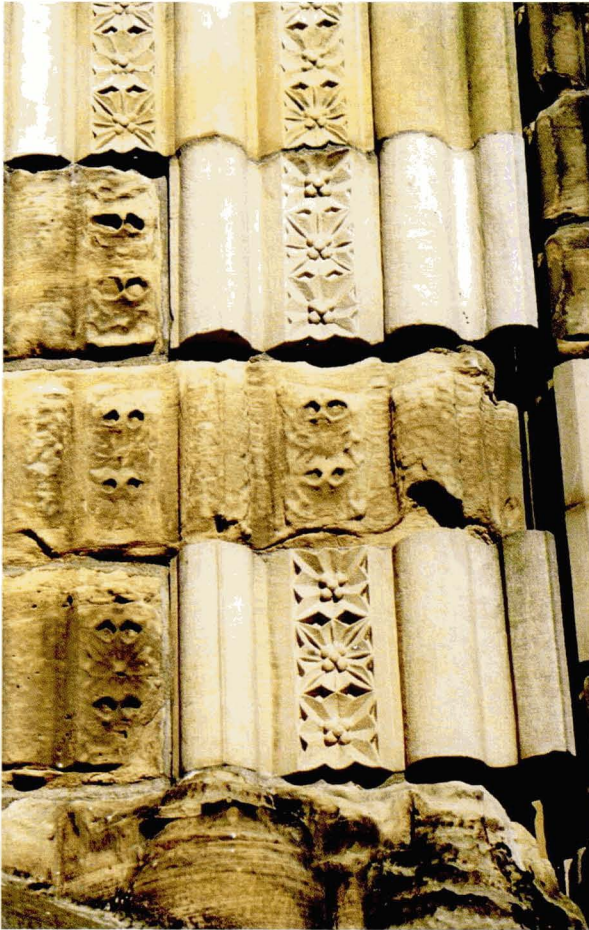
Illus 65. Repair involving replacement of damaged stone. The new stone conforms to the original profile and surface finish of the façade.

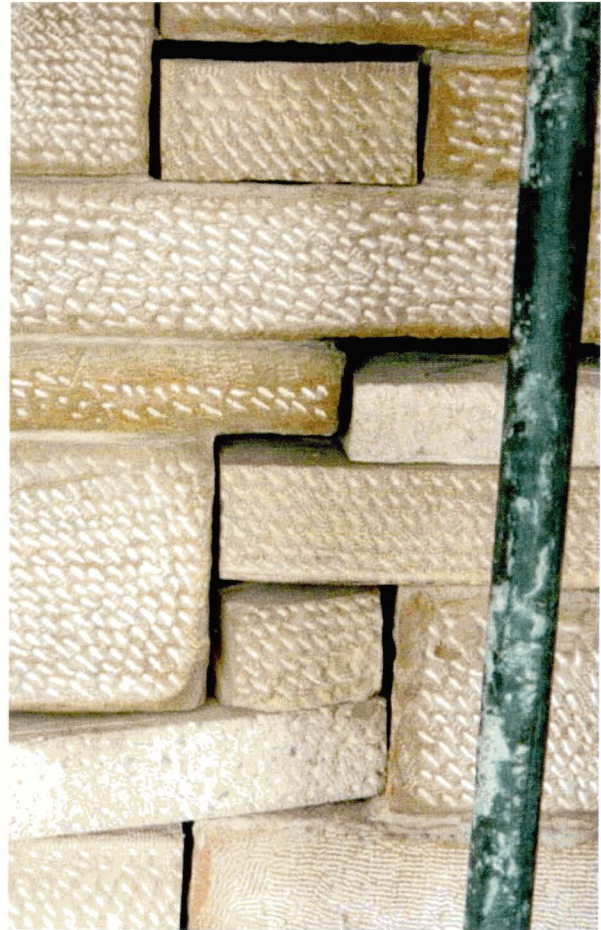
Illus 66. Repair involving partial replacement or indenting of a damaged stone (shown prior to bedding and pointing).

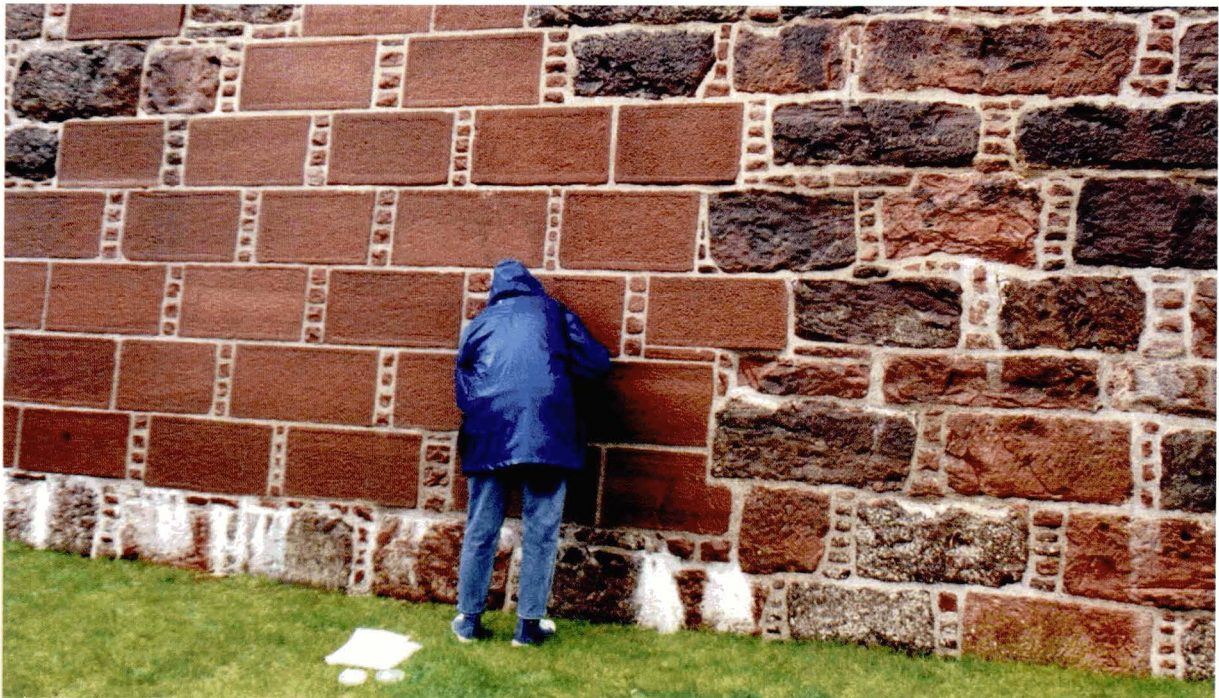
Illus 67. Indented stone will stand out when new but within a few years natural soiling and weathering processes should blend the new stone in with the old.

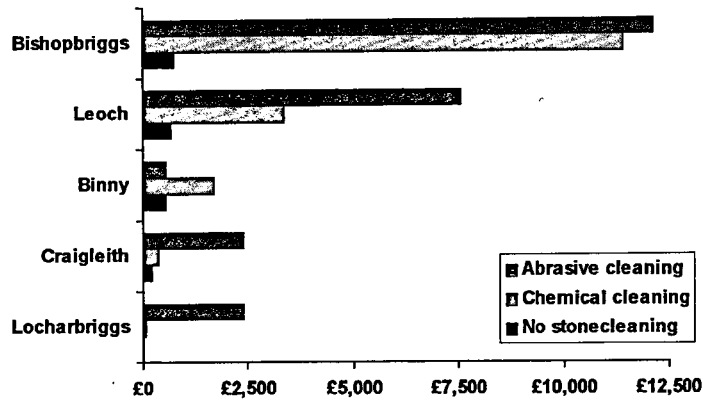
Illus 68a. Mean predicted costs of indenting repairs to a 200m² ashlar sandstone façade ten years after stone cleaning. Data show the predicted behaviour of five different sandstones from the most durable (e.g. Locharbriggs) to the least durable (e.g. Bishopbriggs). Excludes scaffolding and repointing costs.

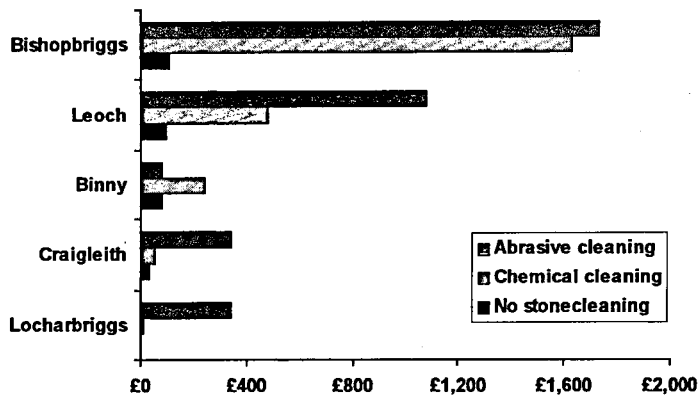
Illus 68b. Mean predicted costs of plastic repairs to a 200m² ashlar sandstone façade ten years after stone cleaning. Data show the predicted behaviour of five different sandstones from the most durable (e.g. Locharbriggs) to the least durable (e.g. Bishopbriggs). Excludes scaffolding and repointing costs.
