TECHNICAL
ADVICE
NOTE

MAINTENANCE
AND REPAIR
OF CLEANED
STONE BUILDINGS

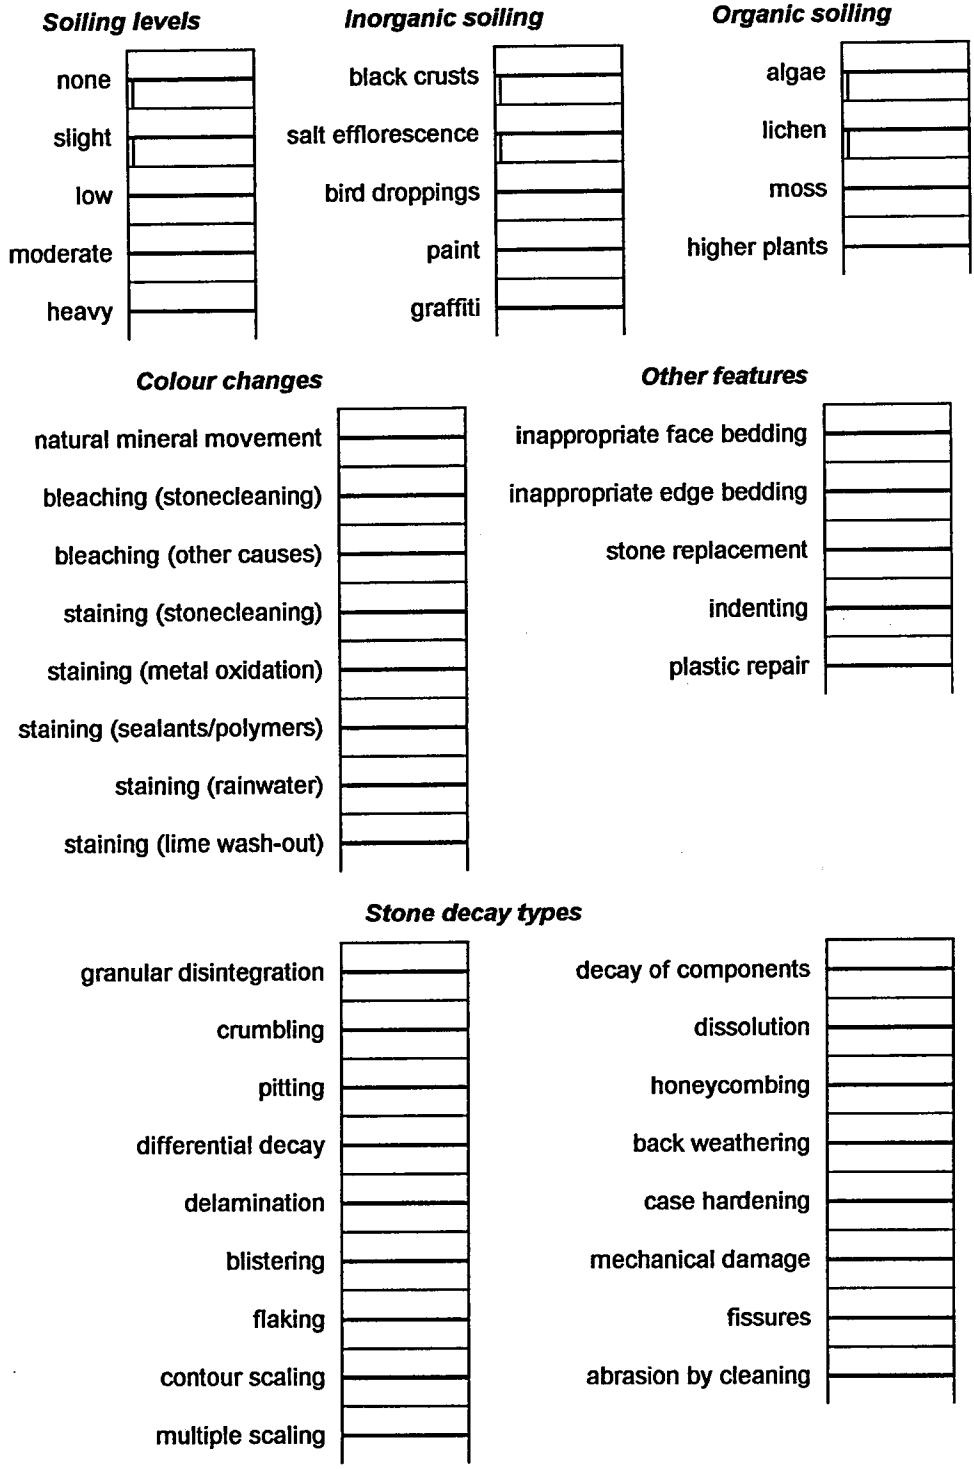
6 Symbols and colours used to map façade condition
