TECHNICAL
ADVICE
NOTE

THE
ENVIRONMENTAL
CONTROL OF
DRY ROT

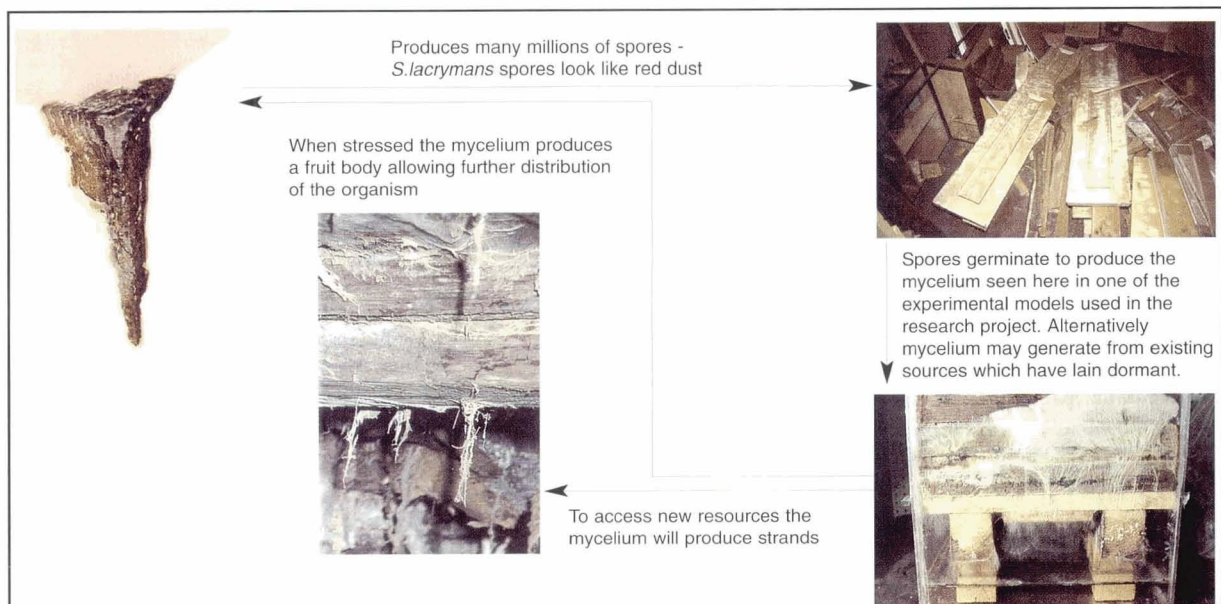
Illustration 1. The life cycle of the dry rot fungus

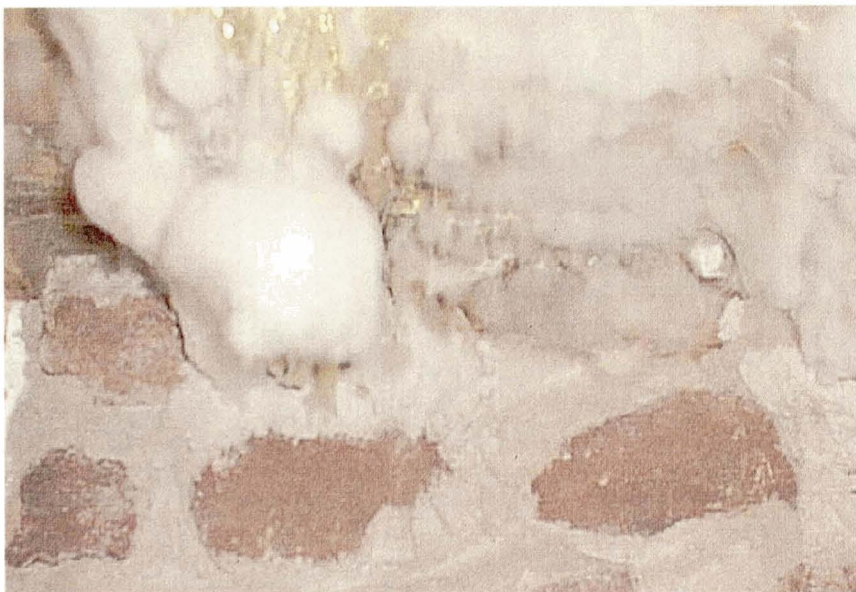
Illustration 2. Lush growth at a wood/ masonry interface
Unlike most other wood decay fungi found in buildings the dry rot fungus has an absolute requirement for both nutrients from the wood and metal ions extracted from masonry (see Appendix F – Bibliography). Because of this the organism grows in a particularly luxuriant way around wood/ masonry interfaces. This is particularly well seen at the rear of lath and plaster or walls and ceilings.

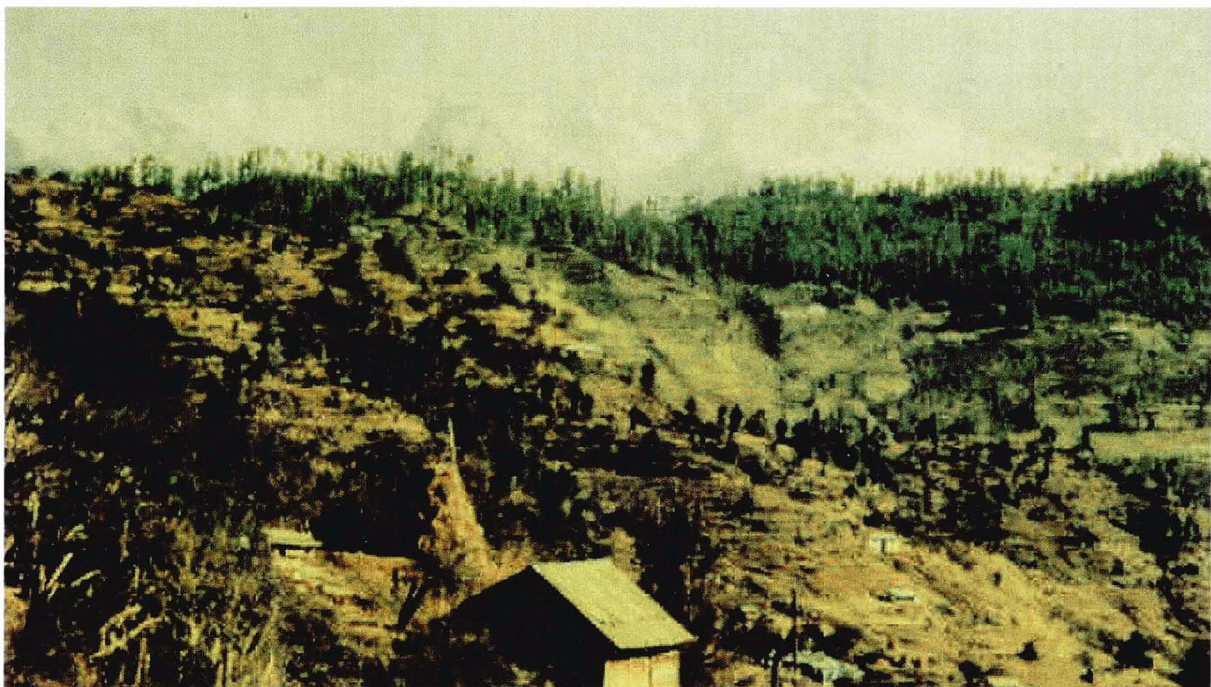
Illustration 3. *The Himalayan environment*

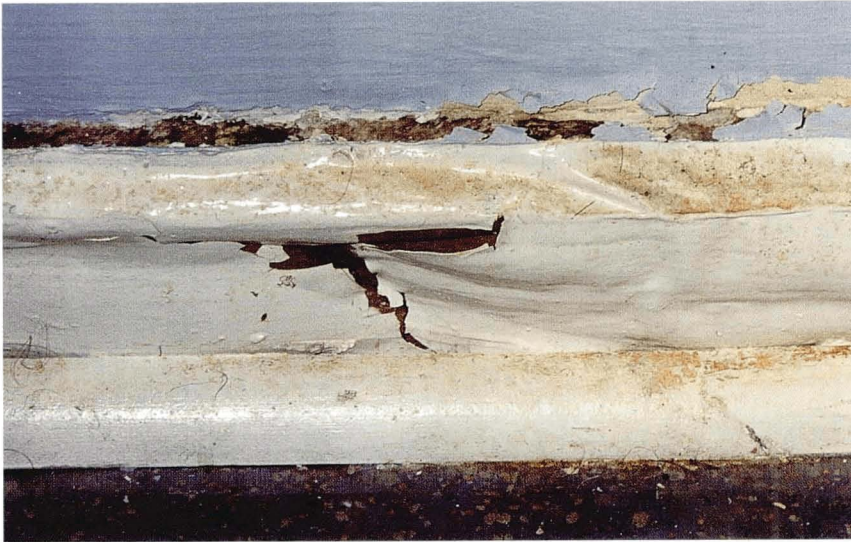
Illustration 4. Surface coatings may mask the destruction of wood. Trying to discover dry rot attacks by looking for decayed wood is an inappropriate strategy as the attack will often not appear on the visible surface of wood. In the case shown severe decay has developed under what was, until recently, an intact paint surface. The cracking across the grain is well illustrated.

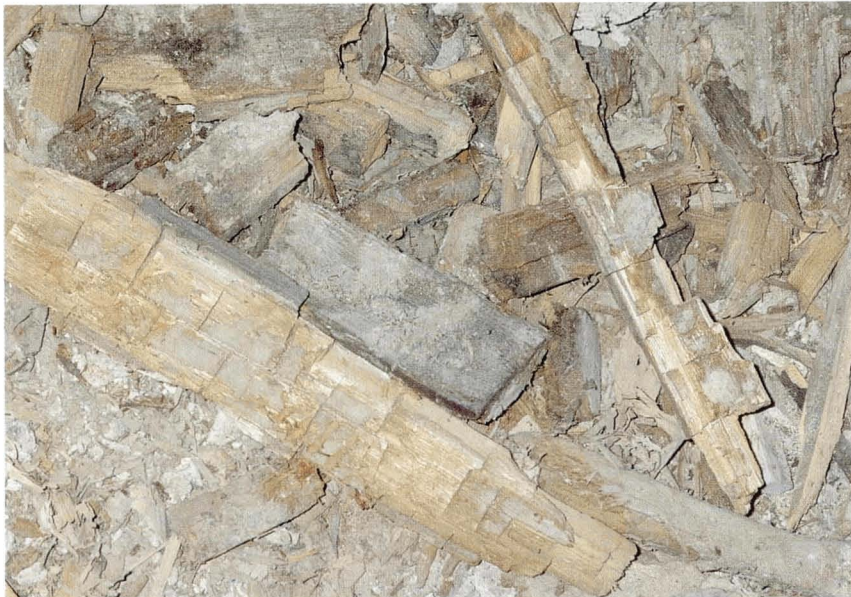
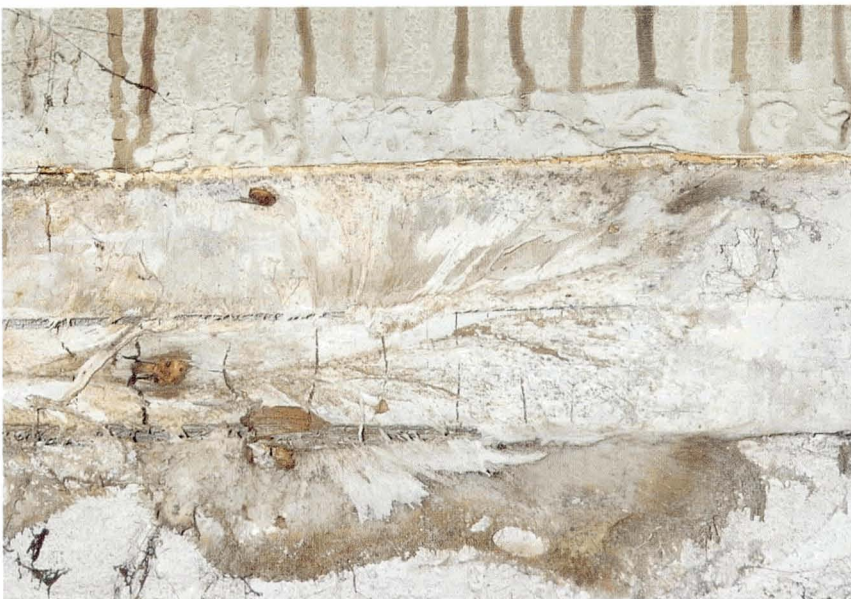
Illustrations 5 a) and b). The appearance of wood after dry rot attack. The final stages of a dry rot attack are typified by the appearance of cuboidal cracking, both along and across the grain. In addition the wood develops a uniform brown character and a friable texture. Often the wood may be dry to the touch, however during active decay the wood will have had an elevated moisture level.

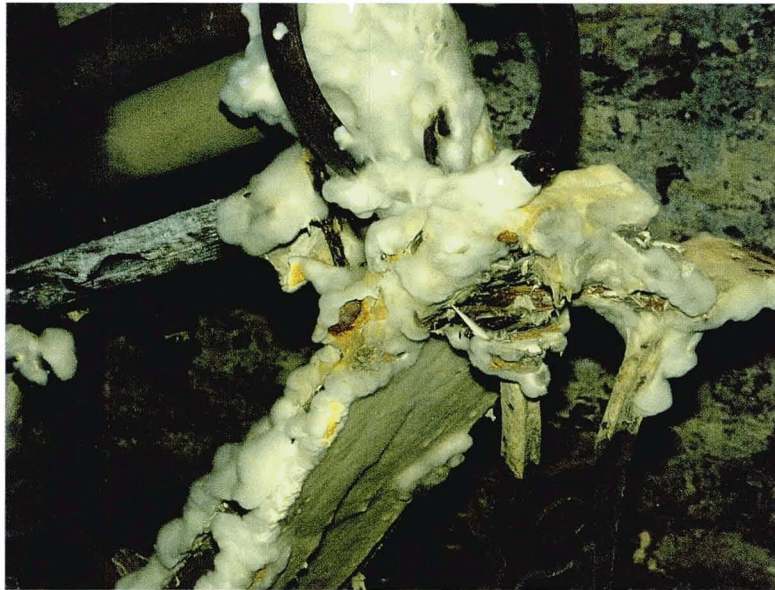
Illustration 6. Growth of the dry rot fungus around a metal object

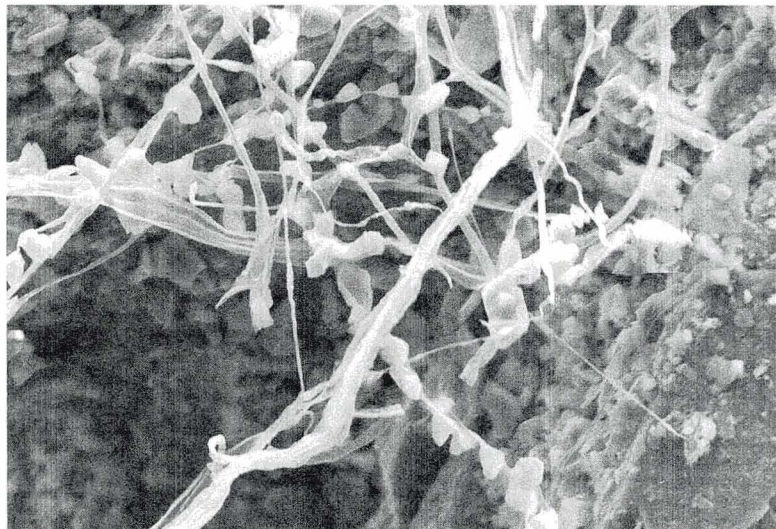
Illustration 7. Photomicrograph of the dry rot fungus growing on sandstone. Mycelium of the dry rot fungus are seen to be coated with crystals which are composed of calcium oxalate. The fungus extracts calcium from the surface of the sandstone, but in such minute amounts that the integrity of the stone does not appear to be compromised. The study illustrated in this Figure was, undertaken with the assistance of Dr Maureen Young of the Masonry Conservation Research Group at The Robert Gordon University, Aberdeen.

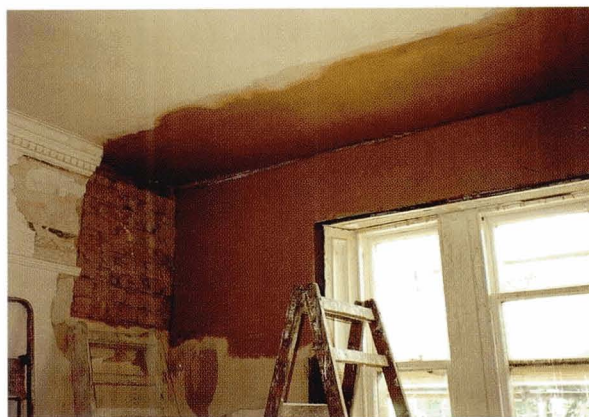
Illustration 8. Conventional dry rot treatment
Conventional dry rot treatments may be very destructive and are not appropriate for the types of repair required in historic buildings or buildings with historic interiors. In this illustration the loss of original fabric is well seen. Note also the 'cutting back' of plaster by at least 1 metre on the party wall and loss of the decorative cornice .

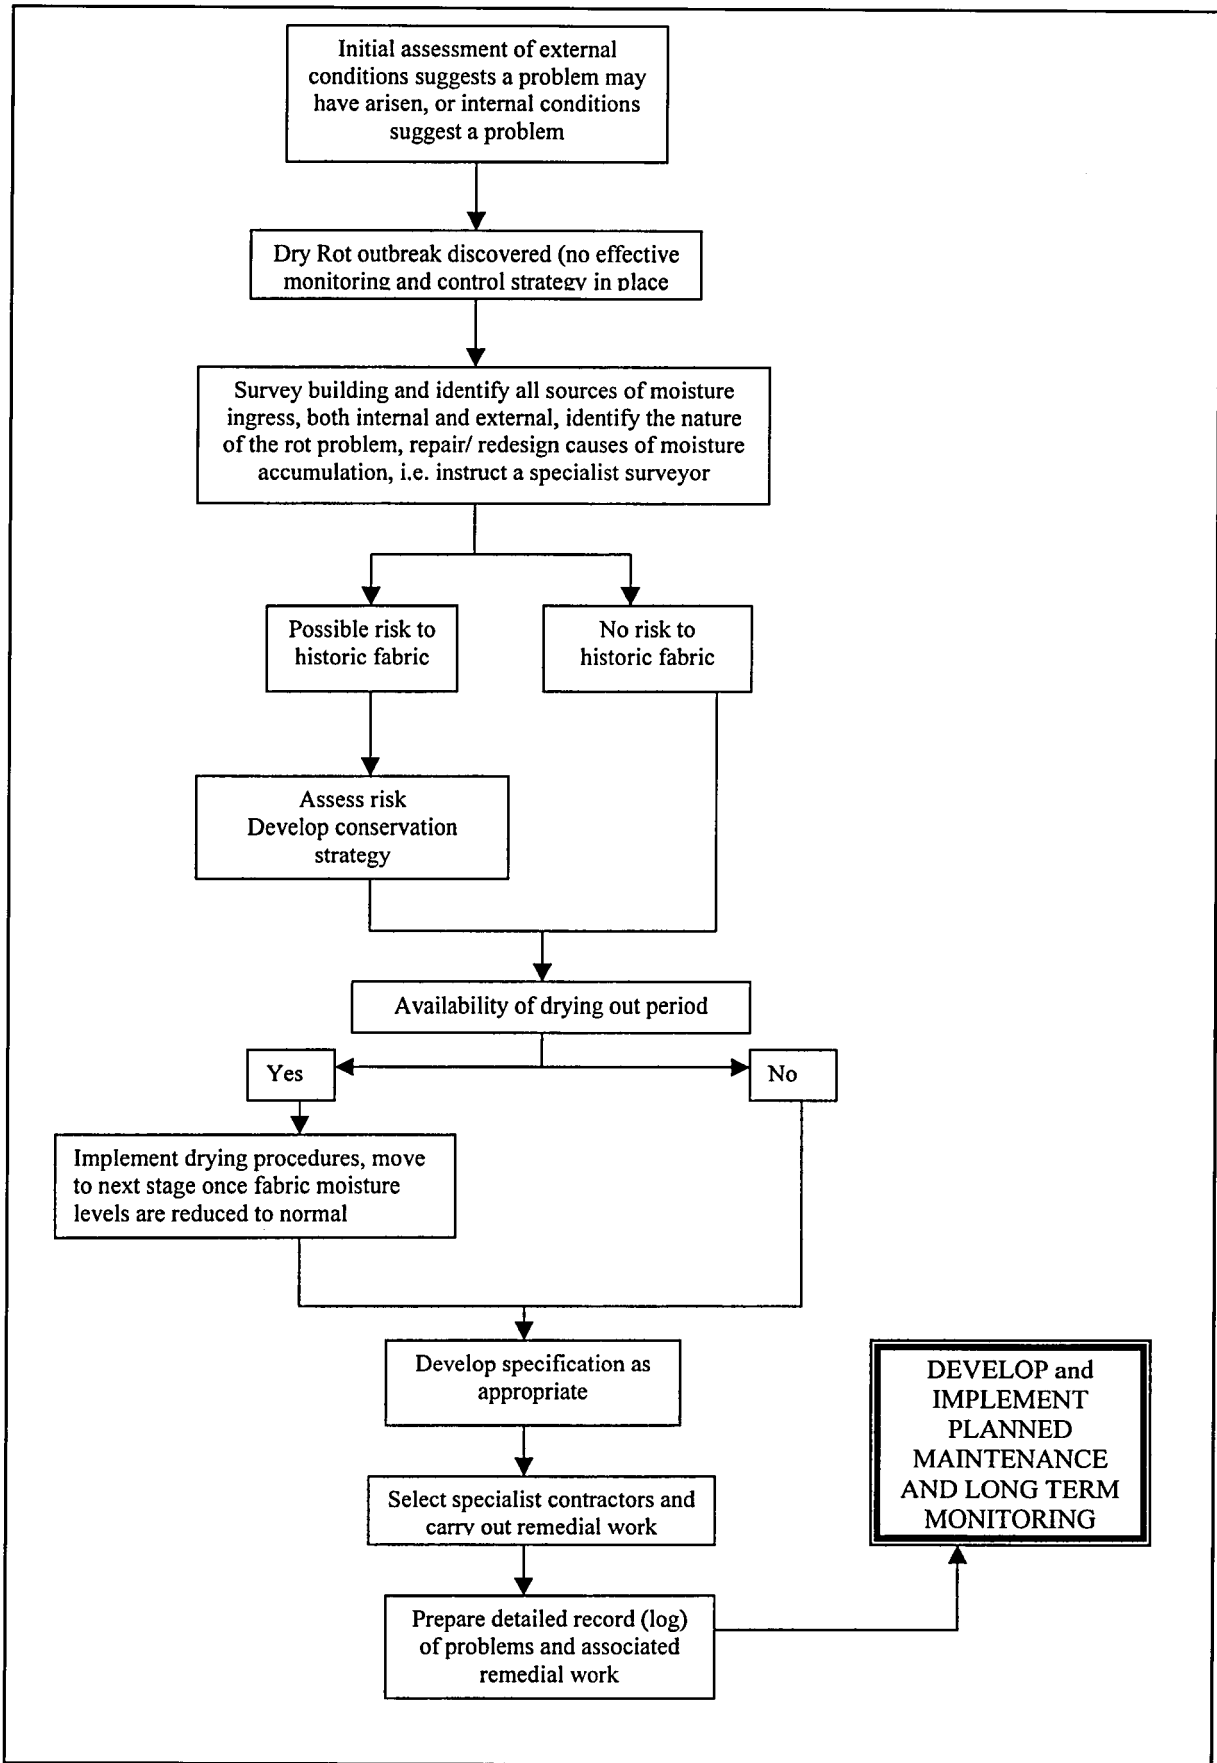
Illustration 9. The strategy of environmental control

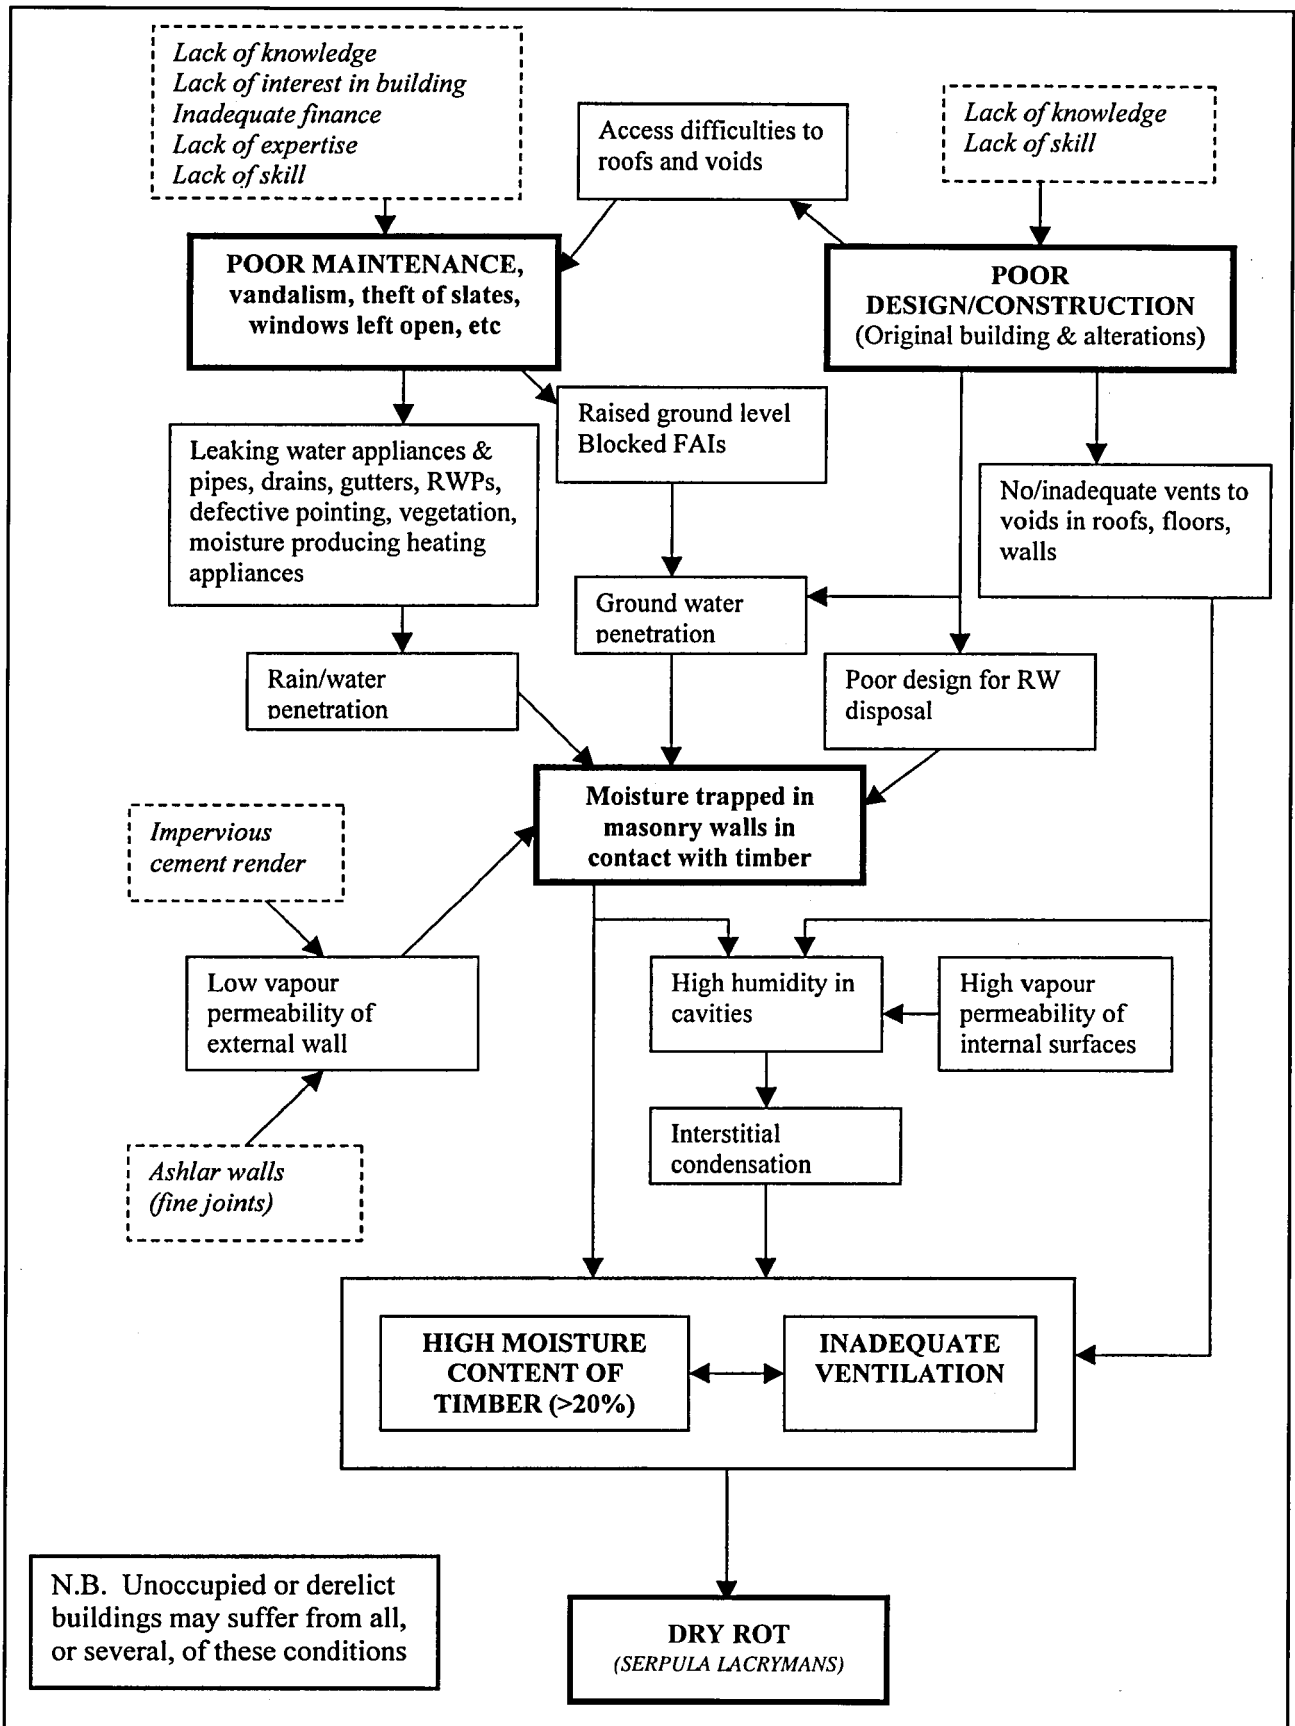
Illustration 10. Analysis of sources of high moisture content in timber.

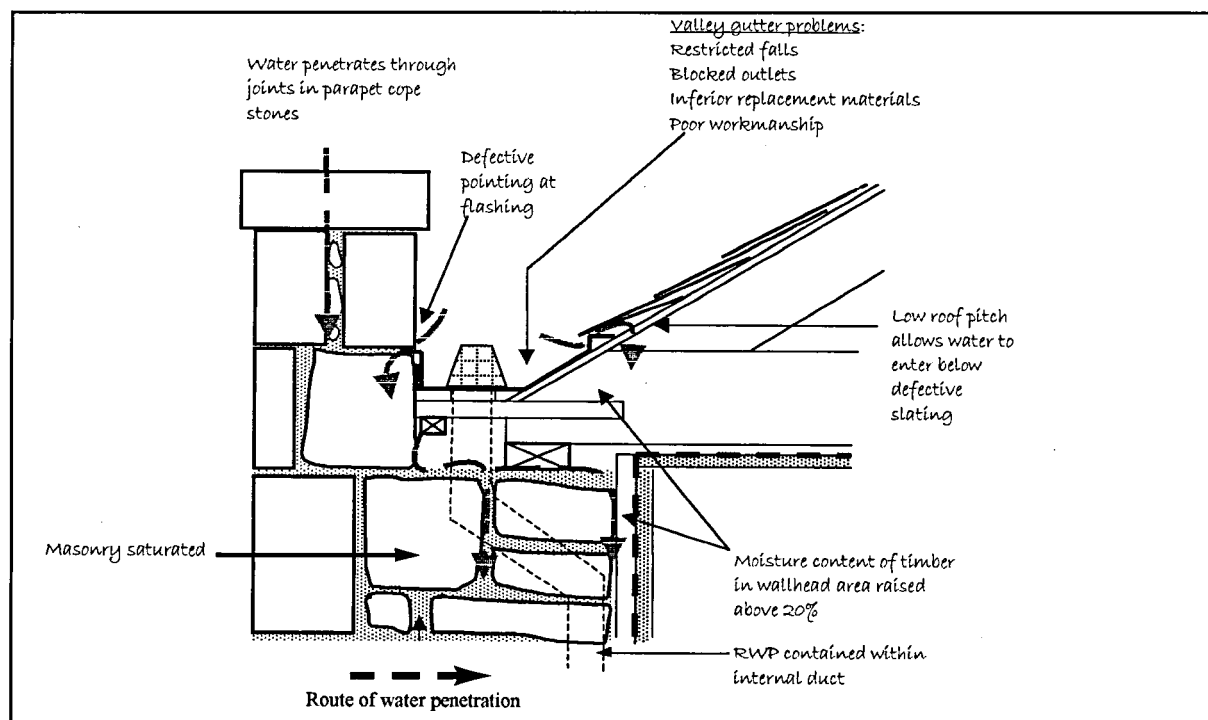
Illustration 11. Detail at a parapet gutter showing possible routes for water ingress. The illustration shows the numerous problem areas associated with a parapet gutter and indicates the need a) for frequent monitoring of performance and b) for high quality repairs.

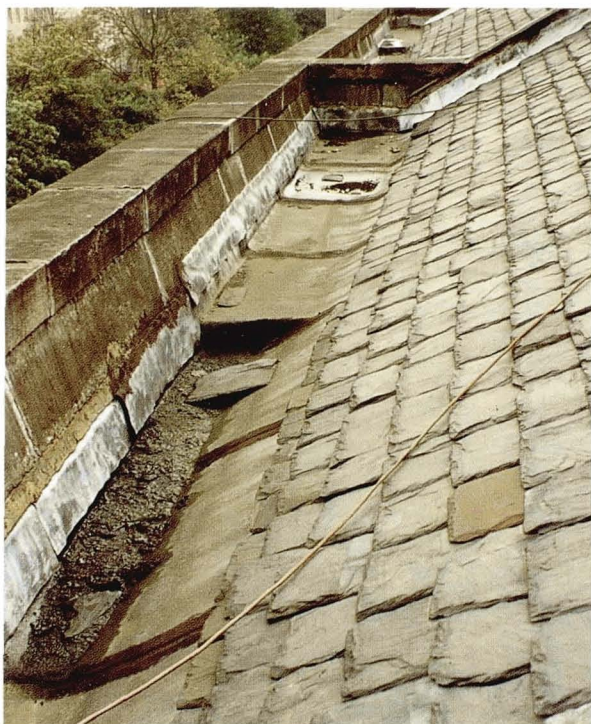
Illustration 12. Poorly maintained parapet gutter responsible for dry rot attack. Poor maintenance, substandard materials, missing and slipped slates, inadequate falls and a choked outlet led inevitably to an associated dry rot attack in this property.

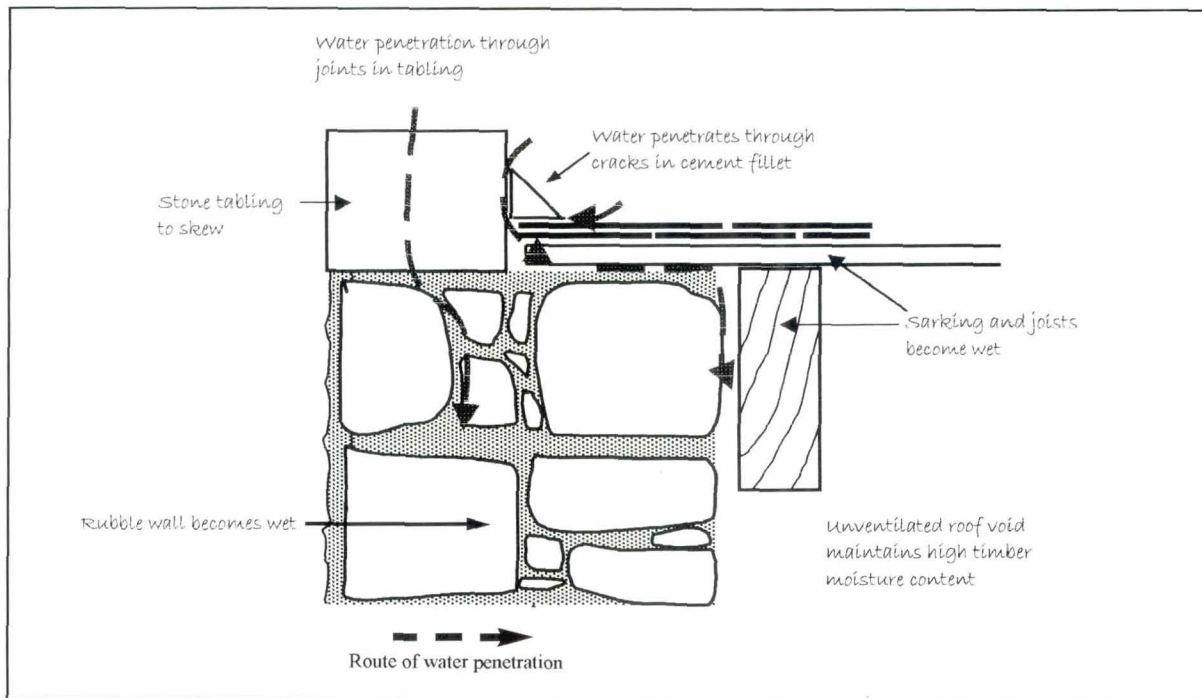
Illustration 13. Routes for water penetration at a skew.

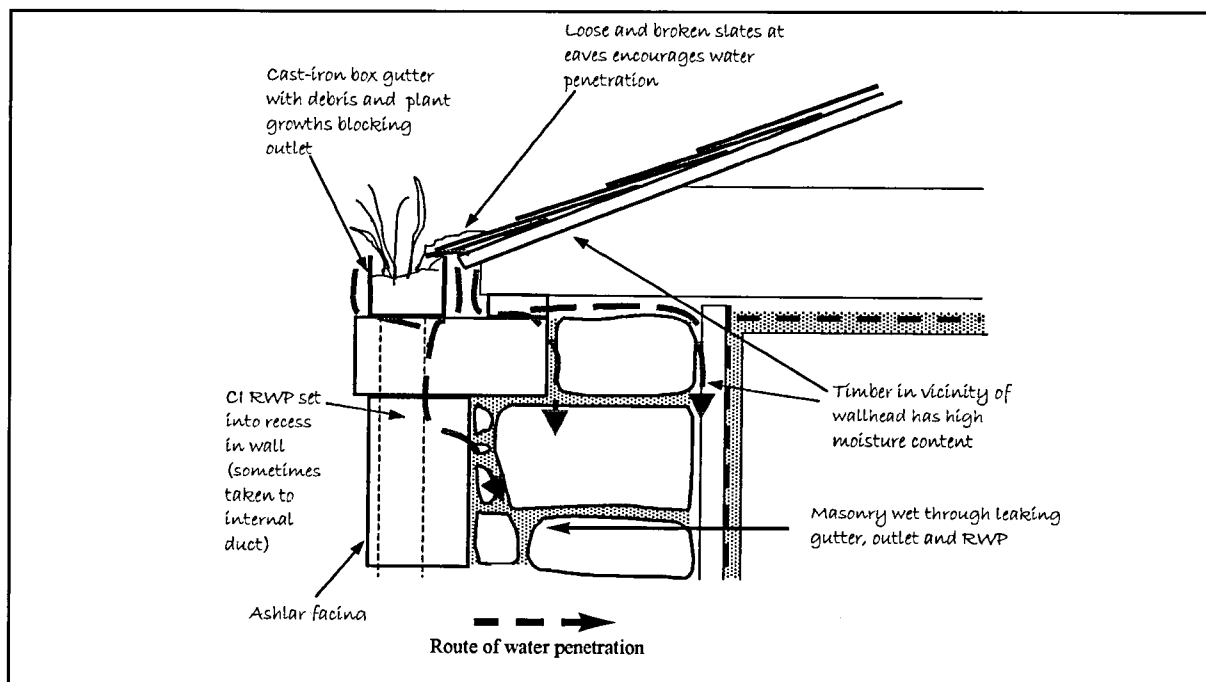
Illustration 14. Detail at eaves using a box gutter set on the wallhead. This arrangement allows ready access of water into the wall should the gutter become broken or blocked. The situation is often exacerbated by loose or broken slates which allow access of water to the wall plate and beam ends (in the first instance)

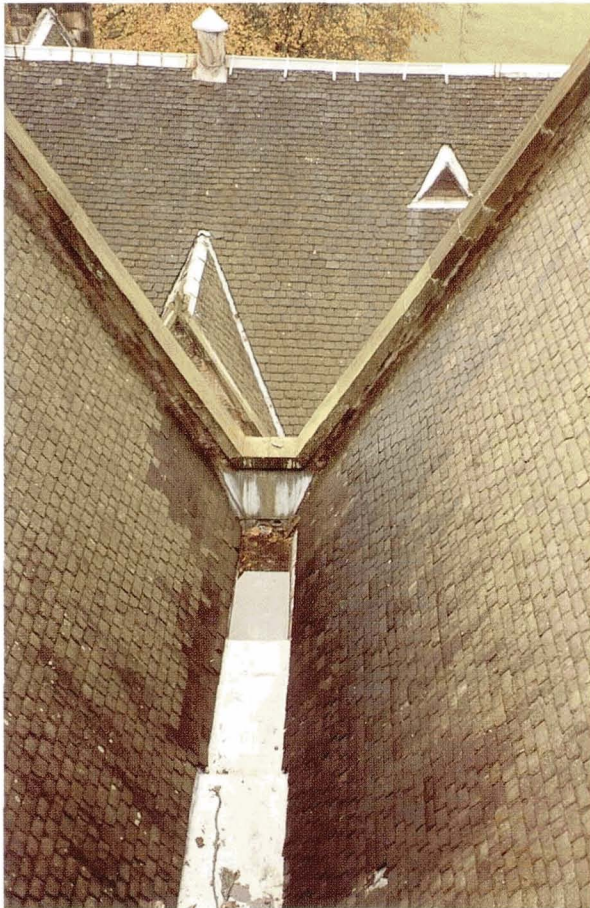
Illustration 15. Access to this internal valley gutter is difficult, leading to lack of maintenance and a dry rot attack.

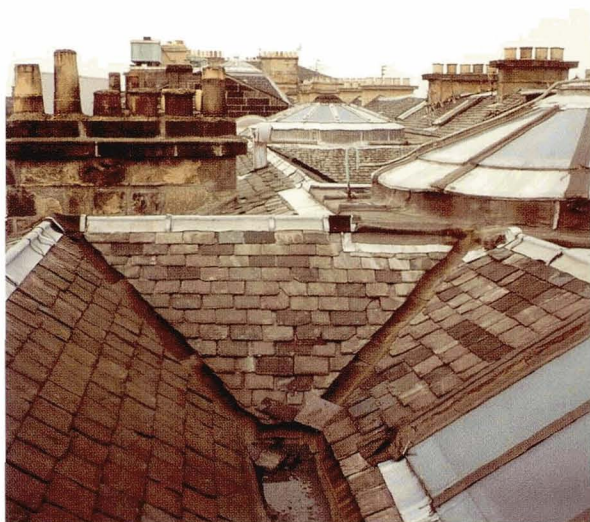
Illustration 16. A complex roof arrangement. Poor quality repairs, lack of maintenance, an internal outlet and inadequate falls have all resulted in water penetration to this property followed by a dry rot outbreak. It is likely that evidence of the water penetration was available long before the development of dry rot.

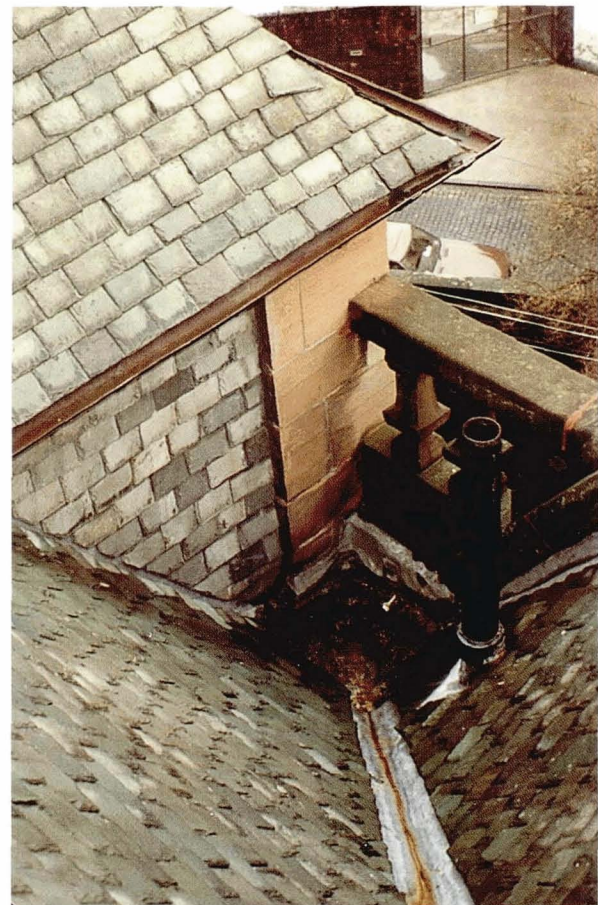
Illustration 17. A blocked and inaccessible roof outlet. Lack of maintenance combined with inaccessibility resulted in a dry rot attack in adjacent timbers.

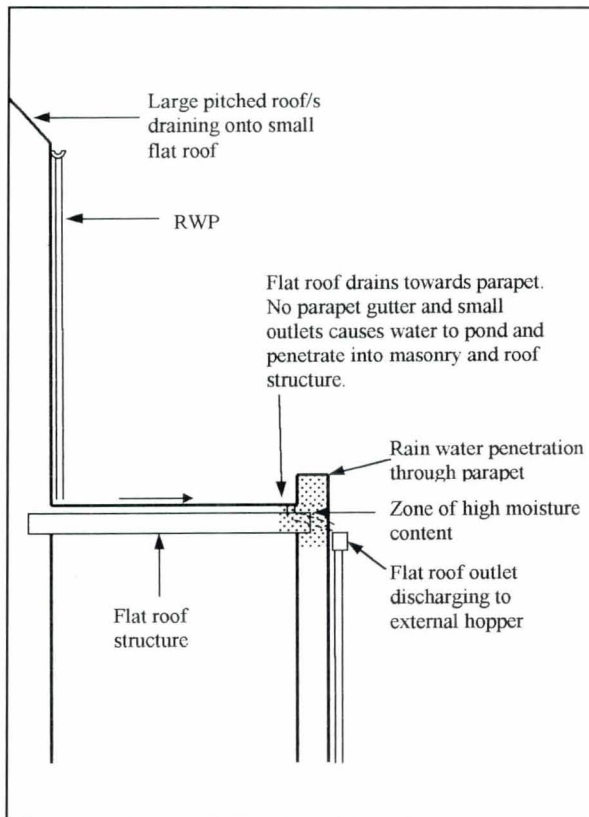
Illustration 18. Detail of rain water discharge at a flat roof.

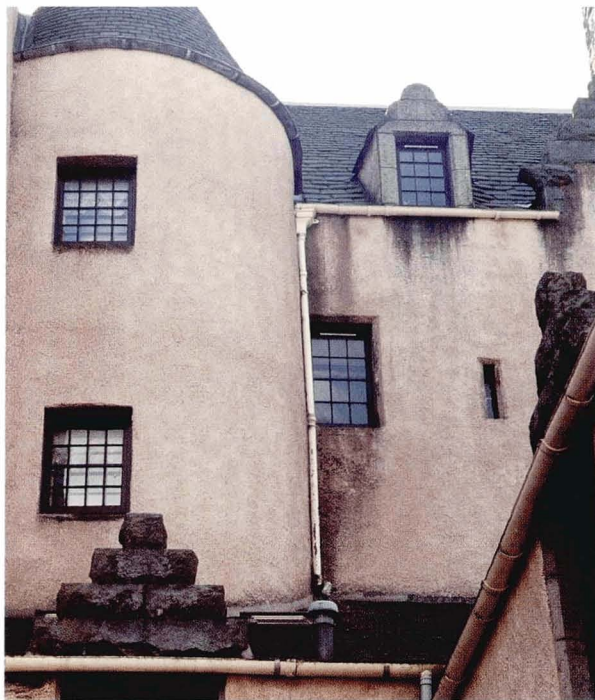
Illustration 19. Complex roof systems present serious challenges to the property manager. A series of roofs at different levels drain to a single small outlet. The wall area around the outlet can get very wet when the outlet overflows and this is inevitable unless maintenance levels are high.

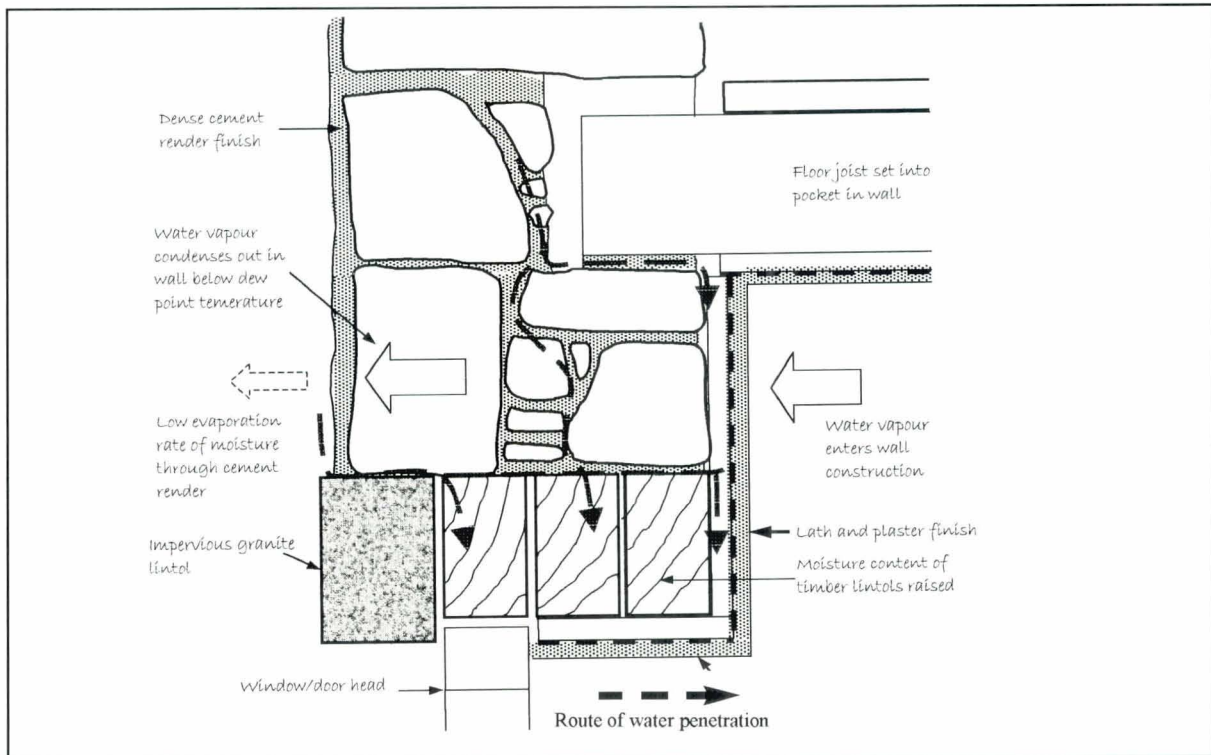
Illustration 21. Detail at window head showing moisture access routes to embedded timber:

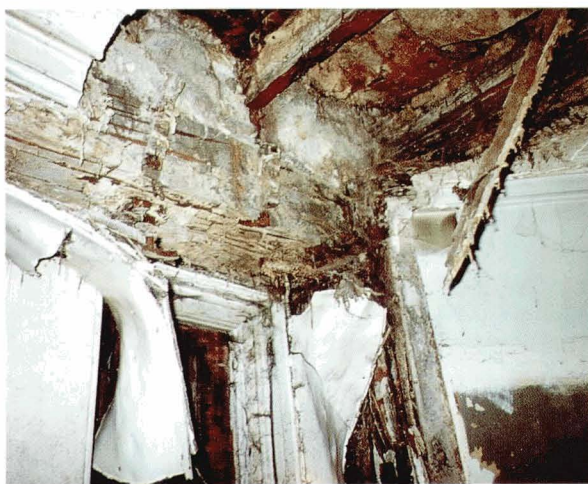
Illustration 22. A severe dry rot outbreak. Dry rot outbreak at intermediate floor level resulting from external wall defects. Note the infected safe lintols and the badly degraded floor joists

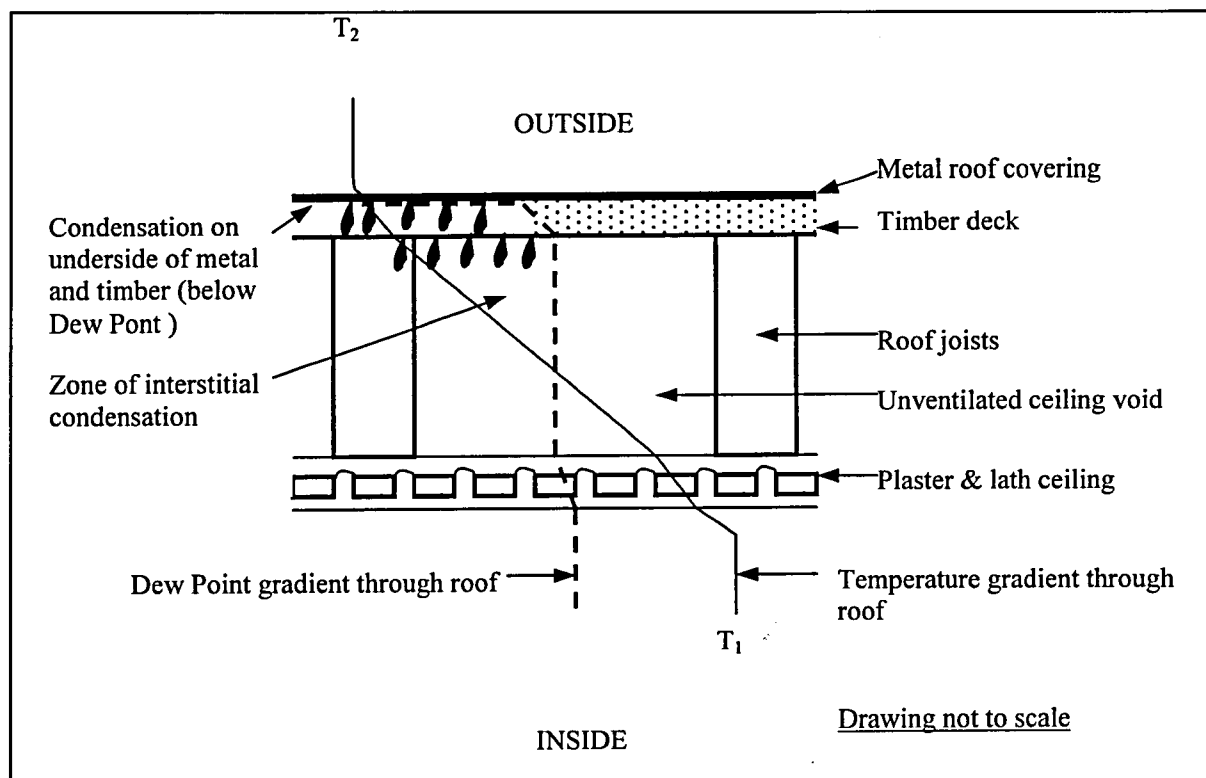
Illustration 23. Diagrammatic representation of the formation of interstitial condensation within a metal covered flat roof.
 1. The point at which the structural temperature gradient crosses the dew point gradient is the point at which the structural temperature falls below dew point and condensation occurs. 2. Water vapour will condense out on surfaces that are below dew point, i.e. on the undersides of the sheet metal and the timber deck. 3. The moisture content of the timber deck and tops of joists may be raised above 20% and, where this occurs in contact with a calcium source, dry rot is possible. 4. Many older flat roofs lack sufficient ventilation to prevent condensation occurring. 5. Temperature gradients are indicative only and simply represent a temperature gradient between outside and inside.

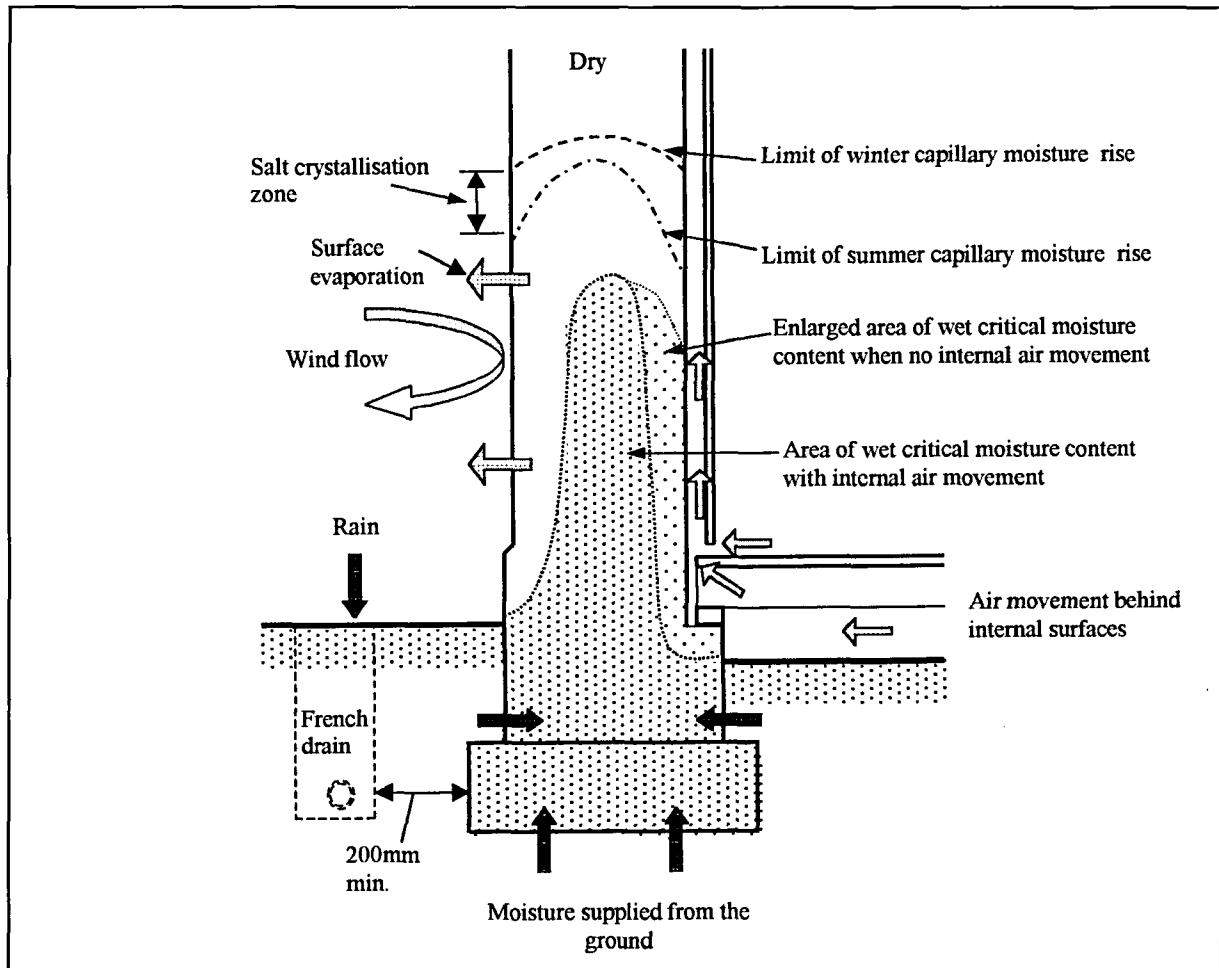
Illustration 24. Hypothetical representation of the effects of air movement on the critical moisture content of a porous masonry wall. This illustration is adapted from a diagram from B. Feilden (1994). The effect of internal air movement is to keep the internal surface critical moisture content of the masonry below the level where the moisture content of timber in contact would exceed 20%. The installation of a French drain can reduce the moisture take-up by the wall due to rising damp. Any excavation adjacent to an historic building should be supervised by an archaeologist.

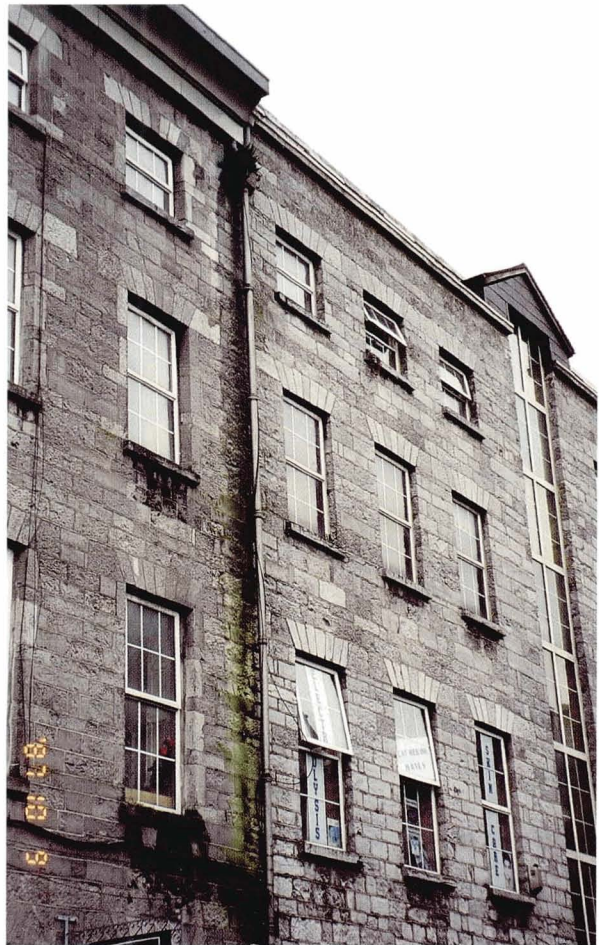
Illustration 25. Faulty downpipes

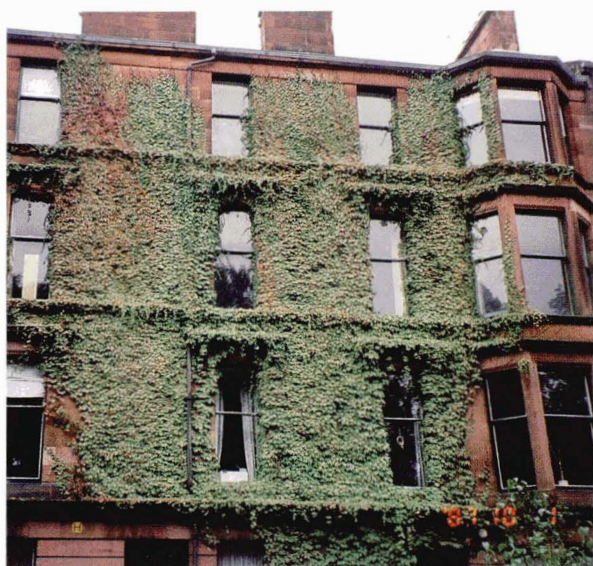
*Illustration 26. Plant growth on a building façade
This tenement in Glasgow boasts a luxuriant growth of ivy on its façade. Such growths may encourage retention of moisture in a wall and certainly should not be allowed to block rain-water discharge systems. However, uncontrolled removal of ivy can cause damage to stonework. The ivy should be cut at ground level (a section of stem removed) and the plant allowed to die before careful removal by hand from vulnerable stonework or brick wall.*

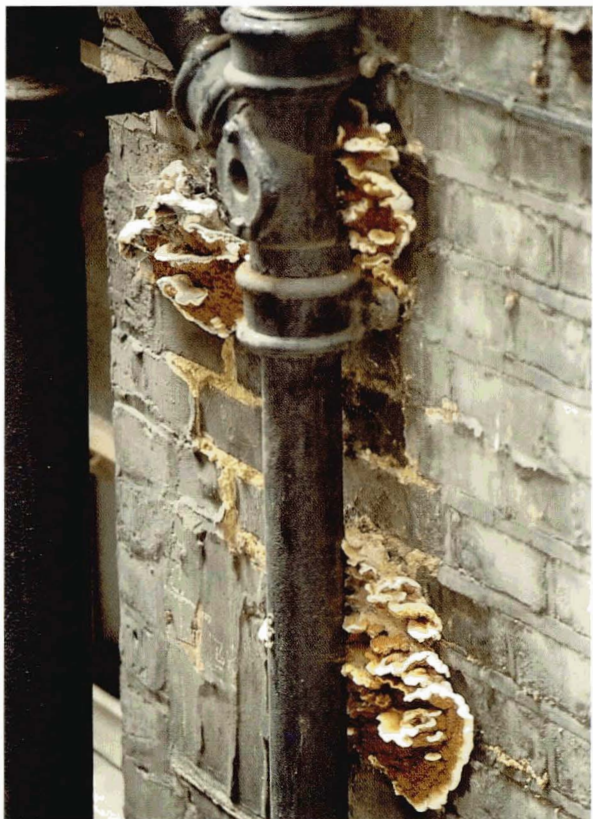
Illustration 27. Faulty rainwater pipe saturating a brick facade resulting in an internal outbreak of dry rot and an external fruiting body. © Hutton+Rostron

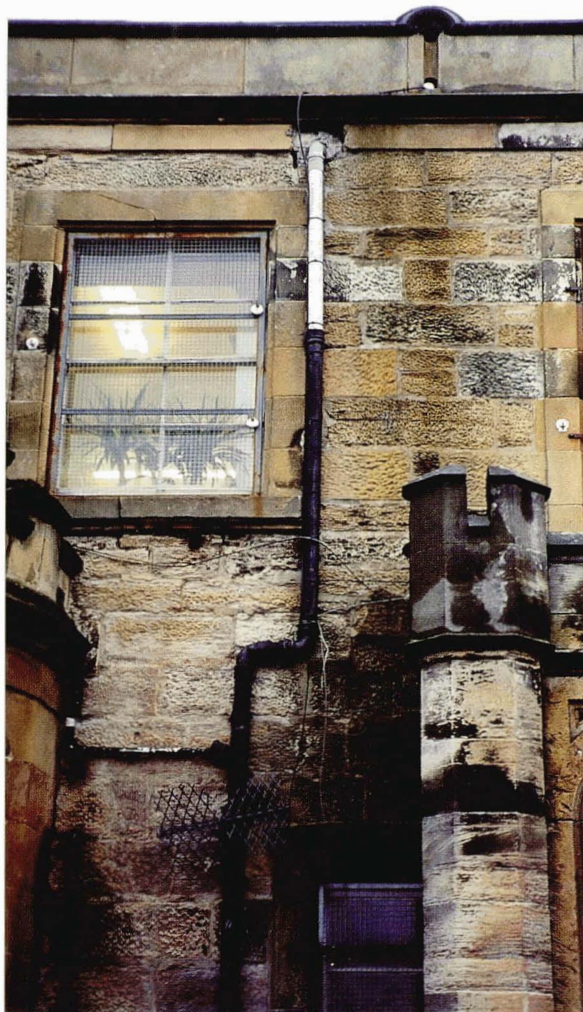
*Illustration 28. Stained walls
The black staining on the walls indicates a problem with the rain water discharge from the roof of this Tudor-style villa of c. 1828 on the outskirts of Glasgow.*

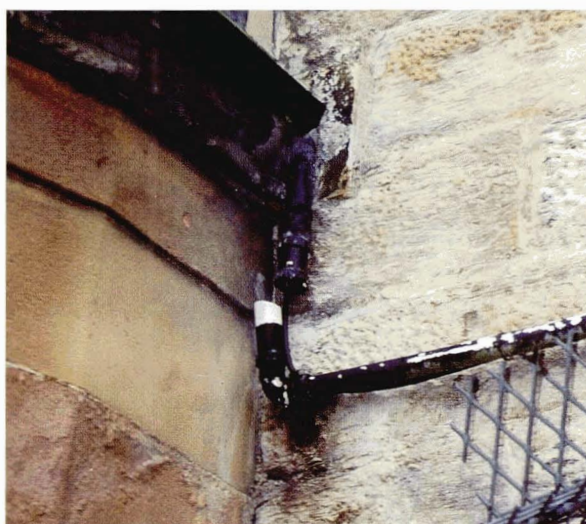
*Illustration 29. Broken rainwater discharge
Closer inspection of Illustration 28 indicates that one of the discharge pipes is completely severed.*

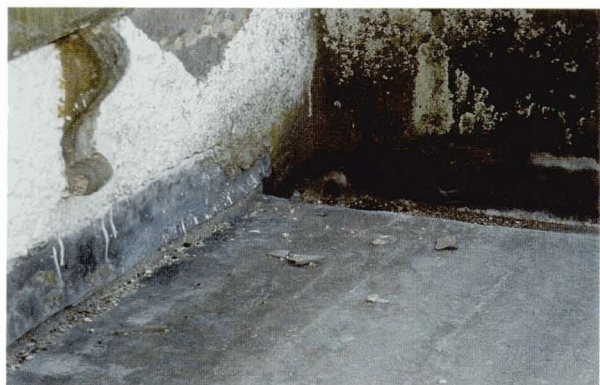
Illustration 30. Flat roof features

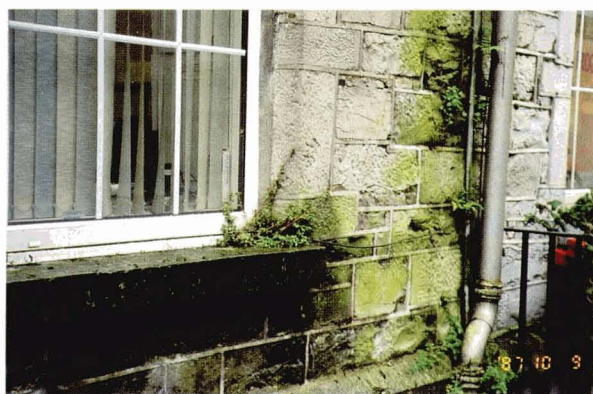
Illustration 31. Plant and algal growth

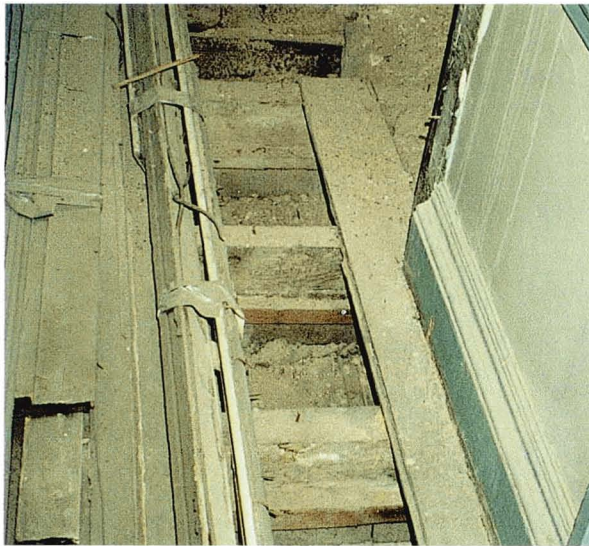
Illustration 32. Floors opened up to increase ventilation. Opening up floors will improve ventilation, promote drying and prevent further decay by the dry rot fungus.

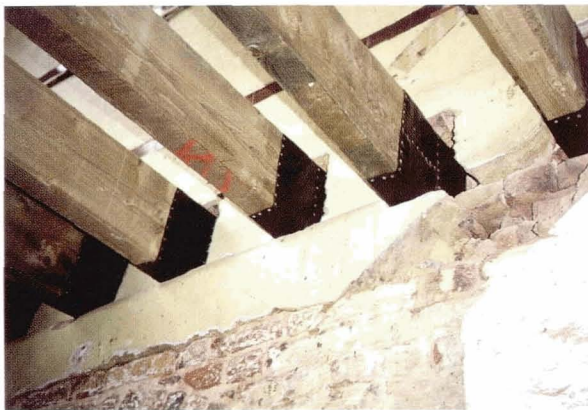
Illustration 33 Use of DPM wrappings to protect beam ends.
