TECHNICAL
ADVICE
NOTE

THE
ENVIRONMENTAL
CONTROL OF
DRY ROT

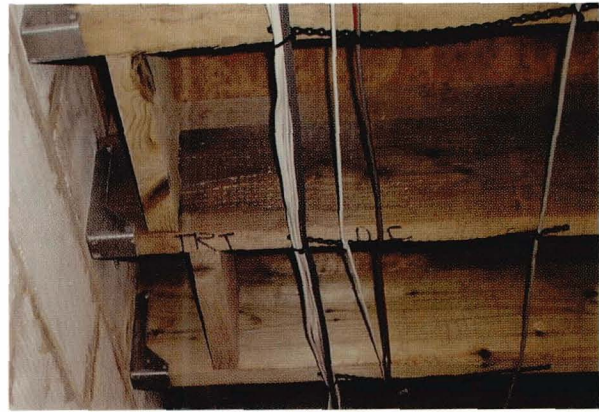
Illustration 34. Use of metal hangers where it is necessary to isolate timbers from masonry

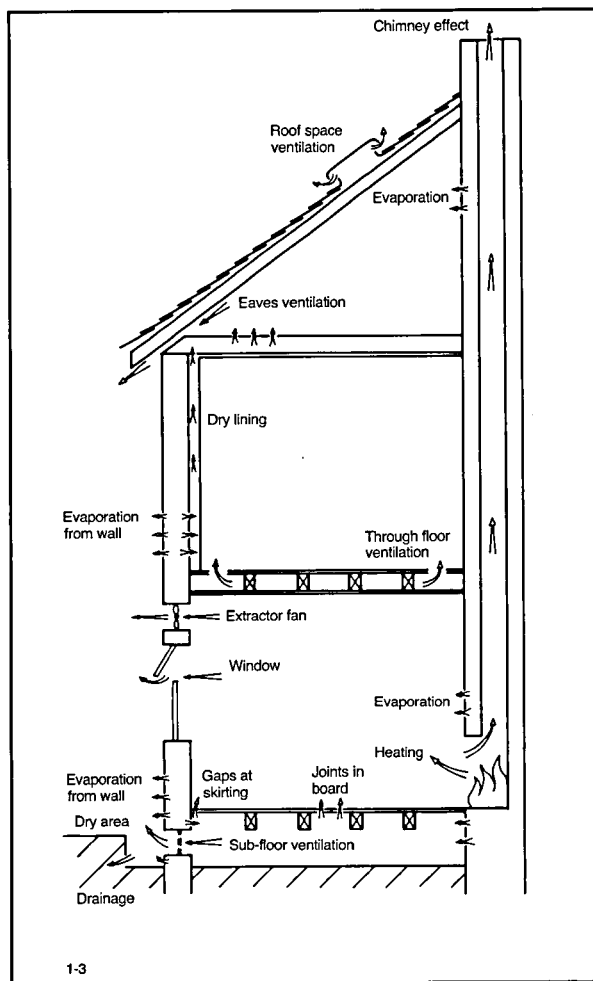
Illustration 35. Environmental control applied in a domestic housing situation. This diagrammatic representation shows the principles of environmental control applied successfully to a number of projects in Perth, Scotland. © Hutton+Rostron

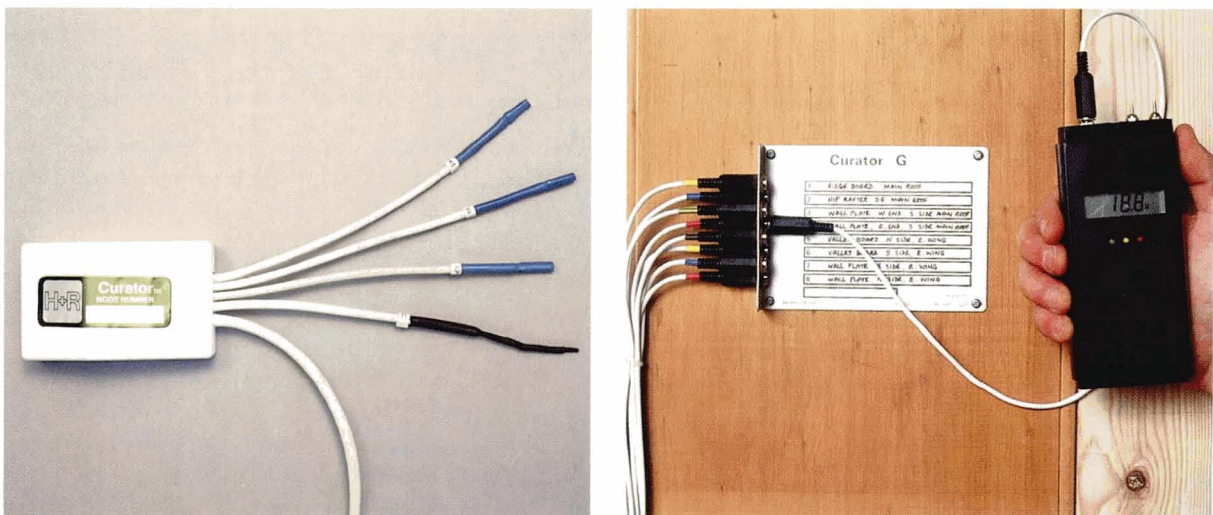
Illustration 36 A remote monitoring system. a) Node with single cable serving four different sensors such as remote humidity or timber moisture content sensors. b) An eight channel Curator® system for manual reading used in small domestic installations. Network can connect to a local control unit and to central station computer. © Hutton+Rostron

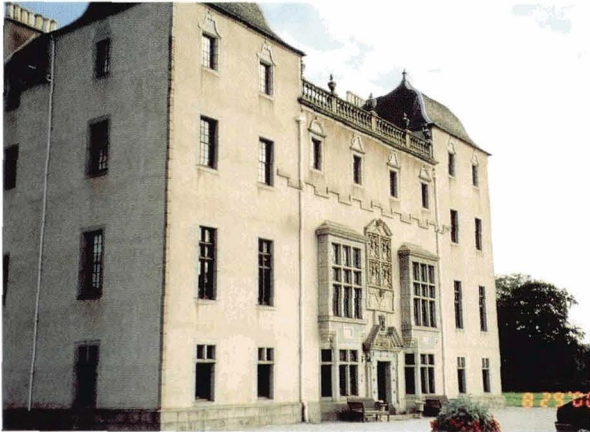
Illustration 36. West front of Keith Hall, Aberdeenshire

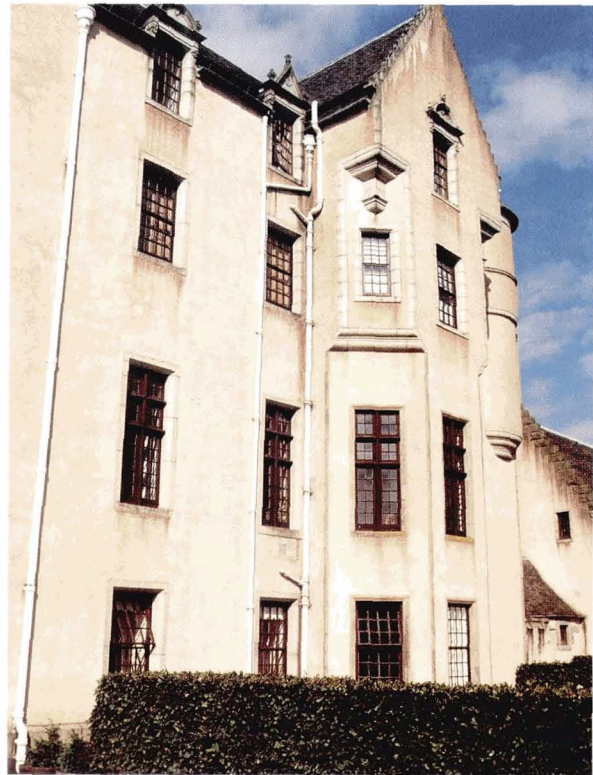
Illustration 37. Detail of part of the west elevation of Keith Hall showing granite lintols, crow's step gable end and new rainwater discharge systems

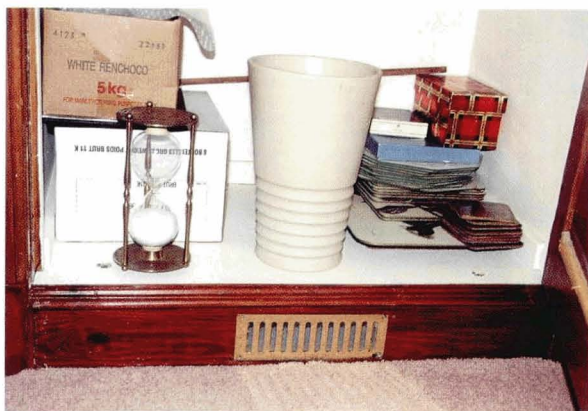
Illustration 38. Methods to increase sub-floor ventilation were introduced throughout Keith Hall

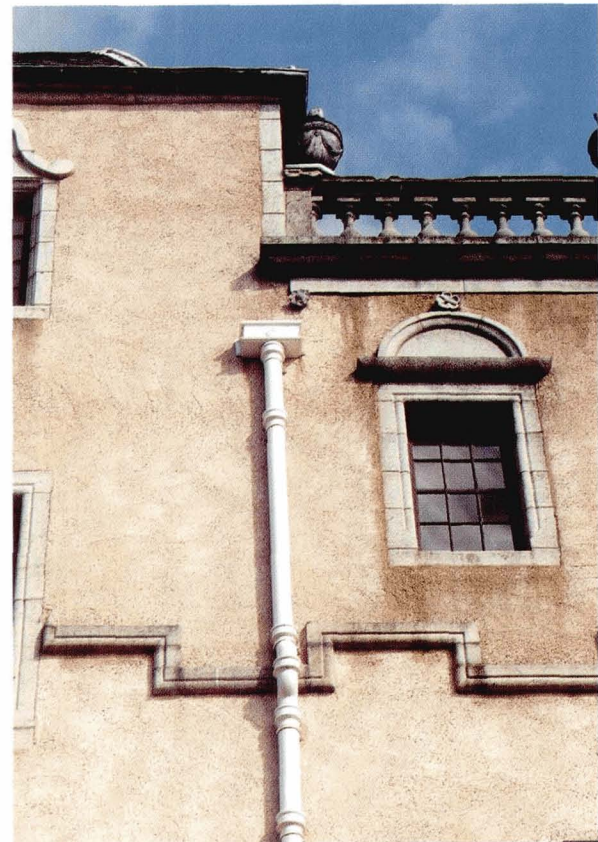
Illustration 40. New, external, downpipes fitted to replace potentially troublesome internal pipes draining from a parapet gutter

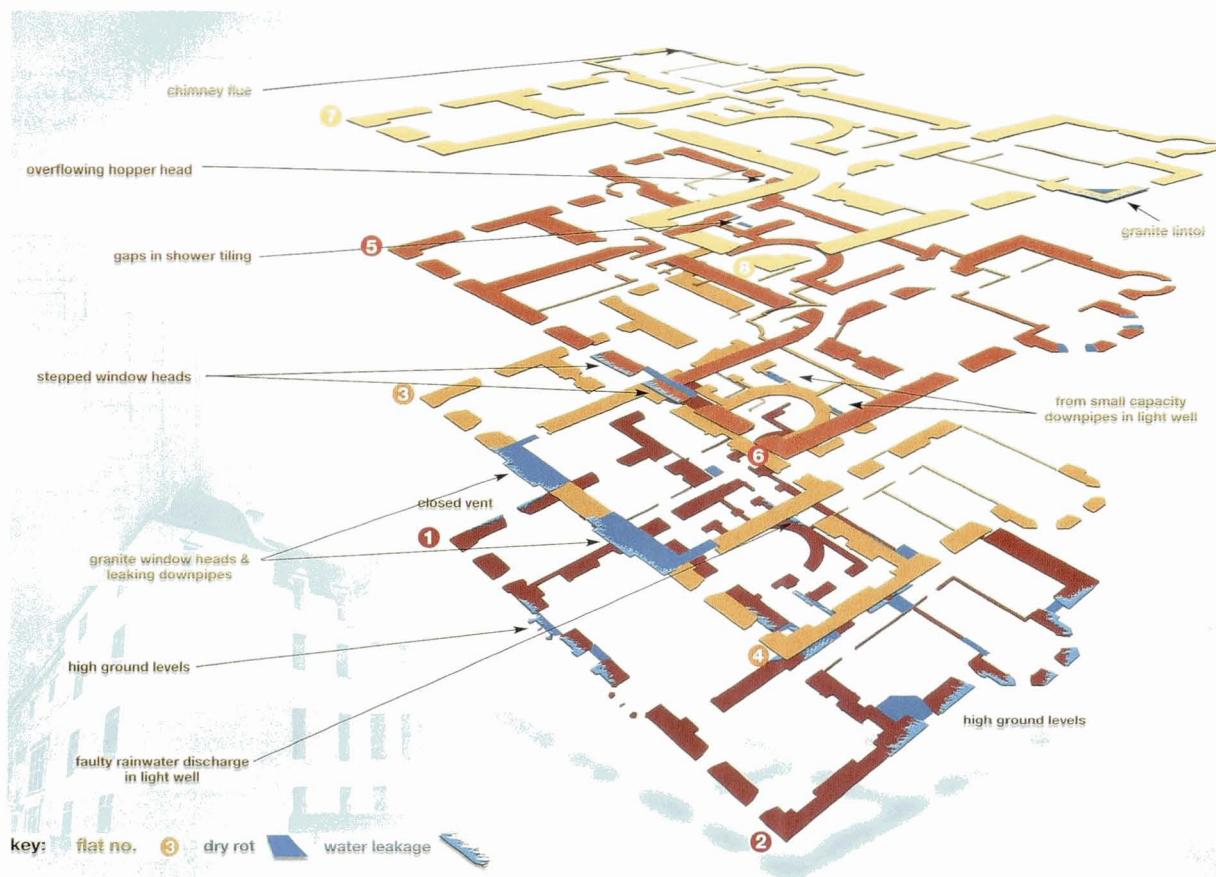
Illustration 41. 3D image of the moisture and timber problems in Keith Hall

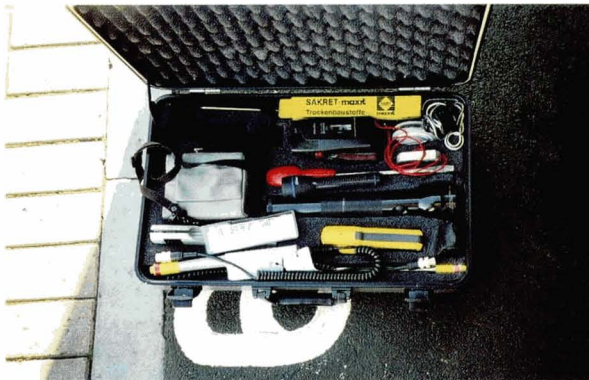
Illustration 42. The tools of the trade
A wide variety of equipment is now available to assist in the detection of rot within buildings. The illustration shows a well equipped operative. However the building manager can do a great deal with a sharp prodding instrument, a moisture meter and a reasonable level of common sense.

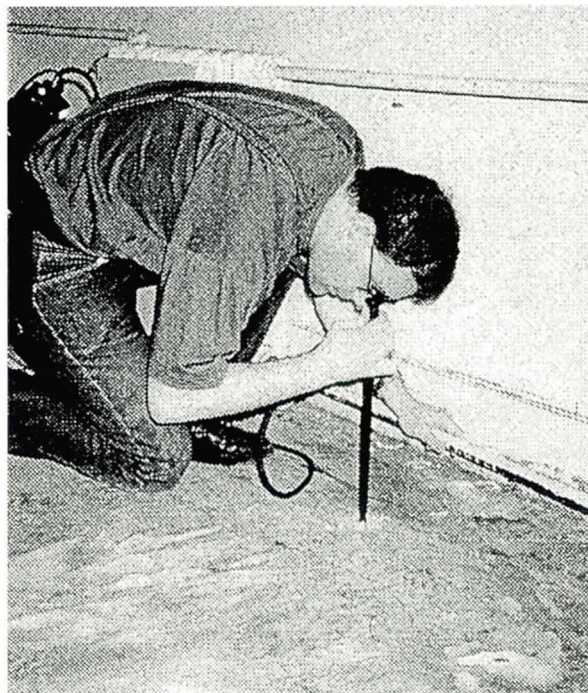
Illustration 43. Use of the borescope

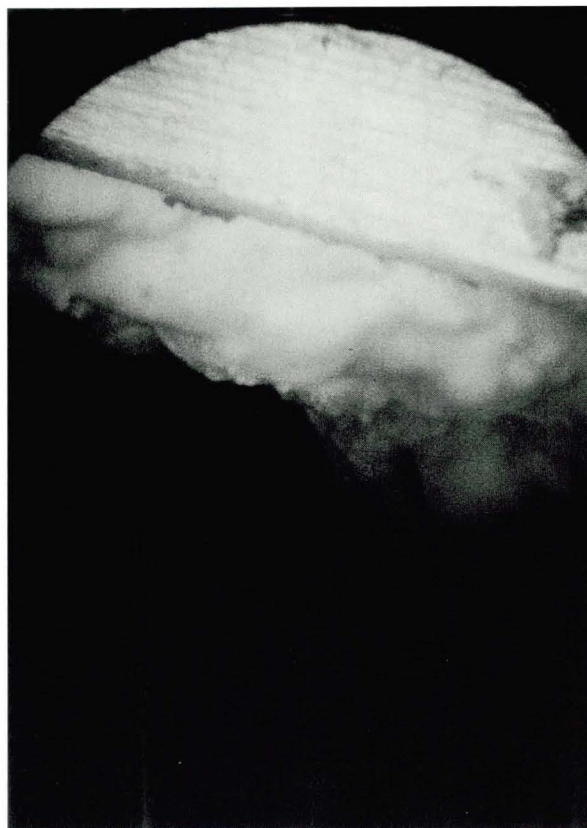
Illustration 44. The borescope view of the world. Interpreting the image from a borescope can be difficult. In this view a mass of white mycelium can be clearly seen on the surface of the wood. However other materials such as spiders' webs and old insulation material can be confused with the mycelium of the dry rot fungus.

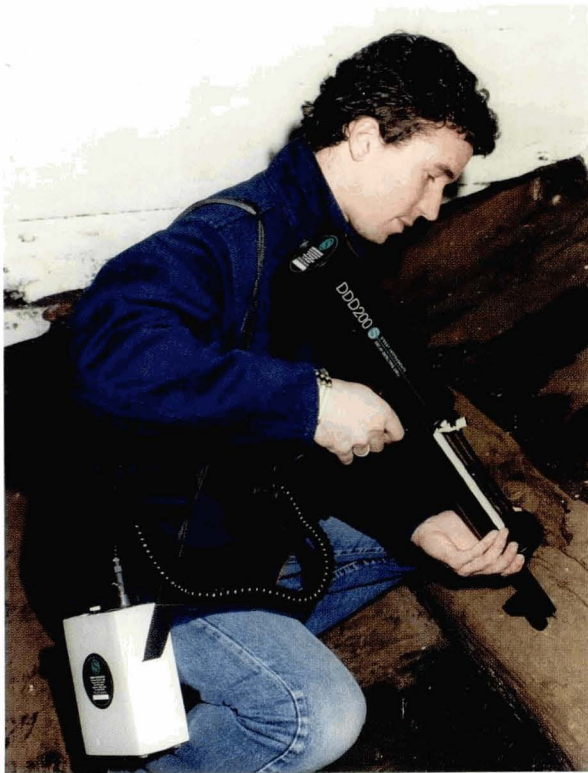
Illustration 45. Decay detection drill the 'Seibert Drill' In the illustration the Seibert Drill is being used. The alternative, more expensive, Resistograph performs the same service. Both pieces of equipment can give information on the integrity of large dimension timbers, and access is only required from one side.

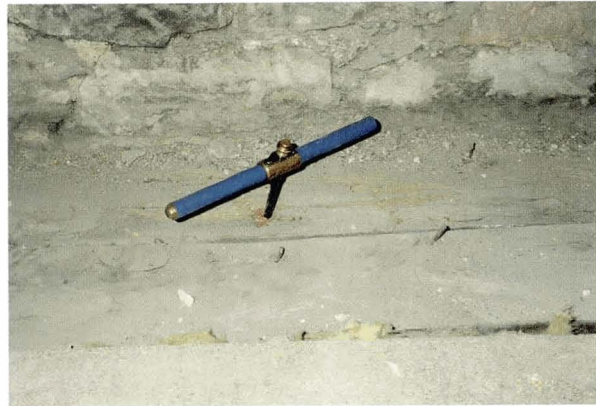
Illustration 46. The Mattson auger
