Short Guide

HISTORIC CONCRETE IN SCOTLAND PART 1: HISTORY AND DEVELOPMENT

Published by Historic Scotland, March 2013

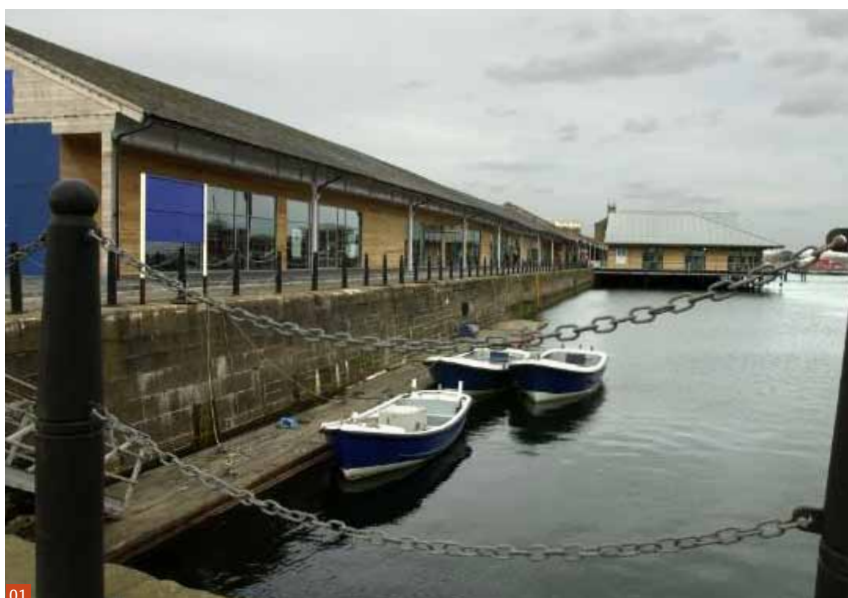
Fig 1 Dundee Harbour dating from 1833. © Historic Scotland

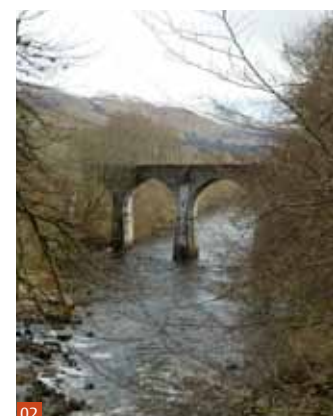
Fig 2 Killin rail viaduct over the River Dochart (1885-86) is the second oldest mass concrete viaduct in Britain after the Falls of Cruachan. © Historic Scotland

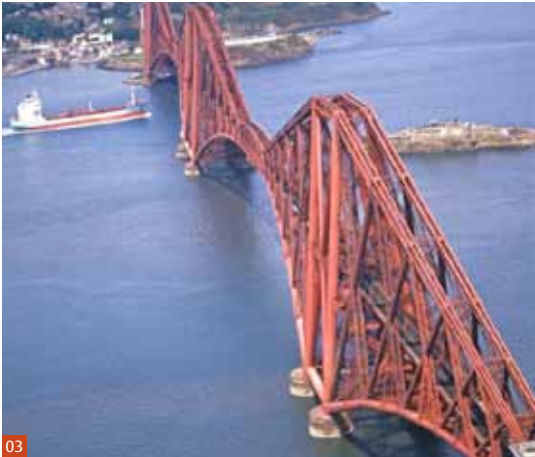
Fig 3 Forth Bridge (1883-90). Britain's first major steel structure is supported upon concrete and masonry piers.
© Historic Scotland

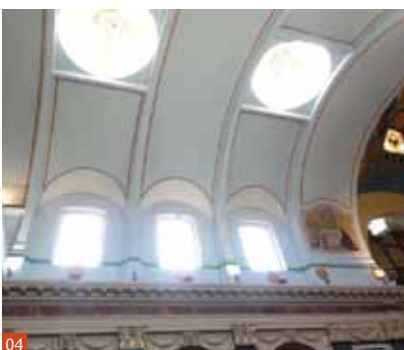
Fig 4 St Aloysius Church, 23, 25 Rose Street, Glasgow (1908-10). A neo-baroque, Jesuit church with concrete roofs and cupolas. The form of concrete construction for the roof is thought to be reinforced.

The use of concrete as a construction material can be traced back to ancient times, with well documented examples of the Romans making extensive use of hydraulic cement concrete, a mixture of lime putty and pozzolana. This material should not be confused with Roman cement, a quite different material developed by James Parker in the 1780s. Roman concrete was used mainly as a filling within masonry and brick walls. As a building material, however, concrete was lost for some time until a revival during the Middle Ages. At this time, and until the mid-to-late 19th century, concrete was made using lime. It was not until towards the end of the century that modern concrete, which used Portland cement instead of lime, began to be used. Patented by Joseph Aspdin in 1824, it was firstly used mainly as mass concrete for floors and engineering structures such as foundations, harbours (Fig 1) and bridges (Figs 2 and 3), where its inherent compressive strength and setting capability could be used to great advantage. Throughout the late 19th century concrete developed into precast elements and reinforced concrete, which expanded its use as a building and structural material (Figs 4 and 5).

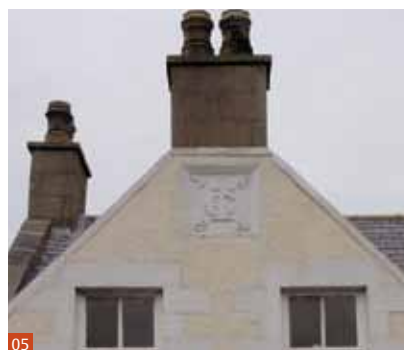
Fig 5 Institute Street, Portsoy, Aberdeenshire (1884). An early example of the use of painted precast concrete for dressings, skews and chimneystacks.

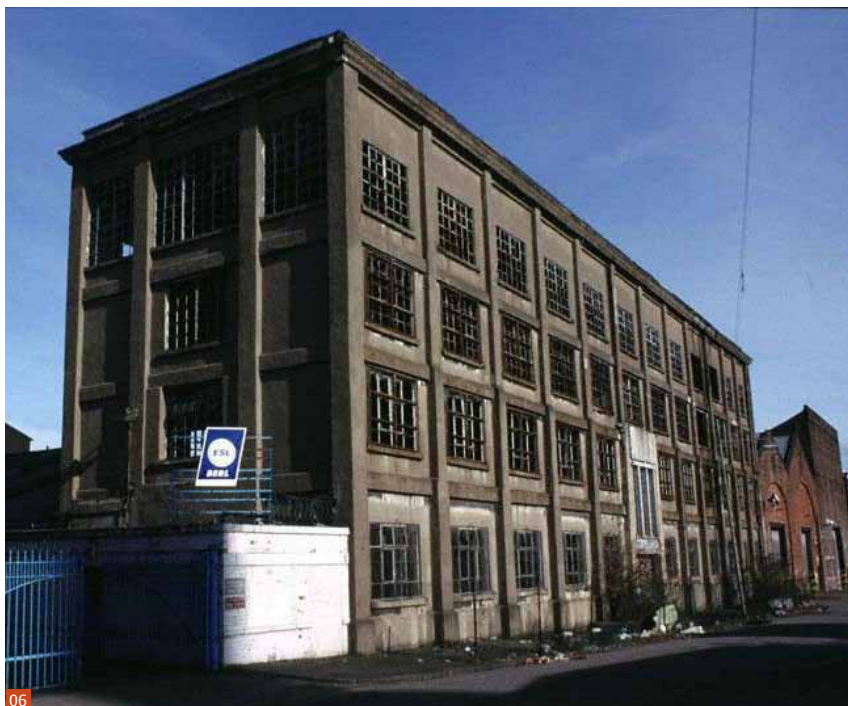
Fig 6 Sentinel Works, 61 Jessie Street, Glasgow (1903-4). An early ferro-concrete construction built on the Hennebique system. © Daniel Dubowitz

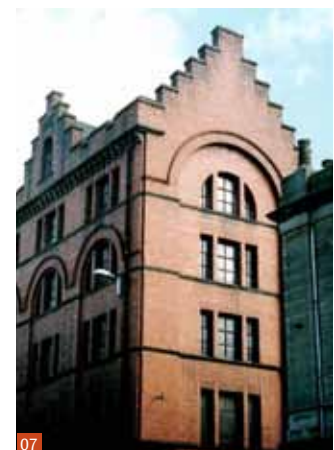
Fig 7 Watson's Bond, Seagate, Dundee (1907). Reinforced concrete frame using the Hennebique system and brick cladding. © Douglas MacKenzie

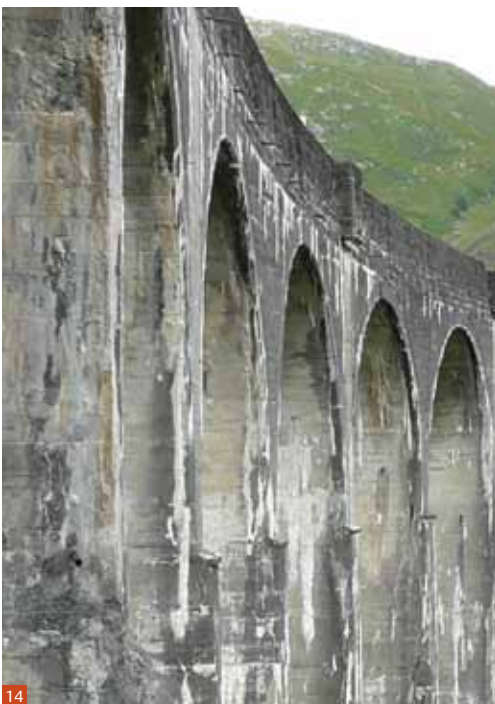
Fig 14 Part-view of the mass concrete Glenfinnan railway viaduct in the west Highlands.

Glenfinnan viaduct, built in 1901, with 21 arches is the longest concrete viaduct in Scotland (Fig 14) and Category A listed. The associated viaduct at Arisaig also built in 1901 was the longest single-span mass concrete bridge in the world at the time of construction.

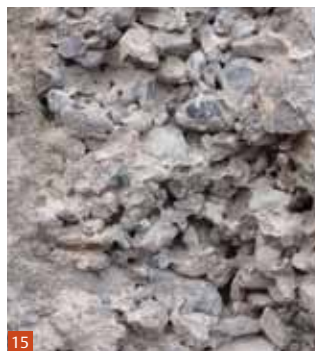
Fig 15 'No fines' concrete on Ardtornish Estate, Morvern (c.1880). Note the aggregate here is simply beach or river shingle.

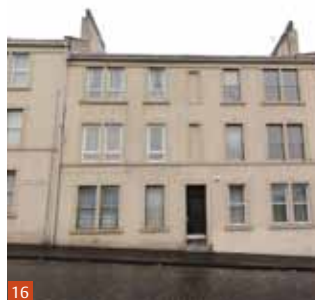
Fig 16 Court Street, Dundee, 'The Connies', (1874-5). An innovative early use of no fines mass concrete with a buff textured paint finish on cement render.

During the late 19th century a form of 'no fines' concrete was sometimes used for wall construction in housing projects. A good example of this is the innovative no fines mass concrete tenements built by David Clunas and the Concrete Building Company in Court Street, Dundee in 1874 (Fig 33). It is unclear how this concrete was designed, mixed and placed or what its properties are. However, the buildings appear to remain in a sound structural condition.

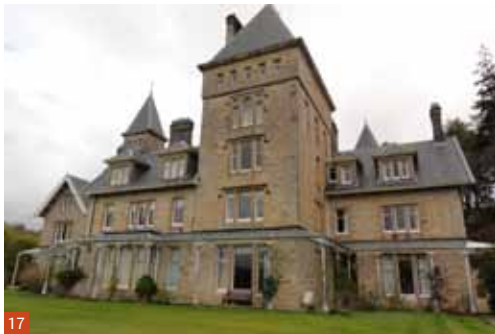
Fig 17 Ardtornish Mansion, Ardtornish Estate, (1884-91). Mainly constructed of no fines concrete with sandstone facing on the south and west elevations.

Ardtornish Estate was a pioneer in the use of no fines concrete in Scotland. A large number of buildings, ranging from the mansion house (Fig 17) to simple cottages and farm buildings, were designed by Samuel Barham who was employed by the Estate between c 1875-90 and used an early form of cement for both concrete mixes and renders. Many of the houses on Ardtornish Estate, including the Estate Manager's (Fig 18), are covered with a cement render and painted finish as a result of the relatively rough surface finish to shuttered concrete, which occurred even with care taken and well formed shuttering.

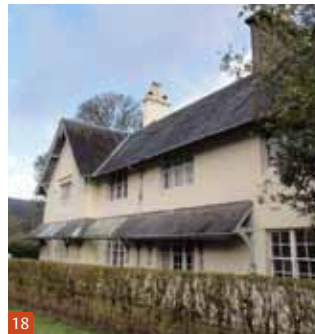
Fig 18 Ardtornish Estate Manager's house (1875). Shuttered concrete with a cement render and painted finish.

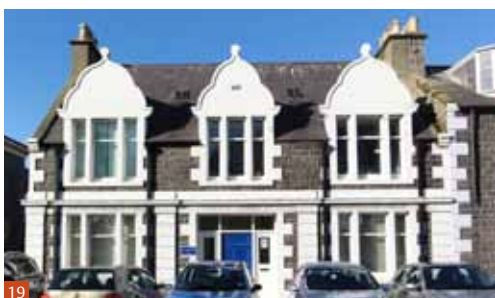
Fig 19 Winston House in Banff (1897). Painted precast concrete has been used to emulate stone quoins, dressings, margins and corniced chimney stacks within the squared rubble front elevation.

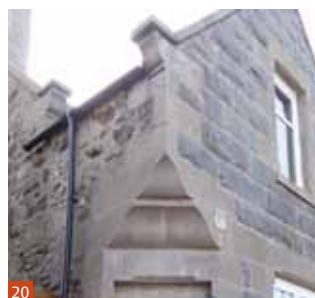
Fig 20 A late 19th century house in Banff. Unpainted precast concrete has been used for dressings, quoins, skewes and corbels within rubble and ashlar elevations.

Precast elements have proven to be durable and long lasting even in exposed maritime locations where arrases and other details survive in good condition (Fig 20).

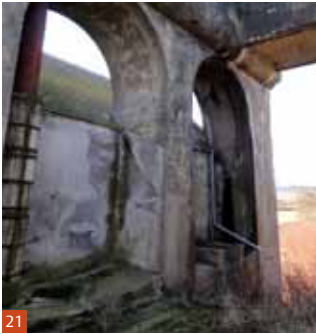
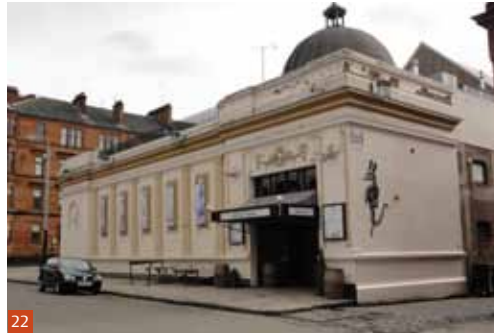
- Cast in a reusable mould or 'form' and then cured
- Generally durable and long lasting
- Used for building components from mid 19th century onwards
- Commonly painted to imitate stone features on masonry buildings

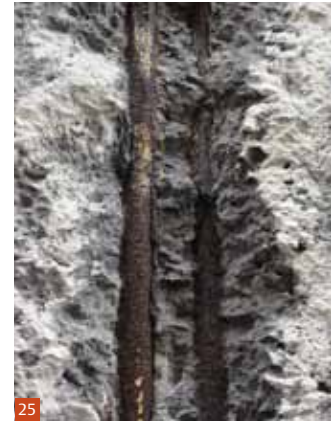
Fig 25 170-2 Hope Street, Glasgow (Lion Chambers) (1905). Due the slender nature of the concrete, limited cover to the reinforcement has allowed carbonation to reach the reinforcement resulting in the serious corrosion.

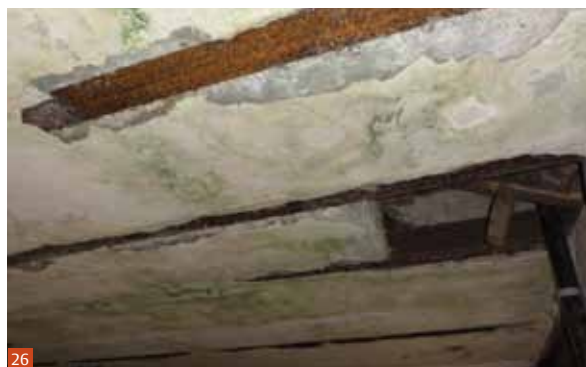
Fig 26 Steading at Ardtornish Estate (c.1880). Spalling on the underside of a concrete floor due to corrosion of the wrought iron joists.

Whilst reinforced concrete was not in general use in Britain for building frames before 1890, it was used for lintels and sometimes walls (Hurst, 2001). In addition wrought iron beams were used within concrete floors (Fig 26) and also sometimes within columns generally for fire resistance in industrial buildings. Wrought iron was commonly used before 1890 but was generally replaced by steel after this date. Rolled or fabricated iron joists at a range of spacing supported a variety of infill panels between the joists, often with a coke breeze aggregate, leading in turn to the development of filler joist floors in the 1890s. While durable and fireproof, concrete floors of this type were vulnerable to cracking and damage in the event of corrosion of the iron or steel beams (Fig 27).

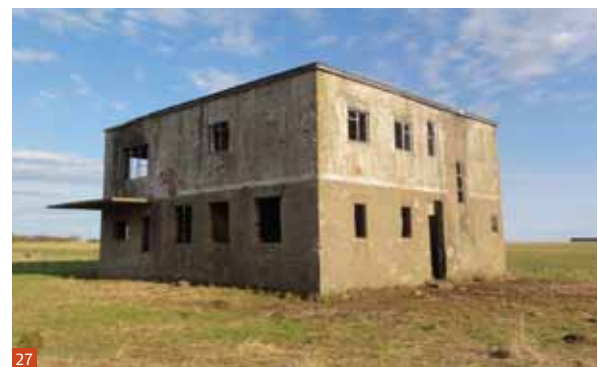
Fig 27 Control Tower, Boyndie Airfield, Banff (1943). Brick walls with reinforced concrete floors, roof and cantilevered balcony. Extensive corrosion of reinforcement has disrupted the ceiling of the intermediate floor.

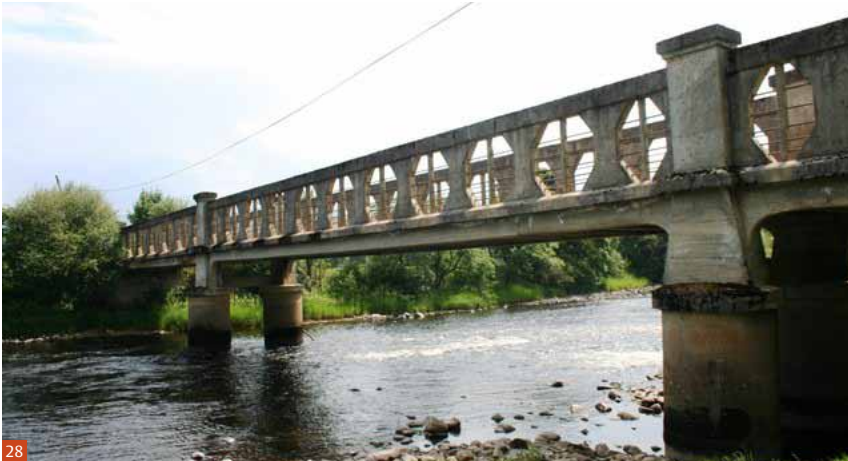
Fig 28 Advie Bridge over the River Spey, Cromdale, Highland (1921-22). Three-span concrete bridge with reinforced concrete trusses on paired concrete piers.

Crubenmore and Advie (Fig 28), and the bridge over the River Findhorn (Fig 29) carrying the old A9 road at Tomatin. An example of an advanced bridge design of this period is the Category B listed three-hinged portal frame bridge over the River Dee at Aboyne (Fig 30), featuring additional flood arches and precast concrete block parapets. Dating from 1937, it was designed by F.A. Macdonald and Partners Engineers and the architect George Bennet Mitchell.

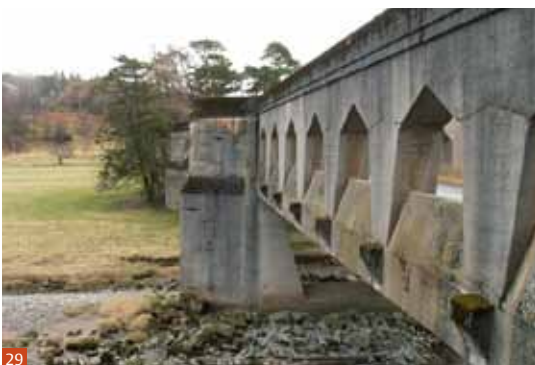
Fig 29 Findhorn Bridge, Tomatin, Highland (1924-26). Reinforced concrete bridge, with two pairs of in-situ concrete beams joined at a central pier.

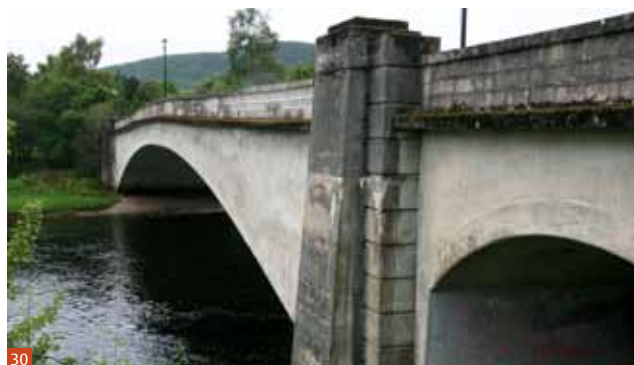
Fig 30 Aboyne Bridge (1937). An example of reinforced concrete with precast concrete block parapets.

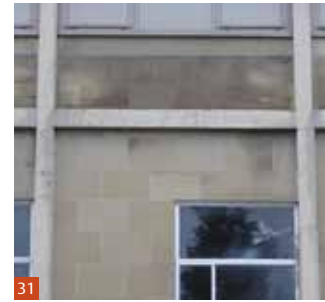
Fig 31 A concrete frame with masonry infill on a 1950s building in Edinburgh. The slender concrete frame provides limited cover to the reinforcement, resulting in its corrosion and cracking of the concrete. © Andrew Wright.

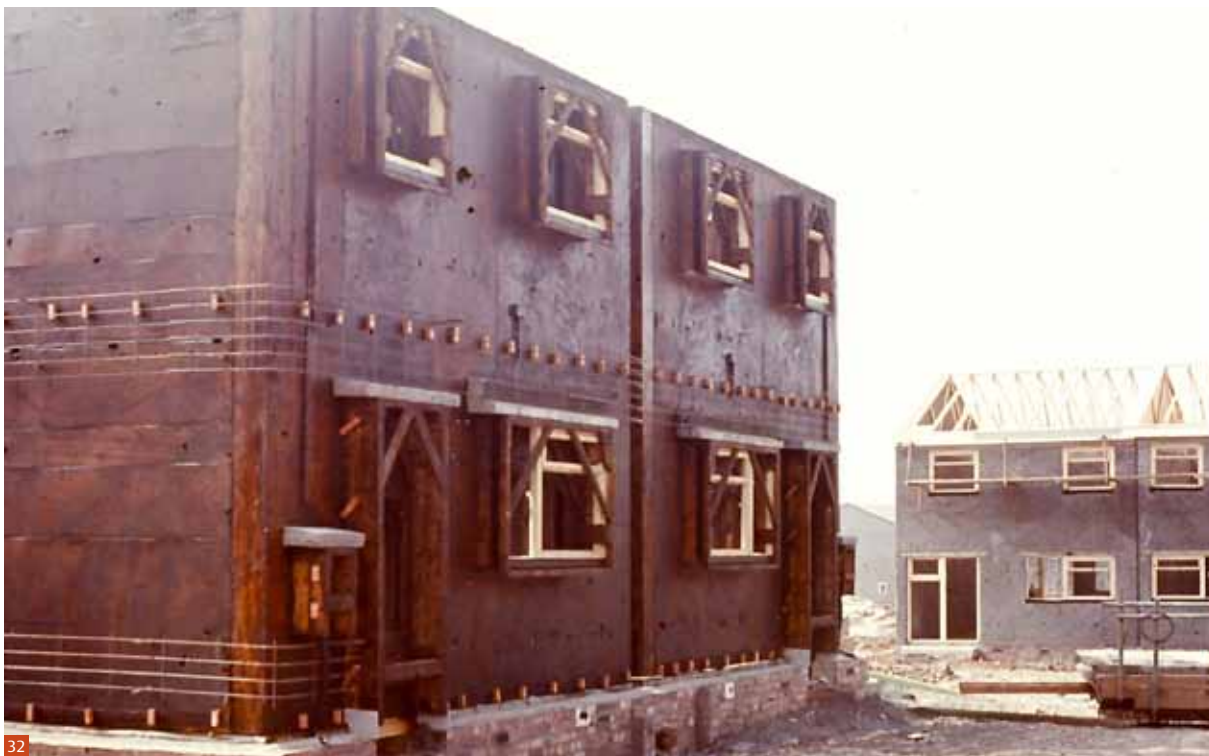
Fig 32 Erection of no fines concrete houses late 1960s. Foreground: two-storey internal shutter ready to receive external shutter and concrete pour.

Post 1945 also saw the widespread use of ‘no fines’ concrete for mass housing in Scotland, mainly by Wimpey and the Scottish Special Housing Association (Fig 32). Off-site manufacture and proprietary precast concrete floor systems proliferated, often reflecting the early concrete flooring systems. Advancements in prefabricated formwork produced sophisticated and fast construction methods such as continuously sliding formwork. This system allows wet concrete to be poured continuously as the movable formwork is slowly lifted upward usually by hydraulic jacks or screw jacks. The technique was fast and economical and used on numerous building projects including ‘bespoke’ high-rise buildings.

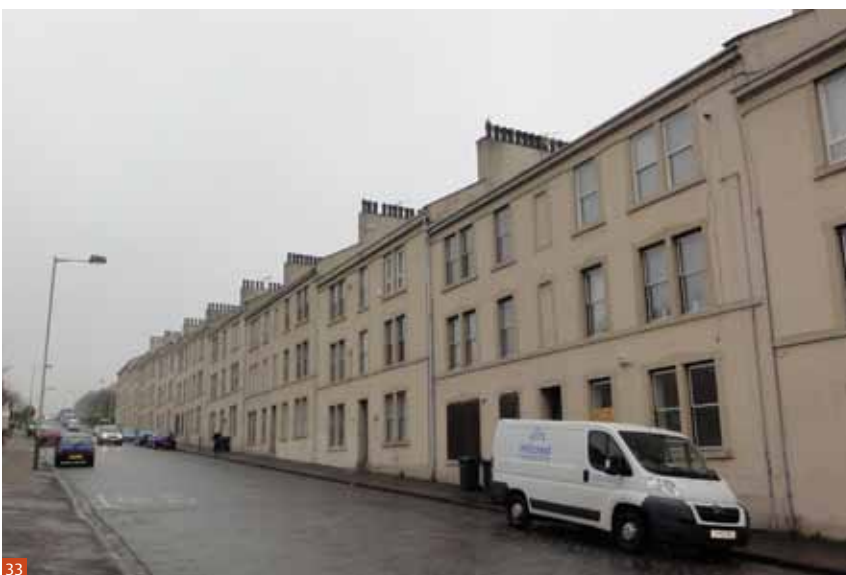
Fig 33 No fines tenements in Court Street, Dundee (1874-75).

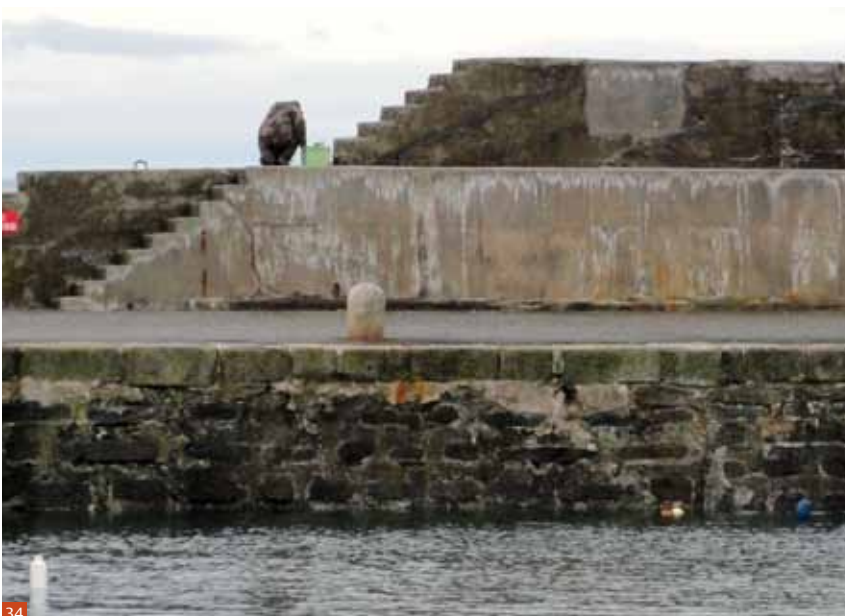
Fig 34 The New Harbour at Portsoy (19th century) showing a poorly matched modern repair to the face of the sea wall.

Assessment of previous repairs can also present significant issues when developing a conservation strategy. For example such interventions may have been carried out as emergency work to keep the structure functioning and will have frequently been done as patch repairs, the more recent having been carried out using modern materials and techniques. Previous repairs can result in an obvious change in appearance, particularly on smooth faced concrete, and the use of an incompatible material can also affect the future performance of the concrete. The different appearance of the new finish can be difficult to prevent but is not necessarily a conservation issue: it represents the building 'as conserved'. Nonetheless, poorly executed repairs may require correction in the future. An example of this is the patch repairs to the harbour wall at the New Harbour, Portsoy (Fig 34), which have been poorly matched to the original face.
