TECHNICAL  
30  
ADVICE  
NOTE

SCOTTISH  
TURF  
CONSTRUCTION

TECHNICAL  
CONSERVATION,  
RESEARCH AND  
EDUCATION  
GROUP

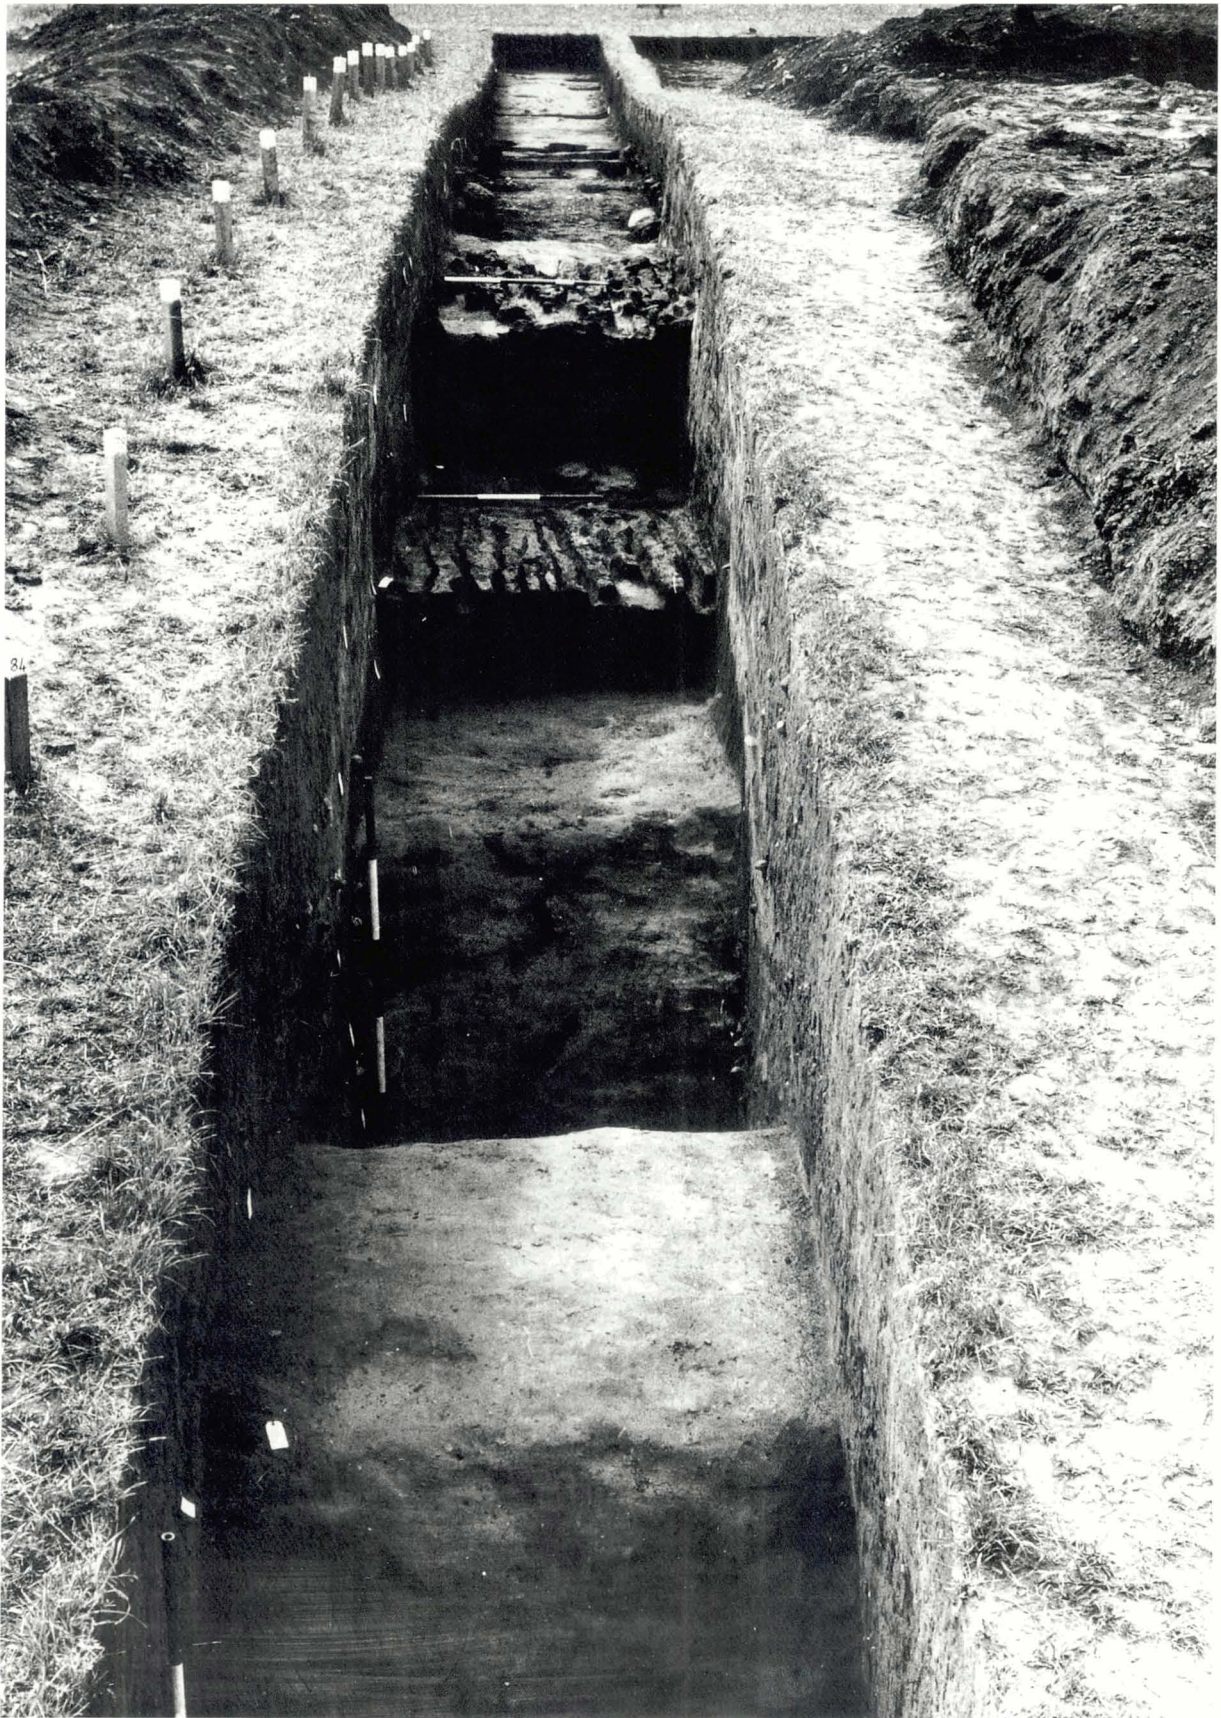
fig 12. The 1973 trench through the east defences, looking west. Behind the two ditches lie (a) the timber strapping at the base of the Antonine I rampart and (b) the Flavian rampart with strapping at a higher level. Scales in feet. © Frere and Wilkes.

The Flavian rampart (fig 12) was refaced in later re-occupations of the fort. The Antonine I rampart (fig 13) was built using large yellow turves and grey turves from an unidentified source. The Antonine II rampart (fig 14) utilised large turves containing a high

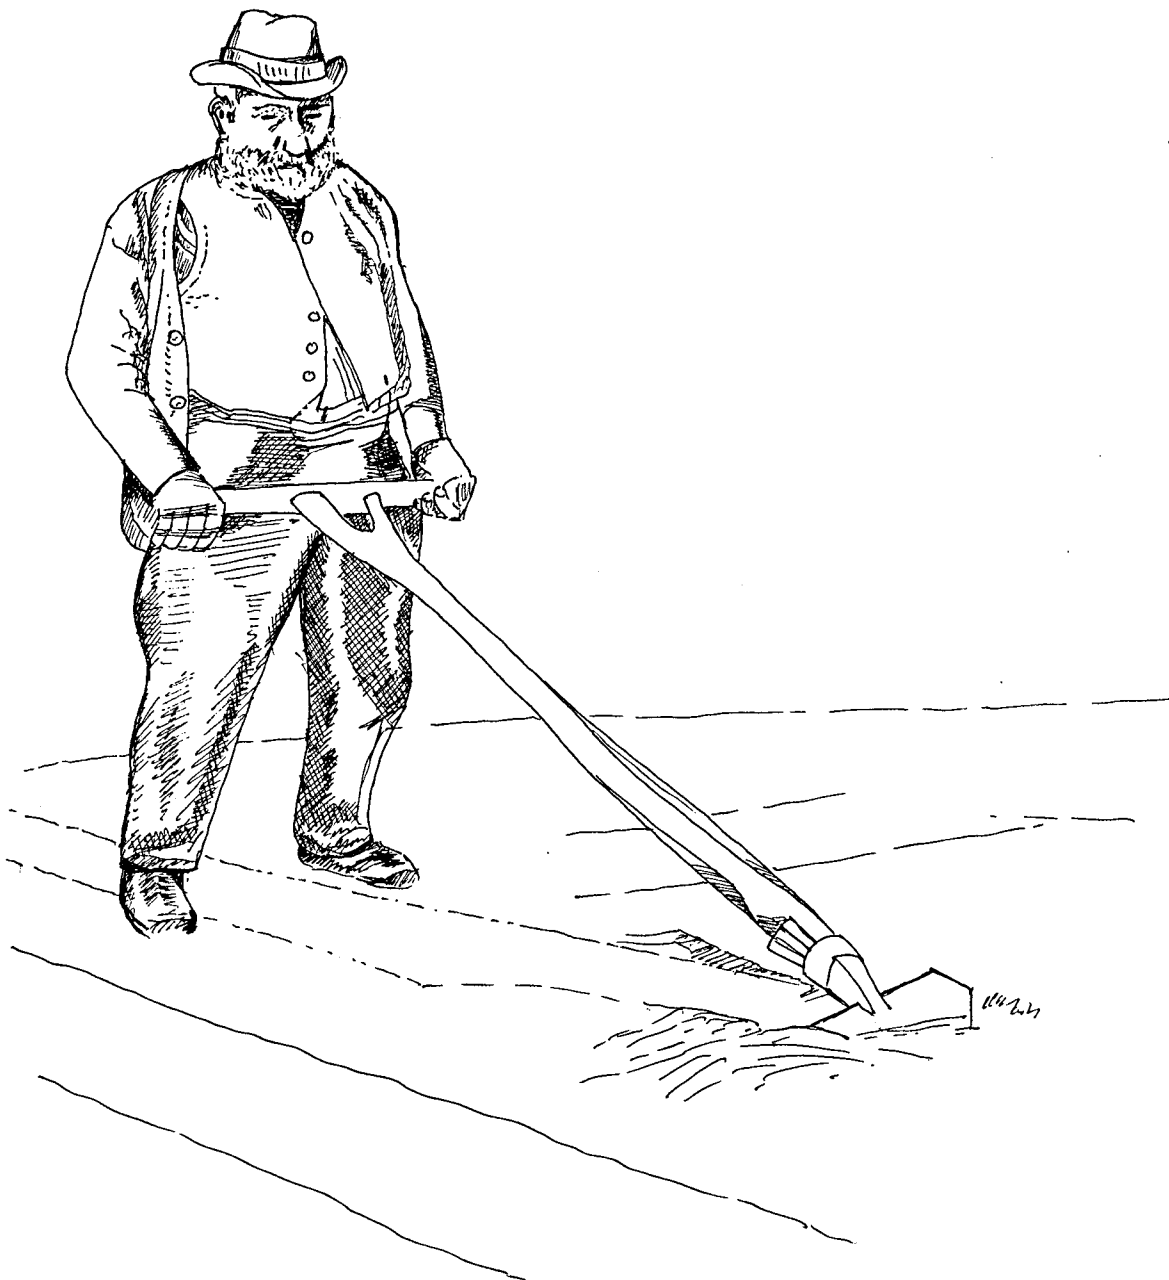
fig 41. Using a flaughter spade in the twentieth century (after Hennell, 1934). © Bruce Walker.

The flaughter spade normally has a crescent, heart or triangular shaped blade set at an angle to the shaft of the spade, so that the blade sits parallel with the ground when the handle is pushed from either side of the pelvis (fig 42).

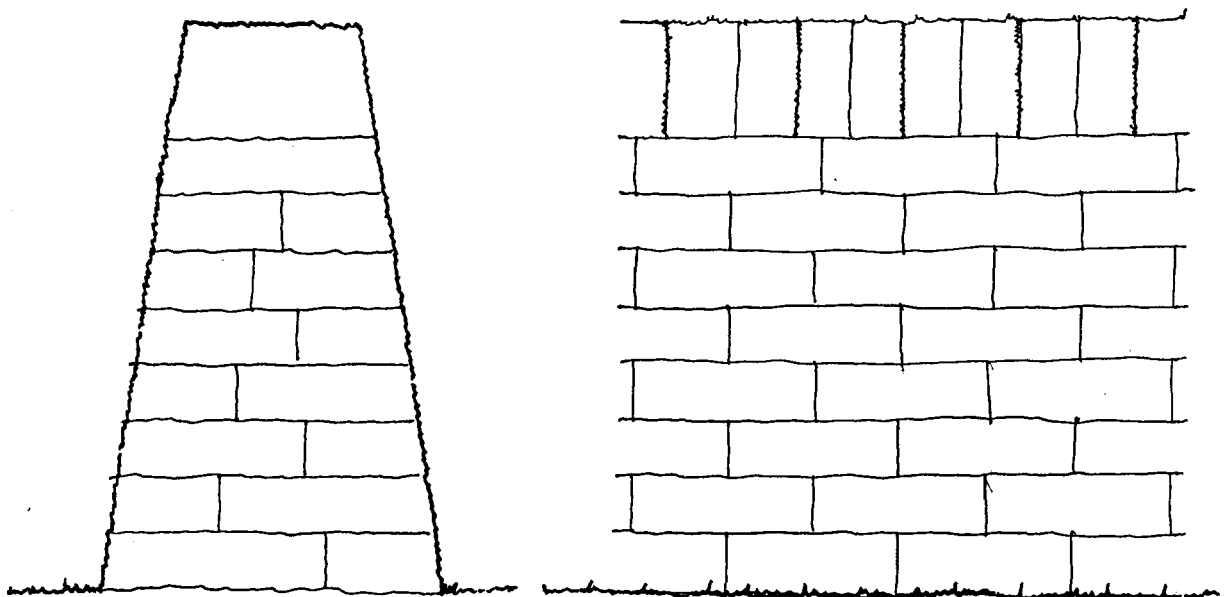
fig 54. Section and elevation of Kailyard Dyke, Burns' Cottage, as preferred by the builder.
