HISTORIC  
ENVIRONMENT  
SCOTLAND

| Property in Care (PIC) ID: | PIC291 (Earl's Bu, Orphir);<br>PIC319 (St Nicholas Church, Orphir) |

## Statement of Significance

# Earl's Bu and St Nicholas Church, Orphir

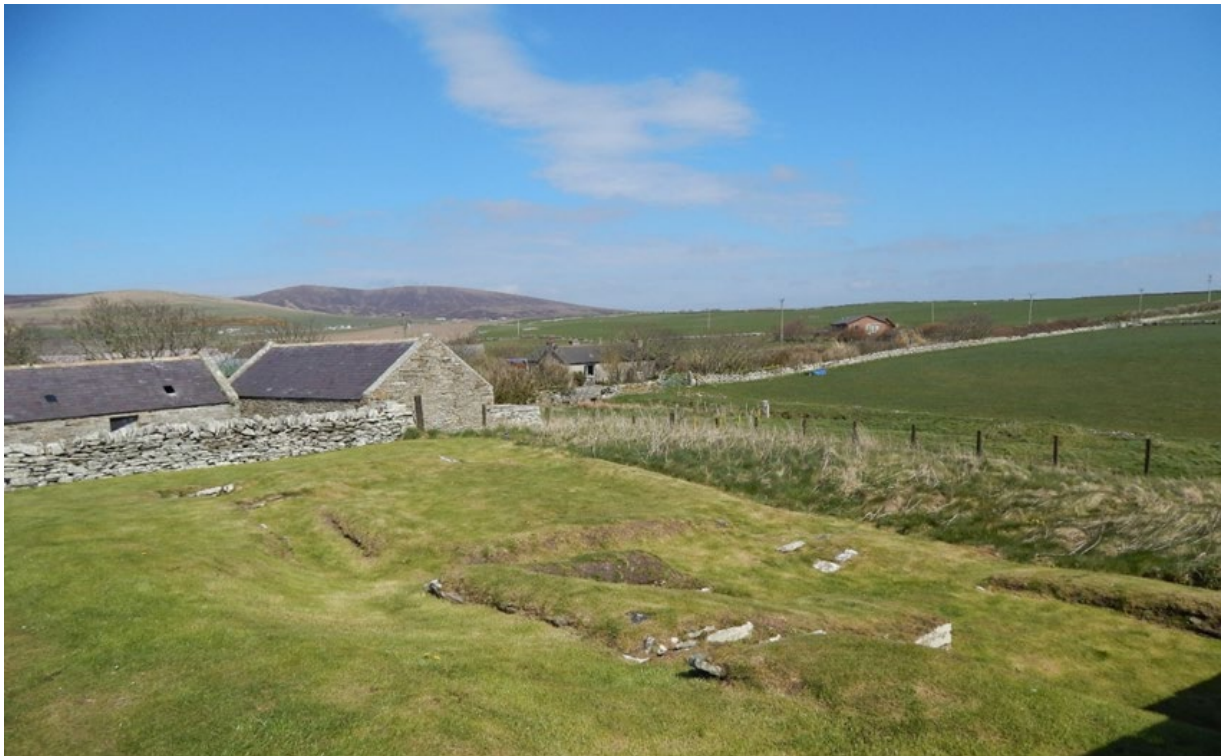
*Figure 5: The major structures of the Norse Hall complex. © Colleen Batey.*

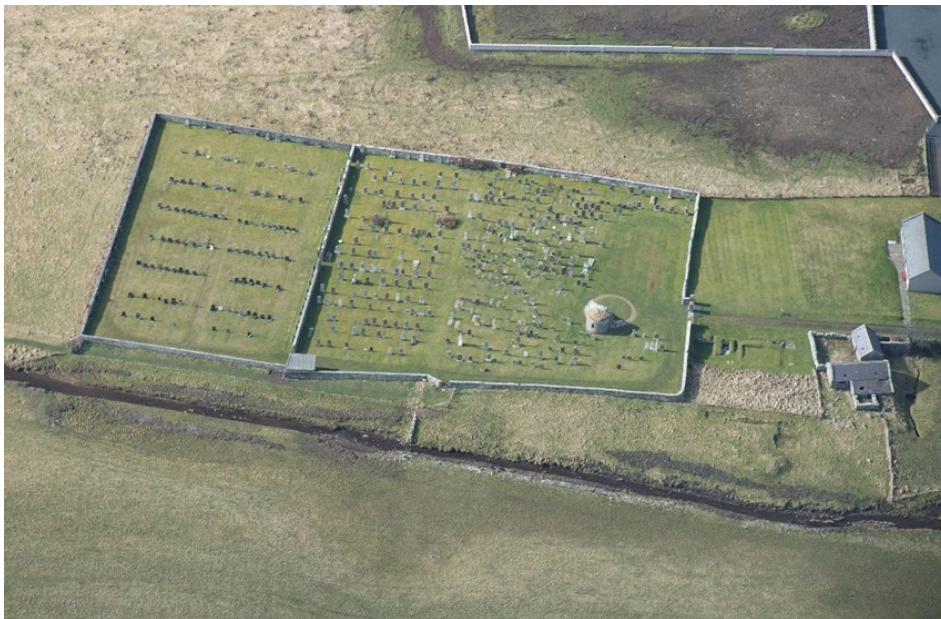
Figure 6: Aerial photograph of site. © HES.

The Drinking Hall structure was partially revealed during early excavations (recalled in Pope's 1866 translation of Torfæus),<sup>13</sup> and subsequently by A.W. Johnston 1899, to be followed finally by the work of Walter Grant in 1939 prior to the site being taken into State guardianship. Today the visible walling is the result of the last phase of activity in 1939, although along the churchyard wall-line, at a slightly different angle, the foundations of an apparently single-phase length of walling can still be identified. The description of the Hall in *Orkneyinga Saga* has significantly influenced the interpretation of these walling segments – a long single-phase wall marking the extent of the large drinking hall, with the 1939 excavations revealing the upstanding eastern part of the so-called hall. It is however clear that several phases of activity are indicated here<sup>14</sup> and the single structure/s are complex. Compounded with the lack of stratified archaeological investigation, this part of the site remains little understood. Yet it is apparent that the buildings do have major Late Norse phases, if not necessarily representing a Drinking Hall.

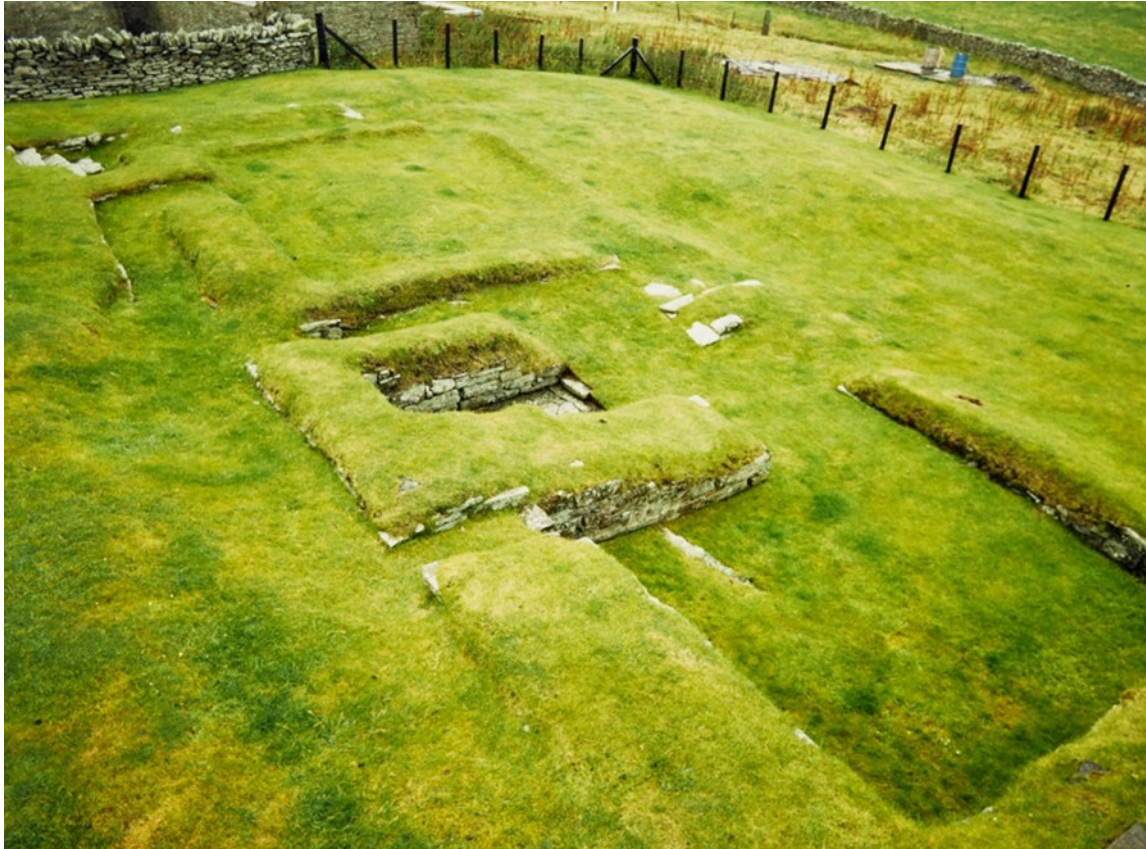
*Figure 9: The remains of the 'Drinking Hall' are today presented as a series of low, turf-covered walls. © Crown copyright: HES.*

The walling fragments which make up the structure referred to as the Drinking Hall were partially revealed during early excavations (recalled in Pope's 1866 translation of Torfæus), and then subsequently by A.W. Johnston in 1899-1901. These were followed finally by the work of Grant and Storer-Clouston in 1939 prior to the site being taken into State guardianship. Today the visible walling is the result of the last phase of activity in 1939 although along the churchyard wall-line, at a slightly different angle, the foundations of an apparently single-phase length of walling might still be visible.

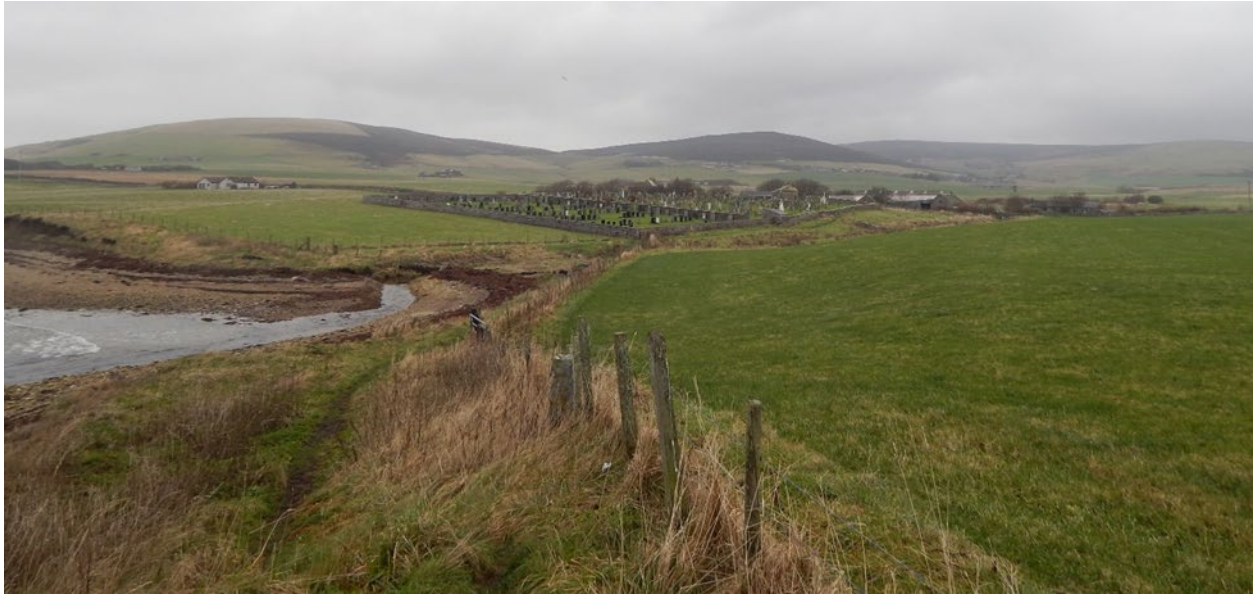
*Figure 10: Wider landscape around Earl's Bu complex, viewed from the south-west.*

The significance of the location lies in its proximity to Scapa Flow and its natural views southwards towards the rest of the Norse Northern Earldom lands across the Pentland Firth. Following the move of political focus from the **Brough of Birsay**, which dominated the north-west corner of Orkney Mainland and the routes around the north of the island, political power was subdivided by a base established at Orphir and the growth of the ecclesiastical centre around the construction of St Magnus Cathedral in Kirkwall.

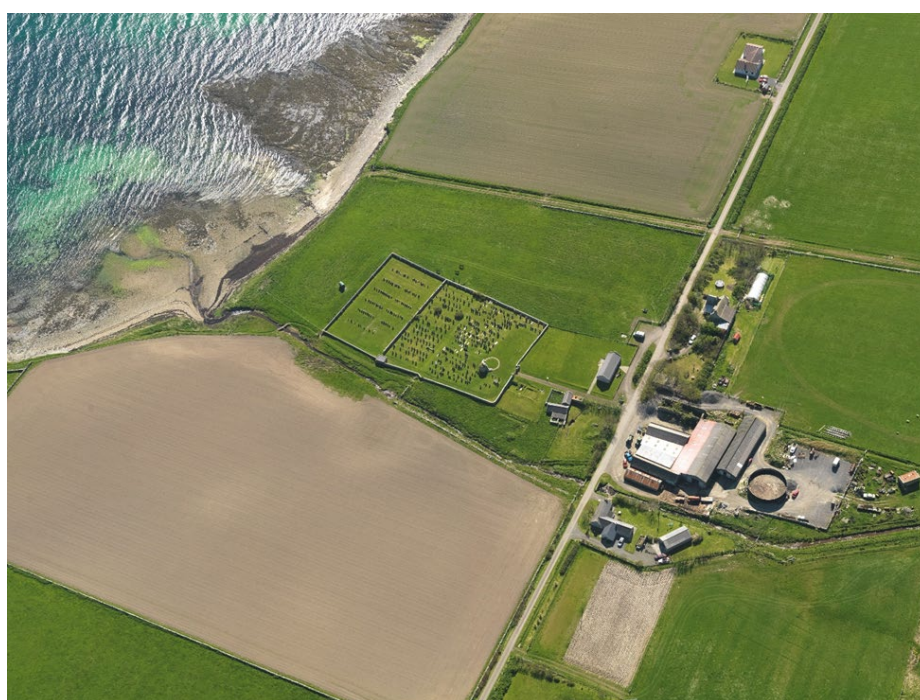
*Figure 11: Aerial photograph showing position of wider Earl's Bu complex, which would have provided excellent farmland for pastorage and easy access to the fisheries of Scapa Flow.*

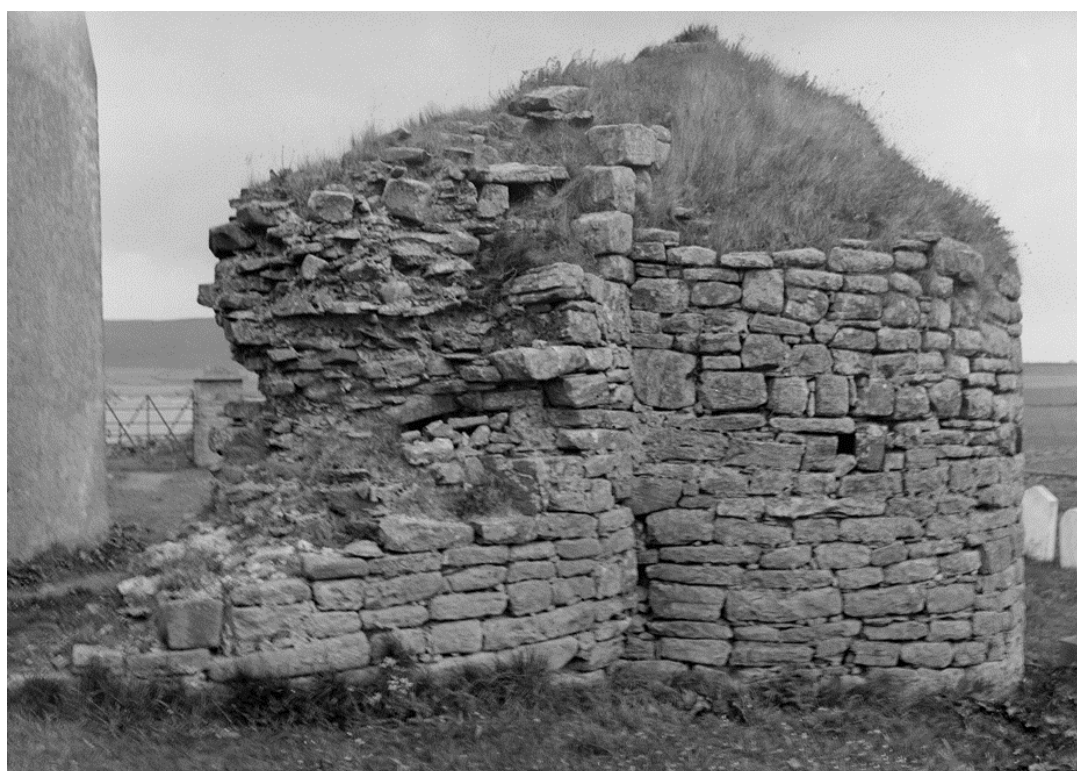
*Figure 12: Early photograph showing proximity of the parish church ([left of image] constructed in 1829) to ruins of St Nicholas Church. The building and subsequent demolition of the parish church removed the full arc of the circular nave. © Courtesy of HES.*

| Date | Event |
|---|---|
| <b>1829</b> | New Parish Church (2) erected to replace earlier structure (1) immediately to the north, the eastern wall of this stood on the western extremity of the Round Church. |

| <b>1952</b> | Removal of Parish Church (2), re-sited some distance to the north-east, but further damage to the Round Church resulted and recovery of runic inscription. <sup>70</sup> |
