RESEARCH  
REPORT

CHEMICAL  
CONSOLIDANTS  
AND WATER  
REPELLENTS FOR  
SANDSTONES  
IN SCOTLAND

TECHNICAL  
CONSERVATION,  
RESEARCH AND  
EDUCATION  
DIVISION

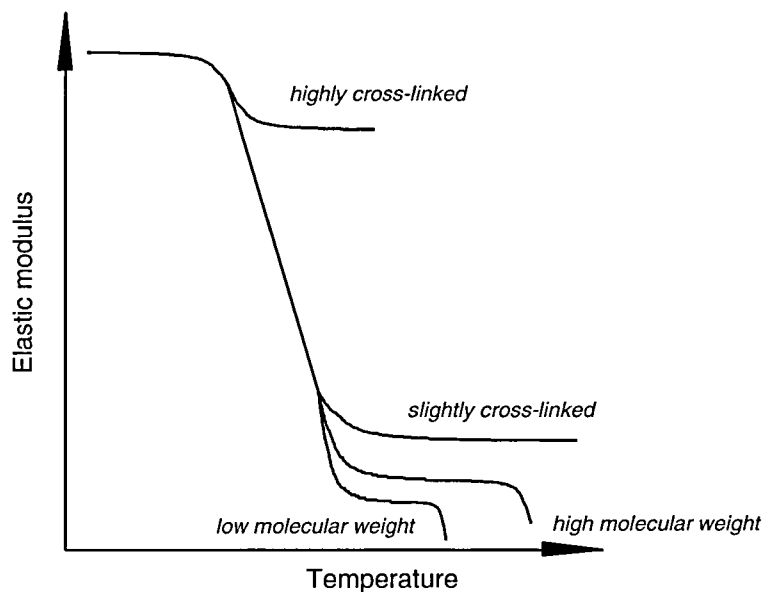
Figure 2 Effects of cross-linking and molecular weight on the glass transition temperature ( $T_g$ ) of polymers (after Horie, 1987).

Organic polymers may deteriorate through the action of light (especially UV radiation), heat and oxygen by a variety of mechanisms including becoming insoluble, yellowing, cracking, weakening, shrinking, expanding, flowing, becoming soiled or reacting with the object they are applied to. Polymer flow and attraction of soiling are due to the physical properties of the polymer, most other deterioration is caused by chemical alteration. The inclusion of certain pigments can increase the rate of ageing of polymers. The presence of gaseous pollutants, such as ozone or oxides of sulphur and nitrogen, can also increase the rate of decay (Horie, 1987).

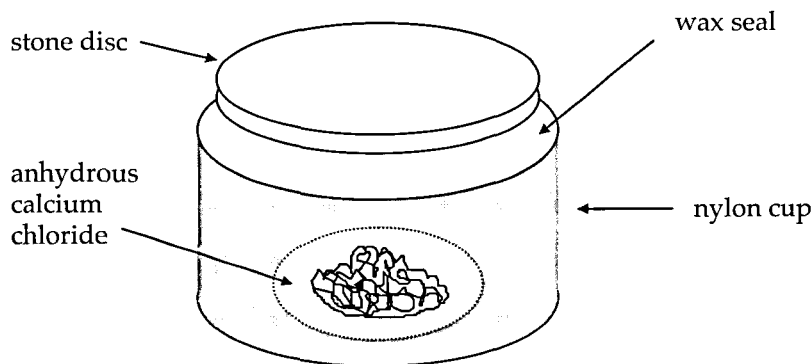
Figure 9 The permeability cup with the stone sample, and a cut away showing the calcium chloride.

One core from each stone type and treatment type was sliced into discs 7-10 mm thick. Several slices were taken from each core to give roughly 1 cm increments into the treated faces. A small amount (2-3 g) of anhydrous calcium chloride was placed in the bottom of the water vapour test cup. The stone disc samples were sealed with wax into the cups. The cups were then placed in a room at 60% humidity and 20 degrees centigrade.

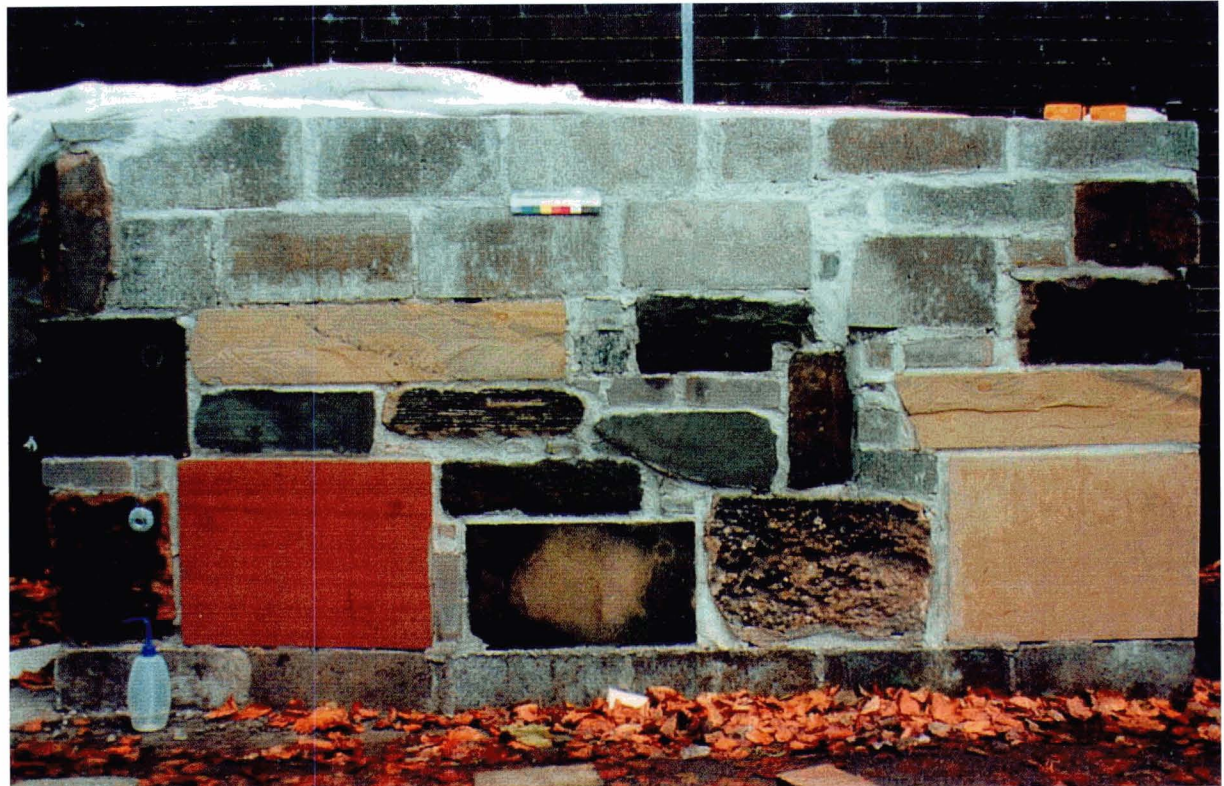
Figure 13c RGU Panel 2. Treated with Consolidant A.

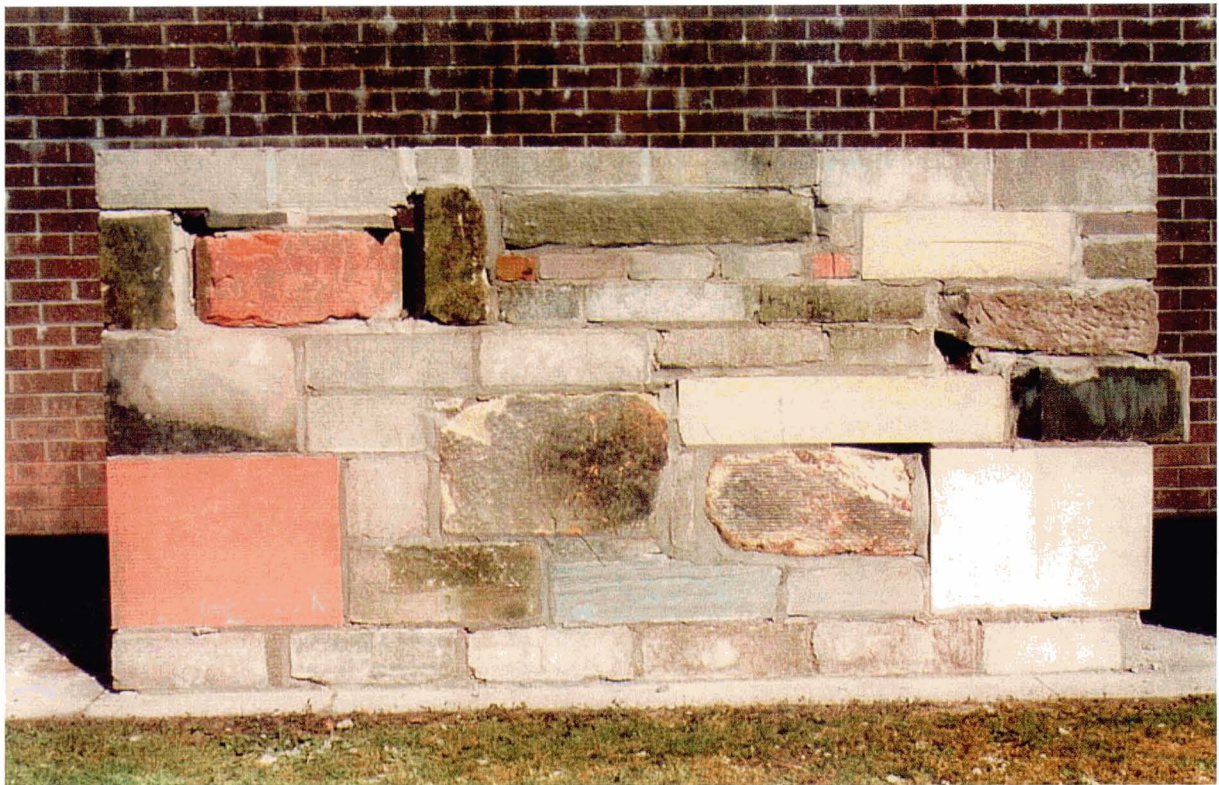
Figure 13d RGU Panel 3. Before treatment.

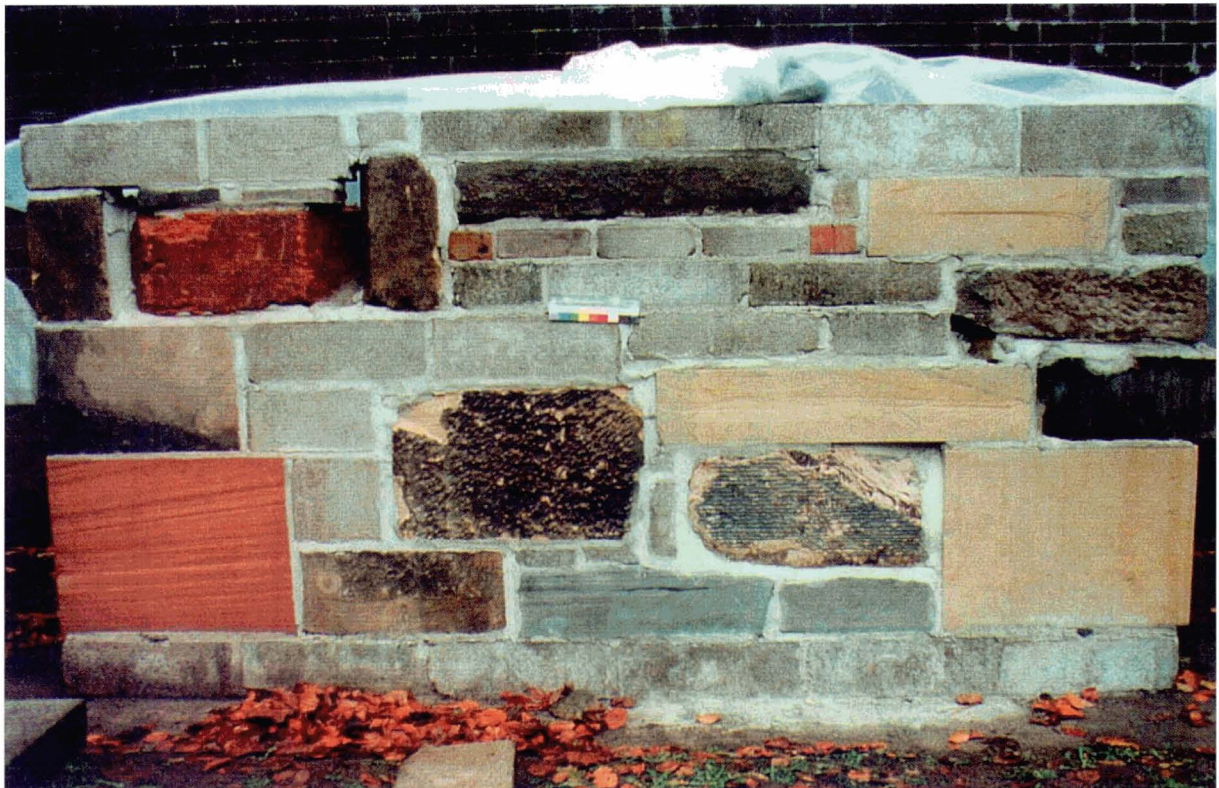
Figure 13e RGU Panel 3. Treated with Water Rep./Con. C.

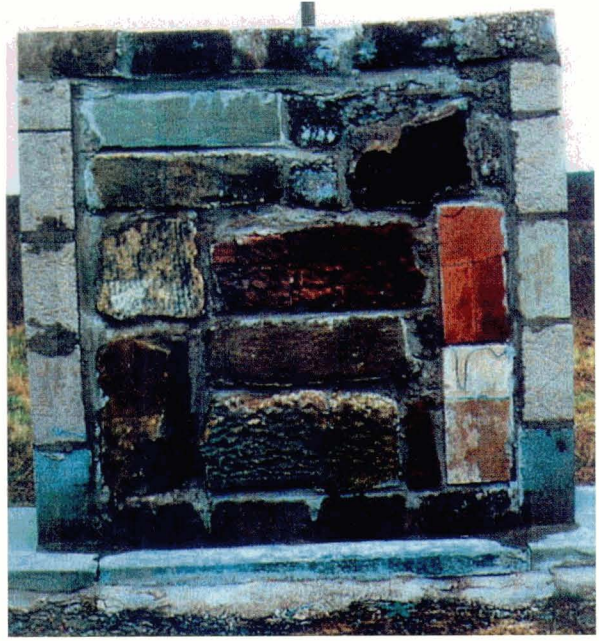
Figure 19 Panels after 6 months exposure (Panel 1 left, Panel 2 right).

The panels were photographed at 6 and 12 months in dry conditions over a period of one year. The photographs are shown in Figures 19 to 20. Visual observation and inspection of photographs was used to assess any changes to the panels.

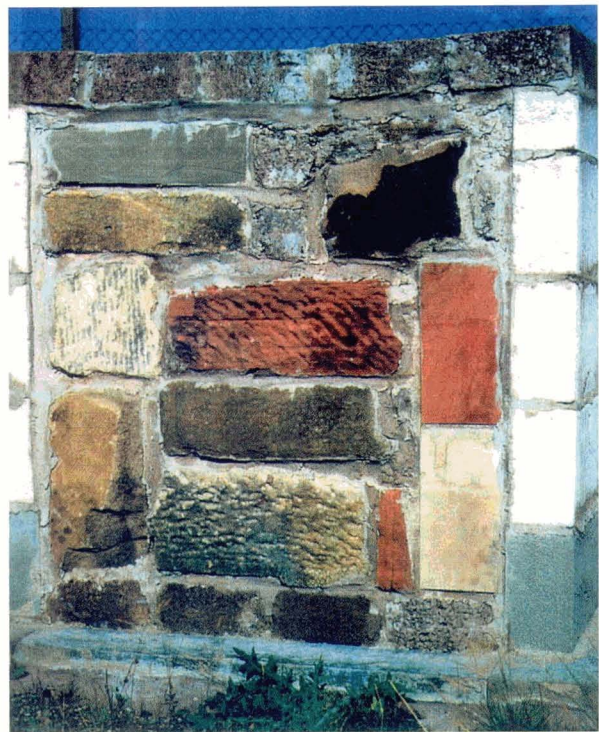
Figure 21 Panel 2 after one year's exposure.

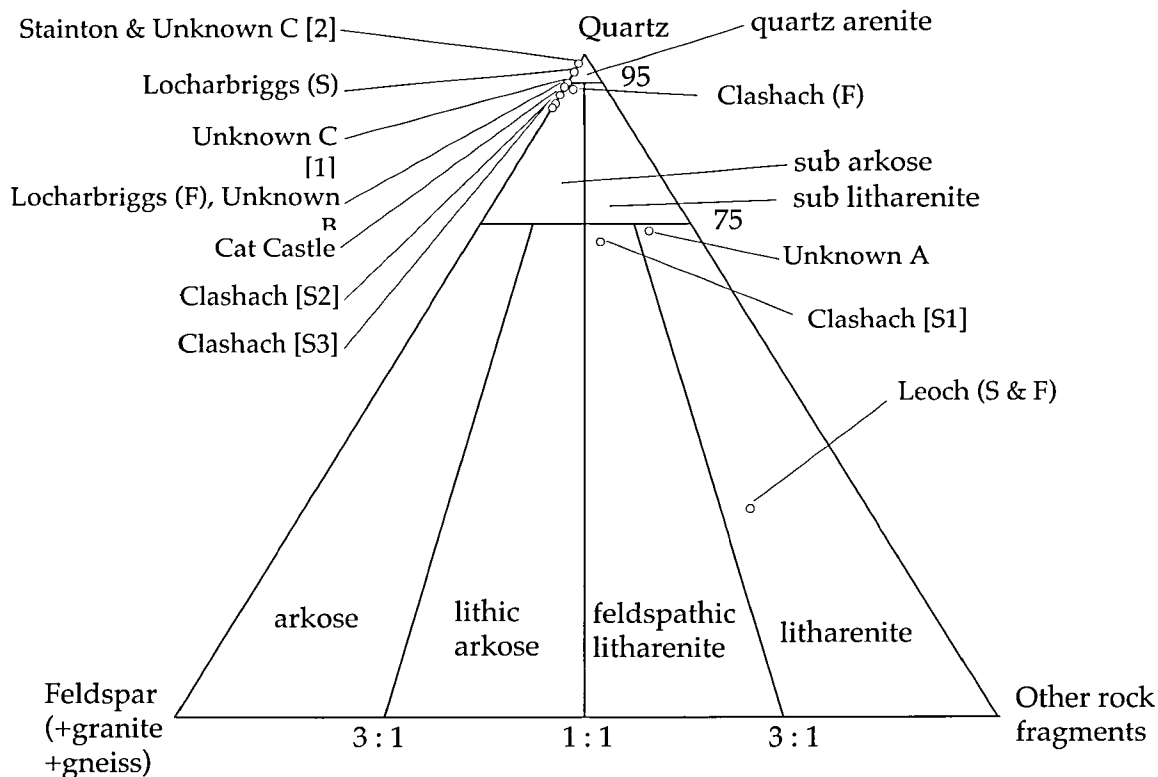
Figure 25 Ternary diagram used for determining the composition of sandstones.

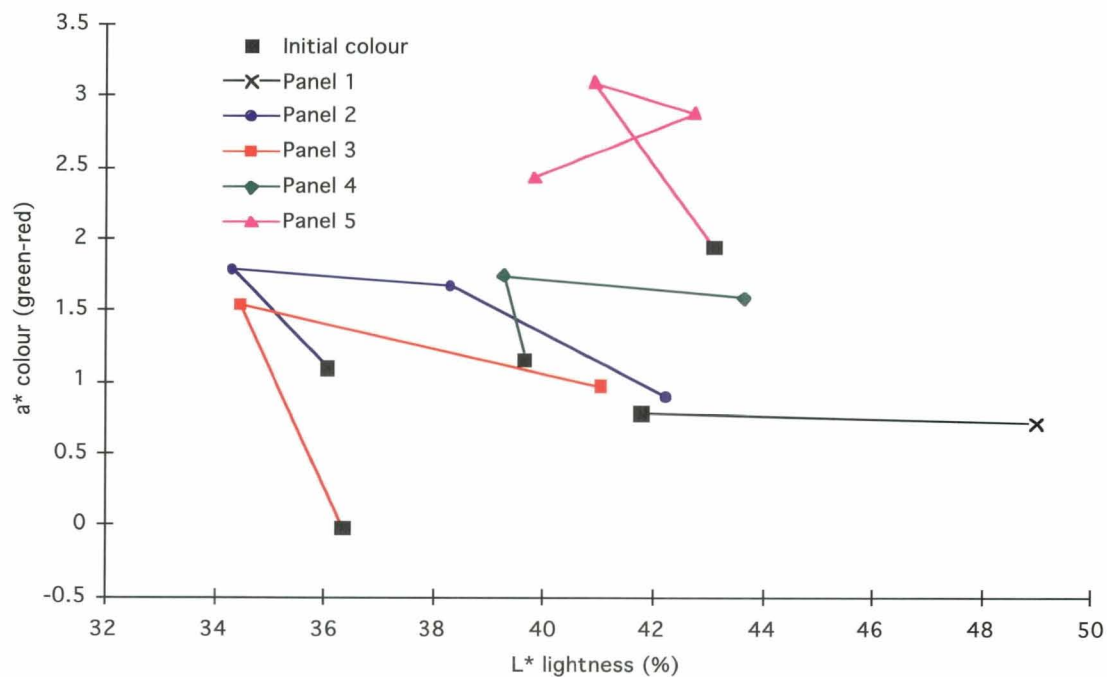
Figure 26f Changes in colour ( $a^*$ ) and lightness ( $L^*$ ) of soiled Unknown B sandstones from before treatment (black square) until 1.5 years after treatment. Panel 1: untreated, Panel 2: Consolidant A, Panel 3: Water Rep./Con. C, Panel 4: Water Repellent D, Panel 5: Consolidant B.

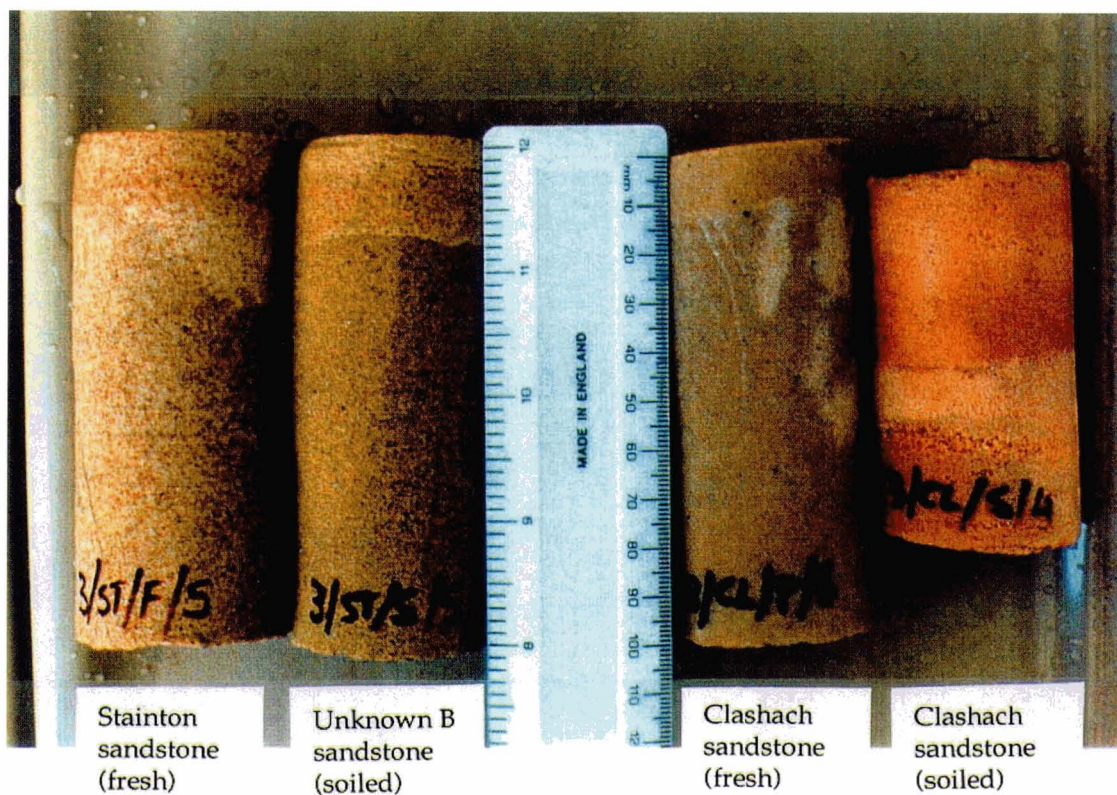
Figure 33 The effects of water wetting on treated sandstone cores. Top: Water Rep./Con. C on Stainton, Unknown B and Clashach. Bottom: Consolidant A on Unknown B, Stainton and Clashach.

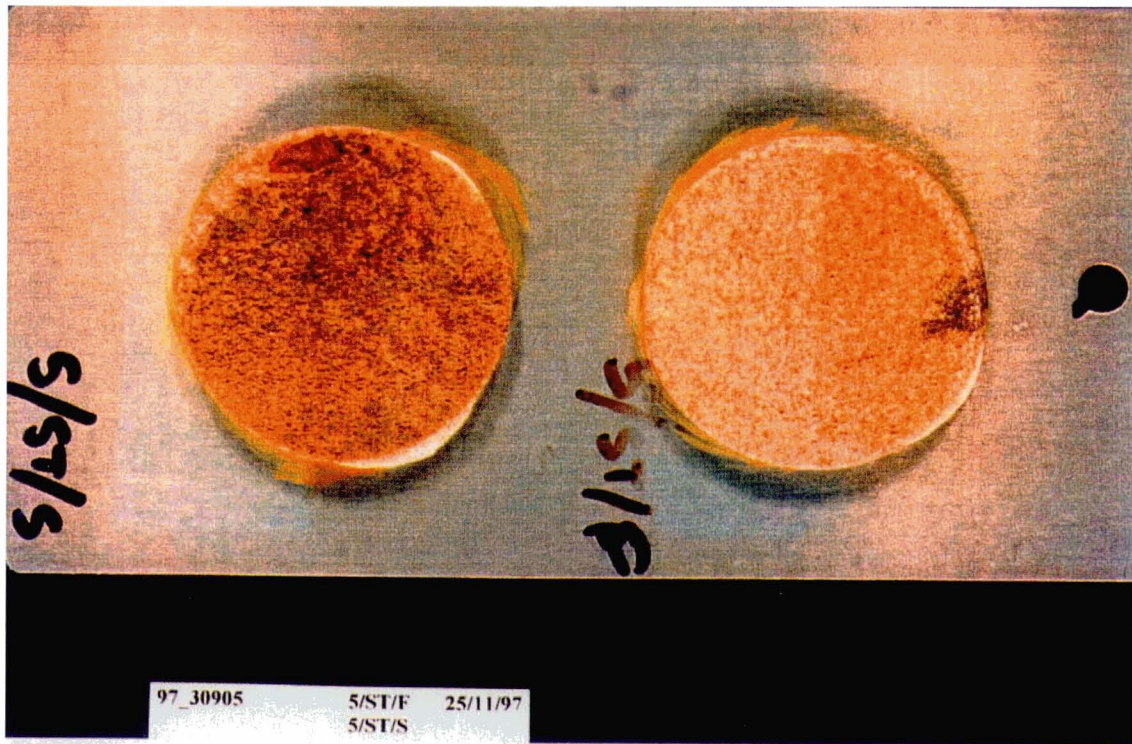
Figure 36a The change in appearance caused by UV-B exposure of Water Rep./Con. C treated samples of: soiled Unknown B (top left), fresh Stainton (top right), soiled Clashach (bottom left) and fresh Clashach (bottom right).

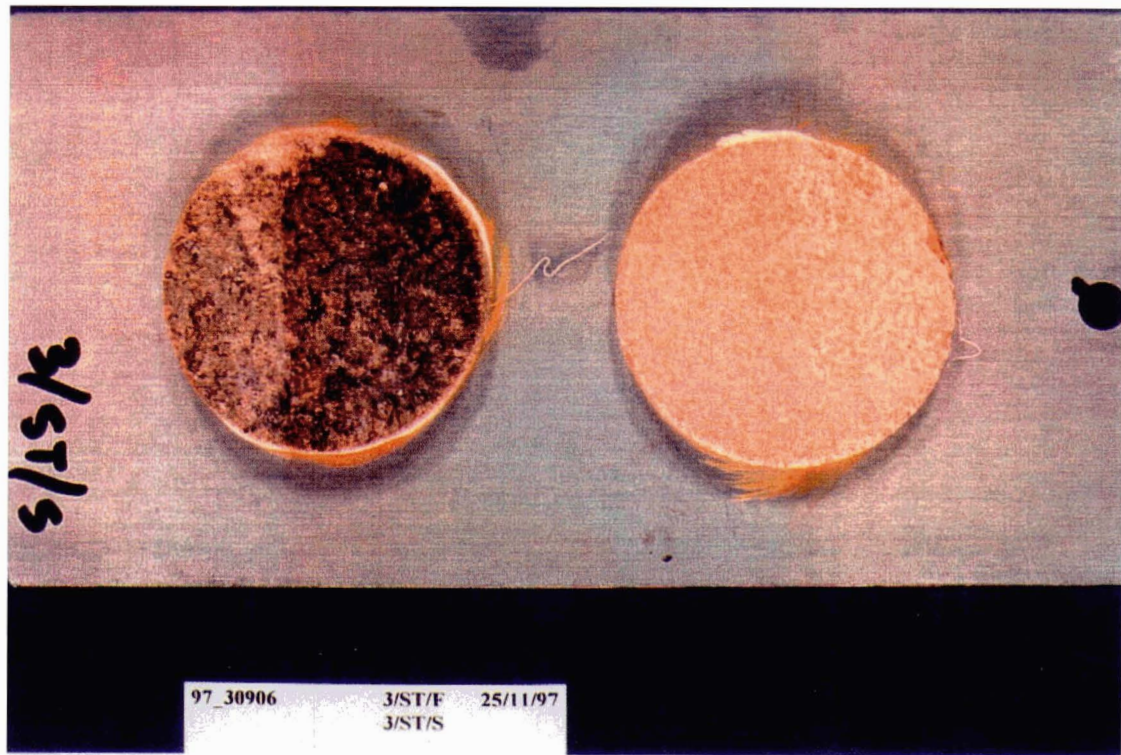
Figure 36b The change in appearance caused by UV-B exposure of Consolidant B treated samples of: soiled Unknown B (top left), fresh Stainton (top right), soiled Clashach (bottom left) and fresh Clashach (bottom right).

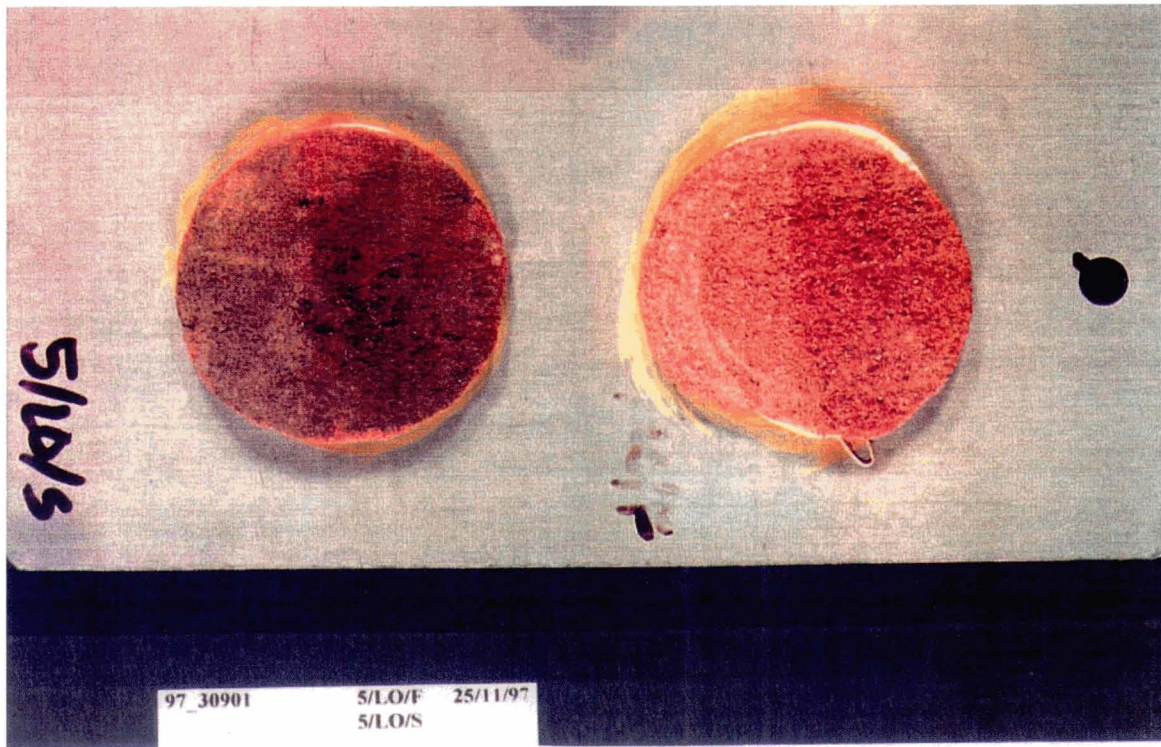
Figure 36c The change in appearance caused by UV-B exposure of Consolidant B treated samples of soiled Locharbriggs (left) and fresh Locharbriggs (right).

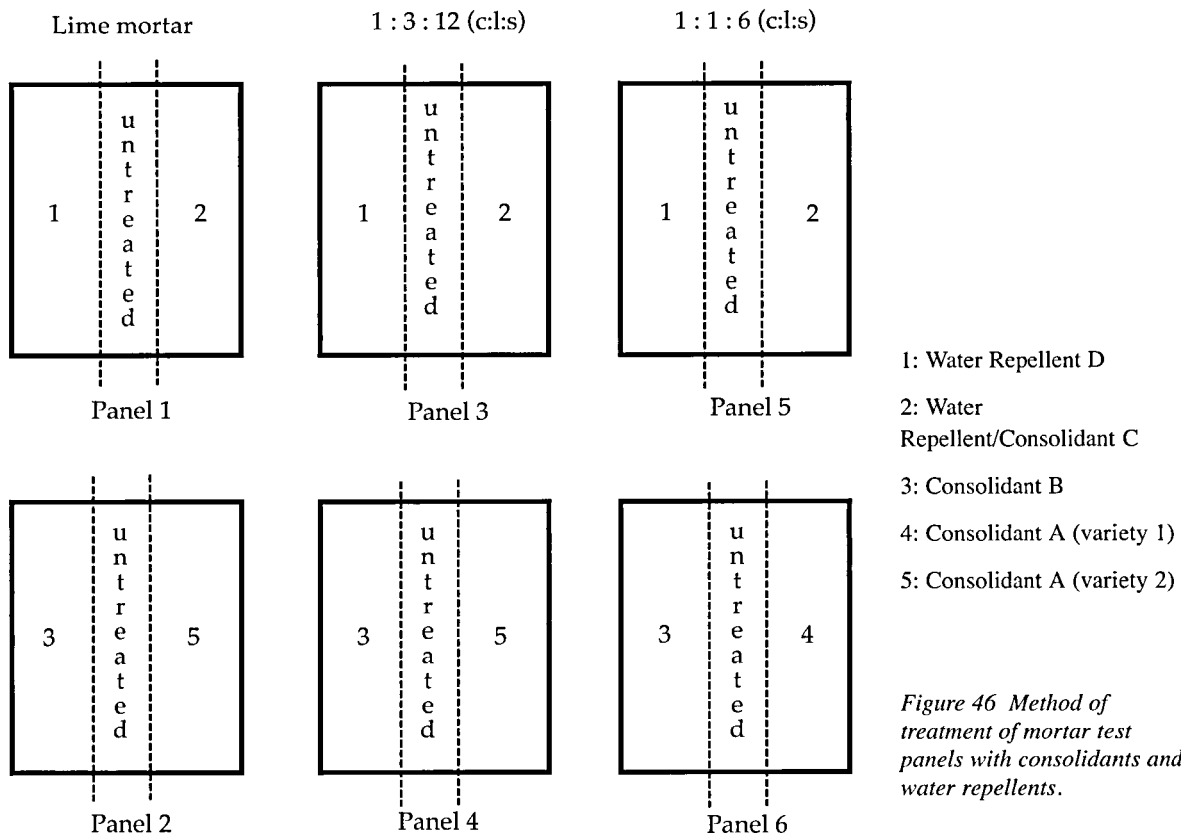
Figure 46 Method of treatment of mortar test panels with consolidants and water repellents.

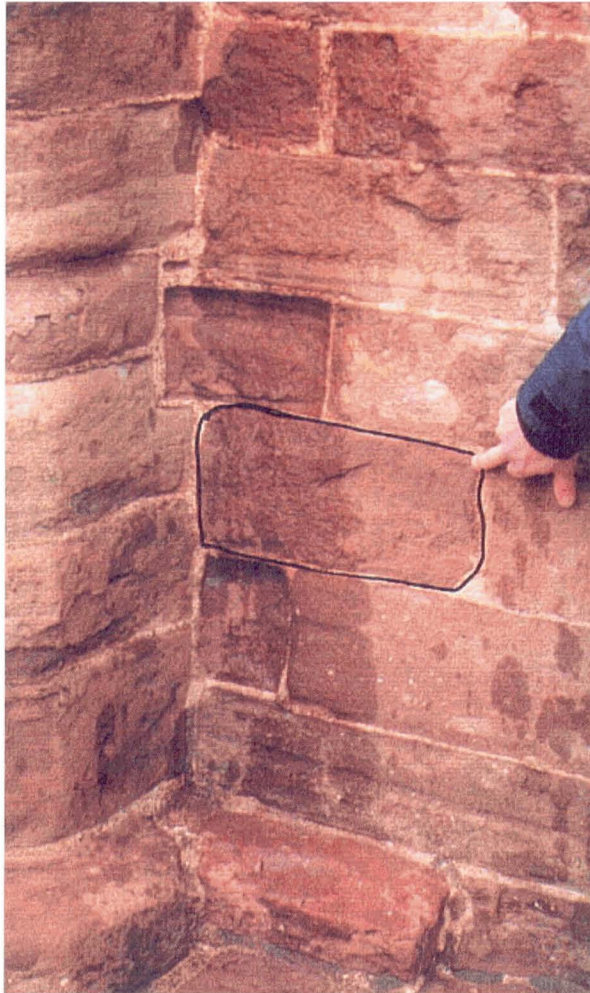
Figure 63 Sandstone block from Arbroath Abbey cored during this research project.

The sandstone block cored in this project is shown in Figure 63. Coring was carried out using a hydraulic coring system on 18th February 1997. Two control cores were taken from untreated sandstone; one to RGU, one to BRE. Three core samples were taken from one sandstone in the Brethane treated site; one to RGU, two to BRE. It was noted that the treated core was significantly water repellent to a depth of 40 mm.

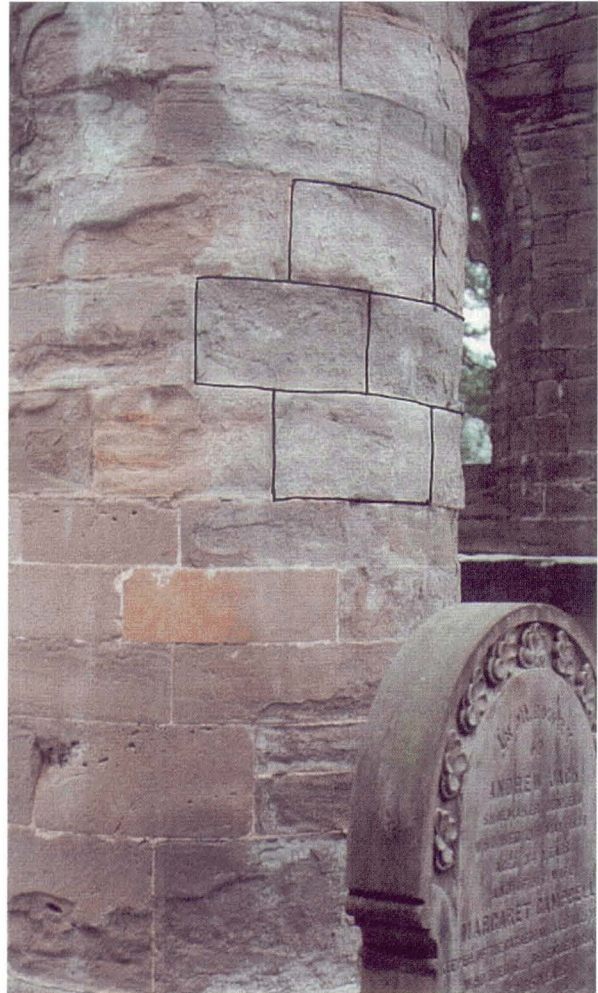
Figure 64 Treated area on column at Dunkeld Cathedral.

Treatment (Table 30, Figure 62) was carried out on 13th October 1976 on the east face of a column on the north arcade nave to the west side of a doorway (Figure 64). Height to the base of the treated area was 1.12 m from the top edge of the column base. The following notes (Arnold *et al.*, 1978) on the treatment have been located:
