HISTORIC  
ENVIRONMENT  
SCOTLAND

Property in Care (PIC) ID:	PIC300
Designations:	Scheduled Monument (SM90163)
Taken into State care:	1930 (Guardianship)
Last Reviewed:	2020

## STATEMENT OF SIGNIFICANCE

# HOLM OF PAPA WESTRAY (SOUTH) CHAMBERED CAIRN

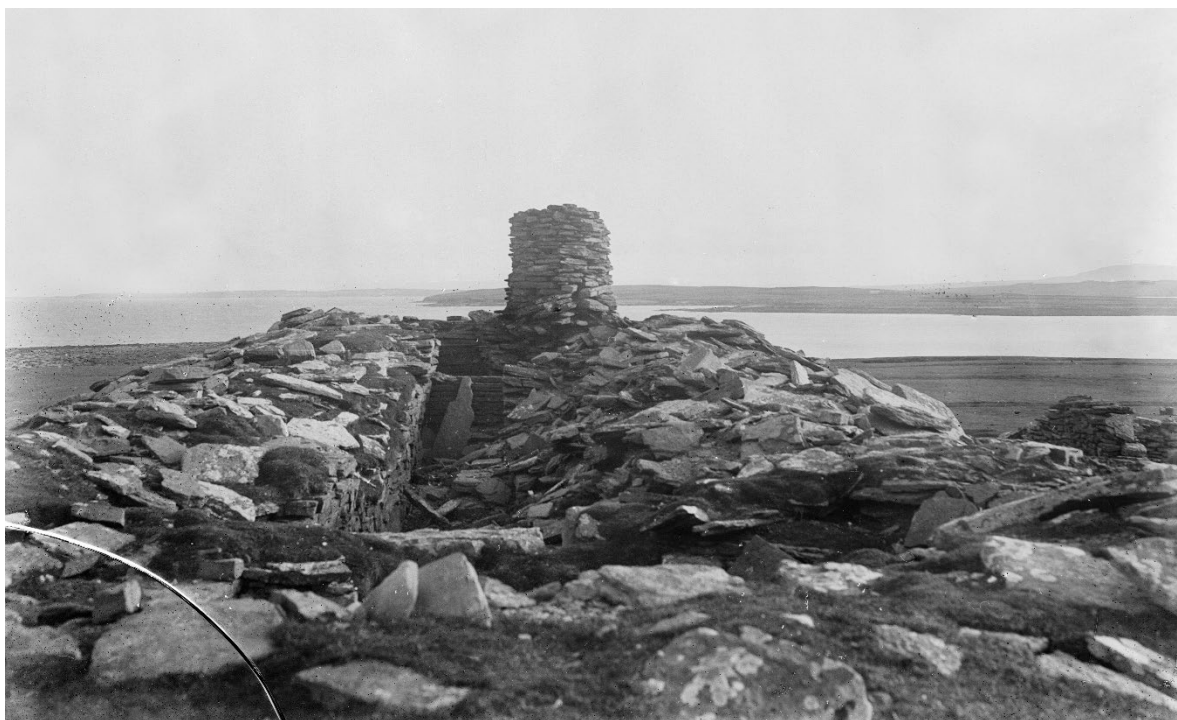
*Figure 2: Early 20th century image (1929?), prior to limited consolidation and installation of concrete roof in the 1931. Following its excavation, the tomb was left open and suffered considerable deterioration prior to entering State care. Note presence of drystone stack as naval navigation marker cairn on the highest part of the island. © Crown Copyright: HES.*

Following Thomas's intervention, the site was left open and unprotected. It gradually deteriorated, and by Joseph Anderson's visit in 1872, the tomb was "much dilapidated"<sup>19</sup>, while Hugh Marwick described it as being "in a deplorable state of collapse" in 1925<sup>20</sup> (Figure 4, below). It was eventually taken into Guardianship.

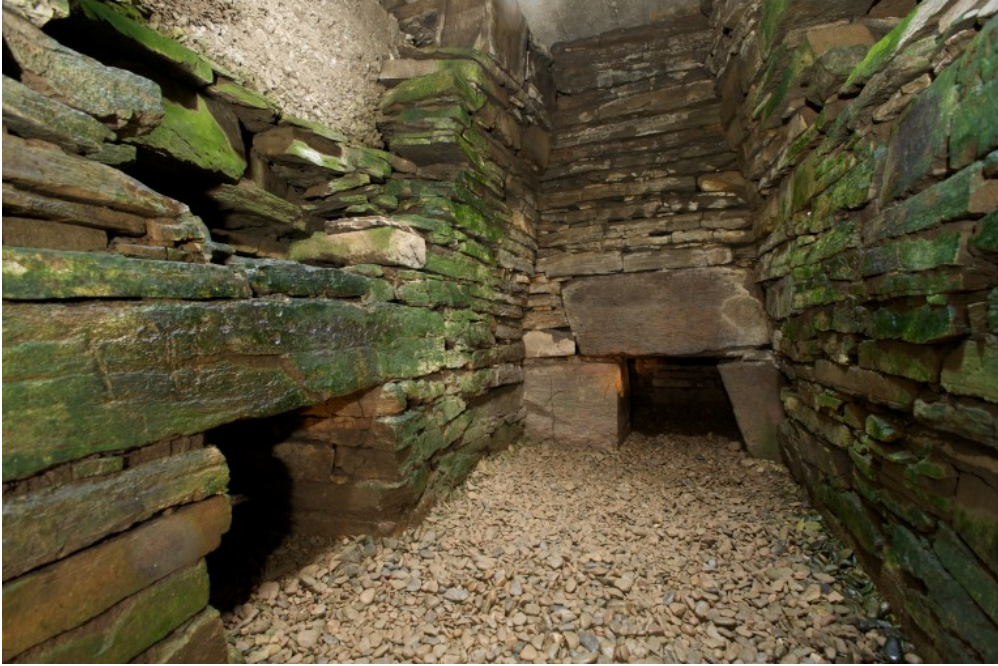
*Figure 3: Interior view of Holm of Papa Westray South, looking south-west. Note large blocks of stone used in construction.*

The monument displays the skill of the Neolithic builders in both planning and construction. Large blocks of stone were carefully placed in certain locations, often using small pinning stones to precisely adjust their alignment and orientation. Large quantities of stone were quarried and moved. In addition to the examples of decorated stonework, many of the stones include geological features forming natural ‘cups’ and meandering lines. The high concentration of these naturally marked stones suggests that these characteristics were deliberately selected for inclusion in the structure<sup>23</sup>.

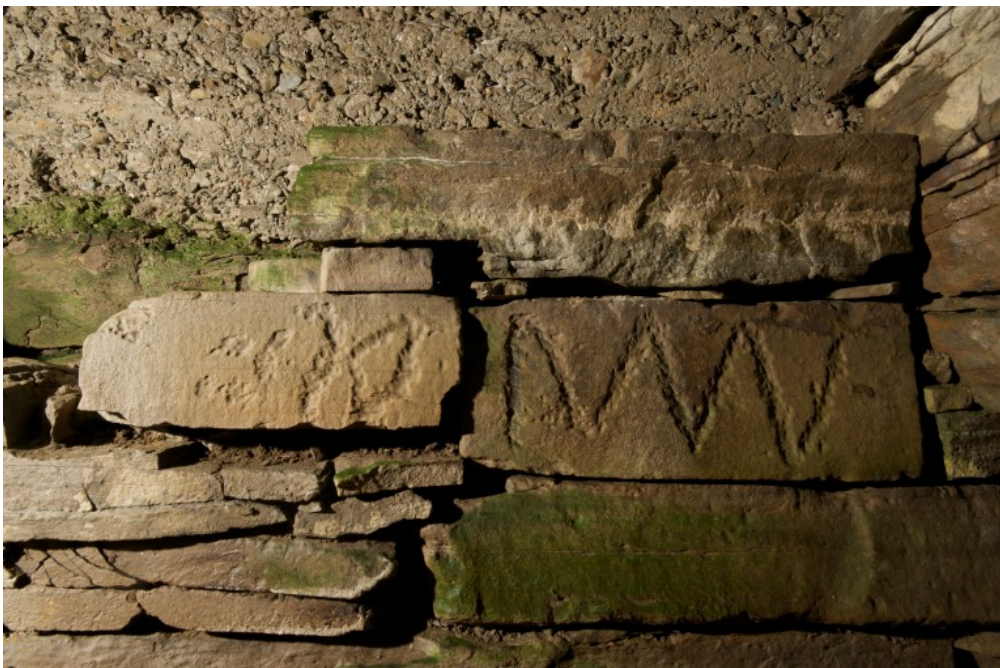
*Figure 4: Examples of decorated stones in south-west chamber (no. 5 and 6 on Figure 1 plan).*

In addition, the artwork here appears to have been deliberately placed in certain locations for visual impact, for example on lintel stones and around certain cell openings<sup>25</sup>. It therefore offers the potential to understand the symbolic placement of art in Neolithic society in greater detail<sup>26</sup>. The location of the decoration has parallels with settlement sites such as **Skara Brae** and **Links of Noltland**, also in Orkney.
