Property in Care (PIC) ID: PIC232

STATEMENT OF SIGNIFICANCE

CLICKIMIN BROCH

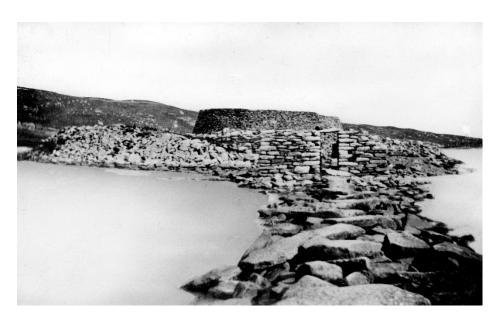
SC 1151590 © Courtesy of HES. - Unattributed photo apparently taken between 1861 and 1874 (on evidence of the loch level): note the modern blocking wall across the causeway.

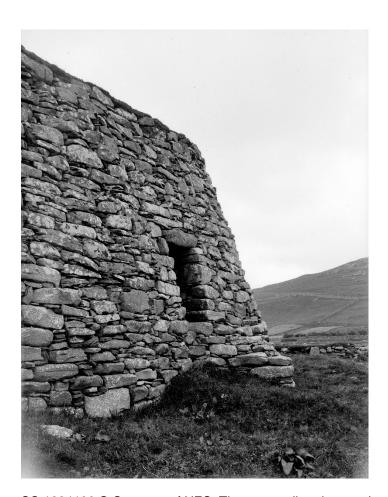
SC 1224136 © Courtesy of HES. The spur wall and second entrance in the broch wall.
