HISTORIC  
ENVIRONMENT  
SCOTLAND

Property in Care (PIC) ID: PIC324

## STATEMENT OF SIGNIFICANCE

# WESTSIDE CHURCH (TUQUOY)

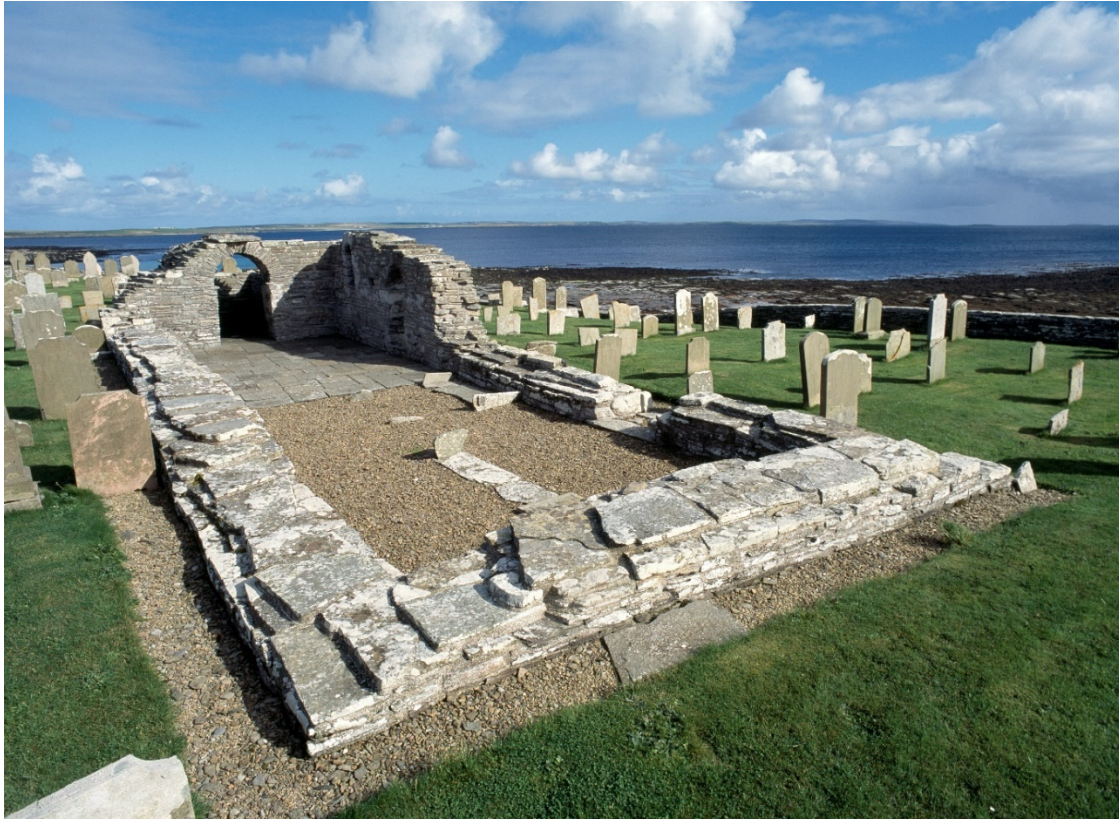
*Figure 2: view from north-west, with internal paving demarcating the original footprint of the nave, before its extension to the west. © Crown Copyright: HES.*

The original nave to the east was approximately 5.65m long by 4.15m wide. Its floor and the site of the west gable are represented by paving laid in 1912 by the (then) Ministry of Public Buildings and Works (MOPBW) when the site came into State care (Figure 2). The butt joints between the earlier and later phases can be traced in both the north and south walls. The joint in the south wall is located 6.50m from the interior south-east corner of the nave. The masonry immediately to the east of the joint has been disturbed and is set back 0.20m from the line of the interior wall face. The disturbance extends 0.85m from the butt joint and presumably represents the site of the earlier (west) gable wall. The joint in the north wall is located 6.65m from the interior north-east corner of the nave and it is noticeable that the basal course, which would formerly have turned south to form part of the west wall, has been cut back. There is no trace of a corresponding

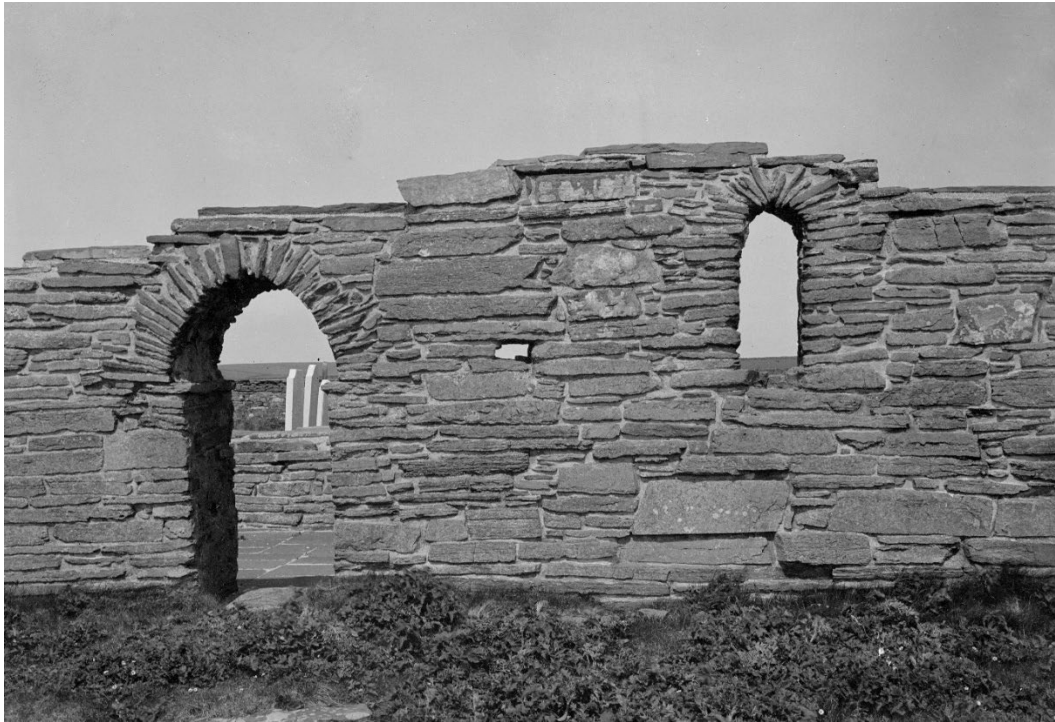
*Figure 3: Entrance and round-arched window, with possible put-log socket in centre of image. Image c.1930, looking north. © Crown Copyright: HES.*

A round-arched window was situated to the east of the original south entrance (Figure 3). This window is 0.30m wide and 0.80m high externally, and 0.50m wide and 1m high internally. The window is splayed, has an inclined sill and has been built without rebates. The arch springs directly from the impost.

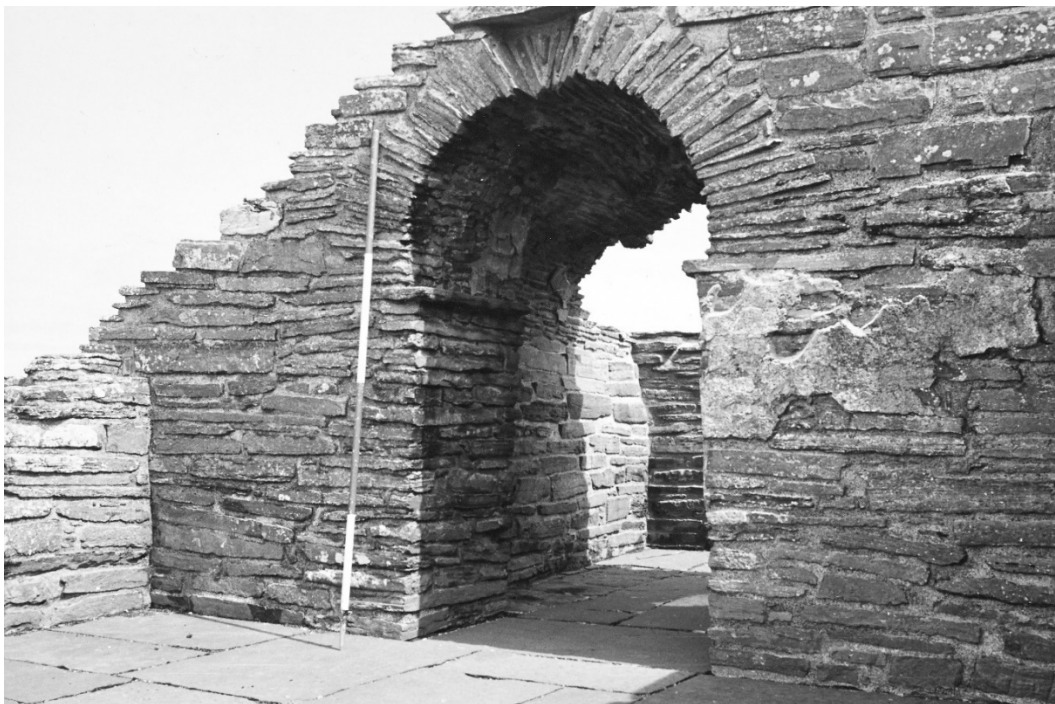
*Figure 4: 1981 image of arch leading to barrel-vaulted chancel, looking north-east. Note traces of plaster adhering to walls within nave. © Dr. Raymond G. Lamb.*

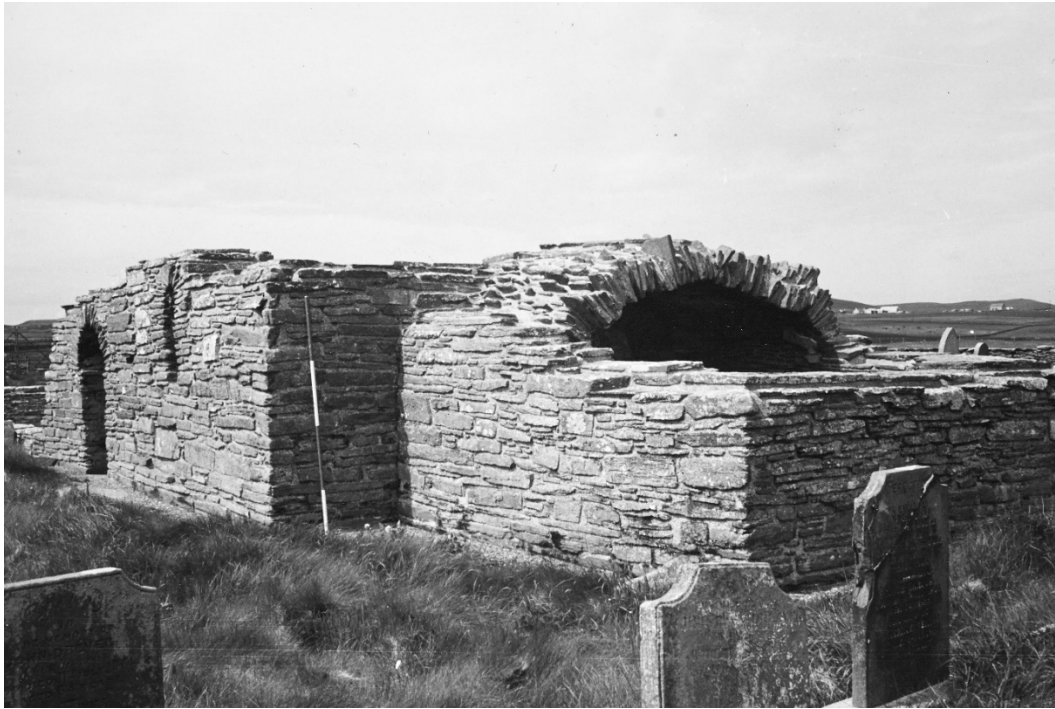
*Figure 5: 1981 image looking north-west. Note remains of the barrel vaulted chancel roof. © Dr. Raymond G. Lamb.*
