DOUNE CASTLE

LANDSCAPE CONSERVATION MANAGEMENT PLAN

HISTORIC
ENVIRONMENT
SCOTLAND

JULY 2021

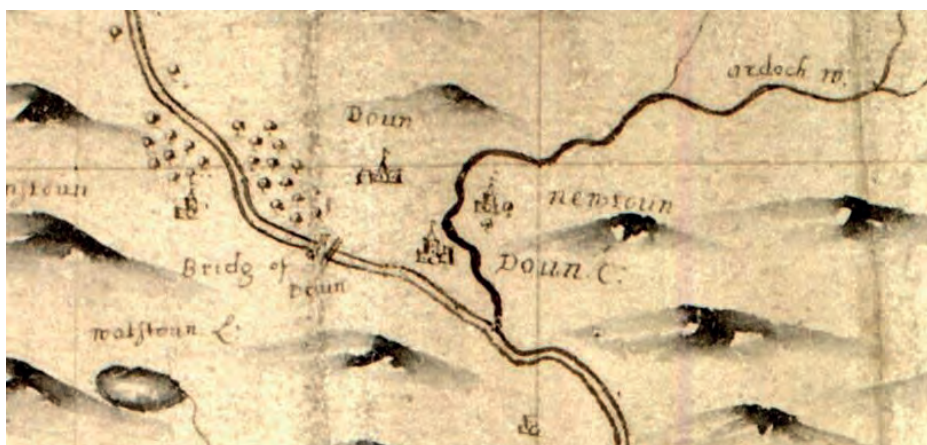
Figure 2.2.1 - Excerpt of John Adair's c 1650-1722 *Map of the countries about Stirling*

On Adair's map (*Figure 2.2.1*), Newtown (not labelled Old Newton at this point) is marked as a substantial residence and Roy's map shows it set within its own parkland.

The two earliest published maps showing Doune in any detail are those by Adair (*Map of the countries about Stirling* c 1650-1722), and Roy's Military Survey of Scotland (1747-55) (*Figures 2.2.1 & 2.2.2*). Although they are not at a scale large enough to illustrate the castle study area in great detail they illustrate some interesting features.

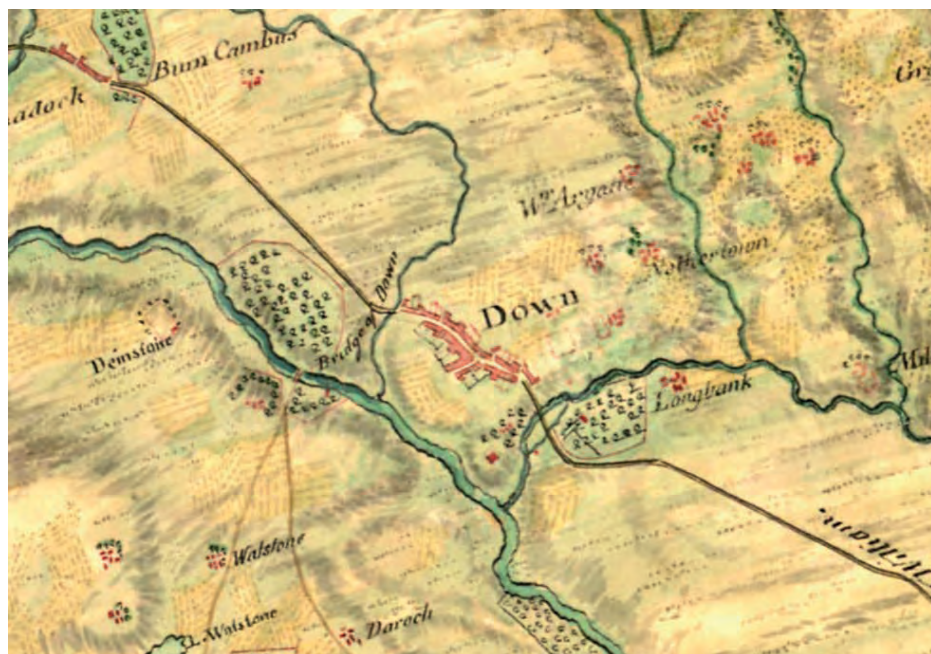
Figure 2.2.2 - Excerpt of Roy Military Survey of Scotland 1747-55

Roy's map (*Figure 2.2.2*) illustrates that by 1747-55, Doune was a large settlement. Doune Castle is illustrated but not labelled, probably indicating that by this date the fortifications were not viable.

To the north-east of the castle, Roy's map also depicts what appears to be the Mill of

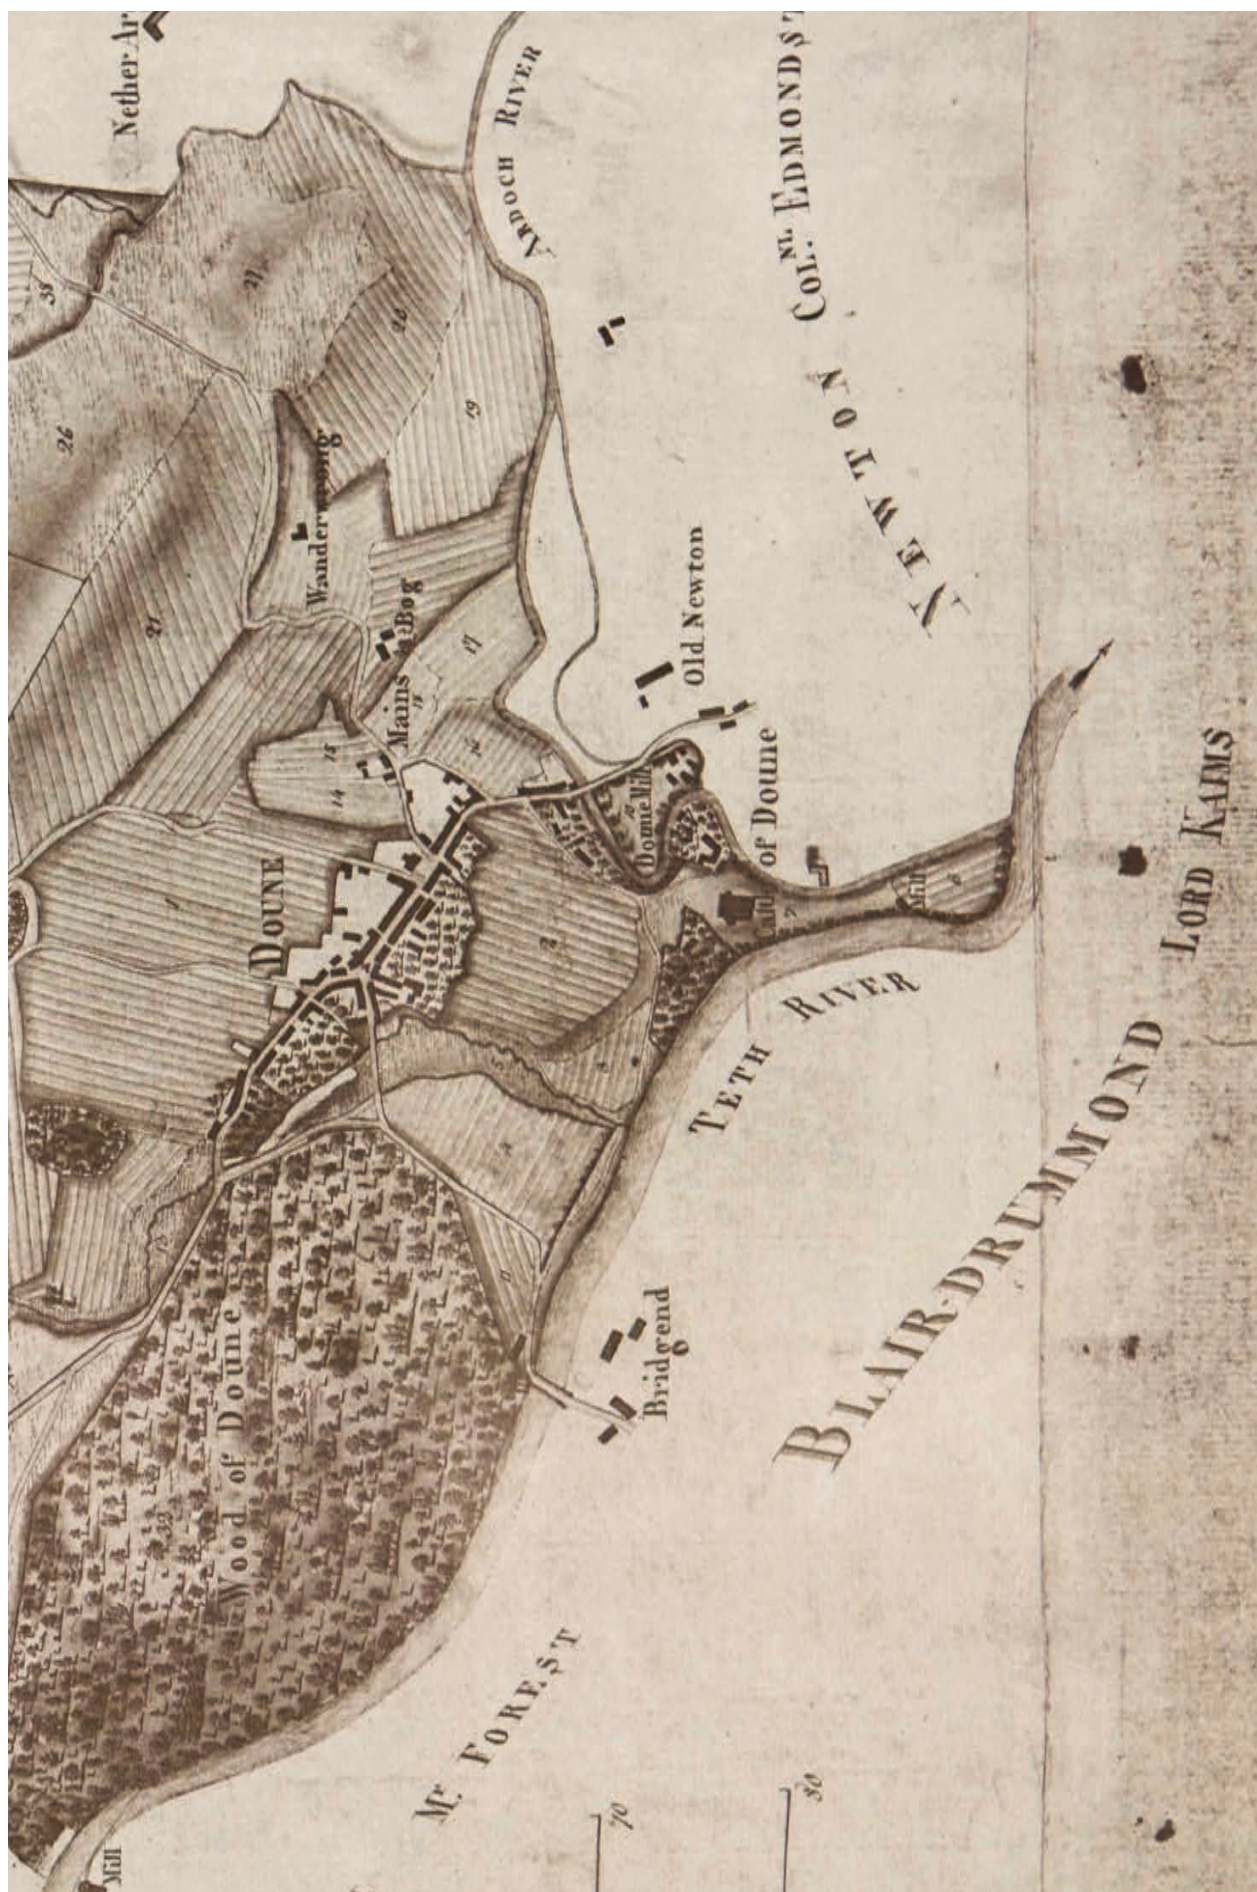
Figure 2.2.3 - Excerpt from Stobie's Plan of Doune (1782; NRS RHP 14316) reproduced with permission of Moray Estates

Doune and buildings within woodland to the north-east of the castle; these are more clearly marked on Stobie's 1782 Plan of Doune (Figure 2.2.3). The enclosed Wood of Doune is also marked. Both the Adair and Roy maps illustrate, at the south-east corner of the woodland, the Bridge of Doune (later known as the Bridge of Teith).

on the map, these appear to have been accessed from the embanked roadway (OA North 2020a Site 21) skirting the edge of Castle Hill scarp, which joins with the road from the River Teith and provides the castles' primary access. North-east of the castle is Castle Farm; depicted as a range of buildings, open to the north and surrounding a courtyard. To its north is a smaller building, fronting on the south bank of the Ardoch Burn and separated from the courtyard range by woodland. A line between the range and the building on the burn may denote a path (possibly that associated with the former bridge; OA North 2020a Site 36). To the south (rear) of the courtyard range is another, smaller building, between the farm and the castle.

Doune Mill, the mill-lade and several other buildings are marked to the east of the Ardoch Burn; the mill is clearly served by the main road from Doune village, which bridges the burn which continues to buildings to the south of Old Newton before terminating. Although its surrounds suggest it may have been re-set, a stone set into the bridge's south-western parapet is inscribed "*Built upon the Publick Expense of the Shire AD 1733*" (OA 2020, Site 19). Prior to this, the bridge was apparently a timber structure (Mackay 1953, 14).

On the peninsular to the south of the castle is a second mill, with a patch of arable to its south, on the east bank of the River Teith. This is not marked on later maps and is visible today as earthworks (OA North 2020a, Site 9).

The layout of the farm shown on Stobie's 1782 Plan of Doune (Figure 2.2.3) broadly correlates with that shown on Nattes' etching of Doune Castle, published in 1804 (Figure 2.2.4). Its viewpoint appears to be from Doune Mill which is in the foreground left; Ardoch Burn is also in the foreground, beyond which is the building on the west bank, shown on Stobie's plan. This is seemingly stone-constructed, and, incorporating chimneys, may have been a dwelling. What appears to be a higher-status gabled stone building figures in the background to the south-west and appears to represent part of the courtyard farm. On the opposite side of the river the present-day natural scarp can be seen, and the ruinous castle beyond.

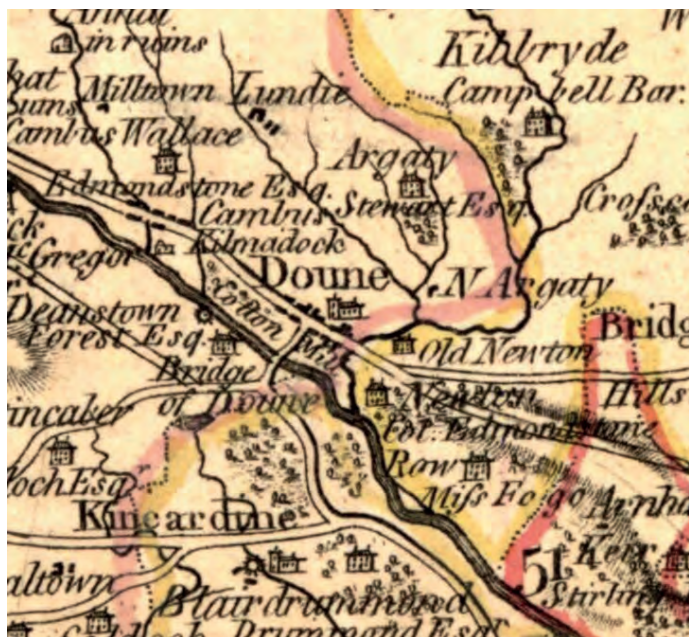
Figure 2.2.5 - Excerpt from Stobie's 1805 Map of the counties of Perth and Clackmannan

Into the earlier nineteenth century, although at a much smaller scale, James Stobie's c 1775-1804 (published 1805) Map of the counties of Perth and Clackmannan (Figure 2.2.5) does not mark the castle but labels Old Newton and Newton as belonging to Col. Edmonston. Newton, to the south of Old Newton, is on the site of the later Inverardoch House.

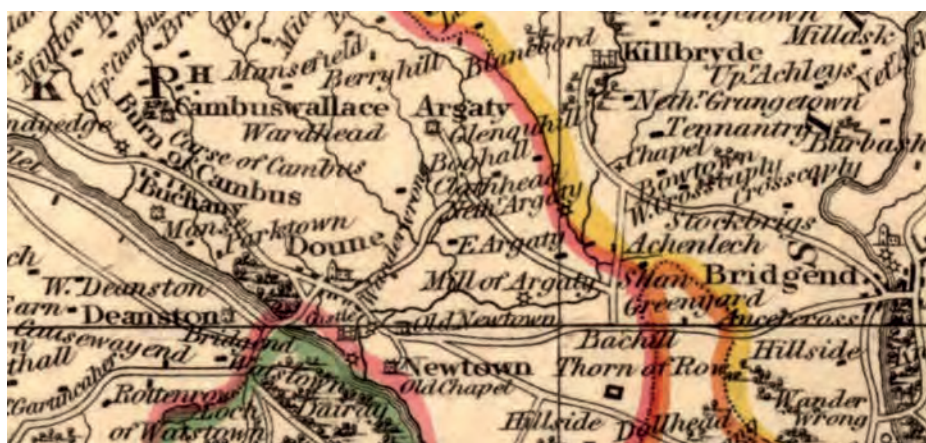
Figure 2.2.6 - Excerpt from Thomson's 1827 Perthshire and Clackmannan

John Thomson's (1827) Perthshire and Clackmannan (Figure 2.2.6) depicts the castle, the Newtons, the Wood of Doune and Parktown Farm, within the former parkland. Two mills are also illustrated, by stylised wheels; one is the Mill of Doune, and there is another, to the south of the castle (as illustrated on Stobie's 1782 plan) and the building now represented by earthworks (OA 2020a, Site 9).

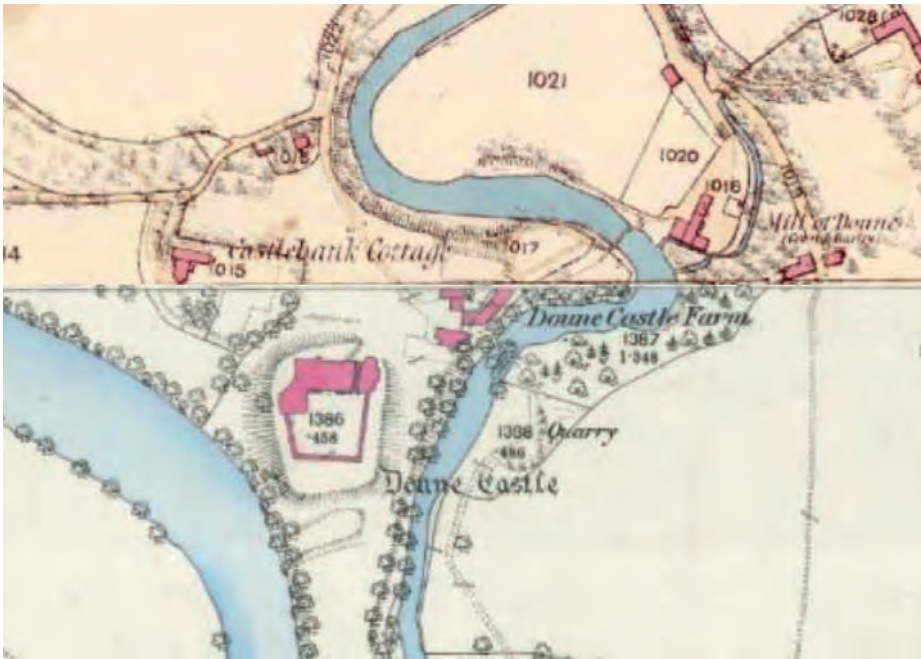
Figure 2.2.7 - The PiC and its environs on the OS 25-inch maps of 1864

OS map sheets nos CXXV.13 (1864) and CXXXII.1 (1893), both surveyed in 1862-3, border immediately to the north of the castle (Figure 2.2.7). The northernmost buildings of Doune Castle Farm appear clipped on the southern map sheet (CXXXII.1) and do not appear on that to the north (CXXV.13). The farm itself is depicted as a range of buildings around a courtyard, the easternmost being long and linear possibly in the form of stabling. There is a larger building, unattached to the courtyard, to the south. There appear to be yards and hardstandings surrounding the buildings. There is no building on the south bank of the Ardoch Burn (as depicted on Stobie's 1782 plan and Nattes' engraving (Figures 2.2.5 and 2.2.6) and on the other side of the burn, the Mill of Doune and its immediate surroundings have also been substantially remodelled, with many of the former buildings demolished. A narrow bridge is shown on the 1864 map accessed via a pathway/wall line also shown on Stobie's plan (on which no bridge is apparent).

To the south-west of the farm, the castle and its earthworks are illustrated in more or less their present form. There are no buildings illustrated on the peninsula to the south. To the immediate north-west of the castle, an enclosed garden (no buildings) is shown

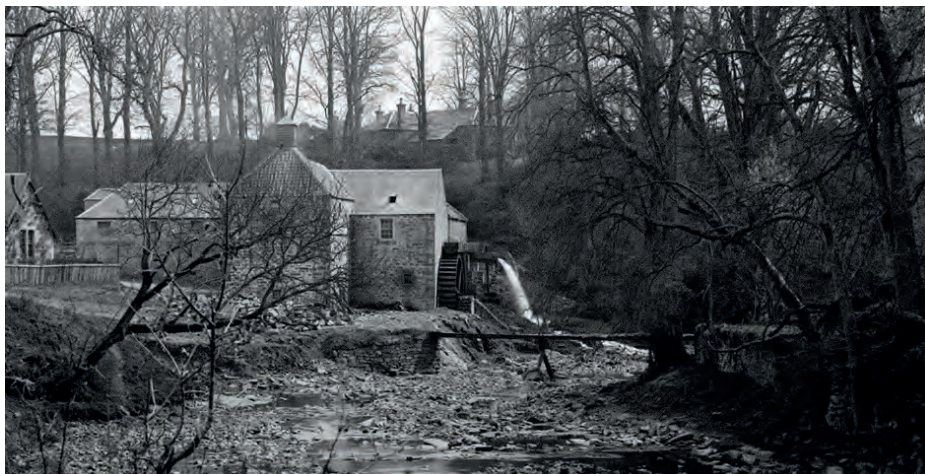
Figure 2.2.9 - Mill of Doune with waterwheel and timber footbridge, early twentieth century

With a farmhouse to the west, the farm itself is arranged around an open-sided yard incorporating a series of hipped cattle sheds, a barn, and a single storey cottage, the latter incorporating a datestone of 1874 (ibid, Site 16). The 1900 map shows that the bridge between the castle and Doane Mill was also removed. What appears to be a very temporary bridge at this point (basically a plank sat on substantial stone-built bridge foundations (ibid, Site 7) is visible in an early twentieth-century photograph of the Mill of Doane (Figure 2.2.9).

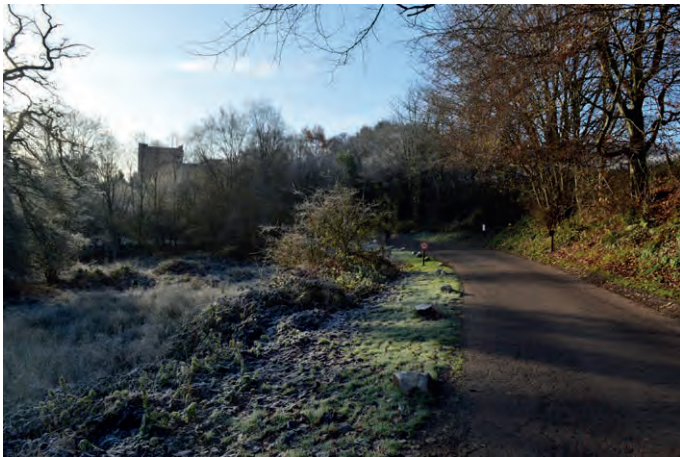
Figure 2.5.2

The first, glimpsed views of Doune Castle are afforded from the drive, with the gatehouse tower visible amongst the trees (Figure 2.5.2).

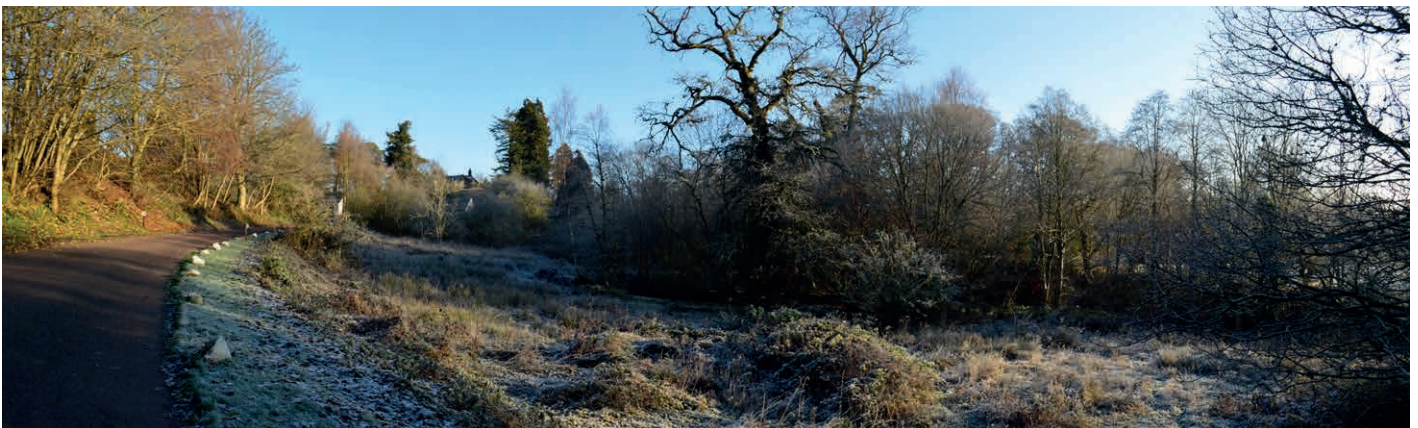
Figure 2.5.7

Two wells are located here, at least one of which is damaged and leaking, hence the area is now a predominantly wet grassland (Figure 2.5.7). Groups of semi-mature trees, principally alder, grey alder, silver birch and bird cherry (*Prunus padus*) are found within this meadow area alongside patches willow scrub and young self-set ash trees.

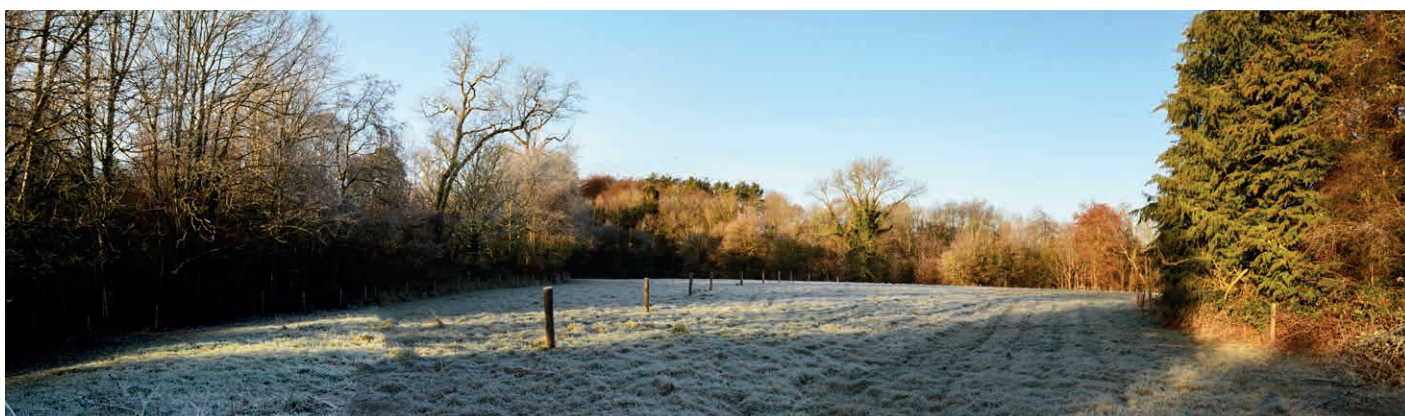
Figure 2.5.9

(*Symphoricarpos albus*) is also present. Three short rows of mature common lime trees (includes T624, T628 and T631) have been planted on a meander bar, formed by a bend in the Ardoch Burn, east of the castle. One is planted on the flat terrace area beside the burn, and another has been planted beside a path down to the river at the top of a sandstone outcrop. The trees have a slender form with numerous epicormics and appear to be of the 'Pallida'-type form. Close to the lower row is a mature holly tree with a distinctive arborglyph which cannot be read but appears to be reasonably old. A large meadow occupies the remaining area to the east of Ardoch Burn and it is understand that this is seasonally grazed by horses (Figure 2.5.9).

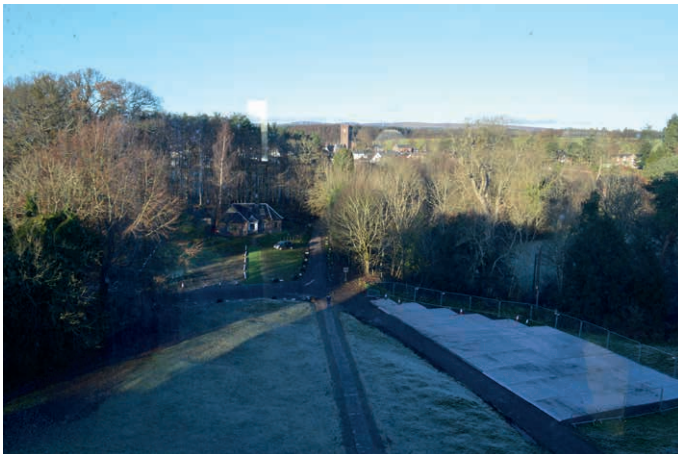
Figure 2.5.10

The Doune Castle character area lies to the south of the access drive and access to the castle is via a cobbled path (Figure 2.5.10). Close mown lawns extend from the car park towards the ditch and bank to the north of the castle, giving rise to a open and spacious character.

A temporary mini-bus parking area has been created to the east of the castle, as visitor numbers continue to rise and parking for mini-buses is difficult due to the small car park. This temporary base is defined to the east by heras fencing and creates a strong negative visual impact upon the scheduled monument and setting of the castle (Figures 2.5.10 & 2.5.11).

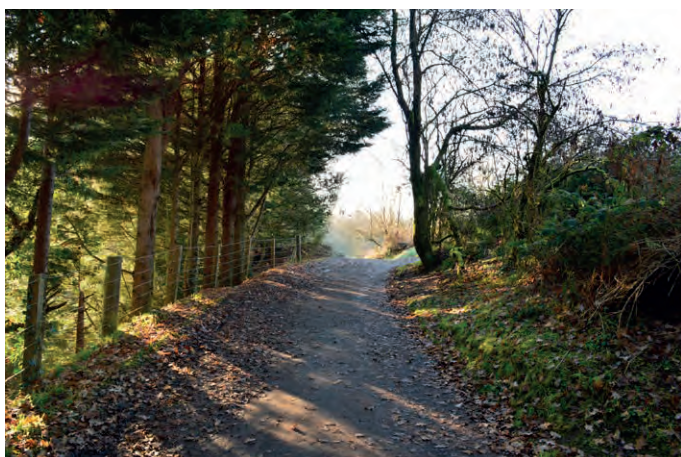
Figure 2.5.12

A narrow track runs north-south to the east of the castle, providing access to the River Teith for fishermen and to the sewage works. Adjacent to the castle is a band of tall Leyland cypress (*x Cuprocyparis leylandii*) planted at the top of the bank, below a line of gabions supporting the track edge. These trees, which were presumably planted to visually screen the gabion wall, are becoming incongruous and are out of character with this landscape setting (Figure 2.5.12).

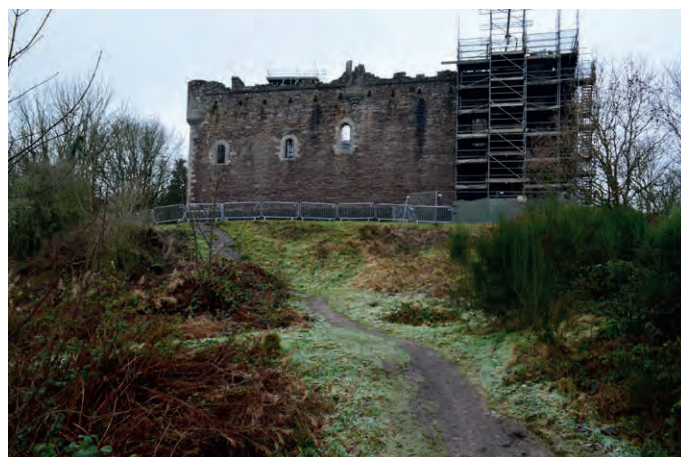
Figure 2.5.13

To the south of the castle is a mound with ditch and bank which is showing signs of heavy erosion from visitors. At the time of surveys, this area was fenced to prevent access whilst essential repair work is being carried out on the castle. It was noted that scrub is developing along the banks of the mound, presumably due to a reduction in management and this in turn concentrates the visitors to specific routes across the mound, creating severe erosion scars, which are causing damage to the below ground archaeology. The scrub is also reducing the visibility of the castle, when viewed from the south, reducing the visual dominance of the castle (*Figure 2.5.13*).

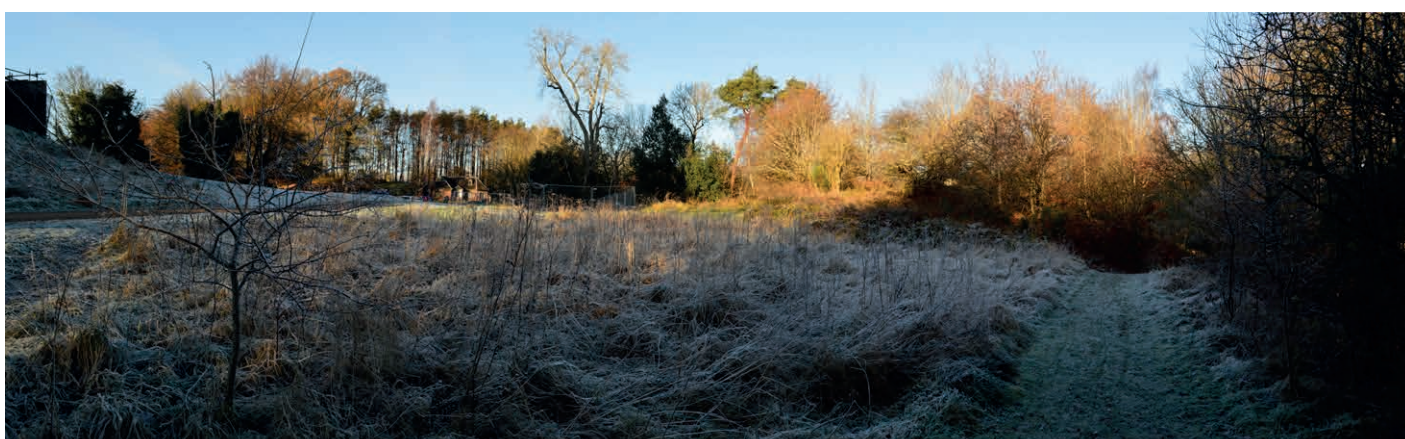
Figure 2.5.14

Lawns to the east of the castle have been allowed to grow longer, with rank grassland developing. The Ice House is located to the east of the castle, which is well hidden at the side of a grassy mound (*Figure 2.5.14*).

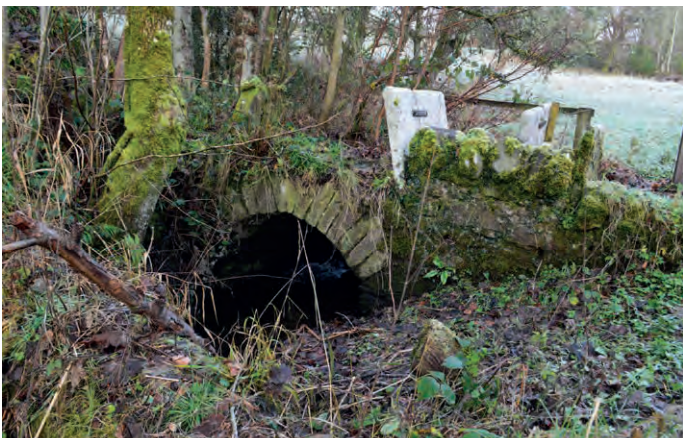
Figure 2.5.35

This is a historic route through the character area and a well-used footpath passes through the wood today, across a small stone bridge over the Dragon Burn (*Figure 2.5.35*) and on to the busy A84 road. The wood extends beyond the footpath to the Bridge of Teith. The remnants of gate piers, with estate railing can be seen adjacent to the bridge (*Figure 2.5.36*). Red squirrels have been observed in the wood during the site surveys. A small number of self-set rhododendron bushes are present here, especially along the northern boundary with the residential properties which lies to the south of the village.

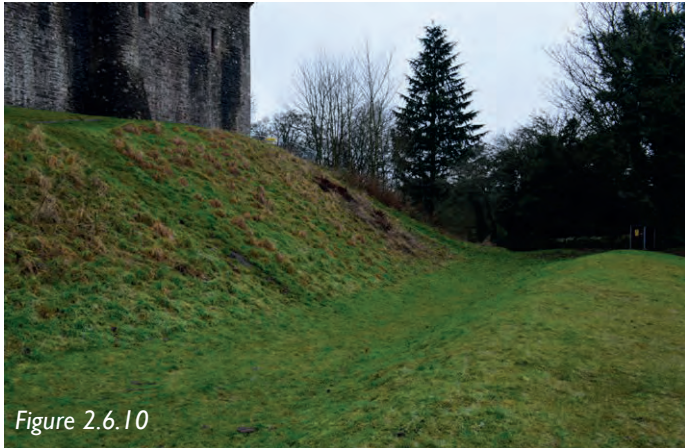
Figure 2.6.10

Doune Castle sits on a substantial raised, grass covered mound, with ditches and banks to the north and south (*Figure 2.6.10*). This mound provides an uncomplicated landscape setting for the castle, with the castle appearing as the dominant element in the landscape scene. It was noted that vegetation is being allowed to grow unchecked around the castle and specifically upon the banks and ditches, which is, over time, reducing the visual dominance of the castle (*Figure 2.6.11*). Early photographs (*section 4.3*) illustrate how this vegetation is changing the landscape.

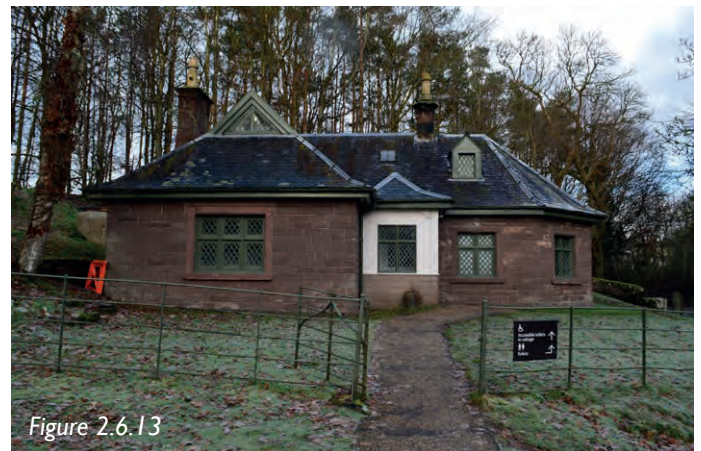
Figure 2.6.13

The other buildings and structures in the study area reflect the use of the site, predominantly during the eighteenth century, with Castle Keeper's Cottage (*Figure 2.6.13*) and Castlebank Cottage being built close to the castle and the farm buildings relocated to the east of Ardoch Burn. Castlebank Cottage has a tenant resident and is outwith the study area, although the building forms a visible part of the wider landscape, especially from views from the west of the study area.

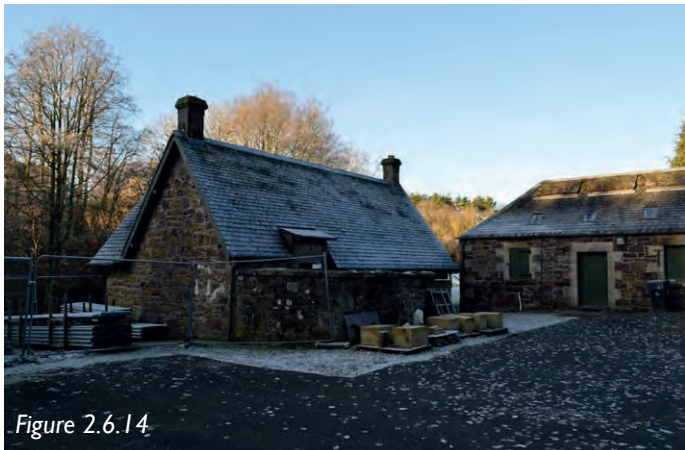
Figure 2.6.14

The farm buildings and yard to the east of Ardoch Burn are now occupied by the Monument Conservation Unit (MCU) (*Figure 2.6.14*). The ruins of Doune Mill are located within character area 2 and are not accessible to visitors due to poor structural condition (*Figure 2.6.15*). Glimpsed views of the mill are afforded from the western bank of Ardoch Burn, however the building is largely concealed by incongruous vegetation.

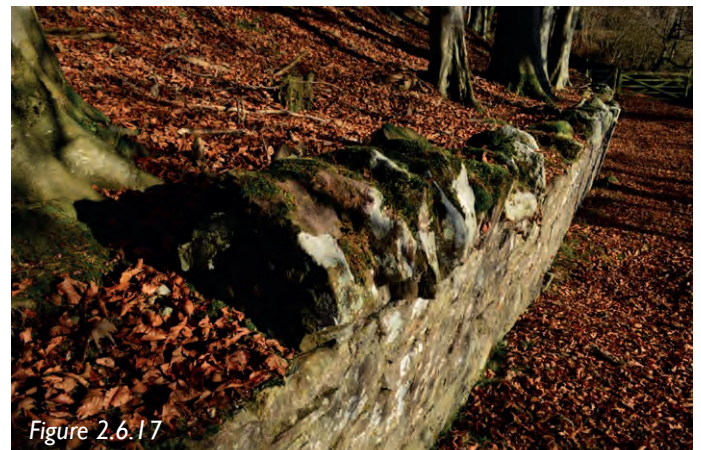
Figure 2.6.16

There are a series of stone walls which are an integral part of several areas within the landscape. Predominantly random coursed, these stone walls retain earth banks, define the drive (*Figure 2.6.16*), partially enclose the farm yard and are visible within the landscape as semi-extant features. Within character area 2 there are extant retaining walls, the most substantial is up to 3m in height, and extends for approximately 50m, protecting the pronounced bend in the Ardoch Burn to the north of Doune Mill. Although largely obscured by vegetation, the wall is built of roughly coursed stone.

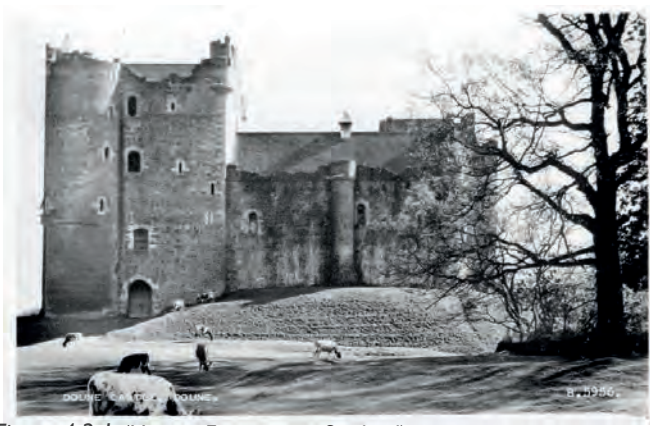
Figure 4.2.1 (Historic Environment Scotland)

Figures 4.2.1 (early 1900s) and 4.2.2 (2019) illustrate the view looking south towards the castle from the car park. The early photograph illustrates land management, with cattle grazing on the earthworks. Despite this being a cropped image, there are relatively few

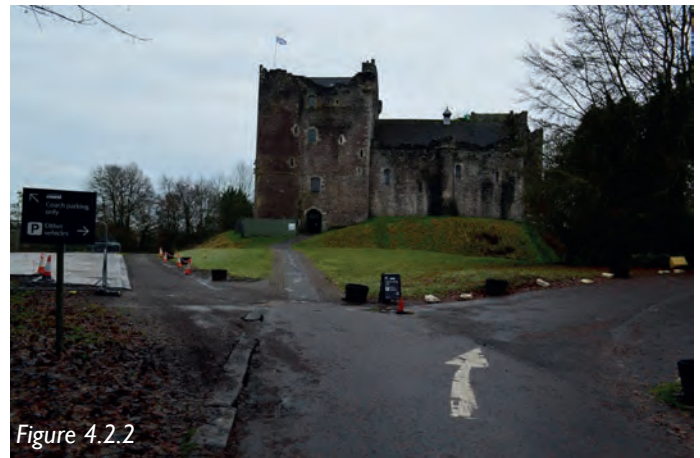
Figure 4.2.2

trees adjacent to the castle whereas in 2019, trees grow within close proximity on the east and west. The earlier photograph also illustrates that the path to the castle from the car park is a relatively recent addition, with no hard surface visible. The management of the sward by grazing cattle results in a simple and uncluttered grassed mound, which is very much subservient to the castle.

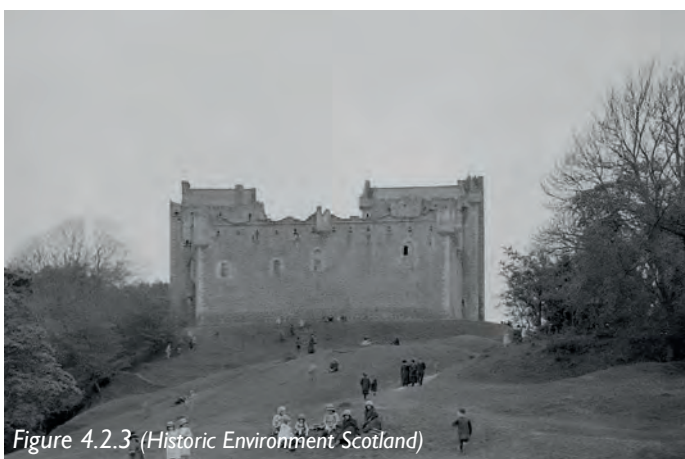
Figure 4.2.3 (Historic Environment Scotland)

Figures 4.2.3 (c1929) and 4.2.4 (2019) illustrate how the southern ditches and banks of the earthworks were open and well defined in c1929, however in 2019, scrub vegetation and trees have largely colonised the earthworks and the ditches and banks are now difficult to interpret.

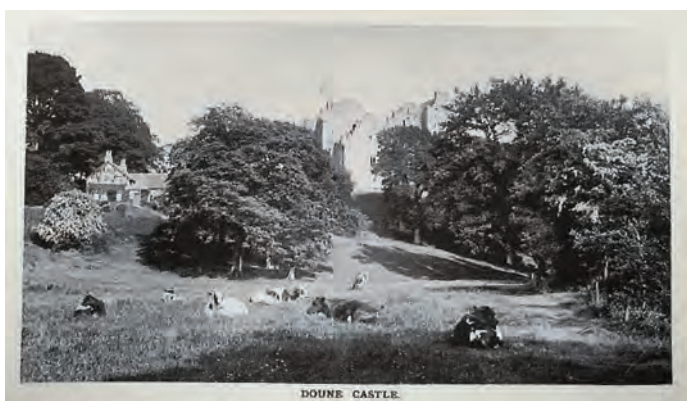
Figure 4.2.7 (Historic Environment Scotland)

Tree cover adjacent to the castle has increased, however there appears to have been some tree losses in the meadow. There appears to be no fence between the castle and the meadow in *Figure 4.2.7* and it is likely that the landscape was grazed as one meadow, giving rise to a sward with a consistent length and character.

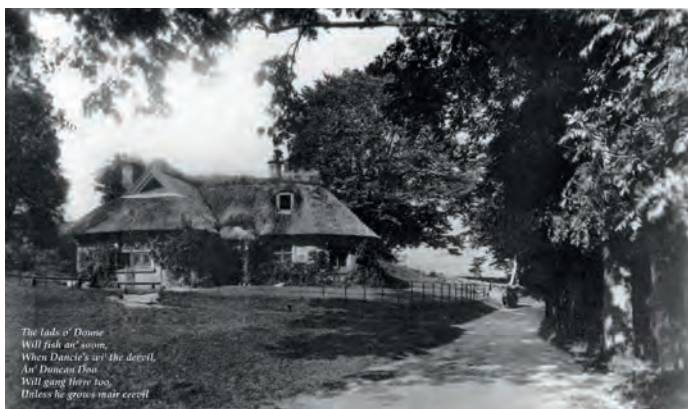
Figure 4.2.9 (Historic Environment Scotland)

Castle Keeper's Cottage is seen in *Figures 4.2.9* (late 1800s-early 1900s) and *4.2.10* (2019). Originally with a thatched roof, the estate railings still define the garden area, however there is no longer any ornamental horticulture. The woodland to the rear of the cottage now encloses and dominates the cottage, whereas it was originally far more open. An informal drive can be seen to the east of the cottage, which has been replaced by a tarmac surface.

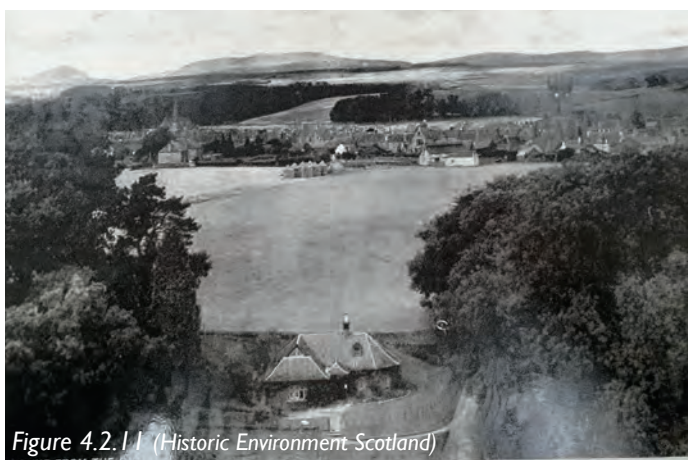
Figure 4.2.11 (Historic Environment Scotland)

Figures 4.2.11 (c1930) and 4.2.12 (2019) illustrate the view from the castle looking across Castle Keeper's Cottage towards Doune. This view has changed with the addition of the plantation to the southern edge of Castle Hill. In the earlier photograph, Doune Primary School had not been built and there was clear intervisibility between the castle and the village. The tower of the Kilmadock Church can be seen in both photographs.

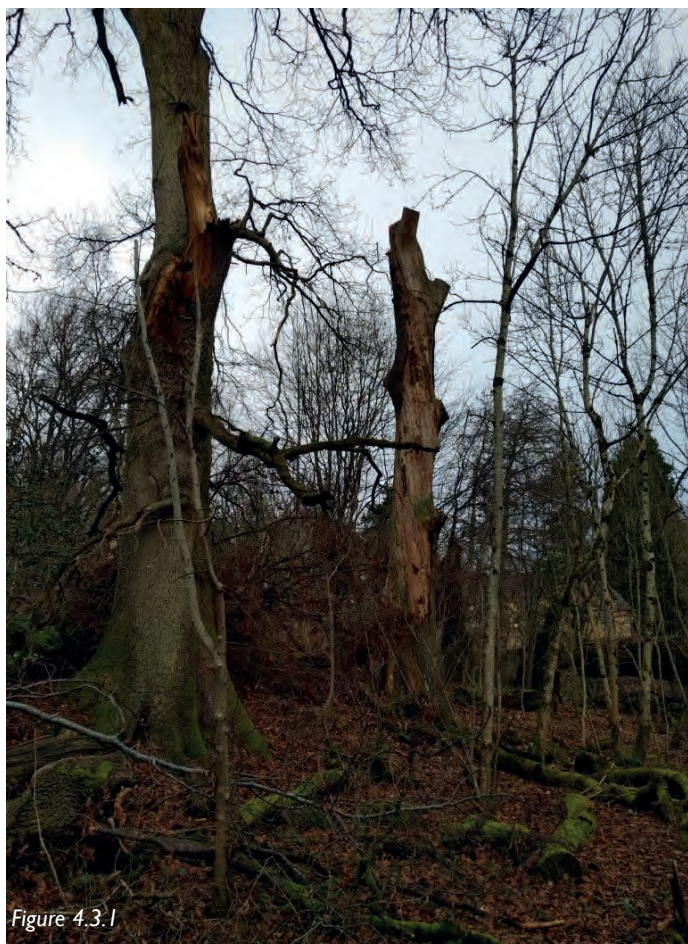
Figure 4.3.1

The site surveys noted that two of the trees growing in the area of wet meadow alongside the entrance drive in character area 2 (T742 and T744) (Figure 4.3.1) have suffered recent large branch loss, and T742 has a birch 'air tree' growing in its crown.

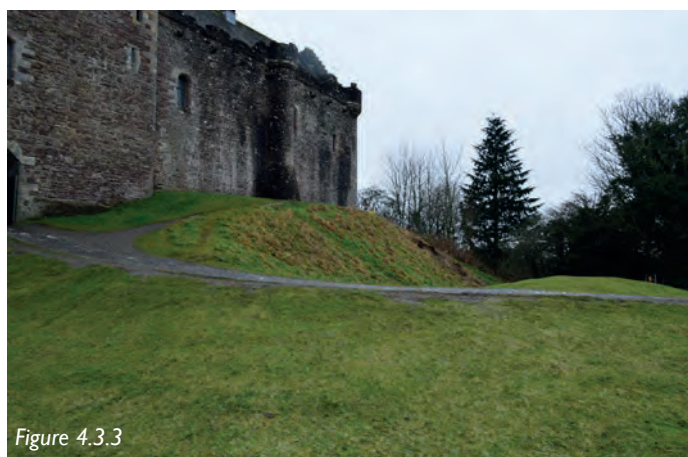
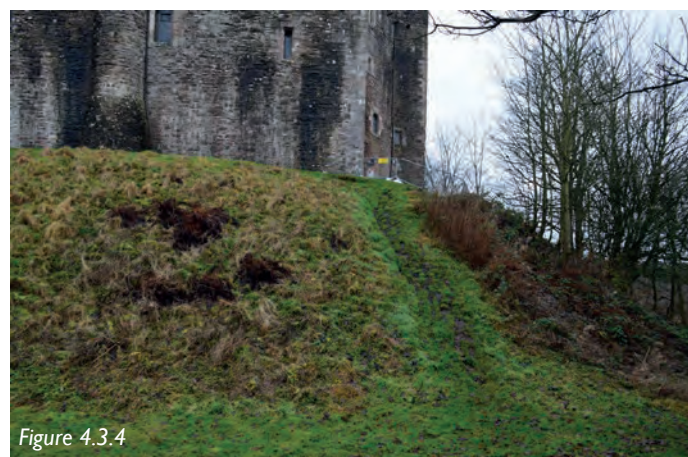
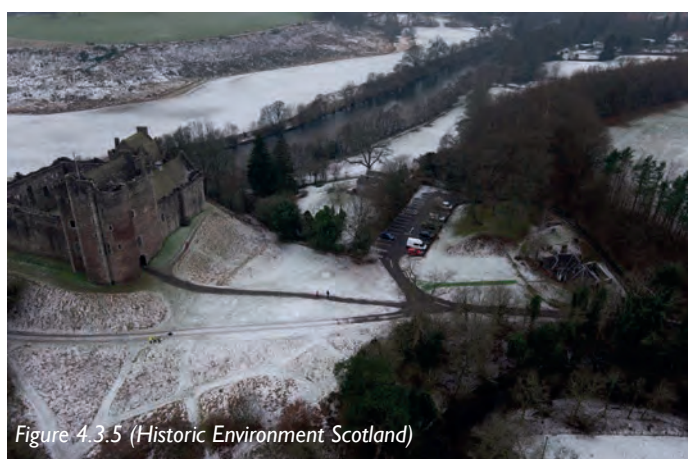
The grassed mounds upon which the castle stands are maintained as close mown grass, however areas on the steep banks and to the east of the castle have been allowed to grow long with narrow paths mown through (Figures 4.3.3, 4.3.4 and 4.3.5). It was noted that some of these areas of longer grass looked untidy and unmanaged.

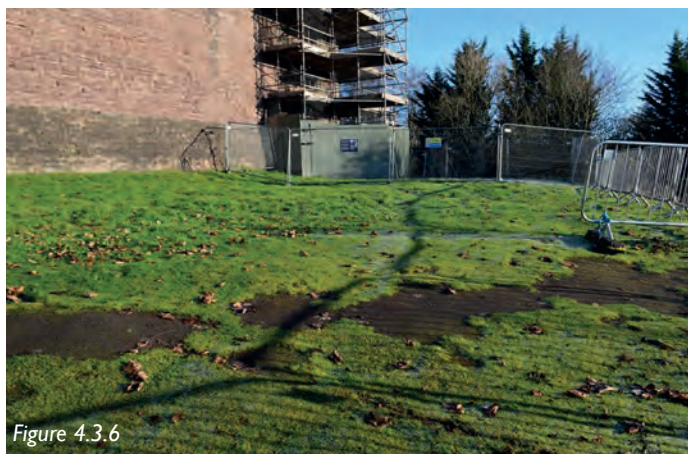
Visitors to the castle generally congregate on these grassed mounds, and seek access around the external face of the curtain wall. Heavy footfall around the external curtain wall has resulted in significance damage to the sward and the subsequent exposure of below-ground archaeology (Figure 4.3.6).

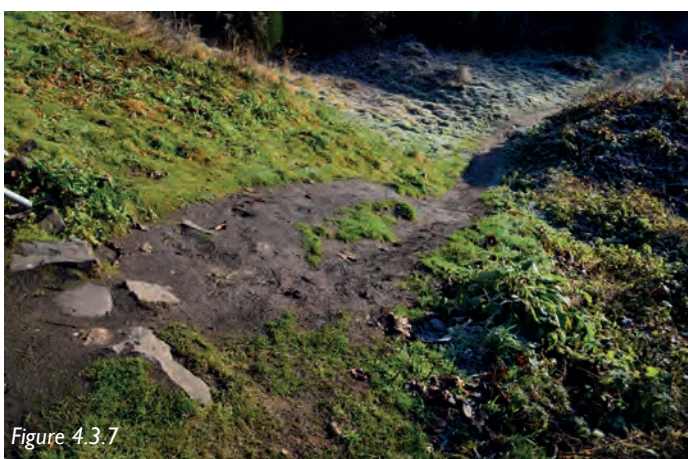
4.3.2 Man-made Fabric Banks & Ditches As previously noted, the condition of the sward on the grassed banks and ditches of the earthworks is deteriorating in places. Visitors to the castle enjoy exploring the external face of the curtain wall, however the impact of high numbers of visitors on the earthworks can be seen as erosion scars. At the time of surveys, there was also an issue with water draining from the castle directly onto the earthworks, which was also noted to be contributing to the erosion. Where scrub vegetation is restricting free access across the earthworks, strong desire lines are forming, which cut into the banks and ditches, exposing below-ground archaeology (Figure 4.3.7).

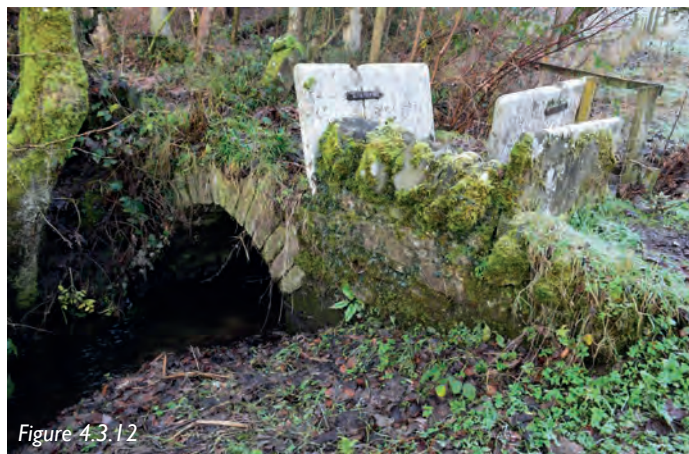
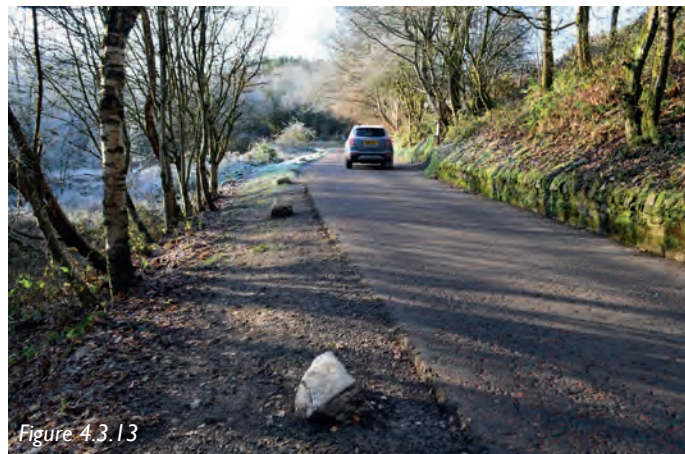
The single-span, stone-built, arched bridge which crosses the Dragon Burn is a delightful structure, which is now mostly hidden within the vegetation surrounding the burn. The stone parapet had been largely removed, possible as the bridge was modified to retrofit the vertical slabs in a kissing gate formation. The slabs lean significantly and may

cause significant damage to the bridge, should they collapse. As the bridge lies on a well used footpath, it is worthy of repair and conservation (Figure 4.3.12).

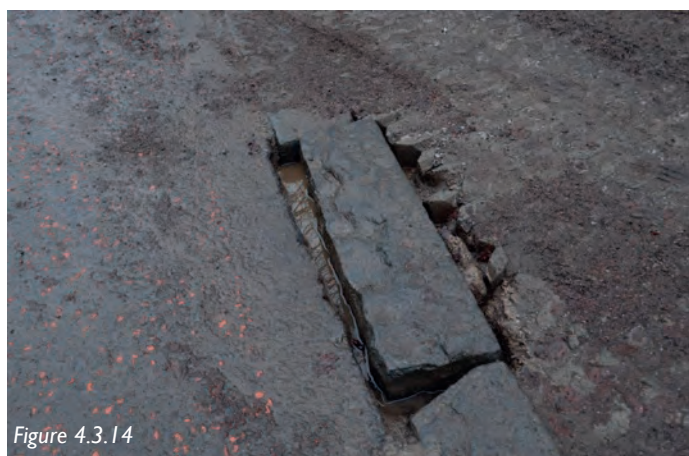
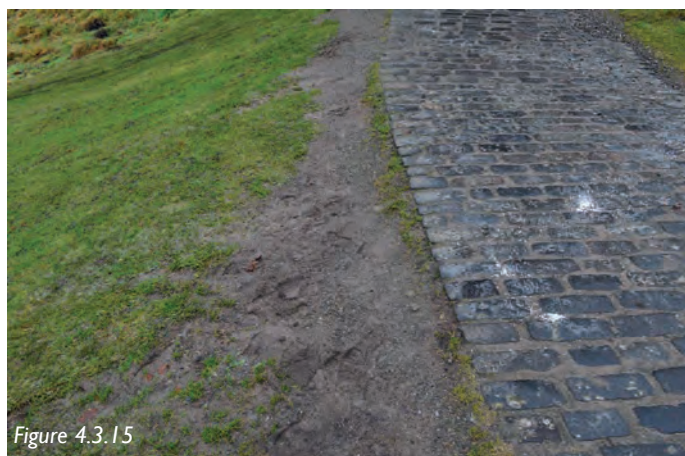
Where mini-buses have driven across the kerb to access the temporary parking area,

there has been damage and at the time of site surveys, a number of the kerbs were loose and broken. This area is also accessed by tankers for the sewage works, which contribute to the wear and tear of this hard surface (Figure 4.3.14).

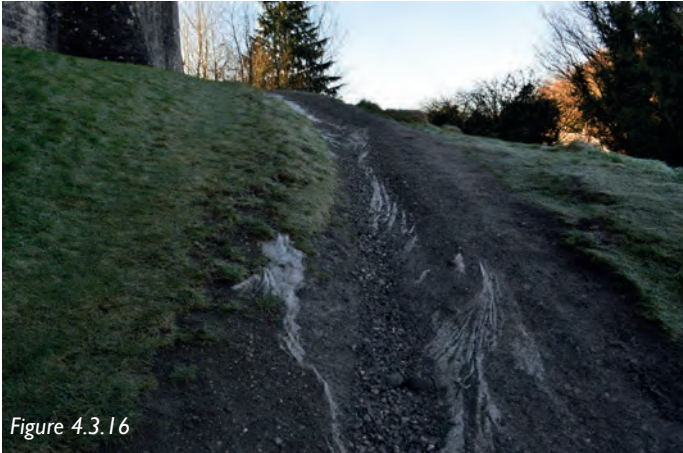
Figure 4.3.16

The condition of footpaths across the PiC study area varies according to the surface treatment. The cobbled path which runs from the car park to the castle is in excellent condition, however the edges have been eroded as visitors walk off the hard surface and across the earthworks (Figure 4.3.15). Informal paths through the wider landscape were observed to be in a wet and muddy condition, however the site surveys were carried out throughout the winter months. A short section of informal, gravel path was installed to the north of the castle, as works to consolidate the castle walls is being carried out, however this path is being eroded by visitors and the surface was observed

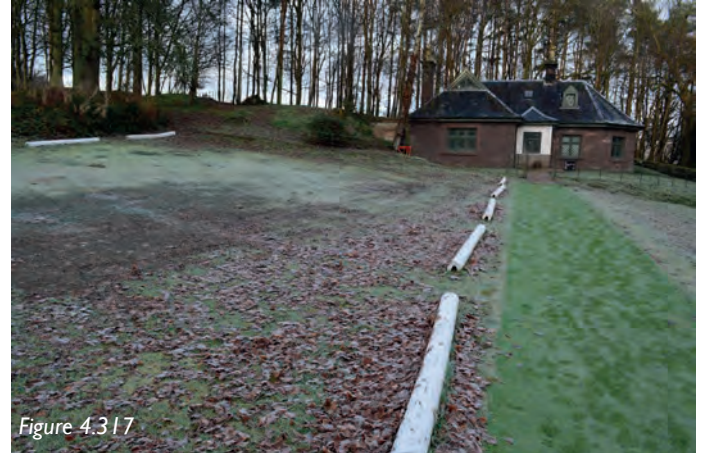
to be migrating across the earthworks (Figure 4.3.16). The path only allows access to the north western, external corner of the castle and appears to be very well used.

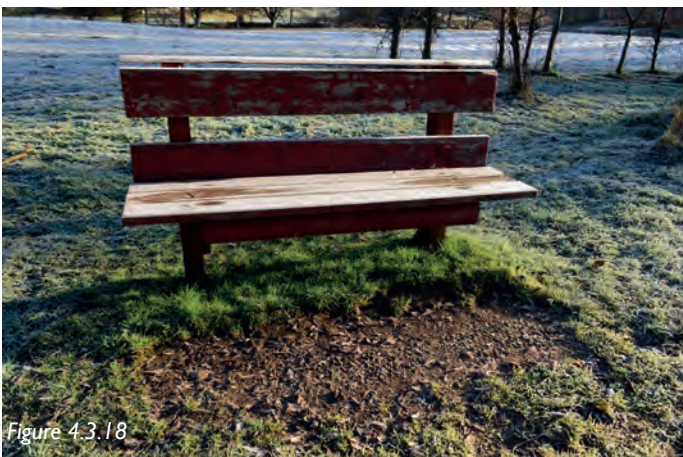
Figure 4.3.18

Seating opportunities throughout the landscape are poor, however those that do exist appear to be in good condition, however infrequently placed. Benches in character area 4 are located in ideal positions to appreciate a view of the River Teith although the benches themselves have an urban character (Figure 4.3.18). There is no design integrity or 'house style' between different pieces of furniture.

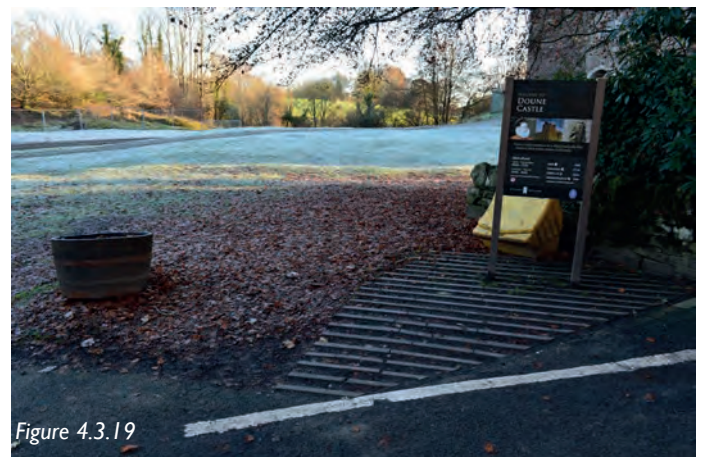
Figure 4.3.19

Information for visitors to the castle is limited to one board located at the edge of the car park (Figure 4.3.19). The landscape is cluttered, with a salt box located behind the information board. This board is difficult to see if cars are parked close by (Figure 4.3.20) and would benefit from re-location to the left of the entrance drive. There are no other information boards within the PiC study area.
