Technical Paper 10

U-values and traditional buildings

In situ measurements and their
comparisons to calculated values

Dr. Paul Baker (Glasgow Caledonian University)
January 2011

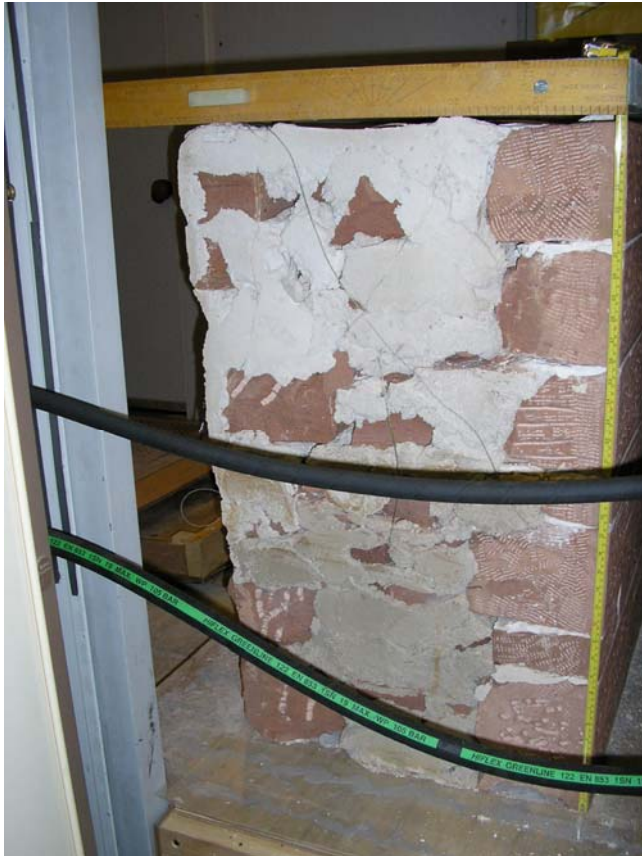
Figure 3: Solid wall construction. The example is of a test wall built by Historic Scotland's masons for GCU from Locharbriggs sandstone (see [Laboratory measurement in section 5](#)). The outer leaf (right) has an ashlar finish, whilst the inner leaf is a rubble construction. It has been estimated that the proportion of mortar in the wall is about 30% by volume.

Of the solid walls measured, most were made from stone (of differing stone types) bedded in mortar (generally lime mortar). Such stonewalls are not homogenous in their build-up but consist of inner and outer stone leaves with the centre of the wall being packed with smaller stones and mortar (Figure 3).

However, it is likely that the proportions of stone, mortar and voids are unknown, without intervention, which is the case for the buildings in this study. The sandstone test wall ([Figure 3](#)) described in [Baker et al. \(2007\)](#) was inspected and found to consist of about 70% sandstone and 30% mortar.

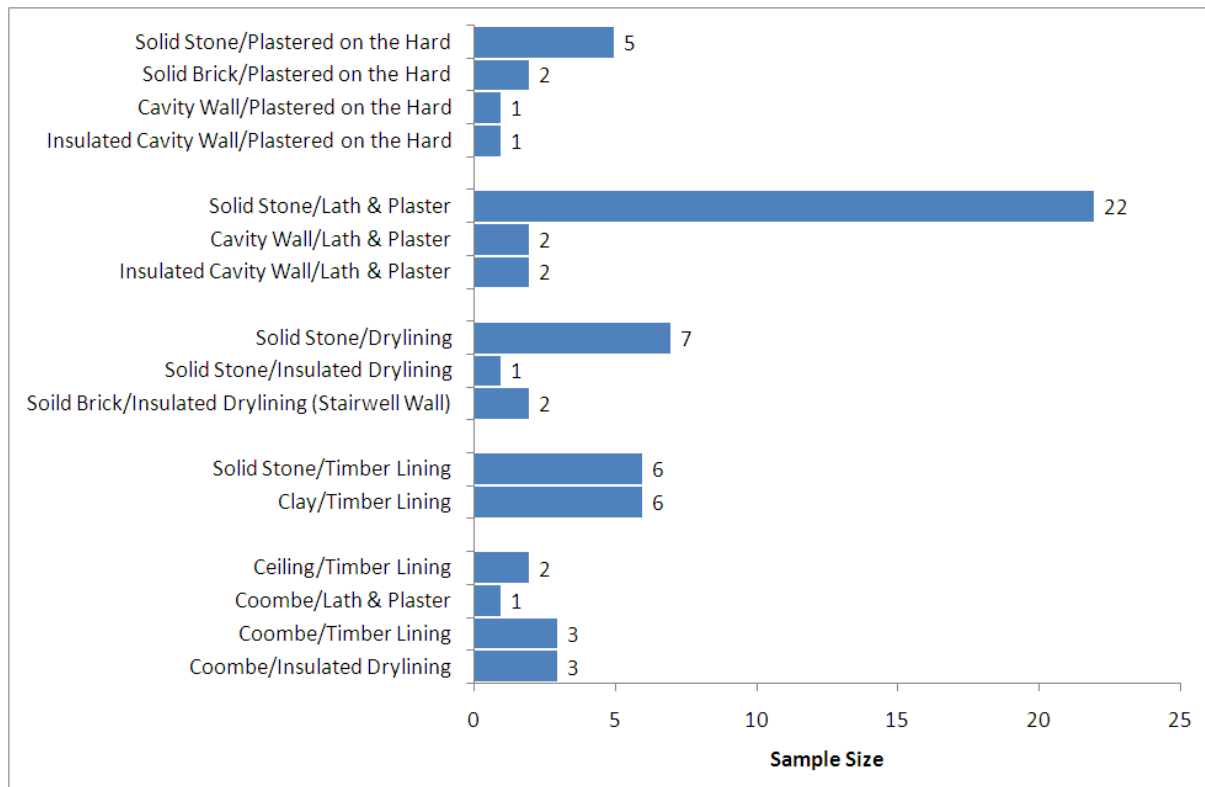
Figure 4. Distribution of measurement samples by construction type and surface finish

Figure 4 shows the distribution of measurement samples by construction types and surface finishes.

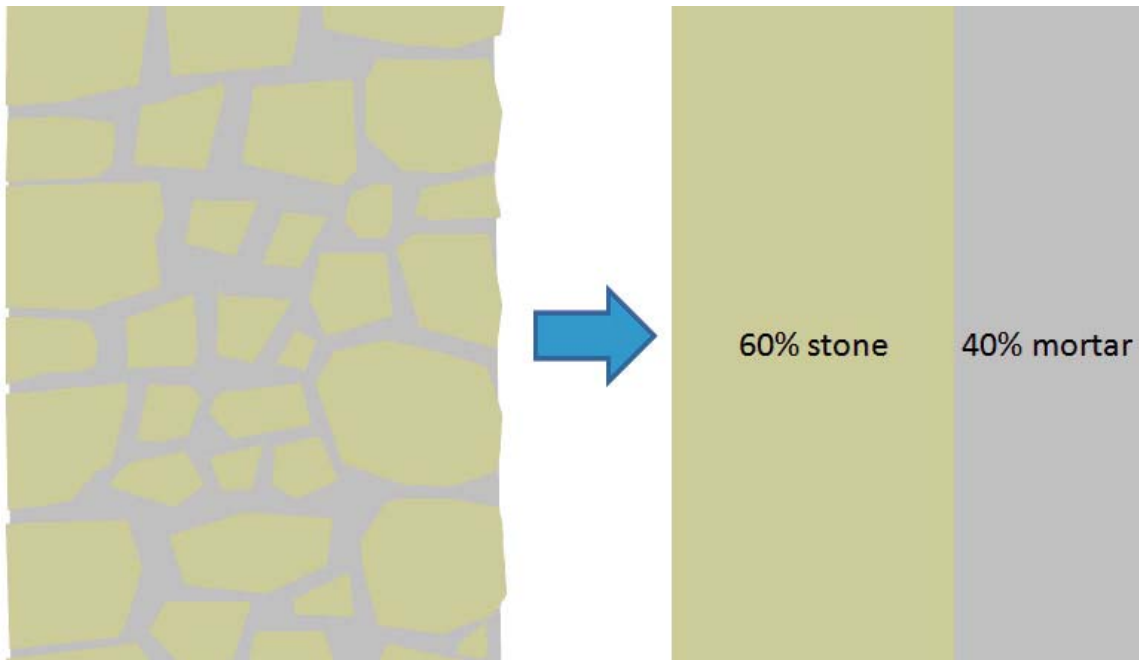
Figure 5. Traditional solid wall construction: the left figure (a) shows a schematic diagram of a rubble wall construction with 40% mortar; and the right figure (b) shows its representation as two layers for modelling.

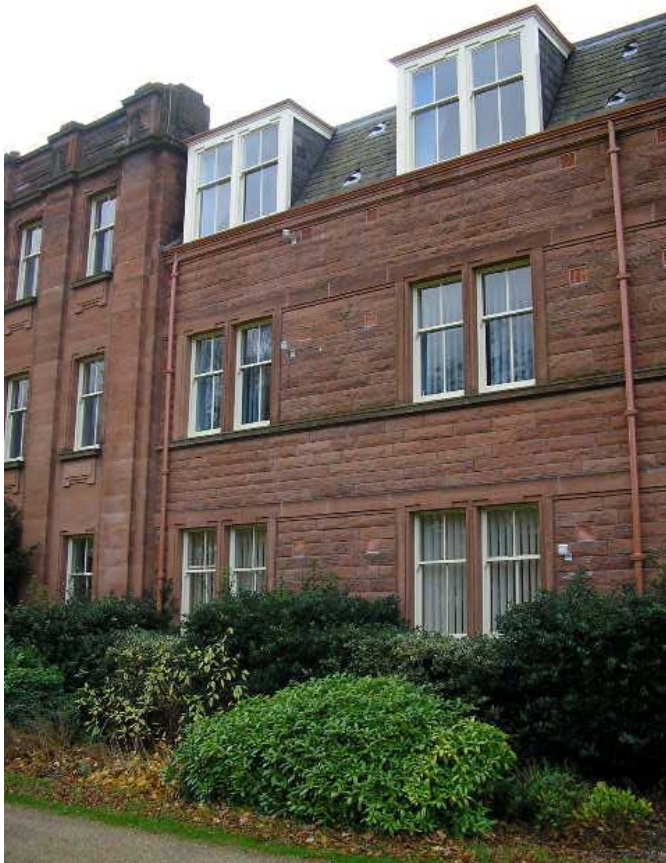
Figure 7. McCowan House (ID13) with several external ventilation grilles visible at high level either side of the windows.

The results for McCowan House (ID13) are also uncertain since an existing ventilation system in the walls has some influence on the U-value estimates, particularly on the top floor of the building. It is thought that warm air from rooms may enter the ventilation system through grills in the internal walls and circulate behind the internal leaf of the wall, before exiting via external grills. External air may also enter the system via the external grills (Figure 7). There is also some evidence that wind speed and direction, measured at a local

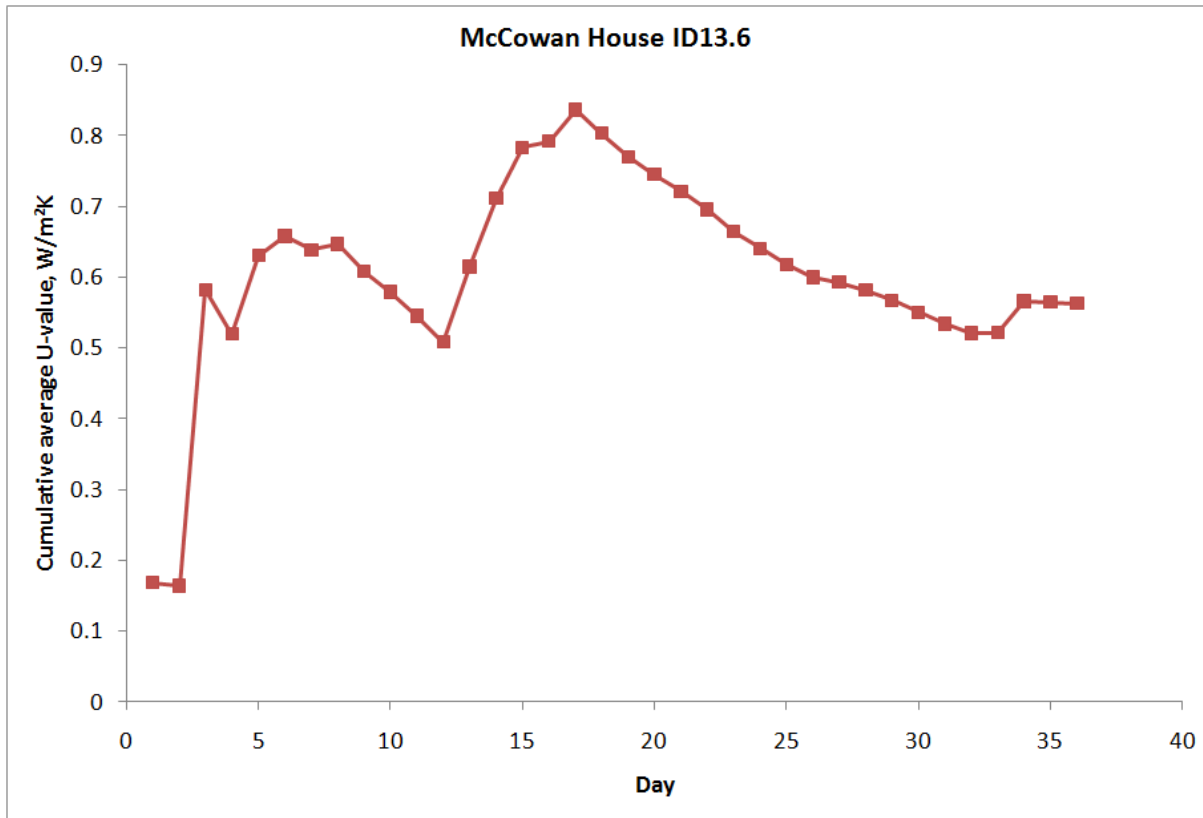
Figure 8. Cumulative average U-value over a 36-day period for McCowan House, measurement ID13.6 (North elevation, 2nd floor). Compare this graph to [Figure A8 in Appendix A](#).

weather station, may influence this behaviour. Using the analysis method described in [Section 3](#) and Appendix 1 does not produce a stable value, for example if the cumulative average U-value is plotted daily for measurement location ID13.6 (heat flux sensor on North-facing 2nd floor wall) the U-value does not approach an asymptote after a reasonable test duration, ≥ 14 days ([Figure 8](#)).

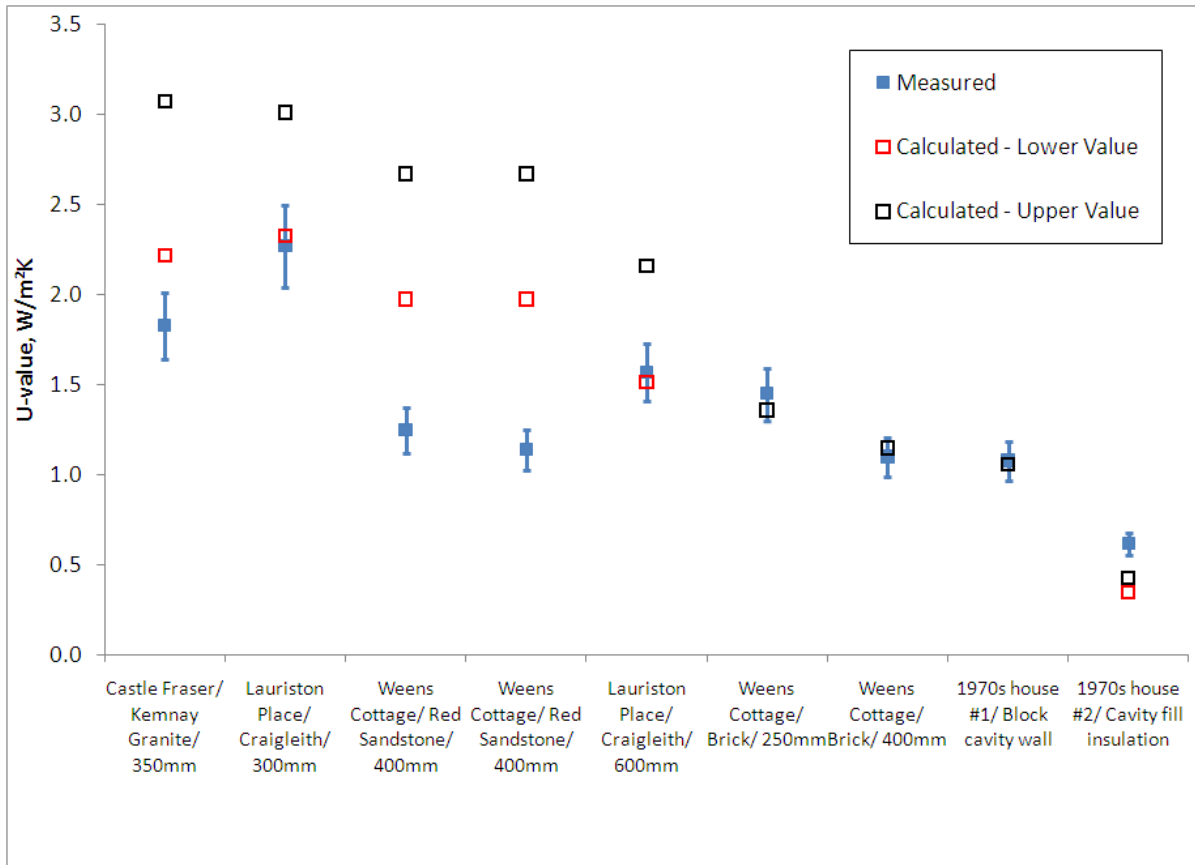
Figure 9. Results for walls finished with plaster on the hard

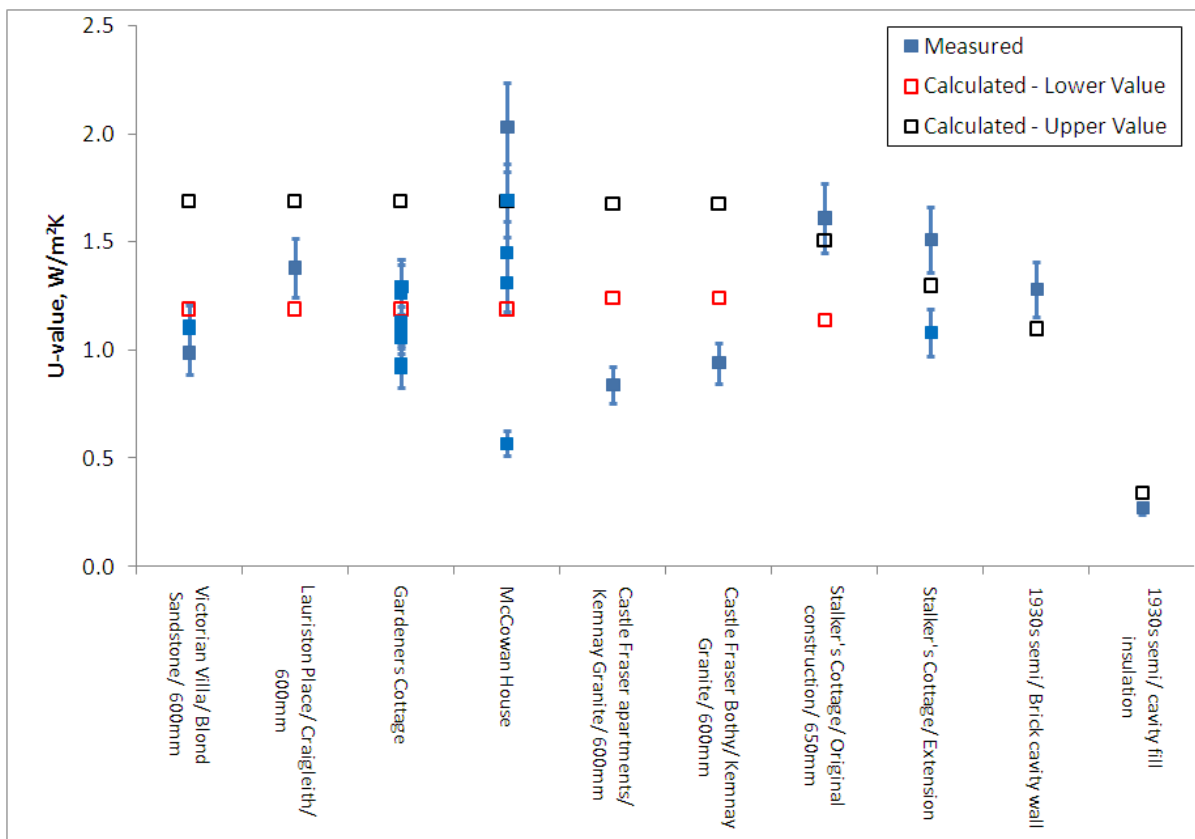
Figure 10. Results for walls finished with plaster on laths

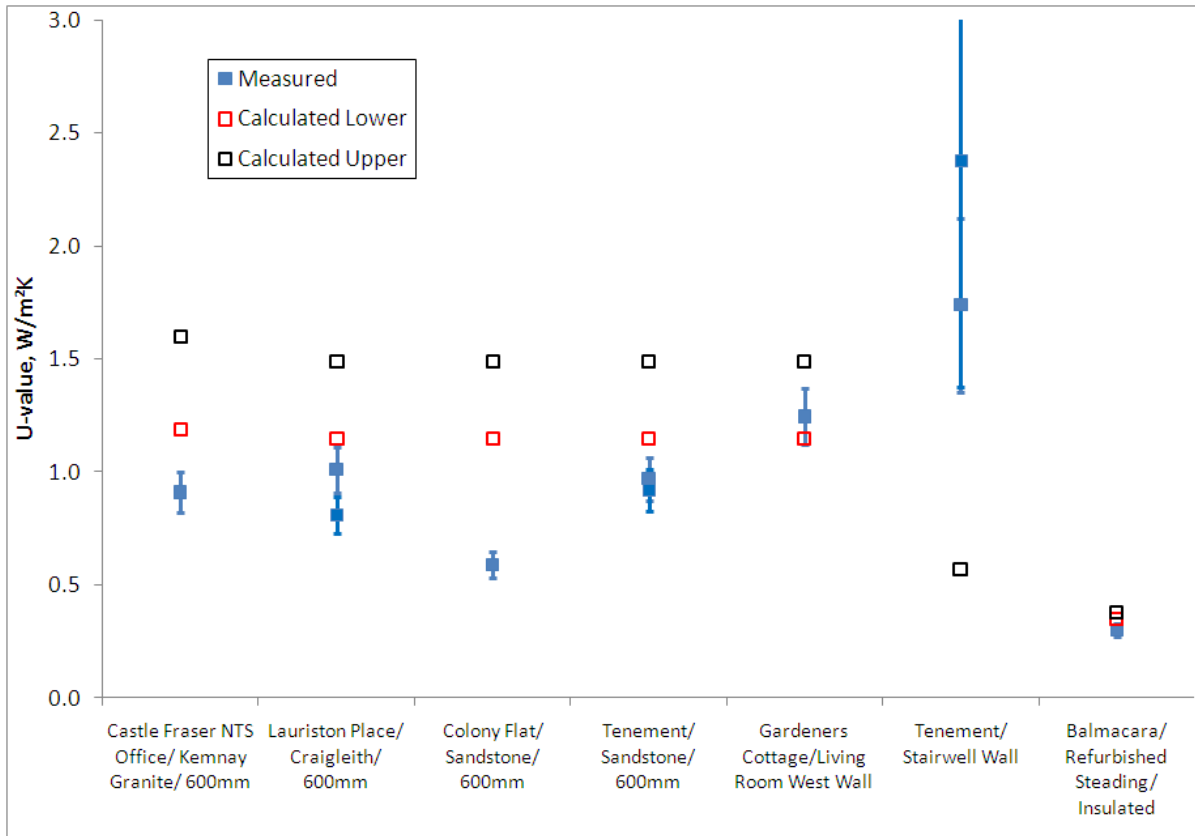
Figure 11. Results for walls finished with drylining

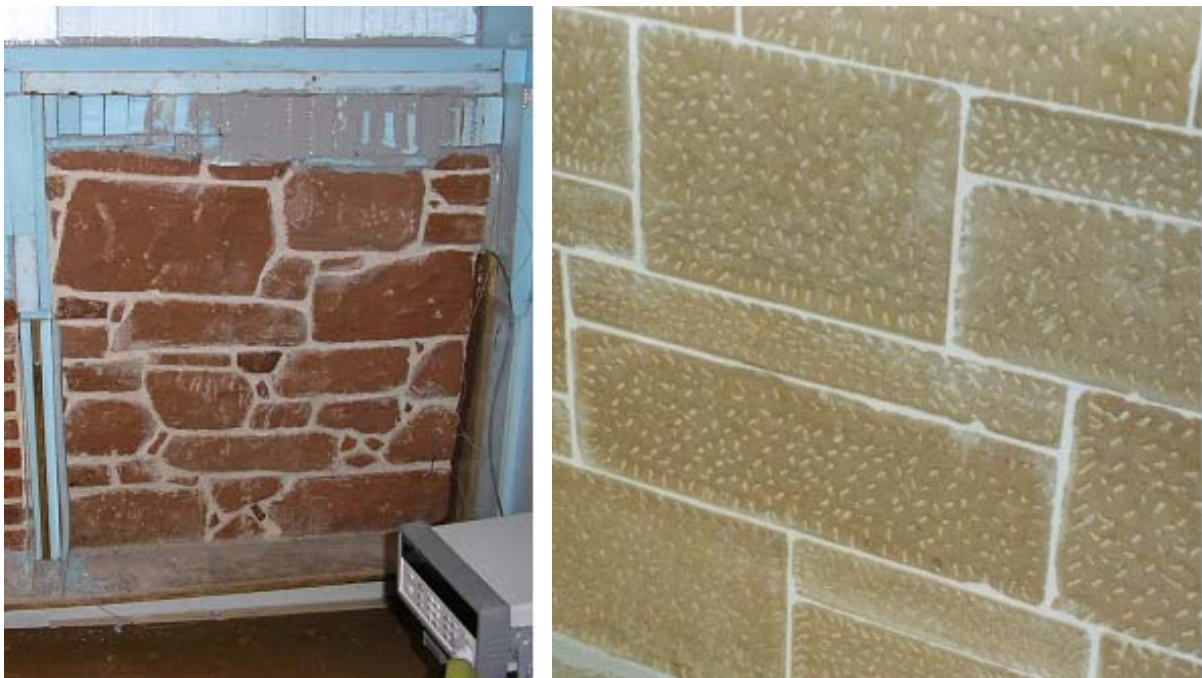
Figure 14. Locharbriggs sandstone wall in test chamber. The left photo shows the internal rubble face; the right photo the external ashlar face.

In addition to the measurements within buildings, two *situ* U-value measurements were made on a Locharbriggs sandstone wall constructed within an environmental test chamber at GCU. The wall thickness was 550 mm and has an ashlar exterior, and a rubble interior, face ([Figure 14](#)). A heat flux sensor was mounted in the centre of the interior wall face.

Temperatures of 23°C on the warm side and 8°C on the cold side of the wall were maintained. The U-value was determined from 10 days data which are sufficient under steady conditions.

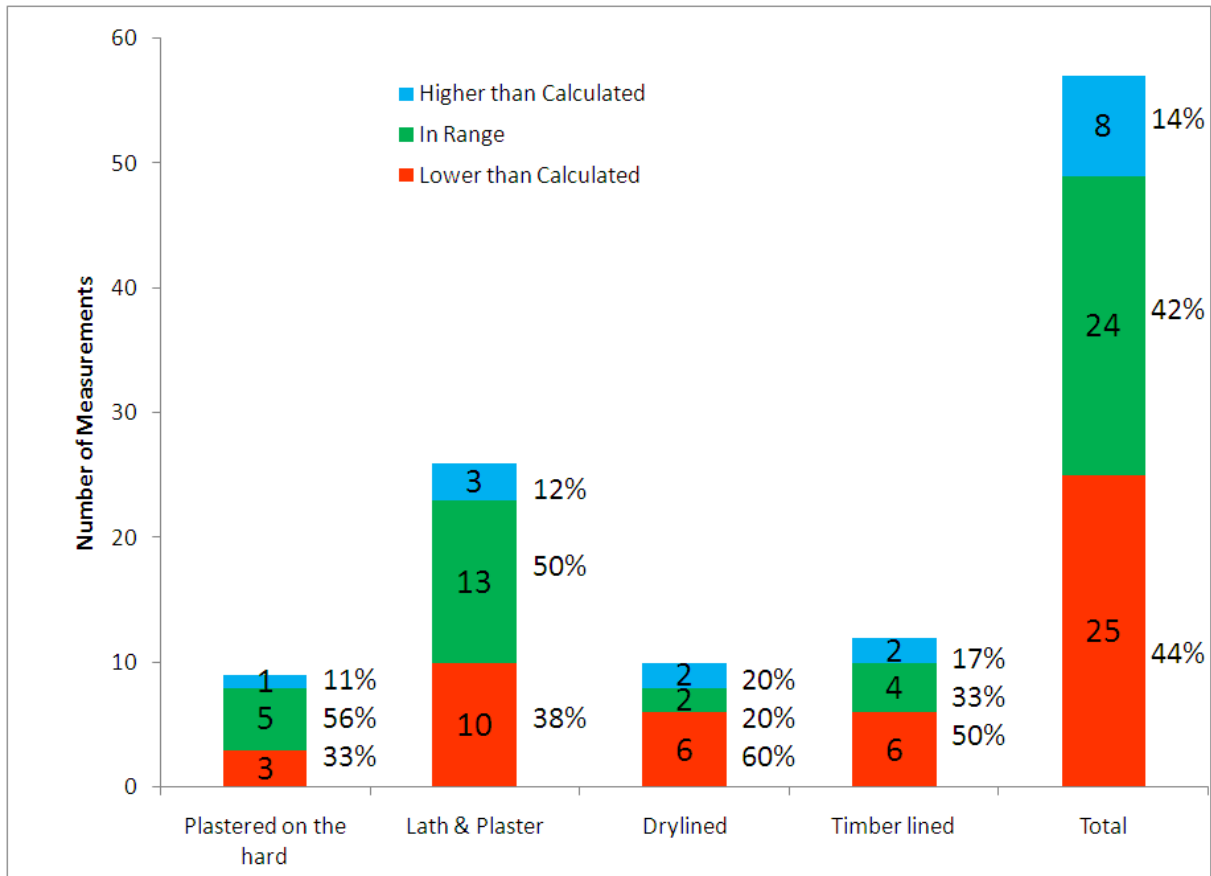
Figure 16. Comparison between measured and calculated results by category and total number of measurements for solid stonewall constructions only. "Upper limit" categories represent the calculated U-values for stonewalls modelled as internal finish and stone without allowance for mortar. "Range" categories represent the possible range of calculated values for stone/mortar ratios between 60/40 to 100/0.

Considering solid stonewall constructions only, if only the upper calculated value is taken, as may be the case if the solid stone part of a wall build-up is modelled solely as “sandstone” without considering the proportion of mortar in the wall, then only two of the measurements (5%) are within range of the predicted U-value compared with 18 (45%) considering the range of possible calculated results for different stone/mortar ratios (Figure 16).

Figure 16 indicates that if the build-up for solid stonewall is simply calculated without considering the proportion of mortar in the construction, this will result in an overestimation of the U-value. Some improvement in matching measured and calculated values is achieved if the solid stone portion of the wall is modelled as a mixture of stone and mortar. However, this approach is unsatisfactory for more than 50% of the *in situ* measurements.

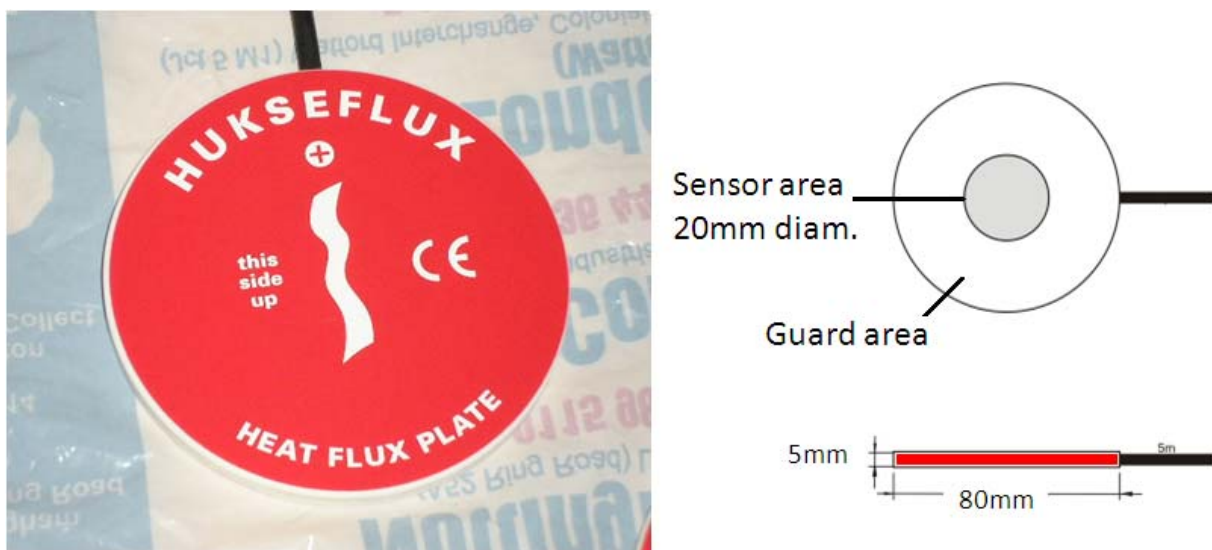
Figure A1. Heat flux sensor

Hukseflux HFP01 heat flux sensors were used to measure heat flows through the selected walls (Figure A1). The sensors are 80 mm in diameter and 5 mm thick. The sensors were mounted by firstly applying a layer of double sided adhesive tape to the back of the sensor. Secondly, low tack masking tape was applied to the wall. Finally, the heat flux sensor was applied firmly to the masked area. This arrangement was generally satisfactory for two or more weeks monitoring on painted surfaces. Wallpapered surfaces were not generally used in case of damage. Sensor locations were chosen to avoid probable thermal bridge locations near to windows and corners, with the sensor ideally located about half-way between window and corner, and floor and ceiling (Figure A2). Where possible a North-facing or sheltered elevation was selected to reduce the influence of solar radiation on the wall.

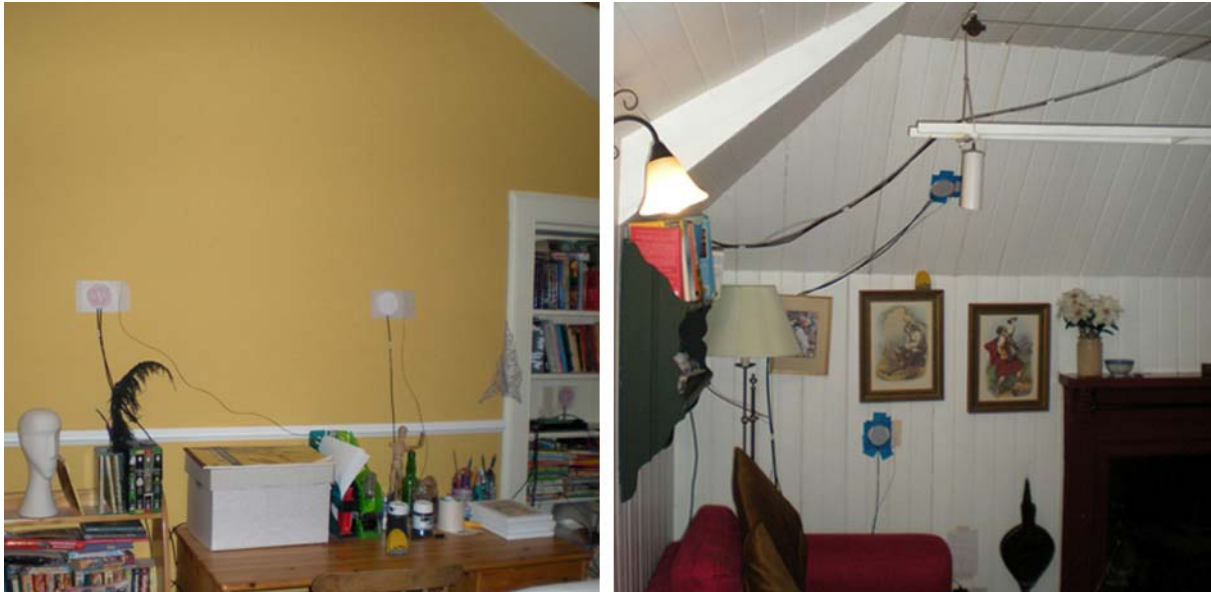
Figure A2. Typical heat flux sensor and room temperature measurement locations

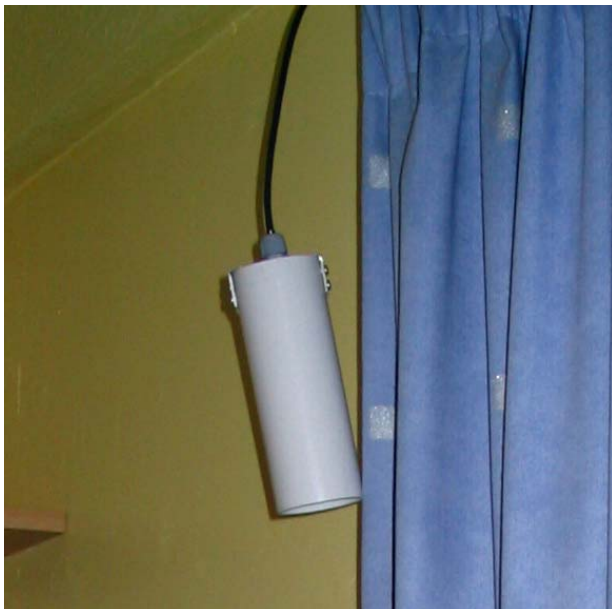
Figure A3. Room air temperature shield

To measure room air temperature, stainless steel-sheathed thermistors, Campbell Scientific type 107 temperature probes, were used internally mounted within a simple radiation shield in order to minimise the influence of solar radiation and other heat sources (Figure A3).

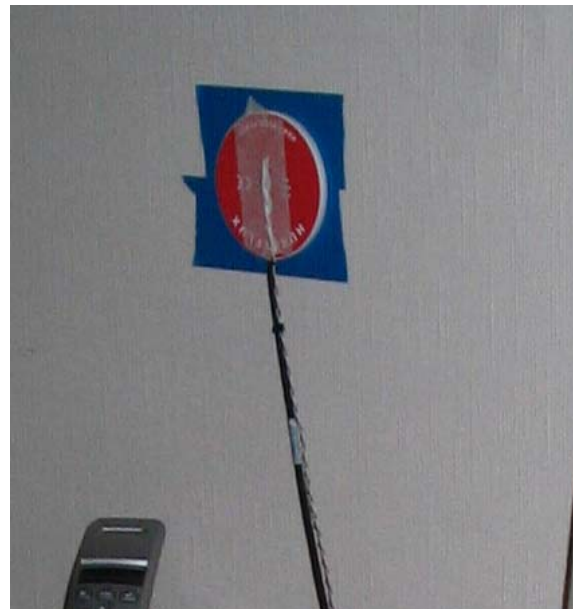
Figure A4. Type-T thermocouple mounted on surface of heat flux sensor

The surface temperature of the face of each heat flux sensor was measured using type-T thermocouples taped onto the surface of the heat flux sensor (Figure A4).

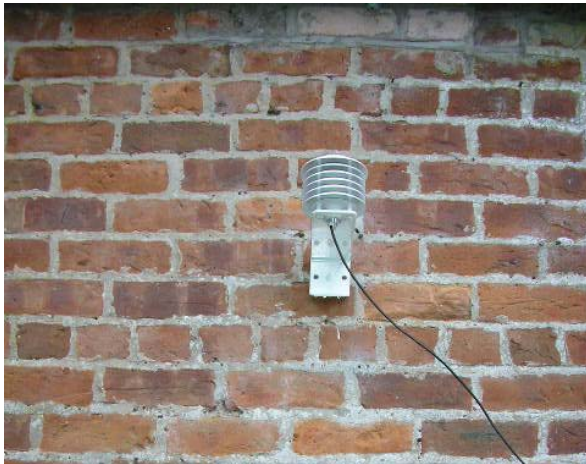
Figure A5. Campbell Scientific 107 Temperature Probe in a radiation shield screw-fixed into a mortar joint of the external wall face. The probe is connected to a data logger inside the building.

exterior wall surface by screw-fixing the bracket of the shield to a mortar joint (Figure A5), or by tying the bracket to a rainwater downpipe. External temperatures were also measured using separate data loggers (Gemini Tinytag Plus 2 with Tinytag Standard Thermistor Probes) which could be mounted outdoors (Figure A6), as it had been found that, during the first phase of the project, it was not always possible, or practical, to run an external sensor cable back into the building, particularly through sash windows without leaving the window slightly open to accommodate the cable. In contrast modern windows fitted with a gasket seal can be closed onto a cable.

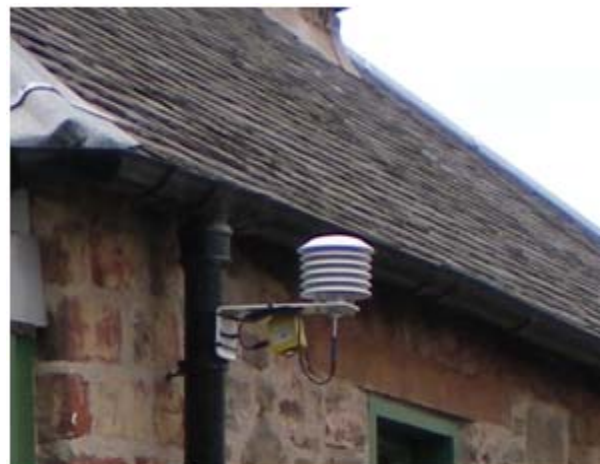
Figure A6. Tinytag Standard Thermistor Probe in a radiation shield tied to a rainwater downpipe. The probe is connected to a Tinytag Plus 2 data logger hanging from the shield bracket.

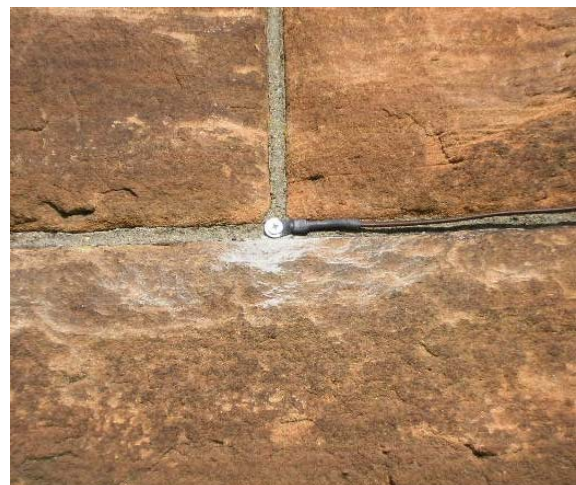
Figure A7: Method of mounting external surface temperature sensor to mortar joint not made where access was a problem, or fixing in the manner described would damage the external finish.

External wall surface temperatures were generally measured using type-T thermocouples. Crimp-on terminals were used to secure surface temperature sensors to mortar joints, by drilling and plugging joints (Figure A7). External surface temperature measurements were
