TECHNICAL PAPER 38

DIGITAL DOCUMENTATION, COMPUTER
VISION AND MACHINE LEARNING FOR
MASONRY SURVEYING AND MAINTENANCE

HISTORIC
ENVIRONMENT
SCOTLAND

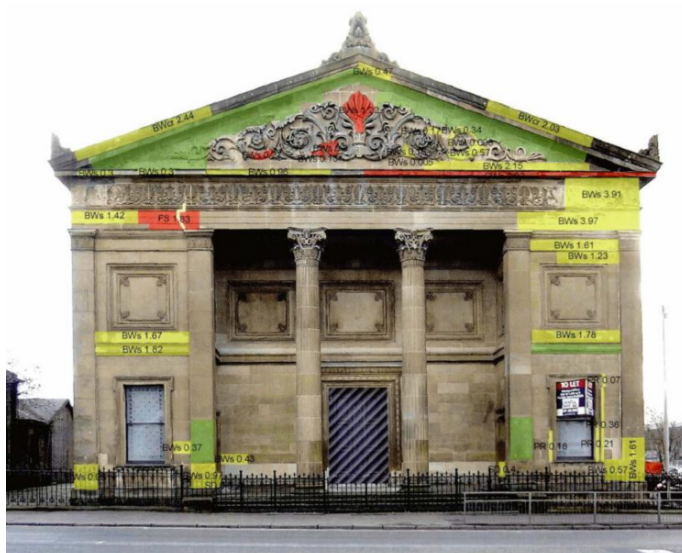
- Stone requiring immediate replacement
- Stone requiring replacement within 20 years
- Stone requiring replacement within 20 years unless urgent maintenance is carried out
- Stone showing some deterioration but will last more than 20 years
- Stone requiring future replacement (>20 years) unless maintenance is carried out

Figure 1: Rectified image of façade with overlays showing stone decay codes and repair needs. Image reproduced from *Stonemasonry skills and materials* (2007).

The second stage is a preliminary survey that is usually conducted from the ground. This often utilises a good quality digital camera (i.e. DSLR) that is used to capture each masonry elevation. The subsequent images can be 'rectified' to provide an elevation view that can be 'marked up'. The façade elevation is often the focus of much of the time and cost associated with a survey given the architectural importance and likelihood of decorative carved enrichment, relative to other elevations. From this image, a drawing showing each stone may be produced. This is onerous in terms of time, cost, and at times access, and is also prone to measurement error given the often large number of individual masonry units. Beyond the recording of each stone, additional information such as condition and defects can be marked in the drawing. This is attained via visual survey from ground level using binoculars or from working platforms. Damage to masonry and their levels of degradation may be recorded using Fitzner's Damage Index method (Fitzner *et al*, 2002). Figure 1 illustrates an example of resulting annotated image. Note that scaling of the image is obtained by measuring some elements on site, here the hatched doorway. This process is finely described the guide *Stonemasonry skills and materials: a methodology to survey sandstone building façades* produced by HES (Urquhart, 2007).

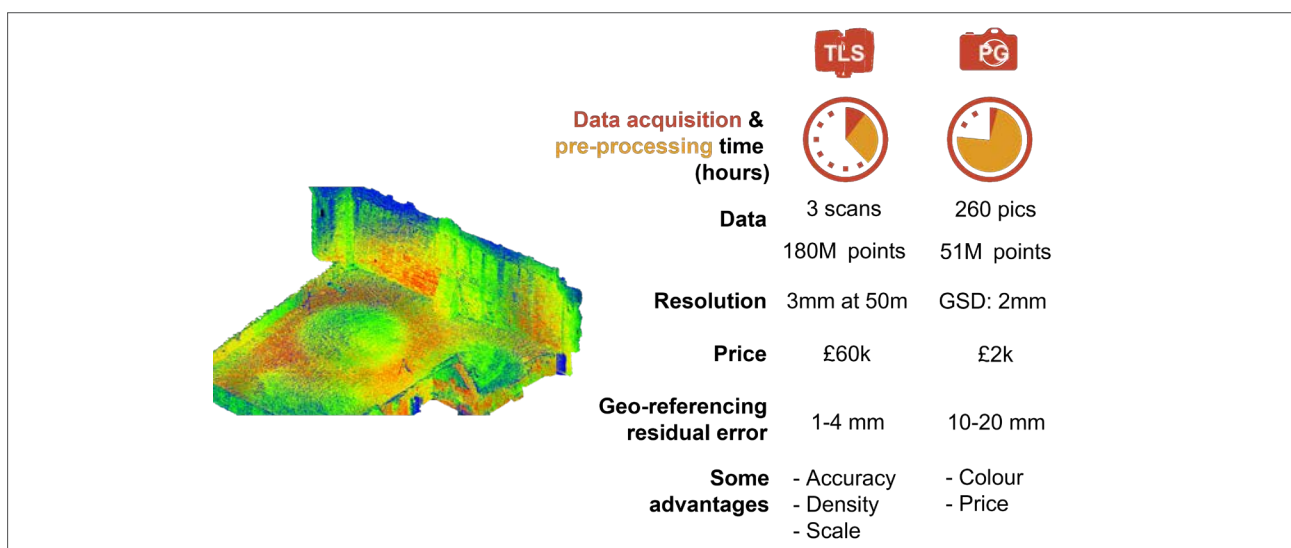
Figure 2: Comparison for TLS and PG technologies for the data acquisition and pre-processing of the east garden of Craigmillar Castle (Edinburgh).

These pre-survey considerations may be thought of as being largely circumvented in digital data acquisition, but, as was shown in the Craigmillar Castle example and illustrated in Figure 3, poorly planned digital surveys can lead to incomplete data debasing the survey findings. Within this context, minimising occlusions, ensuring the right level of point cloud density, and conducting surveys in favourable light conditions (if colour information is important) are part of the planning for scanning/photogrammetry strategy.

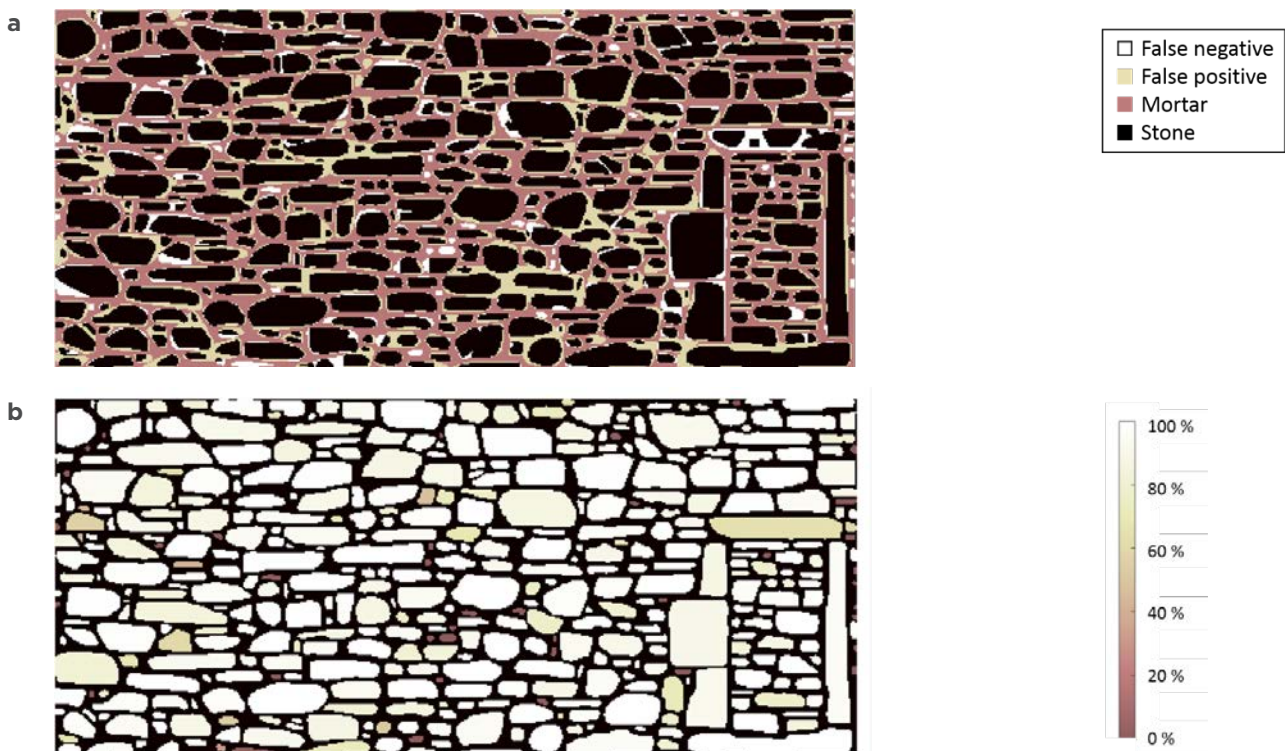
Figures 7a and 7b: Illustration of the assessment of the performance of the proposed wall segmentation algorithm. In a) the labelling performance results are shown. Black and magenta regions are pixels that are correctly recognised as stone and mortar respectively. Yellow regions are 'false positives', i.e. mortar areas that are incorrectly labelled as stone. White regions are 'false negatives', i.e. stone areas that are incorrectly labelled as mortar. In b) each stone is coloured according to the percentage of its area (in the orthophoto) that is properly labelled as stone.

A quantitative assessment of the segmentation accuracy has been undertaken by comparing the results obtained by the algorithm against those obtained through a meticulous manual segmentation in the section's orthophoto. Figure 7a illustrates the labelling performance results. It shows good overall results, although the size of the stones seems slightly over estimated by the current algorithm. Figure 7b further summarises the results of Figure 7a by colouring each stone according to the percentage of its area in the orthophoto that is correctly labelled as stone. As can be seen, the area of most stones is typically well segmented, with ratios over 75% for the majority of stones. The few errors appear for some (but not all) of the smallest ones.

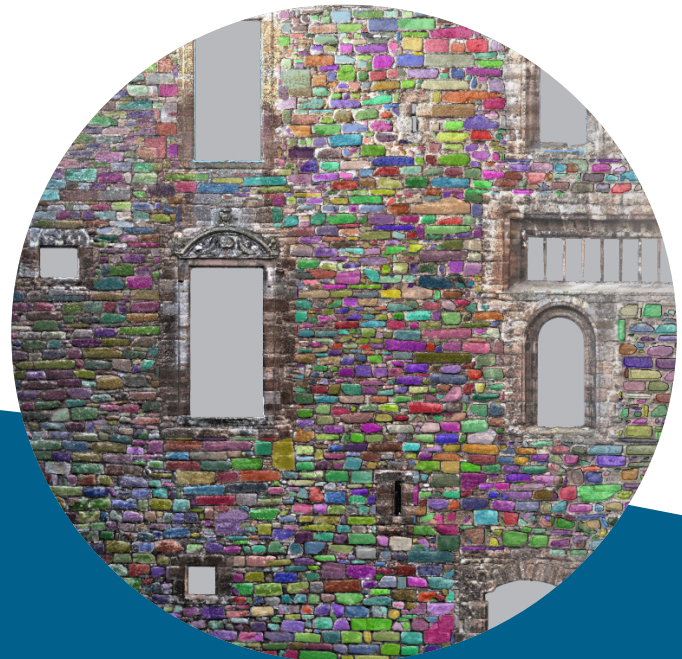
Figure 9: Linlithgow Palace courtyard west wall. 9a) 3D coloured point cloud; b) segmented and labelled stones; and c) mortar depth map.

The above algorithm for the automated segmentation of rubble masonry is demonstrated at a larger scale for the west wall of Linlithgow Palace courtyard (Figure 9). In that example, architectural components such as windows and doors, have been removed from the point cloud as these elements are not meant to be processed by means of the method proposed in this paper; they are not the ‘wall’ component. Only the points corresponding to the building component ‘wall’ were processed by the proposed algorithm. Figure 9b shows the stones detected in the walls, and Figure 9c the mortar regions with their calculated depth.

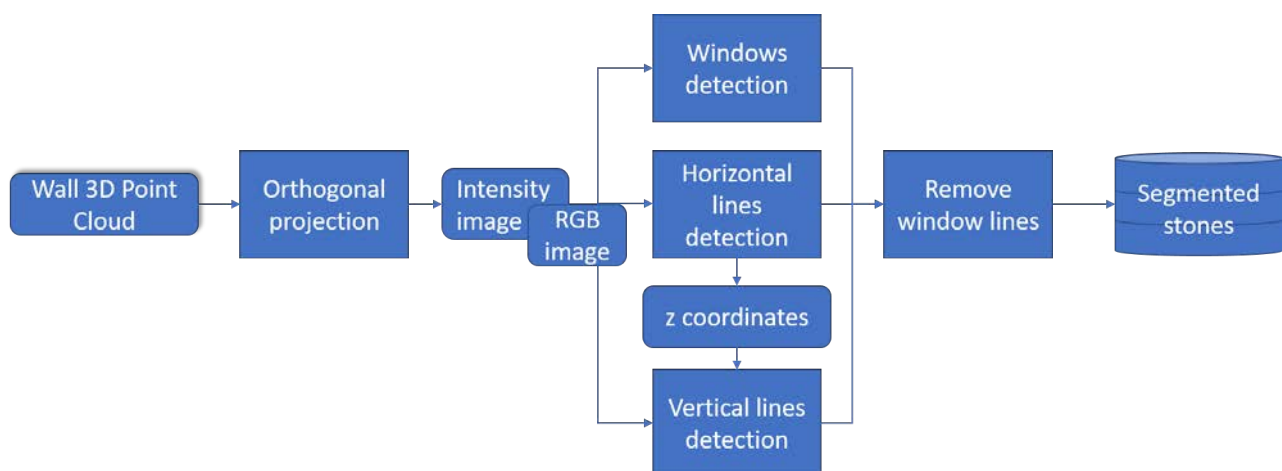
Figure 10: Data processing pipeline for the segmentation of point clouds of ashlar masonry into individual stones and mortar regions.

The data processing pipeline is summarised in Figure 10 and the individual stages are briefly summarised below:

- **Orthogonal projection:** the input to the process is the 3D point cloud of a wall façade. We fit a plane to that data and create intensity and colour images (i.e. maps) of the wall by projecting the 3D points on that plane. In both maps, each pixel value is the average intensity, red, blue, and green of the 3D points that orthogonally project onto that pixel.
- **Window edge detection:** this process takes as input the intensity map and identifies empty regions (where no 3D points have been projected) that correspond to openings in the wall. The bounding boxes of the areas without projected points are considered the boundaries of the windows.
- **Horizontal mortar joint detection:** this process takes as inputs intensity and grayscale maps (the

latter derived from the RGB values) and delivers the vertical coordinates of the horizontal mortar joints. To obtain these, median values of intensity and grayscale are calculated for each row of the map and compared with the median values of the adjacent rows, following a strategy based on the analysis of histograms (Acas, 2021). Those rows containing an important number of pixels with intensity/grayscale values considerably different to the adjacent rows are labelled as horizontal mortar joints.

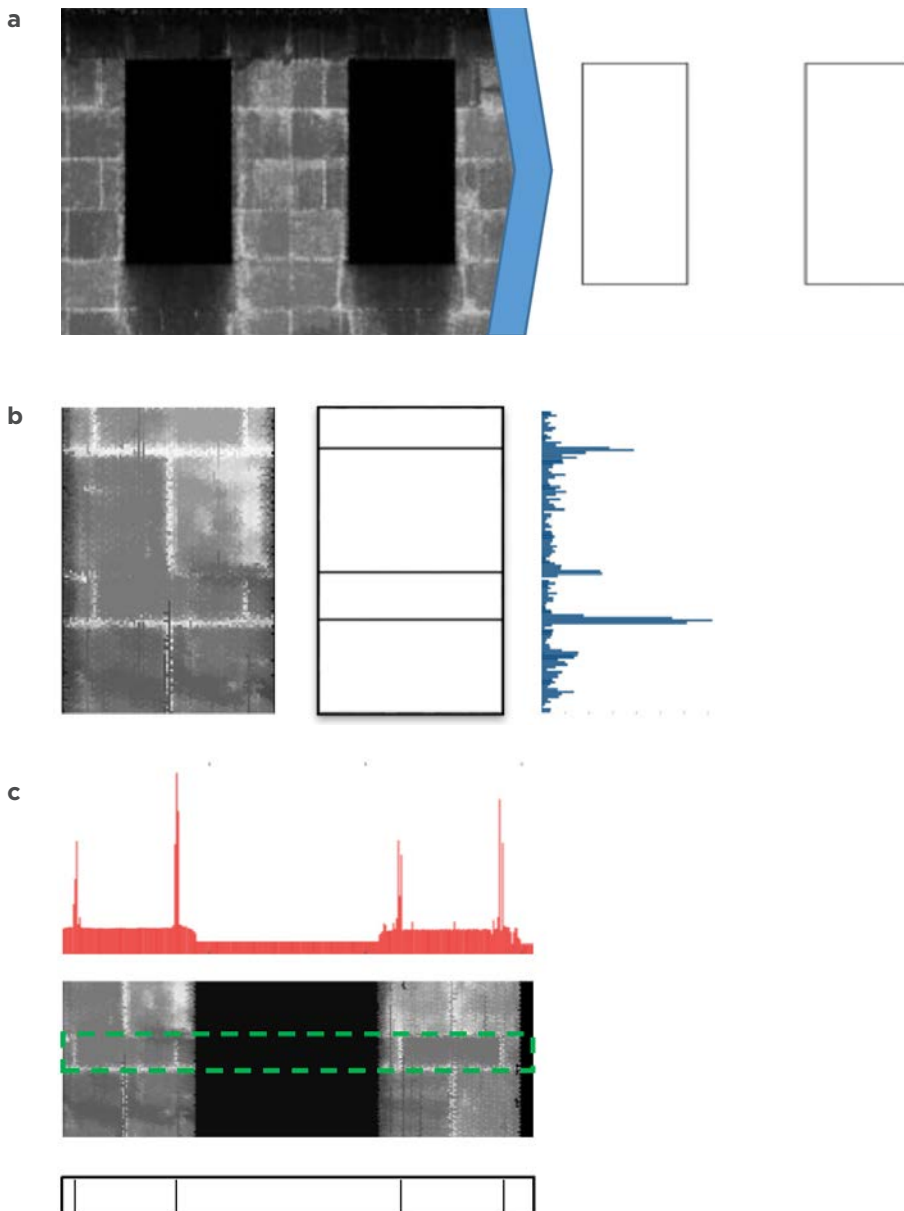
Figure 11: a) Windows; b) horizontal; and c) vertical mortar joints identified for ashlar masonry. See Acas (2021).

- **Vertical mortar joints detection:** the vertical coordinates of the horizontal mortar joints are utilised to define horizontal strips (see Figure 11a) that represent each row of stones. These strips are then evaluated using a similar approach to now identify vertical mortar joints (Figure 11b).

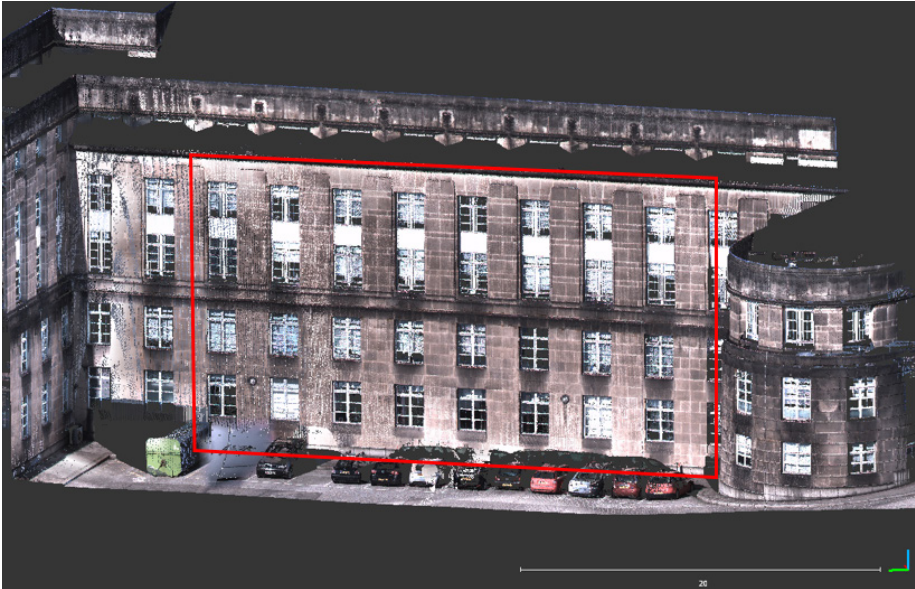
Figure 12: South-eastern façade of St Andrew's house. The region of interest is highlighted in red.

The algorithm for the automated segmentation of ashlar masonry has been tested at larger scale with data from the south-eastern façade of St Andrew's House, in Edinburgh (highlighted in red in Figure 12). As can be seen in Figure 13, due to varying wall patterns in terms of brick configuration, colouring, and window positioning, the point cloud has been divided into two trial datasets: the upper wall section and lower wall section. The significant height of the façade makes this division into the upper and lower sections useful to evaluate the potential effects of the inclination of the laser beam hitting the wall for capturing geometric data. Note that the bottom part of the lower wall section is occluded by parked cars, and therefore incomplete, so it has been removed from the cloud.

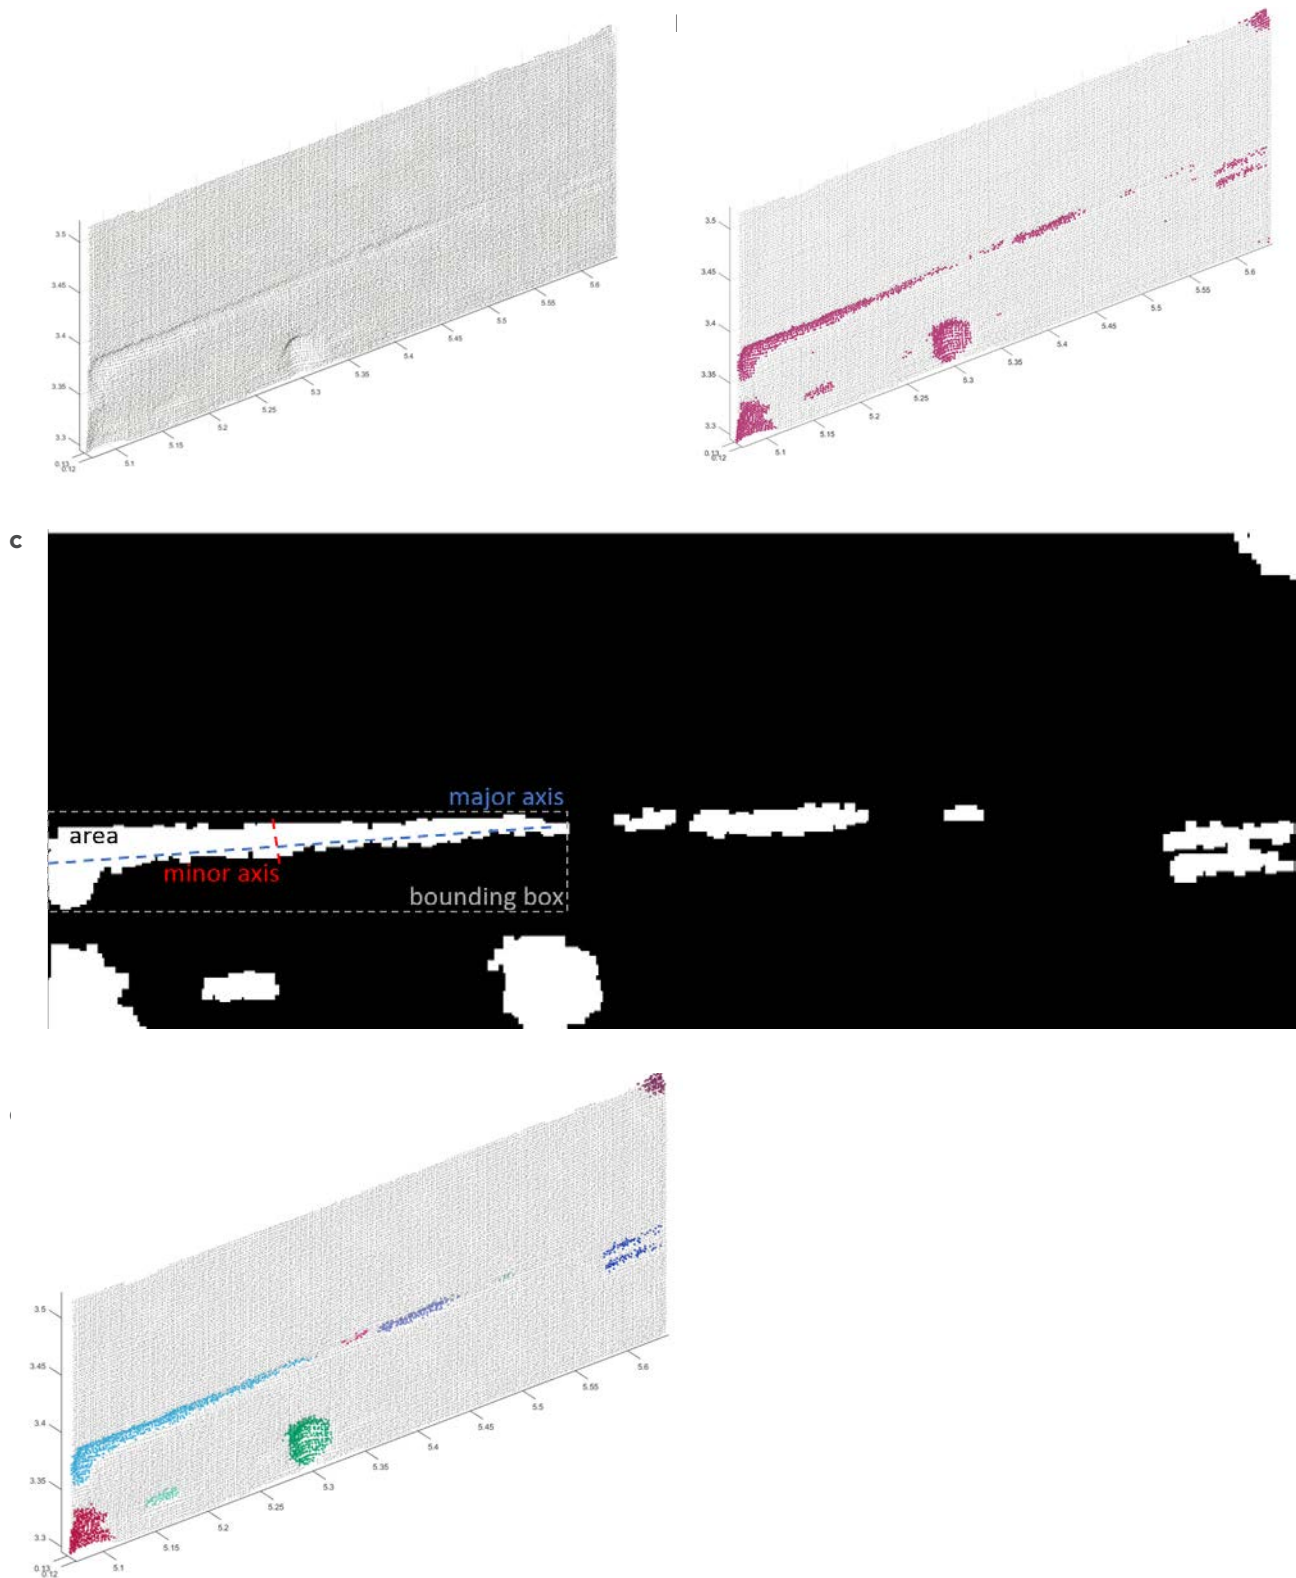
Figure 17: Process for the extraction of geometric parameters. 17a) Point cloud of an ashlar masonry wall; b) outliers, highlighted in pink; c) binary map after orthogonal projection of outliers; d) potential geometry-related defective areas highlighted in different colours. In subfigures including axes, values are in meters.

For deterioration associated to geometry, a plane is fitted to the surface of each ashlar stone. Areas containing outliers, characterised as being points far from the plane, can be considered potentially affected by decay (see Figure 17a and Figure 17b). Depending on the finishing of the ashlar, a threshold (i.e. distance point to plane) is set to identify the outliers. Aside from unique treatments, ashlar face tooling depth is normally below 2.5mm. We thus set the threshold to that value. The layout of the outlying points and how the regions are connected can subsequently help identify the nature of the defects.

Each masonry unit may present one or more defect. To detect different decayed areas, a binary map with a resolution of 1mm is created by projecting the above outliers onto the fitted plane, as illustrated in Figure 17c. Compact regions are then segmented from one another using a region growing algorithm. Finally, the original 3D points corresponding to each detected defective area are correlated, as shown in Figure 17d. The segments, enclosed by bounding boxes (i.e. Region of Interest or ROI), are stored as independent entities for which geometry-related metrics are subsequently calculated to characterise the deterioration patterns.

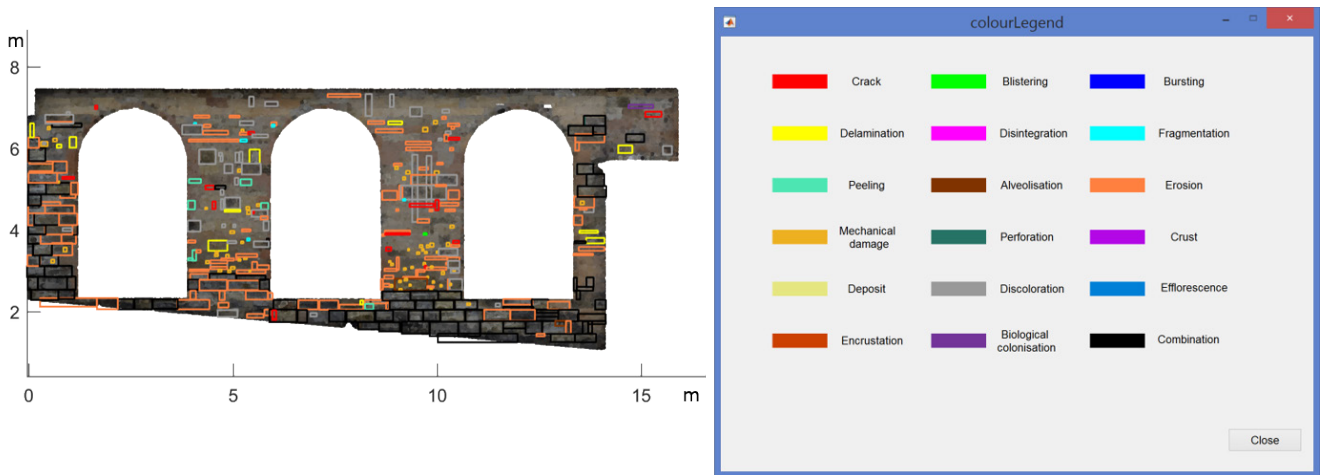
Figure 19: Defective areas labelled by surveyors.

For training the supervised classifier, deteriorated regions have been manually segmented and labelled by experienced building surveyors who specialise in stone, and following the criteria presented by ICOMOS (see Wilson *et al* (2018) and Figure 19). Each segment, which is marked as a rectangular ROI, is given a label indicating the defect observed in the area. The feature parameters described above are then calculated using XYZ and RGB data contained within each rectangular boundary.

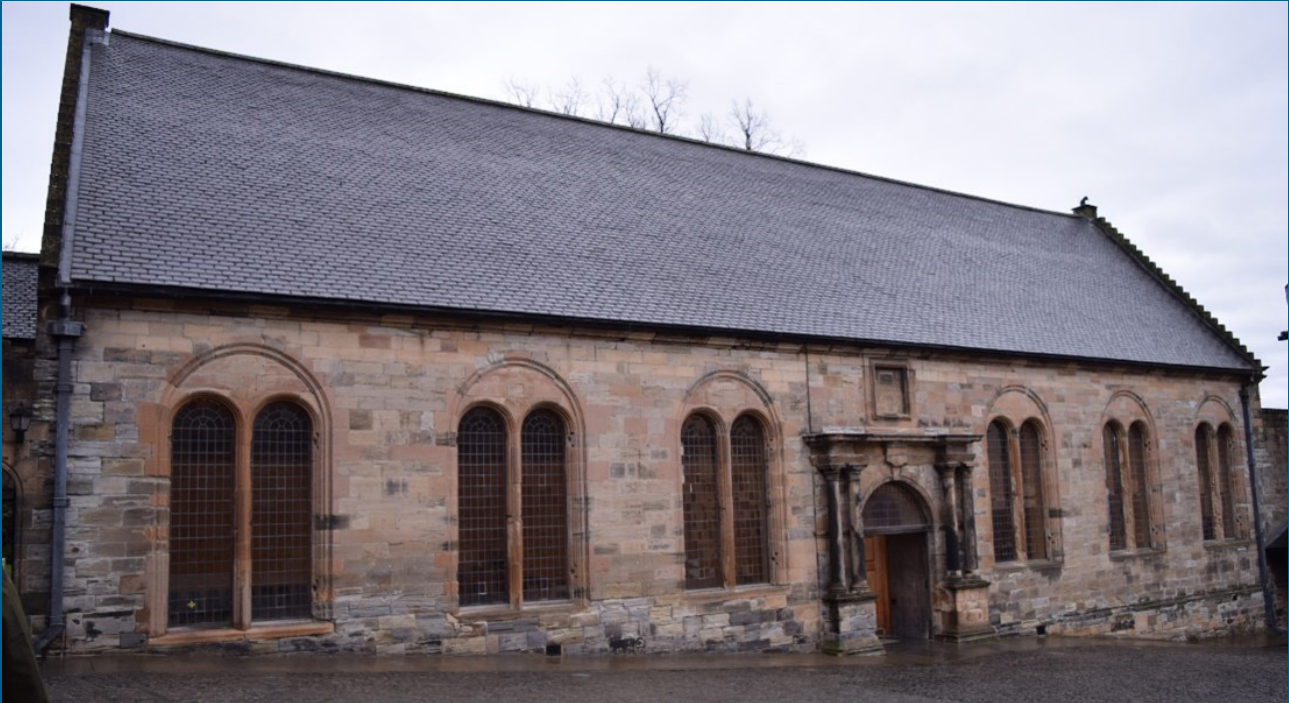
Figure 20: South façade of the Chapel Royal in Stirling Castle.

The ML-based defect detection approach summarised in the previous section was tested on the main façade of the Chapel Royal at Stirling Castle (Figure 20). The castle typifies ashlar masonry construction and experiences many of the defects most commonly encountered in natural stone by surveyors, such as erosion and discolouration due to salts or moisture. The chapel is a Category A listed building and a scheduled ancient monument.

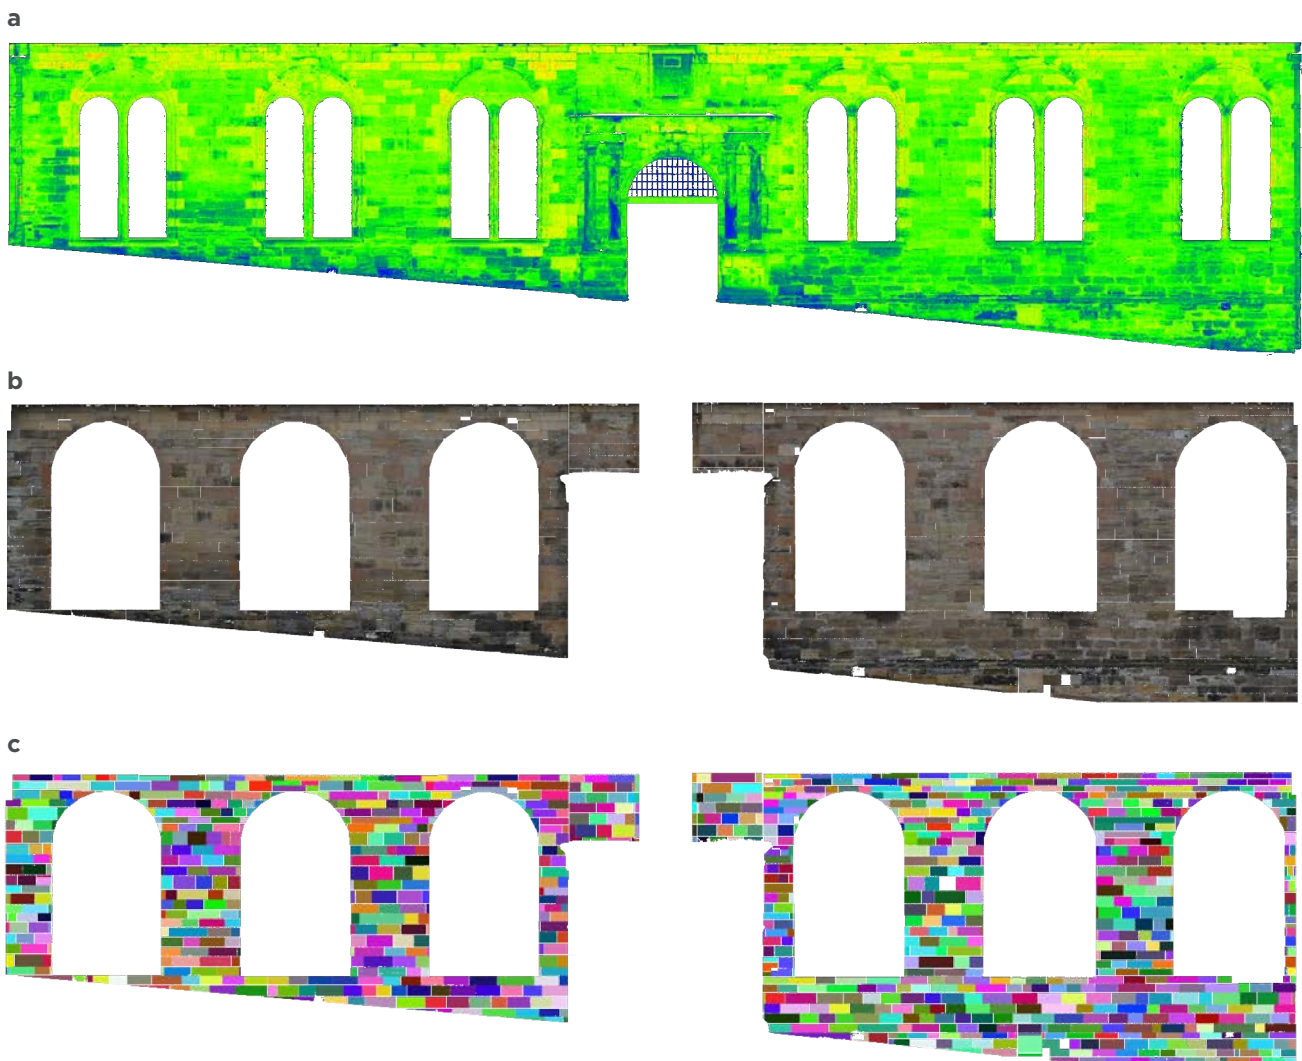
Figure 21: a) Point cloud obtained from terrestrial laser scanning; b) Point cloud coloured with photogrammetry RGB values; c) Segmented ashlar point cloud.

Several laser scans were taken at approximately 10m from the wall (Figure 21a), and a set of photographs taken to produce a 3D point cloud of the scene through structure-from-motion photogrammetric techniques. Both point clouds, obtained from TLS and PG, were registered in the same coordinate system. Subsequently, colour information in the TLS cloud was automatically replaced with RGB data from the photogrammetric cloud (Figure 21b), because colour from digital single-lens-reflex cameras is of higher quality than that captured by the TLS device. Finally, the ashlar stone segmentation algorithm presented in Section 3.2, was applied to detect all units of the main wall plain (Figure 21c).
