HISTORIC
ENVIRONMENT
SCOTLAND

Property in Care (PIC) ID: PIC307

STATEMENT OF SIGNIFICANCE

MID HOWE BROCH (MIDHOWE BROCH)

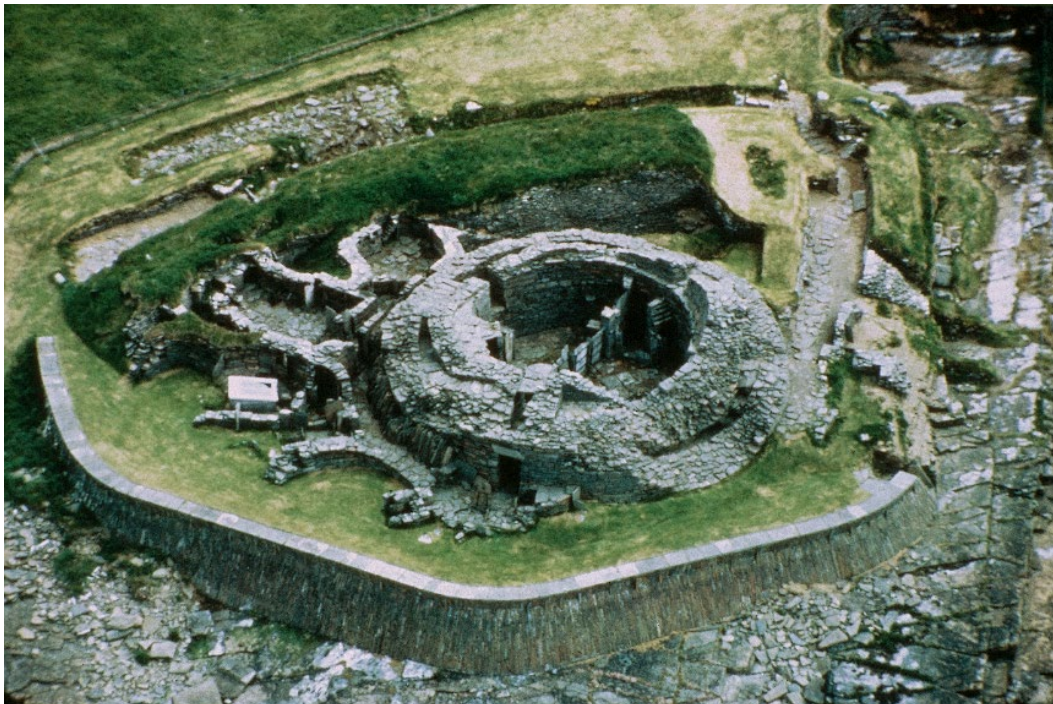
Midhowe Broch, aerial view showing 1930s seawall towards bottom of image

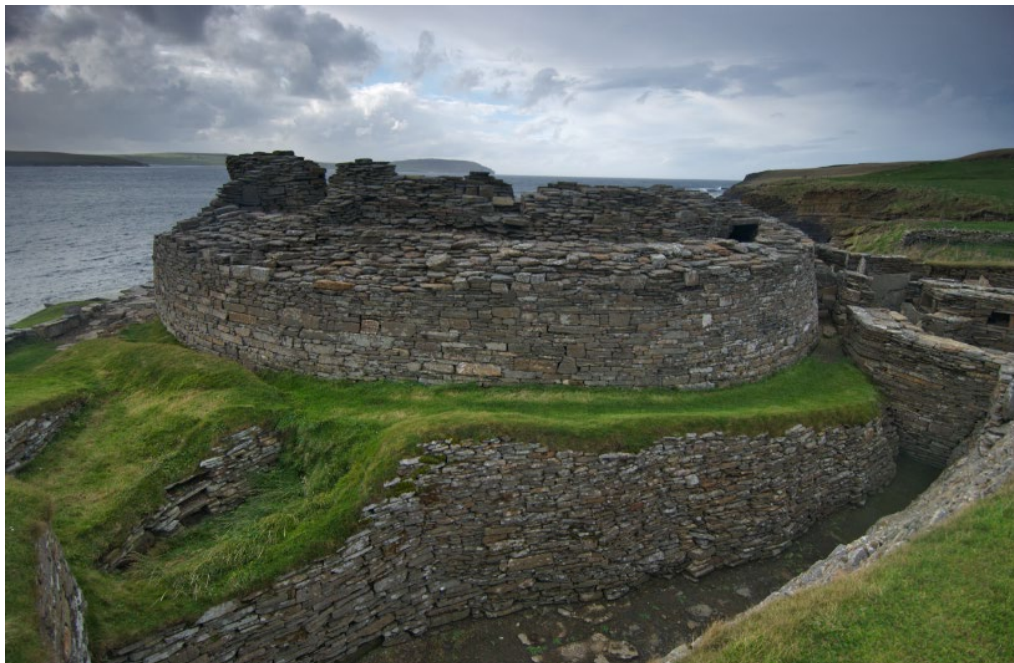
Midhowe Broch seen over ditch and forework

Midhowe Broch is built on a promontory with defences on the landward side, consisting of a massive drystone (or at least drystone-faced) rampart with a ditch on either side. The foundations of smaller buildings partially surround the broch. The enclosed area was once more extensive, as there is clear evidence for erosion in the form of the partial loss of several of the external buildings on the west side of the broch. (The protective sea wall erected at the time of the 1930s consolidation is itself an impressive piece of building work, constructed in local stone and entirely sympathetic to the character of the monument.)

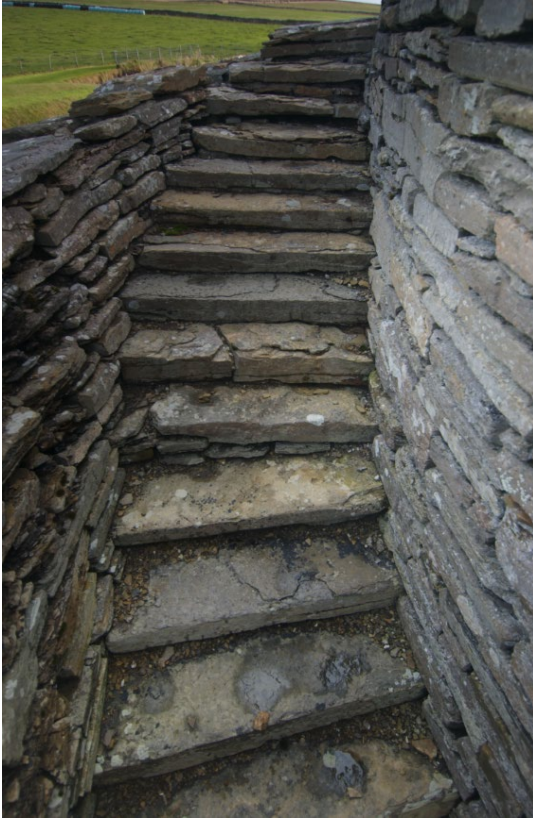
Midhowe Broch, stair

At a later stage, the broch was reduced in height, the original access to the space within the wall thickness seems to have been closed off and replaced by a stone-built stair within the interior of the broch which led up to a chamber in the wall thickness partly quarried into the broch wall at what was probably by then the wall-head.

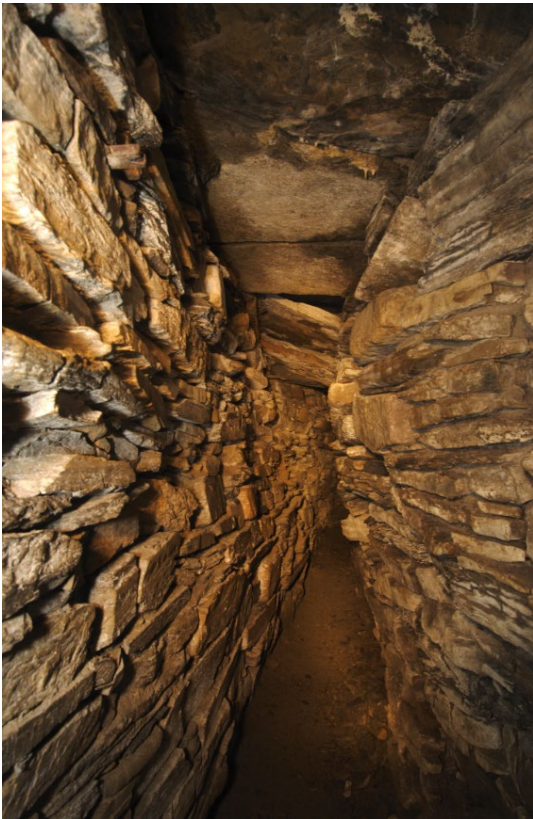
Midhowe Broch ground level gallery showing displaced lower courses and stone packing of gallery

Early settlement of the broch structure, soon after construction, led to slight outward distortion of part of the lower broch wall, which was combatted by filling the ground-level wall-space with stone: this can clearly be seen on site. It is not clear whether the root of the problem was outward movement of the foundation layers or crush-failure of stones under compression, but it seems as if prompt action was able to avert further collapse (unlike the situation at Gurness, where a very similar event occurred).

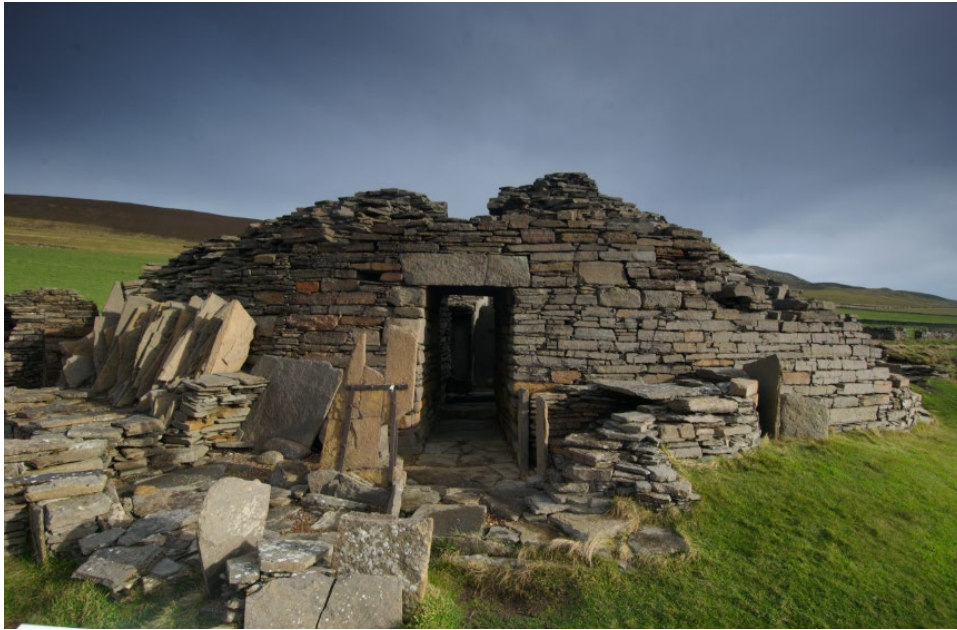
Midhowe Broch, entrance with stacked slabs to left – once thought to be evidence of buttressing, these are now interpreted as material being removed as the broch was reduced in height, and set aside for use in later building work

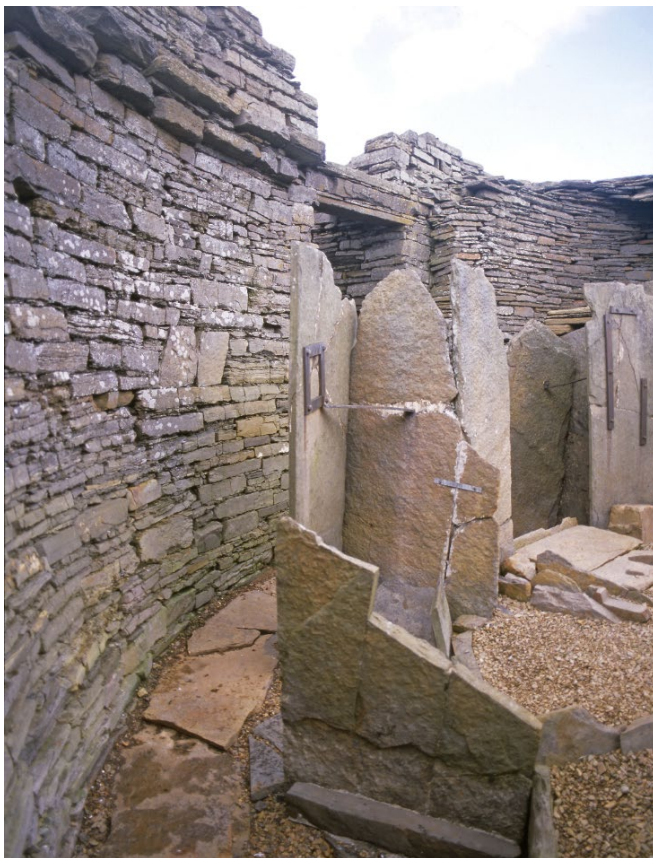
Midhowe Broch interior showing slab-built fittings and partially-masked scarcement ledge: these features all post-date the broch's construction, possibly by many years

Within the broch’s interior is a deep rock-cut tank, and also elaborate stone-built partitions and other features which are clearly secondary to the broch’s construction. The level area outside the broch contains the remains of at least six smaller structures. These are usually described as houses, though they may also have served other purposes: one at least was used as a workshop for metalworking in bronze and iron. These buildings are demonstrably later than the broch and, in their final form at least, are also later than the inner ditch and the forework: how much later is not clear in either case.

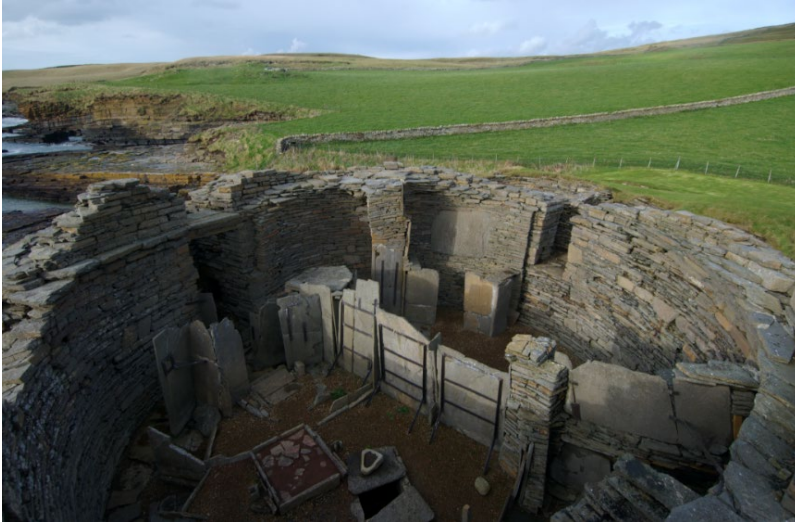
Midhowe Broch interior from above showing bracketed slabs – emphasising that Midhowe has been extensively consolidated

The broch is constructed in tabular slabs and blocks of sandstone, of the Rousay Flagstone series within the Devonian Middle Old Red Sandstone³². This is a superb raw material; easy to work and to build with, lending itself to high-quality drystone work. It is assumed that this was quarried from the immediately adjacent foreshore and the site itself: there are possible quarrying hollows above the inner ends of the geos (inlets) on both sides of the site. However, the stone is prone to failure under stress, and also tends to delaminate once exposed to weathering: both of these weaknesses have contributed to the decay of some features at Midhowe Broch, particularly lintels and upright slab-built features, so that some of those on site today are in fact recent replacements, while others have been heavily patched and bracketed since the site came into State care.

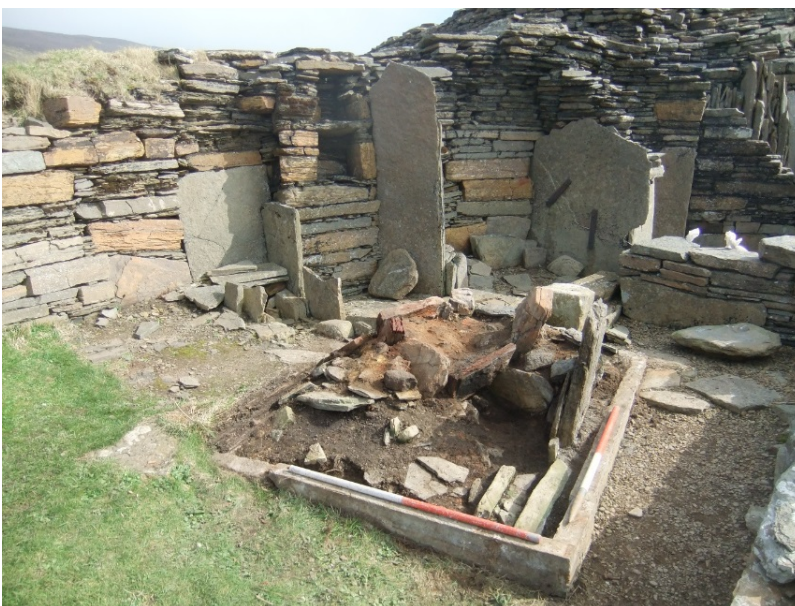
Midhowe Broch, excavation trench showing good survival of hearth deposits
