SUNNYBRAE
COTTAGE,
PITLOCHRY

SUNNYBRAE COTTAGE, PITLOCHRY

Timothy G Holden* and
Bruce Walker**

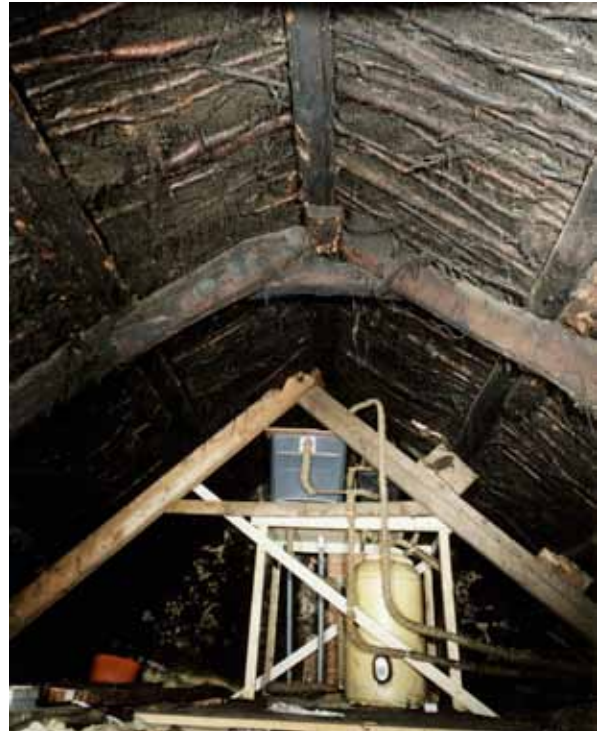
Illus. 5 The roof space 1998 (Historic Scotland)

plasterboard. This was nailed directly to the timber lining beneath. The range in the W room was replaced by a gas fire and a central heating system was installed. This included the insertion of a gas-fired boiler in the wall between the bathroom and living room and a hot water tank in the loft (see Illus. 5).

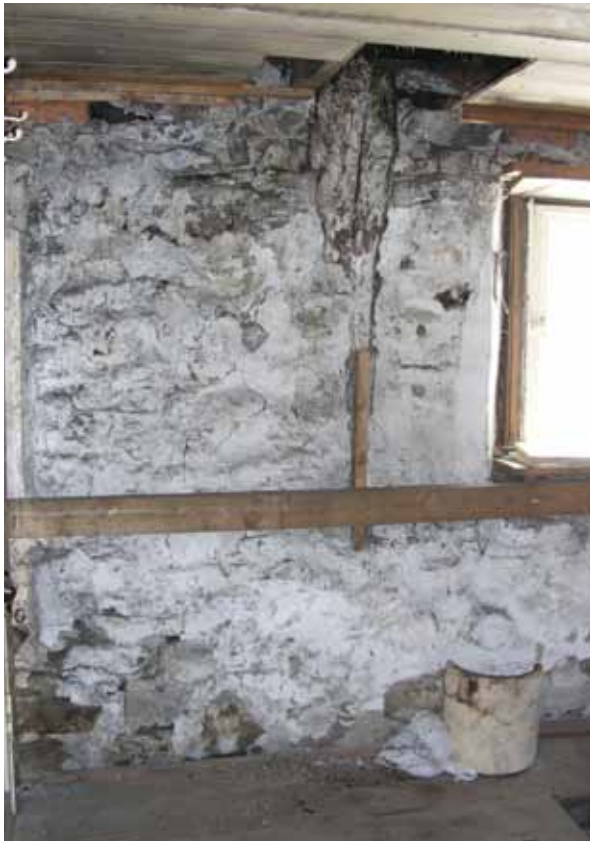
Illus. 6 Photo of exposed cuppill in W room (Historic Scotland)

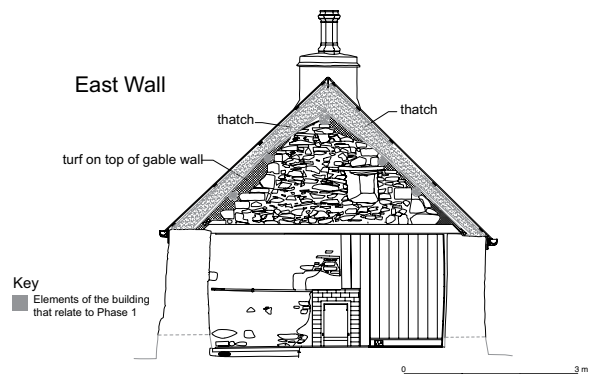
d) Phase 1-2 Cross section and elevation. – E wall (Historic Scotland)

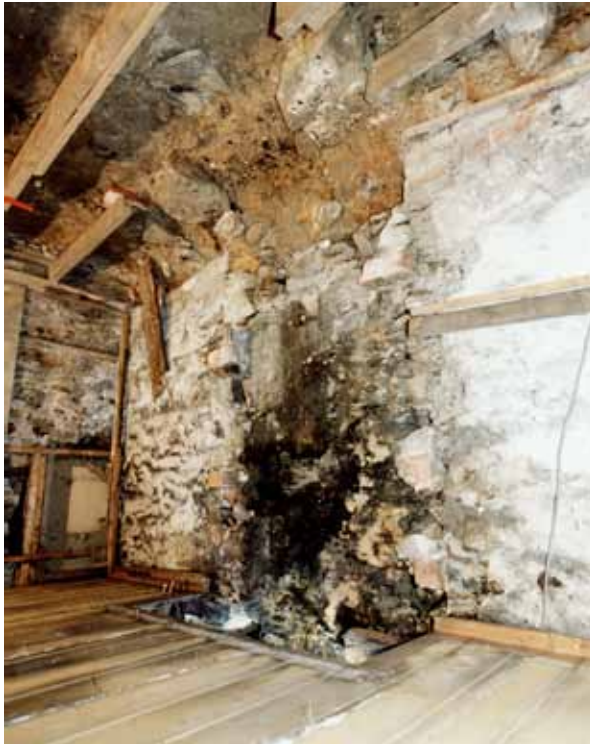
Illus. 11 The W gable wall showing an area of exposed wall core is formed of orange subsoil and has been raked out and replaced with brickwork wherever it remained exposed (Historic Scotland)

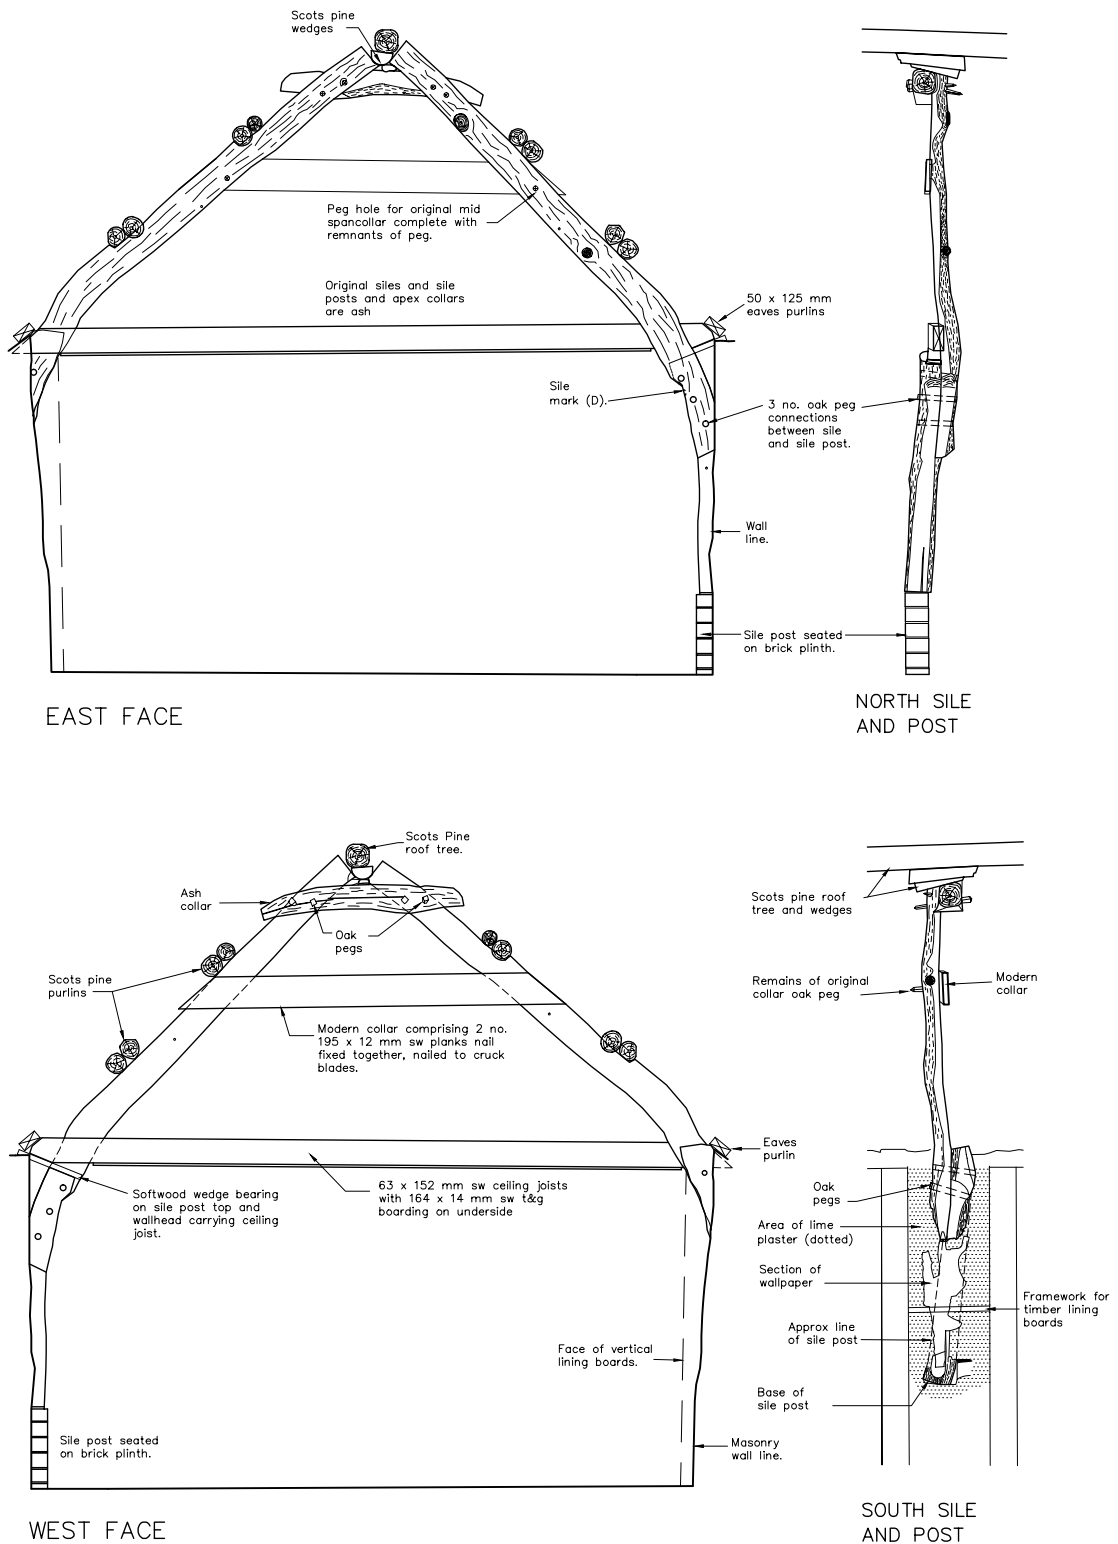
Illus. 14 Details of the E cuppill (HS)

ELEVATIONAL SECTIONS OF EAST CUPPILL

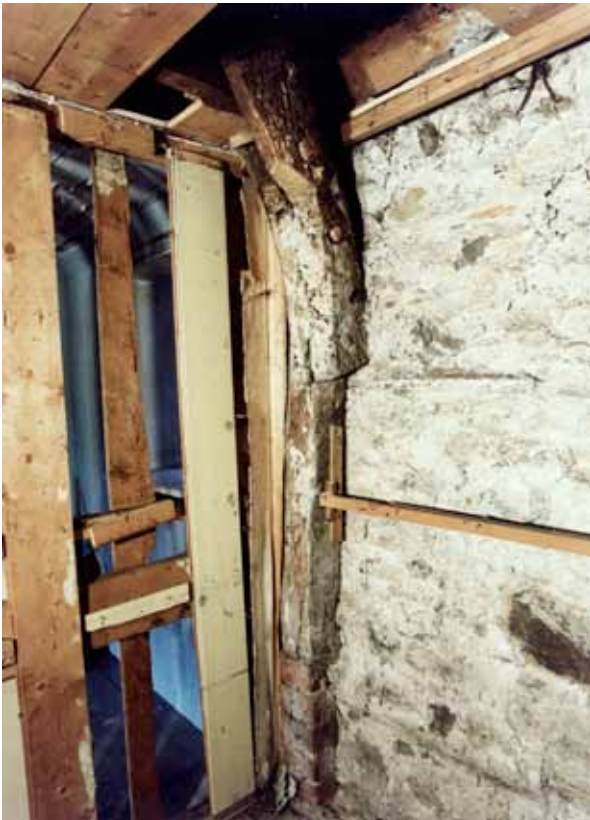
Illus. 15 Exposed cuppill post and joint in N wall of E room (Historic Scotland)

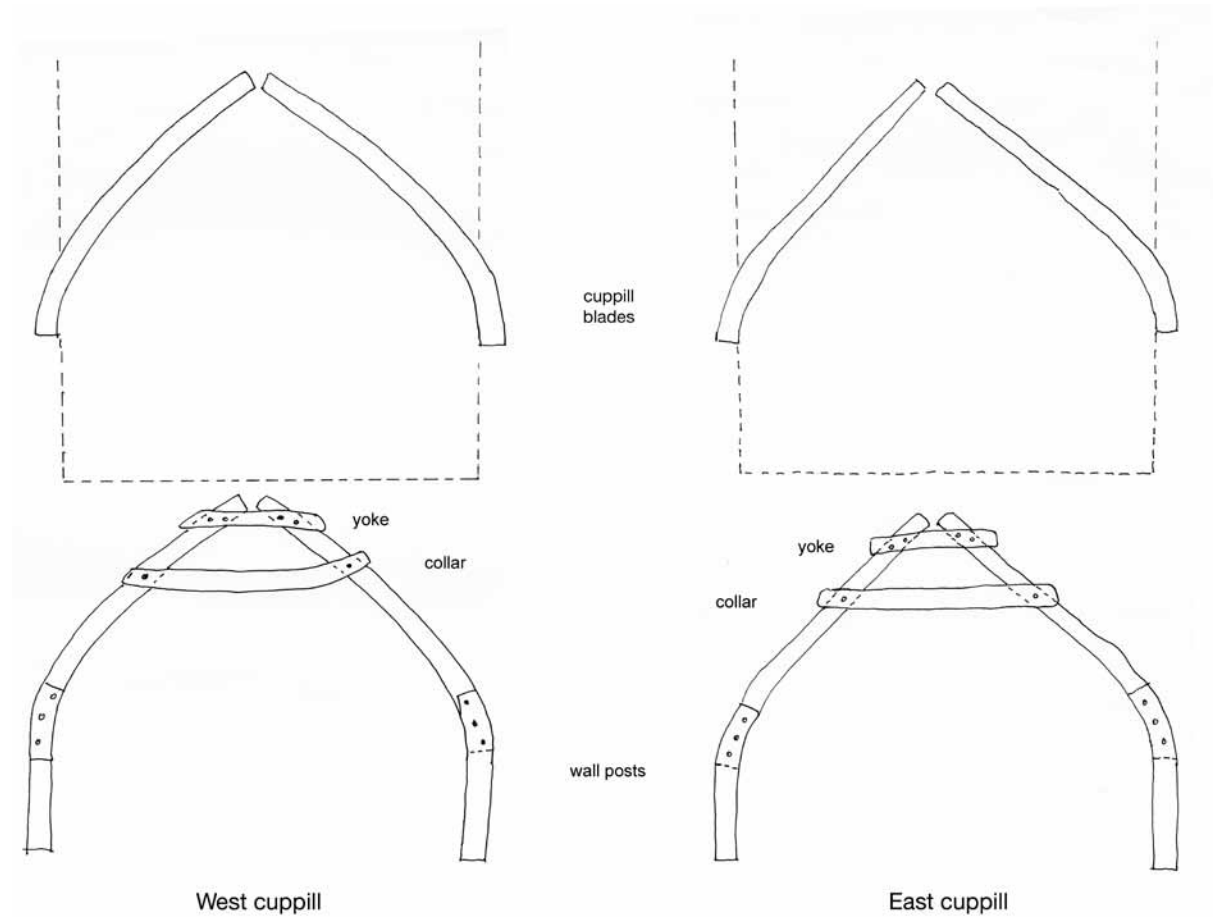
Illus. 20 Inferred mid-collar form (BW)

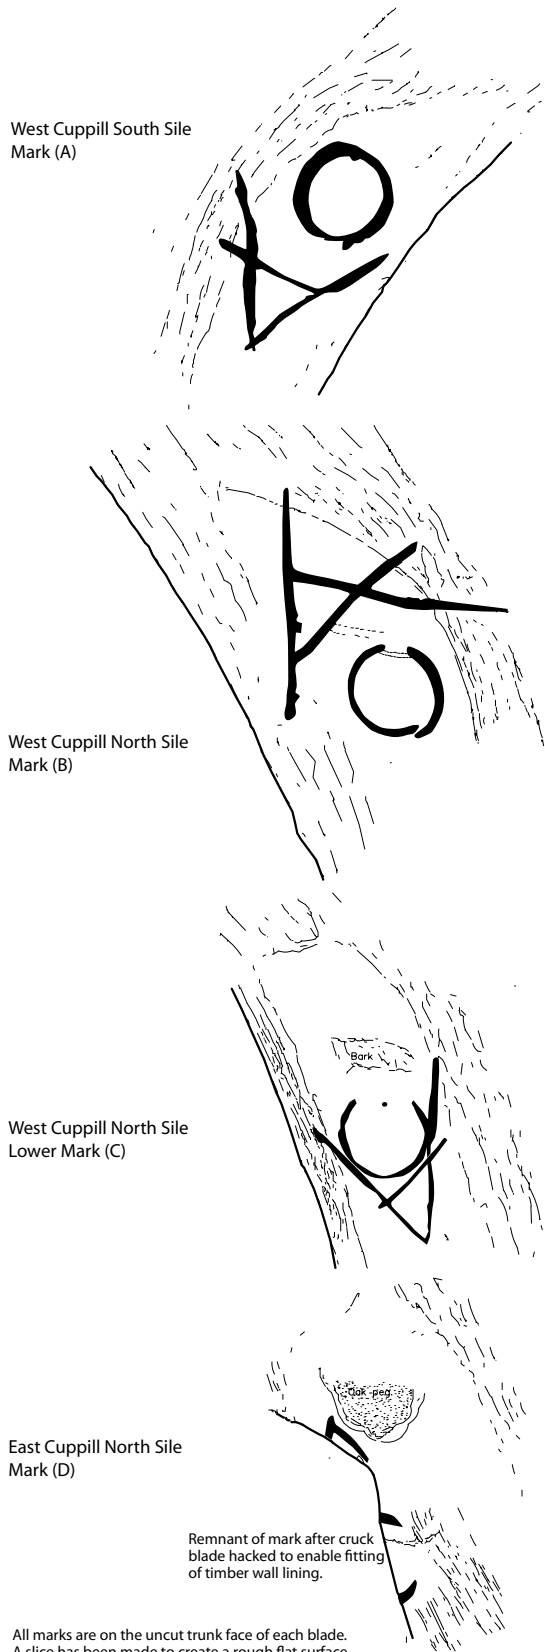
Illus. 21 Timber marks (LP)

All marks are on the uncut trunk face of each blade. A slice has been made to create a rough flat surface into which the marks are incised.

A series of carved 'marks' in the timbers survive well on the siles (Illus. 21 & 22). The marks may have been used to help in setting out the cuppill but they would usually be found on the flat face and are only present on the sile. It is perhaps more likely that the marks were made

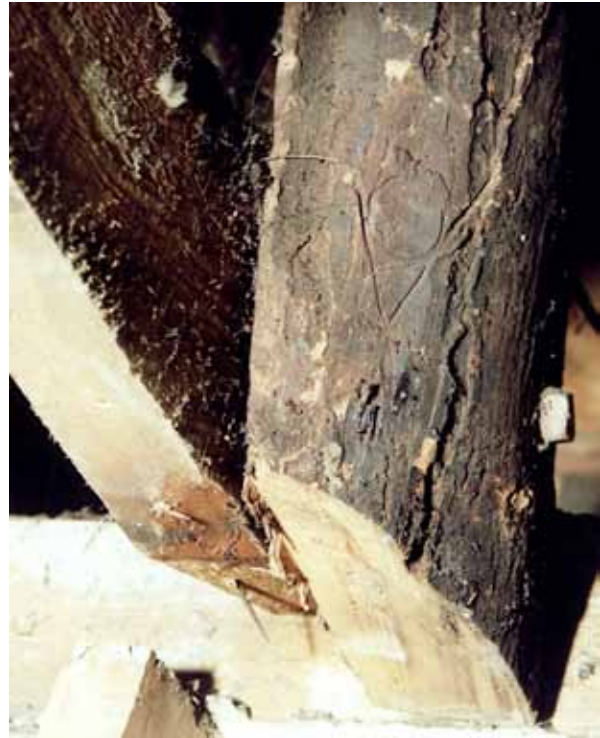
Illus. 22 Detail of timber marks – W Cuppill, N sile (Historic Scotland)

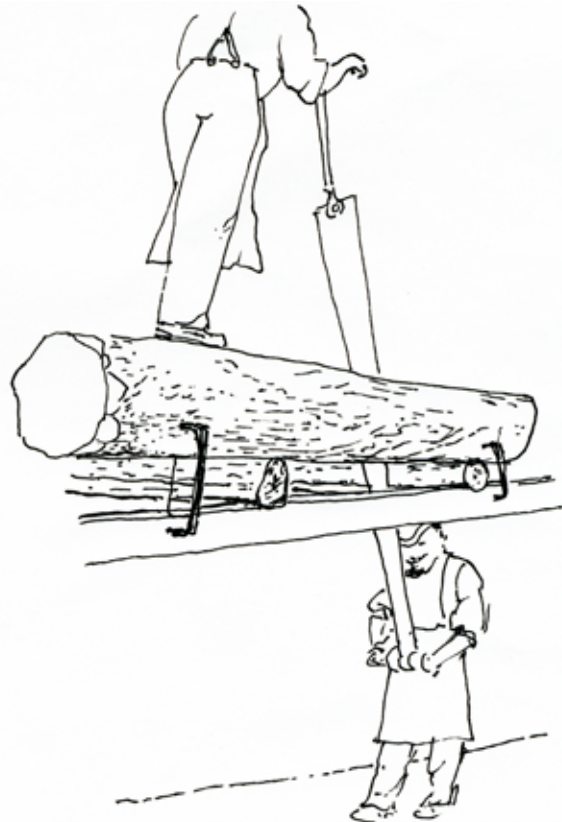
Illus. 26 Pit sawing on a trestle or in a pit (BW)

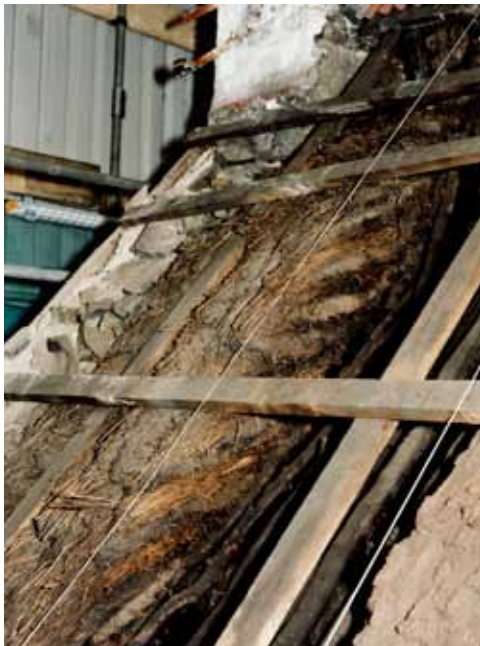
Illus. 31 An excavated section through the thatch (Historic Scotland)

Excavated sections through the thatch revealed how the roof had been thatched (Illus. 30, 31 & 32). The two lowest courses, at the eaves, were formed by twigs of broom. These would have provided extra strength against wind, bird and vermin damage at this vulnerable point of the roof. Subsequent courses comprised alternating layers of turf and rye straw (Table 1).

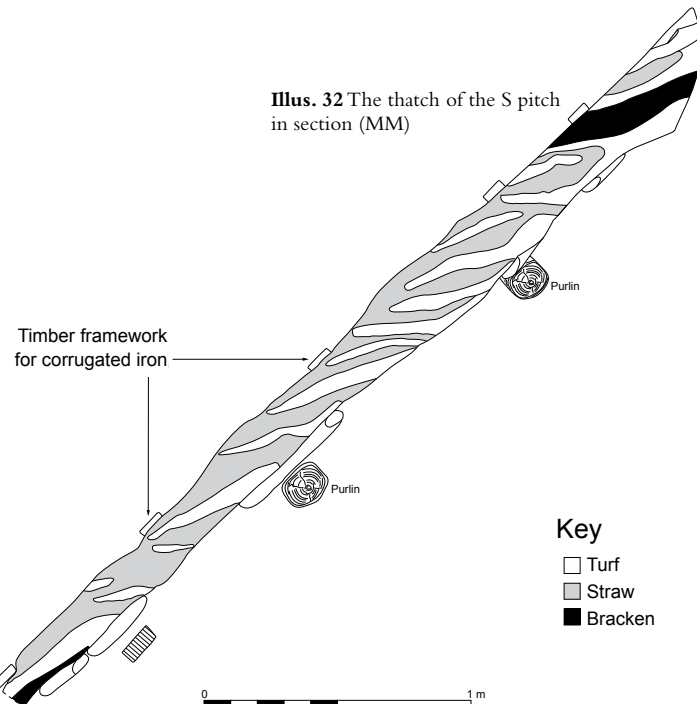
Illus. 32 The thatch of the S pitch in section (MM)

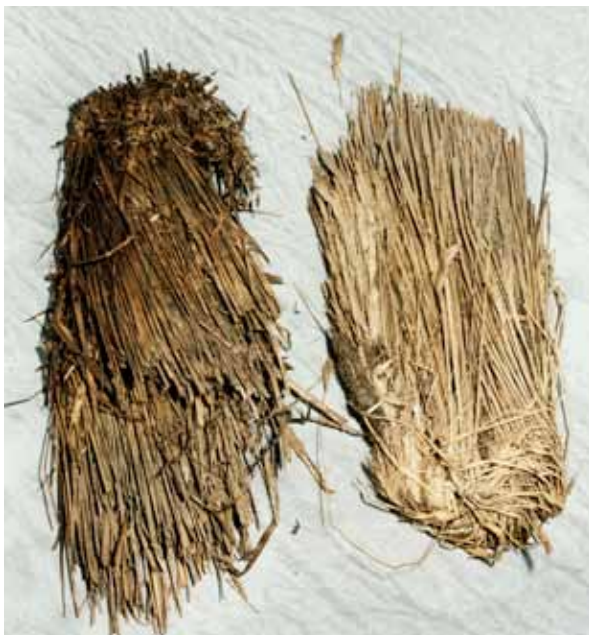
Illus. 33 Tippets or grips from the body of the roof (Historic Scotland)

The straw used in the thatch was prepared by forming handful-sized bundles which were twisted over at the flowering end to form what is known as a tippet or grip. Courses of these were then fixed in position by turves placed vegetation-side down (Illus. 33). The weight of the turf would have held the straw firmly in place but additional fixing in the form of roping may also have been used, particularly to hold down the straw at the eaves and skewers. The ropes may have been secured by timber wands and pegs on the outer surface, or with a fixing hidden under the tail ends of the bundles above.

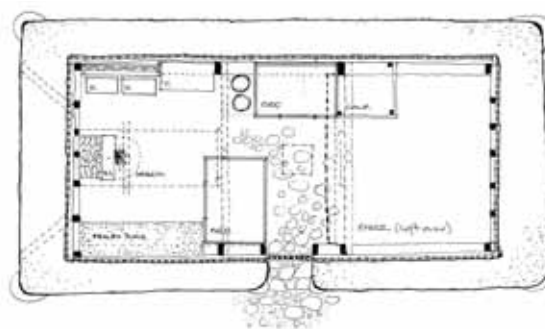
Illus. 37 Reconstruction – interior plan (BW)

A byre-dwelling therefore seems likely and Illustrations 37 & 39 offer an interpretation of how the building might have looked if there had been a byre in the E half of the building. This would probably be lofted to allow a certain amount of bedding material and fodder for the cattle to be stored above them (Illus. 40). When there was a chimney, this provided an ideal space to put guests since they would be warm and comfortable but unable to move about freely during the night. This was important since Highland hospitality demanded that any person looking for shelter should be taken in if at all possible. Access to the loft was by a ladder that was removed once the guests were established in the loft. Even without a chimney the existence of cattle under a loft would result in a warm air current rising across the end closest to the hearth and this would prevent the penetration of smoke sufficiently to allow the loft to be slept in. At this stage there would be no ceilings other than a crude floor to the loft.

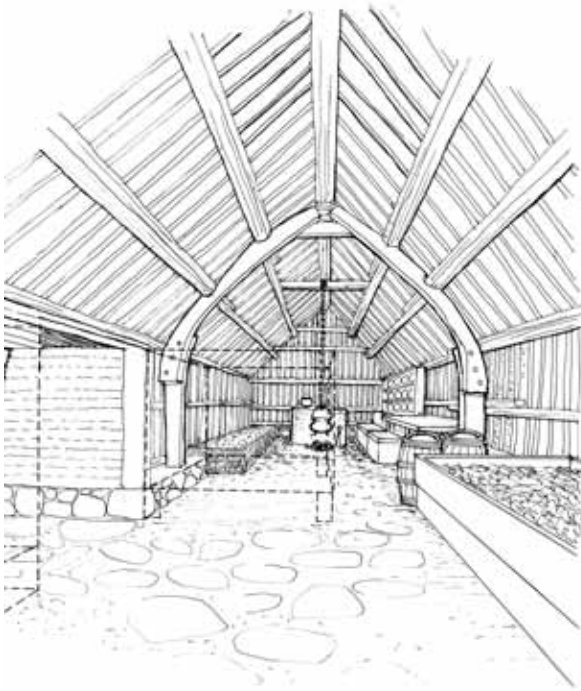
Illus. 39 Reconstruction – perspective
a) facing W

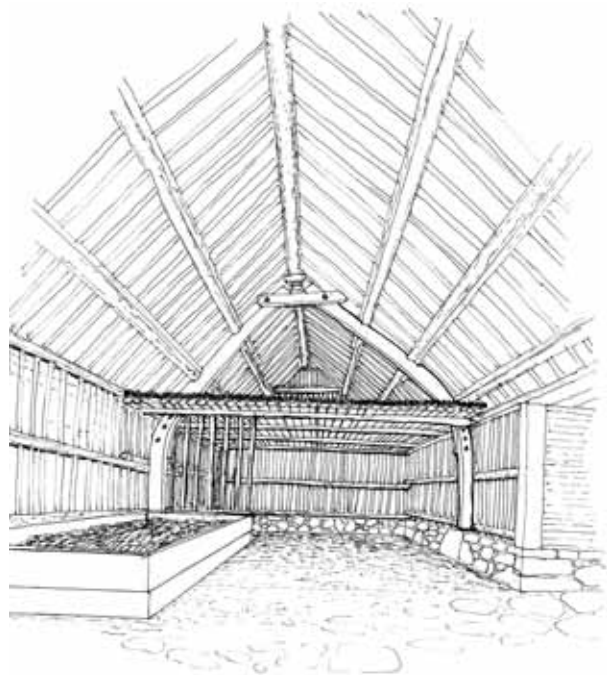
b) facing E (BW)

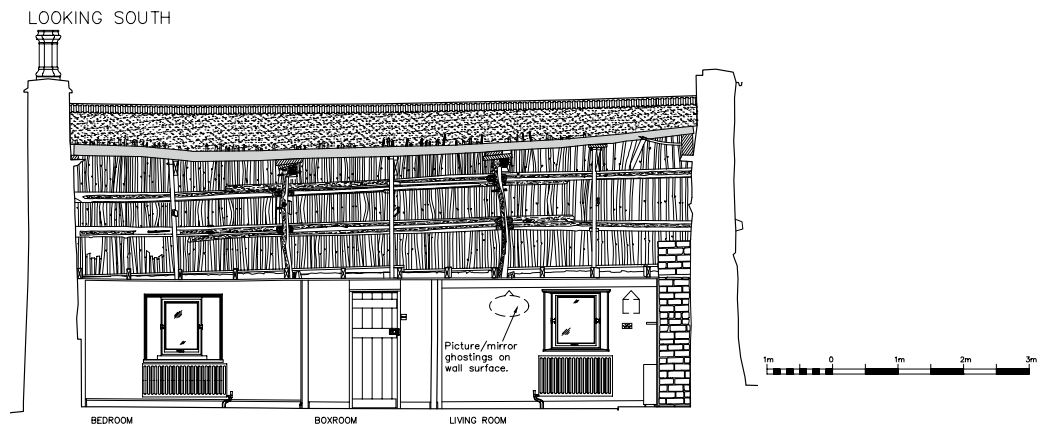
b) Longitudinal section looking towards S internal wall (HS)

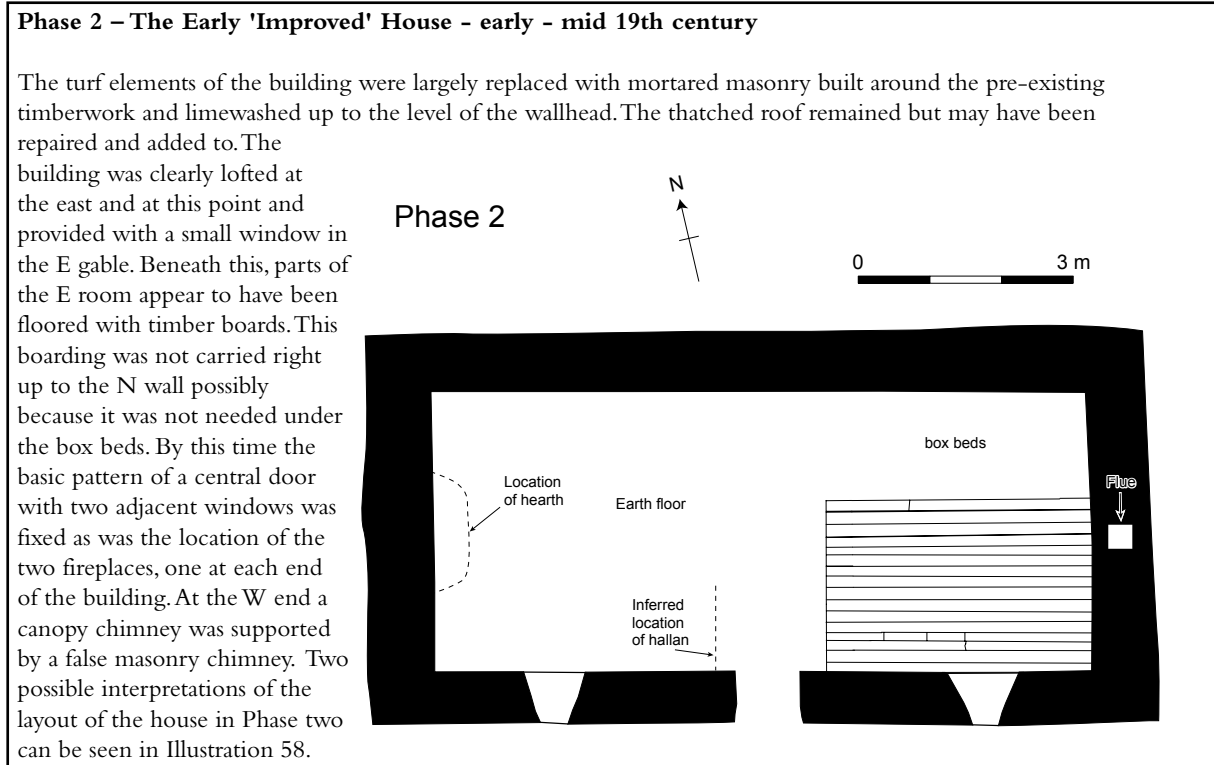
Illus. 47 Ground plan of the Early 'Improved' House (HS)

Interestingly the early boards did not run right up to the N wall leaving an un-floored area of 1.5 m x 2.6 m. This is thought to have been the site of two box beds up to which the first boards were taken. This gap was patched later with tongue and groove boards on half-rounded joists.

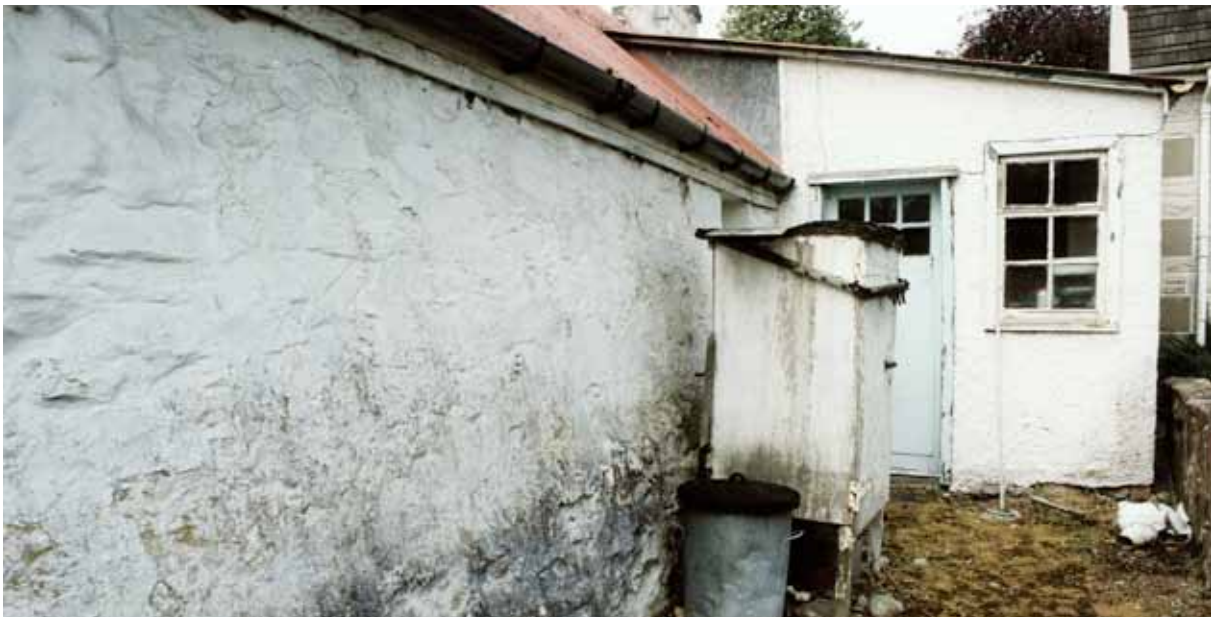
Illus. 48 A section of the battered N wall (Historic Scotland)

Above the stone footings, the walls of the original turf building were removed and replaced with clay-mortared random rubble masonry. At the rear of the house the walls were, and still are, battered, presumably to resist the slide of the building down the gentle slope to the N (Illus. 48). In most places the walls were up to 0.7 m wide and were built up to the wallhead height on the N and S walls. The gables were also constructed at this time but it is clear from the surviving walls that were not taken up to their full current height. It therefore seems very likely

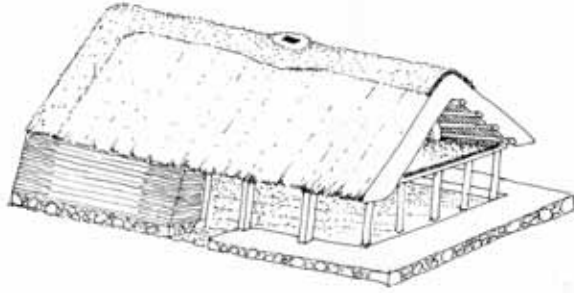
a) The turf walls are removed in sections with roof supported on the cuppills (BW)

This was a simple operation since the roof was fully supported on the cuppill structure that carried the weight to the foundation course. This was necessary since turf walls had a tendency to shrink vertically as material dried out and consolidated. The shrinkage could be made up with new material inserted

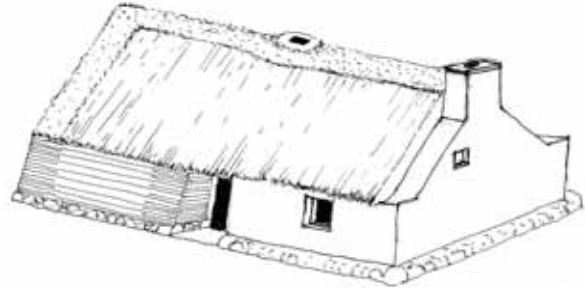
b) Sections of turf are replaced by stone masonry (BW)

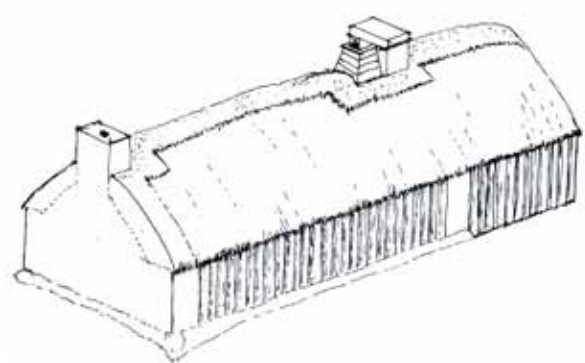
f) The completed building and outhouse from the rear showing the possible use of 'backs' (BW)

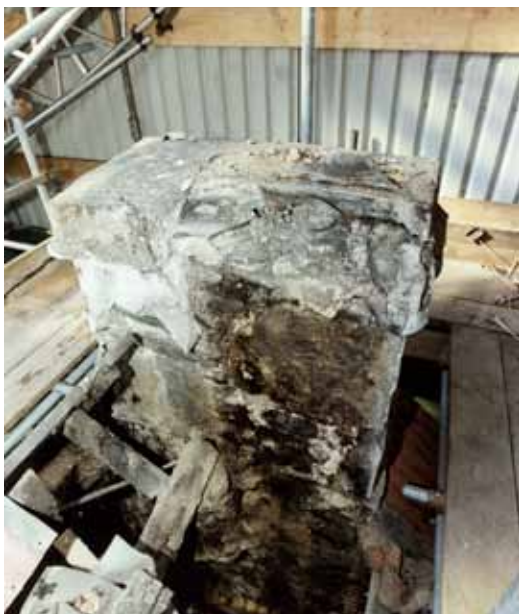
Illus. 52 Close up of the false chimney on the W gable (Historic Scotland)

At the E end of the building the gable wall incorporates a hearth, flue and chimney. From the outside the W end appears to be an exact mirror image but the chimney is, in fact, a purely decorative feature with no matching hearth and flue (Illus. 52). The hearth at this end of the building evidently projected into the room and was vented via a canopy chimney supported against the gable wall (see section 3.6 below).

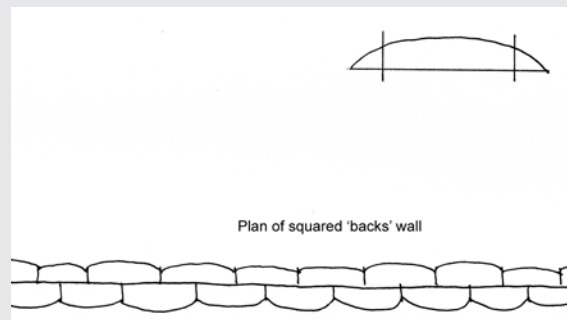
Illus. 56 Squared 'backs' wall (BW)

Timber "backs" used in this way would provide a reasonably substantial wall for a few years but they would not last very long since they are essentially sapwood and subject to insect infestation and rot.

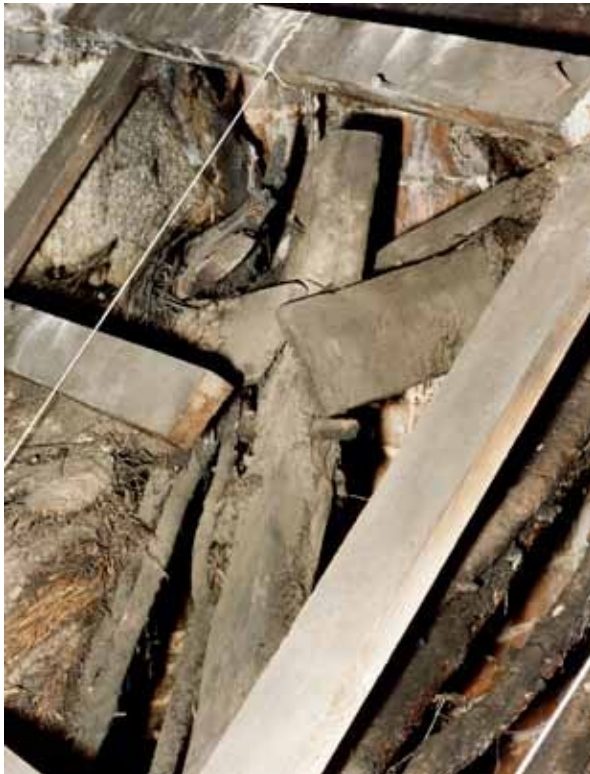
Illus. 60 Timbers of the canopy chimney taken through the excavated section of the thatched roof (Historic Scotland)

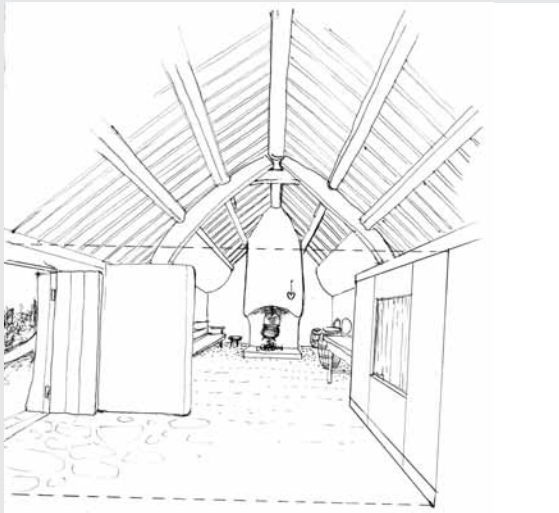
Illus. 64 Phase 2 Reconstructions
a) facing W

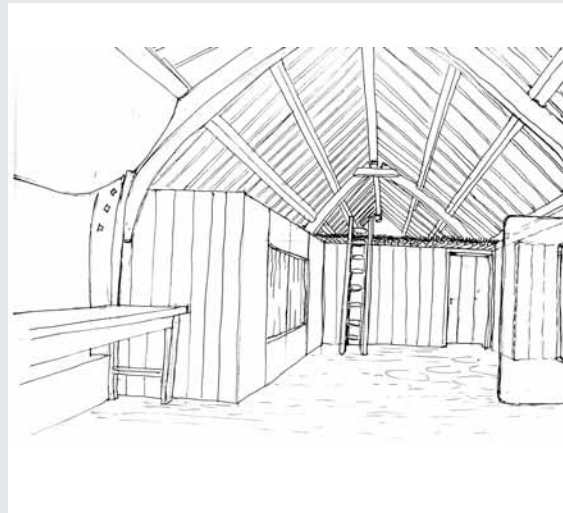
b) facing E (BW)

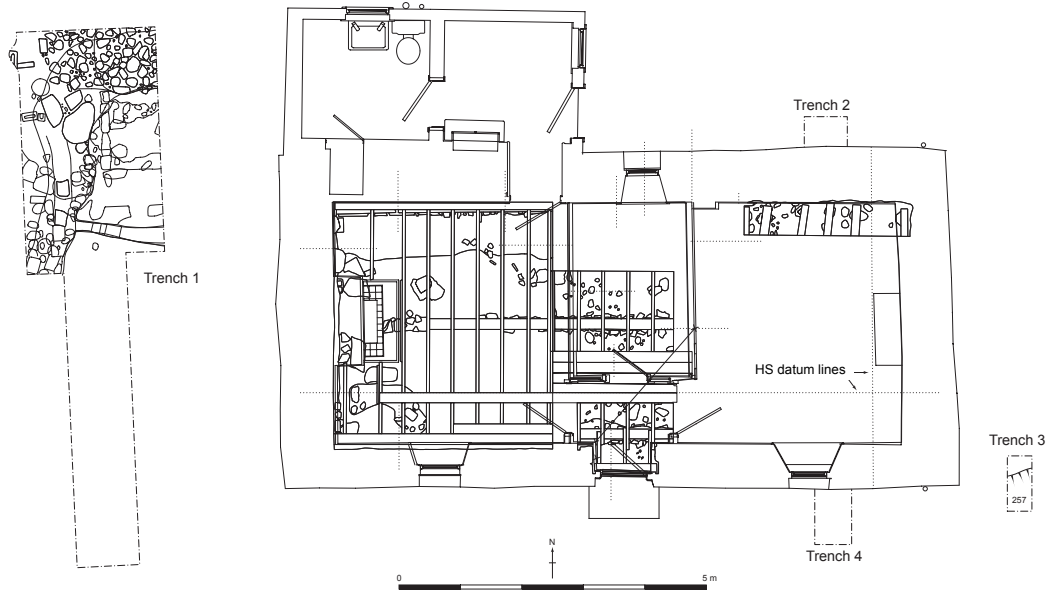
Illus. 67 Plan of excavation undertaken in and around the building

the original clay floors in the kitchen half of the house had been raked-back to retain the headroom when the suspended floors were added (Illus. 67 & 68).

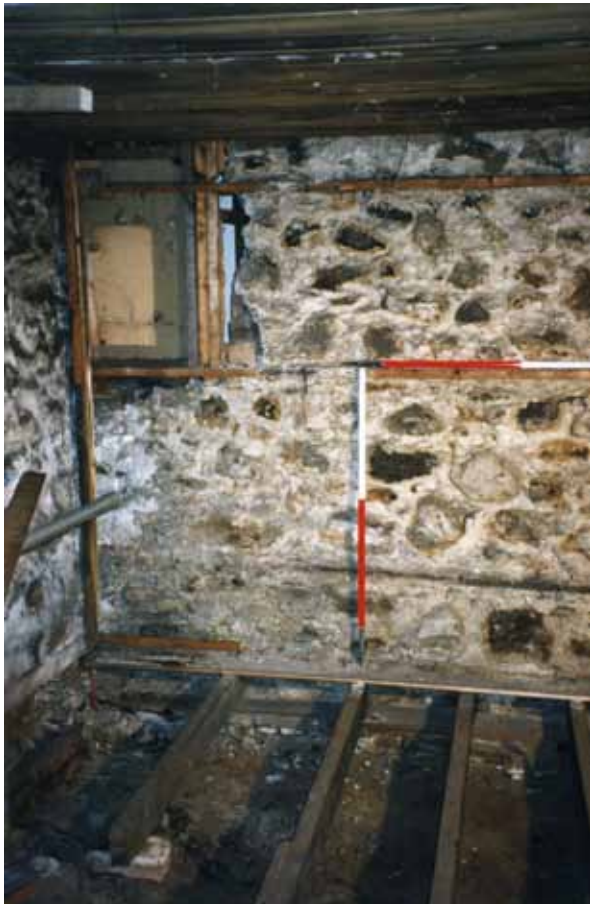
Illus. 68 Exposed sections of the floor and N wall in the W room (Headland)

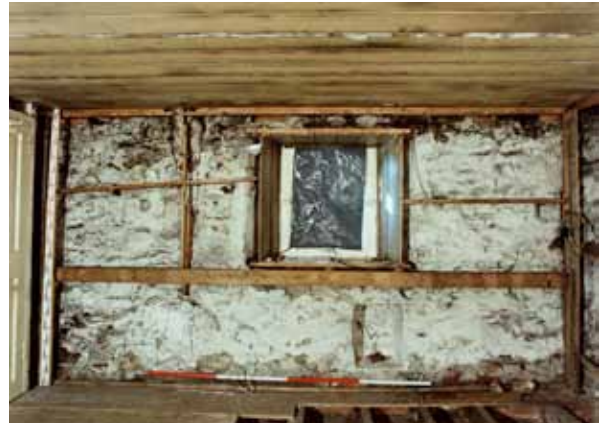
Illus. 69 Exposed section of the S wall (Historic Scotland)

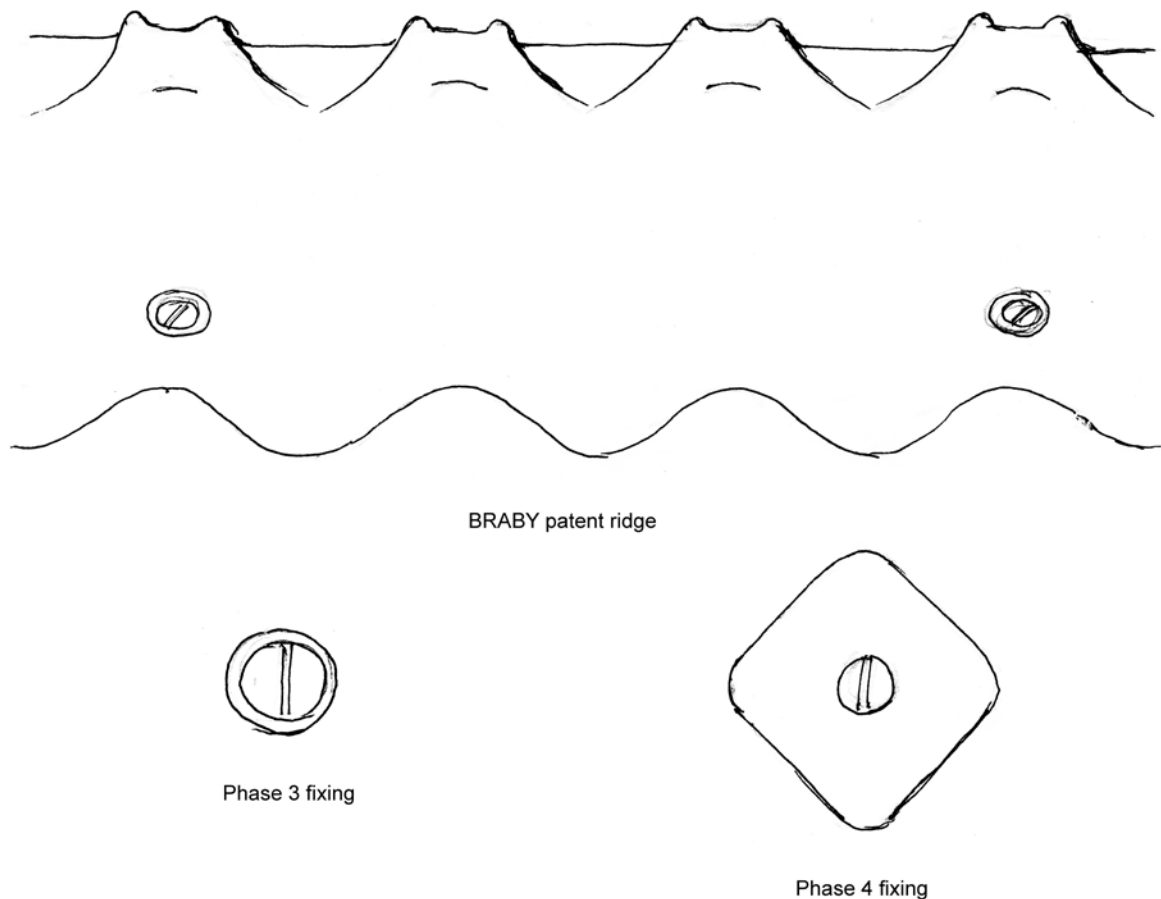
Illus. 70 Corrugated iron details and fixings (BW)

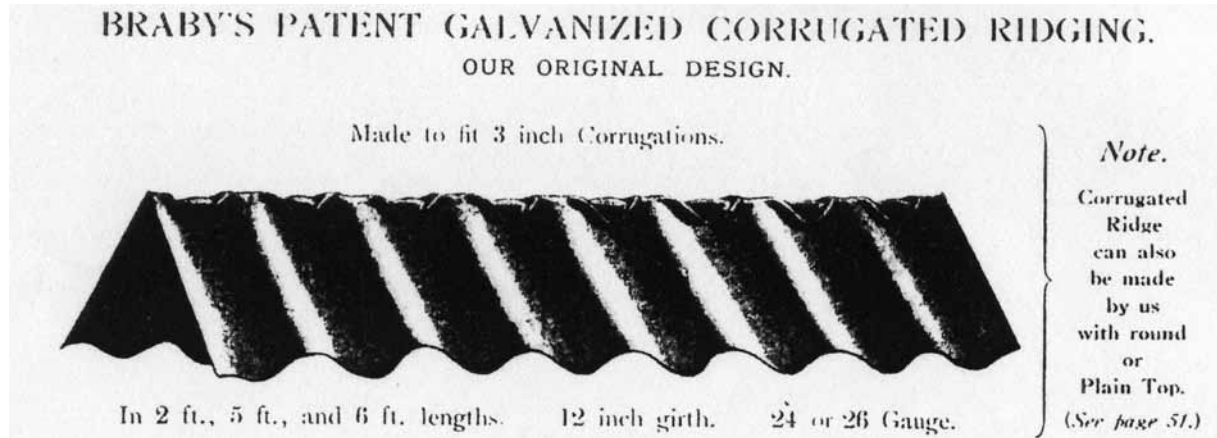
Illus. 71 Braby's patent ridge

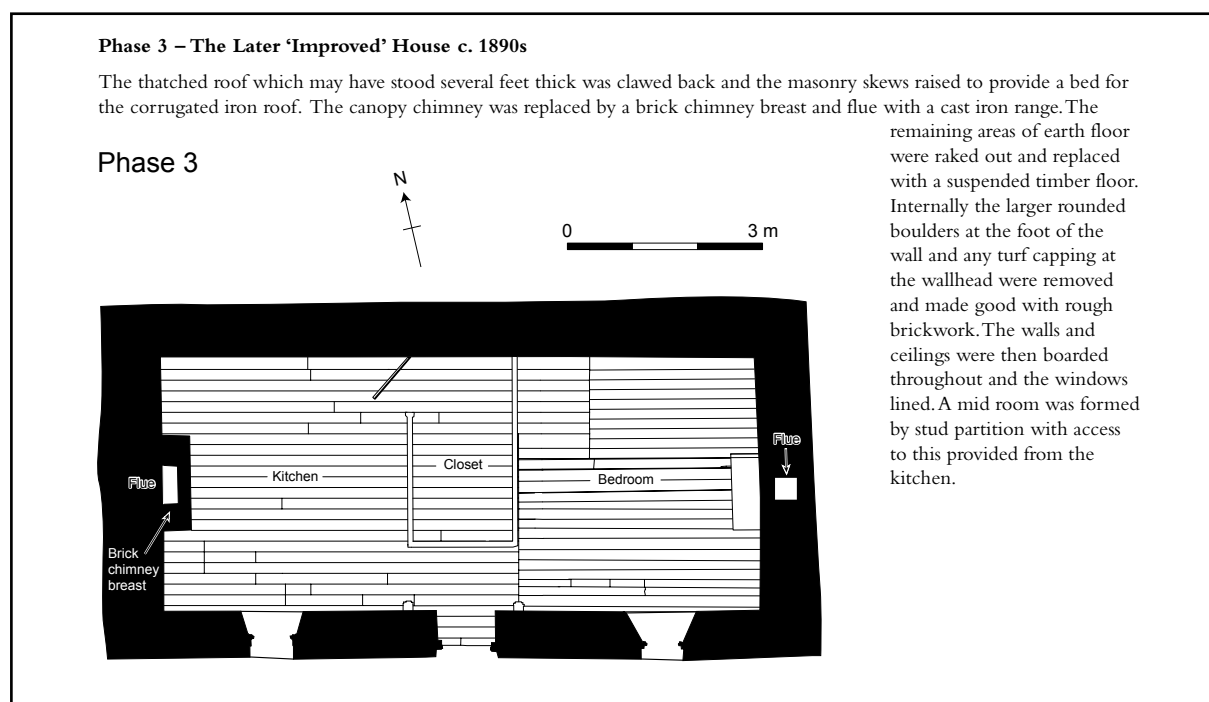
Illus. 73 Plan of the Phase 3 building (HS)

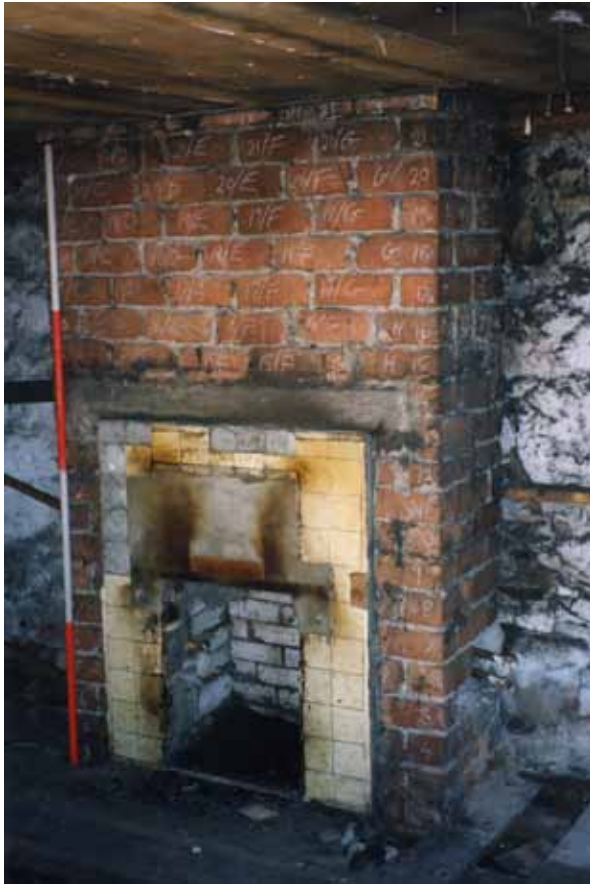
Illus. 74 The brick chimney breast against the W wall (Headland)

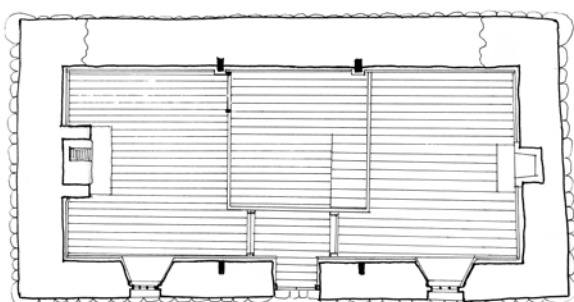
Illus. 80 Reconstruction plan of the Phase 3 building (BW)

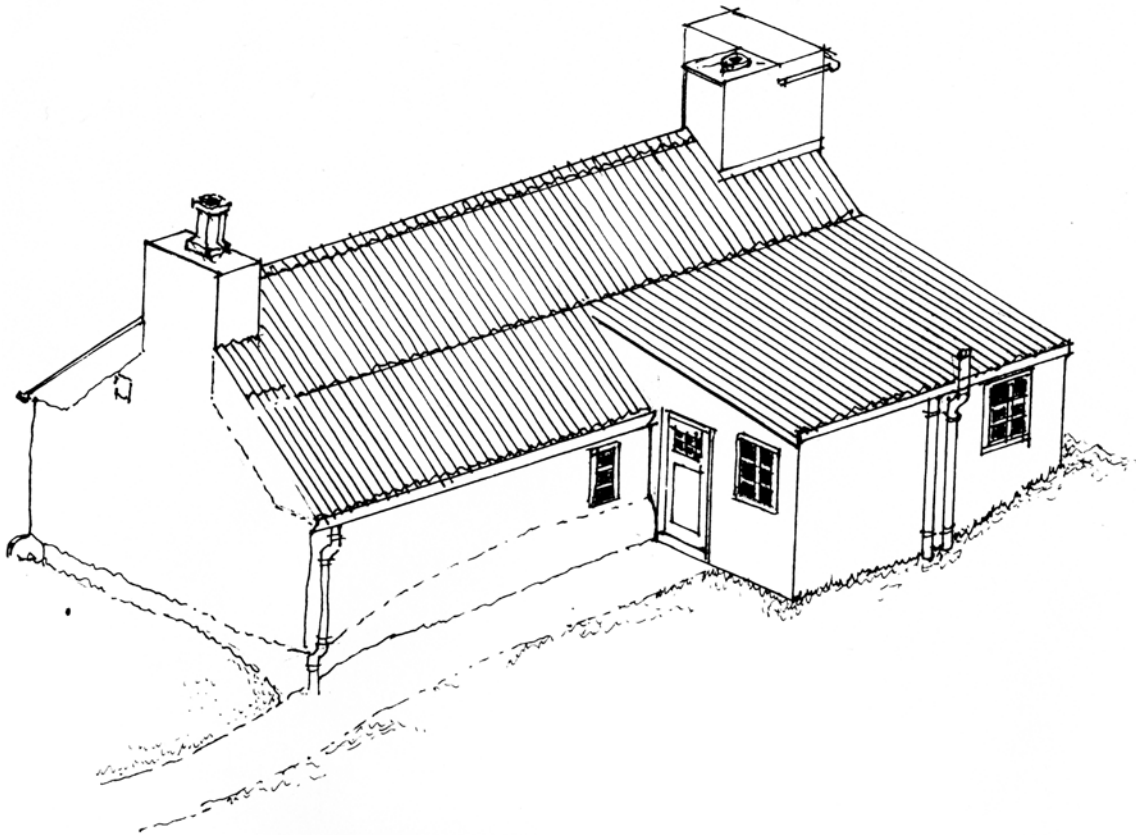
Illus. 89 A brick extension is built against the N wall (BW)
