| Property in Care (PIC) ID: | PIC331 |
| Designations: | Scheduled Monument (SM90152) |

## Statement of Significance

# Dun Troddan

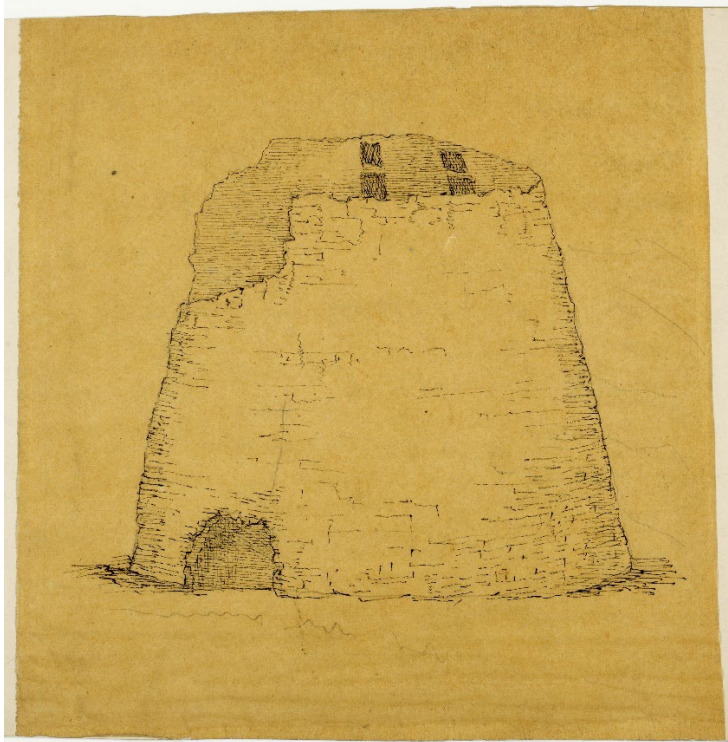
Figure 3: Sketch of Dun Troddan (based on Gordon's Tour, 1726) DP 285111 Reproduced with kind permission of the Society of Antiquaries of Scotland. © Crown Copyright: HES

Alexander Gordon visited in 1720 and his description<sup>4</sup> is particularly valuable, since both brochs appear to have been much more complete at that date, still standing tall around more of their circuits. He said that the broch stood 33 feet (9.9 metres) tall, presumably above some thickness of internal or external rubble, and that "Castle Troddan" was "by far the most entire of any in that Country". The illustration accompanying Gordon's account shows most of the circuit of Dun Troddan still standing tall, with a ragged aperture corresponding to the entrance.

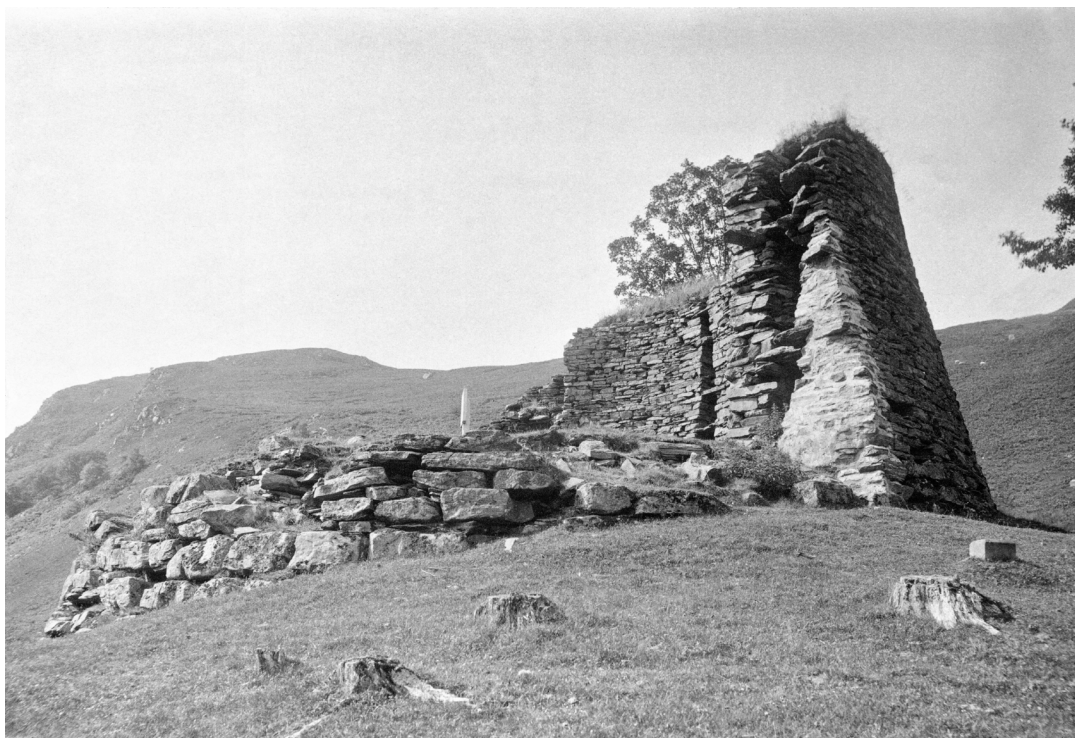
*Figure 6: 1897 photograph by Erskine Beveridge – with early cement repairs clearly visible on right. SC 1142521 © Crown Copyright: HES*

In 1885 the landowner passed the Glenelg Brochs into State care under a Guardianship agreement, at least partly in recognition of structural problems, particularly at Dun Telve. While no written record has been located of any pre-20th century repair works, photographs taken in 1897 by Erskine Beveridge<sup>9</sup> clearly show that Dun Troddan, like Dun Telve, had recently been repaired with crudely applied

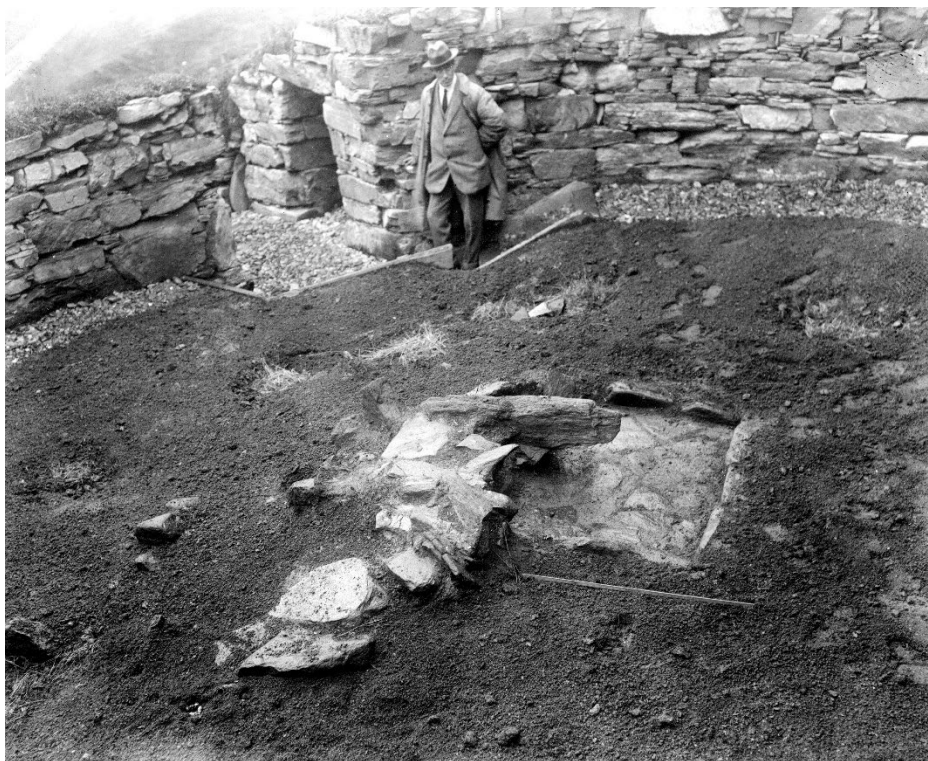
*Figure 8: 1920s excavations showing superimposed hearths: note depth of deposits.*  
 SC 1171827 © Crown Copyright: HES

Curle had the workmen dig systematically through the remaining deposits, excavating these in horizontal layers since no clear stratification could be observed. In the uppermost levels he noted traces of numerous fires of wood and peat, not set in formal hearths. Halfway down, he came on the remains of a rectangular, stone-edged and stone-lined hearth under a layer of peat ash, and immediately below it a further, even better-made, example. The northern parts of both had been destroyed in the earlier digging, but they lay partly above the hearth which had already been cleared before Curle’s arrival on site. The top hearth lay at right angles to the one below, which itself was set at 45 degrees to the bottom-most one. Curle’s interpretation was of several relatively short-lived phases of occupation, followed by a long period in which the centre of the now-ruined broch was used as an occasional camp-site. It is worth noting that Curle did not remove these deposits entirely, stopping at the level of the second hearth he had uncovered.<sup>13</sup>

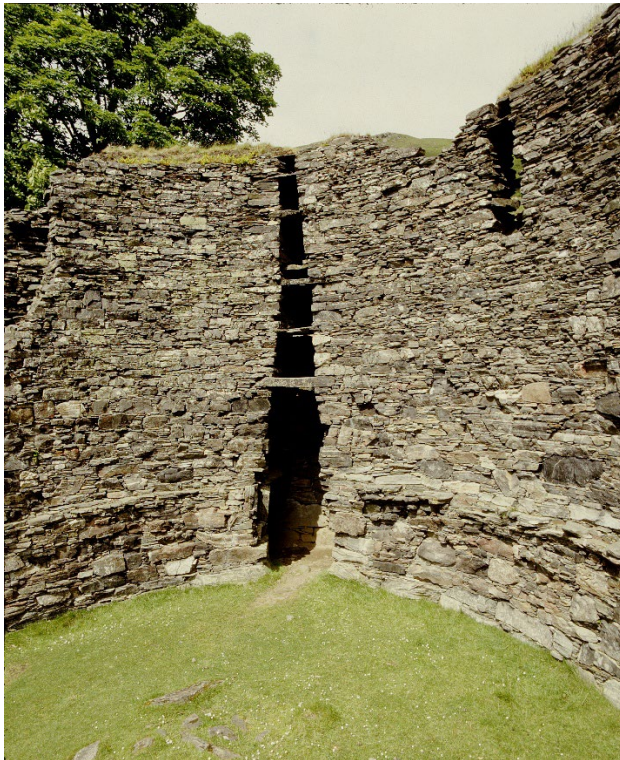
Figure 12: Interior, showing scarcement. 008-001-000-083-R © Crown Copyright: HES

At the same level as the first gallery floor, a corbelled ledge or “scarcement” runs around the interior wall-face. This may have supported the edge of a raised wooden

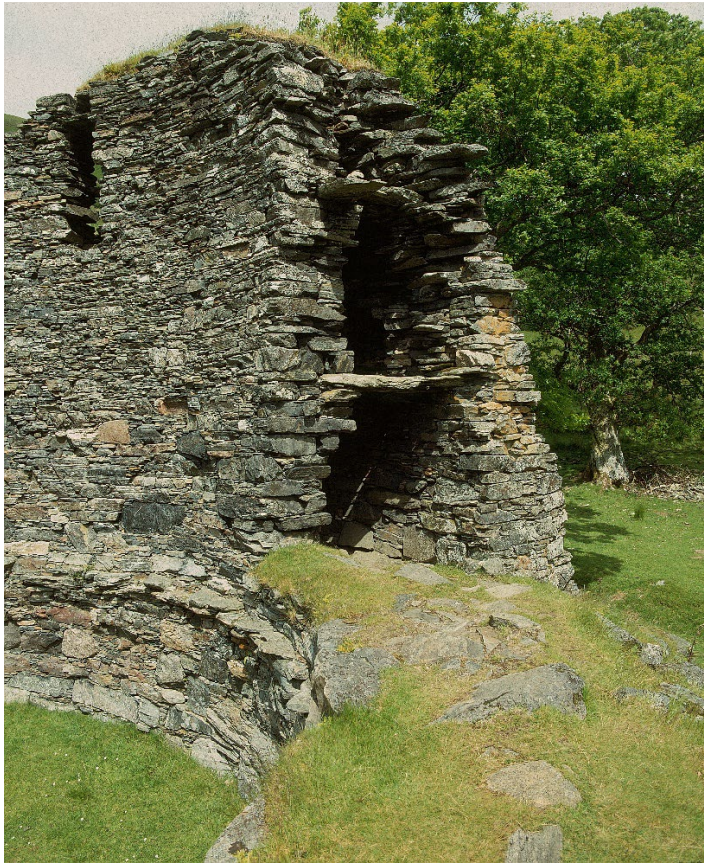
*Figure 13: Eastern end of high-surviving wall, showing gallery levels. 008-001-000-081-R*  
© Crown Copyright: HES

Only the northern part of the wall now survives above head-high, reaching a height of about 7.6 metres above ground level. Above the solidly-built lowest level, the wall is double-skinned and contains the remains of three superimposed galleries, with slight traces of a fourth above. The gallery walls converge as they rise, but less so than at nearby Dun Telve. Away from this high section, the majority of the broch’s wall circuit survives to less than two metres tall.
