DUNS PRIMARY SCHOOL, SCOTTISH BORDERS

SELECTIVE DEMOLITION CASE STUDY

USE AND ADAPTATION OF LISTED BUILDINGS

Duns Primary School

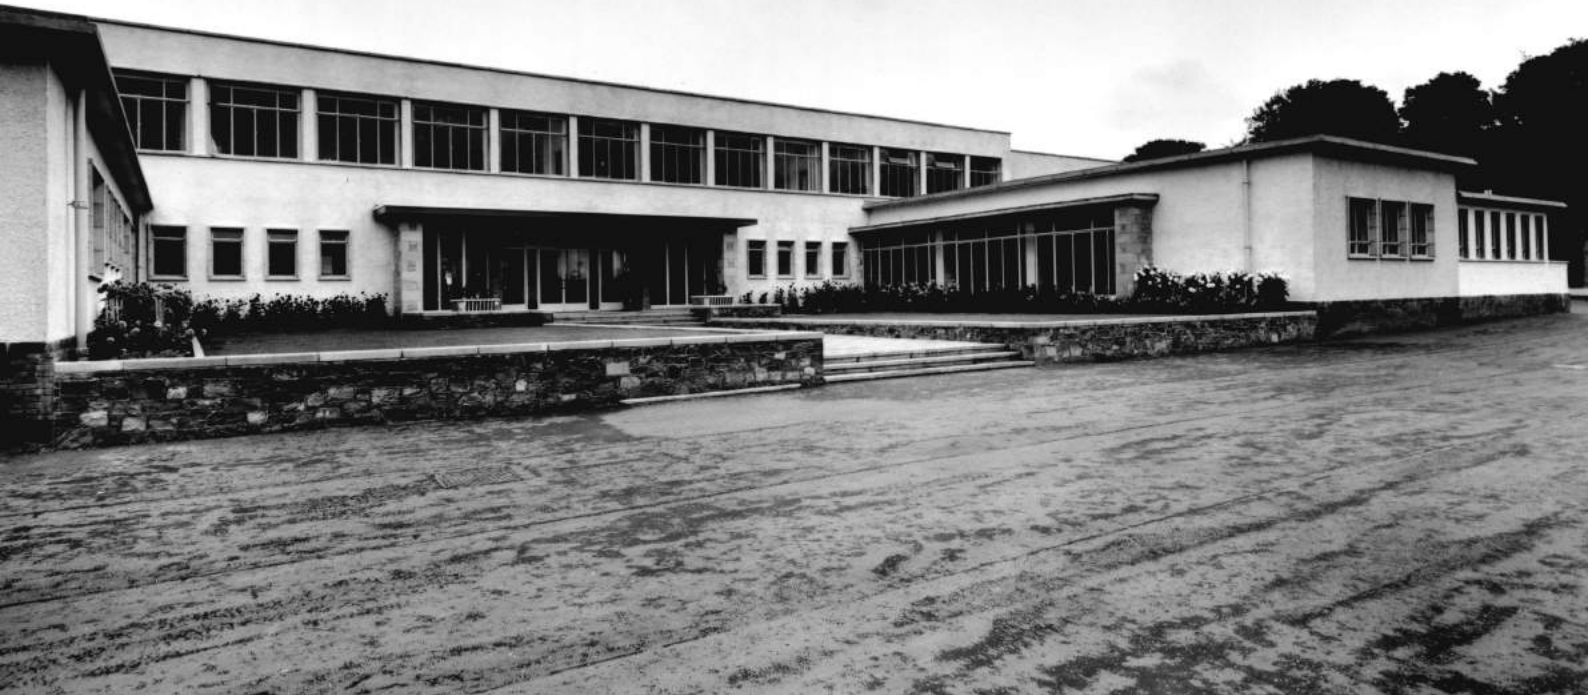
Above:
View of the front elevation of the school c. 1955 ©Courtesy of HES (J and F Johnston and Partners)

One of the most distinctive elements of the building is its low horizontal frontage. So a key focus of the scheme was to keep that element. This meant losing some of the later buildings at the back, which were not original. But it also meant losing two rear wings which were part of the original structure. This balance meant that the most important parts of the building could be kept, and, most importantly, brought back into use.

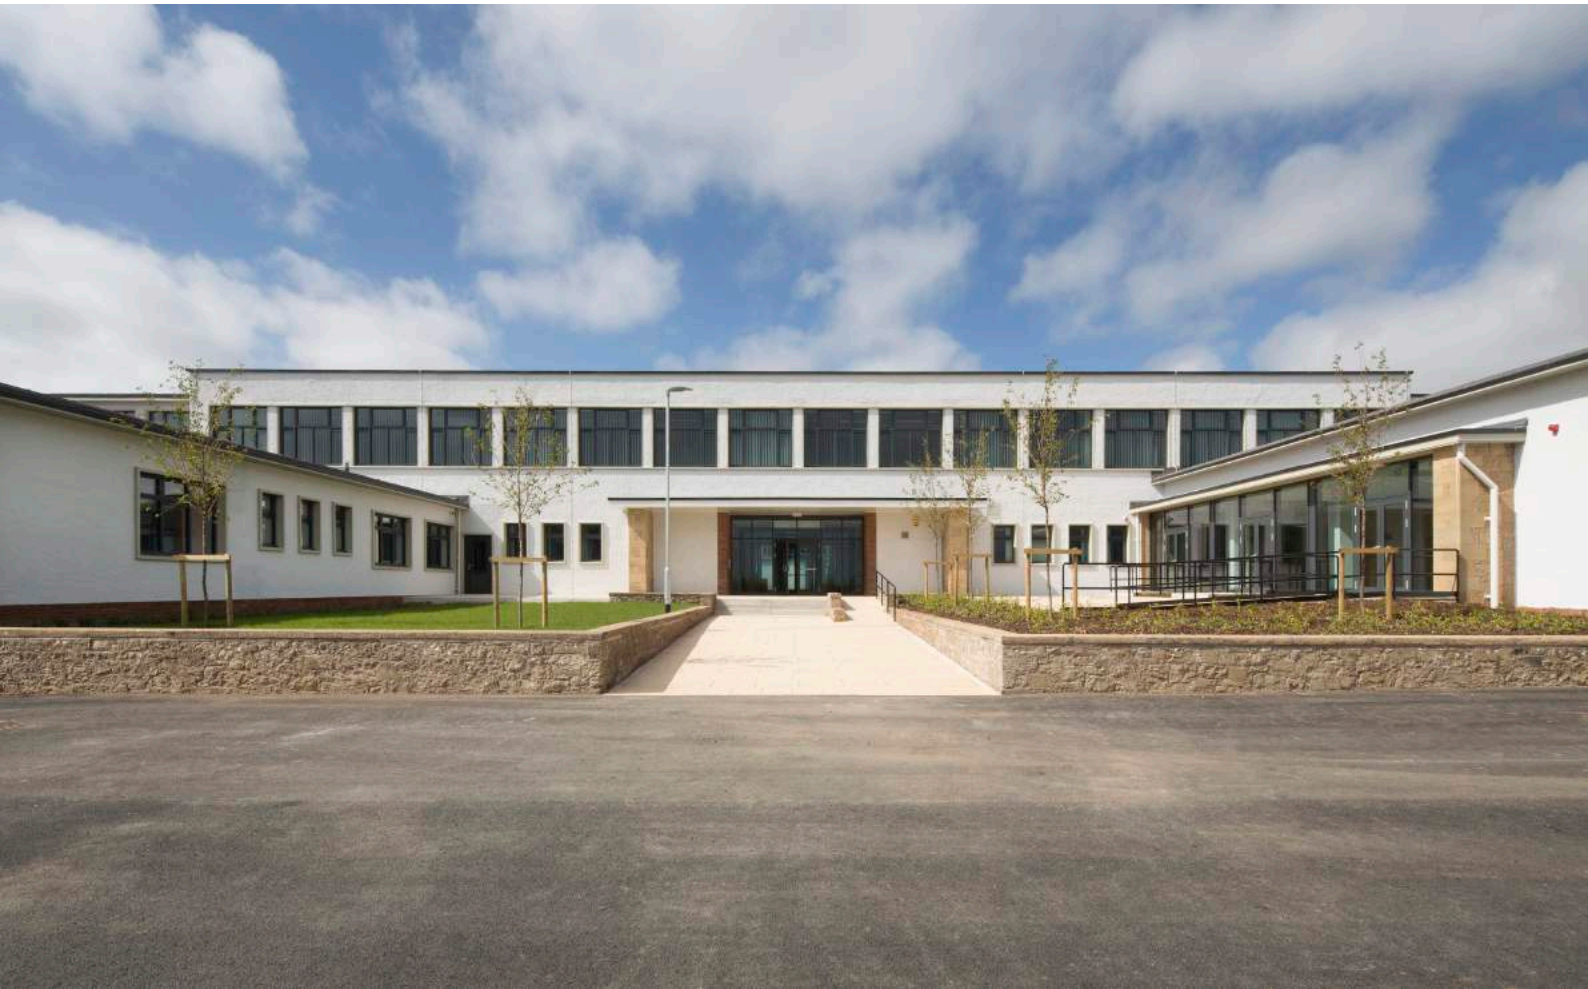
Below:
View of the front elevation of the school after the refurbishment ©McAteer

More work was needed to the original building. This was an opportunity to increase its energy efficiency by adding double glazing and roof insulation. The new windows had to be thought about carefully in order to find a solution that was sensitive to the listed building.

Thin window frames were used throughout to minimise their visual impact.

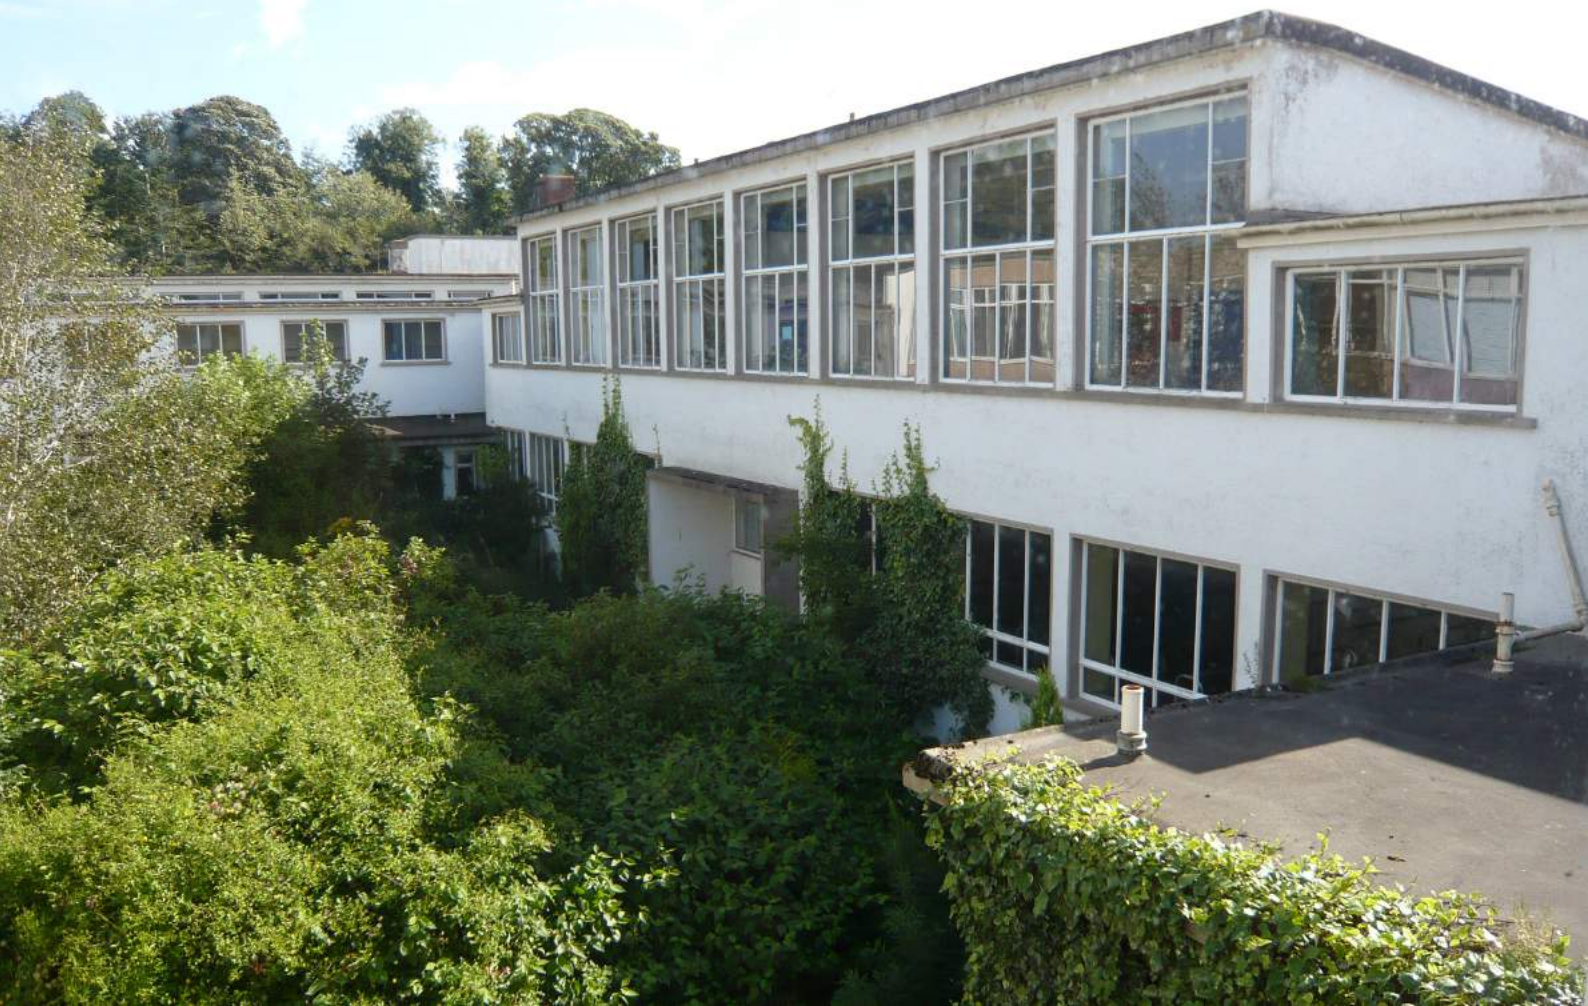
Above:
View of the back elevation of the school before the selective demolition ©Courtesy of HES

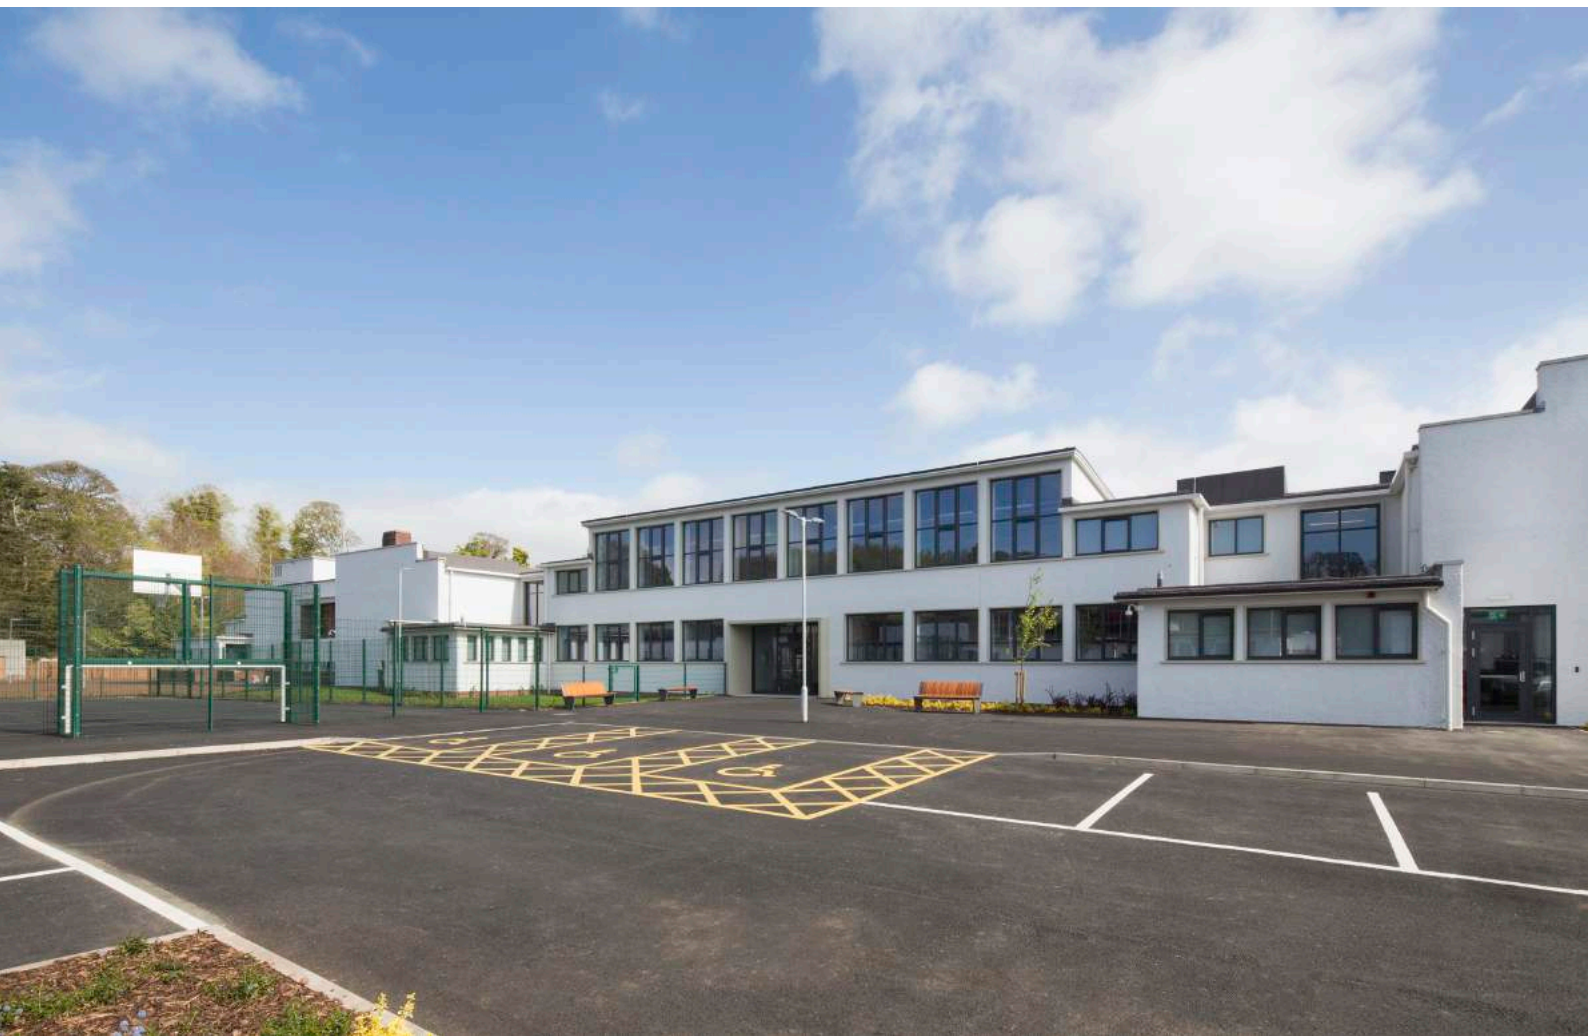
Below:
View of the back elevation of the school after the selective demolition ©McAteer

It can take up to 450 pupils, and provide them with a high-quality learning environment, with the latest facilities and infrastructure. Reducing the size of the building has allowed its most important elements to be kept; bringing it back into use has ensured its survival in the longer term.

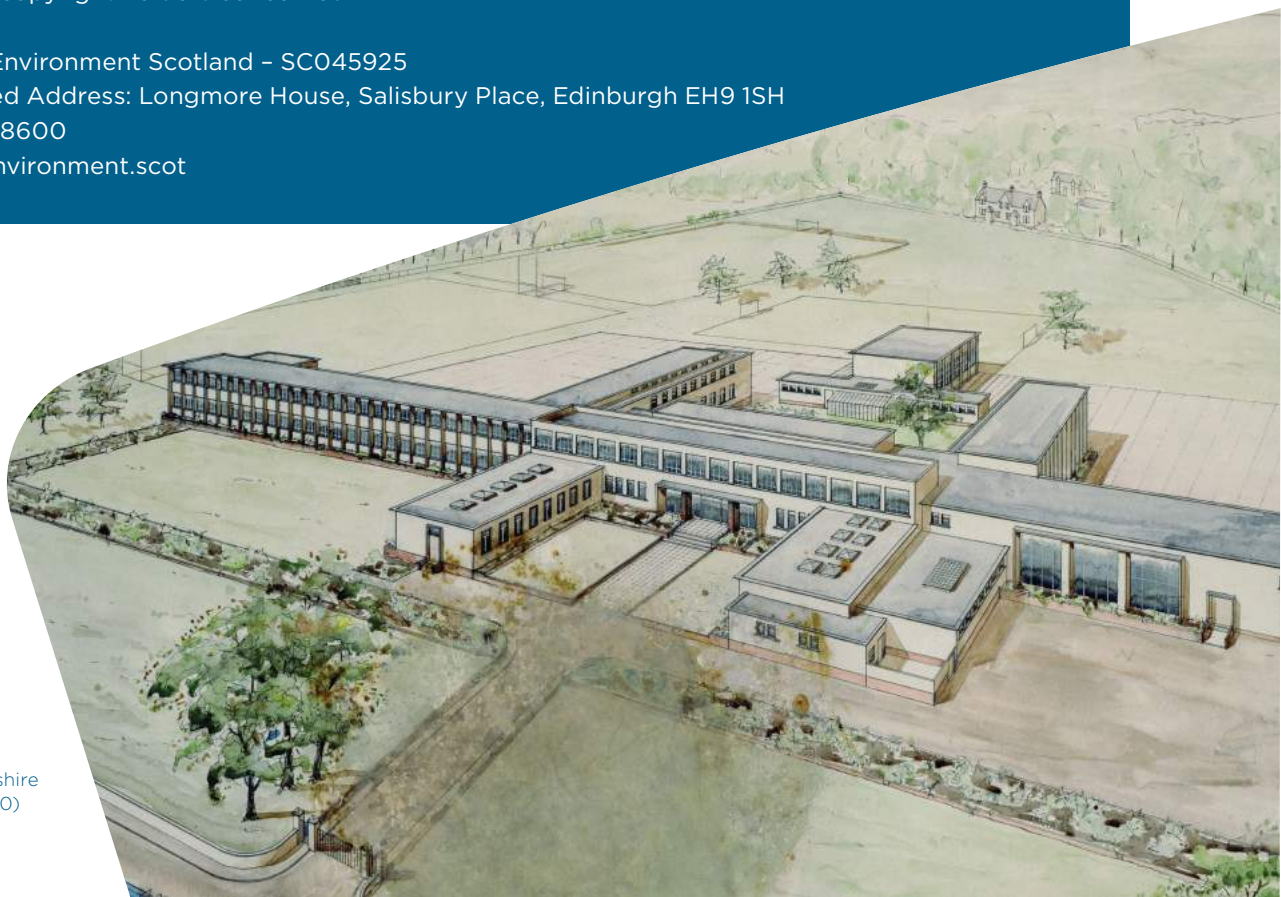
Drawing of the Old Berwickshire High School (c.1955 to 1960)
©Crown Copyright: HES
