Property in Care (PIC) ID:	PIC291
Designations:	Scheduled Monument (SM90154)
Taken into State care:	1908 (Guardianship)
Last Reviewed:	2021

## STATEMENT OF SIGNIFICANCE

# GRAIN EARTH HOUSE

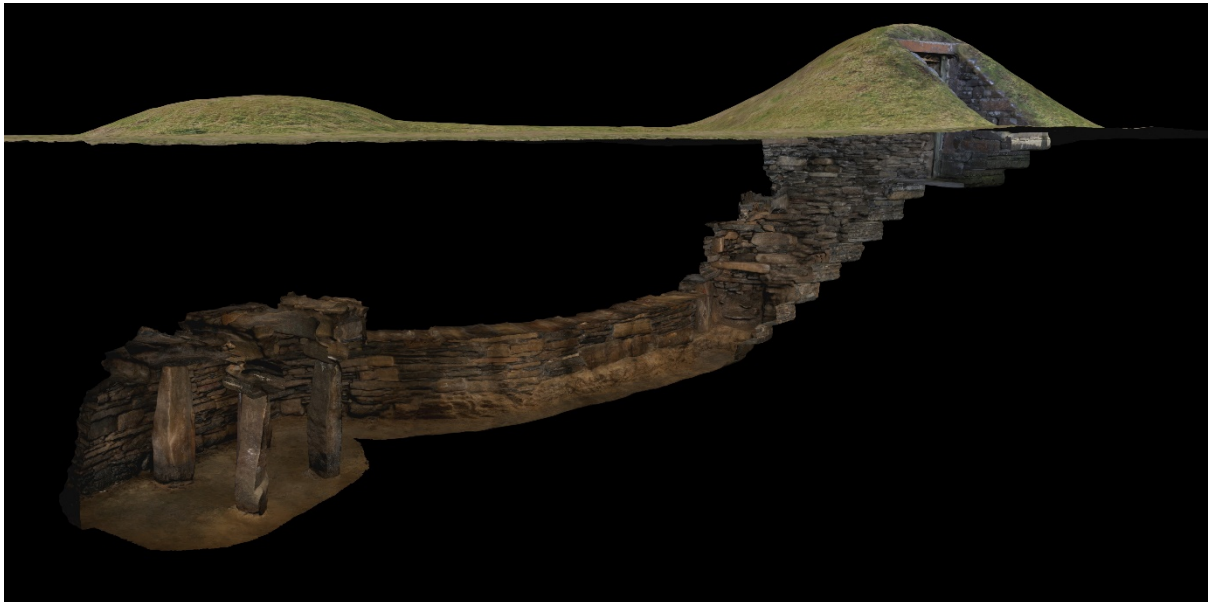
Cover: Still image from 3D photogrammetric model of Grain Earth House, showing interior of structure in relation to above-ground mound.

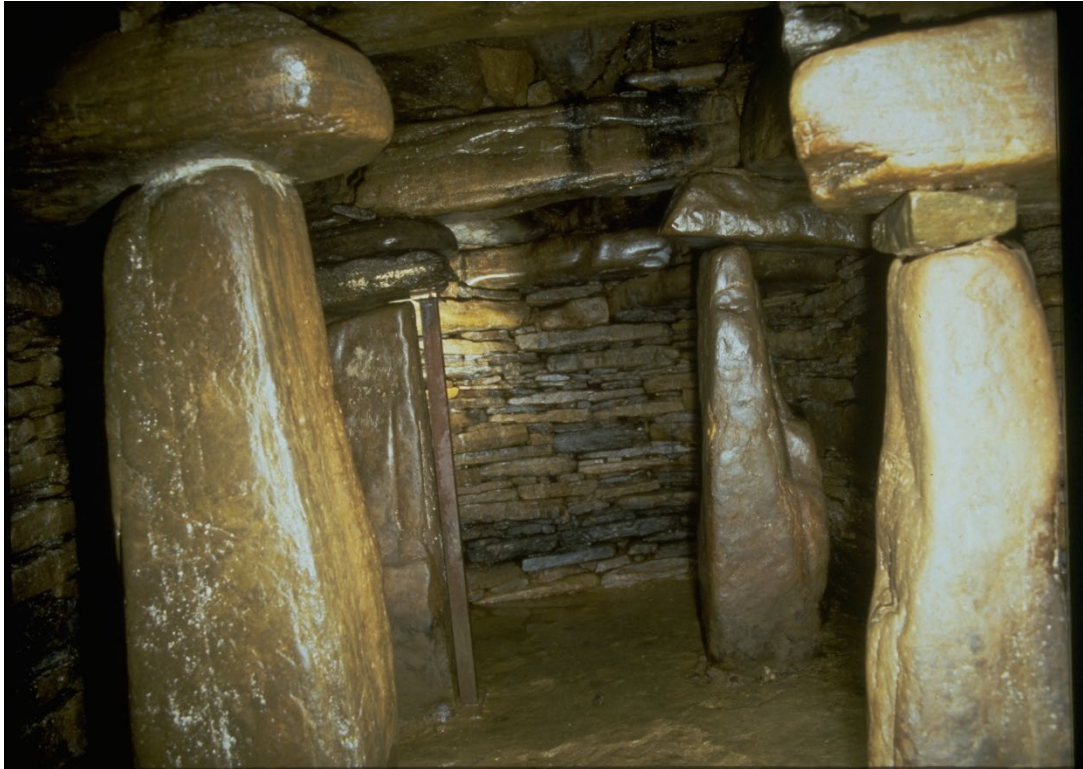
Figure 3: Looking north within the subterranean chamber of Grain Earth House. Its lintelled ceiling is supported by freestanding orthostats; a feature typical of Orcadian examples. At Grain these have been reinforced with modern, metal bars (visible next to rear, left pillar). The floor is exposed bedrock, which gently slopes in places, causing water to pool. © Crown Copyright reproduced courtesy of Historic Scotland.

Within the overall construction, individual elements of the structure emphasise the quality of construction, and skill and knowledge of the builders. Within the chamber, the four orthostats that support the roof stand well away from the side walls. This is an unusual feature for earth houses that is only to be found in Orkney. Each upright supports a massive horizontal slab that is pinned into the wall behind, and these slabs collectively provide support for the great slabs that provide the main structure of the roof. Thin pinning stones have been skilfully used throughout in order to level up the slabs and provide stability to the whole structure.

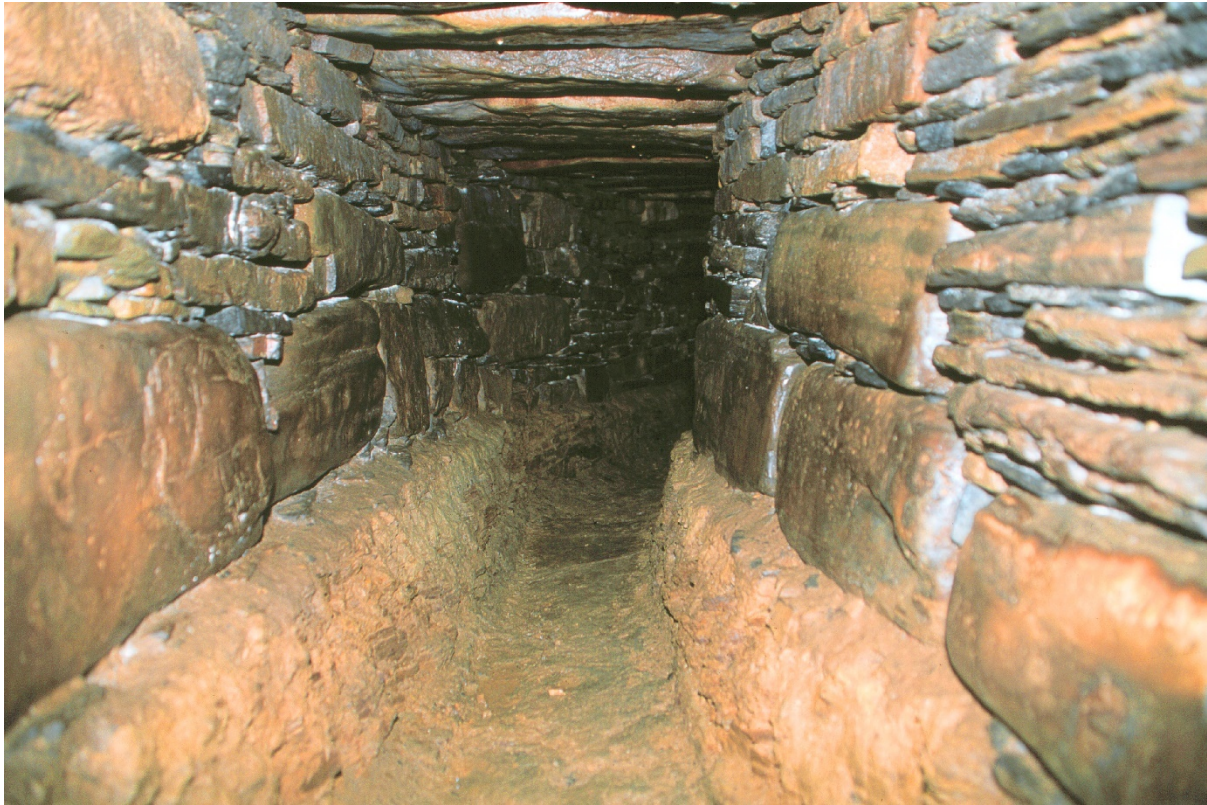
Figure 4: View along curving passageway of Grain Earth House, looking north on approach towards the chamber. The central channel within the rock-cut floor was cut in modern times to facilitate visitor access to the site; the original floor level is visible at the base of the lowest course of stonework (see too Figure 2, section A-B). Visitors with claustrophobia may not be comfortable within this narrow, restrictive space. © Diego Meozzi.

The floor of the structure was originally cut into bedrock, but in the passage, it has been deepened to facilitate access in modern times (see Figure 4). The sloping nature of the floor elsewhere causes water to pool in some places.

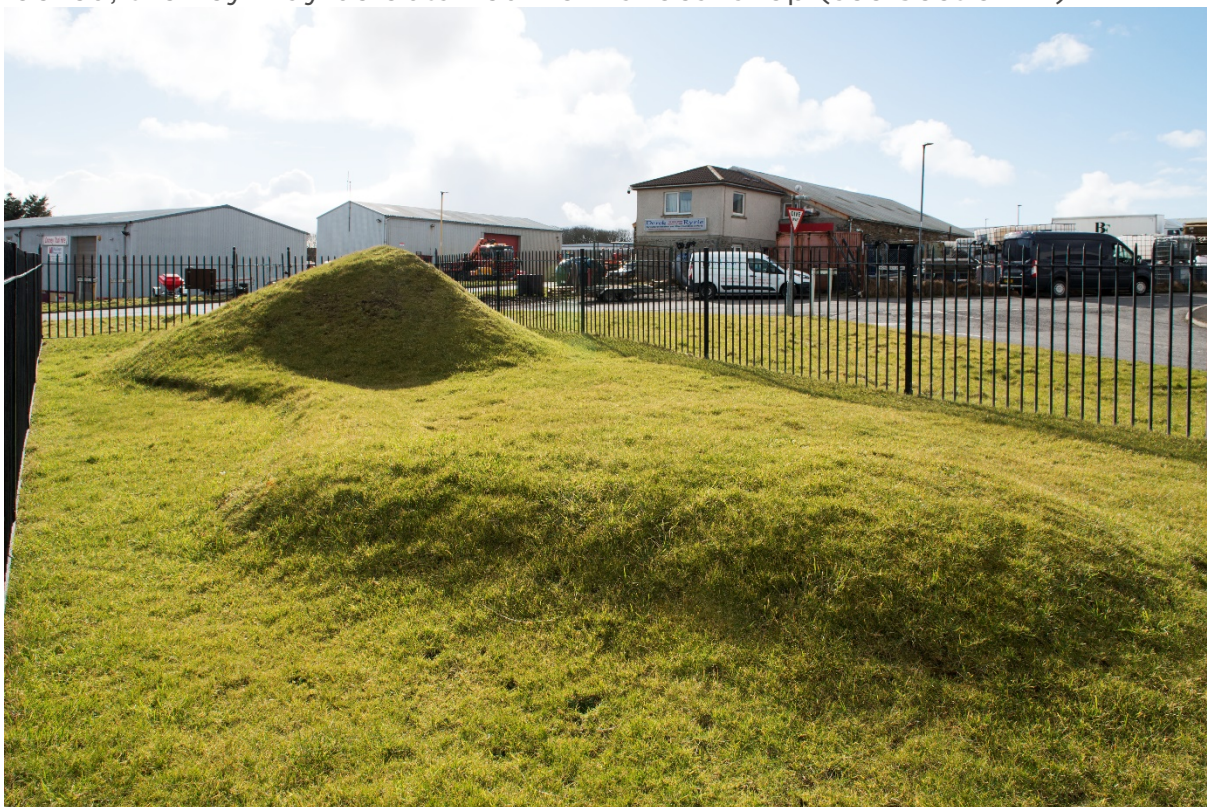
Figure 5: From the exterior, the site is visible as a grassy mound, within a fenced enclosure. The mound is of modern construction and indicates the ground plan of the subterranean structure beneath. The highest point of

the mound (at the rear of this image) encloses a modern entranceway. Both the fenced enclosure and entrance require a key for access. © Crown Copyright: HES.

On the surface of the ground, the site is visible as a low grassy mound, located within a small, fenced enclosure in the industrial estate. The estate originally served as an airfield in the Second World War, and relics of this survive in some of the buildings and street names. The mound and enclosure were created when the site came into State care in 1908, at which time the upper levels of the staircase were inserted to allow public access. There is no lighting within the earth house, though a torch is supplied on site.<sup>17</sup> The enclosure and entrance to the earth house are kept locked, the key may be obtained from a local shop (see Section 1.1).

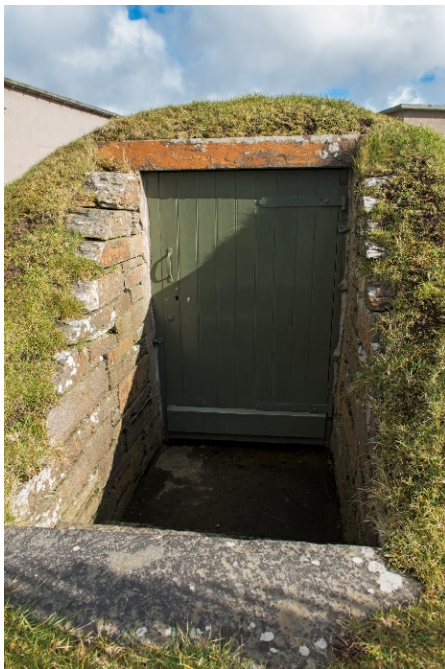
Figure 6 (left): The modern entranceway © Crown Copyright: HES.

The upper levels of the entrance stair and the entranceway itself with its associated grassy mound were added between 1901 and 1908 when the monument came into State care. As such, they provide good examples of a level of (re)construction work that, while adding considerably to the visitor experience and wellbeing of the monument, might not be undertaken today.

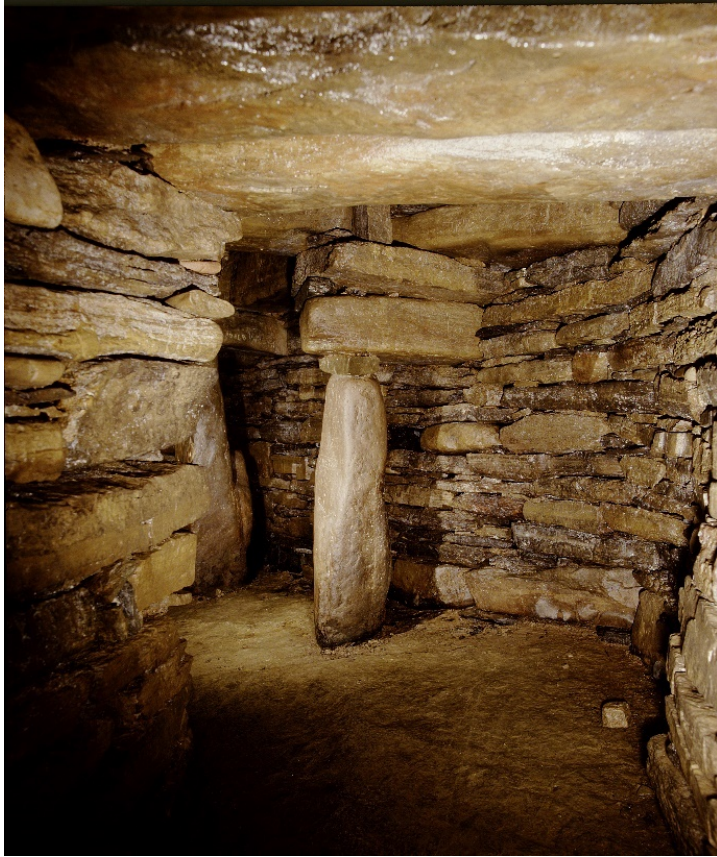
Figure 8: First view of the internal chamber of Grain Earth House, after progressing along the passage. The building stone used in its construction is a mixture of quarried and rounded stone. © Crown Copyright HES.

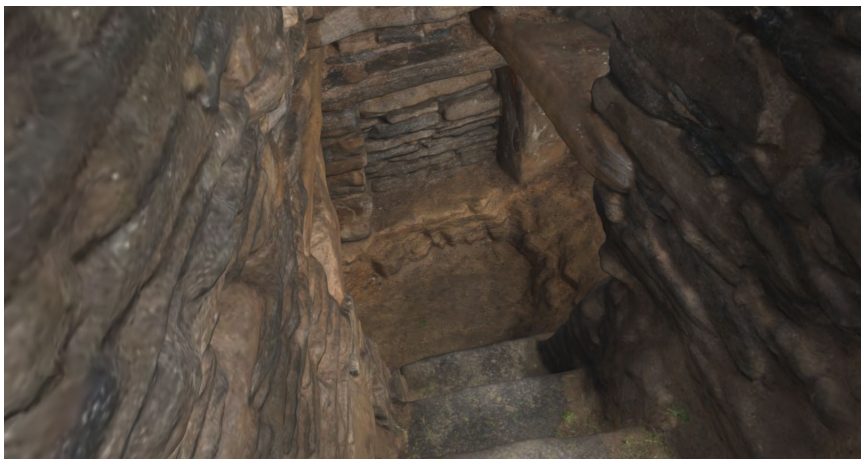
Figure 9: At the foot of the stairs are recesses ahead (east) and to the right (south). The passage opens off to the left (north). Image is a screenshot from the photogrammetric model of the site, accessible via the HES sketchfab page. © Historic Environment Scotland.

The planning of the underground chamber and passage incorporated additional spaces at the foot of the stairs. The original purpose of these is unknown. As you descend the stairs, a shallow recess ahead of you almost gives the impression of a shelved aumbry, while to the right lies a larger recess that has been suggested as a possible alternative entrance or even the start of a passage leading to a second chamber. These structures were not built for simplicity, they were carefully designed to serve the specific needs of their builders, and many were altered in the course of their usage.
