## Blair Castle, Perthshire

### The re-instatement of an early micro-hydroelectric plant

This publication should be quoted as:  
Historic Environment Scotland  
Refurbishment Case Study 21

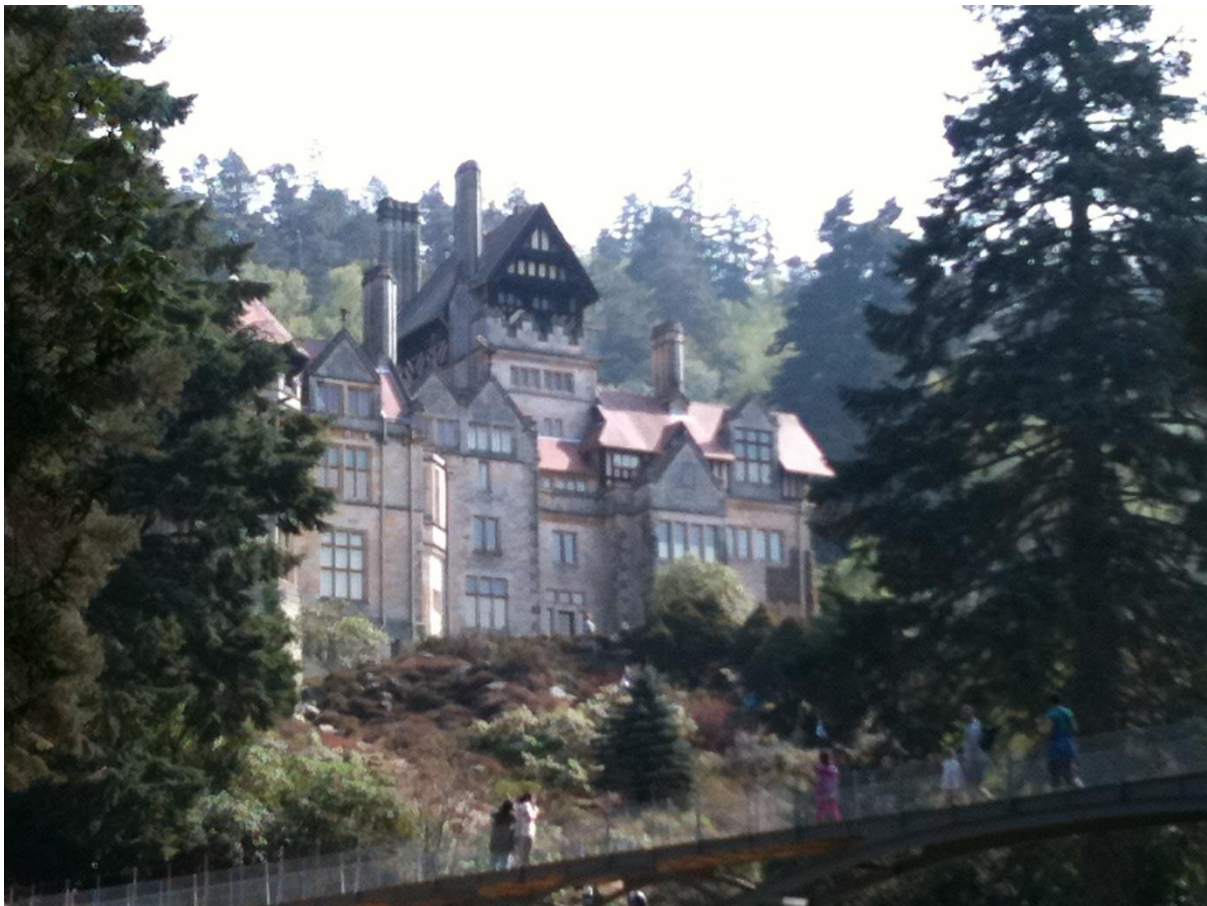
Figure 1: Cragside in Northumberland, the first house in Britain to have electricity. This was generated by a turbine system powered from a dam close to the house.

As is often the case today, developing technology and increasing demand obliged upgrades, and in 1886 a Gilkes turbine was installed; this again was upgraded in 1895. The water power came from a dam and turbine system in the river close to the house, with a vertical fall of about 100 metres. A reliable source of water and a reasonable height or fall of water was (as is now) a requirement for such domestic hydro projects. Such systems were quickly

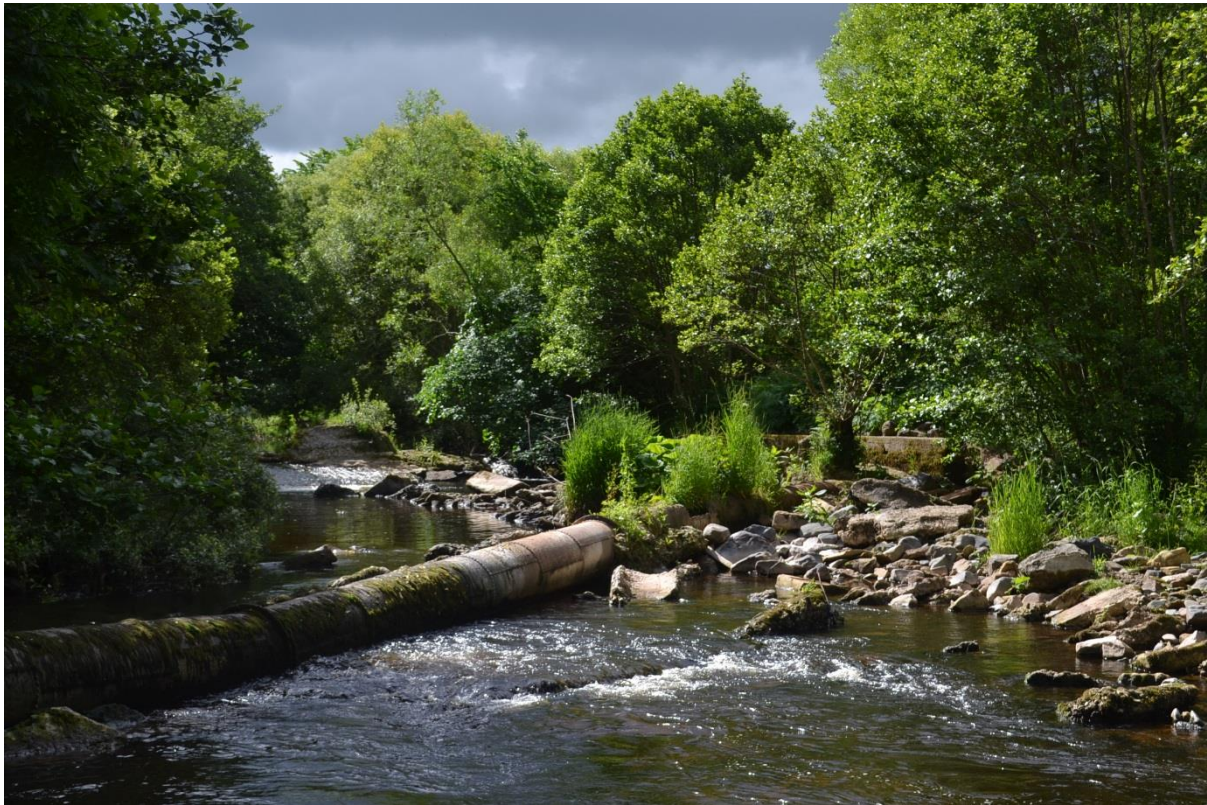
Figure 2: Remains of the steel penstock for the Wells House hydro system of 1905. The remains of the cauld can be seen in the background.

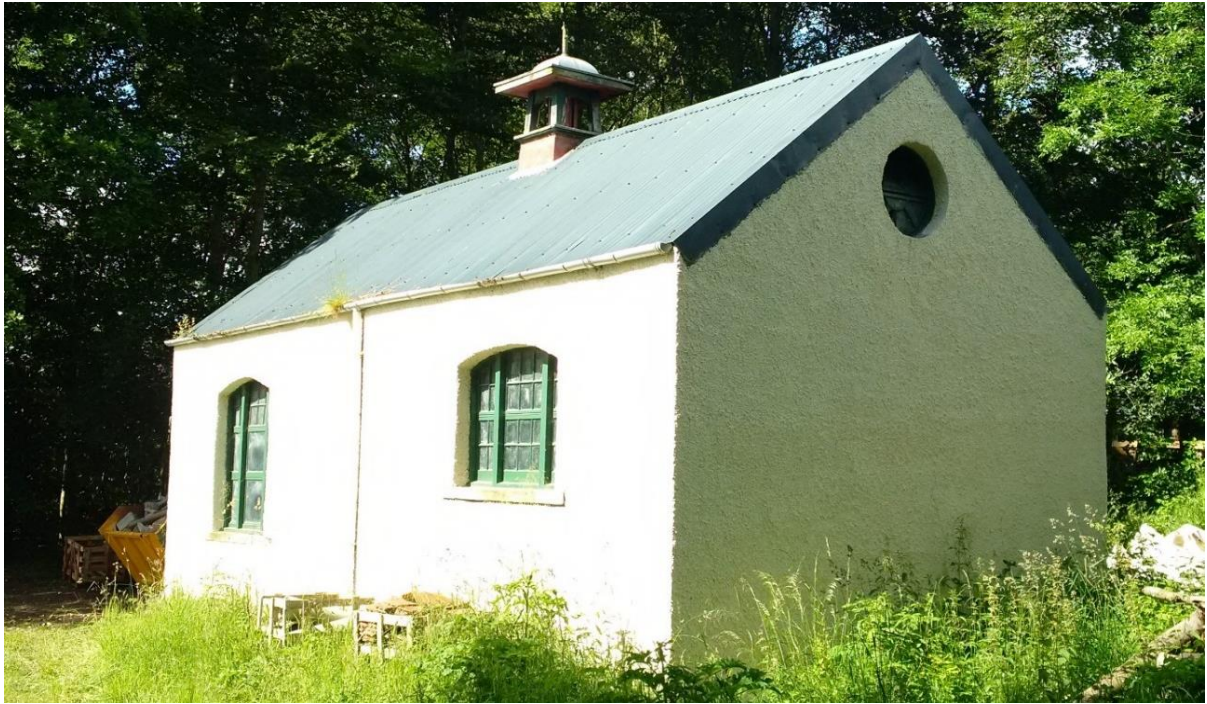
Figure 3: The former battery house at Wells.

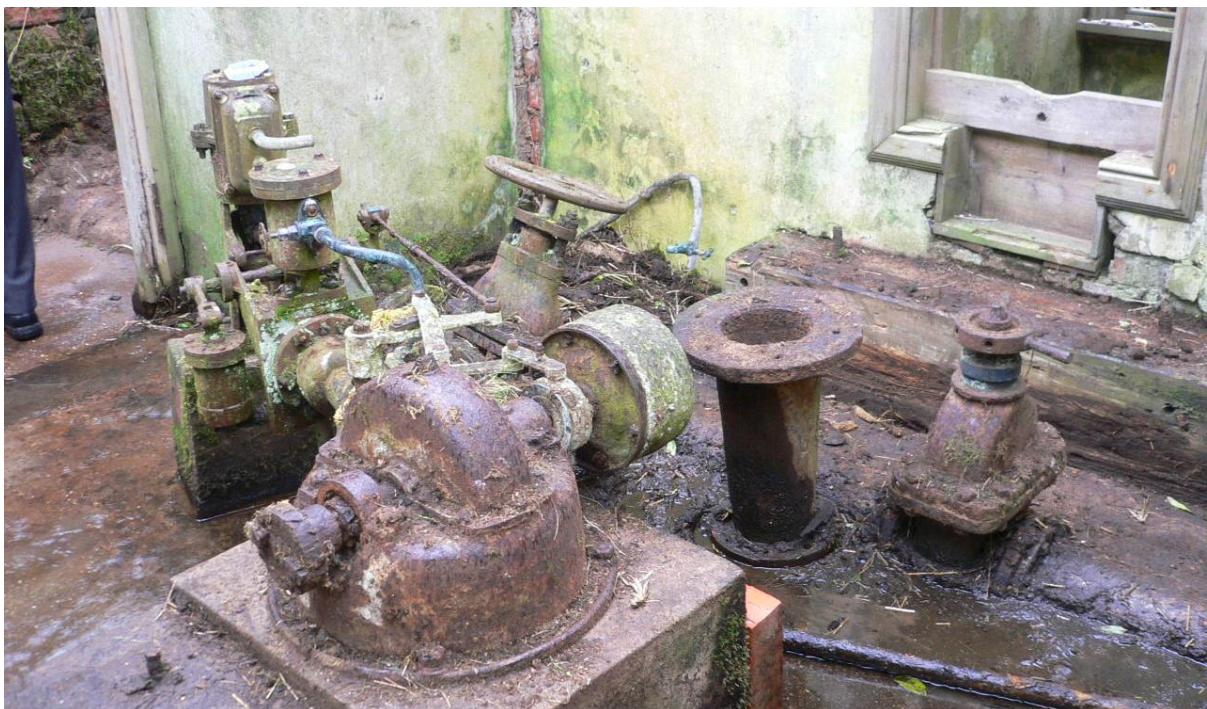
Figure 4: A 1909 Gilkes turbine surviving near a country house in Berwickshire.

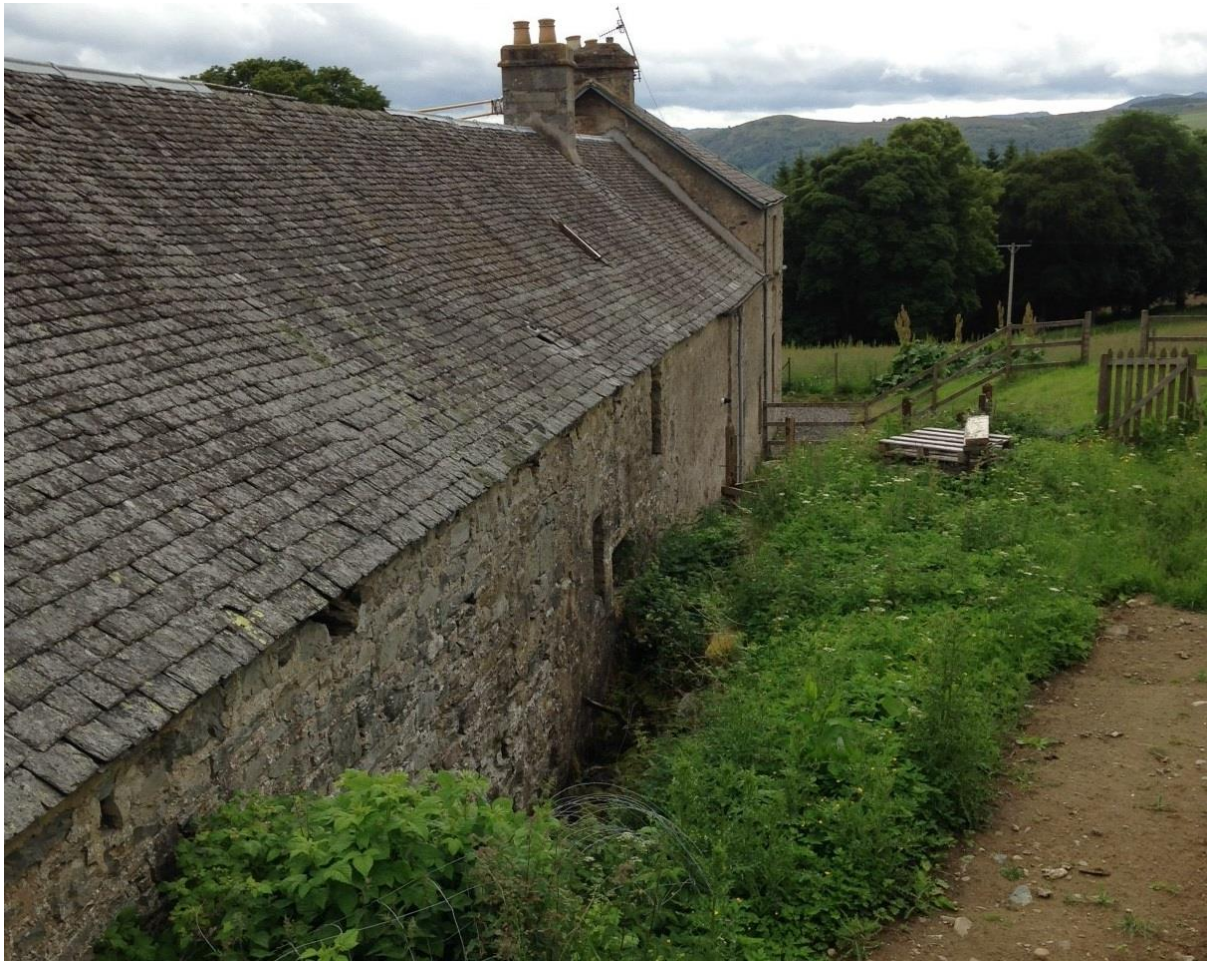
Figure 5: The former Estate sawmill at Blair; this was water powered until 1905. The wheel pit is visible in the middle foreground.

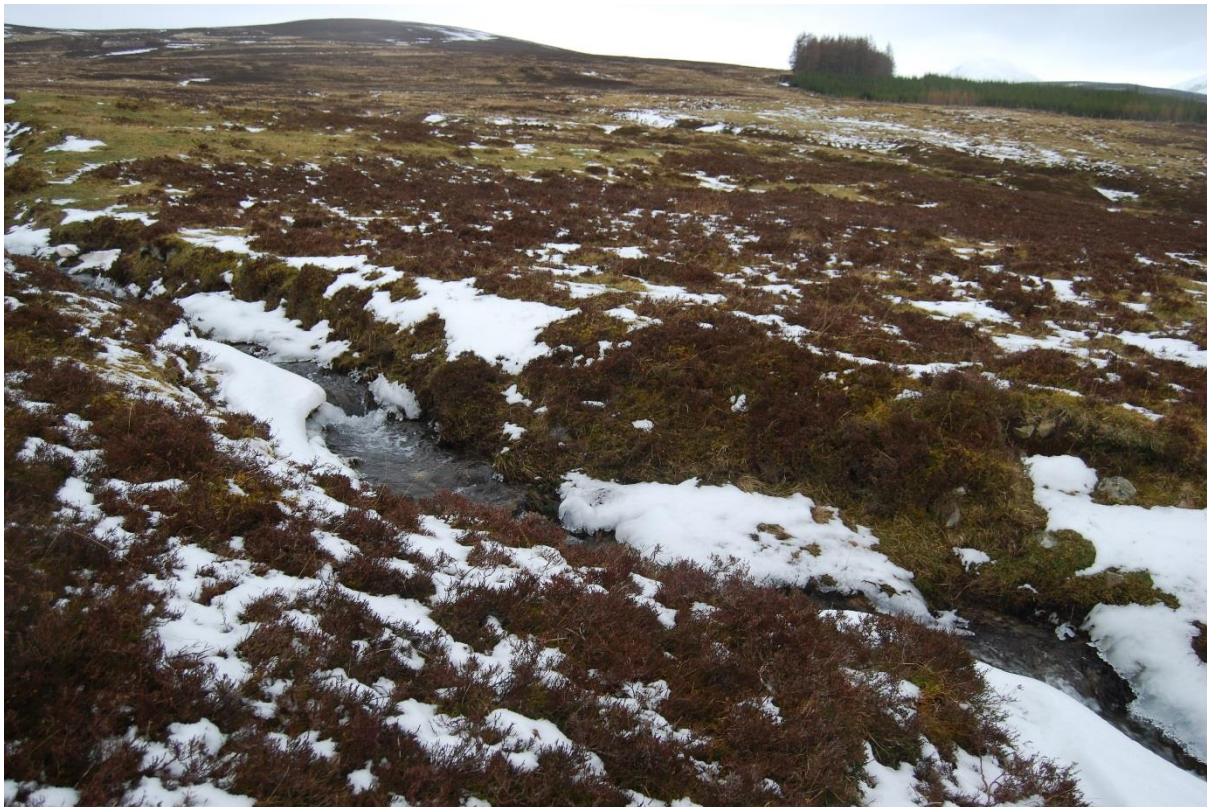
Figure 6: Part of the 1908 ditch system on the moor above the castle; this was crucial in ensuring a continuous water supply for the new turbine.

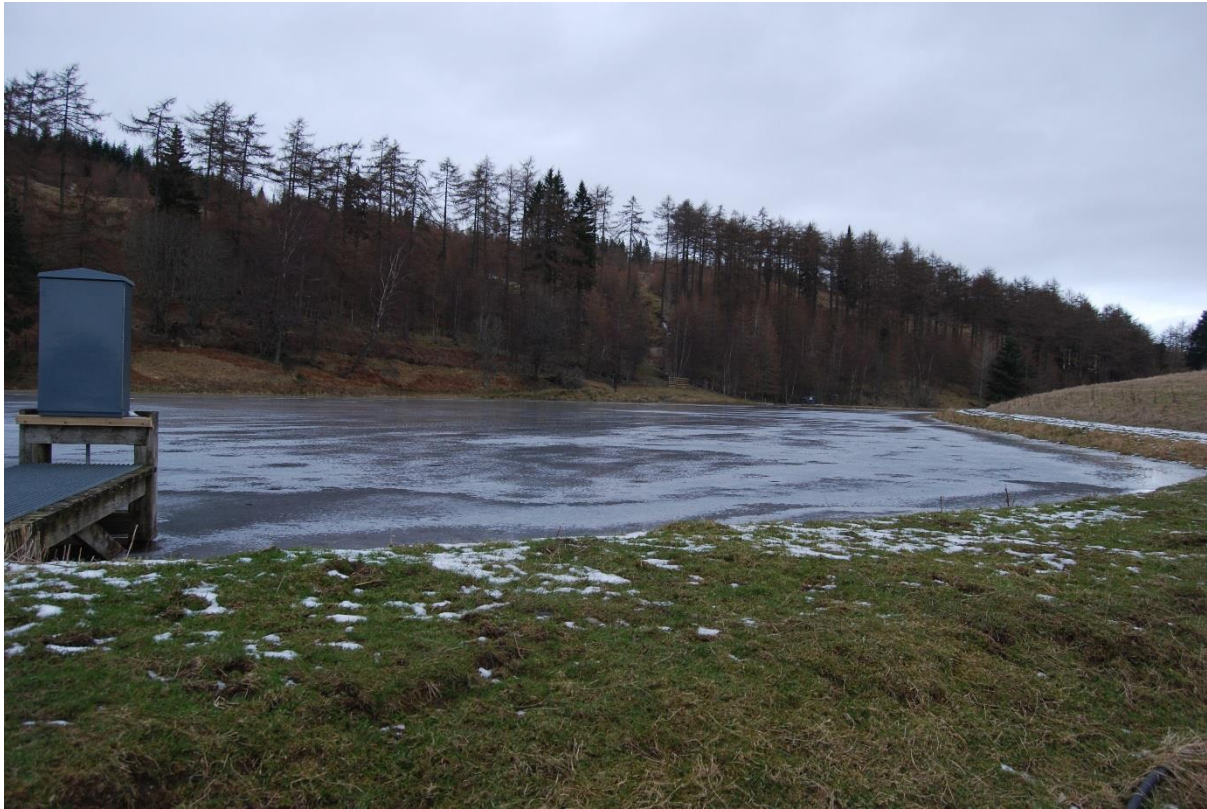
Figure 7: The larger holding pond (called 'Top Pond') for the turbine water supply, excavated in 1908.

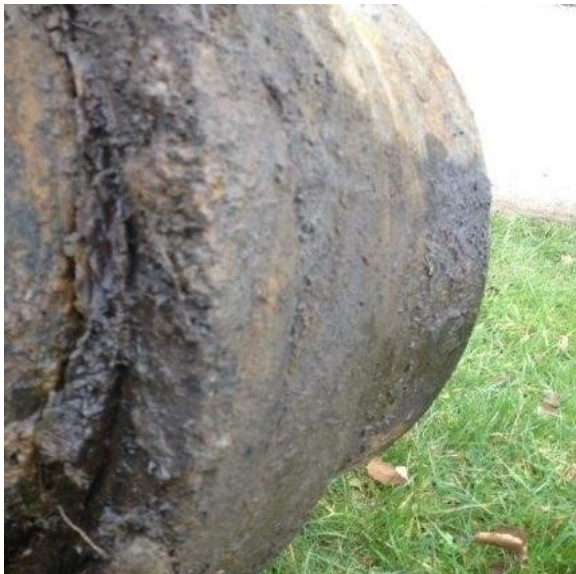
This was a critical aspect of the feasibility study. The re-use of the existing penstock, upon which the economic viability of the projects depended, was fundamental. To assess condition, the original penstock was excavated at four points, and a section was removed for inspection and assessment as to condition (Figure 9). A cut section through the steel works showed it to be in very good condition with minimal rust on either side (Figure 10). Its condition was therefore assessed as very satisfactory and fully able to handle the required water pressure from the hill supply. While a pressure test was possible and desirable, this was not progressed in case it caused damage to the pipe, and in any event, having held water at pressure for the fire system for many years, it had passed its own test.

Figure 9: A section of the 1908 steel penstock was removed to allow close inspection and assessment (image Atholl Estates).

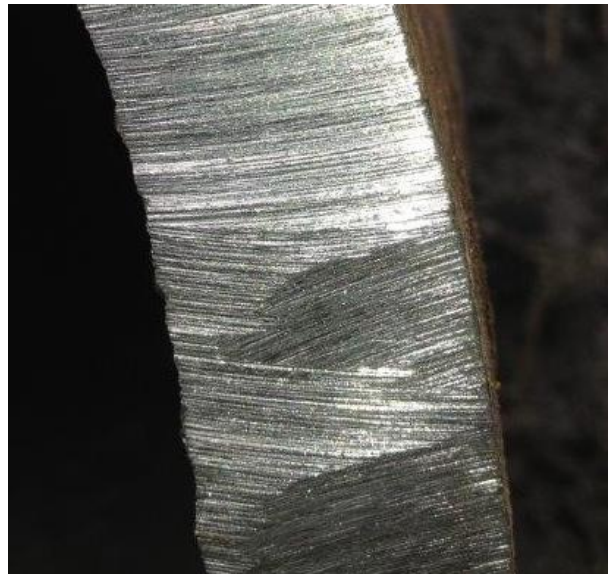
Figure 10: A close view of a cut through the 1908 steel of the penstock; the amount of corrosion was minimal (image Atholl Estates).

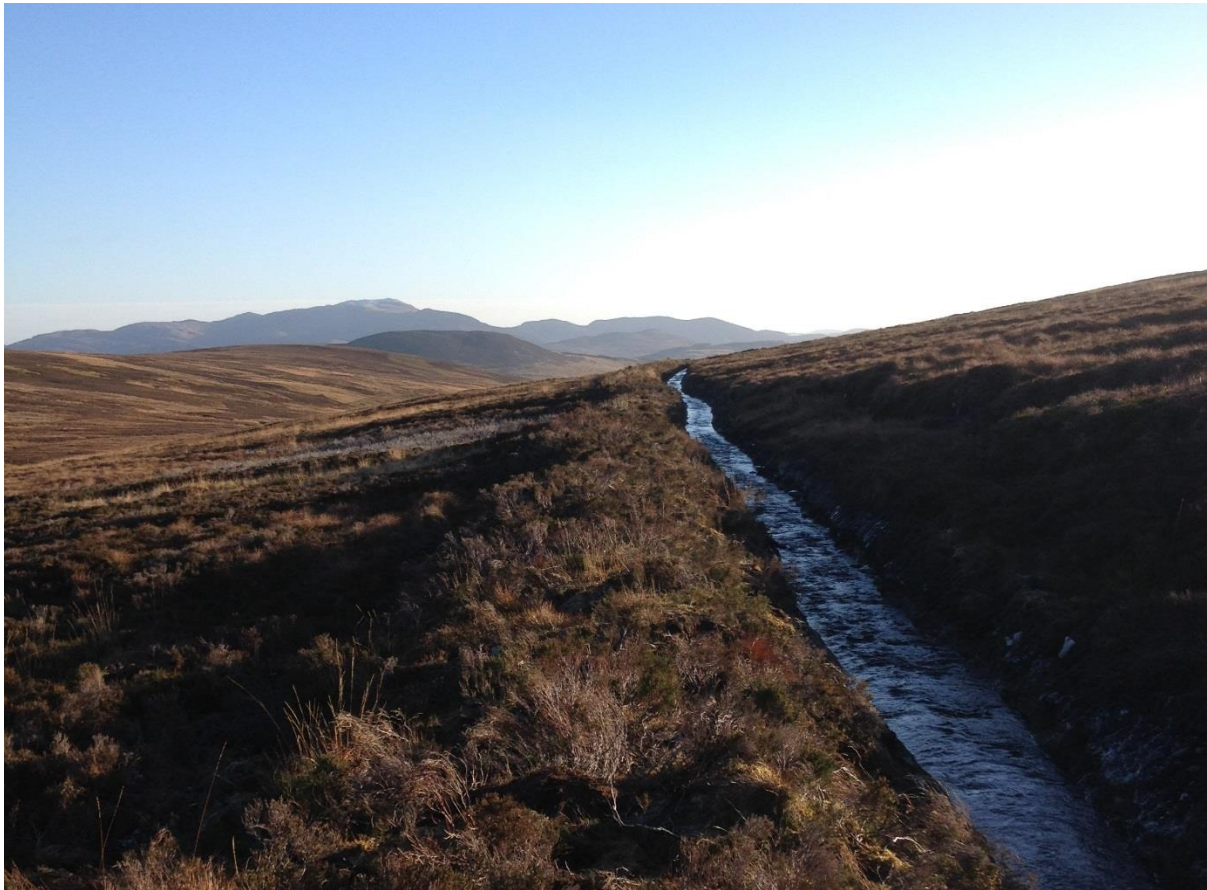
Figure 11: The recently cleared ditch on the hill above the castle, termed ‘the 4 mile ditch’ (image Atholl Estates).

The existing ditch from 1908 needed clearing. While it was simple in concept to clear and open up the route, and to a degree it was in practice, the work still took some time. A mechanical excavator worked for 6 weeks to clear the route. The cleared ditch was termed ‘the 4 mile ditch’ (Figure 11) and reflects the scale of the project.

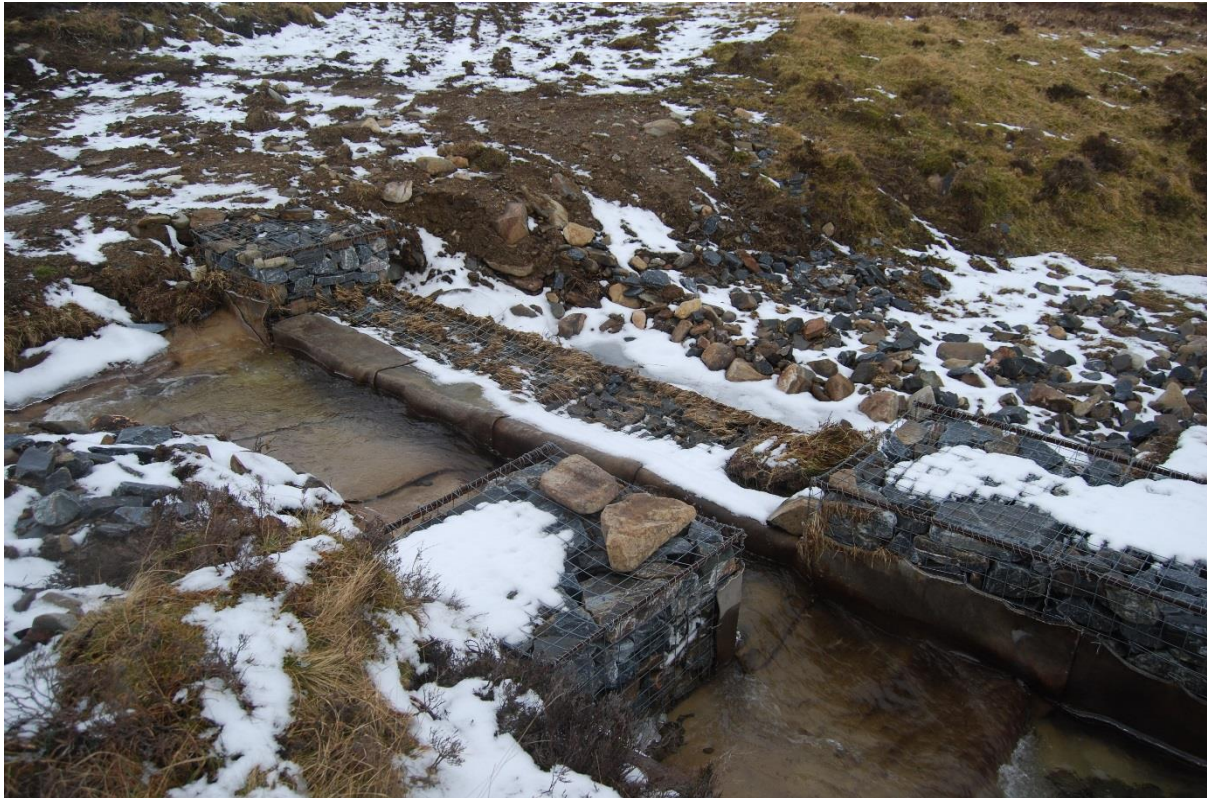
Figure 12: One of the new spillways needed to manage surges in water coming off the hill in periods of high rainfall or snow melt.

In all the work on the hill, the governing principle was that of ensuring an even and steady water flow into the Top Pond. This required the construction of several overflow cills or spillways along the route to manage and handle additional water during times of heavy rain. The new spillways were constructed using wire gabions and concrete matting (Figure 12).

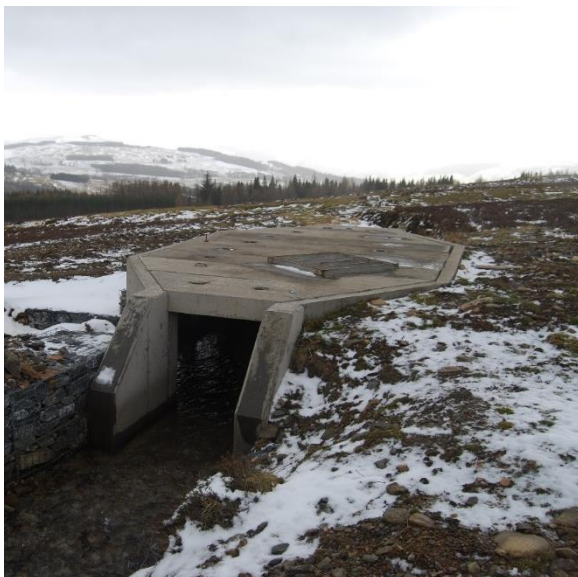
Figure 13: The new concrete silt trap on the hill moor behind the castle.

Whilst most of the works on the hill were essentially agricultural in nature, the requirement from SEPA for the construction of a silt trap required a designed structure, constructed from reinforced concrete (Figure 13). Transport of materials for this was resource intensive.

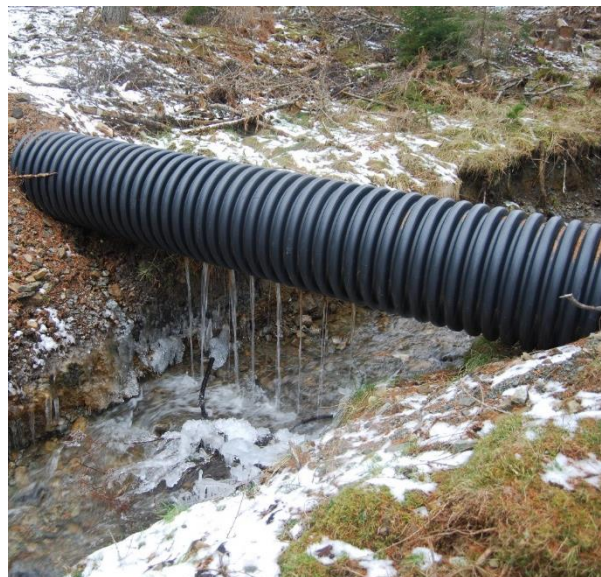
Figure 14: Surplus water management was important at all stages of the pond supply, and lower down the hillside new solutions were needed to route excess water clear of the pond.

Lower down the ditch route, where the construction of spillways and the routing away of water was not possible, some burns had to be channelled over the pond supply ditch in order to reduce flow into the pond. This required imaginative engineering (Figure 14).

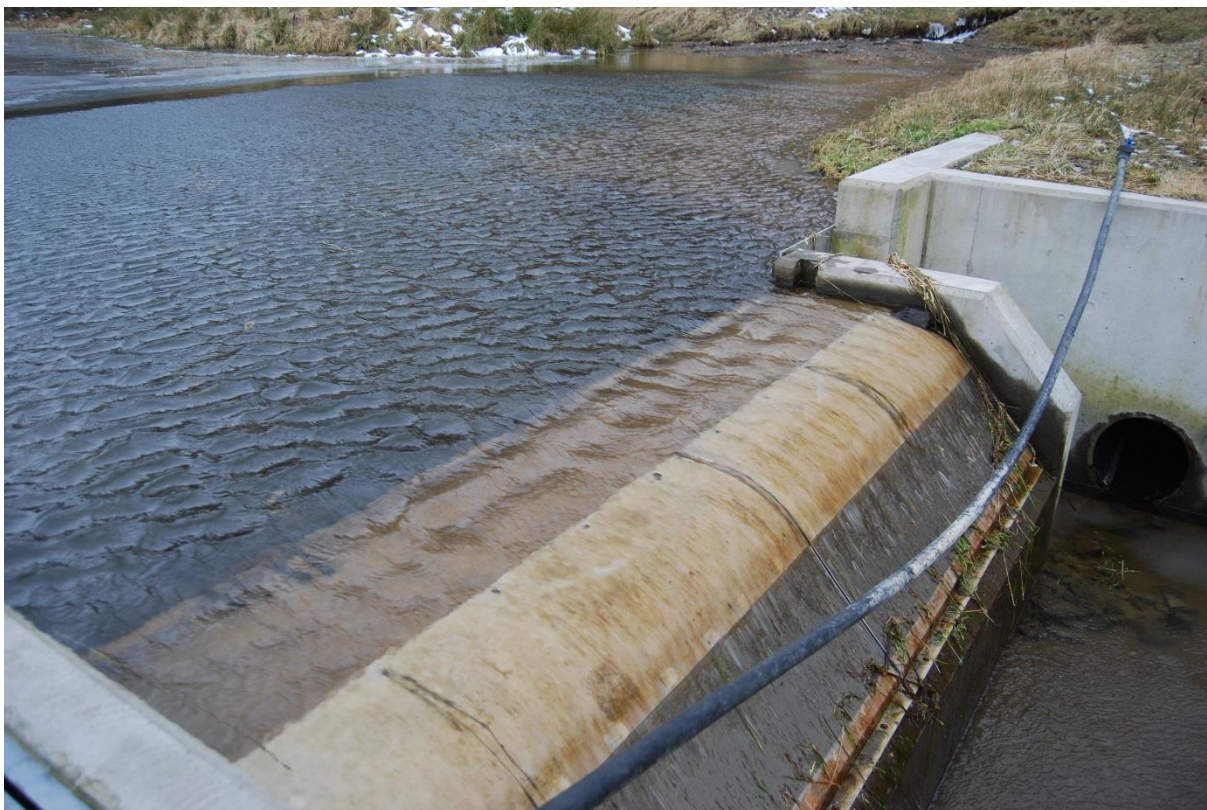
Figure 15: The new cill for the holding pond. Note the filter screen designed to keep debris out of the penstock.

As with the old system, a holding pond was required to keep the water in the penstock at a constant pressure. The pond from the 1905 scheme (Top Pond) had been kept for fishing use, and although partially silted up, was still adequate for the restored scheme. The penstock entry point was moved however, and a new cill and spillway was formed. While this was mainly to regulate the water flow, it was also designed to catch debris and prevent it progressing down into the turbine (Figure 15).

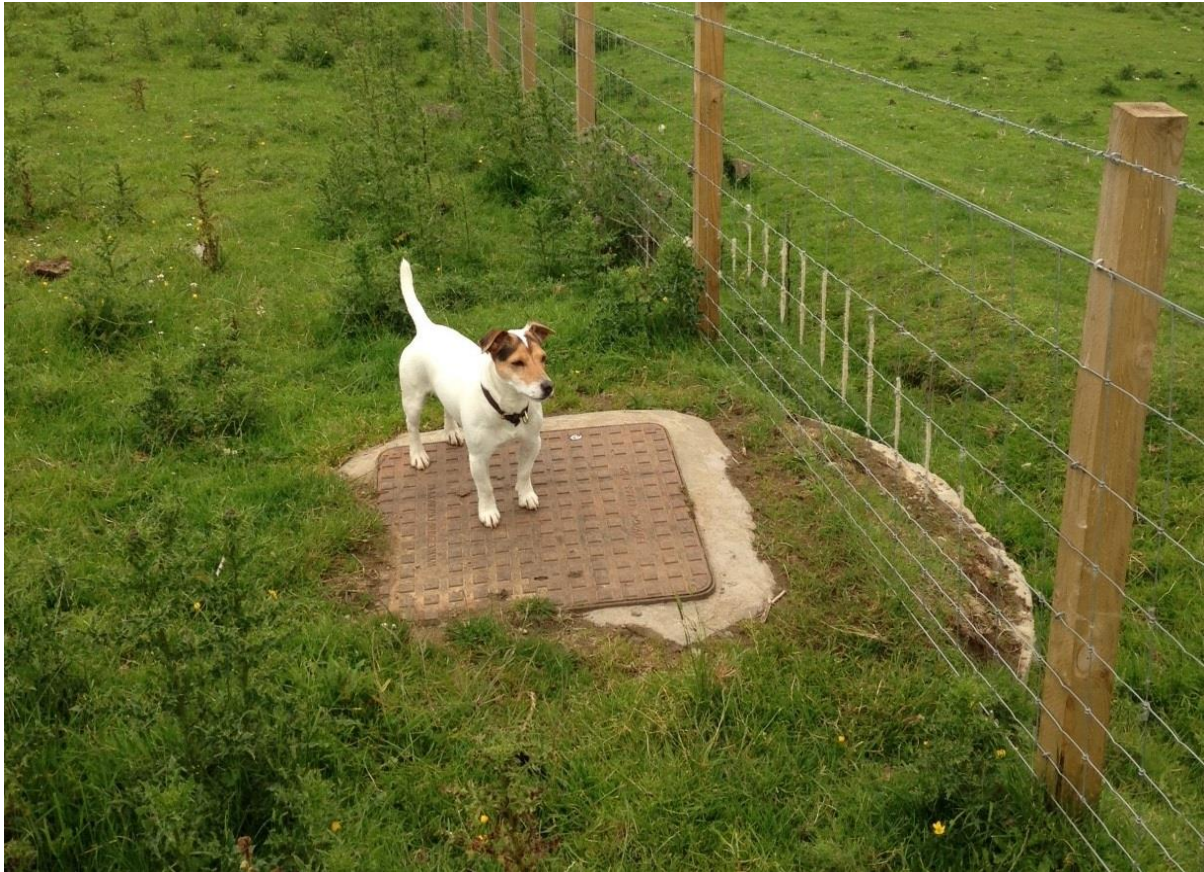
Figure 16: The manhole cover over one of the new chambers for the isolating and air bleeding valves (image Atholl Estates).

The existing access chambers to the penstock, located at four positions in the parkland of the Castle, were dug out and new inspection chambers constructed using standard concrete manhole components (Figure 16). New isolation valves, to allow selective draining of the penstock, were fitted. New air valves were installed to ensure air pockets could be bled from the restored penstock.

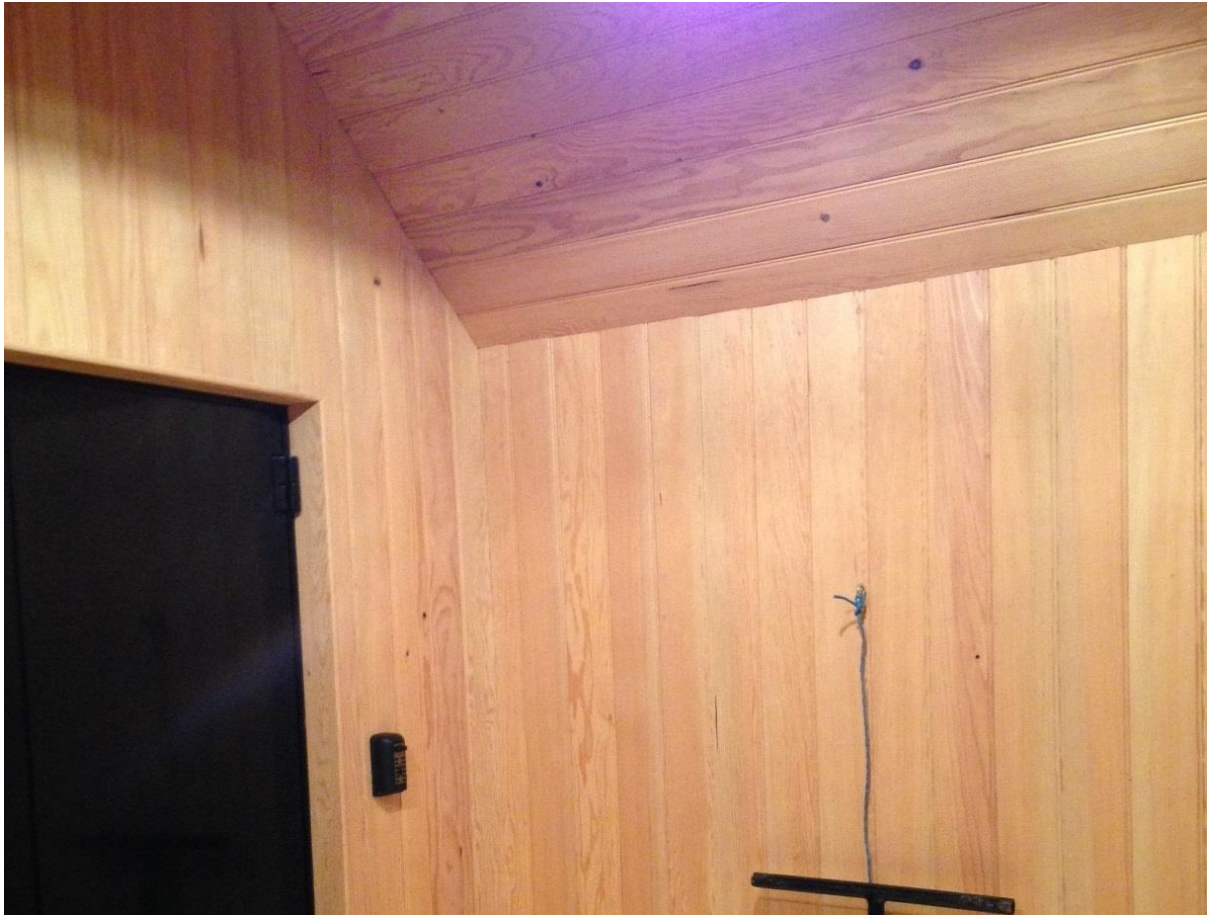
Figure 17: The new entrance lobby of the turbine house finished in local Scots Pine from the Blair Estate.

It was also decided by The Blair Charitable Trust that the existing turbine house would be used as a showcase for the project, so from the outset there was an intent for the building, and the plant inside, to be viewed both by casual visitors as well as by engineers and other professionals. This meant that the presentation and finish of the structure was going to be of a higher standard than other similar structures. The brick structure from 1905 was in reasonable condition; and the structural repairs were relatively simple, with its existing profile metal roof covering, new internal linings, a new concrete slab and a new entrance lobby being formed. This lobby contains the firefighting systems and equipment for the first response team for the castle. The internal walls of the lobby were lined in vertical timber lining of Scots Pine, a common 19th century finishing detail in the Highlands (Figure 17).

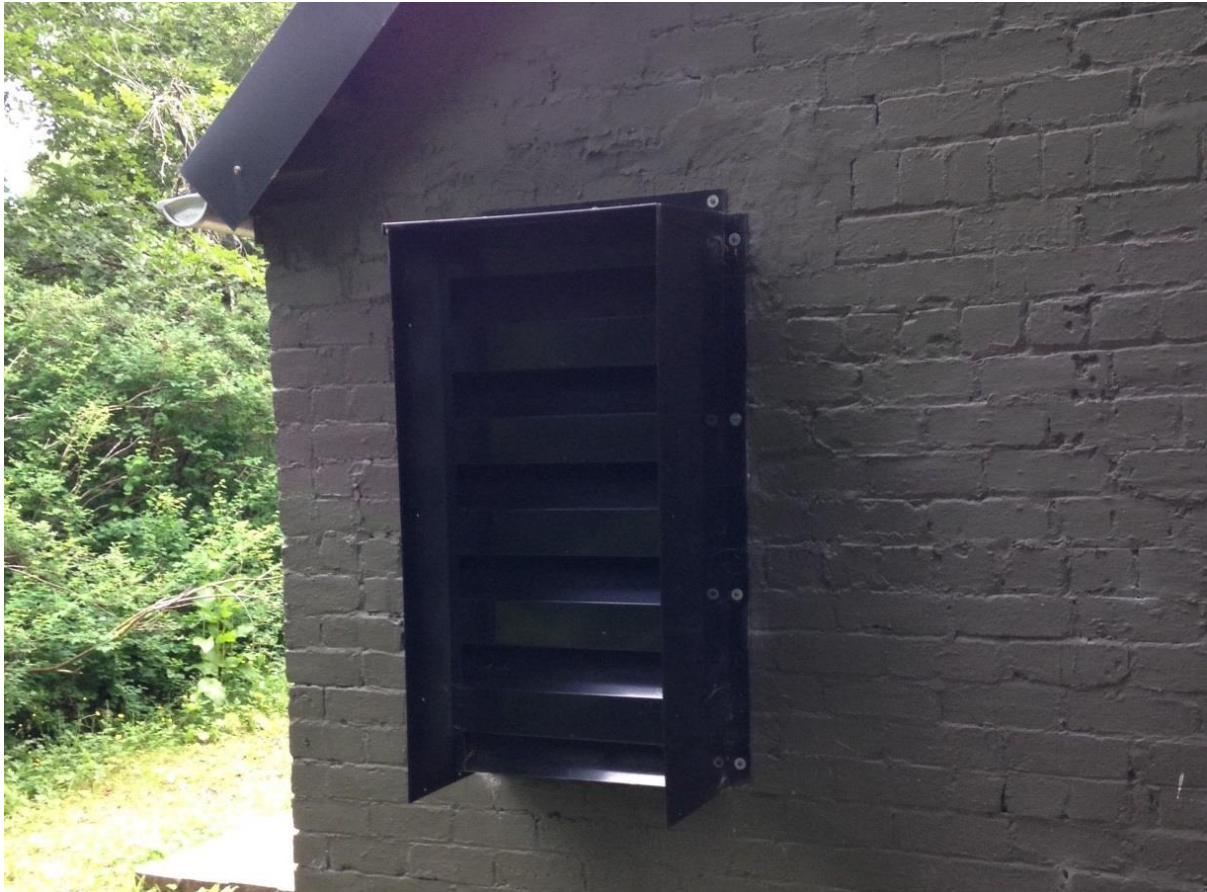
Figure 18: One of the noise mitigation features in the turbine house – a sound proofed ventilation opening.

Turbines create heat, so ventilation was a key requirement; however turbines operating at capacity are noisy and an important factor for The Blair Charitable Trust was noise management. The Gilkes 82kw turbine will produce about 85 decibels, and the visitor experience for those visiting the castle and the historic landscape had to be considered carefully, along with all residents and those working in the estate office close by. Therefore a high degree of acoustic engineering was required. The lobby to the turbine house acted as a noise buffer, and was entered through acoustically sealed doors. These were highly engineered and consequently costly. In addition the intake and extract air ventilation louvres were designed with acoustic baffles, one of which is shown in Figure 18. Such bespoke equipment was costly (costing about £14,000), but considered necessary in this situation. An 'S' trap sump contains all mechanical noise on the outfall. With these works completed, there was no discernible mechanical noise outside the turbine house.

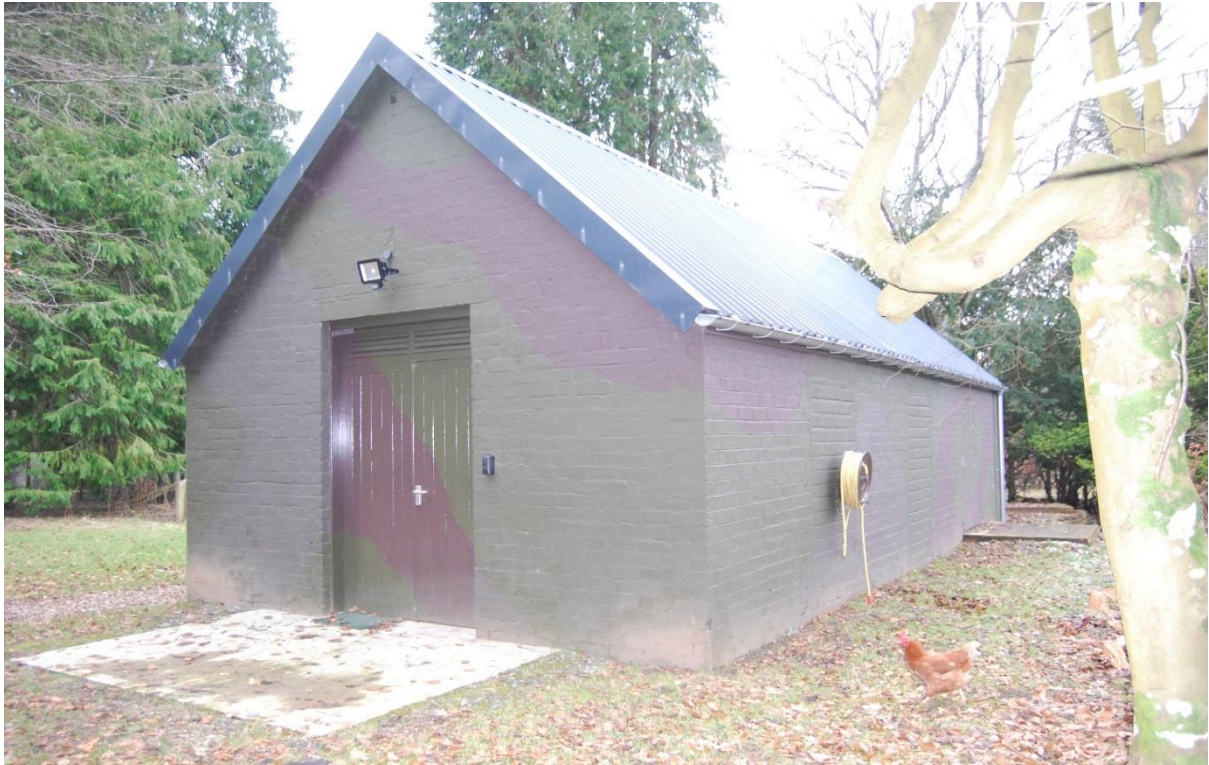
Figure 19: The restored power house in the re-instated disruptive camouflage pattern.

During the 1939-1945 conflict the castle grounds were used for military training, and many new temporary structures had been put up. Remains of paint, possibly representing a camouflage paint from this time were found on the turbine house, and the building was painted in a disruptive pattern in acknowledgement of this. The exact details of such schemes are a separate study in themselves, but at Blair a credible new version was painted (Figure 19).

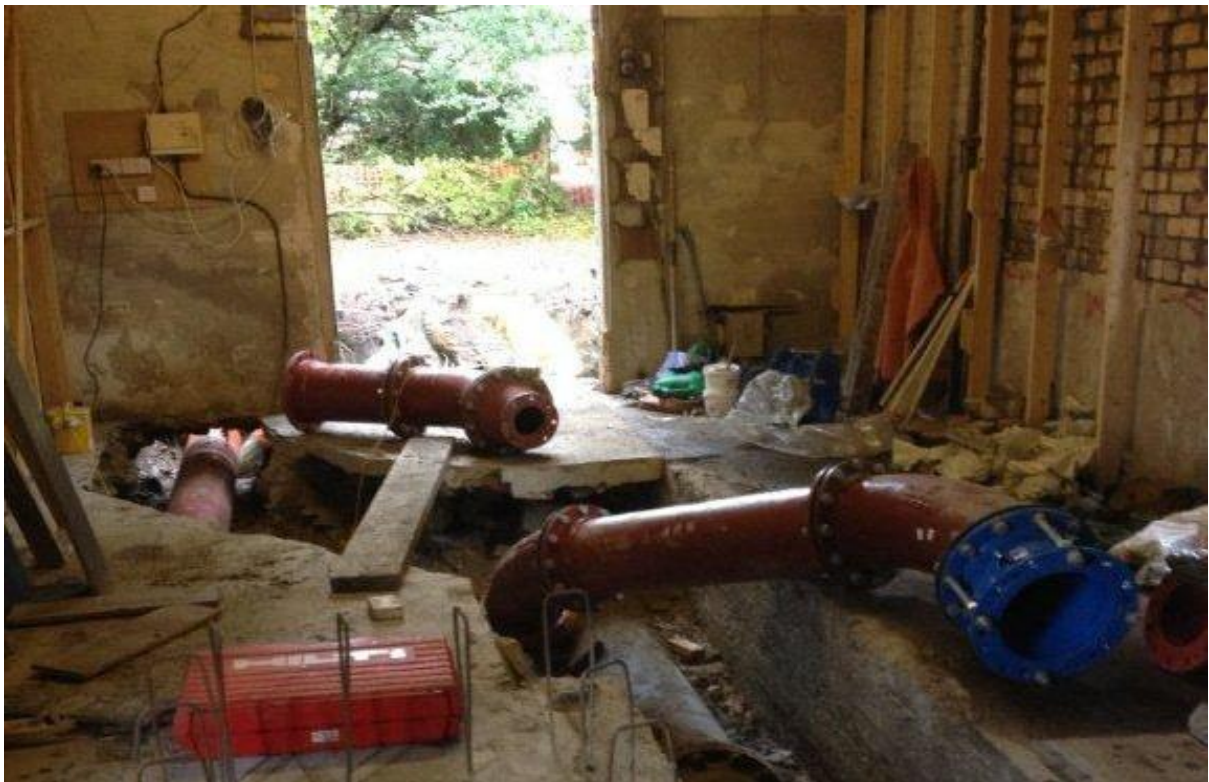
Figure 20: The installation of the new pipework in the turbine house (image Atholl Estates).

The route for the penstock into the turbine house had to be adjusted to align with the new turbine position internally with new pipework (Figure 20).

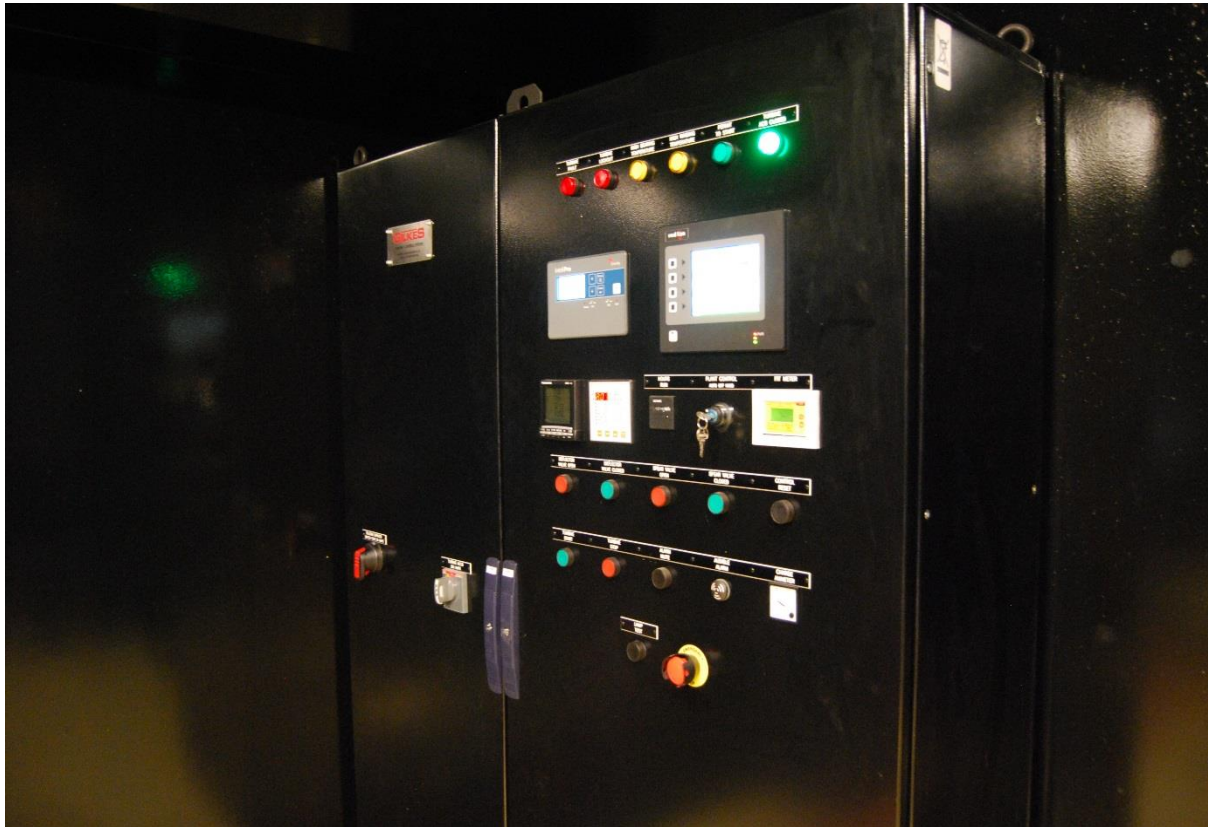
Figure 21: The new control panel and switchboard for the turbine and dynamo.

The turbine itself was delivered to site in November 2013, and installation took 2 weeks, including the electrical connections. All electrical below slab ducting was covered with Douglas fir boards – in effect trench covers. This is an old fashioned, but durable system that Atholl Estates had adopted for all its five power stations. It allows easy access at modest cost and utilised local materials that could be easily be replaced in the event of wear or damage. The control panel is fully automated and allows remote monitoring and assessment by The Blair Charitable Trust and maintainer (Figure 21). To add visual interest, a display of animal skulls was mounted on the inside.

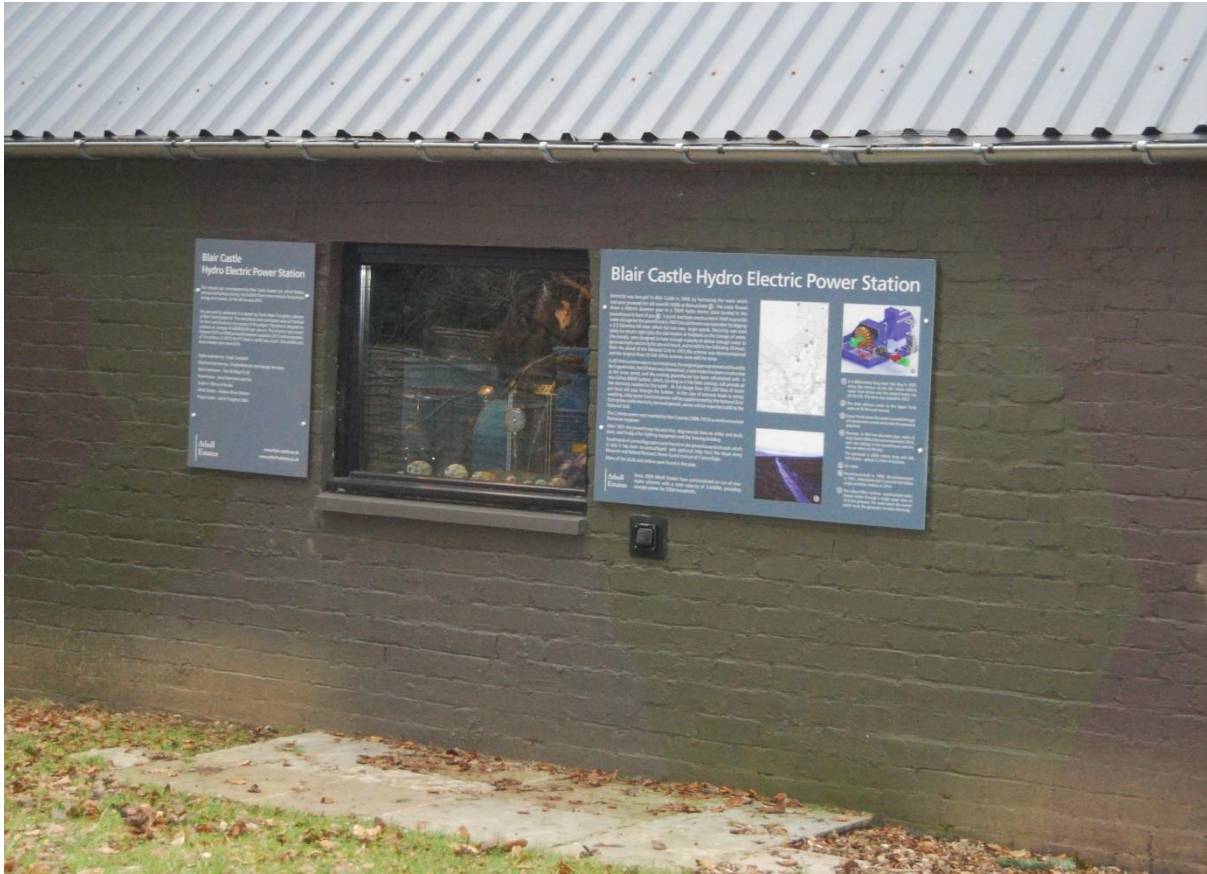
Figure 23: The interpretation board and the viewing window into the power house.

The Estate was keen to ensure that the hydro system and the source of renewable energy that it gave was demonstrated to the visitors to the castle and to the wider public. As such the interior of the turbine house was finished to a higher standard than might otherwise have been the case, and an interpretation panel and viewing window was provided (Figure 23).

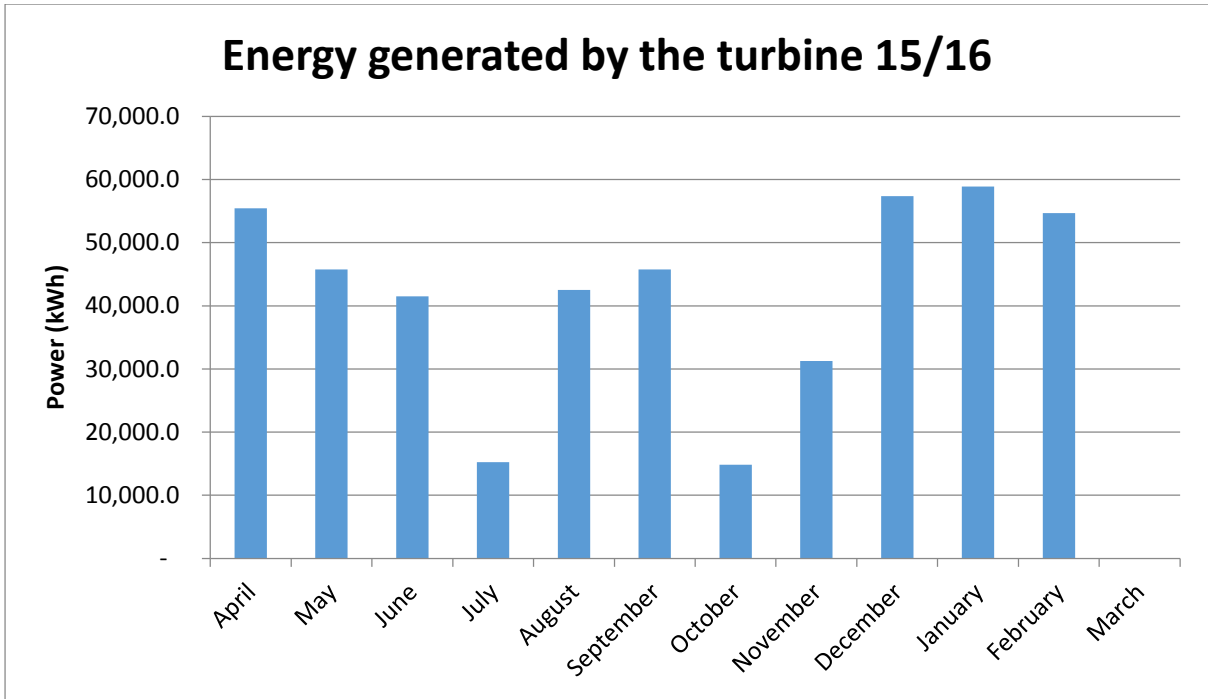
Table 2: Energy generated by the restored turbine system in 2015/16.

The system runs very well. Power was first generated in September 2014. The pattern of electrical energy demand at the castle is different to many businesses in that peak requirement is in mid to late summer, and is lowest in the winter when the castle visitor operations were quieter. Therefore the hydro system is able to export the most electricity when the grid needs it. This maximised the revenue from the Feed in Tariff. Graphs showing the Energy generated in Financial Year 2015/16 is shown in Table 2.

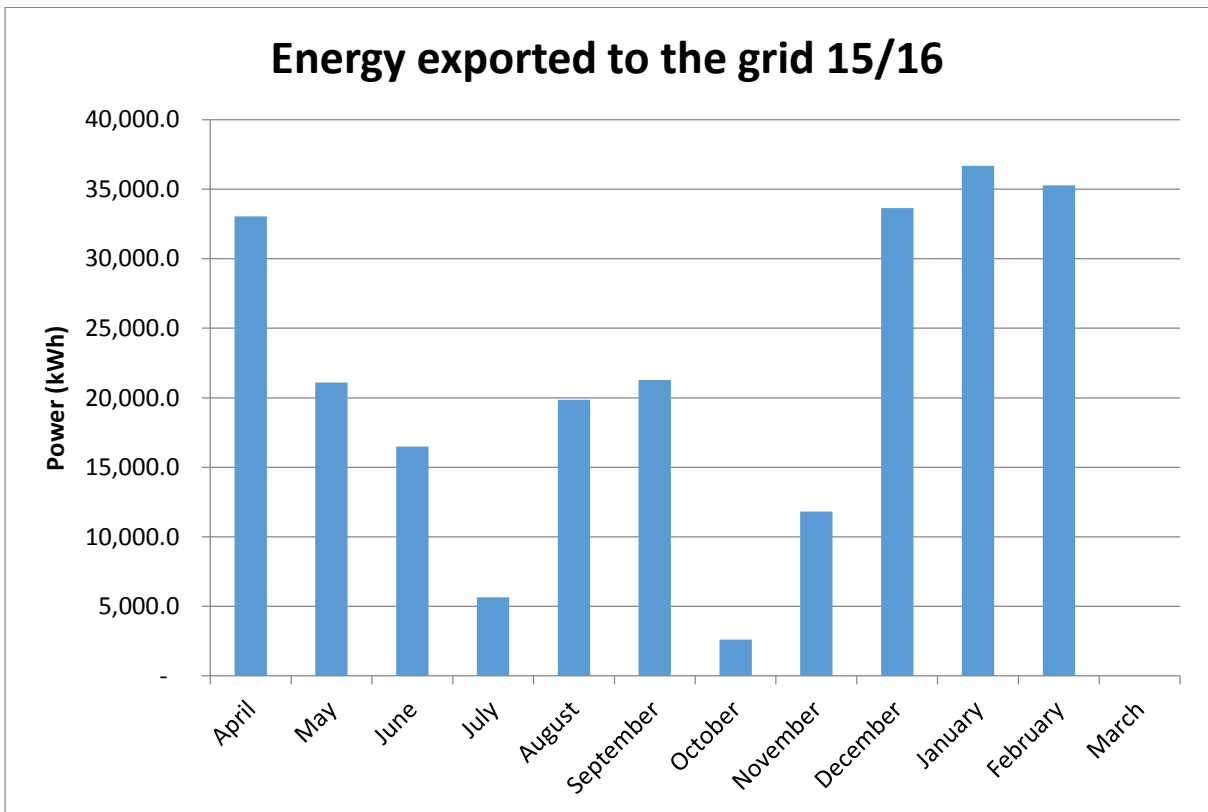
Table 3: Energy exported to the Grid in FY 15/16.

Power not required for the operation of the castle and the estate is exported to the grid. Energy exported to the Grid in FY 15/16 is shown in Table 3.
