5  
GUIDE FOR  
PRACTITIONERS

SCOTTISH  
IRON  
STRUCTURES

TECHNICAL  
CONSERVATION,  
RESEARCH AND  
EDUCATION  
GROUP

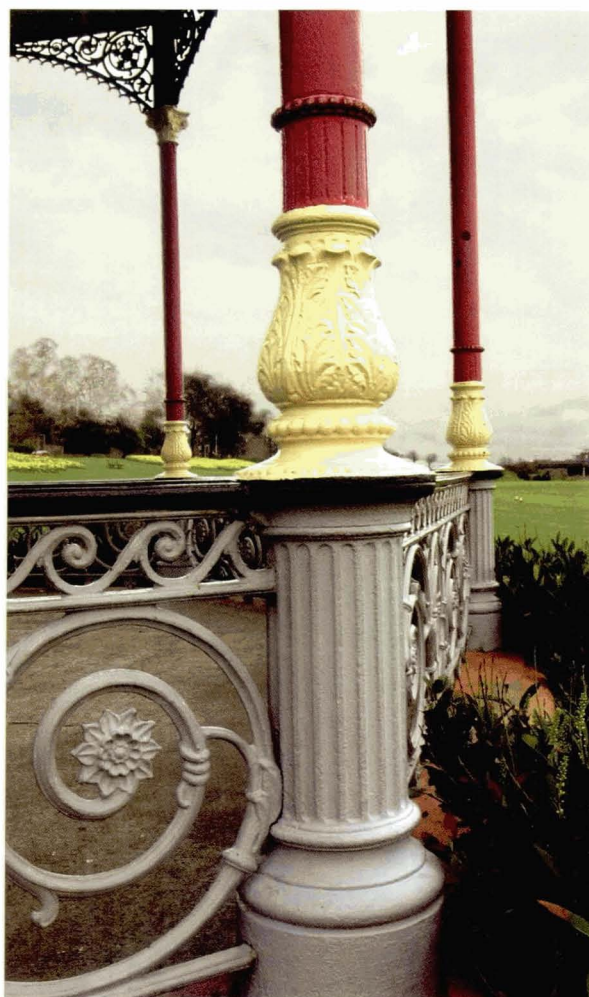
*Illustration 4 Magdalen Green Bandstand, Dundee  
Detail 2 (Picture: D Mitchell)*

*Architectural cast iron from the Saracen Foundry of Walter MacFarlane & Co. Dundee City Architect's Department oversaw conservation in 1990, with some replacement castings by Alyth Foundry.*

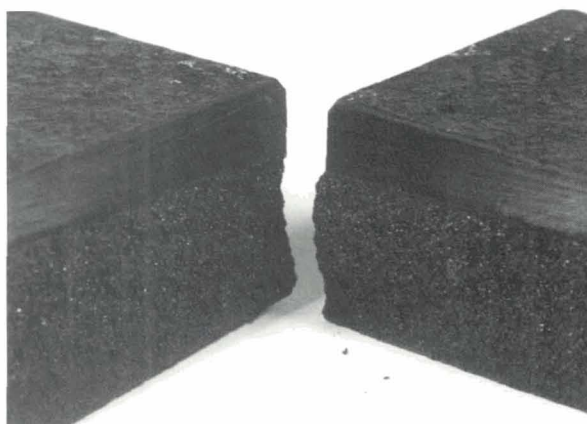
*Illustration 7 Cast iron fracture. A 1 1/4 inch (31mm) thick cast iron plate, part sawn through then broken to show a grey, crystalline fracture (Picture: T. Swailes)*

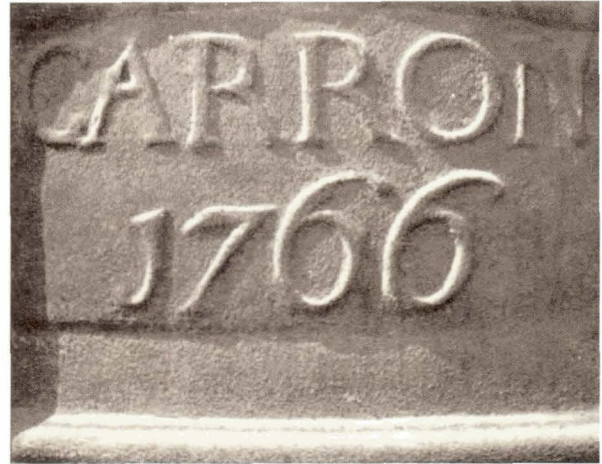
Illustration 9 Part of a cylinder for an early steam engine (1766) Cylinders for James Watt were cast at the Carron Works, but they proved unsatisfactory. Early Carron workmanship lacked the necessary precision and it was left to John Wilkinson of Shropshire to perfect the art of casting and boring engine cylinders in the 1770s (Barker, 1992). (Picture: 'The Story of Carron Company, 1759-1959').

The industrial revolution in Scotland is considered by many to have begun in 1759 with the creation, on an unprecedented scale, of the first integrated coke-fired ironworks at Carron (Illustration 9). Scottish ores were particularly suitable for making fine castings and the Carron Works established a reputation for Scottish decorative cast iron that was to last well into the twentieth century. With Carron a notable exception, the iron industry in Scotland developed much later in Scotland than in England and Wales. The civil engineer Thomas Telford, for example, relied in the early nineteenth century on the expertise of the North Wales foundry of William Hazledine for sound structural castings (Illustration 10). From the early 1830s,

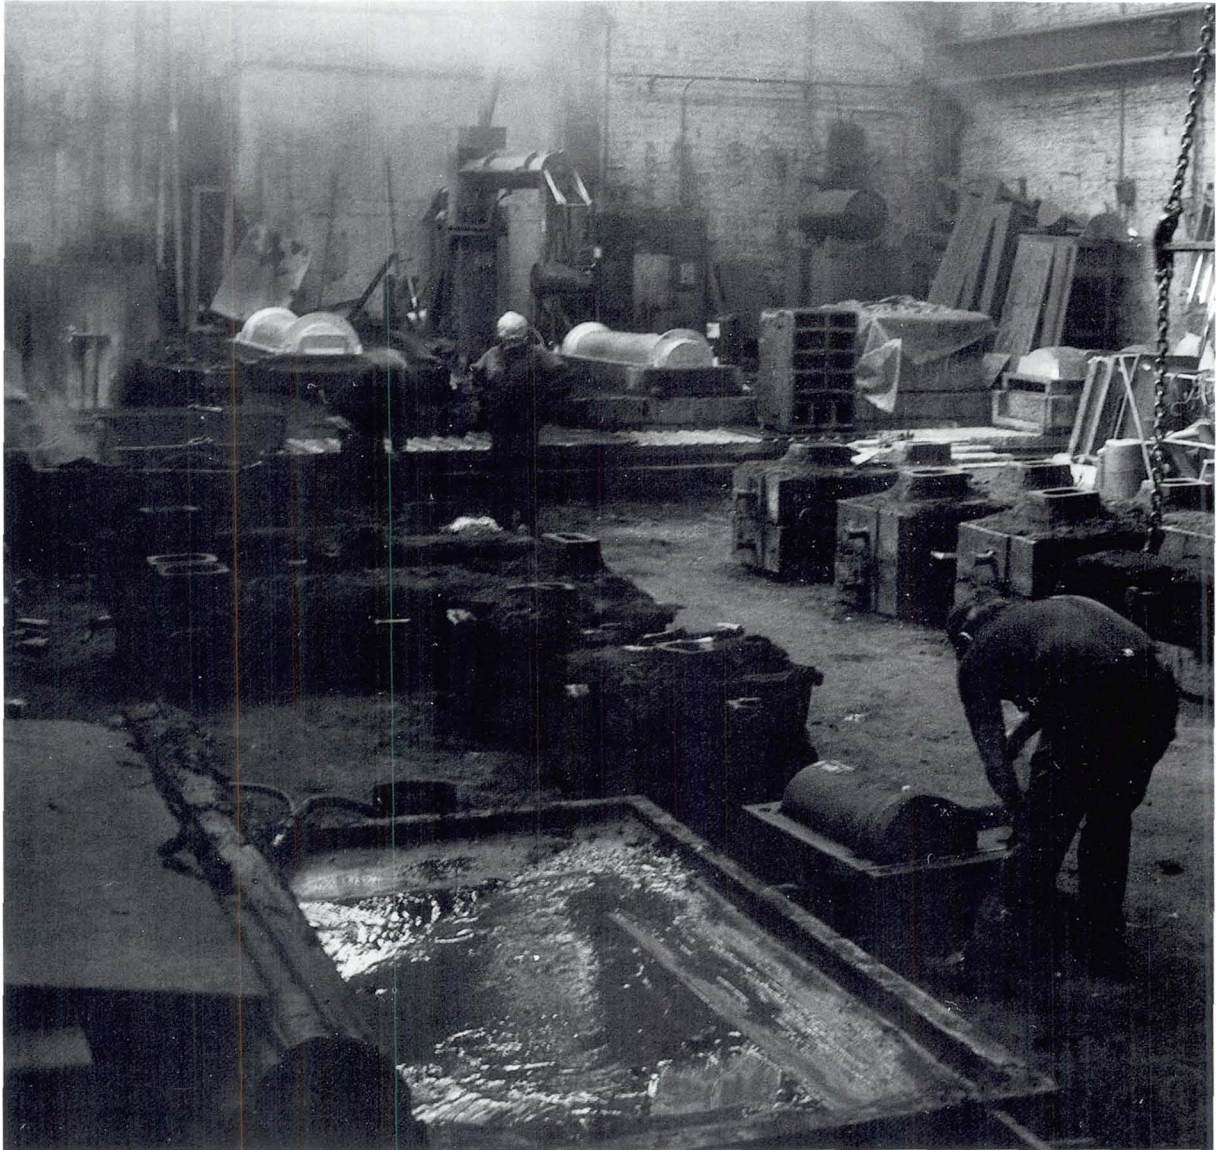
*Illustration 11 Moulding cast iron letter boxes at Ballantine Bo'ness Iron Company Ltd, Links Road, Bo'ness, West Lothian in 2000 (Picture: T. Swailes)*

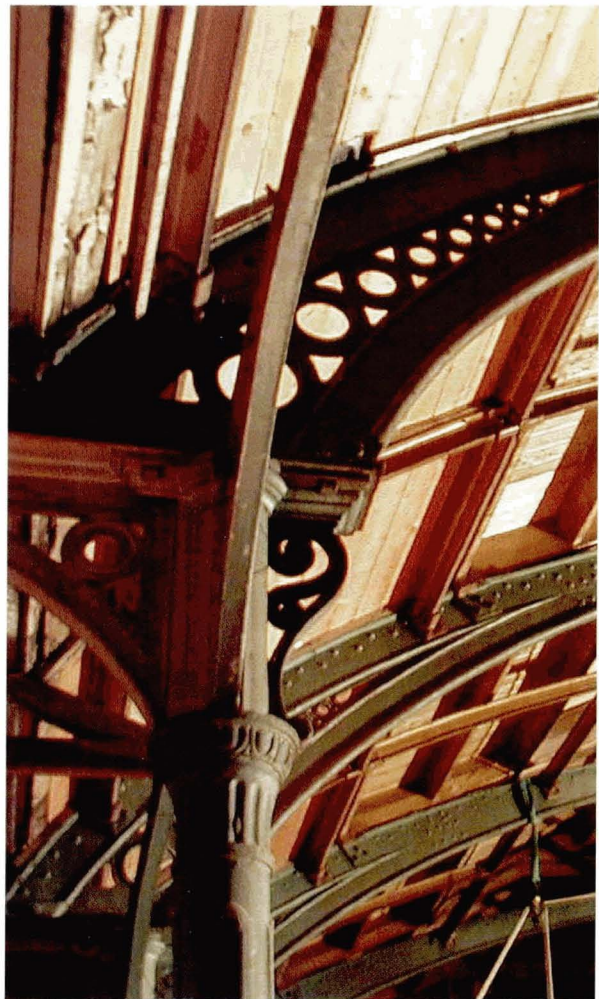
*Illustration 13 The Old Fruitmarket, Glasgow. Ironwork Detail (Picture: M. Watson, Historic Scotland)*

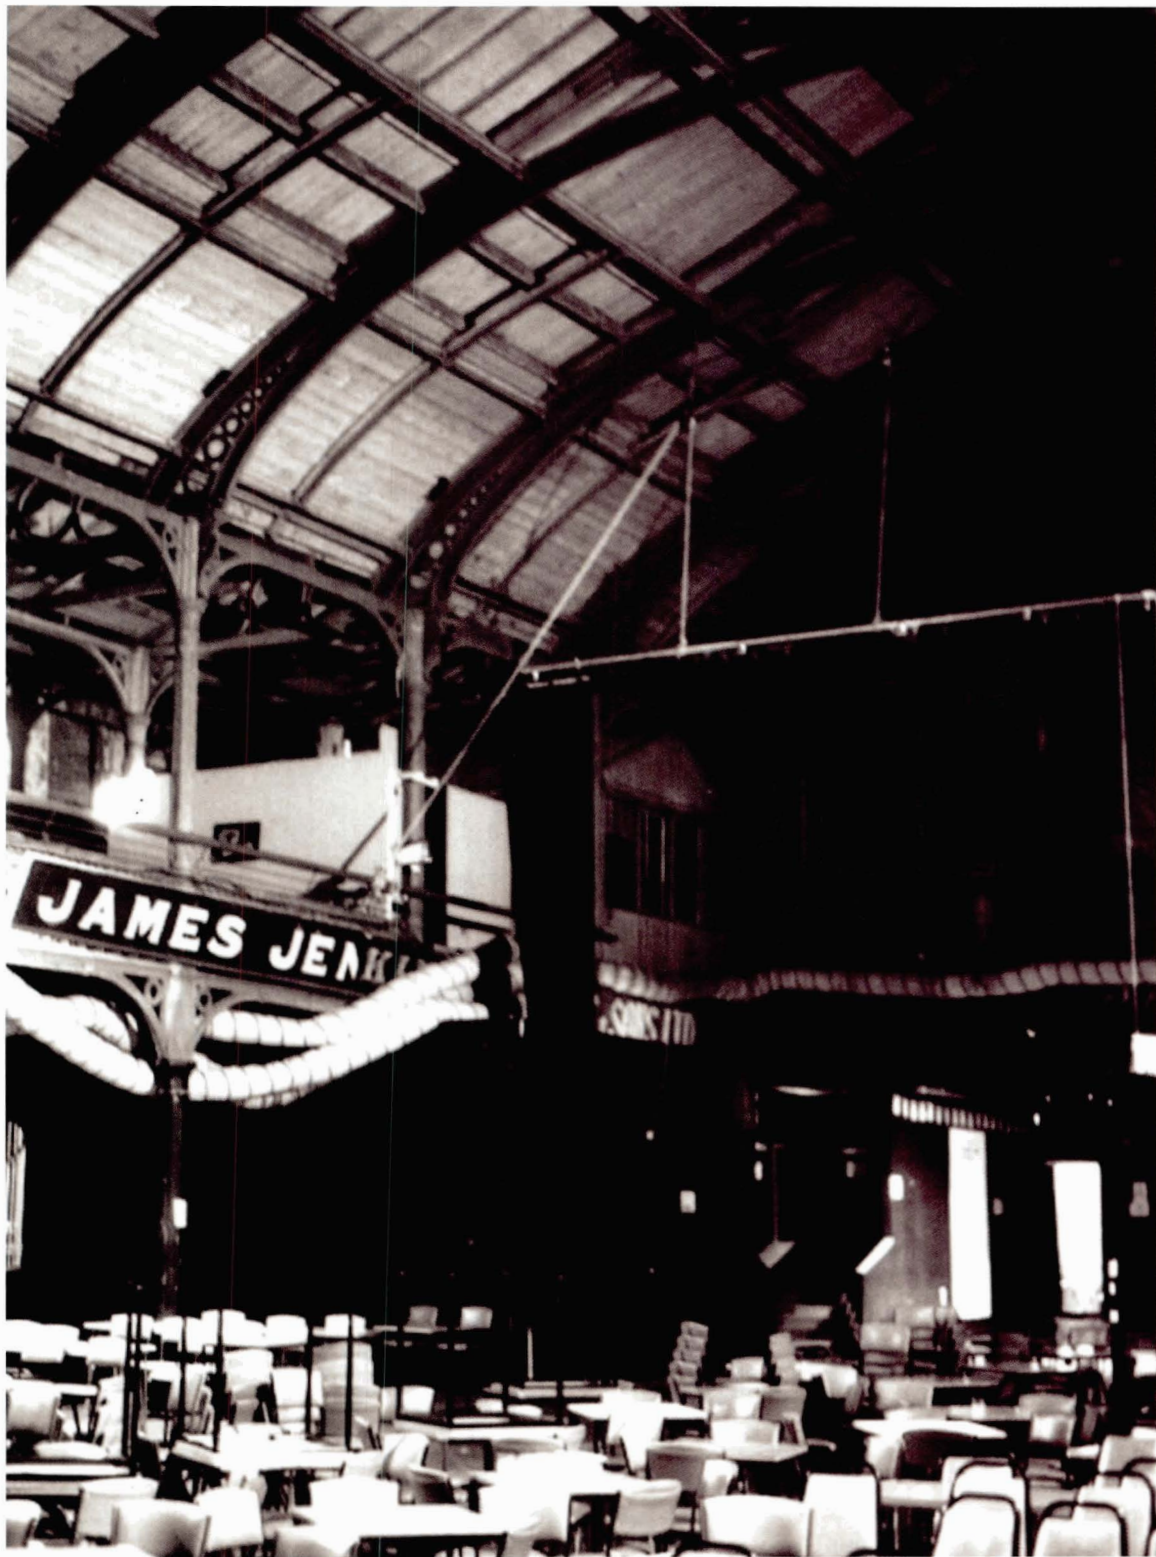
*Illustration 14 The Old Fruitmarket, Glasgow (1852-4) Interior*

*In February 1852, Robertson & Lister submitted a tender in the sum of £4,028-4s-1d for "covering over that part of the Bazaar property to the North of City Hall" (Corporation of Glasgow Minute Book C2-14-3). The main hall and its galleried side aisles are reminiscent of the building erected in London's Hyde Park in 1851 for the 'Great Exhibition'. By the summer of 1854, Lister and Robertson had not quite completed the work, and the Council had understandably complained about slow progress. The Glasgow Directory of 1845 lists "Robertson & Lister (successors to Bankier & MacKenzie), smiths, engineers, millwrights and iron roof constructors, Victoria Works, 79 Mitchell Street". The last entry for the firm, in 1856, described them simply as "iron-house builders" (Picture: T. Swailes)*

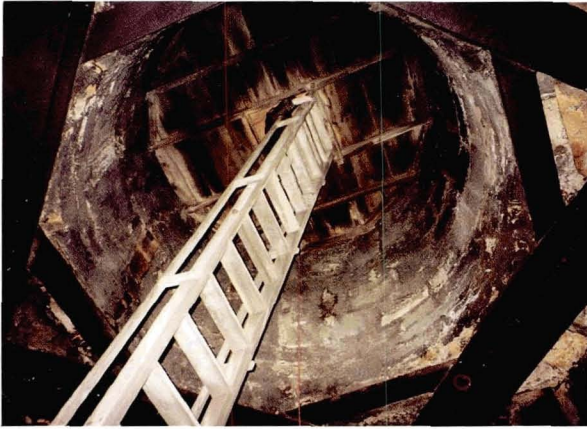
Illustration 16 St. Vincent Street Church, Glasgow  
Photograph of cast iron lintels to internal corbelling in the tower (Picture: Jacobs Babbie)

Hidden behind the façades and within the floors of Scottish public and commercial buildings, and even in private houses, cast iron is to be found to a surprising extent (Illustrations 15 and 16). In towns and cities throughout Scotland, shop fronts and lintels to upper floors that might elsewhere in Britain or Europe be timber are found to be cast iron. Occasionally the entire façade is of iron. Glasgow in particular has some fine examples with innovative iron frames and floor systems behind, contemporary with iron buildings in New York by James Bogardus. In 1892, well ahead of London, Glasgow introduced regulations concerned with the strength of iron in buildings. Scotland's distinctive architecture is rightly celebrated, but many Scottish buildings also occupy an important place in the history of the development of modern structural framing systems. This aspect of their character deserves recognition and requires careful conservation.

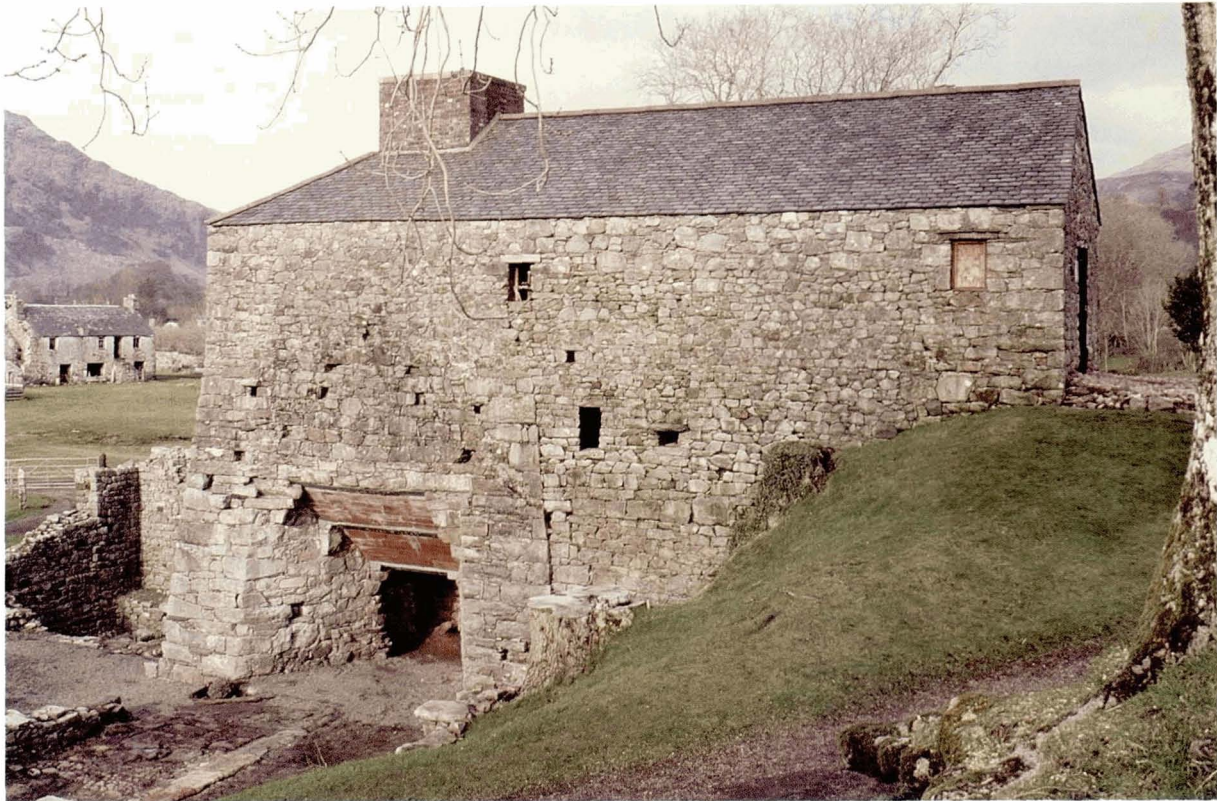
*Illustration 23 Bonawe Ironworks Casting house and furnace (Picture: Historic Scotland)*

woodland nearby. Most early works in Scotland were short-lived. An exception was the furnace established in the early 1750s at Bonawe by the Newland Company, of West Cumberland, later Harrison, Ainslie & Co. The works smelted iron-rich haematite ore brought from Furness and supplied iron principally to English markets, so location was determined to a large extent by access to the sea. Bonawe provided a niche market with high quality iron into the second half of the nineteenth century. The remains of the works, now in the care of Historic Scotland, include one of the best-preserved charcoal blast furnaces in Britain (Illustration 23).

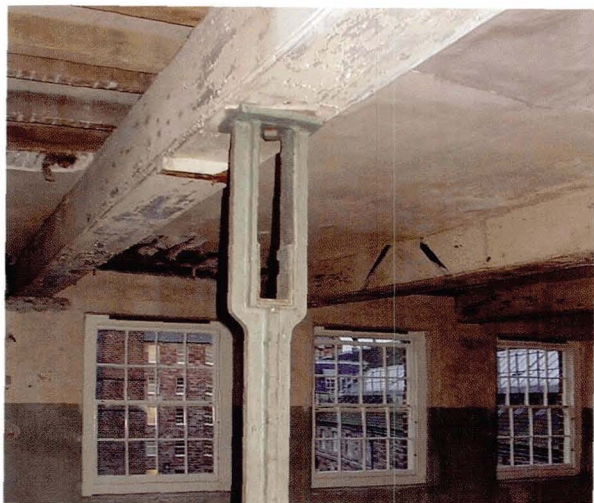
*Illustration 28 Bell Mill (or West Mill), Stanley Mills, Perthshire (1786-7) Cast iron storey posts with timber beams continuous over (Picture: Mark Watson, Historic Scotland)*

Bell Mill at Stanley in Perthshire is a fine example of the first generation of water-powered cotton mills, built in 1786 by Arkwright and his Scottish partners to house water frames (Cook, 1977). The five-storey building follows a pattern established by mills in England, with external walls of solid brickwork above a lower storey stonework plinth. To the upper floors, slender cruciform section cast iron 'storey posts' halve the spans of timber primary beams over the 24' internal width of the building (Illustrations 27 and 28). Prior to refurbishment, it was noticed that several of the cast iron posts were loose and it may be that their primary function was machinery framing rather than floor support.

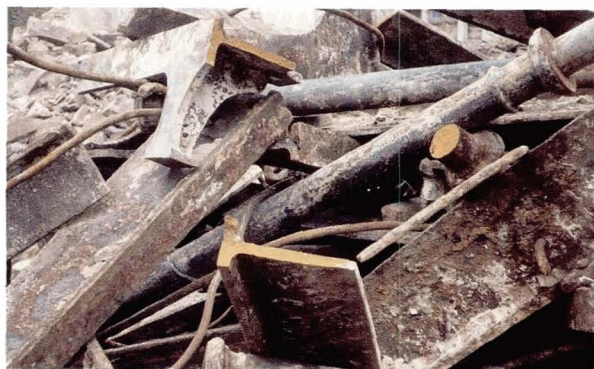
*Illustration 29 Green's Mill, Arbroath (1837) (Picture: Mark Watson, Historic Scotland)  
A relatively unusual solid circular section cast iron column, lying on the scrap heap after demolition of the building in 1993. Columns were almost always made hollow to reduce weight, save expensive iron and because quality was very difficult to maintain in a very thick, solid casting.*

ends of cylindrical columns socketed into separate cast iron bases and capital. These are either of simple bell form, or extending into a plate to distribute the load over a greater area of timber. Circular cast iron columns are usually hollow, but solid columns are found occasionally, and more complex cross-sectional shapes were sometimes used for the sake of appearance (Illustrations 29, 30 and 31).

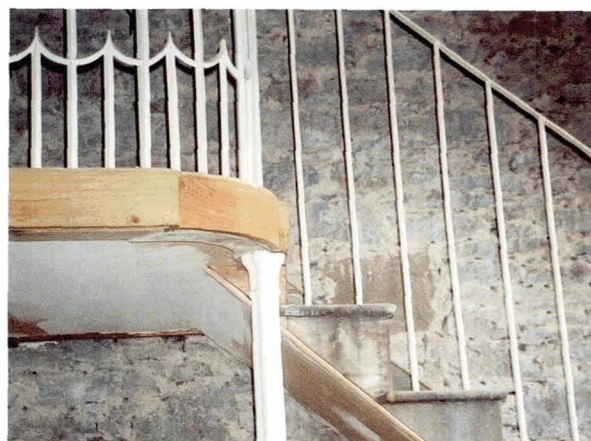
*Illustration 31 New Lanark Schoolroom (1817). Cast iron column with a quatrefoil cross-section (Picture: T. Swailes)*

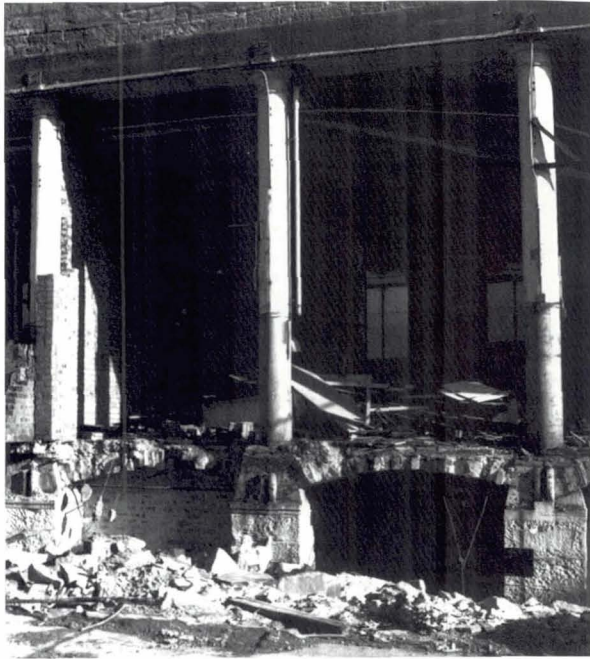
*Illustration 32 South Mills Dundee (c. date of this building 1864). Fireproof basements, partially demolished (Picture: RCAHMS)*

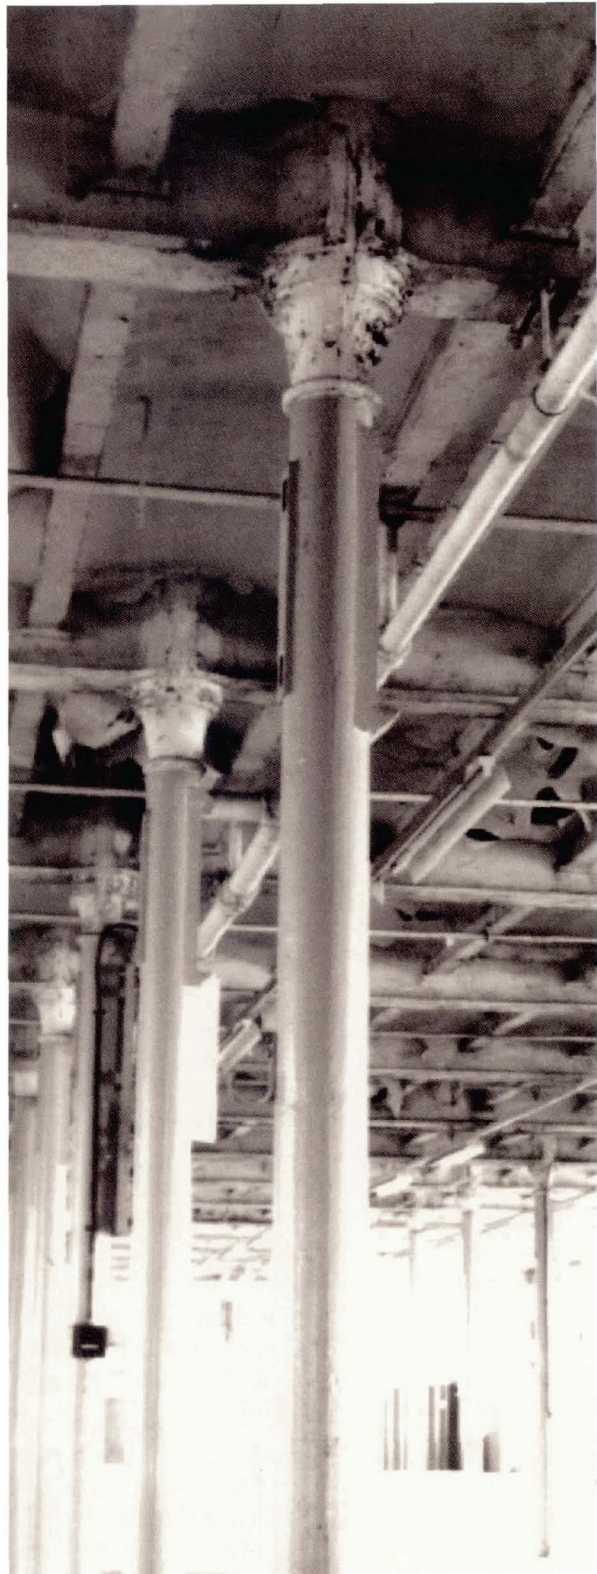
*Illustration 33 Crofthead Mill, Neilston: No 3 Mill built in 1881 (illustrated, to the Potts multiple arch system: compare Victoria Mill, Miles Platting) and No 4 Mill, 1885 (single arches, not shown) (Picture: T. Swailes)*

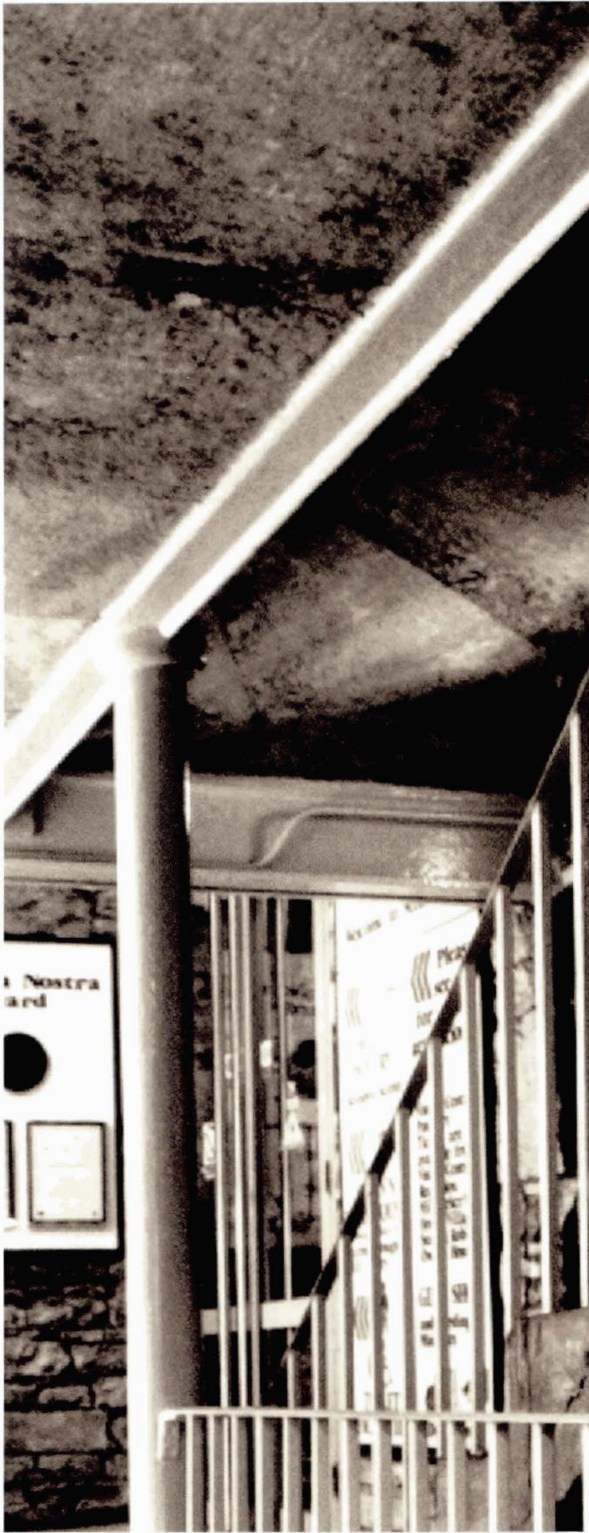
*Illustration 35 New Lanark: East End of Mill 3 (c. 1826)  
Cast iron supports to stone stairs and landing. Mill 3 was  
built fireproof to replace a timber floored mill destroyed by  
fire in 1819. The east end of the building formed an iron  
framed firebreak against Mill 4 also destroyed by fire in  
1883 (Picture: T. Swailes)*

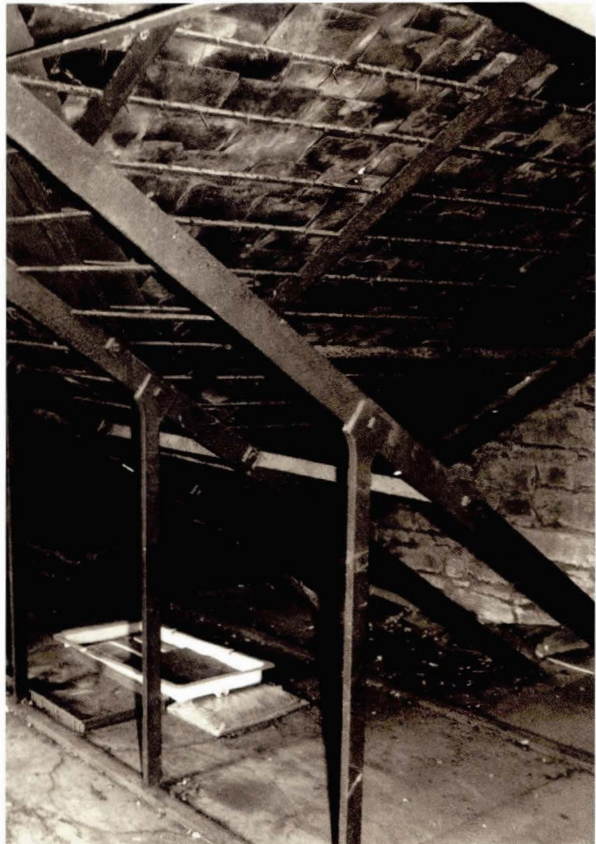
*Illustration 37 New Lanark: East end of Mill 3 (c. 1826)  
The iron-framed attic (Picture: T. Swailes)*

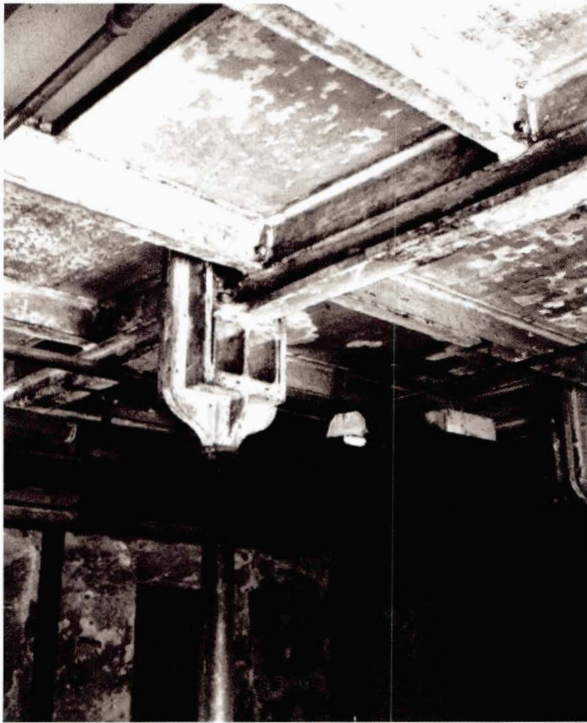
Illustration 38 Grandholm Works, Aberdeen: Old Spinning Mill (1793-4, modified 1820s) Iron framing and stone flag floors (Picture: T. Swailes)

At New Lanark, there are some remnants of a scarcer form of fireproof flooring system than the brick arch. Floors and a very unusual pitched roof entirely framed in iron were built in the 1820s as a lightweight construction over a waterwheel pit and to fill in between two existing gable walls (Illustrations 35 to 37). Sandstone flags supported on iron joists provided an incombustible floor. A similar form of construction is to be found in Beehive Mill, a Manchester contemporary (Swales, 1998). An interesting variant from the same period has survived at the Grandholm Works in Aberdeen (Illustration 38).

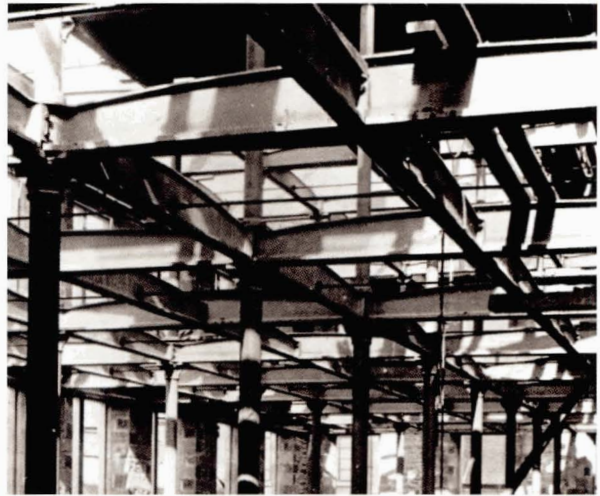
Illustration 39 Mid-Wynd Works, Dundee (1894 and 1903) The iron framing to a power loom factory under construction. The specialist textile engineering firm Robertston & Orchar of Dundee used cast iron beams here in the structural framing at a time when rolled steel beams were being used in other kinds of building. The vibrations due to power looms demanded a very solid floor and weaving sheds were usually of single storey construction with ground bearing floor slabs. In this case a constricted, steeply sloping site made 3 and 4 storey buildings with heavy suspended floors necessary (Picture: Dundee Archive and Record Centre)

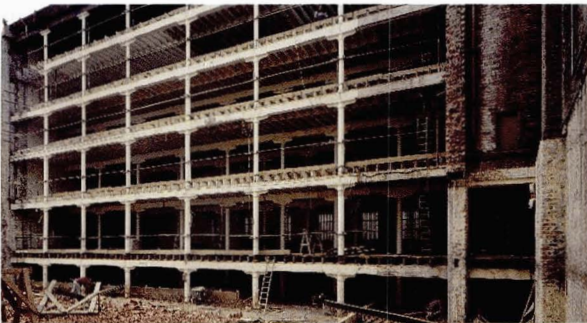
Illustration 40 Robertson's (later Watson's) Bond, Seagate, Dundee (1897, rebuilt after a fire in 1907) The structure exposed by partial demolition of this former deep-plan bonded warehouse during conversion to residential use (Picture: RCAHMS/ The Drawn Evidence)

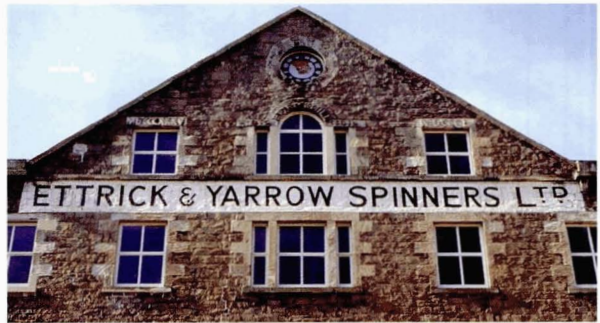
Illustration 41 Ettrick Mills, Selkirk (1835 and 1850) Front gable elevation, with date stones. Built as a mule spinning woollen mill in 1835, with timber floors on cast iron columns, extended in 1850. The fireproof floors in one of the 1850 wings are unusual in being built of local whinstone rather than brickwork (Picture: Shannon Tofts)

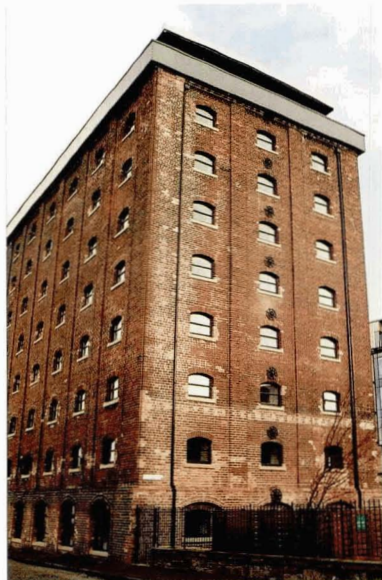
*Illustration 48 Bonnington Sugar Refinery, Leith (1865-6) External view of building following conversion to residential use showing retained original cast iron parrress plates to gable and roof level water tank enclosure. For details of the collapse of the building that this replaced, refer to 'Fall of a new sugar refinery at Leith', The Builder; v23, March 4th, 1865, p159. (Picture: P. Beaton, Historic Scotland)*

upper floors are timber rather than brick, reflecting the different imposed loads associated with different stages of the refining process and perhaps a desire to minimise foundation loads (Illustrations 47 to 50).

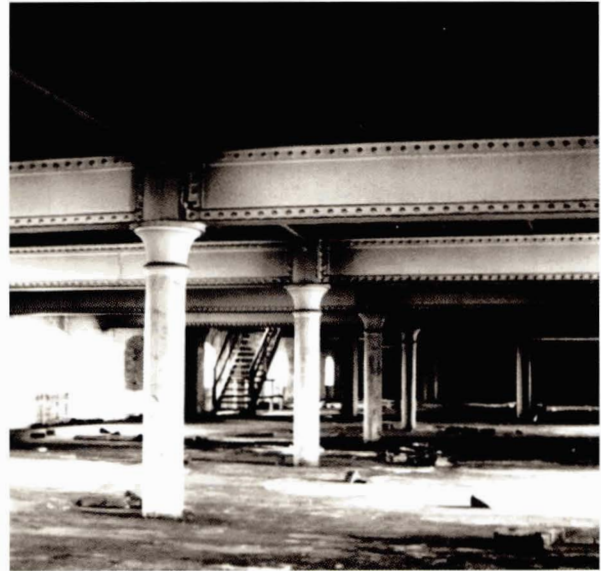
*Illustration 49 Bonnington Sugar Refinery, Leith (1865-6) Interior view prior to conversion (Picture: T. Swailes)*

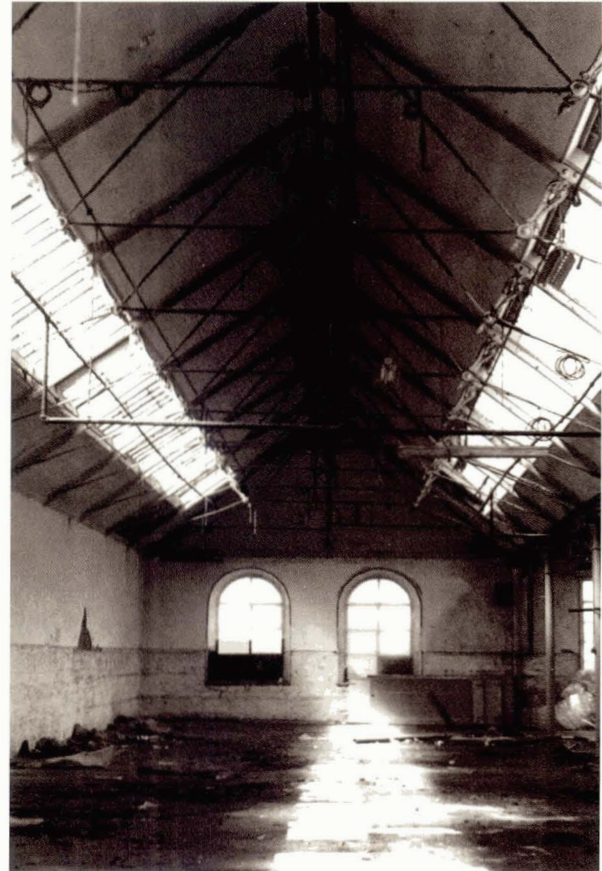
Illustration 56 Seafield Works, Dundee: West Factory (1859) Internal view of weaving shed: The Seafield Works specialised in the manufacture of jute carpet. The High Mill has been converted to housing in 1988-92 but the single storey iron framed weaving sheds demolished. (Picture: Mark Watson, Historic Scotland)

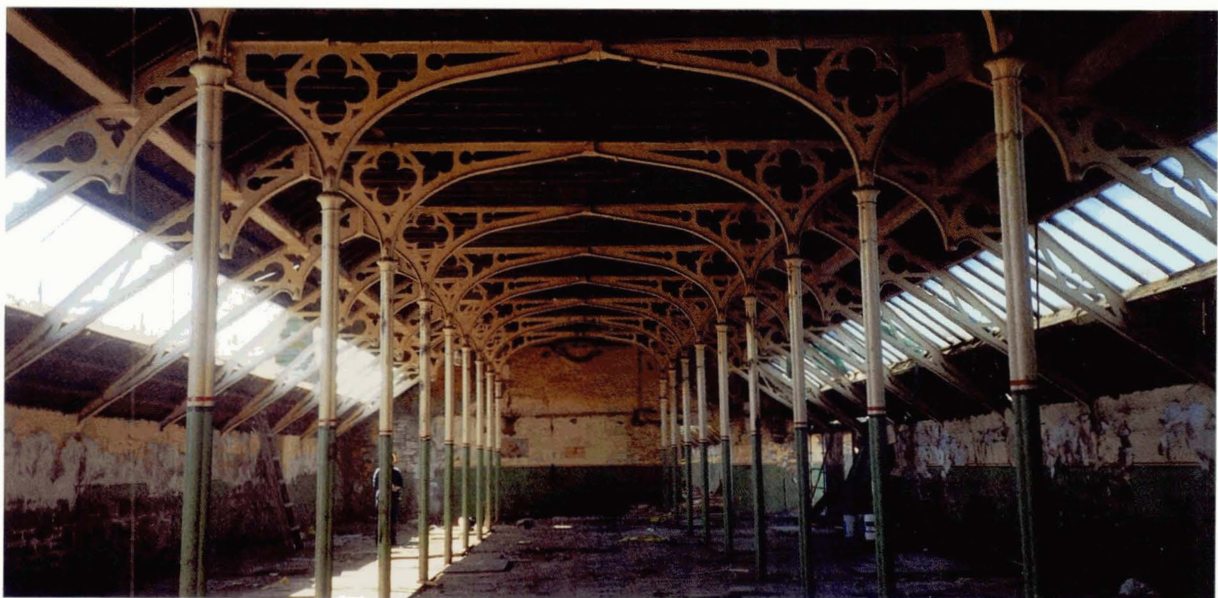
Illustration 55 South Mills, Dundee: New Mill (1851-7, extended 1864 and 1874). A 'Gothic' cast iron framed attic Reeler used structure housed powered reel spinning machinery. Good natural light from above was required so that the reeler could see flaws in the yarn. Large beam spans were not needed for the floors below because the spinning frames were static, though heavy, and unlike the 'mules' used for cotton and wool, did not move backwards and forwards on tracks. About a dozen attics of this type were built in the Dundee area (Picture: Mark Watson, Historic Scotland)

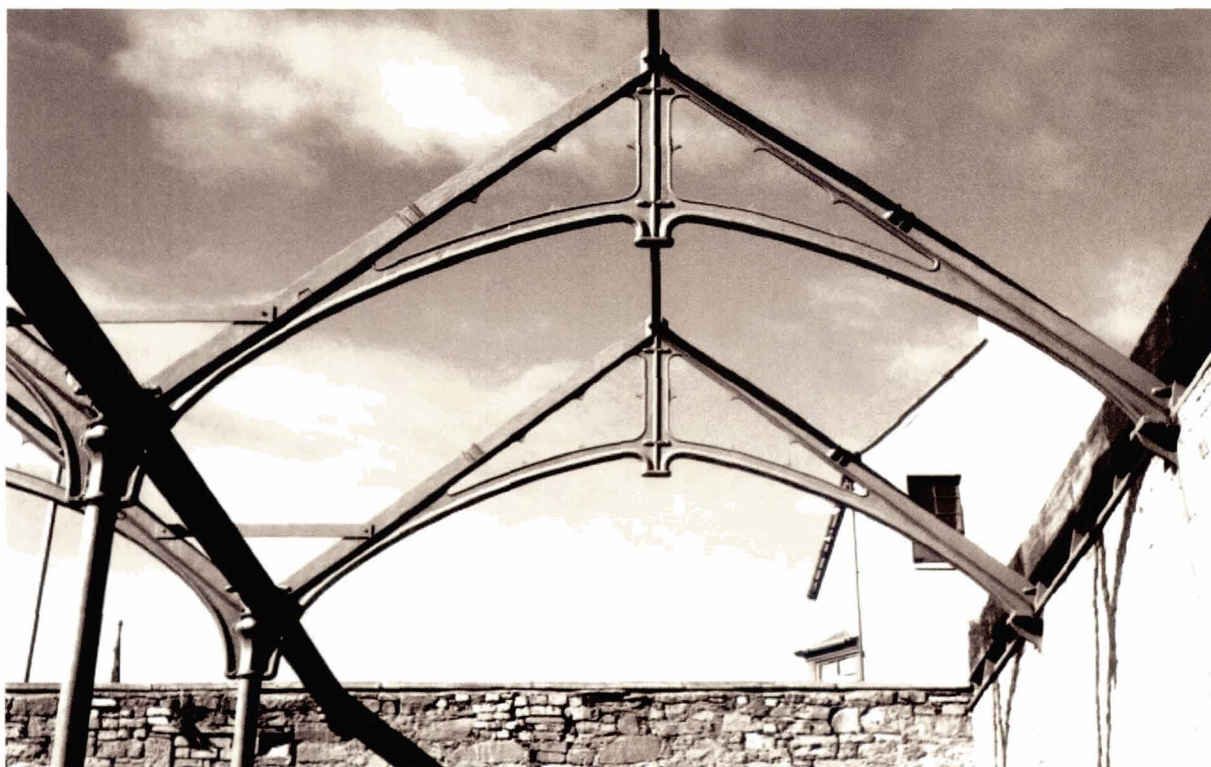
Illustration 60 Seafield Works, Dundee: Boiler House (1861)  
The iron skeleton of the boiler house was preserved as an interesting structural feature when the High Mill was converted to housing 1988-92. (Picture: T. Swailes)

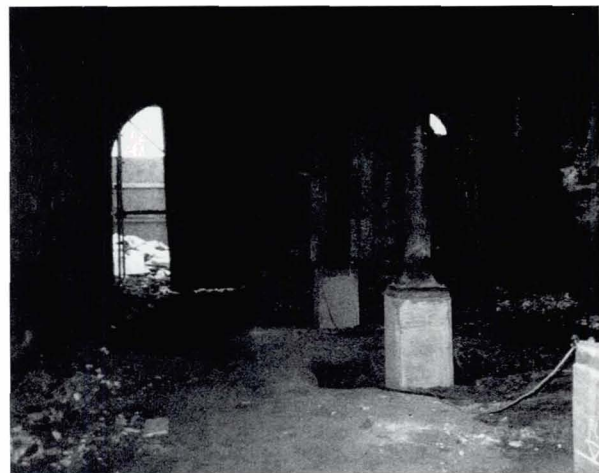
Illustration 67 The Edinburgh and Dalkeith ('Innocent') Railway Goods Shed and Terminus (c.1840). Internal view at 'rail level' prior to refurbishment. The present floor level is marked on one of the bases. (Picture: Crown Copyright: RCAHMS. Reproduced courtesy of JR Hume)

Many railway buildings are essentially of traditional construction. An early example is the three-storey goods shed at the Edinburgh terminus of the Edinburgh to Dalkeith Railway (Illustrations 66 and 67). Steel beams have replaced the original timber floor beams, supported on a line of cast iron columns down the centre of the building (Illustration 68).

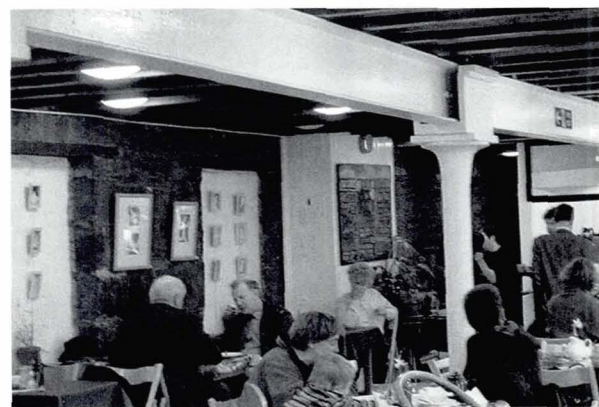
Illustration 68 The 'Edinburgh and Dalkeith ('Innocent') Railway Goods Shed and Terminals (c.1840) Steel beams on cast iron columns, over the cafe at first floor level. The steel beams replace early timber beams and bear the rolling mark LANARKSHIRE STEEL CO LD SCOTLAND 12 x 6 (Picture: T. Swailes)

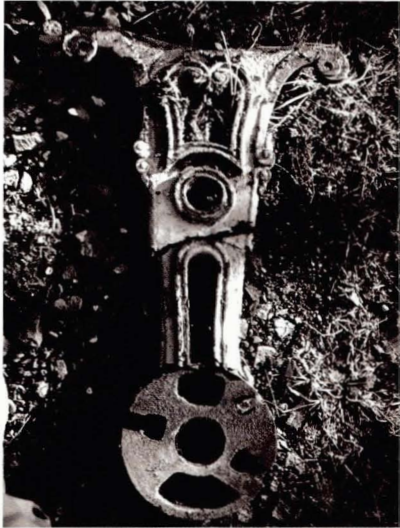
Illustration 71 Haymarket Station Edinburgh (1840). A broken cast iron strut from a roof truss in storage at the Bo'ness Heritage Area where most of the trainshed is now re-erected. The cover plate has been removed, showing anchorage slots for 'upset' iron tie bar ends. (Picture: T. Swailes)

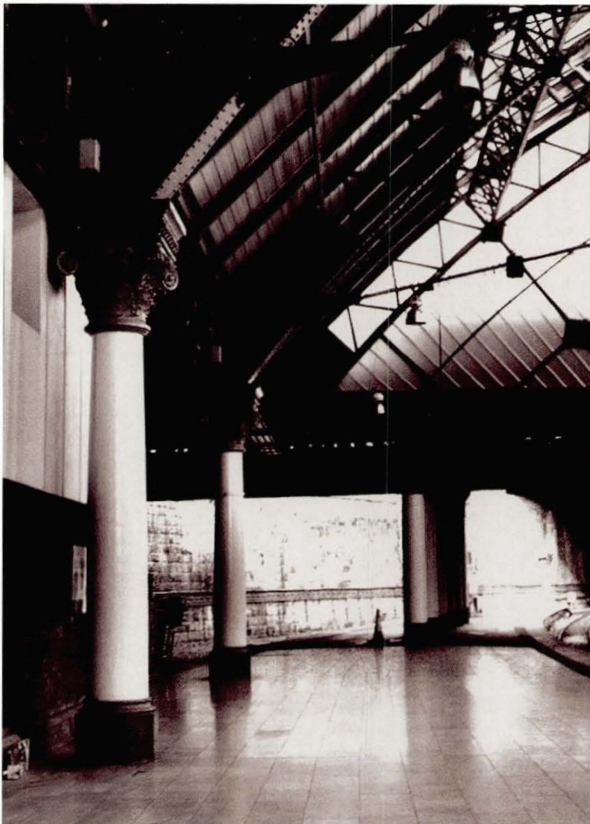
Illustration 78 Queen Street Station, Glasgow: Main train shed roof (1880) Tied wrought iron arches on cast iron columns. Designed by the civil engineer James Carswell, with steel tie bars to the principal wrought iron roof arches. (Picture: T. Swailes)

(Illustration 75). Howard & Ravenhill's patent tie bars were specified for the original roof to Aberdeen Station, now replaced (Howard 1849; Hird 1869) (Illustration 77). A feature of many of the large 'engineered' iron roofs is tension cross-bracing between the principal rafters and beneath the roof covering. This is apparent at Glasgow's Queen Street Station, which has a fine over-arching roof (Gomme & Walker, 1968) (Illustrations 76, 78 and 79).

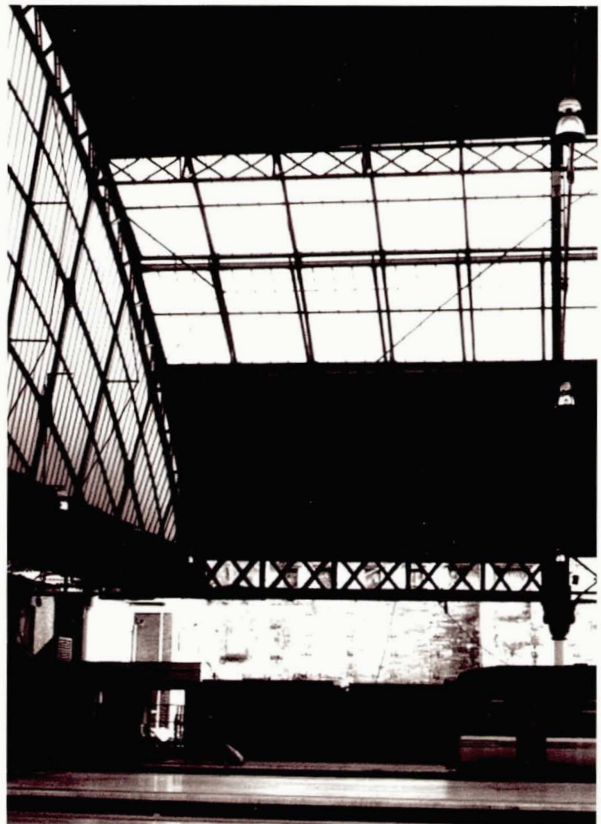
Illustration 79 Queen Street Station, Glasgow: Main train shed roof (1880). The gable screen and the cross-braced roof (Picture: T. Swailes)

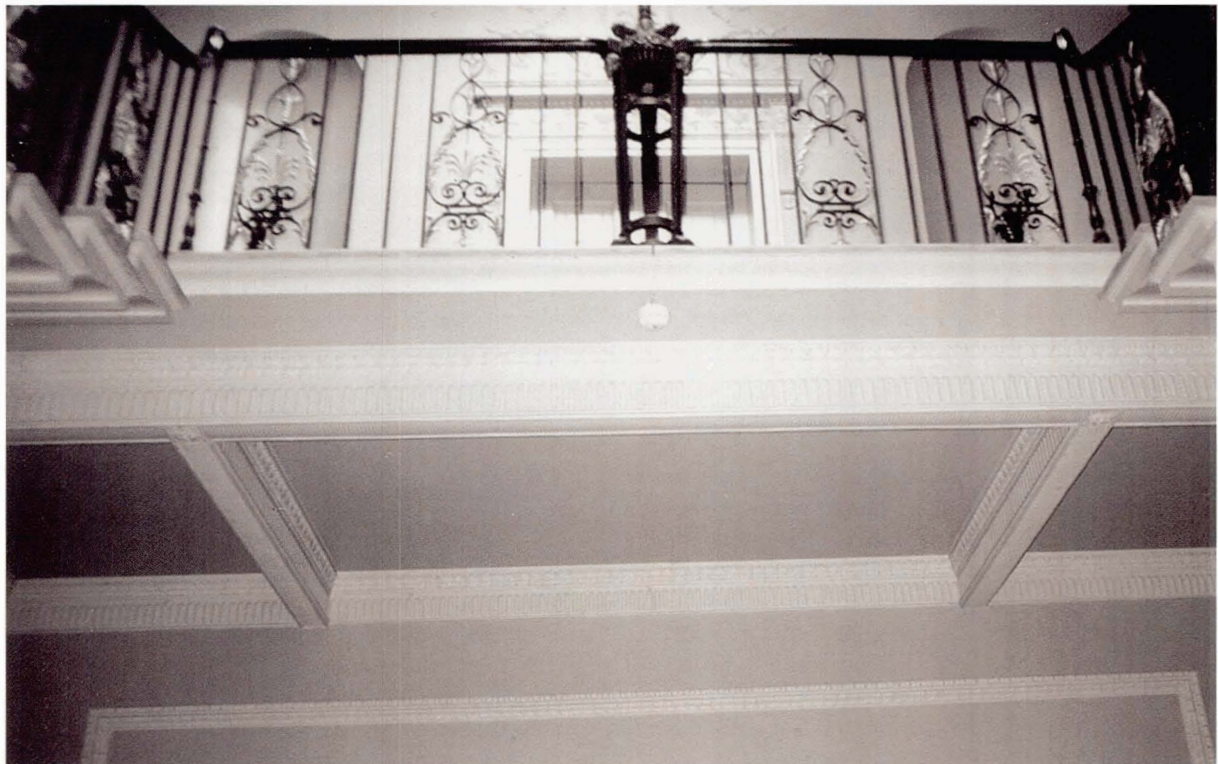
Illustration 82 Heaton Hall, Lancashire (1776)  
 Staircase landing support beam. Examined initially from ground floor level, the slender beam was assumed to be timber with an iron flitch plate. On investigation with a 'cover meter', the beam was found to be (most probably) of solid cast iron, moulded to exactly match the decorative plasterwork. Secondary beams of identical appearance provided a second surprise, being hollow 'dummies', provided purely for aesthetic reasons.  
 (Picture: Joe Marsh, UMIST)

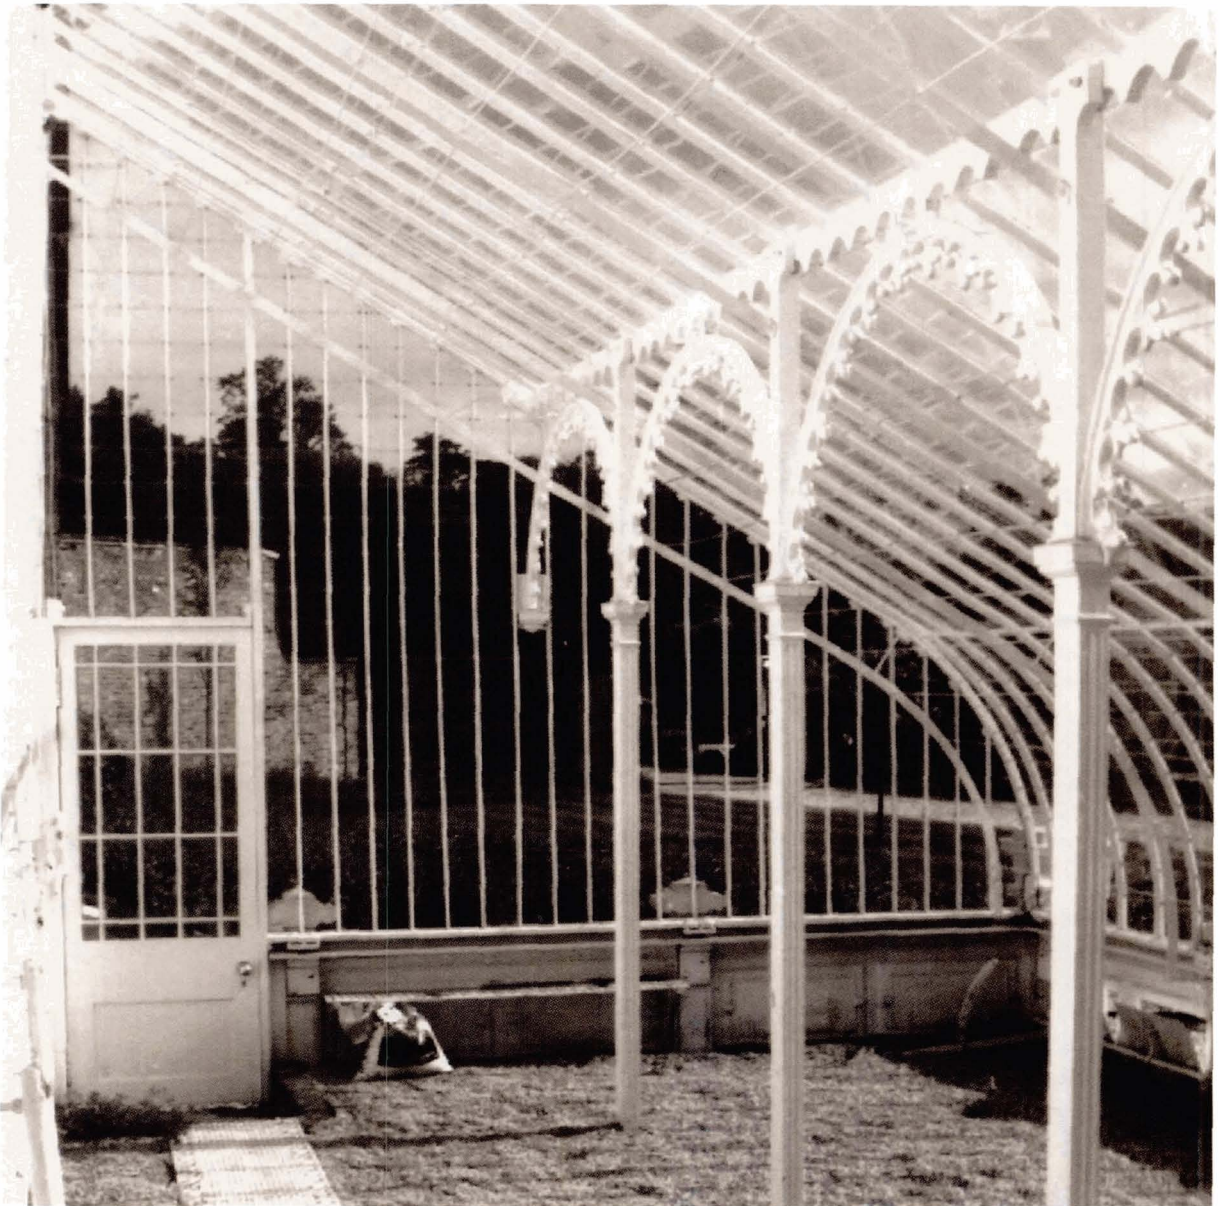
*Illustration 96 Fairfield House conservatory, Dalkeith (c.1835) Internal view. It seems likely that all the parts were made in the foundry next door to George Mushet's house. This small but very fine lean-to structure has recently been restored. (Picture: T. Swailes)*
