5  
GUIDE FOR  
PRACTITIONERS

SCOTTISH  
IRON  
STRUCTURES

TECHNICAL  
CONSERVATION,  
RESEARCH AND  
EDUCATION  
GROUP

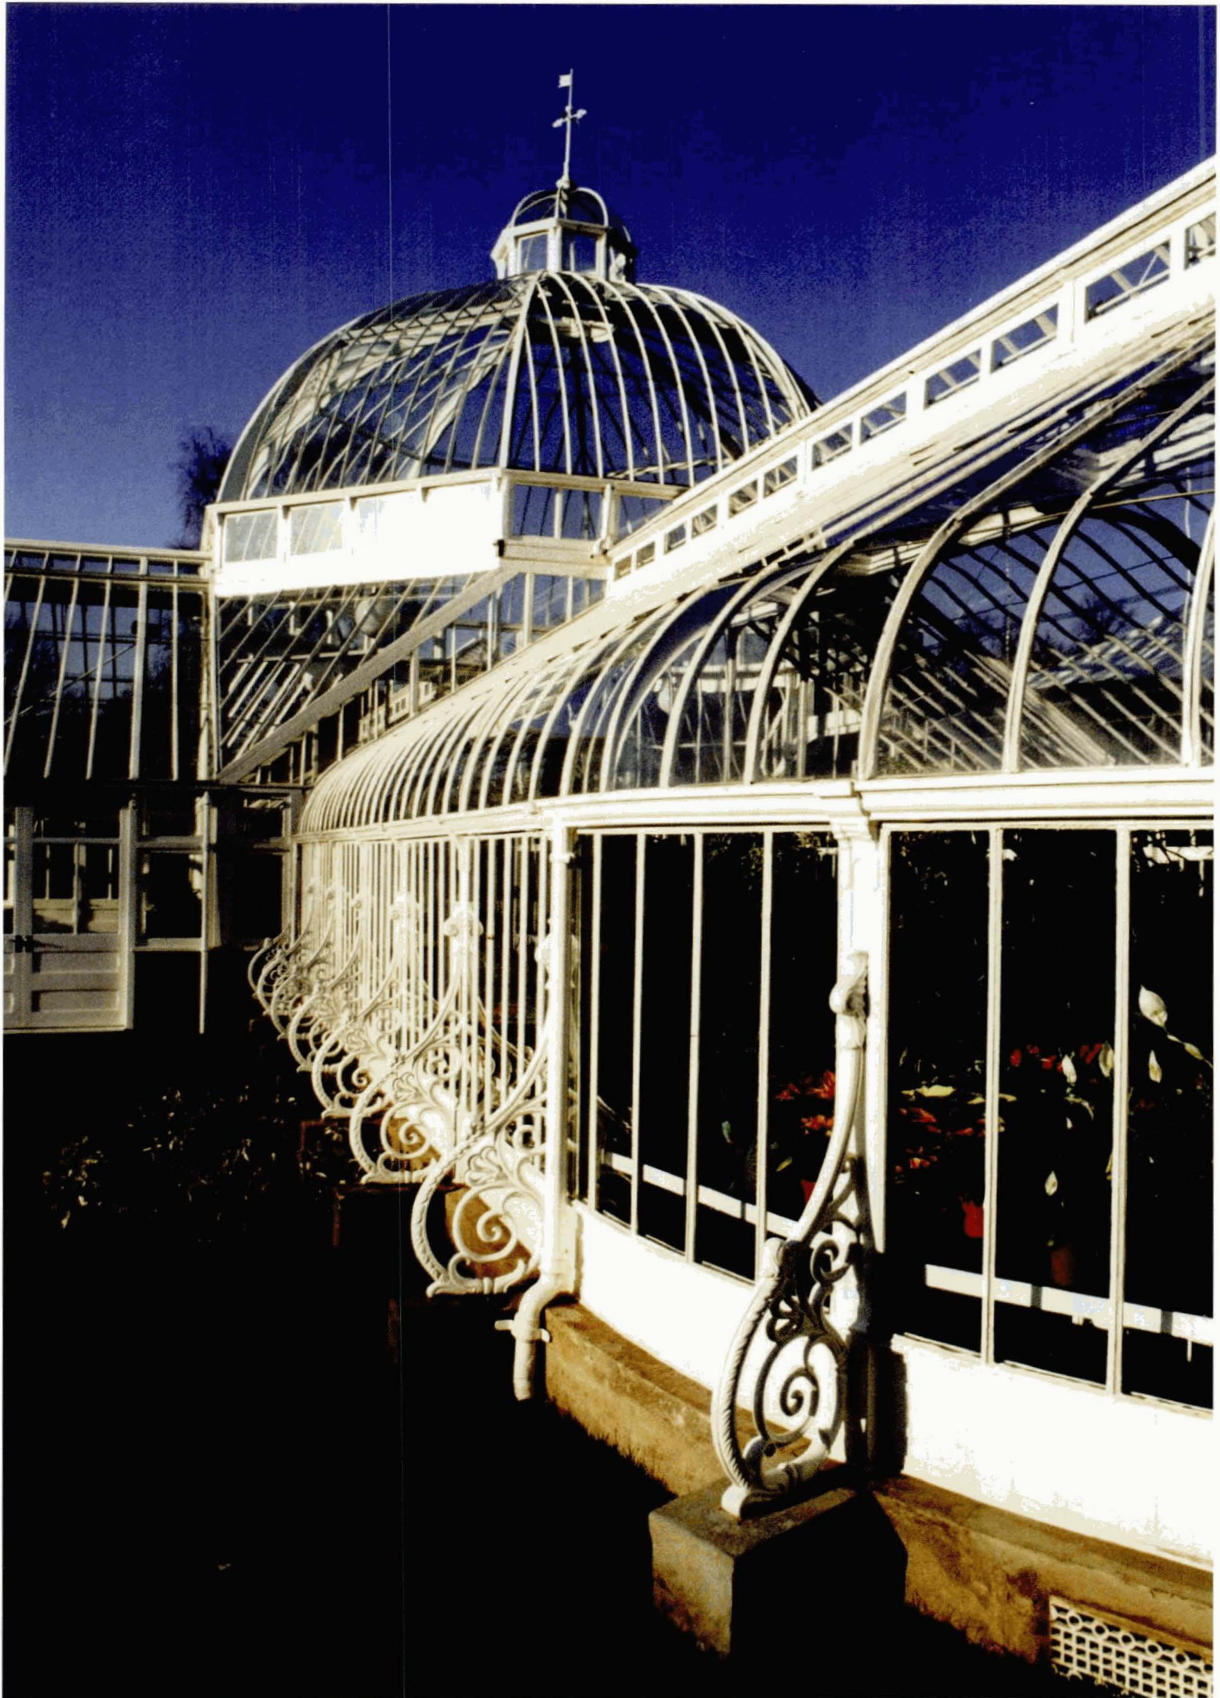
*Illustration 101 Tollcross House Conservatory, Tollcross Park, Glasgow (1858) The structure after restoration (Picture: Heritage Engineering, The Industrial Heritage Co, Ltd)*

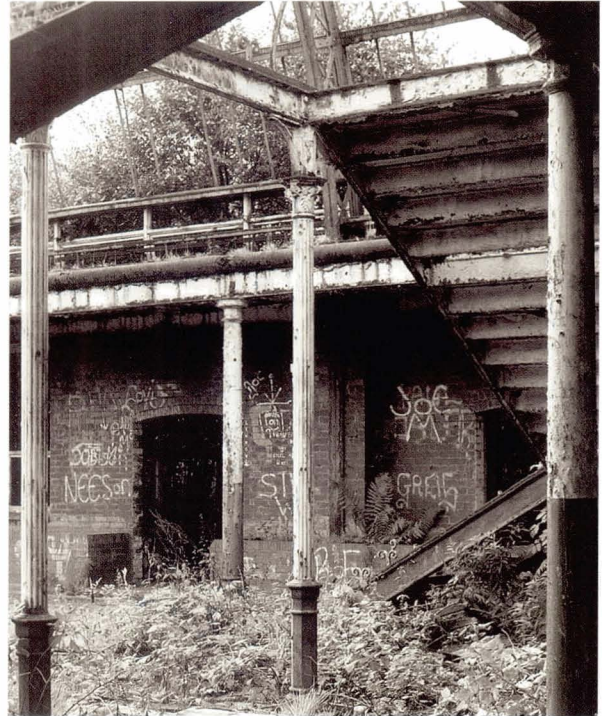
*Illustration 104 Springburn Park Winter Gardens (1899). The dilapidated iron-framed interior in 2001. The filler joists to the gallery floors are likely to be steel (Picture: T. Swailes)*

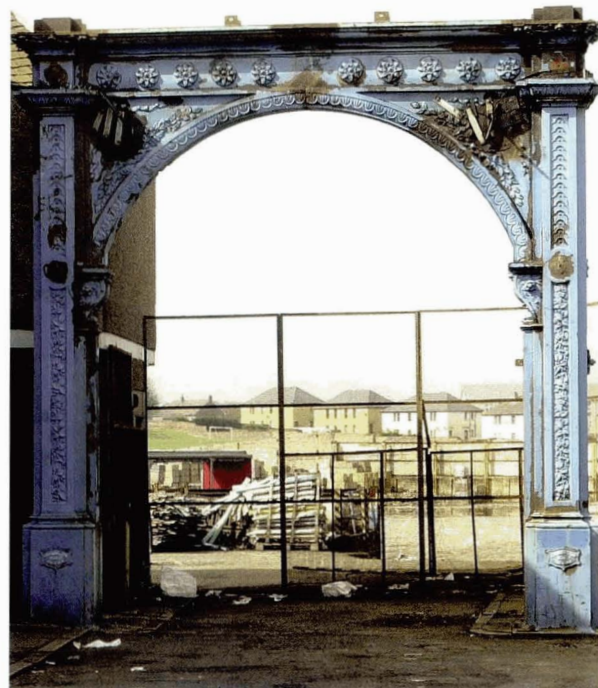
Illustration 110 The Grahamston Gate  
Unightly makeshift repairs to cracks, prior to conservation work (Picture: Historic Scotland)

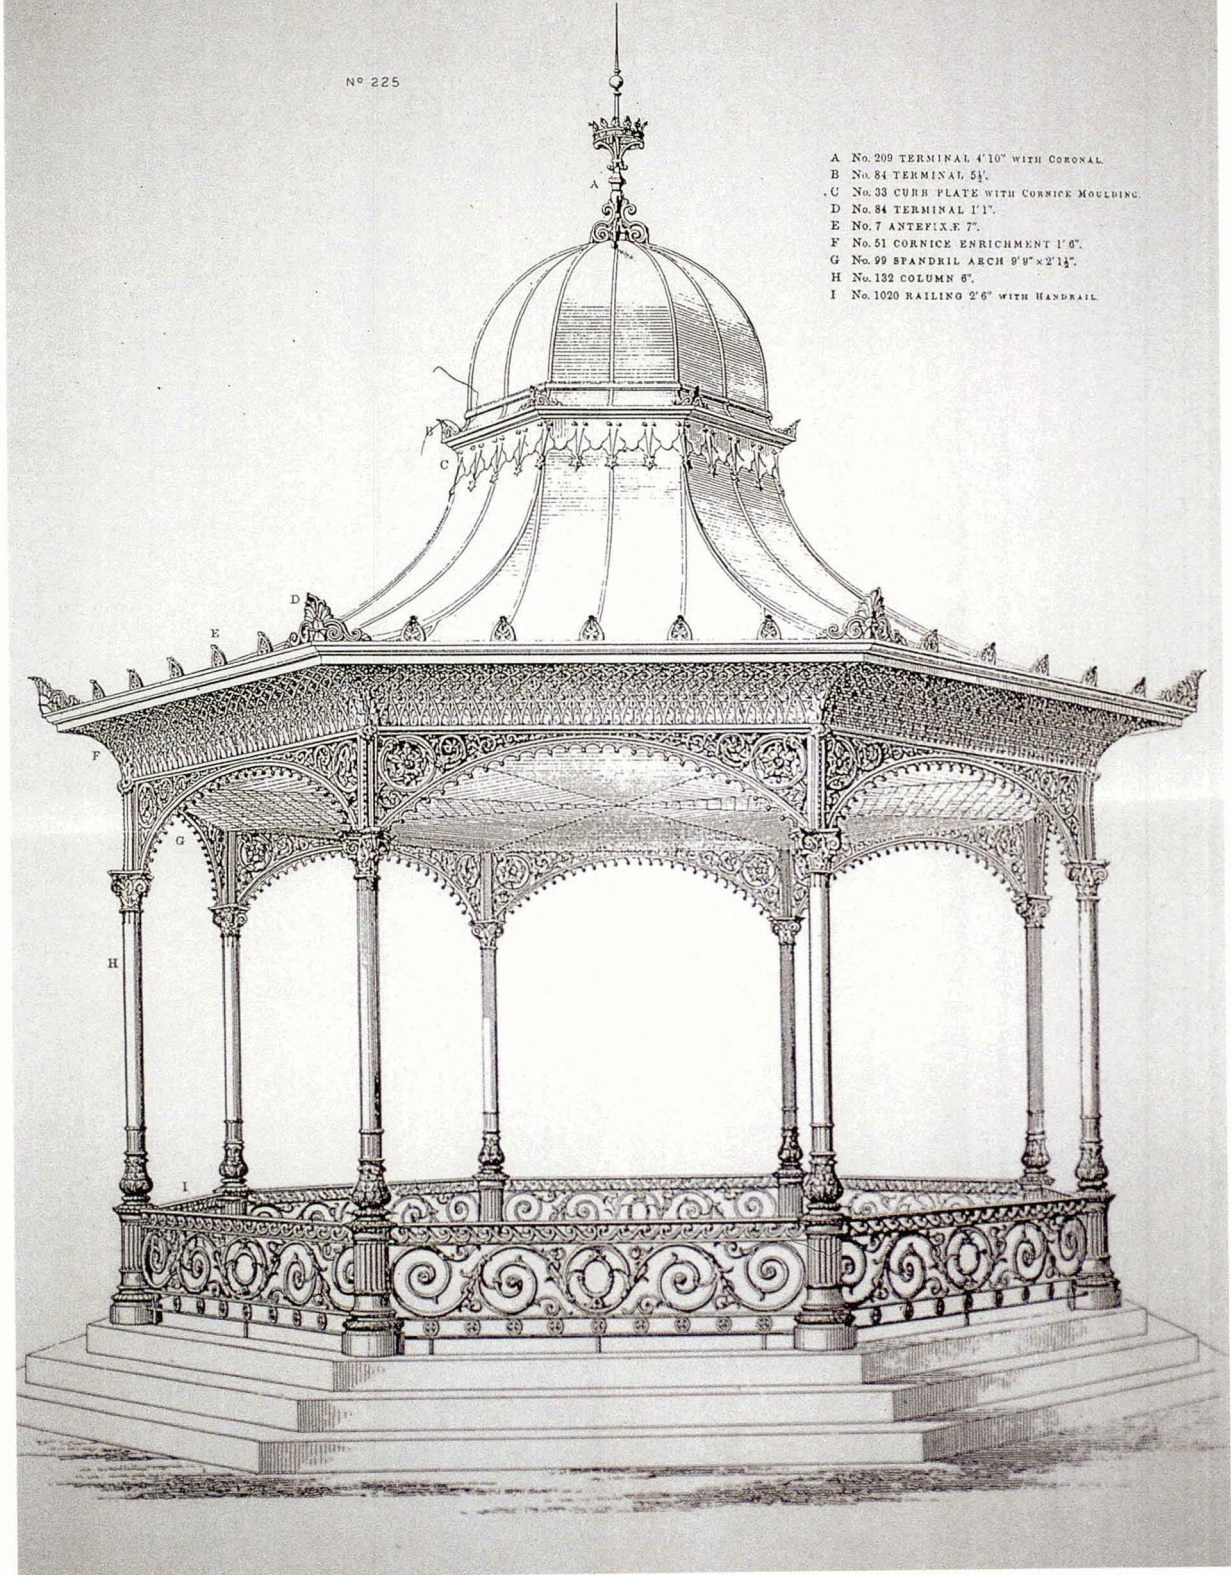
- A No. 209 TERMINAL 4'10" WITH CORONAL.
- B No. 84 TERMINAL 5½'
- C No. 33 CURB PLATE WITH CORNICHE MOULDING.
- D No. 84 TERMINAL 1'11"
- E No. 7 ANTEFIXE 7"
- F No. 51 CORNICHE ENRICHMENT 1'6"
- G No. 99 SPANDRIL ARCH 9'9" x 2'13"
- H No. 132 COLUMN 6'
- I No. 1020 RAILING 2'6" WITH HANDRAIL.

Illustration 111 A bandstand from the catalogue of Walter MacFarlane & Co. This illustration may be compared with the structure at Magdalen Green, Dundee, shown in illustrations 2, 3 & 4.

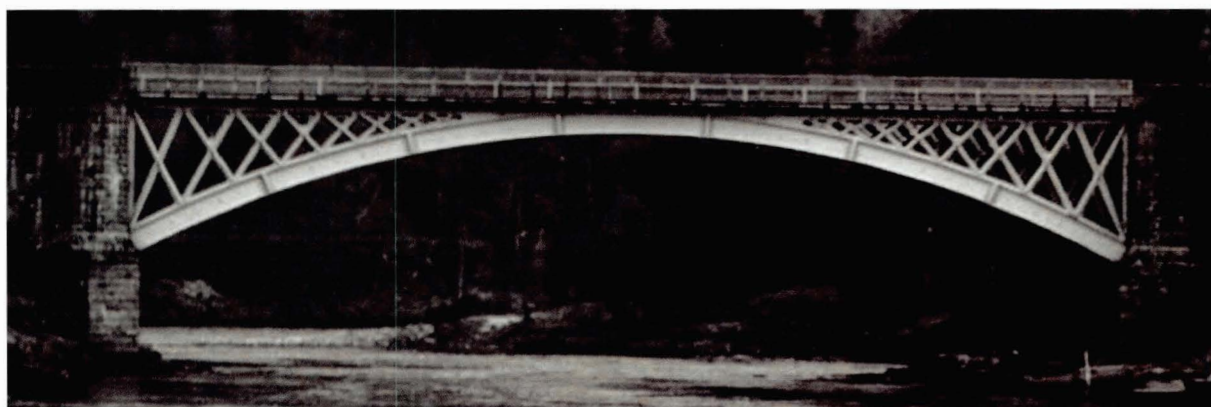
Illustration 115 Carron Bridge (1863) General view  
Alexander Gibb, a pupil of Telford, was the engineer. The ironwork contractor was William McKinnon & Co. of Aberdeen, a general engineering company who at one time specialised in making plantation machinery. (Picture: Historic Scotland)

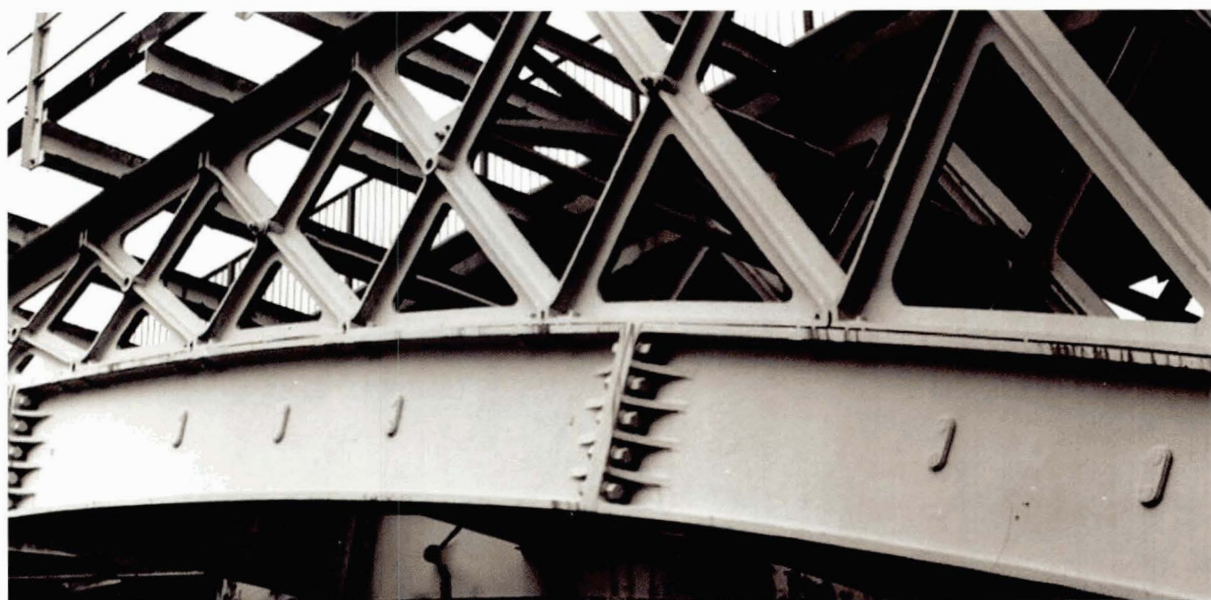
Illustration 116 Carron Bridge (1863) Structural ironwork details. (Picture: Mark Watson, Historic Scotland)

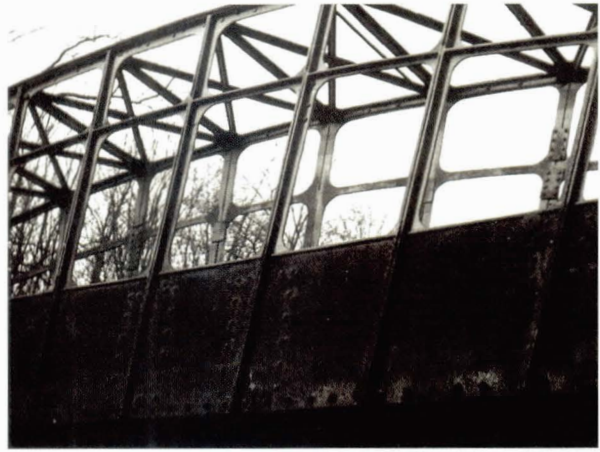
*Illustration 118 Aqueduct over the River Almond carrying a feeder to the Edinburgh & Glasgow Union Canal (1818-21) Detail (Picture: Roland Paxton)*

*The engineer Hugh Baird used a series of open cast iron frames in the shape of voussoirs bolted together to form an arch either side of the trough (Paxton, 1980). (Picture: Roland Paxton)*

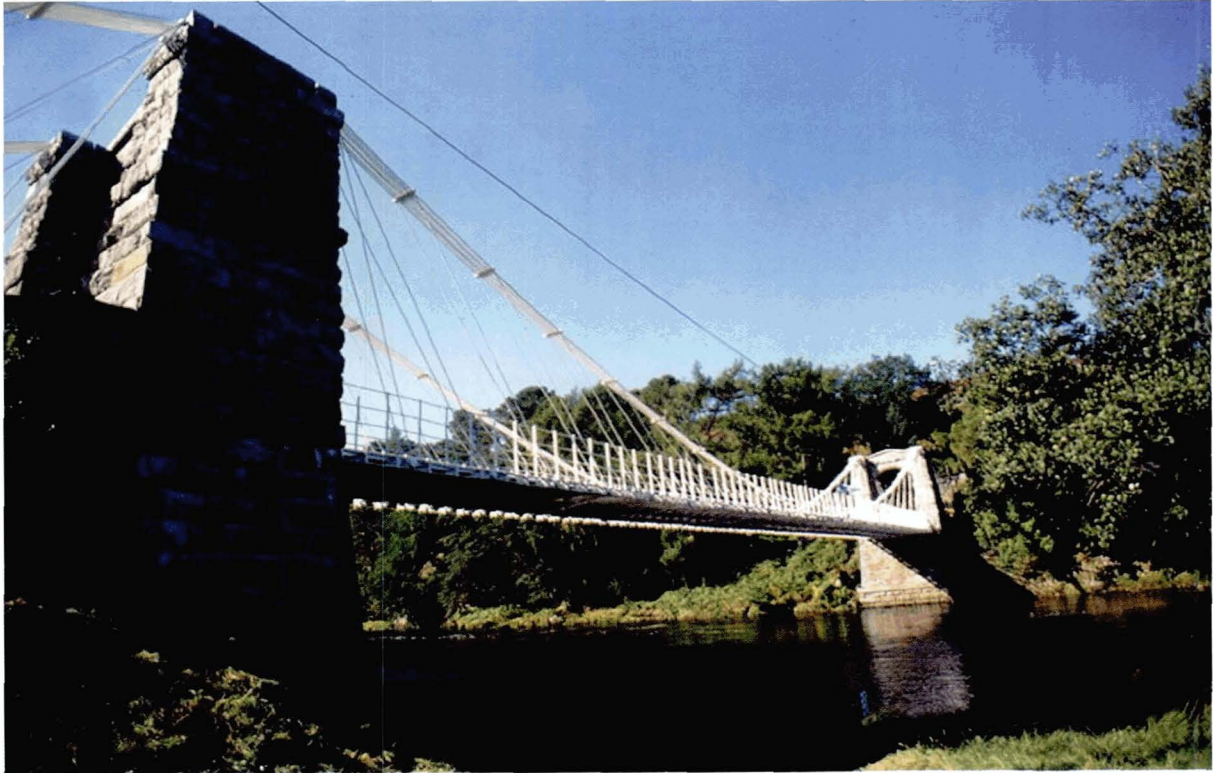
*Illustration 124 Bridge of Oich, Abercalder, Invernesshire (1854) The bridge, built to the Dredge patent, had been deteriorating since it was by-passed in 1932. It was taken into the care of Historic Scotland in 1996 and its refurbishment completed in 1997 led to a national civil engineering commendation in the 1998 Saltire Awards (Picture: Historic Scotland)*

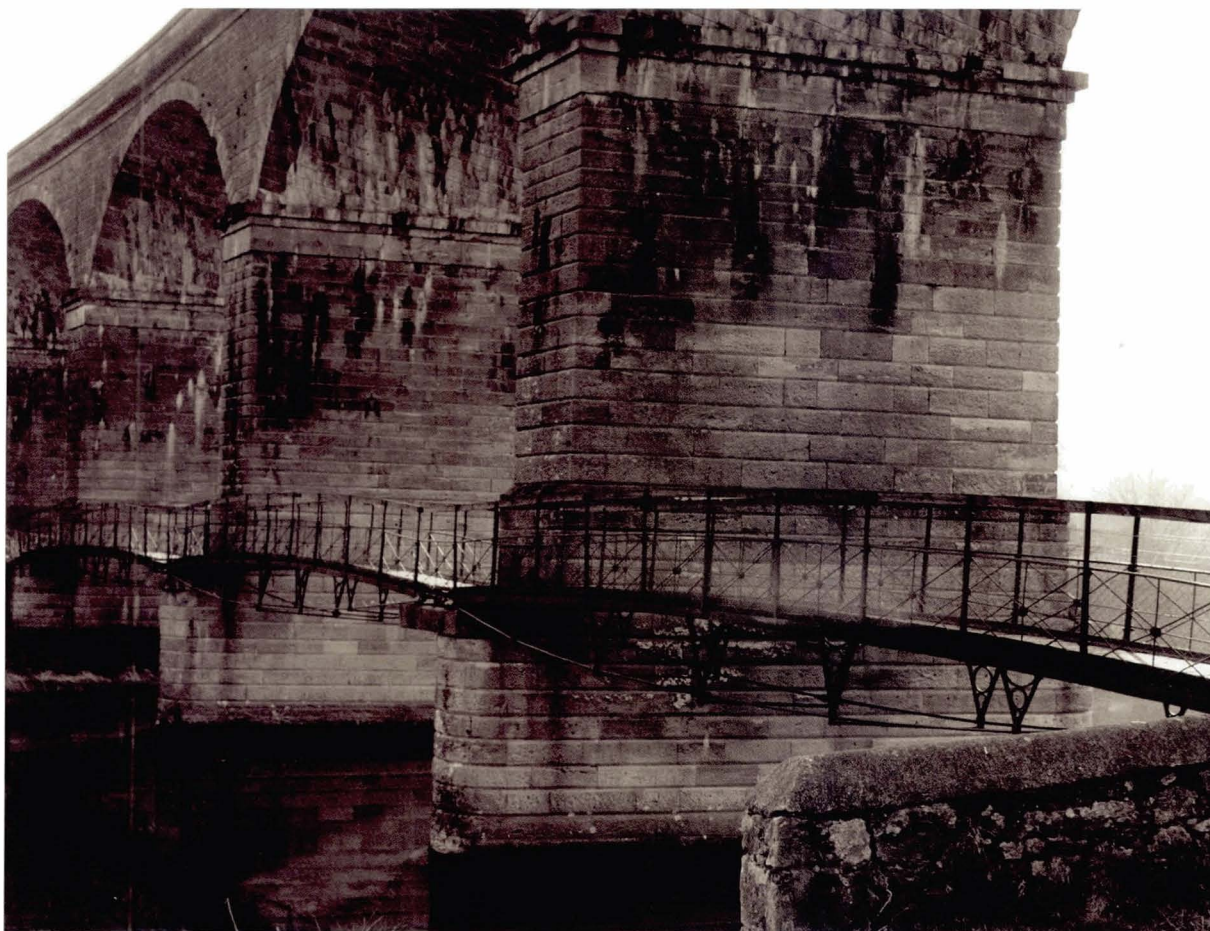
*Illustration 126 Roxburgh Viaduct Foot bridge (1850) (Picture: Crown Copyright: RCAHMS. Reproduced courtesy of JR Hume)*

Around 1820 Robert Stevenson proposed a novel form of suspension bridge, with the roadway supported above the level of the chains, for a crossing of the River Almond near Edinburgh (Leslie, 1999). This bridge was not constructed, but in 1822 architect John Herbertson Jnr designed and built a bridge across Glasgow's River Kelvin on the 'suspension girder' principle (Boyce, 1996) (Illustration 125). The iron footbridge alongside Roxburgh Viaduct over the Teviot on the North British Railway's Kelso branch is an interesting variant (Paxton, 1981) (Illustration 126).

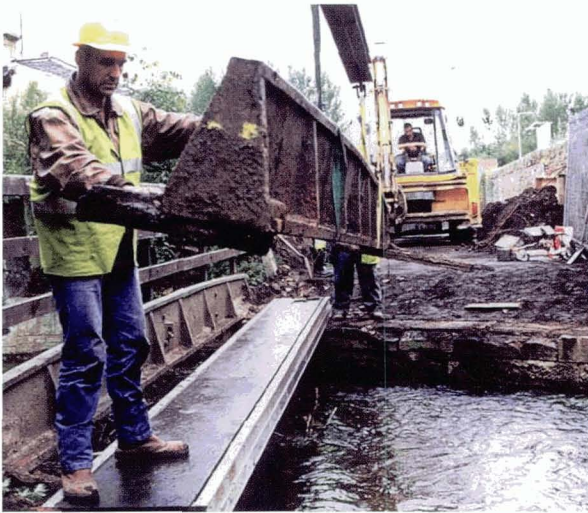
Illustration 127 Edinburgh & Dalkeith Railway, Braid Burn Bridge (1831) General view. Made and erected by Shotts Iron Co. in 1831, the bridge was conserved in 1983 by Lothian Regional Council and raised in level in 2001 (Picture: New Civil Engineer/Roland Paxton)

Level girder bridges of cast iron were used for short spans where approach gradient and headroom restrictions made it necessary. Made and erected by the Shotts Iron Co in 1831, Braid Burn bridge, Duddingston, on the former Edinburgh and Dalkeith Railway, is a very early example (Paxton, 1983). Lothian Regional Council carried out conservation works in 1983 and raising works in 2001 (New Civil Engineer 2003) (Illustration 127).

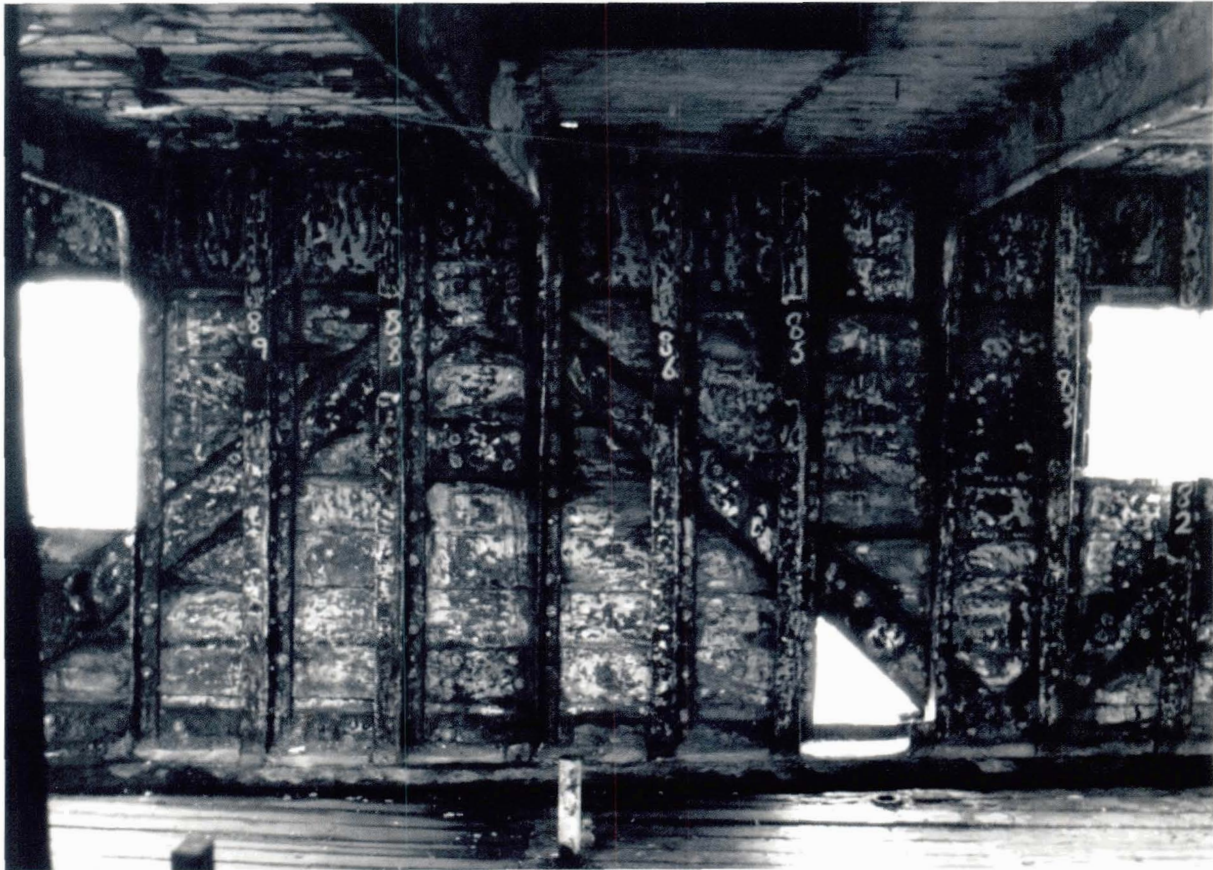
*Illustration 134 The Carrick (1864). Braced hull and knee braced deck beams (Picture: T. Swailes)*

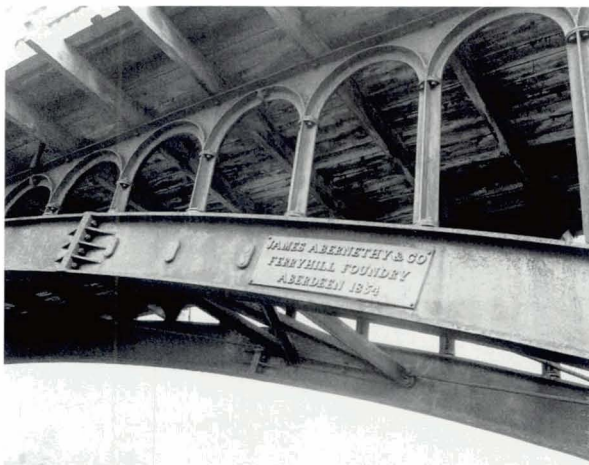
Illustration 135 Park Bridge, Aberdeenshire (1854).  
Abernethy & Co, Ferryhill Foundry (Picture: RCAHMS,  
J.R. Hume)

gleaned from documents or existing drawings the better. Iron bridges are quite often marked with a date and makers details but this is less often the case with buildings (Illustration 135). In any case, plaques or date stones may mislead. Similarly, drawings do not always present a true picture of what was built or how it may have been altered. Section 9 of this guide contains information of use when researching a building.

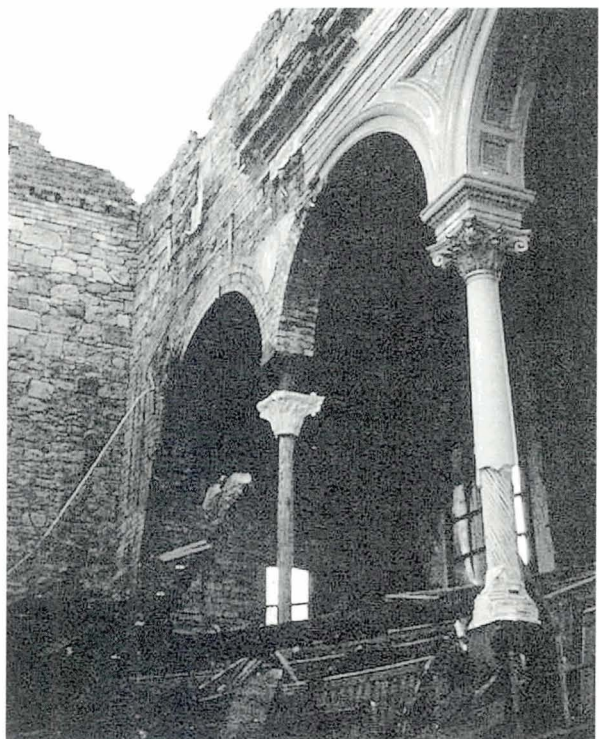
Illustration 136 Langside Hill Church, Glasgow (1896)  
Cast iron columns beneath lath and plaster. The building is  
now a restaurant (Picture: Neil Ross, Historic Scotland)

In a conservatory, all of the structural elements may be iron, but in most buildings iron will be present alongside other materials. Factory and warehouse buildings often have a visible skeletal frame of iron, steel or timber within external masonry walls. In contrast, in nineteenth century residential, commercial and institutional buildings, iron supports may have been concealed to maintain an illusion of more traditional construction (Illustration 136). A search of archival sources for information about constructional

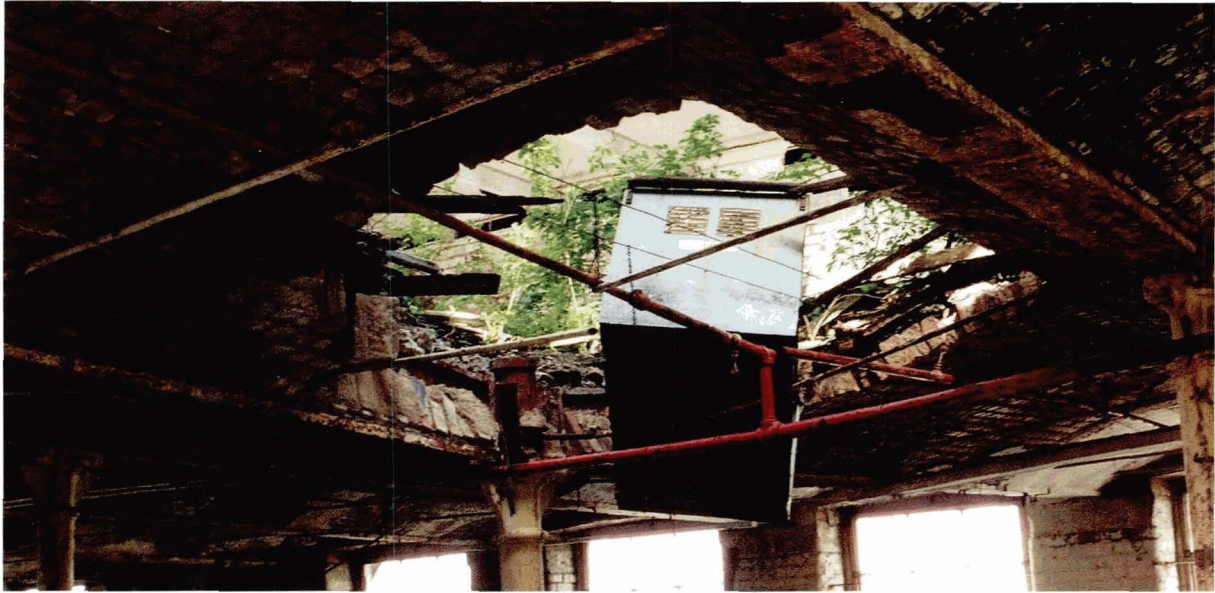
*Illustration 137 Gourock Rope Works (1866) Partial floor collapse (Picture: Malcolm Waters, Historic Scotland)*

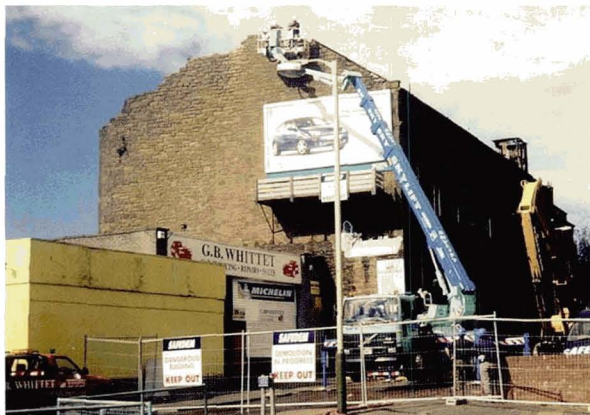
*Illustration 138 Larchfield Works, Dundee (1865) High level inspection of fire damage (Picture: Mark Watson, Historic Scotland)*

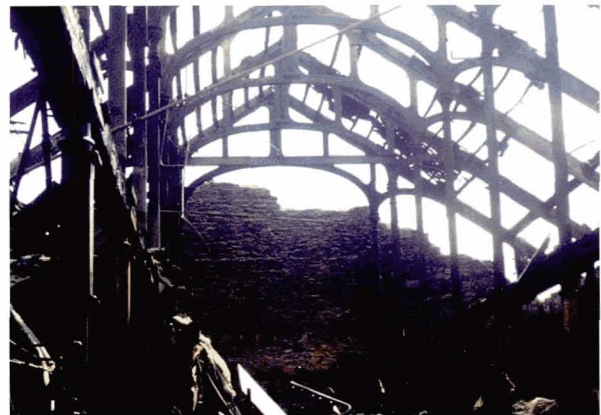
*Illustration 139 Larchfield Works, Dundee (1865) The interior, destroyed by fire (Picture: Mark Watson, Historic Scotland)*

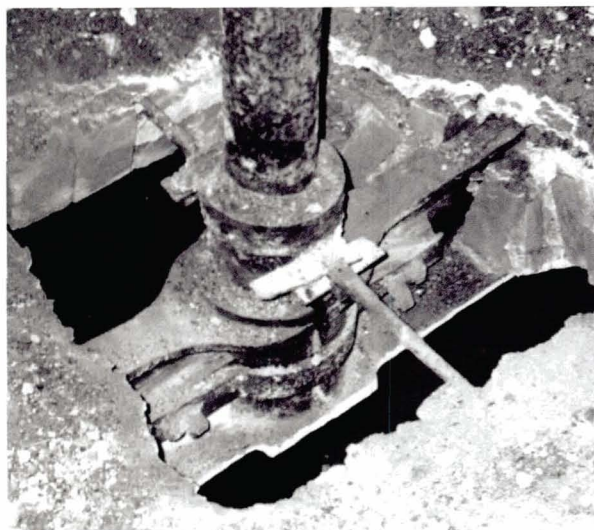
Illustration 142 Clarence Mill, Bollington, England (1854)  
Opened up beam-column connection (Picture: T. Swailes)

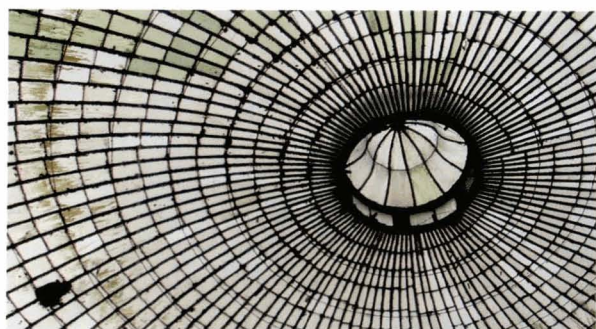
Illustration 144 The Kibble Palace, Glasgow Botanic Gardens (1873) (Picture: Glasgow City Council)  
The rotational twist of the dome between the inserted clerestory and the lantern is apparent from the curvature of the glazing bars.

As well as being safe, a building must also be fit for its purpose, or serviceable. Serviceability failures include excessive deflections or vibrations under load, unsightly cracking, or poor resistance to water penetration. Early in its life an old building may have deformed, perhaps severely, into a state of equilibrium, and sometimes it will be both structurally and aesthetically desirable to leave it that way (Illustrations 143 and 144).

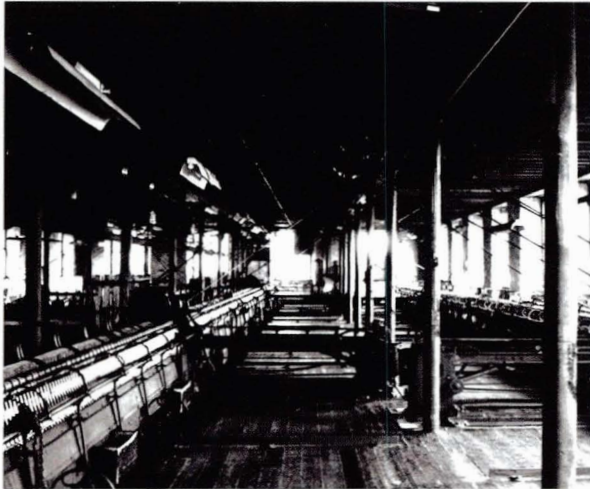
Illustration 145 Dangerfield Mill, Hawick (1874) (Picture: T. Swailes) Original spinning mules by Platt Bros. of Oldham, and original drive shaft destroyed by fire in 2004

their original power transmission arrangements (Illustrations 145 and 146). Preservation of these rare in-situ survivals is of considerable historical importance.

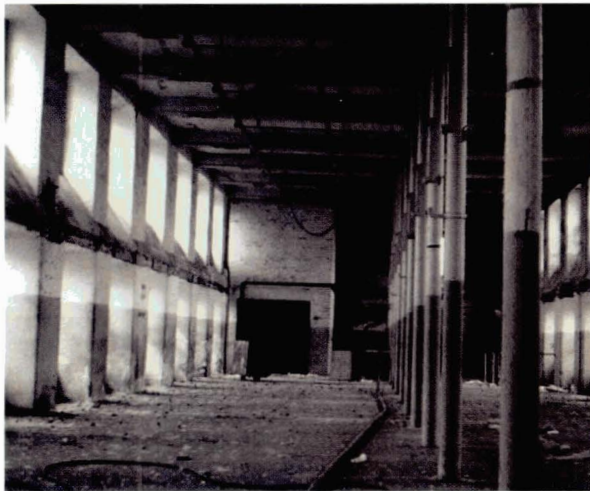
Illustration 147 (a) and (b) Bell Mill (or West Mill), Stanley Mills, Perthshire (1786-7)  
(top) an original floor and (bottom) double height ground floor created by the removal of the original first floor.  
(See Illustration 28 for the original storey post details)  
(Pictures: T. Swailes)

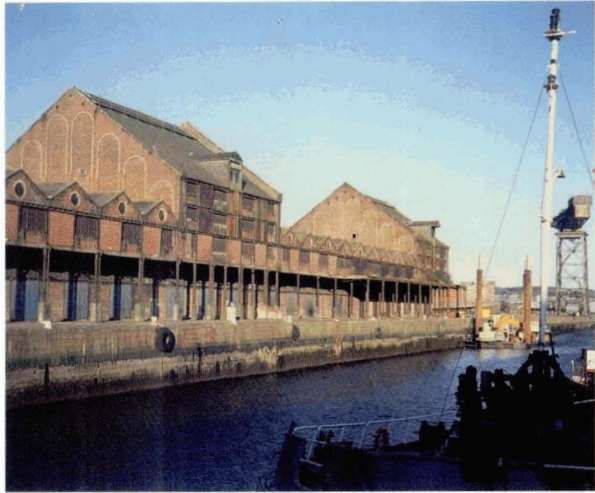
Illustration 148 Warehouse, James Watt Dock, Greenock (1885)  
(a) General view (b) Detail of elevation to dock  
Many elements of the iron frame have cast in part numbers presumably related to assembly drawings.  
(Pictures: Mark Watson, Historic Scotland)

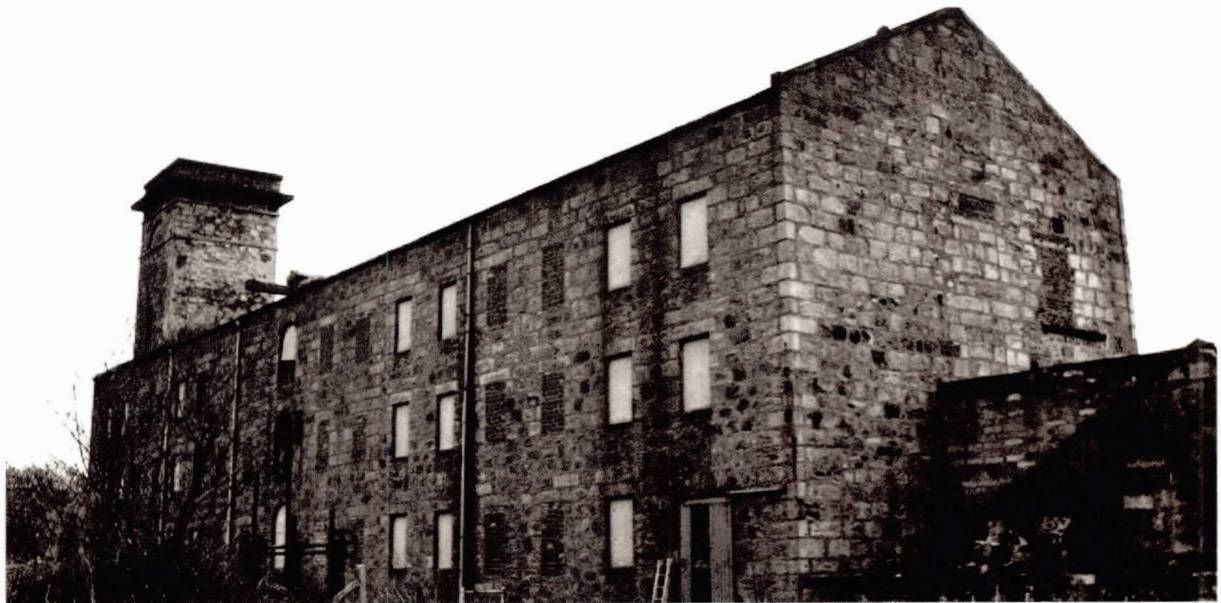
Illustration 151 The Old Spinning Mill, Grandholm Works, Aberdeen (c. 1790, modified 1820s and c. 1900) : Occupied from 1858-1991 by J&J Crombie, famous for tweeds and the Crombie coat, a flax spinning mill was here in 1793. Historical research has revealed that after a fire in 1900 the building, except the water/stair tower, was reduced in height by two storeys. (Watson, 1992) (Picture: T. Swailes)

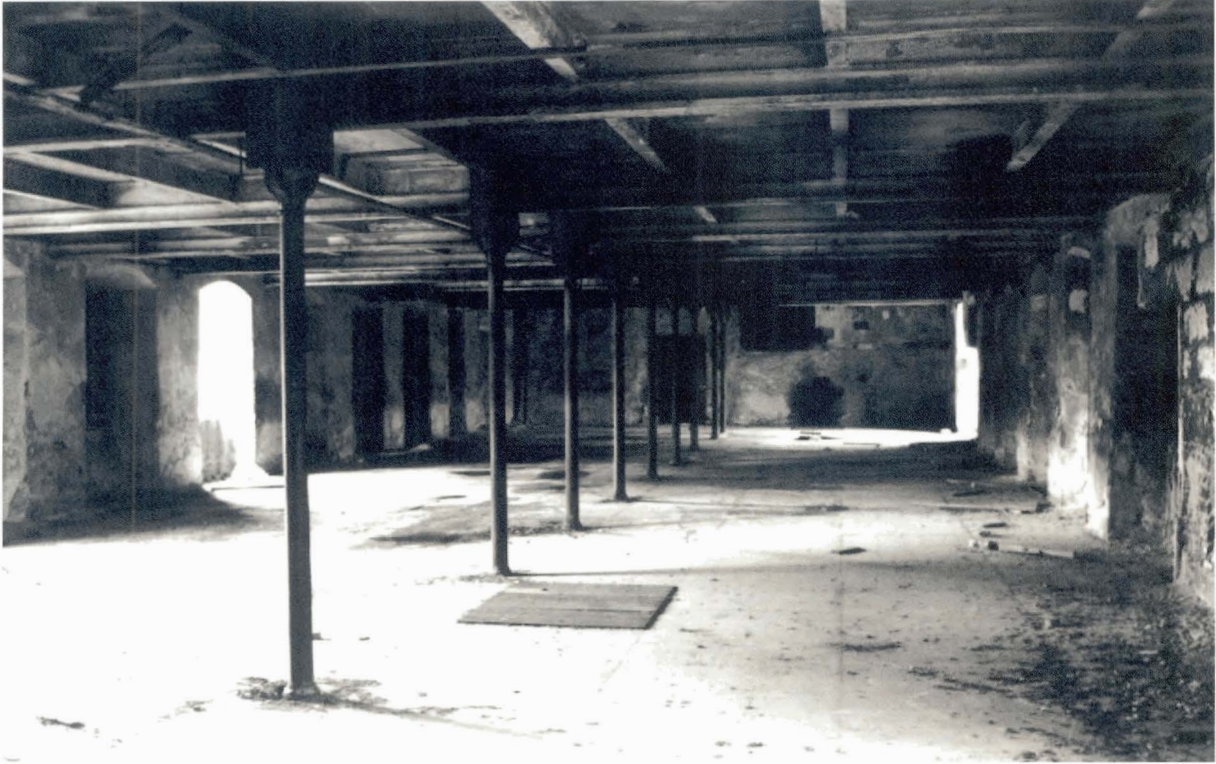
Illustration 152 The Old Spinning Mill, Grandholm Works, Aberdeen (c. 1790, modified 1820s and c. 1900)  
Interior view (Picture: T. Swailes)

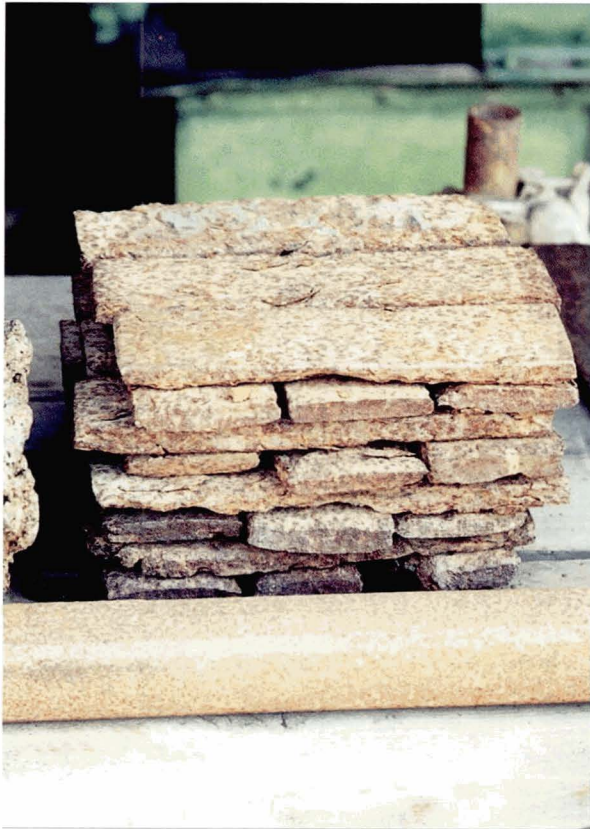
a. Piled bars, each 240mm x 70mm x 12mm

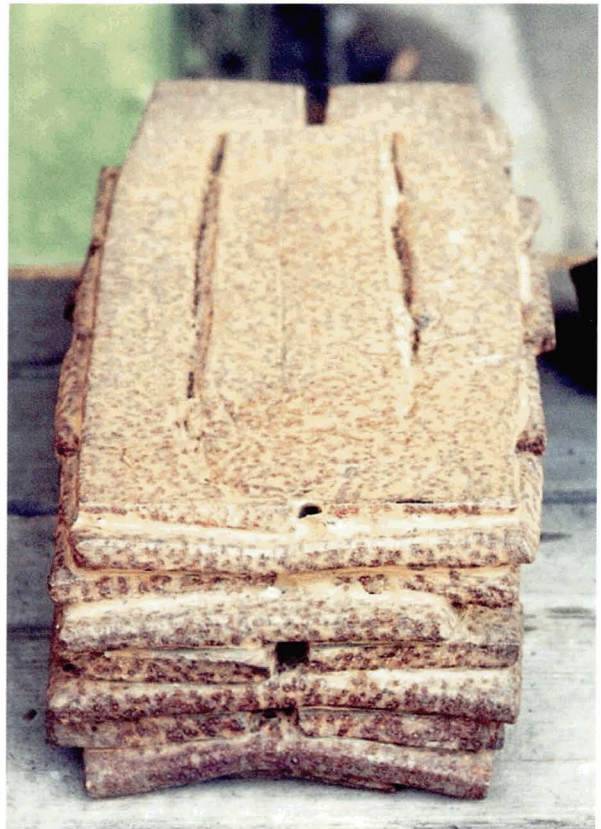
b. Shingled pile (welded under the hammer)

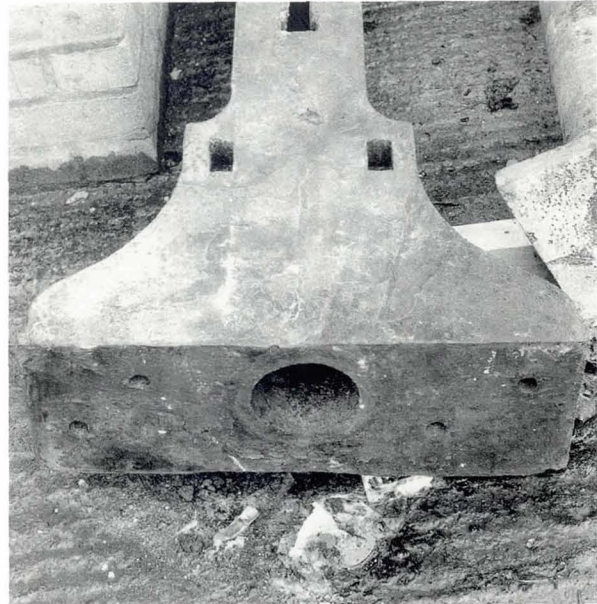
*Illustration 179 Cast iron column top (other side) with horizontal bearing table (Picture: T. Swailes)*

defects have no structural significance. Requirements for features such as drive-shaft bolting faces often determined the orientation of the column in the mould (Illustrations 178 and 179). Movement of the core within the mould was common and most columns suffer from core eccentricity to a greater or lesser degree (Illustrations 180 and 181). This does not much affect load-carrying capacity (the cross-sectional area being unaffected), but wall thickness needs to be measured at several points around the circumference in order to determine an average for purposes of calculating cross-sectional area. This may be done via drilled holes or non-destructively, using ultrasonic measuring techniques. A small degree of curvature or lack of straightness arising from imperfect manufacture is quite normal, but where curvature is clearly visible, overload or accidental damage should be suspected (Illustration 182).

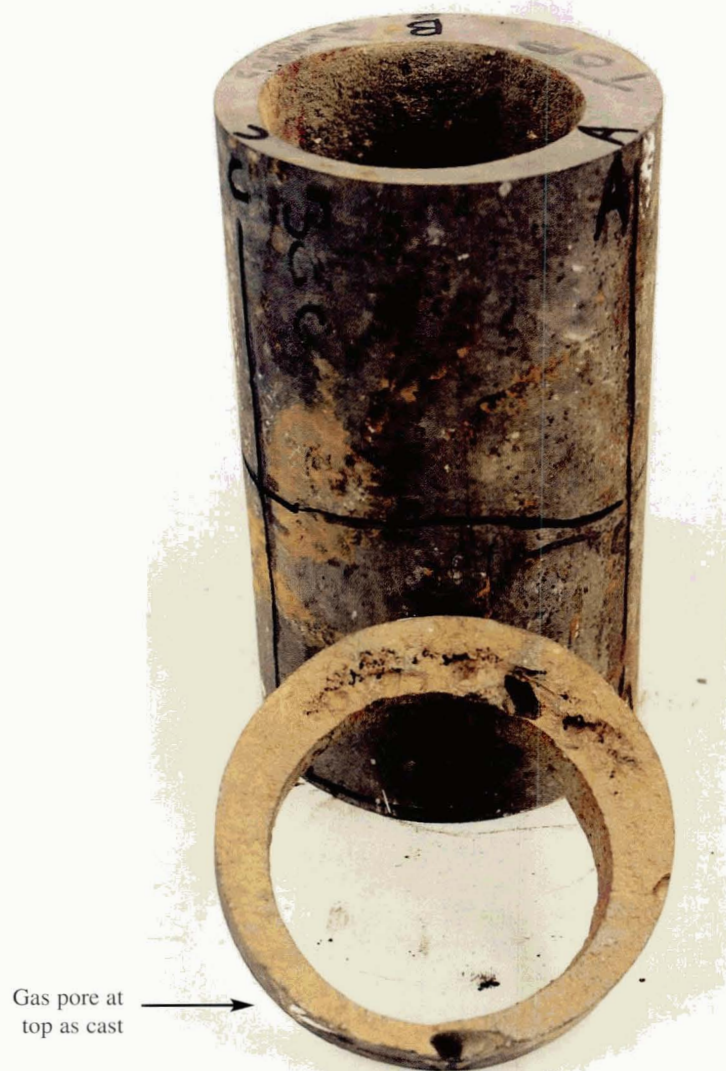
Illustration 180 Cast iron column cross-sections, showing defects: core eccentricity, voids and porosity (Picture: T. Swailes)

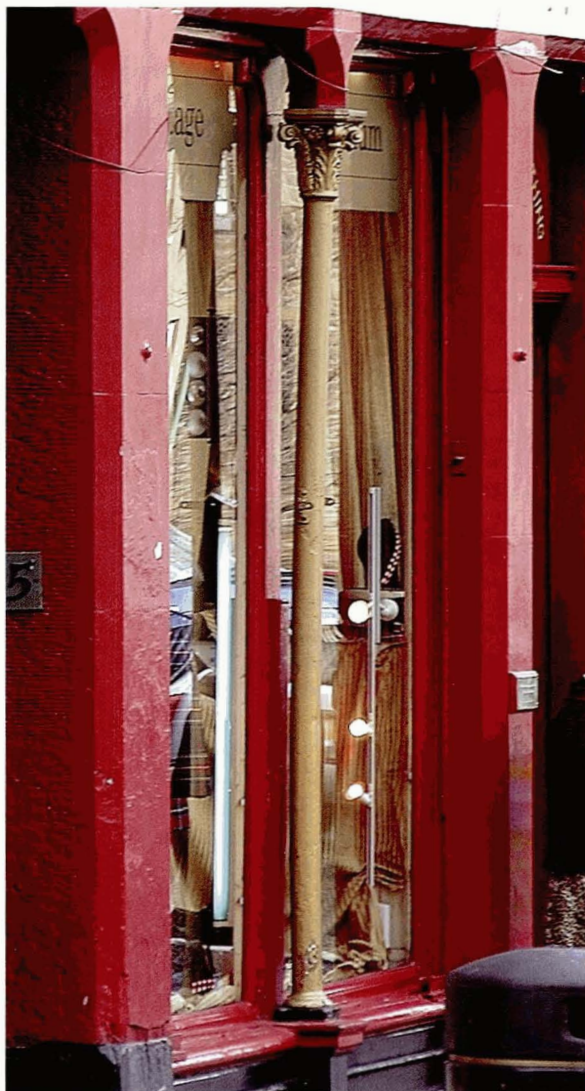
Illustration 182 The Grassmarket, Edinburgh (1875)  
A bent cast iron supporting lintels over a shop front (Picture: T. Swailes)

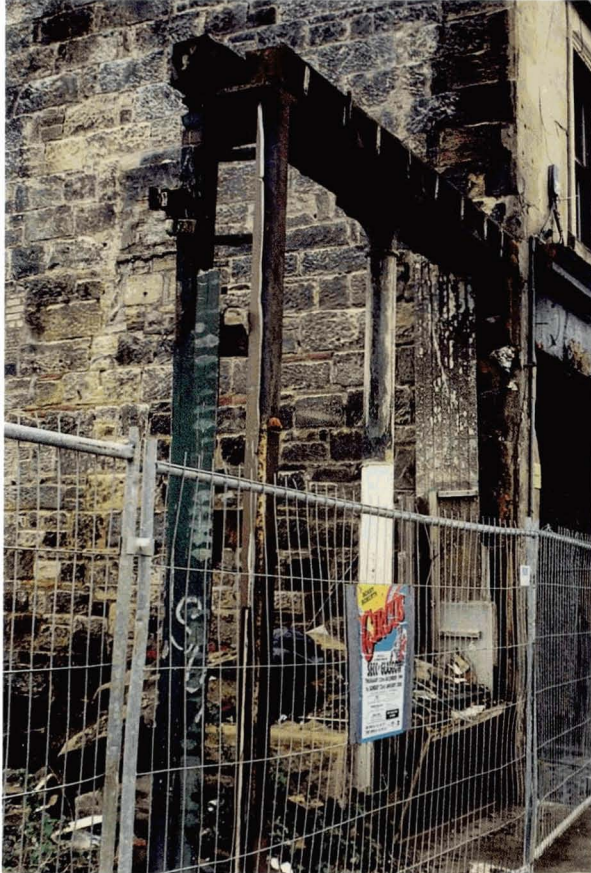
Illustration 183 Glasgow Green (probably c.1850) Shop front framing during demolition (Picture: T. Swailes)

Mid-nineteenth century shop fronts were often framed in cast iron. Exposed columns are usually circular, but concealed columns take a variety of forms (Illustrations 183 to 185). Hollow circular columns of very large diameter, or piers as used in railway bridge construction for example, were generally made in thin-walled sections. These would be cast vertically in loam moulds (formed using brickwork and without patterns) and joined via spigoted ends and/ or internal bolted flanges. Often such sections were filled with brickwork or rubble. Cracking may occur as a result of corrosion and expansion of fixings, or due to restrained thermal movements.

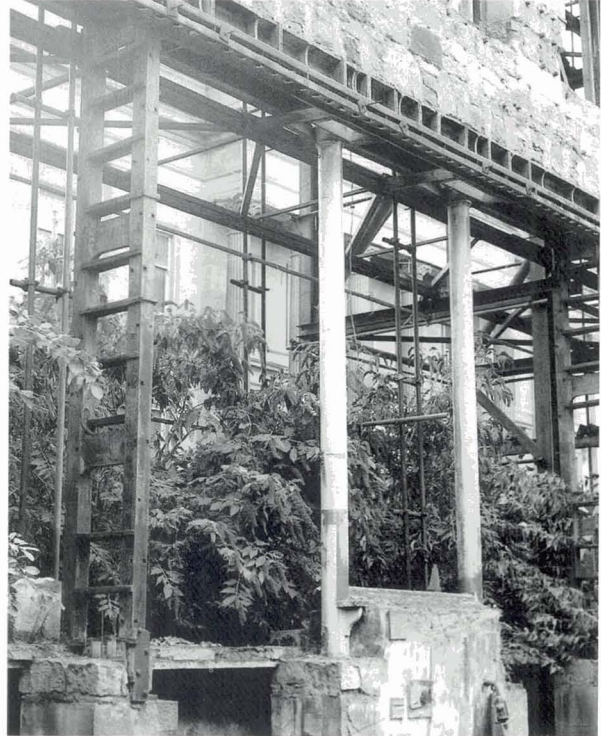
Illustration 185 Ingram Street, Glasgow (c.1854) Rear view of a façade retained for inclusion in a future development (Picture: T. Swailes)

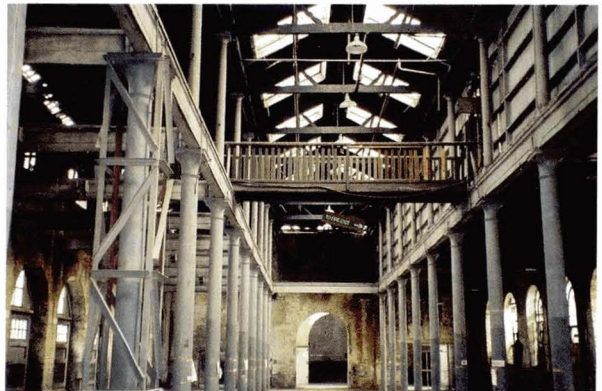
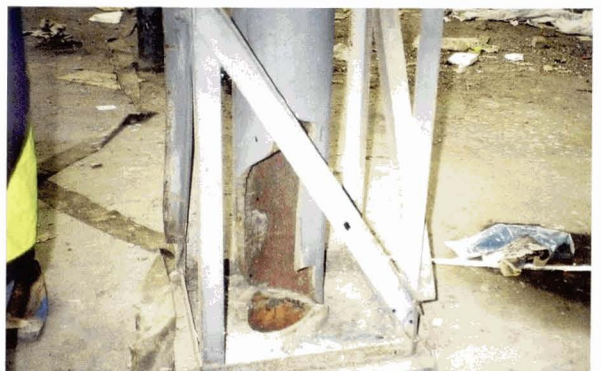
Illustration 186 Former Rail Store, Gidea Park, Essex (above) Internal view (below) Detail  
A 'historic repair', with a replacement column of light angle truss construction providing vertical support to an overhead crane rail support beam. The badly damaged hollow circular cast iron column was left in place, still supporting the roof (Picture: Morrison Construction)

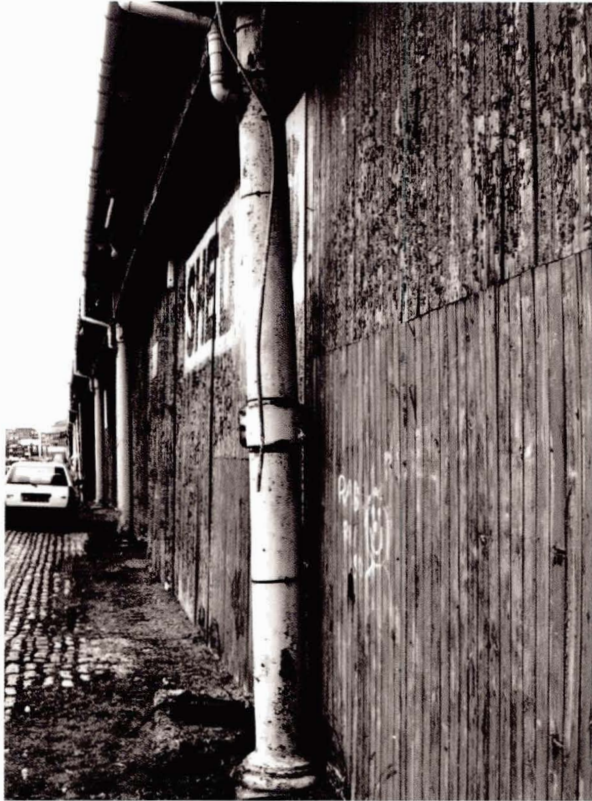
*Illustration 187 Dockyard Transit Shed, Victoria Dock, Dundee (1874) Fractured quayside column (Picture: T. Swailes)*

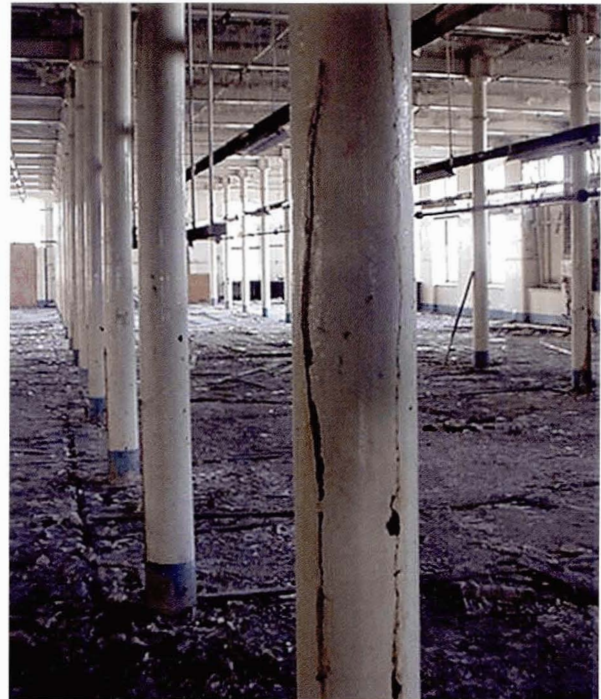
*Illustration 188 Domestic Finishing Mill, Anchor Mills, Paisley (1889) Cast iron columns split by ice. Several columns became filled with water due to a defective flat roof. The water in the columns froze over winter in the semi-derelict building, which was largely open to the elements. (Picture: Buro Happold)*

In cast iron columns that have served as rainwater pipes, localised internal corrosion may be severe, and its extent difficult to determine. Where columns are not sealed, they may become filled with water, which then has nowhere to drain. To find water in hollow columns is by no means unusual. Vertical splits were found in a significant number of columns when structural engineers inspected the derelict Domestic Finishing Mill at Anchor Mills in Paisley (Illustration 188). Drilling holes in other columns to determine wall thickness, they were found to be partially filled with water, drained from the defective roof. The building was largely open to the elements over winter, and it appeared that water in the columns had turned to ice. Splitting had been caused by the expansion associated with freezing. One nineteenth century report has been found of a cast iron column 'exploding' as the result of ice formation within. More recently, the problem has caused the splitting of the hollow tubular legs of steel towers.
