5  
GUIDE FOR  
PRACTITIONERS

SCOTTISH  
IRON  
STRUCTURES

TECHNICAL  
CONSERVATION,  
RESEARCH AND  
EDUCATION  
GROUP

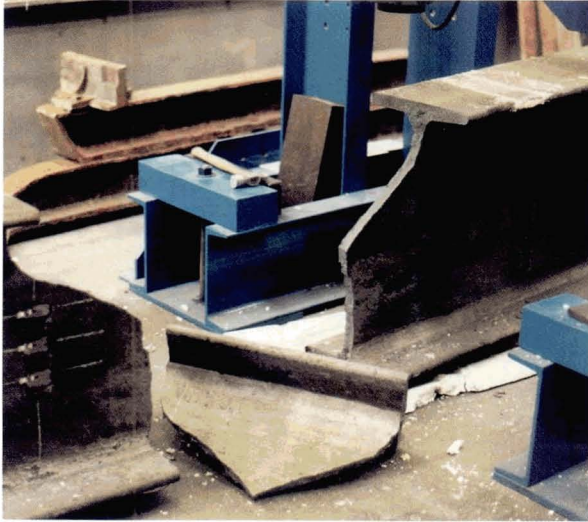
*Illustration 197 Large I-section columns from a c. 1855 Engineering Workshop at Chatham Dockyard  
Fracture after testing in bending, with compression zone wedge (Picture: T. Swailes)*

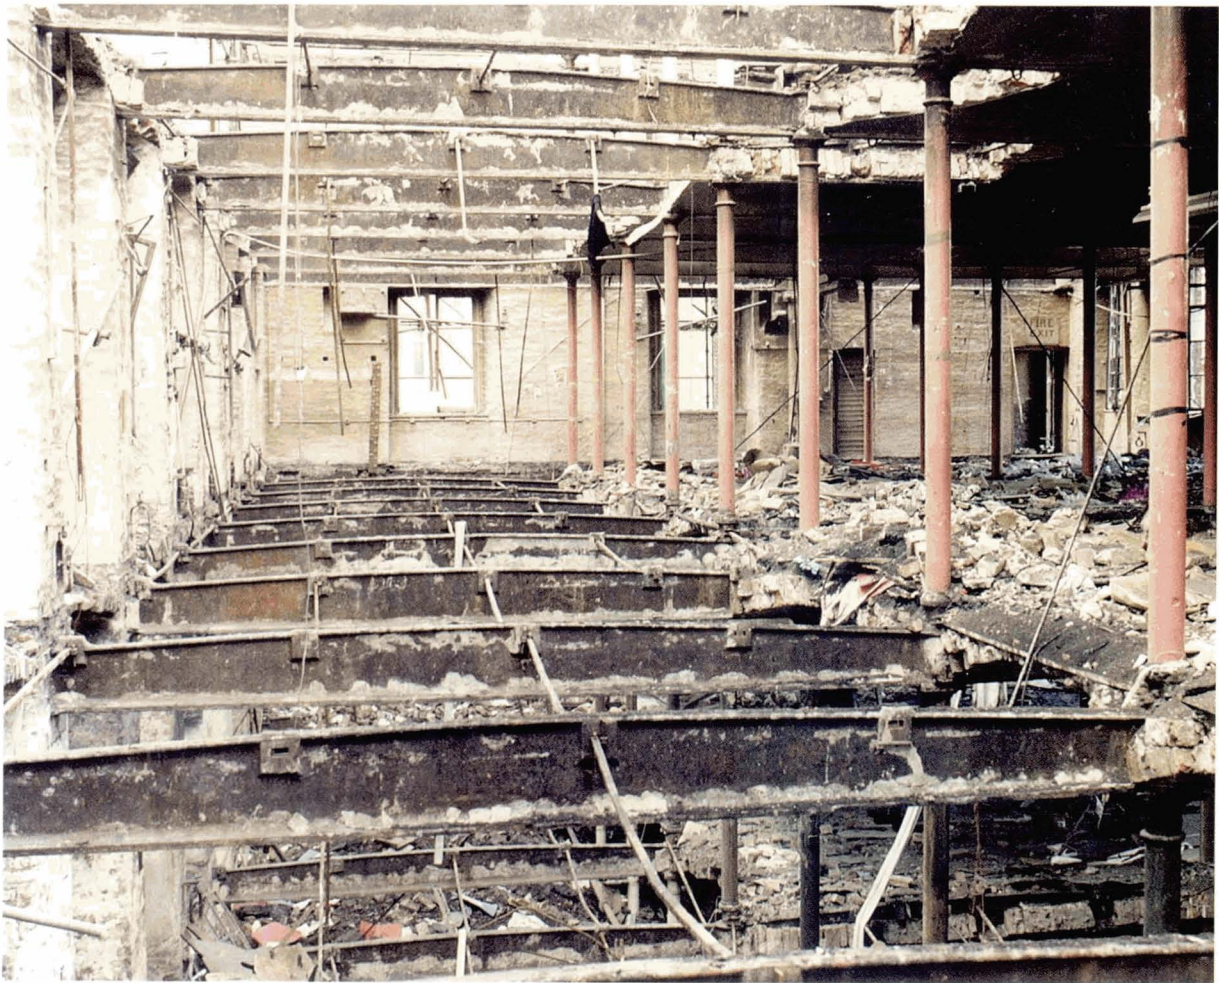
*Illustration 199 Havelock Cotton Mill, Manchester (c.1845) Iron framing exposed during demolition in 1995  
(Picture: Joe Marsh, UMIST)*

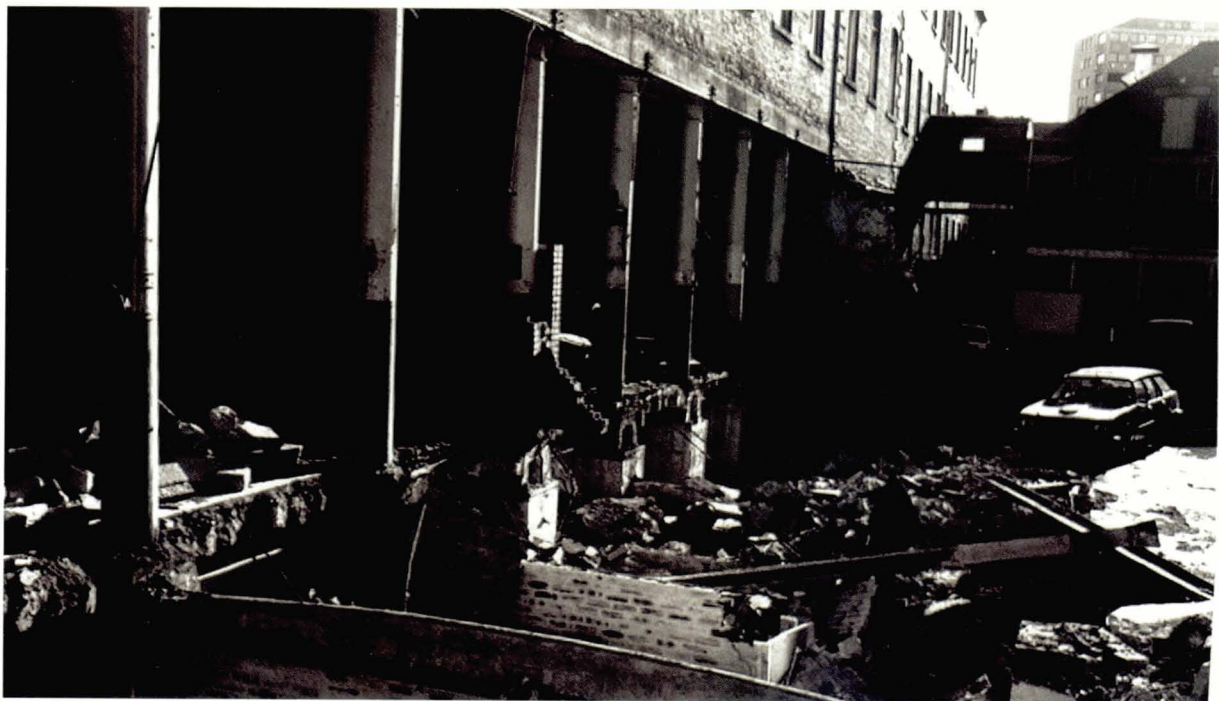
Illustration 201 South Mills, Dundee (1864) A Hodgkinson type beam over a partially demolished fireproof basement (Picture: RCAHMS)

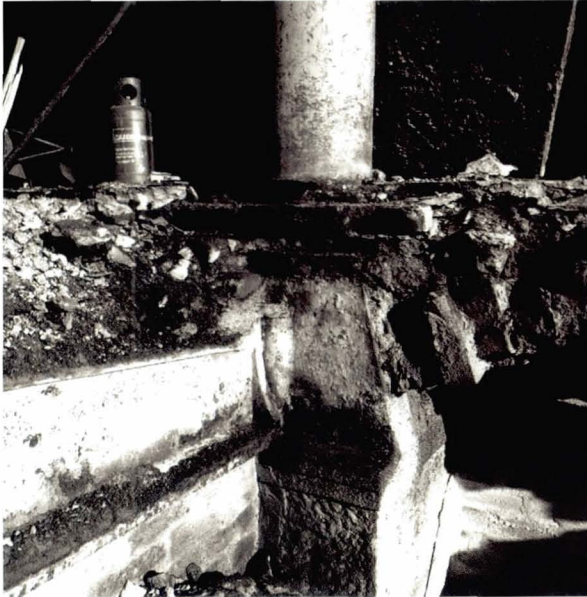
*Illustration 202 South Mill, Dundee (1864) A cast iron column on a large cast iron base, also supporting a ground floor beam (Picture: RCAHMS)*

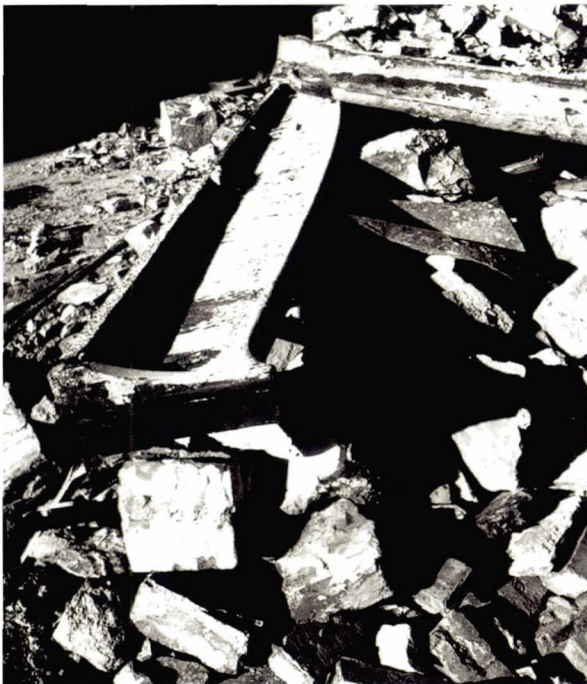
*Illustration 203 South Mill, Dundee (c.1851, date of this building 1864) A cast iron beam with a hog-backed profile (Picture:RCAHMS)*

*Note the small bulb-shaped top flange and the dovetail on the beam end, to slot into a recess in the cast iron base of Illustration 32*

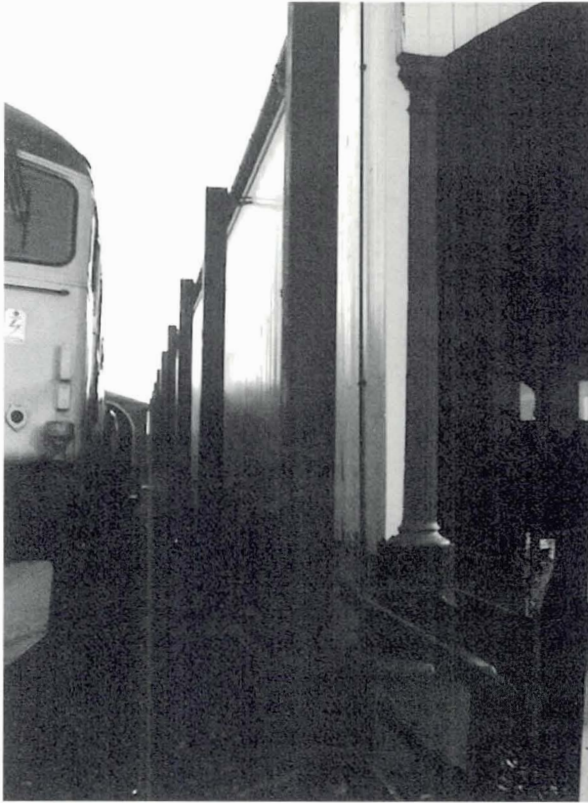
*Illustration 206 Haymarket Station Train Shed, Bo'ness Heritage Area, Falkirk (1840) Cantilever steel columns attached to the existing frame at eaves level cater for higher side wind forces than in Edinburgh (Picture: T. Swailes)*

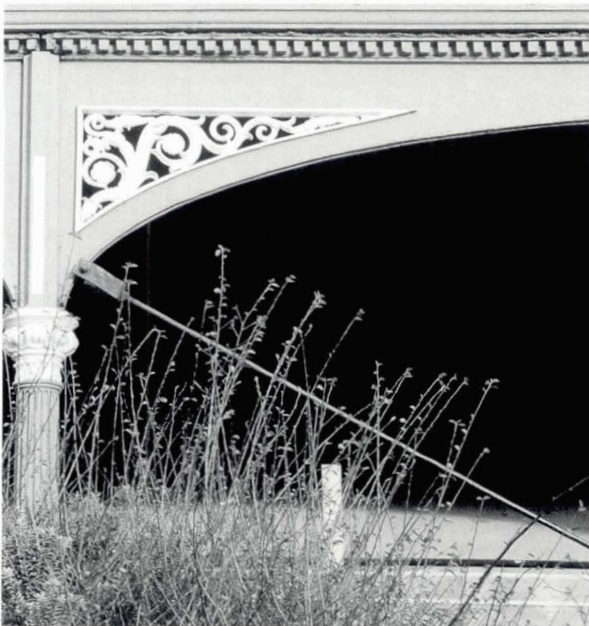
*Illustration 207 Haymarket Station Train Shed, Bo'ness Heritage Area, Falkirk (1840) Diagonal bracing to cater for higher longitudinal wind forces (Picture: T. Swailes)*

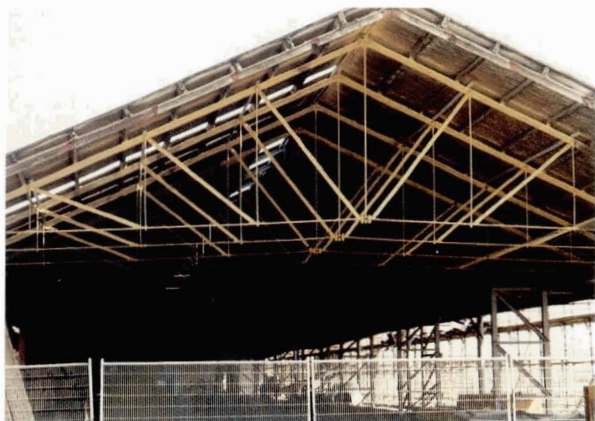
*Illustration 208 Dockyard Transit Shed, Victoria Dock, Dundee (1874) Braced iron frames are visible at intervals along the length of the building. They support a horizontal structural steelwork wind girder at ceiling level, providing a calculable level of safety. (Picture: Mark Watson, Historic Scotland)*

Dockyard transit sheds similar in cross-section to the Haymarket Railway Station train shed were probably less vulnerable to wind damage as their doors could be closed during severe storms. Structural engineering calculations may indicate that such structures have inadequate resistance to crosswinds, contrary to the evidence of satisfactory performance over many years. However, where refurbishment provides an opportunity to introduce additional bracing in a discreet manner, it may be acceptable (Illustration 208).

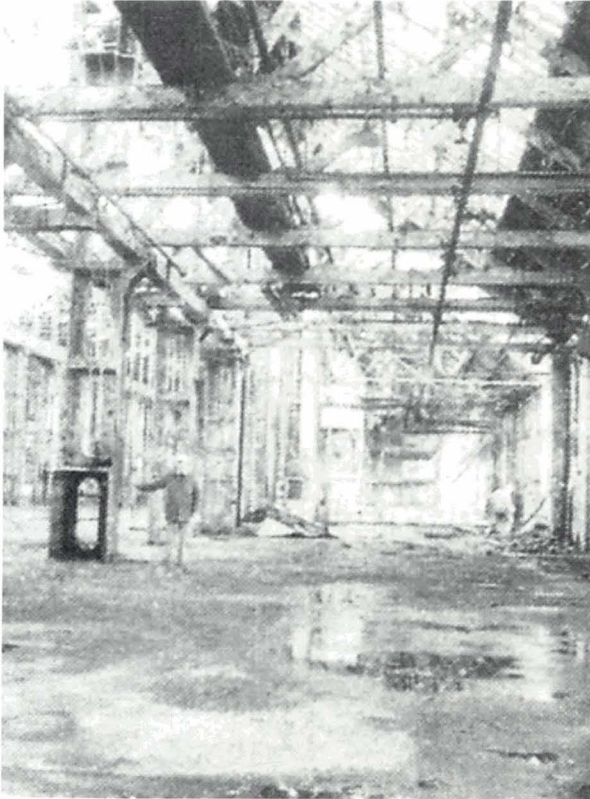
*Illustration 209 Linthouse Marine Engine Works, Scottish Maritime Museum, Irvine (1872)*

*Relocated from Alexander Stephen's yard on the Clyde in the early 1990s. Through portal frame type action, side aisles help the tall structure withstand cross winds.*

*Occasional column bays are cross-braced in the longitudinal direction. These braced bays transfer wind forces normal to the gables to foundation level, as the I-section stanchions would be unable to do so as cantilevers bending about their weaker axis. (Source: The Scottish Maritime Museum)*

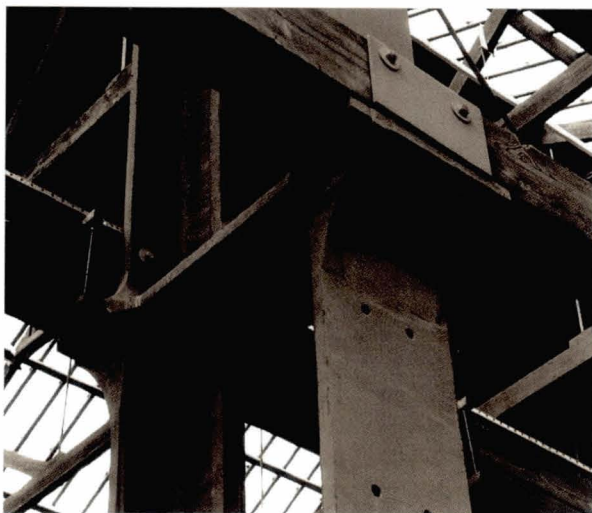
*Illustration 210 Linthouse Marine Engine Works, Scottish Maritime Museum, Irvine (1872) Cast iron stanchion detail (Picture: T. Swailes)*

The Linthouse Engine Shop, now at the Irvine Maritime Museum, is well thought out in structural terms. Massive cast iron I-section stanchions with large bases are a characteristic feature of this type of building. They support heavy loads from overhead travelling cranes and also provide lateral stability in the plane of the structural framing (Illustrations 209 and 210). Buildings that followed the pattern established for the Great Exhibition of 1851 also have a central hall, but with two-storey galleried side aisles. Knee braces are used extensively in the framing of Glasgow's Old Fruitmarket to stiffen the beam-column joints in both the transverse and longitudinal directions (see Illustrations 13 and 14). Where stability is provided by portal frame action, avoiding diagonal cross-bracing, realistic modelling of the joints for assessment by structural calculation is likely to be rather difficult.

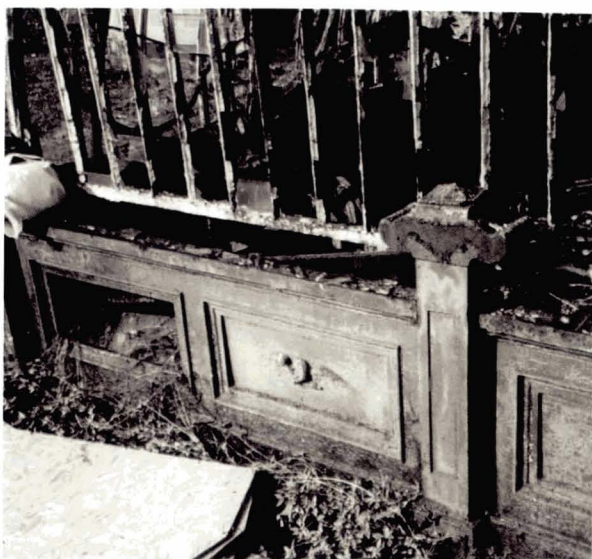
Illustration 215 Fairfield House conservatory, Dalkeith (c.1835) Ironwork detail, prior to restoration (Picture: Heritage Engineering, The Industrial Heritage Company Ltd)

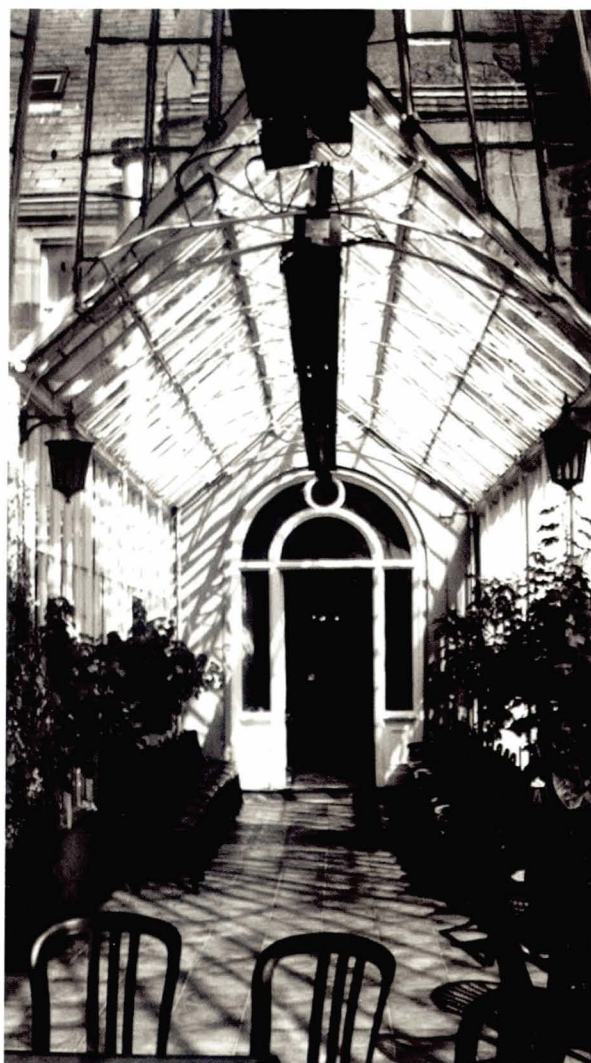
Illustration 217 Kingsknowe Hotel, Galashiels (1868): Conservatory Link passage to the hotel (Picture: T. Swailes)

Eaves spread may be resisted by tying or trussing, though such arrangements may sometimes appear to be more decorative than structurally efficient. A good example is the passage linking the Kingsknowe Hotel to its conservatory (Illustrations 217 to 220). Domes usually have a perimeter tie or ring beam that prevents eaves spread. Bar or angle iron purlins, supported on principal ribs, may serve as ring ties at higher level. The main dome to Glasgow's Kibble Palace has a series of concentrically placed tie bars between the glazing bars, up the roof slope (see Illustrations 143 and 153). Lateral stability may be enhanced in rather complex ways by abutting structures or decorative features (Illustrations 221 and 222).

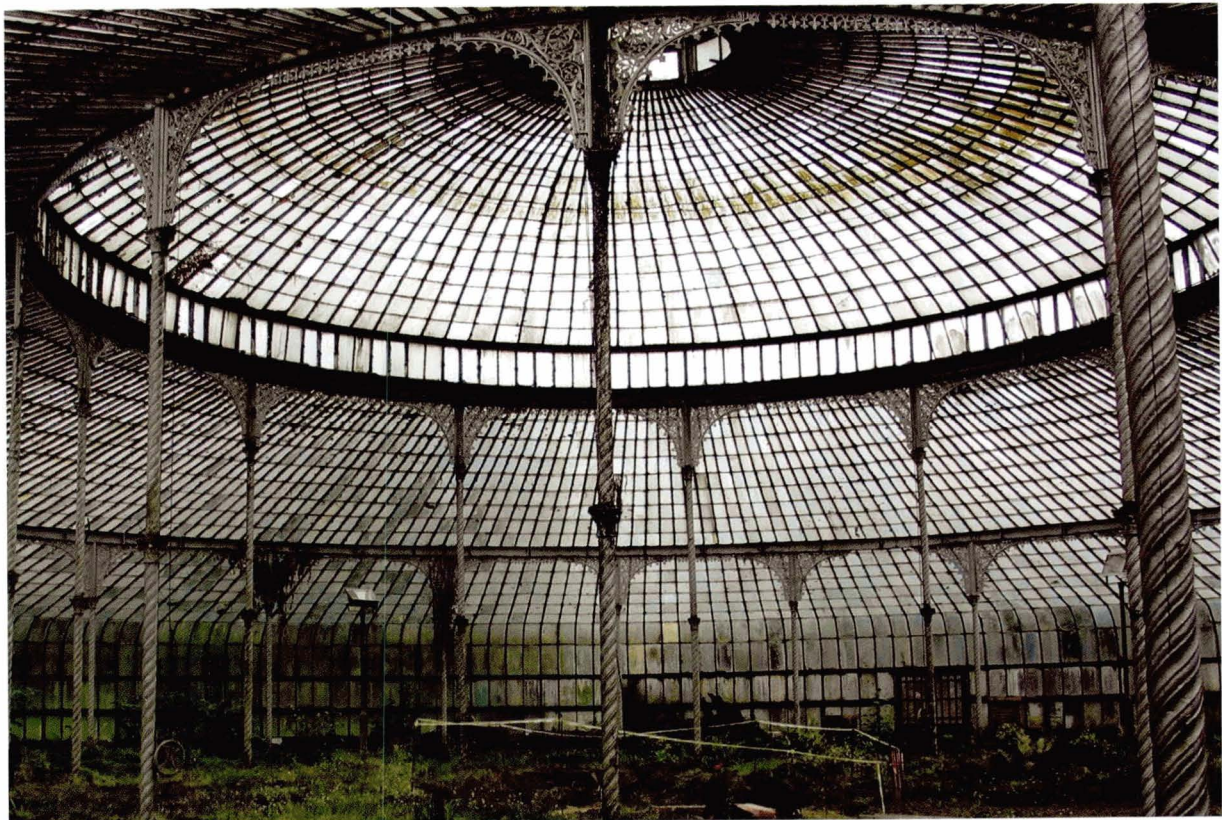
*Illustration 222 The Kibble Palace, The Botanic Gardens, Glasgow (1873) (Picture: David Mitchell, Historic Scotland)  
Cast iron columns, with standard braced support a ring beam beneath the clerestorey*

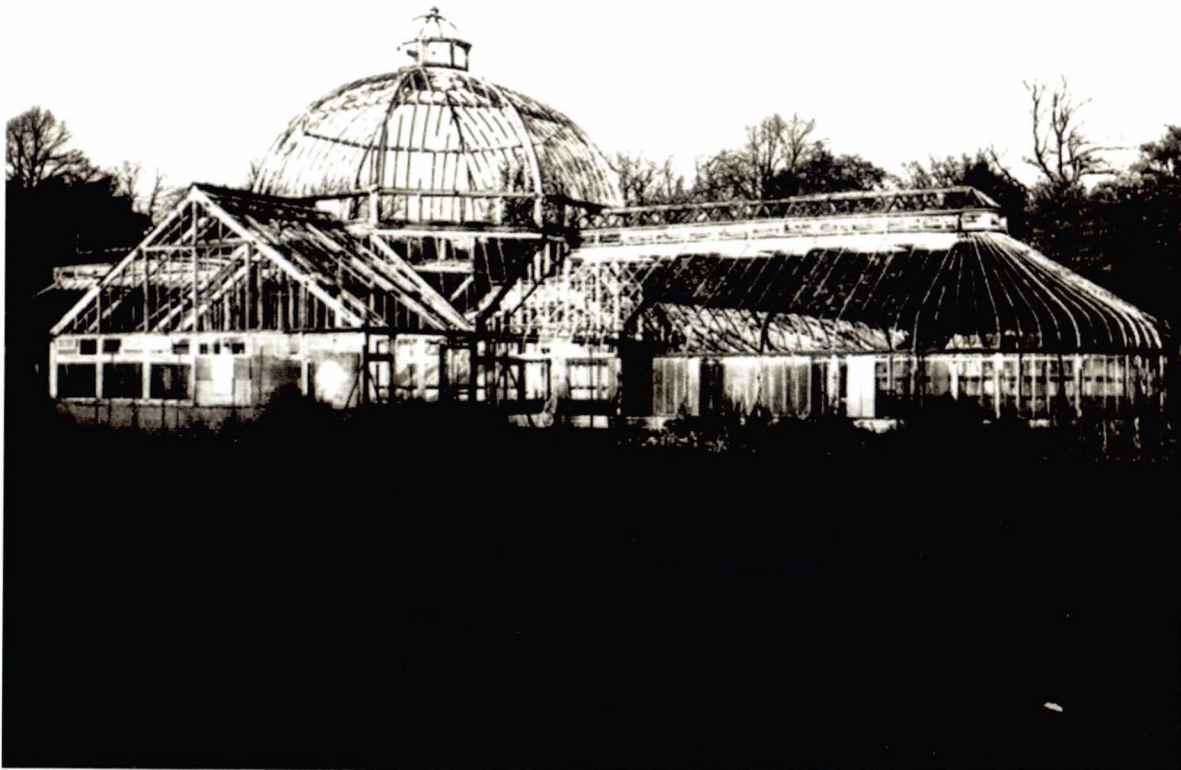
*Illustration 223 Tollcross Winter Garden, Tollcross Park, Glasgow (1858)*

*The derelict structure before renovation, with glazing removed and security fencing in place to discourage unauthorised access to the building. (Picture: T. Swailes)*

the in-plane resistance of the glazed surfaces. The glass should be removed from a large conservatory which is out of use or becoming derelict, where falling glass is a danger to passers-by. All glass removed should be kept safe until such time as it can be re-used. Temporary bracing may be needed to ensure the stability of the bare iron frame. A structure weakened by partial removal or loss of glazing can offer considerable resistance to the wind and be susceptible to storm damage. (Illustration 223).

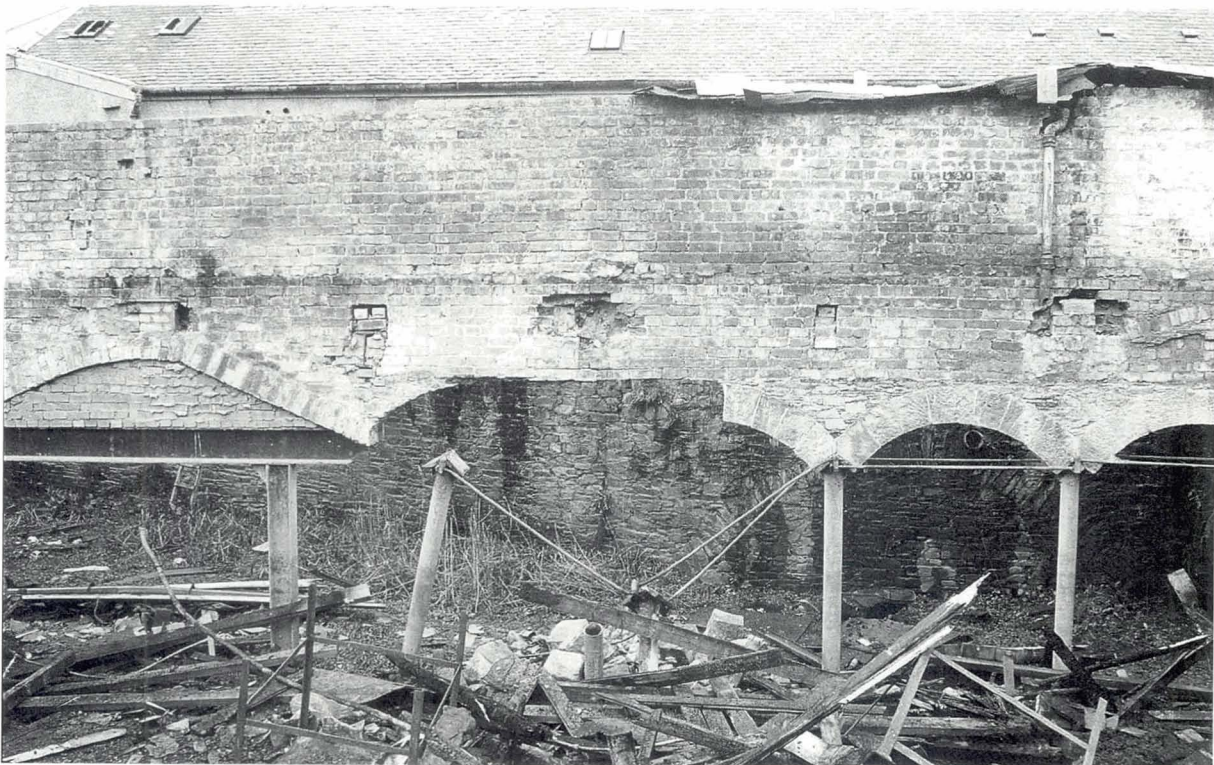
Illustration 227 Weensland Mill, Hawick (1850) After partial demolition of the remains of the burnt out mill, a masonry wall bridges over two fallen supporting columns (Picture: T. Swales)

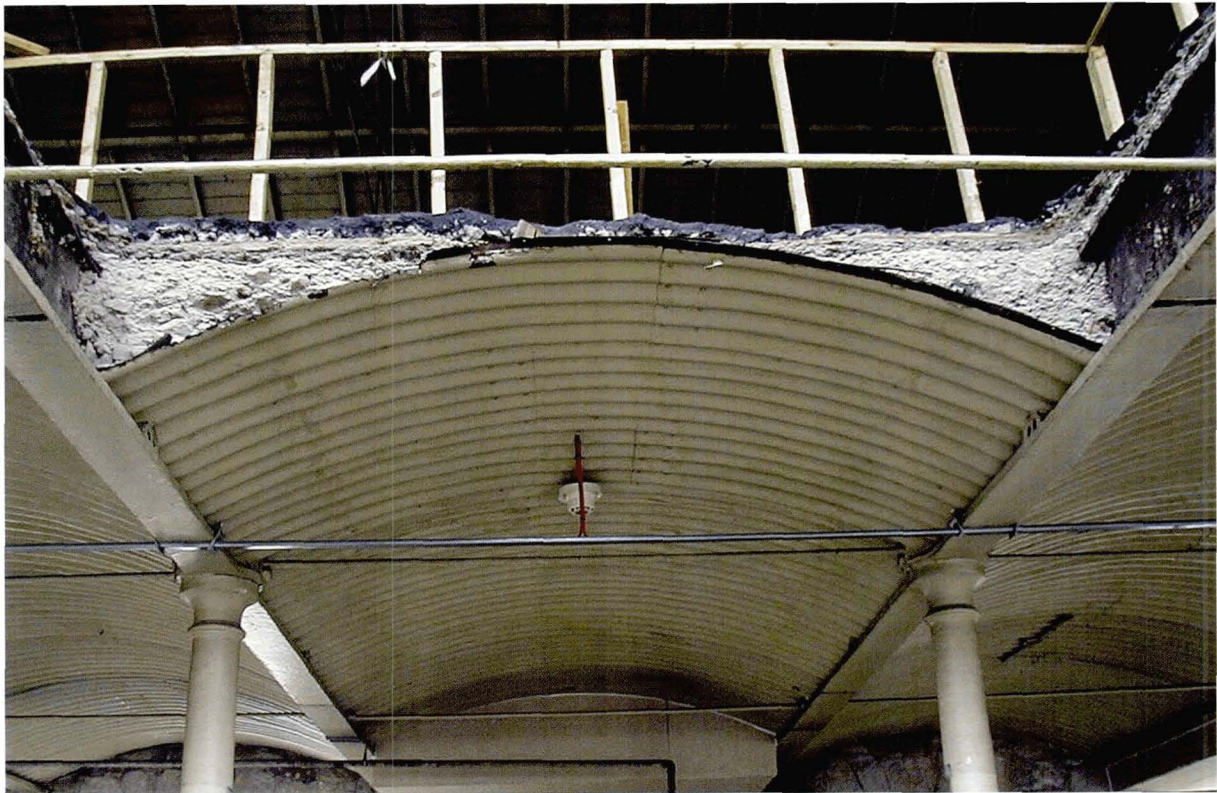
*Illustration 231 The Great Eastern Hotel (Alexander's Mill), Duke Street, Glasgow (1848) Floor Details*  
Corrugated iron to the floor arches has the corrugations running in a perpendicular direction to Naysmith's patent illustration. The relatively small sheets, which must have been curved in the rolls in the direction of the corrugations prior to delivery to site, have carefully riveted side and end laps. The binder in the arch concrete appears to be gypsum rather than Portland cement. (Picture: Mark Watson, Historic Scotland)

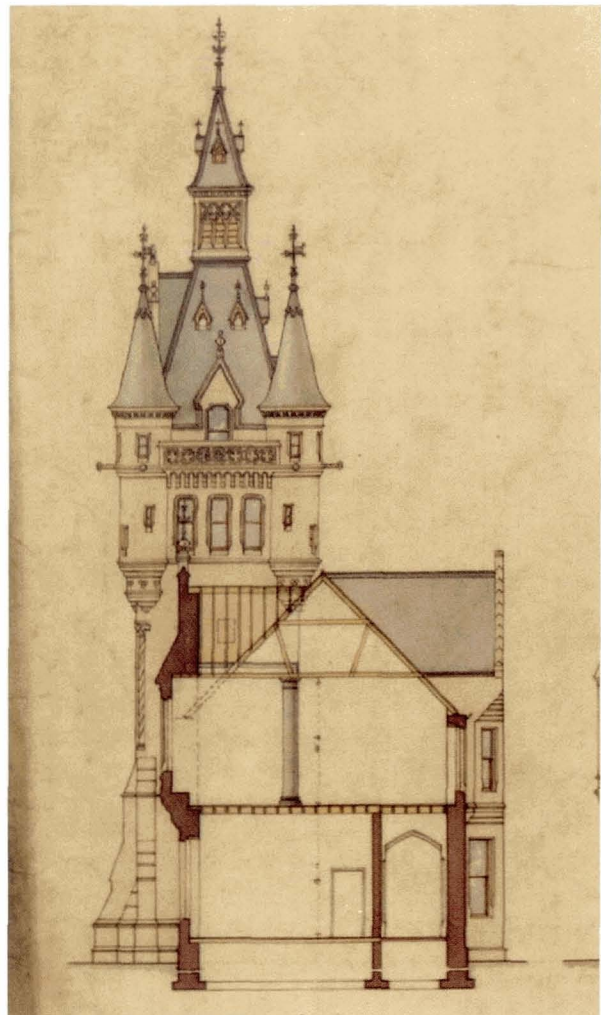
Illustration 239 Morgan Academy, Dundee (1868) Peddie & Kinnear Drawing extract (Reproduced courtesy of RCAHMS (Dick Peddie and McKay Collection))

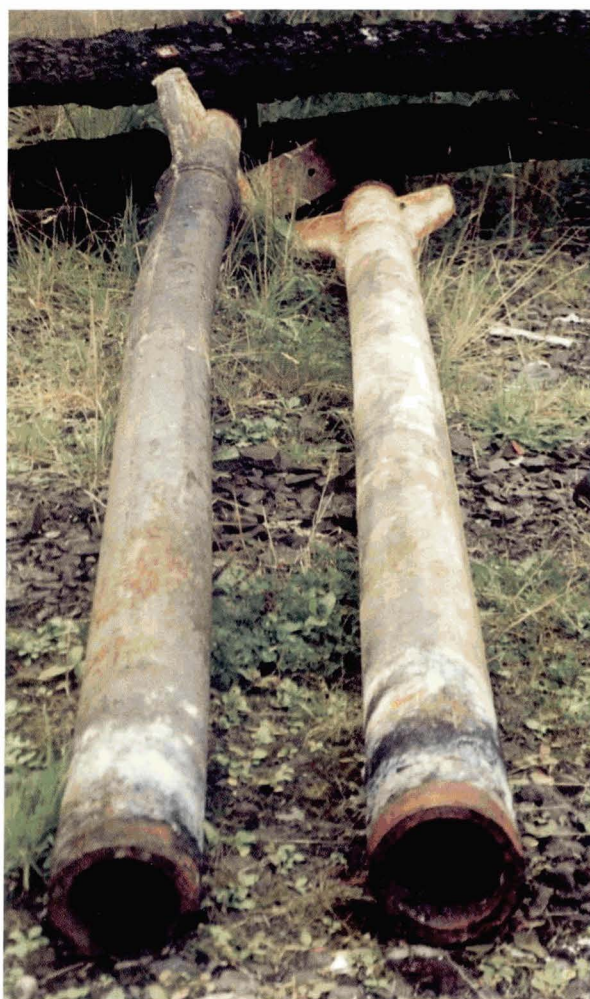
Illustration 242 Stanley Mills. Cast iron column bent in fire  
(Picture: T. Swailes)

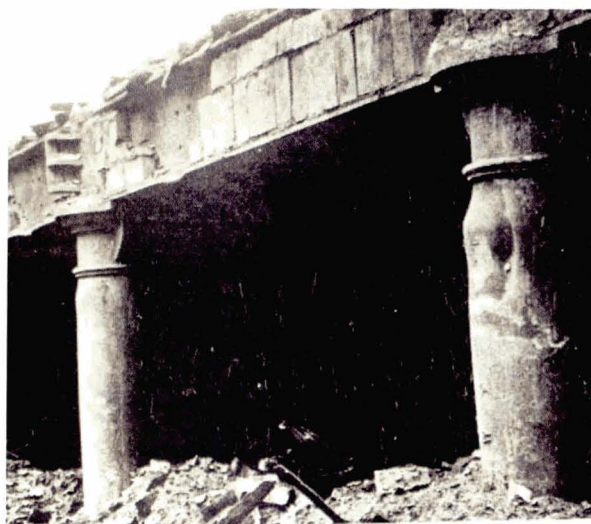
Illustration 243 Local bulging at the tops of cast iron columns as the results of high temperatures reached during a particularly severe fire (Kirby, 1986)  
(Picture: Mr. C. Ashton, reproduced by permission of Corus (UK) Ltd)

At a temperature of 600°C, cast iron loses about half its strength and the length of a 4m long beam of cast iron (or wrought iron or steel) would increase by about 25mm. Even though an individual beam may possess good fire resistance in itself, it is necessary to consider how the various parts of a building structure interact during a fire. There are many unknowns. For example, what forces are exerted on the supports of a beam, as they tend to restrain its thermal expansion? One conclusion of studies for the Greater London Council in the 1980s was that there was no realistic alternative to fire protection of cast iron elements in buildings in which there is a significant fire load, such as shops and offices, hotel bedrooms and domestic dwellings.

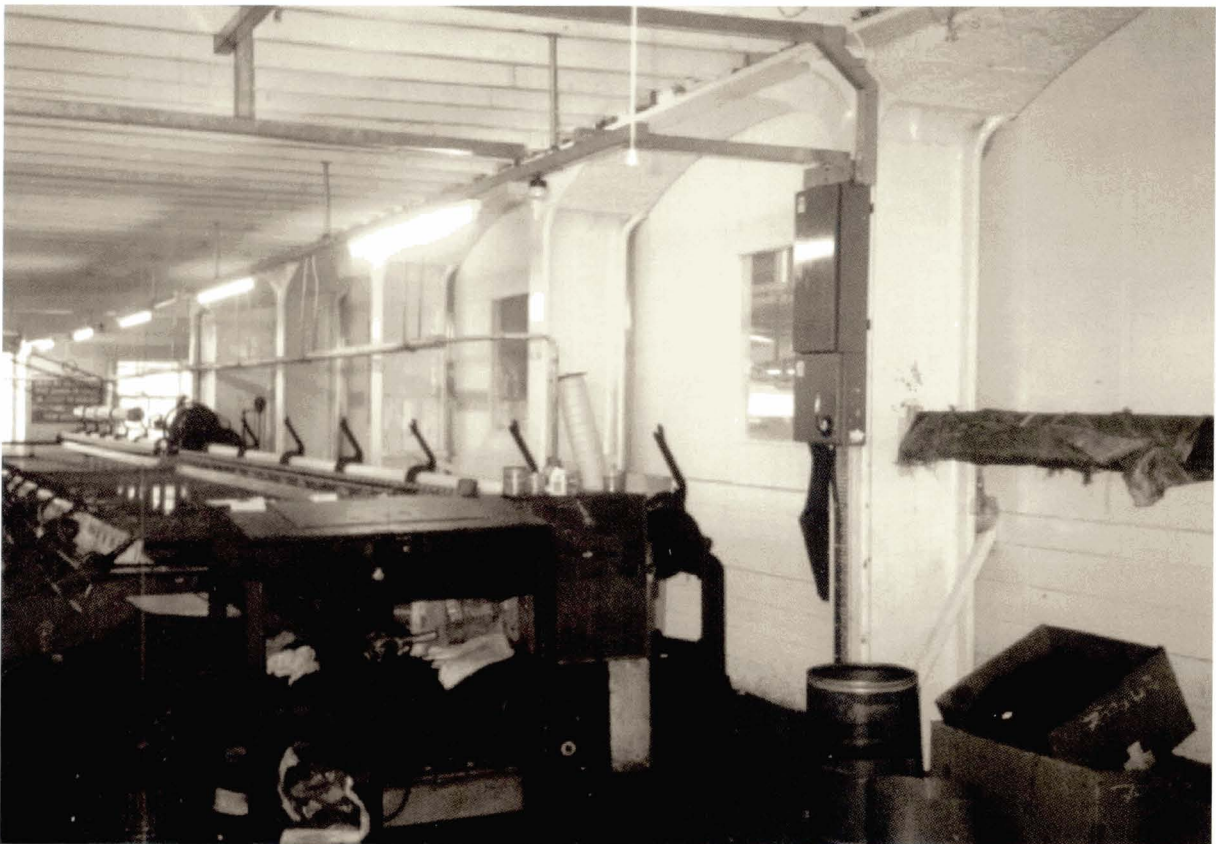
*Illustration 245 Weensland Mill, Hawick (1850) Heavy I-section columns supporting stone masonry arches  
Spinning mules stand in the foreground of this photograph, taken in 1989. (Picture: Mark Watson, Historic Scotland)*

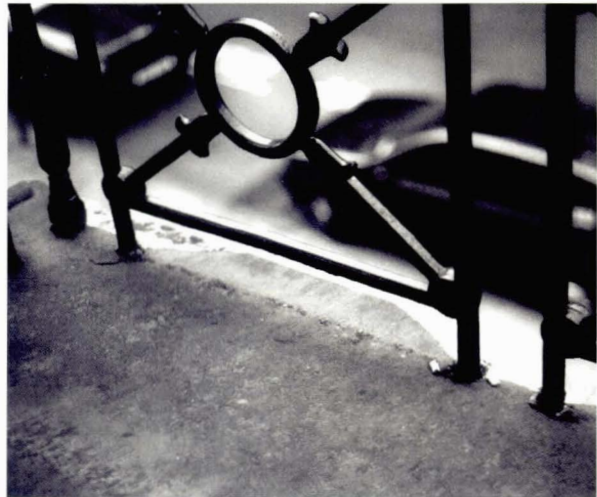
*Illustration 247 Spalling and (structural?) repair of stone balcony slab, caused by expansion (thermal or corrosion related?) of inset cast iron railings (Picture: T. Swailes)*

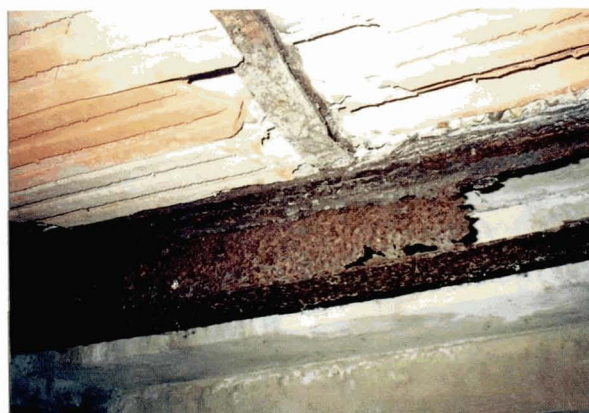
*Illustration 249 Beam web loss due to corrosion  
A patent block floor over a neglected basement, supported  
(just) by a severely corroded wrought iron or steel beam.  
(Picture: Joe Marsh)*

conservation should not be considered in isolation. The neglect or inappropriate treatment of one part of a building often leads to the deterioration of other parts. Putting off apparently trivial regular maintenance tasks can lead to unnecessary repair works that have a cost out of proportion to their cause (Illustration 248). Once damage has been caused to masonry it may be extremely difficult to repair in a satisfactory manner (Illustration 247). Basements and covered light wells should not be neglected, as they can provide environments where corrosion can progress unseen, to a point where structural safety is compromised (Illustration 249).

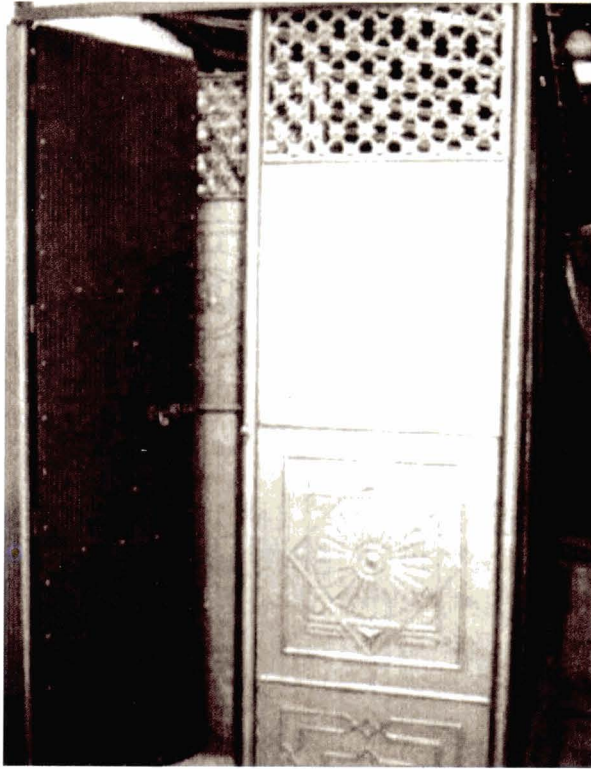
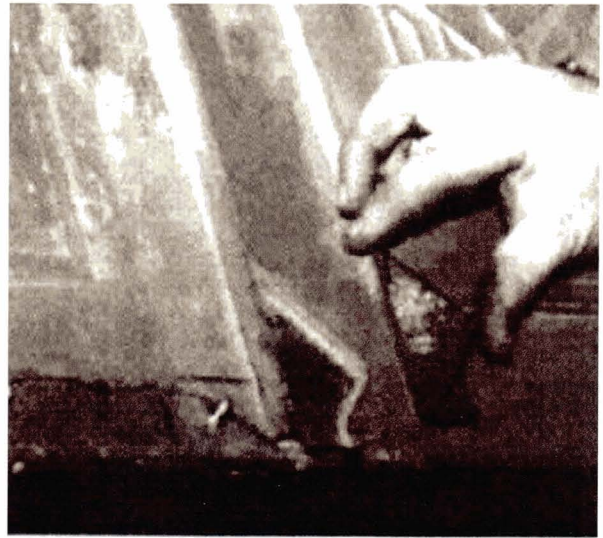
*An unusual conservation project: a gentleman's toilet in central London, made of cast iron panels only 6mm thick. Conservation work included a broken panel which was repaired by bolting to backing plate of galvanised steel 2mm thick bedded on resin and sealed round. If such a thin plate of cast iron had been welded, it would have cracked repeatedly: welding is not recommended for thin sections.*

*Illustration 253 Cold repair and reinforcement by plating  
A broken decorative cast iron panel reinforced with a stainless steel backing plate.  
(Picture: Dorothea Restorations Ltd)*

Mechanical cold repairs to castings involve the limited removal of some original material. Where additional strength is required, one solution is to bolt on additional material to make a sufficiently robust repair (Illustration 253). Decorative cast iron panels, probably too thin to weld, have been successfully repaired by bolting 2mm thick galvanised steel backing plates to

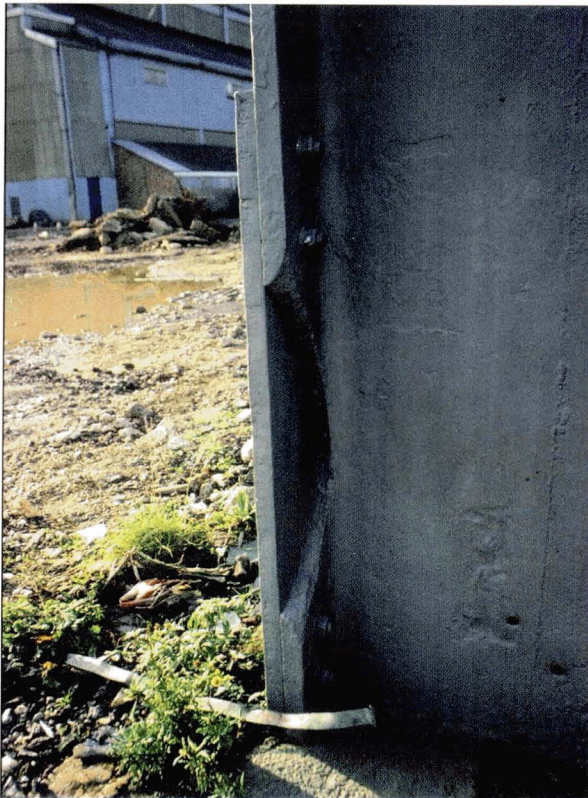
*Illustration 254 Cold repair and reinforcement by plating  
Old repair to damaged cast iron I-section stanchion  
(Picture: Michael Bussell)*

their plain inside faces. The reinforcing plates were bedded in resin and sealed round. Aesthetics were not generally considered in past repairs to industrial structures, but such past repairs should be left as found where possible (Illustrations 254 and 255).

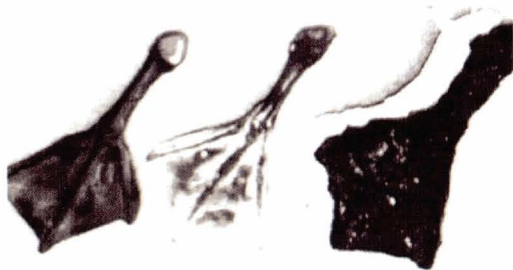
*Illustration 260 Replication of missing cast iron fragments using a 'pattern' of vinyl rubber backed with plaster (Picture: Dorothea Restorations Ltd)*

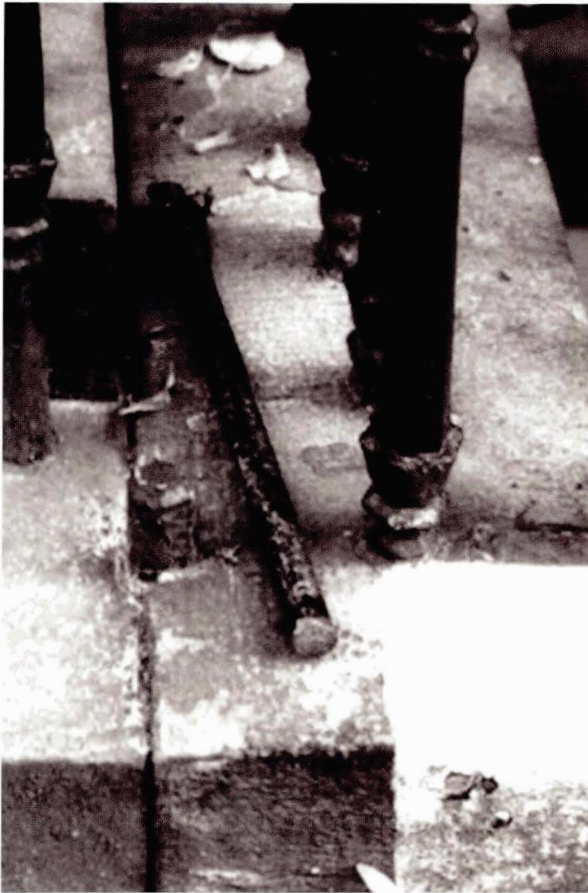
Illustration 262 Broken cast iron railings  
(Picture: T. Swailes)

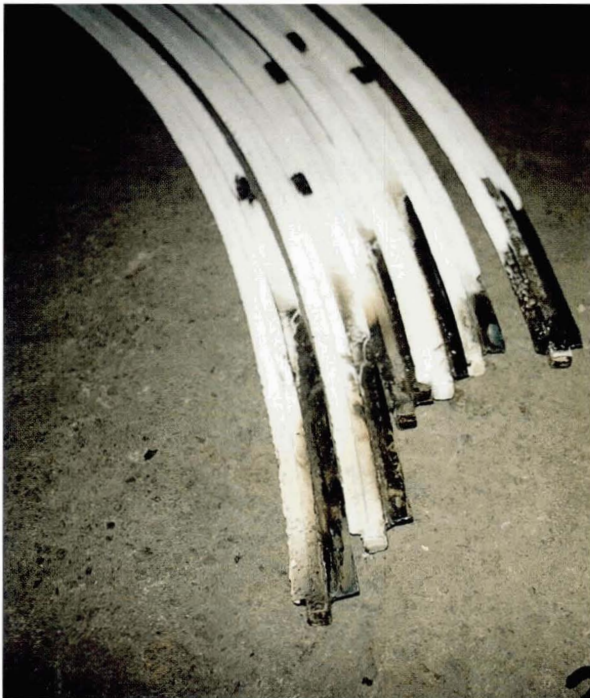
Illustration 263 Welded repairs to wrought iron glazing bar ends  
(Picture: Heritage Engineering Ltd)

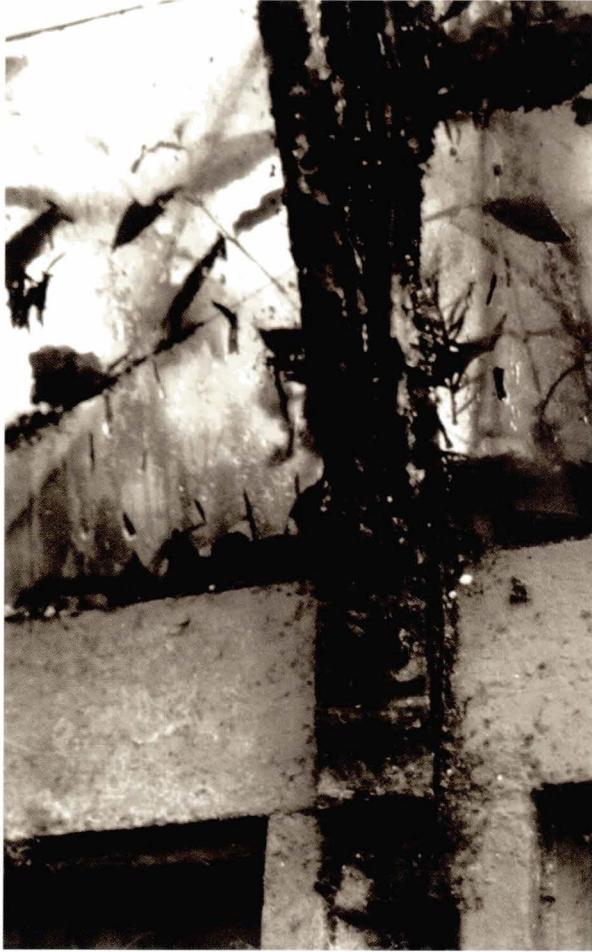
*Illustration 265 Skelmorlie Castle, Largs: garden conservatory (c.1860) Severe corrosion at the lower bearing of a wrought iron rib. Note that the supporting cast iron member remains in good condition (Picture: T. Swailes)*

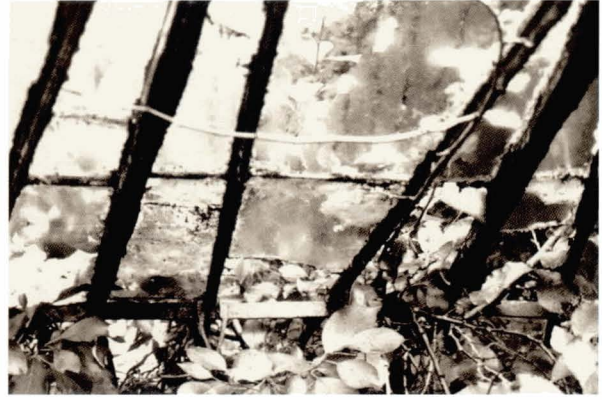
*Illustration 266 Skelmorlie Castle, Largs: garden conservatory (c.1860) Curved wrought iron ribs to the roof comprise strip riveted to the sides of rectangular bar, as a bearing for the glazing. With the glazing incomplete, the detail traps water (Picture: T. Swailes)*

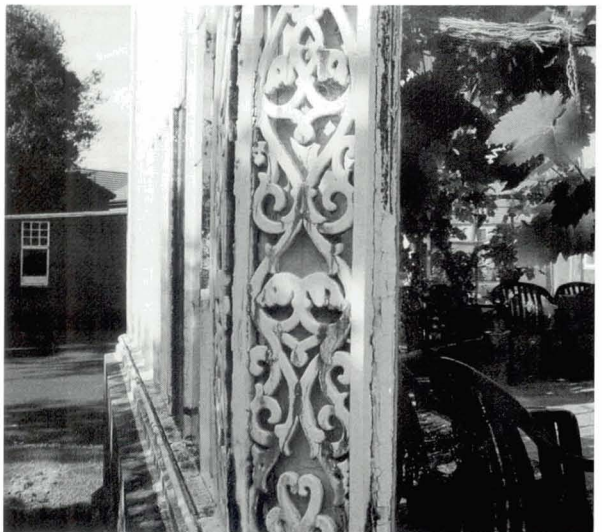
*Illustration 268 Kingsknowe Hotel conservatory Damage to cast iron facing panel. Water can penetrate to the rear face of the panel, which is inaccessible for cleaning and painting. Water ingress is also likely to lead to deterioration of the timber elements (Picture: T. Swailes)*

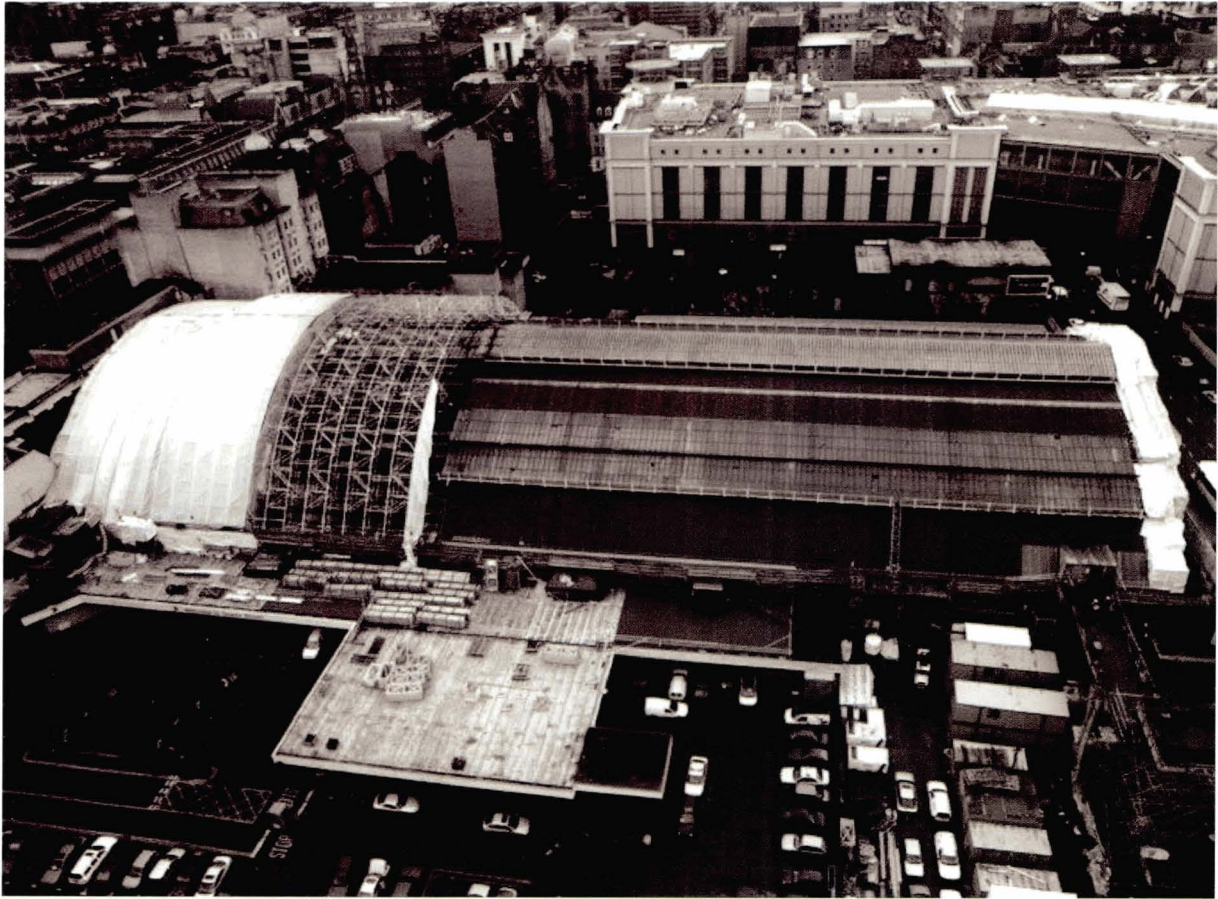
*Illustration 269 Queen Street Station, Glasgow: Main train shed roof (1880) The roof from above, the temporary covering and containment structure for removal of lead-based paints at one end. (Picture: Network Rail)*

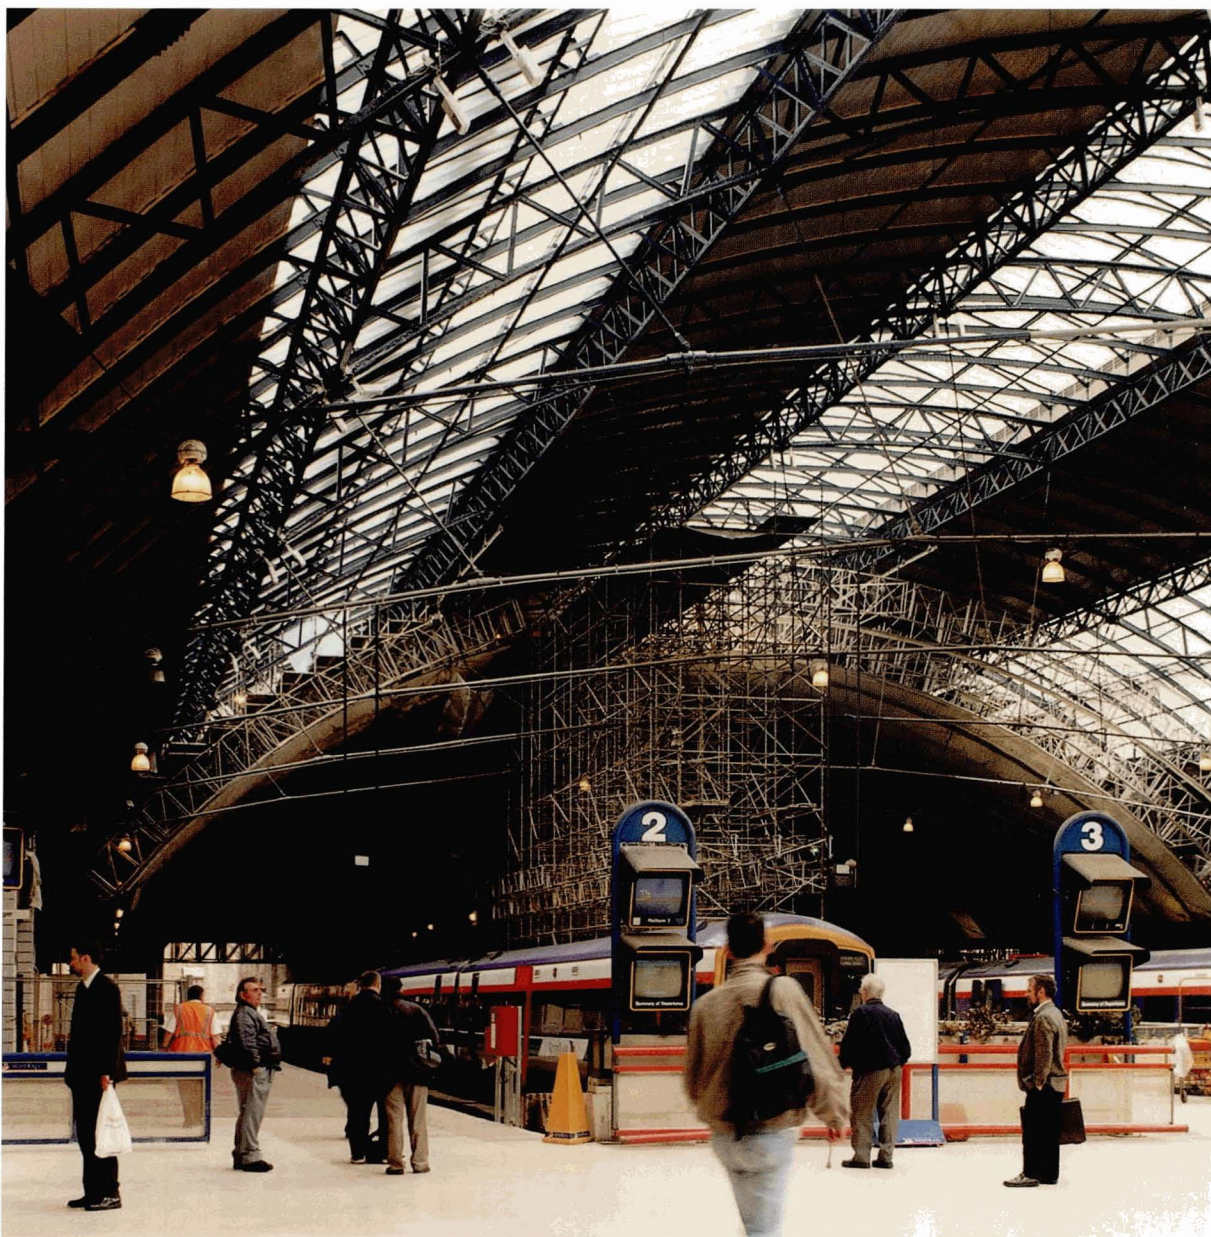
*Illustration 270 Queen Street Station, Glasgow: Main train shed roof (1880)  
Access maintained for railway passengers at platform level (Picture: Network Rail)*

Before privatisation, British Rail policy was to examine the condition of all its structures at six-yearly intervals. For a railway station roof this involved inspection from

platform level. Access provision for painting at twelve yearly intervals enabled closer inspection of less accessible areas (Connell, 1993). In such circumstances, where access for maintenance is difficult and expensive, a paint system with a long life to first maintenance will be appropriate.

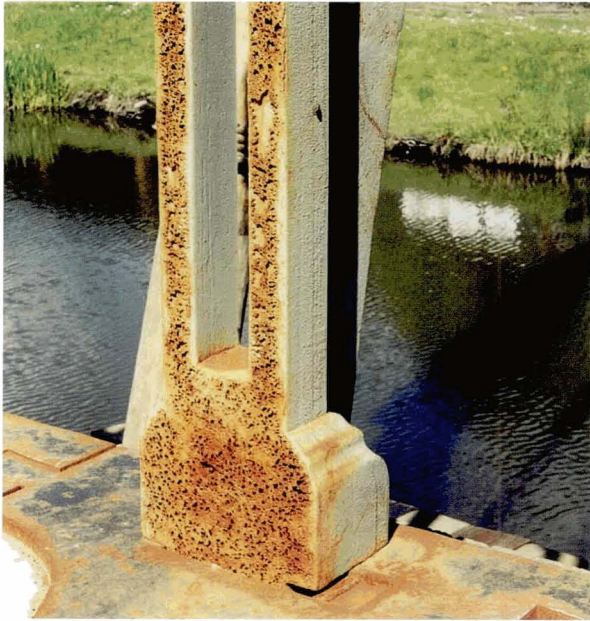
*Illustration 273 The Iron Bridge (copied at half-scale), Blist's Hill, Ironbridge, Coalbrookdale Uprights cast in 2001 by H Downs & Sons of Huddersfield. The honeycombing is the result of moulding in an open sand bed, in the manner of the originals. This may have been reduced by spreading loose sand over the top of the molten casting. (Picture: T. Swailes)*
