5  
GUIDE FOR  
PRACTITIONERS

SCOTTISH  
IRON  
STRUCTURES

TECHNICAL  
CONSERVATION,  
RESEARCH AND  
EDUCATION  
GROUP

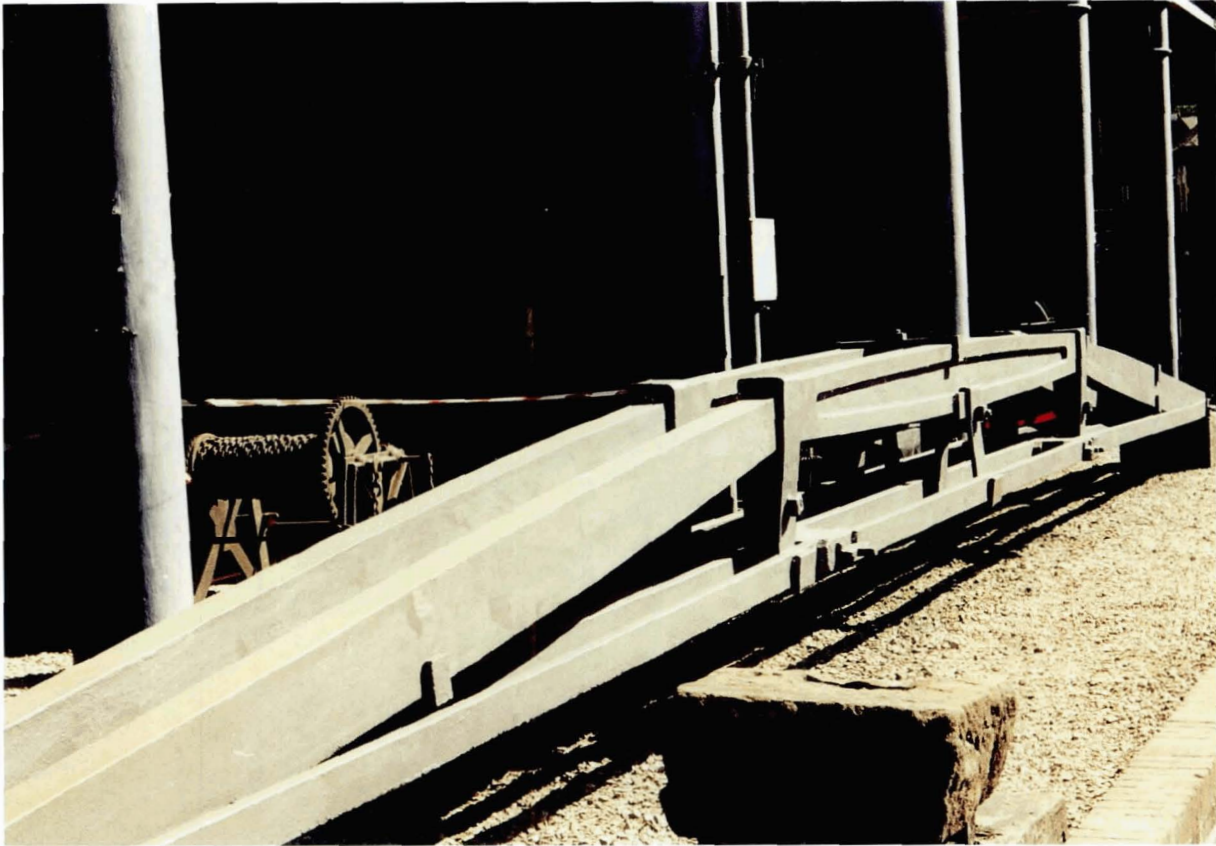
*Illustration 275 An iron truss of 44 feet span, from Goldsmith's Hall, City of London (c.1830) Relocated to Ironbridge Gorge Museum in 1990 The bottom tie bars are wrought iron and the upper members are cast iron. An ornate plaster ceiling was suspended below the truss, on wrought iron rods. The truss bears a close similarity to a design by Thomas Tredgold (Sutherland, 1979). (Picture: T. Swailes)*

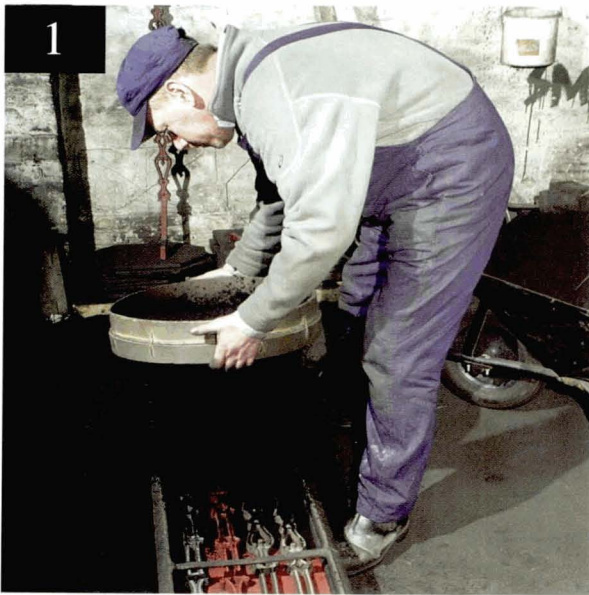
*Pattern laid on a wooden board and bottom box placed over. Sand sieved over patterns.*

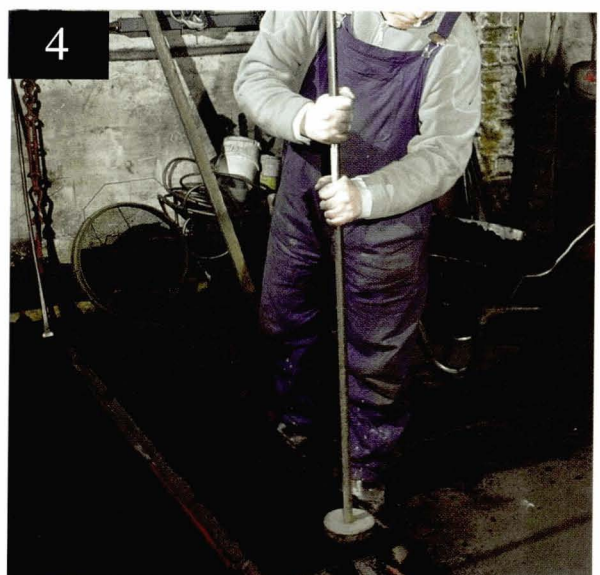
*Ramming within the "Peg Rammer", a plain bar, is followed by ramming with the "Dog Rammer" (as shown)*

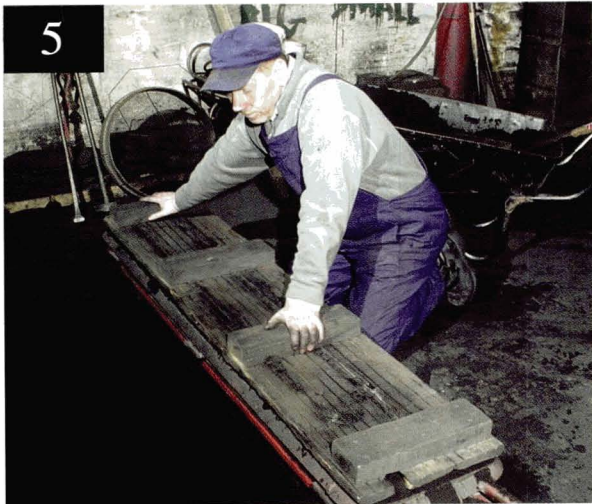
*A board is placed on top, prior to turning over*

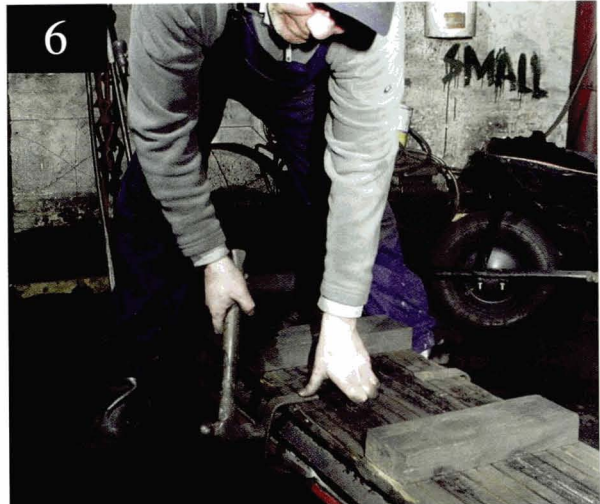
*Clamps are fixed, prior to turning over*

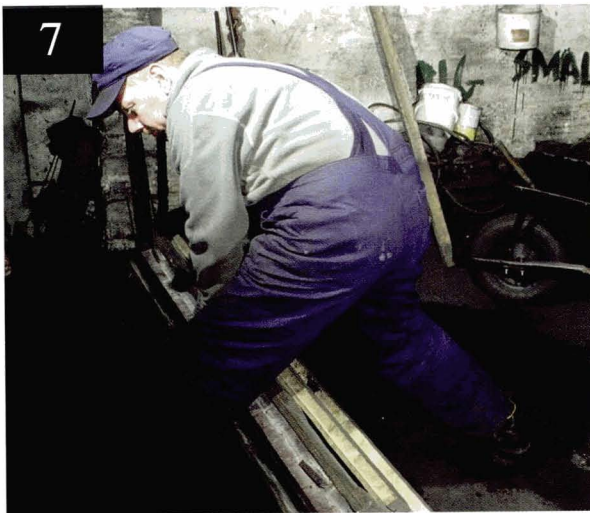
*Turning over*

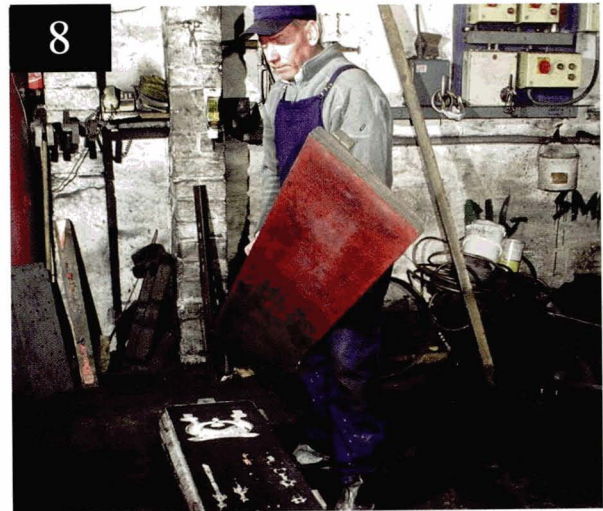
*The clamps and then the board are removed*

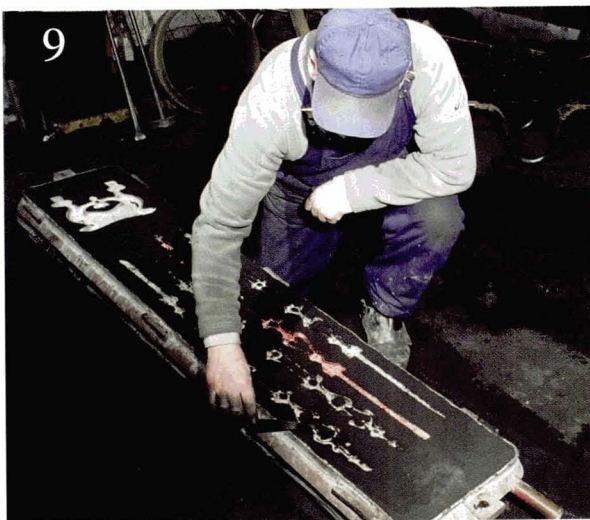
*Tidying up this surface and edge with a trowel*

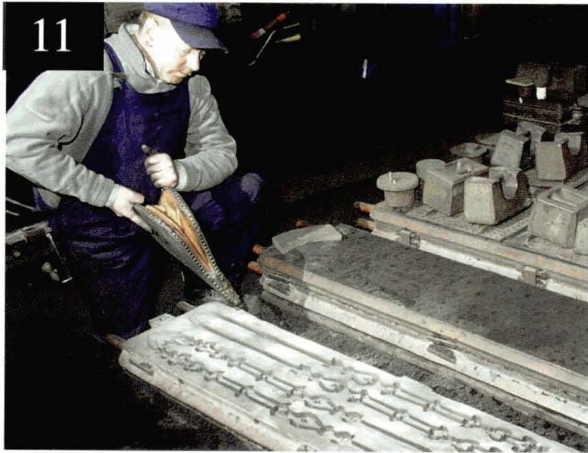
11  
*Patterns removed, sand dusted with parting powder and loose powder blown off with bellows. In the background, a mould with the top box in place, and others weighted down.*

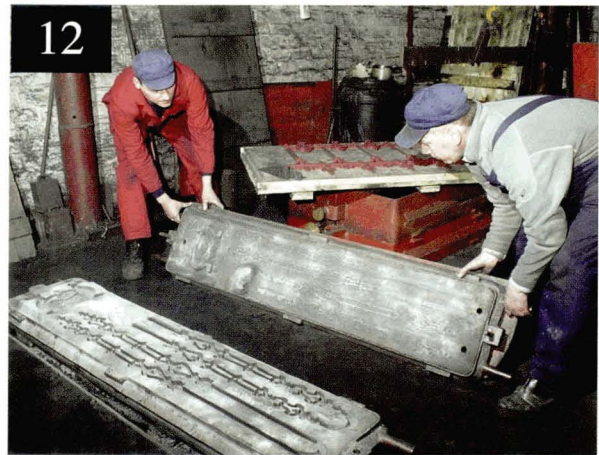
12  
*Placing the top box. Note the sand is level across the top box, and all the detail of the pattern is in the bottom box.*

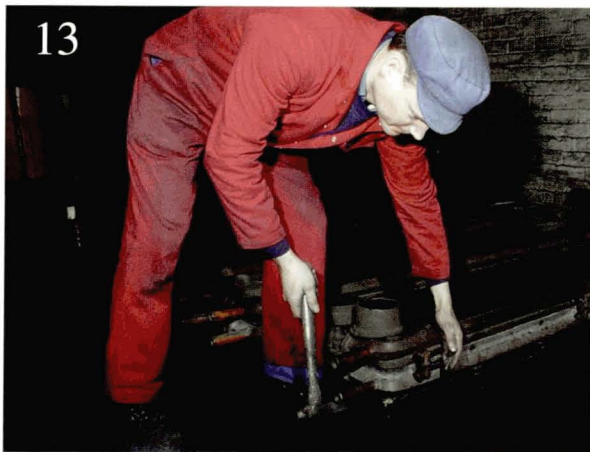
13  
*Fixing mould clamps. Note the "pouring bushes" or "slag traps" are now in place.*

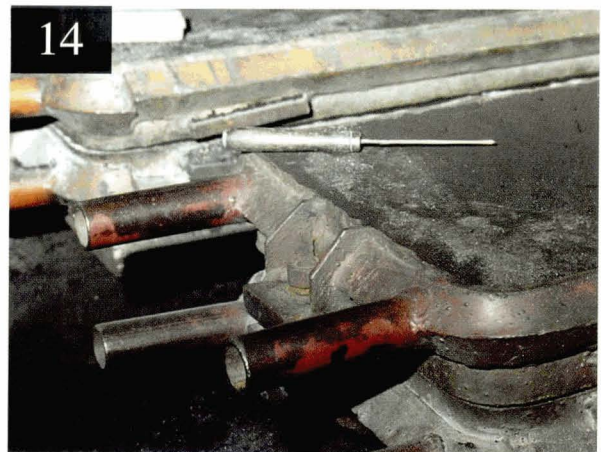
14  
*Mould box detail. Note the vent wire, used for perforating at the sand to aid release of mould slag.*

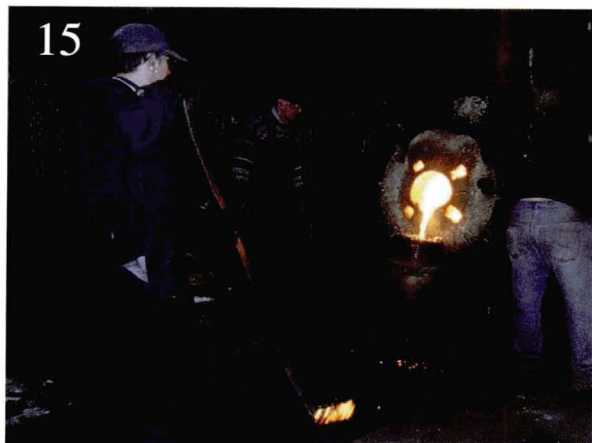
15  
*Filling the crucible from the furnace. "Slagit" (crushed sea shells) is sprinkled on top of the iron in the ladle to help fuse together the impurities which rise to the top.*

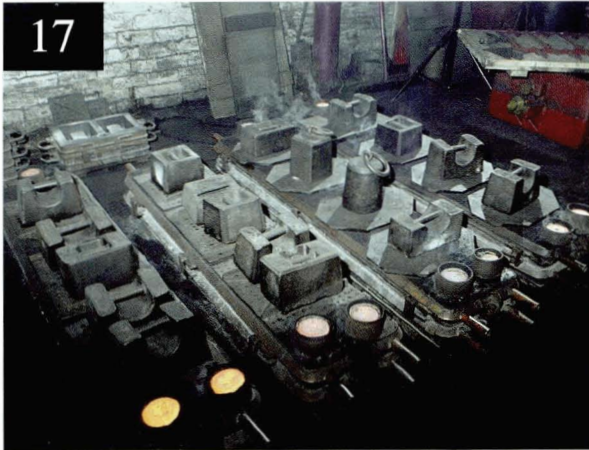
*Casting complete.*

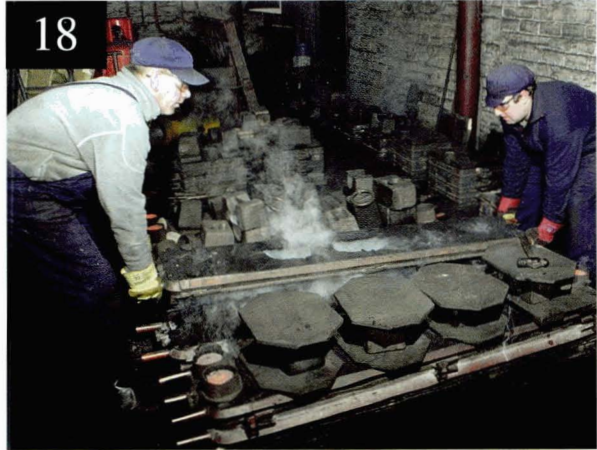
*Removing the top box about an hour later.*

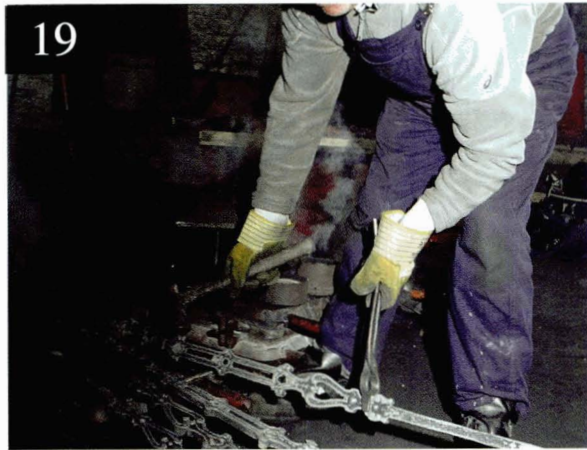
*Removing the balusters from the sand, ready for "fettling"*

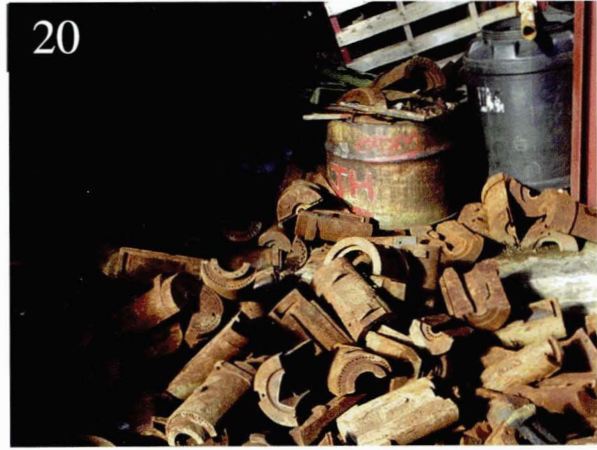
*Any defective castings are recycled. Other raw materials include bus engine block castings and bottle moulds.*
