# Scotstarvit Tower Cottage

A study of infrared electric heating installed in a refurbished 19th Century dwelling

**Historic Scotland Technical Paper 22**

**Research Report by Diane Hubbard**

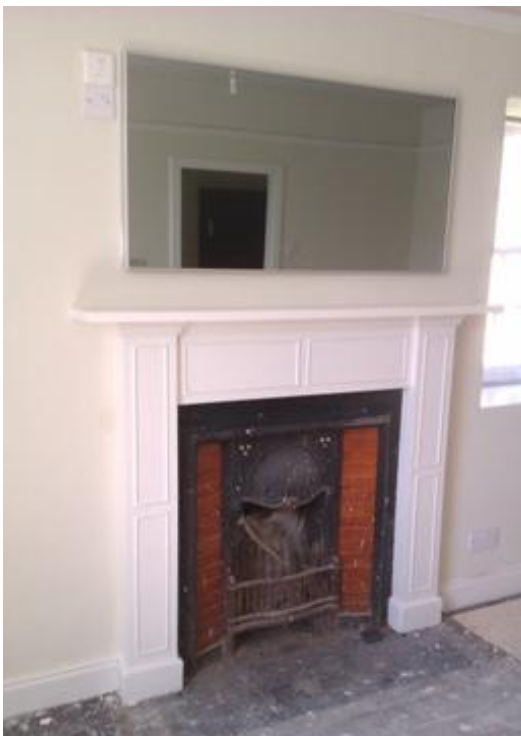
*Fig. 2 Radiant heaters installed in the living room (mirror finish)*

Radiant heating panels were installed mounted flat onto walls in the property (Fig. 1) at a variety of heights. These are detailed in Table 2. Initially a mirrored heater had been installed in the bathroom above the basin, but this proved unsatisfactory to the occupant and was replaced with a heater on the adjacent wall (as specified in the table). There was no heater fitted in the kitchen in the original installation, but subsequently a heater was installed on 4 March 2013. Radiant heating panels were either mirror or white finish (Fig. 2 and 3).

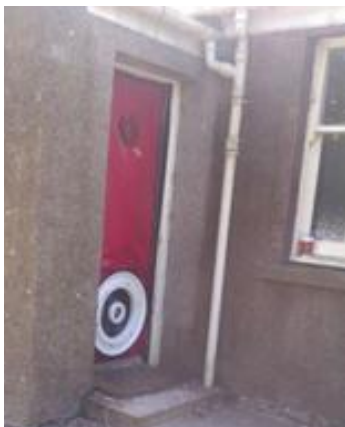
*Fig. 4 Blower door fitted to test for air-tightness*

Air permeability testing is a way of quantifying infiltration (or air tightness) and is established using a blower door (Fig. 4) which maintains a set pressure difference between inside the building and ambient pressure. Though air permeability testing does not fully represent the infiltration situation, it is the most favoured indicator for measuring it – reflected in the fact that there is a requirement for new buildings to be tested using this method. A further test has been carried out as part of this study in order to establish the final air tightness after final draught proofing. Thermal imaging has been used in conjunction with this technique and the following should be noted regarding the thermal imaging included in this report:

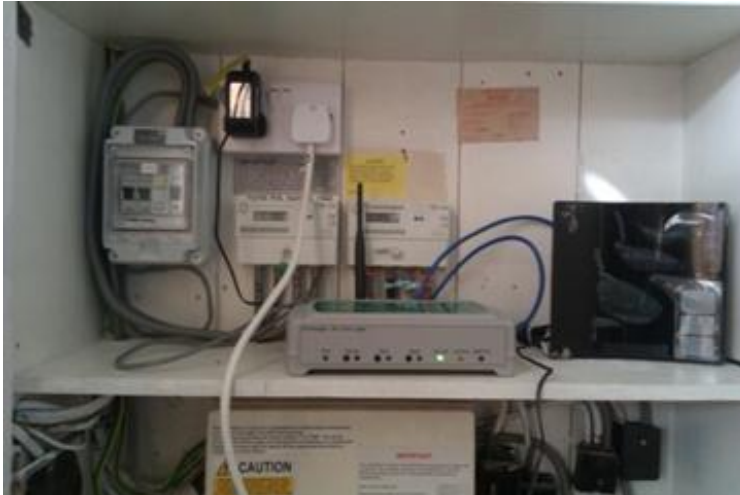
*Fig. 5 Monitoring equipment installed at Scotstarvit Tower Cottage. Web logger (with green light) and power meter above.*

- Power meter – taking its signal from the two separate circuits on which the radiant heaters are installed (Fig. 5)

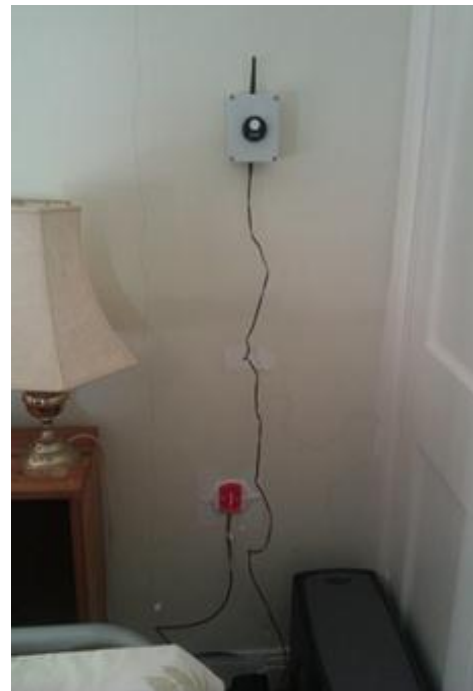
*Fig. 7 Monitoring equipment installed at Scotstarvit Tower Cottage. Internal CO<sub>2</sub>, temperature and RH sensors in living room. Note: red heat flux plate at base of this picture is not associated with this study.*

- External CO<sub>2</sub>, temperature and RH sensor, powered by PV panel feeding into battery (Fig. 6 and 7)
- Internal CO<sub>2</sub>, temperature and RH sensors for three rooms – living room, kitchen and bathroom (originally planned to have equipment in the main bedroom as well)
- Web logger to collect data and transmit intermittently using the existing broadband connection, for remote access to the collected data (Fig. 5).

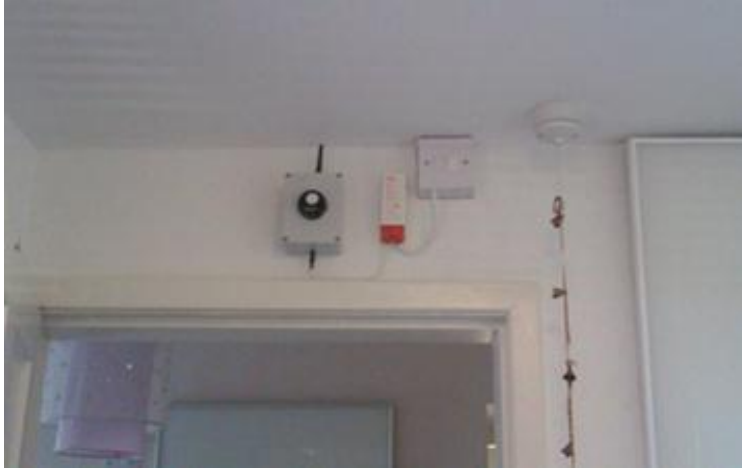
*Fig. 8* Location of sensor above door in the bathroom

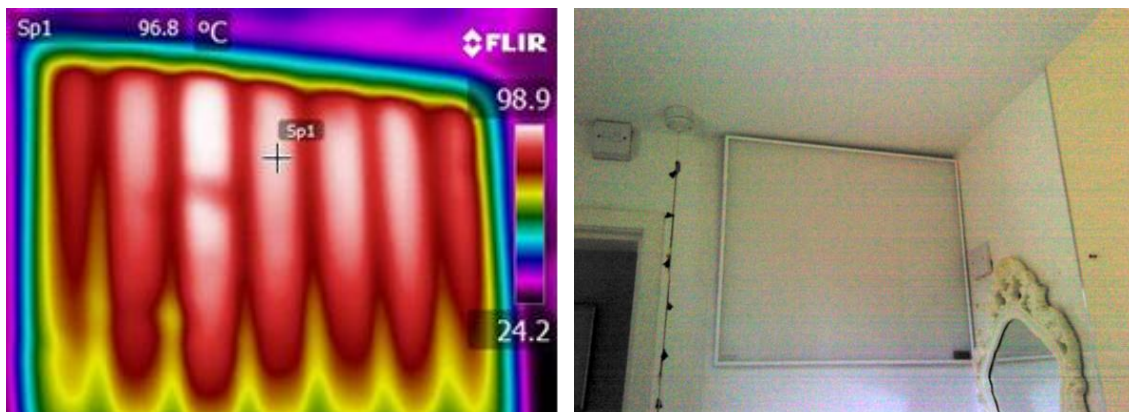
Fig. 10 Images of the heater in the bathroom

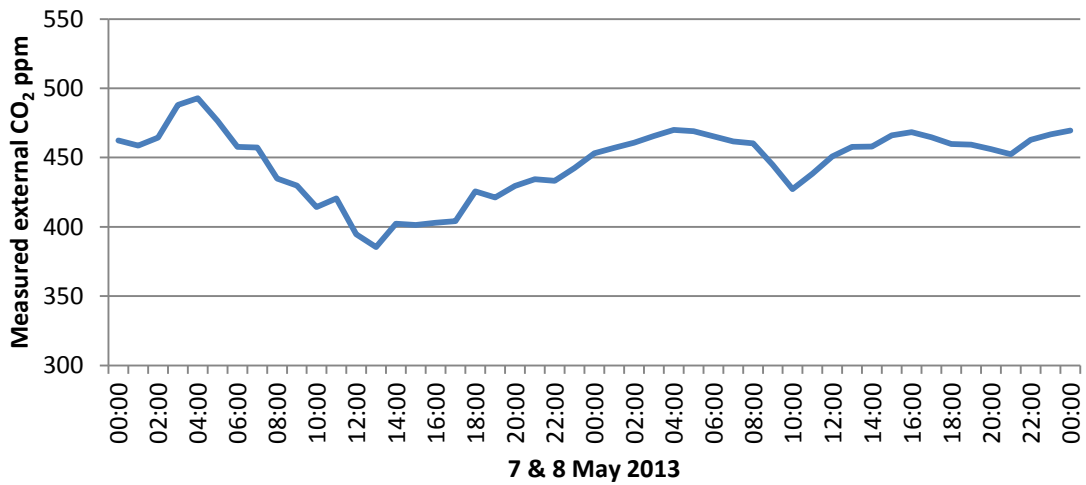
*Fig. 13 Measured external CO<sub>2</sub> levels over duration of project (top) and detailed variation over a 48 hour period compared to temperature (bottom)*

The level of CO<sub>2</sub> recorded in the external environment varies considerably (Fig. 13). Examining a 48 hour period, the variation appears to represent the level of respiration of the vegetation. The temperature graph also illustrates the issue of the screen not being wholly effective over shading the equipment from solar gain.

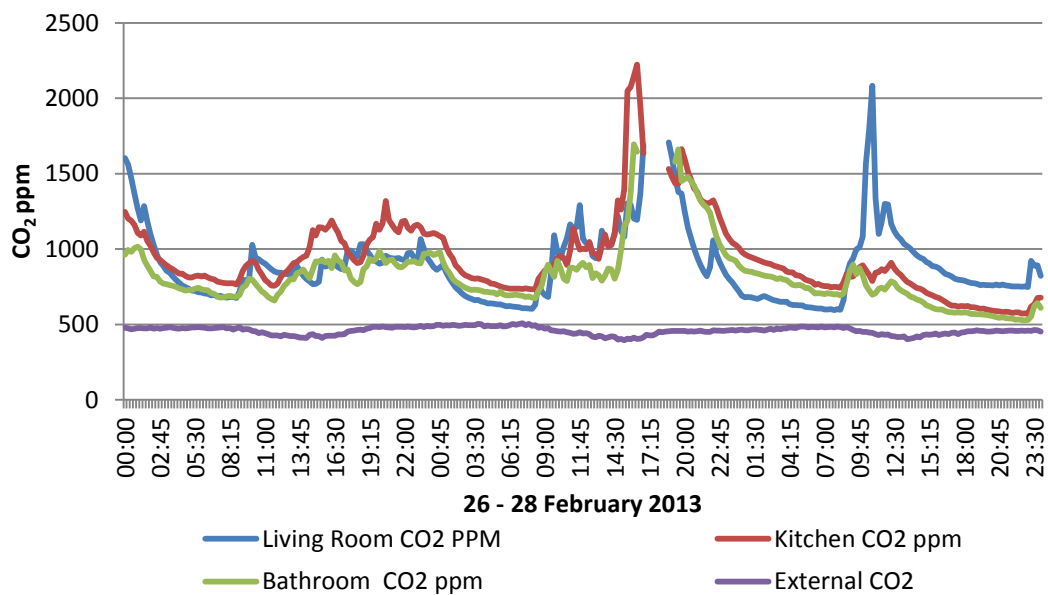
Fig. 16 CO<sub>2</sub> levels during 26-28 February 2013

In order to explore the effect of an increased level of activity in the property, one of the project visit days at the property has been examined. On 27 February visit, there were 4 additional people present for part of the afternoon. Fig. 16 shows the effect of the additional occupants on the CO<sub>2</sub> level, whilst an impact on RH is not seen (Fig. 17). The gap in the data in both graphs represents the period when the room sensors were taken outside for cross checking.

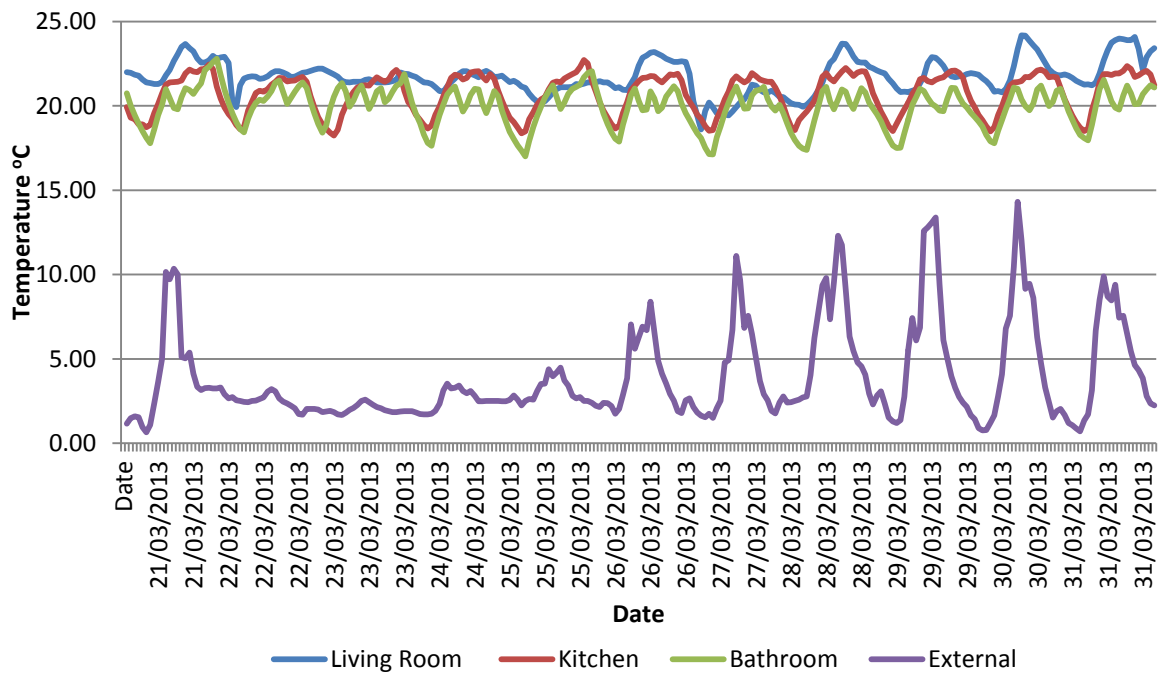
Fig. 19 Logged temperatures 21-31 March 2013 inclusive

During Heating Regime 4, the temperature was uniformly set to 18°C from 0745 until 2345 and set back to 16°C overnight. Fig. 19 shows the data recorded under this regime between 21 and 31 March, compared to the recorded external temperature. The pattern of the bathroom heater switching on and off in response to the thermostat is shown in Fig. 19. Due to the height of the sensor in the bathroom, the temperature recorded is expected to reach temperatures in excess of that set on the thermostat. However, this is not the case for the equipment in the living room or kitchen. The kitchen heater was installed before this period and unfortunately the sensor is in direct line of sight of the heater and will be receiving direct radiant gains, elevating the recorded temperature. With respect to the living room, the building occupant may have boosted the heating further, but this cannot be confirmed. In order to investigate further, a direct comparison was made and this is shown in Table 7.

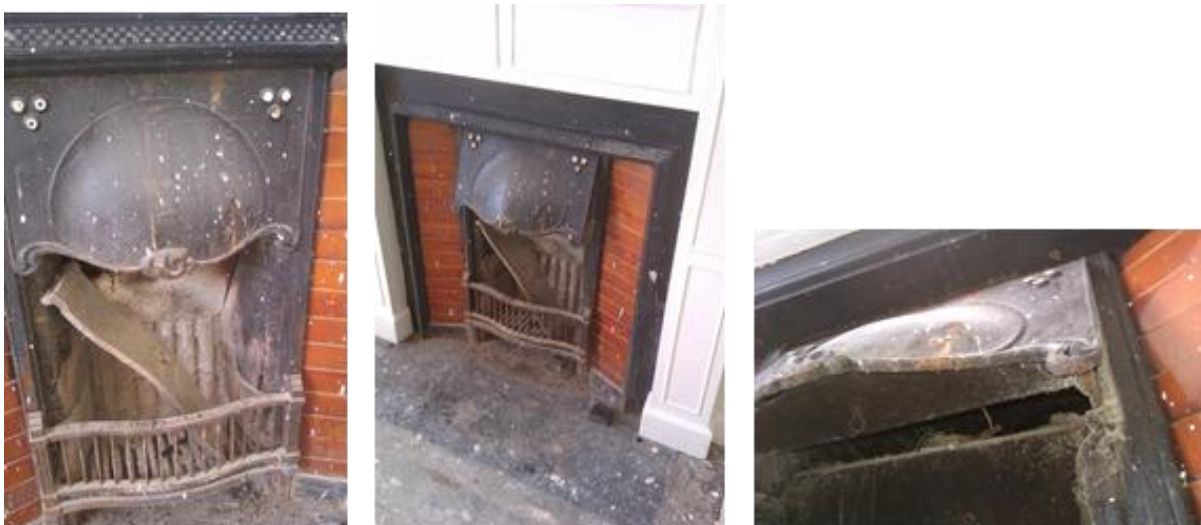
Fig. 26 Living room fireplace shown with damper closed (top left), open and suitable for use (top right and bottom).

The ventilation effect of the chimney flue in the living room on IAQ was assessed as part of the study. The flue and chimney stack appear to date from the mid-19th century and are likely to be original. The hearth and chimney piece appear to be later, probably from the late 19<sup>th</sup> or early 20<sup>th</sup> Century and feature a cast iron insert and grate. The inset features a built in hood that can be pushed back flush with the inset, largely closing off the chimney flue from the room (Fig. 26). Under standard air test conditions, the air flow relating to flues is excluded from the air permeability test. However, the air flow relating to the flue was evaluated under pressurised blower door test conditions. This will not directly relate to the actual air flow experienced but offers a means of comparison. Whilst the integral baffle appeared to work satisfactorily, to allow extra quantification of the opening a board perforated by a series of holes was fixed to the fireplace with the baffle closed and its outer edge sealed (Fig. 27). The intention was to vary the air flow in the flue and to measure the effect of the reduced air flow on indoor air quality. The board was put into place on 20 December and as a first step all holes covered over to see the effect of closing the flue off completely. As discussed in Section 6.3 above, this action did not result in significant air quality issues and the fireplace and flue remained sealed for most of the monitoring period (apart from during part of the air permeability test process on 31 January). A further reason for not uncovering the flue was to avoid introducing another variable into the changing heating regime.

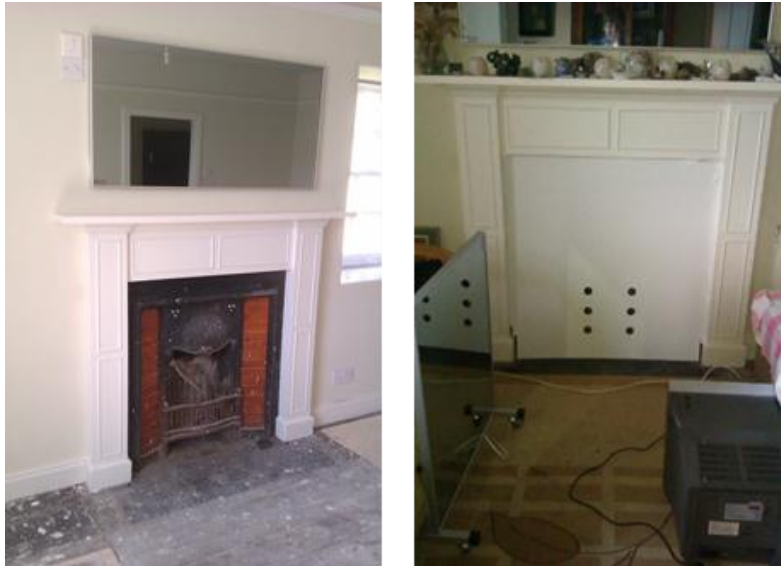
*Fig. 27 Living room fireplace showing temporary board fixed into place.*

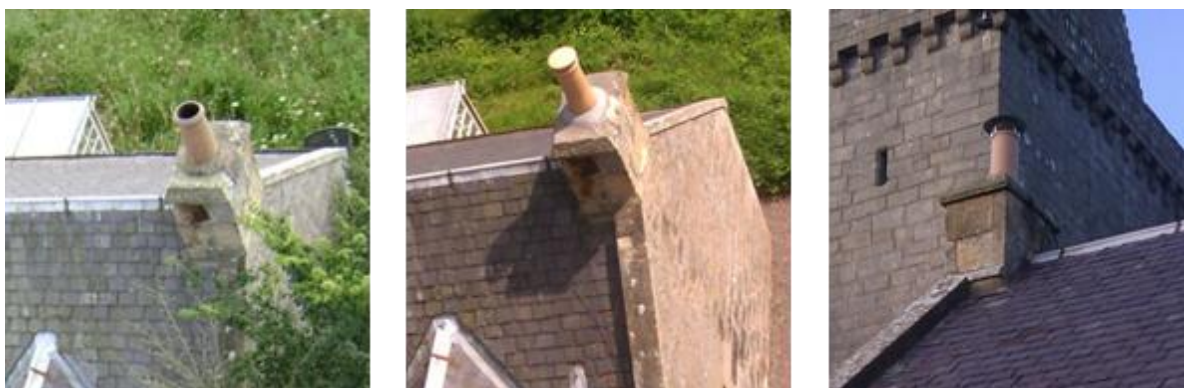
*Fig. 28 Change in chimney pot. Left to right: 2011, 2012 capped with an "elephant's foot", 2013 – replaced with a cowl so the hearth or flue can still be used.*

Measurements were taken with the flue open and the baffle closed in the 2012 and 2013 tests and these are shown in table 9. It must be highlighted that these figures may not reflect the actual air flow in the flue as this will be governed by a range of effects including the interior to exterior temperature difference and wind speed. It does however offer a means of comparing air flow under a standard set of conditions. The test results reflect the change in chimney pot shown in Fig. 28.
