INFORM

INFORMATION FOR HISTORIC BUILDING OWNERS

Foundations and Wall Footings

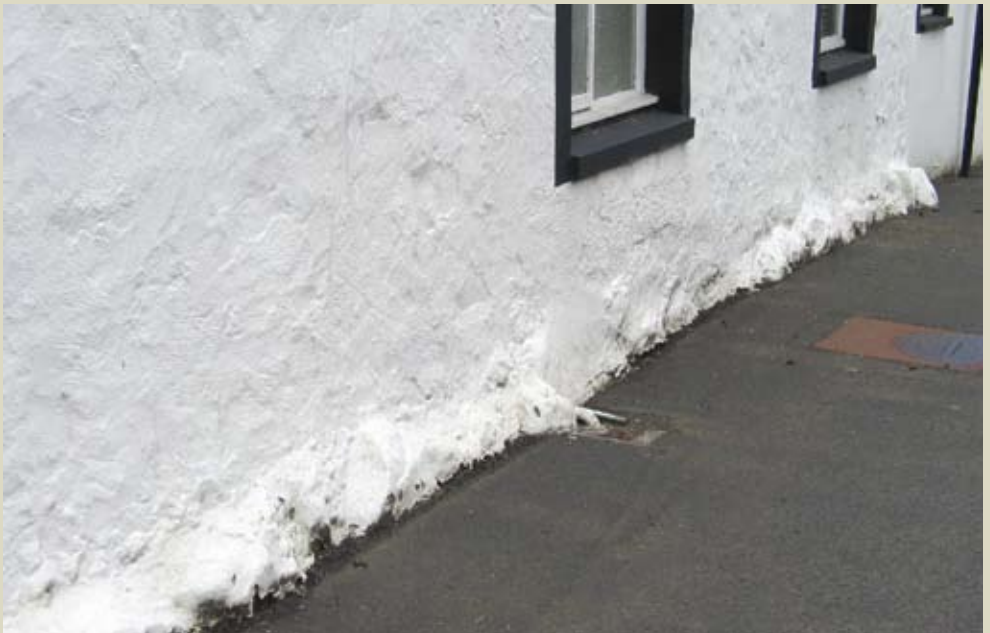
Masonry buildings, from medieval times until the early 20th Century were generally built straight into the ground. For defensive reasons, castles tended to be built upon rocky promontories and, as a result, often had their walls constructed directly from the bedrock. Ecclesiastical structures however tended to be located in a wide range of situations, including river flood plains. Consequently, the walls of such buildings tended to be constructed on a broader foundational pad so that the structural load could be spread over a larger ground area. As the construction of masonry domestic buildings became more commonplace during the 18th Century, large rough boulders were laid in a shallow trenches to create rudimentary foundations. The dimensions of these stones tended to be larger than the width of the wall that was to be built on top; so many buildings of this period can still be found with exposed foundation stones, or with a distinct protrusion occurring at the wall footing.

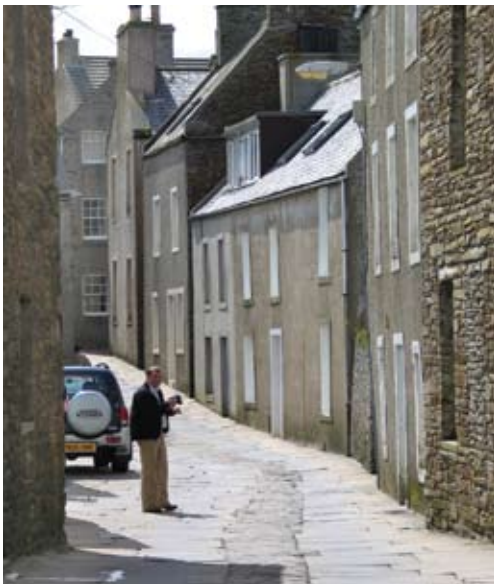
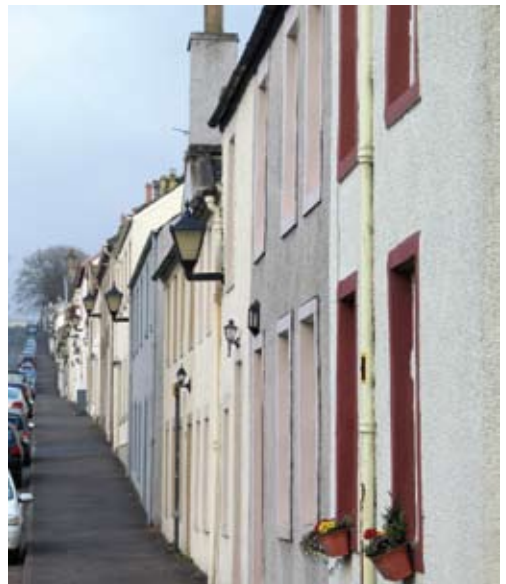
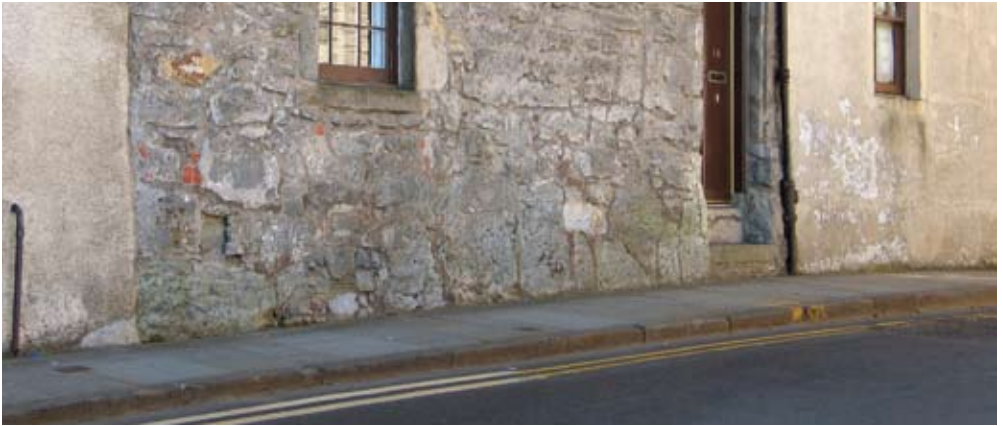
Occasionally, the entrance doorway was located in the highest part of the slope with the floor made up above the external ground level to avoid this problem. Access into the property was over a raised entrance platt or step as this prevented surface water from gaining direct access through the doorway. But, this arrangement still left the problem of dealing with any rainwater discharged from the building itself, and the need to control surface water discharging down the slope. On steeply sloping sites, complex original arrangements of gutters, slabs with channels cut in them, bridging entrance platts and applied skirting blocks helped, although later external road and pavement surfacing works can often add to the difficulties.

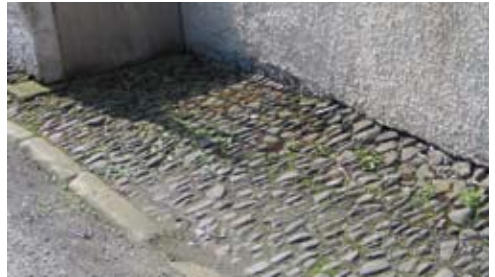
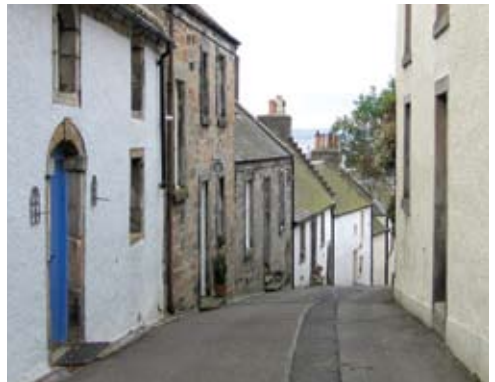
Pavements adjacent to buildings should, ideally, be laid on a slope that falls away from the wall as this helps direct rain water from the footing towards the road-side gutter. Prior to the introduction of tarmac or concrete slab pavements, traditional detailing could involve the construction of a pavement made up from rows of thin cobbles or split stones. To ensure that these discharged water properly the stones were laid at right angles to the building thereby allowing surface water to drain down the slope between the stones. Sometimes, such pavements also included the construction of an integrated cobble lined gutter which took the collected water away from the area. A further traditional detail that could be found is the use of a dimensioned kerb stone used to contain the cobbles and to provide a drop into the adjacent gutter.

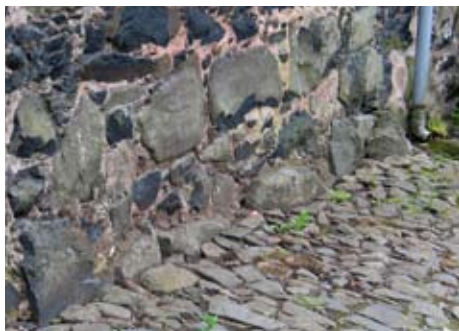
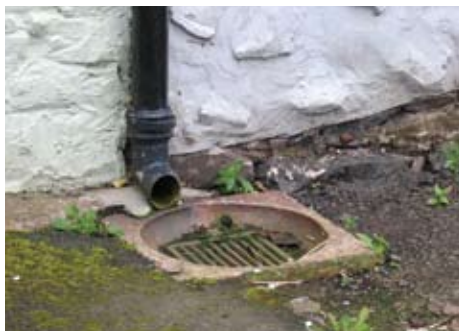
the build up of pavements leads to creating a small well at the foot of the building into which rainwater is discharged. This arrangement can also encroach onto the external face of wall foot ventilators, allowing water access directly into the sub-surface of the building through the vent slots. Unfortunately, increases in modern road level surfacing sometimes also eliminates

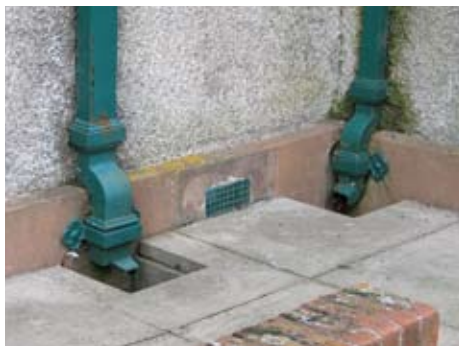
the gutter, running the risk of surface water flowing back towards the building's wall footing and foundations, especially if the surface slope away from the wall is slight, or non-existent. In addition, the impermeability of modern paving materials can trap underlying moisture adjacent to the wall footing.

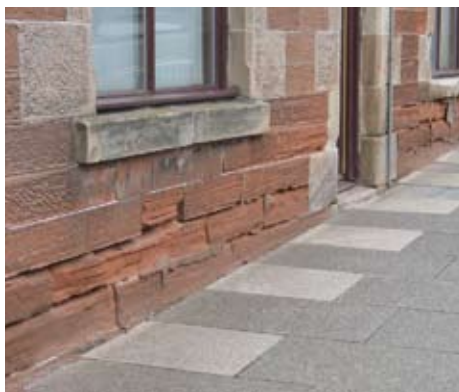
It also needs to be recognised that the regular application of winter road salt on pavement and road surfaces can be particularly damaging. Some stones, especially sandstone, are at a considerable risk of induced decay where the salt splashes against the building as salt contamination can lead to the accelerated degradation of the stone. The first signs of this happening usually occur in the vicinity of the masonry joints and beds where there is an easy route for salty moisture movement through the lime mortar. Here, it is best to try to prevent winter road salts to coming into direct contact with the masonry.

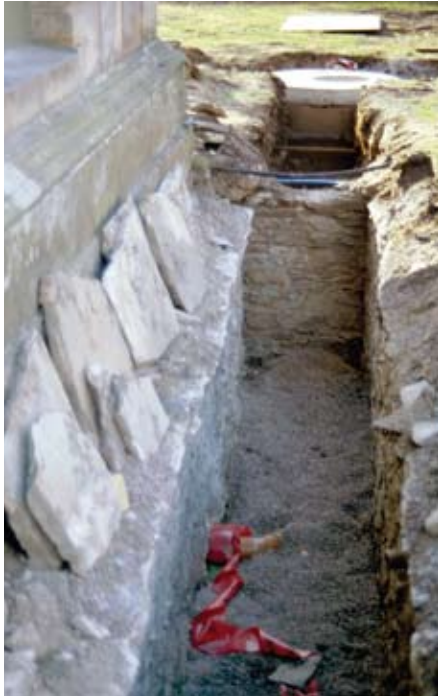
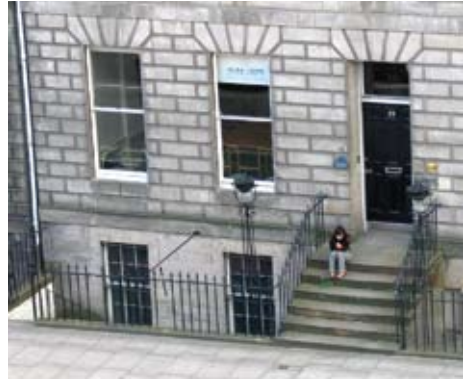
In the late 18th and early 19th Centuries the beneficial use of air drains around buildings was well recognised. The air drain allowed evaporation of moisture from exposed wall faces into the constructed trench as a method of dealing with rising damp in wall footings and foundations. Used on a small scale in mansion houses, the same principle

was applied to urban developments where basements were constructed to either a half or full level below the public pavement. By aligning and constructing the building in from the pavement edge, a combined air-well and light-well was created with the open space readily allowing moisture to evaporate from the lower wall into the free air. As part of the arrangement, care needs to be taken to ensure that water does not build up and flood into the bottom of the air drain or well by ensuring any drains flow freely.

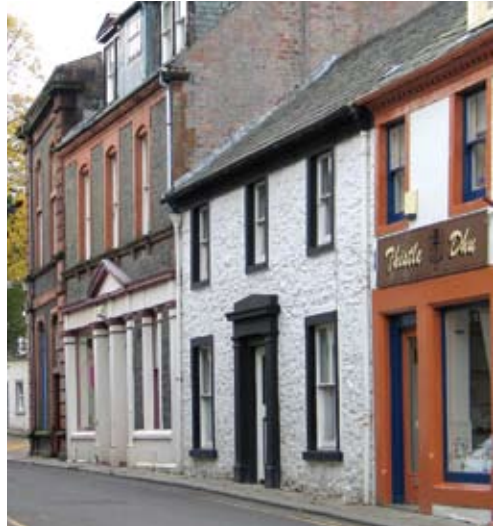
In Victorian times the application of a layer of asphalt through the wall thickness above the foundations created the first serious attempt to put a damp-proof membrane in traditional construction. Unfortunately, due to the thickness of the layer of the asphalt, over time this seal can be squeezed out, thinned and broken due to the imposed load of the building constructed on top of it, to become less effective.

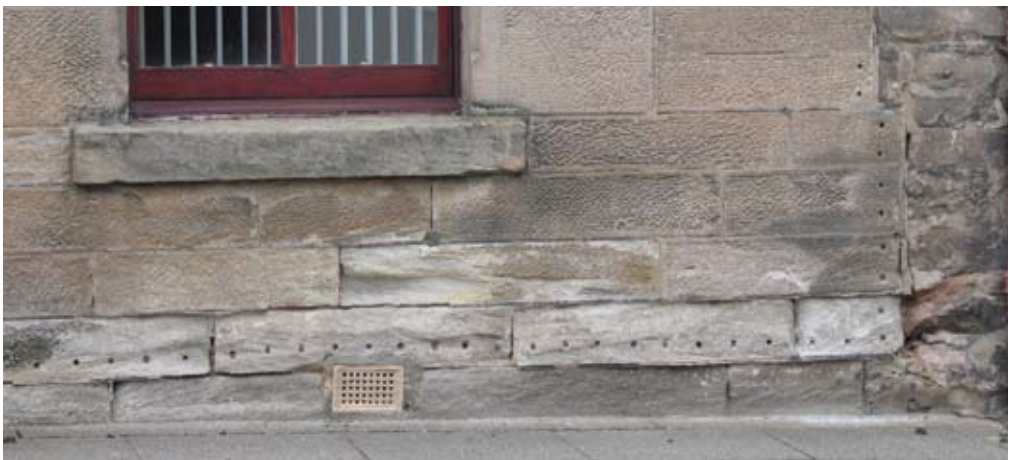
Attempts are often made to inject chemicals into a course of wall foot masonry above foundation level to try to prevent water from rising up through the structure. This creates a chemical barrier within the structure of the stone. The technique is only likely to be effective in sandstone and is not so successful in less porous stones like granite or whin. Where used, the technique leaves the disfiguring tell-tale signs of a series of horizontal (and sometimes vertical) holes into which the chemical injection process was carried out. Other proprietary methods involving cutting

into the wall might include active and passive electro-osmotic techniques where electric currents are passed through the installed system in an attempt to control dampness.
