# REFURBISHMENT CASE STUDY 32

## CRUCK COTTAGE TORTHORWALD

THATCH AND CLAY REPAIRS  
TO A TRADITIONAL COTTAGE

STEPHANIE WEINRAUB

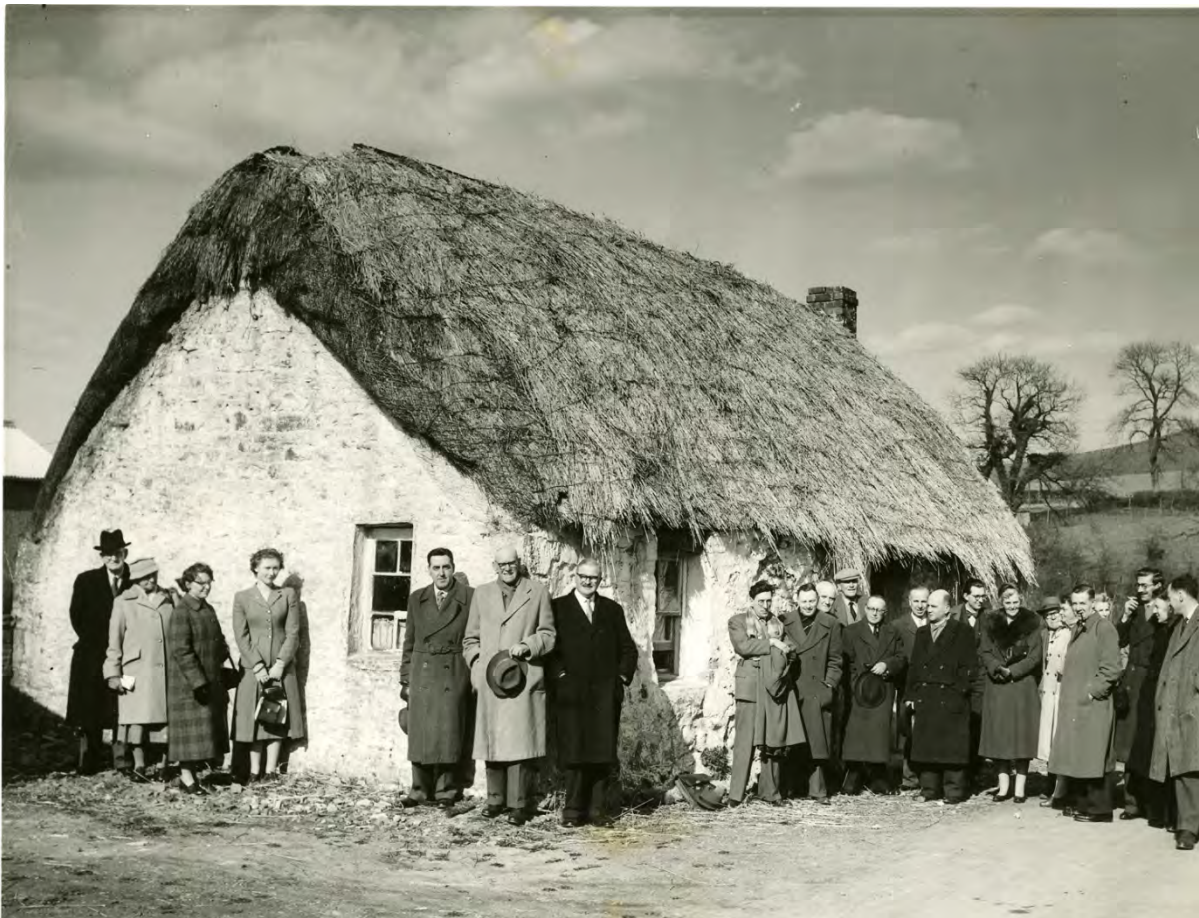
Figure 3. Photograph on the completion of the 1963 restoration (Image courtesy of Dumfries Museum).

By 1970 the cottage had been bought by the Greiner family, who lived there until 1976, making some changes to the house (such as the addition of a second door), and maintaining and improving the timber framing. A subsequent owner, Ian Mills, gifted the cottage to Solway Heritage in 1990, for restoration into a museum. Judging by photographic evidence, this restoration removed the masonry chimney on the east gable, while heightening the clay chimney on the west gable. The rethatching (by Jeremy Cox of Castle Douglas) changed the form and fixings of the roof to a tidier wheat straw over turf, with concealed fixings and a continuous ridge overlaid with evenly spaced horizontal ropes (Figure 3).

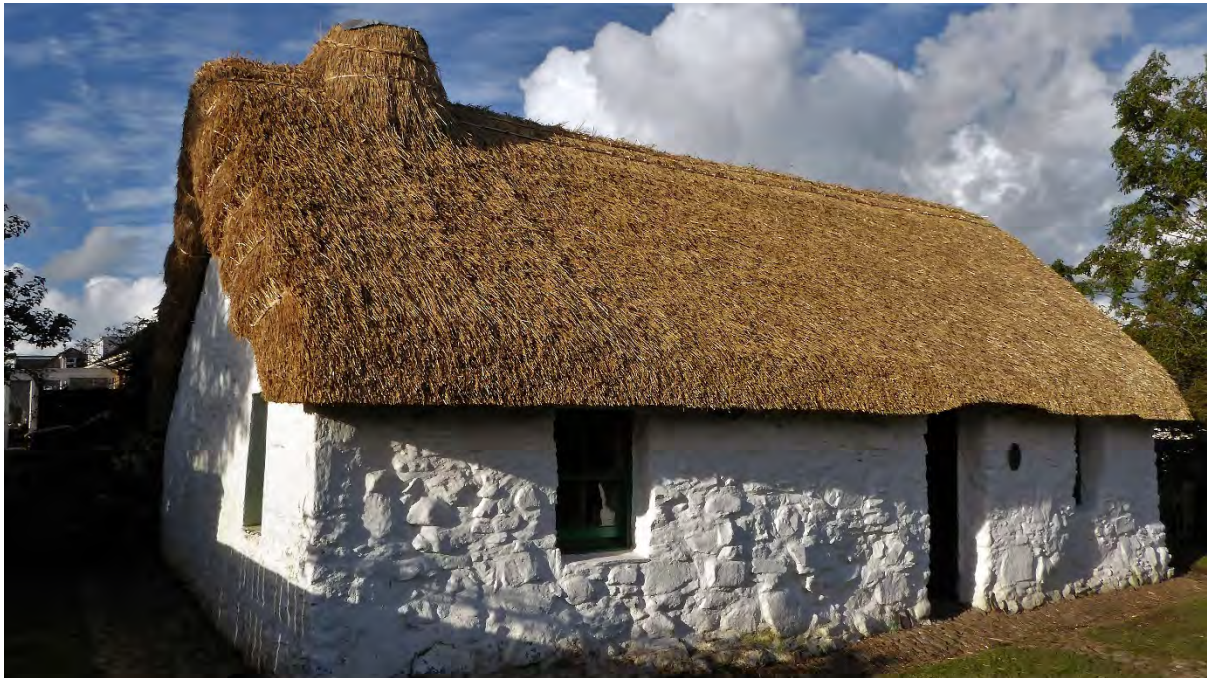
Figure 4. Appearance of the cottage following refurbishment in 2017. Image courtesy Cruck Cottage Heritage Association.

In 2017 an extensive refurbishment was undertaken which involved complete rethatching, as well as various internal and external repairs. This work was well documented through photographs, articles, and documentary videos by the Cruck Cottage Heritage Association (Figure 4). The work was supported by the South West Environmental Trust, Solway Heritage and Historic Environment Scotland (HES).

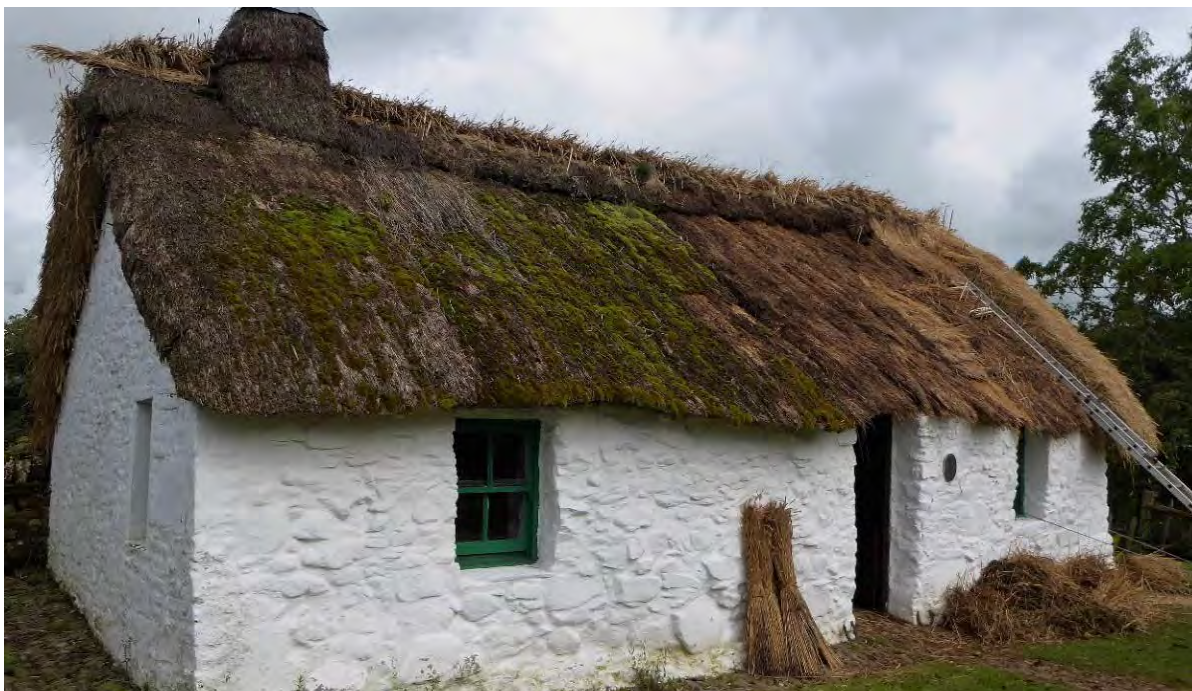
The rethatching began in the summer of 2017 under the supervision of thatcher Jonathan Botterell. Photographs indicate that the roof covering, most of which dated from 2004, was somewhat decayed and supporting moss growth (Figure 5). Rather than stripping the roof completely, the thatcher cleaned off the plant growth and the outermost decayed layer, and applied a new layer of straw thatch on top of the old one.

Figure 5. Cruck Cottage in 2017 prior to rethatching. The moderate decay of the thatch was likely being exacerbated by vegetation growth. Image courtesy Cruck Cottage Heritage Association.

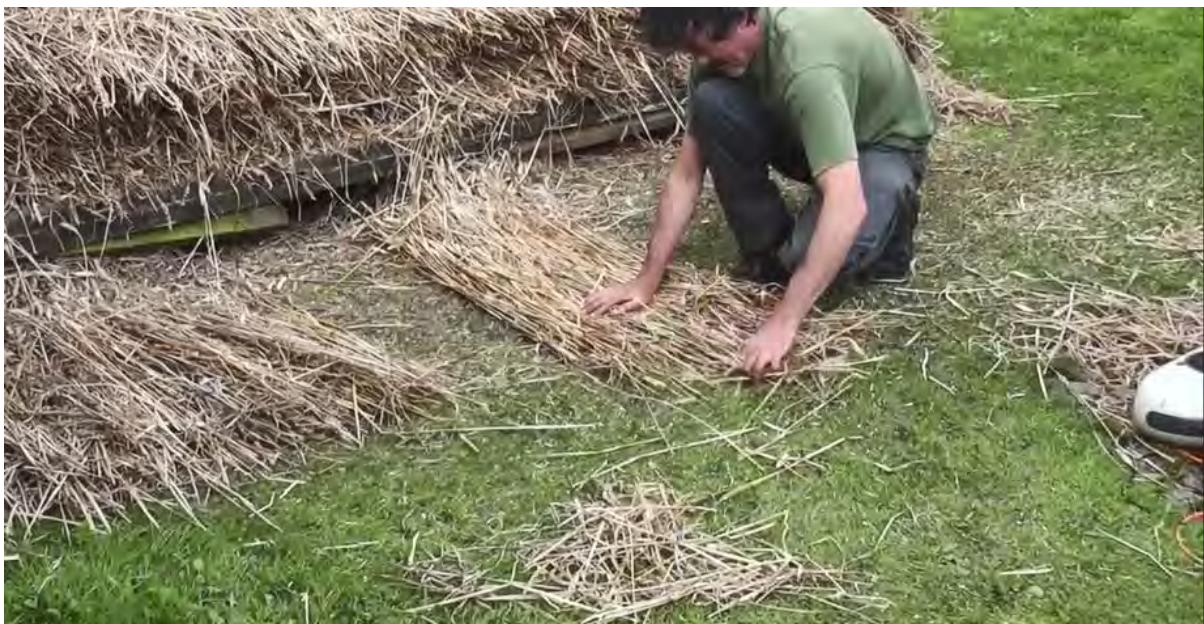
Straw was delivered to site in bales already arranged longways, with the heads of corn along the same side. Having them pre-arranged in this way saves labour since thatching practice generally places either the stems or heads out, depending on the thatcher's preference. However, a great deal of preparatory work was still necessary in 'yealming' the straw, a vernacular term for arranging it into small bundles (Figure 6). Each of these bundles was laid out on the ground before being passed up to the roof, arranged and 'combed' by hand either by the thatcher or his apprentices. Combing not only tidies the appearance of the straw, but compacts the bundle by removing the more irregular and straggly strands. These strands can be discarded or placed where the thatcher thinks best.

Figure 6. Yealming the straw - arranging it into bundles on the ground before combing it by hand. Image courtesy Cruck Cottage Heritage Association.

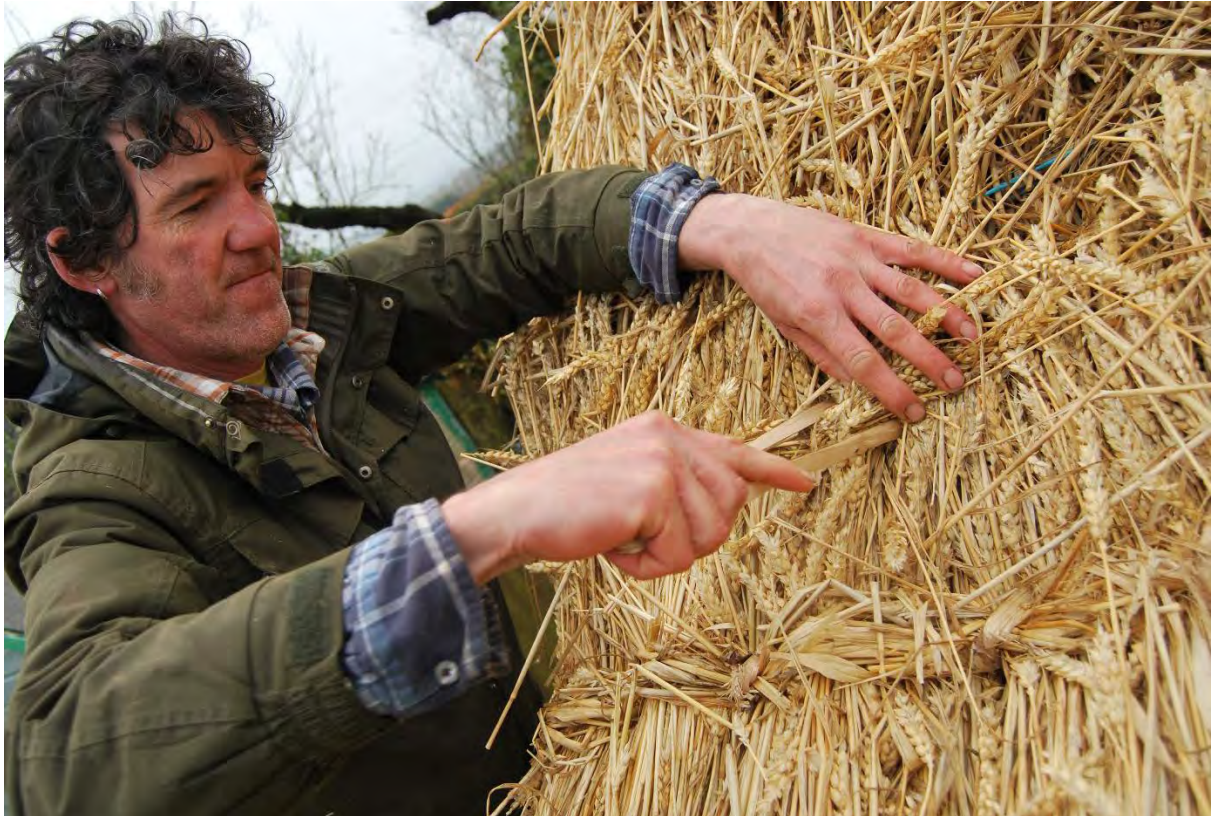
Thatch was laid on the roof in horizontal courses, and fixed down using sways made of straw and hazel. The sways were made by taking a small

segment of the thatching bundle, folding and twisting it over the previously laid bundle, then stapling this 'stitch' with a hazel scob (Figure 7). The work moved in courses from the bottom to the top, so that each course of thatch concealed the fixings, giving the characteristic uniform appearance. This method means that the topmost course has its fixings exposed, which perhaps explains the decorative designs incorporated into the ridge detail in some regional traditions.

Figure 7. Fixing hazel scobs over sways formed from the thatching straw.

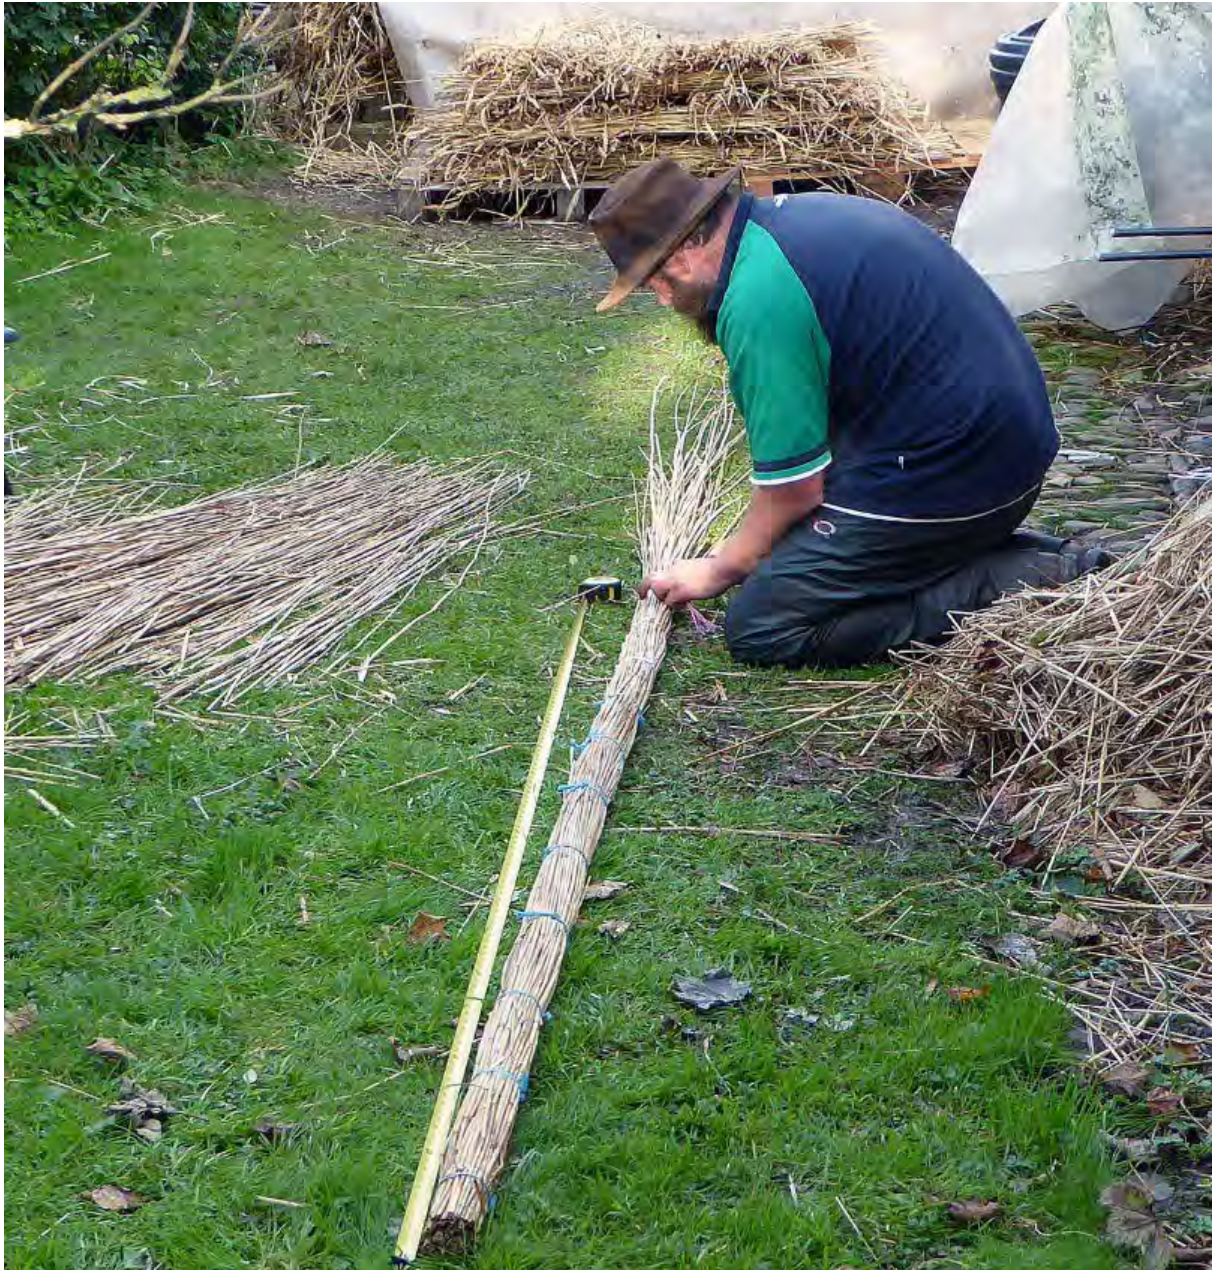
The treatment for the ridge differed slightly from the lower courses, and consisted of a single course of thatch dressed over the top, spanning it evenly. This gave the ridge a shallow pitch. To counteract this and help the roof shed water properly, the thatcher accentuated the pitch by using a row of straw bundles or 'dollies' laid along the ridge beneath the crowning course of straw (Figure 8).

Figure 8. Long straw 'dollies' were added underneath the thatch at the ridge to raise the apex.

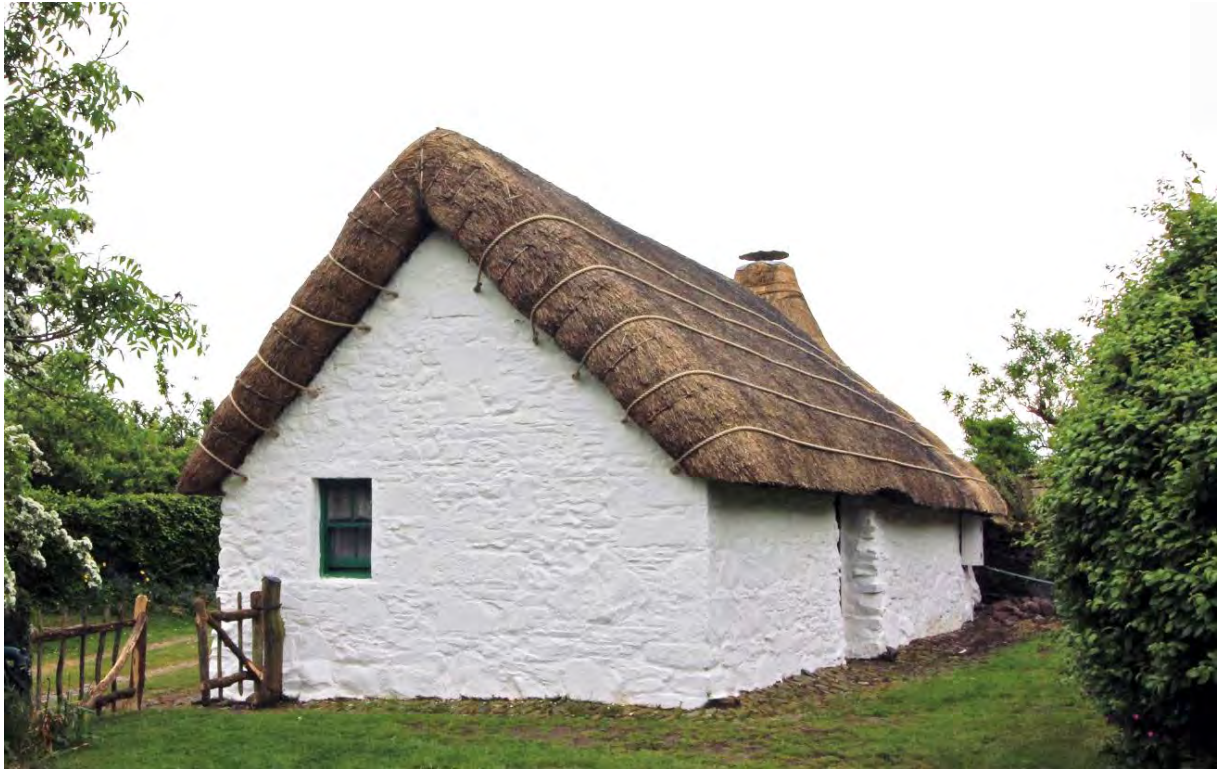
After the thatch was laid, it was combed with a thatch comb and trimmed to leave a tidy appearance. In keeping with details from the 1990s rethatch, the eaves were given a long overhang slightly profiled above the windows and doors to cast water away from the building. The eaves detailing was replicated to match what already existed, namely a rolled overhang at the gables, which was tied down with ropes fastened into hooks embedded in the masonry (Figure 9).

Figure 9. The east gable following the 2017 rethatch, showing the rolled overhang and rope fasteners. The 'eyebrow' profile over the back door is also visible. Image courtesy Cruck Cottage Heritage Association.

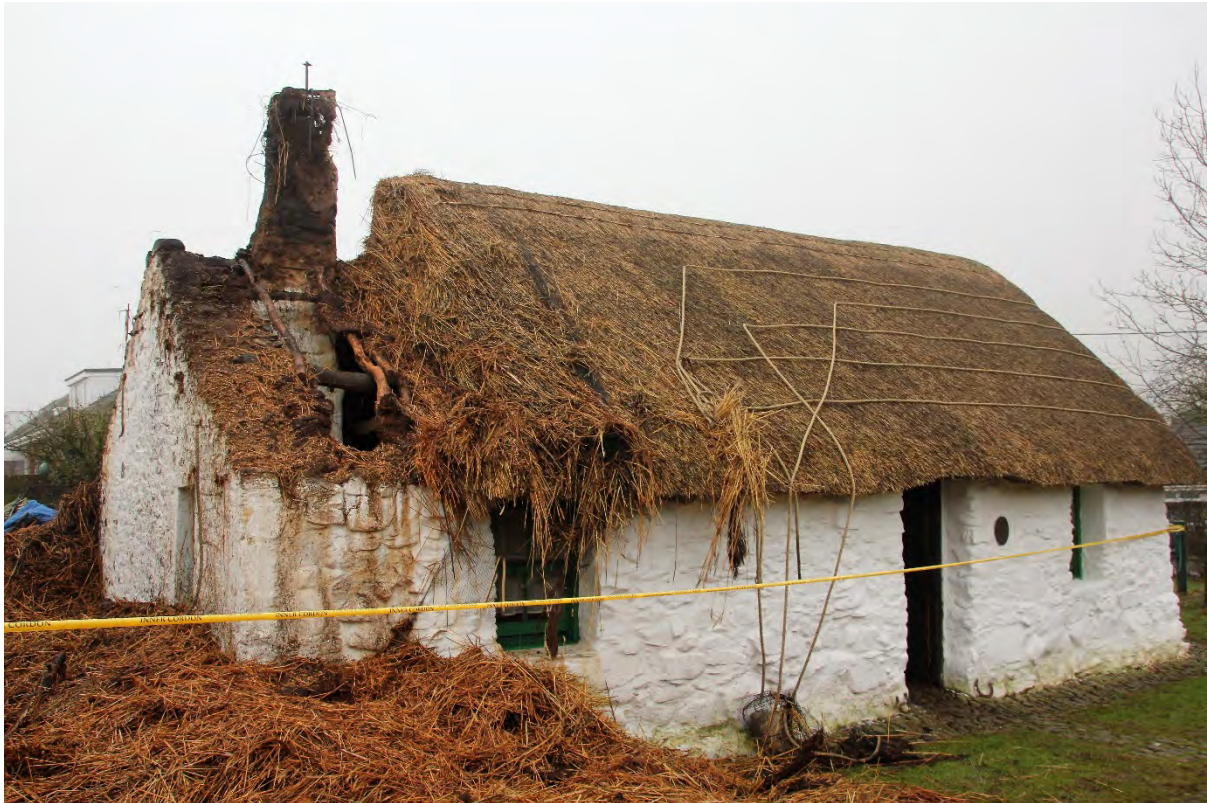
In the early morning of 9 January 2018, only a few months after the 2017 refurbishment and rethatching had been completed, an act of arson set fire to the cottage roof. Fortunately, an easterly wind prevented the fire from progressing quickly, and only a two metre wide section of the western portion of the thatch was damaged (Figure 10). The turves (turf slabs laid under the thatch) provided a firebreak which slowed the progress of the fire and kept the interior, including all cruck timber and cabers, undamaged. The clay chimney also required repair due to the fire and water damage.

Figure 10. The damage from the 2018 fire. A great deal of thatch was rendered unusable and the wooden framework of the chimney was compromised, but the roof frame and historic crucks were essentially undamaged. Image courtesy Cruck Cottage Heritage Association.

Repair work began four months later in April 2018, during which time the damaged portion of the roof was covered with a tarpaulin to keep the interior of the house dry. However, doors and windows were kept open through the winter whenever possible to allow adequate ventilation of the damp caused by the firefighting measures.

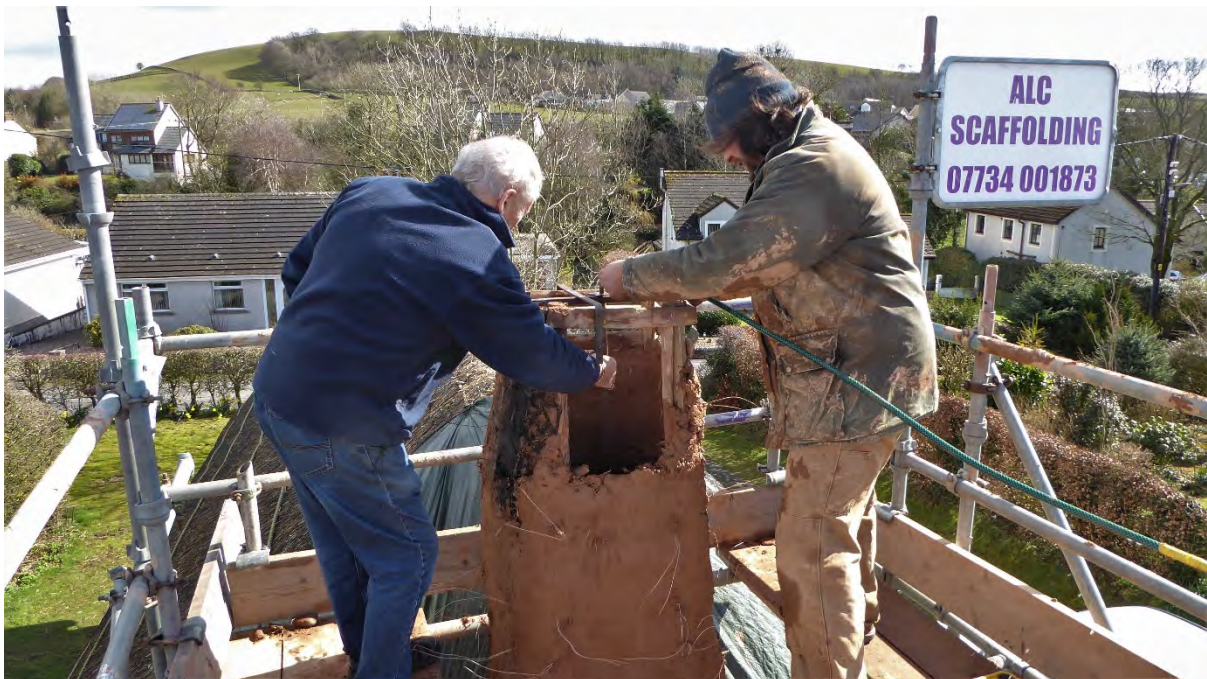
At Cruck Cottage, the fire had penetrated the protective clay, damaging the timber frame enough to render it unstable and unable to take a clay repair. To address this issue, work began by consolidating and rebuilding the timber frame according to its pre-fire shape, which was still evident. When the frame was stable, it was coated inside and out with the fire-resistant clay mix, consisting of clay, chopped straw, and quicklime, which was then smoothed and coated in limewash (Figure 11). The clay was sourced and dug as near to the site as possible, producing a material that was both practical to work with and authentic. It was mixed by foot with chopped straw, which acts as a matrix helping to bind the clay together, and a small addition of quicklime, which helps stabilise the earth and improves moisture resistance.

Figure 11. Clay daubing being laid over the repaired timber frame. Image courtesy Cruck Cottage Heritage Association.

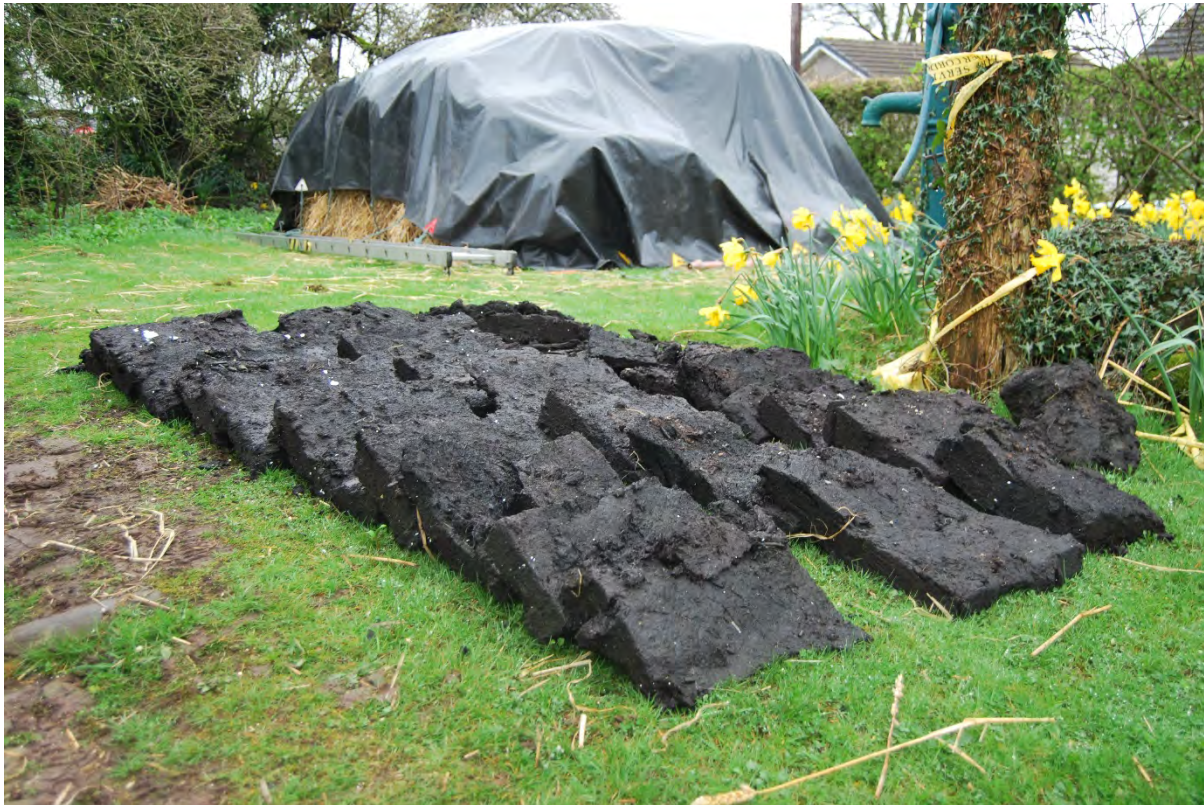
Figure 12. New turves laid out to dry. Each turf was approximately 10cm thick and 25cm roughly square. In the background, thatching straw is kept dry under a tarpaulin.

After the chimney was repaired, the same thatcher finished repairing the thatch. The thatching began from scratch by layering turves over the roof cabers. Cut turves were set out in the work yard to dry (Figure 12). For the 2018 repair, heather turves were cut from nearby Lochar Moss, which is rich in peat and the probable local historical source for any building turf.

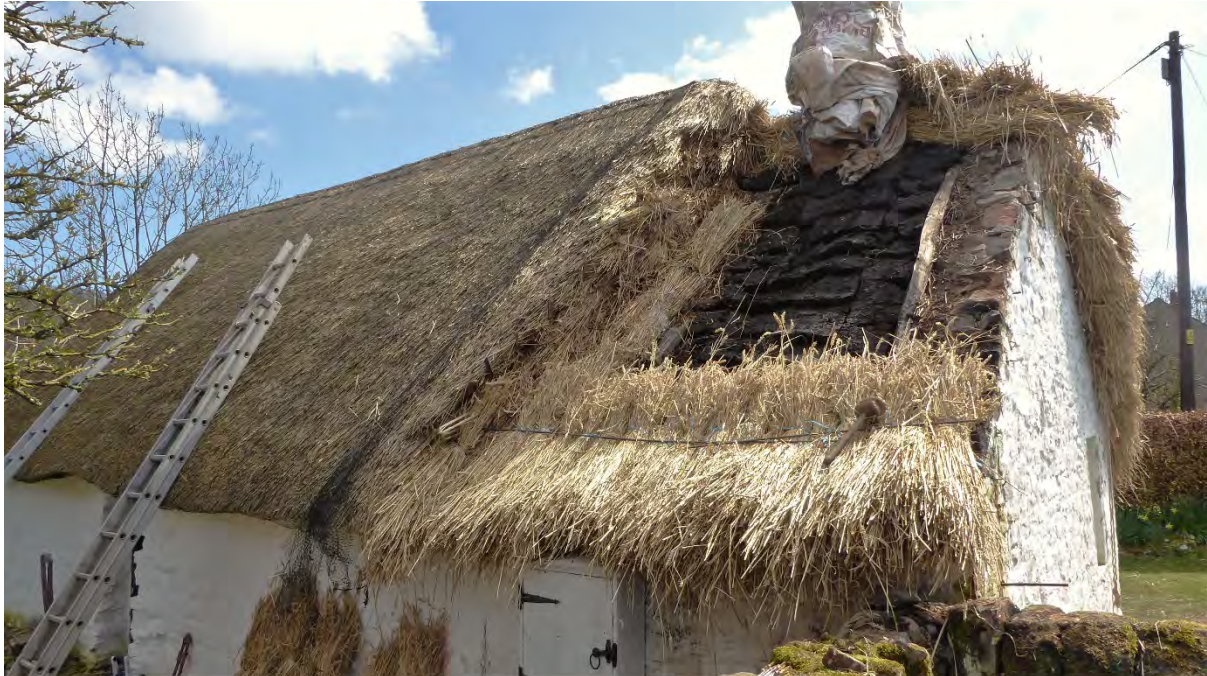
A thin scattering of random straw was spread over the turf layer beginning at the bottom, and thatching began in courses moving upward (Figure 13). Because it was necessary to bulk up the thickness of the new thatch in order to bring it in line with the existing roof – roughly three layers thick – the thatcher laid each course twice, one on top of the other. For the first course, 50cm steel rod sways were used, and were tied to the cabers with wire threaded through the turves. This was because the turf underlay alone was not thick enough to take hazel scobs, and because the location of the hanging lum left an unusually large gap to be spanned, for which the steel rods were well suited. The second layer of each course was fixed with hazel

Figure 13. Layers of the 2018 thatch repair. Turves have been laid like tiles, and the bottom row of thatch bundles has been fixed down with steel rod sways, stitched through the underlay with wire. Image courtesy Cruck Cottage Heritage Association.

scobs and straw sways, as previously. After everything was laid, it was combed and trimmed and the skews rolled under to match the existing thatch.
