INFORM

INFORMATION FOR HISTORIC BUILDING OWNERS

Pantiles Maintaining a Pantiled Roof

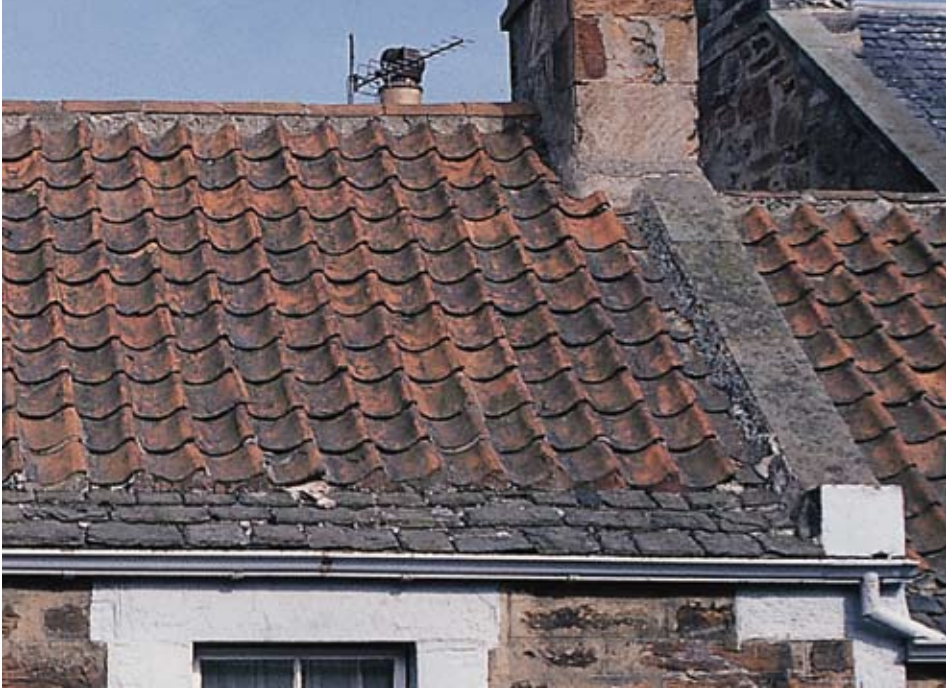
Pantiled roof showing slated easing course

It is uncommon to find fitted rainwater goods as part of a completely pantiled roof. Pantiled roofs would sometimes be bellcast (a slight flattening of the roof near the eaves) This was created in some cases by the bottom 3-5 courses of the roof being slated, known as easing courses. Using slate at the bottom of the roof also gave better protection from the rain at the shallower pitch over the wall head and helped to prevent the lower tiled courses from being uplifted by the wind. In other circumstances for the same

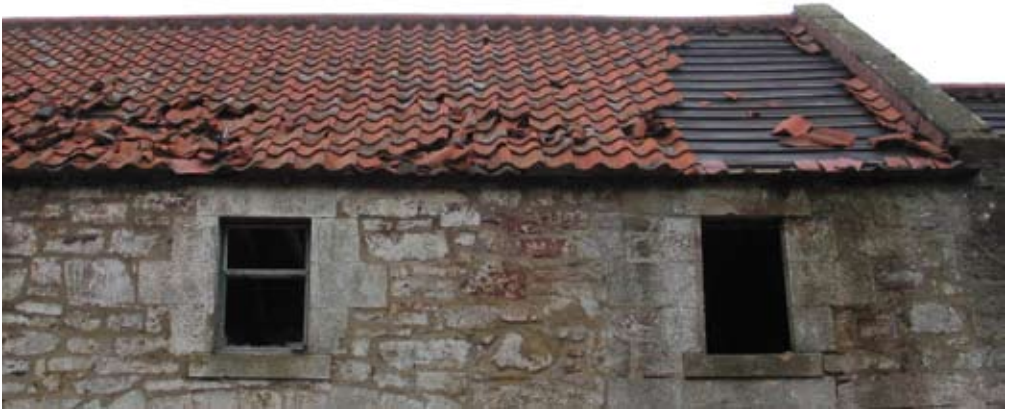
Structural problems make this pantiled roof vulnerable to further deterioration

Movement in the structure of the roof can lead to the deterioration of battens and fixings. This can dislodge the alignment of the tiles and make the roof vulnerable to water penetration. Where this is a problem the roof structure should be fully inspected to establish, and rectify, the cause. Filling the open junctions between the tiles with lime

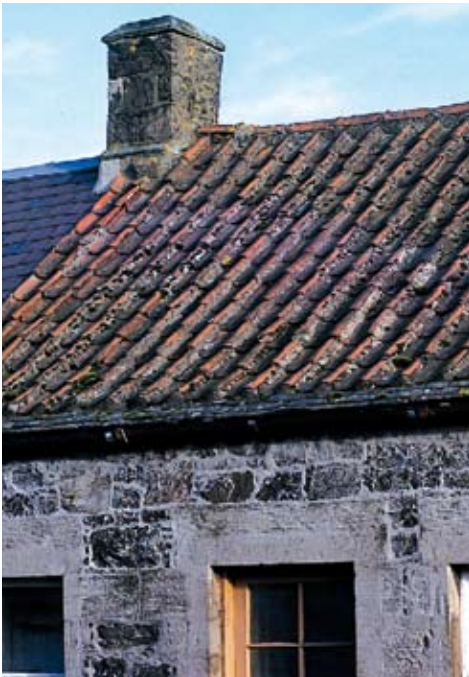
Damage can be caused by cement repair

In re-tiling and repair work lime mortar should be employed, rather than cement. Cement mortar will make it harder to repair a pantile roof in the future, and can have an adverse effect on the softer tiles due to its hardness. In contrast, lime mortar is breathable, allowing moisture to evaporate without damaging the tiles. It is also slightly flexible and can be more easily removed from tiles if repair work is necessary.
