ROMAN SCOTLAND

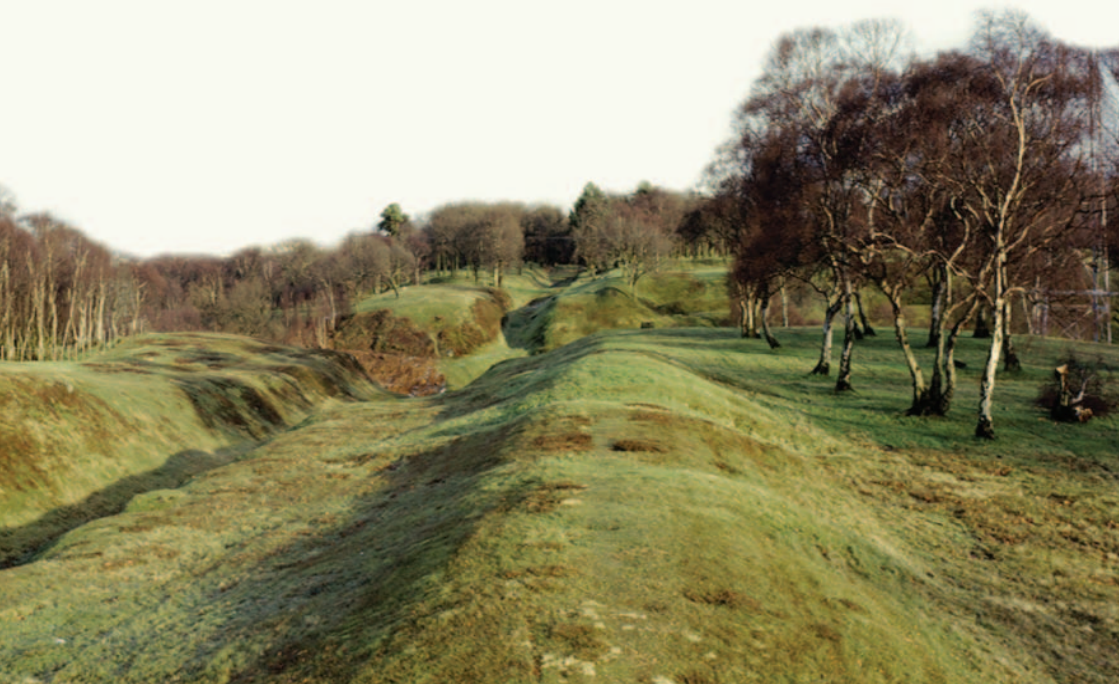
FRONT COVER PHOTOGRAPH:

A section of the Antonine Wall at Rough Castle, with the rampart and ditch still clearly visible. Some parts of the Antonine Wall have escaped complete destruction and, although eroded, the banks and ditch are still visible and sometimes quite impressive even now almost 1900 years after it was built. The roots of trees and scrub cause considerable damage, encouraging further erosion. Other stretches of the Wall have not fared so well but, even where it has apparently been demolished, traces often survive below ground level. © Crown copyright: Historic Scotland

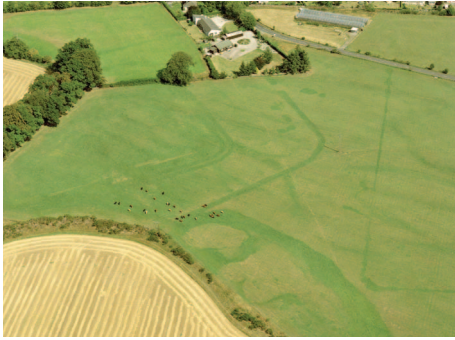
The Romans dominated southern, central and part of eastern Scotland, where roads and permanent forts were built, but they also campaigned as far north as Moray. There are remains of temporary marching camps skirting the Highlands from Perthshire north-eastwards. From the air, in this photograph the straight lines of the ditches of a permanent fort can be seen on the left and those of a temporary camp on the right. © Crown Copyright: RCAHMS. Licensor www.rcahms.gov.uk

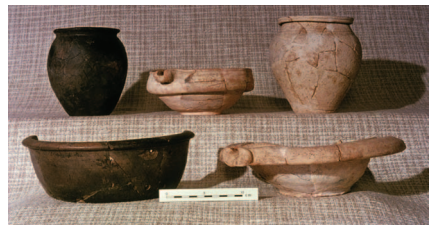
The Roman army used a huge amount of equipment. Typical finds from forts and civilian settlements are broken pots, metal pans, rotary querns for grinding grain and seeds of the cereals and vegetables that were eaten. This pottery was found during excavations of the fort at Bearsden. © Crown Copyright: Historic Scotland, www.historicscotland.gov.uk
