# INFORM

INFORMATION FOR HISTORIC BUILDING OWNERS

## Ceramic Tiled Flooring

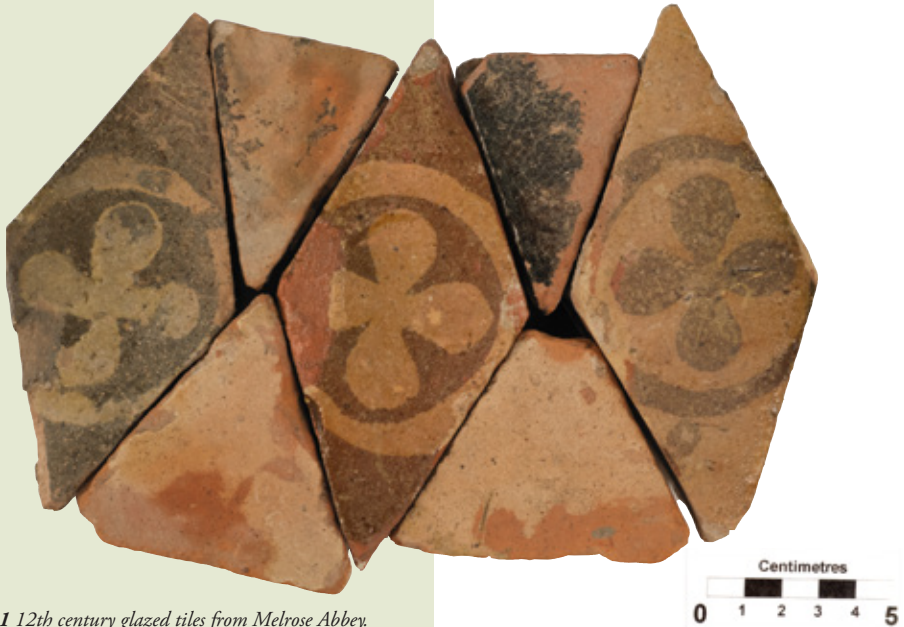
*Fig.1 12th century glazed tiles from Melrose Abbey.*

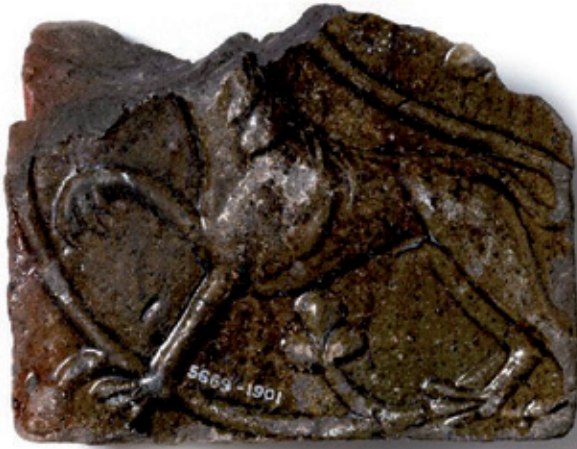
*Fig.2 A 12th century floor tile from The Cistercian Convent at North Berwick.  
Scan No 000-000-638-850-C*

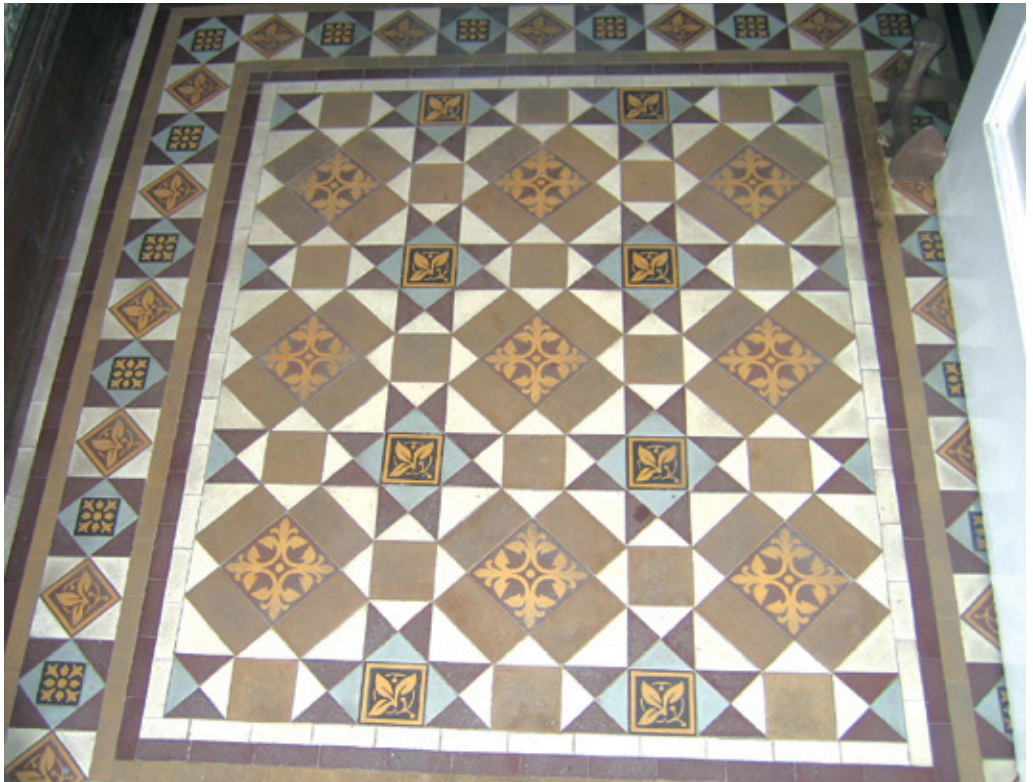
*Fig.3 An early 20th century ball floor in Perthshire, with encaustic and geometric tiles.*

depending on the floor plan and intrusions such as staircases etc. Colours tended to be natural shades (Fig. 3), ranging from buff through to soft yellow, terracotta and red. White, cream and black tiles often formed a border to a central pattern (Fig. 4). In more public areas, stronger pigments were used to create blue and green hues.

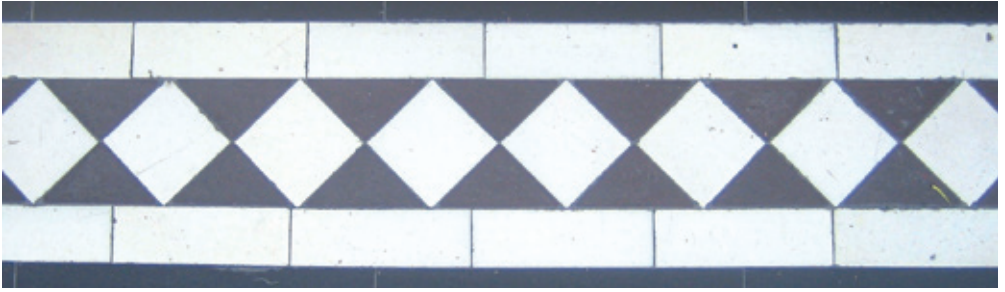
*Fig. 4 Late 19th century geometric tiles.*

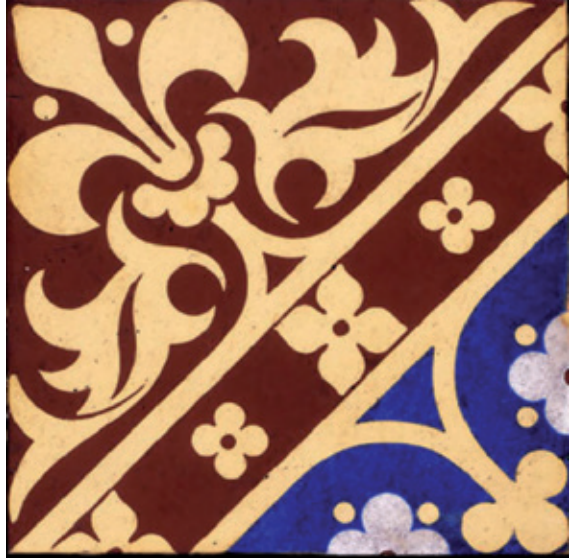
*Fig. 5 A Victorian encaustic tile.  
Scran No 000-000-477-350-C*

Encaustic tiles were made from the same material as geometric tiles. They were used in conjunction with them to form patterns of varying degrees of complexity including coloured glazes. Whereas medieval tiles were hand made, their Victorian successors were factory produced. Traditional designs were copied by several Victorian manufacturers, perhaps the best known of whom was Herbert Minton (1793–1858), whose pioneering techniques remain broadly unchanged today. Often brown in colour with an off-yellow glazed pattern, Minton Tiles can feature a variety of designs, with the fleur de lys and leaf frond pattern common motifs (Fig. 5). Minton and others were also able to make a durable tile by recessing the glaze in a sunken surface pattern; such tiles were as hard as the geometric pieces around them. In some settings, large plain tiles were often made from softer clay and were placed between encaustic tiles. They consequently wore down more quickly than the harder surrounding ones, creating a dished, uneven floor surface that can be difficult to repair without risk of damage to adjacent tiles.

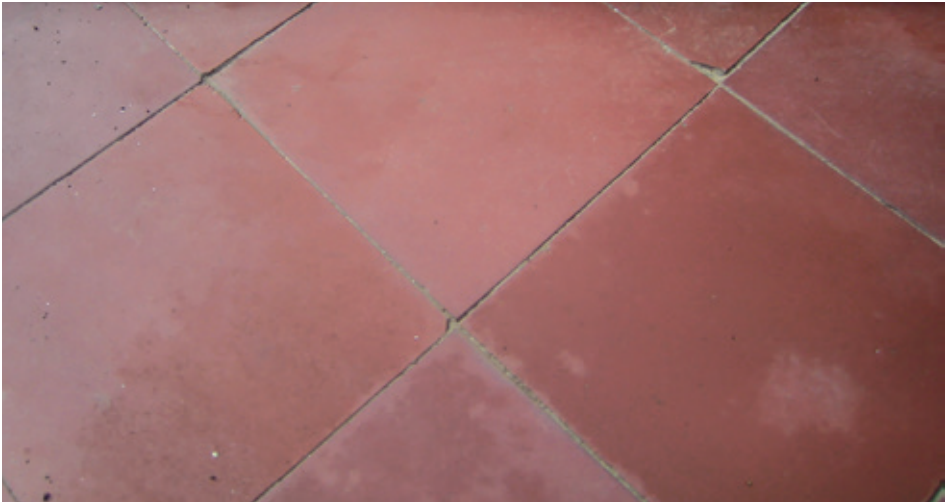
*Fig. 6 Early 20th century quarry tiles.*

Other forms of tiling were also developed during the 19th century. Probably best known is the quarry tile. This was a fired terracotta-coloured clay tile of satin or matt finish (Fig. 6). Due to lower firing temperatures and less refined clays, they tended to be softer. Most quarry tiles were laid in a grid pattern, but other shapes and patterns were used, including hexagons and polygons, that could be laid among stone or slate slabs. Produced in a range of sizes, the most common sizes are approximately 100mm and 60mm square, with the smaller sizes coming into use at the turn of the 20th century. They

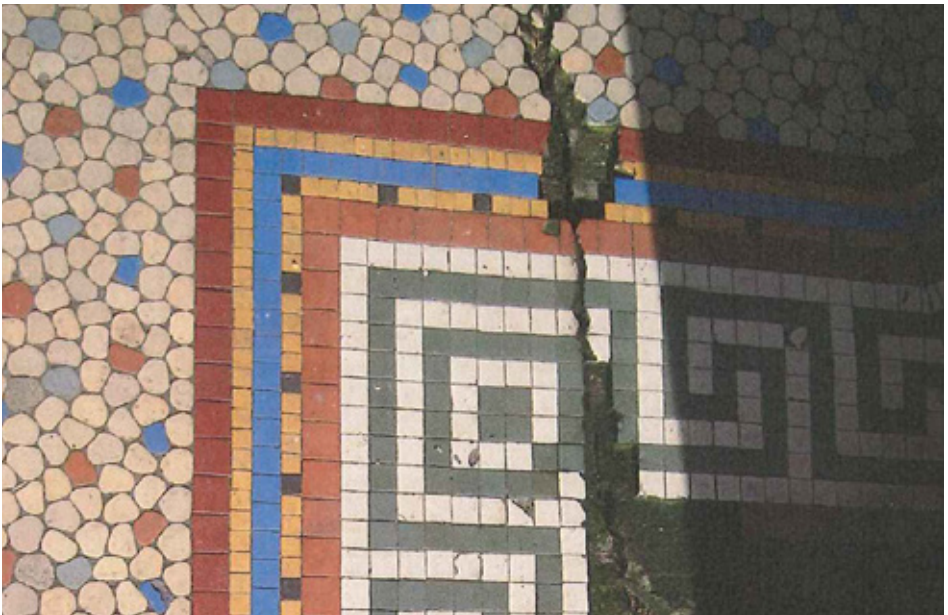
*Fig. 7 Progressive loss of floor following dislodging of pieces.*

Tiles are extremely hard and durable. However, being brittle they are vulnerable to impact, which can loosen the tiles in their bed or crack and shatter them. In severe circumstances there may also be damage to the bedding mortar. Once pieces are lost, the whole floor loses its cohesion, and the disintegration process can accelerate rapidly (Fig. 7).

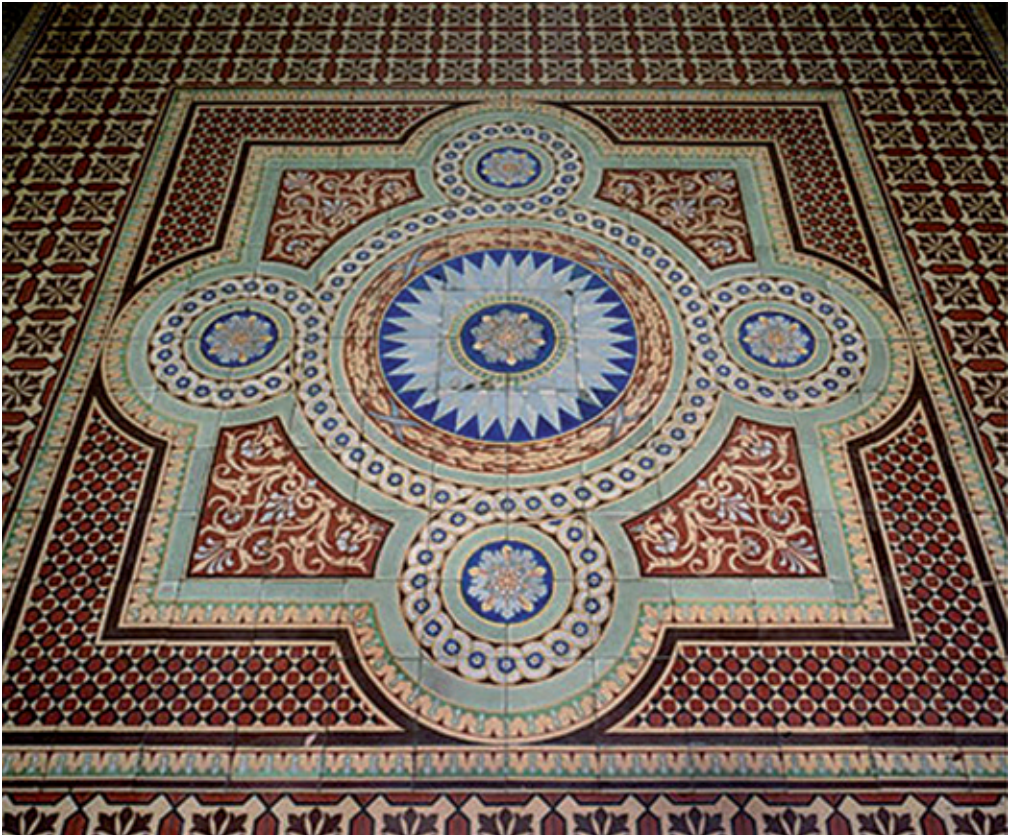
*Fig. 8 Removal of cement based screed revealing the mosaic beneath.*

Over time, and with changing fashion a self-levelling compound (or screed) might have been laid on top of the tiles prior to laying a modern surface such as carpet or lino. The removal of a screed is difficult and time consuming. It may be difficult to get a contractor to do the work properly. In many cases, prising off the screed with a scraper to exploit existing cracks might be the only option. Some modern screeds will soften with an alkali paint remover, while older screeds

can be softened with water alone. Older linoleum might also be glued down with a water-based animal glue which will soften in water. During such works, to control water spread and limit potential damage elsewhere the effect can also be achieved by spreading an old wet towel over the area to be left for several hours or overnight. The glue will soften and expand, and can be removed with a scraper. Whatever the selected method, it will be slow, but rewarding (Fig. 8).
