SOFT CAPPING IN  
SCOTLAND

The context and potential  
of using plants to protect  
masonry

VOLUME 1

Historic Scotland  
© Crown copyright  
Edinburgh 2011

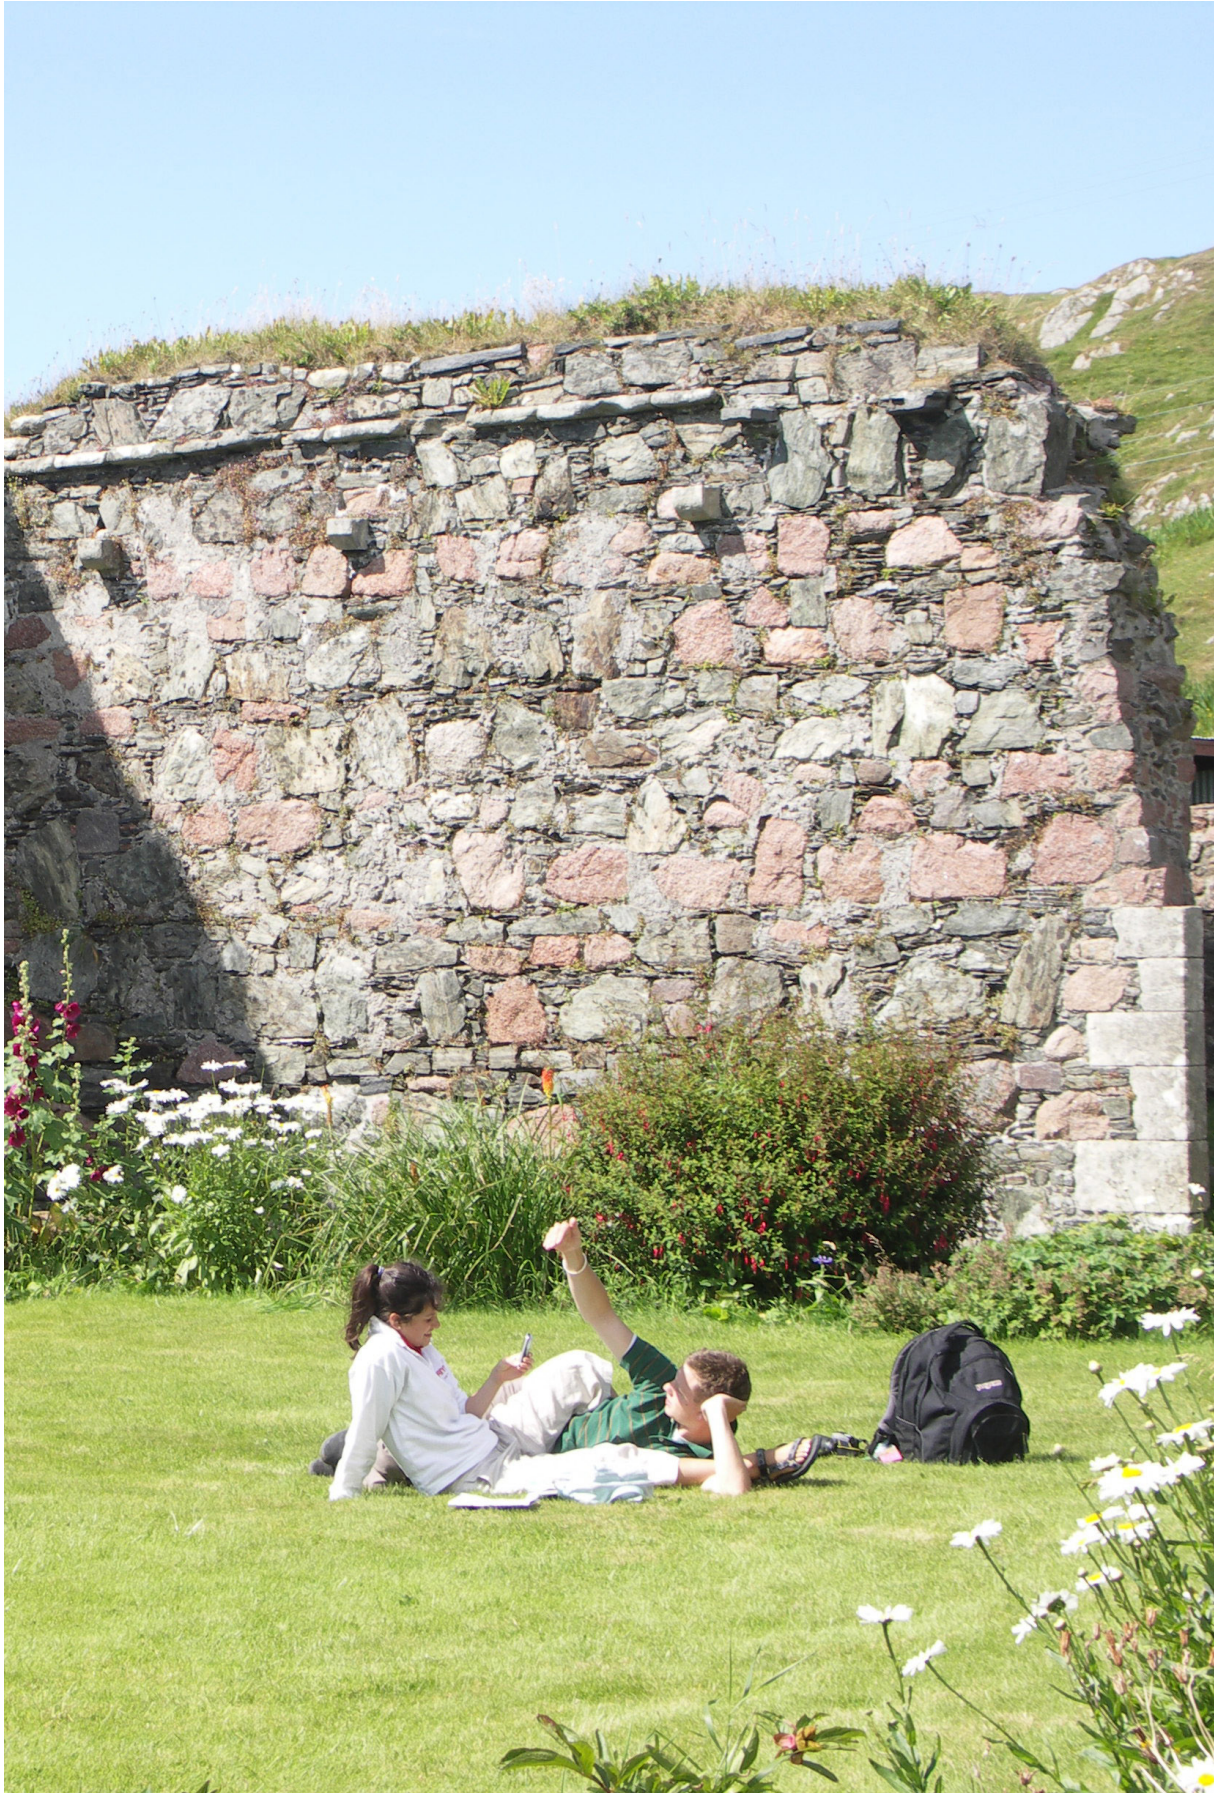
*Fig. 1.3: Naturally established cappings, the Nunnery, Iona, Argyll.*

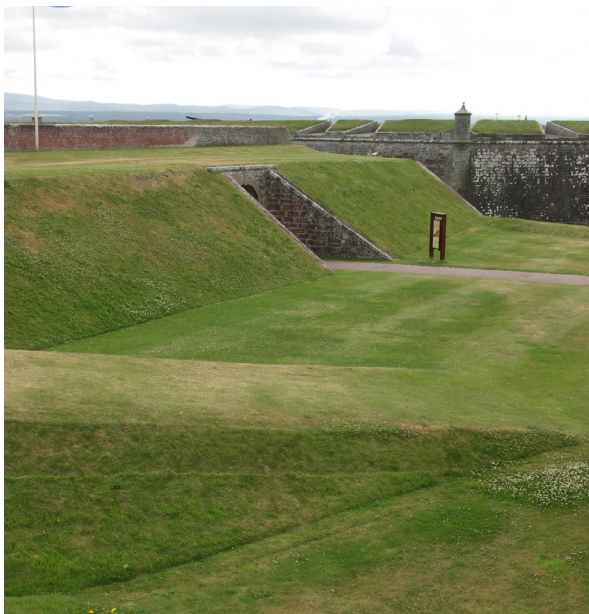
*Fig. 1.4: Fort George, Inverness-shire, earthworks and embasures.*

The research did not consider earth-sheltered masonry structures, for example the large earth works covering fortifications from the 18th and 19th centuries, such as at Fort George, Aberdeenshire. Although these have some relevant aspects, their botanical conditions lack the stresses commonly found in soft cappings.

This review included techniques that can only now be assessed through documentary evidence. It excluded uses of turf and earth materials where they are not directly relevant to the stress conditions of soft cappings, for example the use of soil and turf embrasures and casemates in fortifications, such as at Fort George, Inverness-shire (Fig. 1.4), and the use of puddled clay and turf in Neolithic structures, such as Maes Howe, Orkney.

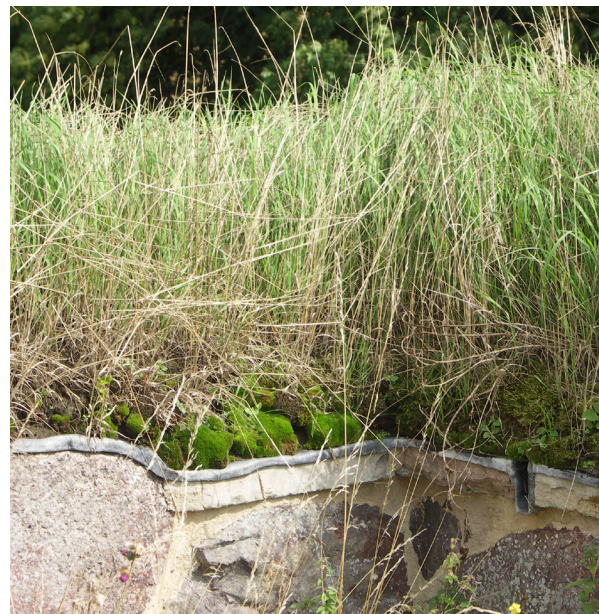
*Fig. 1.5: Alvastra Monastery, Sweden. The vegetation grows in lead containers on the wallhead.*

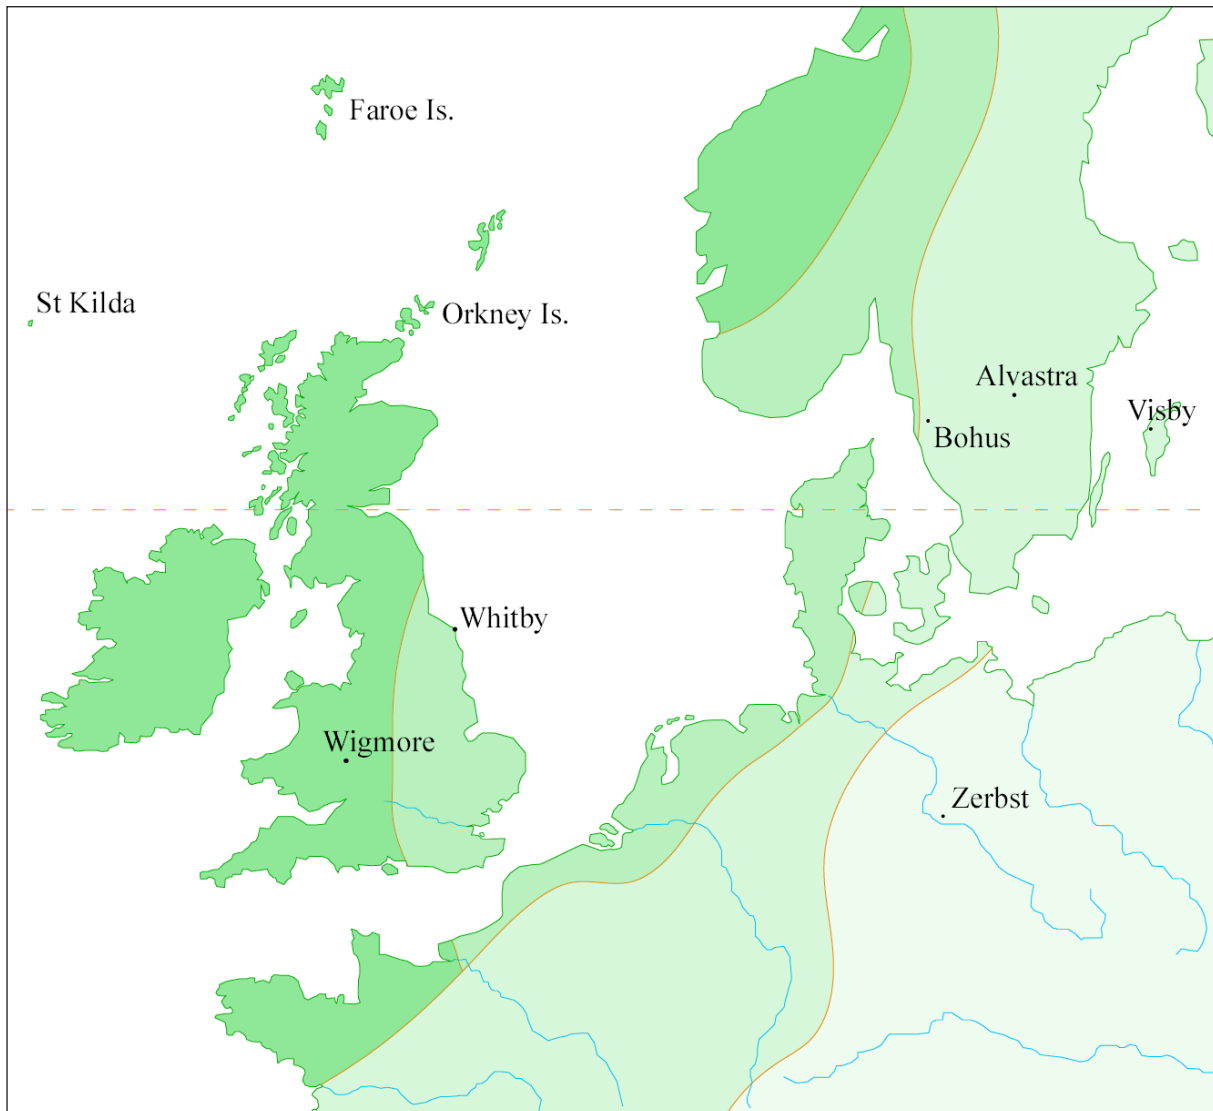
Fig. 2.2: Geographical distribution of conditions for mural vegetation in north-west Europe, with the darker colours representing the most benign conditions. The main southern distribution is after Segal (1969), the northern section a conjectural extension by the author based on the results of this research. The location of notable foreign sites is shown.

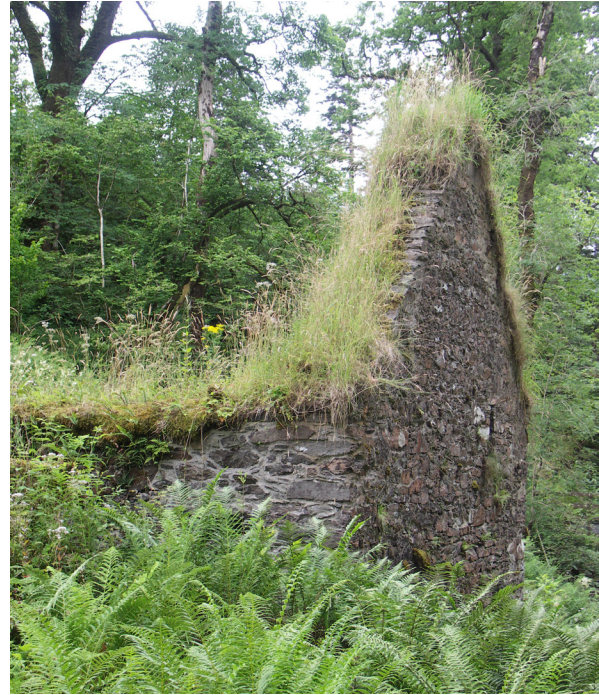
*Fig. 2.5: West Gable, the Old Mill, Ardkinglass, Argyll, species on the walls are in keeping with, but different from those in the surrounding area.*

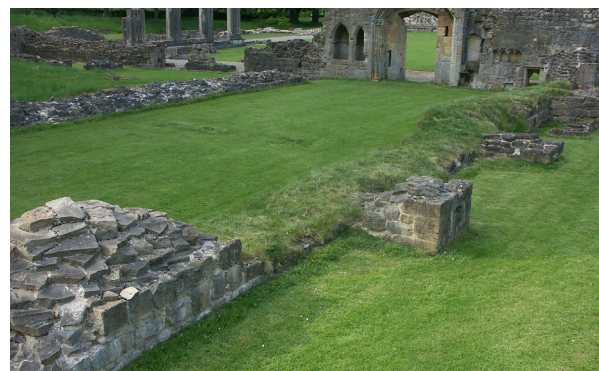
*Fig. 2.6: Hailes Abbey, Gloucestershire, England. Although they obscure the covered surface, soft cappings protect masonry from thermal cracking, leaching of soluble minerals, frost and mechanical damage. Though the core construction of the capped walls cannot be read, their form is clear as a result of the sites closely mown lawns.*

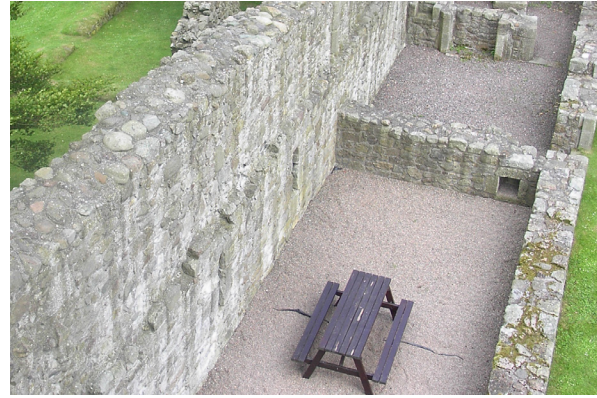
*Fig. 2.7: Loch Leven Castle, Kinross-shire. The consolidated wallheads do not preserve the original fractured masonry exactly as found, while focused rainwater run off results in unsightly surface staining. Note the natural colonisation by mosses of the lower walls, which do not have the domed profile of the higher wall consolidation*

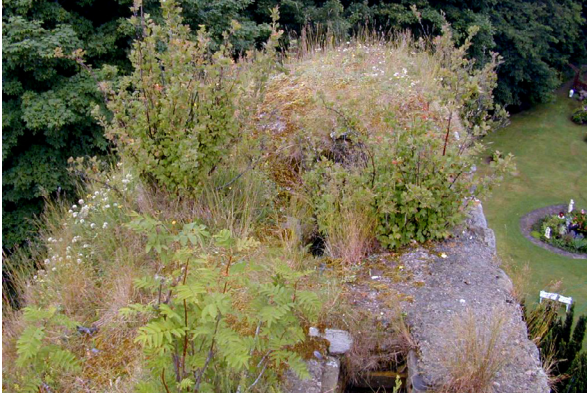
*Fig. 2.8: Drumlin Castle, Moray. The defective hard capping has developed frequent cracks, allowing uncontrolled natural colonisation by species with damaging woody roots. A well designed soft capping could control this relationship.*

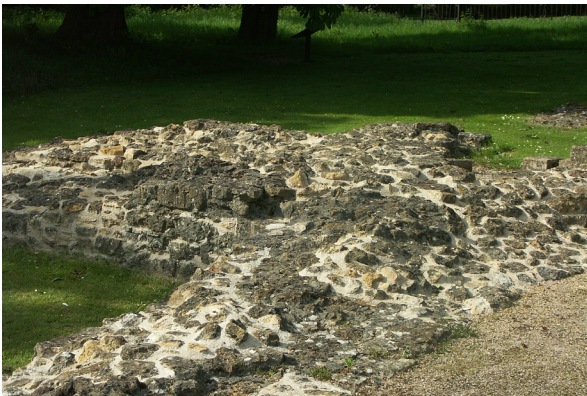
*Fig. 2.9: Hailes Abbey, Gloucestershire, England. Hydraulic lime repairs to cement hard caps can be difficult and expensive. The process of removing defective cement can also be very damaging to weaker stone types.*

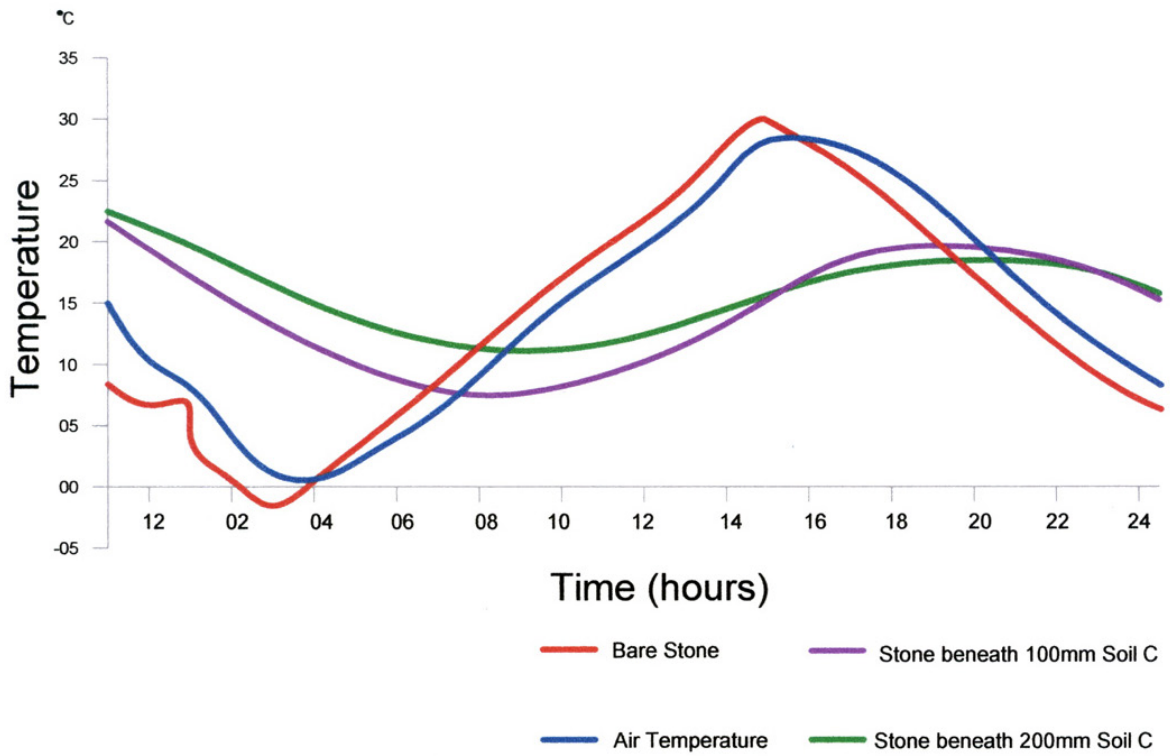
Fig. 2.10: Thermal flux in dry conditions (Viles, Groves & Wood, 2002.)

Soft cappings are also suitable as a remedial repair over older hard cappings. Tests by English Heritage have demonstrated that the isolative effect of soft cappings can moderate the differential thermal flux in such cappings sufficiently to inhibit cracking. This is important as it can be difficult and expensive to remove such hard cappings and further damage to historic fabric inevitably results from such intervention. In contrast, soft cappings are eminently reversible.

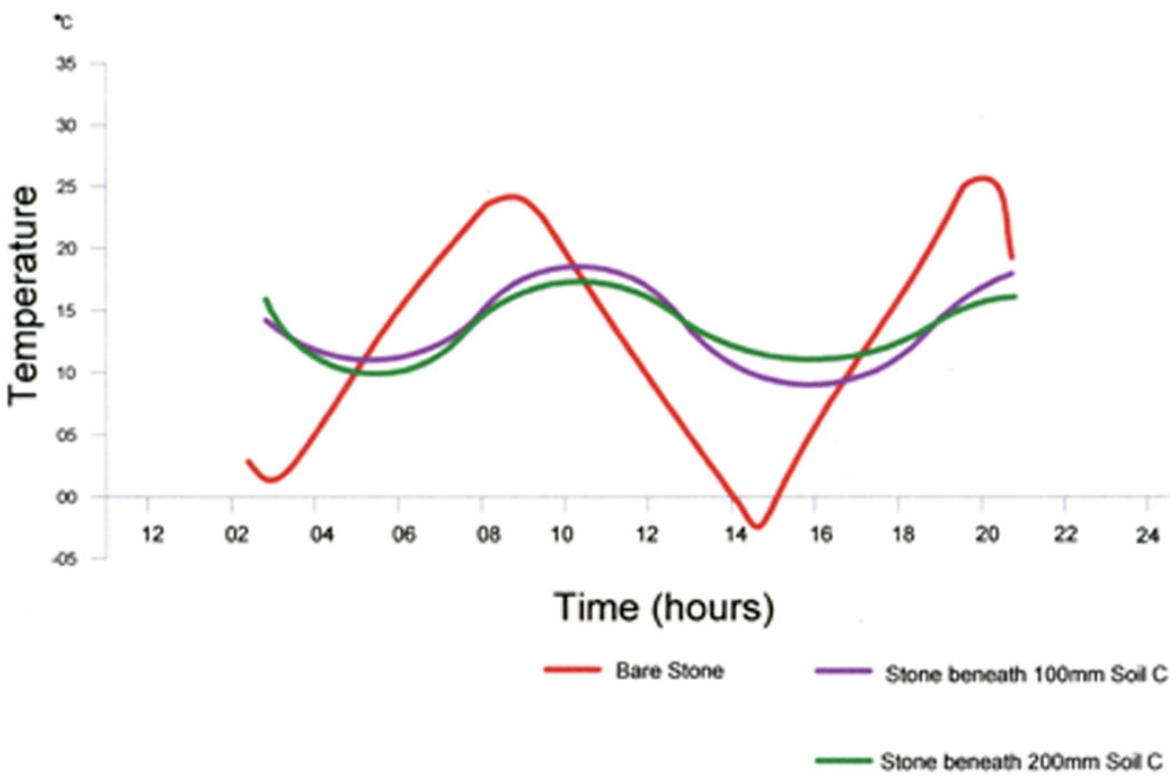
Fig. 2.11: Thermal flux in wet conditions (Viles, Groves & Wood, 2002).

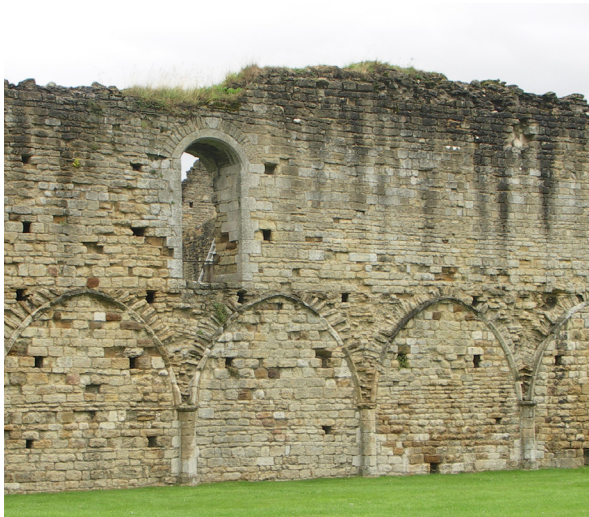
*Fig. 2.12: Kirkham Priory, Yorkshire. In tests, soft cappings have reduced rainwater runoff, lowering moisture levels on the upper face of the masonry wall. As a result, the dark stains of damp and associated microflora on the upper wall face have begun to fade.*

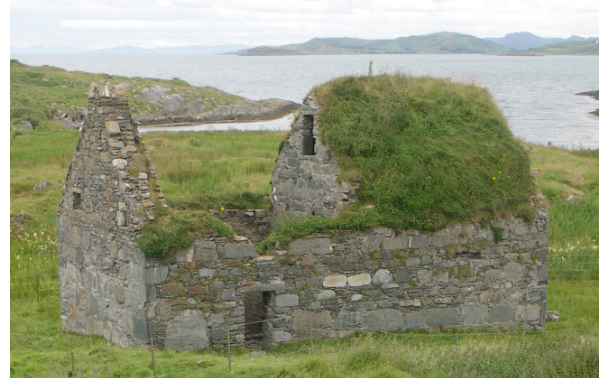
*Fig. 2.13: St. Cormac's Chapel, Eilean Mor, Argyll (CS1). The natural vegetation acts as a living thatch. The complex matrix of foliage disperses rainwater runoff, which is largely cast clear of the wall.*

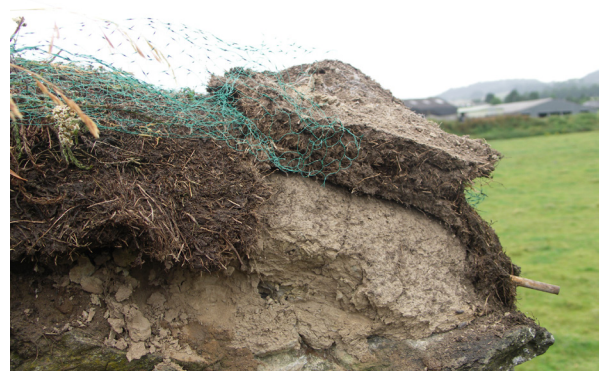
*Fig. 2.14: Black Castle of Moulin, Perthshire (CS13). Locally at an exposed end, the turf has died and clay dried out, though with only minor cracking.*

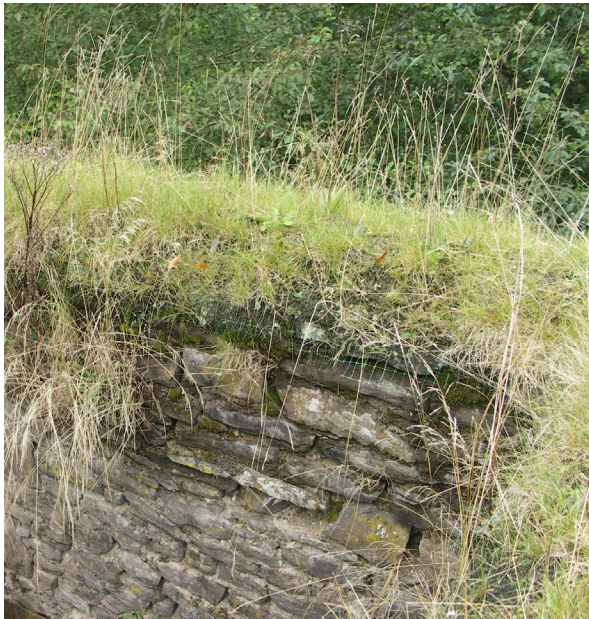
*Fig. 2.15: Doune Castle Mill, Stirlingshire (CS15). The clay and turf cap fails to prevent moisture penetration into the wallhead.*

In the natural cap, the soil was too thin and open textured to retain significant amounts of moisture, and the rainfall was able to penetrate the dense sloping sward.

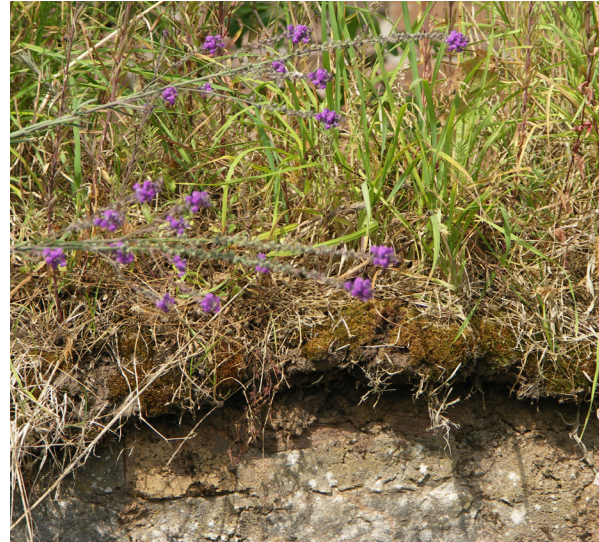
*Fig. 2.16: Hugh Miller's Cottage, Cromarty, Ross-shire (CS20). The thick mossy capping has a high capacity to absorb rainfall, while its projection of up to 50mm beyond the wall face effectively casts runoff clear.*

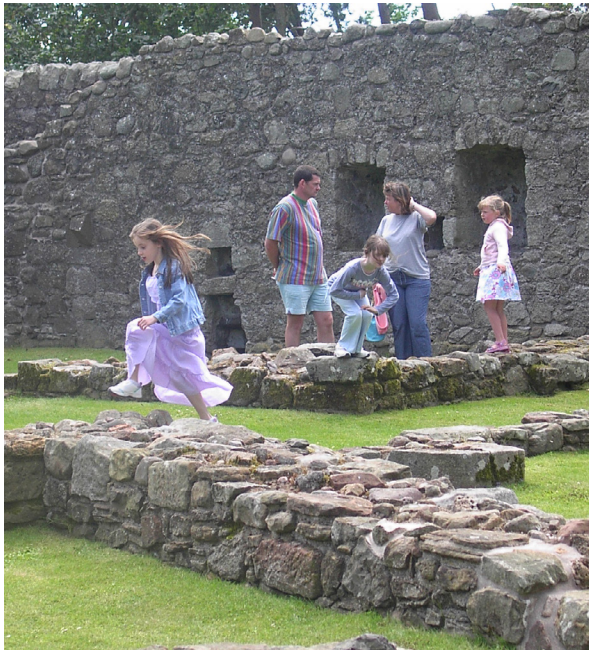
*Fig. 2.17: Loch Leven Castle. Kinross-shire, Even on a manned site, rough racked masonry can suffer under the feet of visitors.*

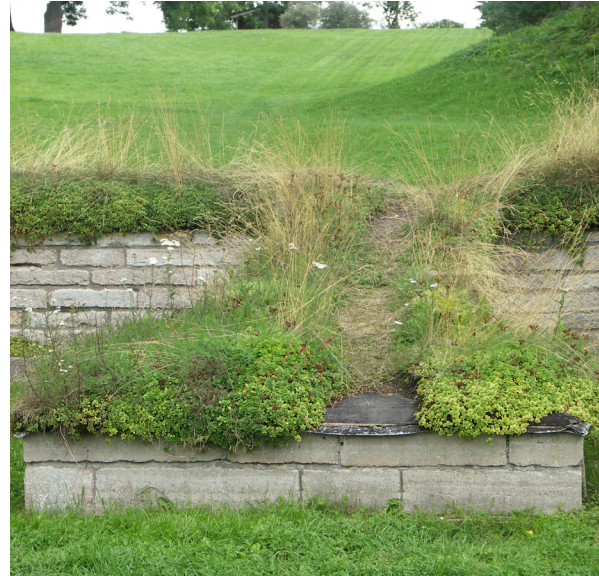
*Fig. 2.18: Alvastra Monastery, Sweden. Pedestrian damage tends to be on focused routes, with the central grass more resilient than the edge sedums.*

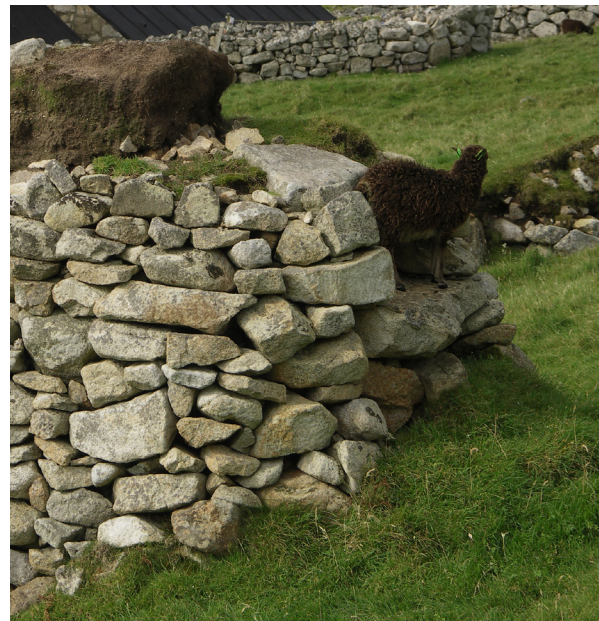
*Fig. 2.19: Cleit 23, St. Kilda (CS7). Progressive decay of the soft capping may have been initiated by damage from the feet of sheep climbing on to graze.*

At unenclosed rural sites, the feet of grazing sheep attracted onto monuments by the vegetation can cause damage to both masonry and soft cappings. On St. Kilda (CS7) the activities of sheep are thought to be a significant contributory factor to the onset of decay. However, another probably more typical site where sheep accessed the capping demonstrated the risk of damage to the masonry and capping to be small and far outweighed by the control sheep exerted over undesirable species (CS3).

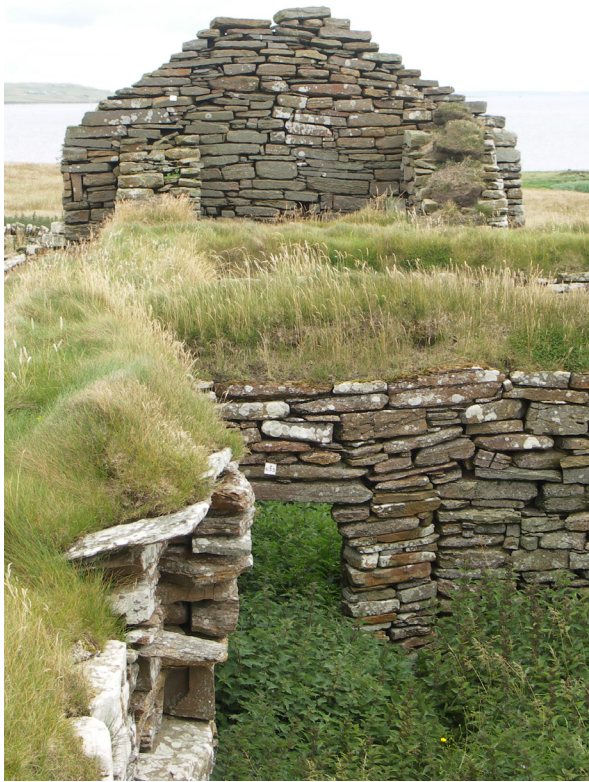
*Fig. 2.20: Eynhallow Monastery, Orkney (CS18). Soft cappings here act as a weak ring beam, restraining movement in vulnerable wallhead masonry.*

On severely exposed sites, soft cappings can significantly counter damage to masonry by wind uplift, especially on drystone or weakly mortared walls.

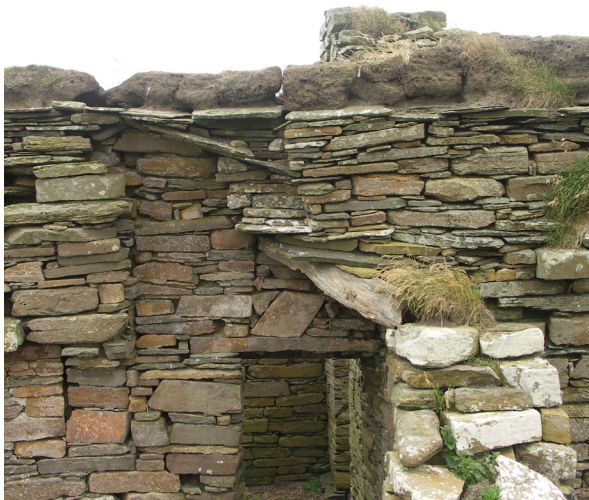
*Fig. 2.21: Eynhallow Monastery, Orkney (CS18). Even dead cappings can protect loose masonry by their weight.*

The 12th century Eynhallow Monastery (CS18) has a particularly vulnerable combination of an eroded clay mortar holding large flat wall capstones of thin sandstone, which may be significant as the remnant of the roof eaves course, in a location with severe wind exposure. Where the cappings are healthy, the rooty turf binds these stones in place, even when they are partly exposed, effectively acting as a ring beam to reinforce the wallhead. Where the cappings are in decay, their dead weight still had a marked effect in holding down stones that would otherwise soon be lifted off, exposing the vulnerable wall core.

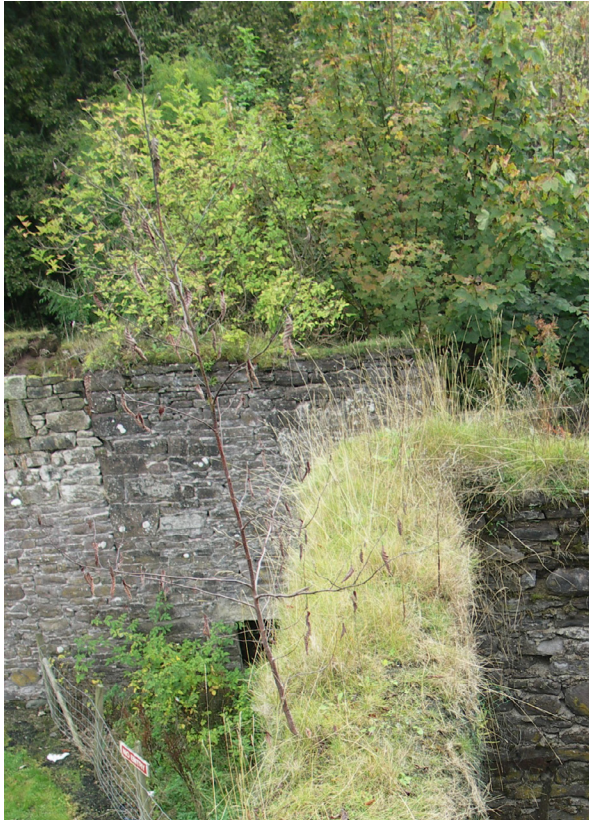
*Fig. 2.22: Doune Castle Mill, Stirlingshire (CS15). This isolated tree sapling would probably die naturally, but its removal would be prudent.*

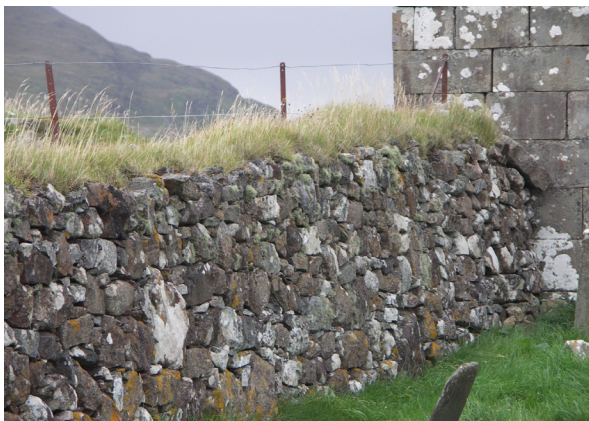
*Fig. 2.23: St. Clement's Church, Roghadal, Lewis (CS37). This unmaintained capping has achieved a stable balance of species.*

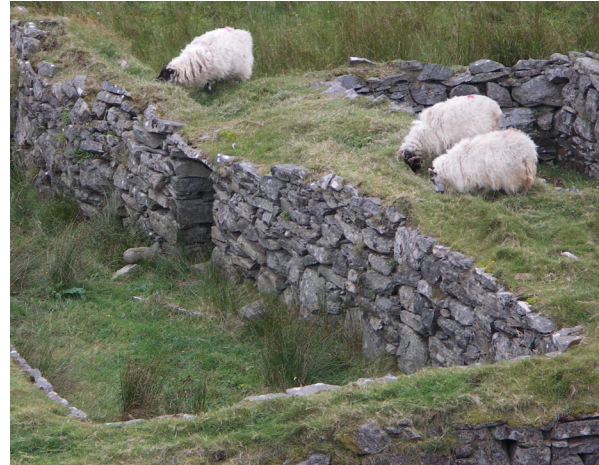
*Fig. 2.24: Blackhouses, Dun Carloway, Lewis (CS3). A good example of benign maintenance by grazing sheep.*

In some situations, where the cappings are low and wide, grazing by sheep can be an effective maintenance arrangement (CS3), though heavy grazing by rabbits on one site significantly accelerated decay of the capping (CS36) (see 3.6.2).

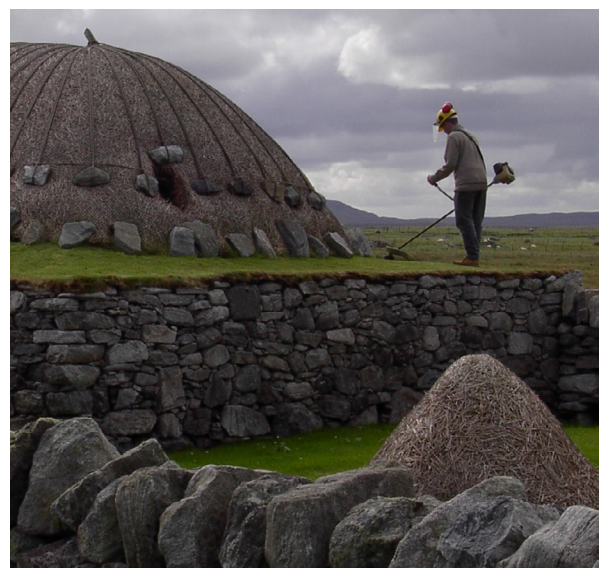
*Fig. 2.25: The Blackhouse, Arnol, Lewis (CS9). One of two sites where there was active maintenance.*

Two very popular sites receiving large numbers of visitors were actively maintained by strimming (CS9 and 10) and this was for aesthetic rather than technical reasons.

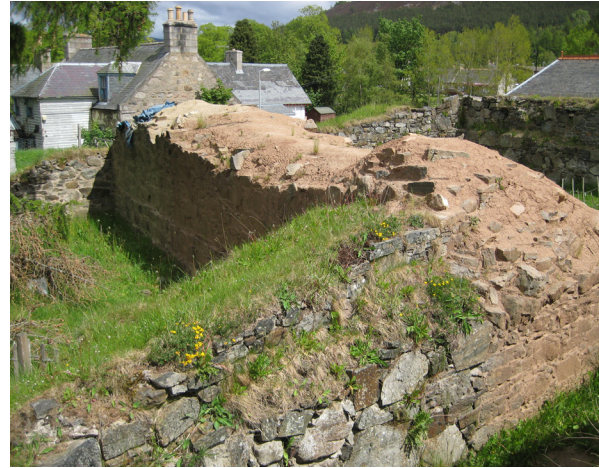
*Fig. 2.26: Braemar Castle. The masonry wall face on the right is stained by soil washed off the failed capping.*

Soft cappings can fail, usually through progressive edge dieback of the vegetation followed by slow erosion of the soil, but no evidence was found of local or complete failure causing any physically damaging effect on the masonry substrate.

A failing capping is unattractive and it is important to understand why failure is occurring. Failure can happen for a variety of reasons. In some rare cases the climatic and physical situation is simply not suitable to sustain the soft capping. More frequently, the materials, design or workmanship is not appropriate. Most often this is because conditions are too dry for the particular plant species.

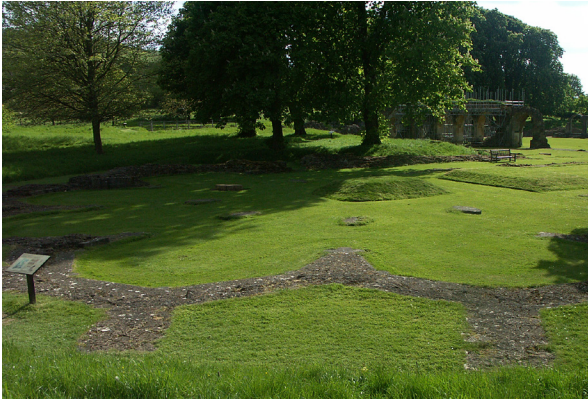
Fig. 2.30: Hailes Abbey, Yorkshire. The altar (centre right) has recently been re-buried, though its form still reads within the low-lying consolidated limestone wallheads, which remain more vulnerable to decay.

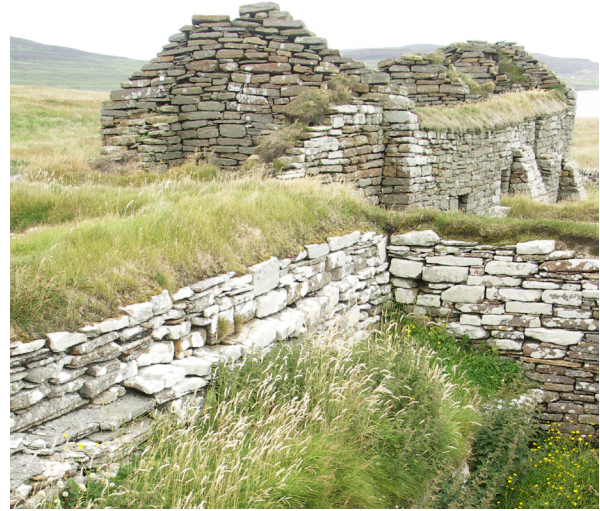
*Fig. 2.36: Eynhallow Monastery, Orkney (CS18). The wallhead vegetation is conservation soft capping from several periods, dating back probably to c.1920.*

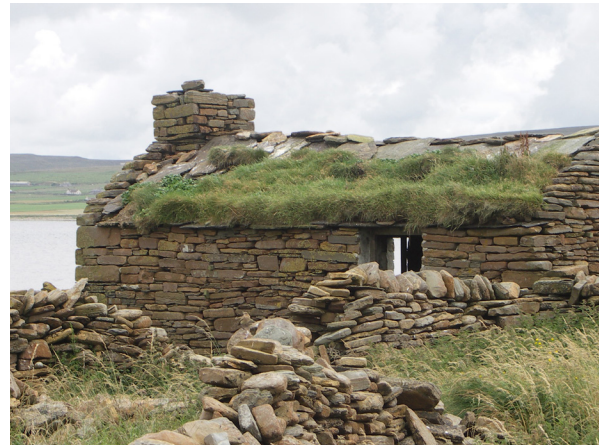
*Fig. 2.37: Ruined Cottage, Eynhallow, Orkney. Less than 1km from the monastery, the vegetation on this roof is a decaying part of the original roof construction of a cottage abandoned around 1851.*

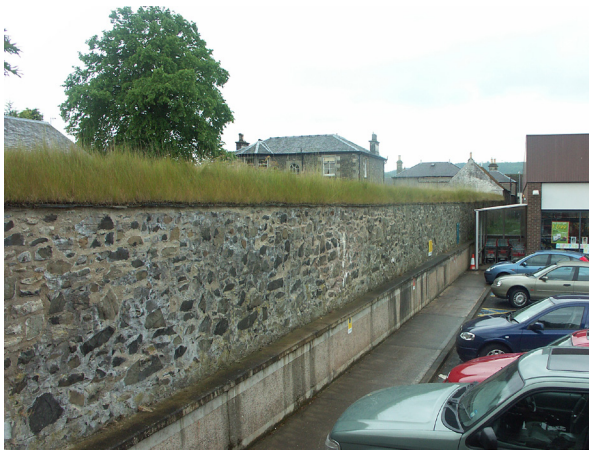
Fig. 2.38: Peebles Town Wall, Peebles, Peebles-shire. Commercial turf has resulted in low visual diversity, giving an even appearance, arguably appropriate for an urban setting.

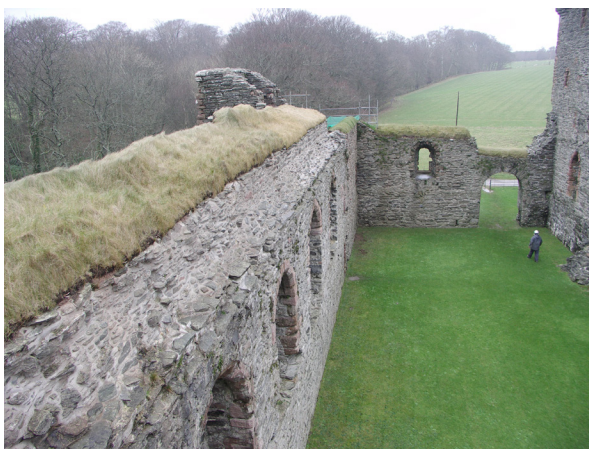
Fig. 2.39: Skipness Castle, Argyll (CS35). A turf capping cut from the grazed field in the background has limited diversity, but arguably link the building to its setting and is in tune with the lawned monument grounds.

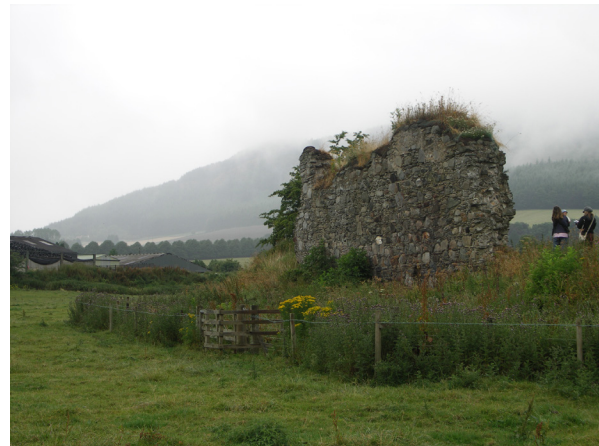
Fig. 2.40: Black Castle, Perthshire (CS13). The conserved cappings echo the botanical context, though this has become more overgrown since grazing cattle were excluded.

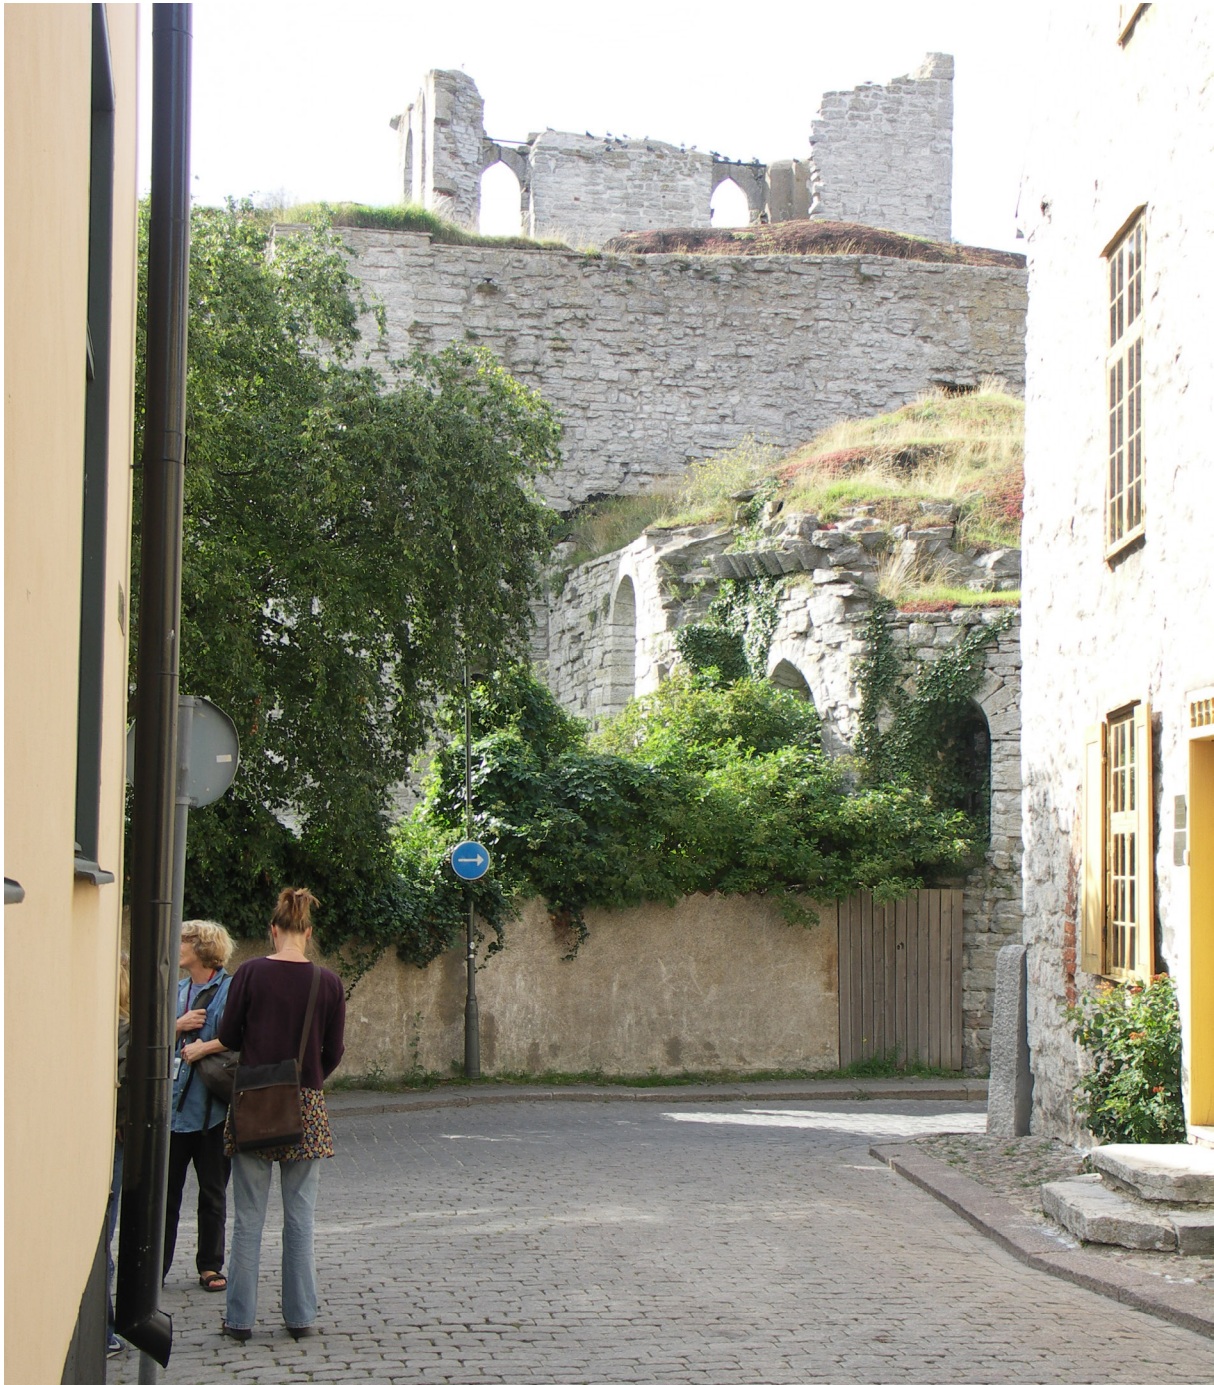
*Fig. 2.41 : St. Lar's Church, Visby, Sweden. One of a series of soft capped ruins in an historic urban setting.*

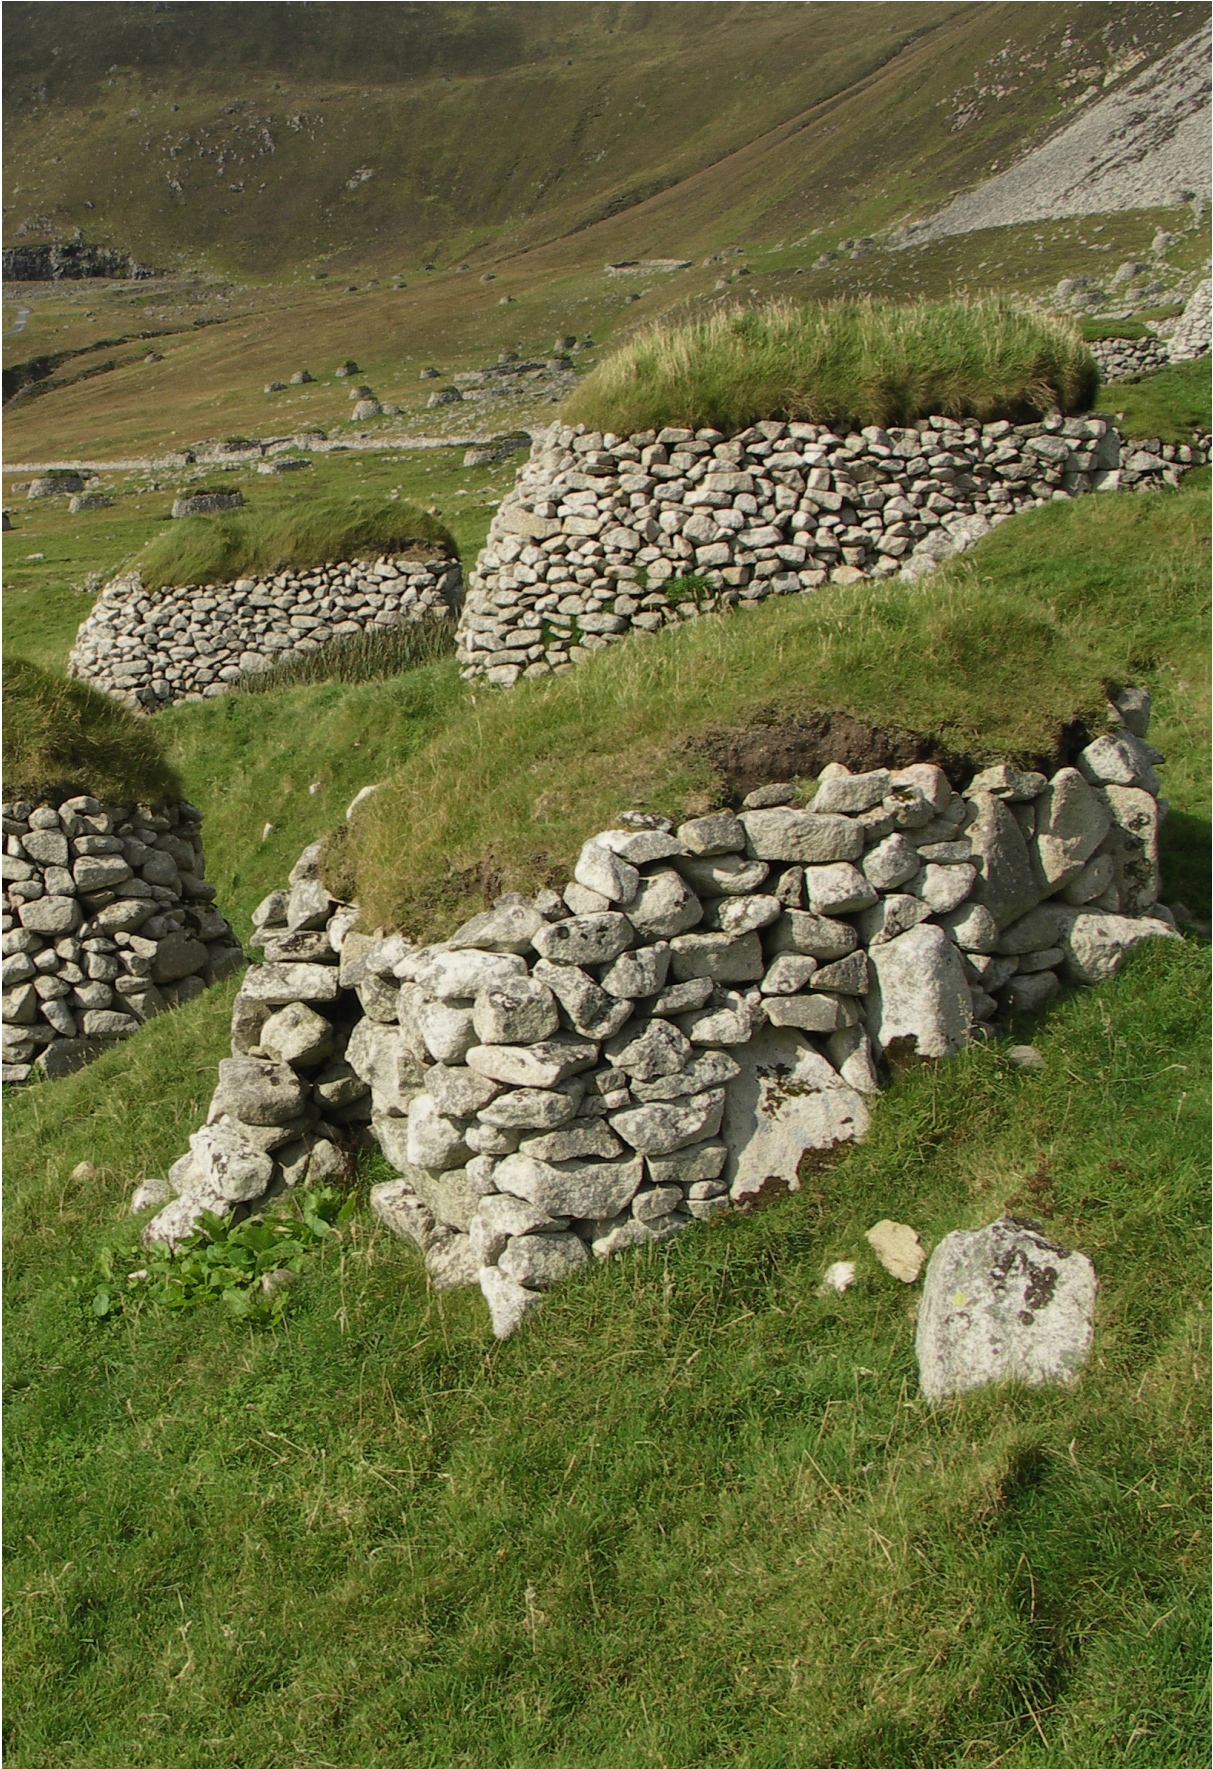
*Fig. 3.1: Cleitean, St. Kilda, Western Isles. Performance of individual cappings varies dramatically for reasons that are not fully understood.*

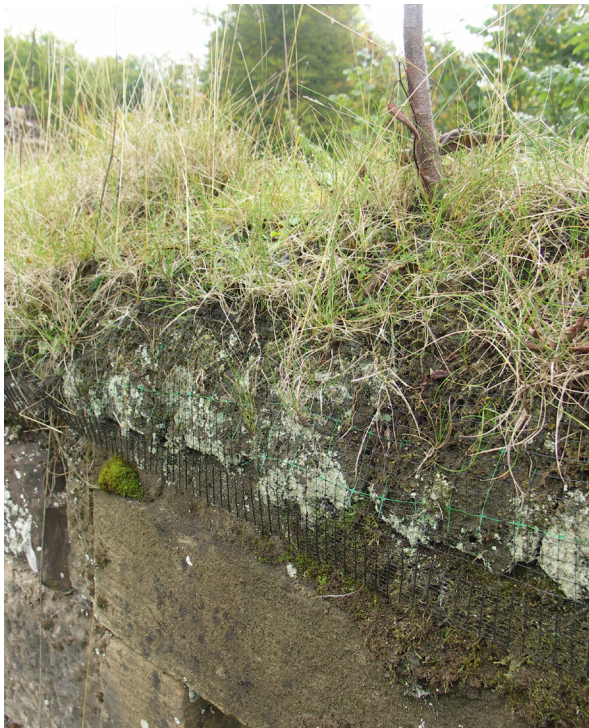
*Fig. 3.2: Doune Castle Mill, Stirlingshire. High levels of moisture seem to have inhibited growth, especially at the edge.*

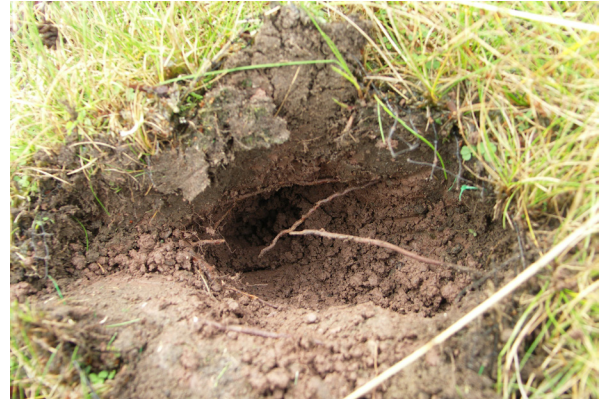
*Fig. 3.3: Doune Castle Mill, Stirlingshire. While the surface of the clay soil was very wet, the core was still crumbly. The core stores and releases moisture over a long period, while the thin plant cover struggles to retain rainwater, perhaps causing high edge runoff.*

One of the two sites (both water mills) that had particularly damp conditions seemed to define an upper limit for moisture levels. Though it does not have the highest rainfall, Doune Castle Mill (CS15) has low evapo-transpiration created by shade, wind shelter and a short sward. The core of the clay cap remains moist through the summer, though the surface saturates in heavy rain. In winter the caps are likely to be wet through and this level of moisture seems to have retarded plant growth, which is low and thin. In one area of high deciduous shade, only moss grew and the clay cap was sliding off slopes.

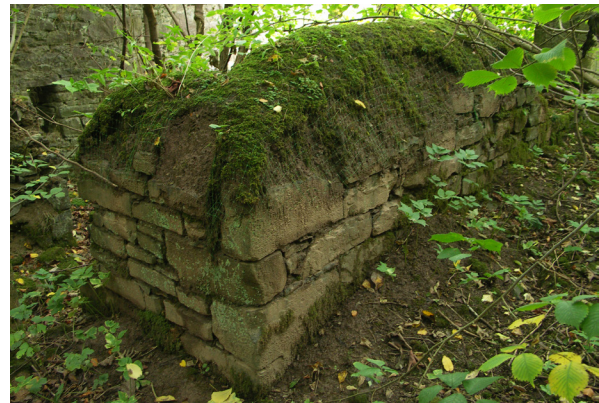
*Fig. 3.4: Doune Castle Mill, Stirlingshire. A shaded cap is unable to sustain vegetation other than moss, with the clay saturated and sliding off steep sections.*

Adequate levels of light are necessary for plant growth and these are generally available in Scotland, except in heavily shaded areas such as shown in Fig.3.4. Elsewhere, there were indications that in the relatively dry east, some shade can be beneficial to reduce evapo-transpiration in summer.

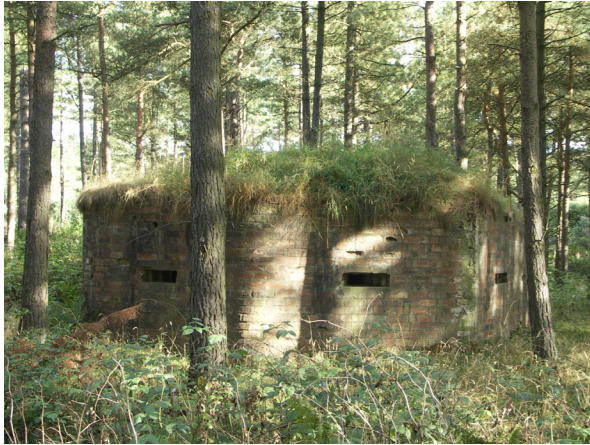
Fig. 3.5: WW2 Pillbox, Fife (CS12). The woodland shade reduces wind exposure and solar radiation and increases relative humidity.

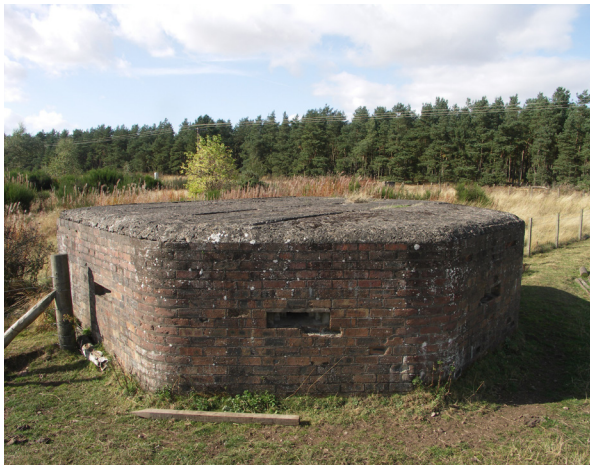
Fig. 3.6: WW2 Pillbox, Fife. High solar exposure, along with wind exposure and density of the substrate, has contributed to complete loss of the capping.

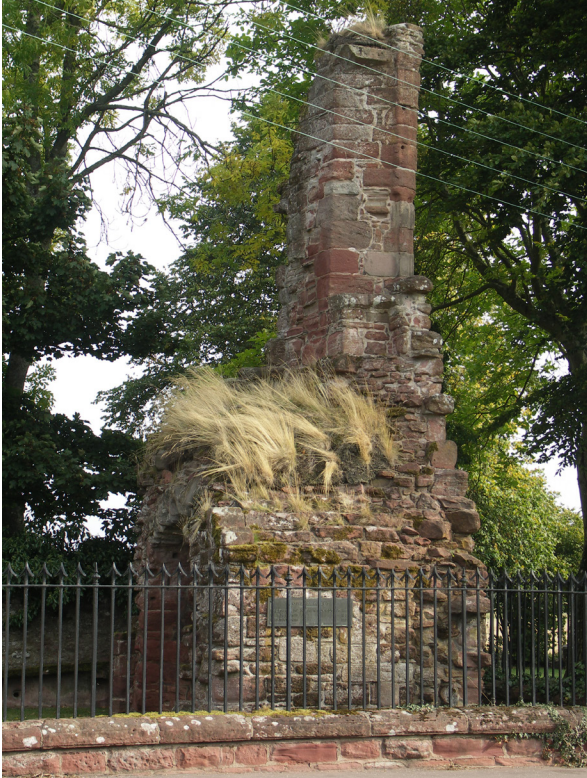
*Fig. 3.8: Coupar Angus Abbey, Angus. The west facing side is exposed to much more solar radiation than the rest of the capping, resulting in local dieback.*
