SOFT CAPPING IN  
SCOTLAND

The context and potential  
of using plants to protect  
masonry

VOLUME 1

Historic Scotland  
© Crown copyright  
Edinburgh 2011

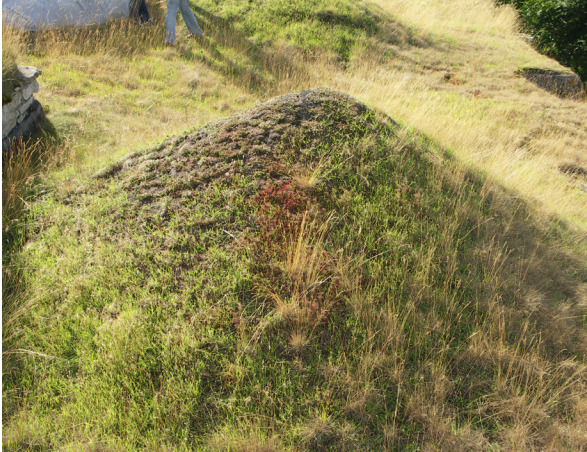
*Fig. 3.9: St Nikolais' Church, Visby, Sweden. The effect of orientation on a site with high solar exposure and little ability to store moisture: sedum mats are failing on the south side, but stable on the north of shallow domes.*

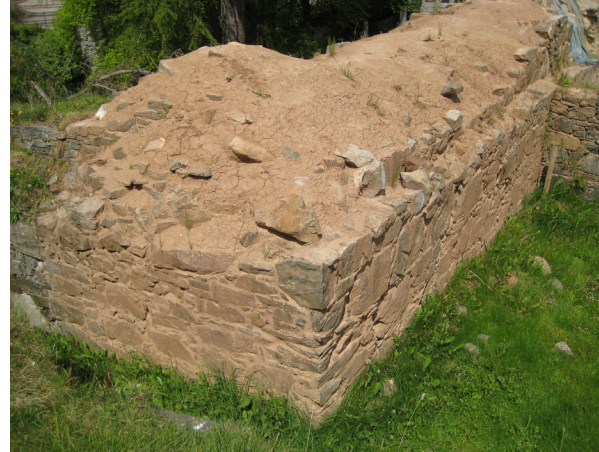
*Fig. 3.10: Braemar Castle, Aberdeenshire. Following complete failure of the vegetation, the clay cap has dried and cracked. Such a surface could be colonised by more appropriate species in time.*

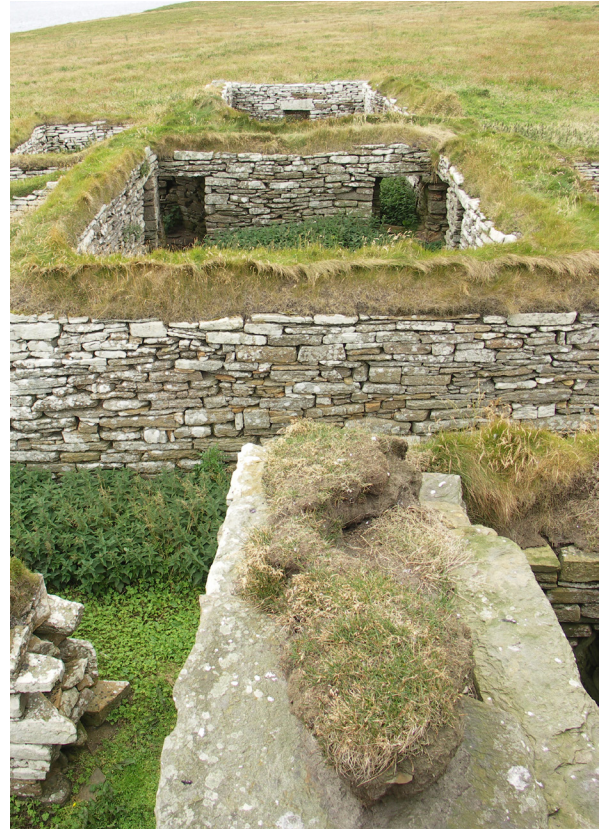
Fig. 3.12: Eynhallow Monastery, Orkney (CS18). The effect of elevation on cappings about seventy-five years old. In this location, wind gives any capping at high level a limited lifetime, irrespective of other factors.

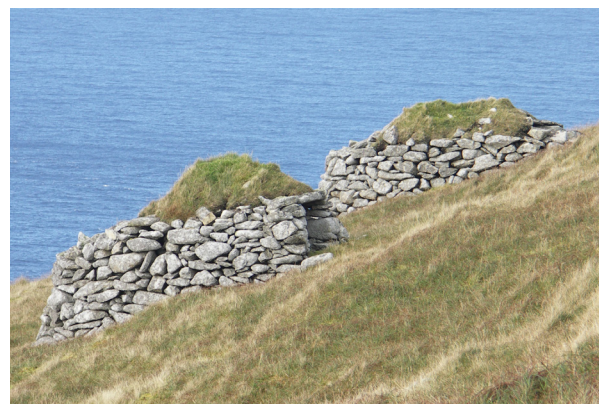
Fig. 3.13: St. Kilda, Western Isles (CS7). Cappings that are thought to be at least a hundred years old, at 600m altitude, west facing, yet proving stubbornly resilient to North Atlantic winds.

The particularity of each site is demonstrated by the vernacular cappings on St. Kilda, which has the highest wind exposure in the British Isles, with gale force winds (39 mph) recorded on one in four-and-a-half-days, and isolated wind speeds of over 120 mph. In this case, the effects of the severe winds were apparently significantly retarded by the densely developed root system, which bound the soil even when the vegetation has died.

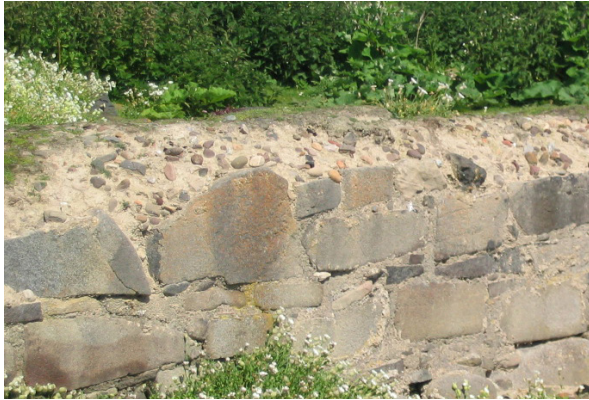
Fig. 3.14: Isle of May, Fife (CS36). Large stones in the capping soil, exposed by accelerated wind erosion of the soil.

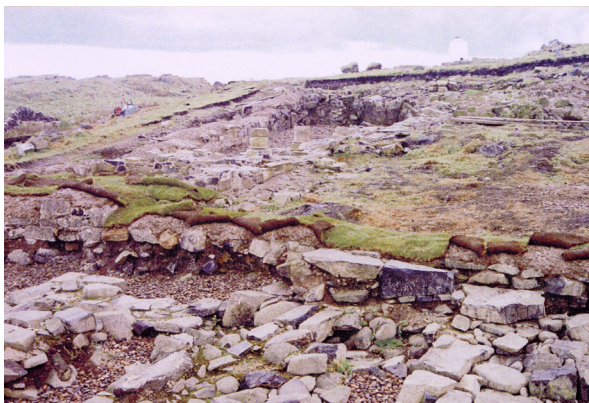
Fig. 3.15: Isle of May, Fife (CS36). Uplift from helicopters delivering materials lifted turfs off the caps during the works.

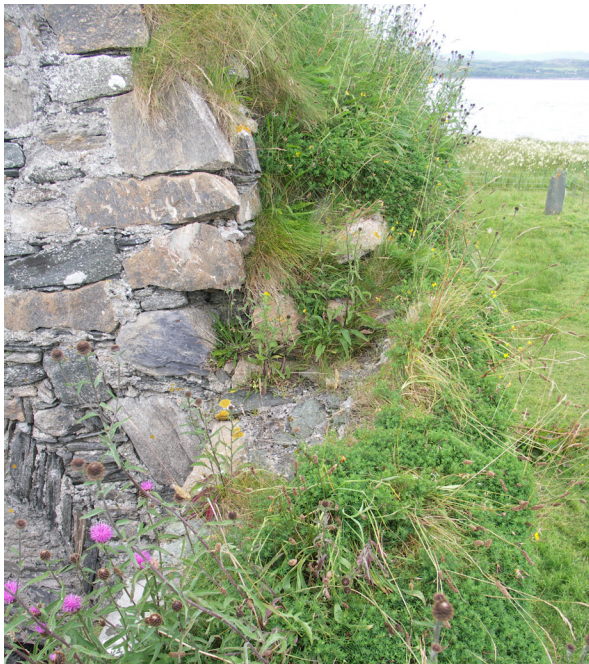
Fig. 3.16: St. Cormac's Chapel, Eilean Mor, Argyll (CS1). Localised effects are hard to predict. Wind currents here focus on an inner corner of the capping, scouring away any soil, while the exposed outside edge has stable, thick growth.

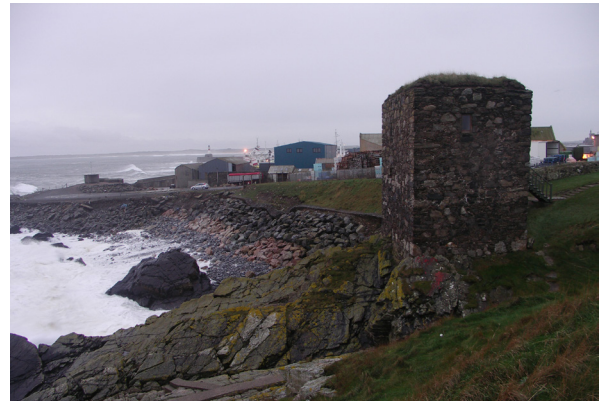
Fig. 3.17: The Wine Tower, Fraserburgh (CS39). An example of high exposure to air-borne salts.

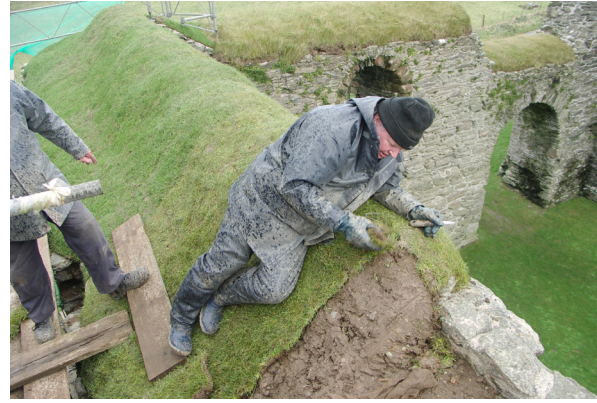
Fig. 3.18: Skipness Castle, Argyll (CS35). The soft capping varies in depth to provide a regular, water-shedding surface.

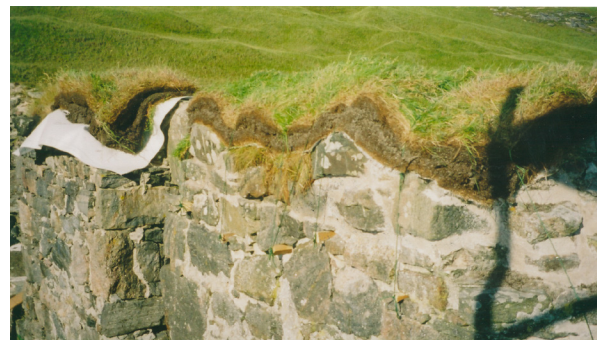
Fig. 3.19: Pabbaigh, Western Isles (CS33). The soft cappings, two layers of turf, root to root, are worked into the sockets left by decayed timber rafters. A permeable geotextile membrane, used as a defining layer, can be seen being installed on the left.

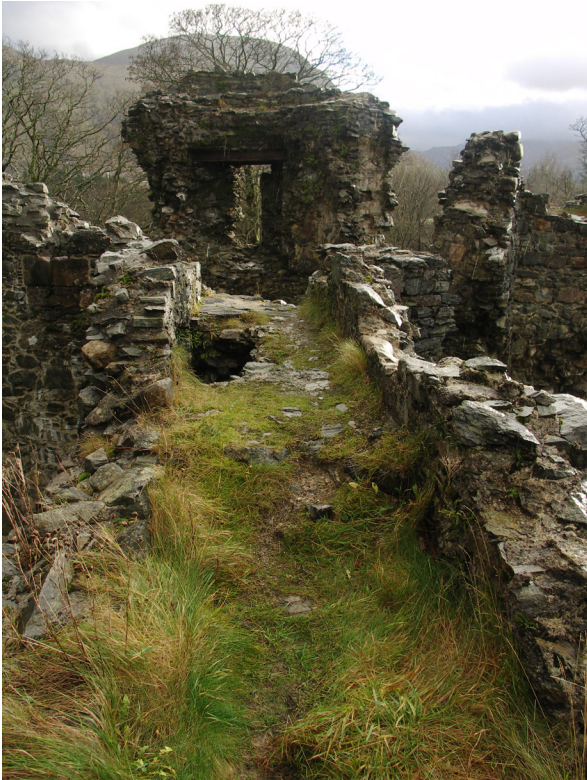
*Fig. 3.20: Inverlochy Castle, Inverness-shire (CS21). The cappings are applied to the walkway surface but not to the parapets.*

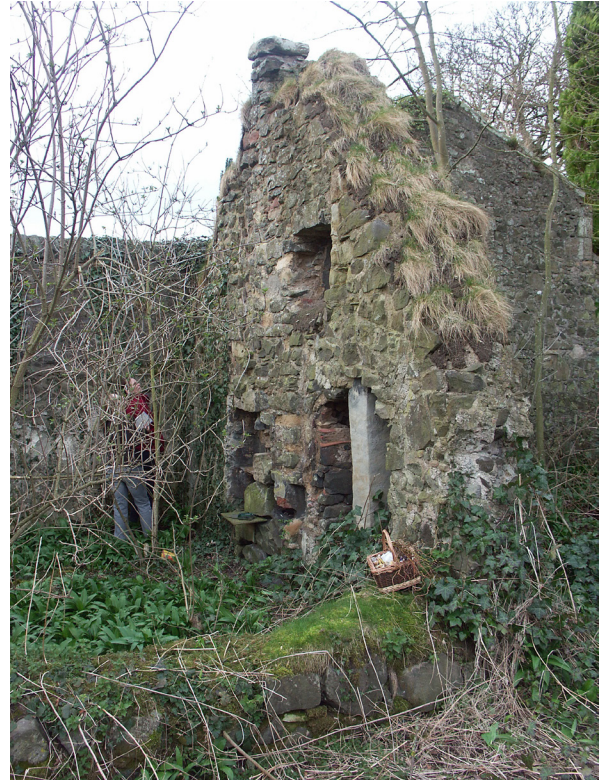
*Fig. 3.22: Monimail Tower, Fife (CS27). Cappings on the gable have tended to stabilise onto shallower inclines, as a series of stepped cappings.*

Gables combine the stress conditions of narrow and inclined surfaces and soft cappings were often found to have partially or completely failed on gables at sites that had successful cappings on other surfaces. Where gable cappings partially succeeded, the cappings tended to stabilise into a series of steps relating to the underlying masonry surface.

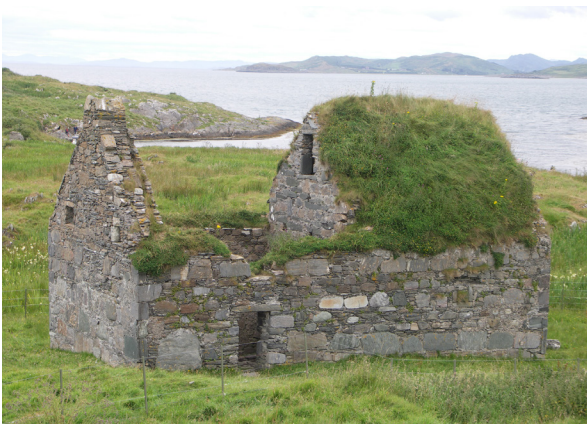
*Fig. 3.21: St. Cormac's Chapel, Eilean Mor, Argyll (CS1). Although the large inclined, and narrow flat surfaces are naturally colonised, the narrow, inclined gable remains essentially bare.*

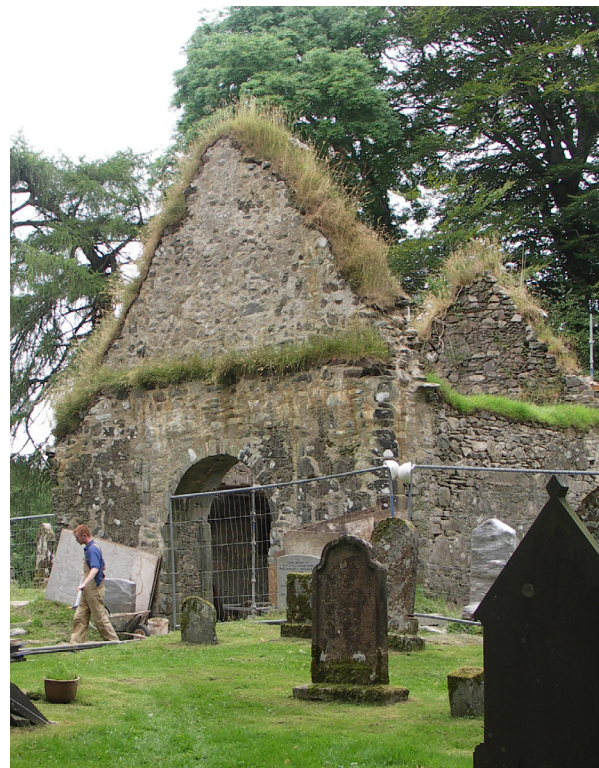
*Fig. 3.23: Kilmory Chapel, Argyll (CS23). The mild, sheltered conditions on this site allow the steep gable in front to be successfully capped. The rear gable still retains its natural vegetation.*

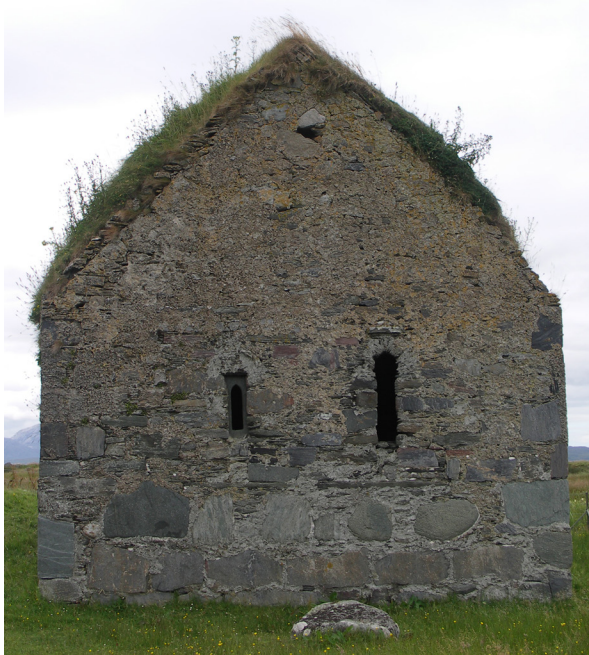
*Fig. 3.24: St. Cormac's Chapel, Eilean Mor, Argyll (CS1). The capping thins towards the ridge and eaves.*

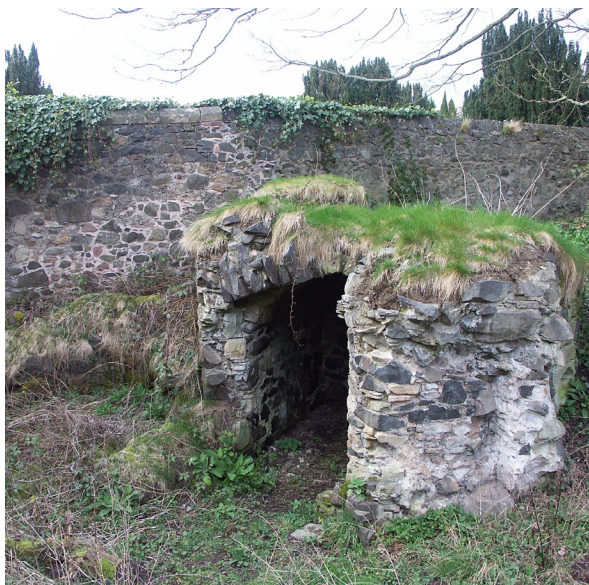
*Fig. 3.25: Monimail Tower, Fife (CS27). The flat upper surface allows some moisture to penetrate through the capping. A thicker clay layer might have adequately improved performance.*

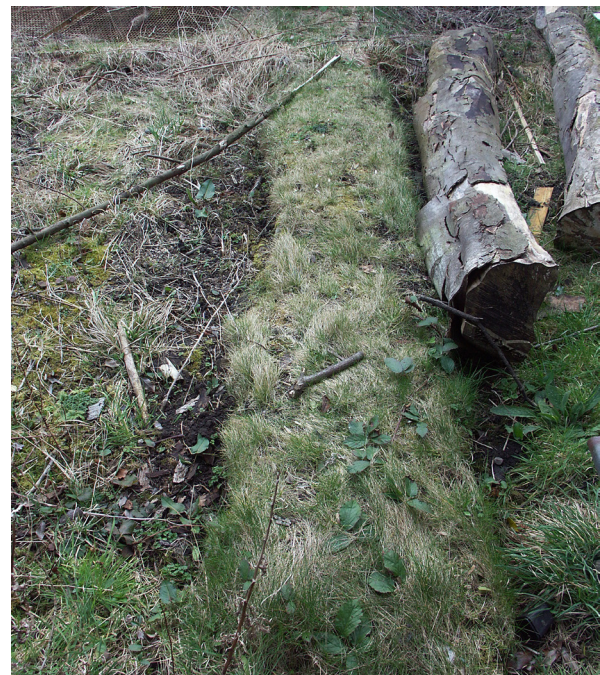
*Fig. 3.26: Monimail Tower, Fife (CS27). An excavated wallhead protected by soft cappings.*

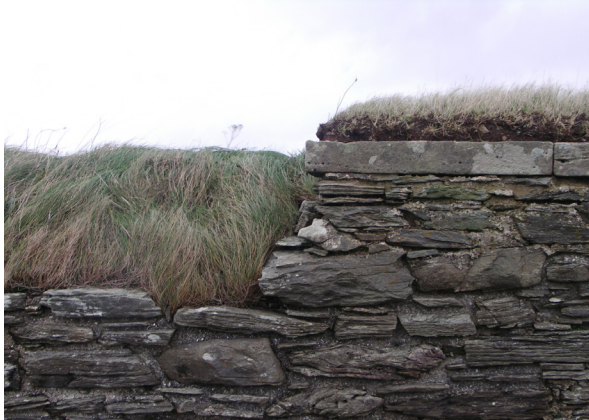
Fig. 3.27: Kilbrannan Chapel, Argyll (CS22). The smoothness of the dressed cope edges meant the soft capping stabilised ~50mm back from the edge, a feature not found on the rough raked wallhead.

The surface texture of the substrate was found to generally have a minor effect, but was more significant where it was very smooth, or on a steep incline.

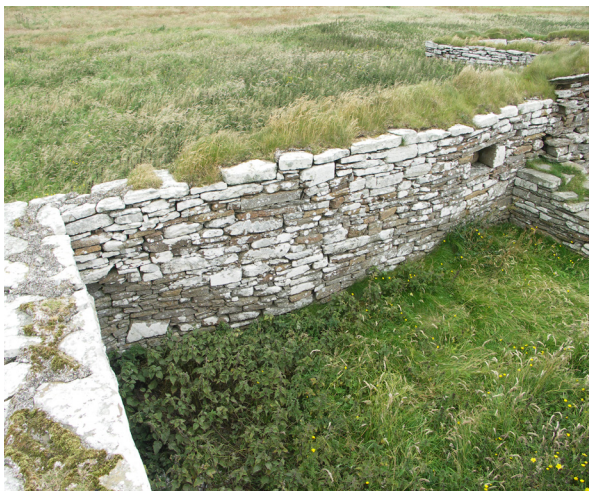
Fig. 3.28: Eynhallow Monastery, Orkney (CS18). Surface texture created by lime mortared stones fails to prevent wind decay.

Attempts to improve wind resistance by increasing surface texture were only partially successful, appearing to slow rather than prevent loss.

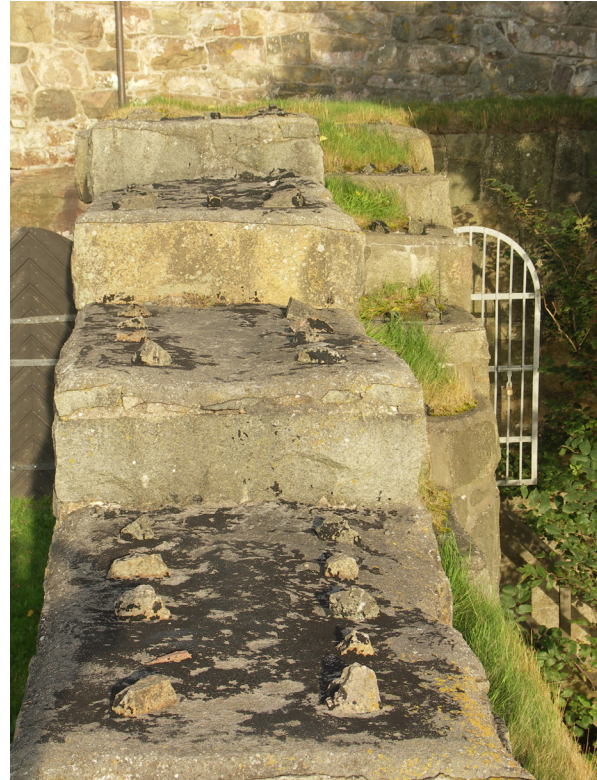
Fig. 3.29: Varberg Fortress, Sweden. Textured wallhead with bitumen remnants failed to withstand wind decay

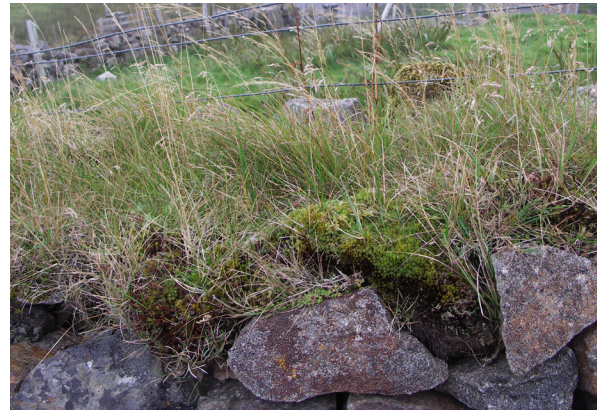
Fig. 3.30: St. Clement's Churchyard, Roghada, Western Isles (CS37). The vernacular soft cappings bind the drystone masonry at the vulnerable wallhead.

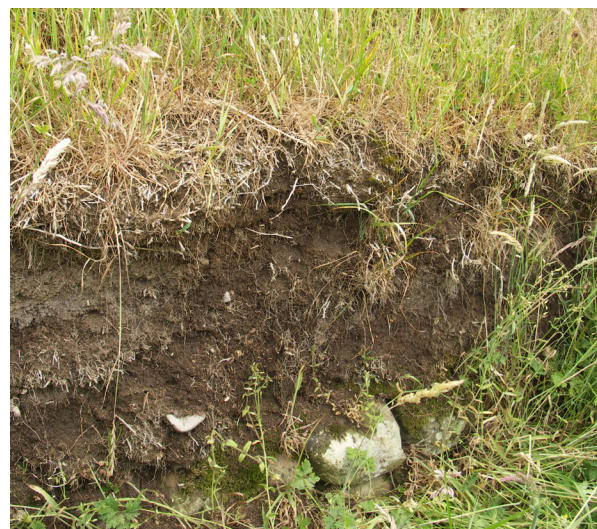
Fig. 3.31: Leannach Enclosure, Culloden, Inverness-shire (CS6). The turf walls sustain good living wallheads, but little vegetation grows on the face.

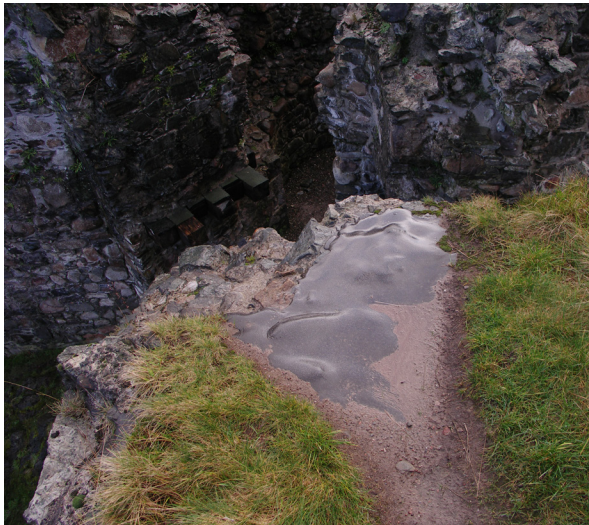
Fig. 3.32: Inverlochy Castle, Inverness-shire (CS21). Asphalt coated concrete cappings revealed after erosion of the soft capping by pedestrian traffic.

Several of the examples were onto hard caps, which had not performed well, and here the intention of soft capping was as much to conceal the cement as to reduce damage from moisture ingress and thermal expansion. Bitumen coatings onto such caps did not seem to make a major difference. Soft cappings over concrete seemed more vulnerable to mechanical damage, especially from pedestrian traffic.

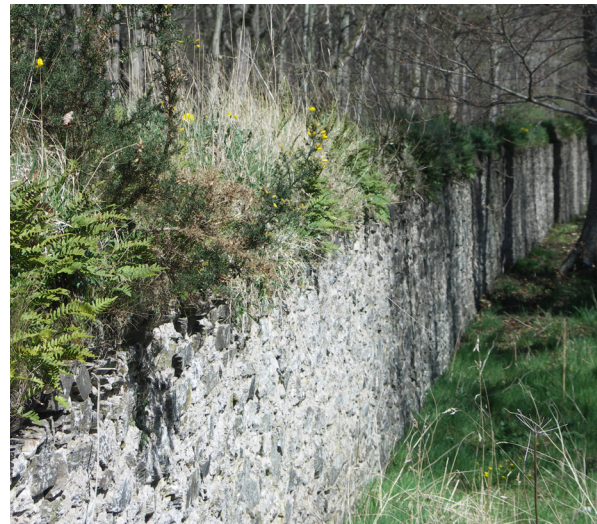
Fig. 3.33: Gordon Castle Estate, Moray (CS4). A bio-diverse setting, for mature, un-maintained soft cap.

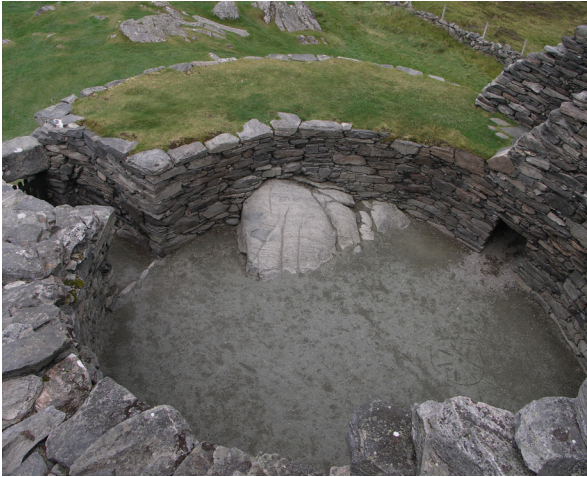
Fig. 3.34: Dun Carloway Broch, Western Isles (CS17). A low bio-diversity setting with an exposed cap, suppressed by strimming.

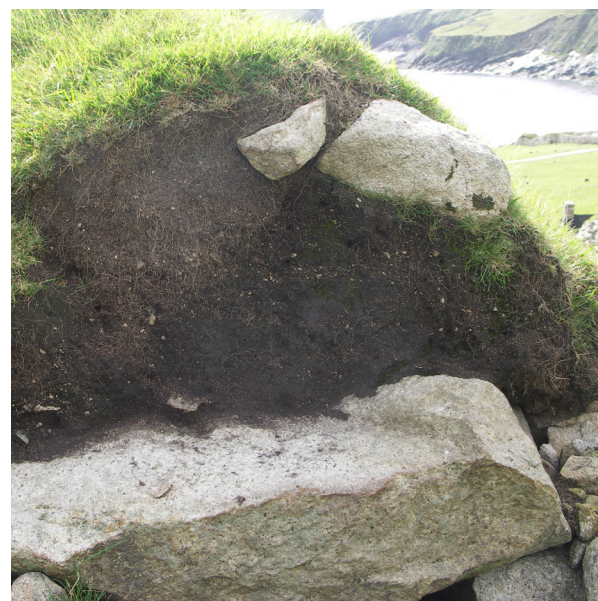
Fig. 3.35: Cleitean, St. Kilda, Western Isles (CS7). Red Fescue creates a root-dense mat.

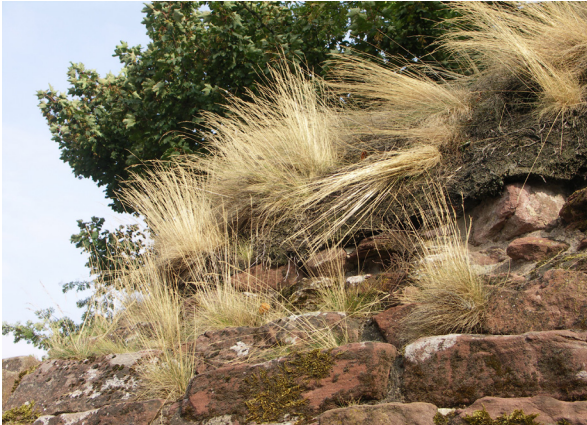
Fig. 3.36: Coupar Angus Abbey, Angus. Sheep's Fescue stands as distinct clumps.

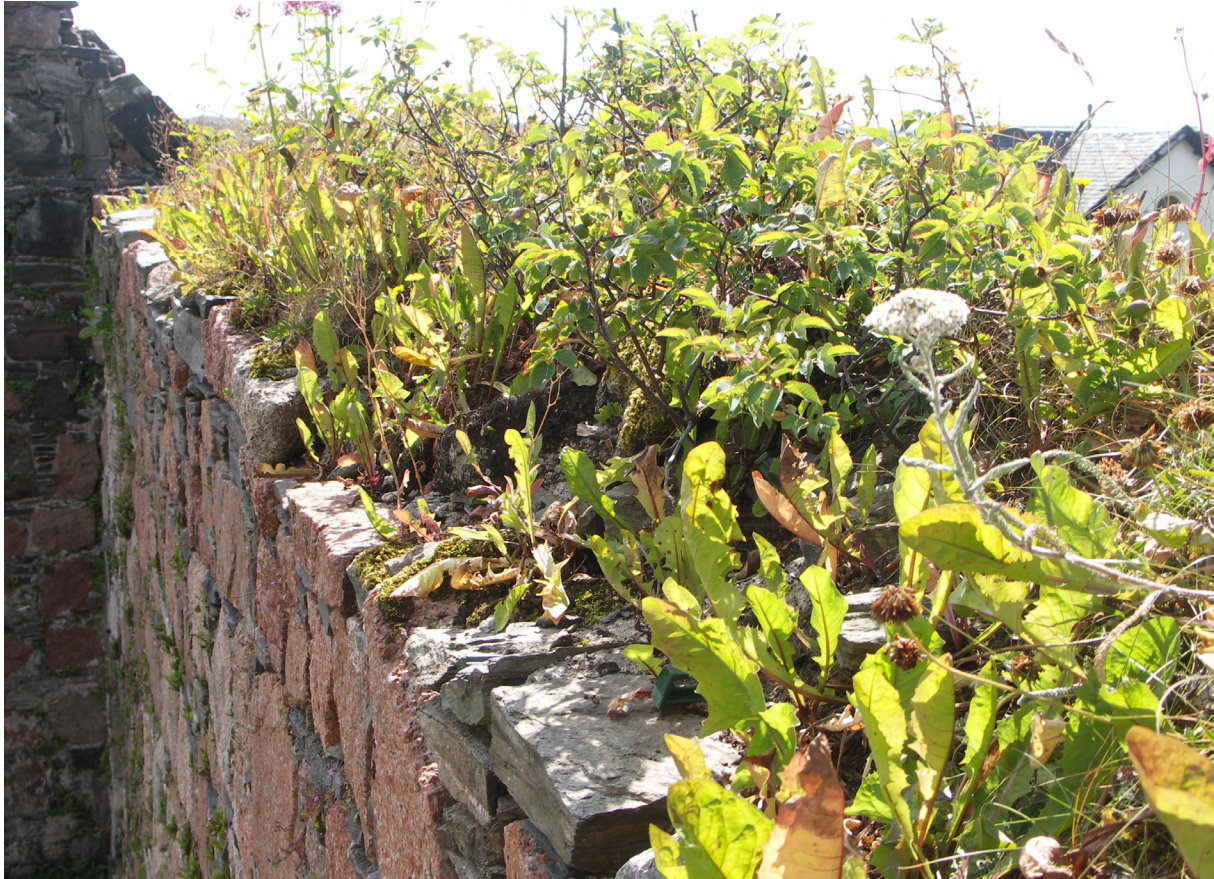
*Fig. 3.38: The Nunnery, Iona, Argyll (CS28). Removal of natural caps has allowed colonisation by roses and dandelions, whose penetrating roots will damage the masonry.*

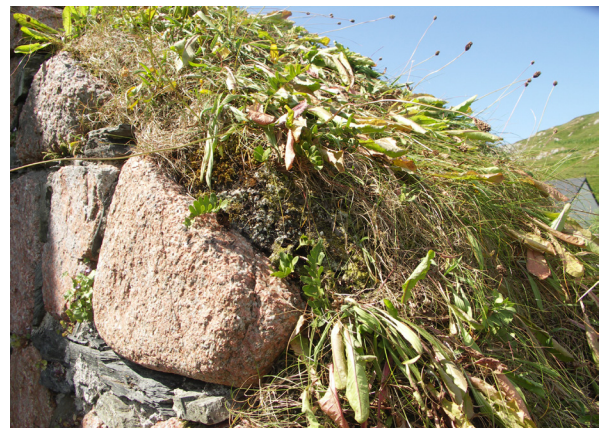
*Fig. 3.37: The Nunnery, Iona, Argyll (CS28). Ribwort Plantain among natural cappings.*

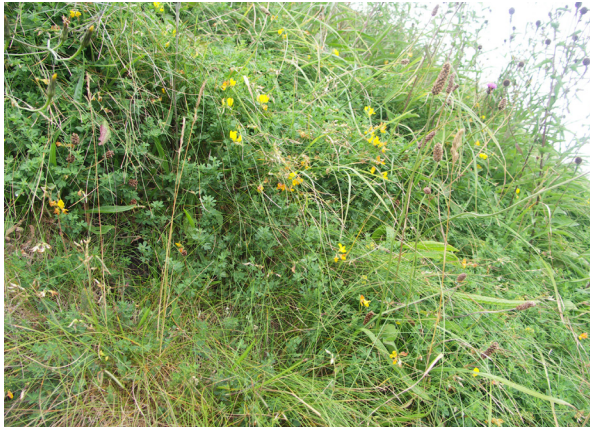
Fig. 3.39: *St. Cormac's chapel, Eilean Mor, Argyll*. Diversity of ruderals and herbs gives great visual interest.

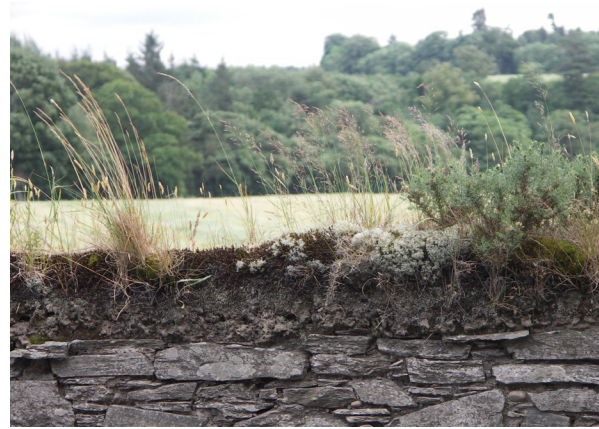
Fig. 3.40: *Gordon Castle Estate Wall, Moray (CS4)*. Mosses form a stable central cap, augmented by lichen, through which grasses rise thinly.

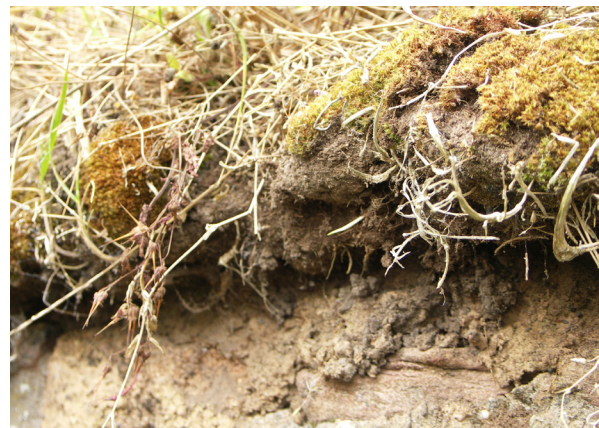
Fig. 3.41: *Hugh Miller's Cottage, Cromarty (CS20)*. Mosses form a thick mat, especially at the edges.

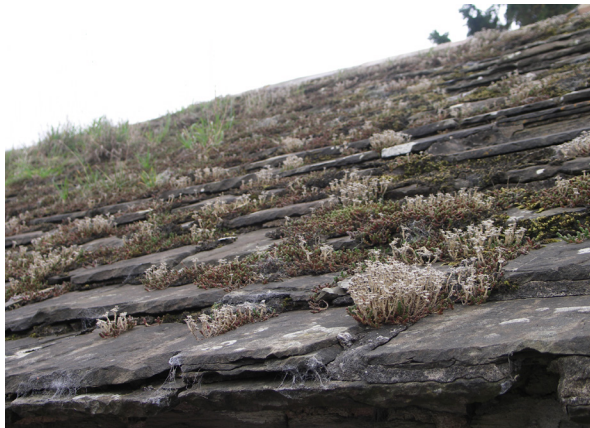
*Fig. 3.42: Sedum alba naturally established on a sandstone slate roof in Angus.*

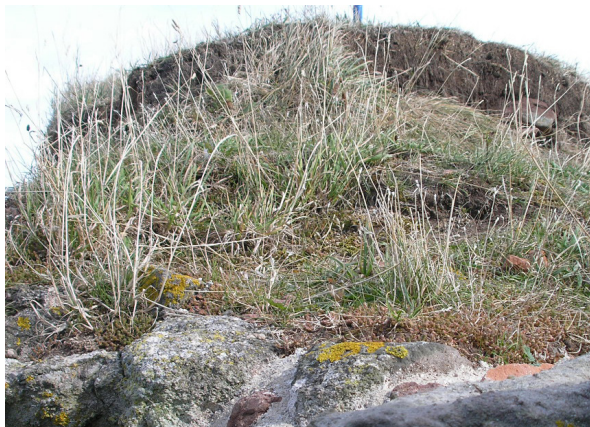
*Fig. 3.43: Sedum alba stabilising a sloping edge at Cressford Castle, Roxburghshire (CS2).*

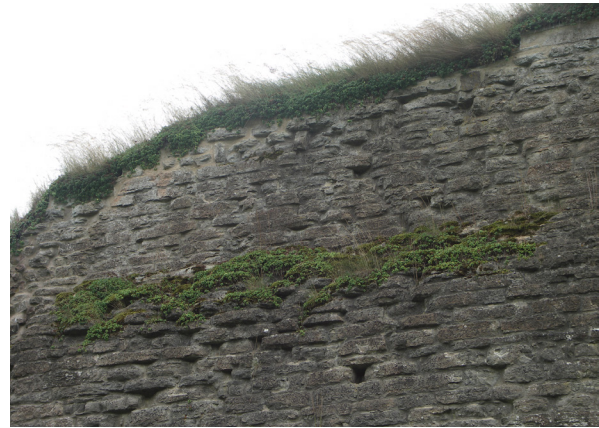
*Fig. 3.44: Alvatsra Monastery, Sweden. Pieces of sedum have dropped from the main capping to colonise ledges below, naturally spreading to protect vulnerable masonry surfaces.*

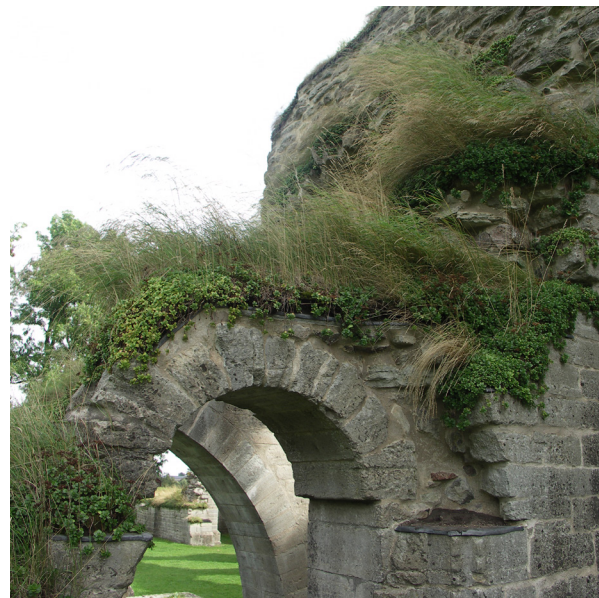
*Fig. 3.45: Alvatsra Monastery, Sweden. The sedums finish well on complex edge shapes.*

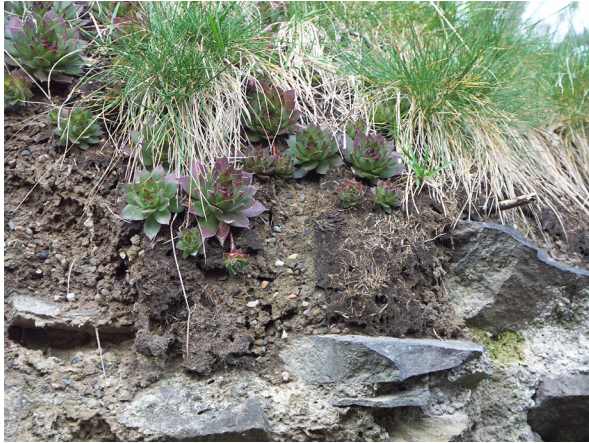
Fig. 3.46: *Sempervivum*, Monimail Tower, Fife (CS7).

*Sempervivum* have a succulent quality similar to sedums, but spread by offshoots. They can create very dense coverings, and were used historically in Sweden on urban ‘green’ roofs for their fireproof qualities. Their rate of growth is quite slow and they are shallow rooted and prone to being picked out by blackbirds, who hunt for worms in the holes created. While this slow growth and vulnerability was demonstrated in the experimental planting of *sempervivum*s for edge stabilisation at Monimail Tower, Fife (CS7), it is thought that they are likely to survive and create an increasingly stable edge.

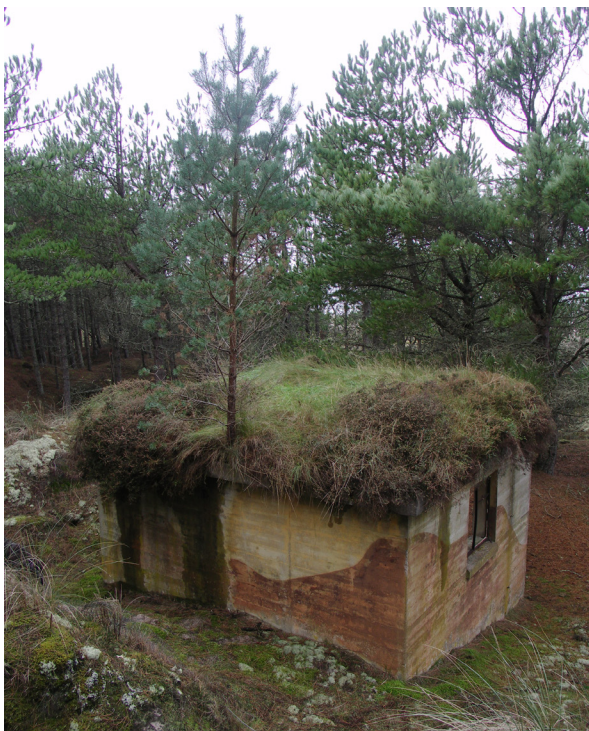
Fig. 3.47: Coastal Defences, Moray, constructed c. 1941. A tree invades the capping vegetation, which fulfilled the same camouflage function as that painted on the walls. This exceptional tree is a direct result of the bountiful supply of pine cones, shade and shelter provided by the surrounding forest.

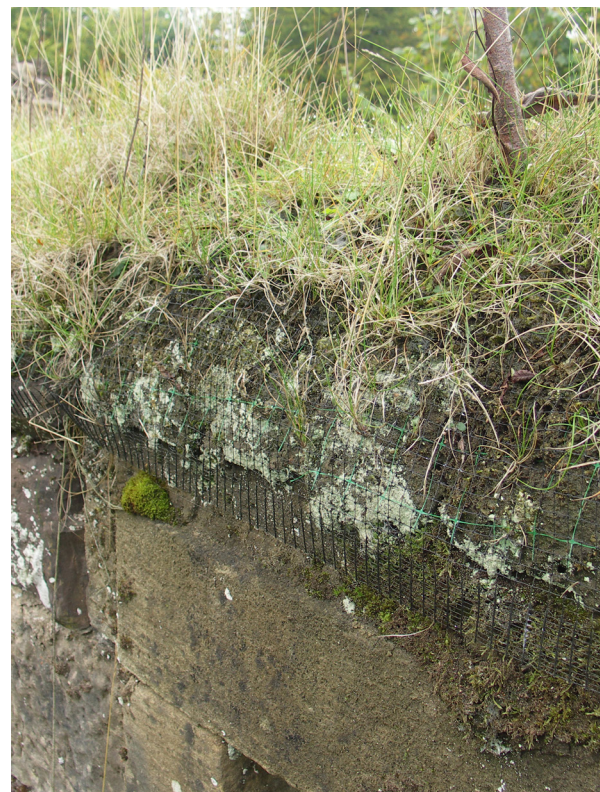
Fig. 3.48: Doune Castle Mill, Stirlingshire. Originally soft capped with commercial turf, dieback has allowed moss and lichen to colonise the sides, while trees invade the grass on top

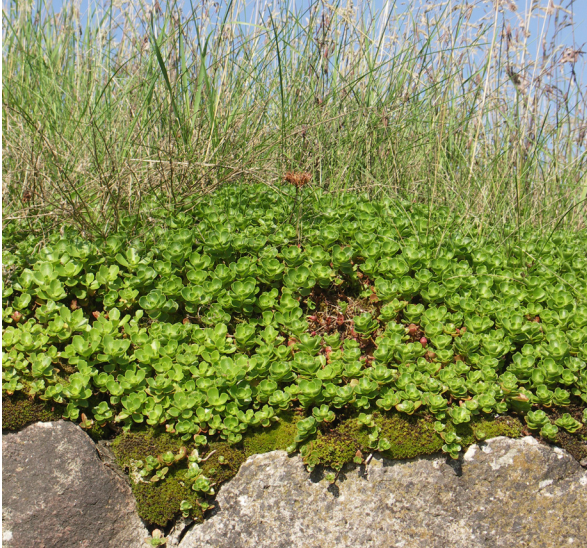
*Fig. 3.49: Bohus Fortress, Sweden. A designed soft cappings, with a central strip of grass, sedum edge, and later colonisation by moss.*

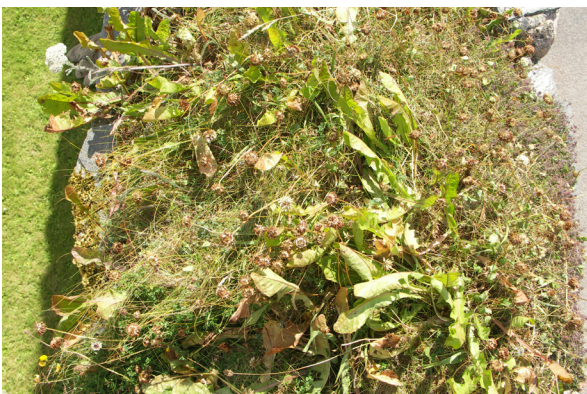
*Fig. 3.50: The Nunnery, Iona, Argyll. Partially successful test of a grass-seeded soil capping.*

One of the case studies (CS28) included two tests of a seeded soil cap, without turf, but given initial protection by hessian. These suffered significant initial soil erosion, but one was reasonably successful in the long-term. Seeded soil is unlikely to be a viable capping technique because of its initial vulnerability to wind erosion and colonisation by undesirable species. The seeding of soils beneath turf cappings could be appropriate in situations vulnerable to initial dieback, encouraging secondary growth within a dying root mat.

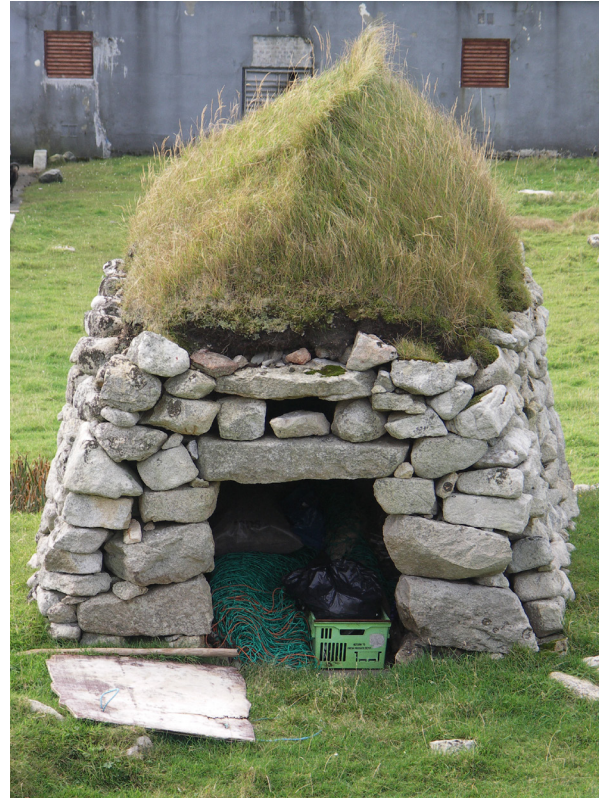
Fig. 3.51: St. Kilda, Outer Hebrides. Soil depths vary up to over one metre.

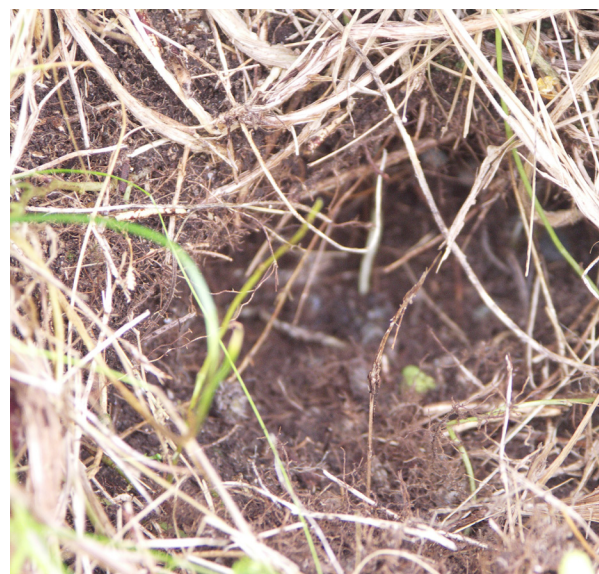
Fig. 3.52: Eilean Mor, Argyll. The thin, rooty soil is only 10-40mm deep.

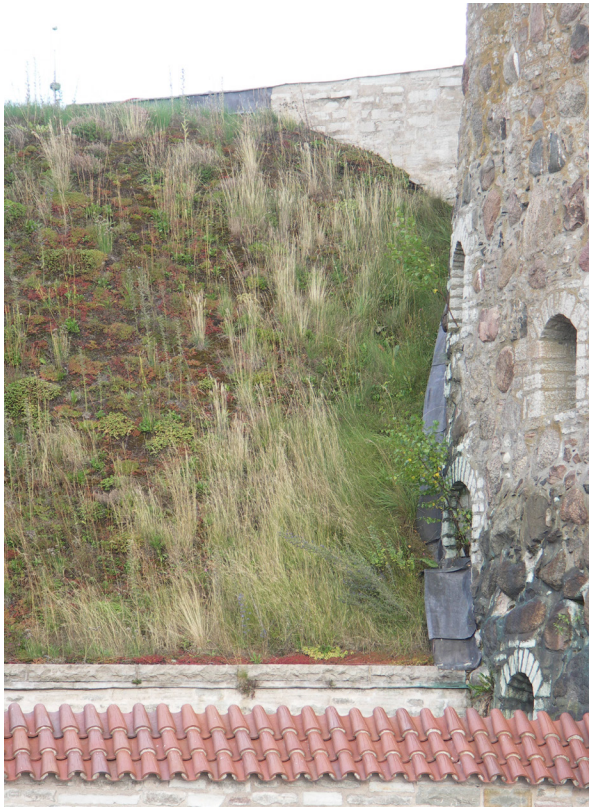
*Fig. 3.53: Vadstena Castle, Sweden. Increased soil fertility has not improved performance on a site prone to drought conditions. In contrast, shade provided by corner towers encourages the desired grass growth over sedum.*

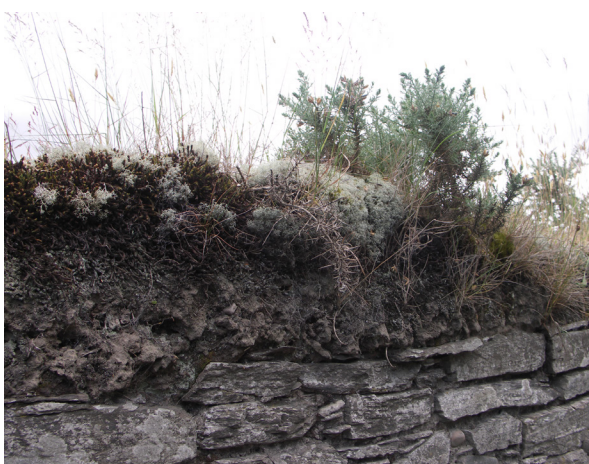
*Fig. 3.54: Gordon Estate Walls, Moray. An old vernacular capping with a high arched profile giving steep sides.*

A high arch creates more difference between the conditions on the top, which is flat and has a thick layer of soil below, and the sides, which are at a steep incline. This shape also creates more climatic difference between one side and the other, if these are orientated north and south. Rainwater runoff will be greater, which may cause soil erosion, but inhibit saturation in wet situations. Wind exposure will be greater, however meeting the wall at ninety degrees gives good protection to cut edges of fresh turf.

Grass grows vertically, irrespective of slope, and can struggle to stabilise on very steep slopes. In exposed climatic conditions, such profiles frequently display a marked difference between lush growth on top and thin plant cover, or exposed earth, on the sides.

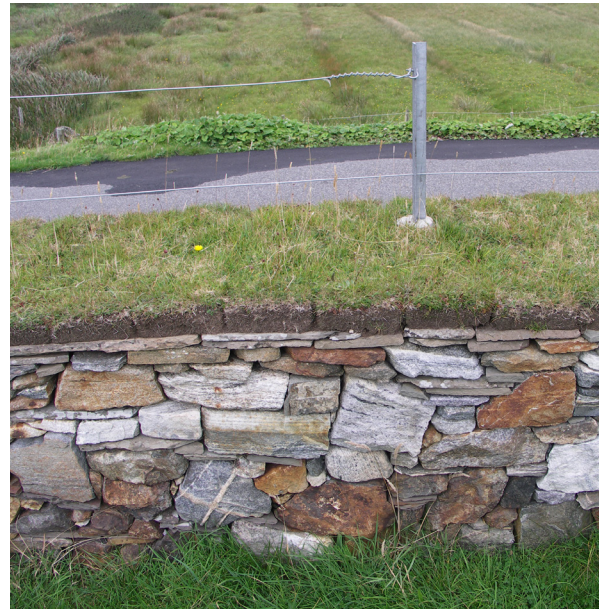
*Fig. 3.55: St. Clement's Churchyard, Roghadal, Western Isles (CS37). This recent capping is flat, with no soil layer beneath the turf.*

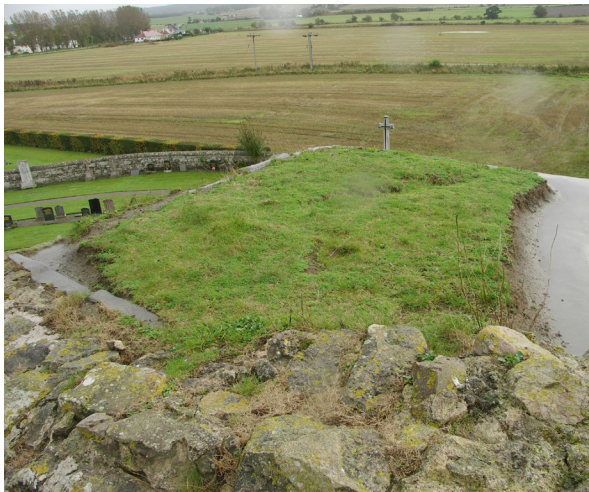
*Fig. 3.56: Kinloss Abbey, Moray. Severe and progressive edge decay over an asphalt capped concrete cap.*

The edges of cappings are invariably where failure of the capping begins, with wall ends being especially vulnerable. Sometimes failure will stabilise, as species distribution adapts and the plants root in, binding the soil. Sometimes the edge of the vegetation stabilises at a high level, leaving soil exposed below on the sides, which may be sufficiently robust to endure without plant cover, or alternatively may progressively erode, leaving a top surface of living turf undermined, with roots exposed.

While the climatic context of a particular site is the most significant factor in this process, the initial period after the application of the capping is when the edge is at its most vulnerable. Before the turf has rooted into the soil layer, its roots can easily dry out under solar and wind exposure. If the sides are at a high angle, or if the soil is dense clay, rooting in is more difficult.

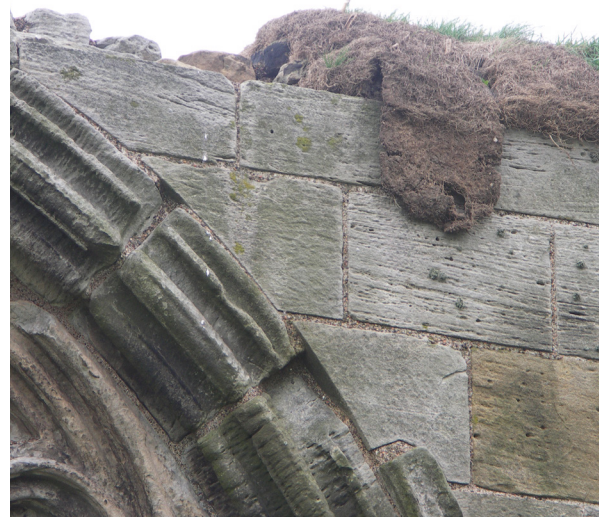
*Fig. 3.57: Whitby Abbey, Yorkshire. The doubled-under edge turf has failed to root into the soil bed, leaving it vulnerable to wind lift.*

If a cut end of turf is exposed, there is little defence against the onset of decay in sites that are not mild and sheltered. The cut ends of turf are protected if they meet the masonry at ninety degrees, or if the turf is tucked under, to form a double layer, with a rounded end, sometimes with earth sandwiched in the middle. If the turf edges are not well fixed, they can be lifted by the wind or by birds, damaging root establishment.

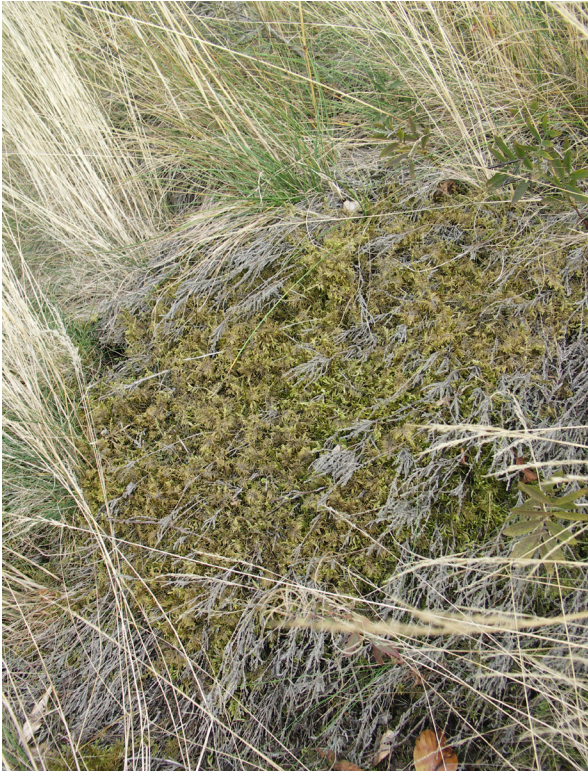
*Fig. 3.58: Coupar Angus Abbey, Angus (CS14). A single multi-species layer of dense turf has remained stable while the species balance adapts to a new environment. Heather has died, but has left a strong structure for the growth of other species, mainly mosses and Sheep's Fescue.*

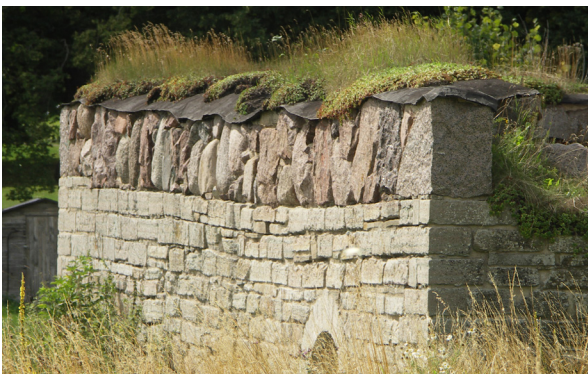
*Fig. 3.59: Alvastra Monastery, Sweden. Sedums struggle to stabilise on a smooth, dark, impermeable membrane.*

Incorporating damp proof courses (dpc's) or damp proof membranes (dpm's) under soft cappings can have the benefit of ensuring a complete barrier to water penetration, should this be required to protect the host structure, or if there is little confidence that the soft capping will perform adequately or survive in the long-term. Slate courses are not considered dpc's under this definition. Dpc's can be metal, bitumen or plastic. Historically, coal tar was also used.

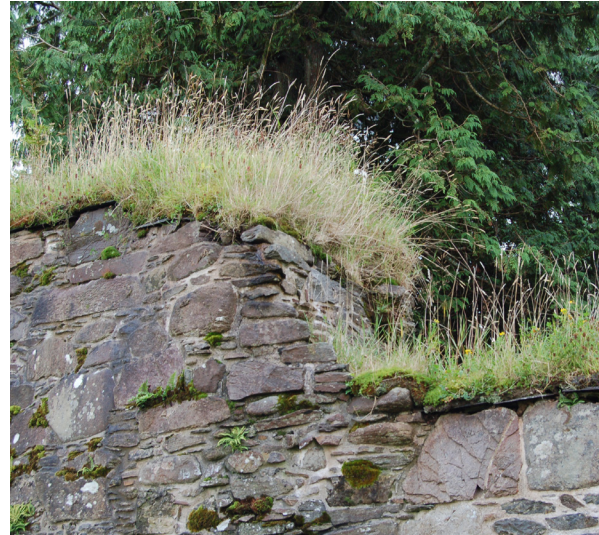
*Fig. 3.60: Saddell Abbey, Argyll. The slate dpc has contributed to unstable edge conditions and visually detracts from the original masonry wallhead.*

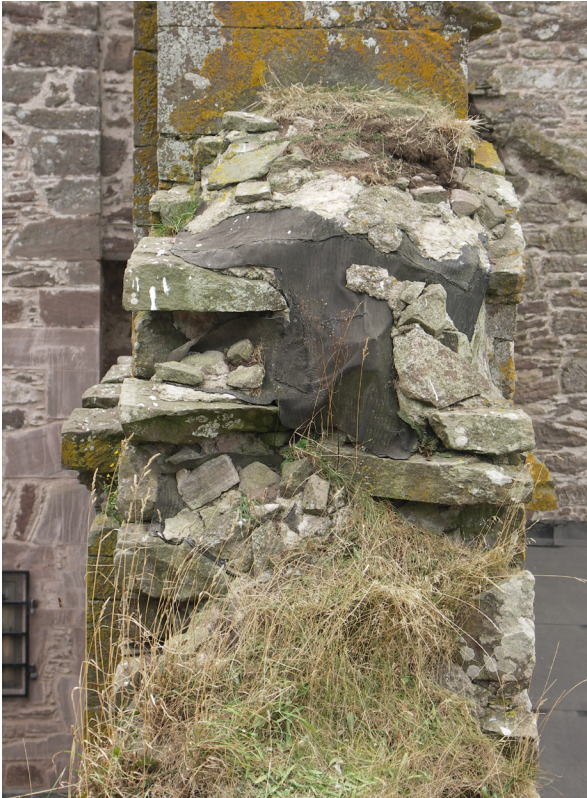
Fig. 3.61: Melgund Castle, Angus. Soft cappings fail over shallow masonry on bitumen-coated lead dpc's.

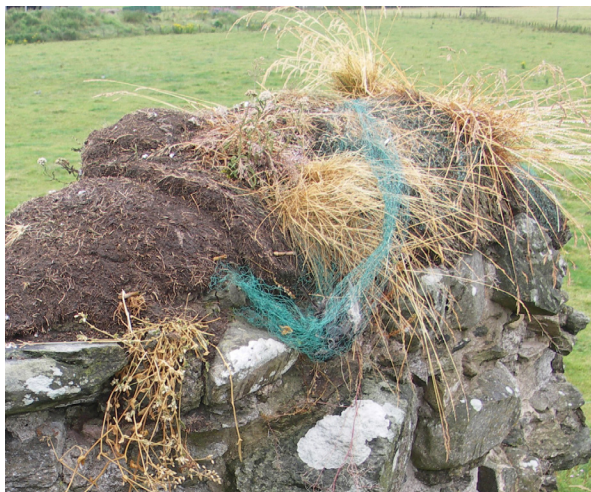
*Fig. 3.62: Black Castle, Perthshire (CS13). Plastic mesh proved problematic in the long-term.*

Plastic mesh has occasionally been used, and this is very long lasting. After several years this frequently becomes loose at the edges and proves unsightly. It can also entangle birds, causing individual death and loss of habitat value. There is no benefit of plastic materials over natural, biodegradable ones.

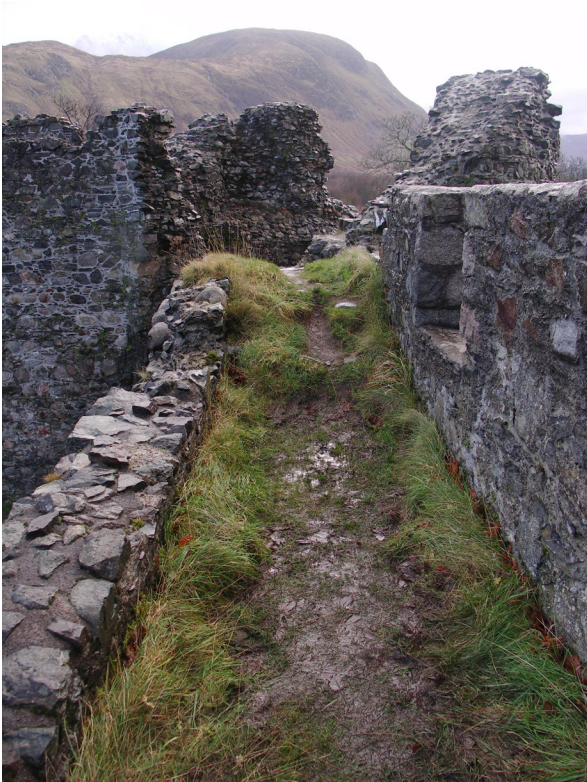
*Fig. 3.63: Inverlochy Castle, Invernesshire(CS21). Although these high level soft cappings have been damaged by visitors, they have effectively protected the masonry beneath.*

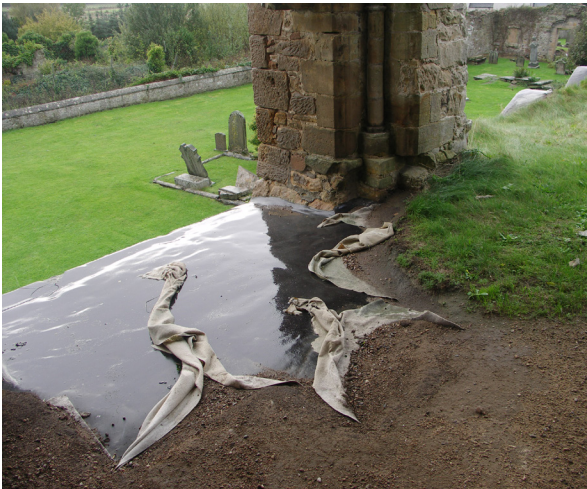
*Fig. 3.64: Kinloss Abbey, Moray (CS24). Vandal damage to soft cappings.*

One site (CS24) had been subjected to acts of vandalism, which included ripping up areas of soft capping.

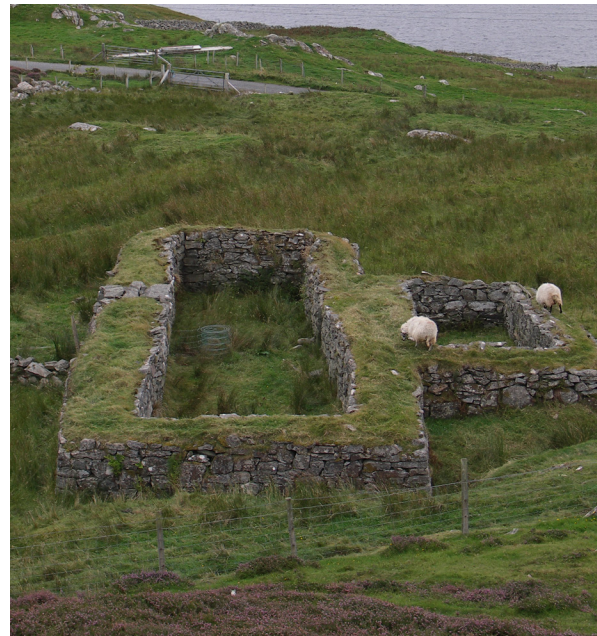
*Fig. 3.65: Dun Carloway Blackhouse, Lewis, grazed by sheep.*

Conversely, sheep can have beneficial effects in other circumstances. In comparing two ruined blackhouses at Dun Carloway, Lewis, Outer Hebrides (CS3), the one that is ungrazed has suffered considerable damage from the roof growth of colonised bracken, while the one that is grazed by sheep has a closely cropped grass capping, with few invasive species and only minor damage to the masonry caused by the sheep's feet.

On balance, in this case, the sheep are a benign form of maintenance, encouraging a good root structure in the grass and removing undesirable species.
