SOFT CAPPING IN  
SCOTLAND

The context and potential  
of using plants to protect  
masonry

VOLUME 1

Historic Scotland  
© Crown copyright  
Edinburgh 2011

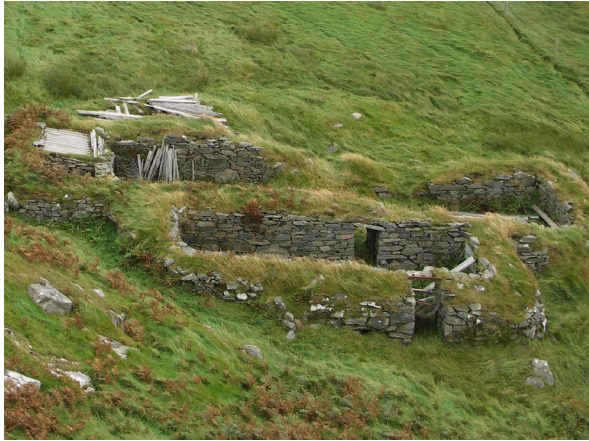
*Fig. 3.66: Dun Carloway Blackhouse, not grazed by sheep.*

Conversely, sheep can have beneficial effects in other circumstances. In comparing two ruined blackhouses at Dun Carloway, Lewis, Outer Hebrides (CS3), the one that is ungrazed has suffered considerable damage from the roof growth of colonised bracken, while the one that is grazed by sheep has a closely cropped grass capping, with few invasive species and only minor damage to the masonry caused by the sheep's feet.

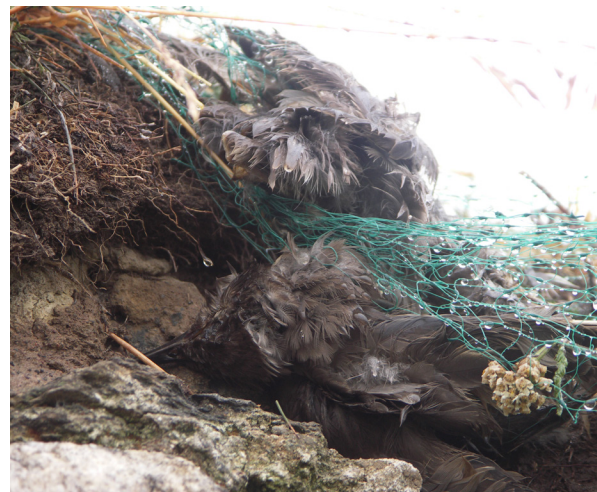
*Fig. 3.68: Black Castle, Perthshire. Two birds died through entanglement in plastic mesh.*

At Black Castle, Perthshire (CS13), the use of plastic netting to restrain new cappings inadvertently entangled birds as they landed or nested on the wallheads. Two dead birds were found entangled during the survey.

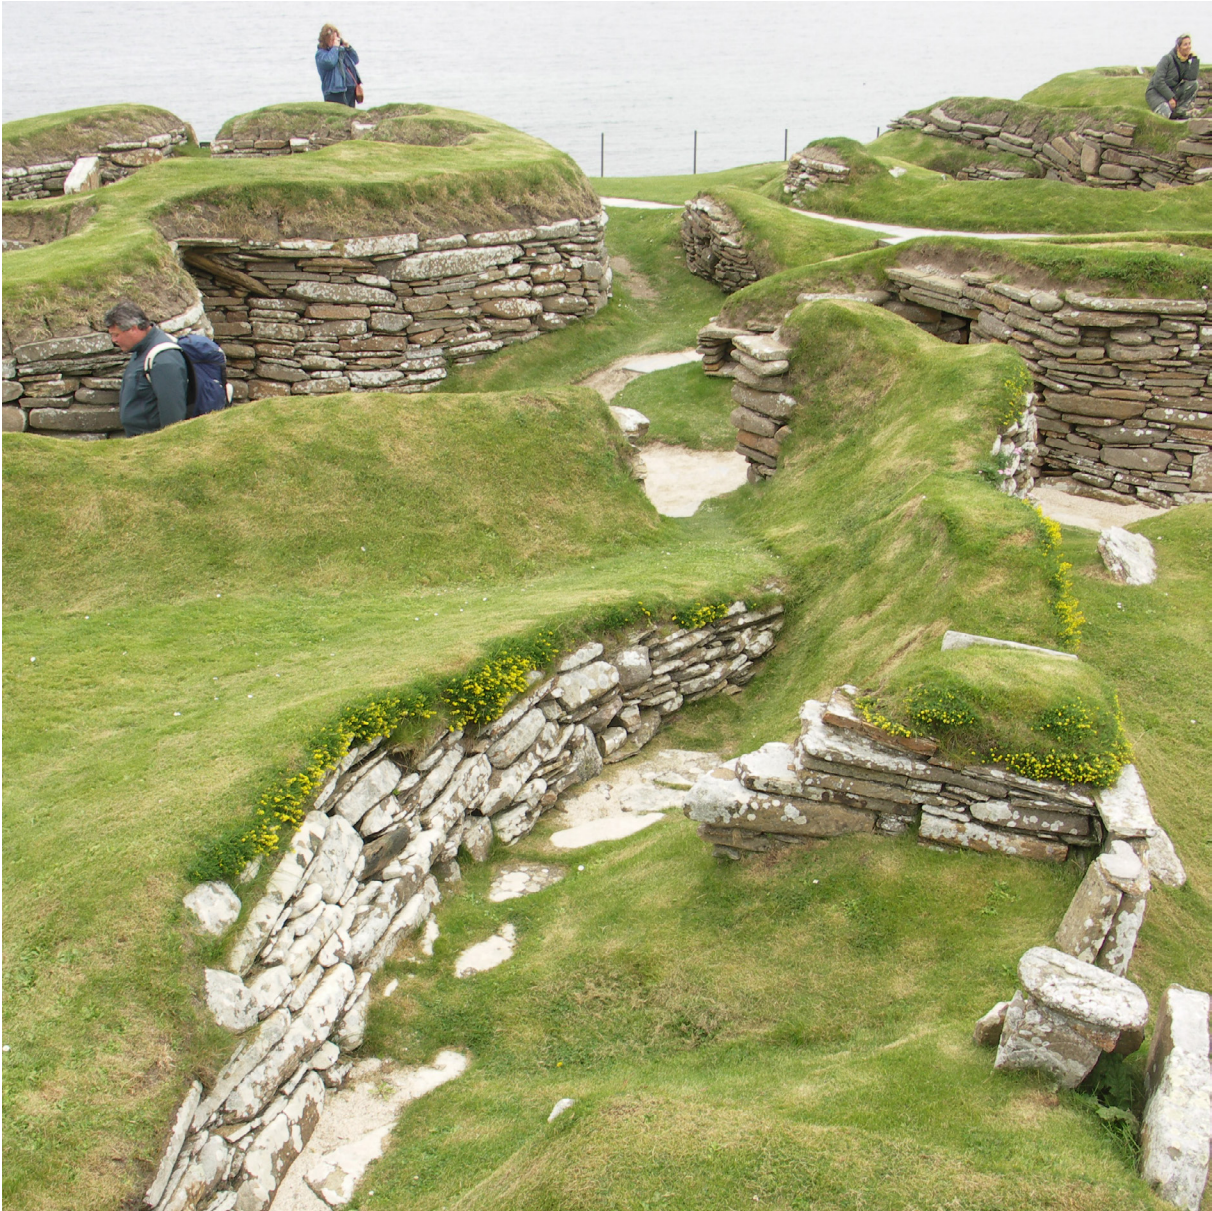
*Fig. 3.69: Skara Brae, Orkney. This site had the highest level of maintenance of the case studies. Edges that were difficult to cut were in the best condition.*

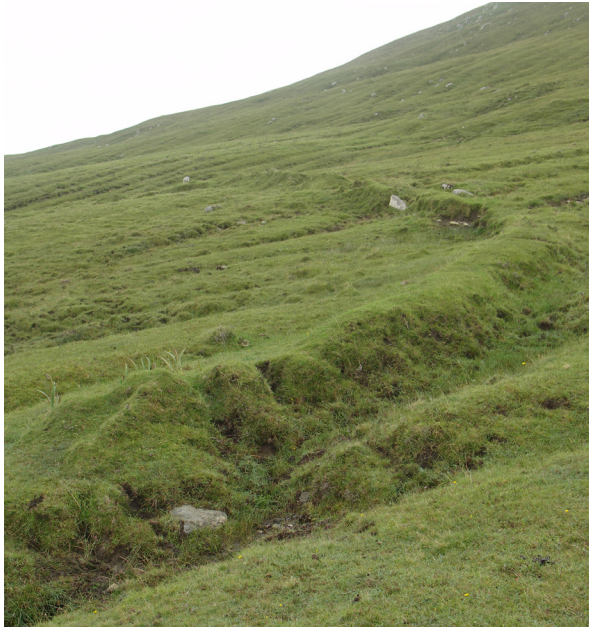
Fig. 4.2: Remnants of turf field walls, Harris, Hebrides.

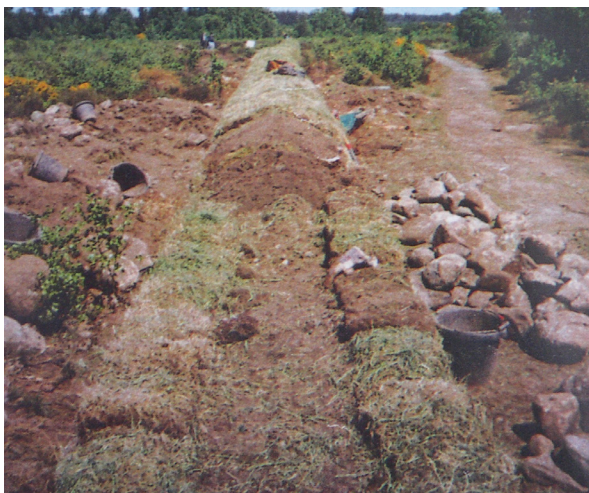
Fig. 4.3: Culloden, Inverness-shire (CS6). Reconstruction of an historic turf dyke.

Enclosure walls at Culloden, which existed during the battle in 1746, were rebuilt in accordance with historical records. These have proved durable, with adjacent potentially damaging species, such as nettles, failing to colonise. They proved vulnerable to damage from grazing cattle, but not from sheep. Grass grows healthily on the top of the turf wall, but not on the near-vertical faces, where the enduring root mass makes the wall effectively an earth/fibre block construction with a soft capping.

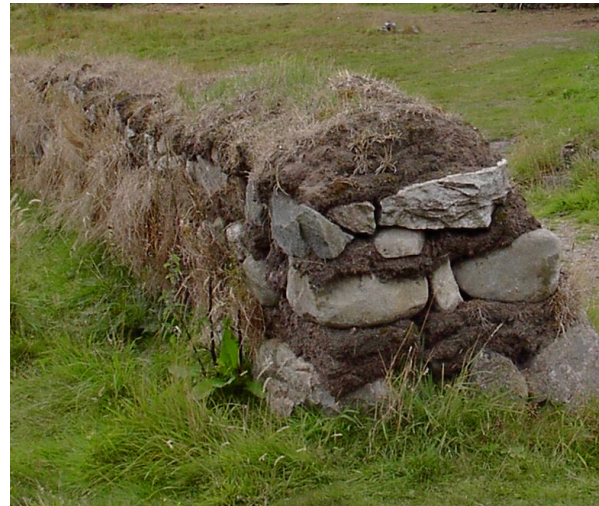
Fig. 4.4: Highland Folk Museum, Newtonmore. Composite turf and stone wall.

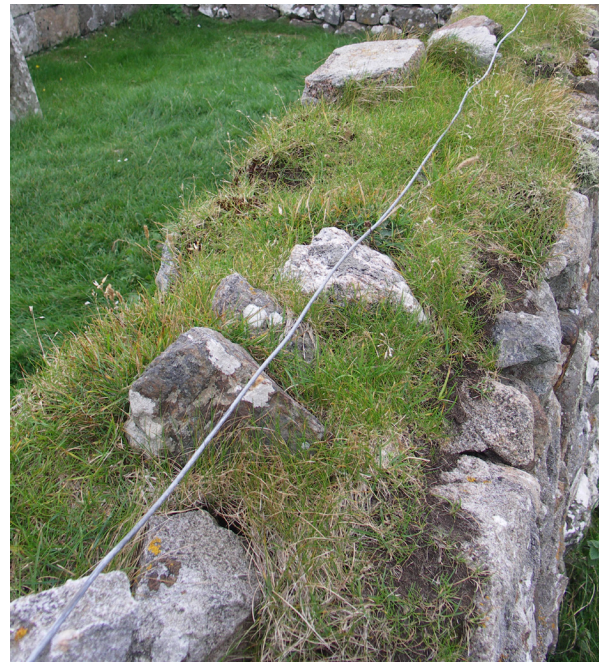
*Fig. 4.5: Stones to counteract wind uplift, Roghadal Church, Harris (CS37).*

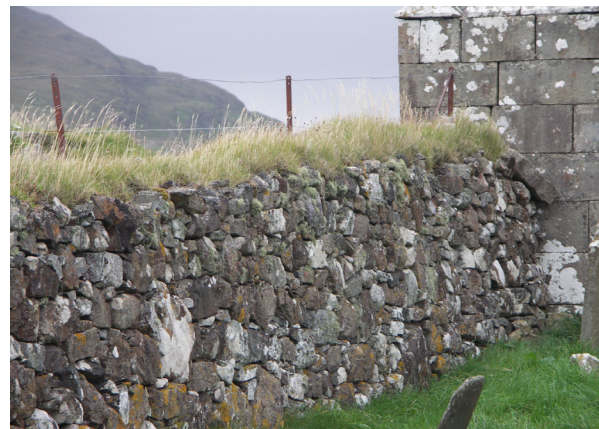
*Fig. 4.6: A domed turf capping, with wire fencing as stock proofing, Roghadal Church, Harris (CS37).*

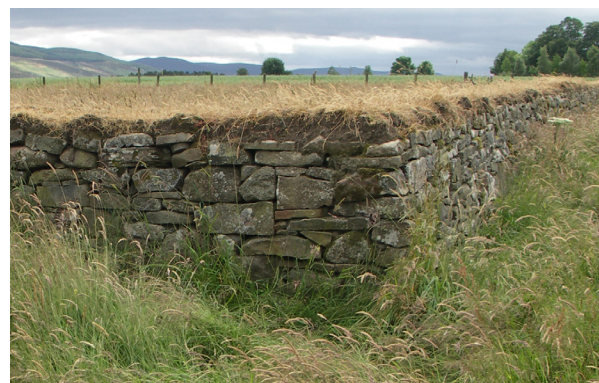
*Fig. 4.7: Reconstruction at the Culloden Battlefield. The poor condition of the turf capping contrasts with that of the adjacent reconstructed turf wall, Fig 3.31, suggesting that the greater moisture retained by the turf was significant.*

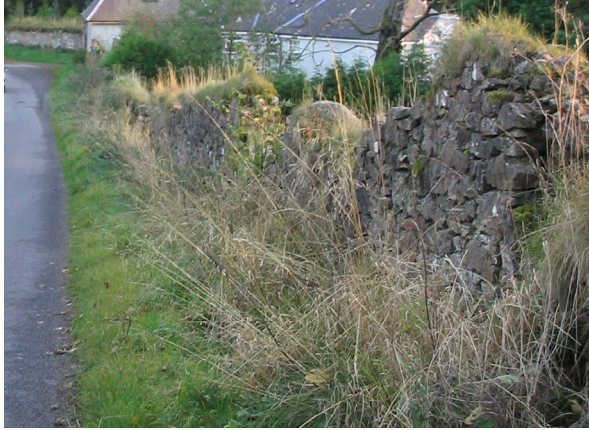
*Fig. 4.8: Turf and soil dome capping, near West Linton, Peebles-shire.*

Two other examples at Roghadal, Harris (CS37) and West Linton, Peeblesshire, illustrate a different technique. While both examples were of sufficient age to obscure the finer detail of their original construction, both had a mound of soil beneath a turf cap. In the Roghadal example, this seemed to be a more durable technique than the pure turf cap, which was used in recent reconstruction.

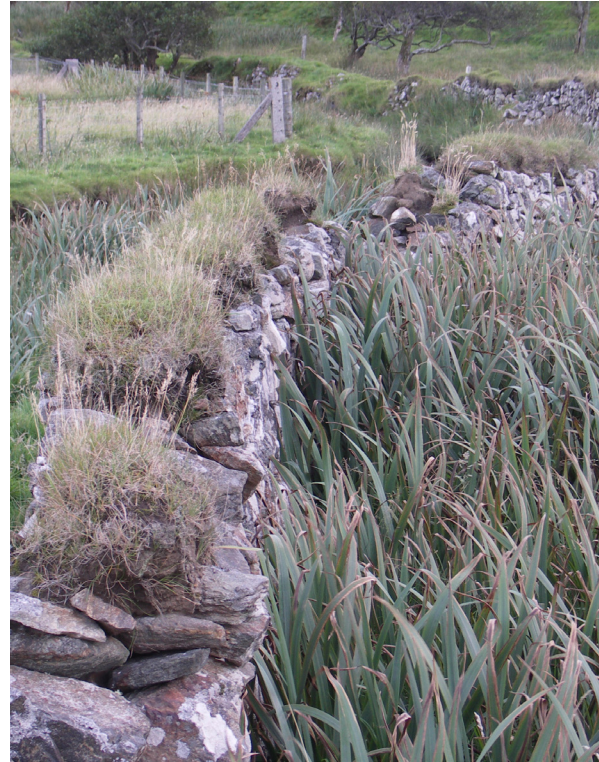
*Fig. 4.10: Roghadal, Harris (CS5) Turf and soil dome capping.*

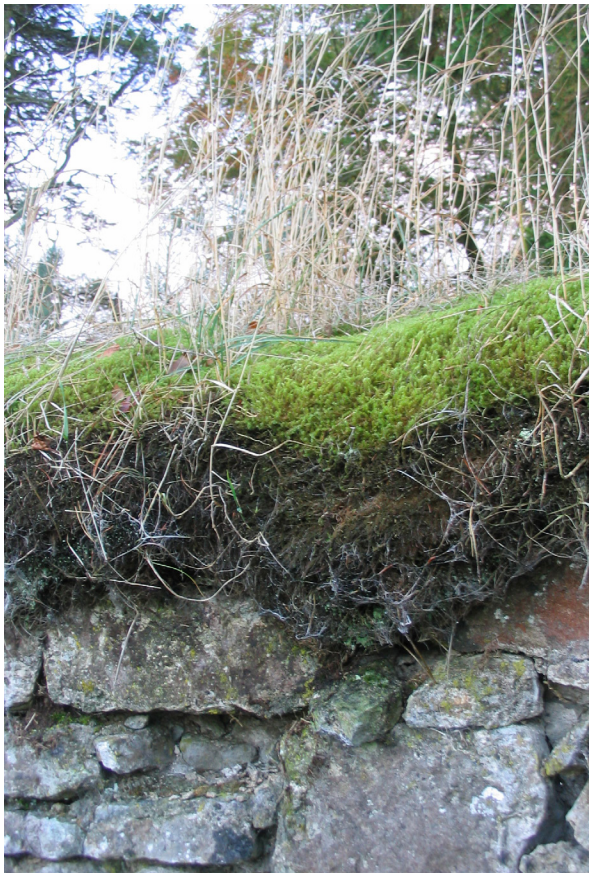
*Fig. 4.9: West Linton, Peeblesshire. Over time, there has been a significant decline of grass species and development of a thick moss mat.*

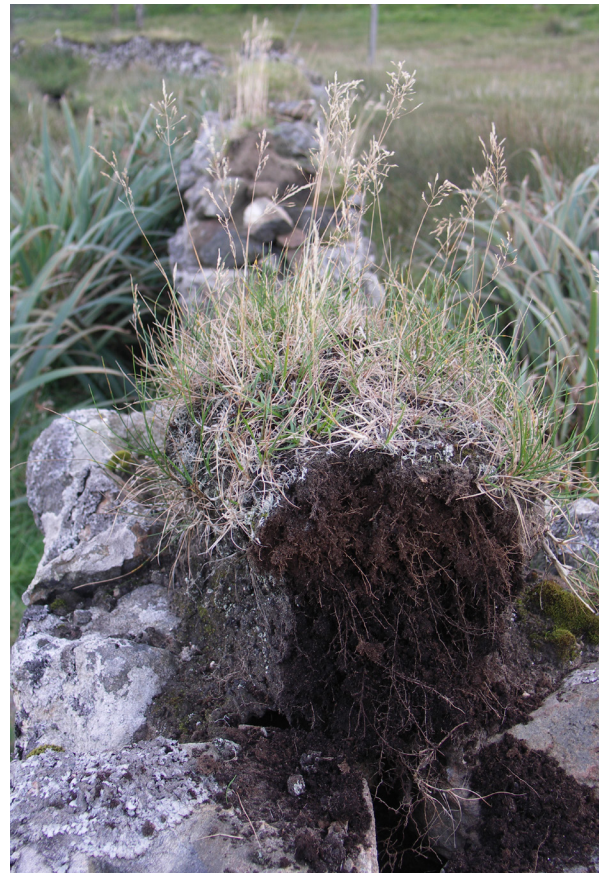
*Fig. 4.11: Roghadal, Harris (CS5). The turf soil is clearly lighter than the soil dome beneath. Note the deep root penetration.*

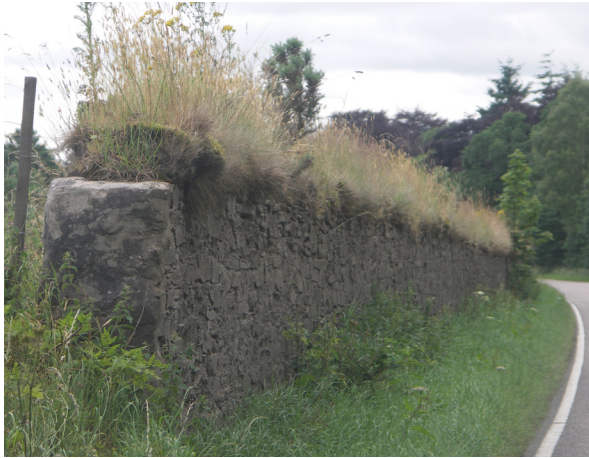
Fig. 4.12: Gordon Castle Estate, Moray (CS4). An extensive, mature and bio-diverse vernacular capping.

One successful vernacular example of such a capping occurs at Gordon Castle, Moray (CS4). A tall dome of clay mortar, with a turf cap, was applied on the head of several miles of boundary walls, thought to have been built originally with a clay mortar and lime pointing.

While the vegetation on this cap varies widely with the exposure and surrounding vegetation in different locations, the underlying clay mortar cap remains in good condition. Even where the steep sides will not support vegetation, there has been minimal decay of the clay earth dome, with the holes for timber fixing pegs still crisp, though the pegs themselves have long since vanished. The masonry beneath is in good condition, despite reportedly not having had maintenance for at least fifty years.

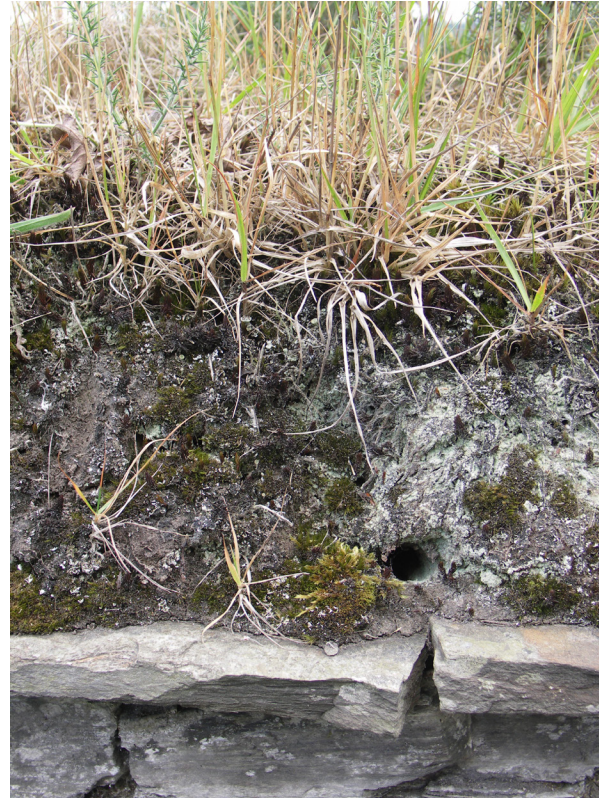
Fig. 4.13: Gordon Castle Estate (CS4). The holes from timber pegs, which held down the original turf layer, remain clear.

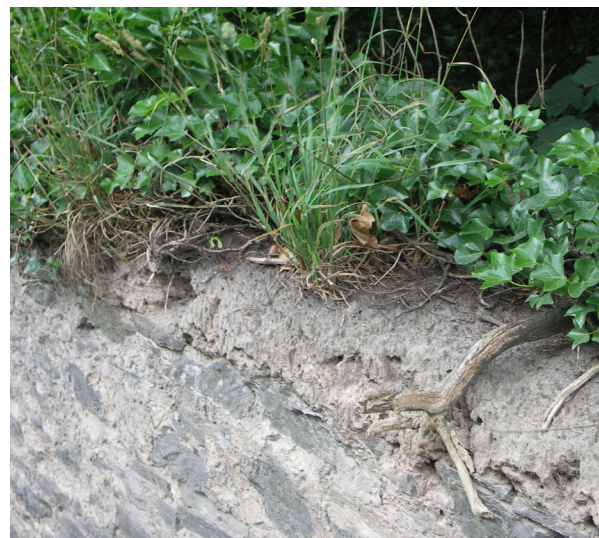
Fig. 4.14: Gordon Castle Estate (CS4). The original domed profile of the clay cap is revealed where there is no plant cover.

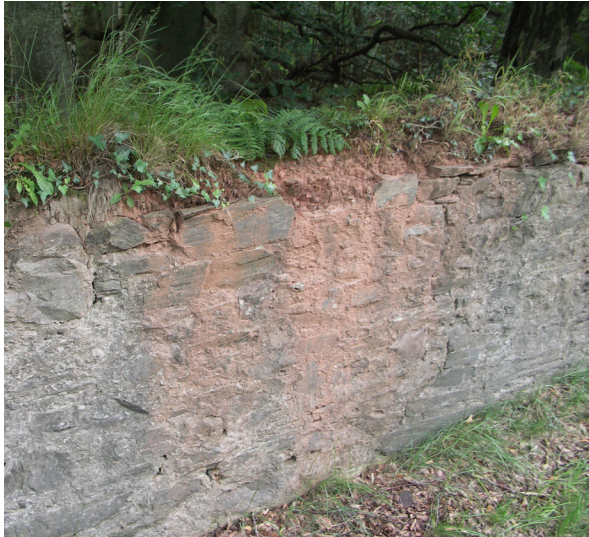
Fig. 4.15: Gordon Castle Estate (CS4). Where the clay changes to a red colour, it is much less durable.

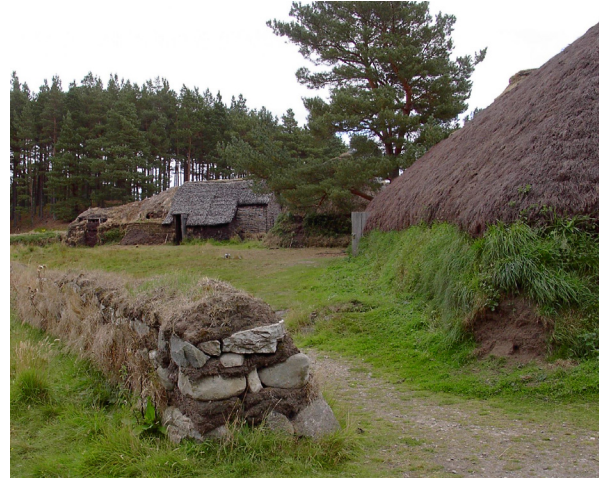
Fig. 4.17: Modern turf walled building at the Highland Folk Museum, Newtonmore. The verdant face of the turf wall, compared to the dry turf and stone enclosure wall, is a result of rain shed from the roof onto the wall face.

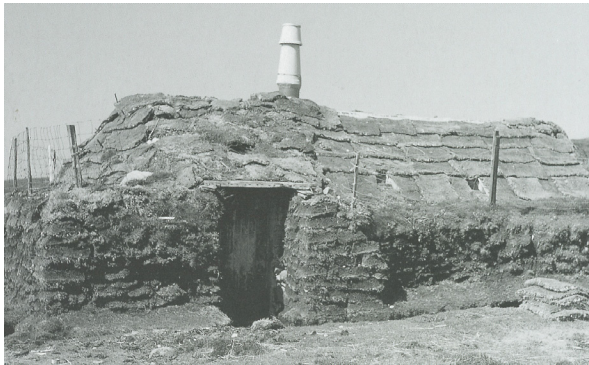
Fig. 4.16: Sheiling, Ness, probably c. 1958. The post and wire fence suggests that sheep grazing of the roof, if not the wallhead, was not welcomed.

Sheilings constructed with balla cheap (Fig 4.16) had wallheads exposed in a similar manner to many Lewis Blackhouses (CS9). The turf would have been in a similar condition to the turf dykes at Culloden, except that on buildings they would have benefited from rainwater run-off from the roof.

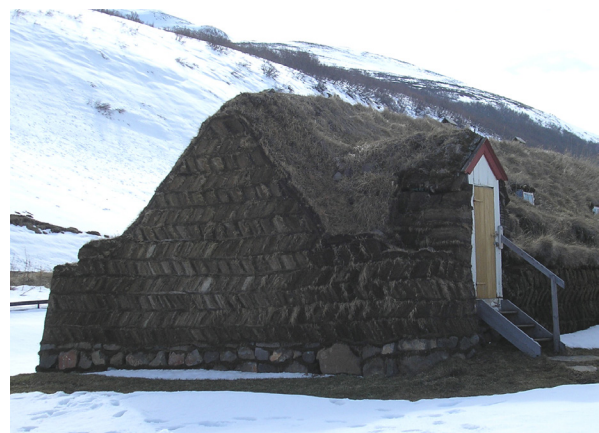
Fig. 4.18: Turf wall construction continues in Iceland, as part of the same bio-regional tradition that existed in Scotland.

This type of turf construction is thought to have been used for Blackhouse walls, prior to the introduction of drystone faces to earth cores. Comparison can be made with the living tradition of turf buildings in Iceland, where similar bio-regional climatic conditions and cultural traditions prevail.

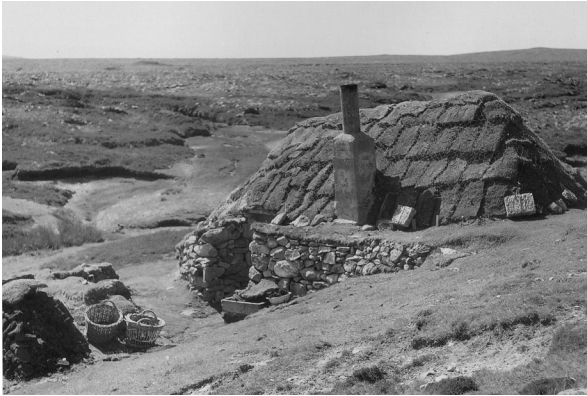
*Fig. 4.19: Sheiling, Ness, c. 1958, The good condition of the thin turf covering to the stone wall suggests it may benefit from moisture retained in the earth wall core, as well as water received from the area of turf roof.*

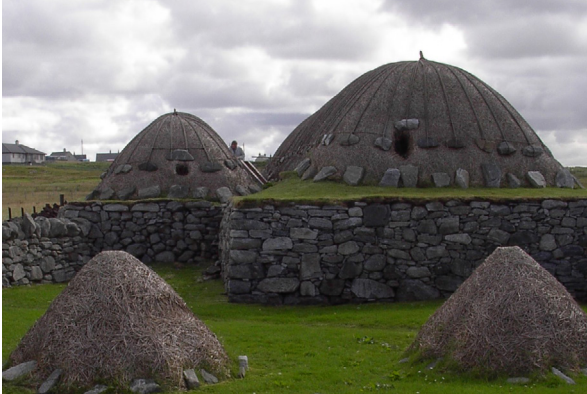
*Fig. 4.20: The Blackhouse, Arnol, Lewis (CS9). The low pitch of the wall cappings implies that much of the rainwater from the roof was not shed off. The profile of the building is testament to the power of the wind.*

As documented by Walker & McGregor (1996), this construction relied on a thin layer of a specific type of blue clay, with an oily character, to waterproof the head of the thick walls, formed of two drystone faces and a vulnerable earth core. A thin layer of turf was laid over the clay to protect it from drying out in the sun and wind, except at valley gutters, where the turf would have grown into the thatch. The turf was turned up against the roof, under the thatch. This form of construction at the Arnol Blackhouse is described in detail in CS9.

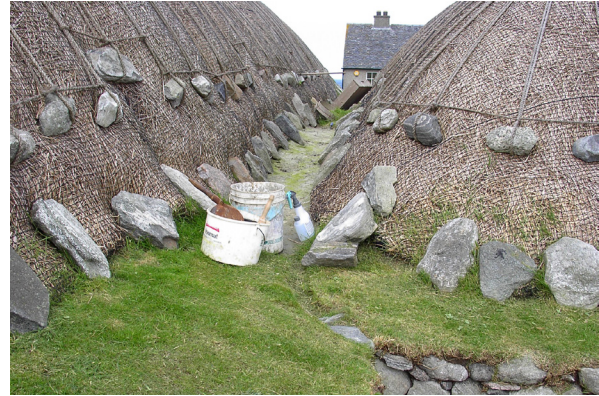
*Fig. 4.21: The Blackhouse, Arnol, Lewis (CS9.) The valley gutter has clay, but not turf.*

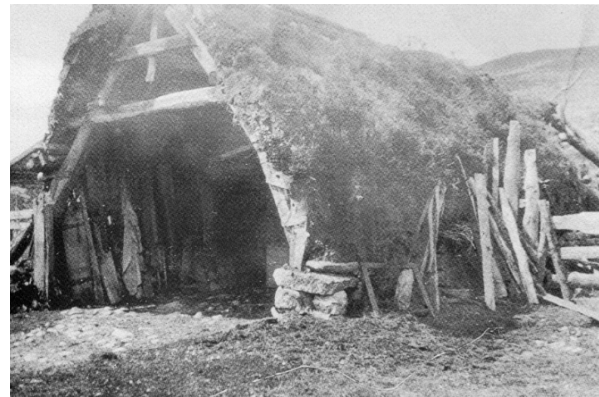
*Fig. 4.22: Cruck framed building, Inverness-shire, 1920s. Apparently a living heather turf over timber framing at steep pitch.*

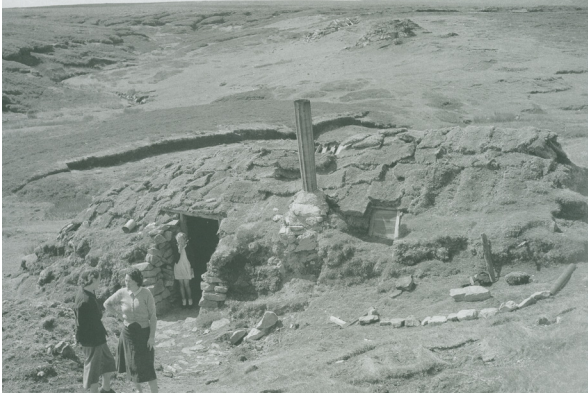
Fig. 4.23: Sheiling Lewis, dated 1958. The turf roofing has apparently continued to grow for some time.

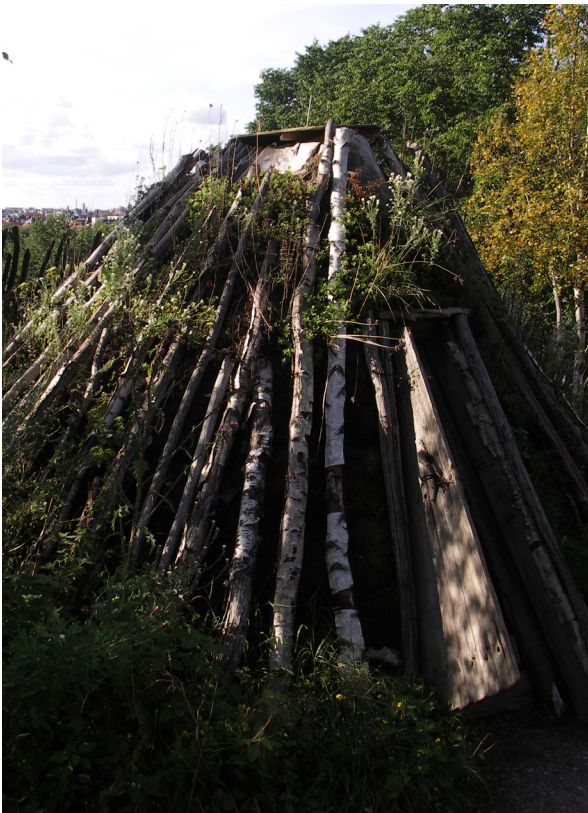
Fig. 4.24: Seasonal hut of the Sami people, Sweden. The birch bark layer under the turf was a valuable resource and often re-used. Birch poles over the turf prevent wind damage to the turf.

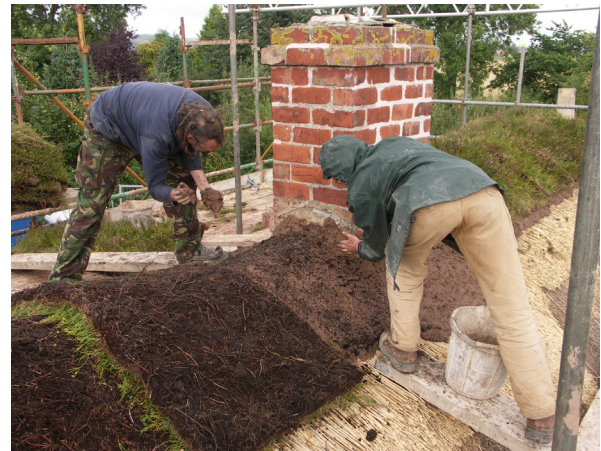
Fig. 4.25: Cottown, Perthshire. A layer of clay being laid over the thatch ridge, to be covered with two layers of turf, root to root.

It is reported that the clay layer invariably dries out and cracks and that waterproofing is primarily achieved by the turf layer alone. (J. Cox, thatcher, pers. comm.). This is reported in repairs to thatch roofs carried out in such climatically diverse locations as dry Collessie, Fife and wet Auchindrain, Argyll.

The clay is found useful in adhering the turf to the thatch, but selection of high quality turf, often with a heather or blueberry content and about 75mm thick, is more important for long-term durability than the presence of clay. This implies that sufficient moisture is retained within the thick rooty mass of the turf, despite its exposure to sun and wind, and that little reaches through to the clay layer, which lies on dry thatch.

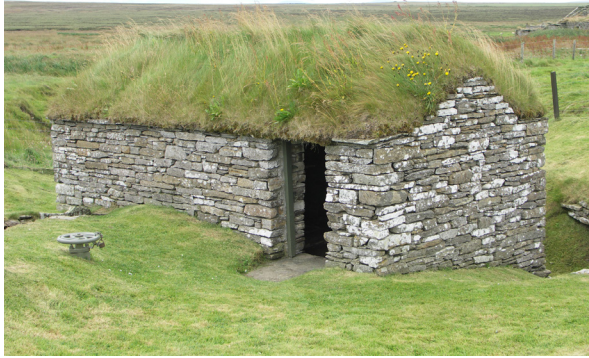
Fig. 4.26: Dounby Click Mill, Orkney (CS7). Roof renewed c. 1980 in a relatively sheltered location.

In Orkney, there is a continuing tradition of covering low-pitched, stone slabbed roofs with a single layer of turf over a thin layer of soil, reportedly sometimes restrained with ropes. In many locations, the climatic conditions, and in particular the severity of winds, mean that the cappings slowly erode and require periodic renewal.

The purpose of these cappings, which occur on all types of buildings, is to protect the underlying sandstone slabs from delamination, by reducing moisture ingress and flux, as well as exposure to frost. A similar covering of turf applied onto pantiled roofs, to prevent them being lifted by the wind as well as for draft proofing and insulation, is reported in Moray by Walker (2003).

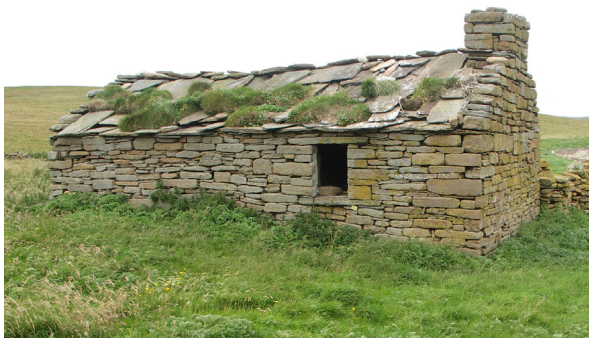
Fig. 4.27: Eynhallow, Orkney. House abandoned c. 1851, in an exposed location.

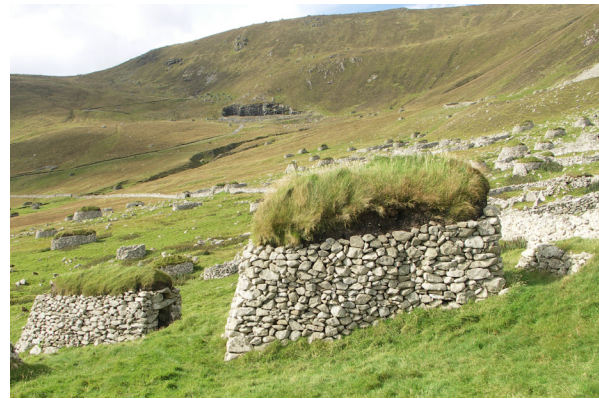
Fig. 4.28: Cleitean, St. Kilda (CS7). The diversity of cappings is not well understood.

The cleitean of St. Kilda (CS7) are another remarkable local tradition. Approximately 1430 cleitean survive in varying conditions, dating from prehistory to the early 20th century. The construction of these structures, which is not fully understood and has little historical record, comprises a mound of soil, varying in thickness from 200mm to 1m, with a turf covering, laid over a flat stone slabbed roof, sometimes mounded with smaller stones, bearing on drystone walls. Stones were often laid on top as a restraint against wind uplift.

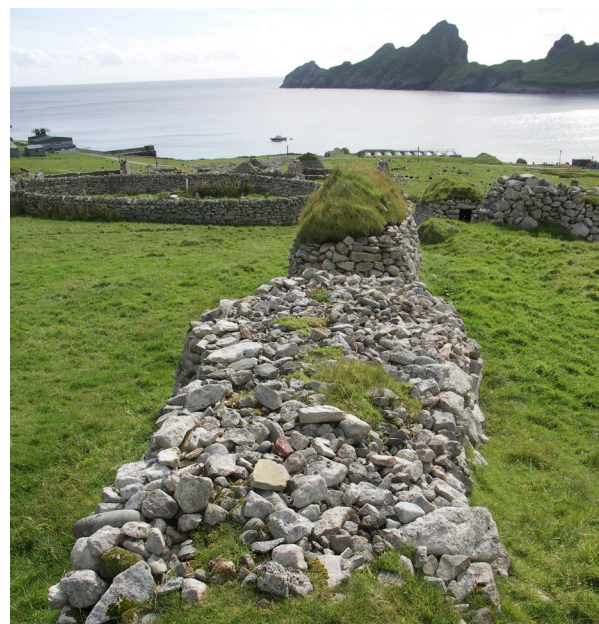
Fig. 4.29: Cleitean, St. Kilda (CS7). The soft cappings sit on a layer of small stones, over large stone slabs.

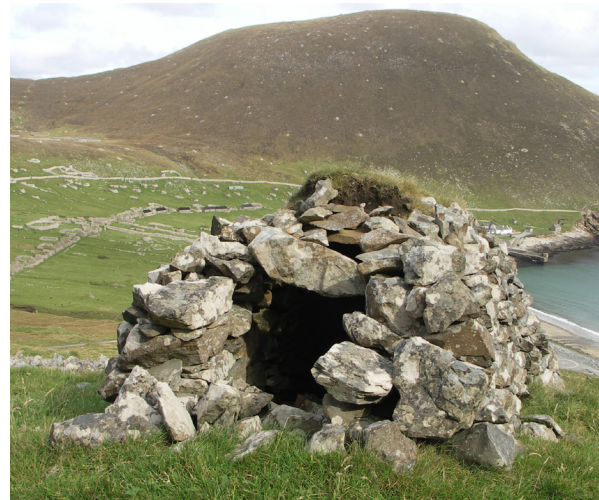
Fig. 4.30: Cleitean, St. Kilda (CS7). Progressive collapse of the masonry inevitably follows decay of the soft capping.

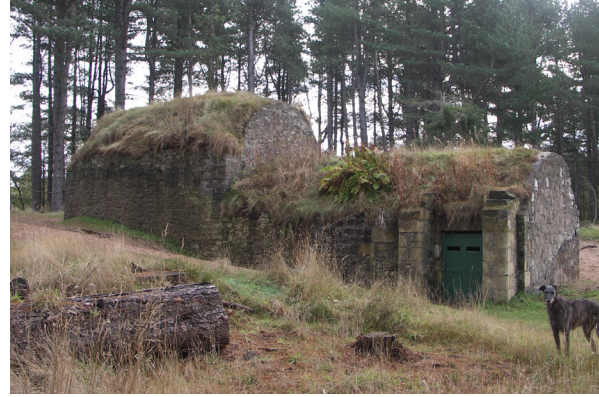
*Fig. 4.32: Icehouse, Tentsmuir, Fife (CS11), early 19th century. The ice storage room has a steeper vault than the preparation chamber, presumably to keep the interior drier.*

The case study example of an east coast fishery icehouse at Tentsmuir, Fife (CS11) has a soil and turf layer, about 300mm thick, over brick barrel vaults. The local soil is very sandy and free draining and yet seems to have been used without a puddle clay layer. This is a relatively dry location and the cold, dry interior of the building would suggest that the combination of roof shape and thick turf are adequate to exclude precipitation and solar heat.

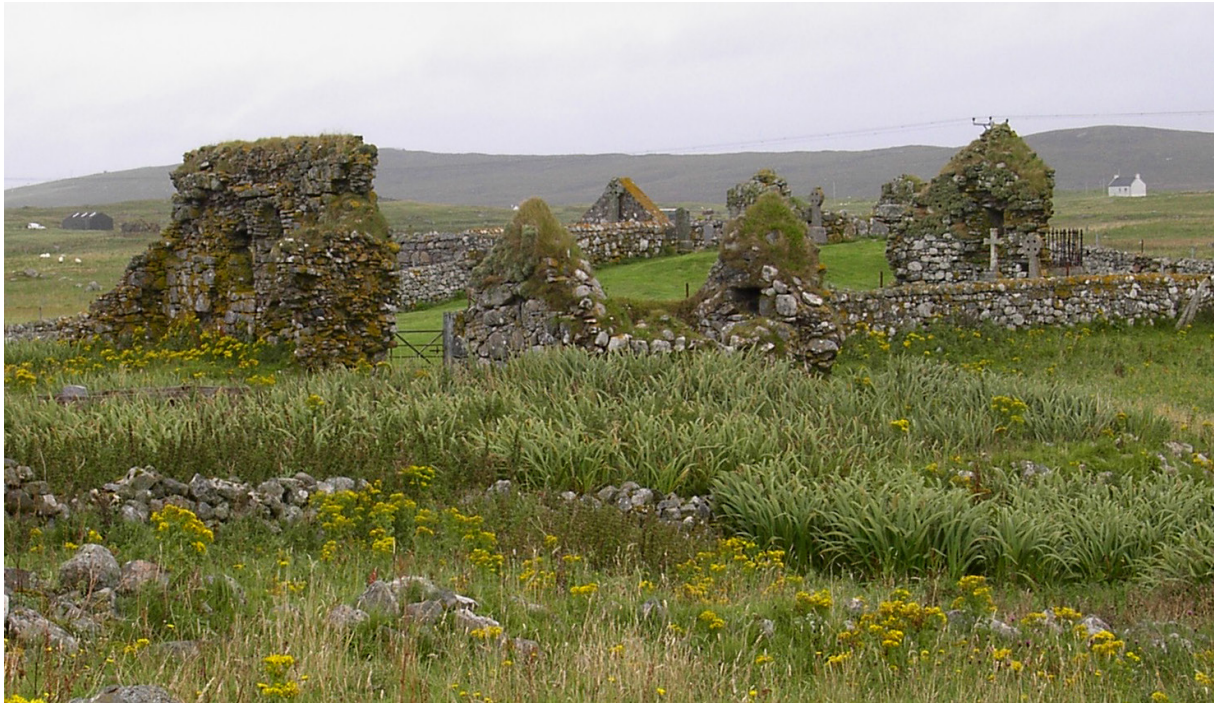
*Fig. 5.2: Howmore Churchyard, South Uist. Amid a bio-diverse setting, only a limited number of relatively benign species have colonised the masonry.*

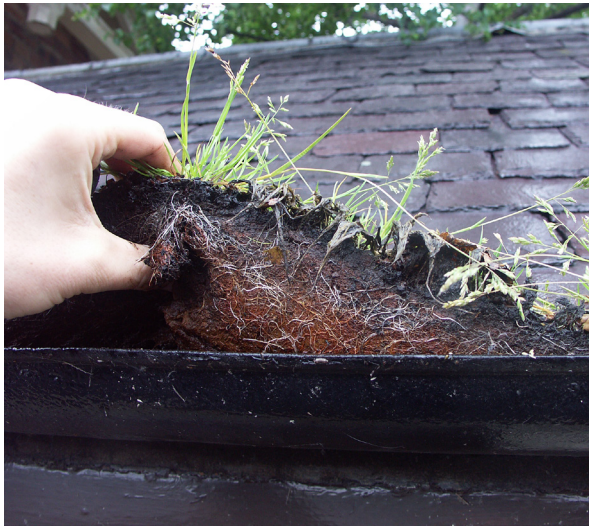
*Fig. 5.3: Grass established in a gutter, collecting deposited material and decayed plant matter.*

Beyond the establishment of algae and lichen, colonisation of structures by 'higher order' plants depends on the accumulation of sufficient soil to allow germination and supply of nutrients. The quantity of soil that is necessary for this purpose can be small, as evidenced by the growth of grass in blocked gutters (Fig.5.3). Generally soil accumulation is a continual, slow process, ultimately controlled by wind erosion. Soil can accumulate on structures by several means.

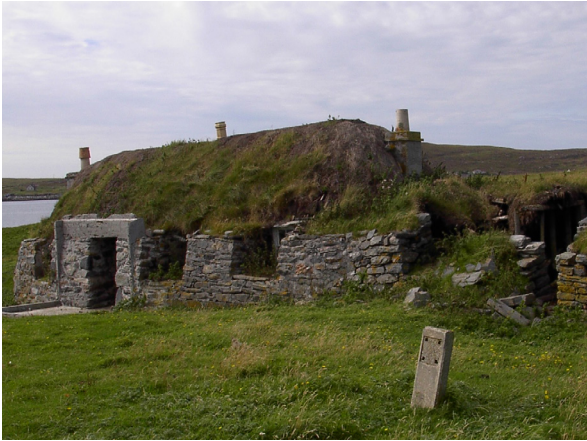
Fig. 5.4: Decaying Blackhouse, Berneray. A decaying roof deposits composted thatch and turf underlay.

The decomposition of organic materials from a building's fabric, typically from a collapsing roof, can be very effective in establishing a protective soil and vegetation layer before the wallhead masonry is exposed. Thatch, especially where it has a turf underlayer, is particularly effective (Fig. 5.4). The decomposition of timber elements is less significant, as these tend to rot away without providing a good host surface for colonisation.

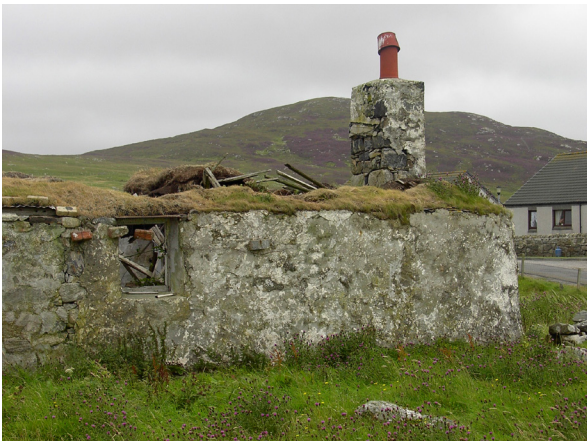
Fig. 5.5: Decaying Blackhouse, Howmore, South Uist. The process of deposition is complete. Note the lack of plants on the chimney head and window sill.

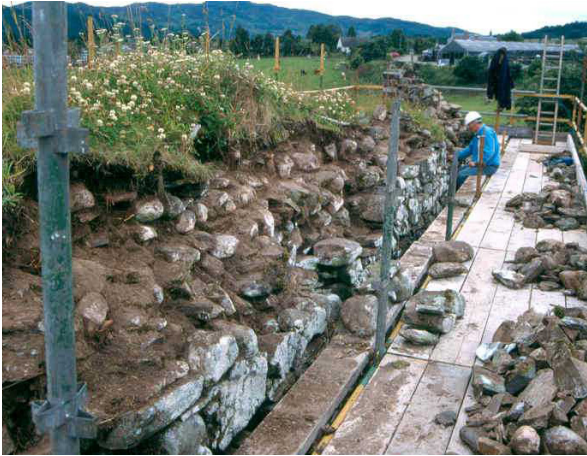
*Fig. 5.6: Black Castle, Perthshire (CS13) Central section of natural capping retained as a seed reservoir.*

In four cases, areas of natural capping were retained, where their condition and that of the underlying masonry was assessed as stable. In at least one case, this was with the specific intention that they would act as a seed bank for the adjacent less bio-diverse new cappings, applied over repaired masonry (CS13).

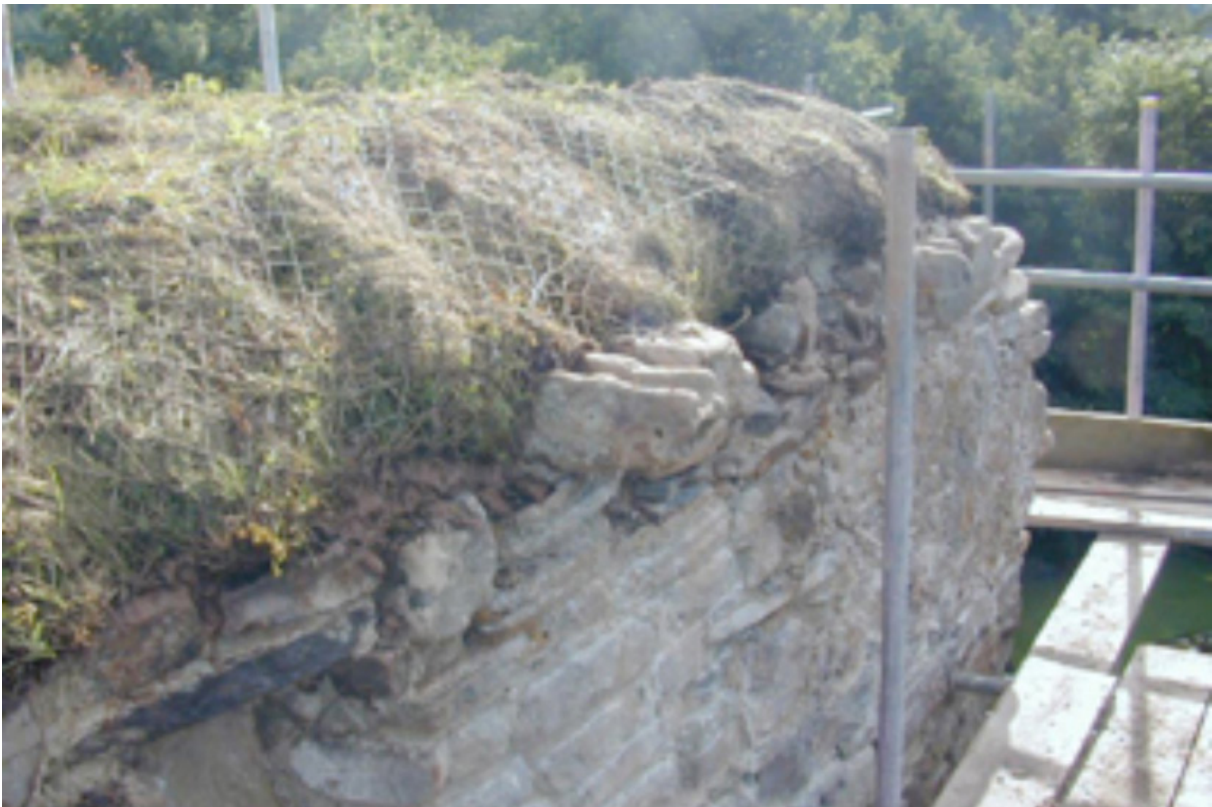
*Fig. 5.7: Drumin Castle, Moray. Plants removed from the walls before the repairs were reinstated, with biodegradable mesh as a temporary fixing.*

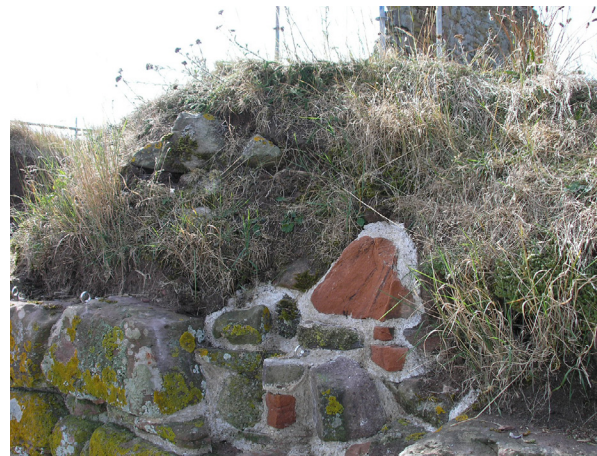
*Fig. 6.2: Cessford Castle, Roxburghshire (CS2). Masonry repairs were only required at the edges.*

Two other case studies made only localised interventions to remove natural cappings, consolidate masonry and apply new cappings, following a careful assessment of the wallhead condition (CS2 and 13).

Commonly, physical investigation found the masonry required some mortar consolidation, but that the core was sound. The wallhead edges were therefore stripped and repaired, with the natural cap retained as a central strip. This approach has the benefit of minimising intervention, which is targeted at the areas where masonry is unstable or actively decaying. It also retains the benefits of the natural cap, which acts as a reservoir for plants, seeds and invertebrates to colonise the new caps.

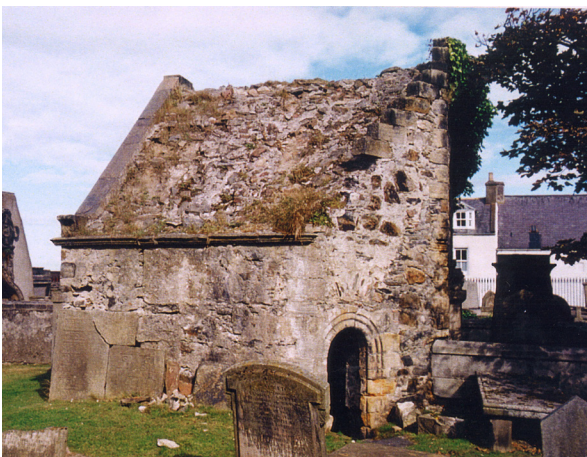
*Fig. 6.4: St. Mary's Church, Banff, after removal of vegetation: fabric decay accelerated.*

In removing vegetation, which has become naturally established on a masonry ruin over a long period of time, an established balance can be disturbed. The climatic exposure of the masonry can be significantly increased, especially exposure to wind-driven rain and thermal flux. In some situations, this will accelerate decay of the masonry, which in turn may subsequently require a higher level of conservation intervention.

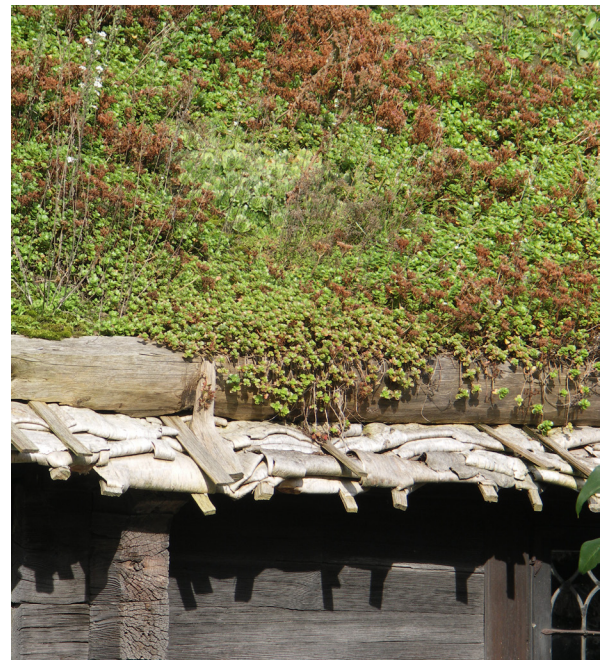
Fig. 7.4: National Building Museum, Stockholm. Grass and sedum over birch bark.

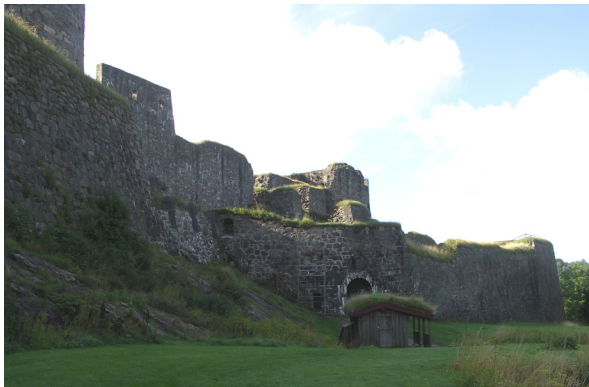
Fig. 7.5: Bohus Fortress, west Sweden, soft cappings on ruined masonry.

One of these, the Bohus Fortress, displays the typical historical progression of Swedish capping techniques. Between 1898 and 1925, the ruined walls were capped with concrete. Thermal movement cracks through the masonry associated with these hard caps can still be seen. As a result, practice changed and between 1925 and 1955, guidance on ruins was that ‘*a continuous layer of mortar should under no circumstances cover the wallhead as such a measure eventually will crack. ... the wallhead should preferably be coated with a thick layer of asphalt or be covered with a thick clay layer. In both cases there must be a fall for the run off of water. Finally the wallhead is covered, where suitable, with a double layer of grass turf with the pieces placed root to root so that they will grow together....*’ (Sven Brandel, 1926).

The legacy of these historic techniques can be read on the walls of Bohus. Recent investigations have shown that although the underlying 1930s bitumen coating has deteriorated badly, the soil covering was largely dry and no intervention was required. The more recent asphalt and aluminium foil membranes have deteriorated badly where exposed at edges, and the underlying concrete can also be seen as a result.

The sedum-edged turf caps are generally successful, though southern solar and local wind exposure, as well as the impermeable, smooth membranes do contribute to local failure. Although there is some native *Sedum acre*, the main species, *Sedum spurium*, is introduced. The well-defined edge fringe this produces on the walls does not seem quite natural, but their pendulous character does successfully conceal the edges of the concrete cappings.

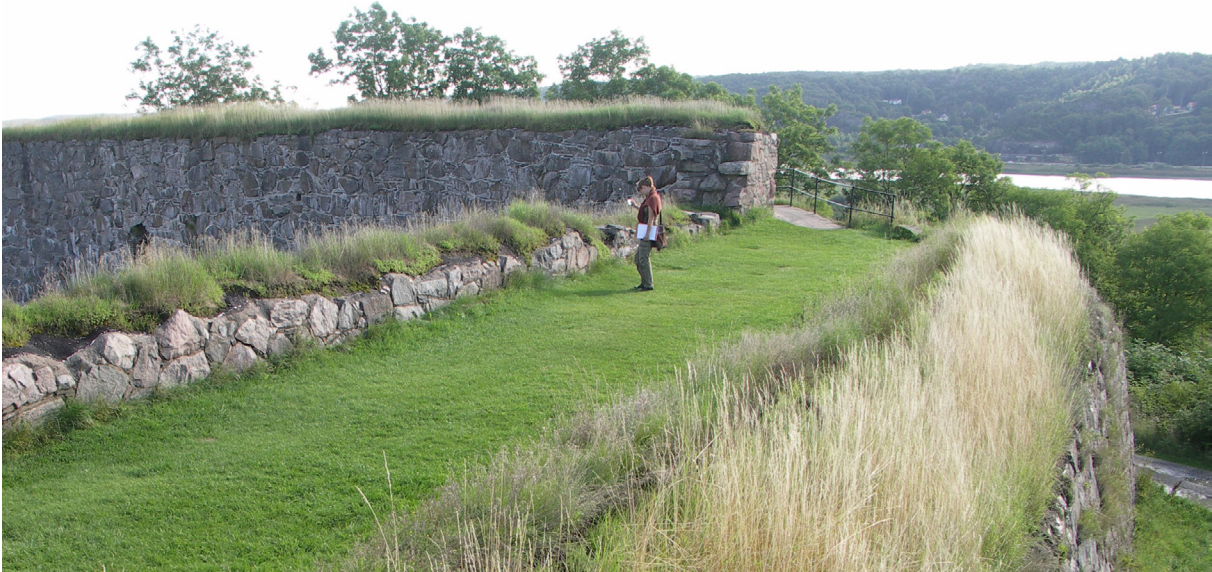
*Fig. 7.7: Bohus Fortress, west Sweden, wallhead soft cappings over bitumen membranes.*

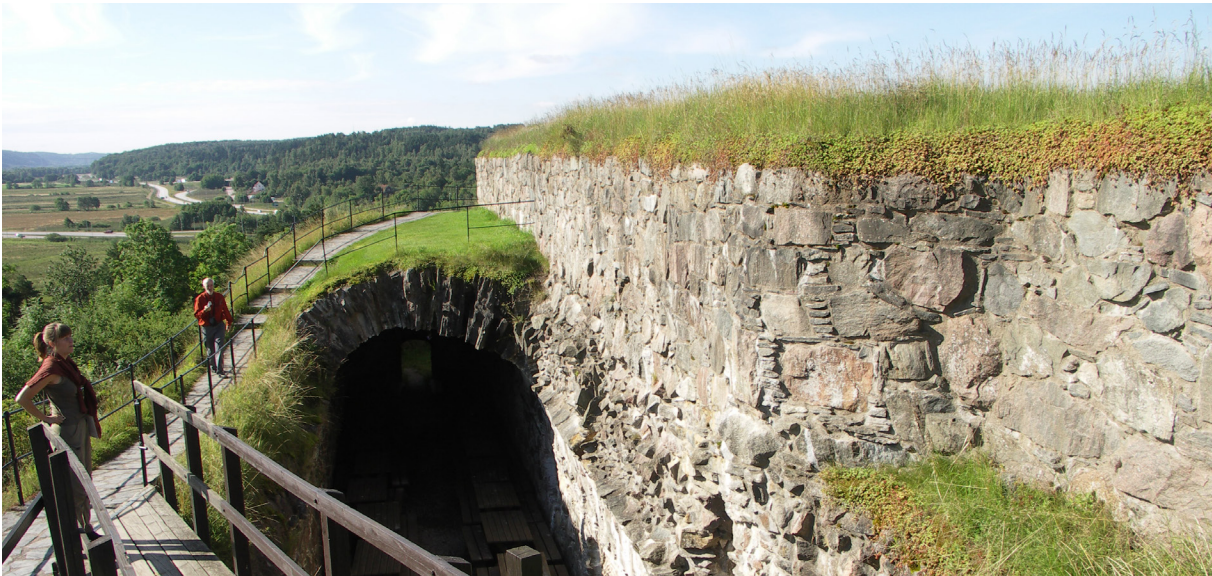
*Fig. 7.8: Bohus Fortress, west Sweden, east facing walls. The soft cap achieves a stable edge, but the species clearly indicate this a modern conservation capping, rather than a natural or vernacular cap.*

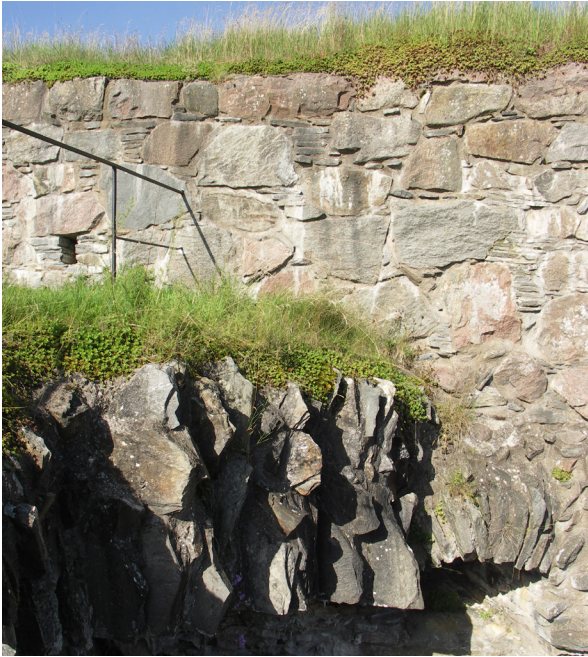
*Fig. 7.9: Bohus Fortress. The edge is well defined, while concealing the hard cap.*

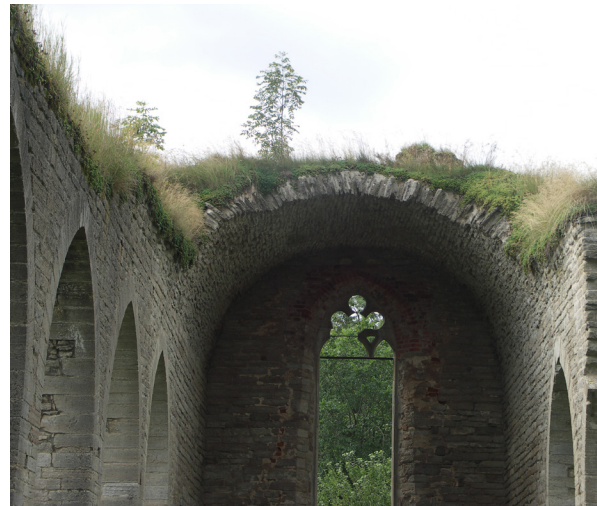
*Fig. 7.11: The Alvastra Monastery, nave detail*

The ruined Alvastra Monastery in central Sweden has one of the most aesthetically successful applications of sedum cappings. Very well established, the sedums successfully colonise isolated ledges and provide sufficient cuttings for ongoing repairs and new cappings. However, their dominance is more than was intended and attempts to increase the ability of grass to compete have been unsuccessful. The site also demonstrates the problems of using smooth rubber or plastic membranes.

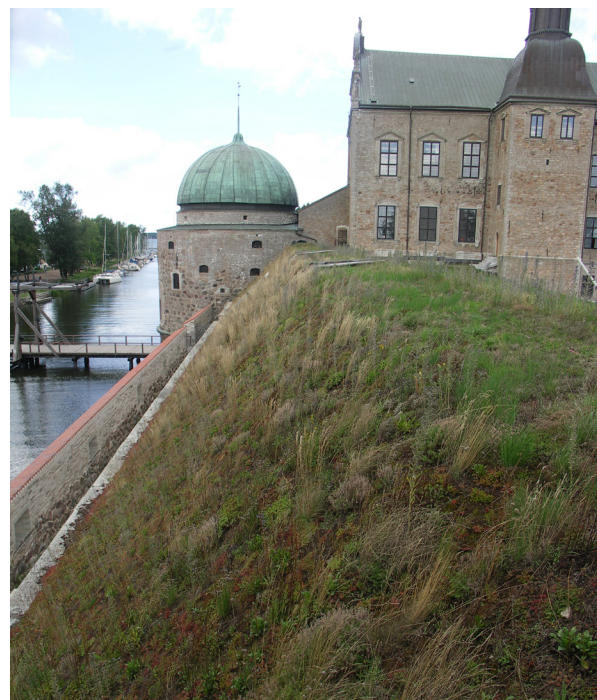
*Fig. 7.12: Vadstena Castle, central Sweden.*

At Vadstena Castle, an attempt was made to reinstate the appearance of original turf embrasures with soil and turf thin coverings over the concrete roof of a new building containing national archives.

The 500mm thick cappings at 45 degrees used proprietary sedum and grass mats over a low fertility, reinforced soil. The dominance of grass on the horizontal tops contrasts with the dominance of patchy sedums and wildflowers on the slopes. The unsatisfactory failure to replicate the original grass-dominant appearance is probably due to the inability of roots to access sufficient moisture. This is apparently due to the combination of a thin soil and the dry summer climate, with a fine reinforcement membrane perhaps also inhibiting deep root penetration.
