SOFT CAPPING IN  
SCOTLAND

The context and potential  
of using plants to protect  
masonry

VOLUME 1

Historic Scotland  
© Crown copyright  
Edinburgh 2011

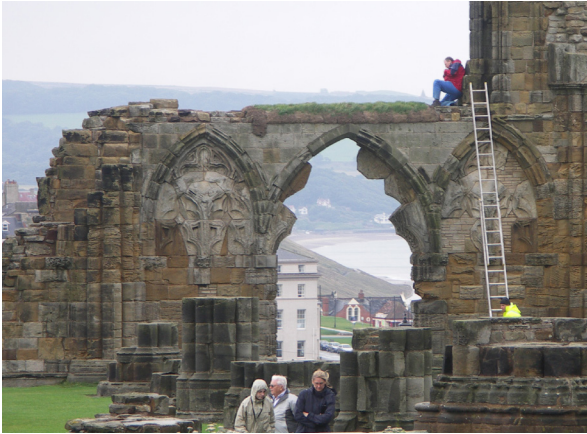
*Fig. 7.19: Whitby Abbey, Yorkshire, experimental capping to test the effect of high winds.*

These trials of soft cappings on English Heritage monuments focus closely on their use to inhibit masonry decay associated with hard cappings applied during the 20th century to monuments in state care. The trials have commonly used British Standard loam soils and turf cut from within the monument site. There has been no use of clay in cappings in England and fixings are generally light, if they are used at all. New cappings typically use a single layer of turf, folded under at the sides to give a double layer, thereby avoiding exposed cut edges. Dpc's and defining layers are not used.

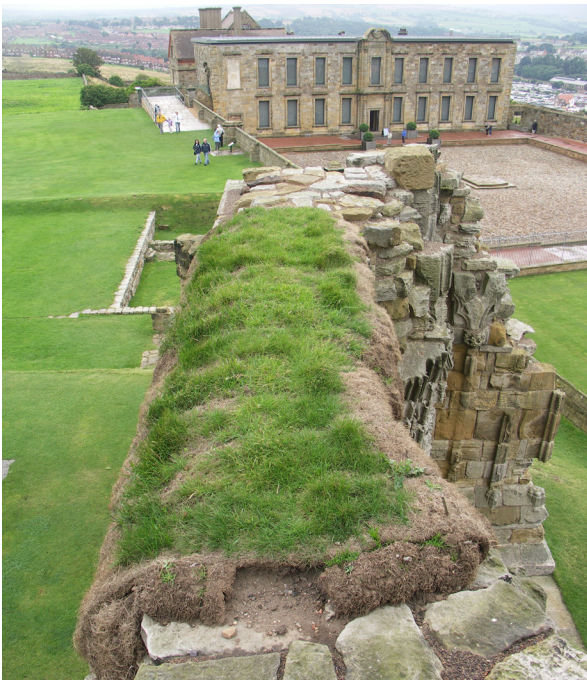
*Fig. 7.20: Whitby Abbey, Yorkshire, edge dieback is severe.*

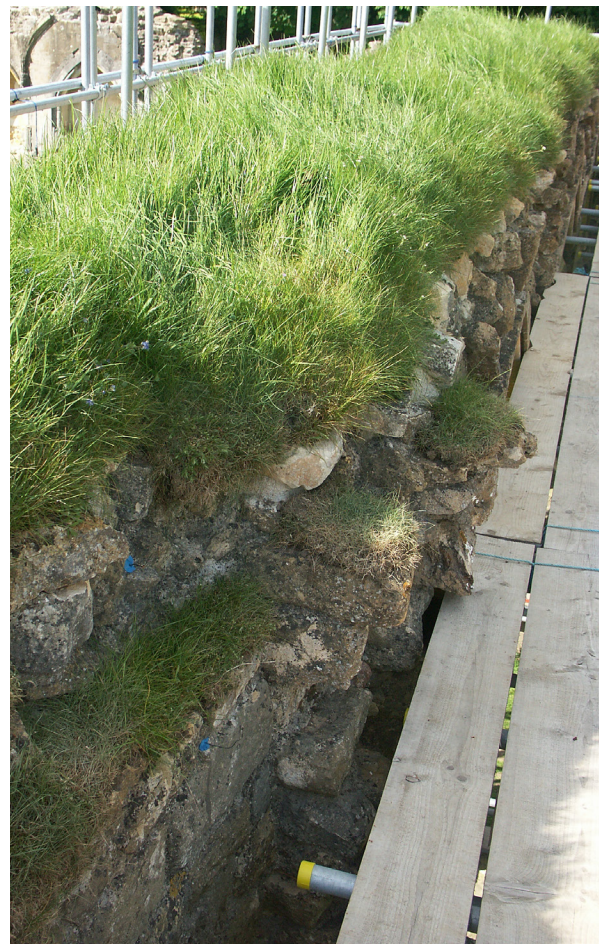
*Fig. 7.22: Hailes Abbey, Gloucestershire. tests show good lush growth, but some failure of small sections.*

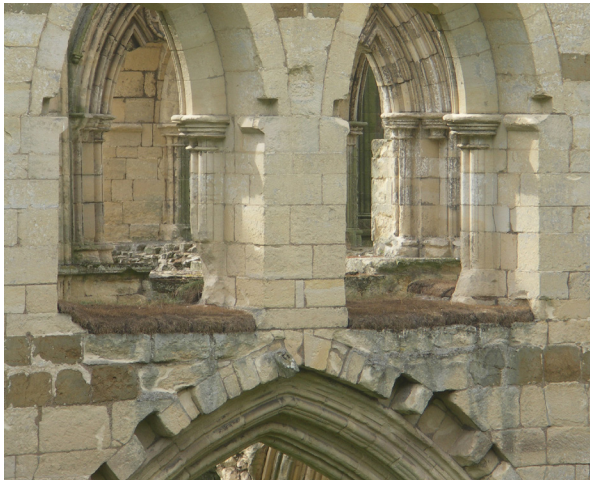
*Fig. 7.25: Rievaulx Abbey, Yorkshire. Failure of turf on relatively sheltered sills, though rainwater penetration and run-off may still be reduced.*

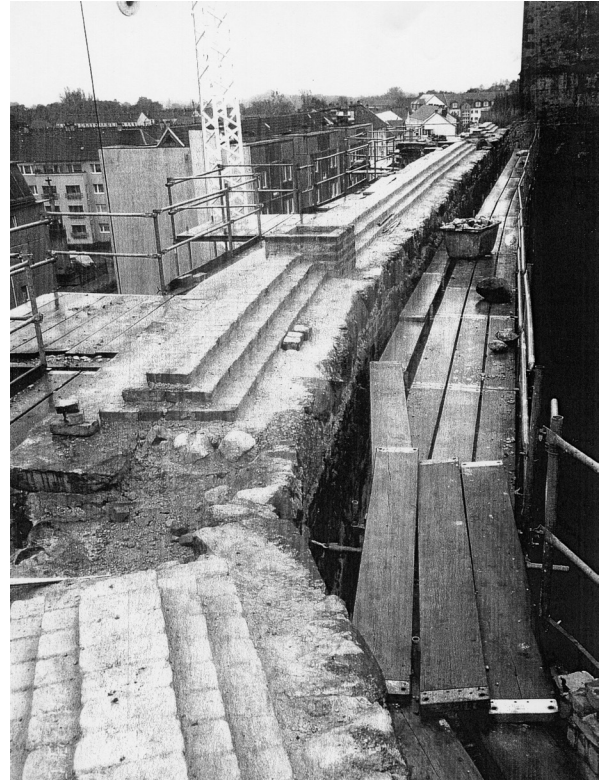
Fig. 7.27: St. Nicolai's Church. Brick profiles, intended to store moisture.

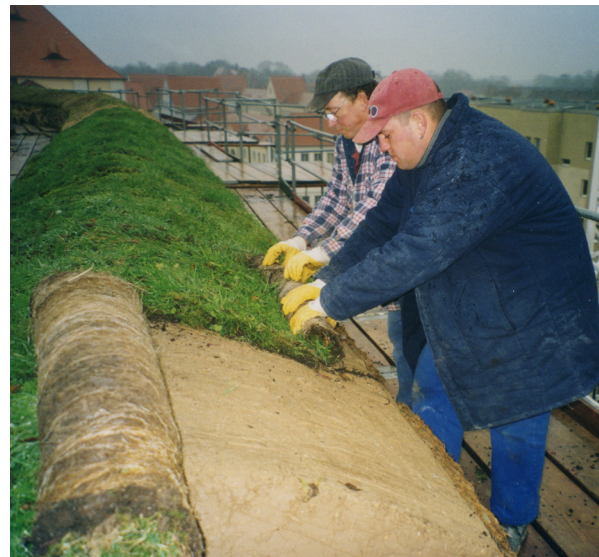
Fig. 7.28: St. Nicolai's Church. Turf rolled over carefully prepared clay caps.

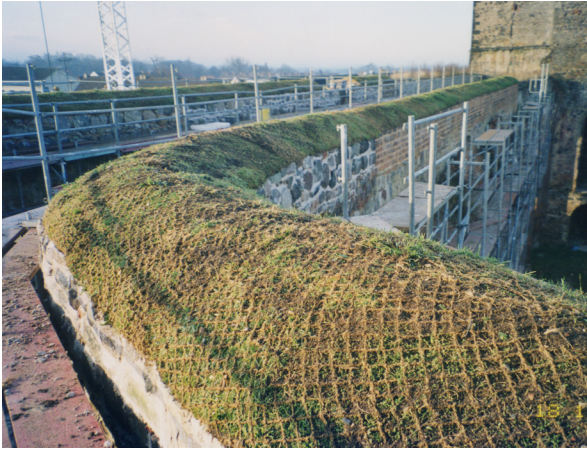
*Fig. 7.29: St. Nicolai's Church. Hessian protecting the finished capping.*

Vegetation mats of five species of drought resistant grasses and three species of herbs obtained from a local horticultural supplier, were applied on top and watered for two weeks by hand. The plants were grown in a geotextile fabric, 0.5m x 2m, to give strength during transportation and installation. The fabric will biodegrade after a few years. Coir netting was applied on top for wind protection.

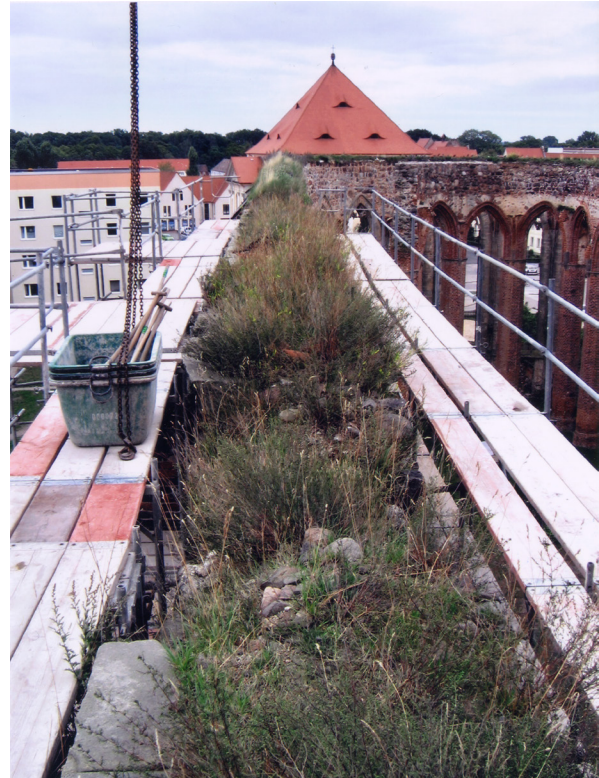
*Fig. 7.30: St. Nicolai's Church. The natural vegetation did not give a stable wallhead.*

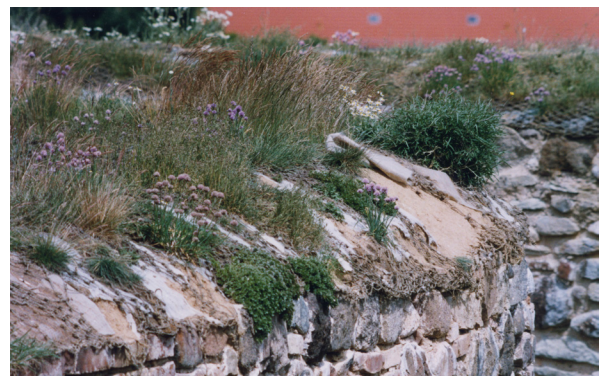
*Fig. 7.31: St. Nicolai's Church. Initial dieback was locally severe.*

It was anticipated that there would be some variation in success between the different planted species and some natural colonisation by other species, which would cause their appearance to mature with increasing complexity. Initially, the cappings suffered significant dieback on the south faces, due to solar radiation. There has also been considerable local damage caused by pigeons. However, there has since been some recovery and colonisation and, three years after application, the general performance was very good (Fig. 7.32).

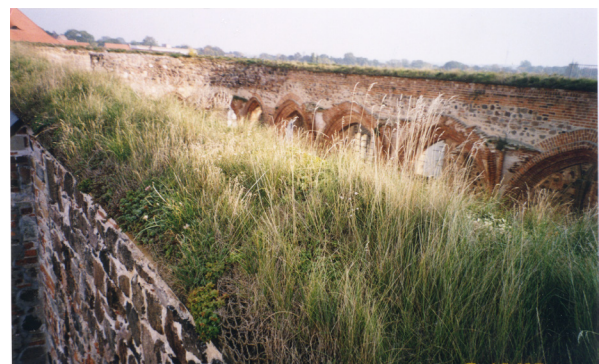
*Fig. 7.32: St. Nicolai's Church. After three years the wallhead was stable and attractive.*

This project highlights the potential of species diversity to overcome initial dieback and create a naturalistic appearance. The success of this high level capping, exposed to strong drought conditions could inform practice on drier Scottish sites, such as Aberuthven (CS38), which have proved challenging.

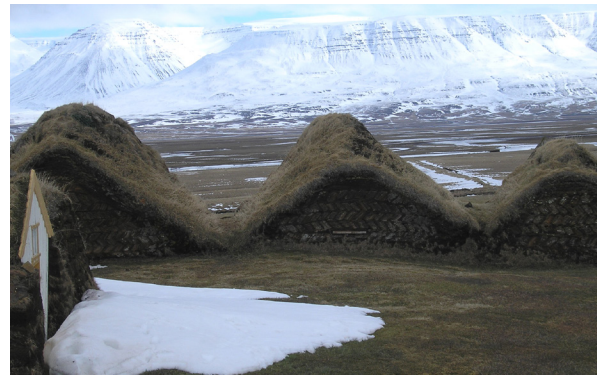
Fig. 7.33: Traditional parallel ranges with turf over timber structures and turf cross-walls.

Iceland has an ongoing vernacular tradition of using living turf as cappings to turf walls as well as roofs over timber structures. Failure is rare, helped by the mass of material beneath. Although Iceland has relatively moderate rainfall, cold temperatures and low humidity help avoid damp conditions developing.

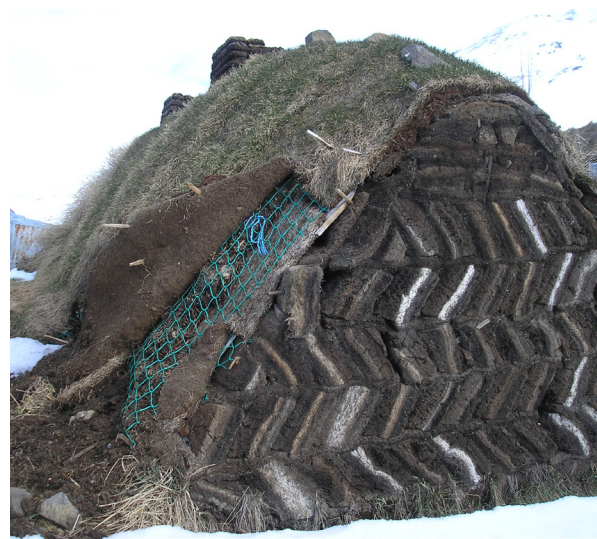
Fig. 7.34: New capping and turf wall.

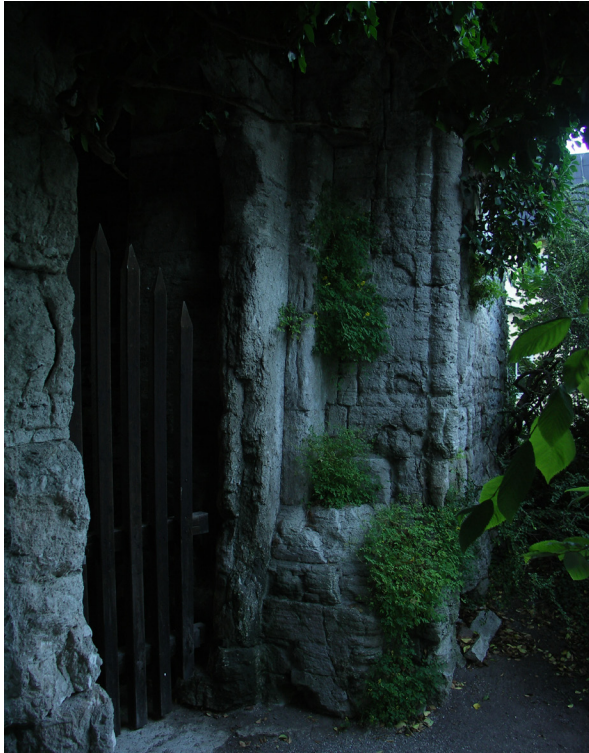
*Fig. 8.3: St. Olof's Church, Visby. Entrance is carefully preserved.*

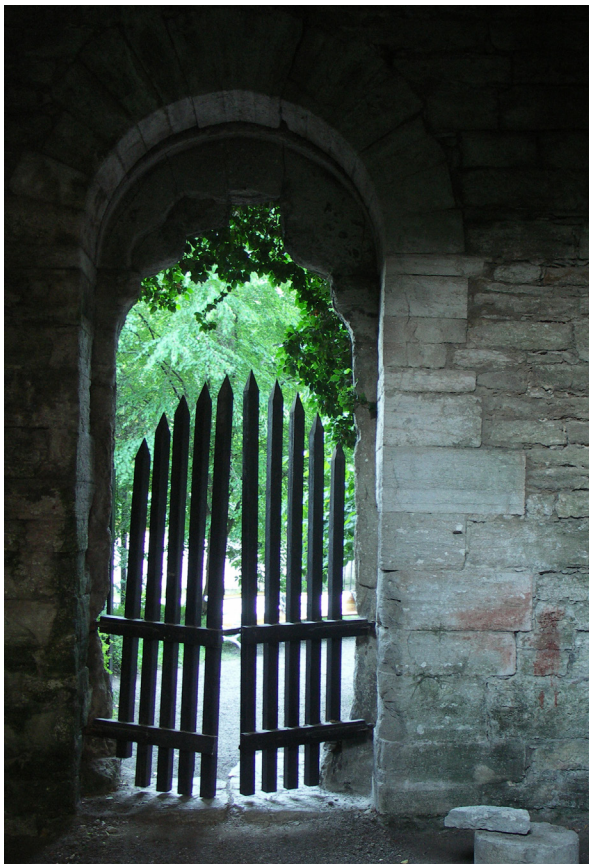
*Fig. 8.4: St. Olof's Church, Visby. The verdant veil has a picturesque appeal prized by local people.*

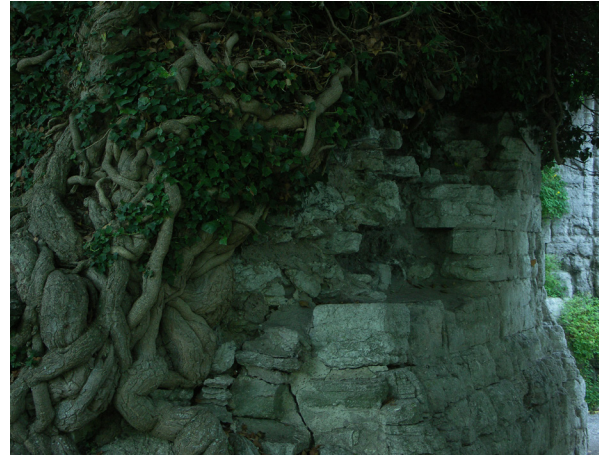
*Fig. 8.5: St. Olof's Church, Visby. The ivy stems grip the masonry, causing local damage.*

There is no doubt that climbing plants can cause damage to masonry walls in certain circumstances. They can root into decayed mortar and stone. Their growth can also add a significant load to masonry structures. However, there are many examples where attempts at complete ivy removal have been unsuccessful, triggering exactly the decay mechanism that was being targeted. If the lower stems are cut, removing plants' source of

ground moisture, tendrils of climbing plants will seek out moisture by growing into the masonry. Even if a substantial amount of the plant subsequently dies and is removed, such rooted-in tendrils may be impossible to remove without considerable disturbance of the masonry. Systemic poisons must be comprehensively applied in such circumstances.

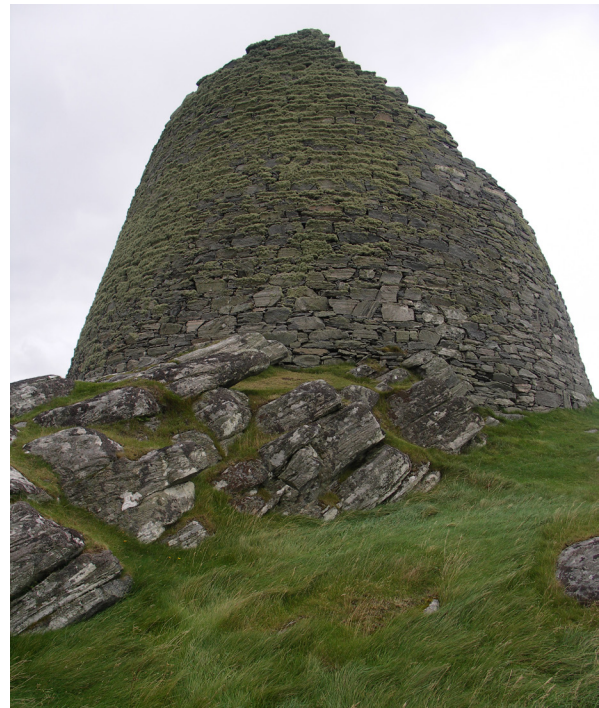
*Fig. 8.6: Dun Carloway Broch, Lewis. Lichen growth is focused on the south side.*

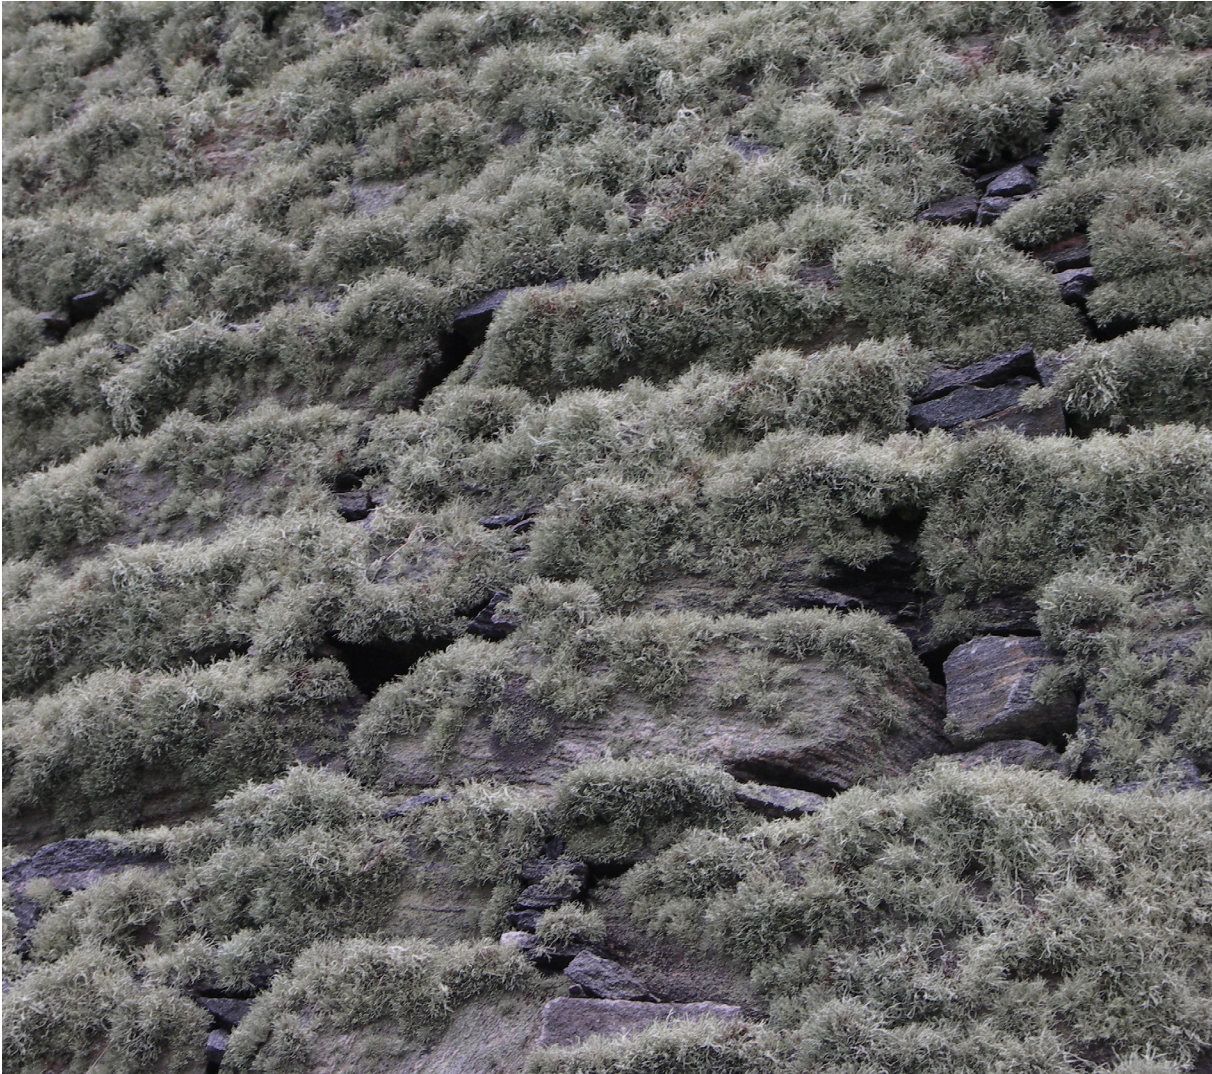
Fig. 8.7 Dun Carloway Broch, Lewis. Lichen growth grows densely from the open joints

The only significant example of green walling noted in the case studies, is of dense lichen growth, possibly the result of around 2000 years growth on a broch in Lewis (CS17). As well as indicating the age of the monument, the lichen, by growing in the open joints, may help to stabilise the structure.

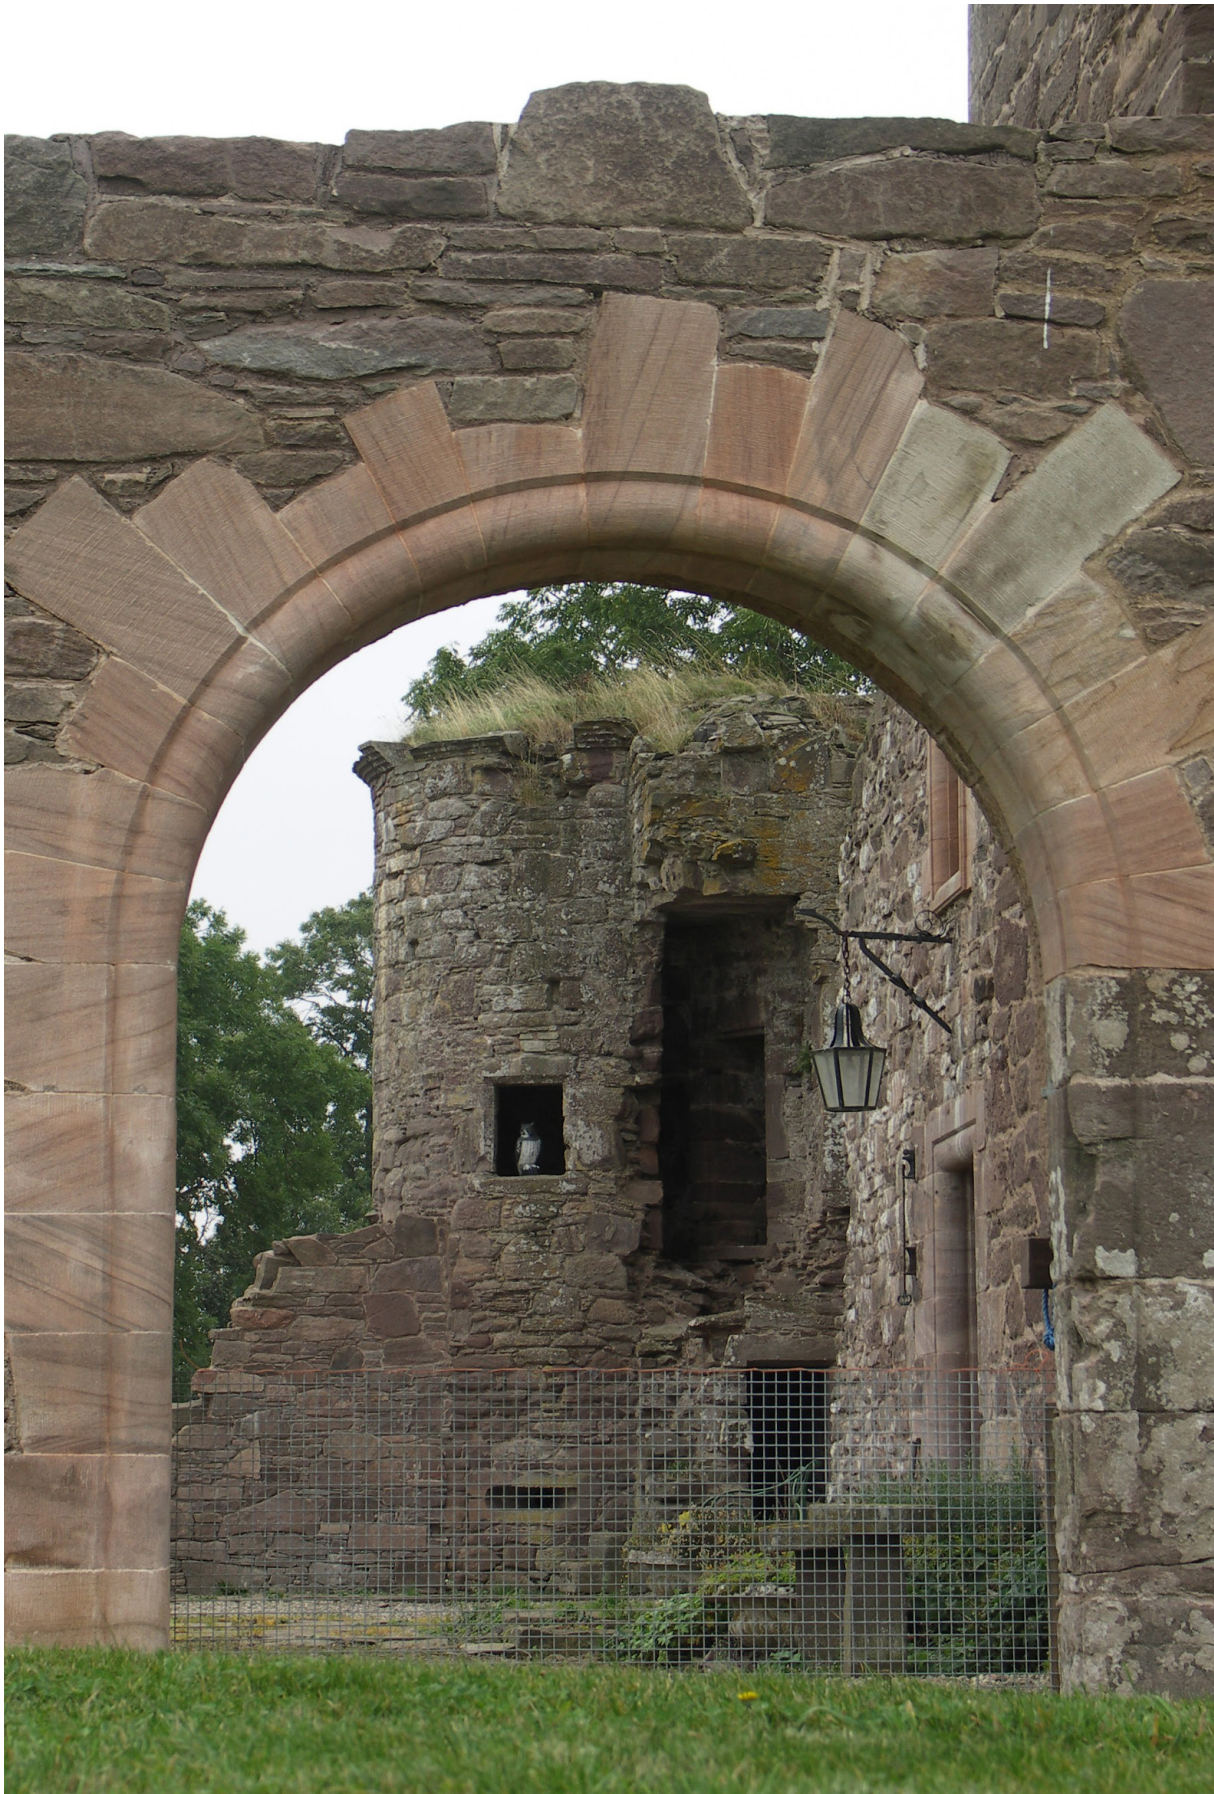
*Fig. 9.1: Melgund Castle, Angus (CS26), where the role of vegetation in a restoration project was well considered.*
