TECHNICAL
CONSERVATION,
RESEARCH AND
EDUCATION
DIVISION

GUIDE FOR
PRACTITIONERS

CONSERVATION
OF HISTORIC
GRAVEYARDS

Published by
Historic Scotland

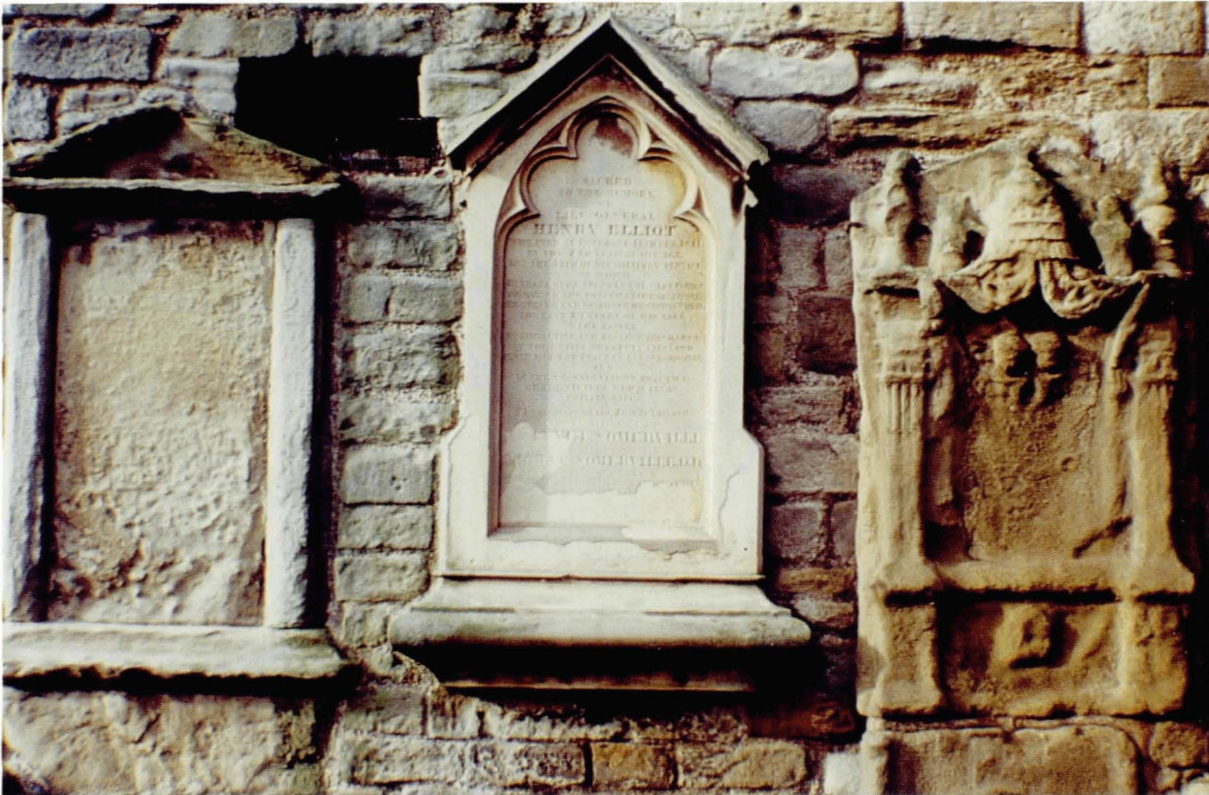
34. Weathering effects on a range of different sandstone wall monuments

Not all materials weather in the same way. Gravestones made predominantly of sandstone suffer the most severe degrees of weathering (Illus 34). To an extent this varies according to the type of sandstone and the minerals which predominated in the stone. Both granite and marble are generally more homogeneous and durable in their geological structure than sandstone. The characteristics of different stones are dealt with in *Technical Advice Note 12: Quarries of Scotland* (1997), published by Historic Scotland

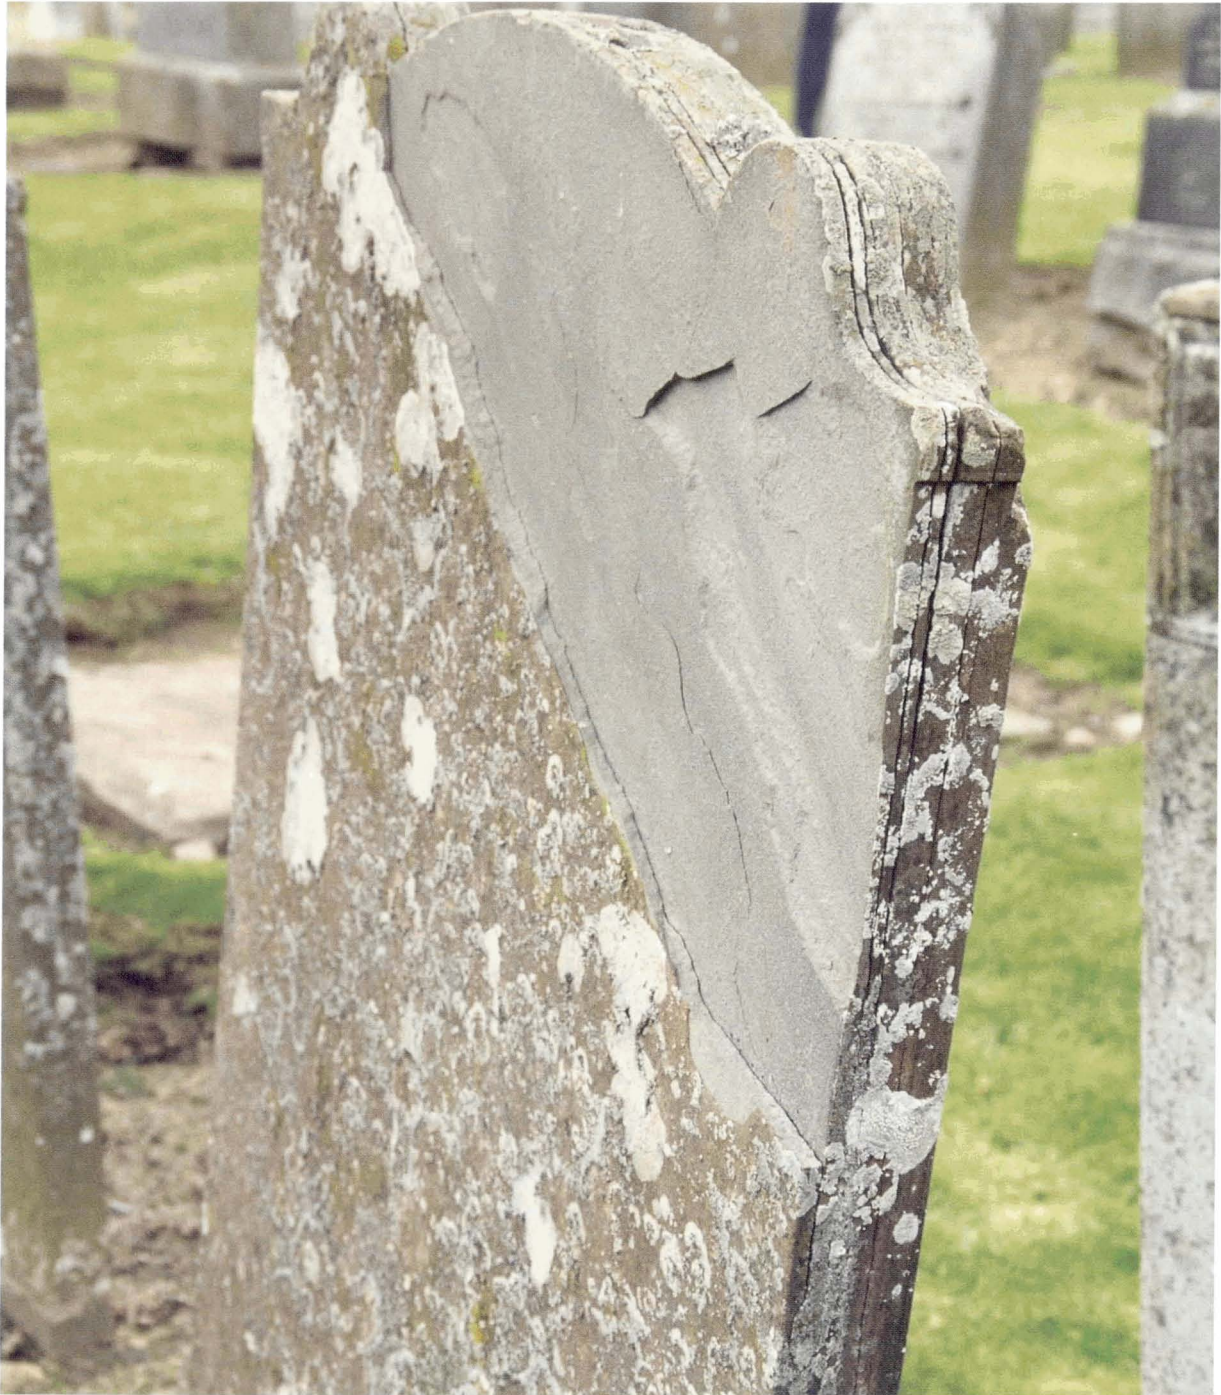
35. *Delamination of a sandstone headstone*

Depending on the thickness of the delaminations, consolidation may require the introduction of non-ferrous pinning and the use of consolidants in order to secure the delaminations. This can be applied by grouting, thereby filling any voids behind the carved surface.

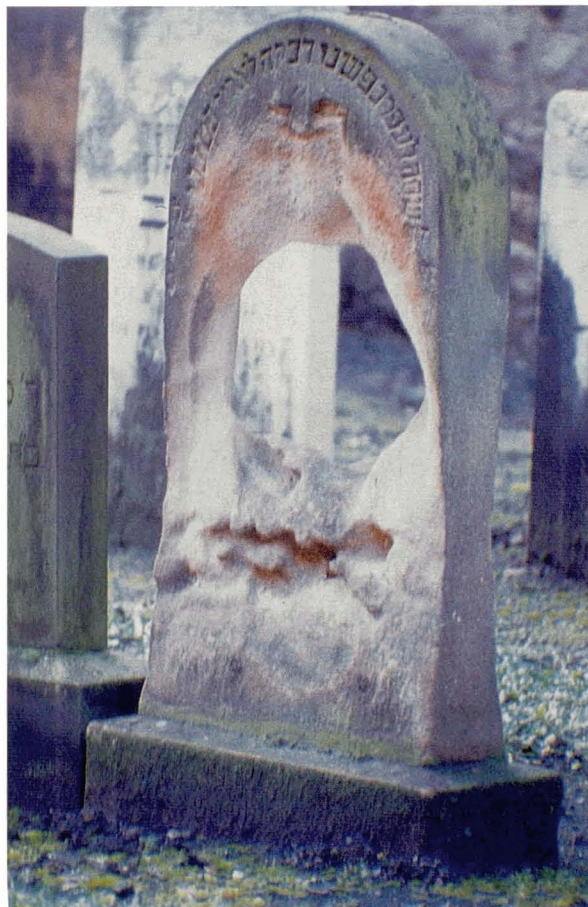
42. An extreme form of alveolar erosion of nineteenth century sandstone graveslab, Edinburgh

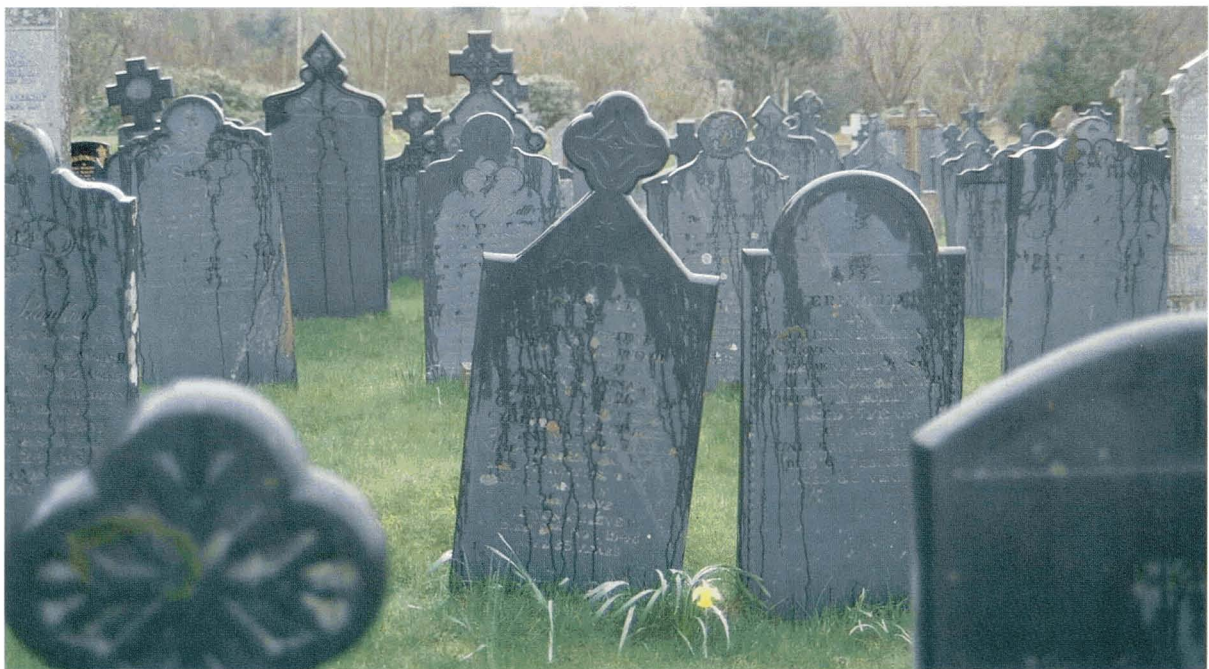
48. Slate gravestones at Ballachulish. Note the sharp arrises and incised inscription

The extremely fine composition of slate allowed monumental masons to exercise their full range of skills. The quality and detail of incised work can be remarkably fine, with edges and arrises appearing sharp and true. This is demonstrated by the finish of the slabs and in their resistance to weathering and exposure. The incised lettering, in particular, tends to remain sharp at the arrises and true in depth. Water runoff over the incised lettering can cause some localised surface staining, though visually unattractive, this is of no physical consequence. Some naturally occurring blemishes in the make-up of the slate may also be noted. The surfaces also generally remain free of organic growths.

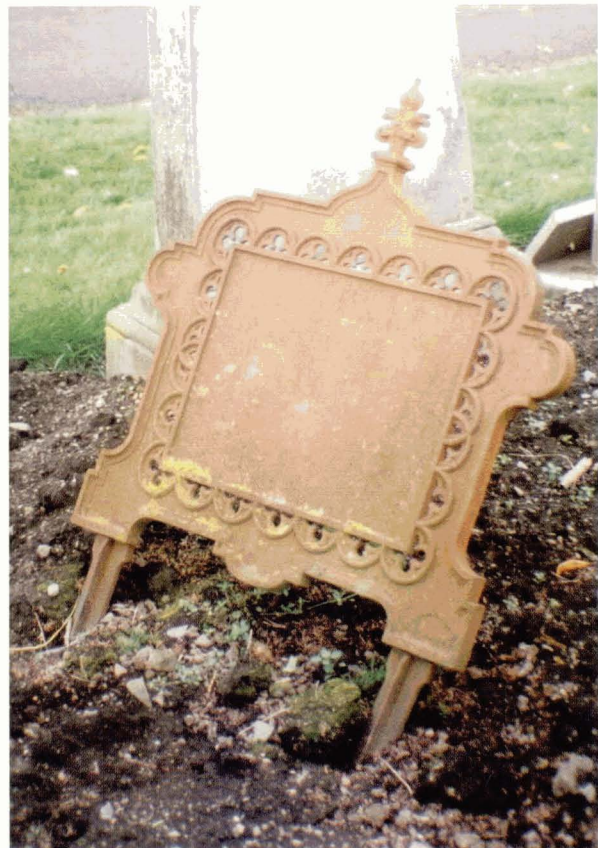
51. A simple cast iron gravemarker

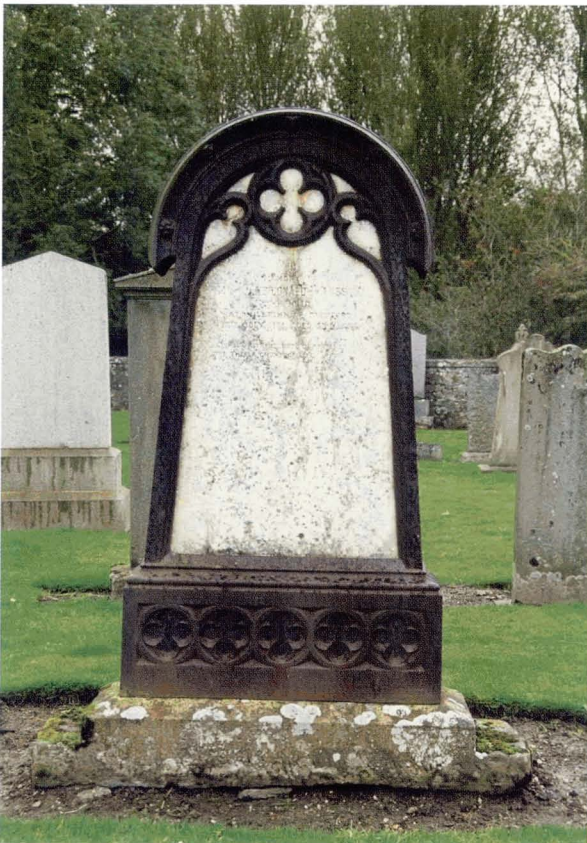
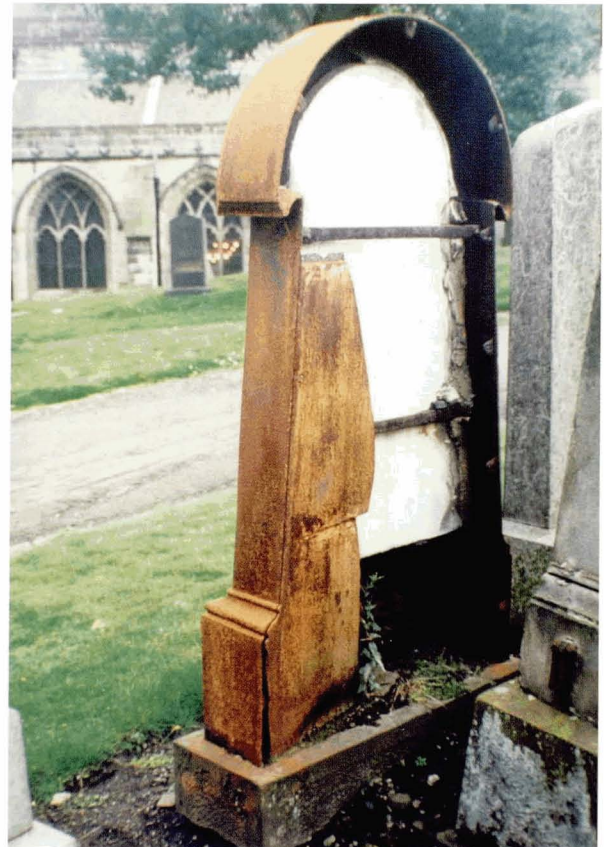
52(a) and 52(b). Typical cast iron and marble graveslabs (circa 1870). The rear face is formed from three flat plates. This is a standard design found throughout Scotland

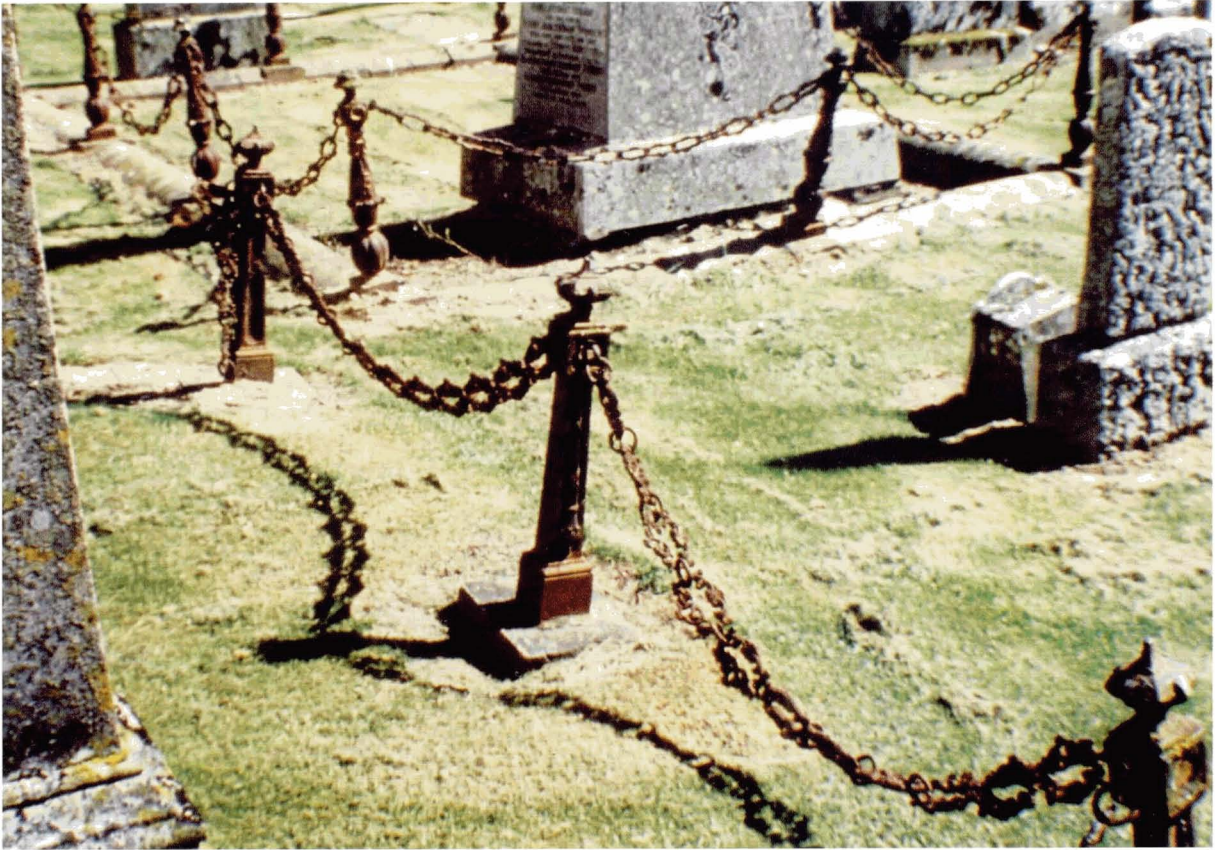
53. Cast iron chains and posts marking burial lairs

Cast iron rails or chains set through a series of small stone or iron marker pillars were commonly used to mark a burial lair. Pillars, like gravestones, often settle in their location and become dislodged and lie out of plumb. While minor leanings and sinking should be acceptable as part of the character, significant displacement could result in the collapse of the whole surround. Such pillars should be reset into a vertical position using a technique similar to resetting stone gravestones (see section 5.10). Where a tilt or a lean is corrected, it must be ensured that the repair is not simply cosmetic but the source of the problem is dealt with. Leaning pillars are also more prone to vandalism.

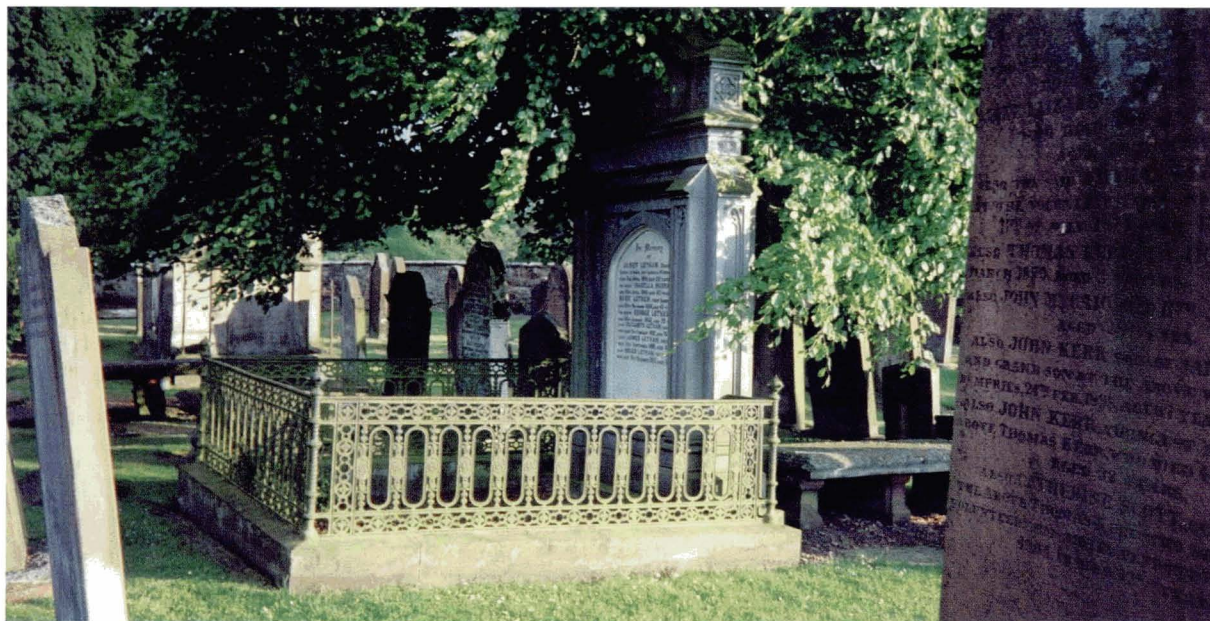
55. Iron railings defining a burial lair. The level of refinement of the casting can cause confusion with wrought iron

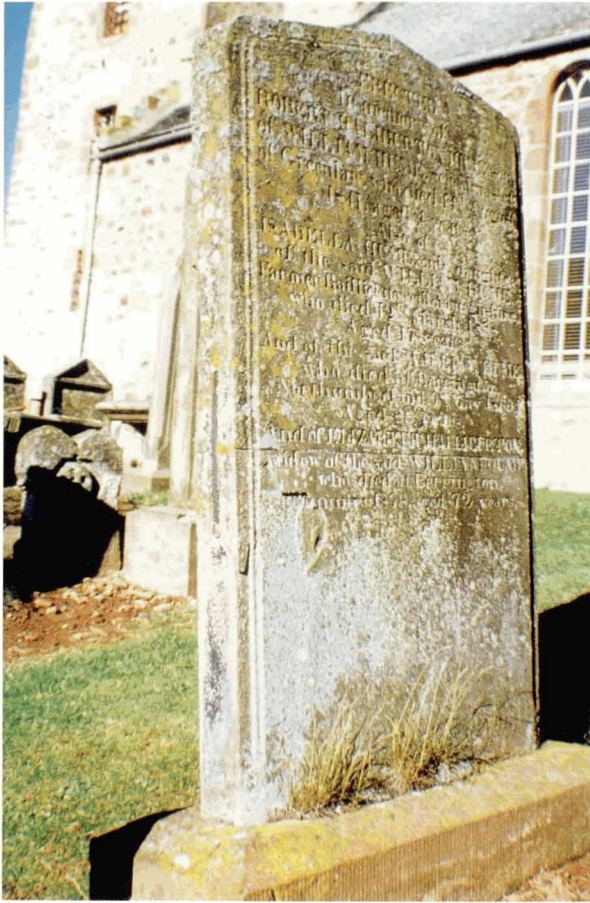
58. Sandstone memorial built by joining two stone slabs. Note the iron clamp across the joint, Greenlaw

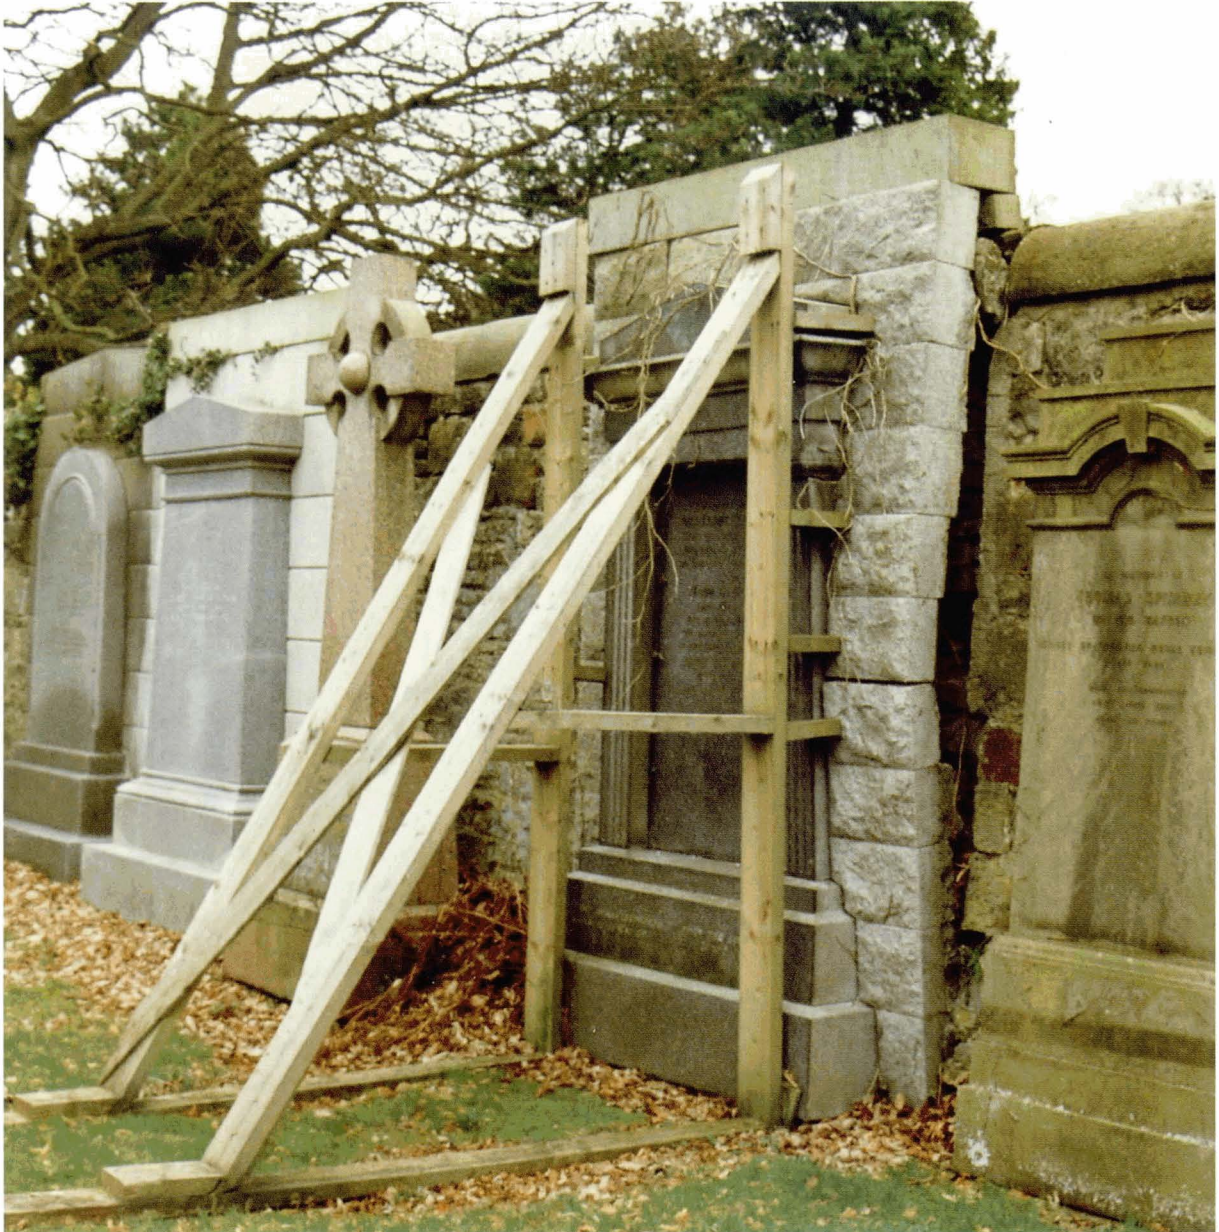
63. Temporary timber shoring to support a badly constructed backing wall which has separated from the adjacent boundary

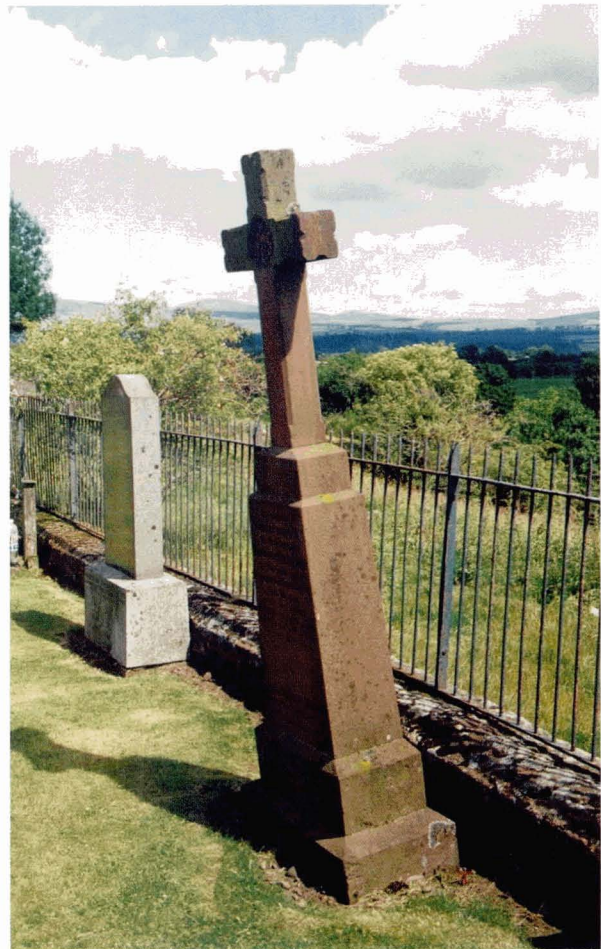
66. Example of a monument with a tilt that is of long standing. Note that the centre of gravity still lies within the area of the base

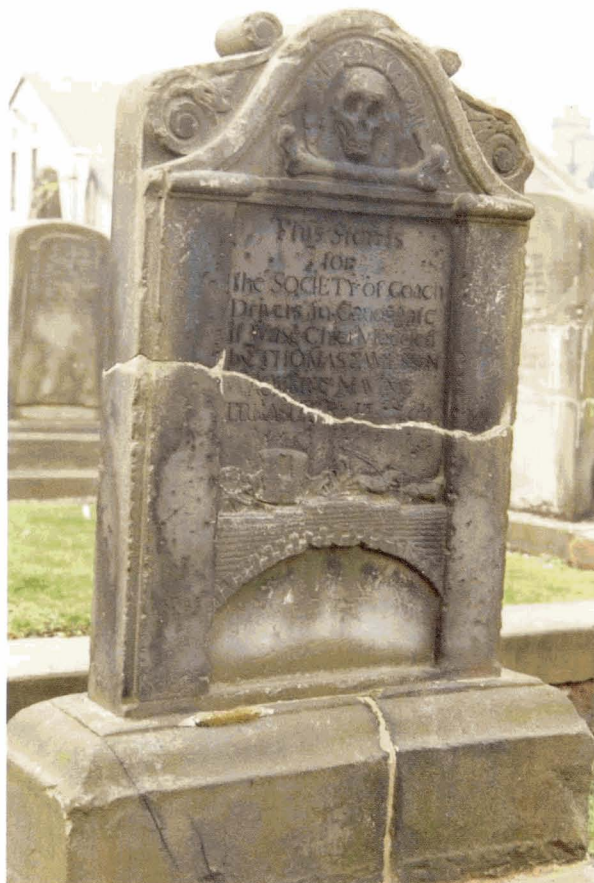
68. Snapped headstone repair with lime mortar joint

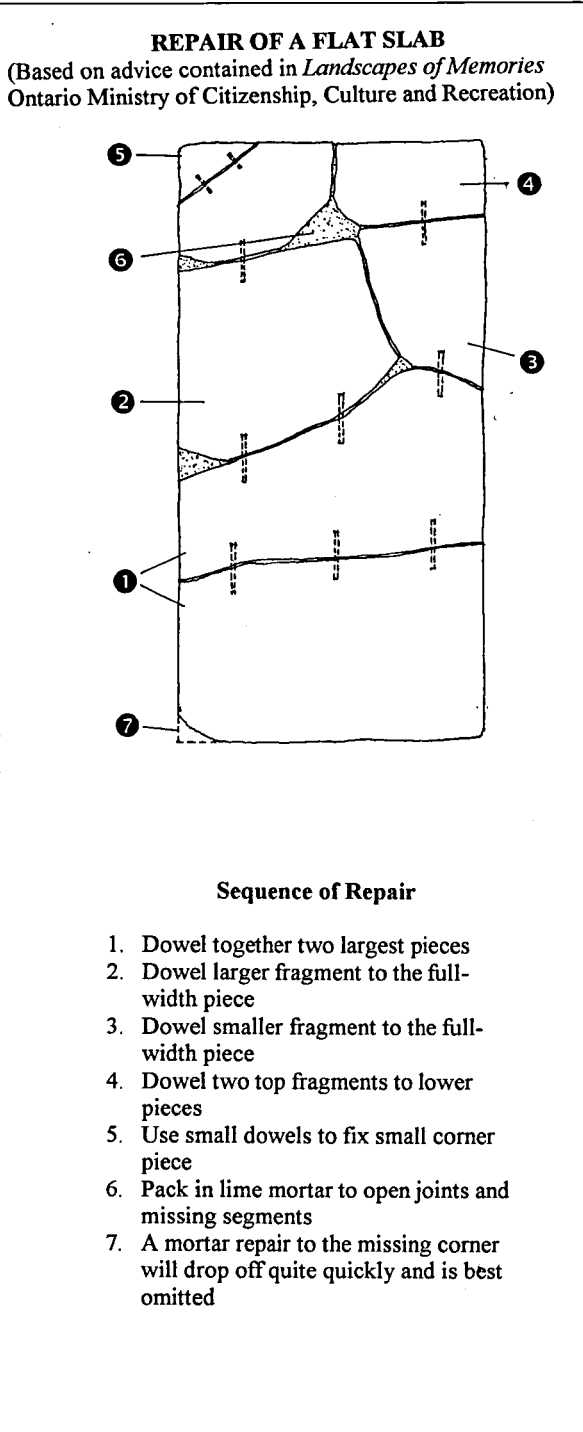
71. Sequence of repair of a flat slab

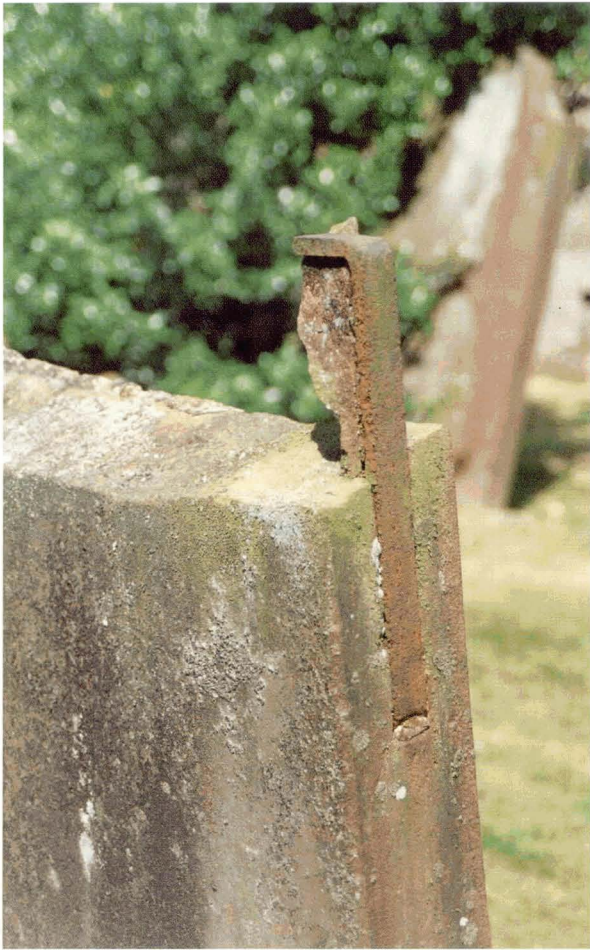
73. An iron cramp has been used to repair the headstone. A volume expansion of the cramp due to corrosion has caused the stone to fracture and increase the scale of the damage

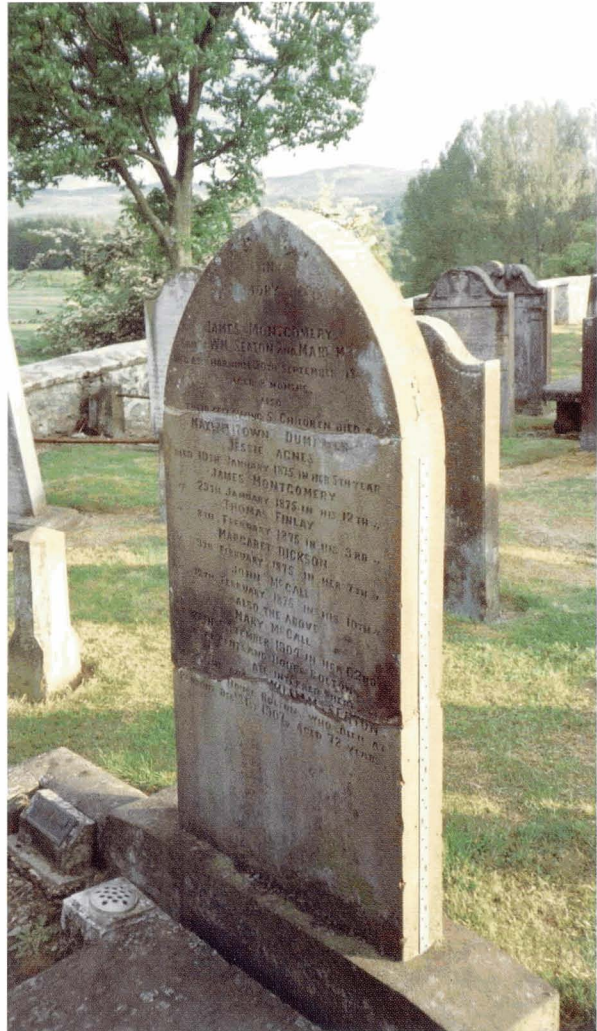
75. Headstone repaired with mortar. The galvanised strap fixed to the edge of the slab will add little to the stability of the repair

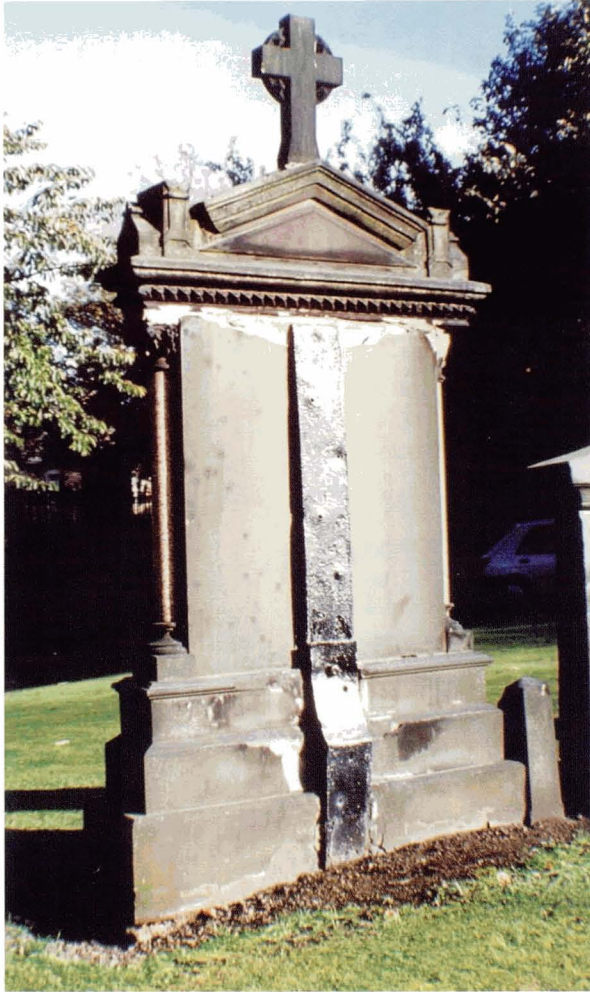
76. A metal armature fixed to the rear of the stone provides additional support, Greyfriars, Edinburgh

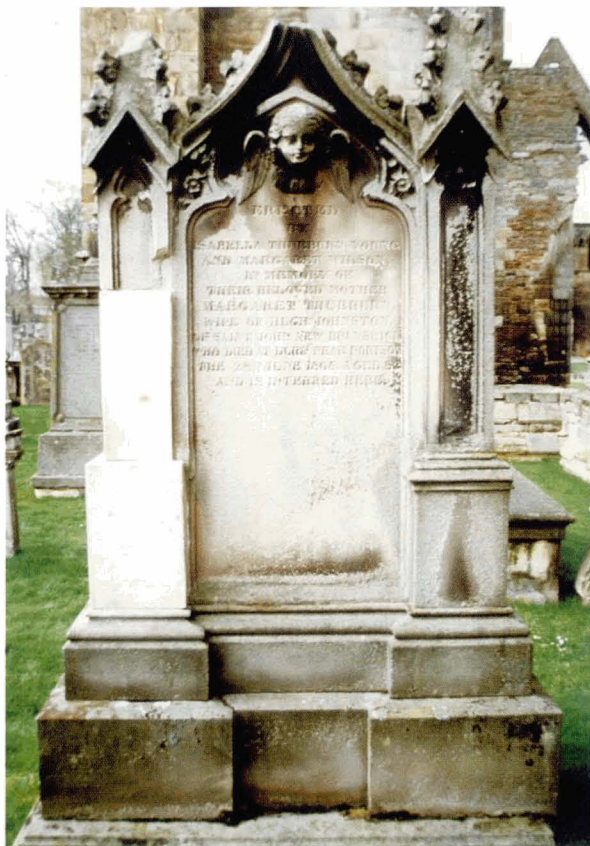
78. Blocked-out repair of stone

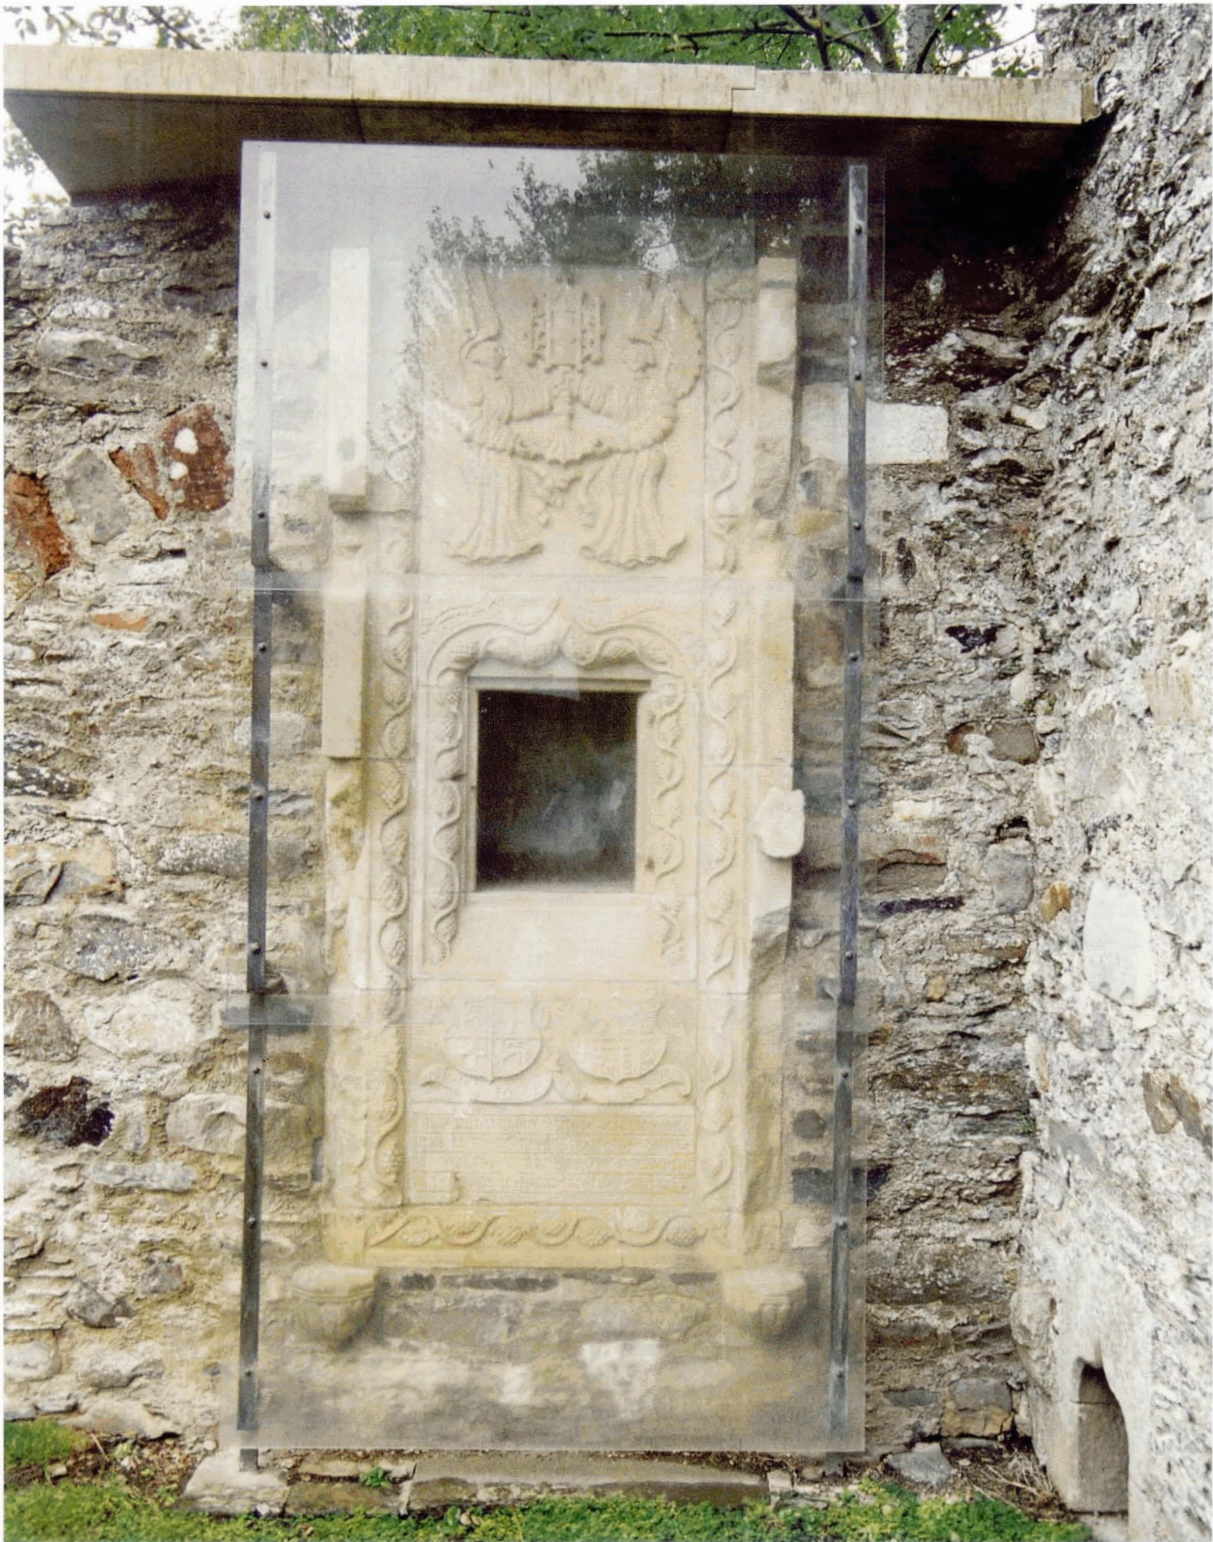
81. Protection to the stone Sacrament House in Deskford Churchyard, Moray, allows natural air movement around the monument whilst protecting it from rain

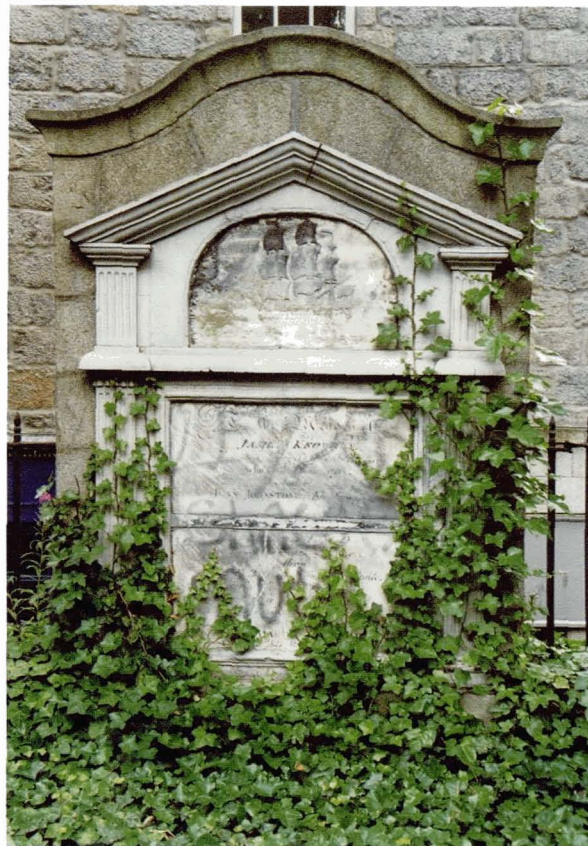
106. Wall monument in danger of becoming obscured by ivy. The ivy will help to protect the monument from further graffiti attack but will also cause damage to the stone

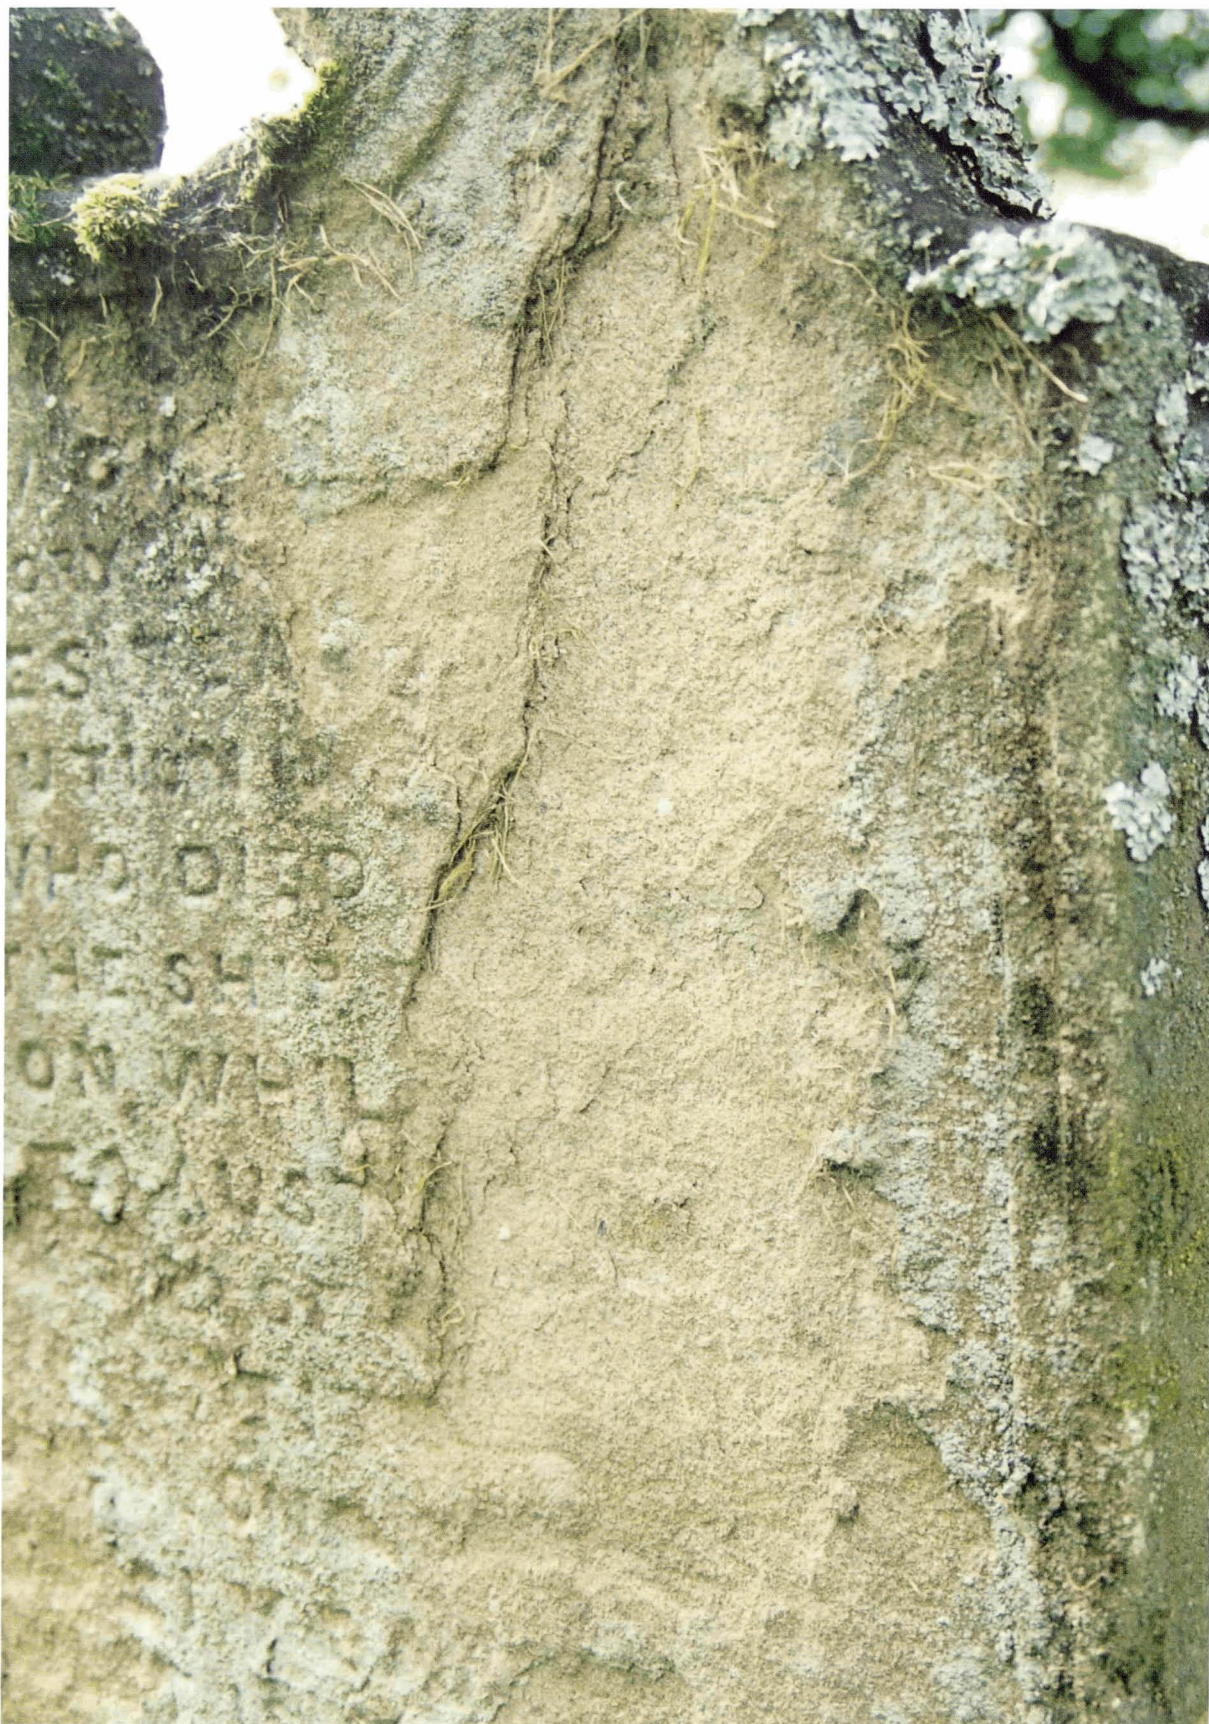
109. Moss root penetration into delaminating sandstone headstone

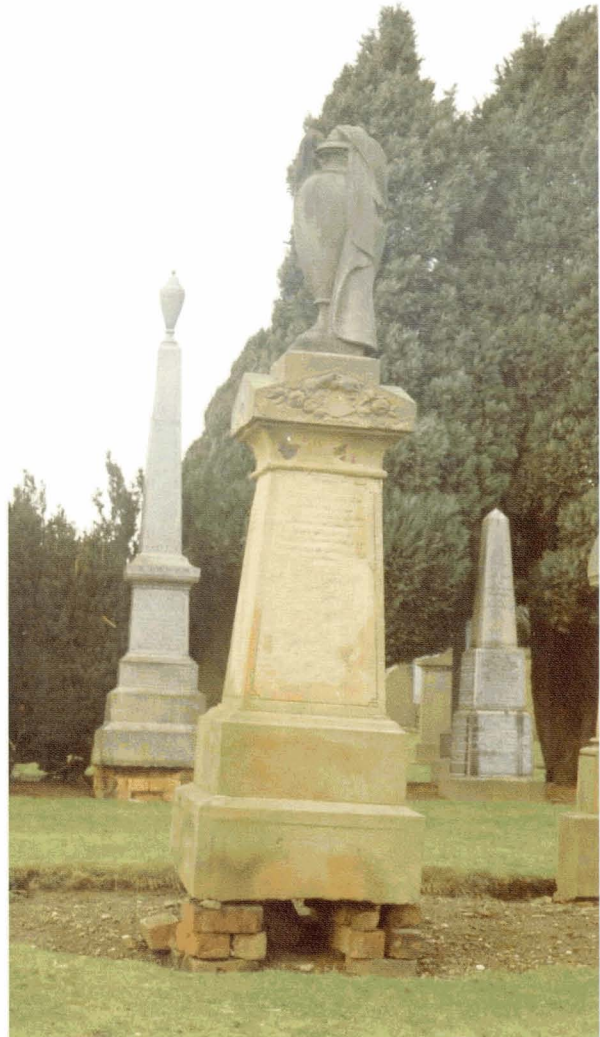
114. Significant erosion, as a result of turf removal, has led to this memorial becoming dangerously unstable

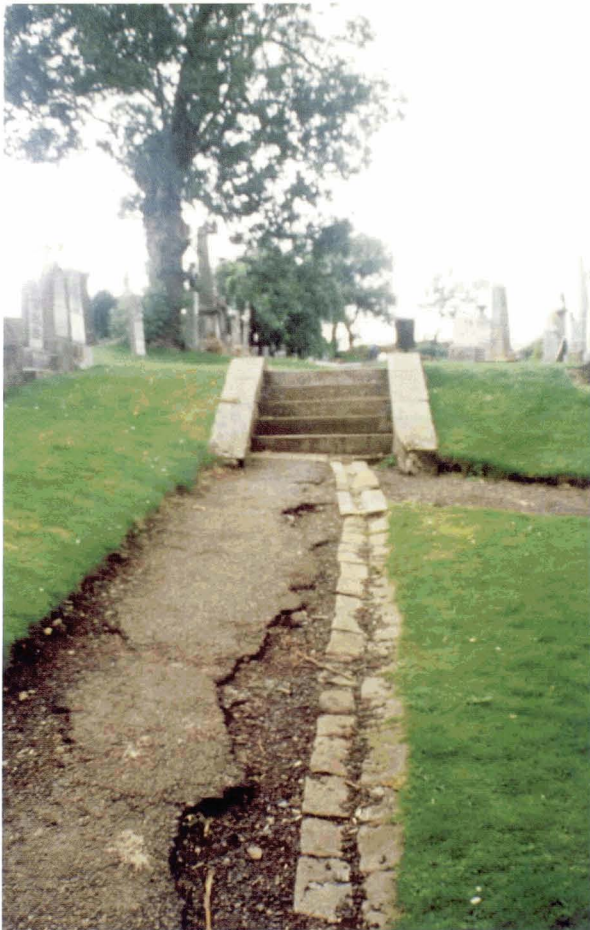
115. Inadequate design of the path to accommodate surface water run-off has resulted in disruption of the tarmac. In this case the use of tarmac has increased maintenance problems and is inappropriate in a graveyard setting of this type

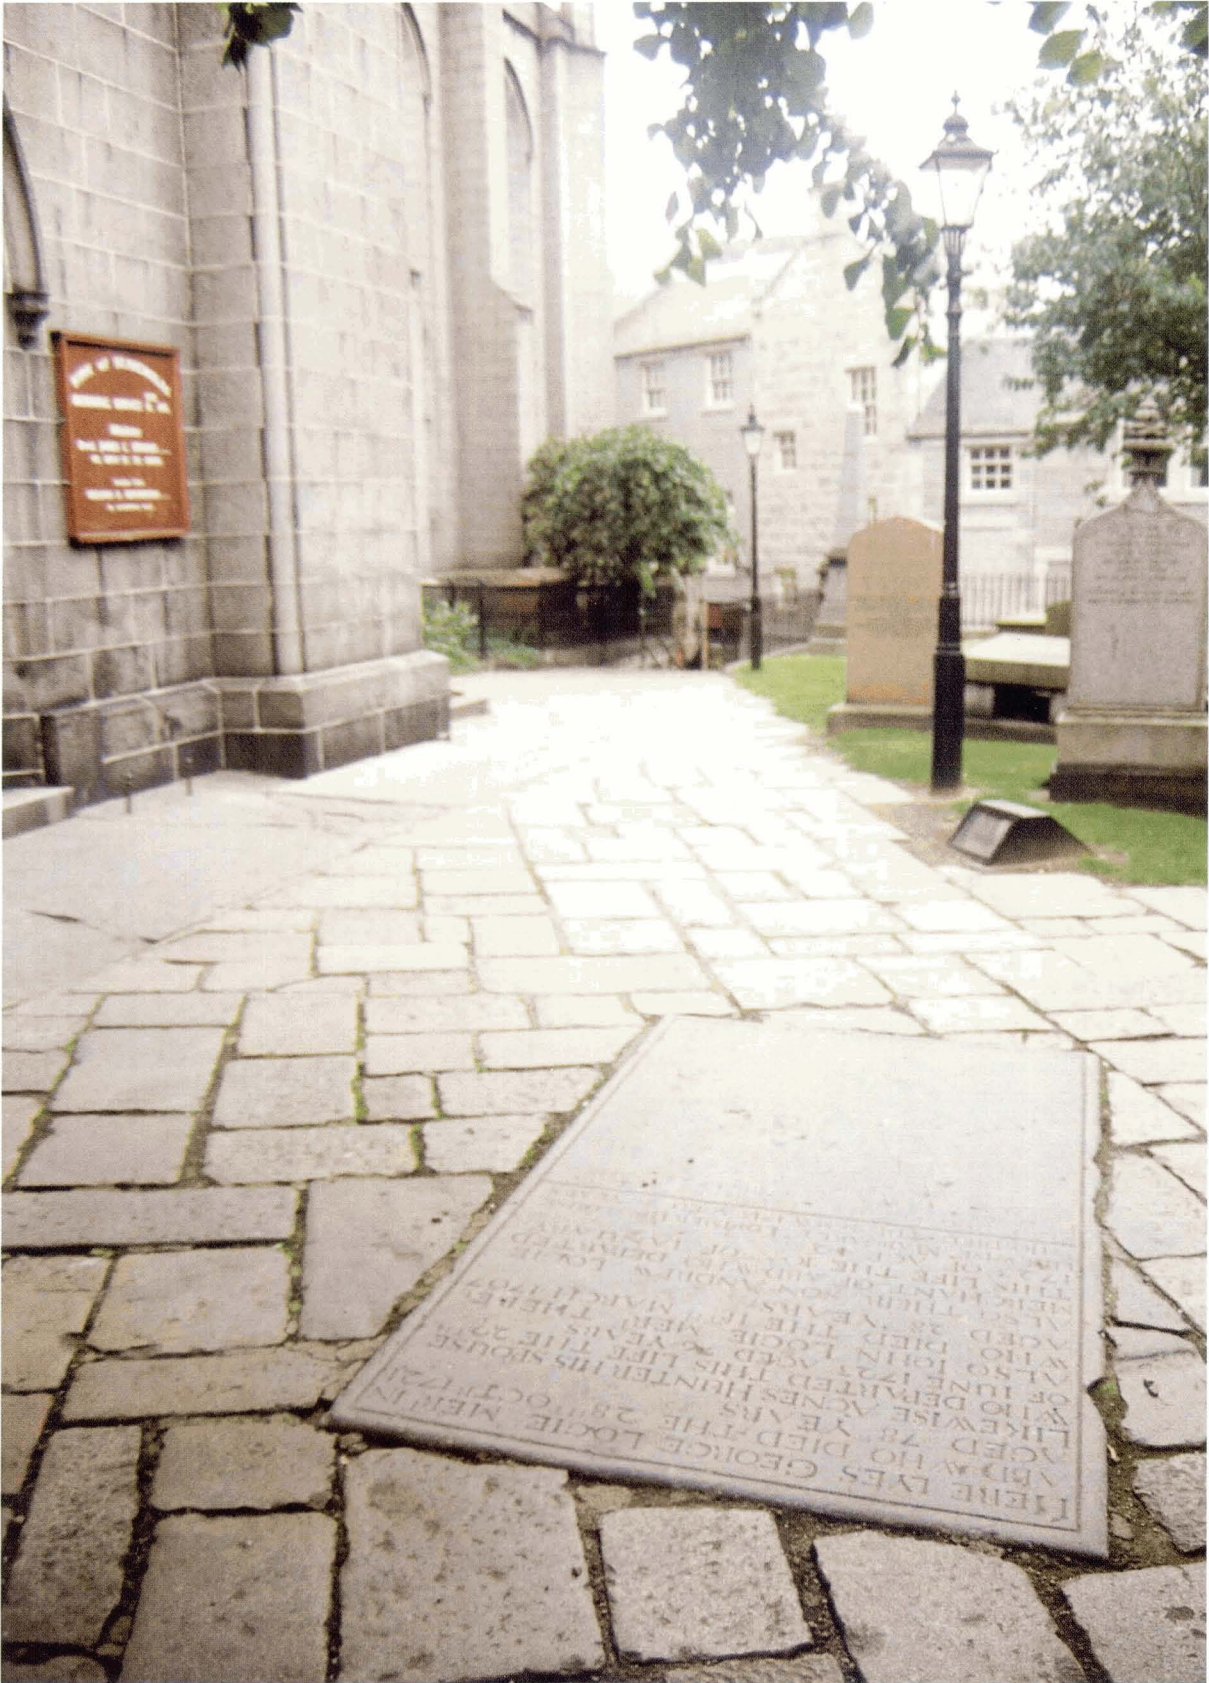
124. The entrance to the kirk is subject to heavy foot traffic and the flat graveslab has had to be incorporated into the paved area to improve access. Whilst the graveslab is granite there has been sufficient wear to result in a loss of inscription
