TECHNICAL
CONSERVATION,
RESEARCH AND
EDUCATION
DIVISION

GUIDE FOR
PRACTITIONERS

CONSERVATION
OF HISTORIC
GRAVEYARDS

Published by
Historic Scotland

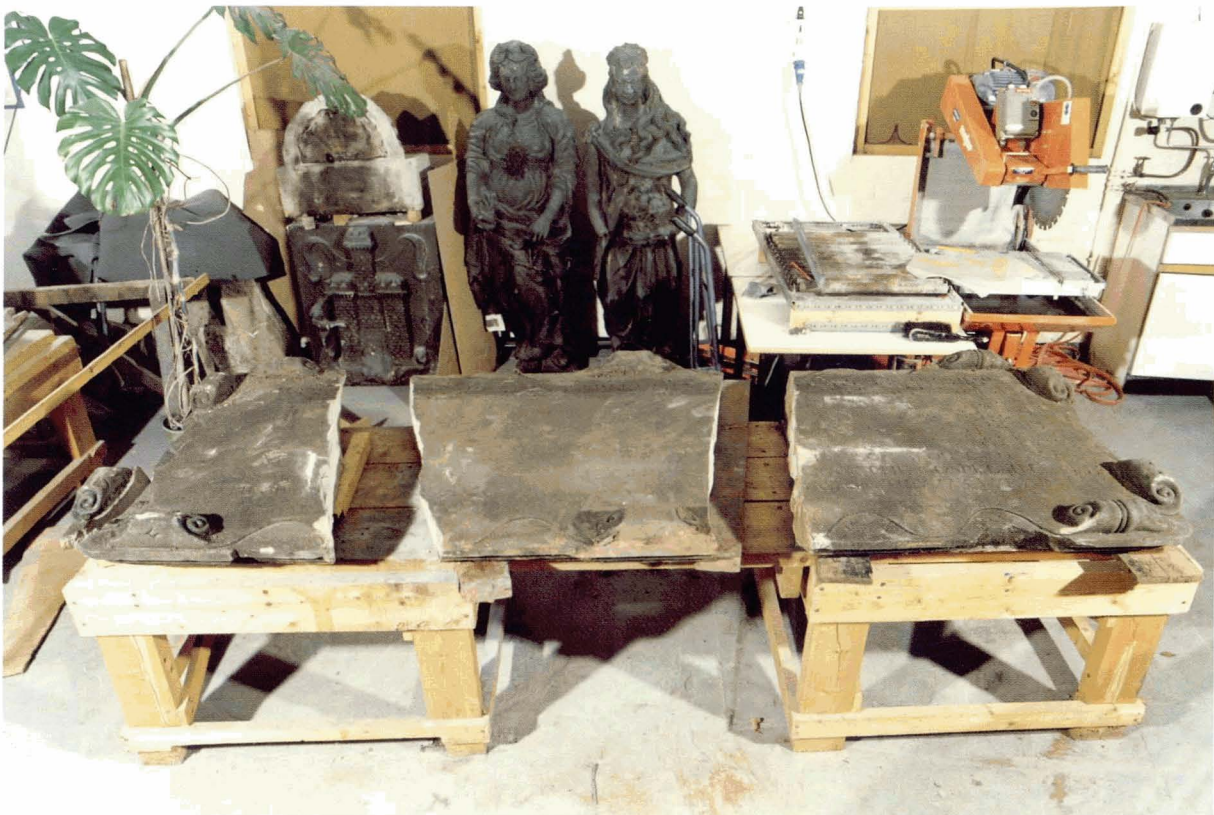
136. Fractured graveslab in the workshop prior to dowelling
