# EDINBURGH CASTLE RESEARCH

# THE STONE OF DESTINY: A REVIEW OF NEW IMAGING

Peter Hill

This re-evaluation of the Stone of Destiny was carried out as a desktop exercise based on low-resolution images of the Stone provided by Historic Environment Scotland, at the request of Mr Steve Farrar, Interpretation Officer, HES in 2015/16. The new imaging was produced through a combination of Reflectance Transformation Imaging (which is a photographic technique) and high-resolution Structured Light Scanning.

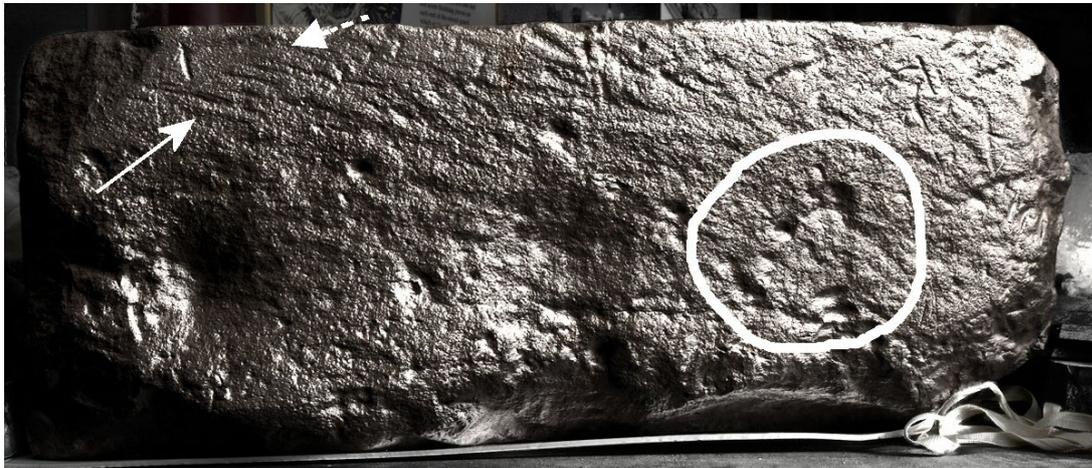
Figure 1 The face. © Historic Environment Scotland.

The scan reveals tool marks with considerable clarity. The upper edge is significantly more neatly worked than the remainder, yet still carries a number of visible random punch marks in both pecks and short furrows.

At the upper left hand the clear marks of a 55mm wide blade are angled slightly down from the horizontal, dipping to the right (arrowed in Figure 1). The full width of all marks is not visible as some stone has been lost immediately above the plain arrow. This is an unusual way in which to work a surface with a chisel; it would be normal to work along the stone from right to left (vice versa for a left-handed

The chisel marks also come very close to the edge of the Stone (dashed arrow in Figure 1), which carries a high risk of the edge of the upper surface being damaged. It is for this reason that margins are always worked as shown in Figure 2. It is not impossible that the blade could have been an axe used in a downward direction with the front face vertical. This might carry a little less risk of damage, but the indications are that the blade was held at quite a steep angle, which would not be safe.

There are two explanations for these unusual blade marks. First is that the Stone was cut down from a larger stone by cutting down to what is now the upper surface. This would have no effect at all on the front face, leaving any tool marks from the original working of that face. However, this would have to have been very early in the Stone's existence, long before it left Scone.

What is brought out by the scans is that the front of the Stone was never worked to be a visible face. The best surviving tool marks, at the upper edge, show a number of punch pecks and furrows which would always have been visible. The damage to the lower edge was almost certainly caused deliberately, probably with a hammer.

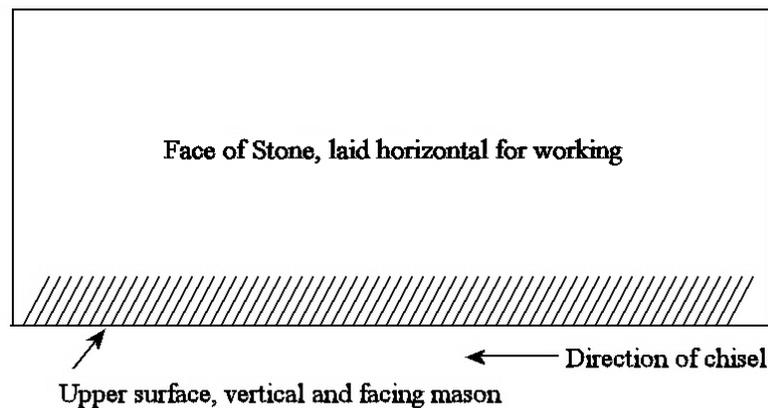
Figure 2 The normal way to work a margin. © Peter Hill

mason) along the long axis while standing in front of the stone (see Figure 2). A chisel of about half the width would be more usual.

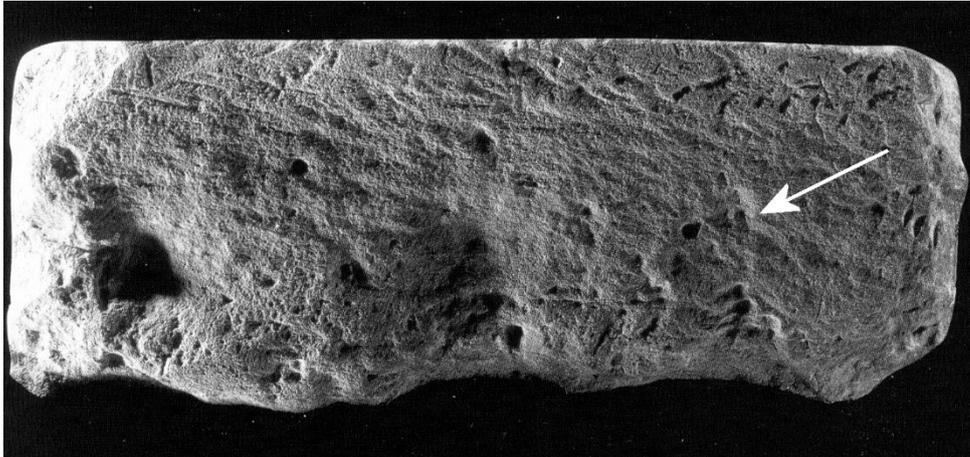
Figure 3 A clear view of the right-hand depression and the band across the top of the Stone. © Historic Environment Scotland.

This depression does show up on the new image, bounded in part by a series of five or six punch marks. This area is circled in Figure 1 and arrowed in Figure 3. However, it is significantly closer to the centre depression than is the left-hand one, and thus is most unlikely to relate to the quatrefoils.

On the whole, Rodwell's suggestion that general wear and damage to the front of the Stone (apart from the visible band across the top protected by the front rail of the chair) was at least in part caused by souvenir hunters is probably correct. But the unequal spacing of the depressions must cast doubt on this as a reason for their existence. Furthermore, they show clear signs of being made by pointed objects similar to a punch used in a conventional way, especially the right-hand one, rather than being cut or scraped by the penknives of visitors. Cup marks cannot be ruled out any more than they can be proved.

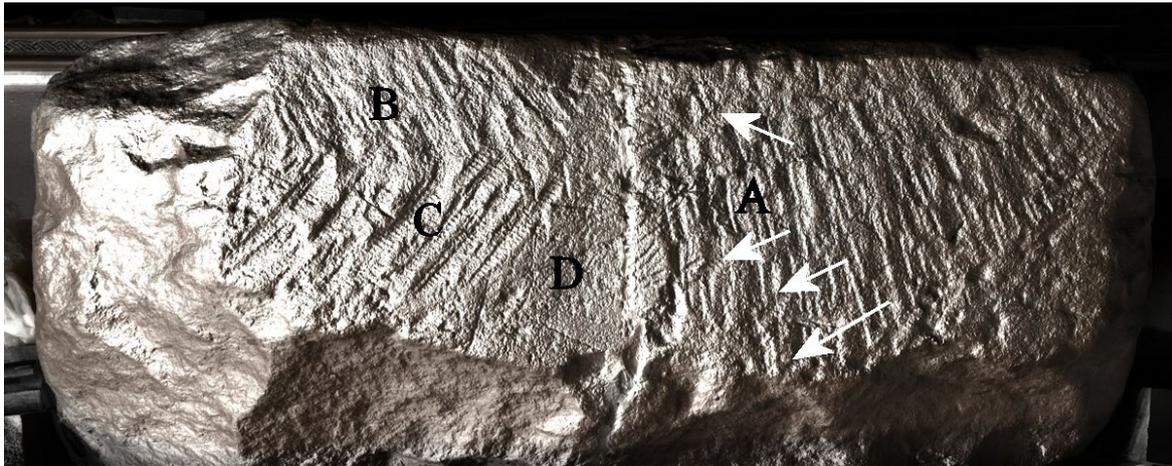
Figure 4 The back of the Stone. © Historic Environment Scotland.

The vertical crack is approximately in the centre of the face, with each half of the Stone treated in a totally different manner. The left-hand side is set 2-3mm below the right, as a result of the very poor repair carried out by Robert Gray in 1951.

The right-hand side is largely worked with a broad chisel, in strokes set about 10 degrees from the vertical (A on Figure 4), apart from the upper right-hand end where they become less steep. In places there are tool marks which slope in the opposite direction, down from top right to bottom left, at about 45 degrees to the vertical. These are referred to below.

The upper part of the right-hand side is also worked with a plain blade, but at a quite different angle and somewhat more neatly (B on Figure 4). Below this area the Stone is worked irregularly and heavily with a claw blade forged from a plain chisel, in up to a dozen strokes (C on Figure 4). The heaviness of this work shows more clearly on Figure 5, although with less detail.

There are also claw marks from the same tool, set at 45 degrees, visible on the right-hand side, indicated by four light arrows on Figure 4. There may be a few more of these, but the scan does not give a clear indication.

All these claw marks are comparatively new, and could date from the 1951 repair work or could be somewhat earlier. There is no obvious reason for this work.

Rather oddly, there is a band of stone immediately left of the crack which was anciently rubbed quite smooth, and widening from top to bottom (D on Figure 4). There is no obvious reason for this.

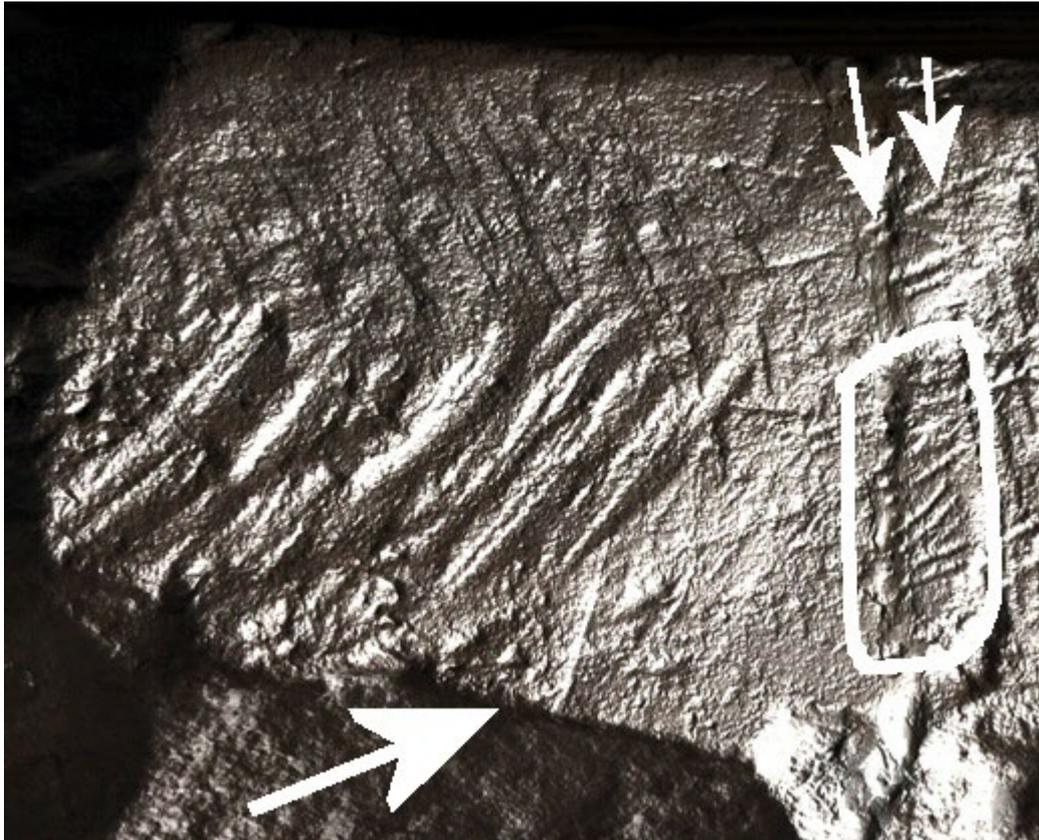
Figure 5 The left-hand side of the back face. © Historic Environment Scotland.

To the immediate right of the crack is a series of irregular, short blade marks, circled on Figure 5, which may be an attempt by Robert Gray to level up the two surfaces.

The most peculiar aspect of this face is that the work to the Stone on either side of the crack is, and was always, quite different. There is only a single instance of a tool mark appearing to cross the line of the crack, and even that is uncertain from the scans. Only a fresh look at the actual Stone would confirm this. The mark is from a plain chisel, double arrowed on Figure 5.

The lower edge of the Stone is very badly damaged, most probably the result of heavy hammer blows, some perhaps as the result of being dropped. The straightness of part of the break on the right-hand side may indicate the use of a pitching tool (single heavy arrow on Figure 5).

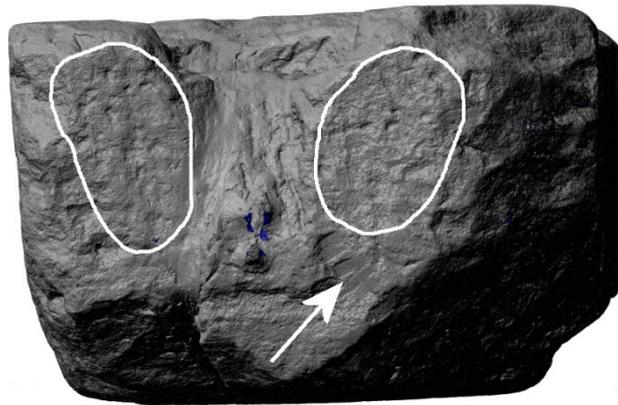
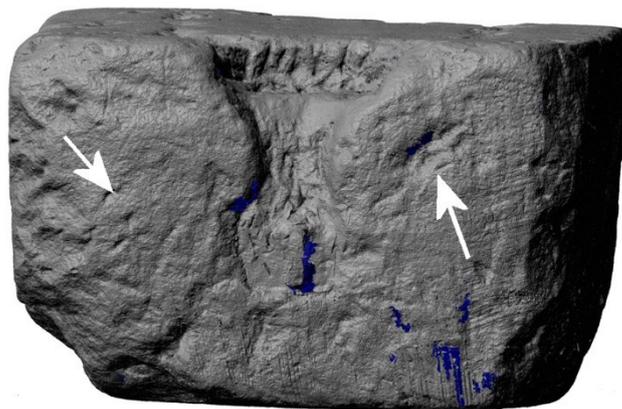
The right-hand end of the Stone. © Historic Environment

The left-hand end of the Stone. © Historic Environment

There is little to be added here to the original report. The only point to be made again is that the right-hand end is more crudely worked than the left. The damage caused to the former during the 1950 theft does not help, but the left appears general rather smoother, and with many fewer obvious punch marks, circled on the right-hand end and arrowed on the left.

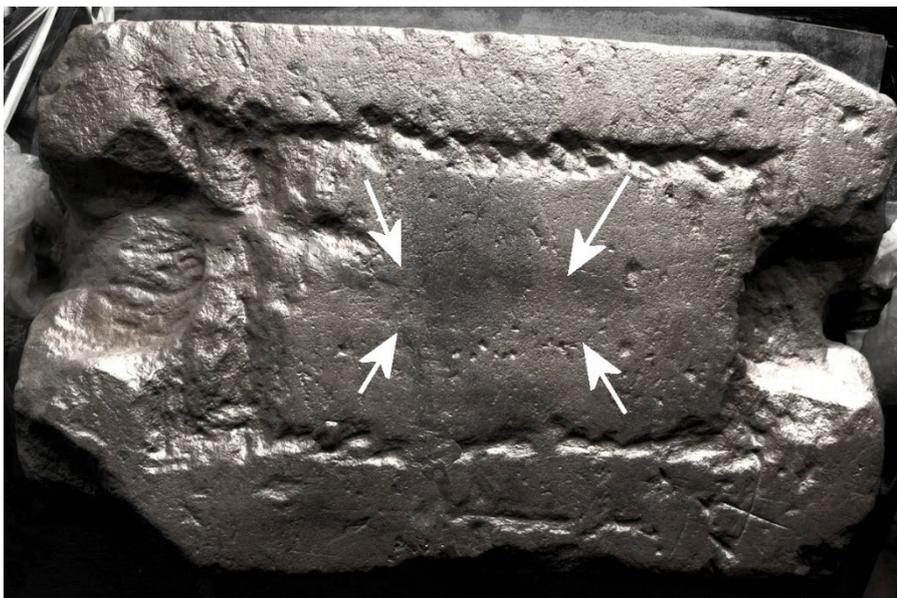
Figure 8 Hollow area on the centre line indicated by arrows. © Historic Environment Scotland.

This begins about 75mm from the front edge, at about the point where the sinking was begun, and continues to the back of the Stone. On the centre line of the Stone the wear is greater in an area of around 70mm × 250mm, depressing the surface by 4-5mm along the long axis (arrowed on Figure 8). This has been suggested as possibly due to the insertion of a bar through the rings, although the original report by the present author was unhappy about this. Furthermore, Rodwell (2013: 112) points out that the left-hand staple to which the ring is attached is set forward of the centre line, which makes the insertion of a bar even less likely as the cause. The reason for this depression, strongly interpreted by Rodwell (2013: 116) as no more than a shadow but showing clearly on the new image, is not known.

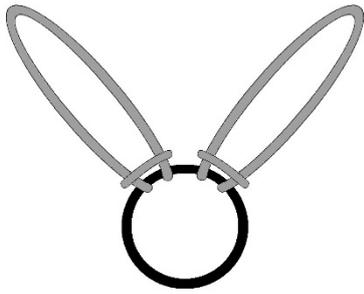
Figure 9 The use of rope slings to lift and move the Stone. © Peter Hill.

It is worth mentioning that putting a bar through the rings is not a likely or efficient way to carry such a weight. In order to lift the Stone from the chair, a bar cannot have been used, owing to the arms being in the way. Four people would be needed to lift the 152kg (336lb) Stone and the simplest way would be to use four short rope slings, as shown in Figure 9. This gives much more control than hanging from a bar, especially when setting the Stone down. An iron bar of 30mm diameter would have added 22kg (49lb) to a not inconsiderable weight.

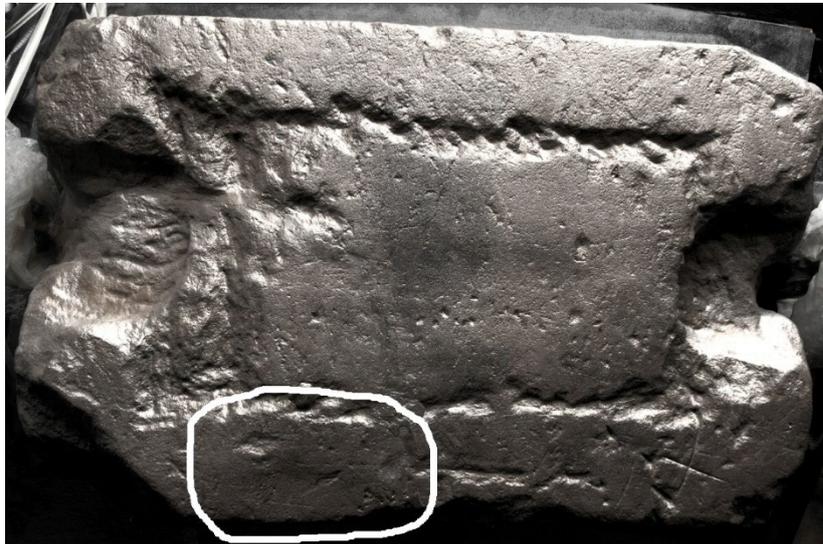
Figure 10 Wear on the back edge following use as a step. © Historic Environment Scotland.

The most significant area of wear shows clearly on the scan (circled in Figure 10), at the right-hand end of the back as viewed from the front of the Stone. It covers an area of around 130mm × 55mm, with a depth of 4-5mm. As given in the previous report, this is explicable only if the Stone were used as a step at some point before 1296. If the Stone were used with the present back as the riser, it is exactly the pattern of wear to be seen if pedestrians had generally approached from the left to ascend the step or steps. The whole of the back edge is worn, although to a lesser extent, with a marked radius to the arris.

Rodwell (2013: 174) attributes wear over the surface largely to the hands of visitors wanting to touch the Stone. However, this does not explain how the area most difficult of access for a right-handed person is right at the back on the right-hand side. Rodwell confirms that the Stone has always been placed in its current orientation in the chair. Equally, the front of the upper surface, a band about 75mm wide, can very clearly be seen on the scan to be significantly less worn than the remainder (arrowed, Figure 11). Surely, if handling by visitors were the major cause of wear, then the front would have suffered at least as much as the rest. The marked difference between the front and back can also be seen on Figure 13.

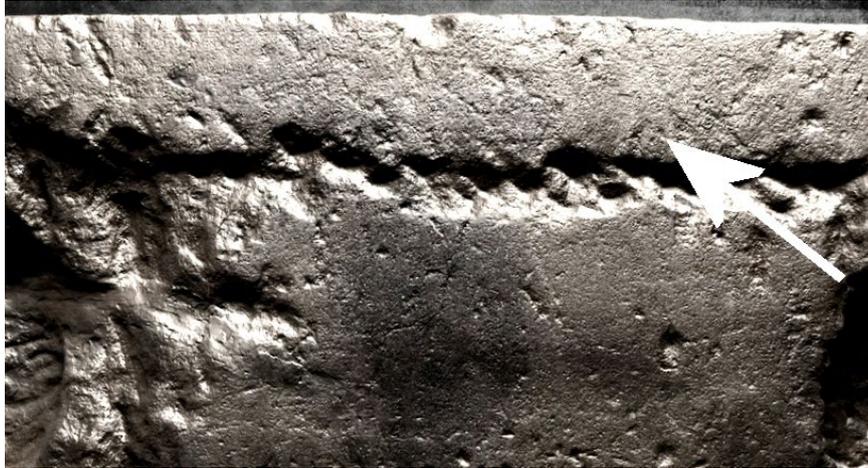
Figure 11 Comparative lack of wear on the front of the upper surface. © Historic Environment Scotland.

Use for a period of time as a step would explain the lack of wear to the present front of the surface, as it would be usual for the next step up to overlap, as shown in Figure 12. It would also explain the general roundness of the back aris, and the greater damage to that part (Figure 13). It is difficult to see how the patterns of wear on the upper surface can be explained other than use as a step prior to its transfer to Westminster. It was most certainly not all caused by handling.

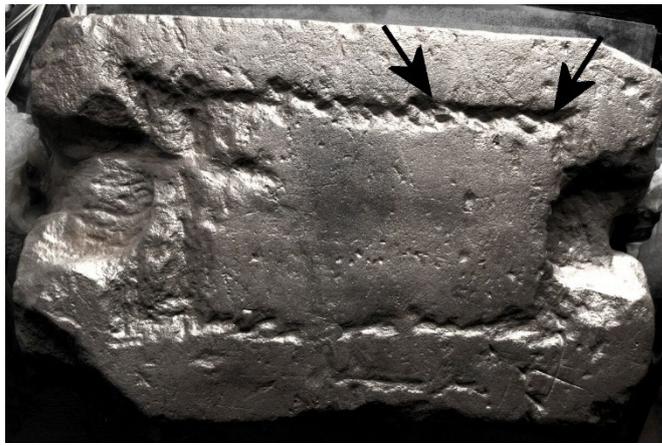
Figure 14 The neat start of cutting in for a sinking. © Historic Environment Scotland.

At 70–75mm from the front edge a start was made on cutting-in as though to form a sinking. This is easily explicable, as Rodwell (2013: 121–3) suggests, as a setting for an inscription in either brass or some other material. However, its

abandonment and subsequent continuation in roughly punched lines cannot be so easily explained. The start of work at the left-hand side, parallel to the face and neatly done with a chisel (between the two arrows on Figure 14), was abandoned and the work continued in very poor fashion, mostly carried out with a punch used to give a very irregular line. By no standard does it form a straight line. This line is mirrored on the back of the Stone by a rough groove made with half a dozen pecks with a punch: execrable work by any standard. The 'best fit' that can be obtained along the two lines shows that they were not even parallel (Figure 15). This may be due to the fact that the front and back of the Stone are not parallel, being wider at the right-hand end. The very rough marking out of a trapezium cannot realistically be seen as a sinking for a tablet. That may have been the intention with the first few chisel cuts, but the idea was soon abandoned, and perhaps some other hand very crudely continued the idea.

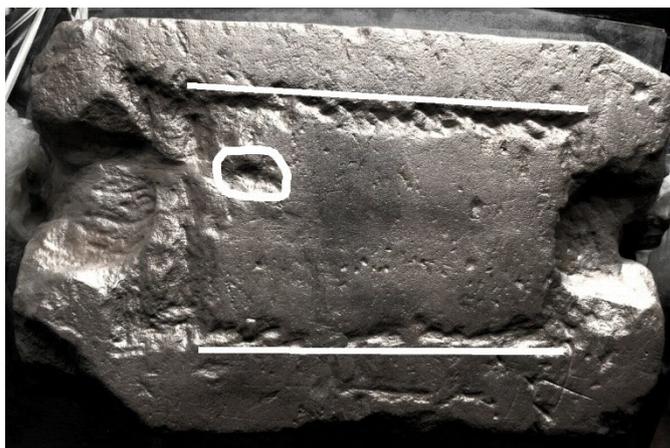
Figure 15 Roughly punched lines out of parallel. © Historic Environment Scotland.

These two 'grooves' are joined by others at each end, single on the left and now mostly lost in the sinking for the ring, and two on the right, the outer of which is also largely lost. The surface of the small area between the two right-hand grooves has been roughly reduced with a punch for some unknown reason. It is

just possible that a start was made on reducing the centre area (circled on Figure 15), but this is much more likely to be due to damage when the Stone was cracked or repaired.

It is not impossible that the much better work with a chisel was in fact an attempt to clean up the rough start, but the scans do not show the area clearly enough to be able to make a serious judgement. The purpose for the double grooves and the dressing down of the surface between them is inexplicable; it is certainly not how any stonemason would begin to work a sinking (contra Rodwell 2013: 122).
