# TECHNICAL PAPER 33

## MASONRY POINTING AND JOINT FINISHING

HISTORIC  
ENVIRONMENT  
SCOTLAND

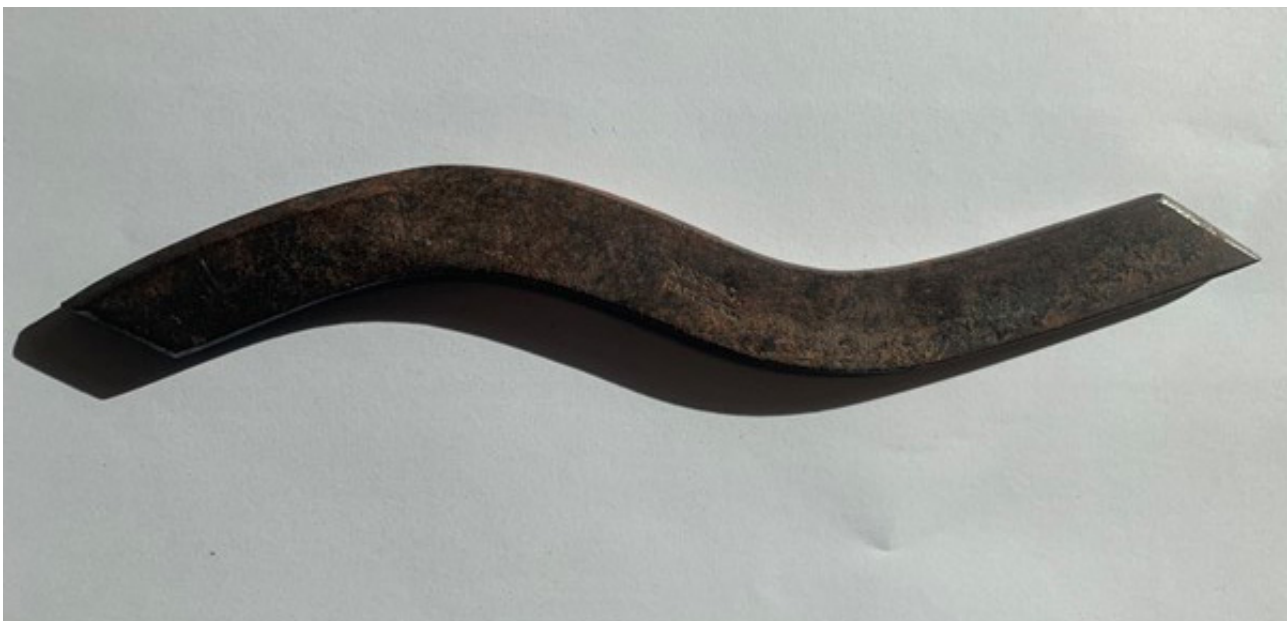
**Figure 1** - A ruling out tool from the 19th century. The manufacturer's mark, indicating production at scale, is just visible in the centre.

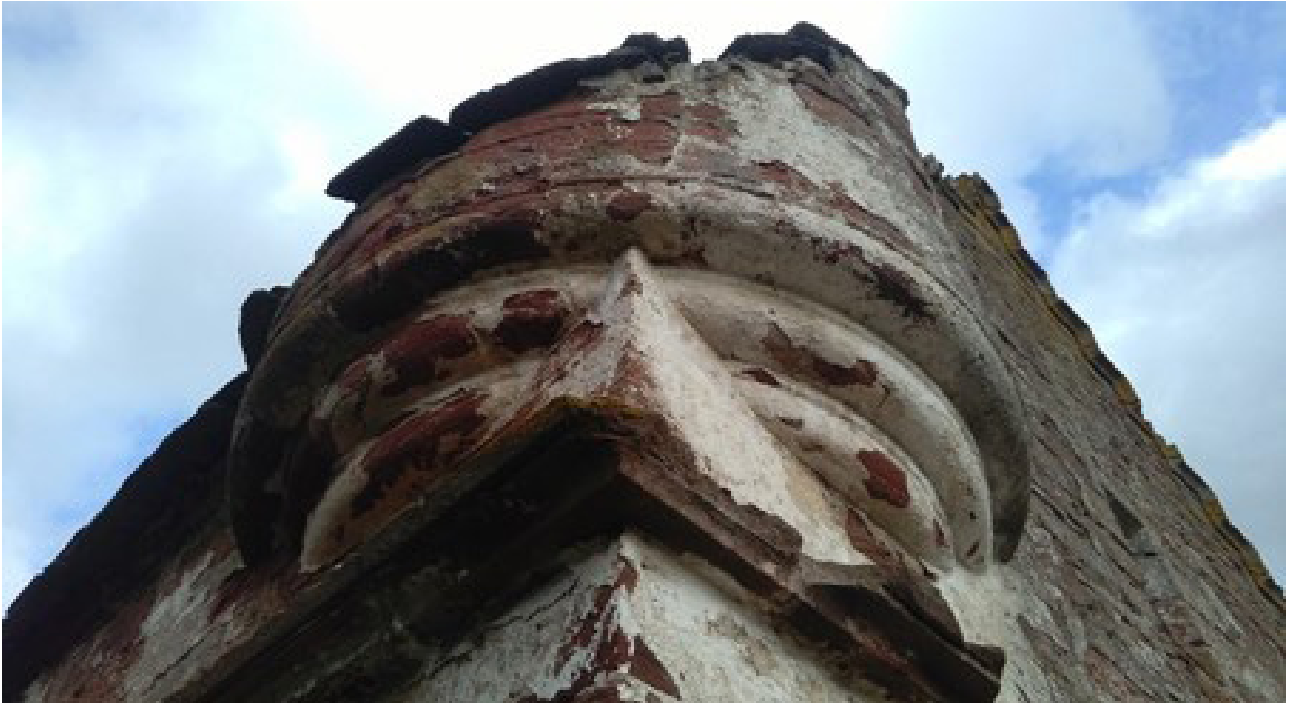
**Figure 3** - Edzell Castle, limewash still adhering on a sheltered corner. This corner of the building represents a significant survival of an original coating. Image: Tom Addyman.

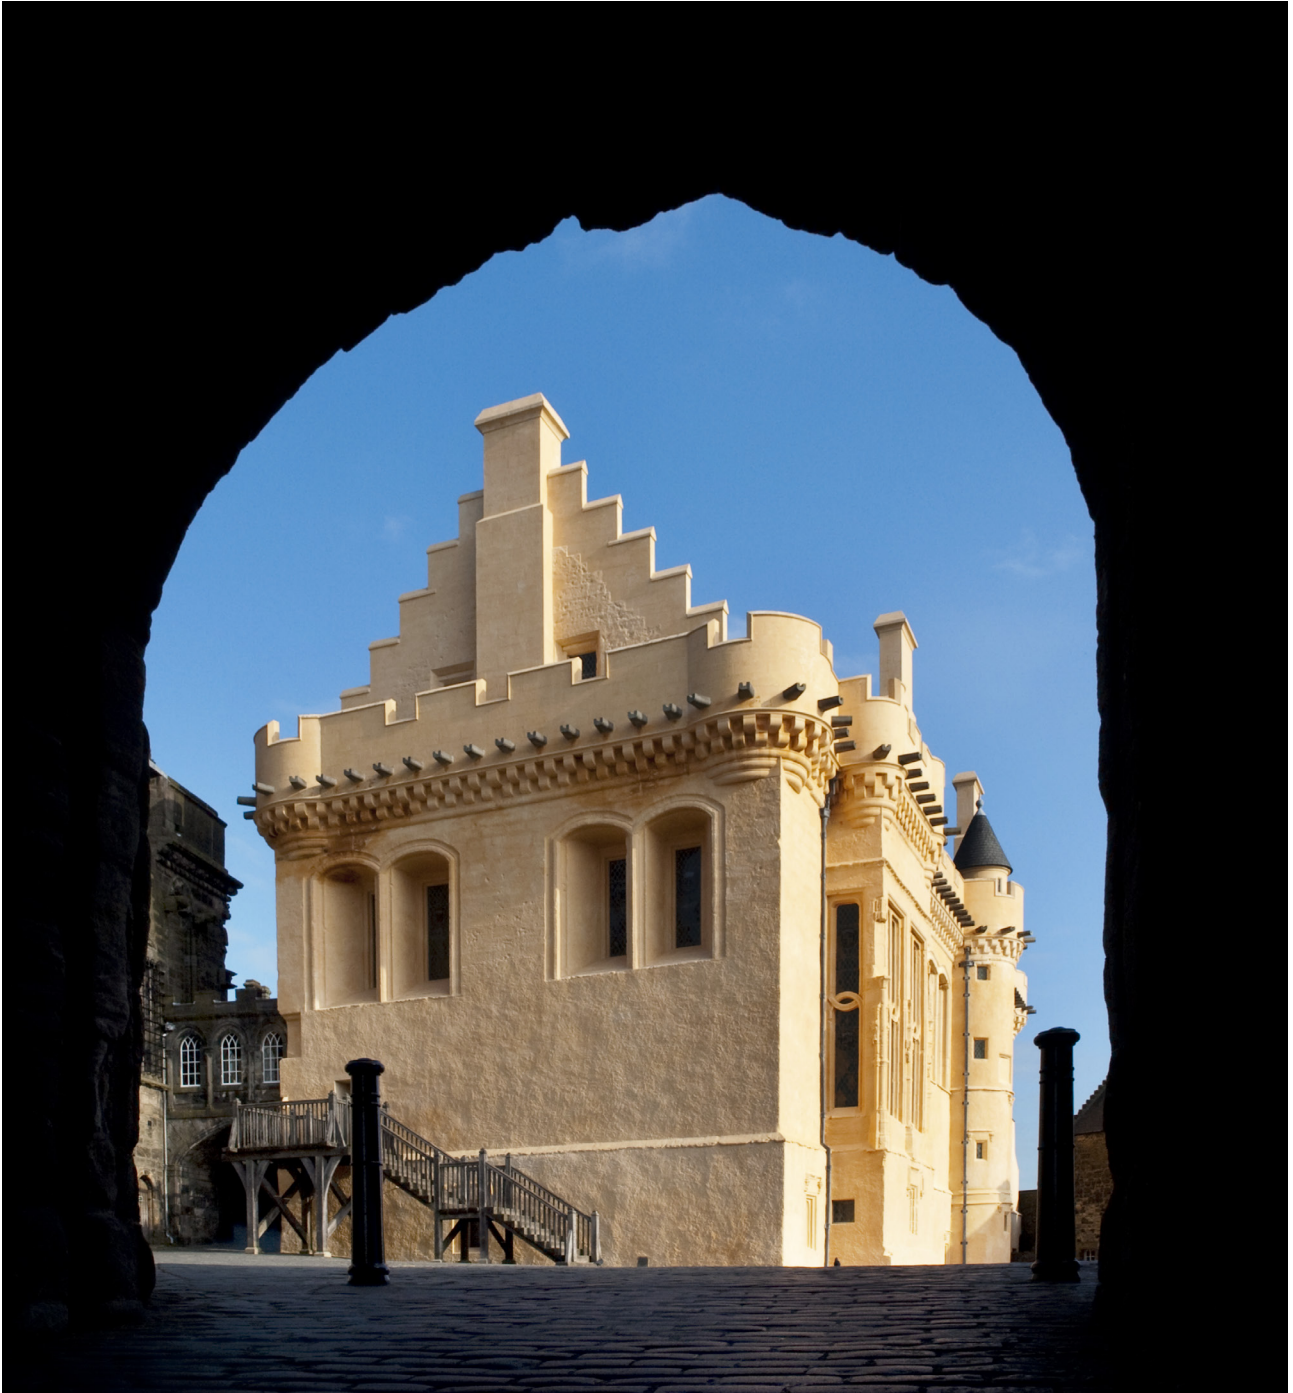
**Figure 4** - The Great Hall at Stirling Castle; the limewash transforms the architectural appearance of the structure, highlighting the carved elements.

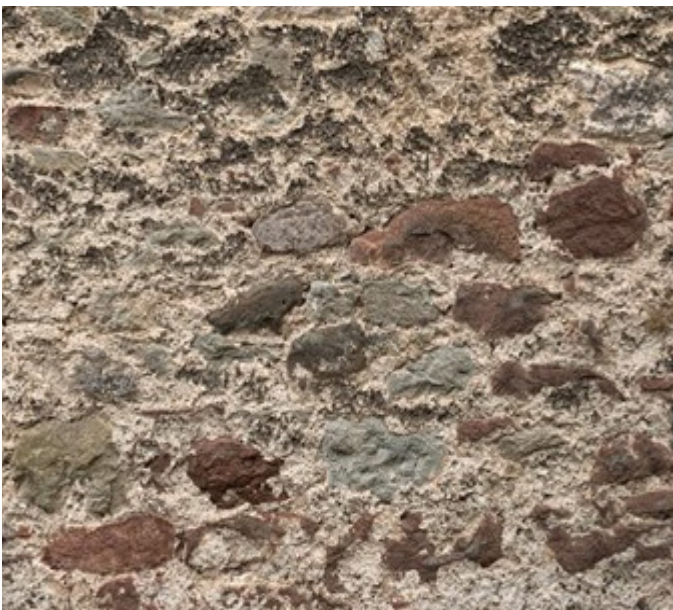
**Figure 5** - Oven Wynd, Kelso. The decayed surface of what was once the typical finish for rubble. The full harl has graded away and it is difficult to differentiate this from an intentional 'sneck harl'.

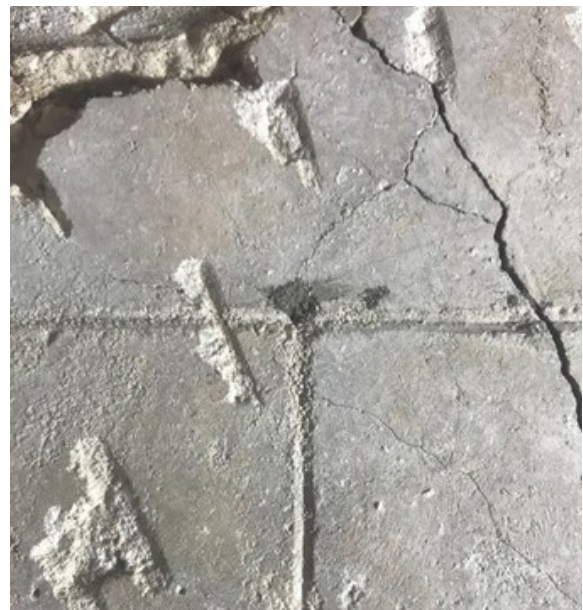
**Figure 6** - Lined out external render at Newhailes House.

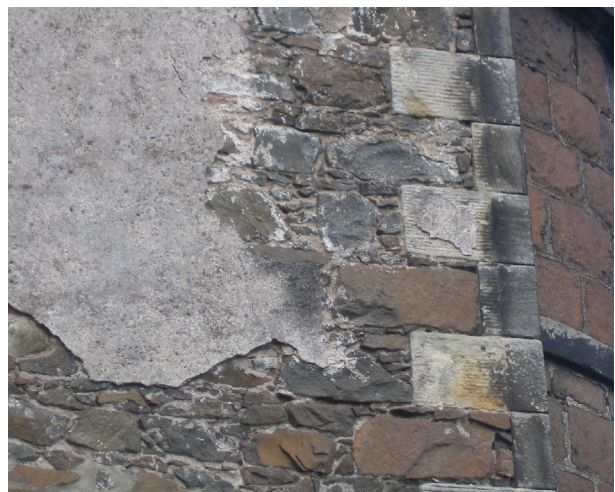
**Figure 8** - A late 18th century building in Stirling showing harled rubble on the gable elevation, and more costly uncovered masonry work to the front. Note the harl fragment on the middle quoin.

The shift from renders to a more partial wall finish was gradual and not universal. In many rural areas, the practice of harling with lime continued into the 20th century. There is no precise moment when Scotland’s architects and people began to favour uncovered stone. Nevertheless, it is possible to detect the origins of the complex social, political, economic and religious influences in Scotland in an increasing predominance of initially ashlar (to achieve the classical ideal), and then unrendered rubble (in the age of Romanticism). That renders were still considered necessary to protect and finish lower cost rubble work on subordinate elevations is seen in a late 18th century building in Stirling, where the principal elevation is well cut, costly ashlar work but the gables are rubble with a protective layer of harl (Figure 8). Harl still adheres to one of the quoins.

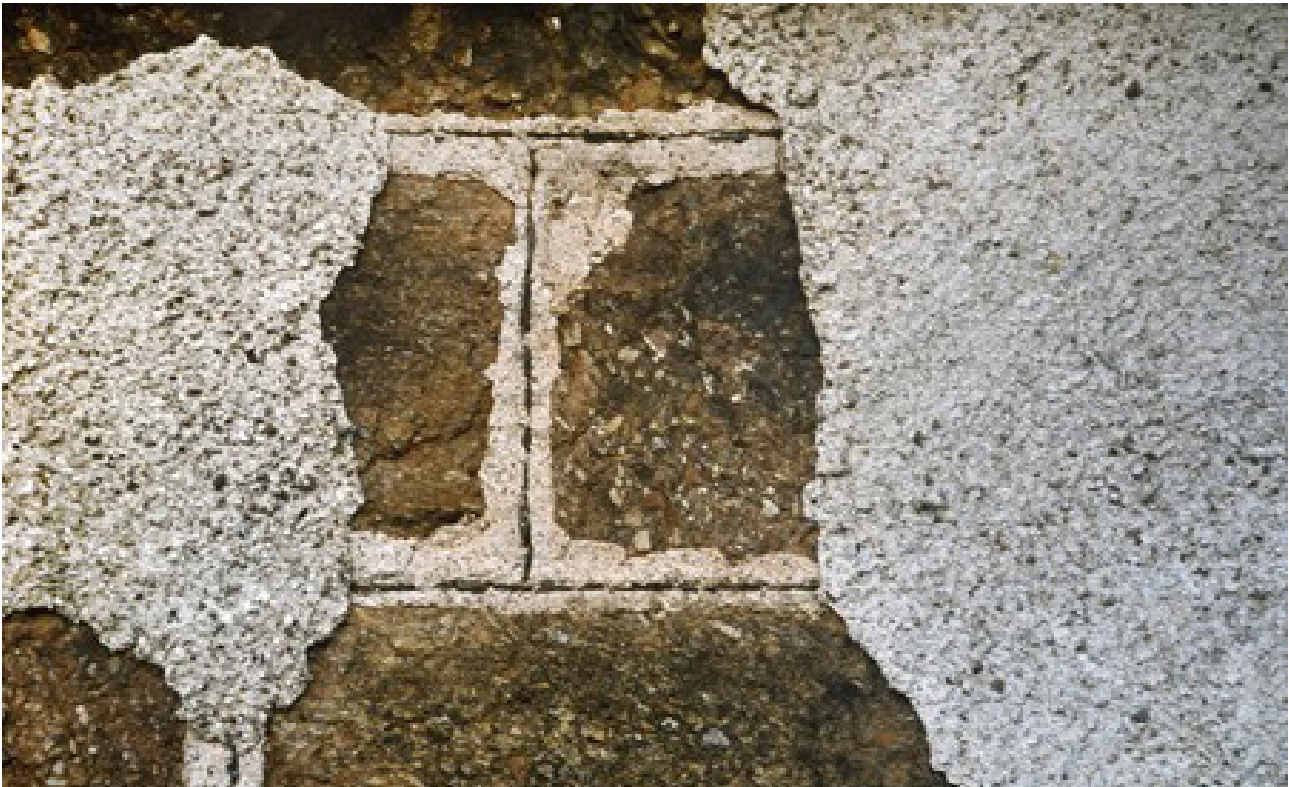
**Figure 9** - An ancillary building at Craigston constructed with poor quality agglomerate sandstone with decorative slate 'cherry-cocking'. This has been retrospectively harled, which is assumed to be in response to decaying sandstone.

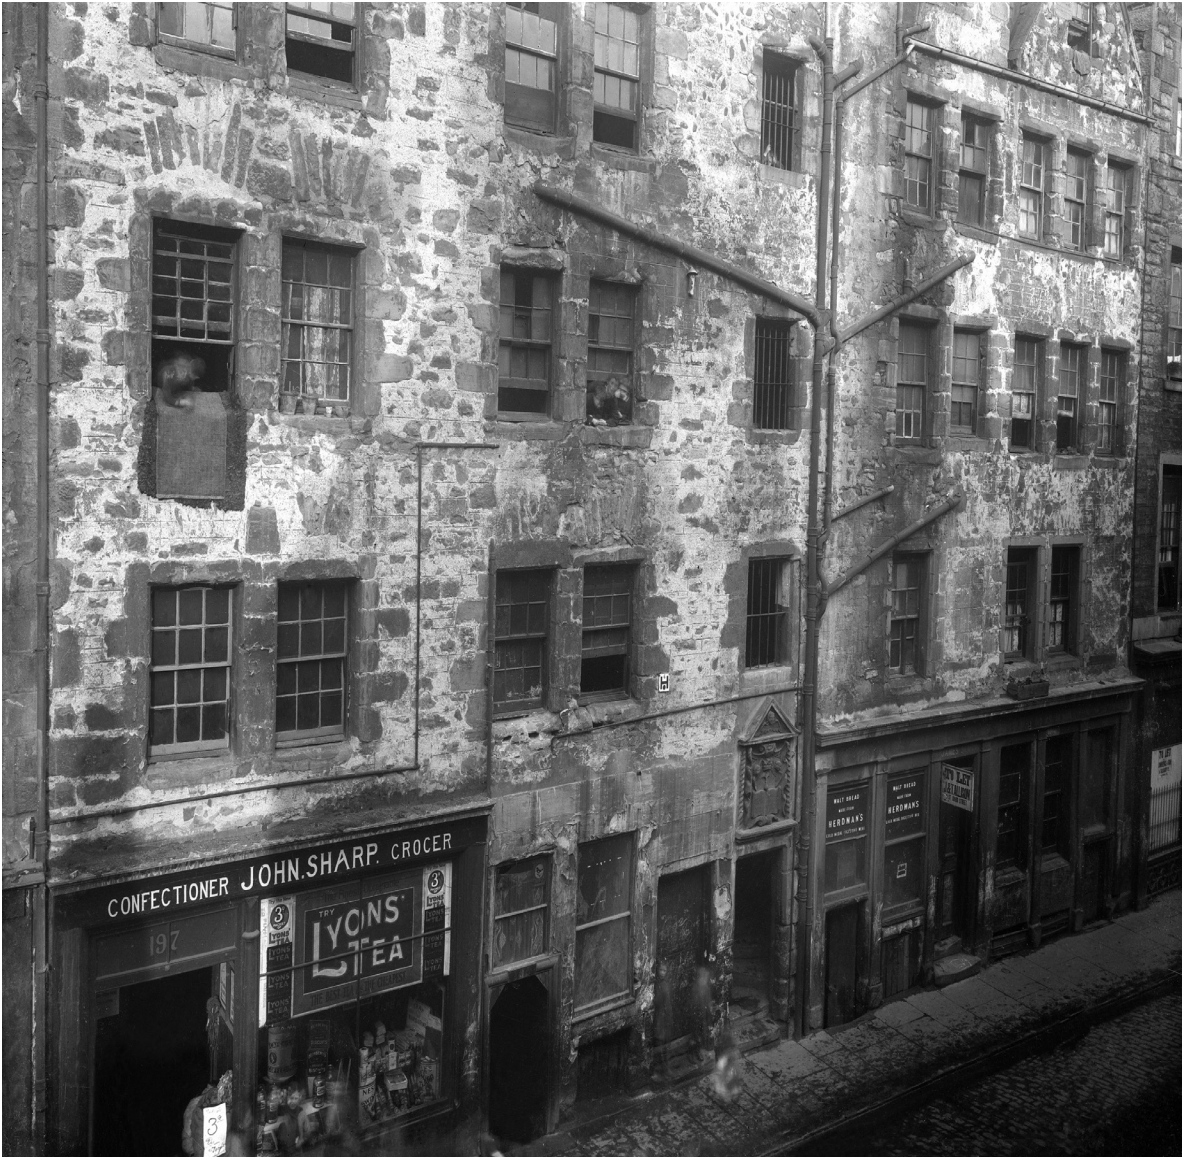
**Figure 10** - The building described as 'Bible Land', 183-187, Canongate, Edinburgh photographed in the late 19th century.

What Figure 10 also shows is the change in the appearance of the building, as the sandstone quoins and margins have lost their coverings. In turn, this condition of disrepair became a 'look' or style in itself which is considered later in the paper. As the 19th century progressed, stone continued to be used for construction in Scotland and elsewhere but was increasingly finished without renders or the covering limewash. Obviously, the joint had to still be covered and this was generally with a flush finish and some form of ruling.

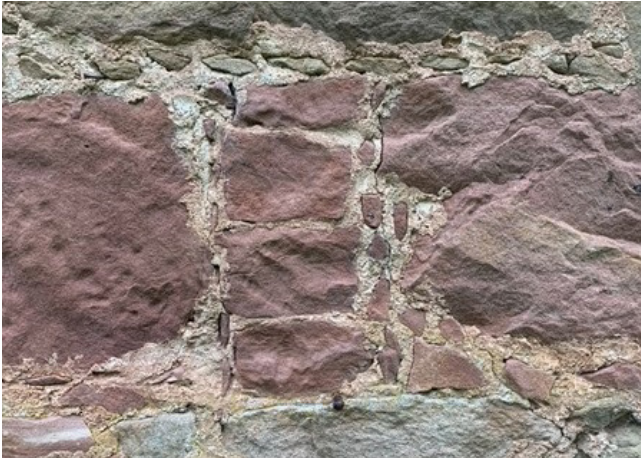
**Figure 11** - Ladder pinning and cherry cocking showing on a building in Cromarty, where the covering harl has been lost.

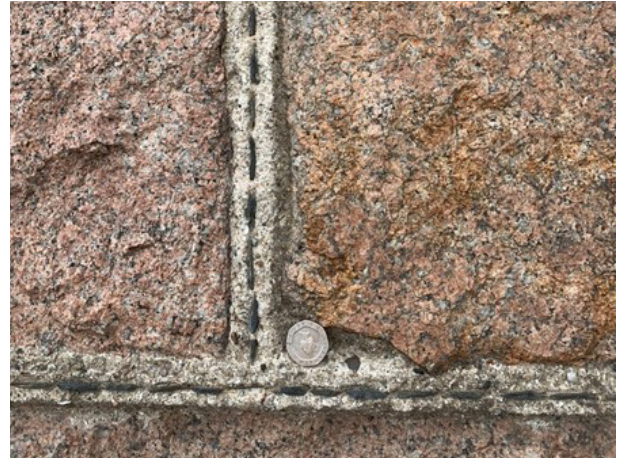
**Figure 12** - Cullen, Moray. An early version of strap pointing with slate pinnings and a raised band of lime to form the joint (1810).

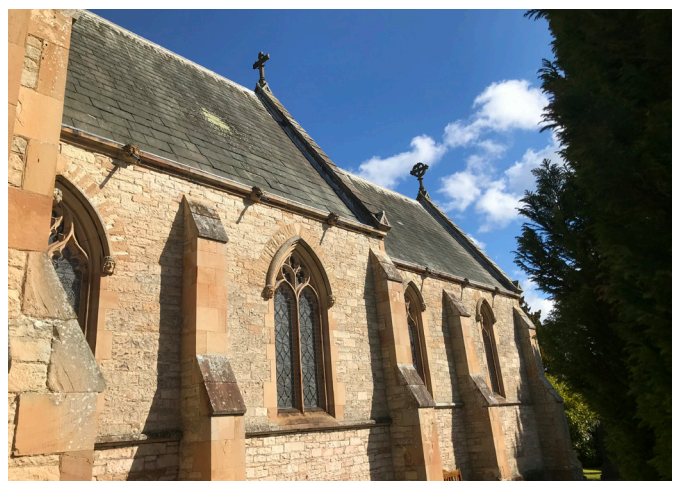
**Figure 14** - The south elevation of St John's Episcopal Church, Jedburgh. A 19th century recreation of a pre-reformation church with many architectural details taken from the middle ages, except for the treatment of the masonry surface.

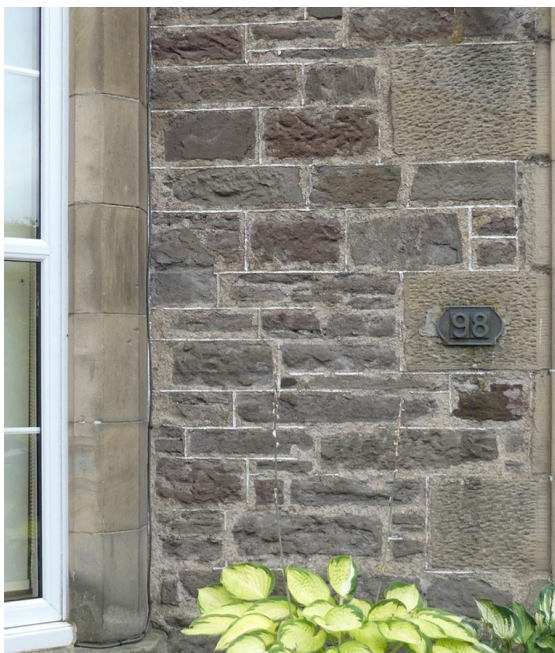
**Figure 15** - Bridge of Allan. Front elevation is flush finished, ruled out and white lined.

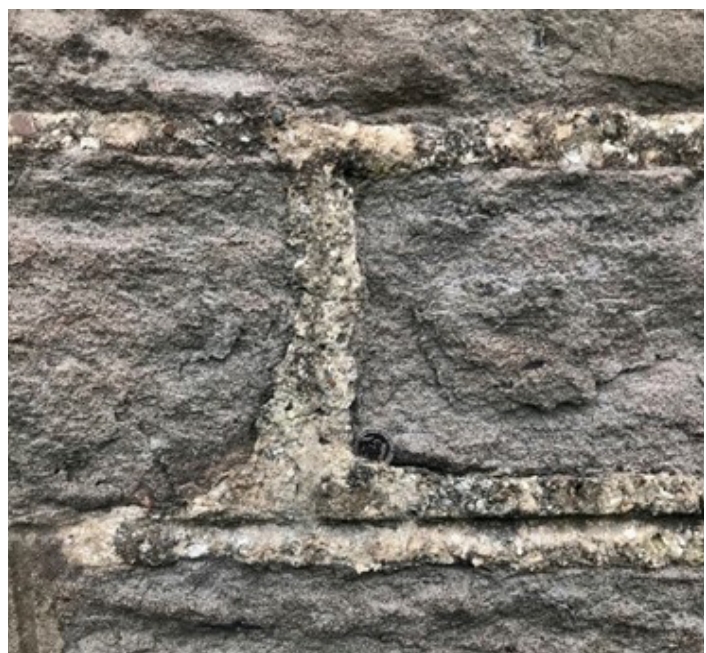
**Figure 16** - Bridge of Allan. The weathered surface of bare stone with ruled out Victorian flush finishing, standing proud of the worn surface.

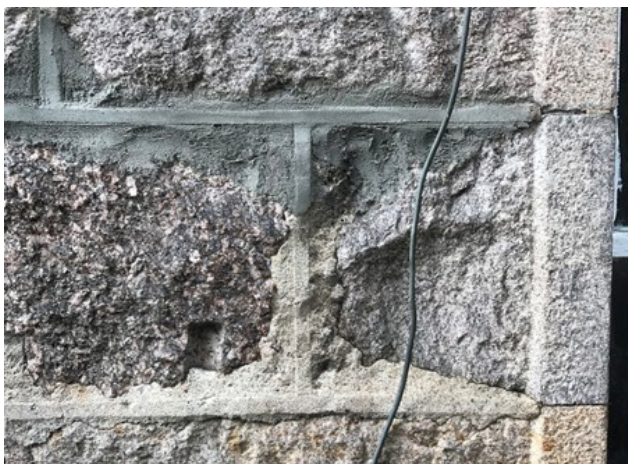
**Figure 17:** Strap or ribbon pointing in lime mortar, with later cement repairs above.

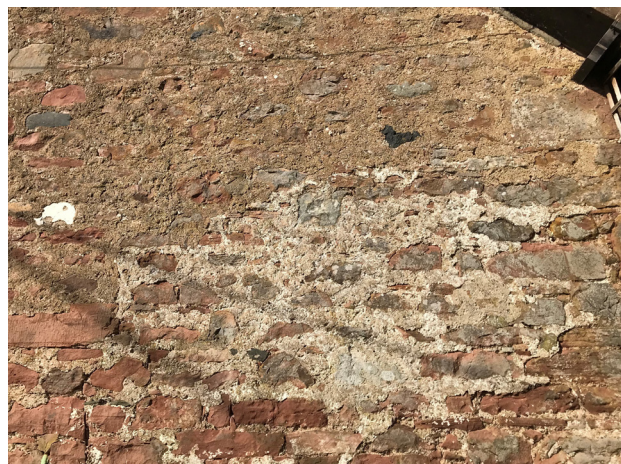
**Figure 18:** Weens Stables, Hawick. Above, un-limewashed flush point from 1905 (brown coloured mortar) with earlier 18th century work and limewashed flush pointing surviving below.

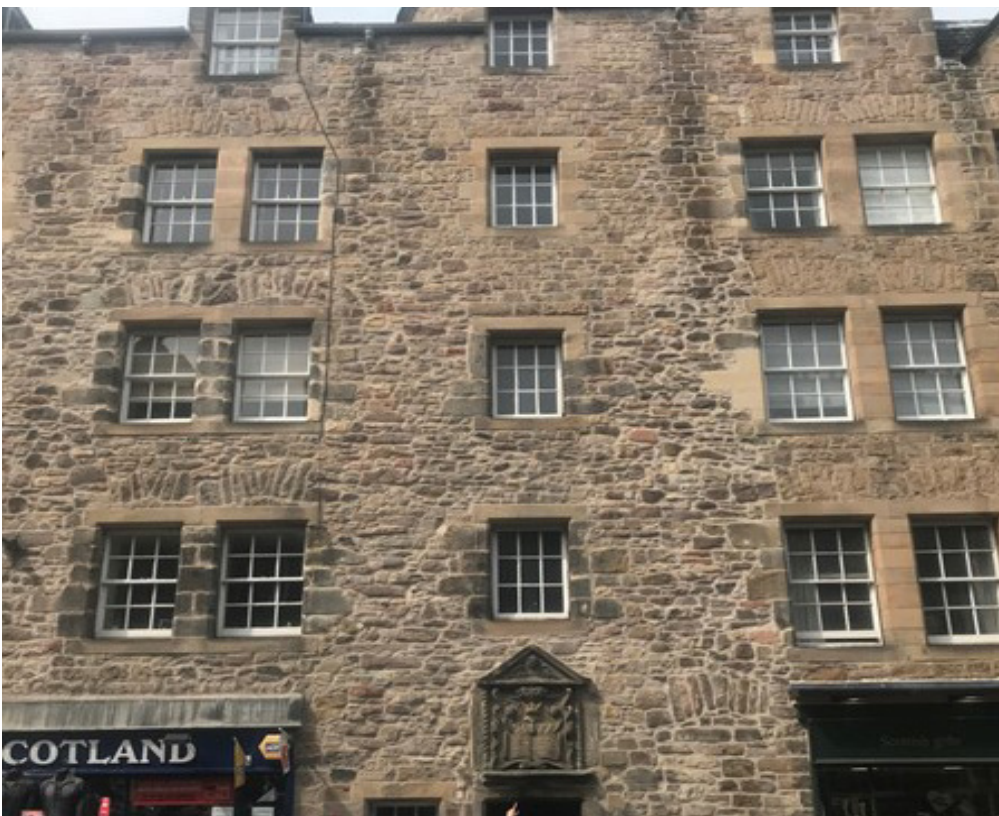
Figure 19 - ‘Bible Land’, 183-187, Canongate, Edinburgh, shown here with modern recessed pointing.

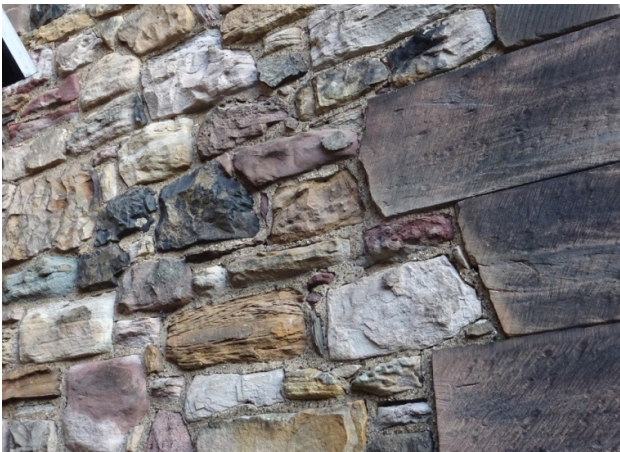
**Figure 20** - Recessed pointing, The Scottish National War Memorial, Edinburgh Castle.

It is significant that, over a period of years, adjacent buildings appear to have been repointed following this style, even though they would not have looked like this when first built. The result of this institutional journey is the eventual appearance of the Governor's House at Edinburgh Castle; a classically inspired domestic building of the 1720s, where the masonry between the windows is now presented as recessed pointing, possibly copying Lorimer's work at the Scottish National War Memorial from nearly 200 years later (Figure 21).

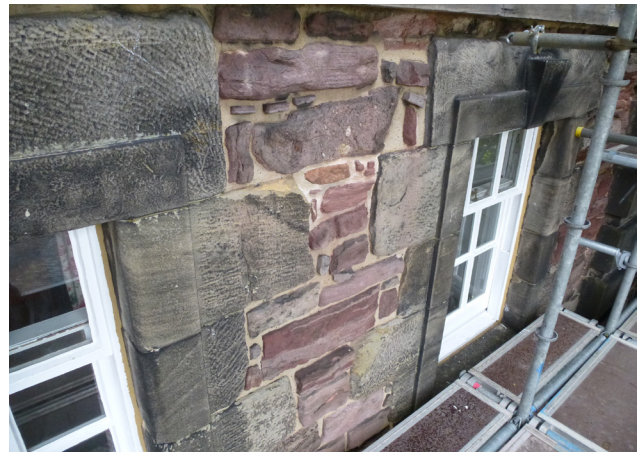
**Figure 21** - The Governors house at Edinburgh Castle. Recessed pointing.

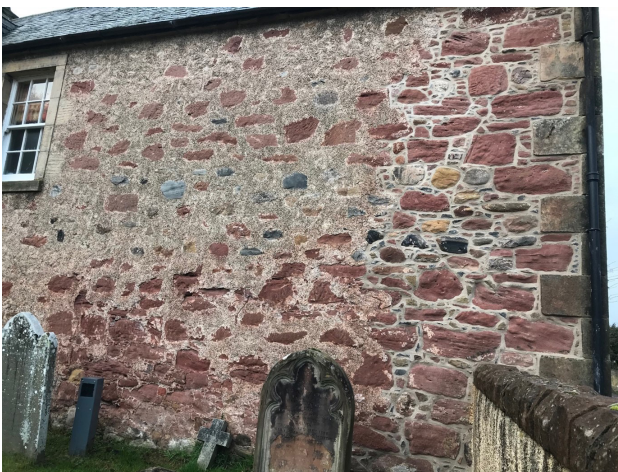
**Figure 22** - This recently repaired building, using a lime mortar, illustrates well the change in the appearance of an elevation when a certain pointing style on the right is used in preference to what was clearly surviving on the left.

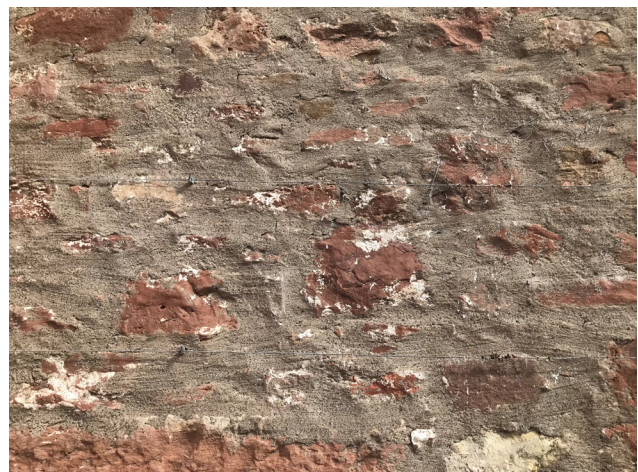
**Figure 23** - A traditional type of finish, the flush point, using a more modern material, cement. The style is a fair repair of what was there before, but with a different material.

Looking at buildings now, later repair works to older structures with Portland cement repairs can often present a confused aesthetic. Given the ubiquity of the ruled 'splaistered' finishes in many parts of Scotland, it is likely that these repairs are simply continuing to use the same approach with a newer material. This might be the case in a house in Southern Scotland, modernised in 1958, as seen in Figure 23.

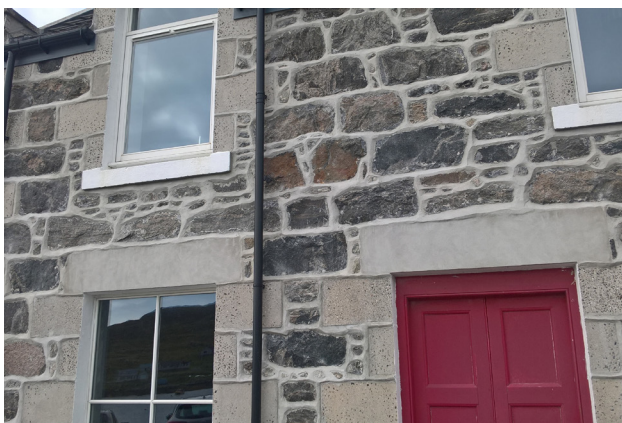
**Figure 24** - New strap type pointing on a traditional building in the Hebrides. A significant change in the appearance of the building and in a style not previously found.

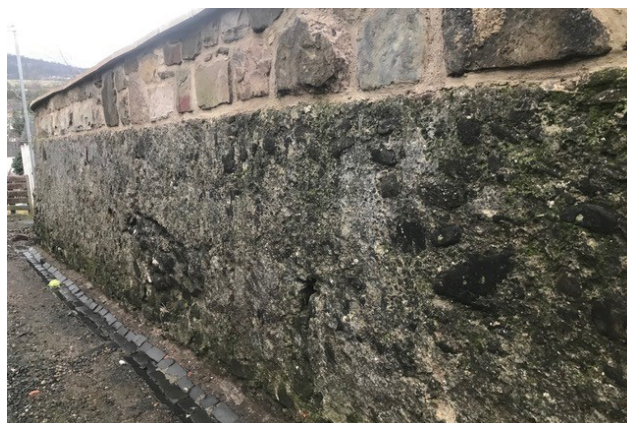
**Figure 25** - A boundary wall in Stirling, probably dating from the early 19th century. The masonry finish on the raised section of the wall illustrates well the ambiguous approach to masonry finishes that this Technical Paper seeks to highlight.

As discussed, the desire to focus on the joint in masonry work has become very dominant, even when the evidence of the earlier finish is very clear. This is well summarised by an image of a wall in Stirling, as seen in Figure 25.

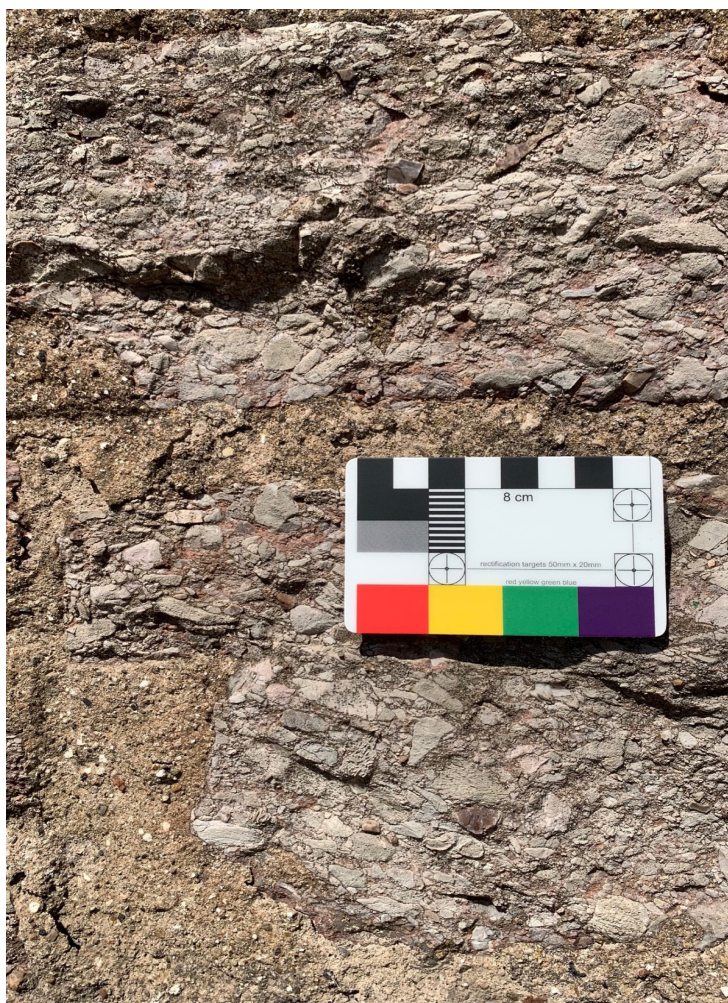
**Figure 25** - A 19th century terrace in Kirkby Stephen. Flush pointing with traces of lining out.

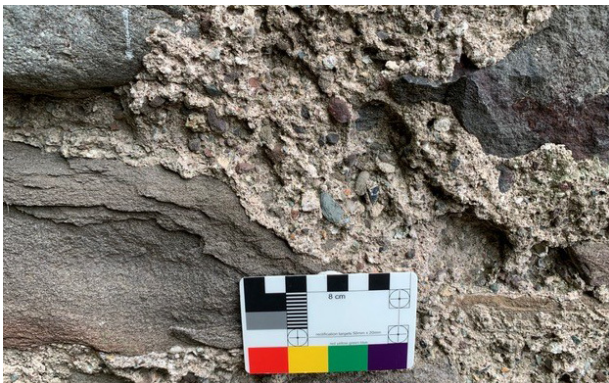
Mortar pressed back to the face during construction or 'point as you go'. Sometimes horizontally lined out. Often has an unfinished appearance and common on agricultural buildings and secondary elevations.
2

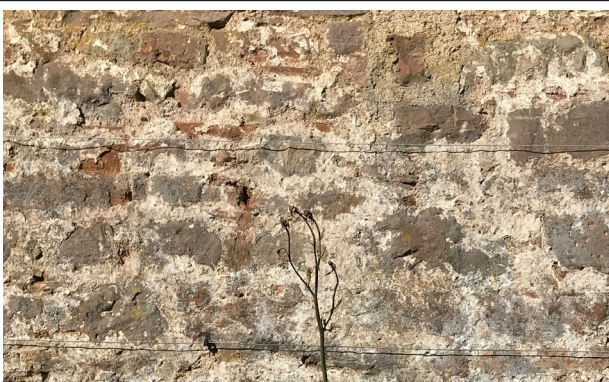
Flush finish with remains of limewash. In many parts of Scotland, this was common on stables, farm buildings and dwellings, where a harl was not used.
3

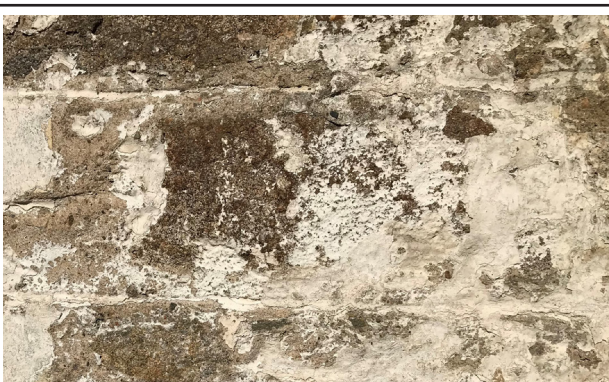
Flush finish, similar to No 2, with ruling out and limewash.
4

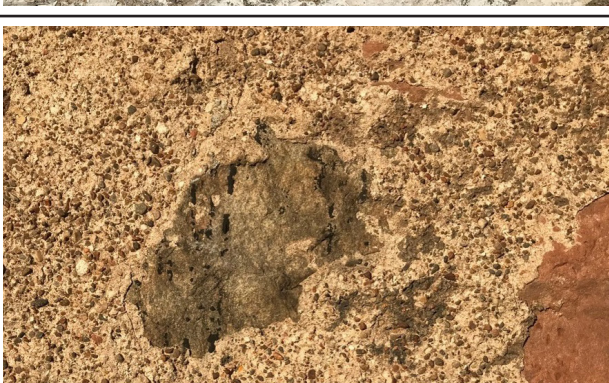
Sneck harl. A harl is thrown over the joints, covering the pinnings or snecks. In this case, the lime has weathered back, exposing the aggregate. Common in most parts of Scotland for dwellings and farm structures.

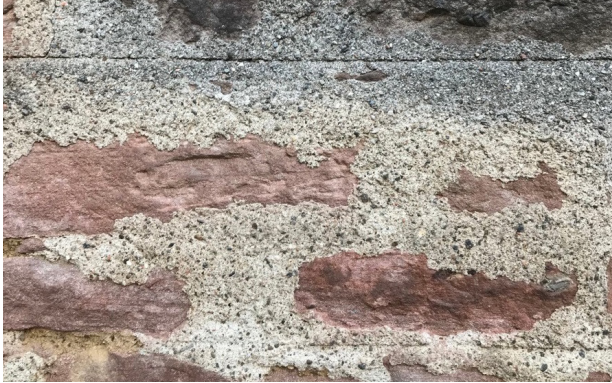
5

Sneck harl horizontally ruled out. The harl is fairly degraded; this is a second part of the construction process.

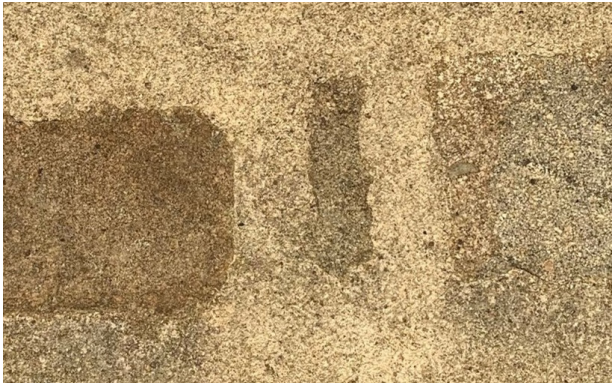
6

Squared sneck harl. A harl is thrown over the joints, covering the pinnings or snecks, but formalisation is achieved by covering the stones with a rectangular board.

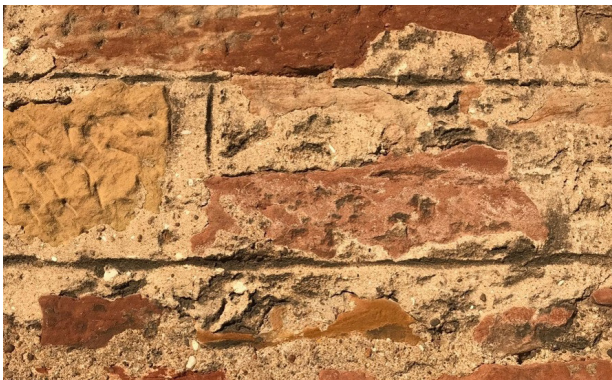
7

Sneck harl or plaster with horizontal and vertical lining in imitation of ashlar. A relatively high-status finish.

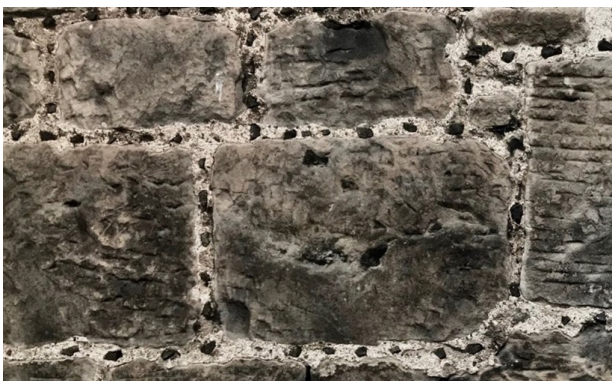
8

Cherry cocked flush finish using pieces of basalt. Some weathering back is evident in this case; likely to date from the 1820s.

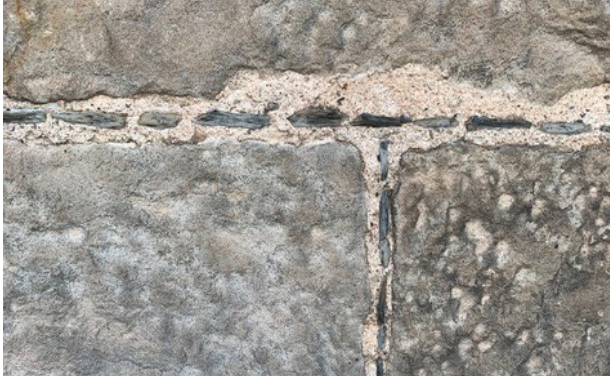
9

Flush pointing and cherry coked with slate pieces, giving the same definition as ruling out.

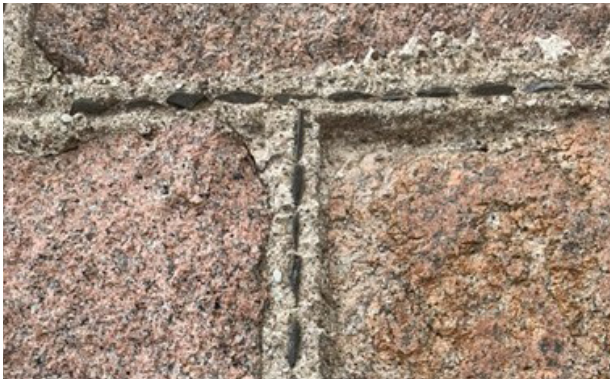
10

Raised ribbon point with horizontal and vertical banding; slate cherry coks in the joint. A more formal way of defining the joint. This is in Cullen, Moray, from 1810.

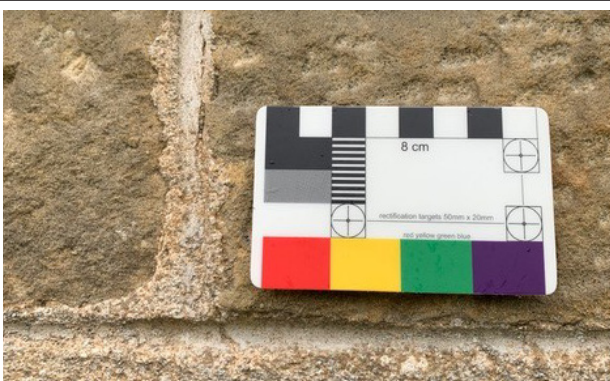
12

Sawn squared stone work with ruling out. Once the bedding mortar had become firm, the joint was flush finished and ruled out. Later, limewash or white lead was used to highlight the formal area of the joint. This was done without any attempt to colour the background.

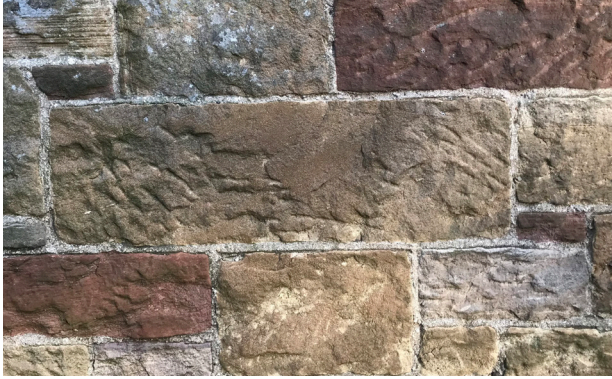
13

Flush pointing to the plane of the stone but smoothed on the upper and lower side to form a convex form in the mortar. This is a common finish on squared coursed rubble with narrow joints; often seen in the south of Scotland.

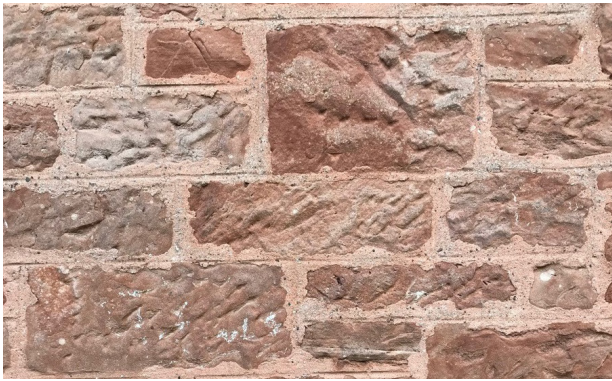
14

Flush finish, either as original bedding mortar or later repair, vertically and horizontally lined out. There are traces of limewash on the masonry in this example, suggesting this may be a later repoint.

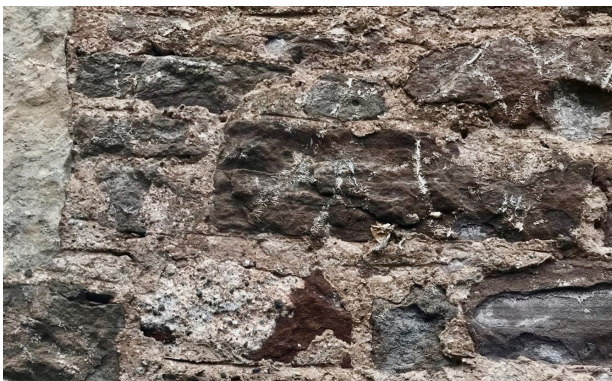
15

Flush finish with informal horizontal lining out; often vertical lining is found as well. Commonly noted as later work following removal of harl.

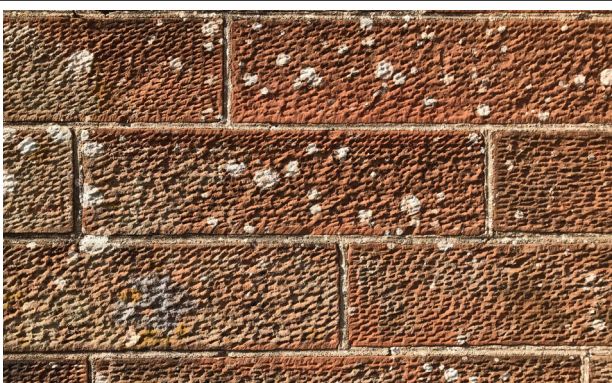
16

Ashlar work; pointing pressed back and smoothed with a central line in the pointing. This type of work is found in many ashlar and coursed rubble, characteristic of the late 19th century, and common in many parts of Scotland.
