Short Guide

HISTORIC CONCRETE IN SCOTLAND PART 2: INVESTIGATION AND ASSESSMENT OF DEFECTS

Published by Historic Scotland, March 2014

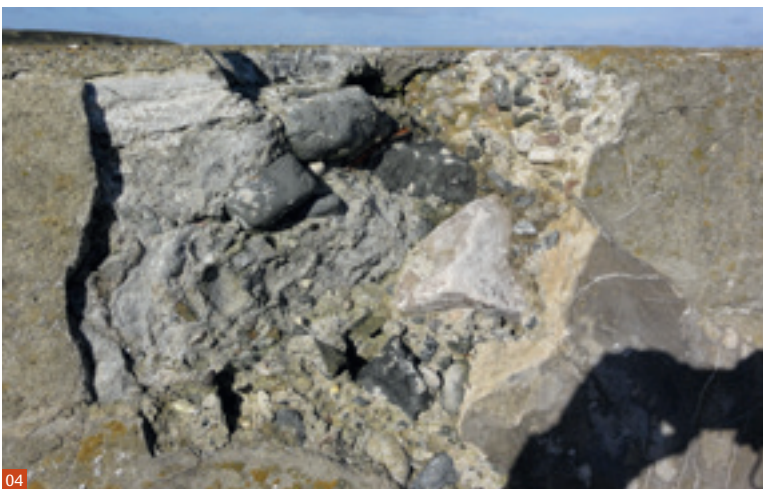
Fig. 4 Concrete harbour wall constructed from locally available aggregate, built c.1890.

Fig. 4 shows an area of disintegrated concrete on a harbour wall from c.1890. It illustrates the nature of the aggregate, which is of local origin, poorly graded with large stones (up to approximately 100mm) and possibly hand-compacted into the formwork. The precast concrete in Fig. 5 contains beach shingle aggregate which has been exposed because the cement binder has been eroded from the face of the block, most likely due to the inclusion of marine salts (chlorides) within the mix.

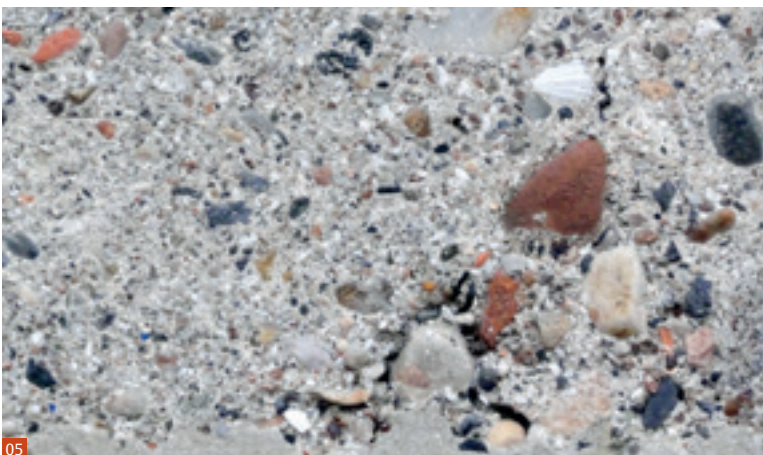
Fig. 5 The exposed aggregate in a precast concrete dressing. The aggregate is beach shingle with shell fragments, built c.1900.

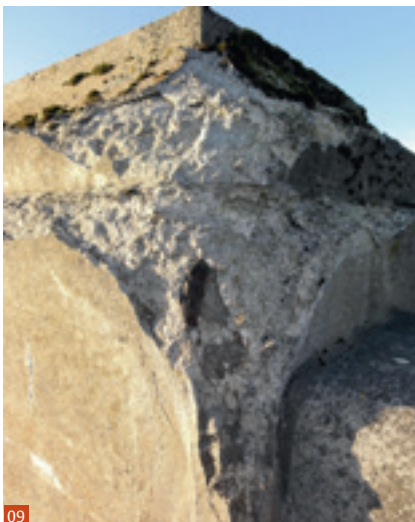
Fig. 9 Salt-induced deterioration of concrete on a reinforced concrete bridge, built c. 1930s.

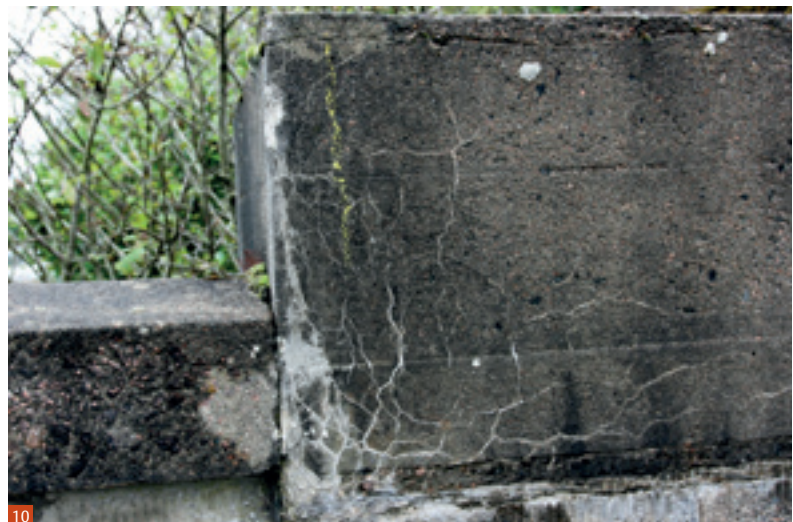
Fig. 10 Concrete deterioration as a result of chloride attack, bridge built c. 1937 (Category B-listed).

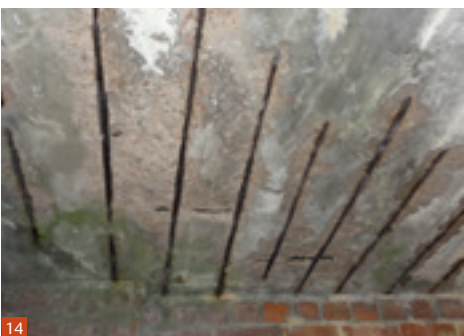
Fig. 14 Carbonation combined with lack of cover has led to subsequent reinforcement corrosion on this floor slab.

With the passage of time the depth of the carbonation and the permeability of the concrete increases. These processes affect the durability of the concrete covering the reinforcement. In the case of historic concrete, carbonation-exacerbated corrosion will become more prevalent as the concrete ages (Fig. 14).
