TECHNICAL  
ADVICE  
NOTE

SCOTTISH  
SLATE  
QUARRIES

# TECHNICAL ADVICE NOTE 21

## SCOTTISH SLATE QUARRIES

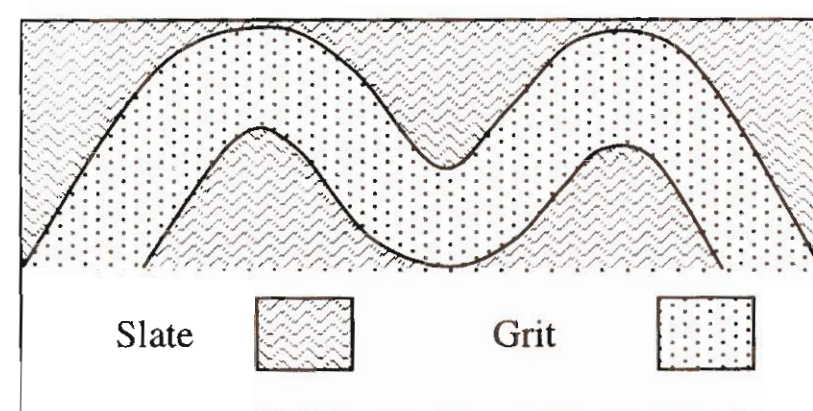
Fig. 1.3 Geometry of the fold is controlled by the competent layer such as grit, while the less competent rock such as slate conforms to the shape of the fold.

The most suitable cleavage for producing slates is the axial planar cleavage found in regular folds such as the large open folds found in the North Wales quarries. Scotland has experienced numerous phases of deformation and the refolded folds often give rise to distortion of the cleavage surfaces.

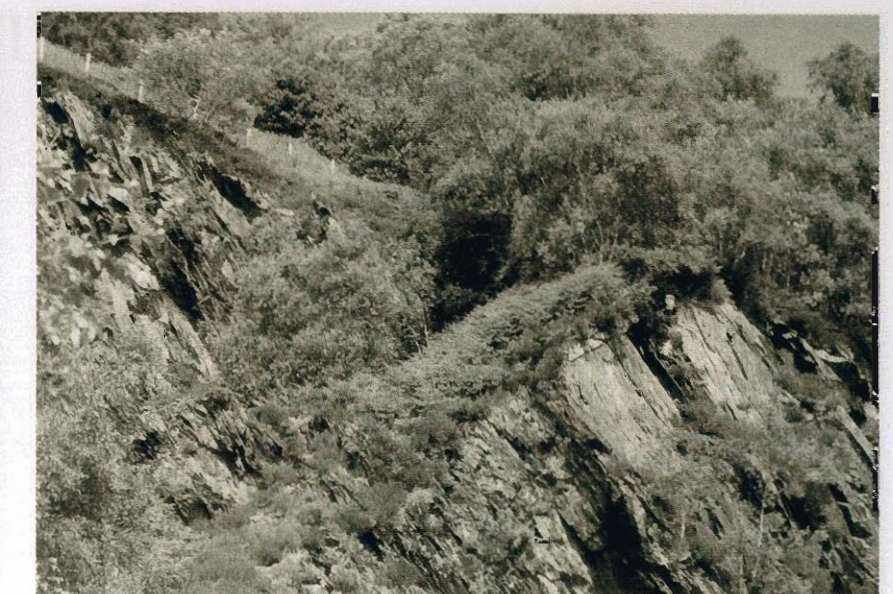
Plate 10 North Ballachulish – East Quarry showing remains of two galleries

The quarry was worked along a narrow band (approximately 5m wide) rising steeply up the hillside along the channel of a stream. Although the quarry is very overgrown, it is still possible to make out the remnants of two or more galleries (Plate 11).

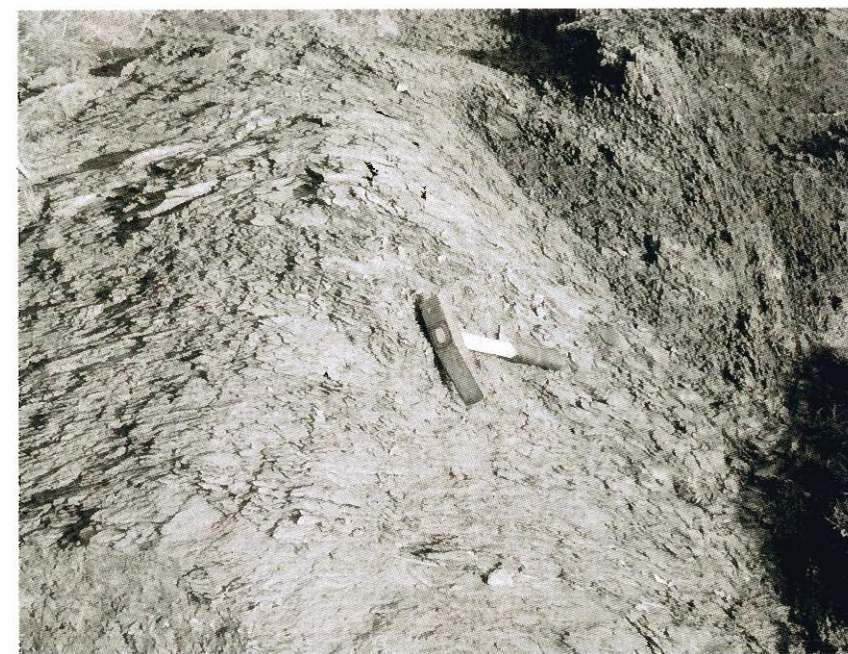
Plate 14 Destruction of cleavage at the axis of folds

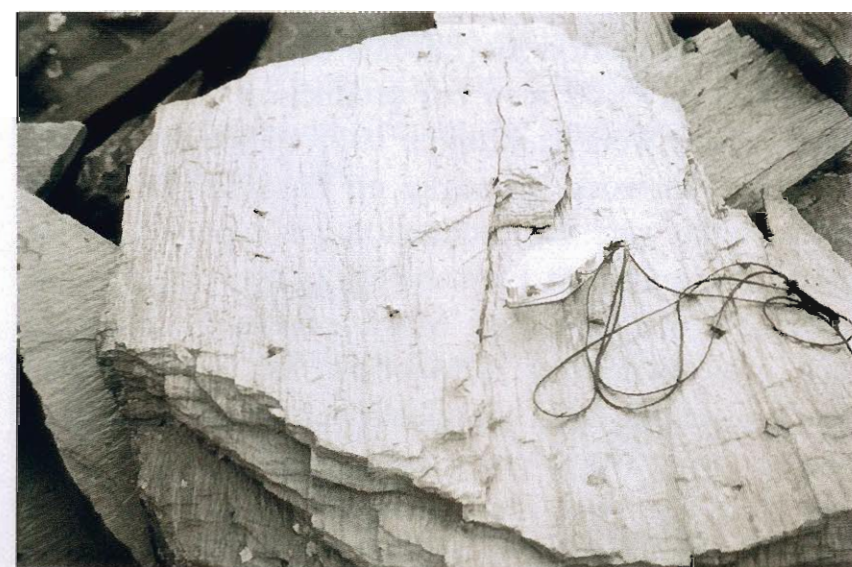
Plate 15 Easdale slate showing the crenulation cleavage. Pyrites show little deterioration after more than 50 years of weathering

- 15 Easdale slate showing the crenulation cleavage. Pyrites show little deterioration after more than 50 years of weathering
- 16 Creag an Dun on north west of Easdale Island, now flooded

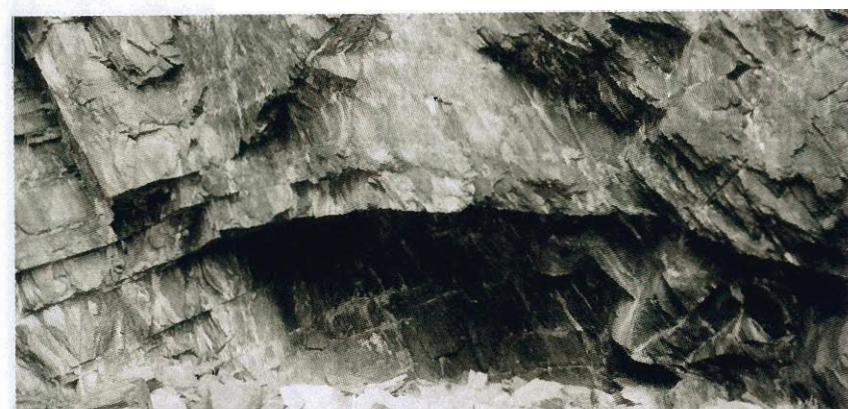
Plate 23 Port Mary Quarry. Cleavage destroyed due to folding of bedding at north end of the quarry

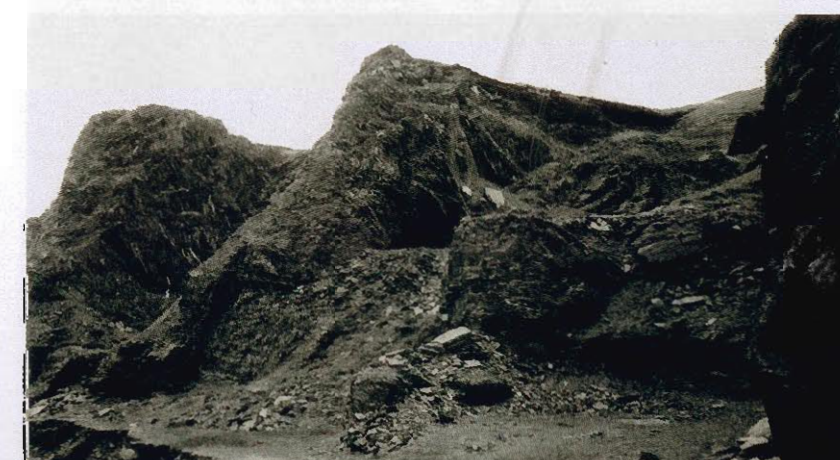
Plate 24 Cullipool Quarries Nos 1 & 2 west of Luing. These quarries open onto the raised beach platform seen in the foreground (NM741137)

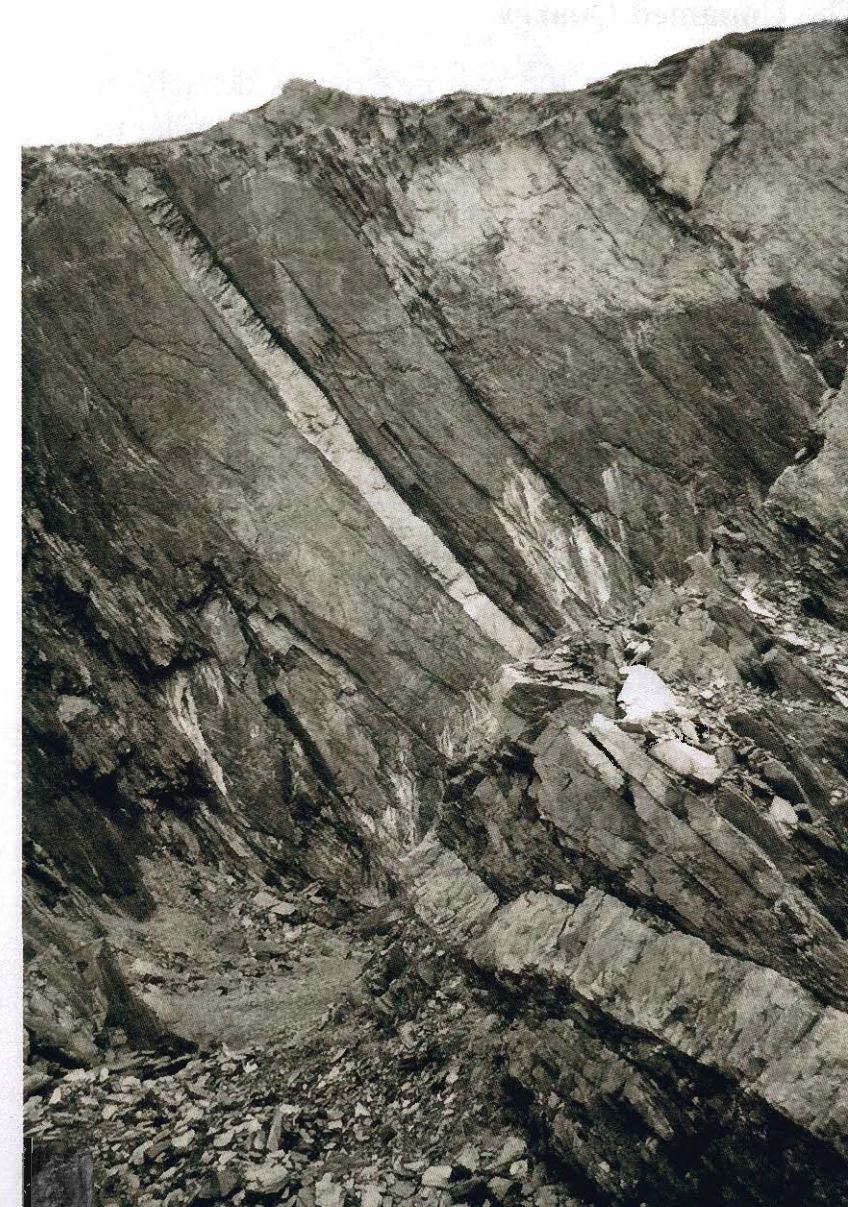
Plate 25 Cullipool No 3. The slate is cut by an igneous intrusion, which runs parallel to cleavage (NM741135)

This is the largest working of all the quarries on the west of Luig being nearly 200m along strike and worked into the cliff a distance of 100m. The northern end of the quarry was worked at three different levels. A dyke separates the lower two levels (Plate 25). The immediate vicinity of the dyke was not worked presumably due to the destruction of the cleavage. Two Tertiary dykes cut across the quarry from WNW to ESE dividing the quarry into 3 sections. Two thirds of the quarry at the southern end was worked to a precipitous height of 40m. The seaward side of the quarry was left intact for part of the length of the quarry, due to the continuation of the folding seen in the previous quarry.

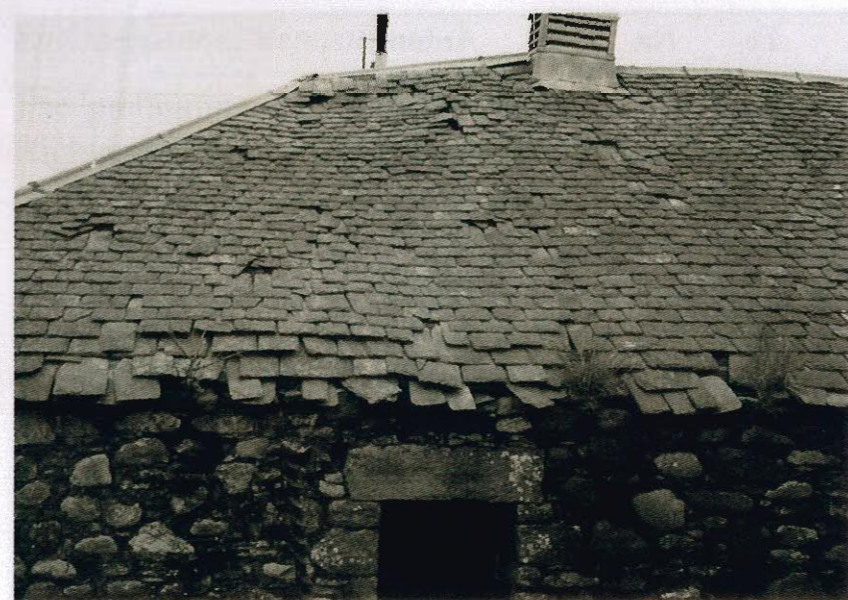
a) The barn at Frances Field (Kipney) is now suffering from nail sickness

Plate 30 Two buildings roofed with slate from Craiglea Quarry

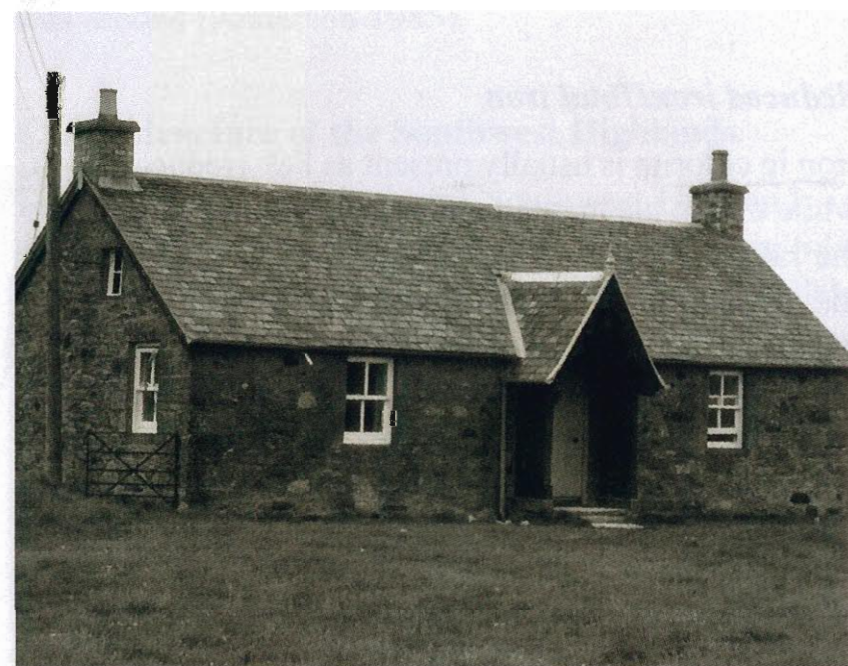
b) Bonellas Cottage has recently been re-roofed using the original slate with less than 10% wastage

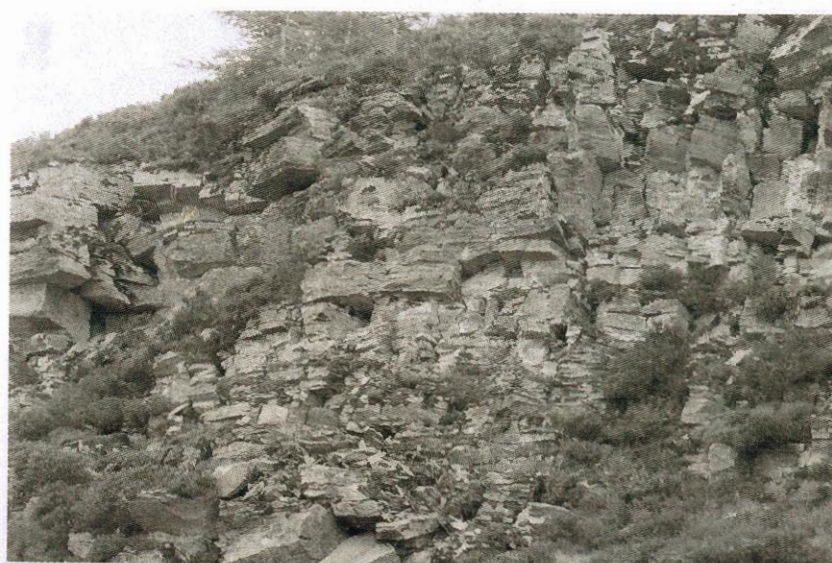
Plate 49 Kirkney Quarry. The overhanging face has collapsed with time, along the pillaring line (NJ503317 to 510320)

The main quarries are situated on the north slopes of the Hill of Kirkney in the area NJ503317 to NJ510320 at a height of 380m. There appear to have been two seams worked along strike ENE (075°). There are two main clusters of quarries each 500m long with a gap of 500m between them. The older workings are at a lower level and have been partly obliterated by the tips from later workings at a higher level. Individual quarries can be identified each with its own entrance/drain, usually on the north side, and accompanying tips (Fig. 5.5b). On the south side of the quarries the face is overhanging or has collapsed with time, often along pillaring lines (Plate 49). The remains of several shelters can be seen with an area nearby where the slates were dressed. None of the quarries has been worked to greater than 10m depth.

**Size of slates:** Samples are fairly coarse grained and would produce a thick slate of approximately 7 to 10mm. In general the overhanging face has collapsed along the pillaring line (Plate 49) and the inclined faces are obscured with debris. It was therefore not possible to assess the effect of density and orientation of jointing on the size of the slates.

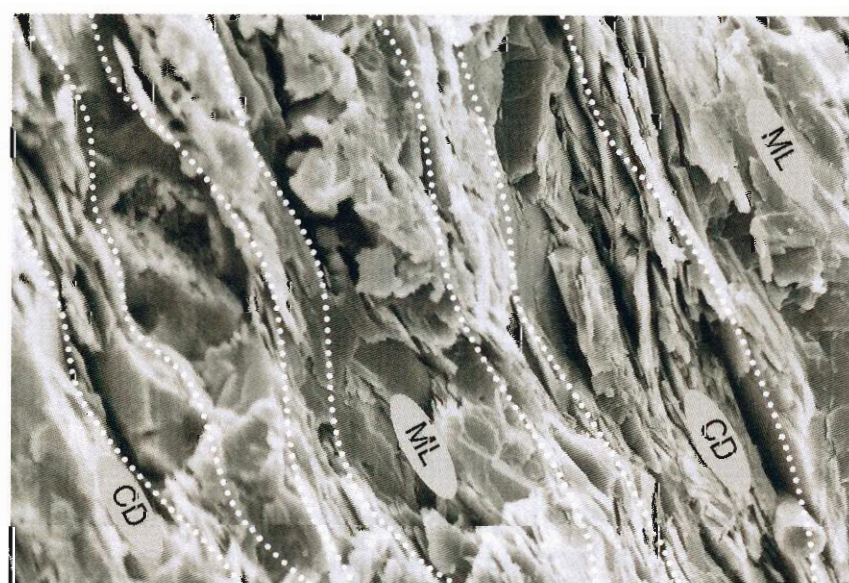
**e) FOUDLAND QUARRIES MF-2**  
 Fairly widely spaced, slightly anastomosing around microlithon with some development of fabric estimated thickness 6.0mm.

Fig. 5.4 Fabric of Macduff slate

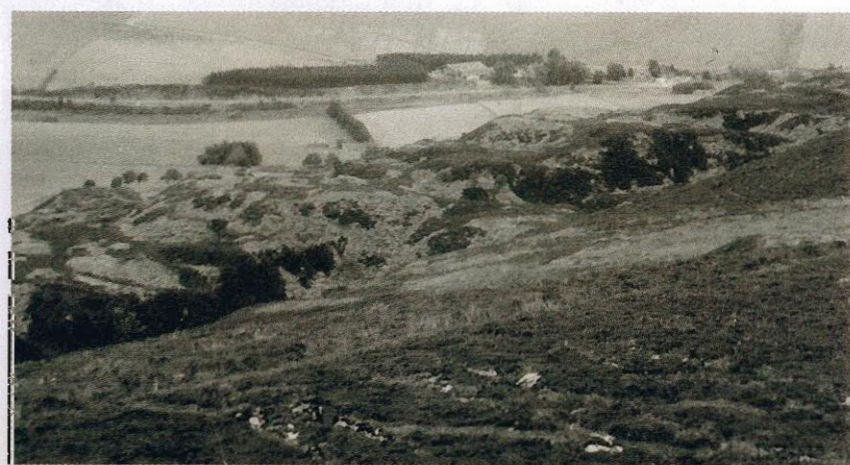
Plate 53 Foudland Quarries. The lower level quarries are choked with debris (NJ597337 to 610339)

The most extensive quarries are found at a lower level on the north slopes of the hill stretching over 800m along strike and up to 300m wide. This is probably due to the proximity of the old road through the Glens of Foudland. Individual quarries are stepped upwards from west to east, the size of the workings increasing in the same direction, judging from the size of the tips (Plate 53). The lower level quarries in this group are very overgrown, but at the upper level it is possible to recognise individual workings.

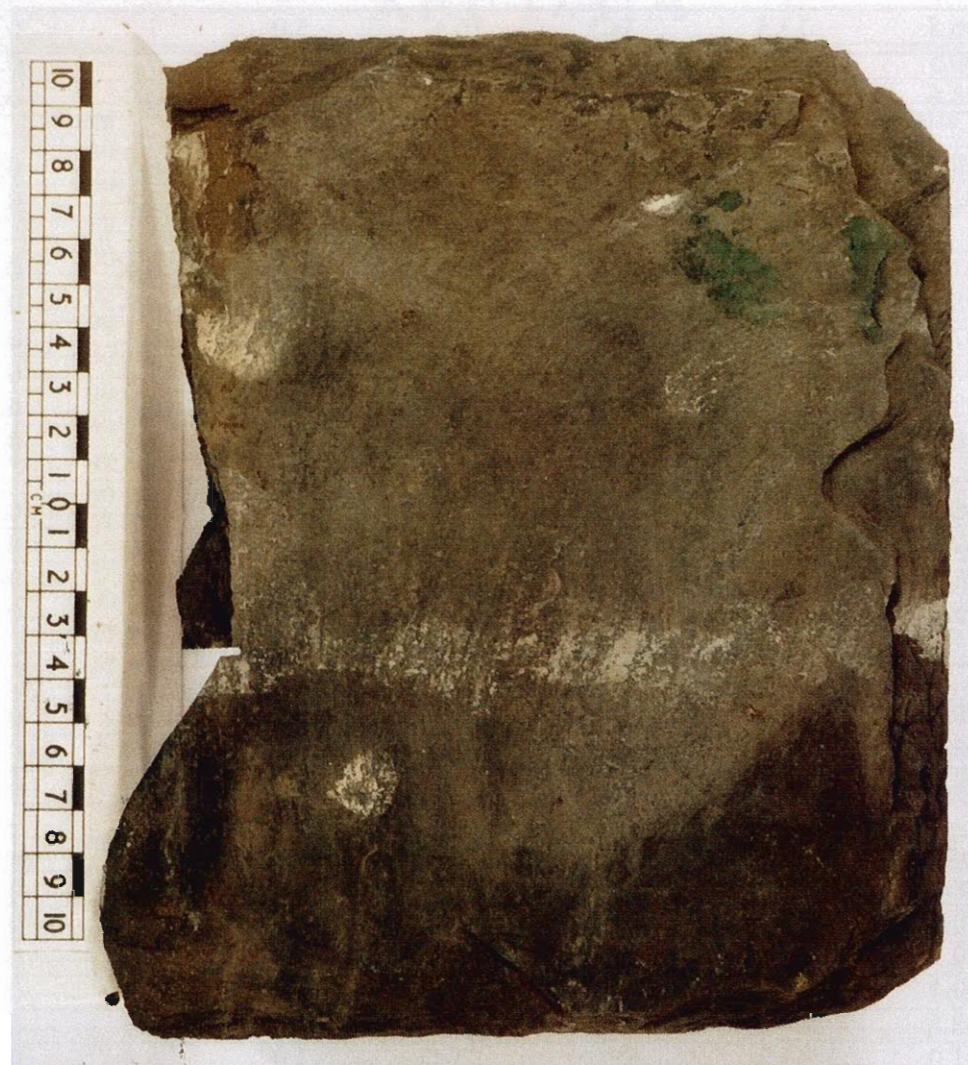
Plate 55 Ballachulish slate from a used-slate dealer estimated at over 100 years old

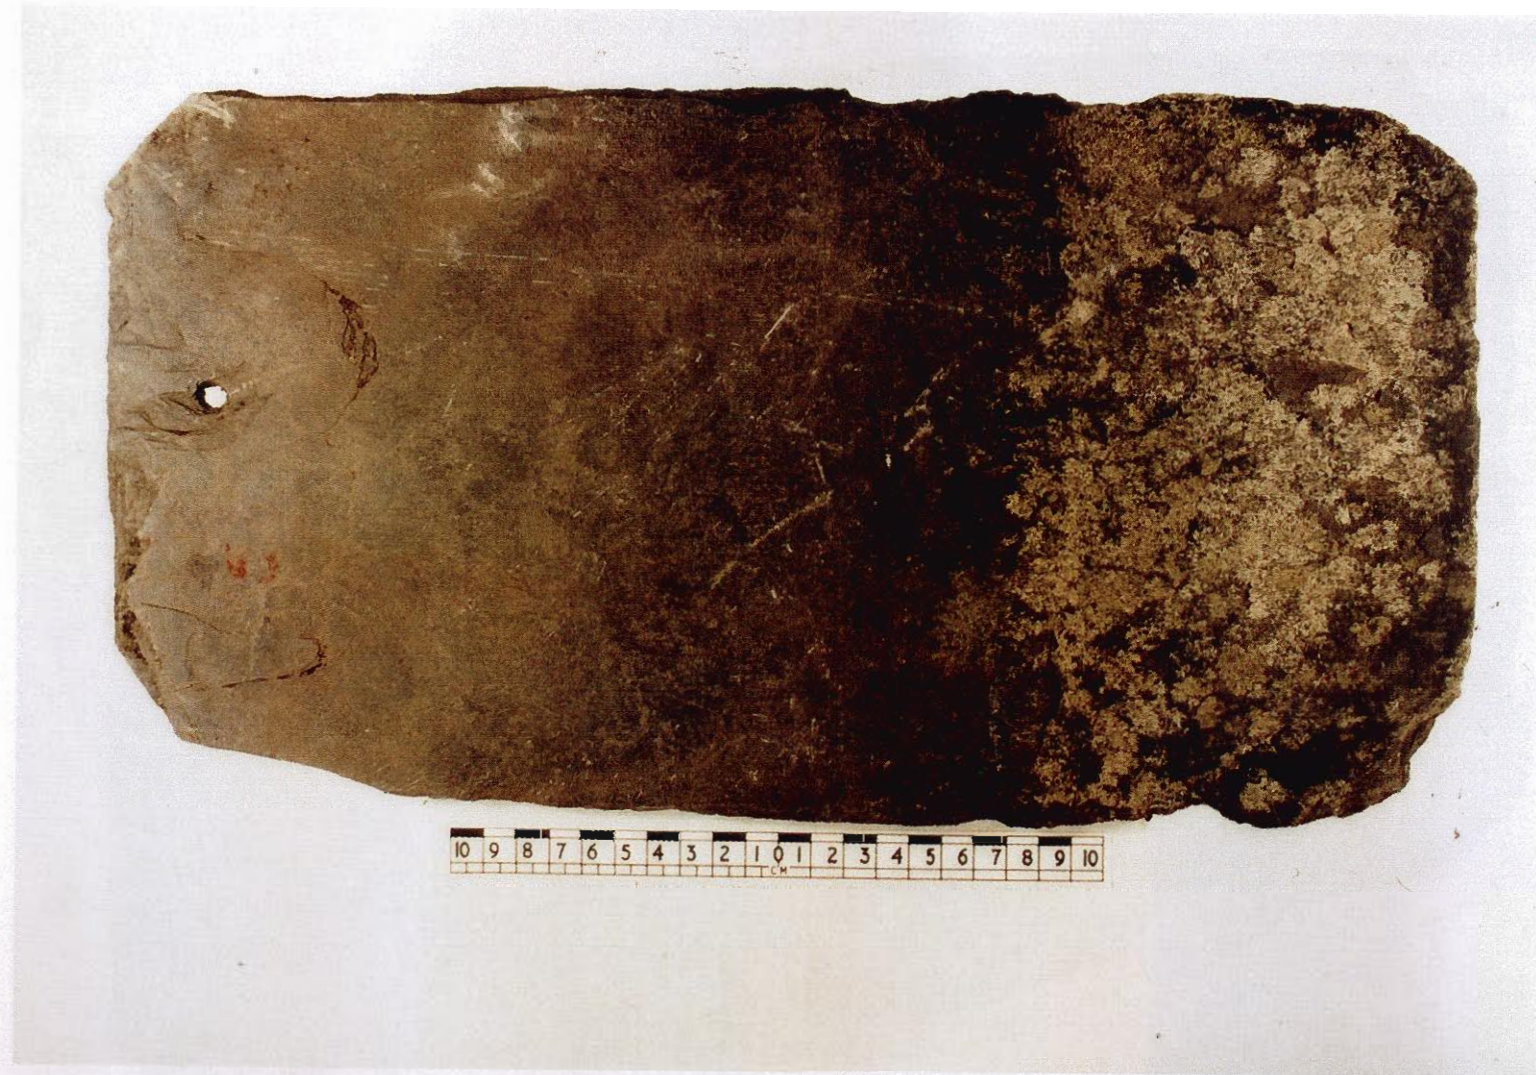
Plate 64 Birnam slate collected from the quarry

**Birnam** NO037403 – NO039405  
(Fig. 4.19, Fig. 4.20, Plate 45, Plate 64)
