RESEARCH  
REPORT

THE  
BLACKHOUSES  
OF ARNOL

by  
Timothy G Holden  
with contributions by  
Louise M Baker

Published by  
Historic Scotland

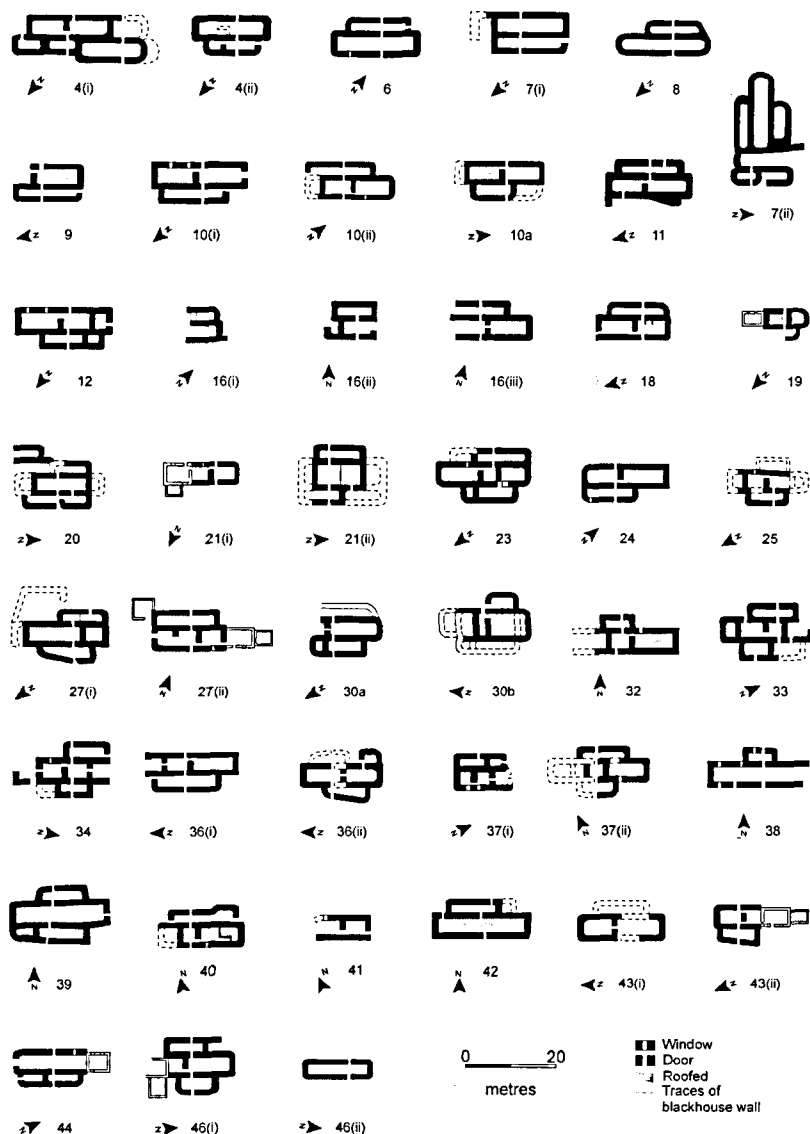
Illus 21 Schematic diagrams of footprints of upstanding buildings surveyed in 1998 (drawn by Laura Speed).

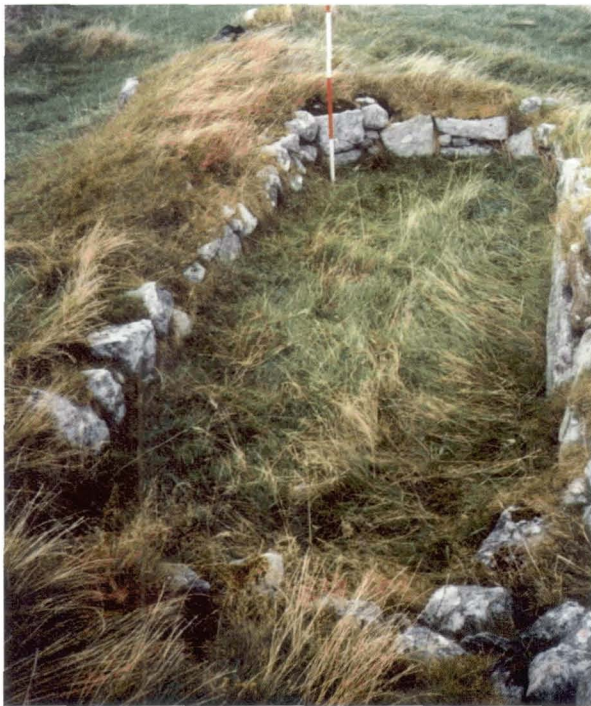
Illus 22 No. 7(ii) A view of the rounded end walls of an early blackhouse constructed of field stones (photograph by Headland Archaeology Ltd).

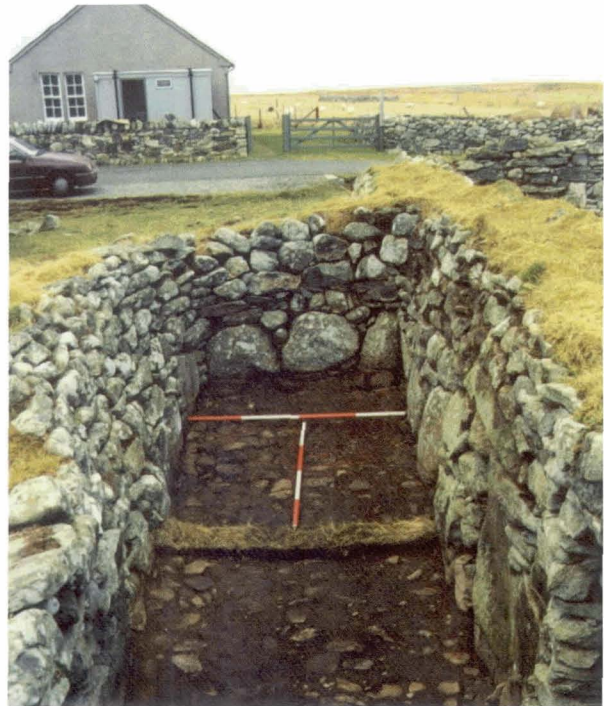
Illus 23 No. 39 Field boulder construction with an additional room abutting the byre/dwelling (photograph by Headland Archaeology Ltd).

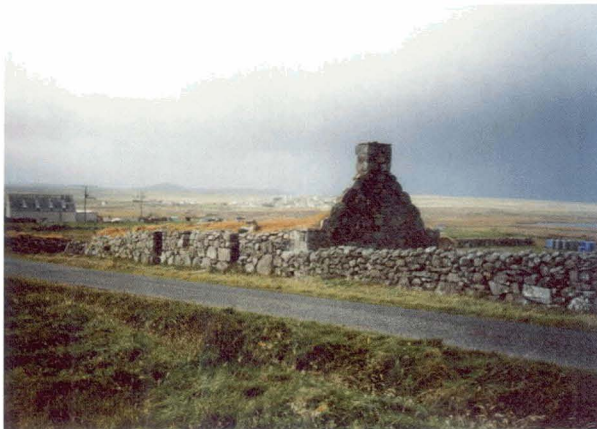
*Illus 26 No. 10(i) A modified later blackhouse with gable (photograph by Headland Archaeology Ltd).*

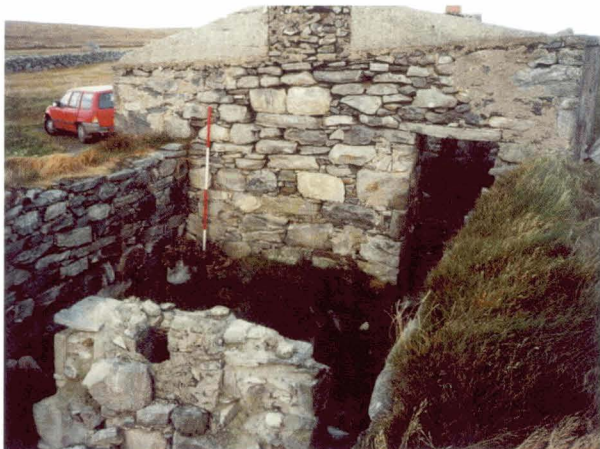
*Illus 27 No. 43(ii) A blackhouse with a later single pitch extension (photograph by Headland Archaeology Ltd).*

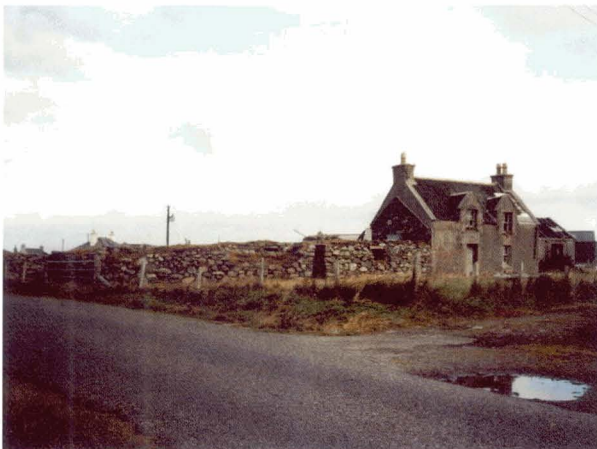
*Illus 28 No. 27(ii) A blackhouse with double-storey DAF extension (photograph by Headland Archaeology Ltd).*

In some cases the single storey extensions were extended upwards into two storey, gabled whitehouses. In other cases new structures were built directly abutting earlier blackhouses. These were usually two-storey structures, frequently with dormer windows in the upper rooms (illus 28). They were commonly used

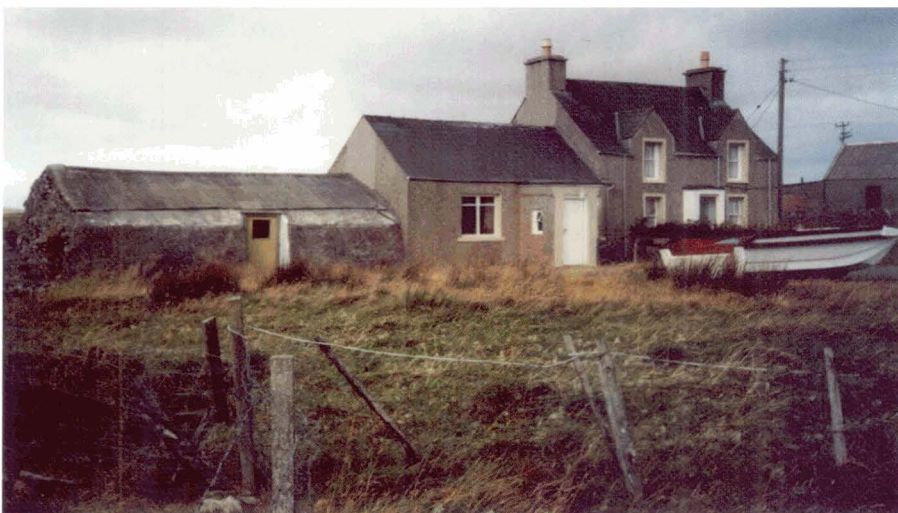
*Illus 29 No. 40 A blackhouse, roofed and harled and still a used part of the building (photograph by Headland Archaeology Ltd).*

as bedroom areas and in some cases the main living area remained within the blackhouse part of the building until their abandonment in the post Second World War period. In only one case (illus 29) have parts of a blackhouse been incorporated into a building that is still lived in. In this case the exterior walls of the blackhouse have been mortared and harled.

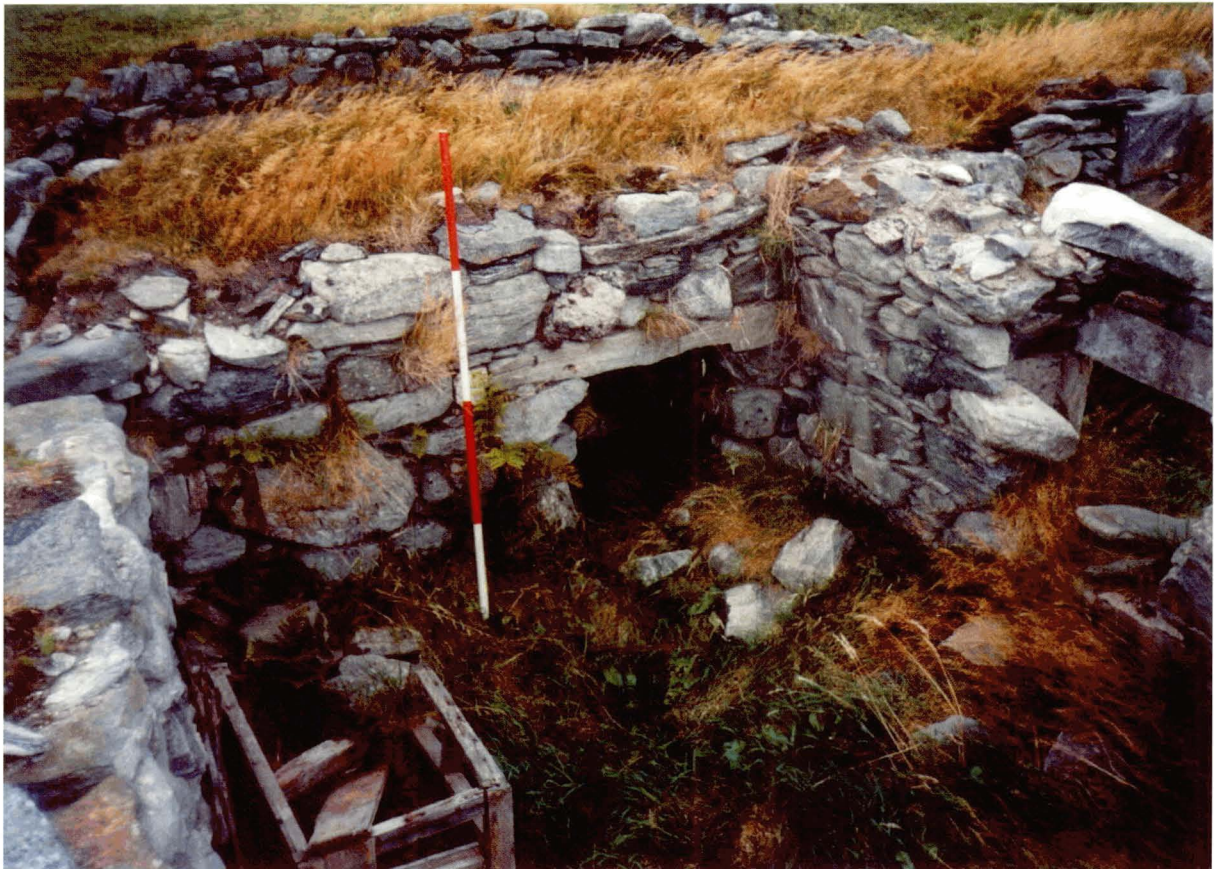
Illus 31 *Crùb* bed within the wall of No. 23 (photograph by Headland Archaeology Ltd).

over the entrance. In No. 37 the *crùb* bed is located in the living area and had an entrance 0.6 m wide and 0.6 m high which then opens out into an intra-mural space 1.2 m long and 1 m deep. In No. 23 the recess is also located in the wall of the living area and is 0.8 m wide, 0.85 m high and 0.65 m deep (illus 32). In their present state both of these features appear to be very close to ground level but this may be illusory, the build-up of debris and later levelling of interior surfaces having altered the original level of the floor.

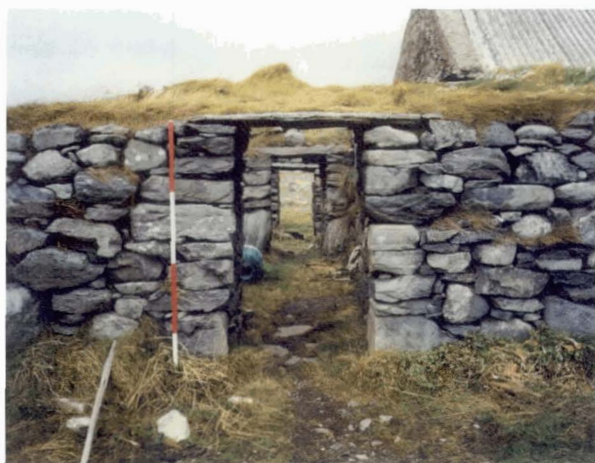
*Illus 33 No. 40 View through three opposing doorways (photograph by Headland Archaeology Ltd).*

The doorways themselves range in width from 0.65 m to 1.0 m with the average height to lintel being approximately 1.7 m (illus 33 and 34). Most are wider at the base than at the top. In some of the later buildings wooden lintels were used but stone lintels were more traditional. These long flat stones were evidently in short supply and were usually one of the first stones to be removed for re-use after abandonment. In many cases doorways were blocked, indicating changes to the basic organisation of the building. This could have happened in order to rectify unsuccessful or imposed 'improvements'.

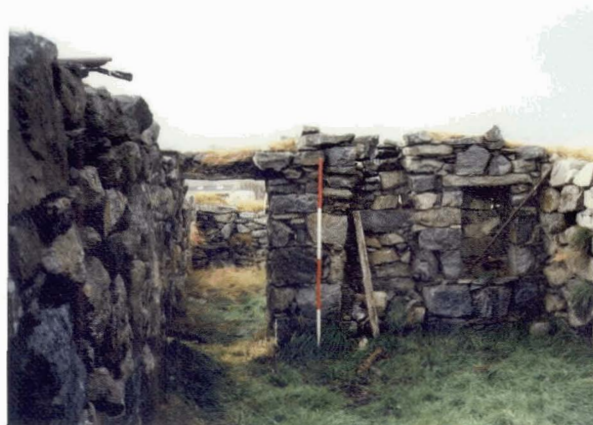
*Illus 34 No. 10(ii) Partition with door, hearth and shelves (photograph by Headland Archaeology Ltd).*

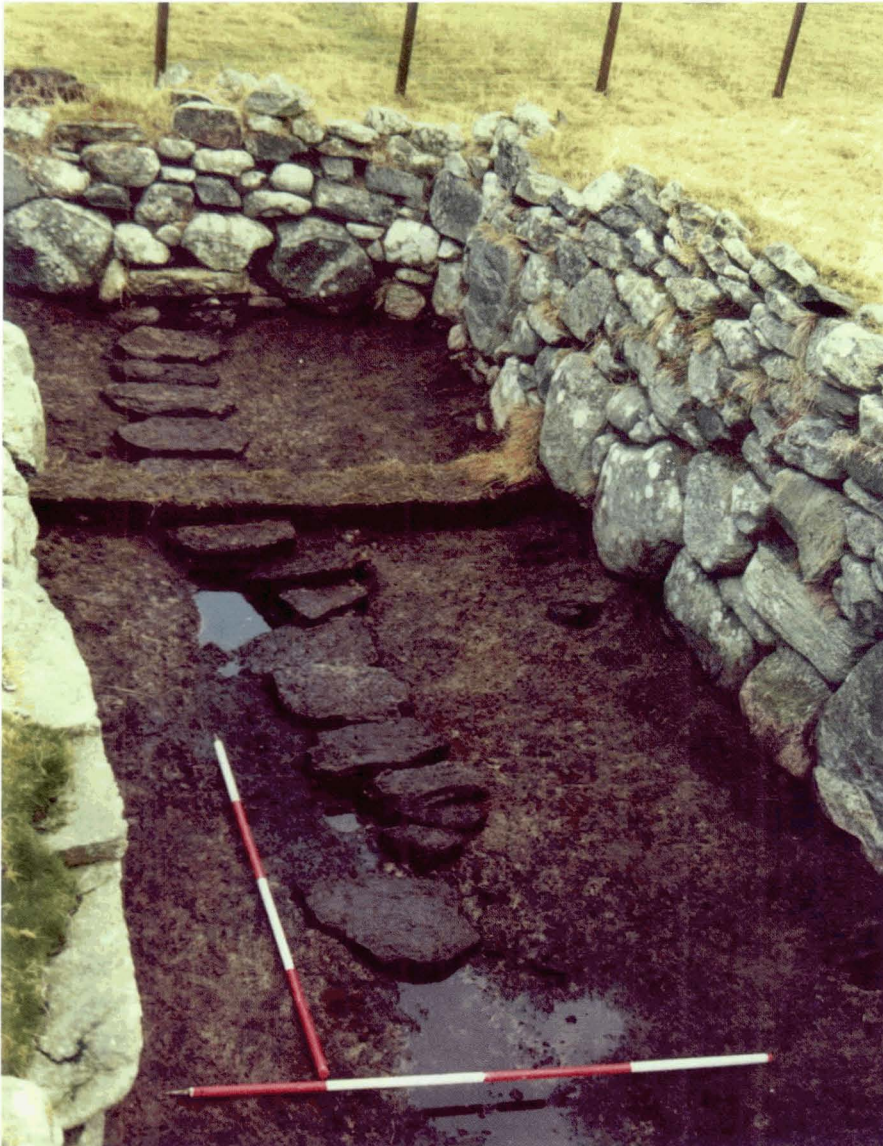
*Illus 35 No. 39 - The byre drain running downslope and exiting the building through a small opening (toll lodain). The capstones in the foreground have been dislodged (photograph by Headland Archaeology Ltd).*

Areas of exposed flooring can be seen in very few buildings and where it is visible it is usually of modern construction in rooms adapted for storage or as loom sheds. If the excavated example at No. 39 and the Blackhouse Museum at No. 42 are typical, however, the living areas in blackhouses from around the turn of the century would have consisted of roughly flagged floors set into the natural green/grey silty sand. At No. 39 a later skim of cement had been added to protect worn areas in passageways or between the box beds in the dwelling area. This was also seen in the barn but a much more crude cobbling was seen in the *fosglan* (illus 36). At No. 42 a clay floor had been laid at the point where threshing was done and other areas had been lined with planks upon which sheaves could be protected from the damp of the floor (Fenton 1978). In cross-section, the byre floor of No. 39 was distinctly concave with the flagged drain set at the lowest point (illus 35 and 37). The floor surface itself is made up of a hardened, yet wholly natural, layer of silty sand. The concave profile may, in some part, have been exaggerated by the repeated clearing out of byre debris every spring. However, in view of the siting of the drain, it was probably an original design feature.

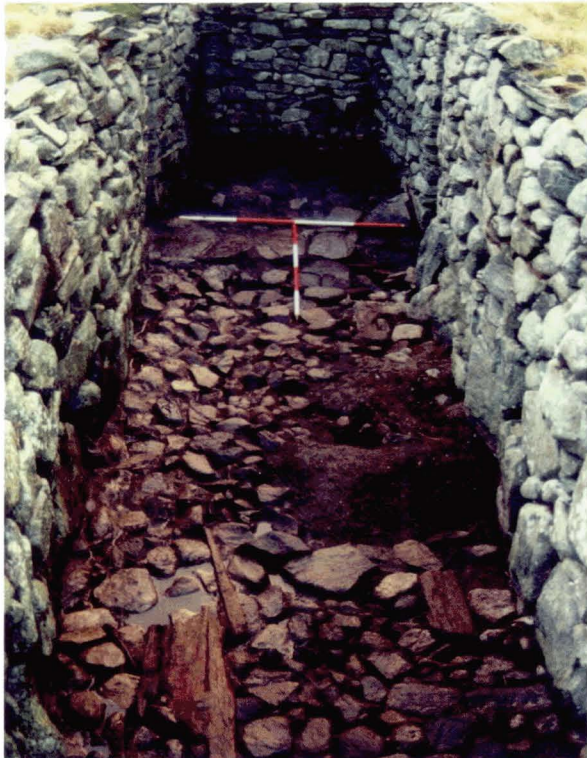
Illus 37 No. 39 The central step exposed during excavation (photograph by Headland Archaeology Ltd).

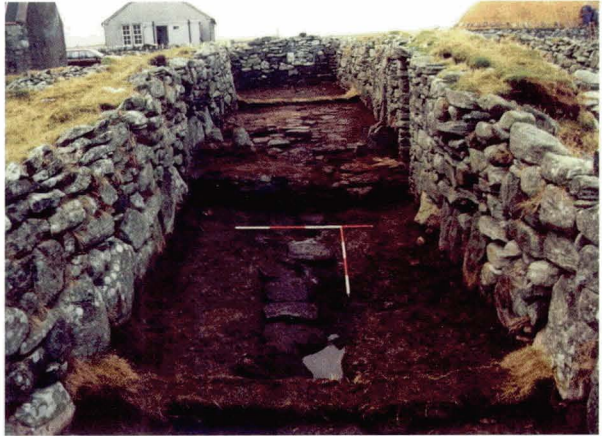
Illus 36 No. 39 Crude cobble flooring in the *fosglan* (photograph by Headland Archaeology Ltd).

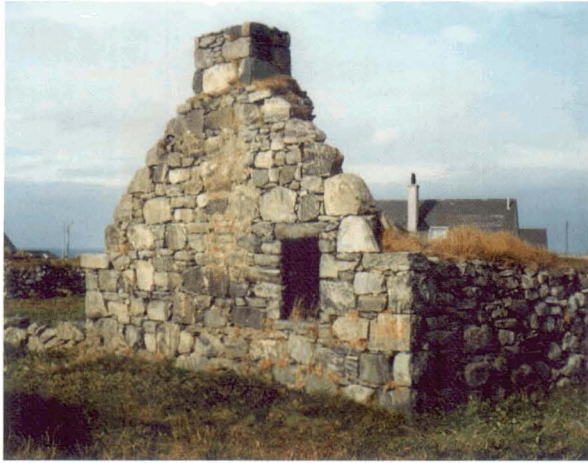
Illus 40 No. 36(i) A gable wall with window (photograph by Headland Archaeology Ltd).

Several types of feature are associated with the gables. Fireplaces are found in most and are similar in style to those seen in the internal partitions. Windows and doors in gables are uncommon but No. 36(i) (illus 40) and No. 41 (illus 41) are exceptions to this.

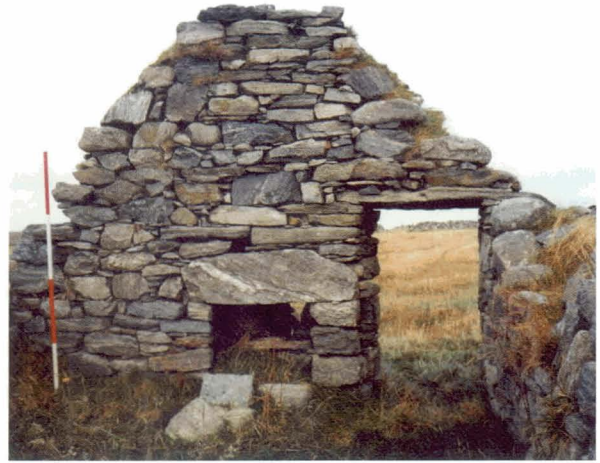
Illus 41 No. 41 A gable wall with door (photograph by Headland Archaeology Ltd).

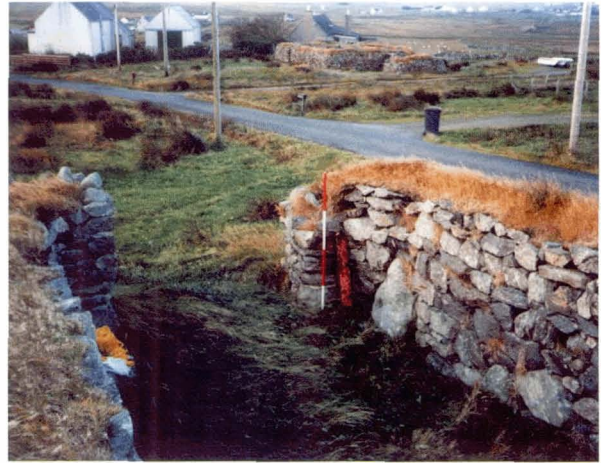
*Illus 44 No. 44 An unblocked horse hole (toll each) (photograph by Headland Archaeology Ltd).*

In later houses the entrance into the byre is constructed to make dismantling and rebuilding easier. In many cases the edges of the permanent wall are deliberately faced so that when the entrance was unblocked it would have a stable piece of wall on either side (illus 44). The masonry in the end walls is often constructed of smaller stones, for ease of removal and is different in character to the more permanent parts of the wall (illus 45). Turf was used in some areas to block the horse hole but this was not seen in Arnol itself.

Many of the horse holes at Arnol survive as blocked entrances and can be identified by the straight line joints between them and adjacent wall. In some cases the entrance walls have been completely removed so that the buildings can now be used as animal pens, tractor- or cart-sheds. These openings range in size from 1.1 m to 4.9 m wide.

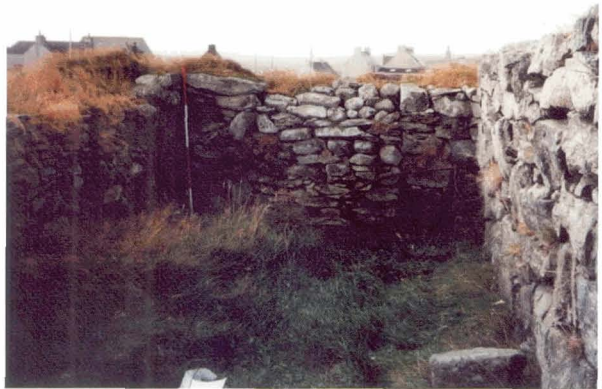
*Illus 45 No. 10(i) A horse hole (toll each) blocked with smaller diameter stones (photograph by Headland Archaeology Ltd).*

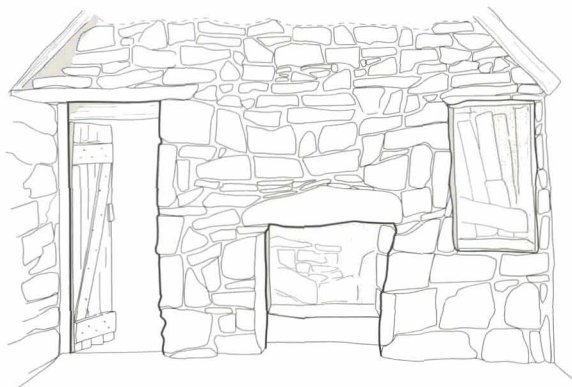
Illus 46 A typical partition wall with door, fireplace and shelves (drawn by Margaret Engl).

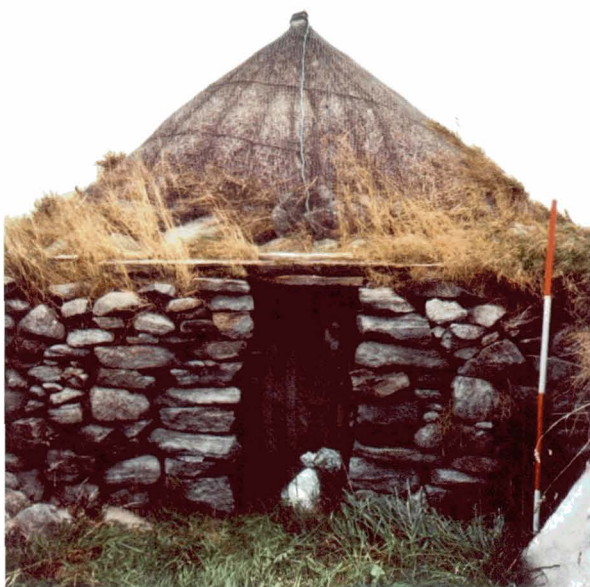
Illus 47 No. 30a One of two thatched roofs surviving in the township in 1998 (photograph by Headland Archaeology Ltd).

Only the Blackhouse Museum at No. 42 retains a well-maintained thatched roof. No. 30a, apparently re-thatched within the last 20 years is now no longer maintained (illus 47). It was constructed of cereal straw laid randomly and is held in position with fishing net. In 1988, No. 9 retains some of its thatch, but the roof had mostly fallen in (illus 48). These buildings illustrate the techniques of roof construction and, as

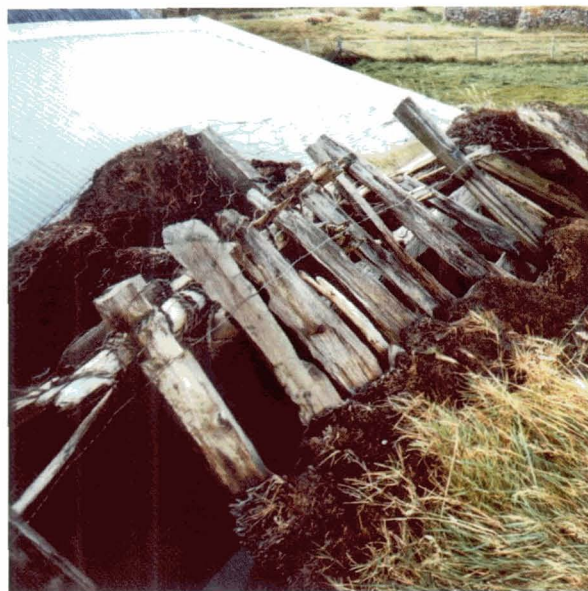
Illus 48 No. 9 Collapsed thatch roof (photograph by Headland Archaeology Ltd).

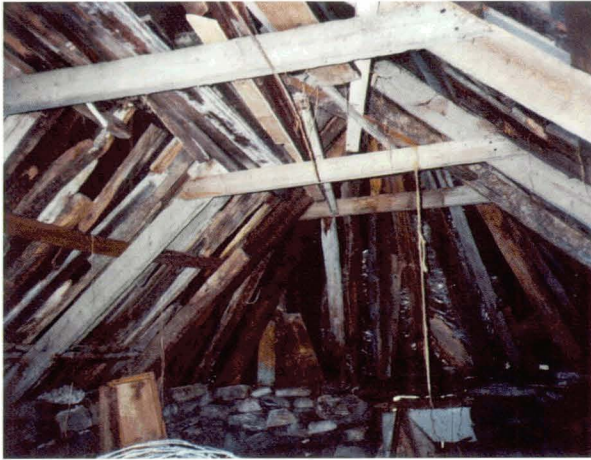
Illus 49 No. 30a Roof timbers (photograph by Headland Archaeology Ltd).

originally at No. 42 Arnol, much of the timber used consists of small planks of driftwood (discussed in detail by Fenton 1978; Walker and McGregor 1996; illus 49). These were supported by simple couples of cut timber standing on the inner edge of the wall-head. Heather (*siomain*) and coir rope fixings for the timbers can be seen in places. The thatch is evidently of cereal straw, but no substratum was noted. This stands in contrast to No. 49 which even in the 1970s (Fenton 1978) had a substratum of turf (*sgrathan*). This point is of interest because in many blackhouses the smoke permeated through the thatched roof and there was no requirement for a smokehole. In some areas the soot-filled thatch was regularly removed and used as a top-dressing for the young potato crop. This is referred to, for example, in the evidence Sir James Matheson gave to the Royal Commission on Housing for the Working Classes (Report 1885). The sooting of straw would, however, also be affected by the presence of a turf substratum and it is probable that houses with this turf layer were smokier and may have required a smokehole. The evidence from James Matheson, seems to suggest that the use of turf may have been a modification brought about by the disapproval of the landlord to the practice of manuring with sooted thatch.

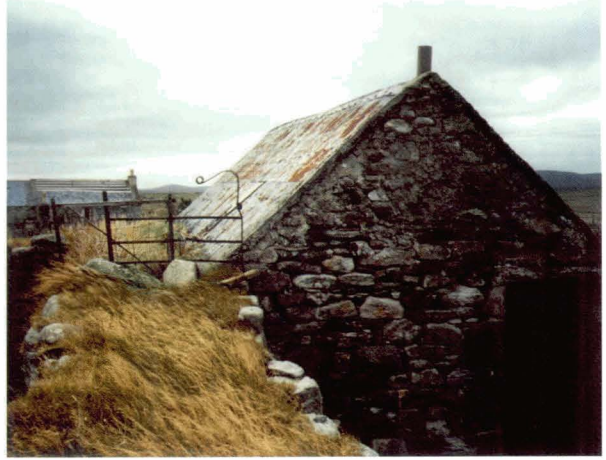
Illus 50 No. 10a Corrugated iron roof (photograph by Headland Archaeology Ltd).

Although in recent times the use of fishing nets and chicken wire is commonly used to keep the thatch on the roof, traditionally a variety of roping techniques using straw or heather and later coir rope were used (see Walker and McGregor 1996). Other roofing materials have been used in more recent times and examples of corrugated iron and asbestos sheeting can be seen (illus 50).

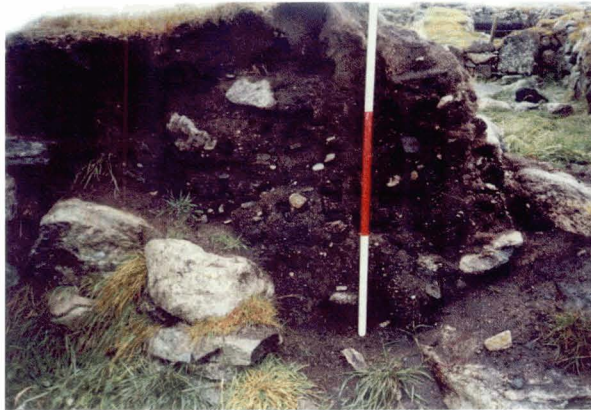
Illus 53 No. 20 Exposed section through the wall (photograph by Headland Archaeology Ltd).

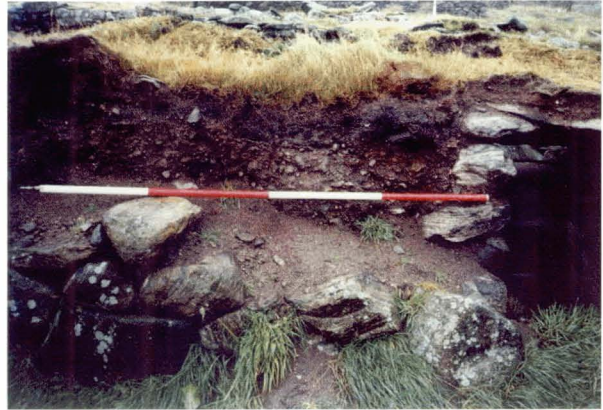
Illus 54 No. 20 Exposed section through the wall (photograph by Headland Archaeology Ltd)

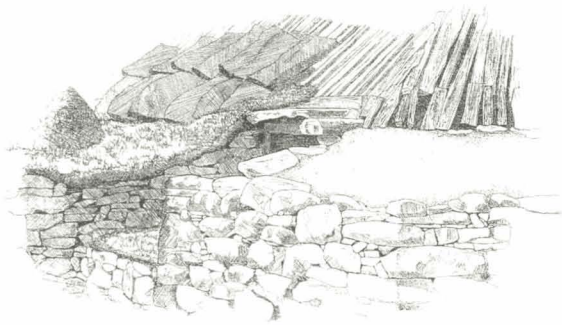
Illus 57 No. 42 Window to room exposed during the replacement of the roof and wall turves (© Chris McGregor).

From what is known about early blackhouse construction it is clear that they had no windows or were lit using oiled lambskin stretched on a wooden frame set into the thatch (Bruce Walker pers. comm.). More recently panes of glass may have been set into the thatch, resting on the bottom purlin (*uinneag tughaidh*). Traces of such glass can still be seen lying on the wallhead of some buildings. Windows set within the walls (*uinneag*) are more recent still. At No. 42 a small window with two fixed panes was set into the inner face of the wall at the bedroom end of the house (illus 57). Approximately half of the surviving blackhouses have windows, but most of these are features of the modernised examples (illus 40). At No. 39 the whole end wall of the bedroom end of the building was rebuilt specifically to accommodate a window which was seated in a well-made opening

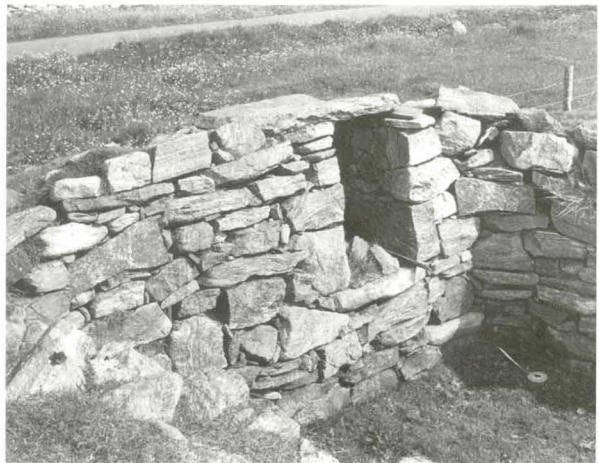
Illus 58 No. 39 A window inserted in the bedroom end of the building, from the interior (photograph by Headland Archaeology Ltd).

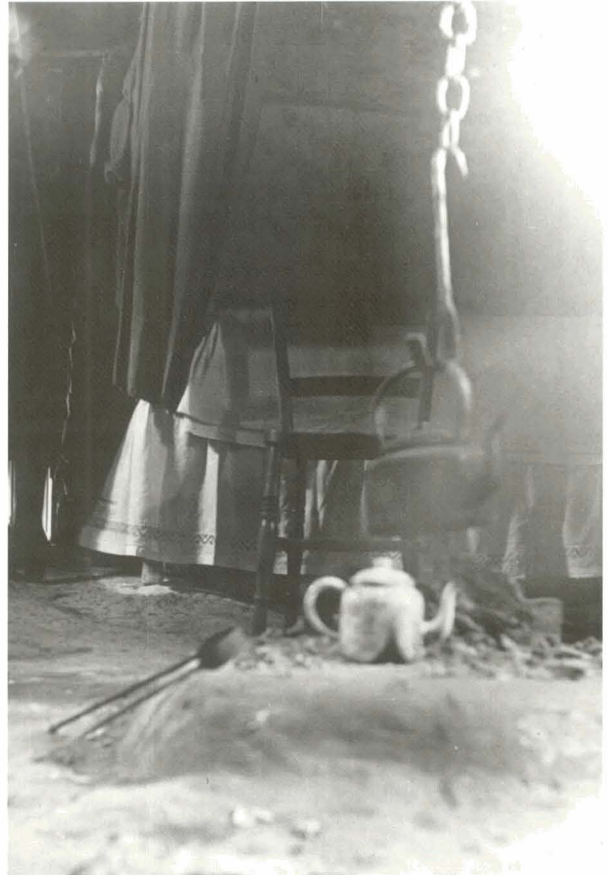
Illus 63 A blackhouse hearth (photograph by Åke Campbell, courtesy of The Institute of Dialectology, Onomastics and Folklore Research, Sweden, ULMA 37510).

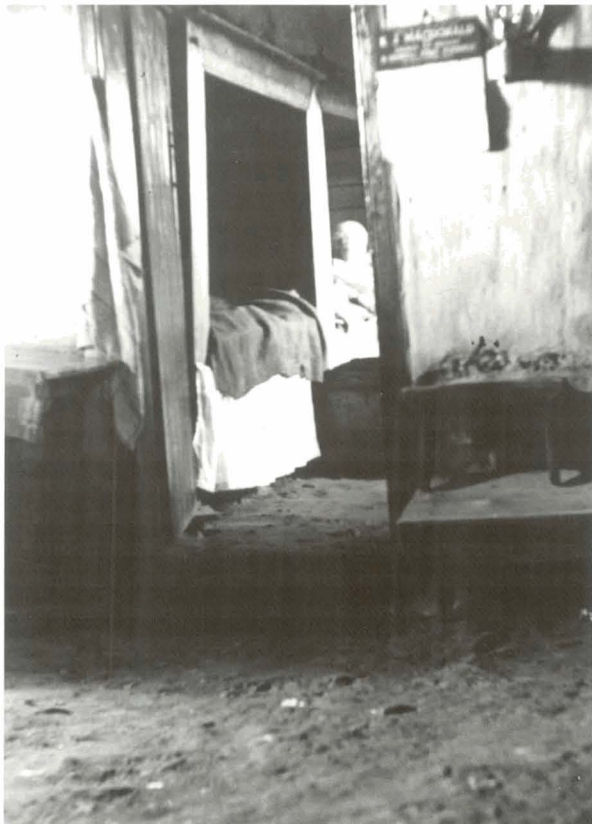
*Illus 64 A box bed, from the living area (photograph by Åke Campbell, courtesy of The Institute of Dialectology, Onomastics and Folklore Research, Sweden, ULMA 37510).*
