Short Guide

CLIMATE CHANGE
ADAPTATION FOR
TRADITIONAL
BUILDINGS

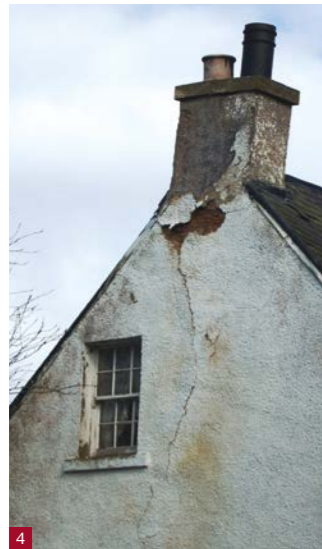
Fig. 4 Water ingress has led to progressive failure of the chimney and masonry below.

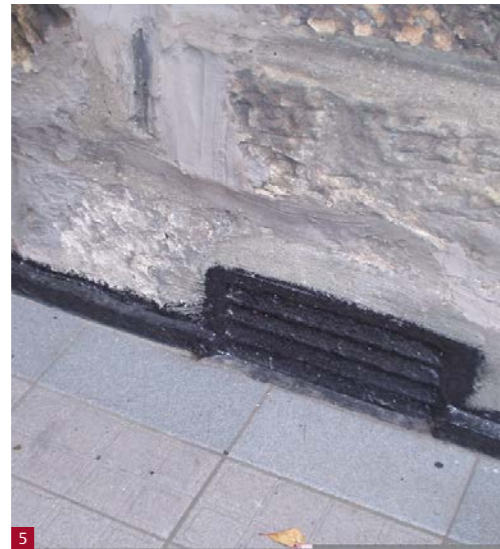
Fig. 5 Poorly designed hard landscaping close to building, partially obscuring the wall vent, inhibiting ventilation and concentrating moisture.

Alterations, such as hard landscaping close to buildings and development leading to loss of gardens, have inadvertently led to increased water run-off and splash back, resulting in high moisture levels in external walls or adjacent areas. Ground levels can become raised over time from natural deposition of organic materials or from poorly designed landscaping work (Fig. 5). Increased levels of water in the soil and impermeable materials next to buildings increase the risk of damp and associated problems. In some areas a rising water table or poor drainage will also have an impact on footings and foundations. Moisture from soils can contaminate porous masonry with damaging salts which can cause or accelerate stone decay.

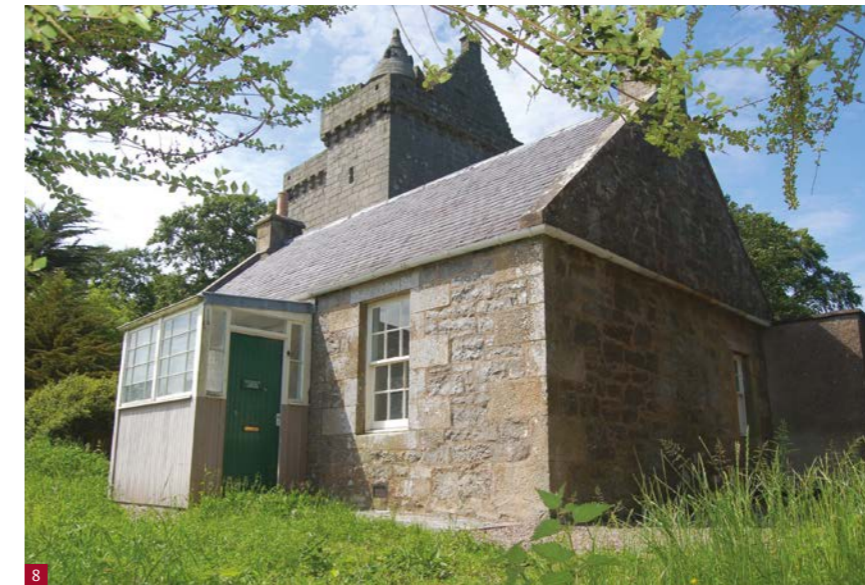
Fig. 8 This 19th century cottage in Fife has been fully insulated and upgraded, without loss of character or fabric.

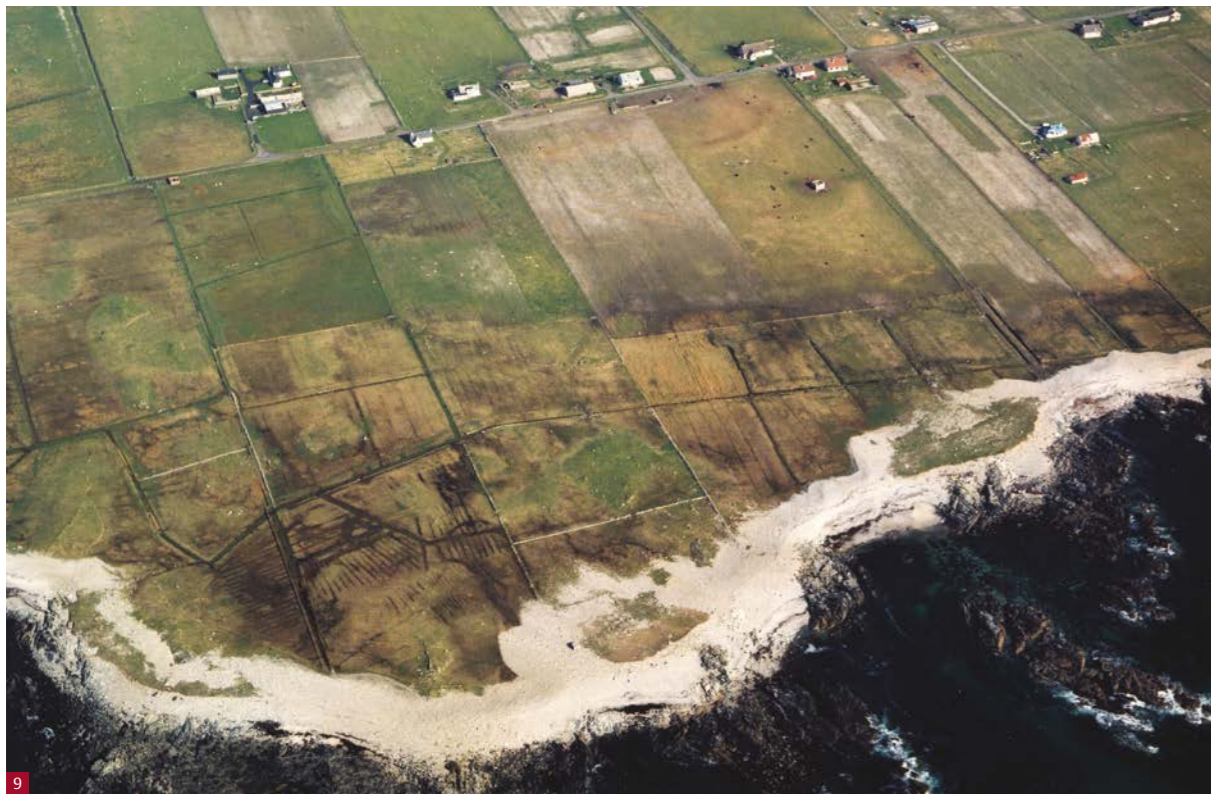
Fig. 9 Coastal damage following extreme weather © Linda Flemming.

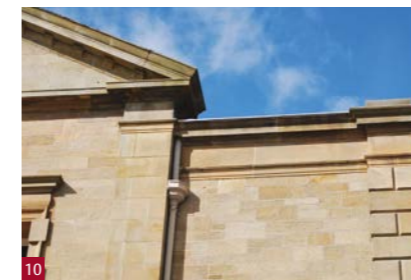
Fig. 10 Cornices, string courses and projecting lintels all perform a protective function as well as being decorative.

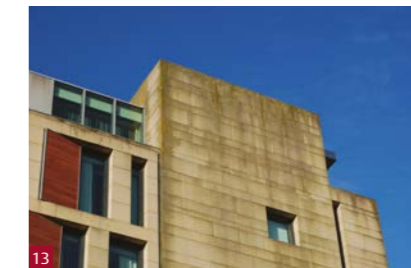
Fig. 13 Poor detailing on a modern building in Edinburgh has led to staining of the masonry.

External details on traditional buildings such as *string courses*, *hood mouldings* and *cornices* exist primarily as functional elements to shed water and protect the building façade, although they can also be decorative (Fig. 10, Fig. 11 and Fig. 12). The rapid weathering and staining sometimes seen on buildings of modern design, often with flat roofs and unembellished *curtain wall* façades, illustrates the purpose of traditional detailing and the need to understand the micro-climate in which a building sits. Buildings which may perform well in a dry, southern European climate are typically poorly suited to Scottish weather conditions (Fig. 13).

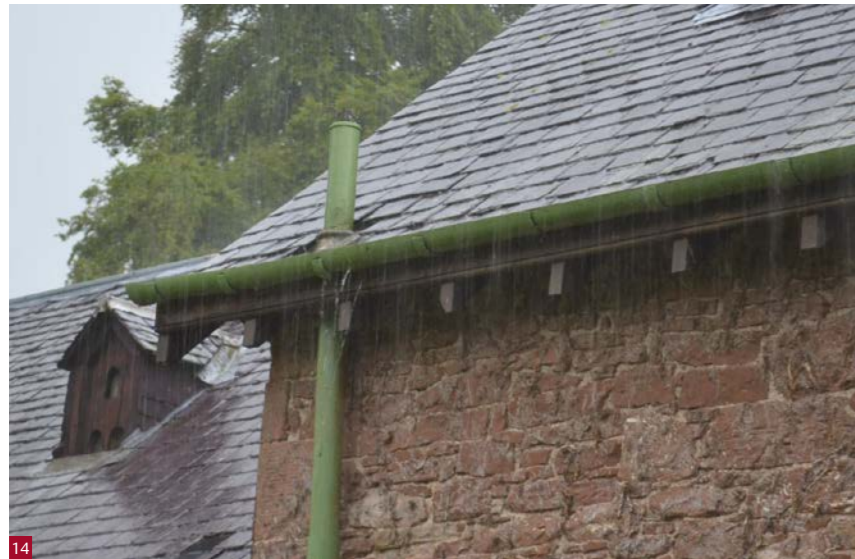
Fig. 14 Heavy and sustained rainfall may overwhelm existing drainage.

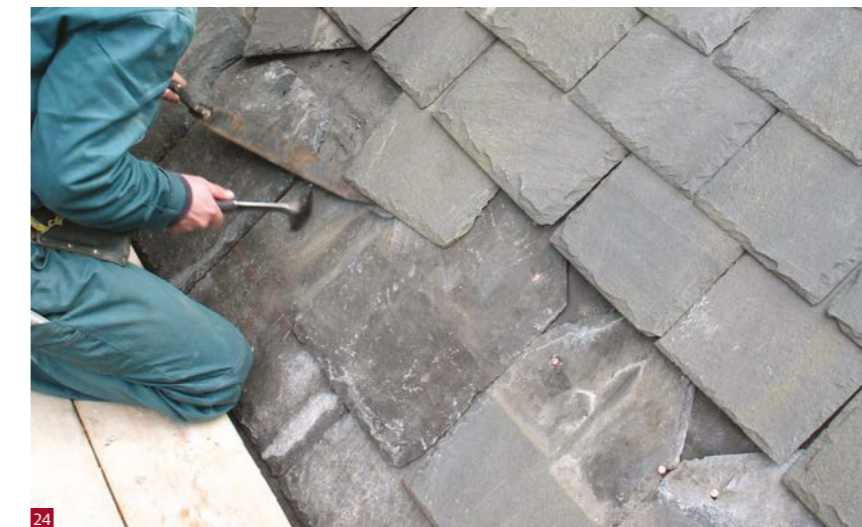
Fig. 24 Fixing slates with additional fastenings to prevent wind lift.

In Scotland the majority of roof coverings on traditional buildings are slates, plain clay tiles or *pantiles*. In particularly exposed areas and in high winds there is a tendency for water to be blown up under the slates, even where they are correctly laid. To address this issue the use of an underlay might be necessary to ensure the roof remains watertight during bad weather. To prevent excessive movement or rattling of slates in high winds, slates can be secured with additional nails to the sides, known as *cheek nailing*, every third or sixth course (Fig. 24). On turrets and exposed areas cheek nailing is sometimes necessary for every course. In some parts of Scotland where larger slates are used they are fastened with two nails on each slate, in the English way. In this case additional nailing is not normally required.

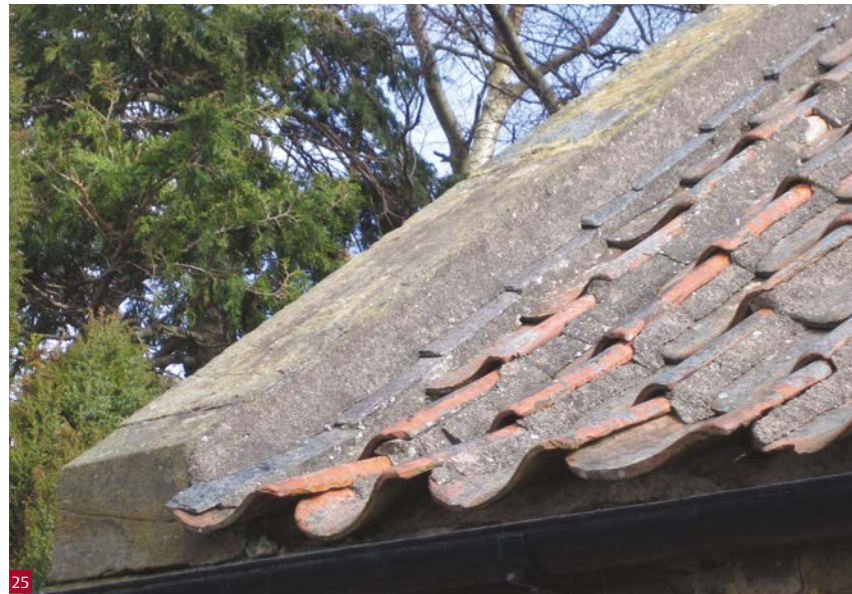
Fig. 25 Mortar torching on pantiles to prevent wind lift.

With pantiles there is little variation possible in fitting or overlap; however, they tend to be more open to ventilation and subject to wind lift, especially at the eaves. This may be the reason for the narrow courses of slates at eaves level (called an *easing course*) which is a common feature of pantiled roofs in Scotland. In some locations lime mortar is used to close gaps in a pantiled roof (Fig. 25). The addition of lime mortar torching or bedding might be necessary where wind driven rain or wind lift is causing problems.

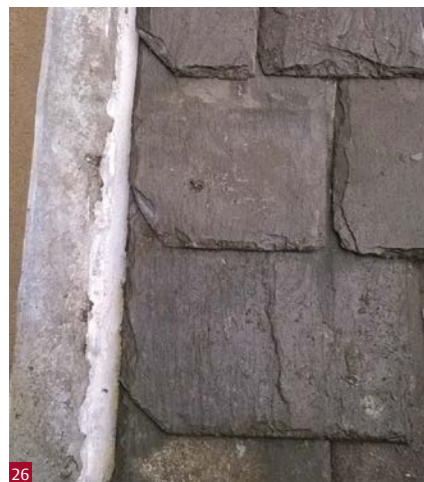
Fig. 26 Edge of slate cut to drive water away from the junction and minimise run off onto the gable.

Where the roof junction with the gable (the verge) is flush, with no overhang, the edge slate is cut with an angle on the edge corner, to drive water onto the middle of the next slate, away from the junction (Fig. 26). This minimises run off onto the gable wall, reducing the chances of saturation and accelerated weathering. Sometimes the verge is secured with a cement *fillet*, but where exposure is more extreme, a zinc or lead ridge roll can be fixed onto the verge (Fig. 27) to give better protection against damage from wind lift and prevent wind driven rain reaching the *sarking* and roof timbers behind.

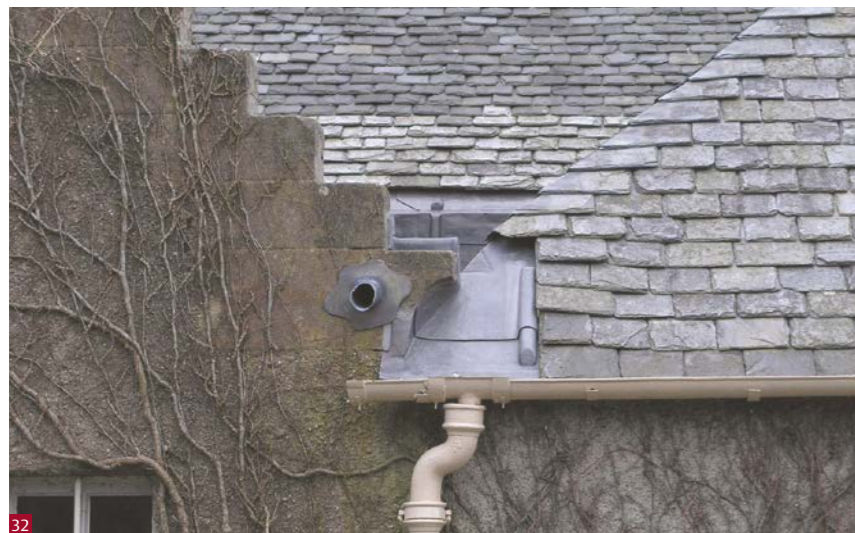
Fig. 32 Enhanced lead detailing, such as the use of a storm roll, can be conspicuous, but is an effective way to improve rainwater disposal in areas of high water flow.

Where water flow at certain points is very high, the use of a *storm roll*, formed from lead dressed over a wooden roll, can be used to ensure deflection of water into the rhone or gutter. While sometimes necessary, they can be visually intrusive, and adoption of this detail must be considered carefully, particularly on prominent roofscapes (Fig. 32).

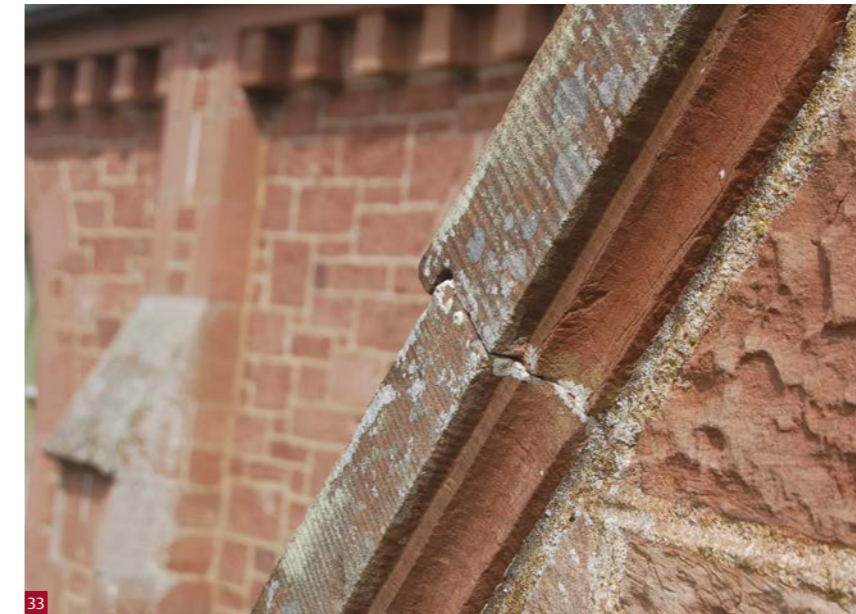
Fig. 33 Raised moulding on upper skew copes to ensure effective water run-off and prevent water ingress.

The stone slabs that are generally used to cover gable end wallheads are often vulnerable to water ingress. The joints between the stone copes should be narrow, less than 5mm, and therefore need a fine ashlar-type pointing. Historically there have been various ways of forming these junctions: plain butt joints, stepped joints with an overlap, or a raised mould on the upper cope to shed water to the sides (Fig. 33). While requiring additional stonemasonry work, such weathering details are particularly applicable today, as increasing rainfall and wind driven rain puts a strain on exposed areas.

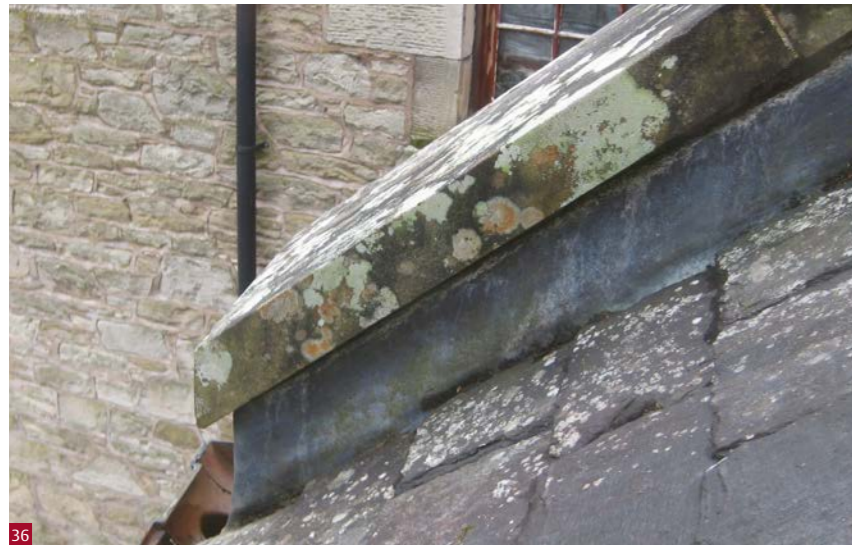
Fig. 36 Bedding of a skew cope with a lead DPC underneath.

In some cases defective skew copes can be re-bedded onto a lead damp proof course (DPC), to provide extra protection against water ingress (Fig. 36). If this approach is taken, the copes will need to be secured in place by additional fixings, to avoid slippage. The edges of the DPC should extend out from the gable wall by about two inches as a drip detail to shed water clear of the wall.

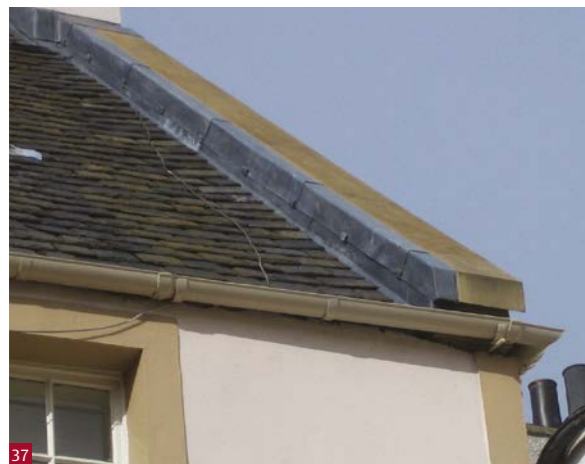
Fig. 37 Half cloaked skew cope giving additional protection.

Where the skew copes have failed badly or the existing detailing is insufficient to adequately protect the roof, supplementary weather protection can be provided using lead sheet. This is a fairly drastic measure and will have a significant visual impact, as well as being expensive. In some circumstances the lead junction with the skew cope is formed on the upper side of the skew, with a raggle cut into the top. This detail is sometimes described as *half-cloaking* and gives additional protection, but is visually distinctive (Fig. 37). Where the skew is fully cloaked in lead, the results are even more striking (Fig. 38). However, such adaptation may be appropriate in situations where other repairs are not possible, or there is a desire to retain existing (historic) material which is no longer performing satisfactorily. Fastenings and detailing must be sufficient to prevent wind lift and the sheet lengths configured to prevent thermal creep and cracking. The effect on the appearance of the gables should also be considered. If the building is listed, alterations may need listed building consent.

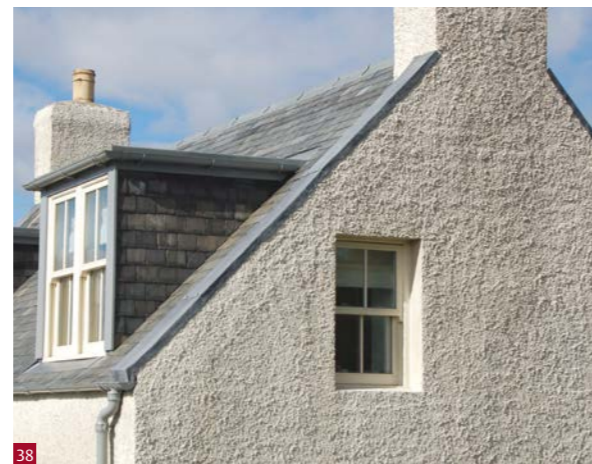
Fig. 38 Here the entire skew has been cloaked in lead.

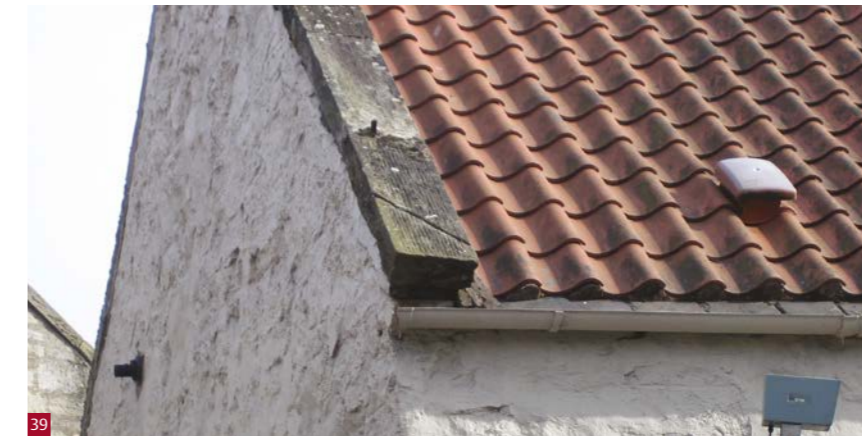
Fig. 39 Small channel detail on a skew cope to keep water off the corner.

An additional detail on a flat stone cope at eaves level is the formation of a small channel, approximately 5 mm deep, that runs at 45 degrees across the lower skew cope towards the slate side (Fig. 39). This traditional detail is seldom seen in new work, but for a small amount of additional labour it ensures that water from the surface of the cope is directed onto the slates, preventing staining and progressive saturation of the *skew putt* and the adjacent gable masonry and mortar.

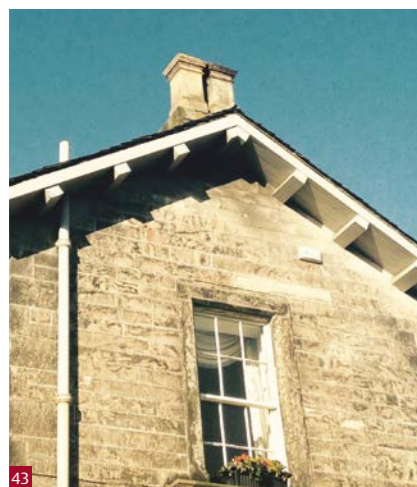
Fig. 43 Oversailing eaves to protect gable.

In parts of Scotland where high precipitation has been an issue for a long time, local architectural styles developed in response to the conditions. Additional detailing was often incorporated in a decorative way and adapted to prevailing fashions. Details might include oversailing eaves (Fig. 43) and extended verges on gables, often finished with decorative bargeboards (Fig. 44). If significant works to the roof are being planned, increasing the protection to the underlying walls by the addition of such details may be an option, where it is compatible with the overall design and appearance of the building.

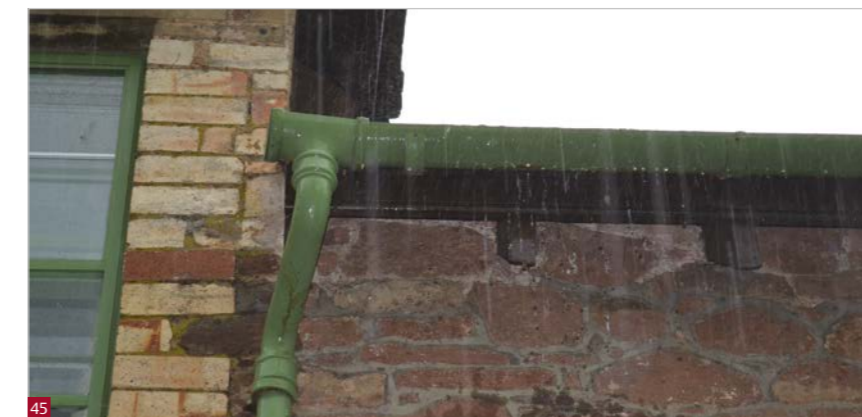
Fig. 45 Overflowing rhones in an area of high water flow.

Generally in Scotland rainwater is collected from the edge of the roof, at the eaves, into rhones or gutters. These carry the water into vertical downpipes. This system forms the roof drainage, with components being referred to generally as *rainwater goods*. Rhones are set at a shallow angle to give a run which allows the water to move along at a suitable rate. Over time the run or height of the rhone can become distorted, causing water to back up or overflow (Fig. 45). Poor detailing can also cause rhones to discharge onto the masonry, leading to persistent damp problems. Increased water flow can cause movement of debris, leading to blockages. Warmer temperatures and wetter winters may result in increased vegetation growth (e.g. moss on roofs, overhanging trees etc.) with potential to block rainwater goods. Regular inspection and cleaning, at least twice a year, is required to keep rainwater goods in working order. In some circumstances a larger width rhone may need to be installed. Rhones normally route water into the downpipes through a small spigot, sometimes called a *drop*, into the downpipe. However, in some cases the drop flows into a cast iron or lead *hopperhead*. The outlets for these can be undersized and may need adaptation.

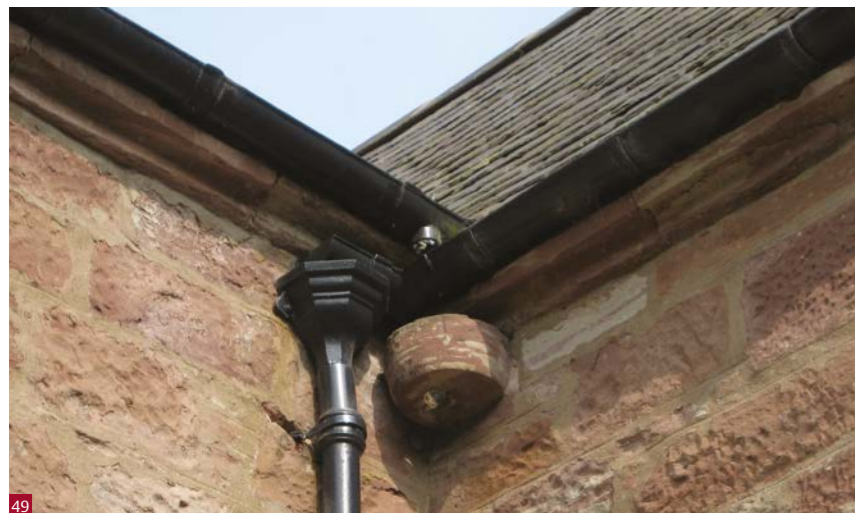
Fig. 49 Works to this building have neglected to reuse the original stone rainwater bracket, resulting in an overly complex arrangement.

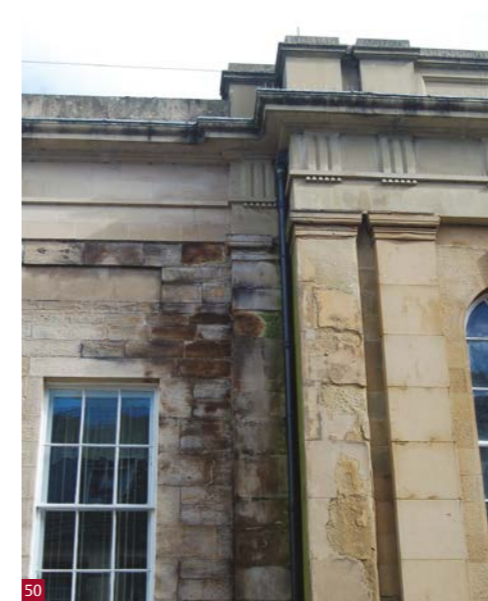
Fig. 50 Staining and decay of masonry resulting from a blocked parapet gutter.

While many parapets have overflow spouts, parapet gutters are always over wallheads and therefore any overspill leads inevitably to water penetration into the masonry below (Fig. 50). While traditional building fabric can cope with a certain degree of occasional wetting and drying, frequent saturation and water flow into a building from such a drainage failure can result in damage to internal finishes and contents. Extended saturation can lead to staining, algal growth and the decay of stone and timber elements, while the leaching out of binders from the masonry can cause progressive weakening of the structure.

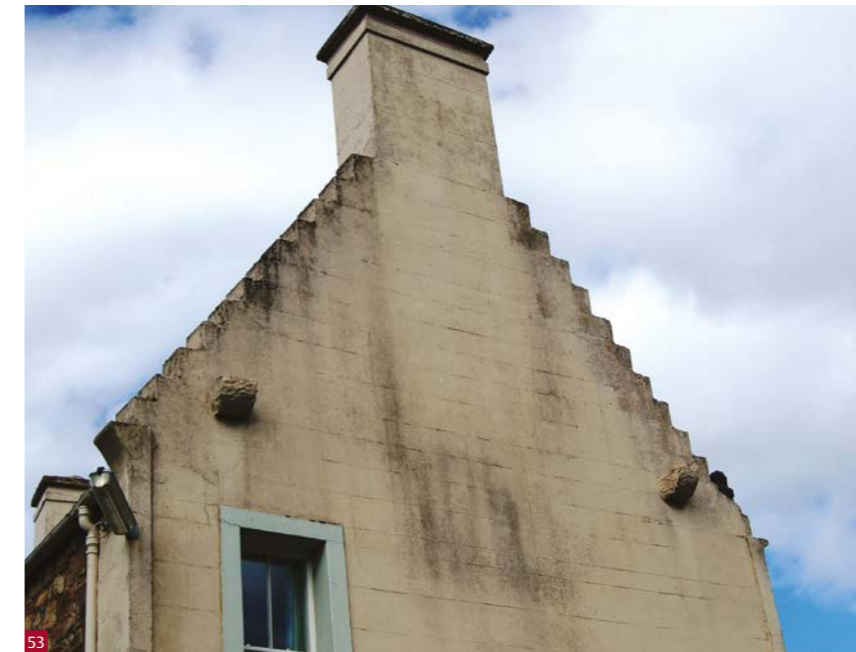
Fig. 53 A lack of protective water shedding detailing has led to staining, and progressive crazing of this cement-rendered gable.

Dampness in gable walls is most commonly due to a combination of defects in the chimney, the skewes, the masonry pointing and frequently blocked rhones and downpipes. Often cement pointing or renders can exacerbate the problem as cement can be vulnerable to cracking and crazing, allowing water to be drawn in and become trapped (Fig. 53). Chimney flues within the masonry of gables can be prone to decay due to weather damage from the outside and corrosive flue gases on the inside, both accelerated by the presence of moisture. Thus the masonry is being attacked both externally and internally, with greater potential for problems arising.

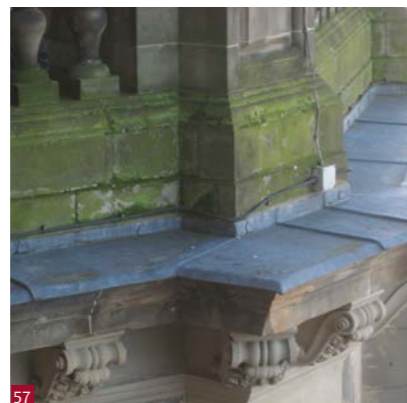
Fig. 56 Indicative details for a parapet and associated cornice, including sheet lead and drip moulds.

In areas of high exposure, the remodelling of parapet or cornice details may be required to ensure the protection of the masonry below if on-going long term damage is to be avoided; this can often be done with the careful use of sheet lead or zinc (Fig. 56). Such alterations will affect the appearance of the building, and will need careful consideration to minimise the visual impact (Fig. 57).

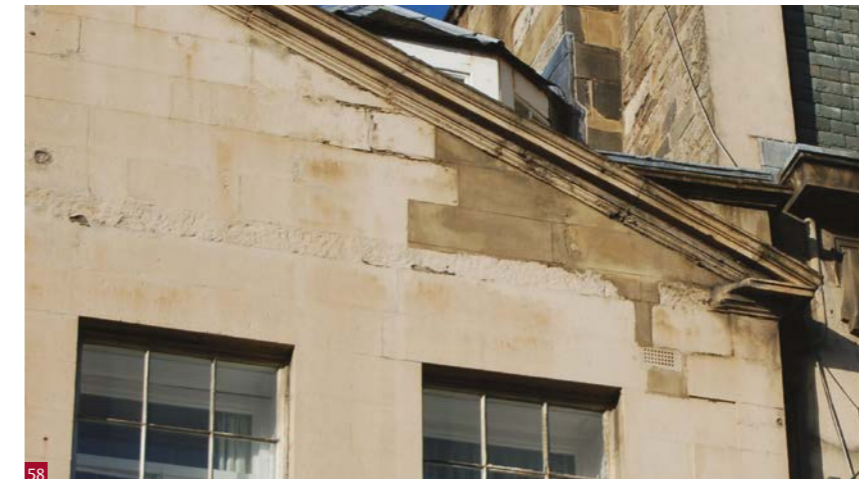
Fig. 58 A traditional masonry elevation where the cornice has been removed.

Often the importance of the details on parapets and cornices is not appreciated; sometimes they are thought to be purely decorative and in a misguided attempt to save money on repair work they are poorly repaired, allowed to decay or even removed (Fig. 58). In addition to the architectural damage, there is a technical penalty as well; the upper parts of a wall become wetter and consequent internal and external defects can develop.

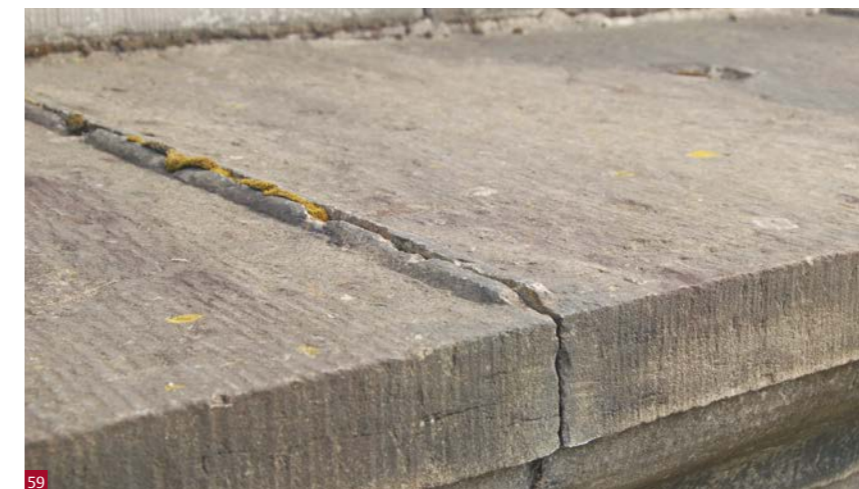
Fig. 59 A raised margin on a parapet to minimise water loading on the mortar joint.

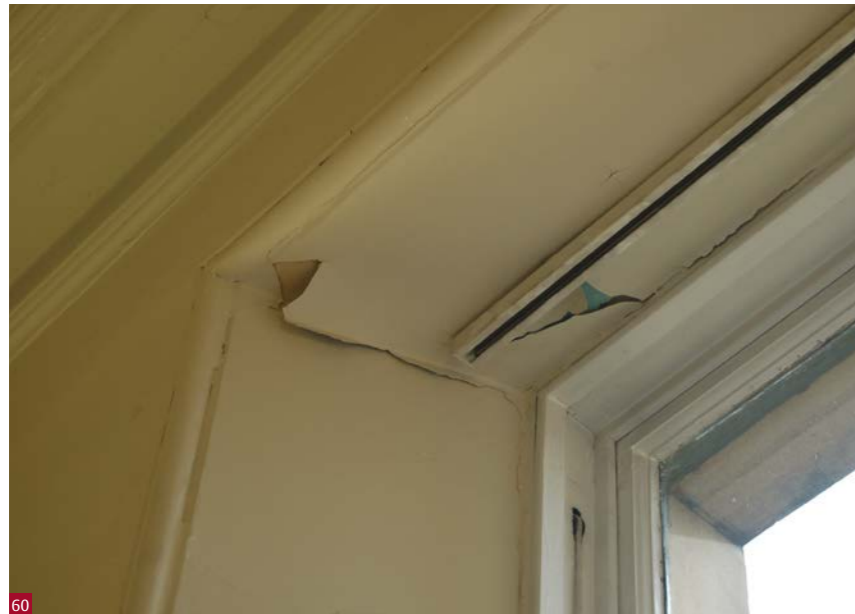
Fig. 60 Internal decorative damage, indicating defects on the external cornice.

Masonry parapets and cornices without such subtle detailing are not necessarily inadequate, but they will be more vulnerable to weathering of the mortar joints, leading to water ingress (Fig. 60). Careful attention to maintenance and appropriately specified ashlar repointing where necessary will adequately manage this risk.

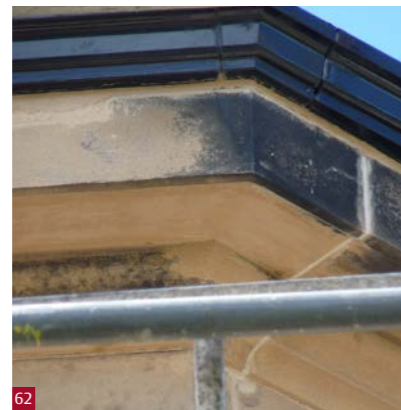
Fig. 62 An eroded cornice detail repaired with a restoration mortar.

Works to parapets and cornices should include the repair, reinstatement or introduction of new drip moulds and associated details to ensure water run-off (Fig. 61). Specialist repair mortars may be suitable in small areas of masonry damage, as they can be moulded and dressed to match the existing material, and are sufficiently durable (Fig. 62). For larger defects a new stone indent will be required (Fig. 63).

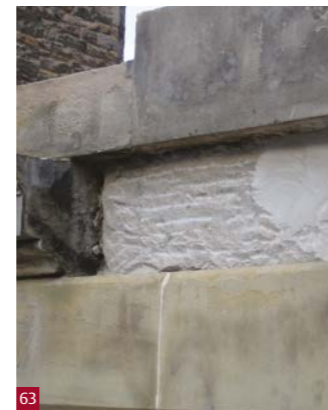
Fig. 63 Missing section of cornice awaiting replacement with a new section of masonry.

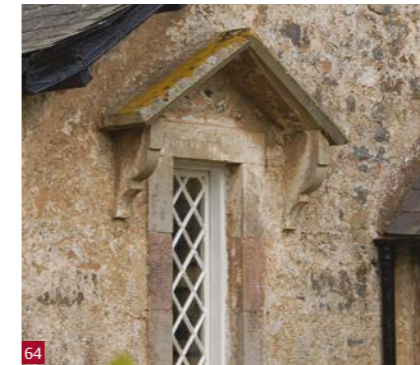
Fig. 64 Stone hood mouldings on a former school house © P. Beaton.

Windows and doorways are vulnerable areas, as water run-off is driven onto the window pane, and below onto the cill and underlying masonry. Over time, where detailing is poor, this excessive wetting can result in damage to window joinery, or water ingress around the window frame. Some architectural styles incorporate masonry hood mouldings which are both decorative and functional, with the practical benefit of directing water away from the window and cills (Fig. 64). On exposed elevations consideration may be given to the addition of an angled hood moulding, formed from a timber frame finished with lead. While their use in Scotland has mainly been for architectural effect (Fig. 65), they may be specified for managing water on elevations in some situations.

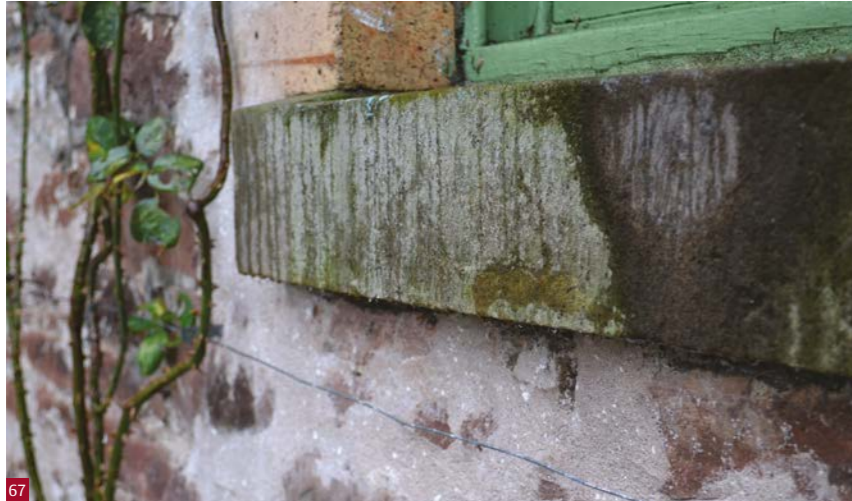
Fig. 67 Water being shed from a projecting window cill.

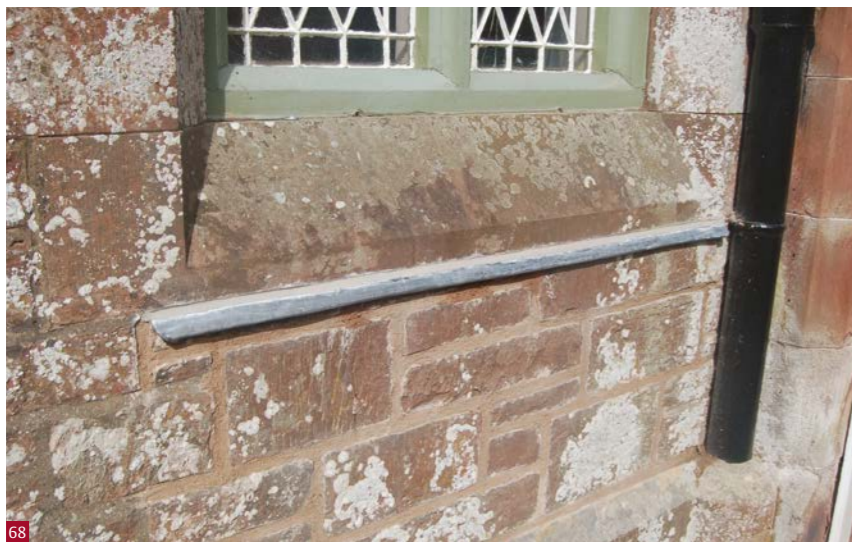
Fig. 68 New drip detail on a 19th century cill.

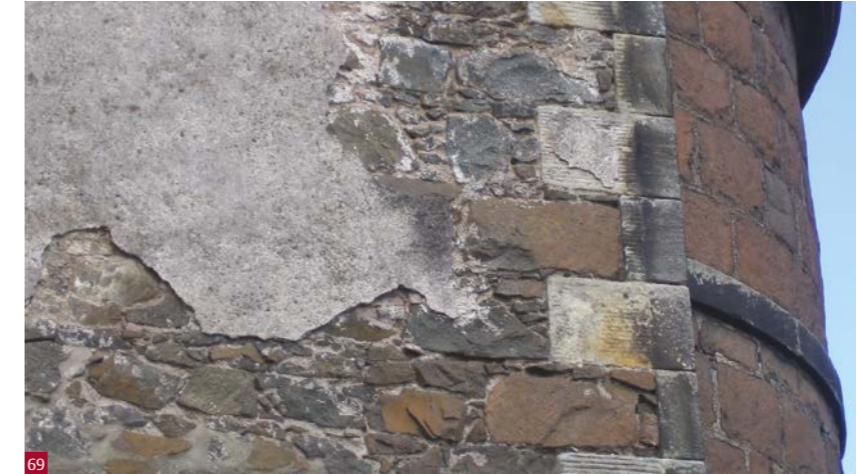
Fig. 69 Traces of original render on the gable end of a late 18th century building in Stirling.

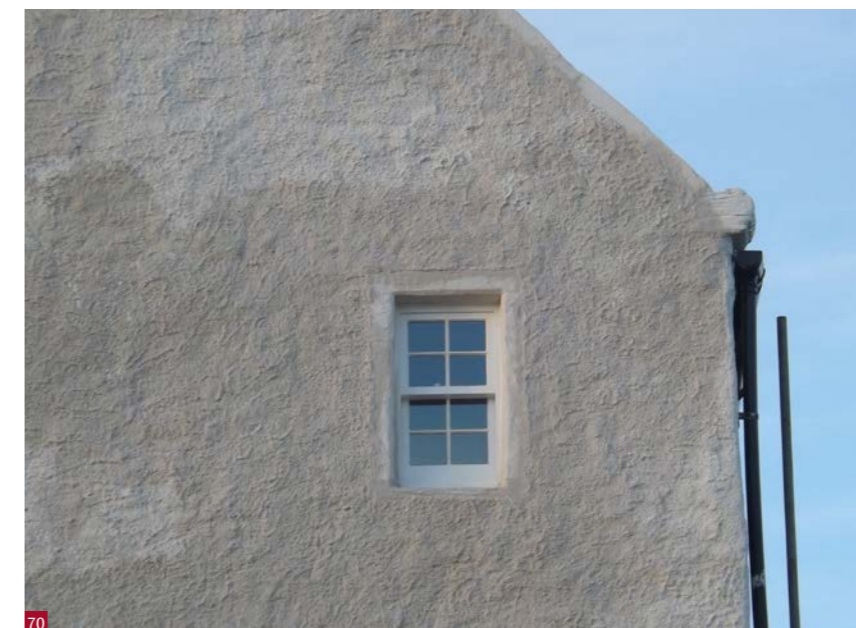
Fig. 70 The condition of this exposed 18th century building in Shetland was significantly improved by the use of a lime harl and lime wash.

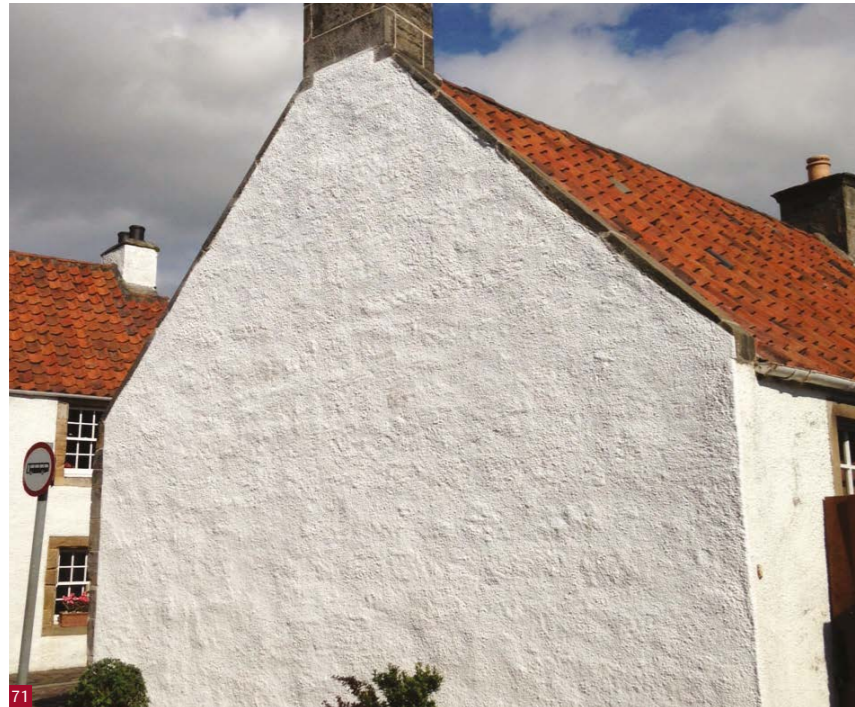
Fig. 71 Limewashing of masonry elevations consolidates the masonry units and the mortar.

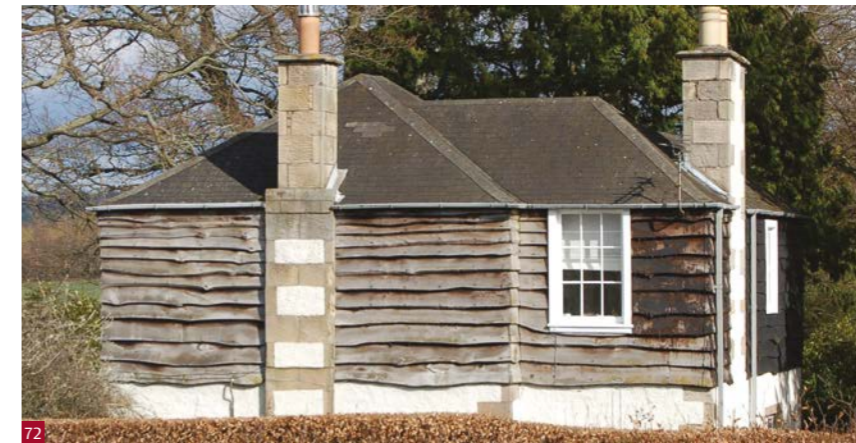
Fig. 72 External timber cladding to a building in the Scottish Borders.

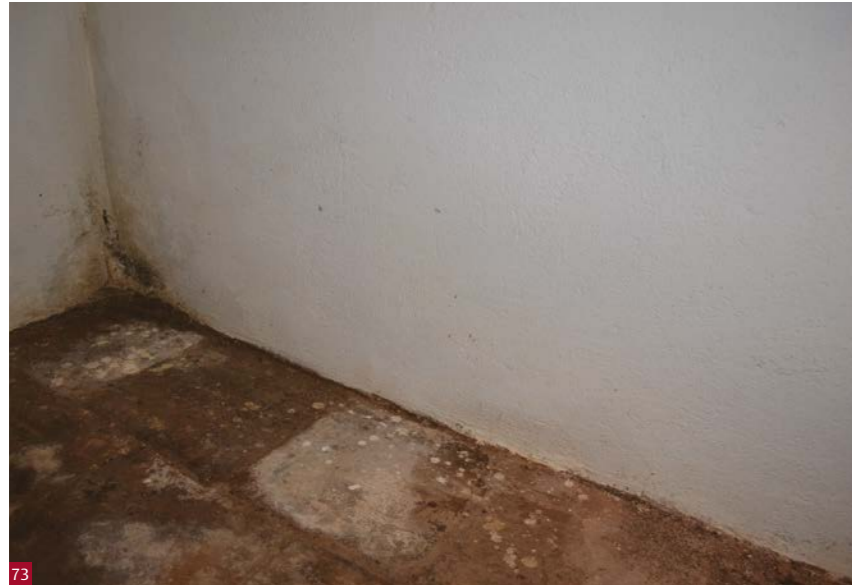
Fig. 73 Lime plaster finish used in a basement.

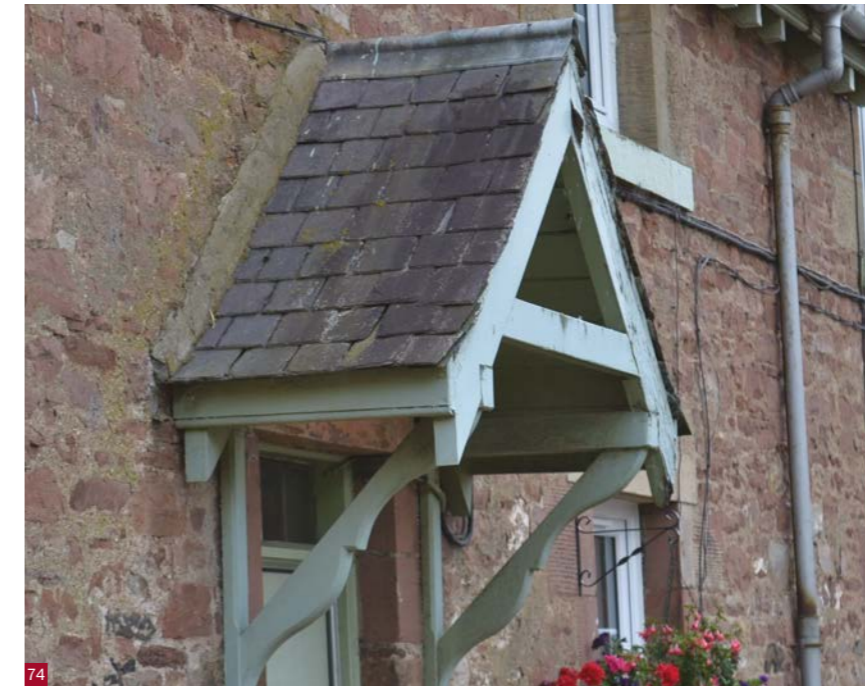
Fig. 74 A decorative porch canopy from the late 19th century.

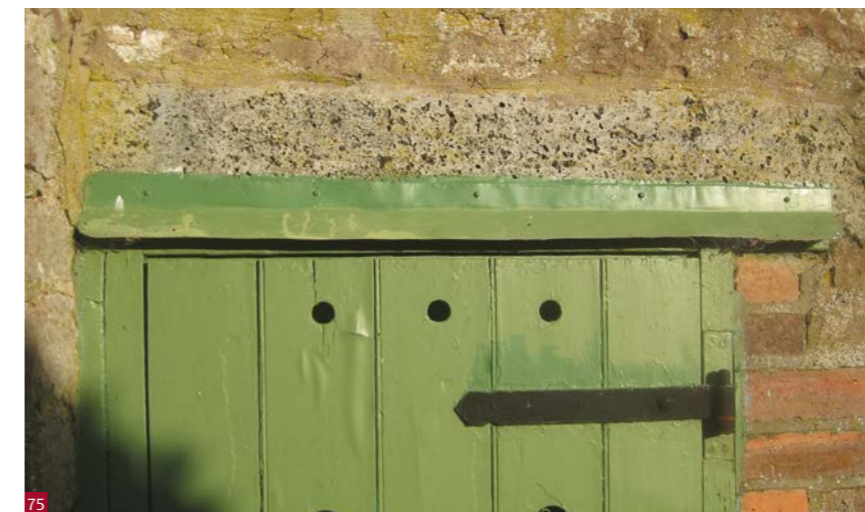
Fig. 75 The addition of a small hood over this flush mounted storeroom door has kept water off the top of the frame and the door.

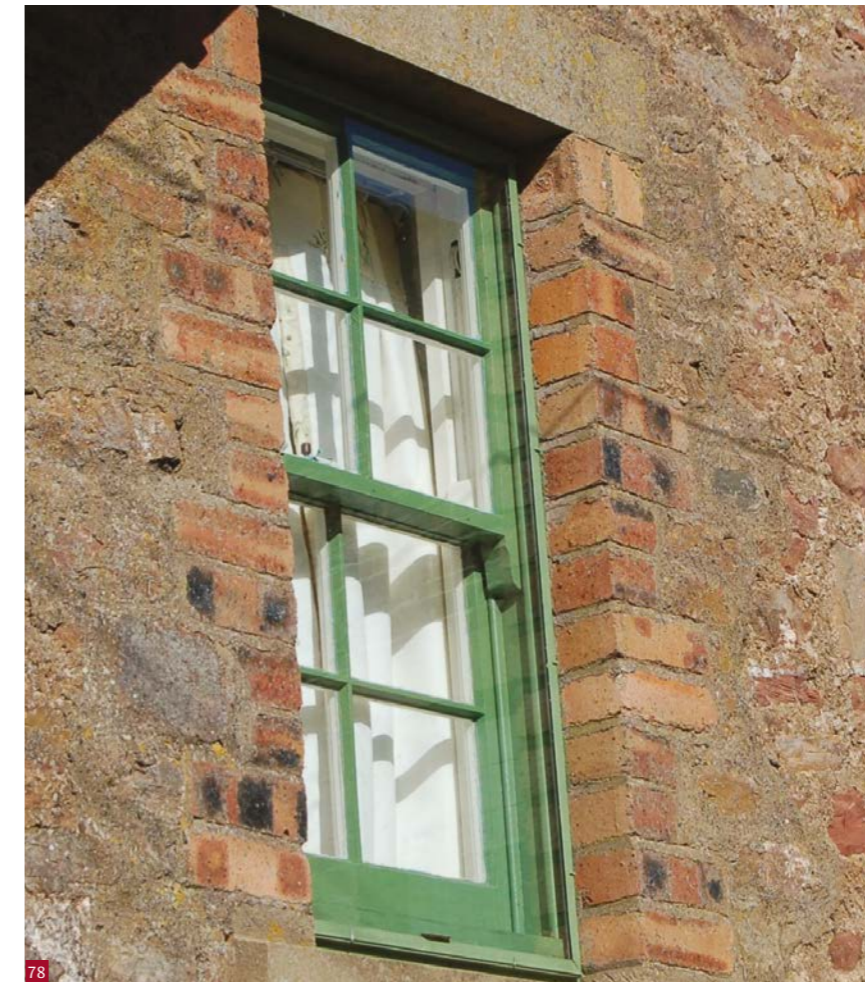
Fig. 78 Storm type external secondary glazing providing weather protection to a traditional window.

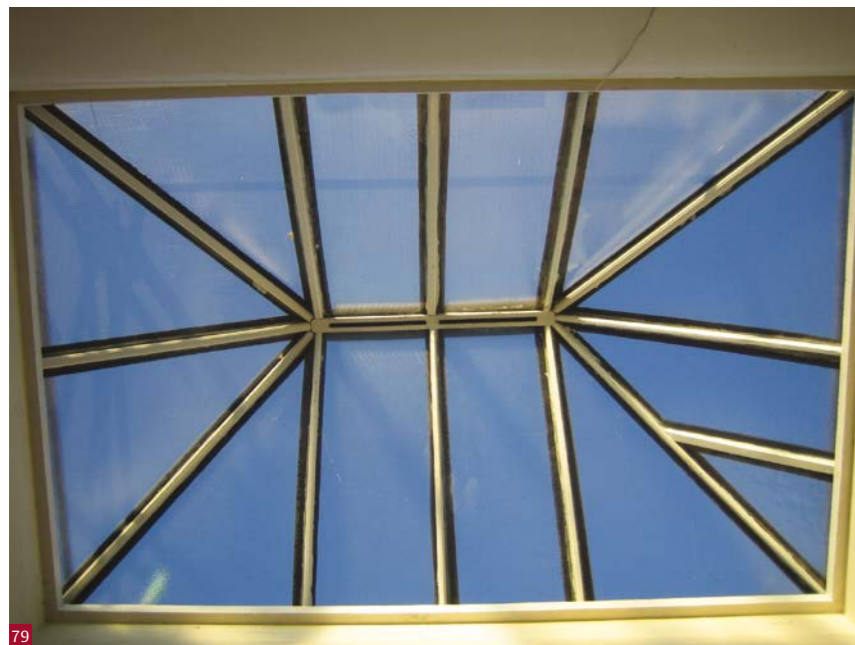
Fig. 79 A discreetly placed vent at the apex of a lightwell in an Edinburgh tenement stair.

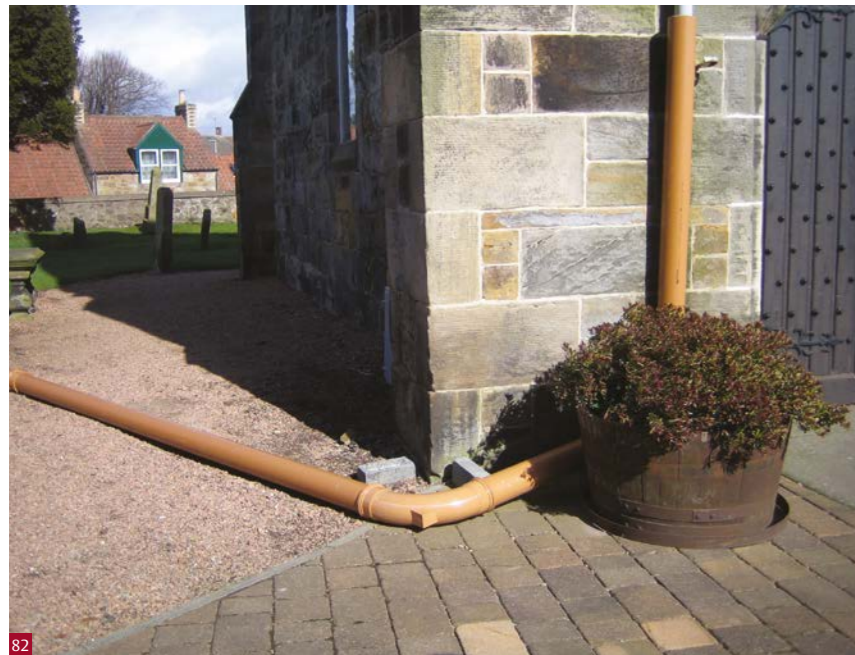
Fig. 82 A temporary but sensible solution to cope with blocked below ground drainage.

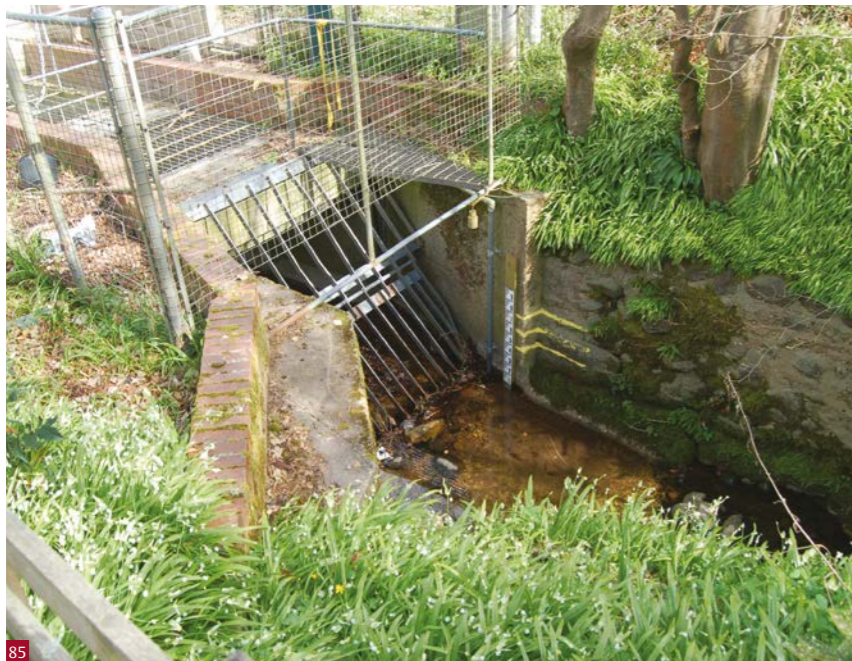
Fig. 85 An urban drainage feature vulnerable to blockage and flooding.

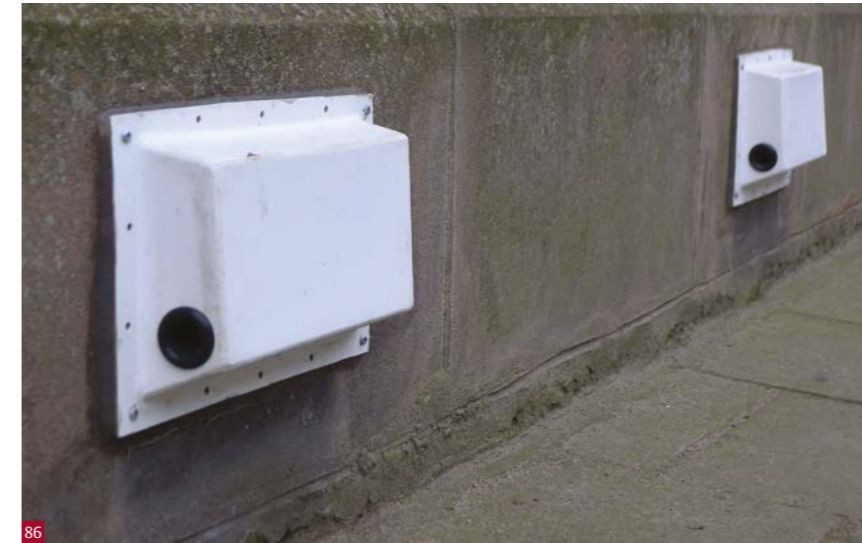
Fig. 86 Temporary barriers can be fitted over openings in flood-risk areas © Paul Hendy.

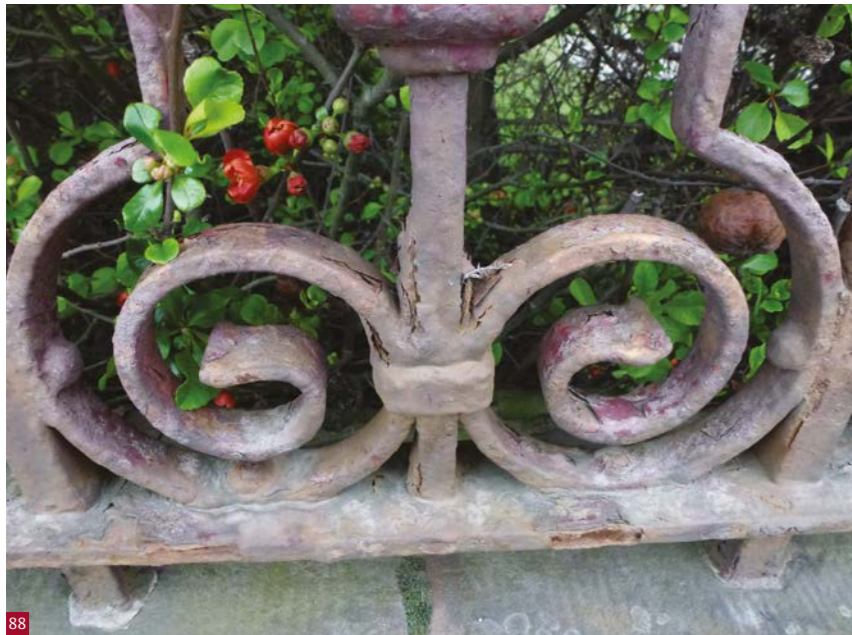
Fig. 88 Example of poor repair and corrosion of iron railings.

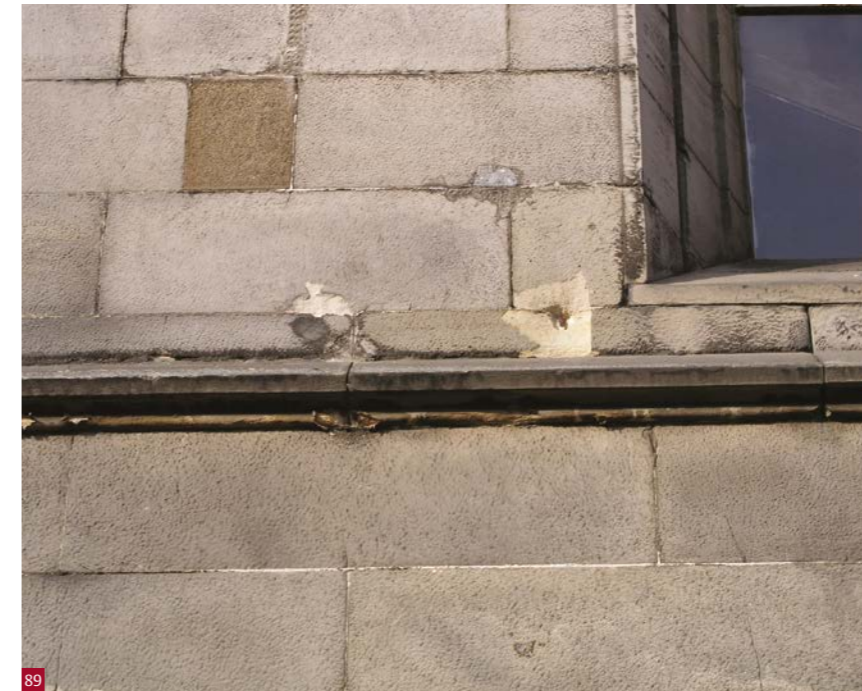
Fig. 89 Open joints in masonry have allowed water to penetrate, leading to corrosion of embedded iron cramps and fracturing of stone.
