Short Guide

CLIMATE CHANGE
ADAPTATION FOR
TRADITIONAL
BUILDINGS

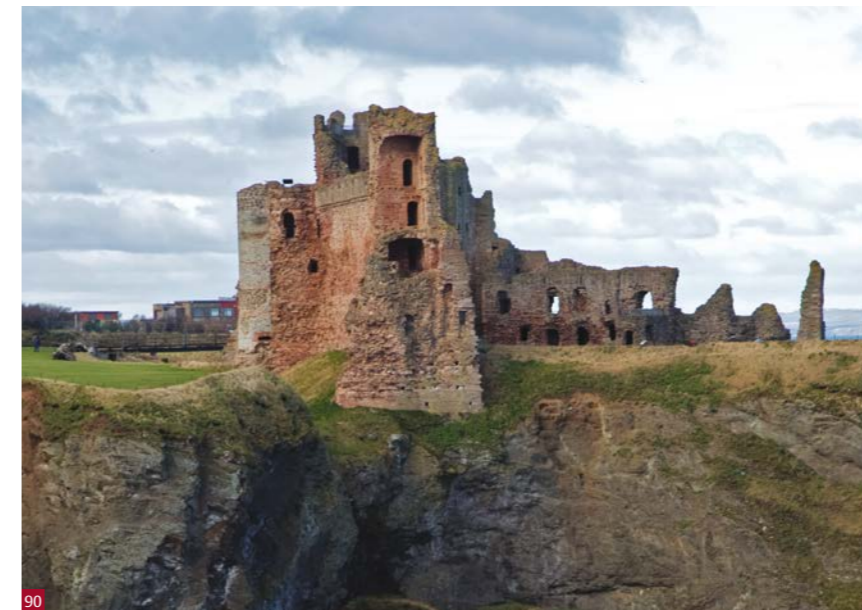
Fig. 90 Coastal erosion at Tantallon Castle, North Berwick.
