# REFURBISHMENT CASE STUDY 36

## KINNEIL HOUSE BO'NESS

REBUILDING OF THE ORCHARD WALL  
WITH HOT-MIXED MORTAR

ROGER CURTIS

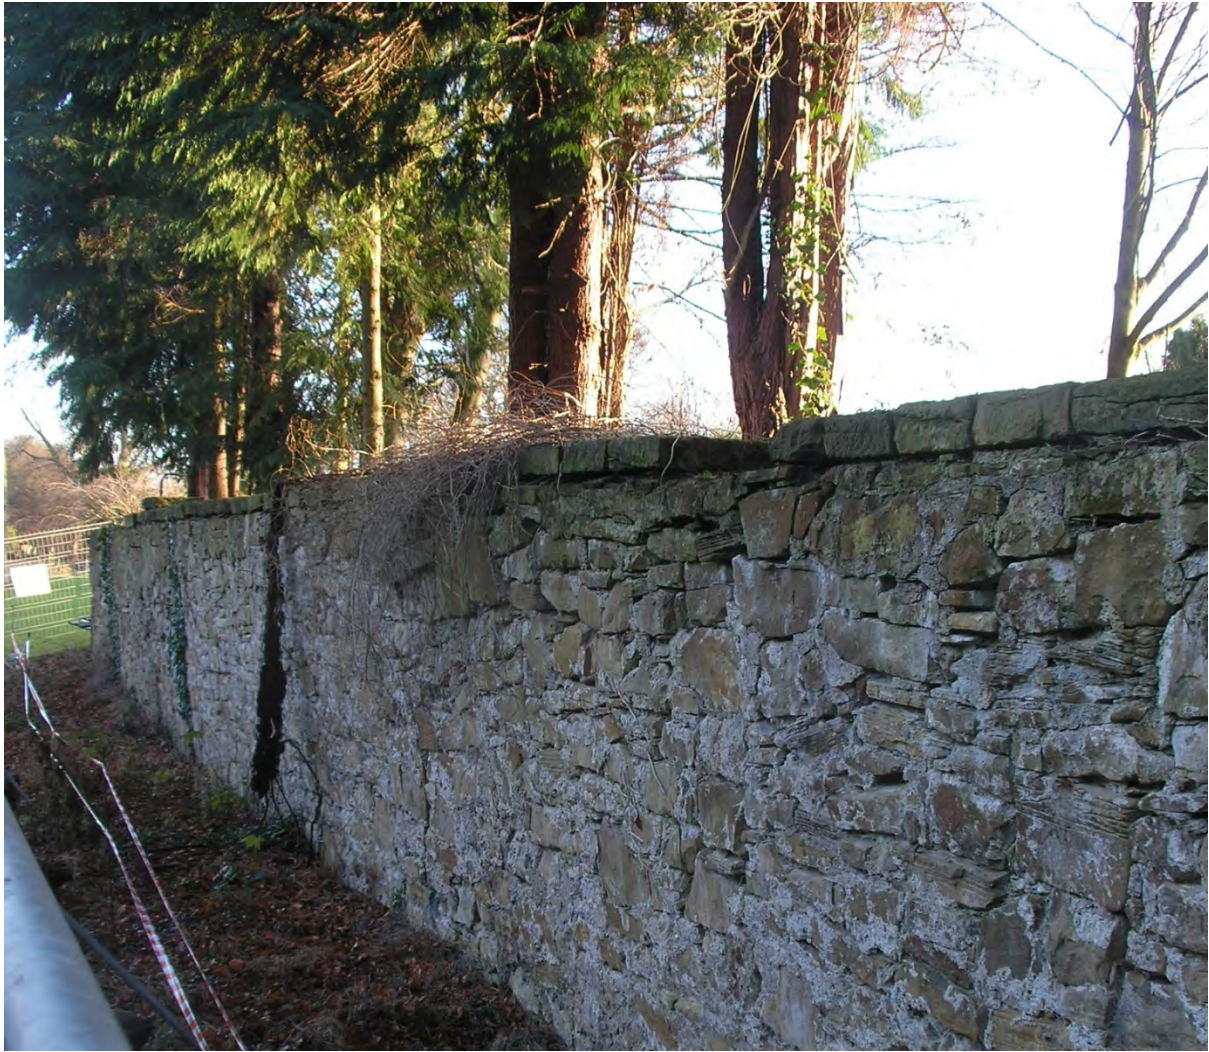
The subject of this study is the remains of the former orchard wall. The wall is 2.44m high on the lower side and 38m in length. It is 0.65m in thickness and is lime bonded. 1.3m of its height is a retaining wall (Figure 2). The masonry construction is a sandstone rubble with ample pinnings. The nature of the mortar remaining on the faces of the stone suggest that the wall was flush pointed and lime washed, possibly with a thin layer of render. The top of the wall was protected by a stone cope formed of cut rectangular sandstone slabs. Approximately 45 years ago, a line of conifers had been planted on the south side of the orchard wall and these had reached full height. The wall was showing significant deflection of the masonry off the vertical along many parts of its length and, if left unattended, this was likely to have led to areas of localised collapse in the future.

Figure 2. The orchard wall prior to the works. Note the trees very close to the upper side which contributed to its instability.

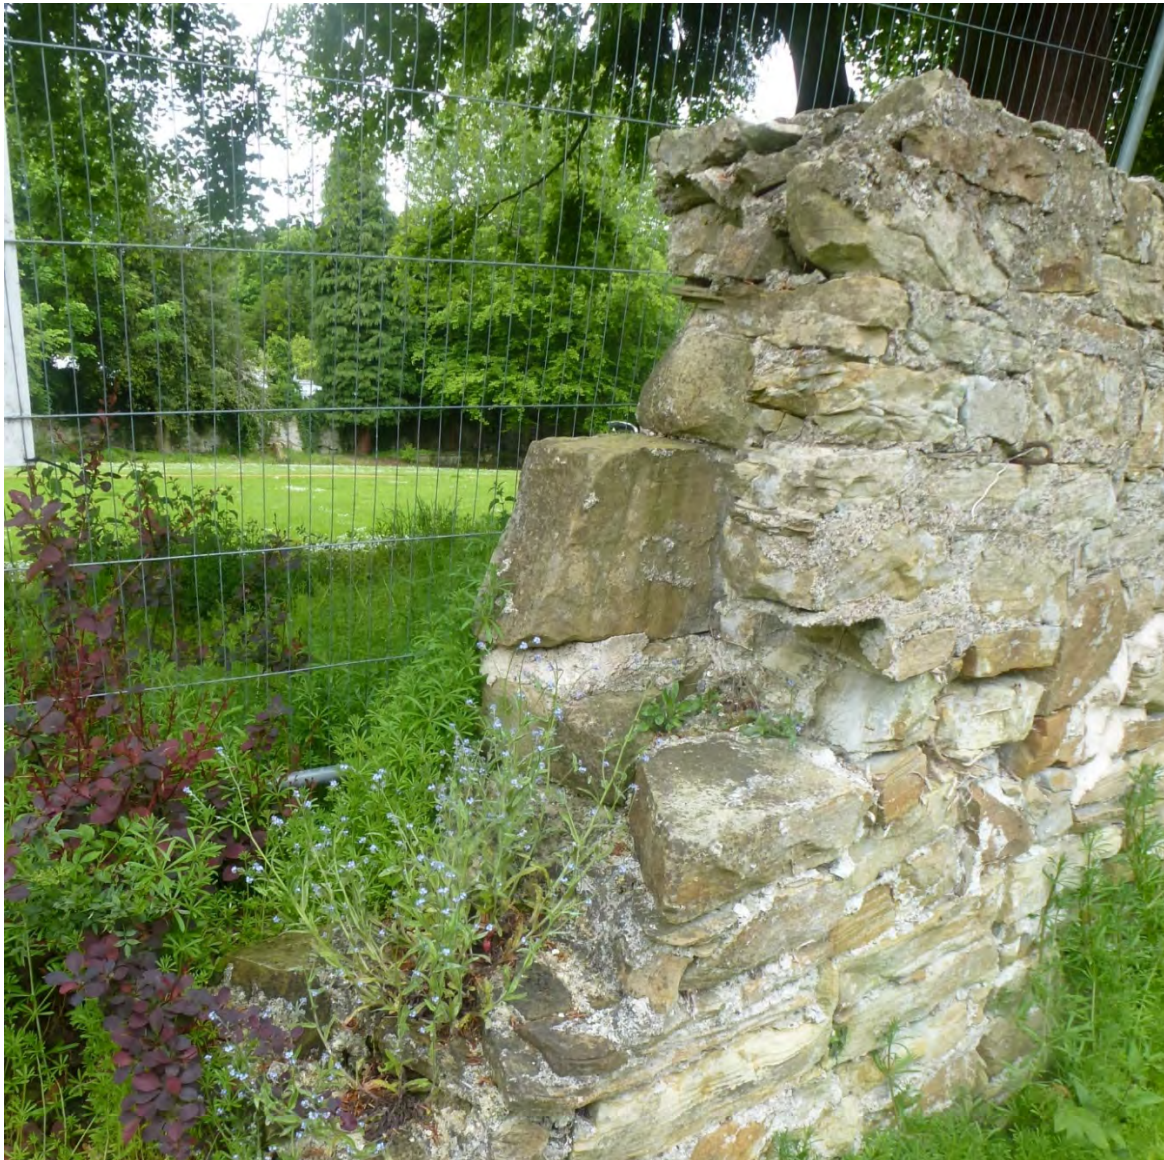
The movement of the wall is probably due to a combination of factors. Retaining walls have been built in rubble for hundreds of years, and many remain in good condition to this day, holding back significant quantities and weights of earth and other materials. However, in the case of the Kinneil wall, the following conditions came together to give an unstable situation: once the trees reached full height, their movement destabilised the earth on the higher side and the tree roots were also exerting outward pressure on the wall. The rubble used in the wall construction varied in size and quality; many stones were entirely decayed. Trial pits dug by HES showed that there was no foundation as such, and certainly no wider masonry plinth onto which most traditional walls are normally constructed. Without this wider footing, it would have been harder for the wall to resist the outward forces from the earth behind. In addition, the well-documented increased rainfall since the 1960s can lead to softer soils with greater weight and plasticity. At Kinneil, the wall is the lowest point along the approach road and water running off the ground to the south will

invariably concentrate there. Such land drainage as there was on the ground to the south will have had little attention and the ground would have been wetter. The absence of weep holes may also have contributed to a build-up of pore pressure. As a result of the combination of these factors, the wall was leaning significantly in several places (Figure 3). At its most extreme, towards the east end of the wall, it was 9 degrees off the vertical.

Figure 3. One of the areas of movement on the orchard wall.

would have to consist of rebuilding works, buttresses, and underpinning works, significantly changing the appearance of the wall. The alternative was to dismantle the wall and re-build it to the same dimensions, but with some improvements for structural stability. These options were discussed by the relevant HES staff; the District Architect, Cultural Resources staff, and Structural Engineer.

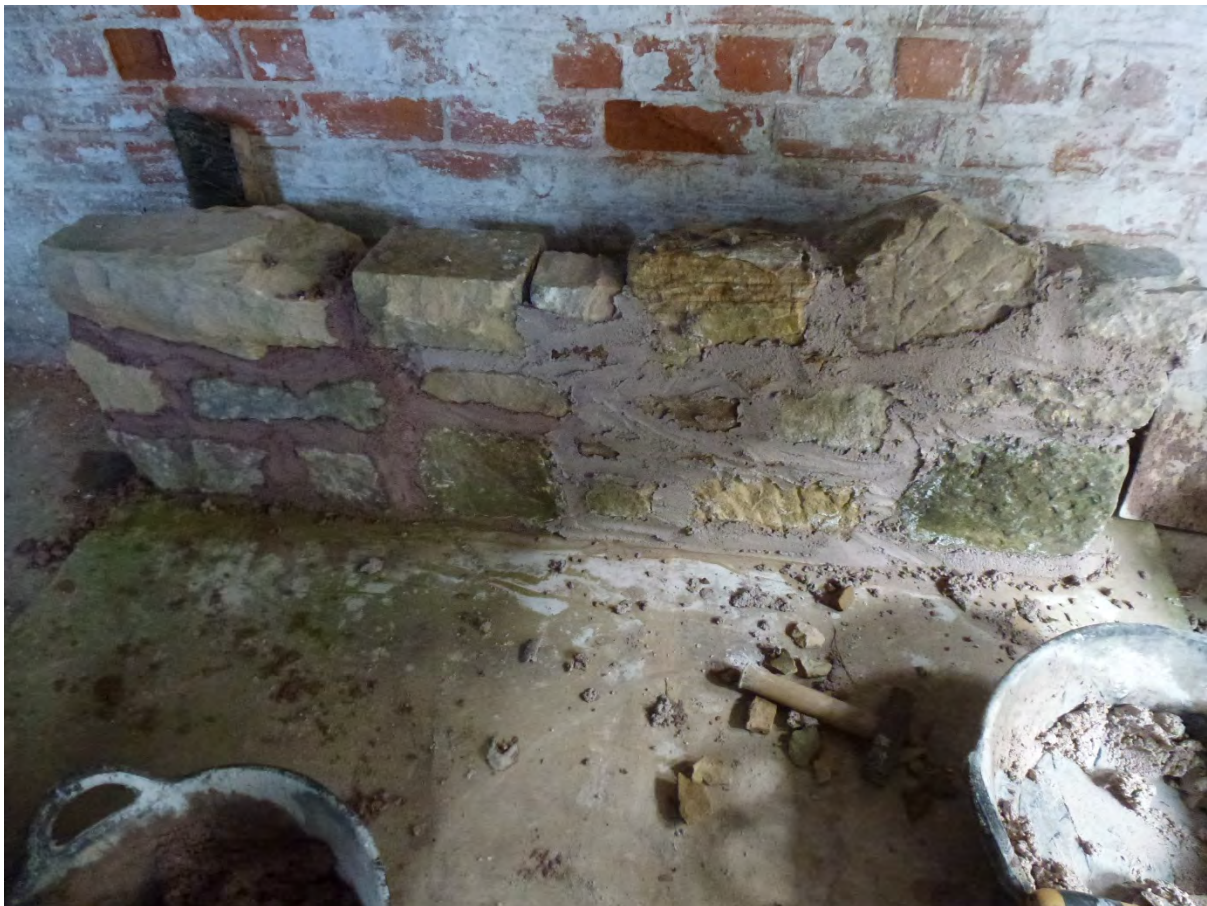
Figure 4. A small area of trial mortar in a new section of rubble wall in the HES yard at Blackness Castle.

In the early spring of 2017, some practical mortar trials were carried out at the nearby HES yard at Blackness Castle. This involved demonstrations and batching up of several mortars for use on a trial wall (Figure 4), and for the

repointing of an existing boundary wall. Following the guidance given in the mortar analysis for a new mortar, and described above, this was batched up in a 20 litre electrically powered forced action mixer. Operatives were encouraged to try mixing and building in order to allow an understanding of the hot-mixed mortar. Crushed shell and crushed brick were added to the mixes to assess their effects on the feel and the curing of the mortar. The ratios were 1 kibbled quicklime (unslaked) to 2 ½ measures of concrete sand and ½ a measure of shell or brick dust. The mortars were pressed back and given the required aftercare over the subsequent weeks. In terms of workability, the crushed shell seemed to give a good mix, but the crushed brick much less so. Following the curing and scraping back of the sample areas at Blackness, it was decided that the crushed shell mix made the best mortar and would be used for the wall works at Kinneil.

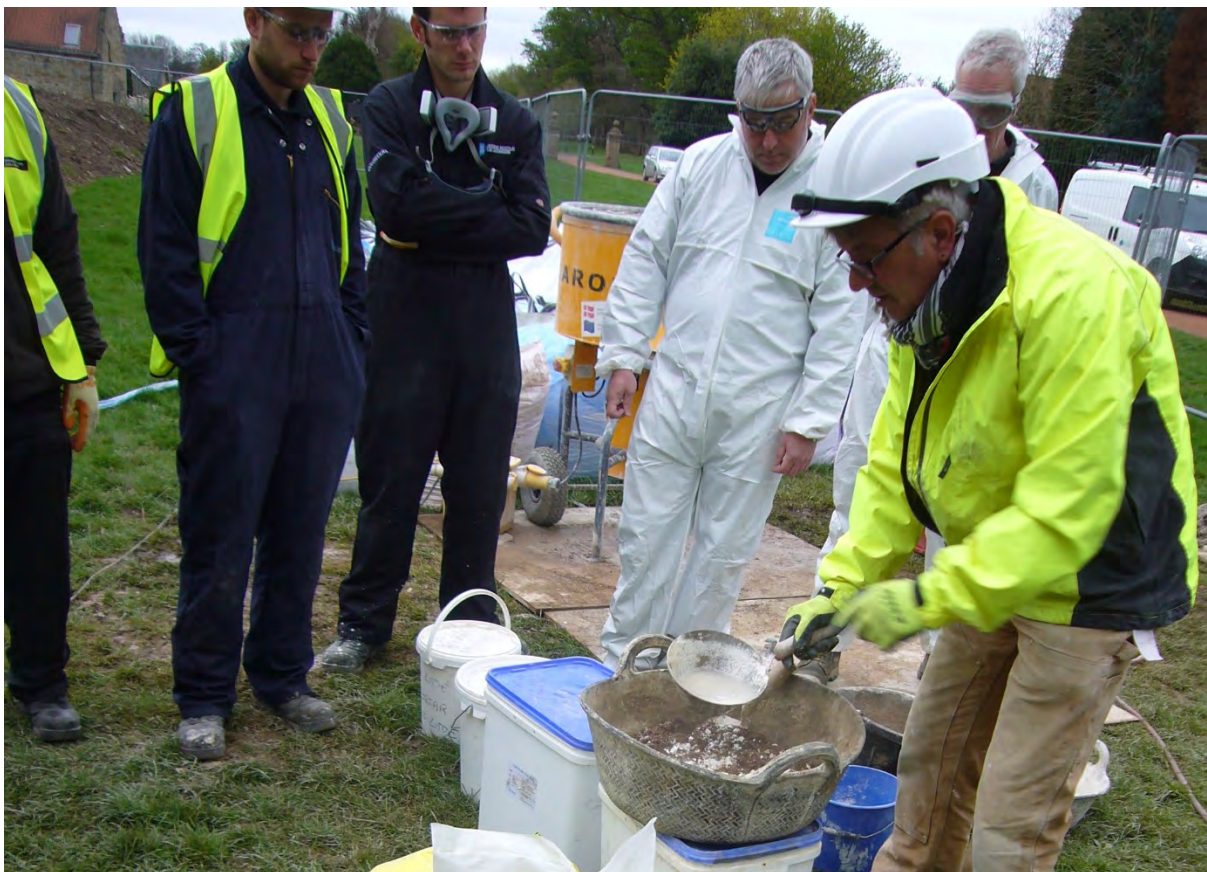
Following the first mortar trials off-site and the establishment of the working site at Kinneil, a further training session was held with members of the Hot-Mixed Mortars Project. Explanations were given regarding hot limes, including various practical demonstrations. Engagement with the HES Monument Conservation Unit (MCU) was important, if the principles of hot-mixed mortars were to be understood, as these are very different from the procedures used with modern hydraulic lime mortars. A half-day session was held at Kinneil with MCU staff from several HES Depots and instructions delivered by contractors and consultants from the Hot-Mixed Mortars Project team. This included demonstration of slaking, discussion on mixing techniques and consideration on the use of additives, such as crushed shell.

Figure 5. Training session on hot-mixed mortars.

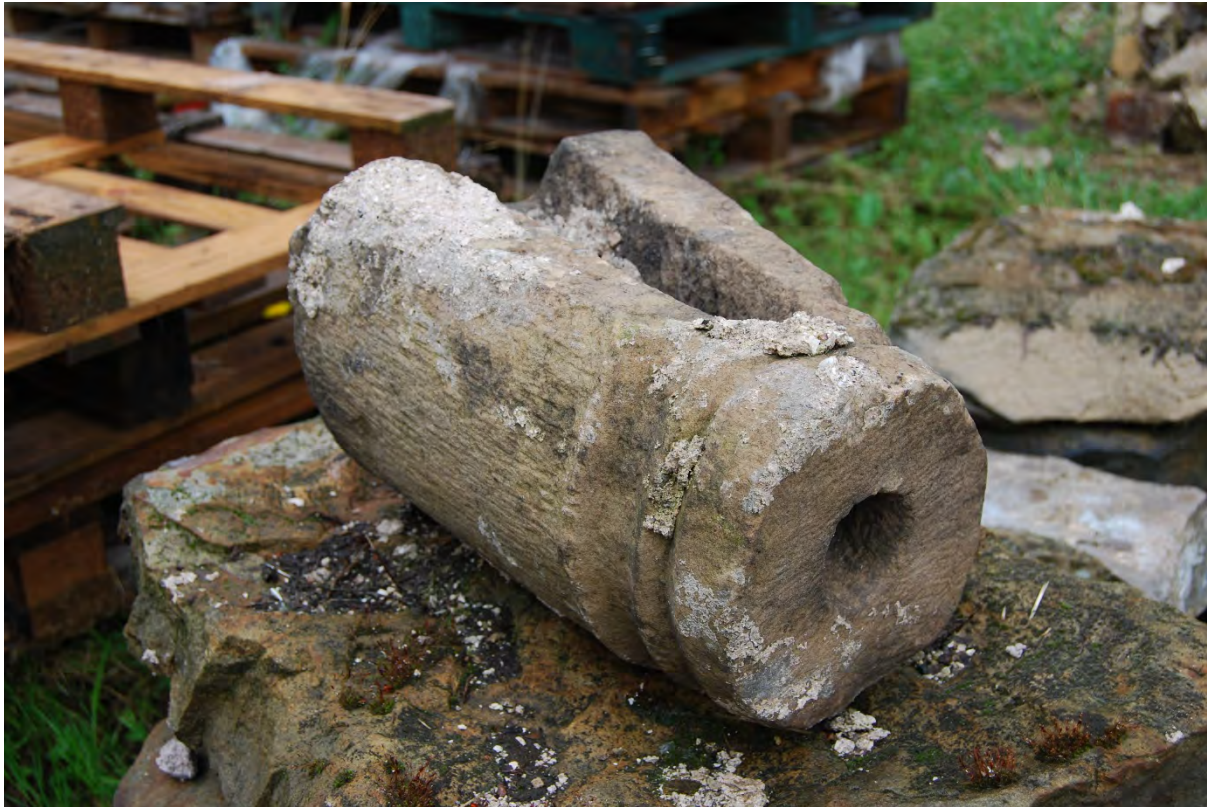
An archaeologist was in attendance during the work with the digger and the downtakings. There was little to report from this work, and although all were watching for carved or reworked stones, only three were found. These comprised of two former rybits and one distinctive and interesting piece; the substantial part of a parapet drain spout (Figure 6). It was not possible to determine its origin, although tempting to consider it might have been part of the parapet from the tower house that formed the core of the north range. As a conclusion to the downtakings, a trench was dug on the line of the dismantled wall to take the new foundation. Again, during this work there was no evidence of any archaeological material or layers; the ground was 'clean'.

Figure 6. The drain spout found during the dismantling of the wall.

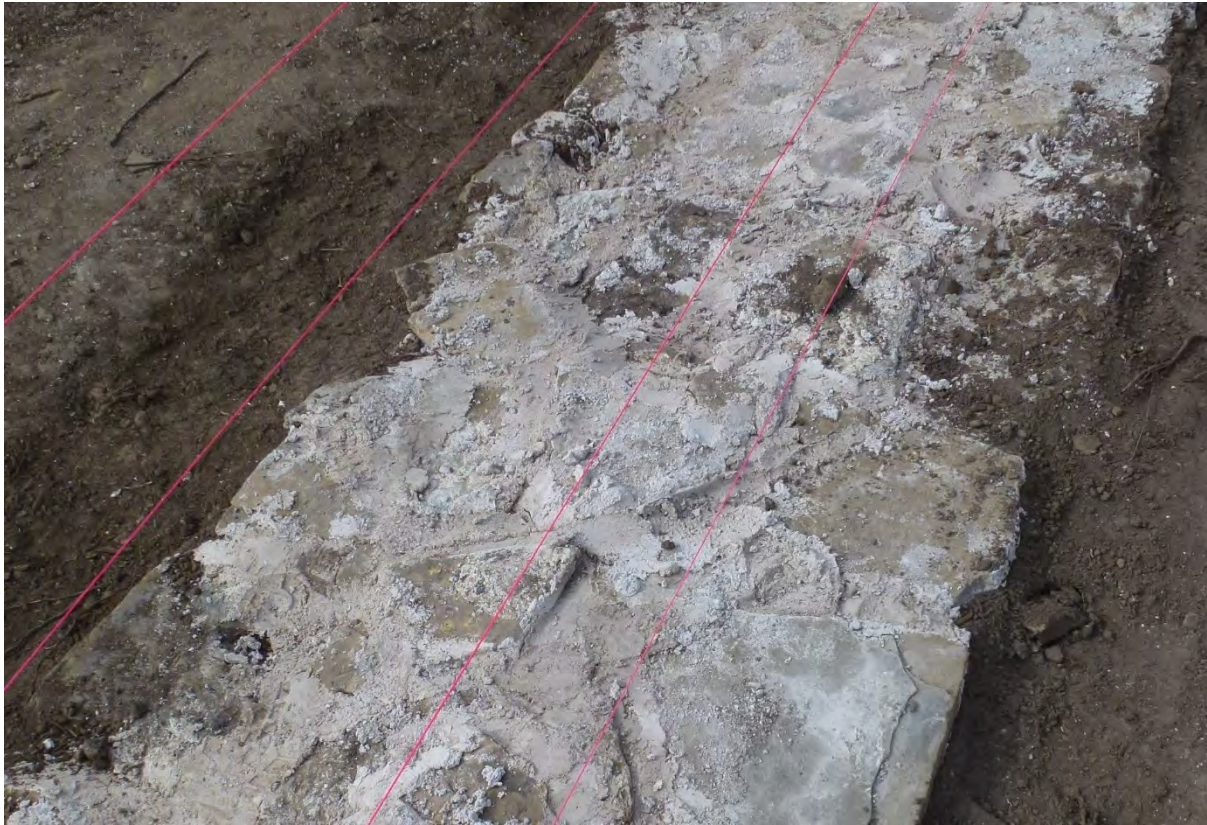
Figure 7. The foundation layer laid with a hydraulic lime mortar. The red lines are the setting out strings for the line of the new wall masonry.

After being dug, the trench mentioned above was laid with large, generally flatter stones, configured to sit about 100mm wide off the wall base (Figure 7). This layer was about 400mm deep. To bind this layer of stones, a wetter lime mortar was used, with the lime binder made up of 50% quicklime and 50% NHL5. This hydraulic component was added to ensure that the foundation mortar set in the damp conditions of the wall base.

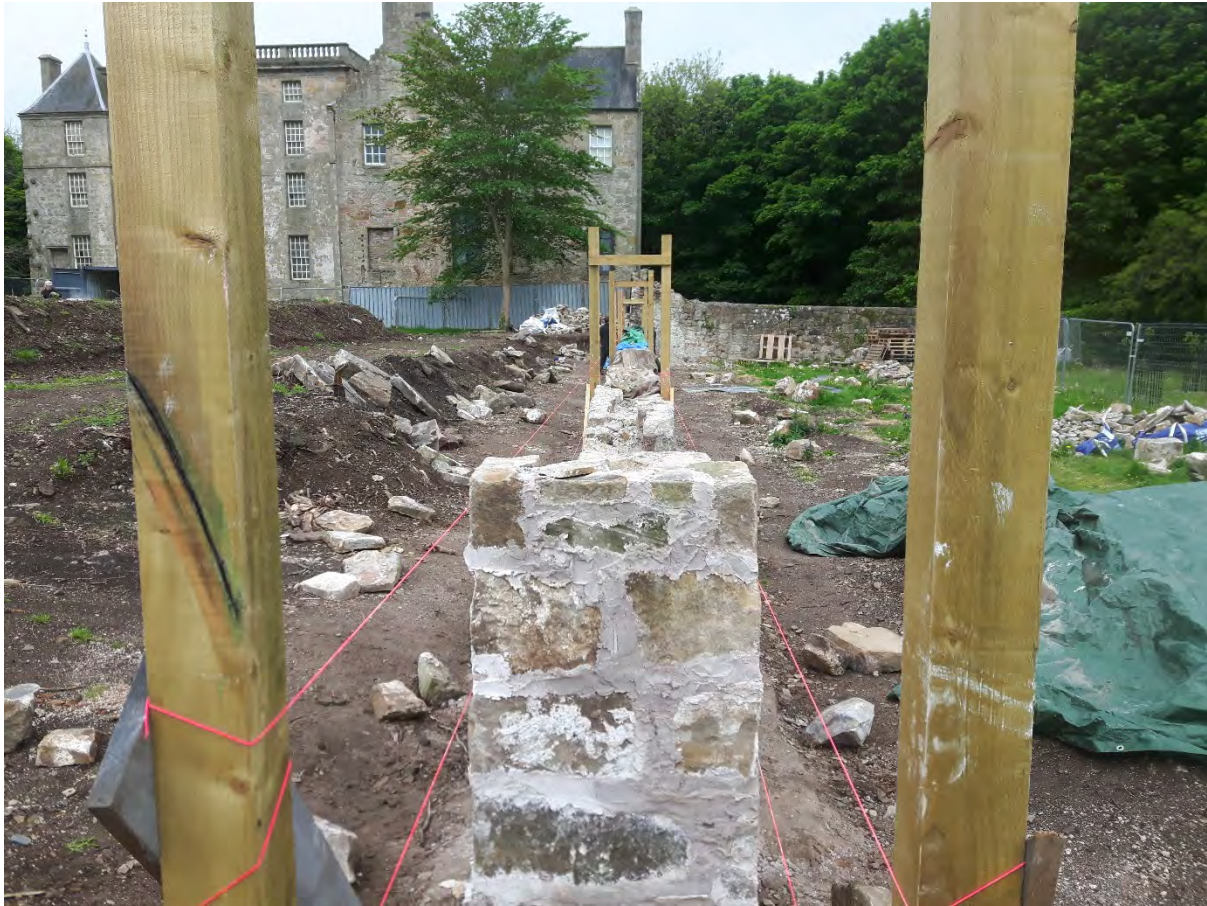
Figure 8. The string lines set up along the length of the new wall.

With the foundation layer complete, string lines were set out between four points to allow the base of the wall to be started on the new foundation (Figures 7 & 8), set 200mm wider than the new wall width. The new wall thickness was the same as the original, and the mortar was changed from a gauged quicklime mix (one with hydraulic lime added) to a simple quicklime-based mortar. The foundation mortar had a hydraulic component to ensure that the mortar would set in the damp conditions below ground level. When building a long wall, it is good masonry practice to start work at intervals along the wall; this is called 'stooling' and is a way of minimising sighting errors. It also allows several work squads to build at the same time along the wall.

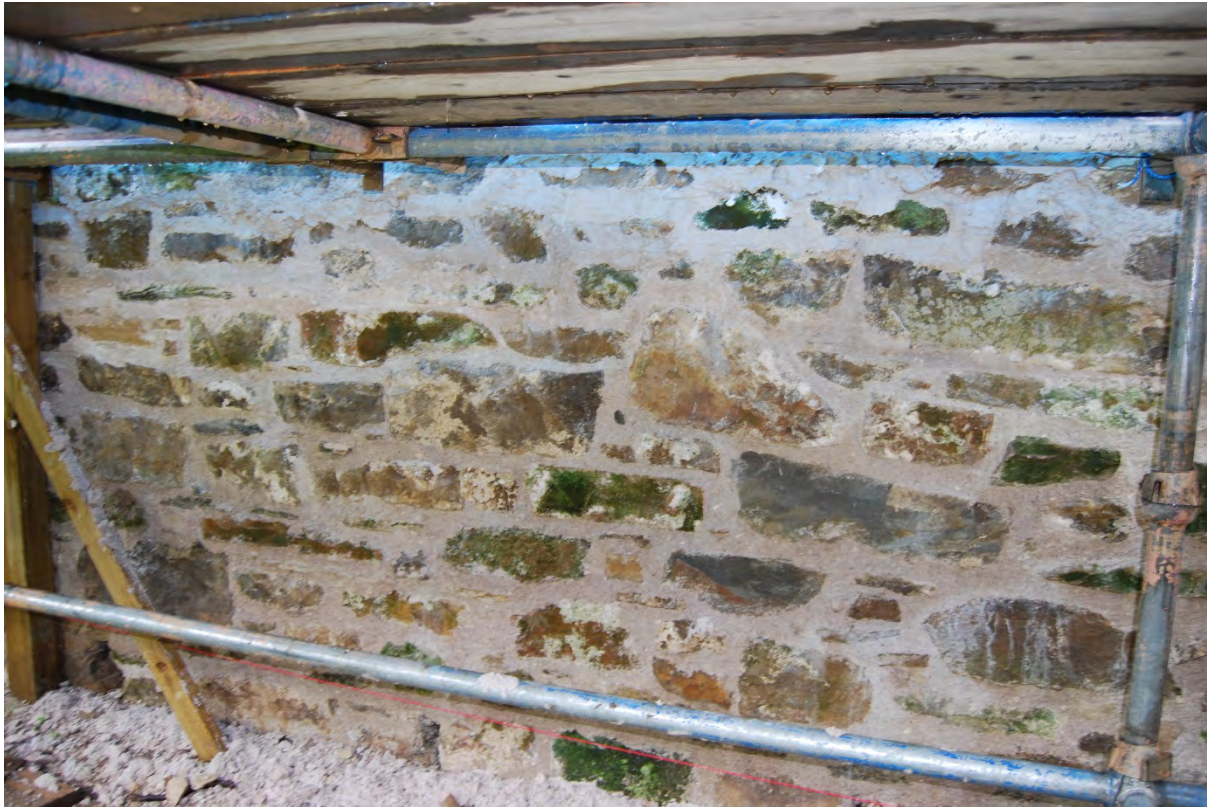
Figure 9. The reused stones in the new wall. Note the original mortar and lime wash still showing on the surface of the re-used stones.

The building of rubble walls is not as common as it once was in Scotland and many modern versions of this masonry style are poor in terms of appearance and strength. It is common for these to be built as two external skins, with many voids and loose debris in the centre. In a desire to build quickly many flat stones are placed 'on end' giving an appearance that is sometimes pejoratively called 'vertical crazy paving'. At Kinneil there was obviously an obligation to re-build the wall in the style and manner of the original and this was largely achieved. The re-used stones were laid so that the faces were aligned as they were originally; in places this allowed original mortar and limewash fragments to be still visible (Figure 9).

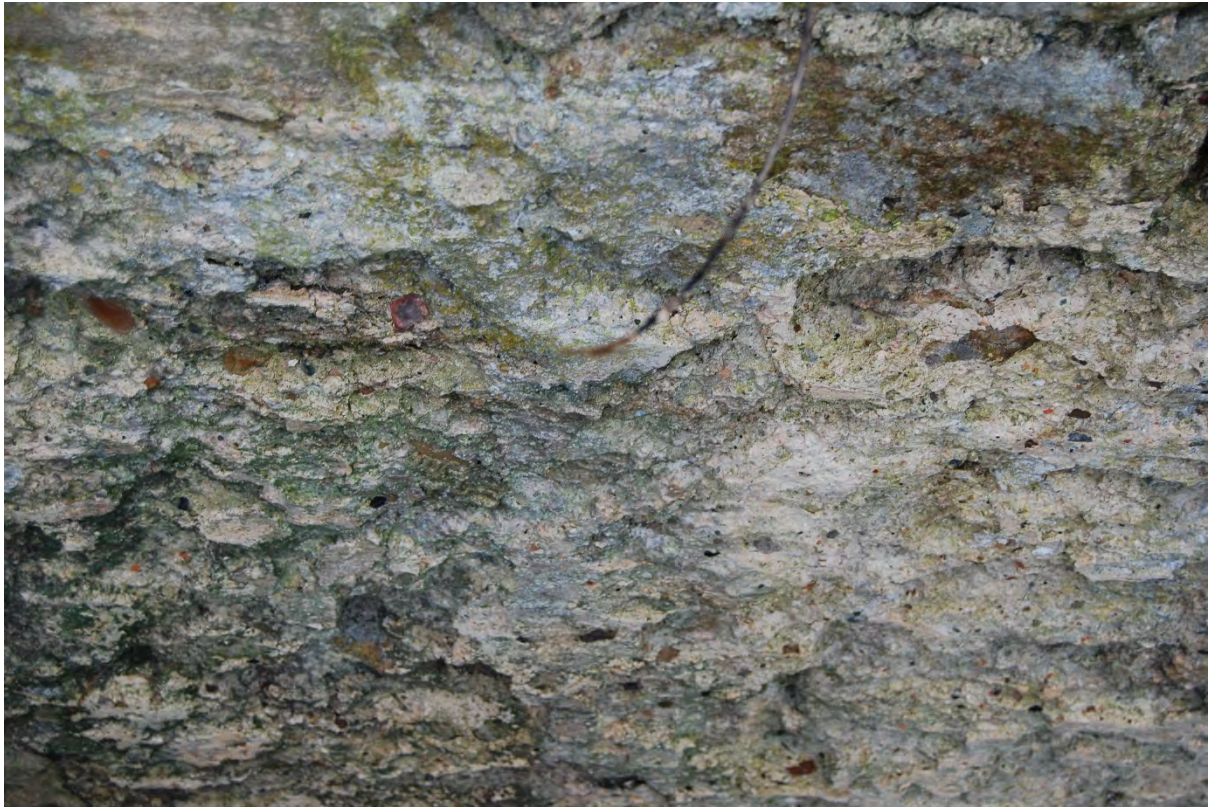
Figure 10. An area of historic masonry finish at the base of the orchard wall prior to the works.

Modern masonry practice encourages sometimes elaborate pointing styles and finishes. With rubble walls, historically, this was not the case; rubble work was quick and simple, and largely intended not to be seen. As such, the pointing finish on older walls was normally a 'flush point', filling the points between the stones to give a relatively smooth undulating surface. There was evidence for such an original finish at Kinneil, with a covering lime wash (Figure 10). The 2017 work sought to replicate this.

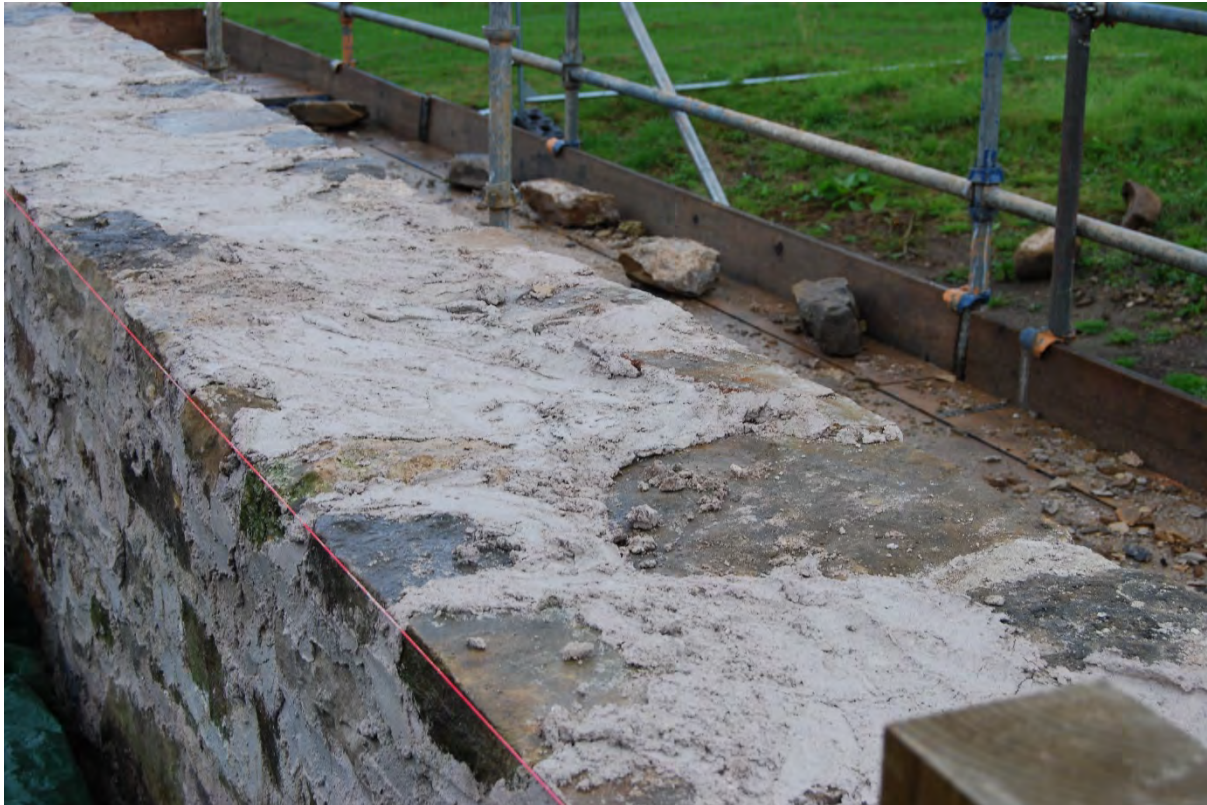
Figure 11. Detail of the completed wall awaiting the cope stones. The pointing on the left-hand side still needs to be scraped back.

In an additional contrast to modern practice, a single type of mortar was used, the bedding mortar extended through the joints, and was scraped off just proud of the masonry plane as the wall was built. This was not only quicker but technically better, there was no discontinuity in layers, and provided a continuation of the vapour and capillary route through the wall.

The work took place in the spring, with day temperatures in the 15 - 18 °C. As a result of this and the nature of the hot-mix, the mortar cured firm in a few days and was scraped back flush with the plane of the wall (Figure 11). The wall was taken up to the original height to provide a level base onto which the copes could be bedded. As is common in the procurement of dimension stone, there was a delay in its arrival on site, and this had implications in the finishing of the project and the curing of the mortar - there was no cope in place over the winter.

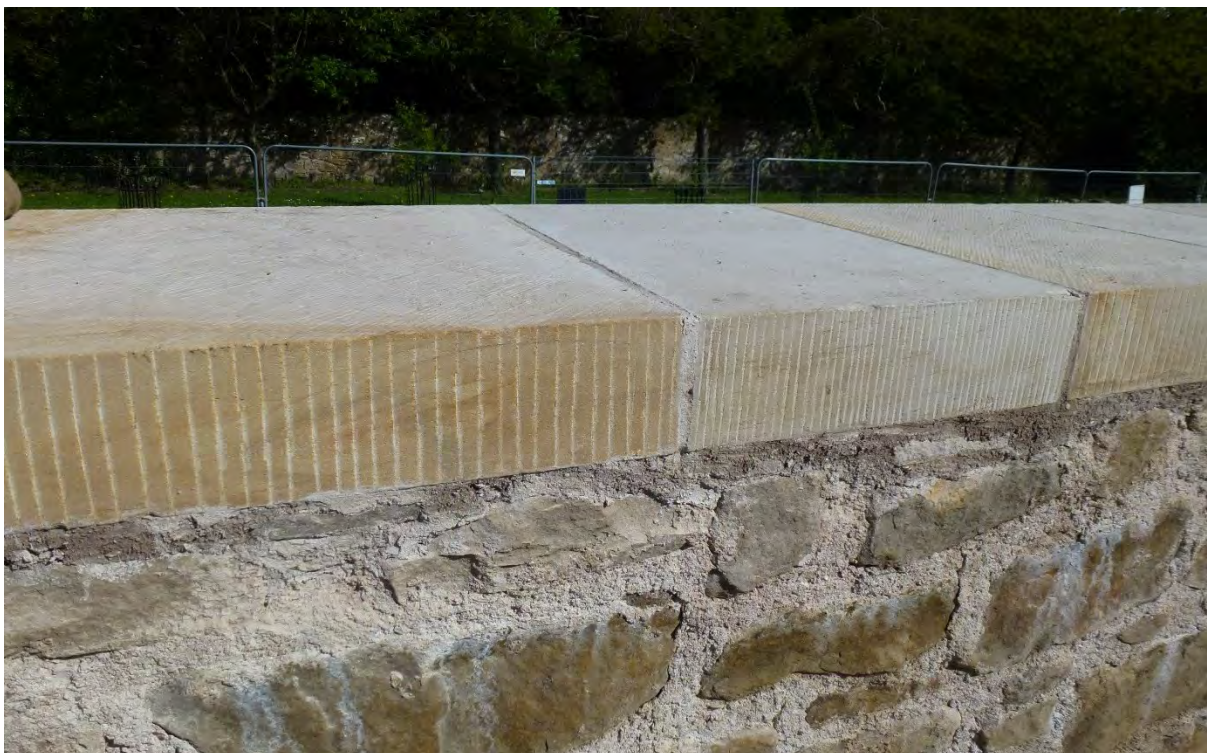
Figure 12. The new sandstone cope with frost damage on the mortar. Note the slight slope, or the 'wash' of the cope.

All masonry structures must shed water from the higher levels. Traditional boundary walls achieved this with a stone covering or 'cope'; the details of this varied but could be a flat slab (a flagstone) or a more crudely worked semicircle of flat stone. The Kinneil wall had a flat flagstone cope, however, many of the stones were missing and what remained had split or broken in many places. In addition, the long length of the wall (38m) meant that ad hoc collection of pieces from various sources was not going to be possible, even if such pieces could be found – they would differ in thickness, size and colour. Therefore, it was decided that a new batch of copes would be procured from the local quarry, ensuring consistency in texture and appearance. Due to issues with extraction of the stones from the quarry, the delivery of the copes was delayed, and they did not go onto the wall until Spring 2018. These were then bedded in the standard mortar mix and the joints between the stones were closed with an ashlar pointing mix. The stone coping was given a very shallow tilt back to the road side, to run the water back in one direction; this is sometimes called a 'wash' (Figure 12).

With the new cope in place the scaffold was taken down and the ground landscaped to its previous levels (Figure 13). The pointing damaged by the winter frost was brushed down, and the wall will be re-pointed as resources permit.

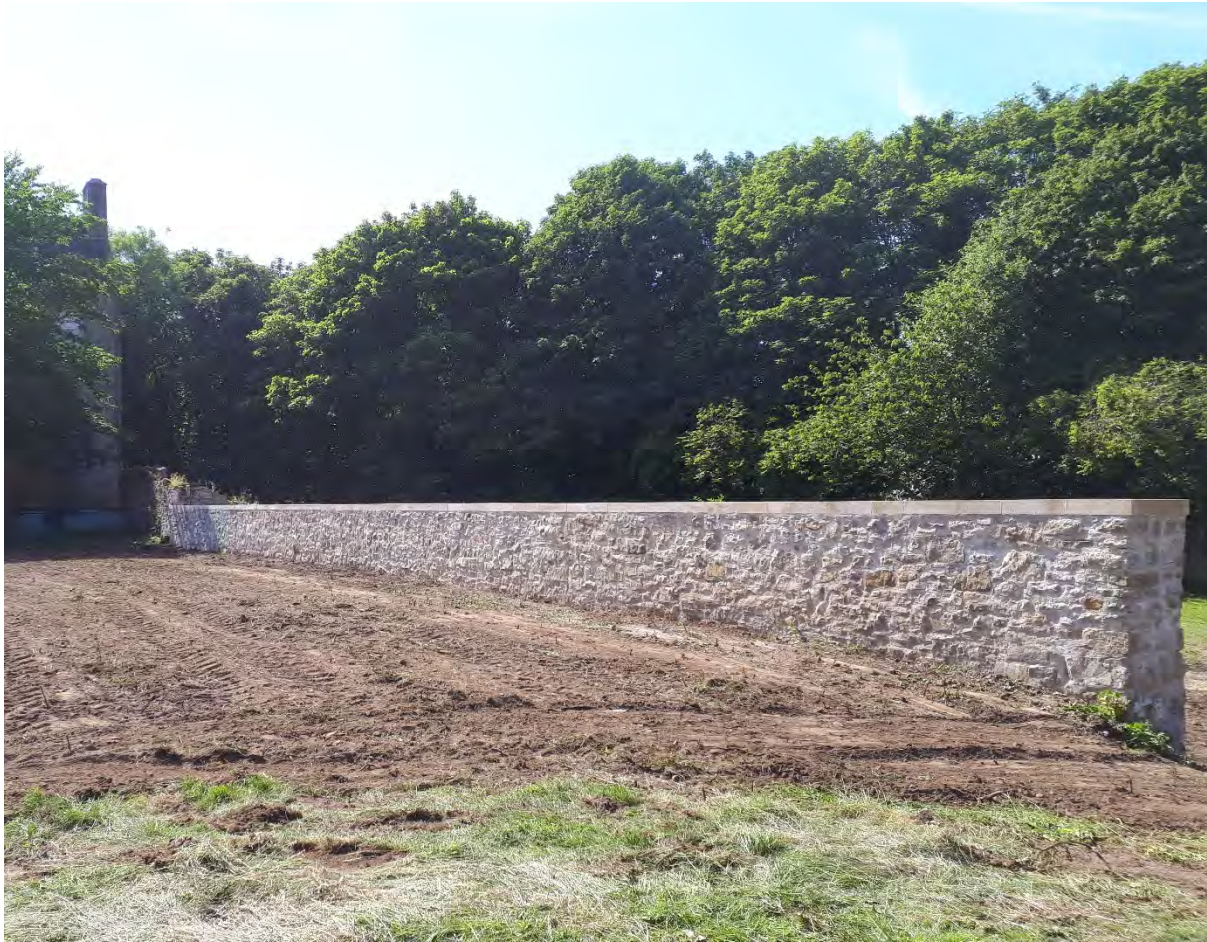
Figure 13. View of the completed wall, with the copes in place, summer 2018.
