HISTORIC  
ENVIRONMENT  
SCOTLAND

Property in Care (PIC) ID:	PIC282
Designations:	Scheduled Monument (SM90065)
Taken into State care:	1957 (Guardianship)
Last Reviewed:	2022

## STATEMENT OF SIGNIFICANCE

# CASTLE OF OLD WICK

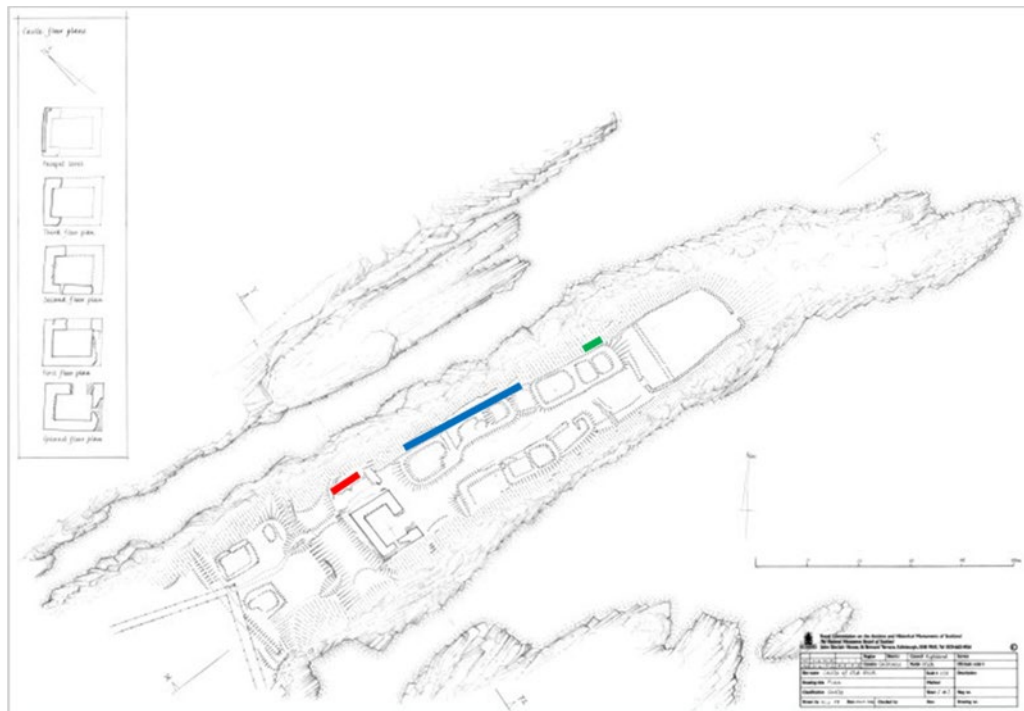
Figure B: Plan of Castle of Old Wick with approximate location and extent of masonry fragments on the north-west cliff face noted, identified in the 2009 survey. Red = masonry fragments 001, 002; blue = masonry fragment 003; green = masonry fragments 004, 005. © Historic Environment Scotland.

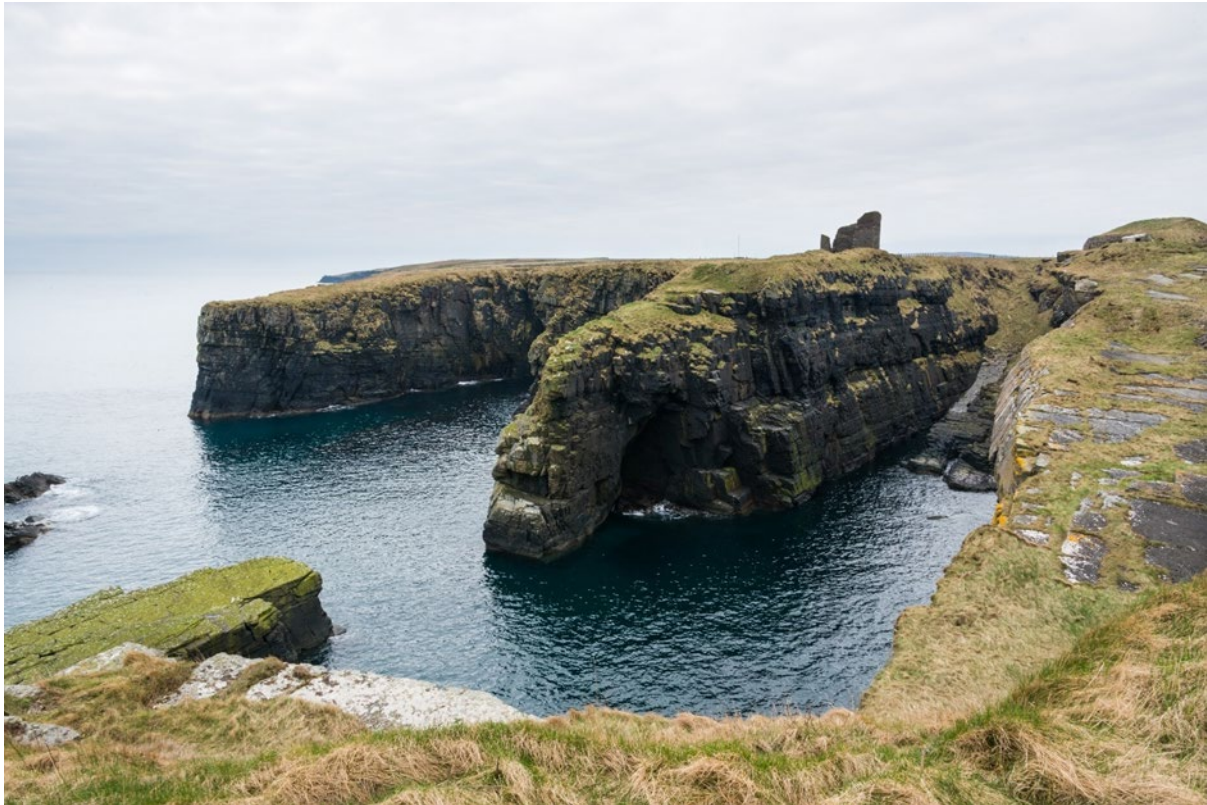
Figure D: The dramatic cliff-top setting of Castle of Old Wick offers an exhilarating visit, but the effects of its exposed location also present conservation challenges. © Historic Environment Scotland.

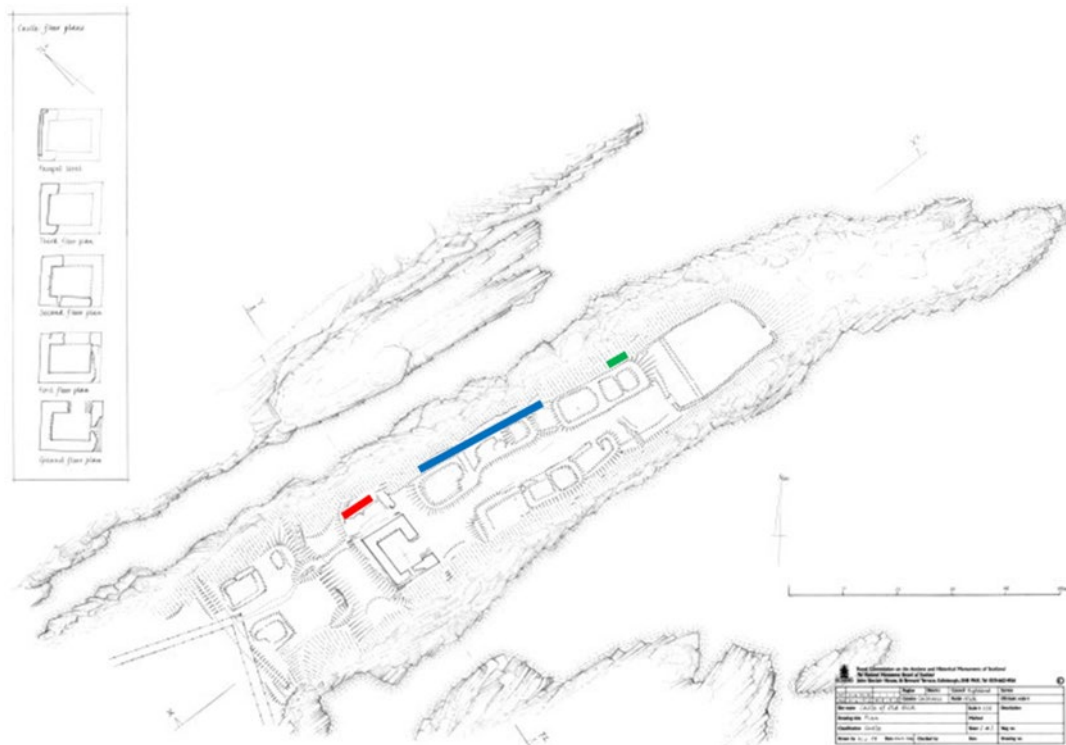
Figure 1: Annotated plan of Castle of Old Wick with approximate location and extent of masonry fragments on the north-west cliff face noted, identified in the 2009 survey. Red = masonry fragments 001, 002; blue = masonry fragment 003; green = masonry fragments 004, 005. © Historic Environment Scotland. [A duplication of Figure B in the main body of the text]

In the same Phase 1, masonry fragment 001 is built upon bedrock (see [Figure 1](#)). It is composed of large flagstones, and it was interpreted in the 2009 survey as revetment for the feature above it; masonry fragment 002, which is composed of smaller flags.<sup>33</sup> Upon closer examination, 001 presented no evidence of bonding agent, whereas 002 featured ‘a very loose, pale yellow sandy mortar rich in shell fragments’.<sup>34</sup> The character of 002 was deemed very different from 001, perhaps representing the remains of a north-west wall of a narrow building on the promontory surface adjacent to the masonry tower.<sup>35</sup> A description of the features on the promontory itself is given in [Appendix 2 \(Section iii\)](#), after a discussion of the masonry tower itself ([Section i](#)).

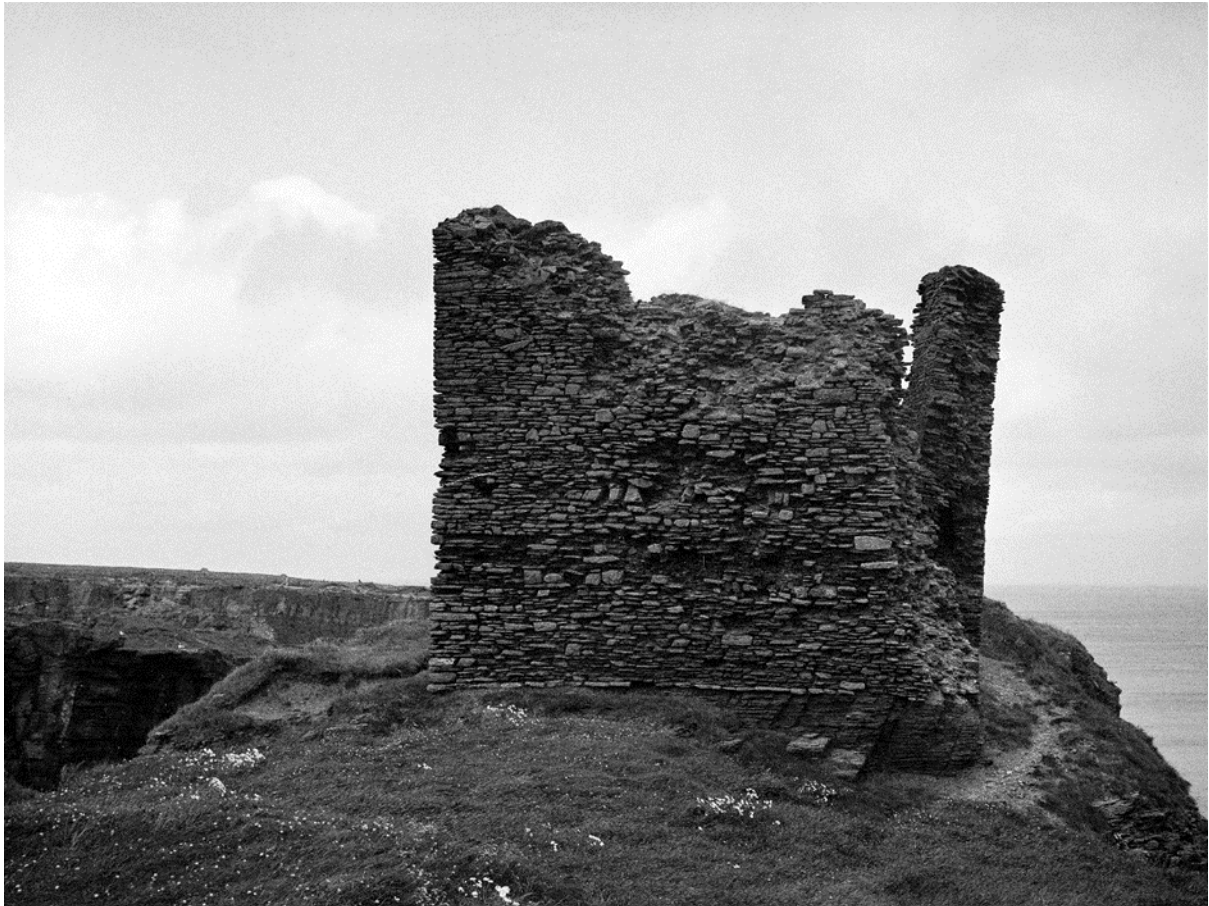
*Figure 2: Photograph of masonry tower, 1952. Note the general decay of the tower's masonry (here the south-west external face), much consolidated since. The lower course, southern end of the tower reveals that it is constructed upon bedrock. Plainly the fronting ditch has also since been cleared. © Crown Copyright.*

Joist holes in the north-west end indicate that the first floor was supported by timber, but these have been lost in remedial work on the south-east. A fragment of timber, since removed for analysis and conservation, was noted to survive in-situ in a joist hole in the north interior wall. The first floor is featureless apart from traces of a small mural passage for a garderobe in the south-east wall. Millar's plan of the tower records the presence of a further slit window along this wall, since lost (see [Figure 5](#)). It also shows the presence of a deep draw-bar hole in the south-east jamb of the first-floor entry. The second floor is supported by a scarcement and there is a small slit window on the south-west overlooking the ditch and slightly offset from the middle of the wall to the north-west. A further small window, now lost, featured on the south-east wall. In the north-west wall there is a pair of joist holes for a chimney hood above a shallow recess for the back of a fireplace.

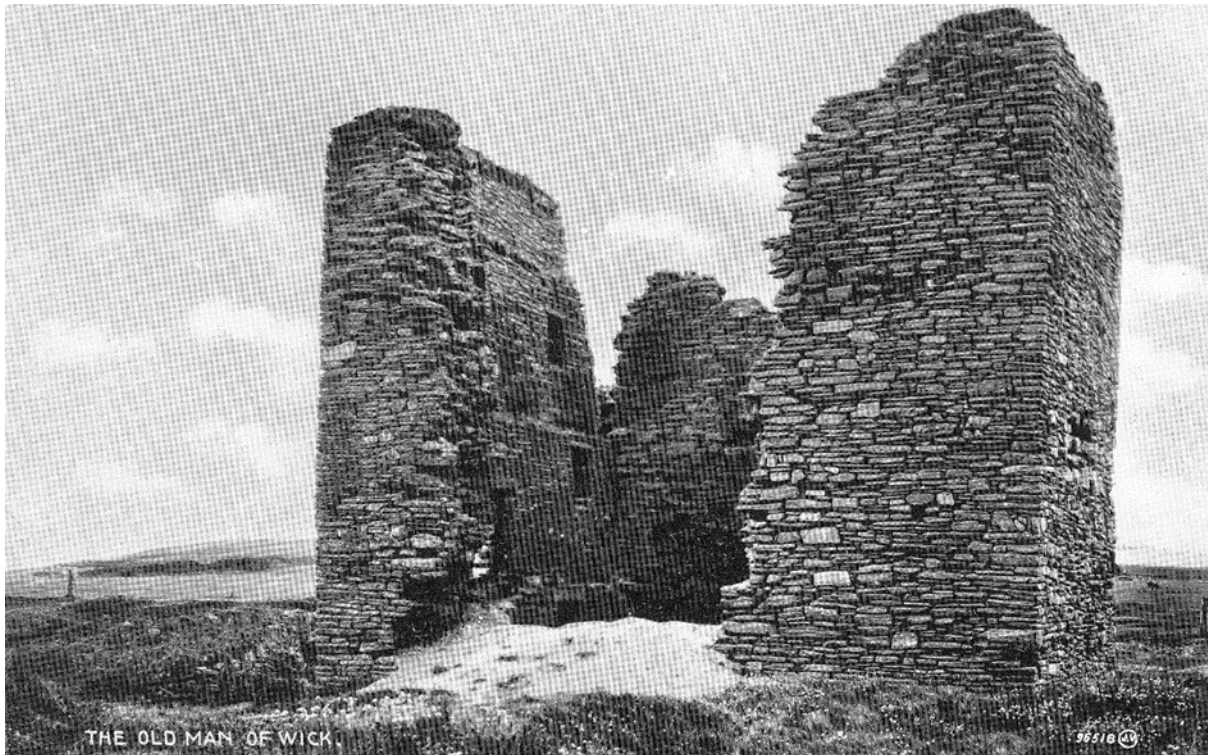
Figure 4: Postcard of Castle of Old Wick (c.1925), looking south-west towards the interior of the masonry tower, from the north-east. Note the presence of two small joist holes on the exterior face of the nearest wall (c.1/3 of the way up the wall), which do not all survive today. The degree of scarring on the tower's north-west face (on the far right here) is also more apparent than is evident today. © Courtesy of HES.

The postcard also reveals the presence of apertures in the tower's first and second floors which have now disappeared owing to significant structural collapse at some point between c.1925 and 1952. According to the 1890 plan of the castle, these are slit windows (see [Figure 5](#)), loosely of the same character as the surviving slit window at second floor on the tower's south-west face.

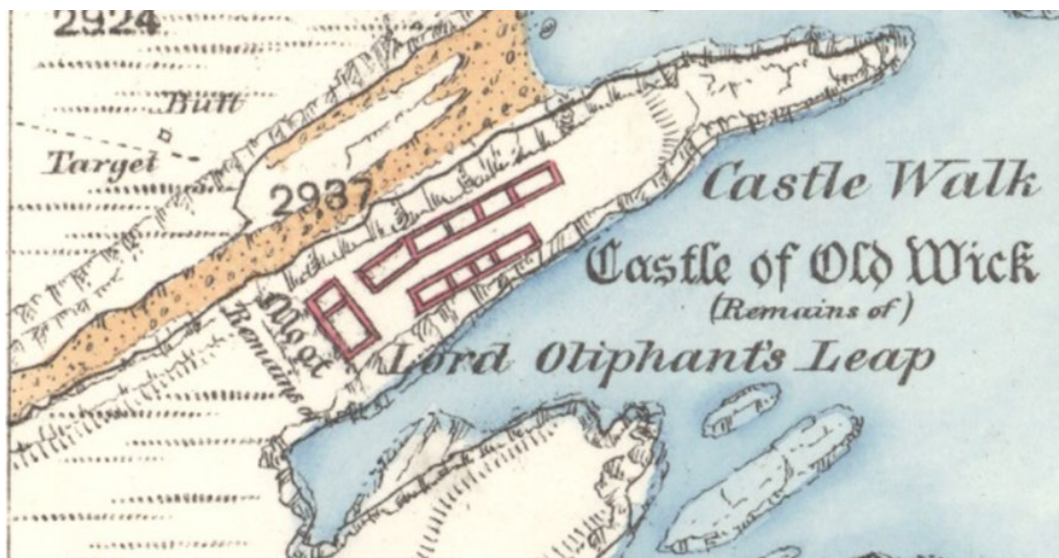
Figure 7: Extract of 1st edition OS map (25-inch), which is of sufficient resolution to suggest a chamber or building NW of the masonry tower. Caithness XXV.10 (Wick), 1872. Reproduced under a Creative Commons Attribution 4.0 International (CC-BY) licence with the permission of the National Library of Scotland.

At several points in the discussion of the fabric at the site it has been suggested that there may be a structure north-west of the masonry tower remains at the landward side of the promontory. It is apparent from early cartographic and illustration sources that there was an adjacent building or chamber in this space until the end of the 19th century (see [Figure 7](#)).

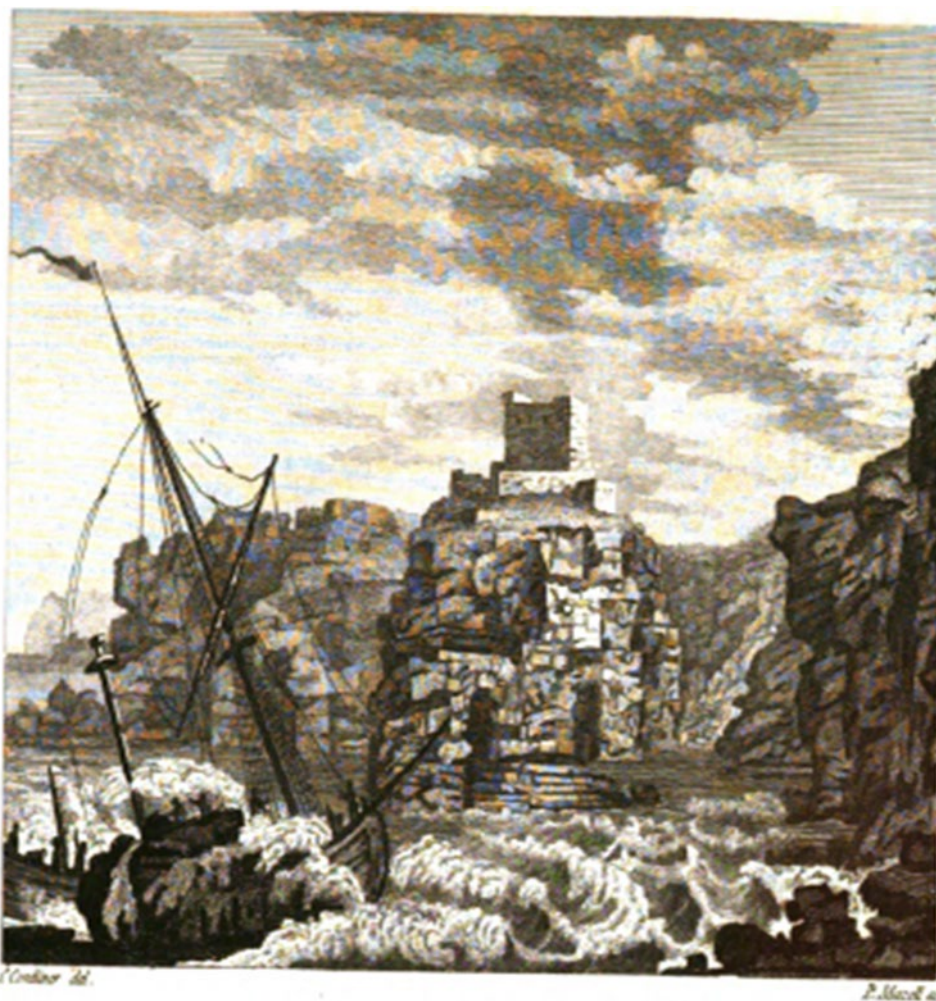
Figure 8: C. Cordiner, *Antiquities & Scenery of the North of Scotland, in a Series of Letters to Thomas Pennant* (London, 1780), opposite p.80.

The evidence for this is not straightforward, however. Charles Cordiner's c.1776 sketch of the castle, by far the earliest detailed depiction of Castle of Old Wick, appears to show a solitary masonry tower bereft of north-west chamber or adjacent building ([Figure 8](#)). The tone of Cordiner's image is one of romantic turbulence, emphasizing the dramatic setting of the castle, with a floundering masted ship in the foreground surrounded by tumultuous foamy waves. A small chamber is depicted projecting north-east of the lowermost portion of masonry on the sketch, but how (or if) this relates to historic material or the evidence discussed from the present site, is not clear. Considered from an alternative perspective, it is, however, possible that Cordiner's sketch depicts both the masonry tower and the adjacent north-west structure before the latter collapsed or was robbed out; from the evidence of Castle of Old Wick today the structures appear to be on the same alignment, so could feasibly appear as a single structure from afar. Again, it is not possible to verify this theory.

In the brief discussion complementing the sketch of [Figure 8](#) is a description of the remains of the tower, which records 'narrow stairs of communication between the upper and lower
